Clyne Valley Shaft Mounds SAMGm455, Swansea

Archaeological Landscape Monument Survey

City & County of Swansea

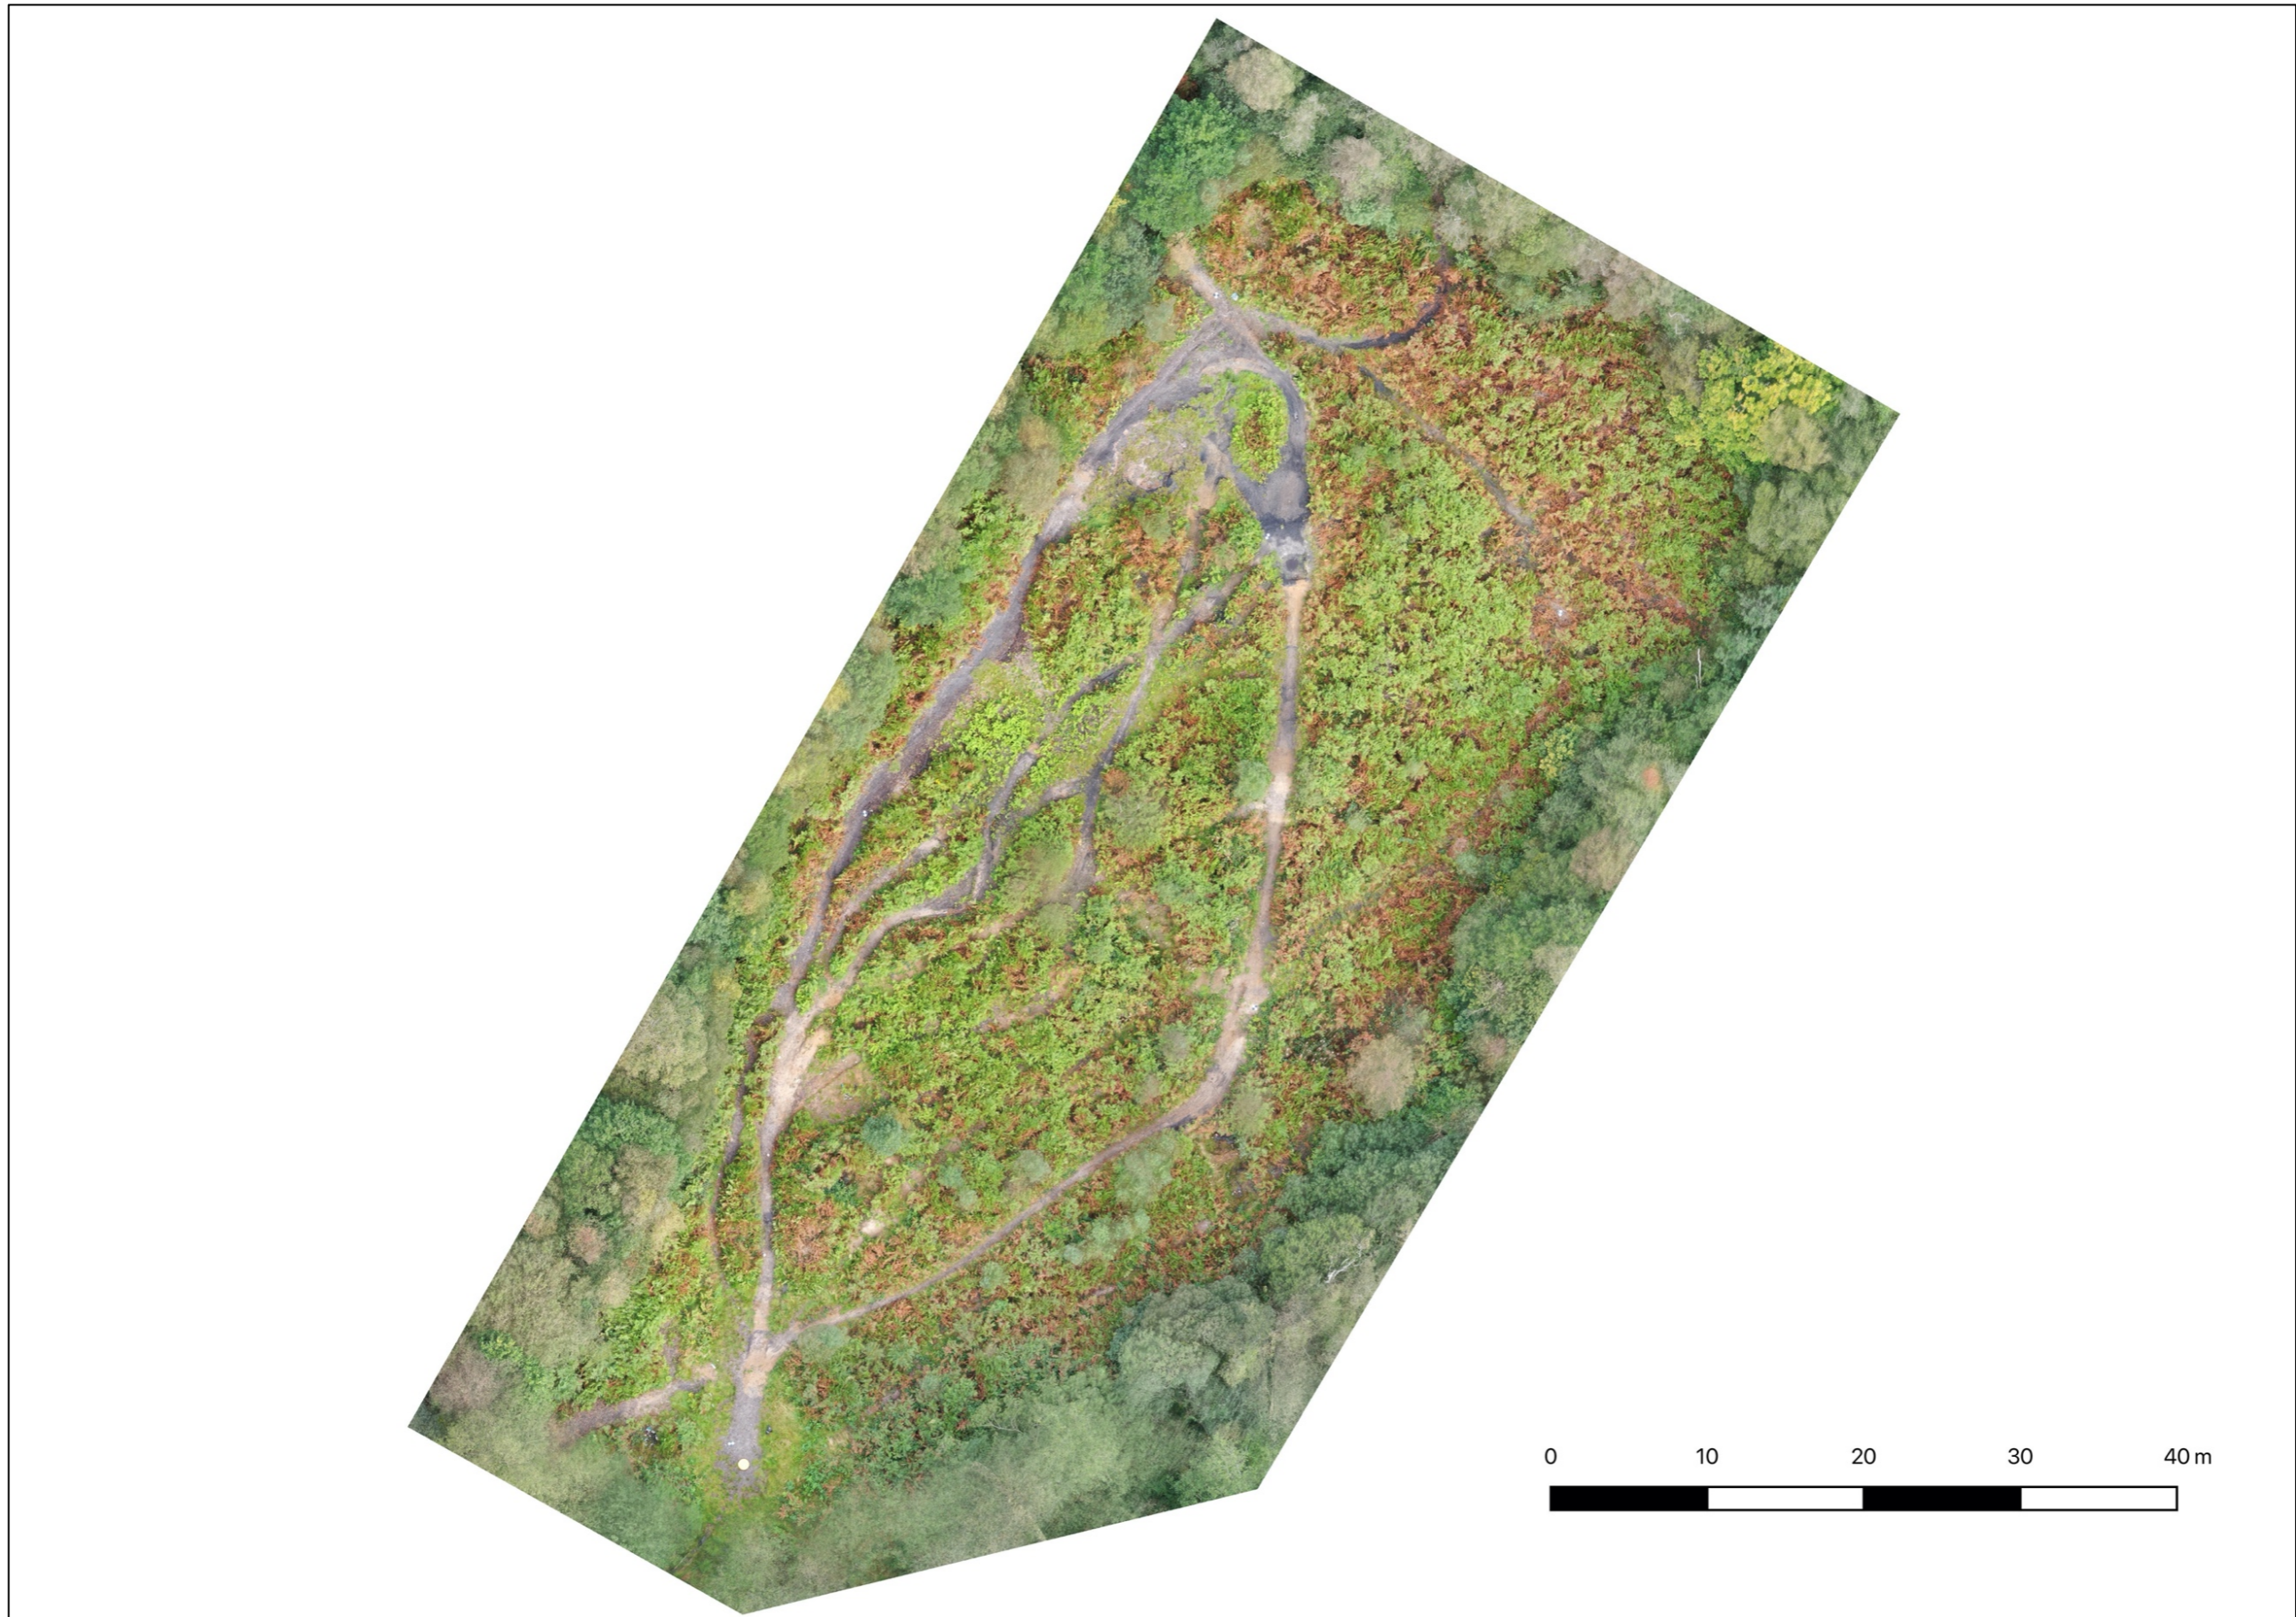
Figure 2. Photogrammetric orthomosaic of survey area showing MTB tracks. Nadir view.

- 7.1.2 The survey area (Figures 1 and 2; Plate 1) is an open area of scrub covered largely by bracken fern. The former LNWR, now National Cycle Network Route 4, runs along the NE boundary. To the SE is established deciduous woodland, to the NW recovering deciduous woodland and scrub. To the SW is more established woodland rising to 120mOD towards Clyne Farm. At least three clearly visible MTB tracks were observed aligned NE/SW through the bracken. The latter obscuring several more. It was assumed at the commencement of the survey that this area of the scheduled ancient monument had been extensively excavated by MTB enthusiasts to create the sweeping tracks, ramps and jumps visible in the bracken. Some excavation was noted exposed along the sides of the MTB tracks and discrete areas used to quarry clay for the ramps and corner bunds (Plate 4). A large hole had been excavated part way down the far eastern MTB track to create a bund for an adjoining corner. Ironically, a broken bicycle had been dumped into the quarried area (Plate 5).

- 7.1.4 The UAV RGB camera was used to produce a measured and highly detailed 3D model (<https://p3d.in/Hs34M>) of the survey area, including a digital surface model (DSM), topographical contour plan at 10cm intervals and orthomosaic (Figures 2-5). The high

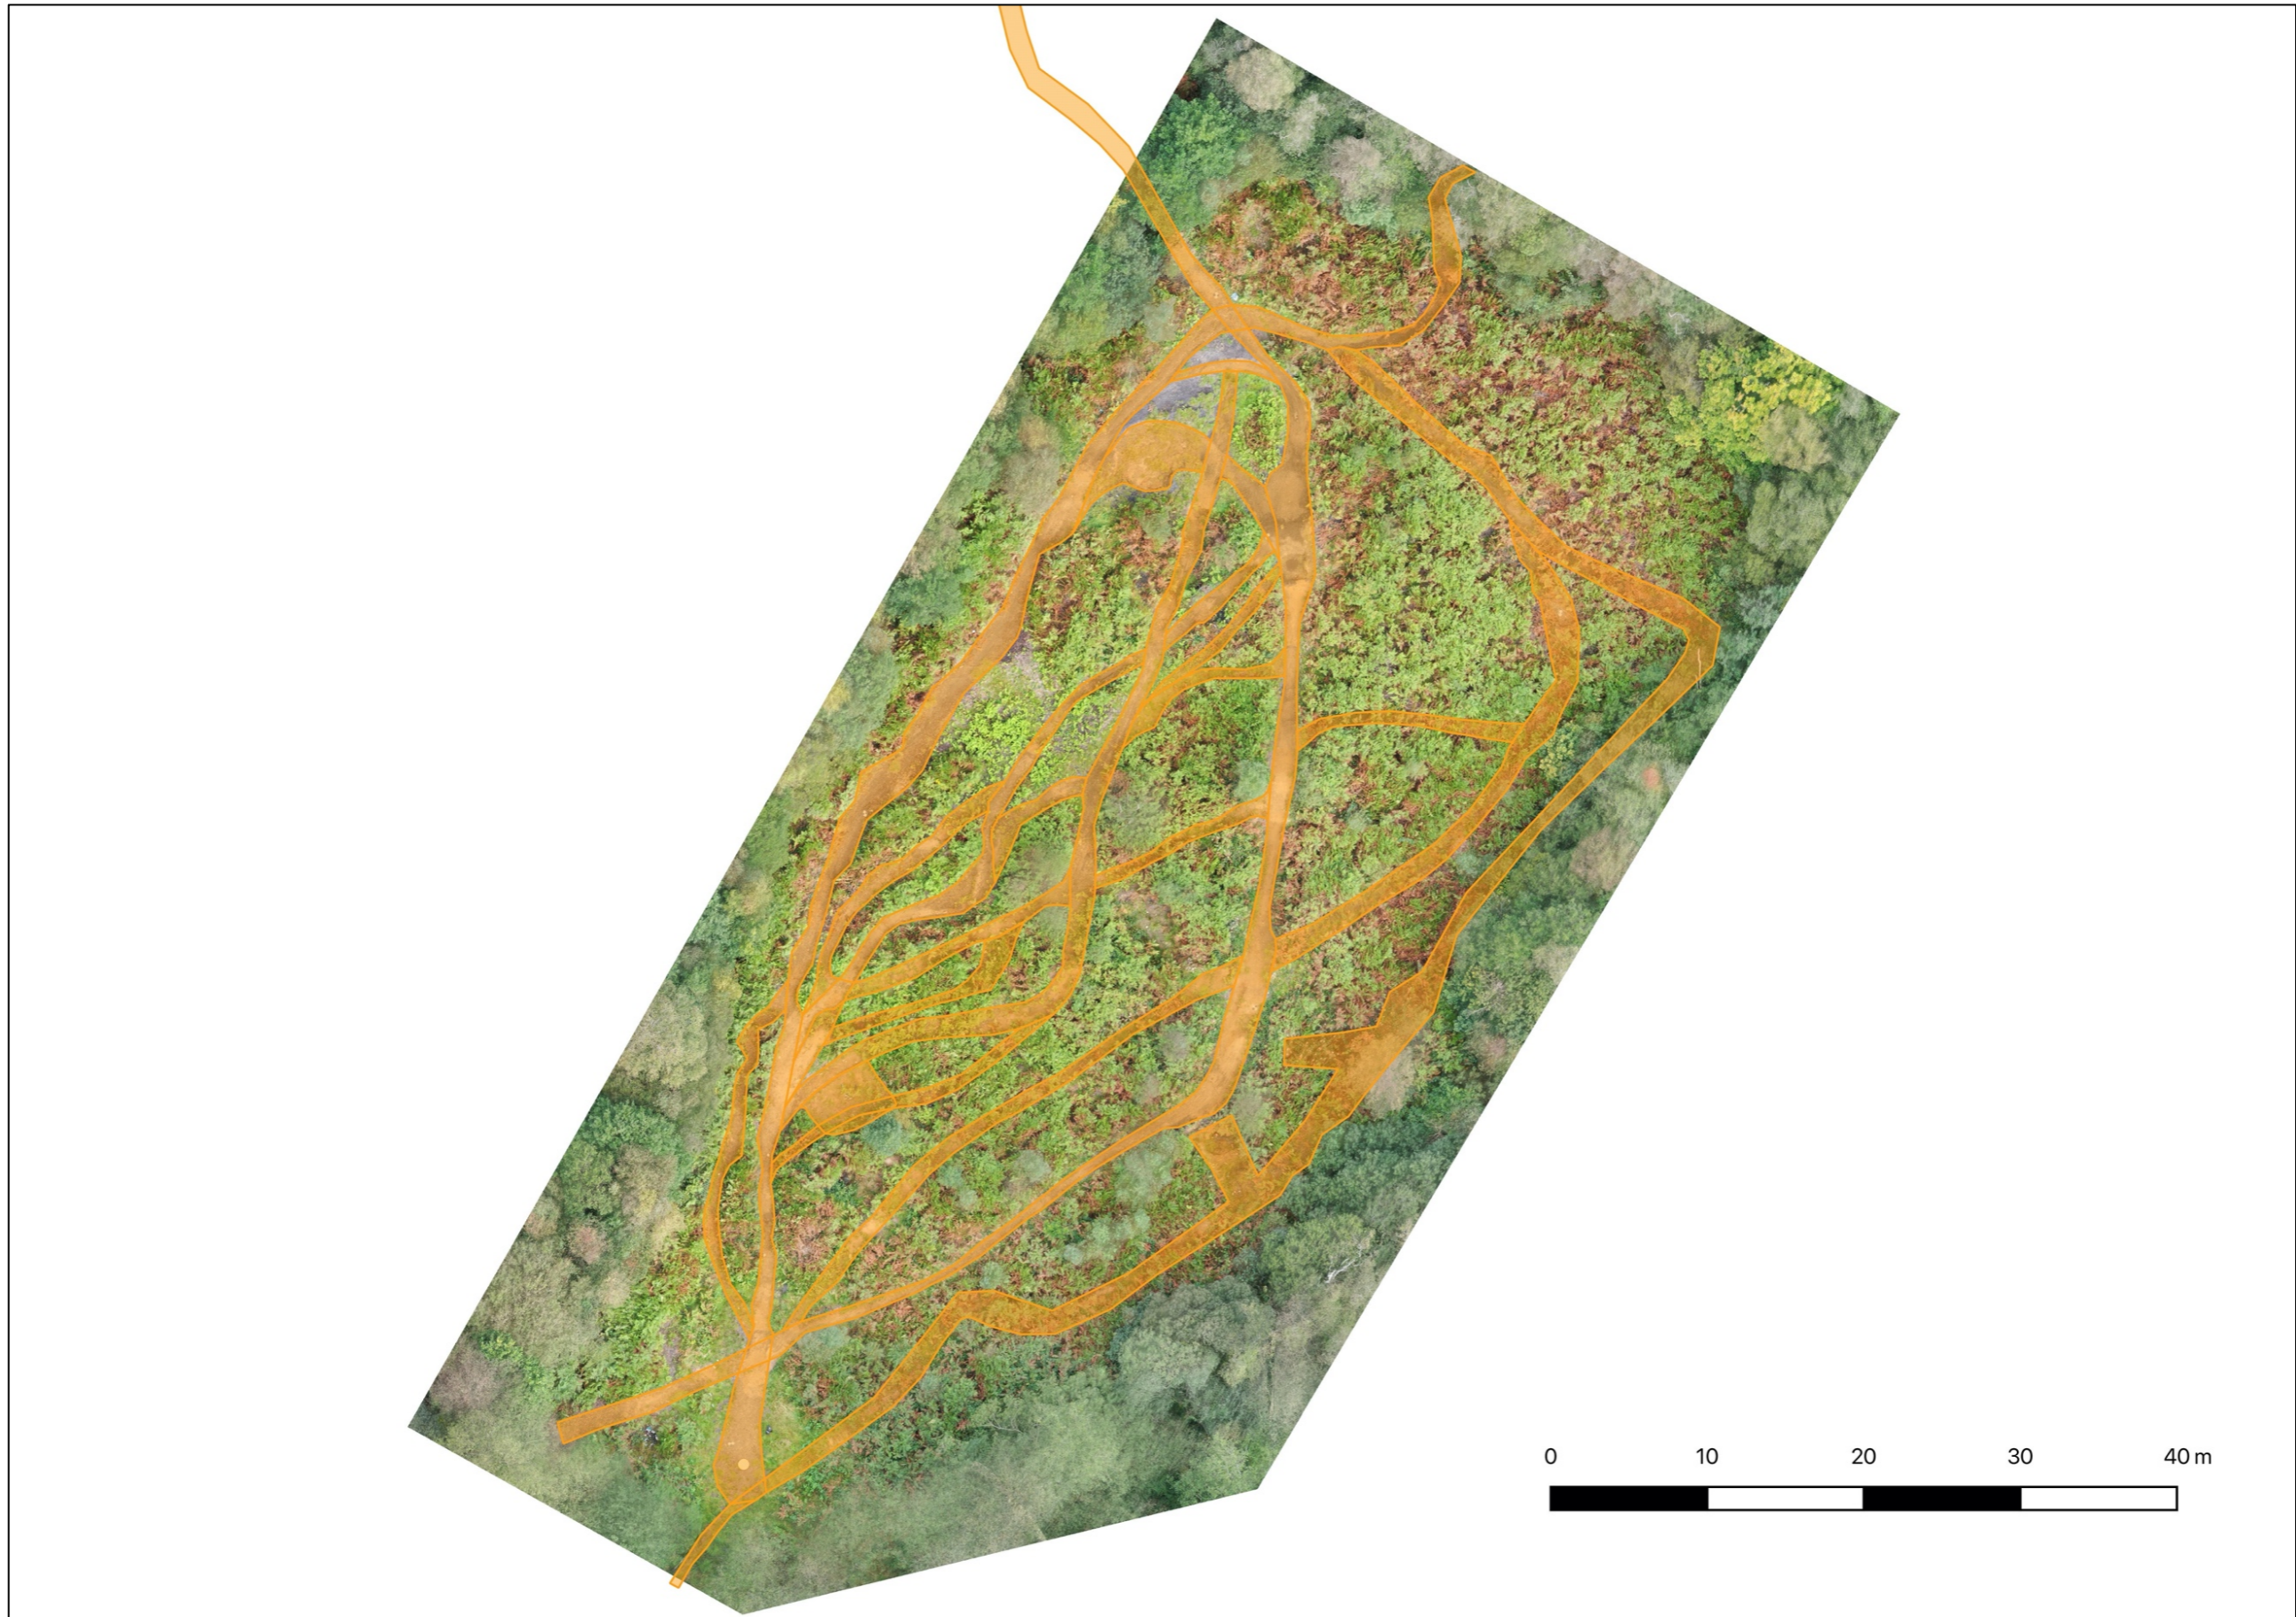
Figure 3. Photogrammetric orthomosaic of survey area showing mapped MTB tracks. Nadir view.

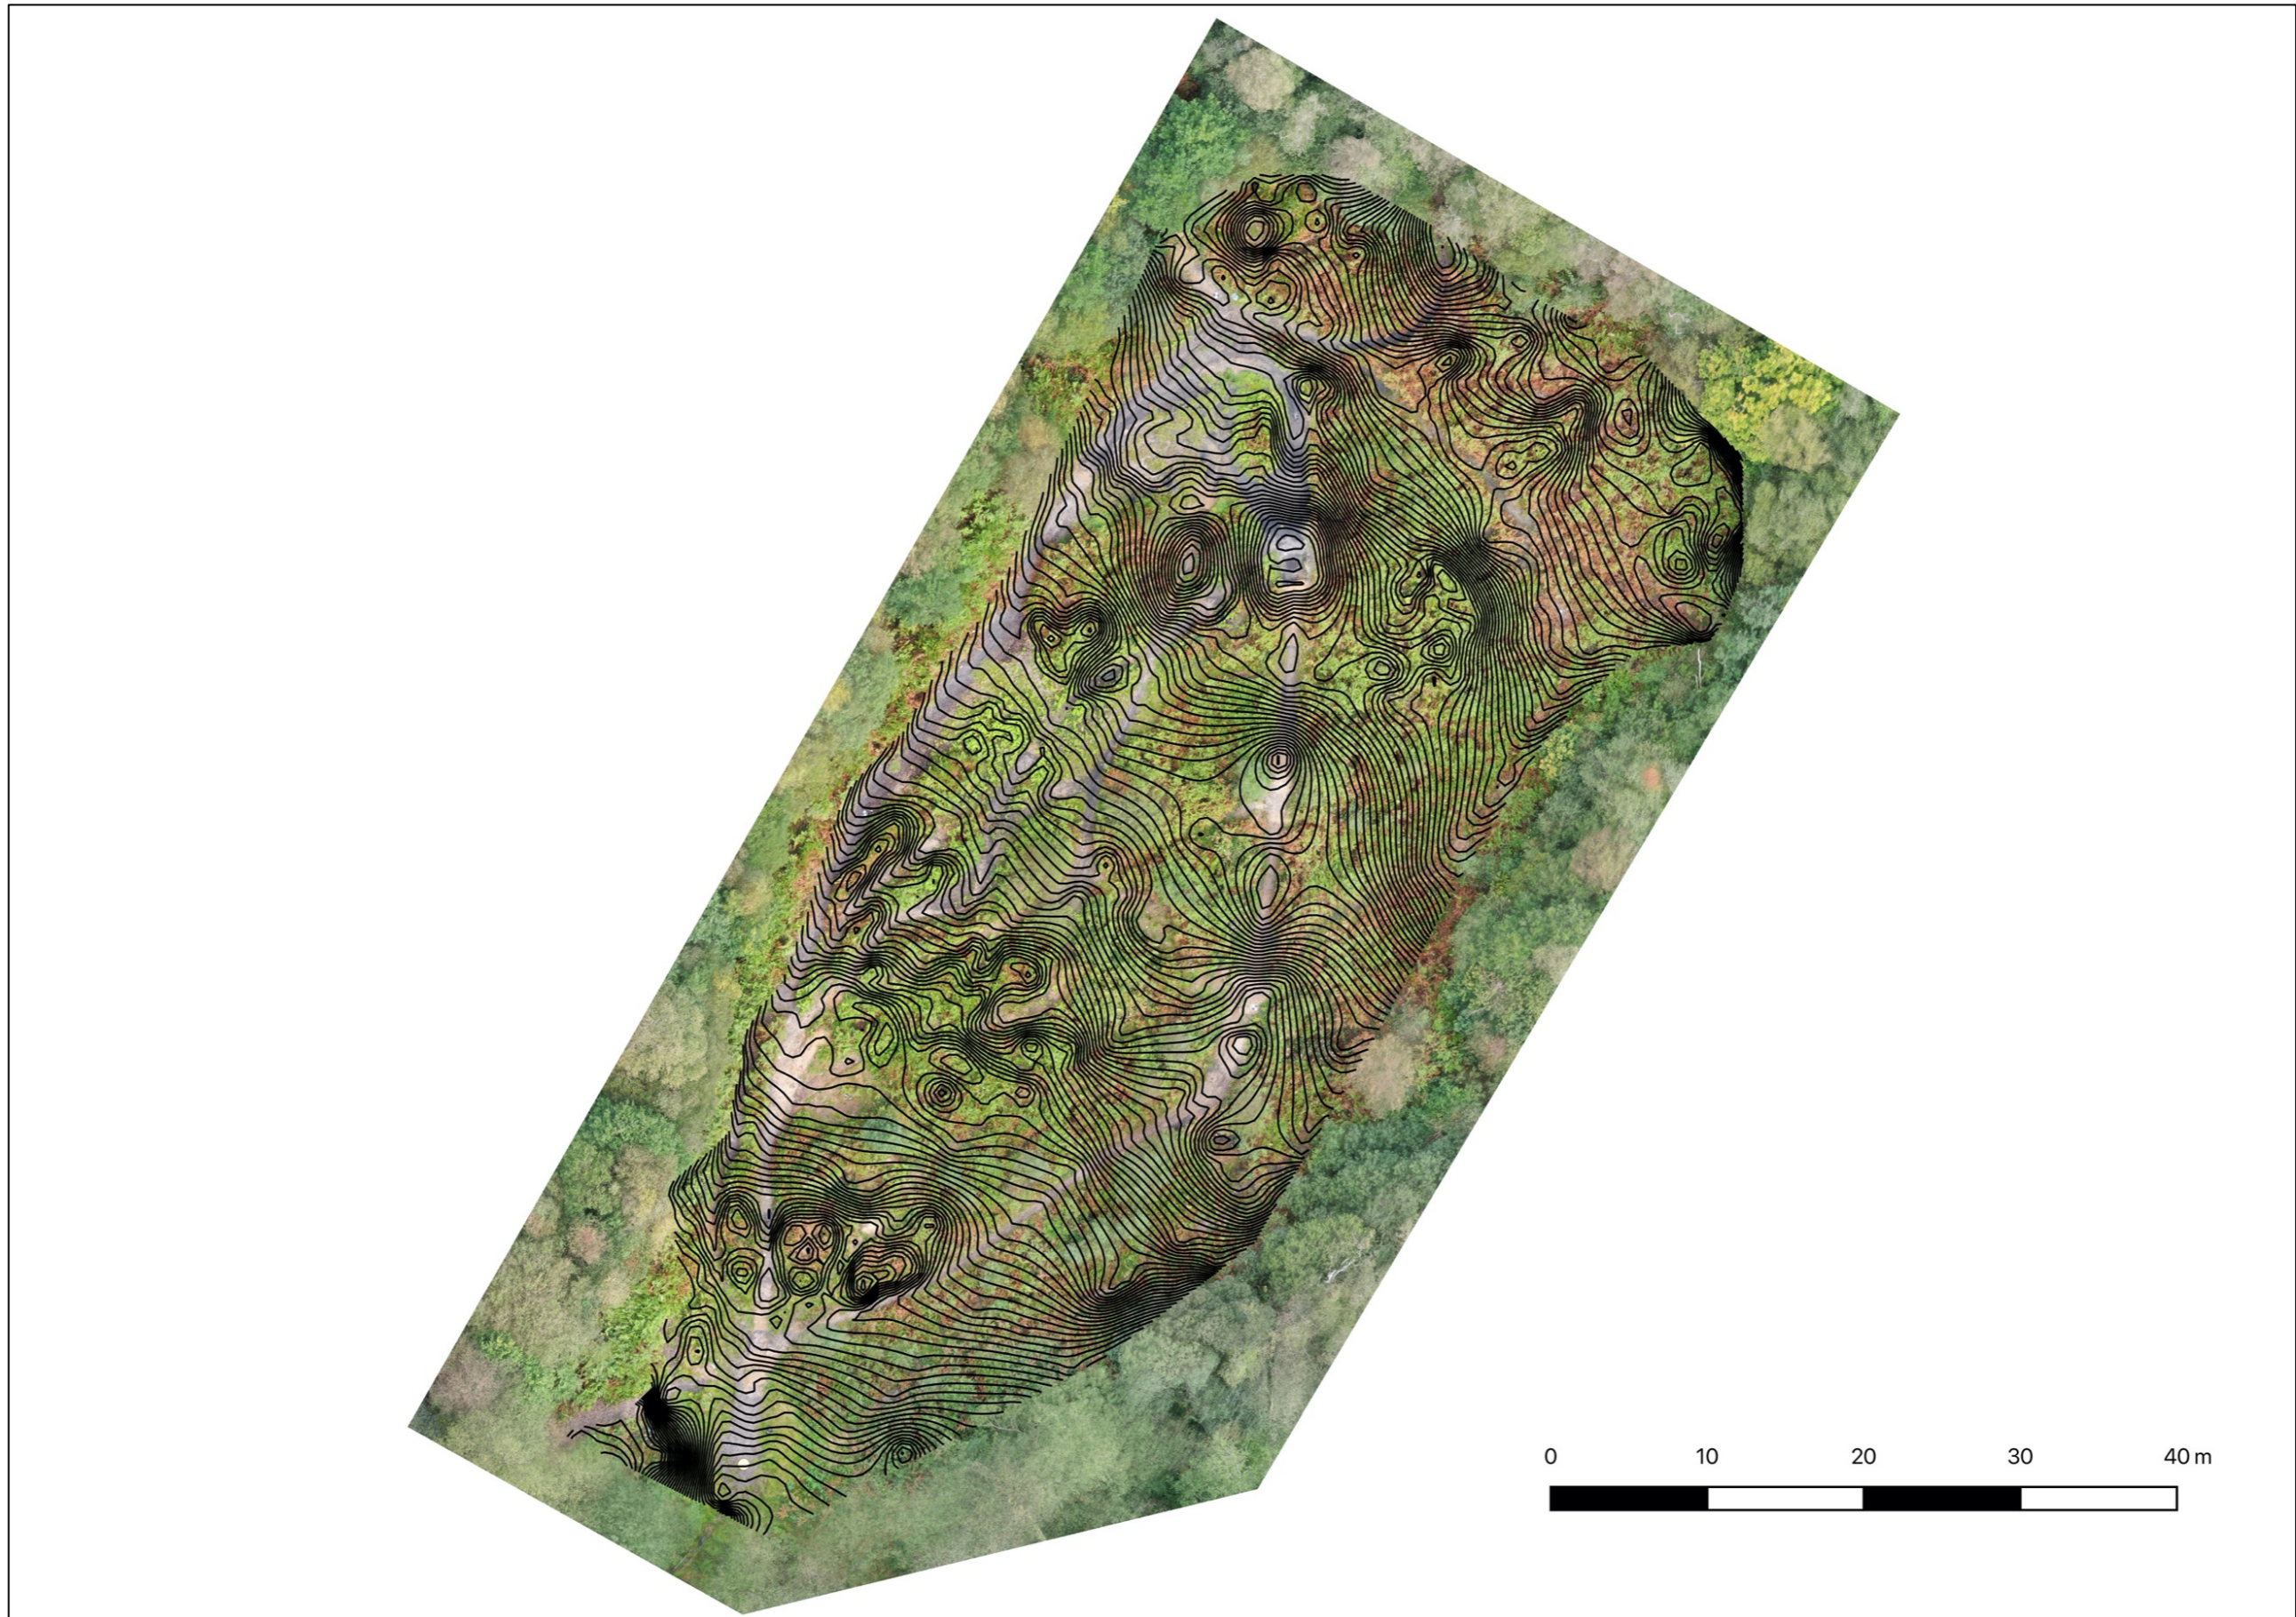
Figure 4. Photogrammetric orthomosaic of survey area with topographic contour survey overlay generated from digital surface model (DSM). Nadir view.

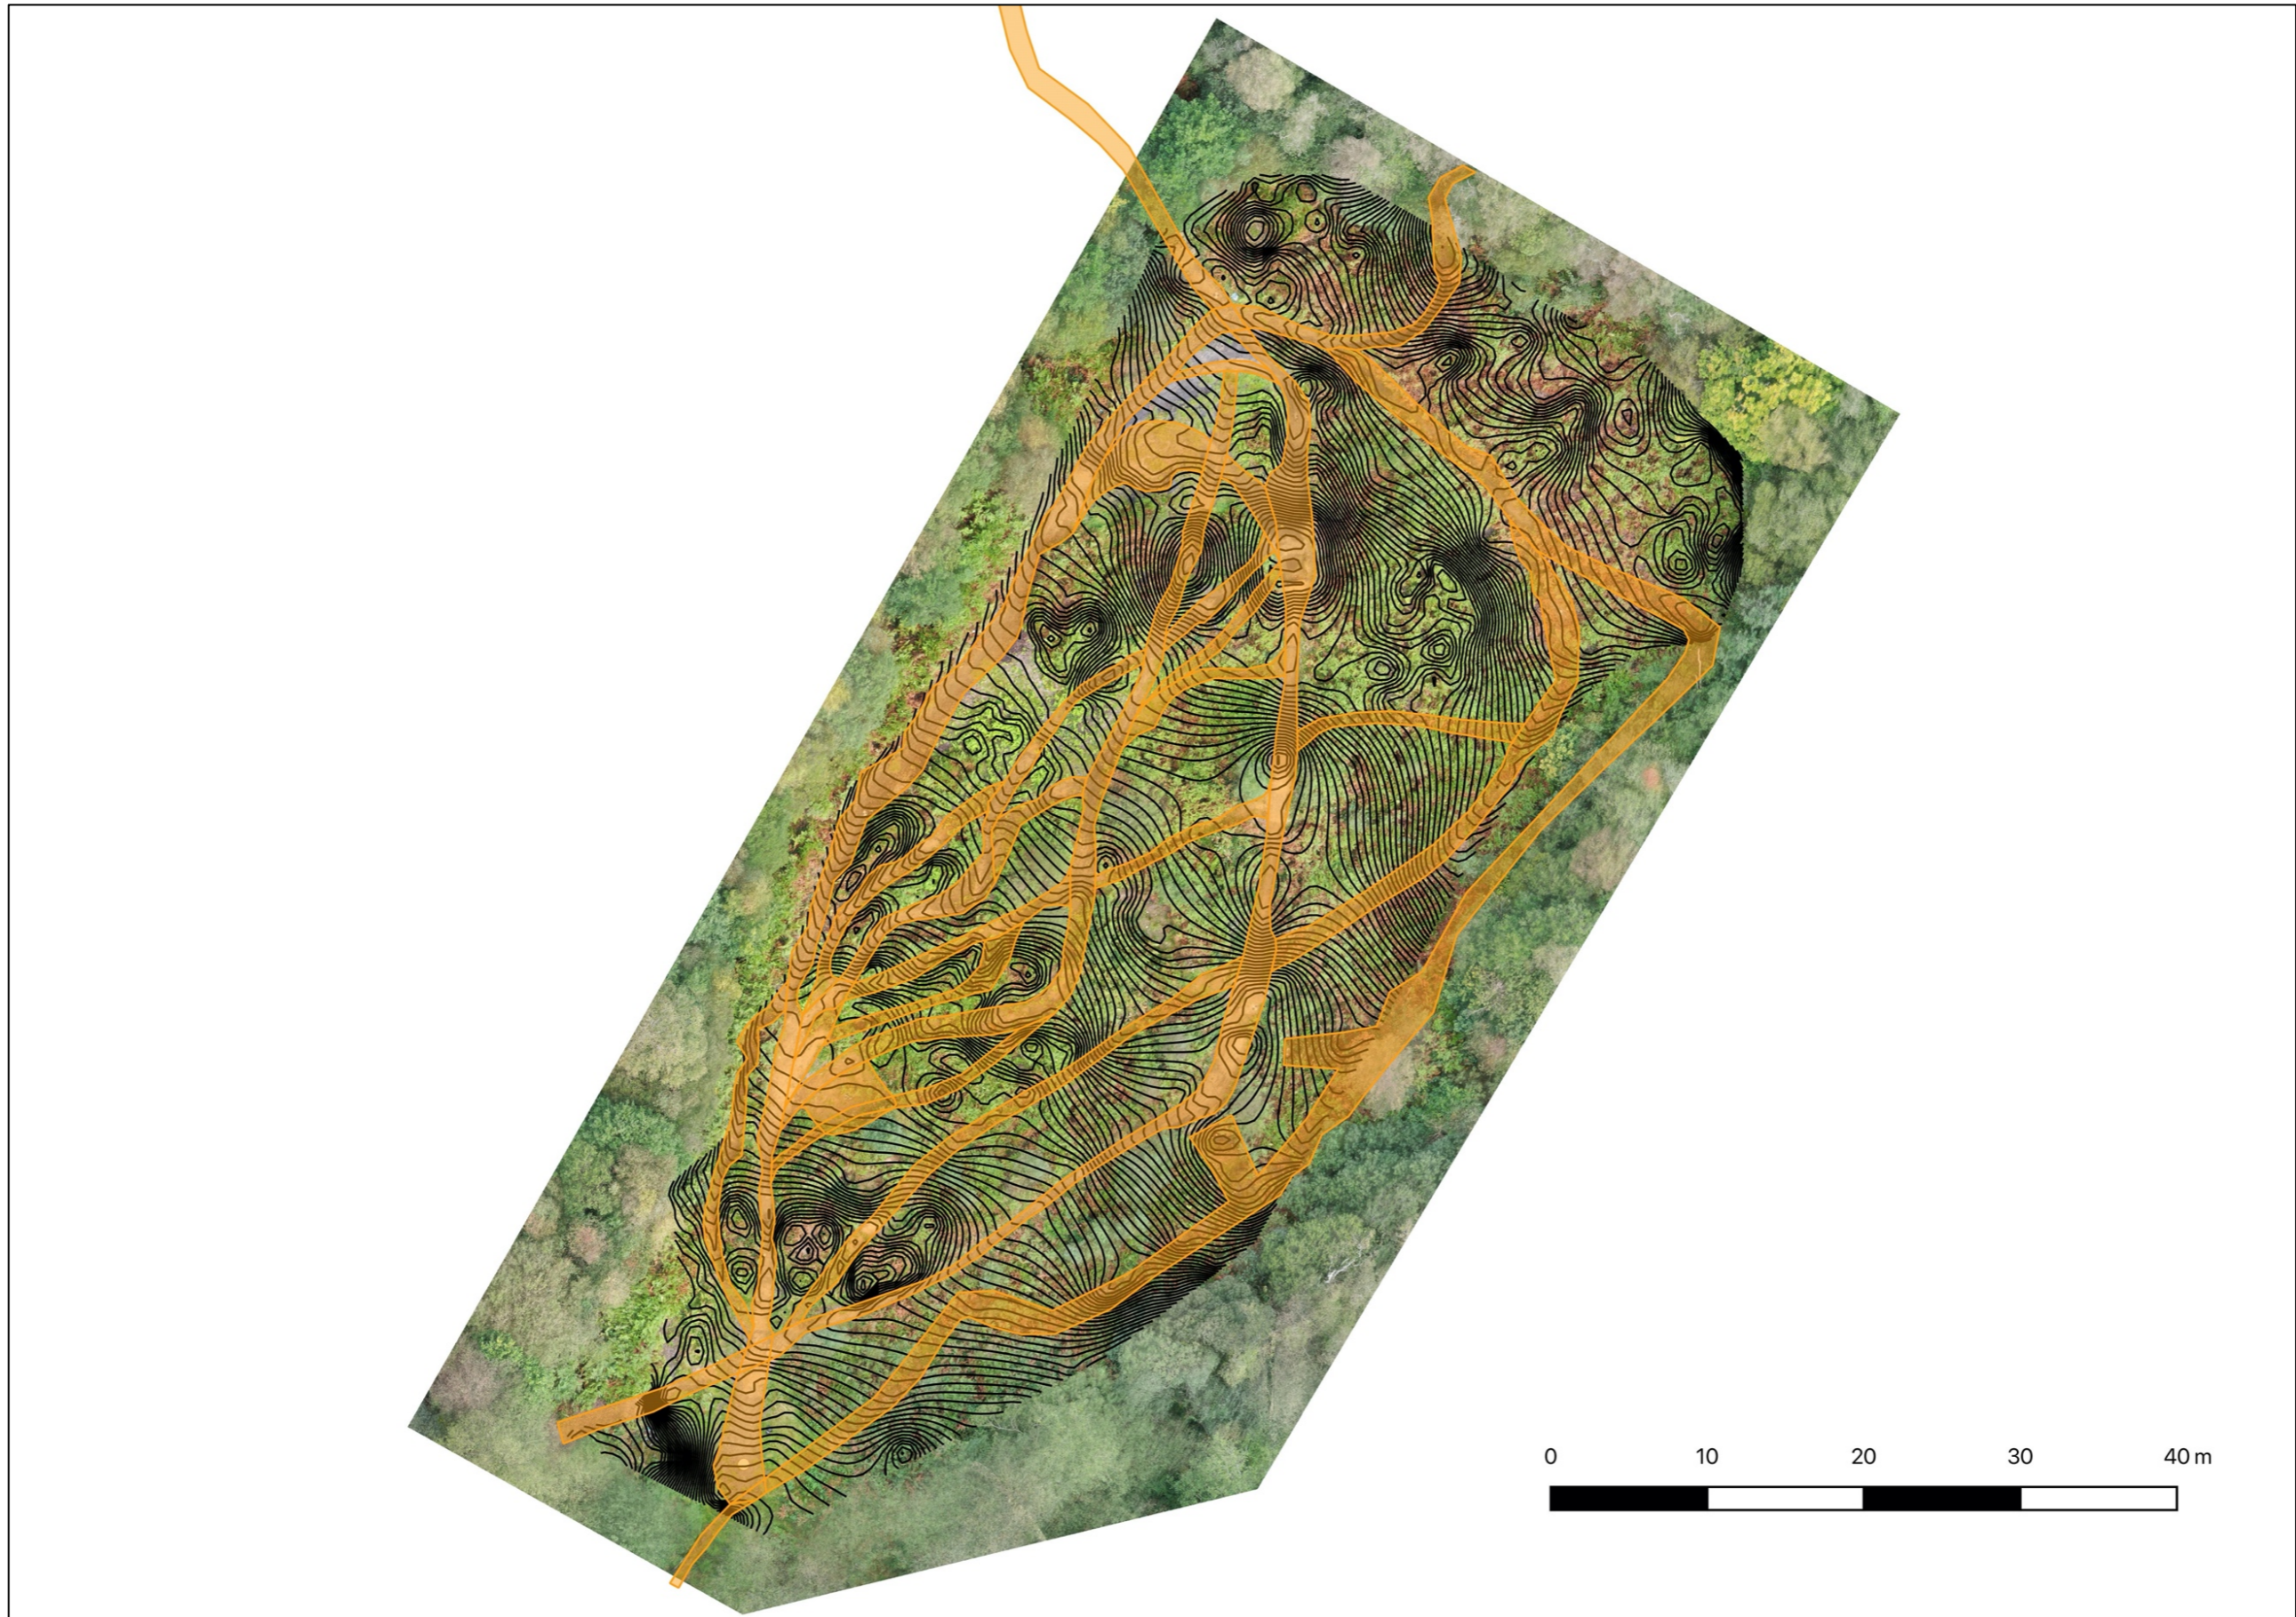
Figure 5. Photogrammetric orthomosaic of survey area with topographic contour survey (DSM) overlay and mapped MTB tracks. Nadir view.

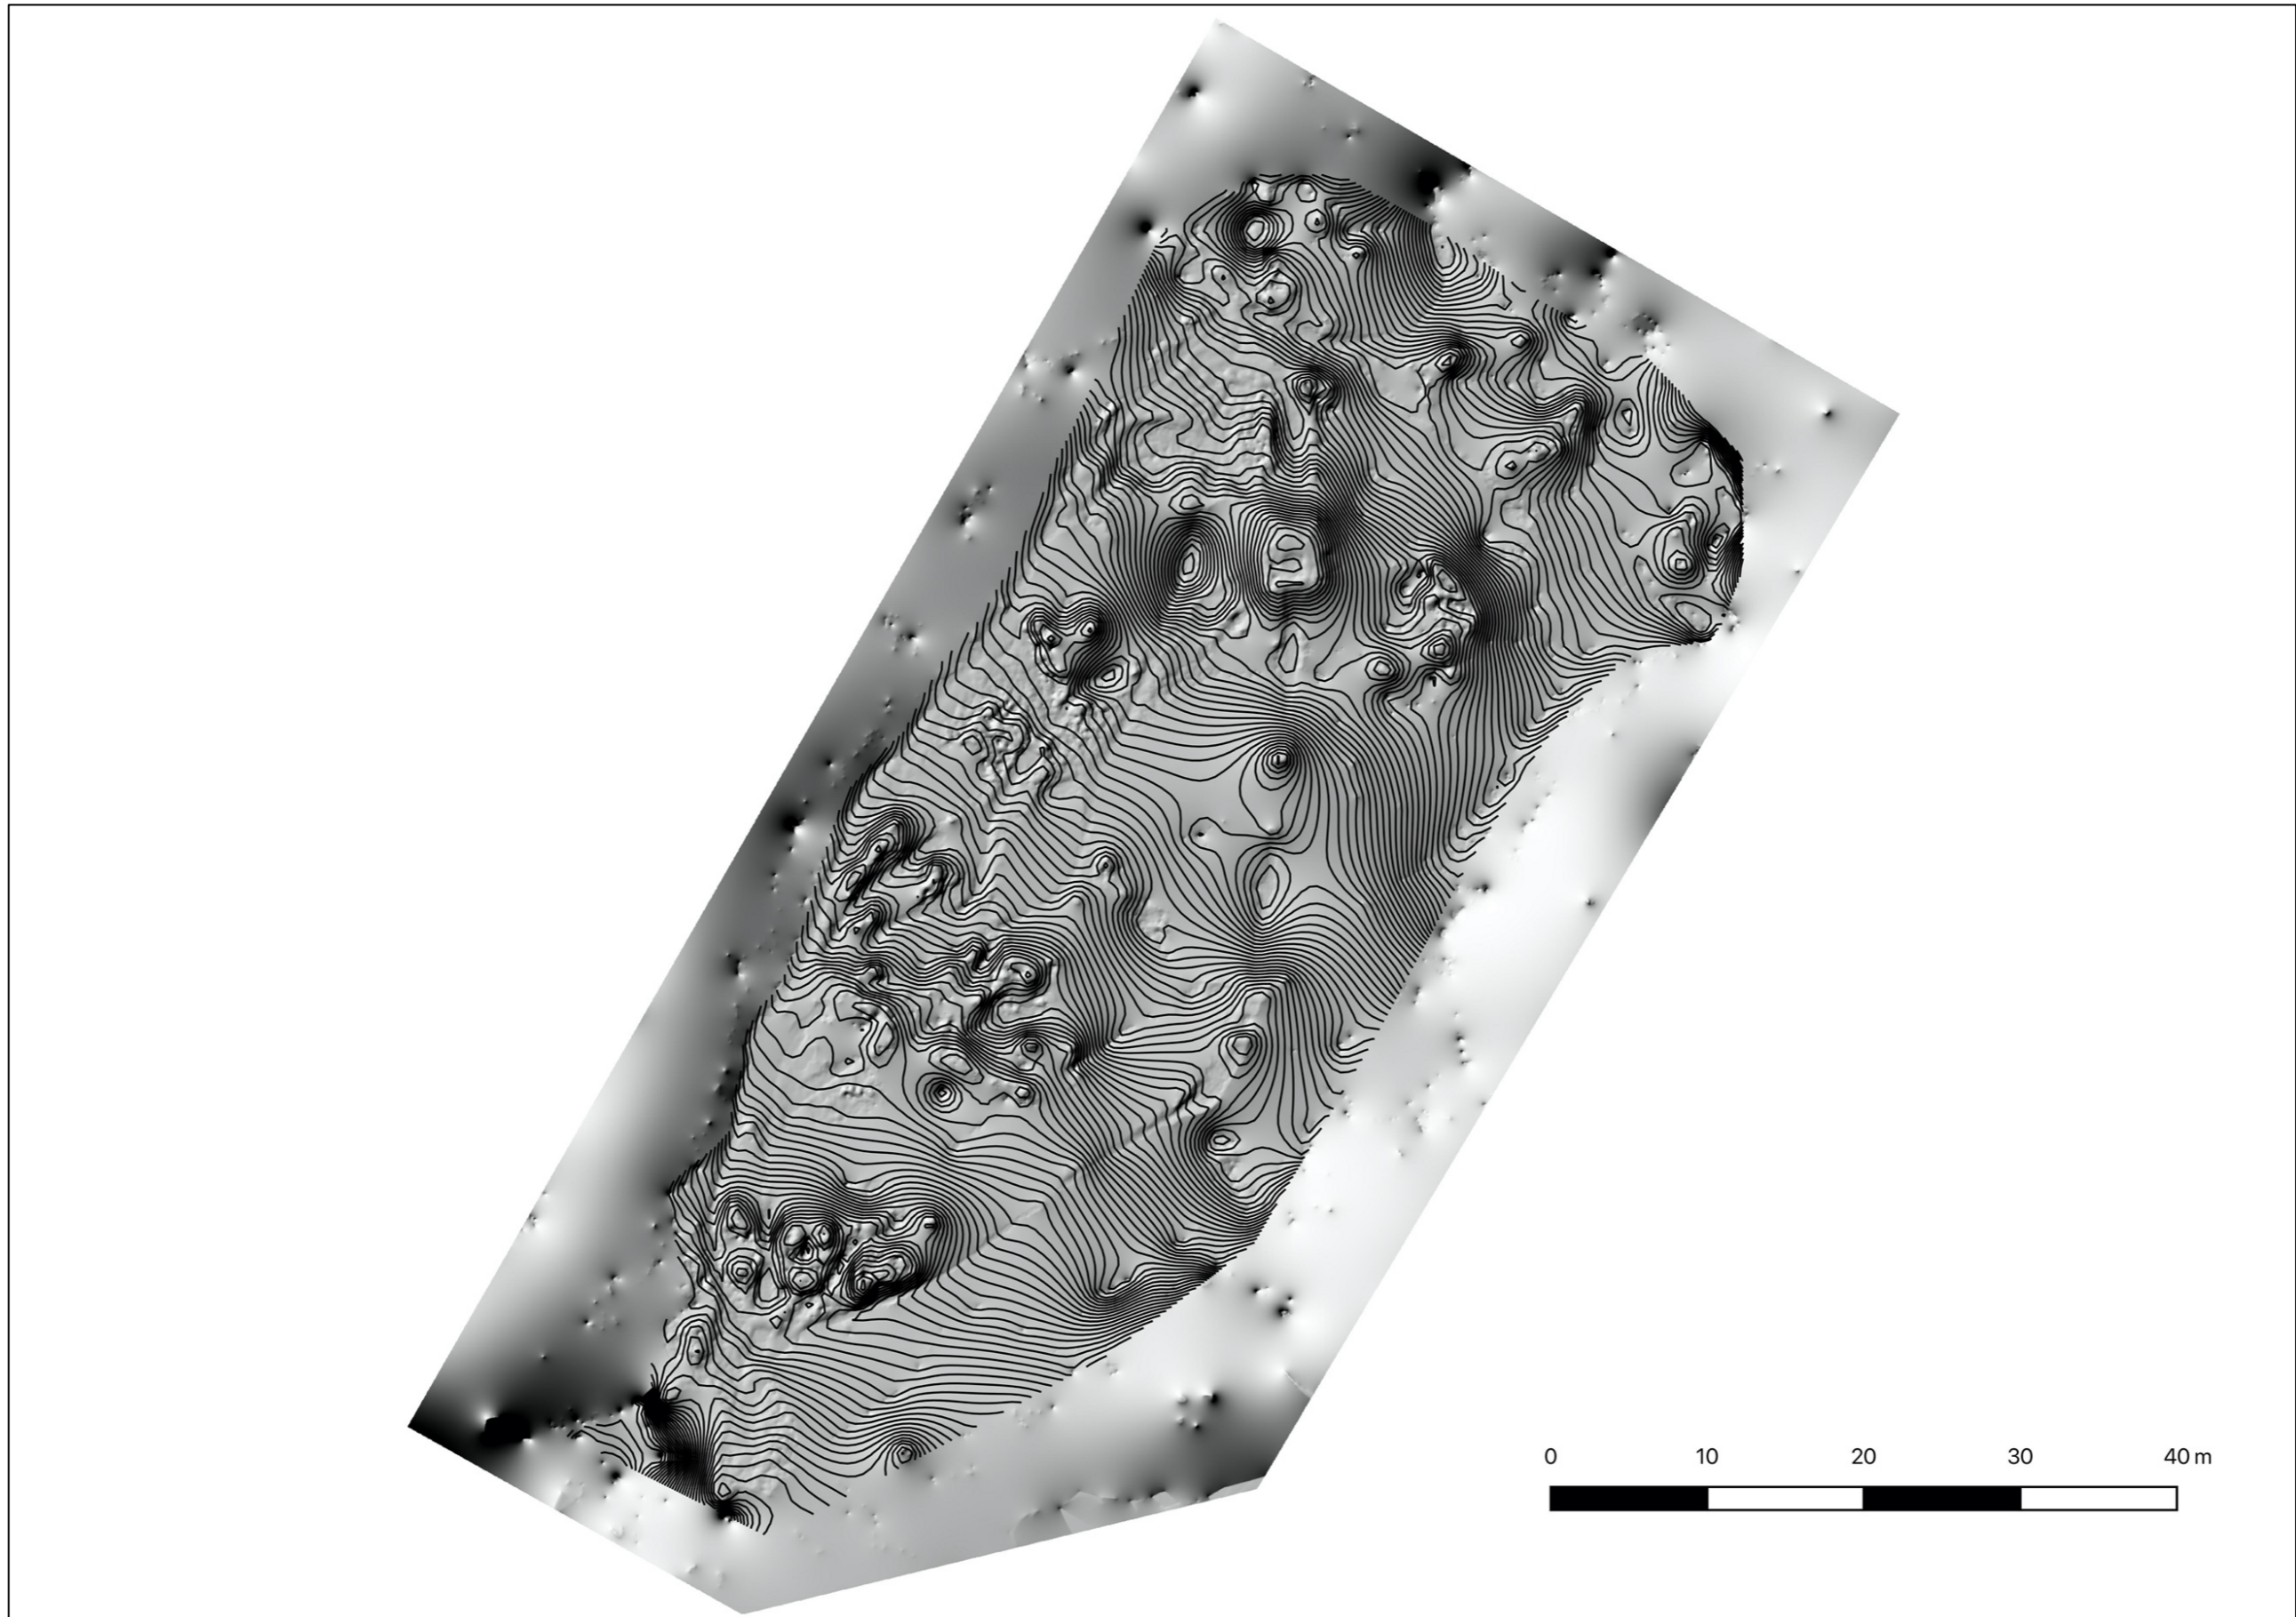
Figure 6. Digital surface model (DSM) with topographic contour survey overlay. Nadir view.

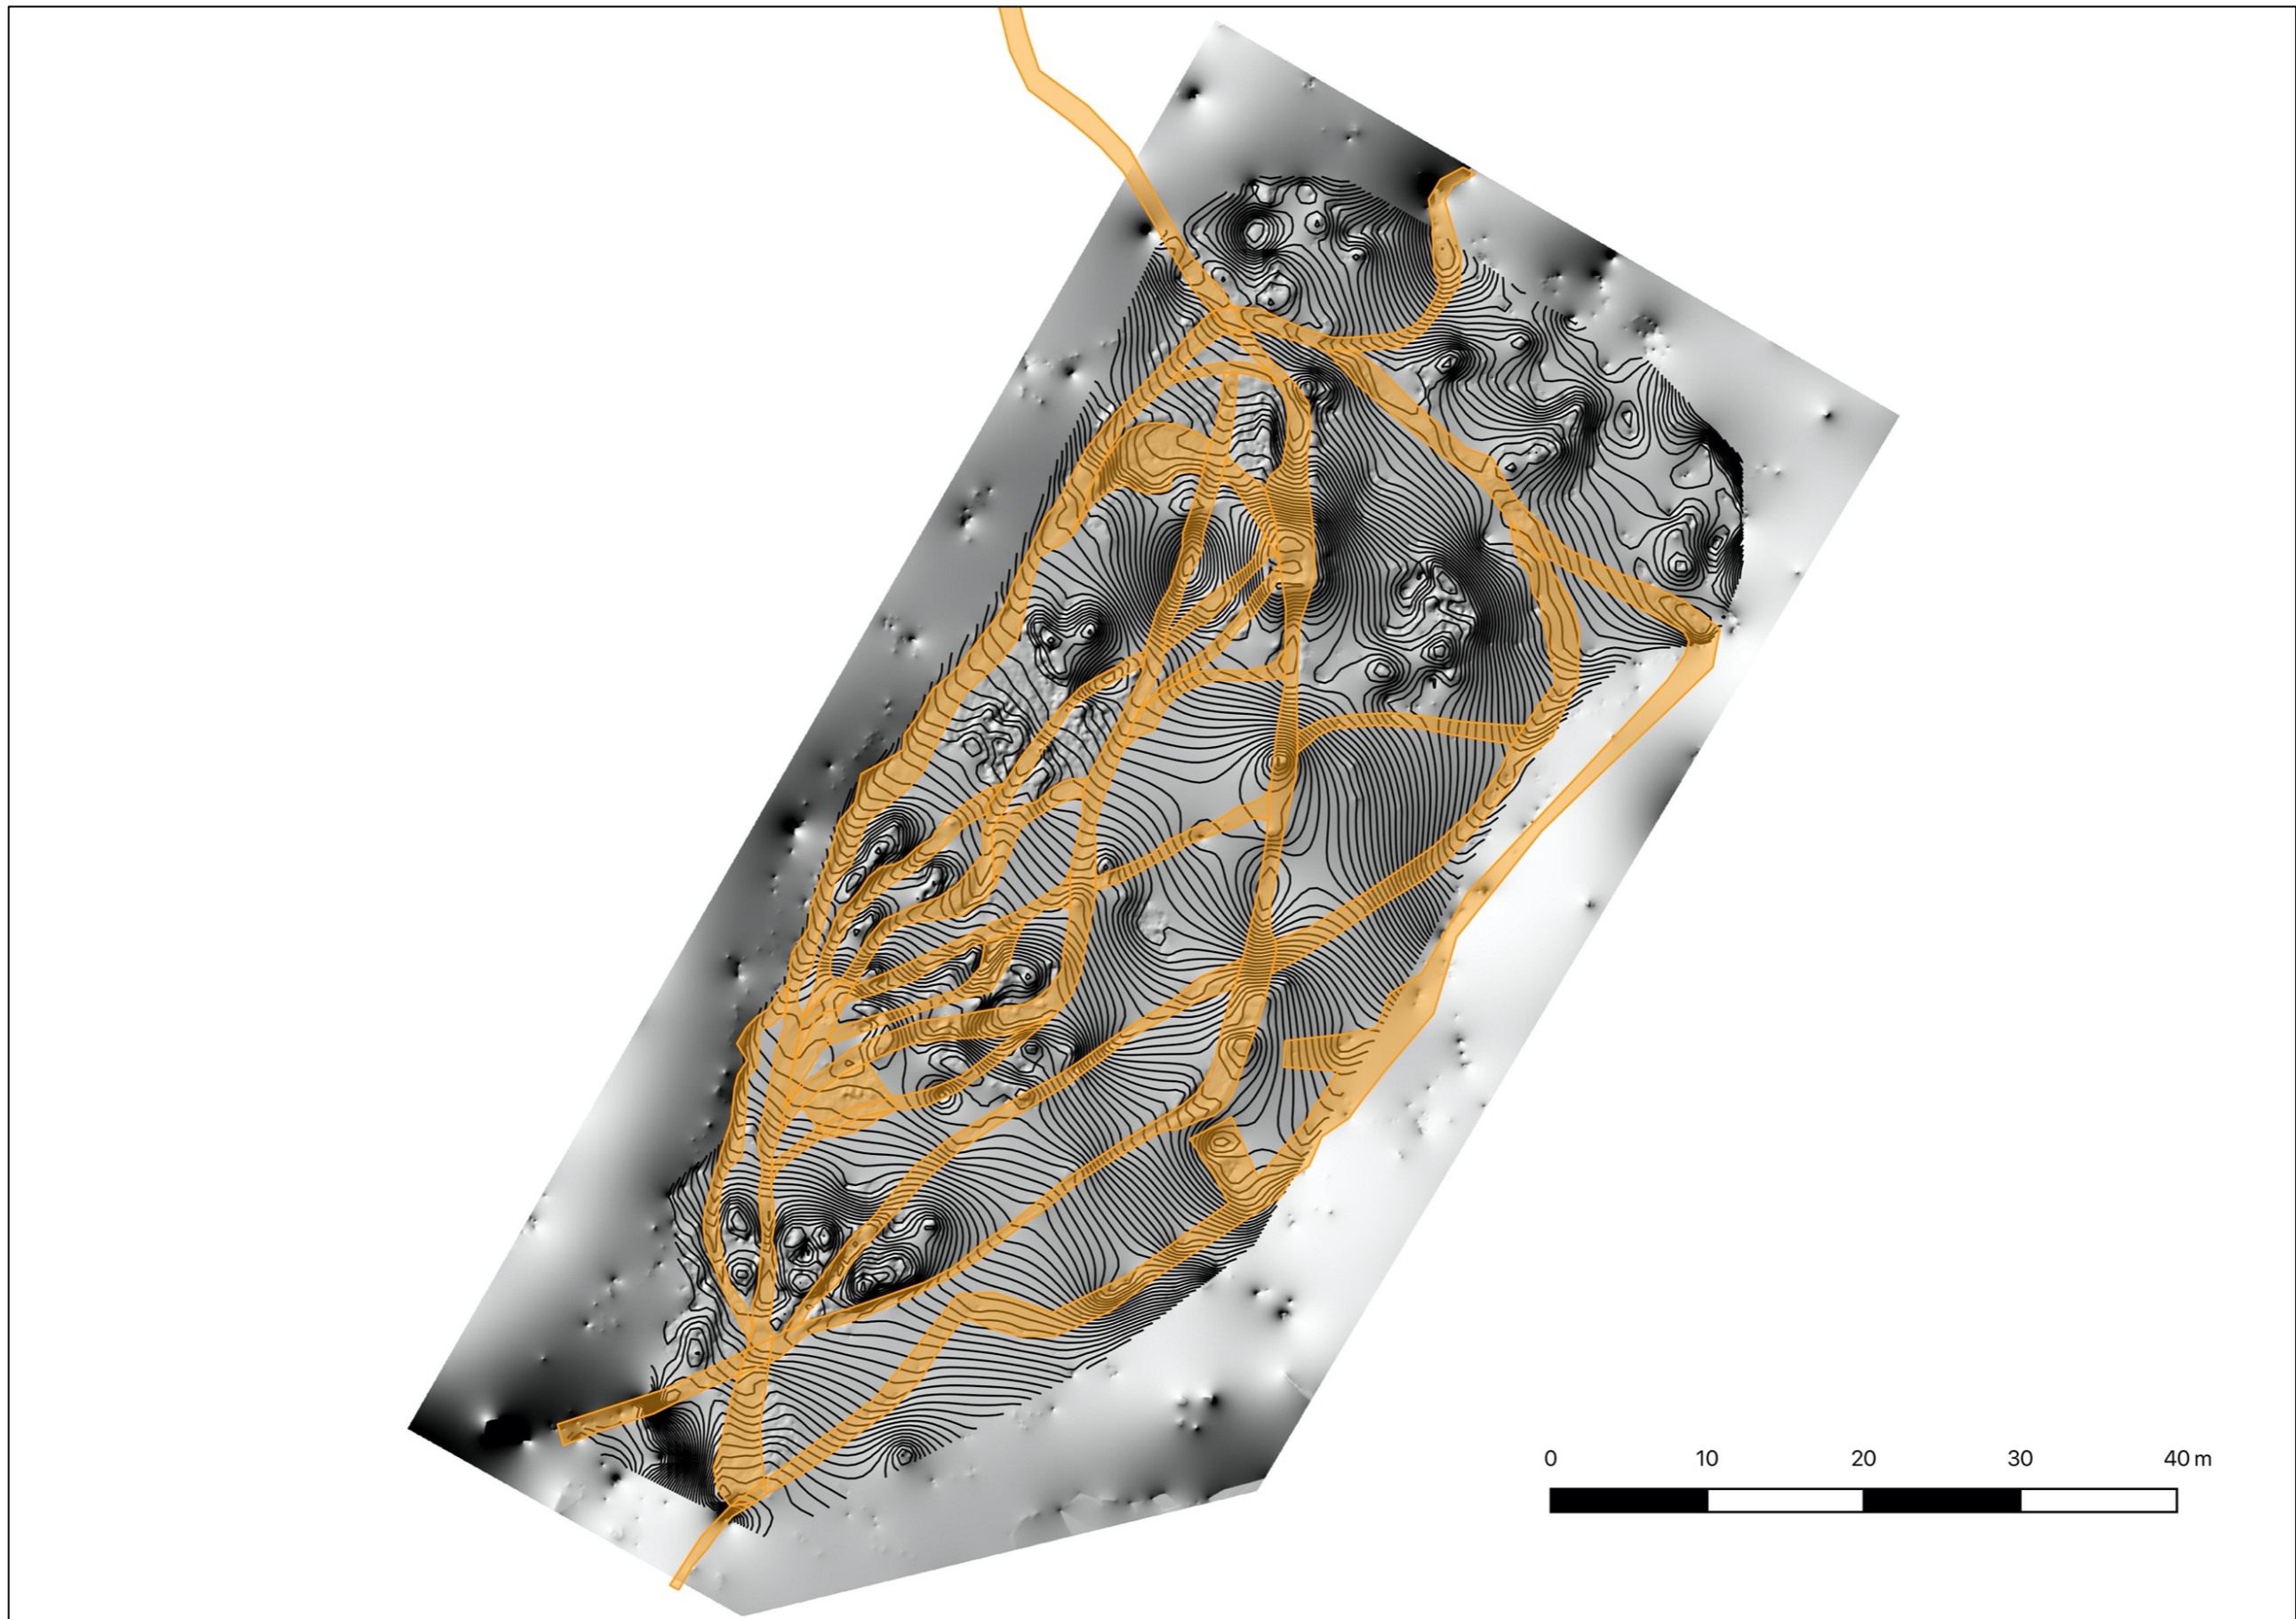
Figure 7. Digital surface model (DSM) with topographic contour survey and mapped MTB tracks overlay. Nadir view
