Clyne Valley Shaft Mounds SAMGm455, Swansea

Archaeological Landscape Monument Survey

City & County of Swansea

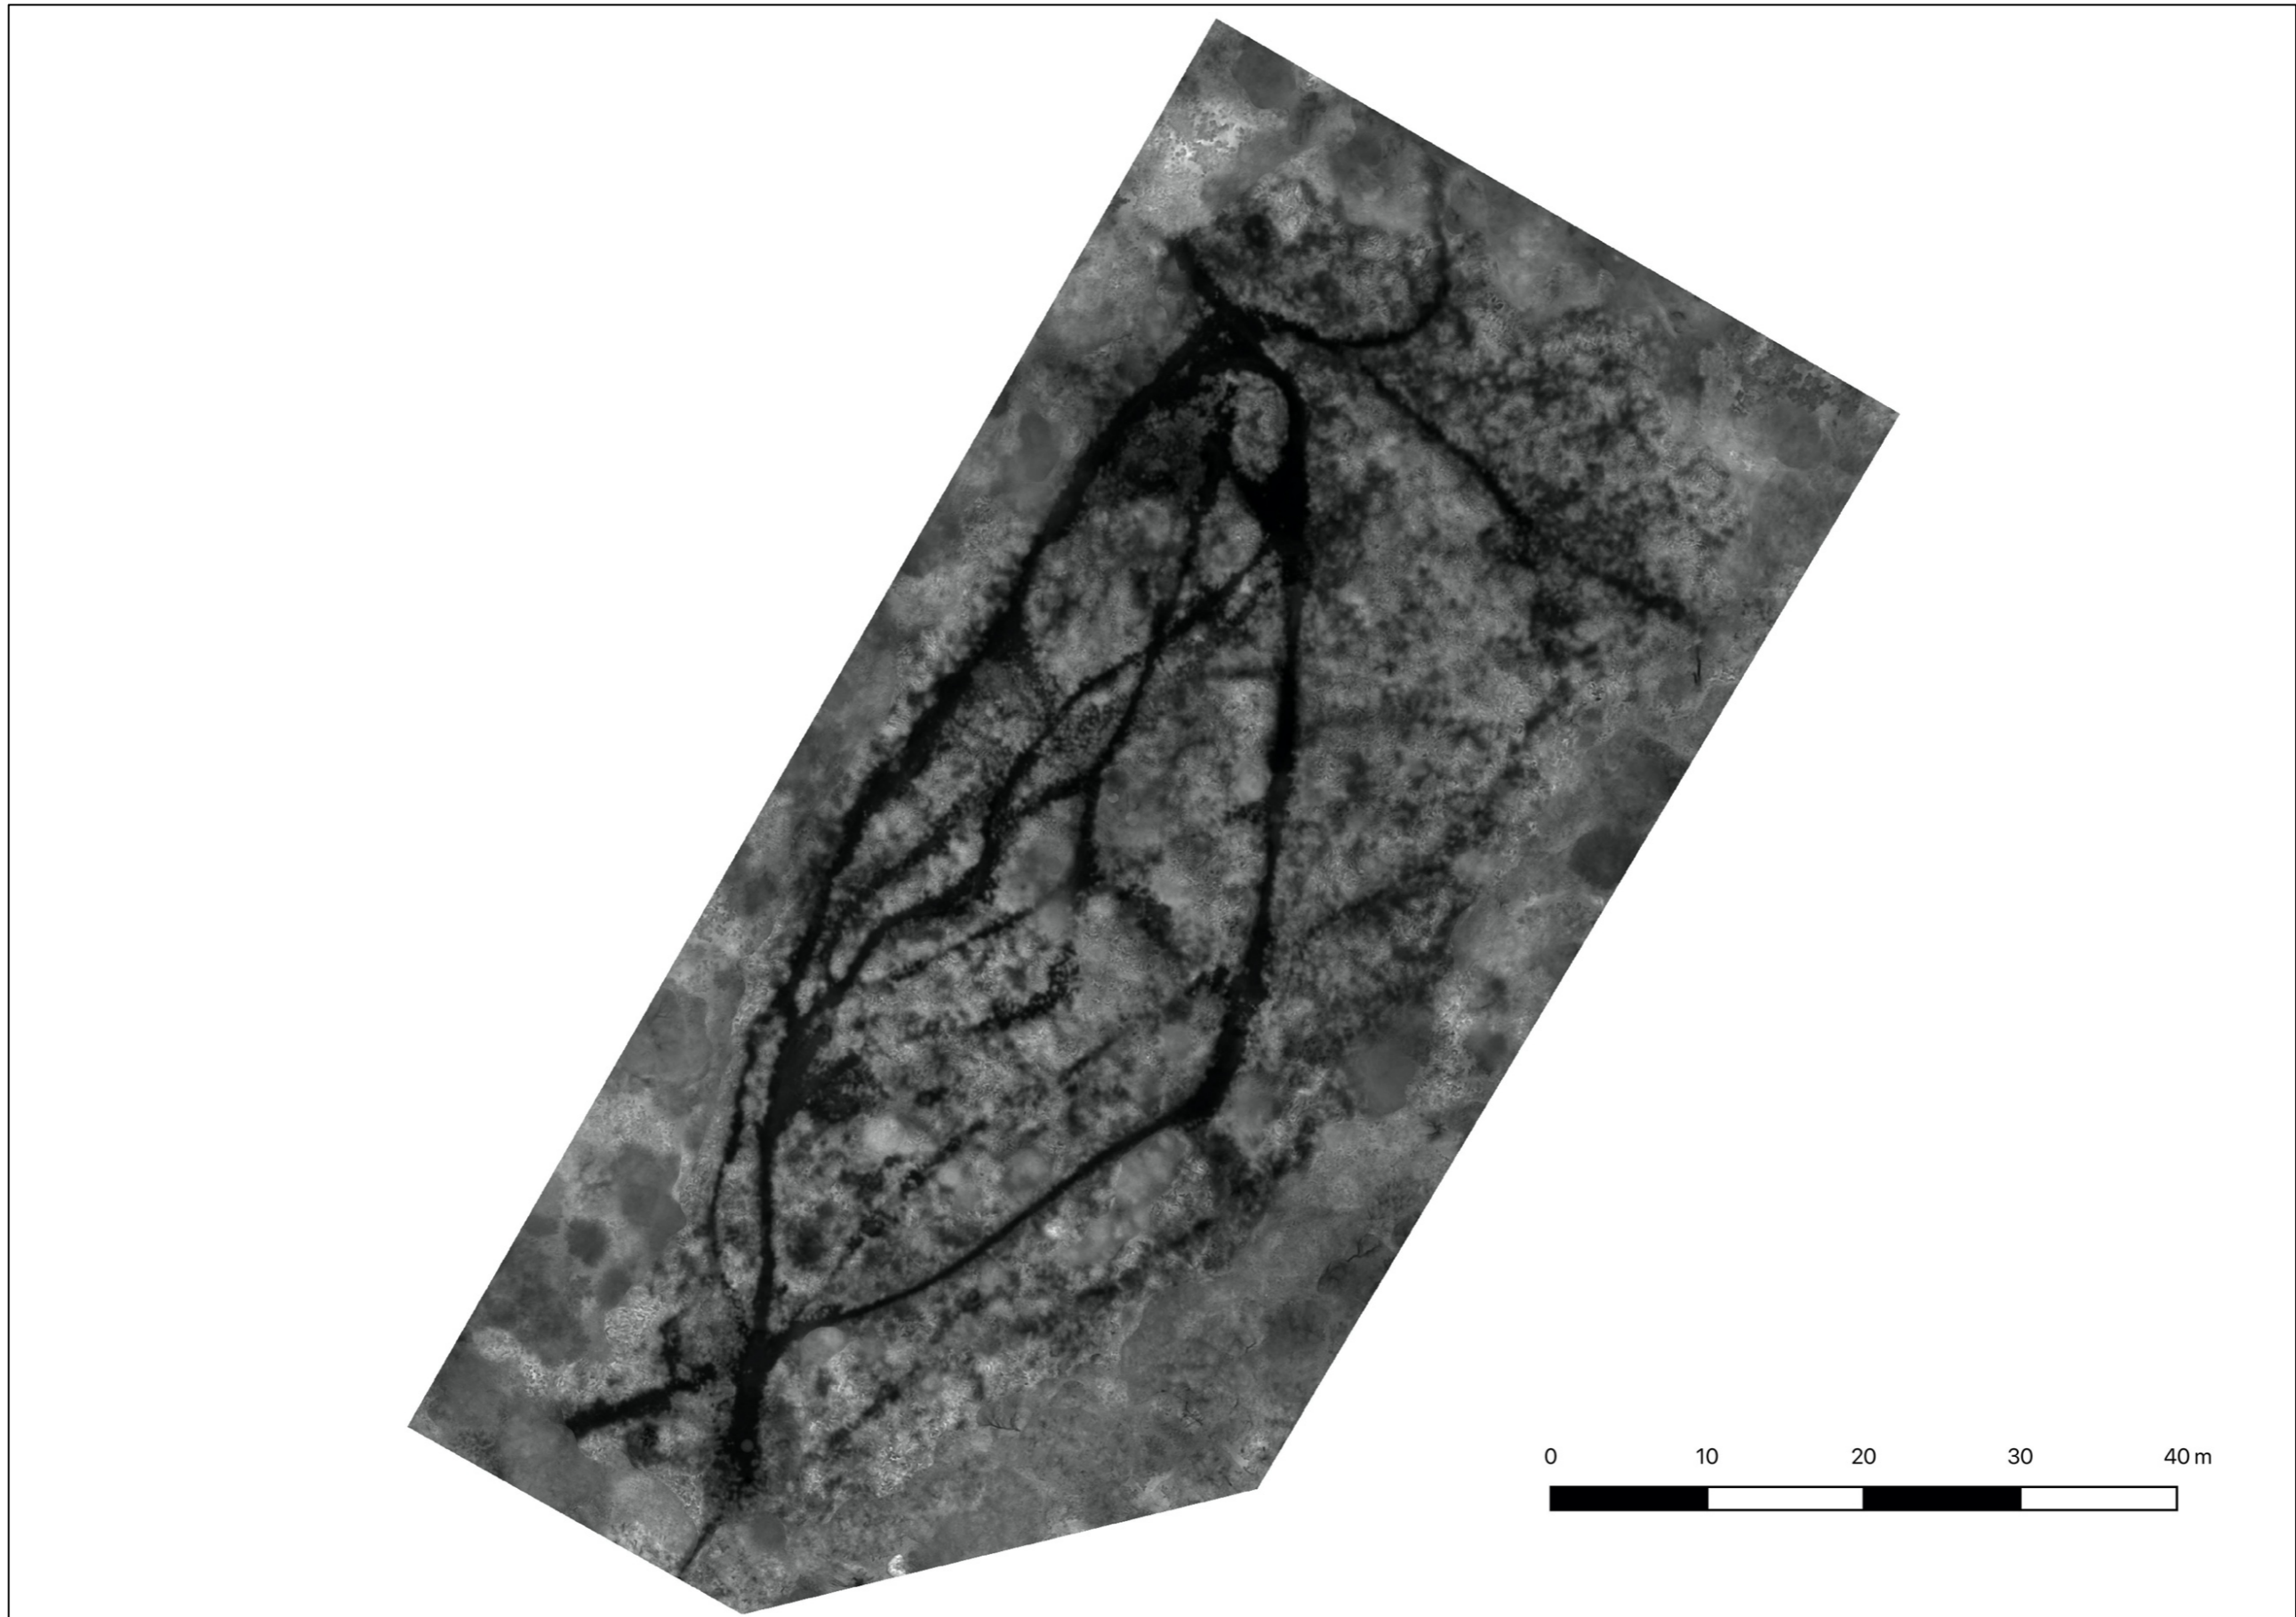
Figure 8. Multispectral photogrammetric orthomosaic showing MTB tracks otherwise hidden by vegetation. Nadir view.

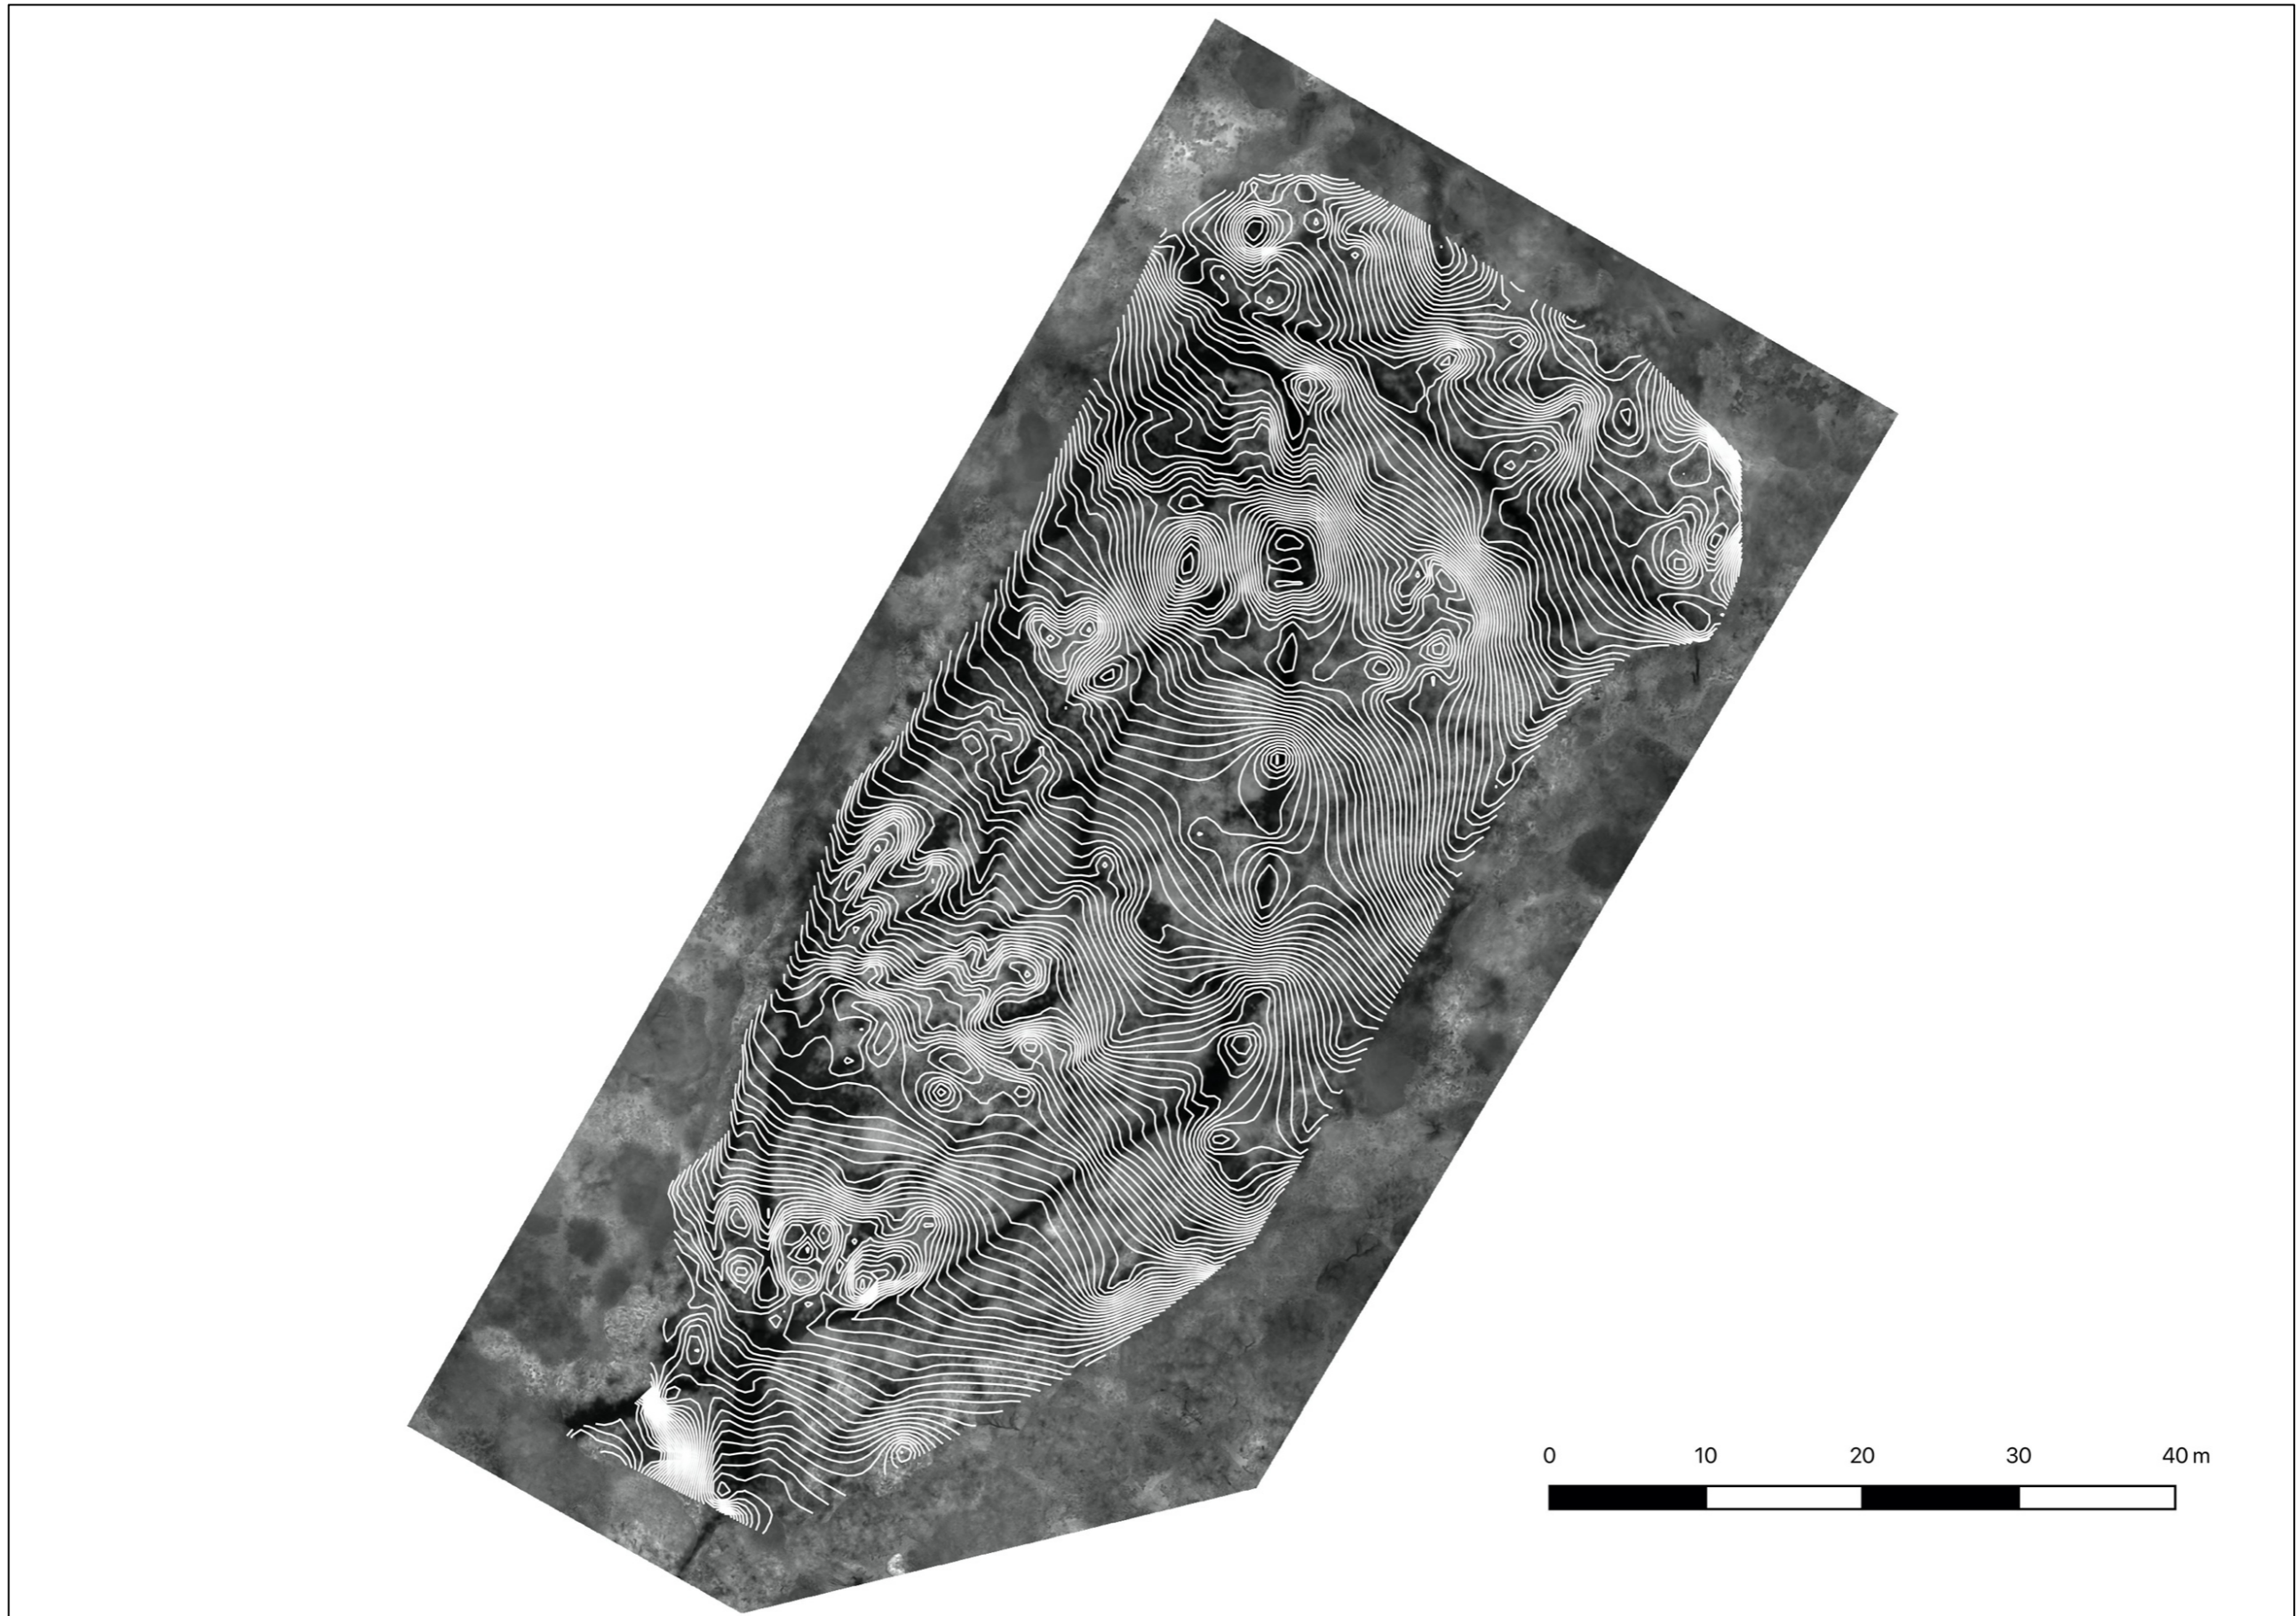
Figure 9. Multispectral photogrammetric orthomosaic with topographic contour survey showing MTB tracks otherwise hidden by vegetation. Nadir view.

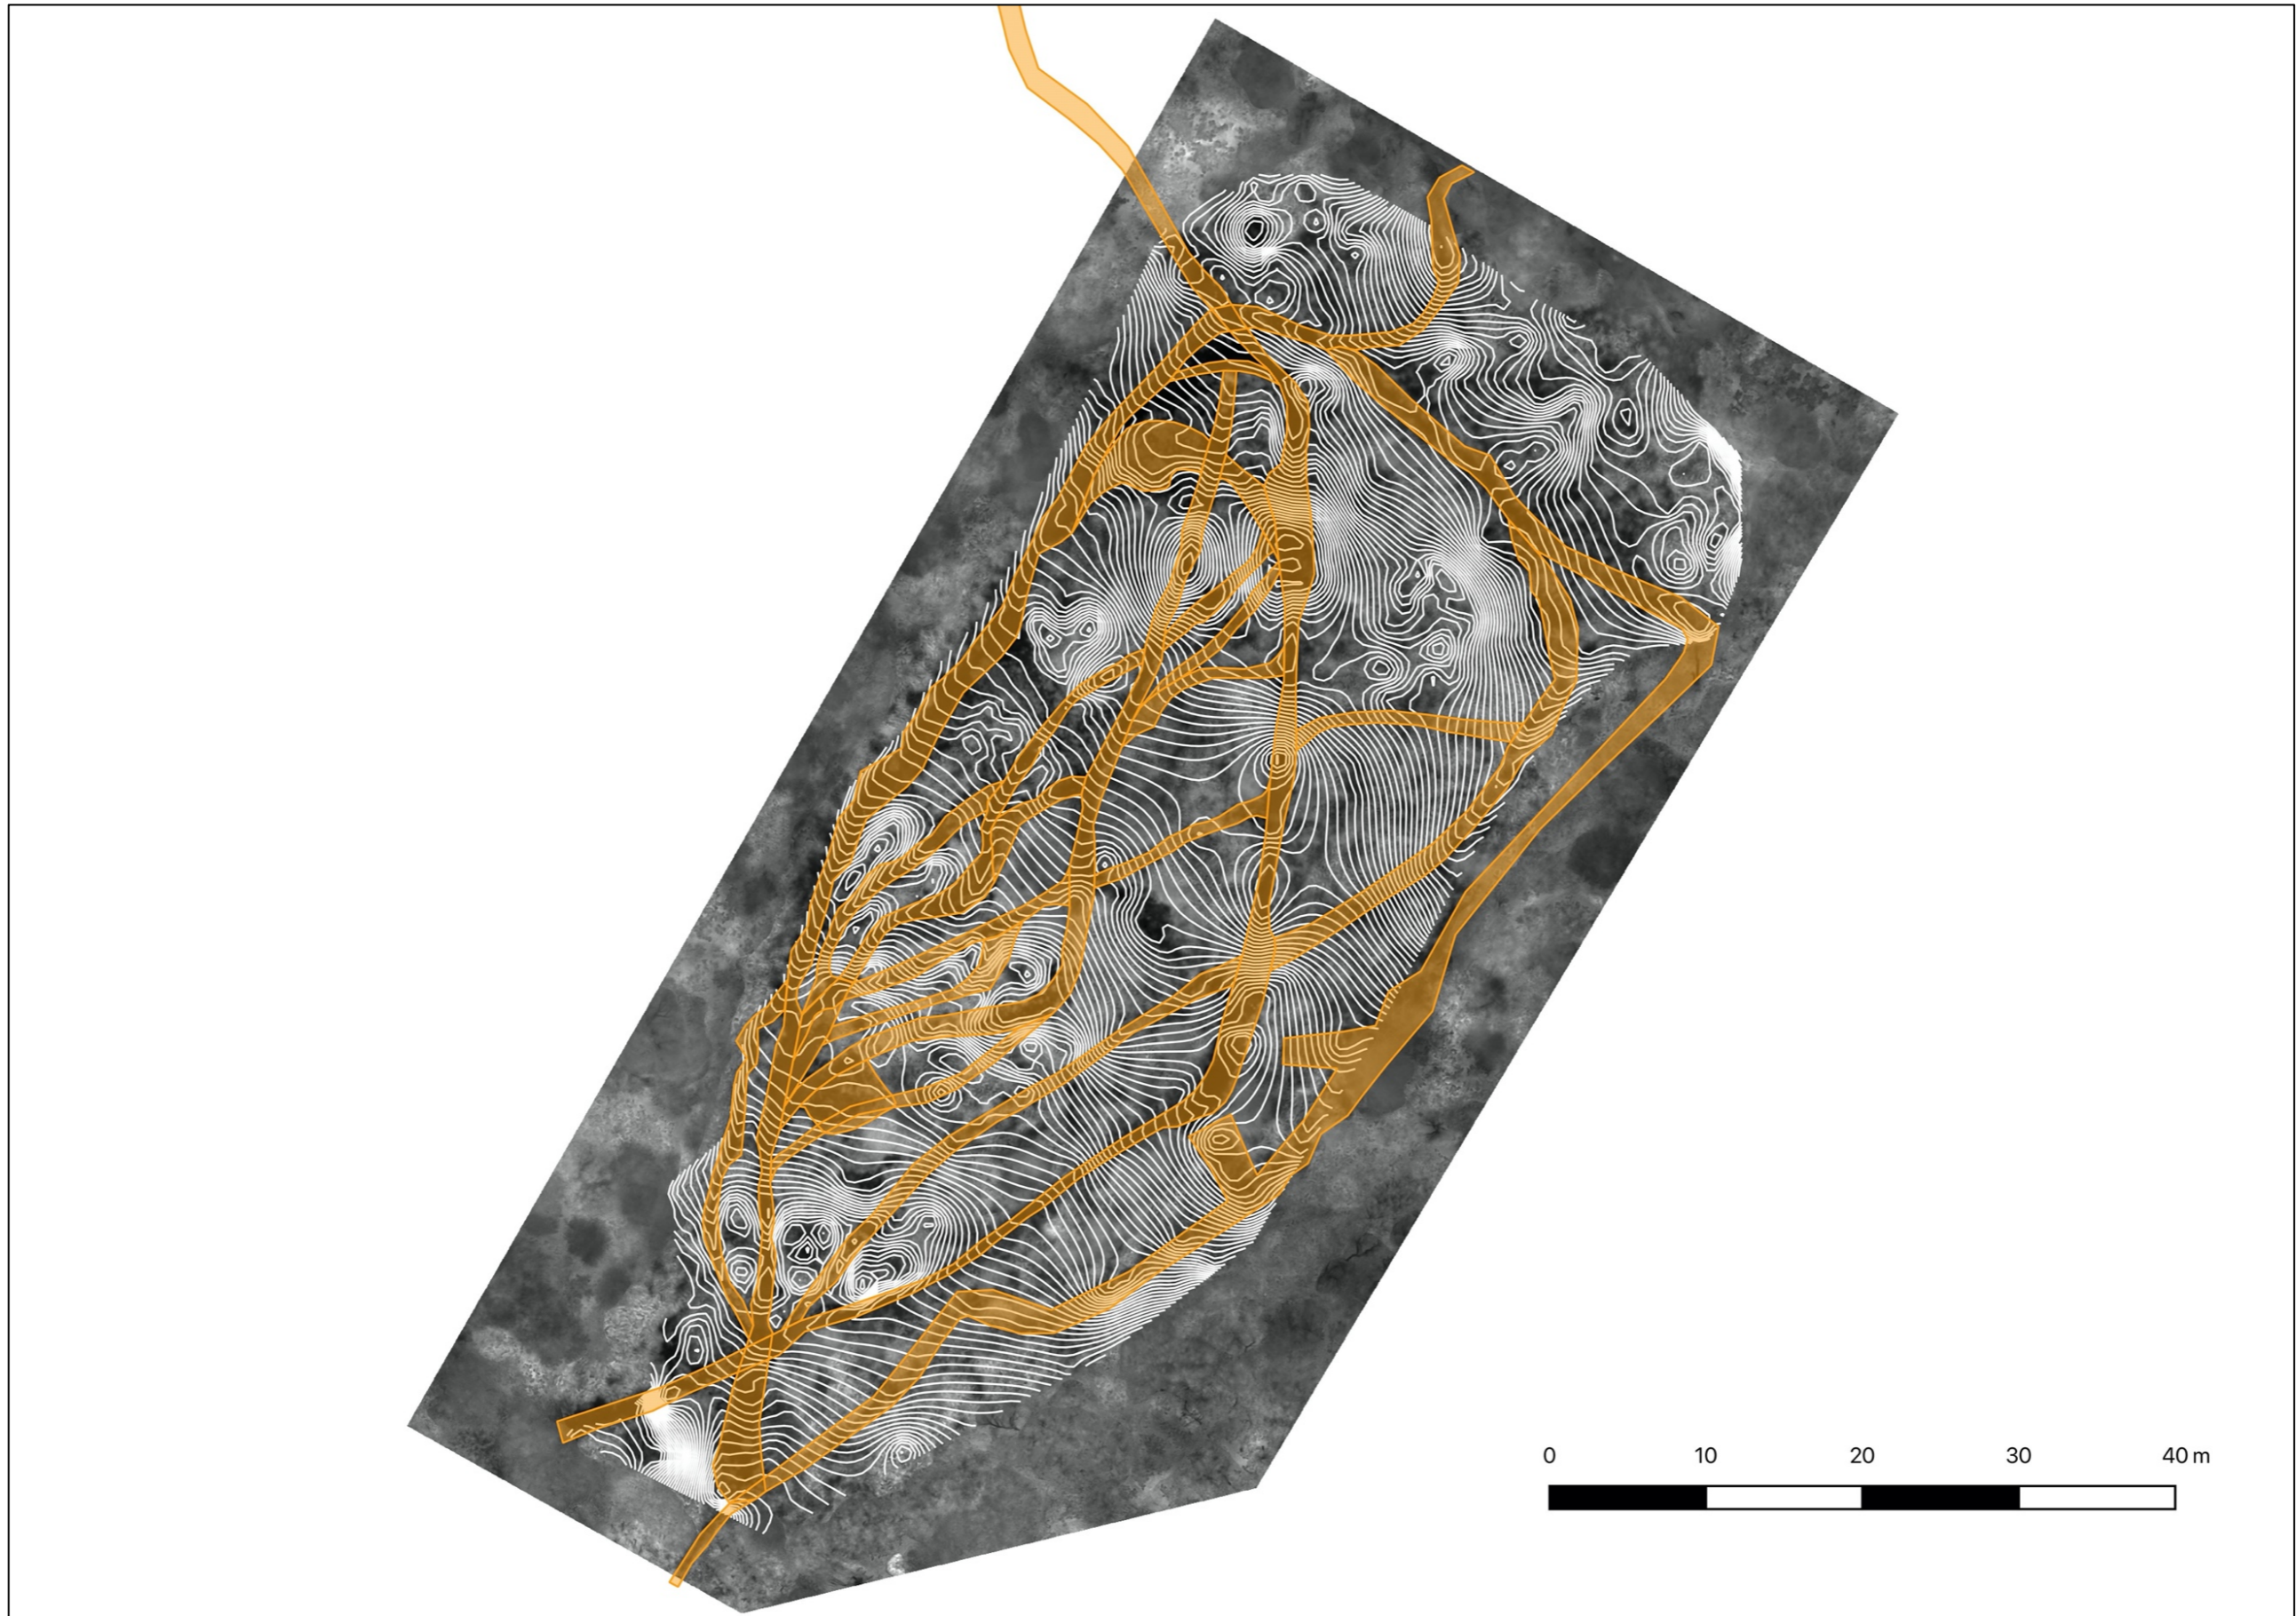
Figure 10. Multispectral photogrammetric orthomosaic with topographic contour survey and mapped MTB tracks. Nadir view.

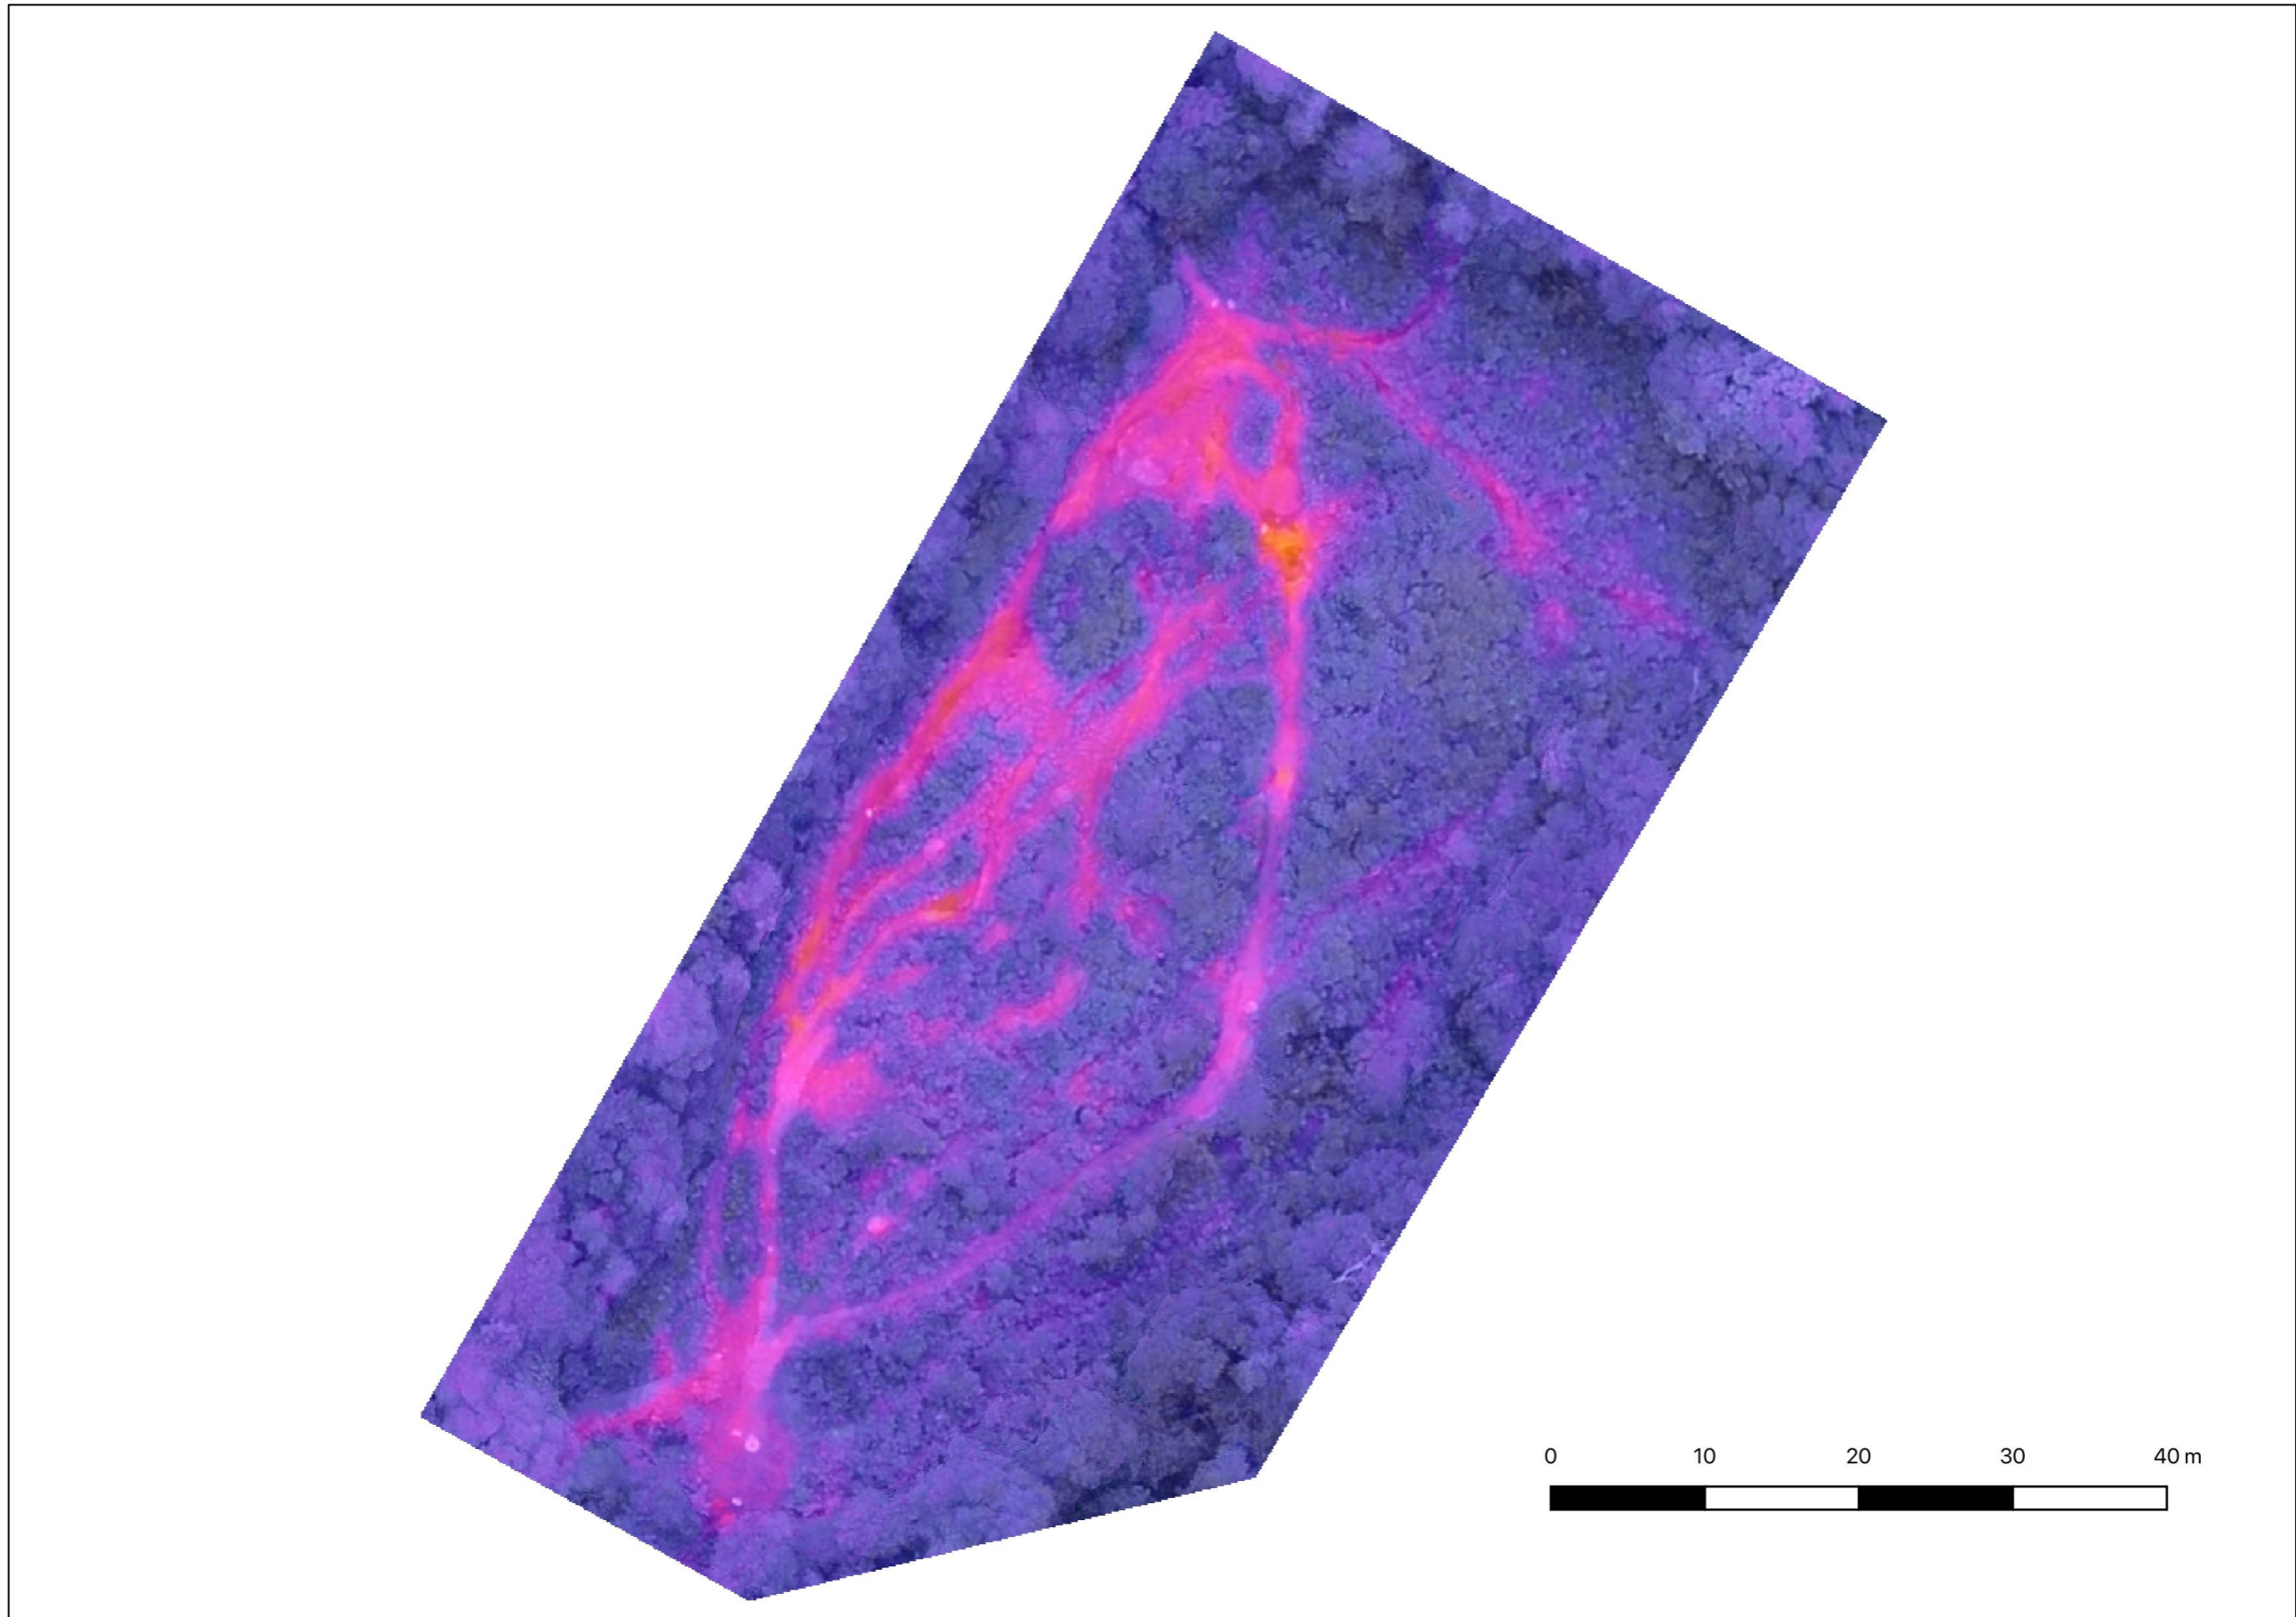
Figure 11. Thermal photogrammetric orthomosaic of survey area showing MTB tracks otherwise hidden by vegetation. Nadir view. Image © ArchaeoDomus.

resolution and centimetre accurate (GSD 0.79cm/pixel) orthomosaic was then imported into GIS and the MTB tracks recorded in detail. At this stage three MTB tracks were identifiable with several more obscured by vegetation. The DSM was then used to create a hill shade relief and topographical contour plans (Figures 6-7). This enabled the MTB tracks to be further refined together with providing greater detail of the form of the surviving historic bell pits and associated spoil mounds. However, the presence of more MTB tracks hidden by bracken cover was suspected so UAV multispectral and thermal cameras were deployed to reveal those light bands outside of the range (RGB) of human sight (Figures 8-13). Essentially unveiling the vegetation obscuring the suspected MTB tracks. Analysis of these images identified a further eight full or partial lengths of MTB track. All interconnected and commencing from the top of the hill to the SW and exiting to the NE or NW onto the cycle track. The use of multispectral images, particularly vegetation indices (Normalized Difference Vegetation Index NDVI), helped to identify which groups of plants (bracken) were more sparsely distributed or were shown to be unhealthy absorbing more near-infrared light. The healthier plants being located on or near overgrown MTB tracks, even though to the naked eye there was almost complete vegetation cover. Similarly the thermal images helped to identify which areas had a higher ambient temperature, the MTB tracks with no vegetation cover producing warmer signatures than the surrounding bracken. This almost certainly is partly due to the whole area being former bell pit spoil mounds. Colliery spoil tips are generally known to create microclimates as they heat up faster than surrounding soils. Unhealthy or stunted vegetation produced cooler signatures, which again allowed the warmer ground of the MTB tracks to become visible.

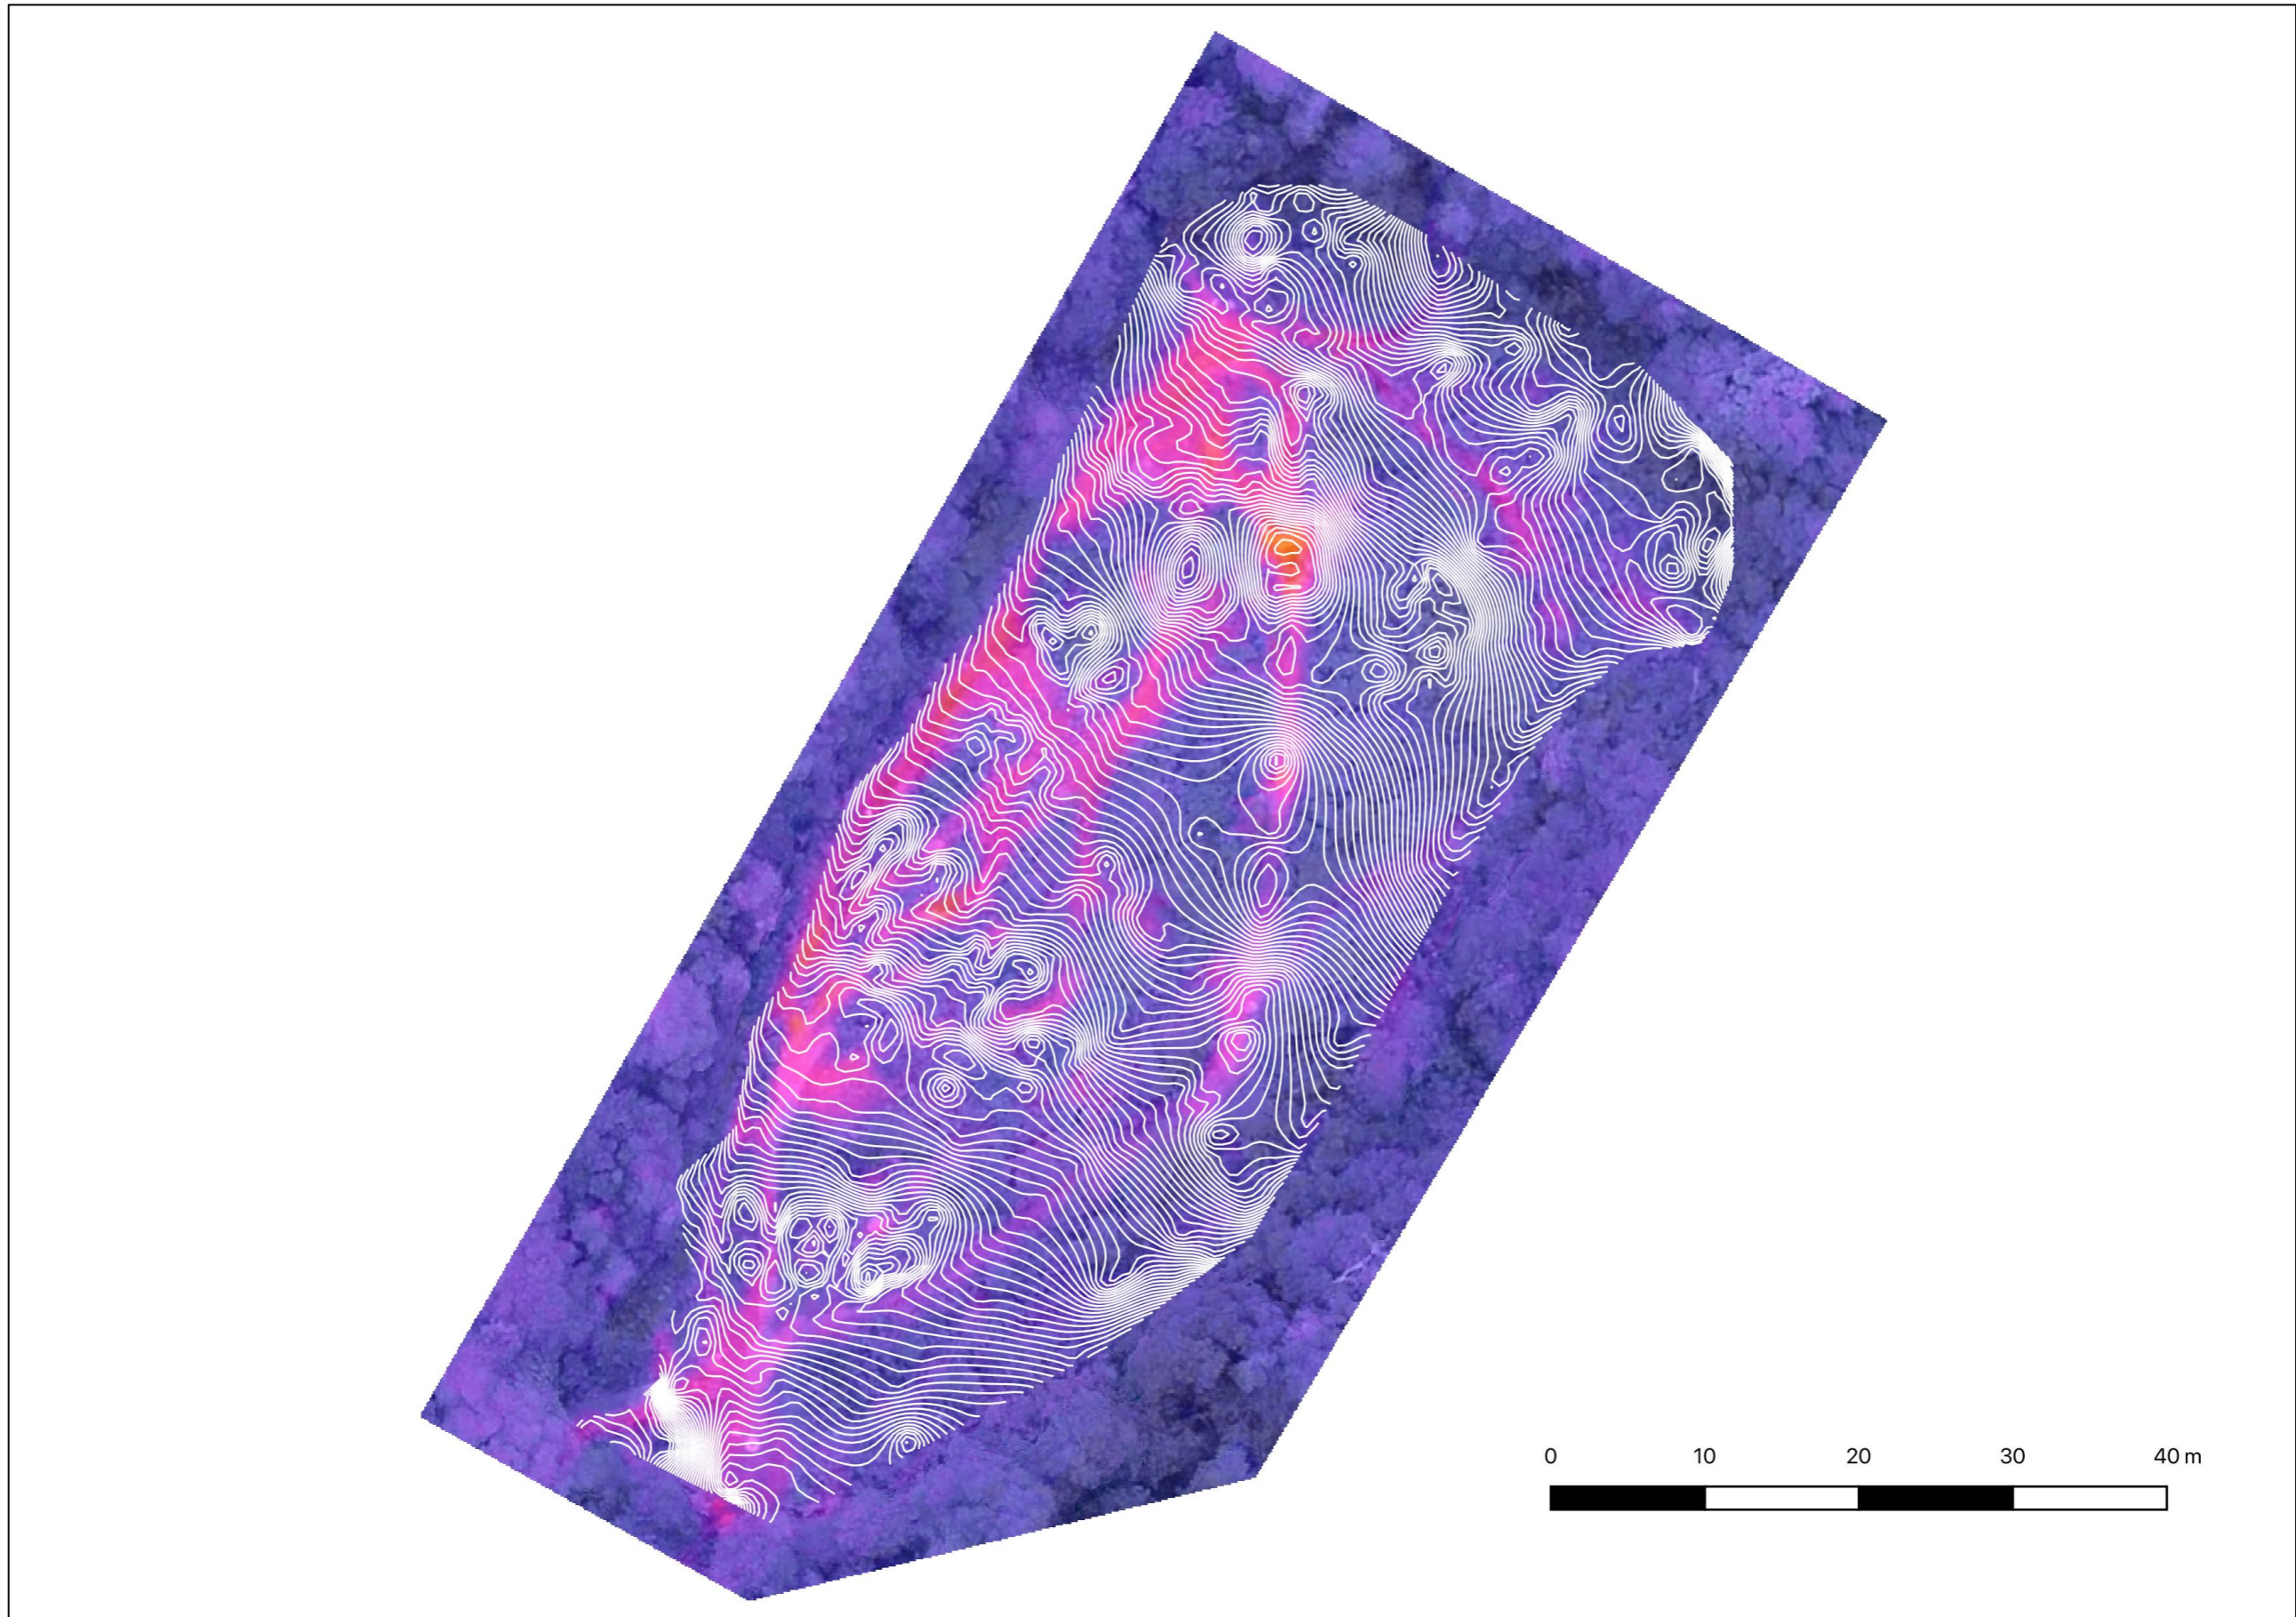
Figure 12. Thermal photogrammetric orthomosaic of survey area with topographic contour survey showing MTB tracks otherwise hidden by vegetation. Nadir view. Image © ArchaeoDomus.
