Clyne Valley Shaft Mounds SAMGm455, Swansea

Archaeological Landscape Monument Survey

City & County of Swansea

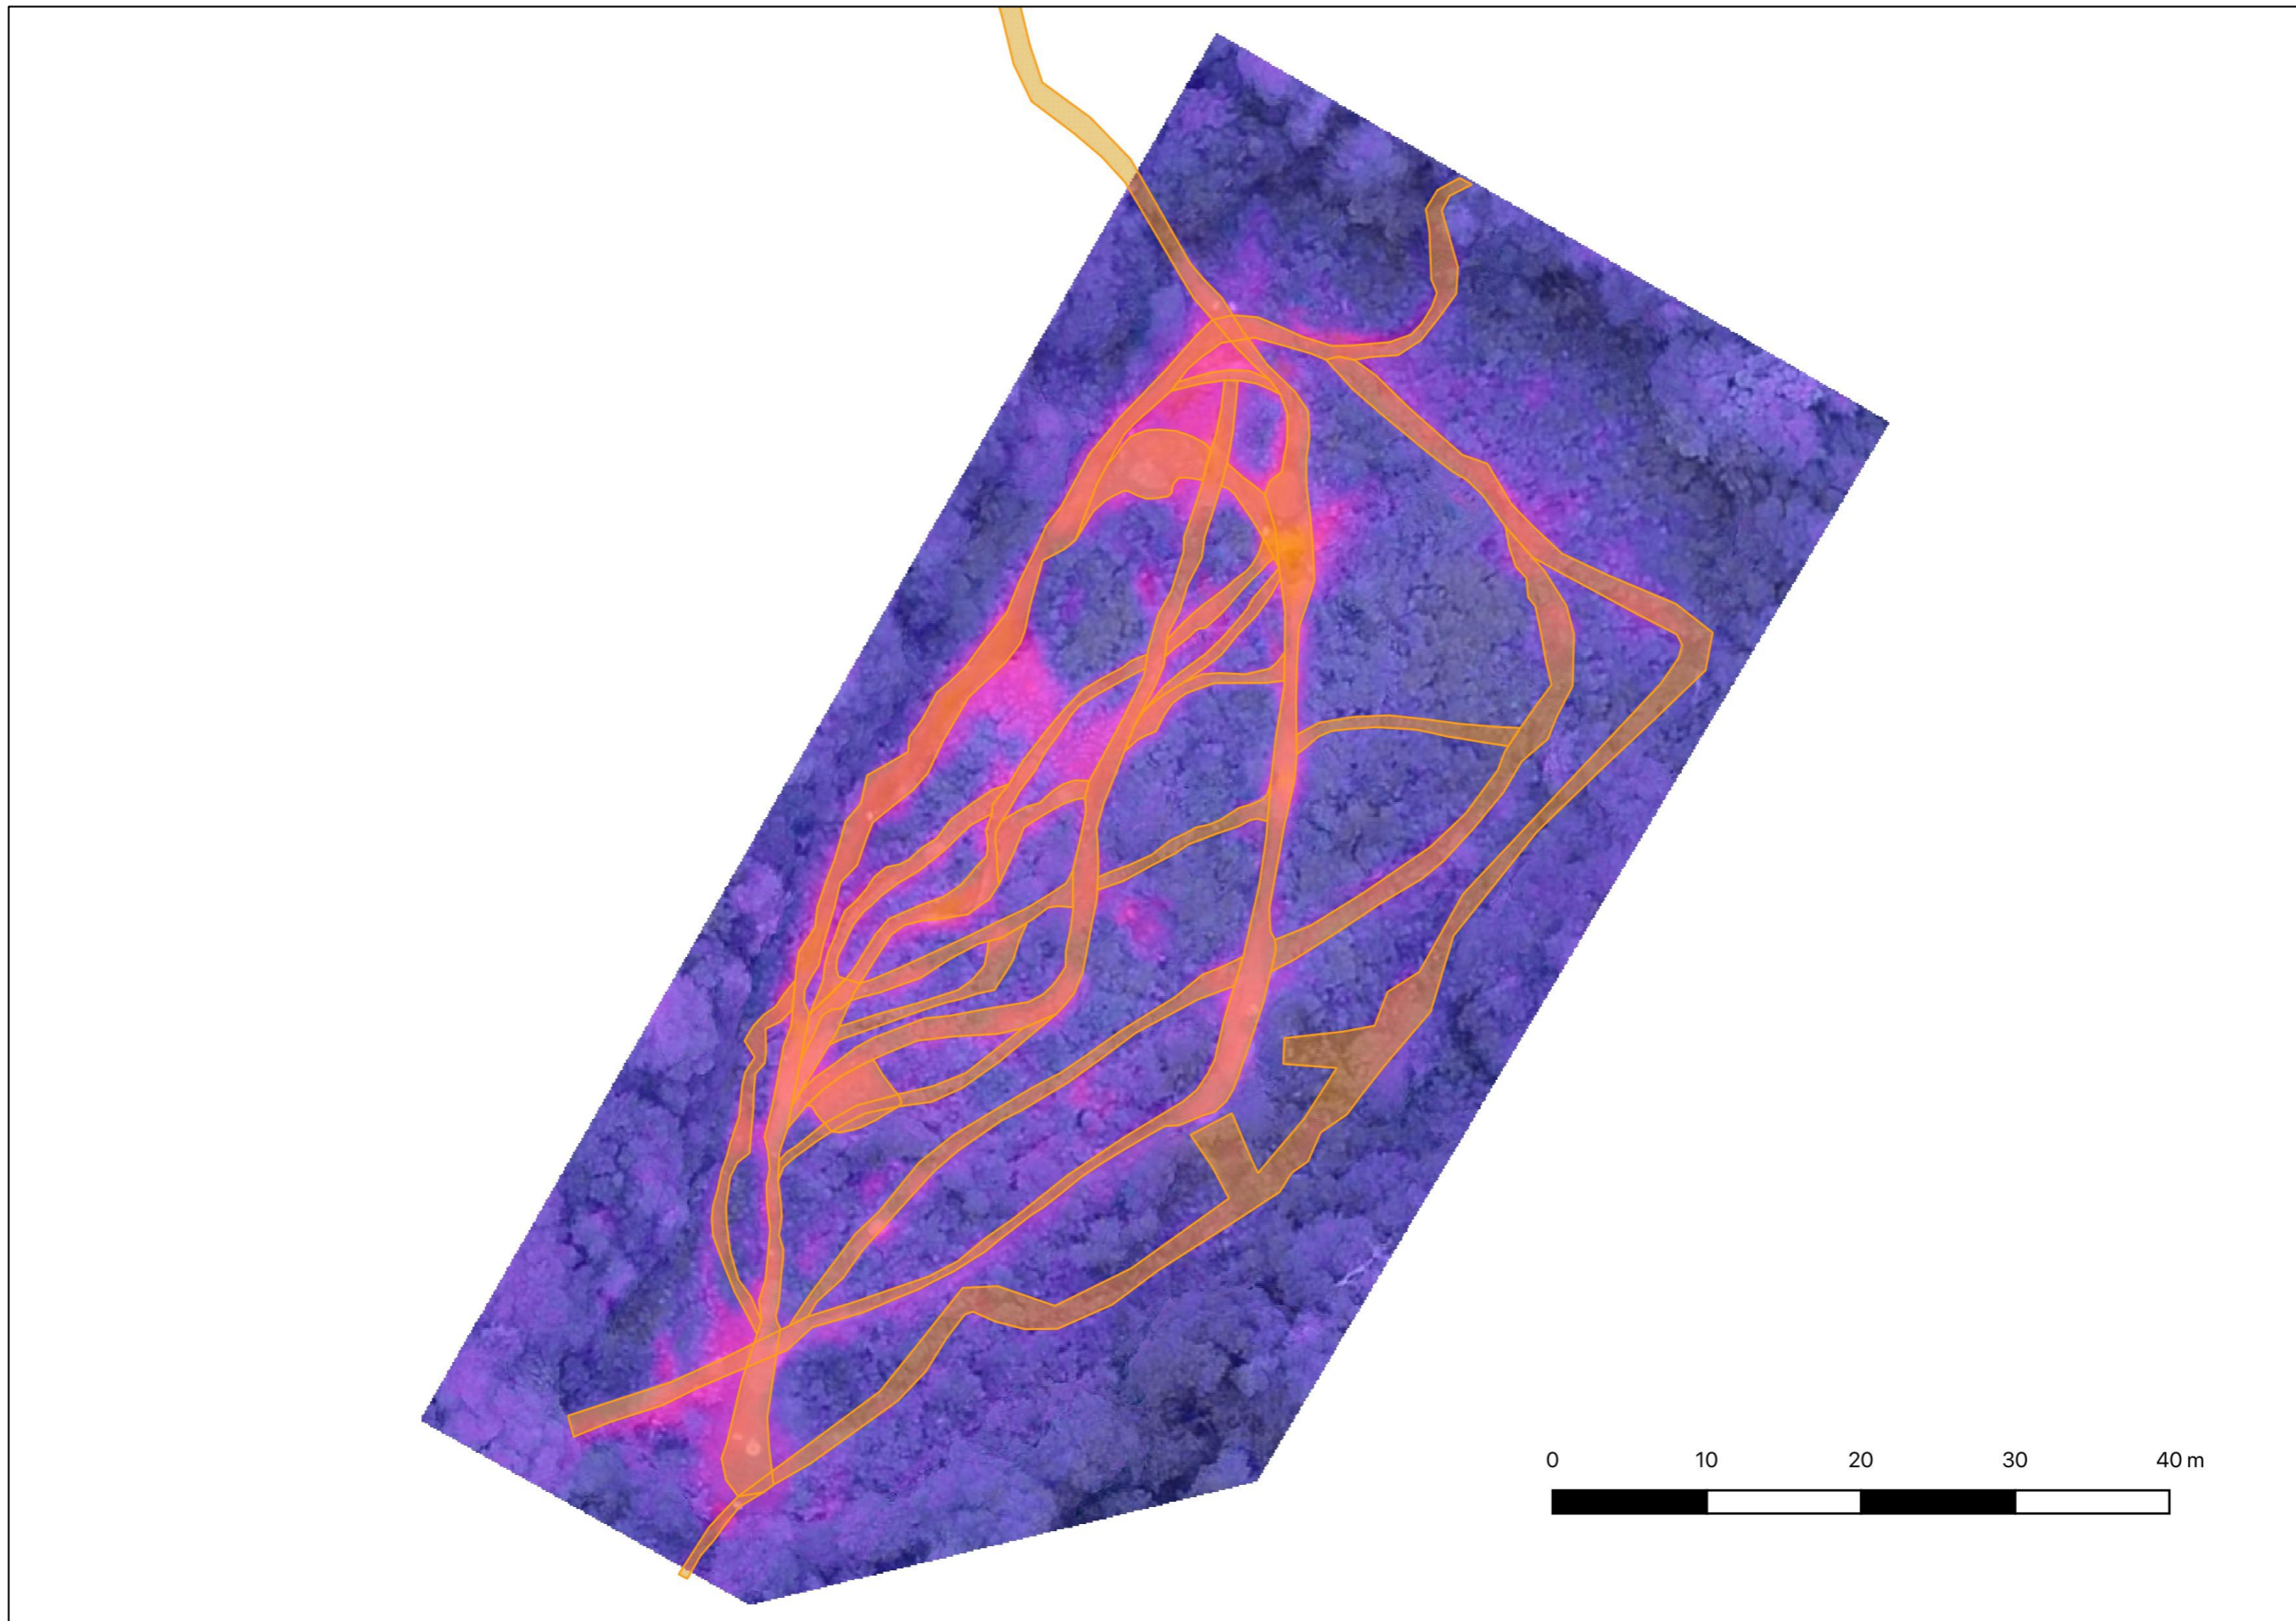
Figure 13. Thermal photogrammetric orthomosaic of survey area with topographic contour survey showing MTB tracks otherwise hidden by vegetation. Nadir view. Image © ArchaeoDomus.

resolution and centimetre accurate (GSD 0.79cm/pixel) orthomosaic was then imported into GIS and the MTB tracks recorded in detail. At this stage three MTB tracks were identifiable with several more obscured by vegetation. The DSM was then used to create a hill shade relief and topographical contour plans (Figures 6-7). This enabled the MTB tracks to be further refined together with providing greater detail of the form of the surviving historic bell pits and associated spoil mounds. However, the presence of more MTB tracks hidden by bracken cover was suspected so UAV multispectral and thermal cameras were deployed to reveal those light bands outside of the range (RGB) of human sight (Figures 8-13). Essentially unveiling the vegetation obscuring the suspected MTB tracks. Analysis of these images identified a further eight full or partial lengths of MTB track. All interconnected and commencing from the top of the hill to the SW and exiting to the NE or NW onto the cycle track. The use of multispectral images, particularly vegetation indices (Normalized Difference Vegetation Index NDVI), helped to identify which groups of plants (bracken) were more sparsely distributed or were shown to be unhealthy absorbing more near-infrared light. The healthier plants being located on or near overgrown MTB tracks, even though to the naked eye there was almost complete vegetation cover. Similarly the thermal images helped to identify which areas had a higher ambient temperature, the MTB tracks with no vegetation cover producing warmer signatures than the surrounding bracken. This almost certainly is partly due to the whole area being former bell pit spoil mounds. Colliery spoil tips are generally known to create microclimates as they heat up faster than surrounding soils. Unhealthy or stunted vegetation produced cooler signatures, which again allowed the warmer ground of the MTB tracks to become visible.

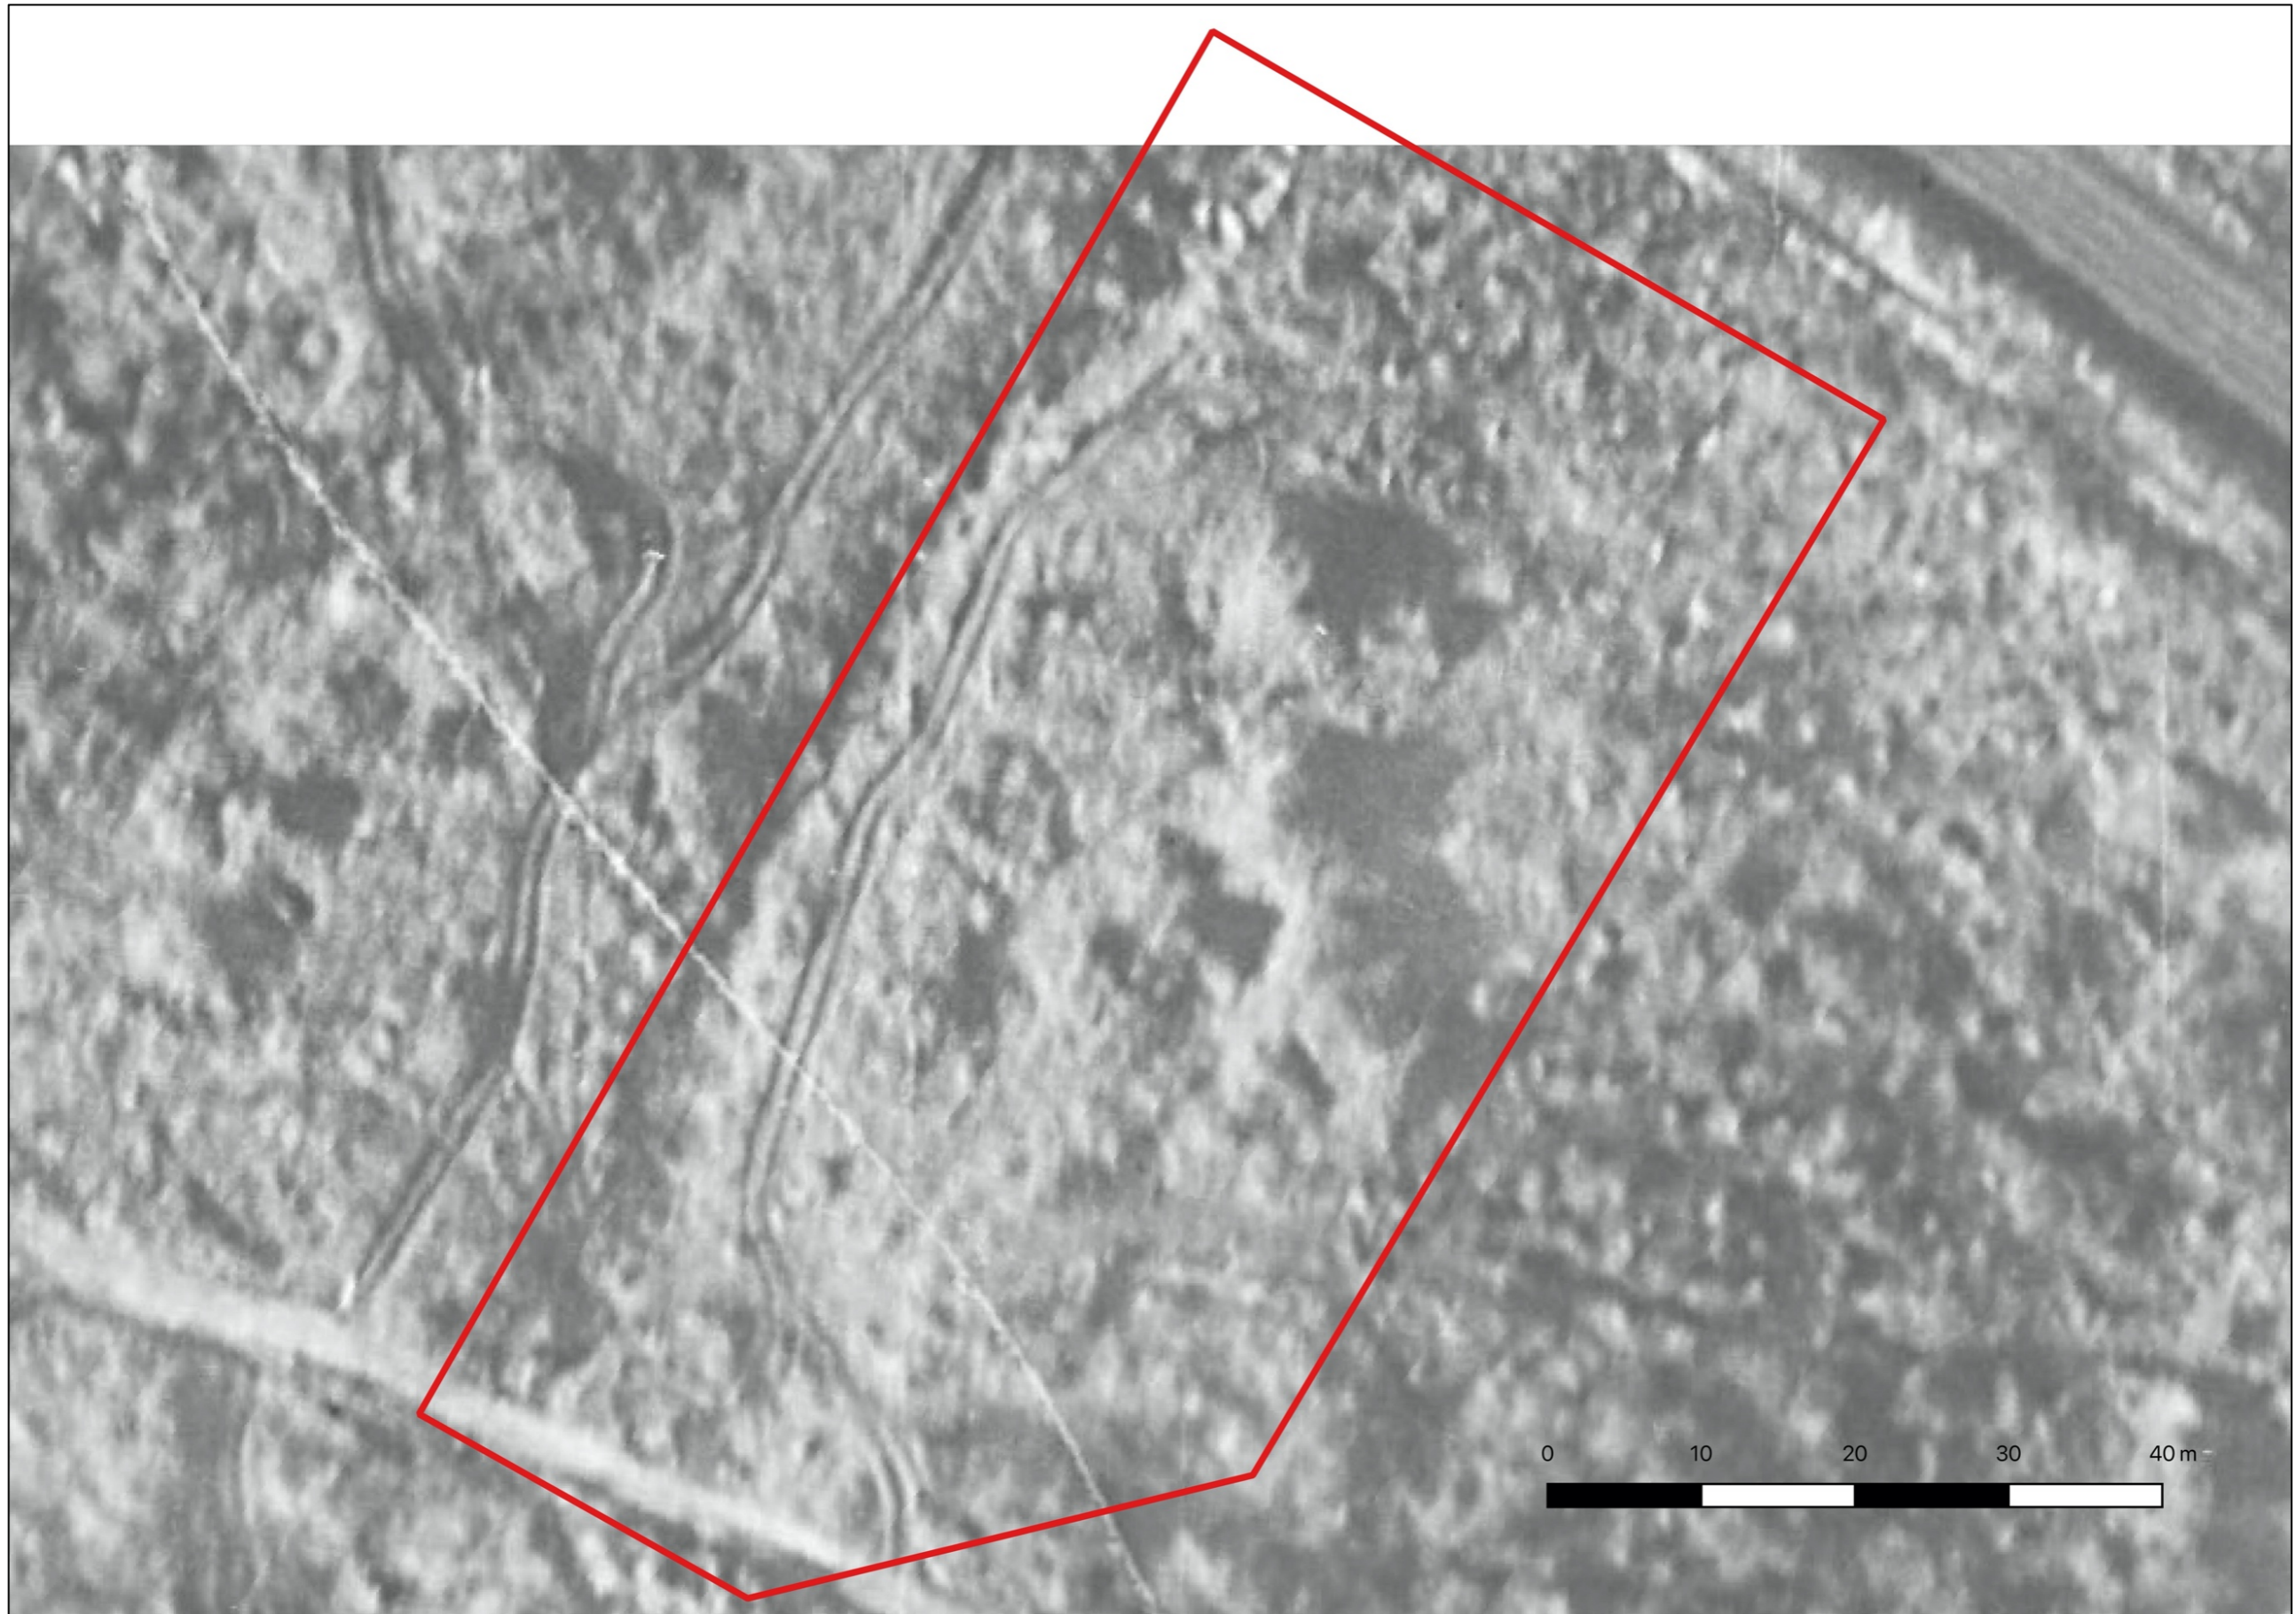
Figure 14. RAF 1946 aerial photograph showing bell pits and spoil mounds (1946 4646 RAF106GUK_1294 6069). Nadir view. © Air Photo Wales.

- 7.1.5 Aerial and historic mapping was studied in detail together with coal authority information and the excellent study by Michael Williams (1958; Plate 2) to correlate the known bell pits and spoil mounds with those identified during the survey. By far the most useful source was Michael Williams Gower entry (1958) and the aerial mapping, particularly the RAF 1946 aerial photographs (Plate 3) that showed the survey area devoid of trees and the bell pits and spoil mounds in great detail (Figures 14-18). The historic images were georeferenced and the bell pits and spoil mounds digitised. These were shown to correlate well with the topographic contour survey (Figures 6, 16-18) indicating the bell pits and in particular the spoil mounds have survived particularly well, despite the recent MTB activity. Later aerial mapping showed gradual reforestation of the wider area but the survey area remaining largely free of trees. By 2006 three large spoil mounds are still visible in a straight N-S alignment (Plate 11) but it is not until 2008 when the first evidence of MTB activity is evident (Plate 12). At this time, around three significant downhill tracks are visible, one track along the line of the spoil mounds together with a number of smaller interconnecting tracks.

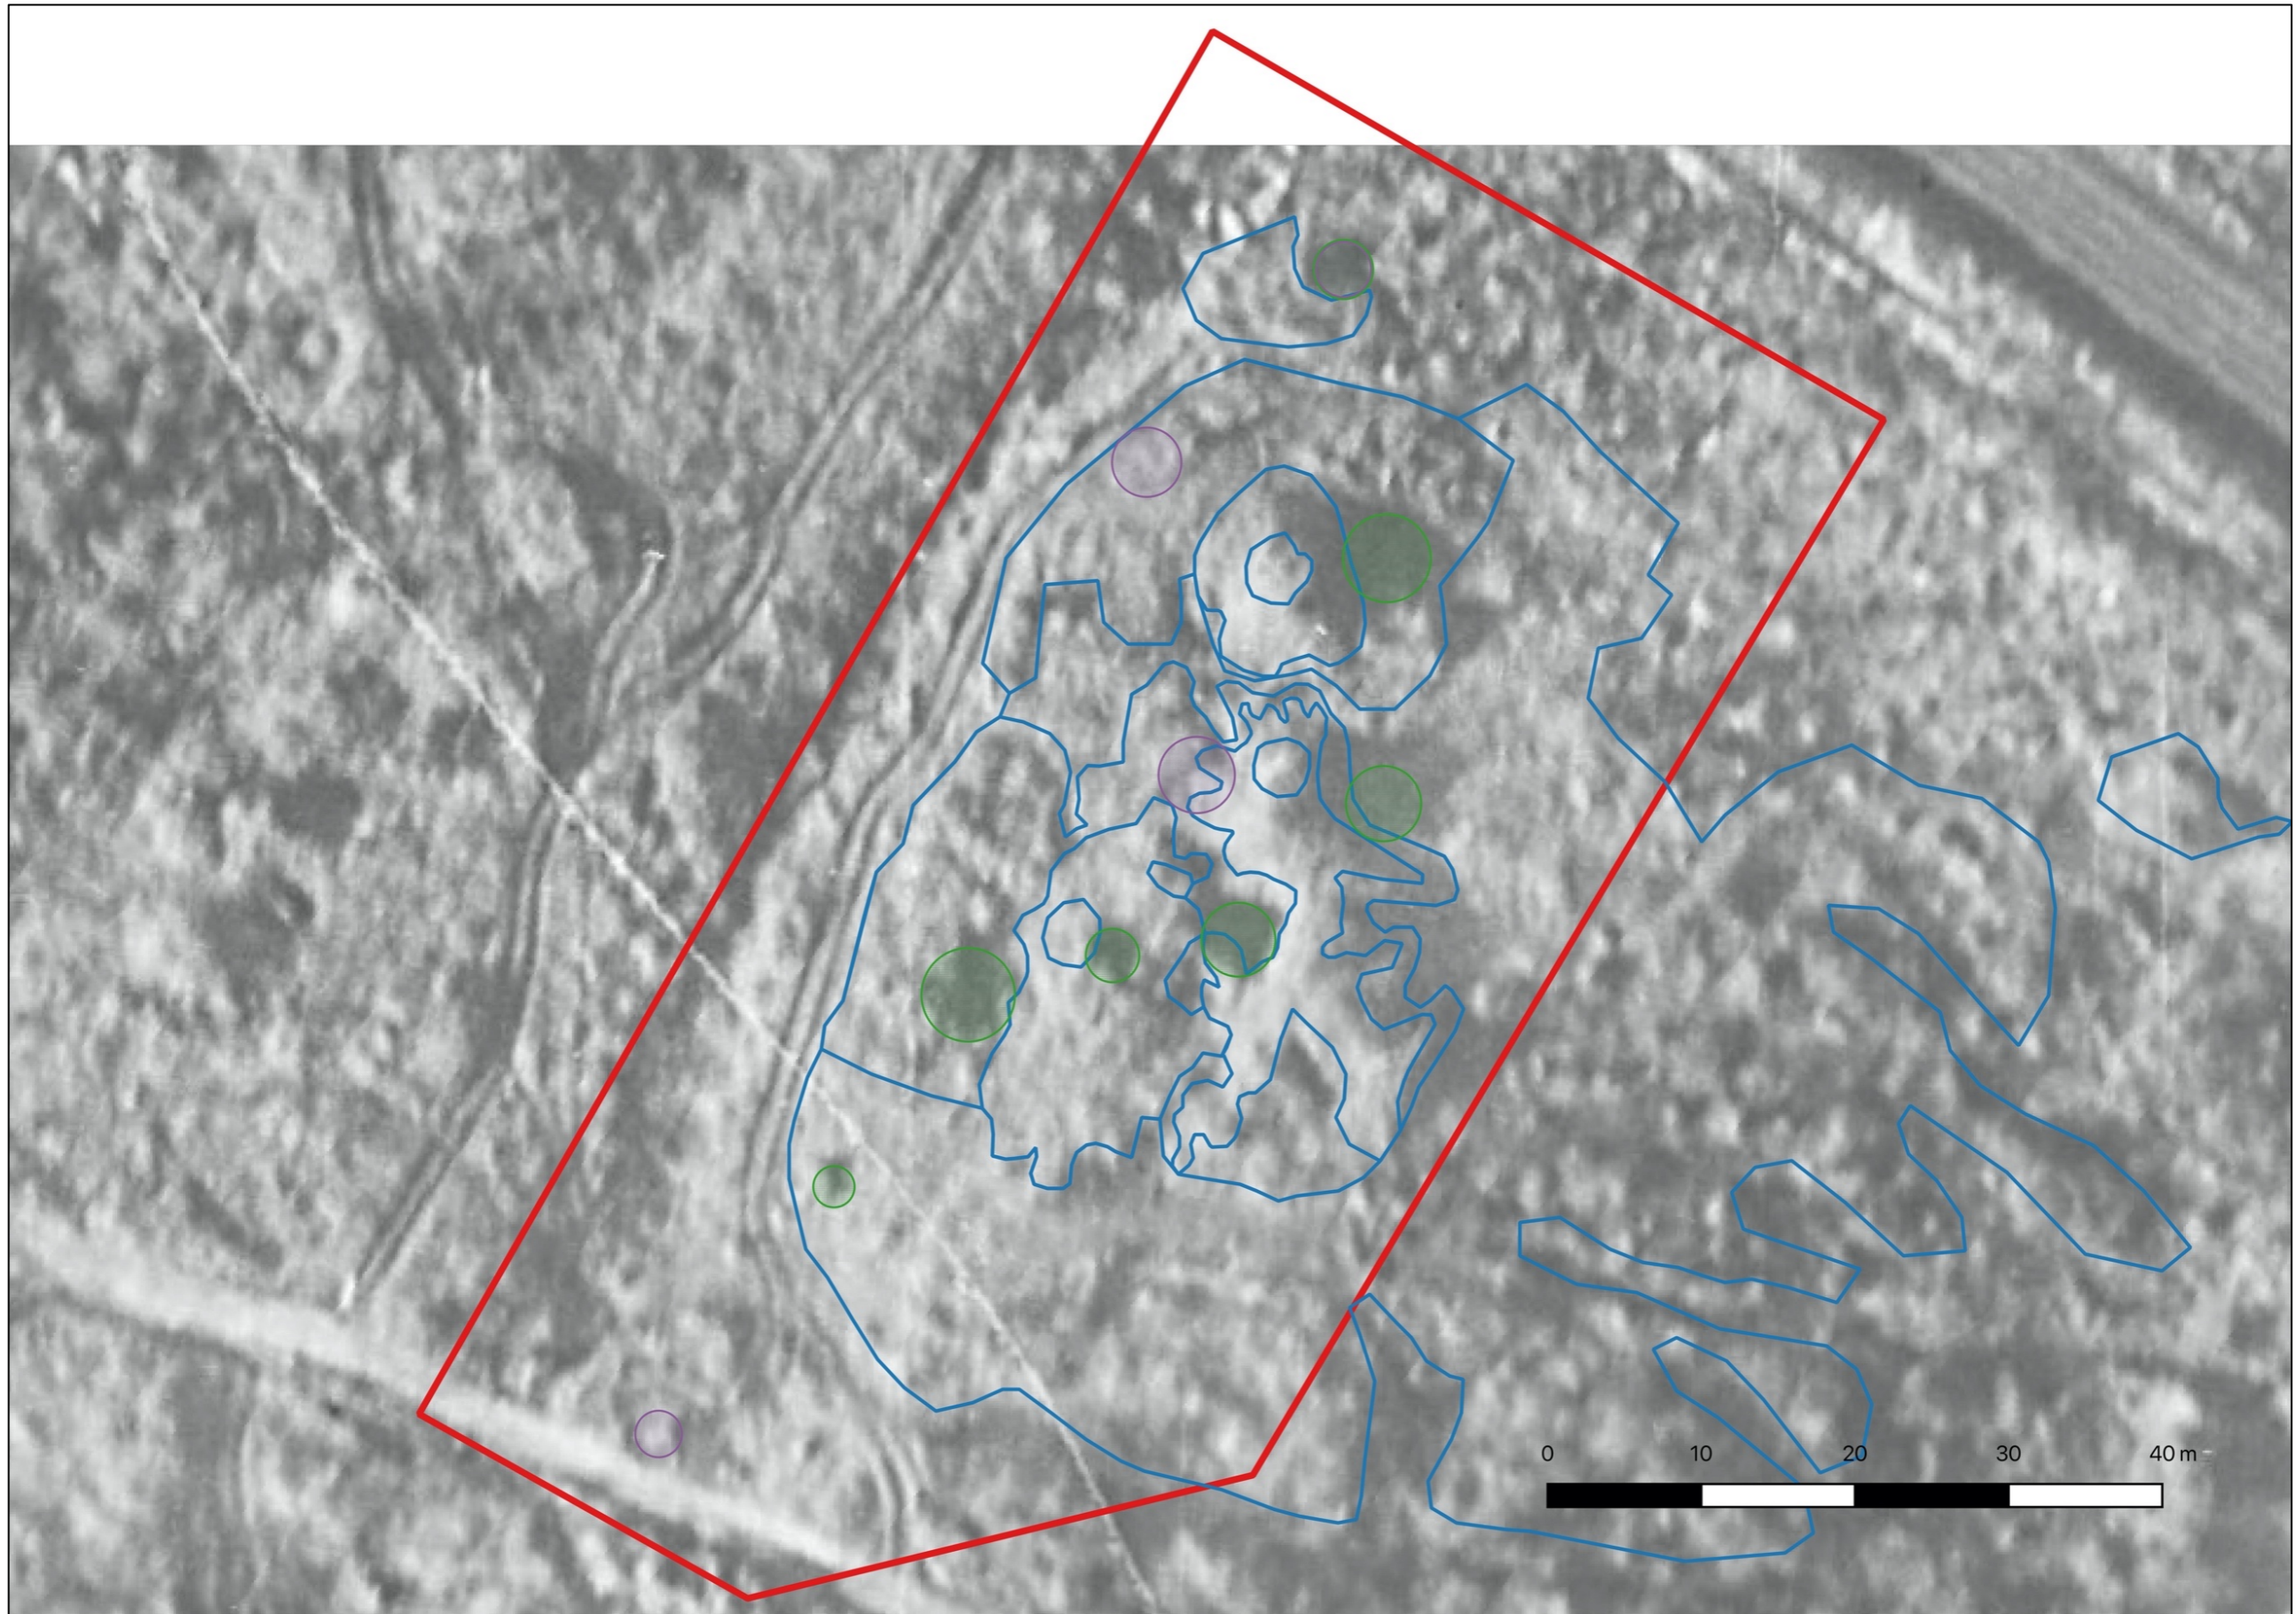
Figure 15. RAF 1946 aerial photograph showing mapped bell pits (green circles) and spoil mounds (blue polygons) (1946 4646 RAF106GUK_1294 6069). Bell pits noted during survey shown as purple circles. Nadir view. © Air Photo Wales.

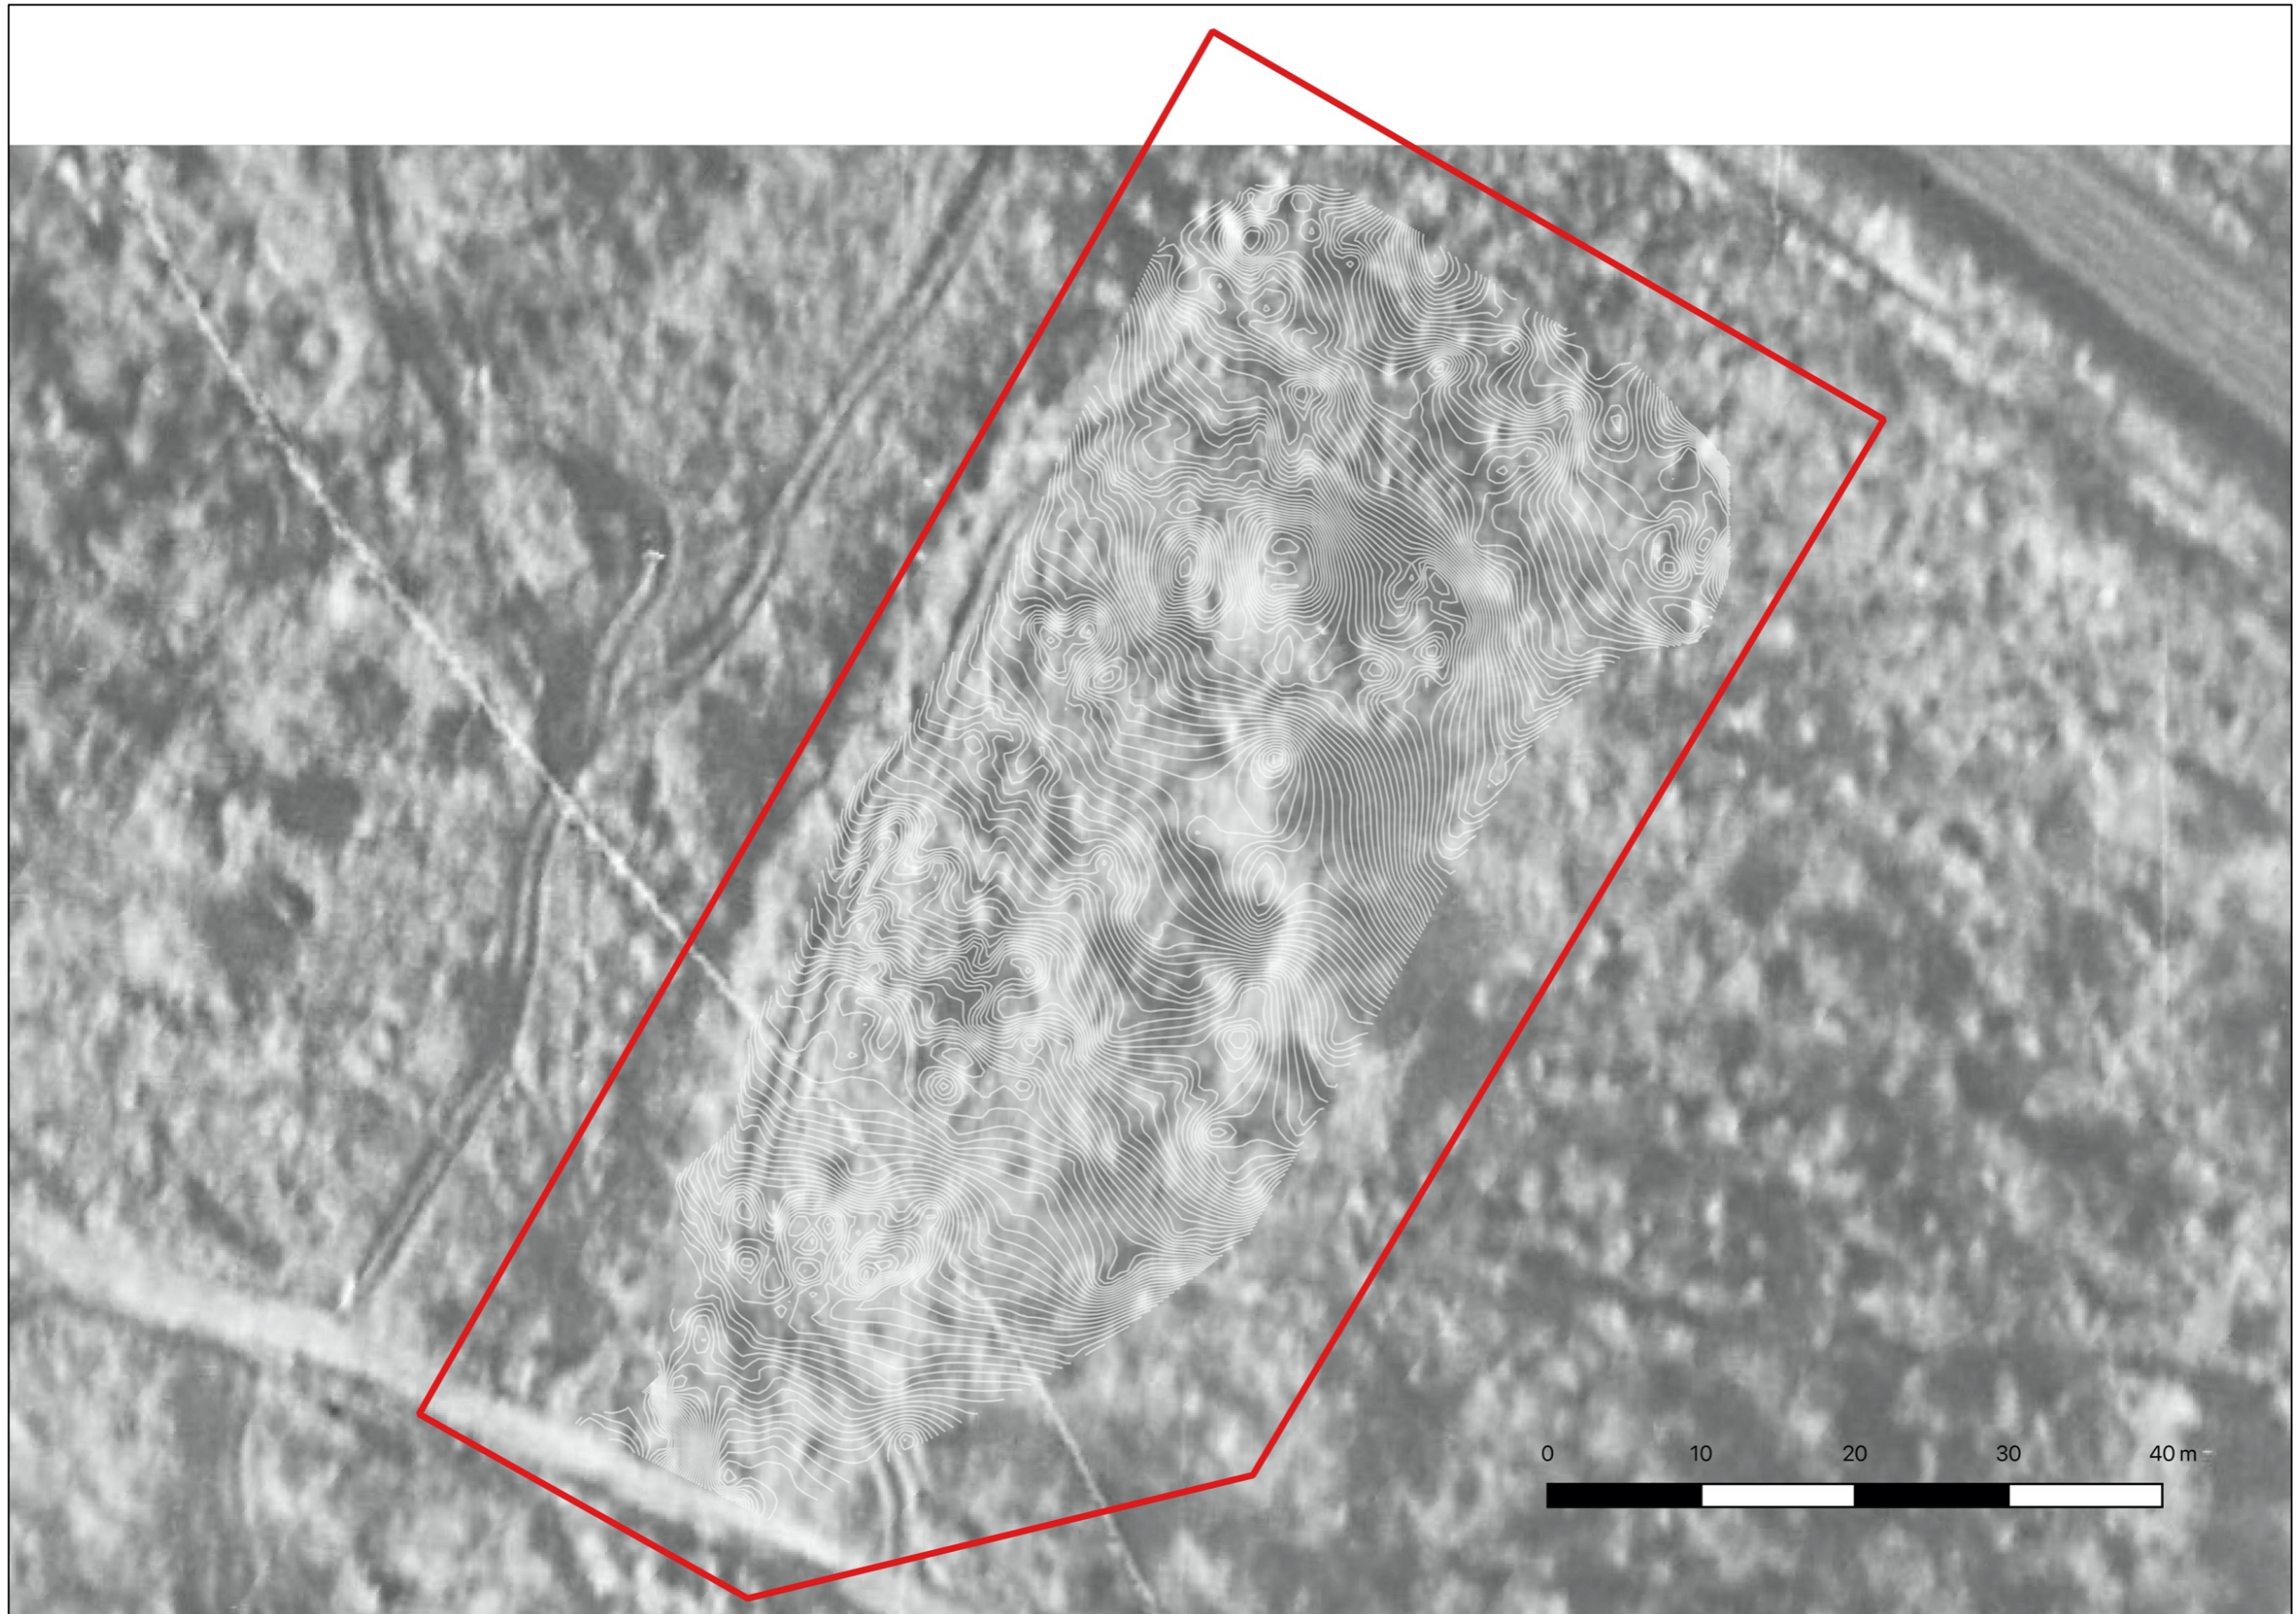
Figure 16. RAF 1946 aerial photograph showing bell pits and spoil mounds with topographic contour survey overlay (1946 4646 RAF106GUK_1294 6069). Nadir view. © Air Photo Wales.

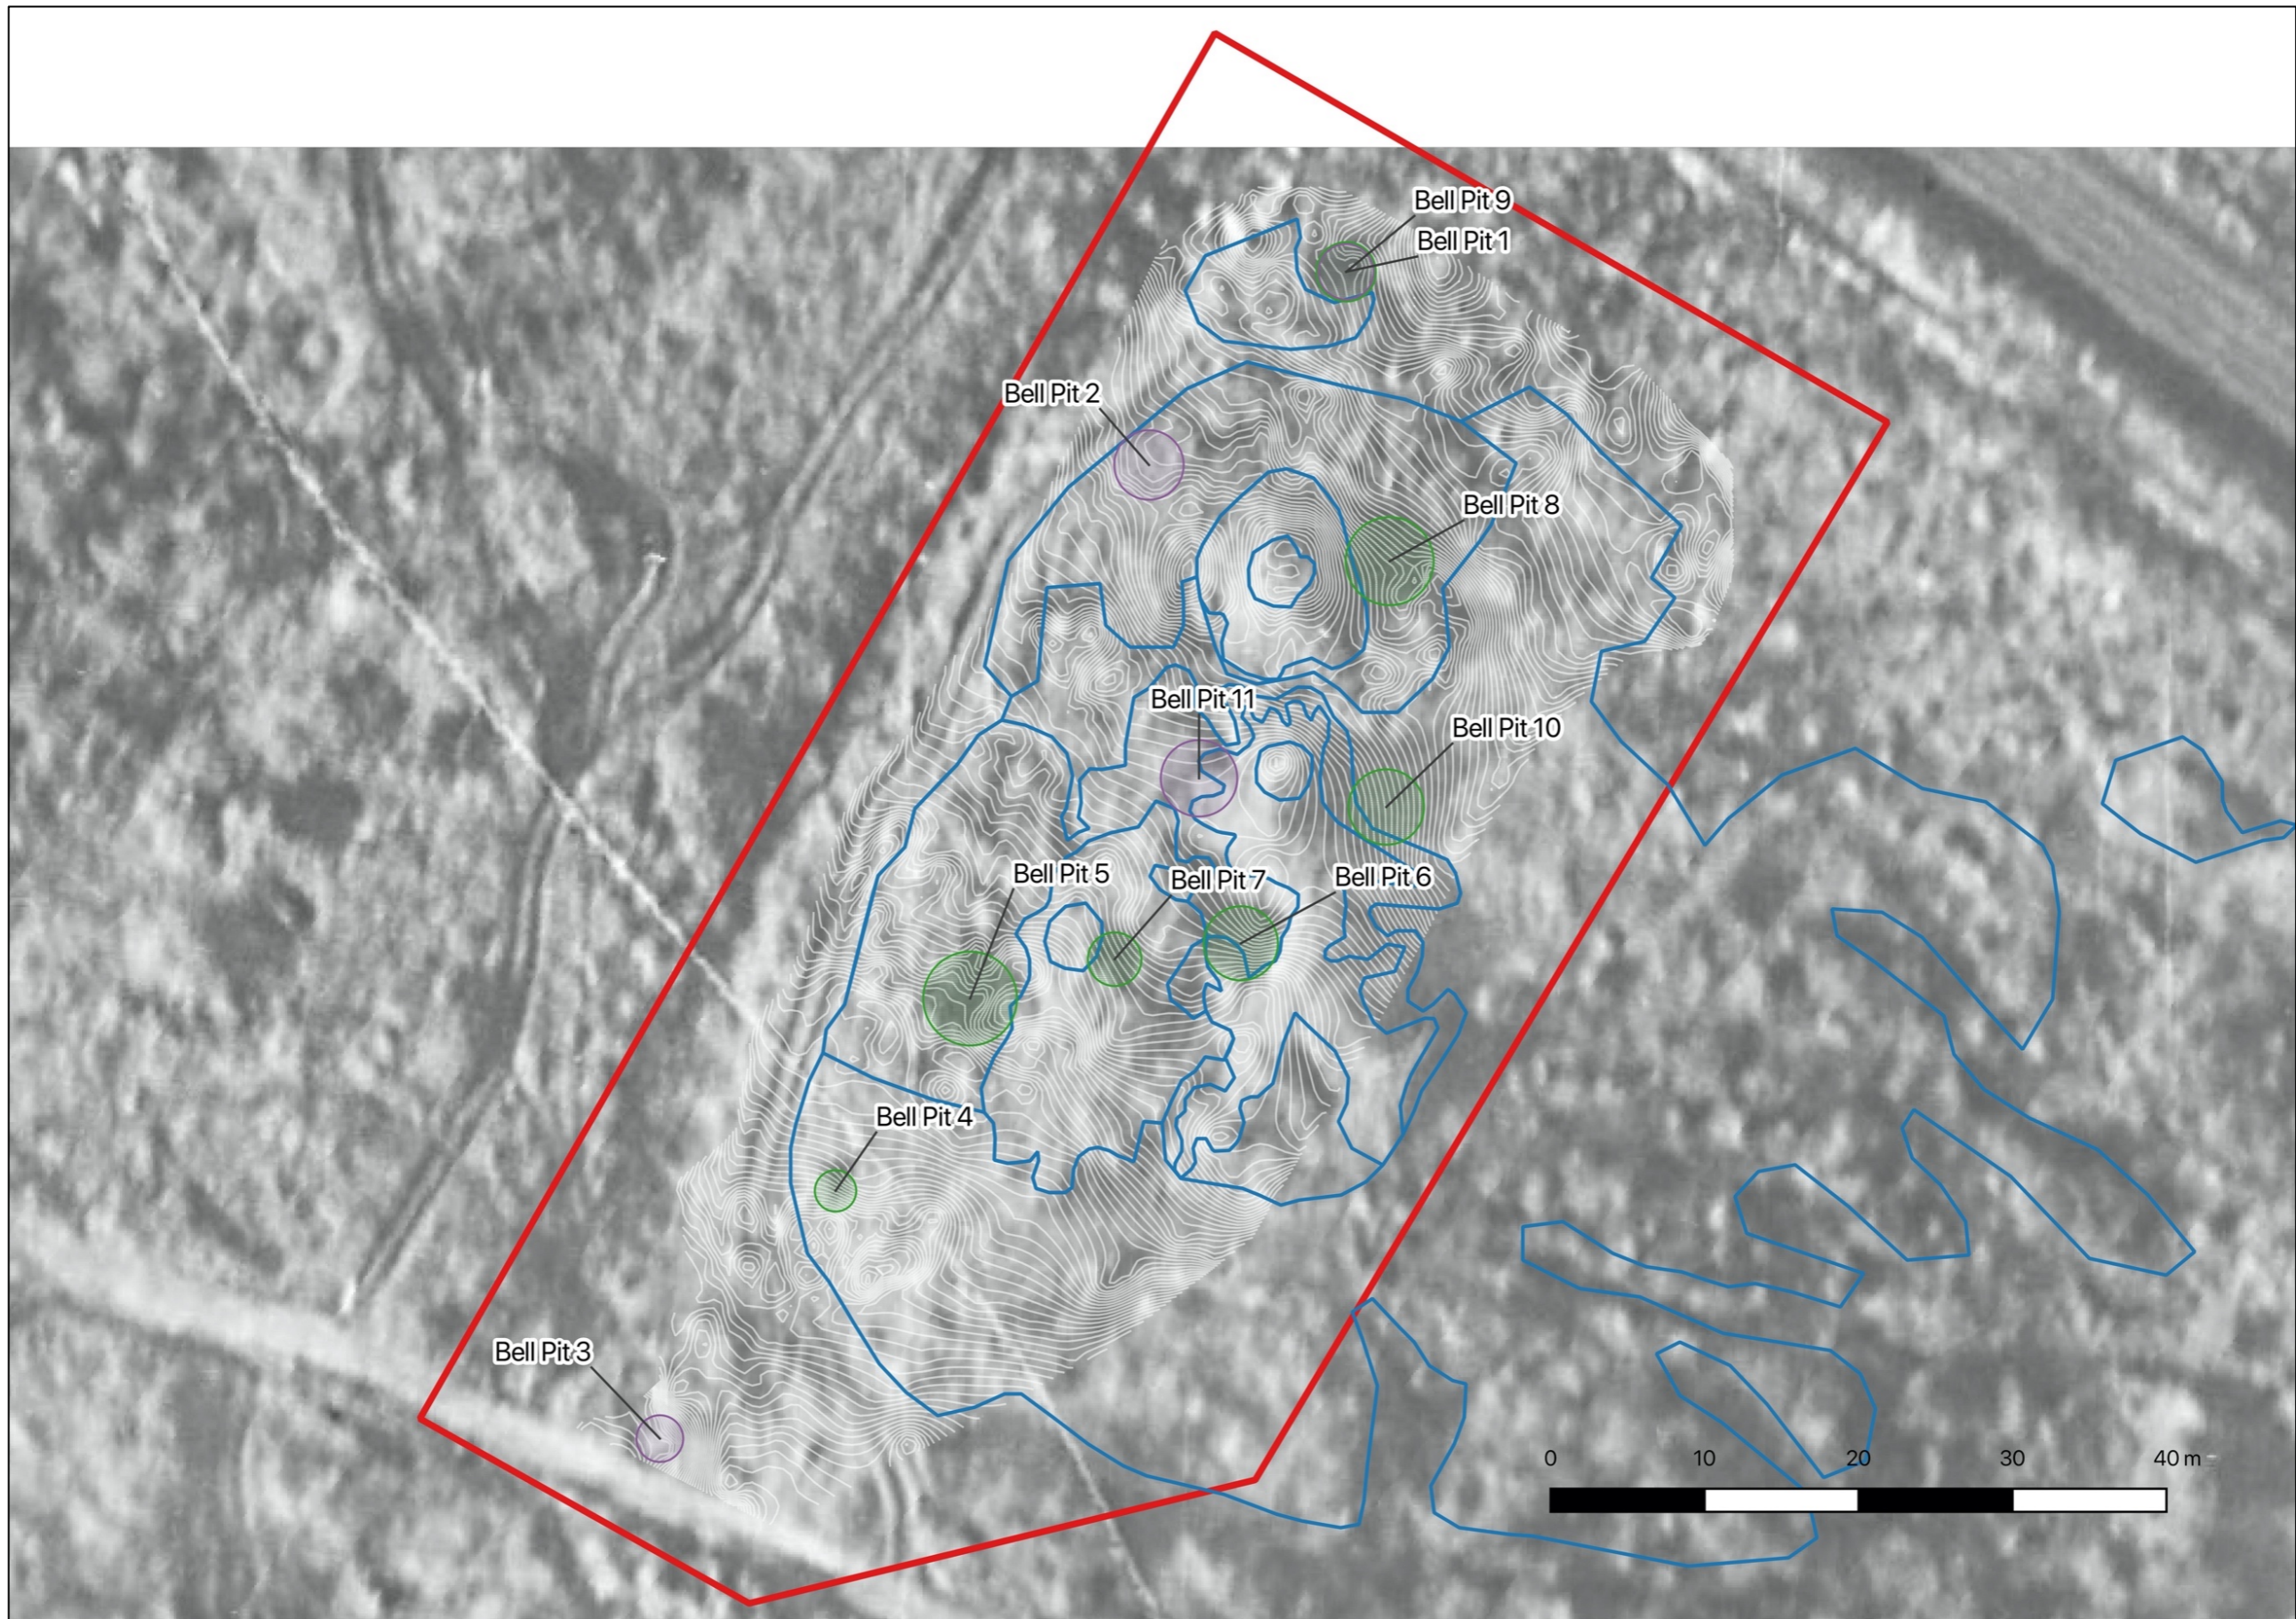
Figure 17. RAF 1946 aerial photograph showing mapped bell pits (purple and green circles) and spoil mounds (blue polygons) with topographic contour survey overlay (1946 4646 RAF106GUK_1294 6069). Nadir view. © Air Photo Wales.
