Clyne Valley Shaft Mounds SAMGm455, Swansea

Archaeological Landscape Monument Survey

City & County of Swansea

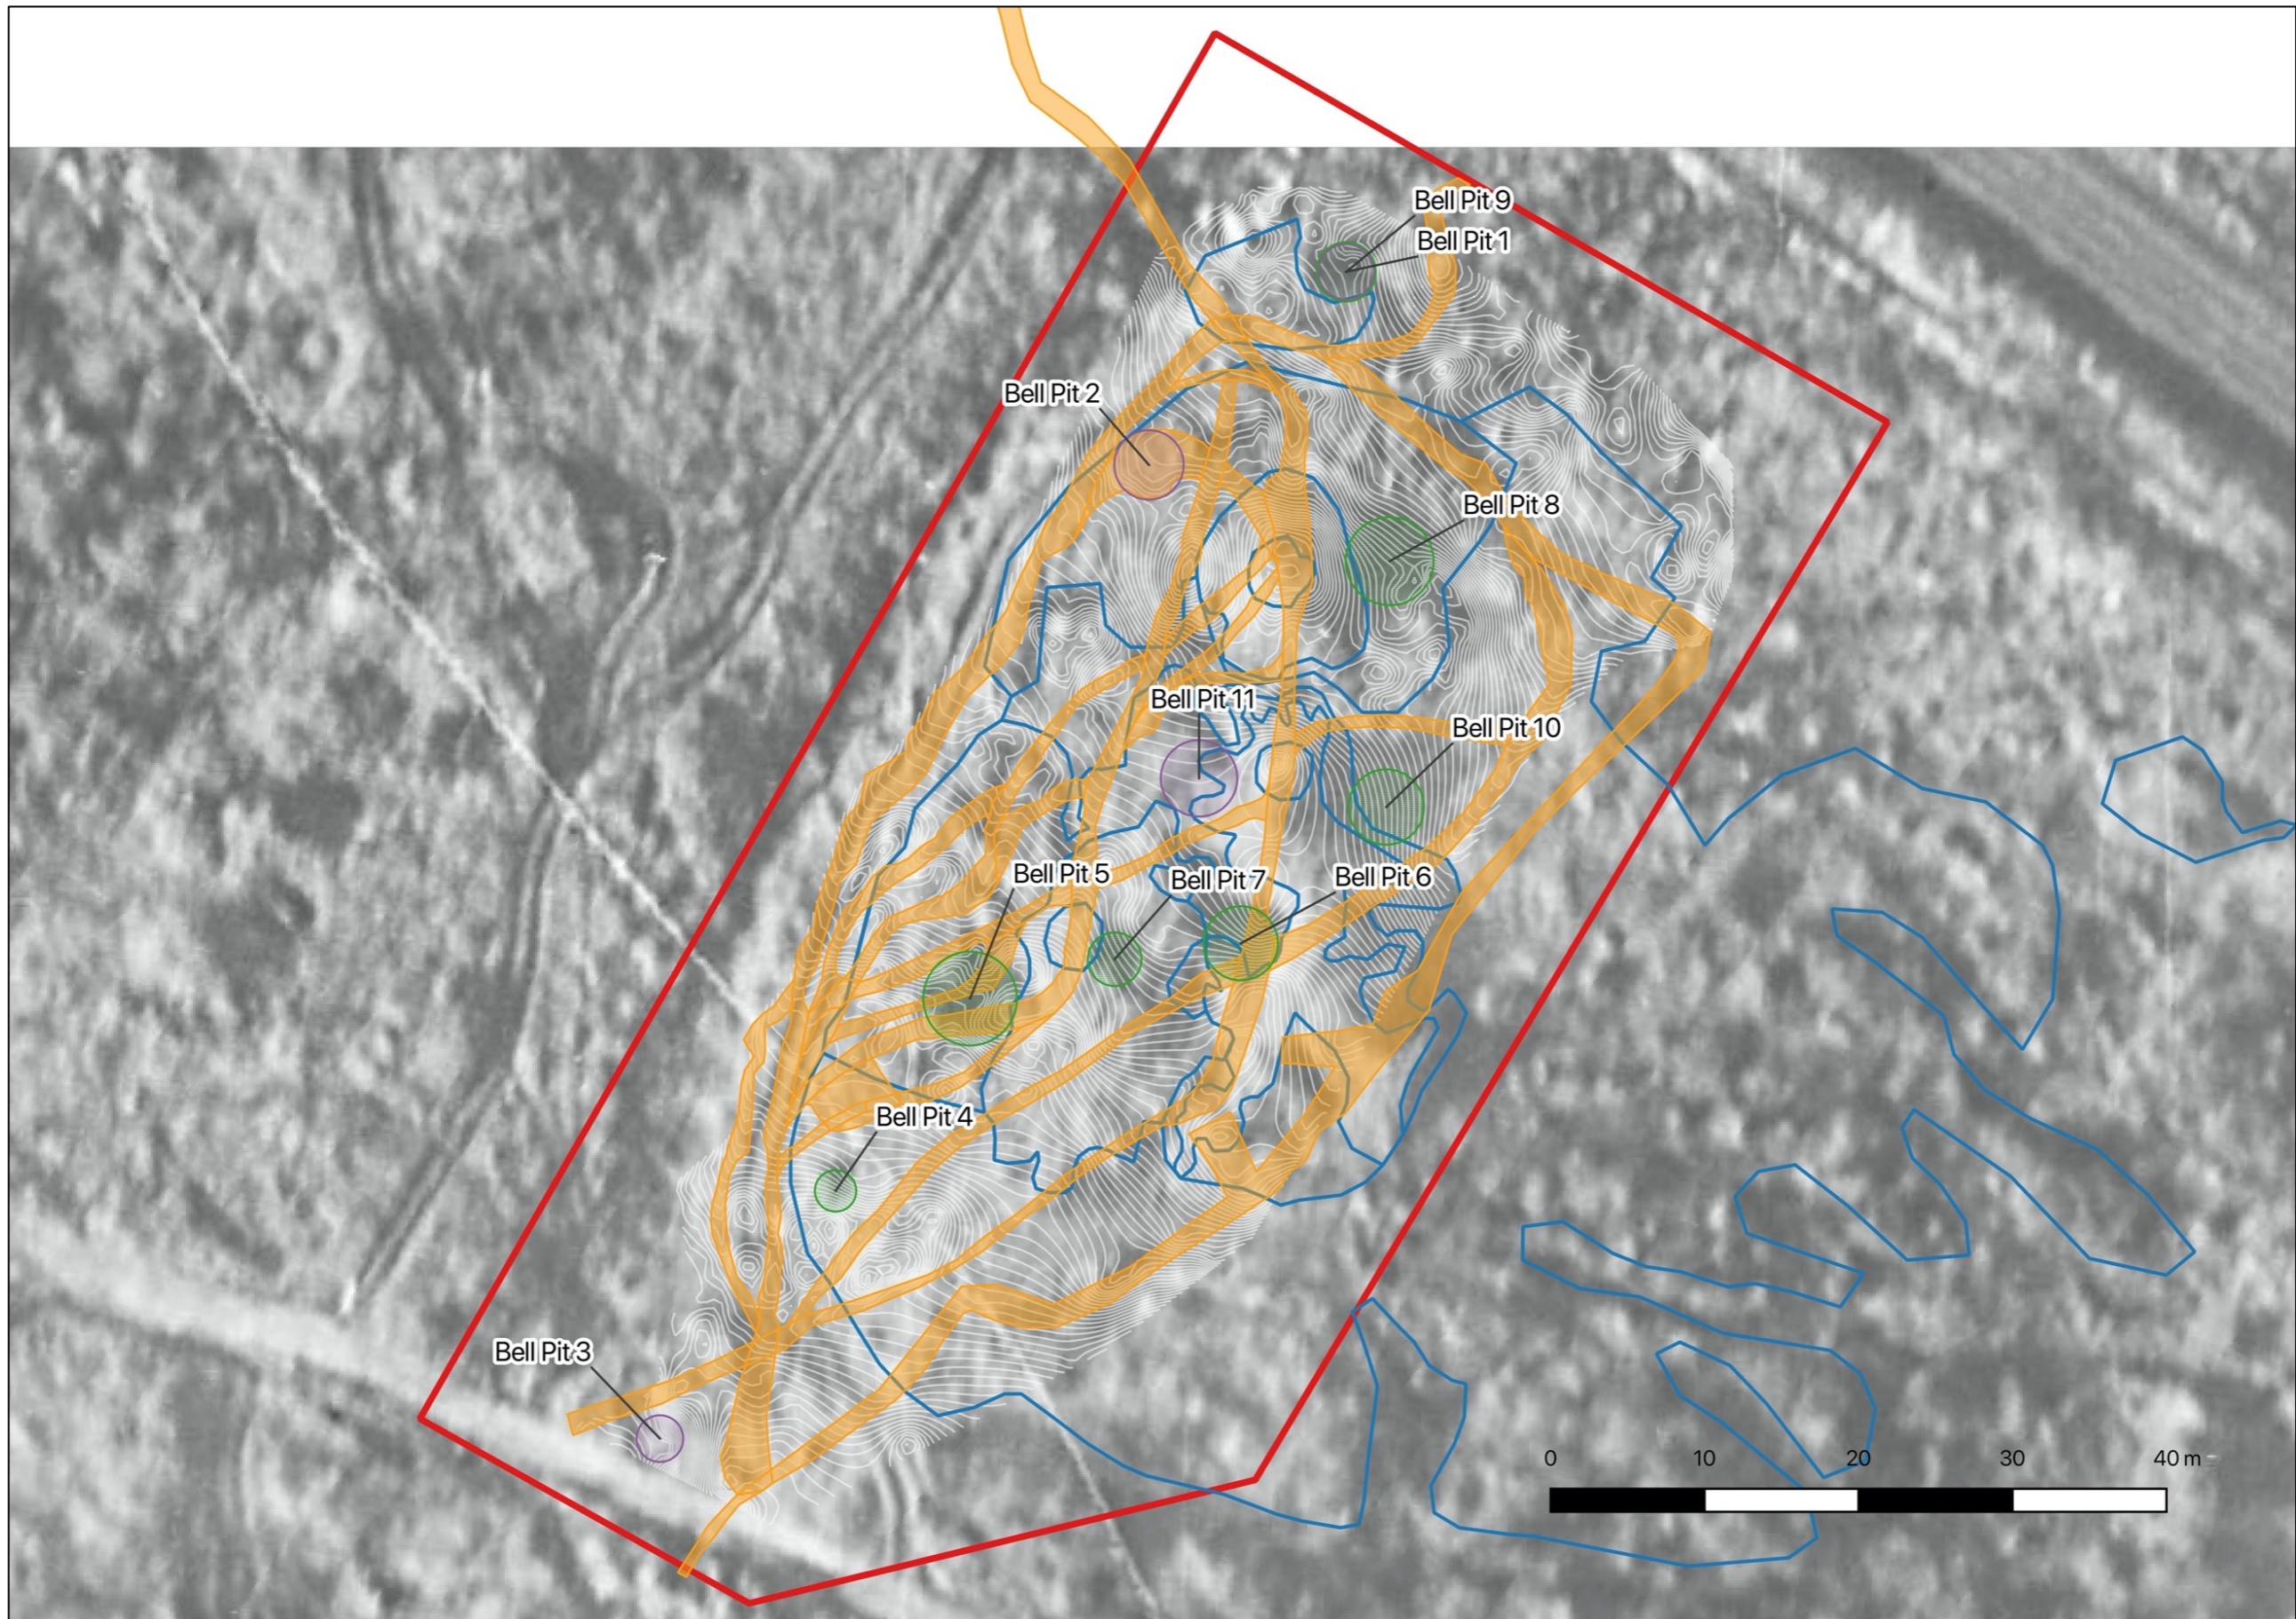
Figure 18. RAF 1946 aerial photograph showing mapped bell pits (purple and green circles) and spoil mounds (blue polygons) with topographic contour survey and MTB tracks overlay (1946 4646 RAF106GUK_1294 6069). Nadir view. © Air Photo Wales.

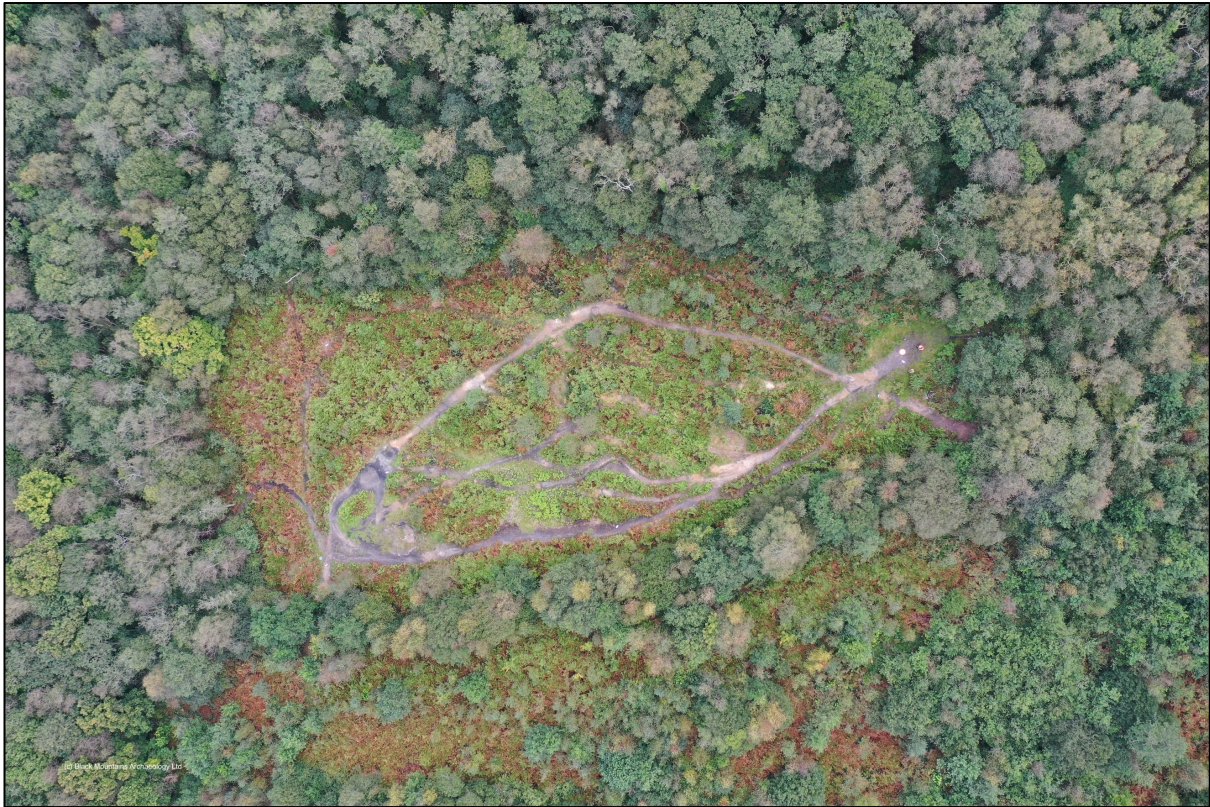
- 7.1.2 The survey area (Figures 1 and 2; Plate 1) is an open area of scrub covered largely by bracken fern. The former LNWR, now National Cycle Network Route 4, runs along the NE boundary. To the SE is established deciduous woodland, to the NW recovering deciduous woodland and scrub. To the SW is more established woodland rising to 120mOD towards Clyne Farm. At least three clearly visible MTB tracks were observed aligned NE/SW through the bracken. The latter obscuring several more. It was assumed at the commencement of the survey that this area of the scheduled ancient monument had been extensively excavated by MTB enthusiasts to create the sweeping tracks, ramps and jumps visible in the bracken. Some excavation was noted exposed along the sides of the MTB tracks and discrete areas used to quarry clay for the ramps and corner bunds (Plate 4). A large hole had been excavated part way down the far eastern MTB track to create a bund for an adjoining corner. Ironically, a broken bicycle had been dumped into the quarried area (Plate 5).

Plate 1 – Aerial view of the mountain bike tracks through Clyne Valley Shaft Mounds SAMGm455.

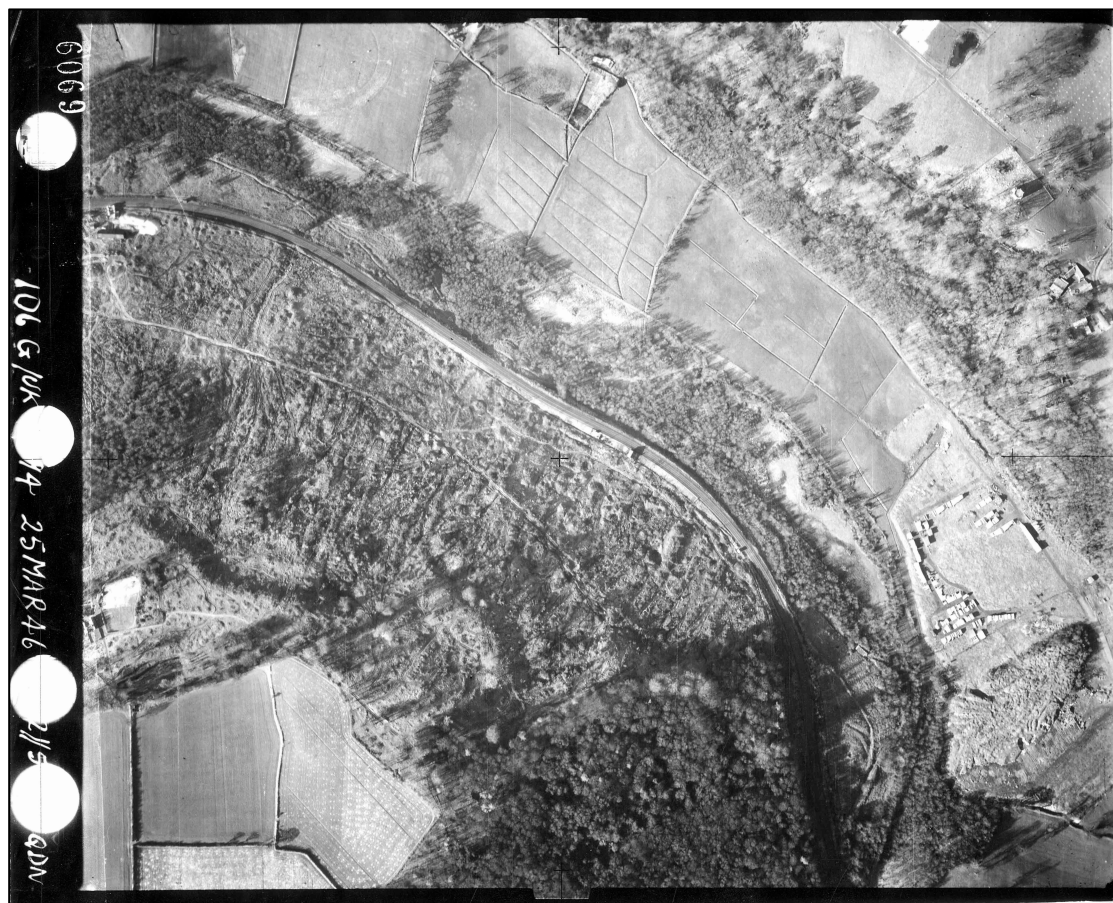
- 7.1.6 A trackway was noted at the far south of the site which married well with forestry track visible on the 1946 aerial photograph (Plate 3). Further bell pits were visible as water filled depressions from the edge of and outside the survey area in the woodland

Plate 3 – RAF 1946 aerial photograph showing bell pits and spoil mounds (1946 4646 RAF106GUK_1294 6069). © Welsh Government1.

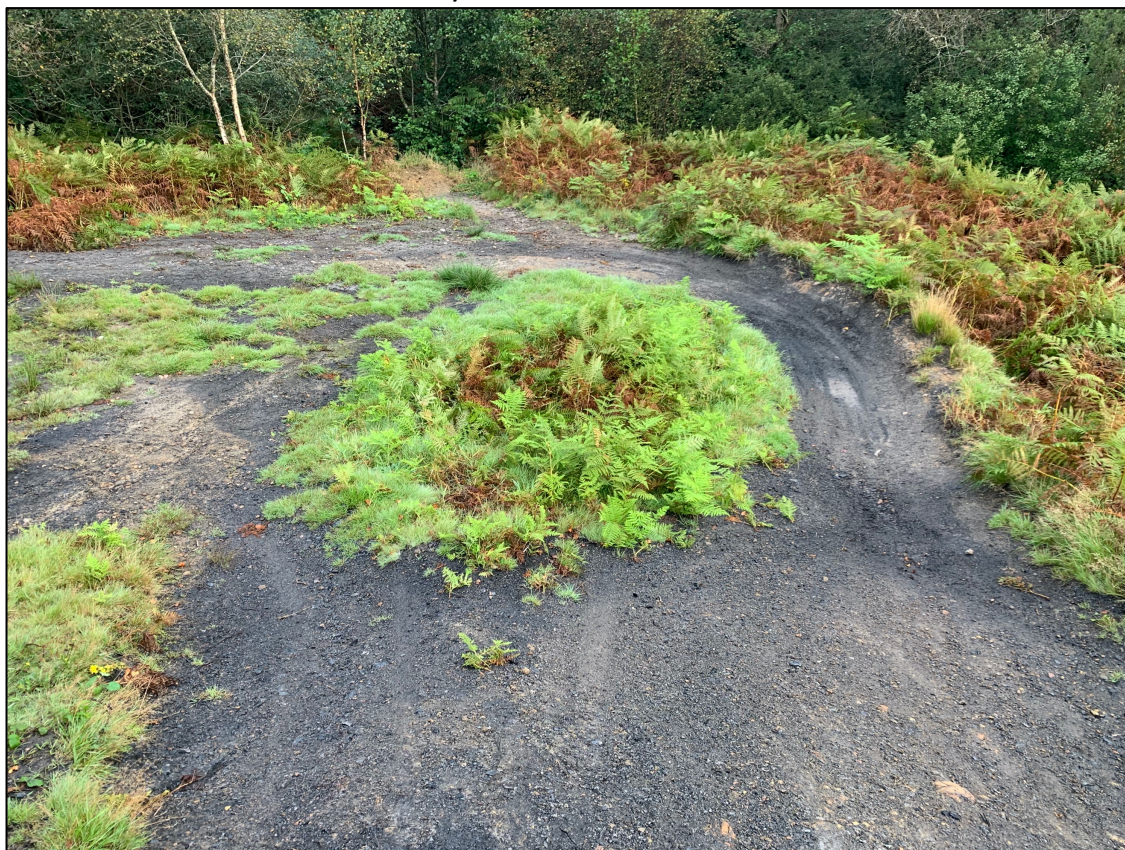
Plate 4 – (IMG5177) View to NW of MTB earthwork corner (right) and track leading NW to cycle track.

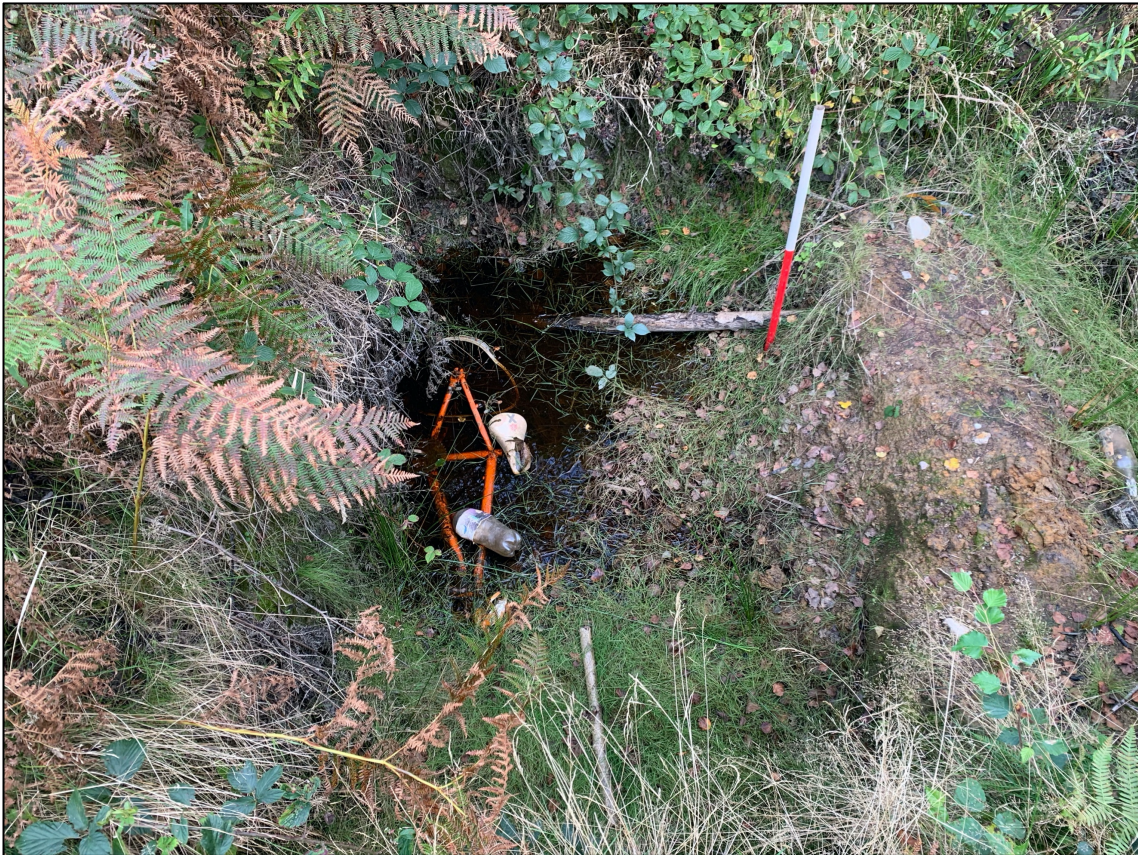
Plate 5 – (IMG5203) View of possible bell pit quarried for clay to build corner bund of far E MTB track.

- 8.1.4 Some remediation work would be beneficial to restore the monument and remove the evidence of MTB excavations and banking. The tops of the three larger spoil heaps have shallow scoups excavated into the tops and together with the MTB track corners these could be restored. The larger excavated areas (Plates 5 and 8) may need archaeological intervention before being back-filled so that we fully understand the

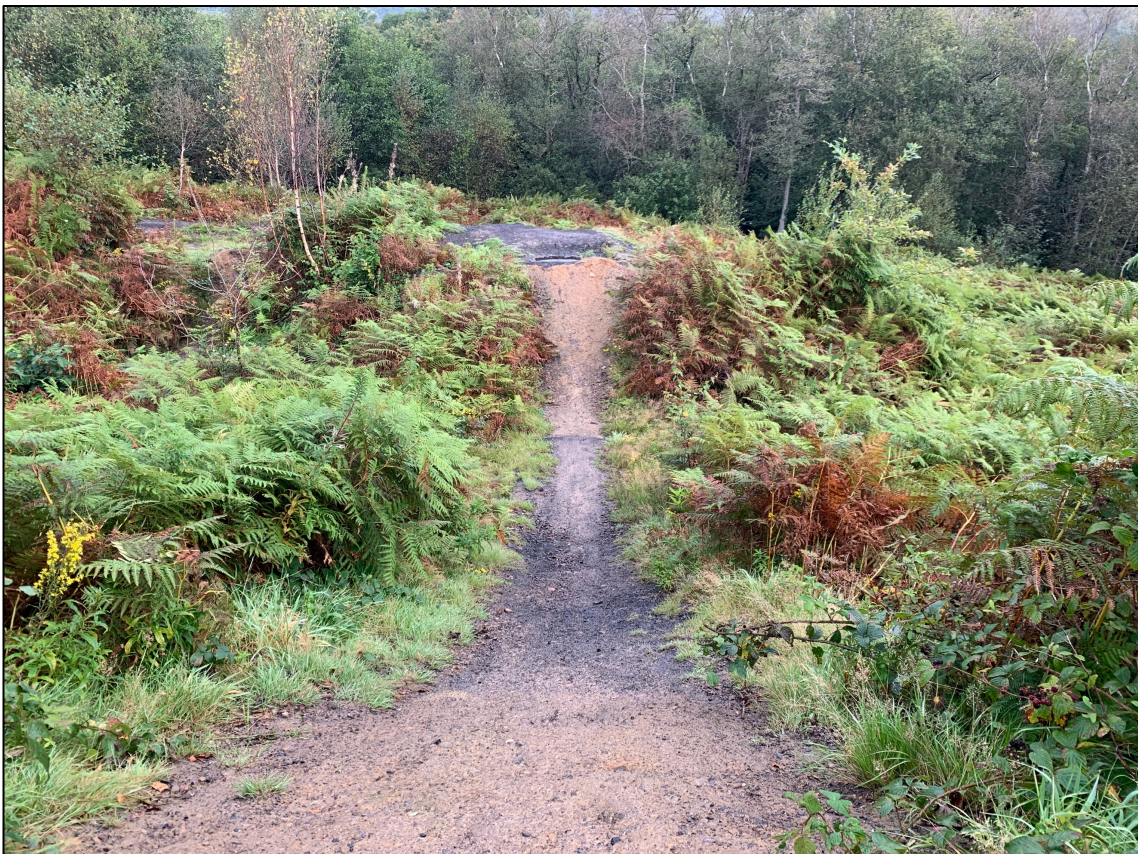
- 7.1.3 Three large mounds were located in the centre of the survey area in broadly a N-S alignment (Plates 6-7). From N-S measuring 9m, 7m and 8m in diameter respectively. These mounds had been incorporated into one of the more established MTB tracks. There were also at least another nine smaller mounds or historic spoil areas but identification of these features was hampered by the bracken cover. Four bell pits were visible (Plates 6-7, 9 and 10), although one (Bell Pit 2) to the NW of the survey area may be a scrape from MTB activity (Plate 8), with a further two bell pits partially obscured by bracken (Plates 9). Review of historic aerial photographs identified a further four bell pits, which compared well with the depressions noted in the contour survey. Bell Pits 1 and 9 being one in the same (Plate 10).

Plate 6 – (IMG5175) View N of largest bell pit mound (centre) and Bell Pit 6 (centre bottom).

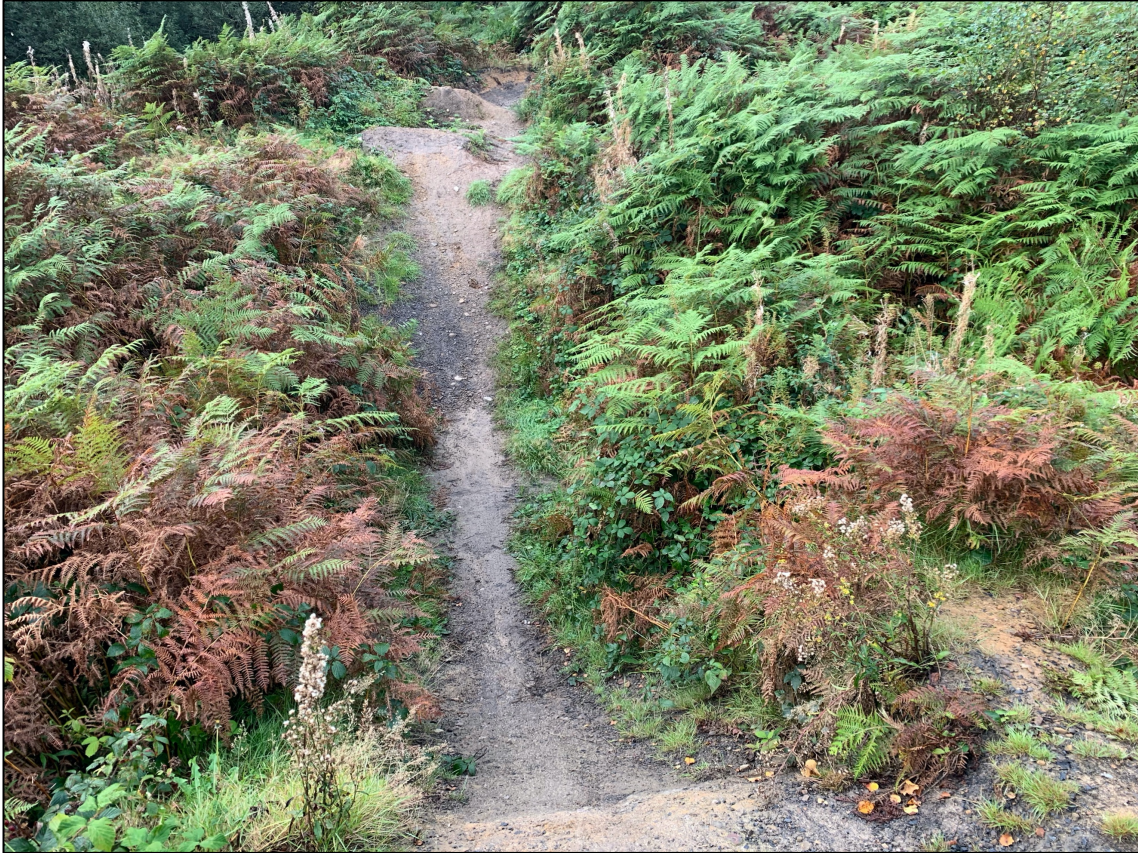
Plate 7 – (IMG5173) View S from large N bell pit mound.

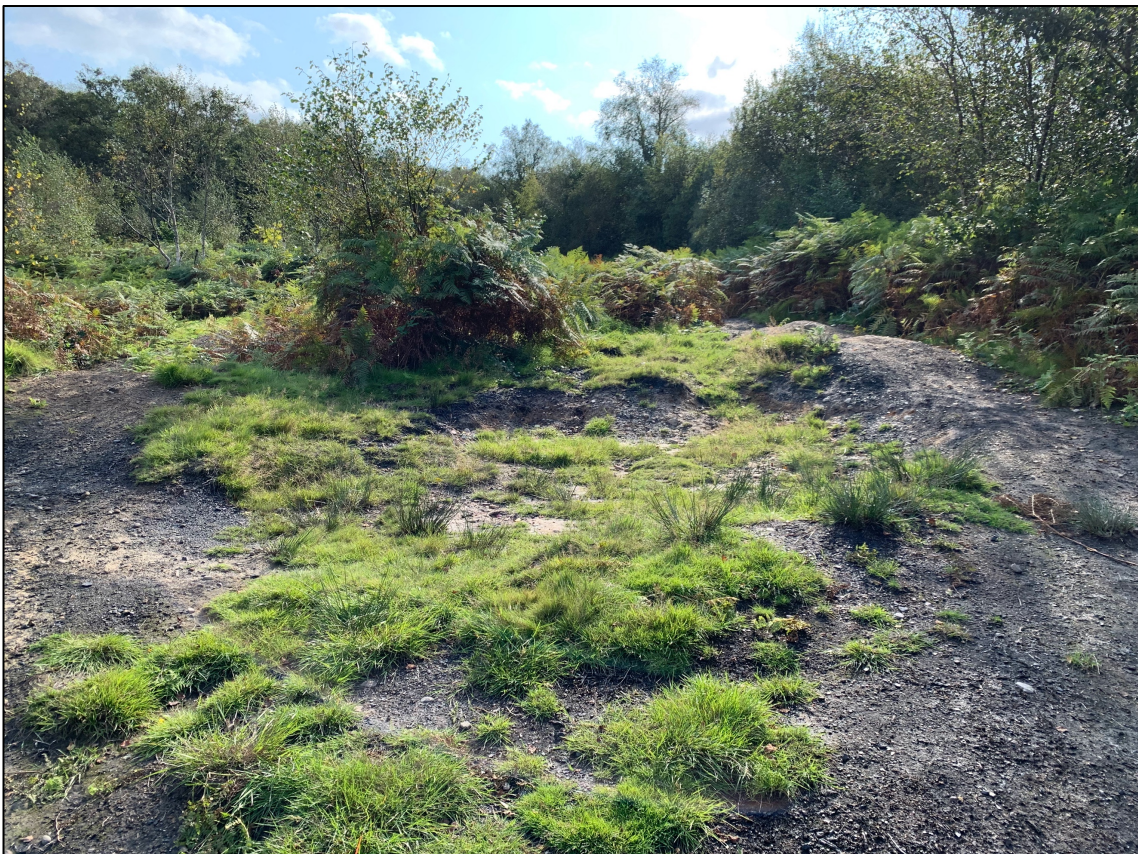
Plate 8 – (IMG5189) View SW of Bell Pit 2 or MTB quarry.

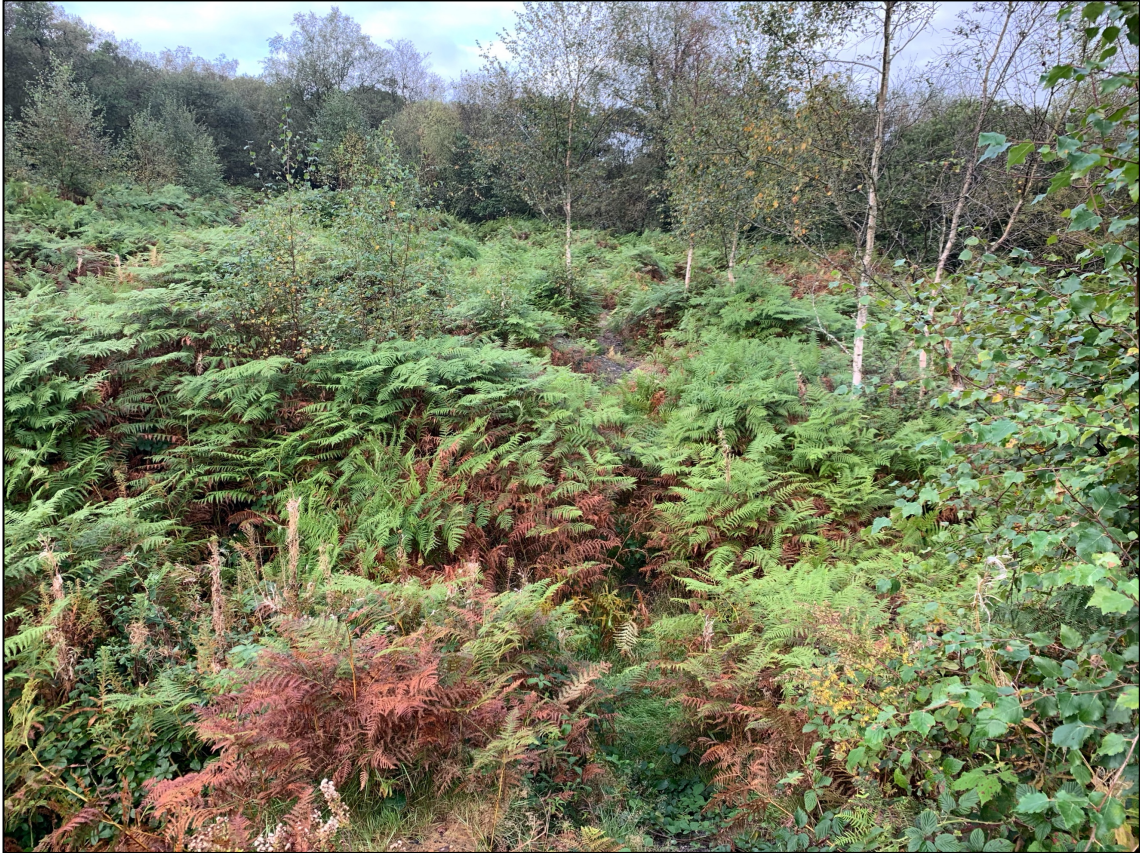
Plate 9 – (IMG5174) View SW of Bell Pit 11 hidden in the bracken.

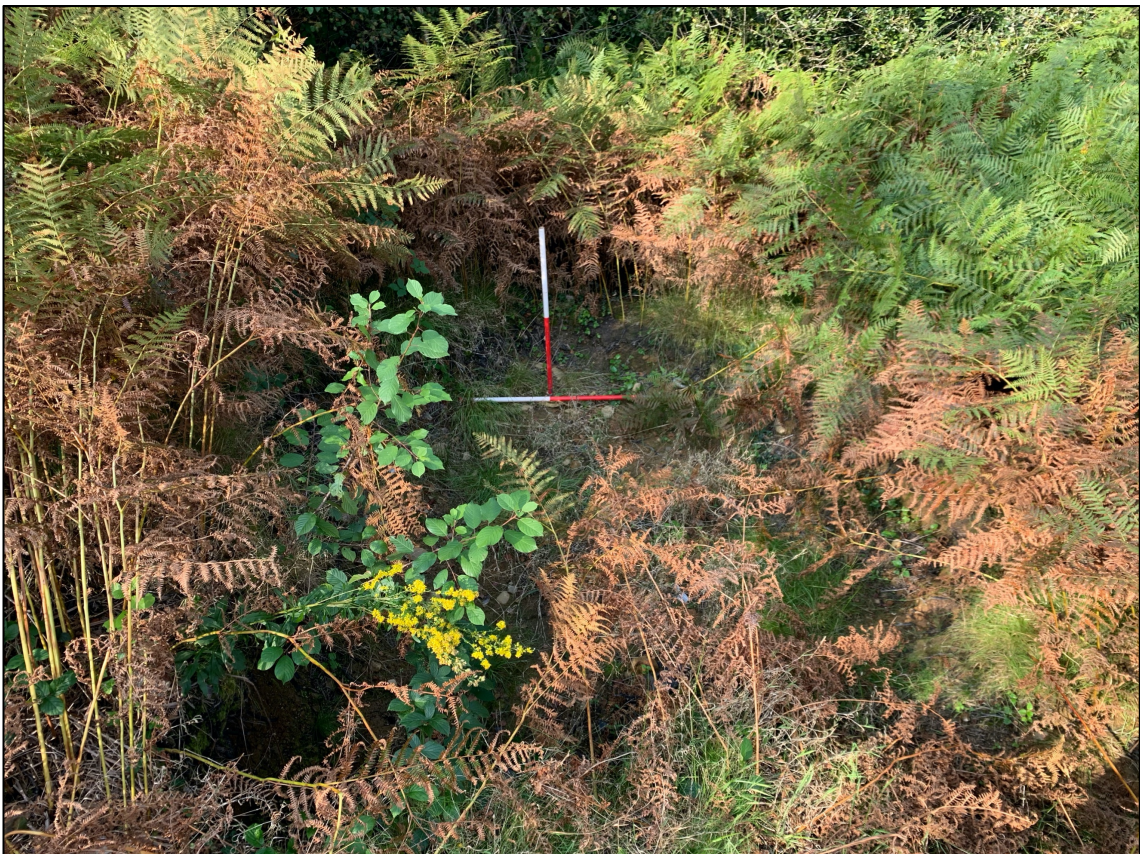
Plate 10 – (IMG5190) View N of Bell Pit 1/9.

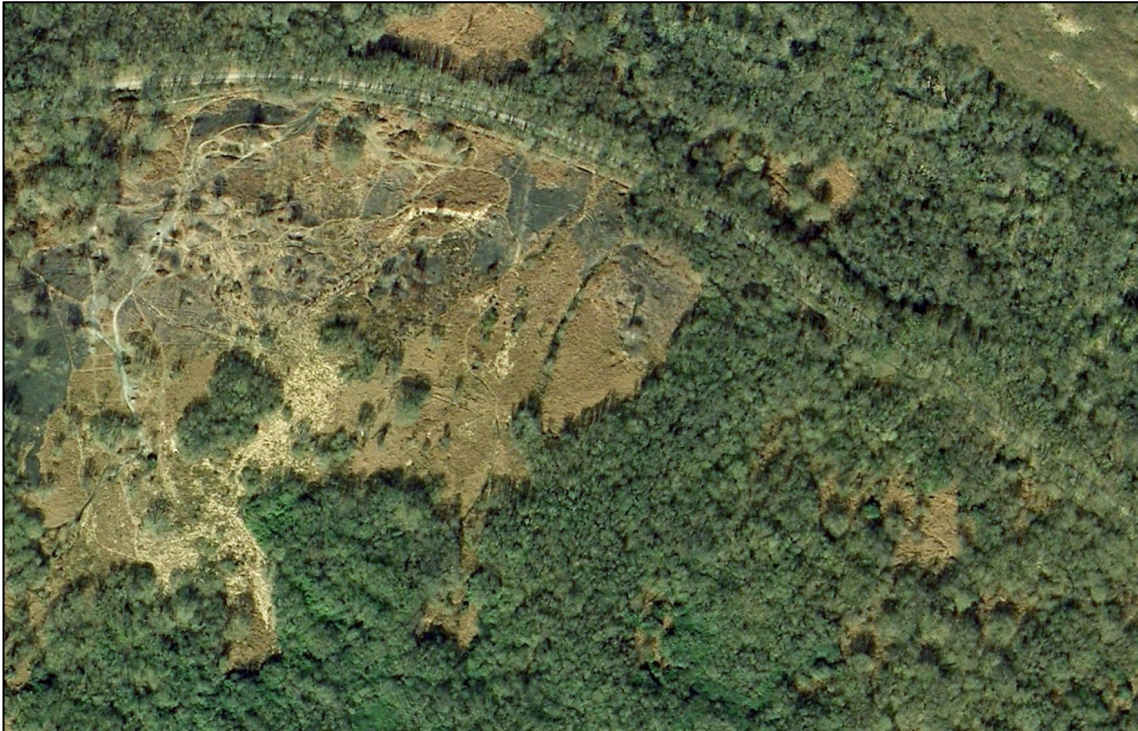
Plate 11 – 2006 aerial image showing no MTB tracks © Map data 2020 Google.

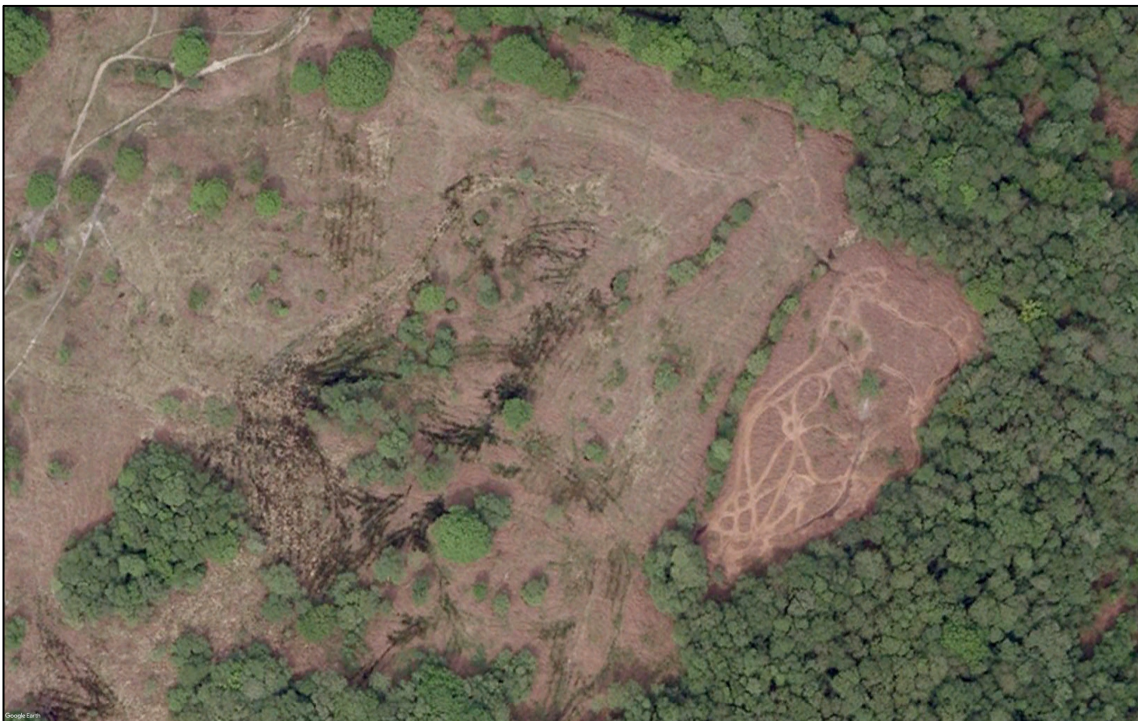
Plate 12 – 2008 aerial image showing MTB tracks © Map data 2020 Google.
