**Ty Canol,
Llangorse, Brecon, LD3 7UB
PL/AP/17/15037/FUL
Archaeological Watching Brief**

Mr Andrew D Milton,

Ty Canol, Llangorse, Brecon, LD3 7UB

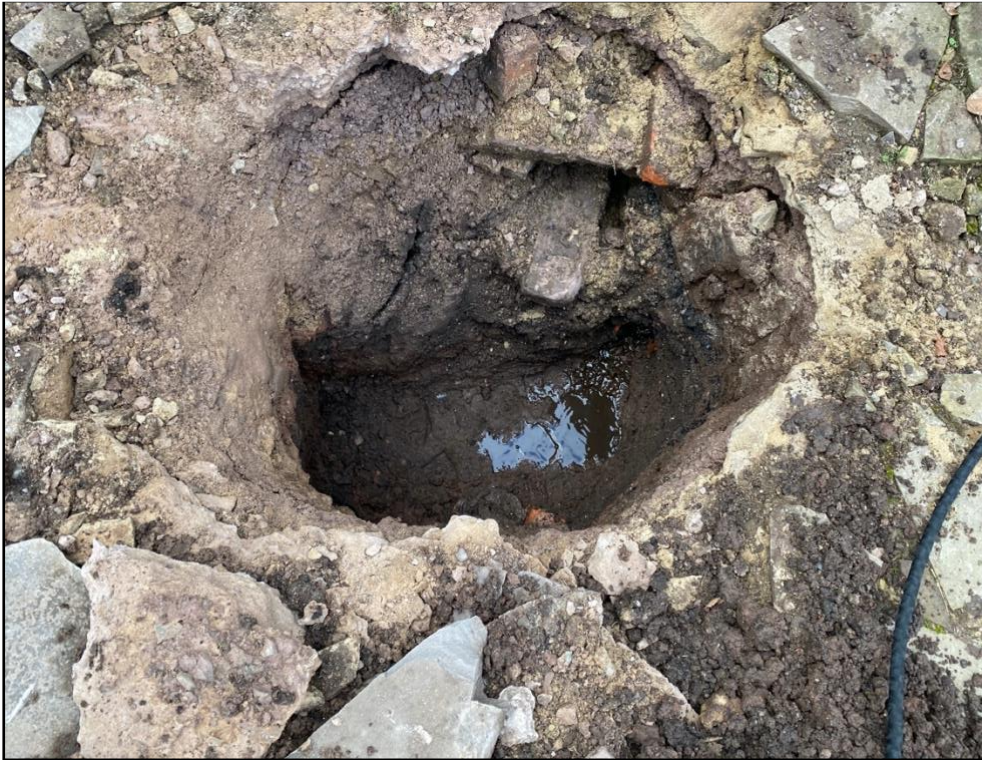
- 3.1.2 **Test Pit 1**
- 3.1.3 Test Pit 1 was situated on the northern edge of the property and measured 1.2m east/west, 1m north/south and 1m in depth. The level of the ground surface at the top of the test pit was 172.50mOD, while the level at its base was 171.47mOD. The south facing section of the test pit was recorded. The uppermost deposit encountered within Test Pit 1 (101) comprised a hardcore deposit for an exterior patio, 0–0.1m deep. Underlying this hardcore was a deposit of mid-brown silty clay with frequent flecks of mortar throughout (106), 0.1–0.3m deep. This deposit was seen to overlie the remains of a possible garden retaining wall [102], constructed from stone, 0.25–0.35m deep. Abutting the western edge of [102] was a thin lens of black grit and coal ash (107), 0.3–0.35m deep, beneath which a deposit of light brown silty clay with occasional flecks of mortar throughout (108) was observed, 0.25–0.4m deep. Deposit (108) was also seen to abut both the western and eastern edges of possible wall [102]. Directly beneath [102] was a deposit of dark brown silty clay with frequent flecks of coal, charcoal and mortar throughout (103), 0.35–0.5m deep. This deposit was cut on its western edge by [105], 0.35–0.75m deep, which constituted a trench for a storm drain [110], 0.55–0.75m deep. Also contained by [105] was a fill comprising mid-brown silty clay with frequent flecks of mortar throughout (109), 0.35–0.75m deep, which overlay drain [110]. Trench [105] was also seen to partially cut through deposit (104), which consisted of dark brown silty clay with frequent flecks of mortar throughout. This deposit was situated directly beneath (103) and was distinguishable from it by its marginally lighter hue. Deposit (104) was the lowermost deposit encountered within Test Pit 1, measuring 0.55–1m+ in depth.

Plate 1. Plan view of Test Pit 1, with wall [102] running along its northern edge (view north)

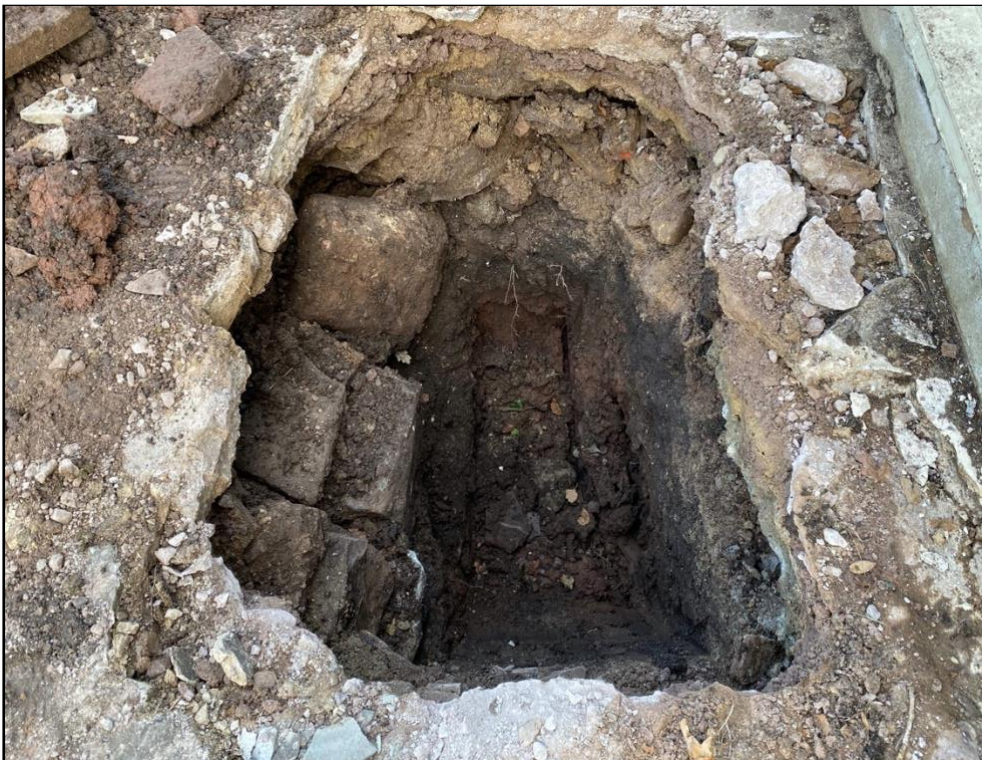
3.1.5 Test Pit 2 was situated on the northern edge of the property and measured 1.2m east/west, 0.9m north/south and 0.87m in depth. The level of the ground surface at the top of the test pit was 172.53mOD, while the level at its base was 171.22mOD. The south facing section of the test pit was recorded. The uppermost deposit encountered within Test Pit 2 (201) comprised a hardcore deposit for an exterior patio, 0–0.12m deep. Underlying (201) was a thick deposit of greyish brown silty clay with frequent demolition material throughout (202). This demolition material comprised, most notably, fragments of mortar, pottery and glass. Deposit (202) was encountered at a depth of 0.12–0.42m. Running beneath (202) were the possible remains of a garden retaining wall [203], constructed from stone, 0.3–0.65m deep. The lowermost deposit encountered within Test Pit 2 (204), which was situated directly below [203], comprised dark brown silty clay with frequent flecks of coal, charcoal and mortar throughout, 0.77–0.87m+ deep.

Plate 2. Plan view of Test Pit 2 showing wall [203] running along its northern edge (view east)

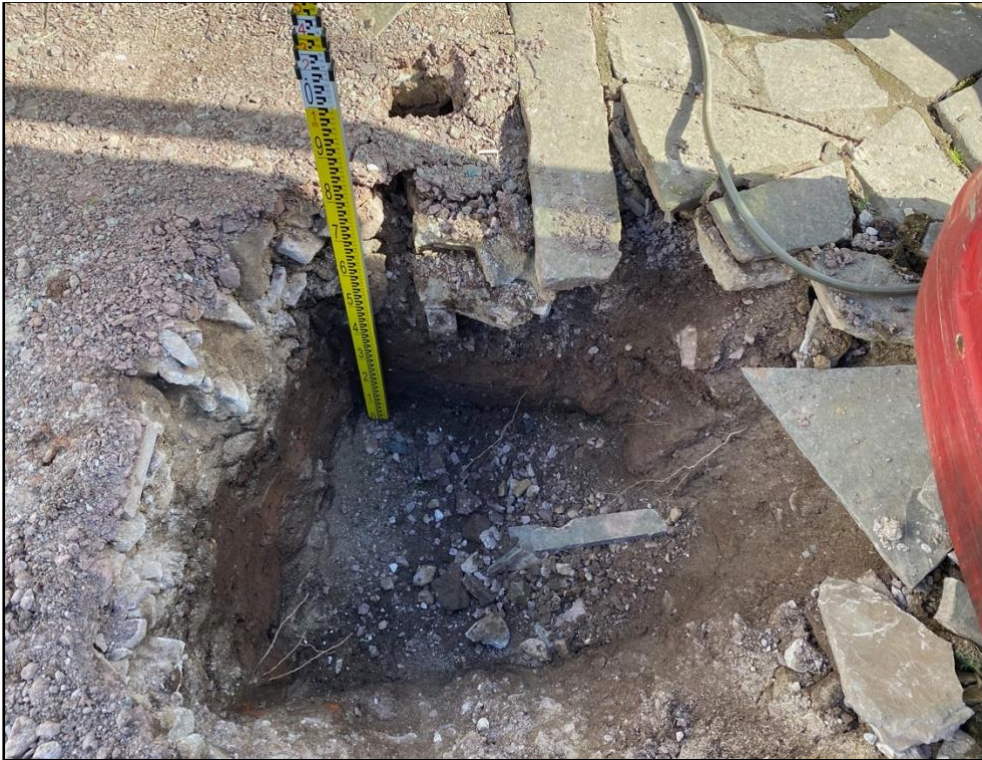
Plate 3. Test Pit 3 (view north)

3.1.7 Test Pit 3 was situated on the eastern edge of the property and measured 1.3m east/west, 1m north/south and 0.8m in depth. The level of the ground surface at the top of the test pit was 172.56mOD, while the level at its base was 171.35mOD. The south facing section of the test pit was recorded. The uppermost deposit encountered within Test Pit 3 was a hardcore layer of gravel and crushed concrete (301), 0–0.2m deep, which comprised the driveway attached to the property. Beneath (301) was a deposit of mid-brown silty clay with frequent demolition material throughout (302). This demolition material was plentiful and comprised, most notably, fragments of brick and timber. Deposit (302) was encountered at a depth of 0.2–0.7m. The lowermost deposit recorded within Test Pit 3 comprised crushed sandstone over a sheet of black plastic (303), 0.7–0.8m deep.

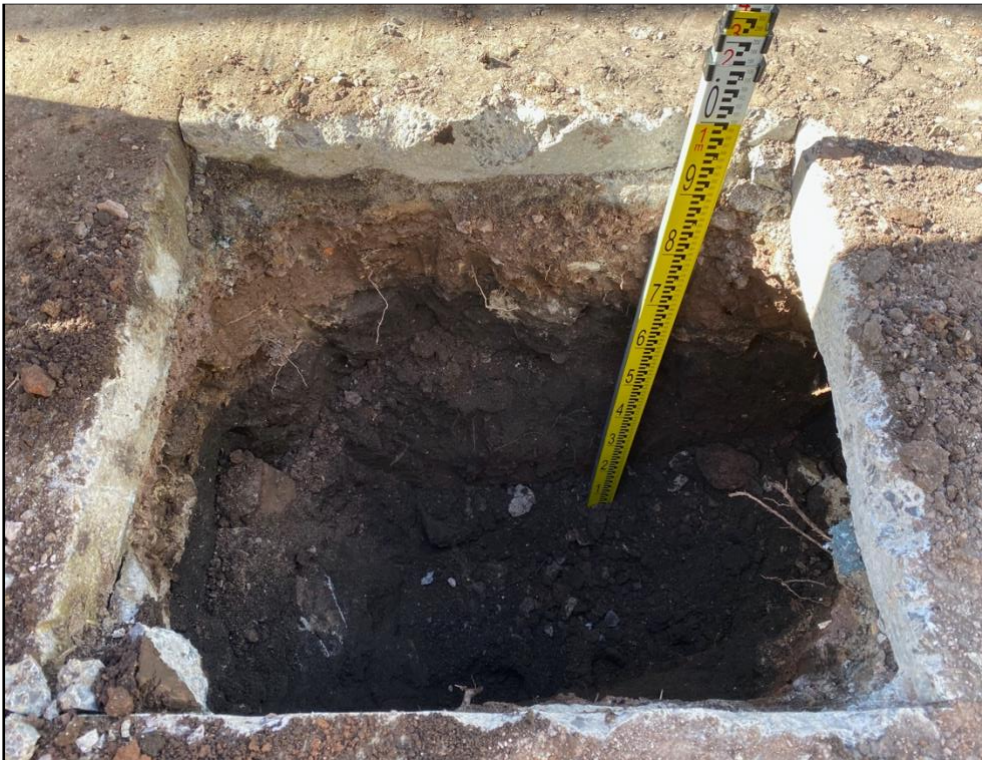
Plate 4. Test Pit 4 (view north)

3.1.9 Test Pit 4 was situated on the eastern edge of the property and measured 0.6m east/west, 0.75m north/south and 0.95m in depth. The level of the ground surface at the top of the test pit was 172.75mOD, while the level at its base was 171.77mOD. The south facing section of the test pit was recorded. The uppermost deposit encountered within Test Pit 4 was a hardcore layer of gravel and crushed concrete (401), 0–0.15m deep, which comprised the driveway attached to the property. Situated beneath (401) was a deposit of reddish brown silty clay, 0.15–0.35m deep, which overlay a layer of dark brown humic silty loam (403) that constituted a build-up of garden soil. This deposit was also seen to contain friable sandstone fragments measuring <0.03m in size. Deposit (403) was encountered at a depth of 0.35–0.85m. The lowermost deposit encountered within Test Pit 4 (404) comprised a mid-brown silty clay subsoil, 0.85–0.95m+, which constituted a superficial geological deposit.

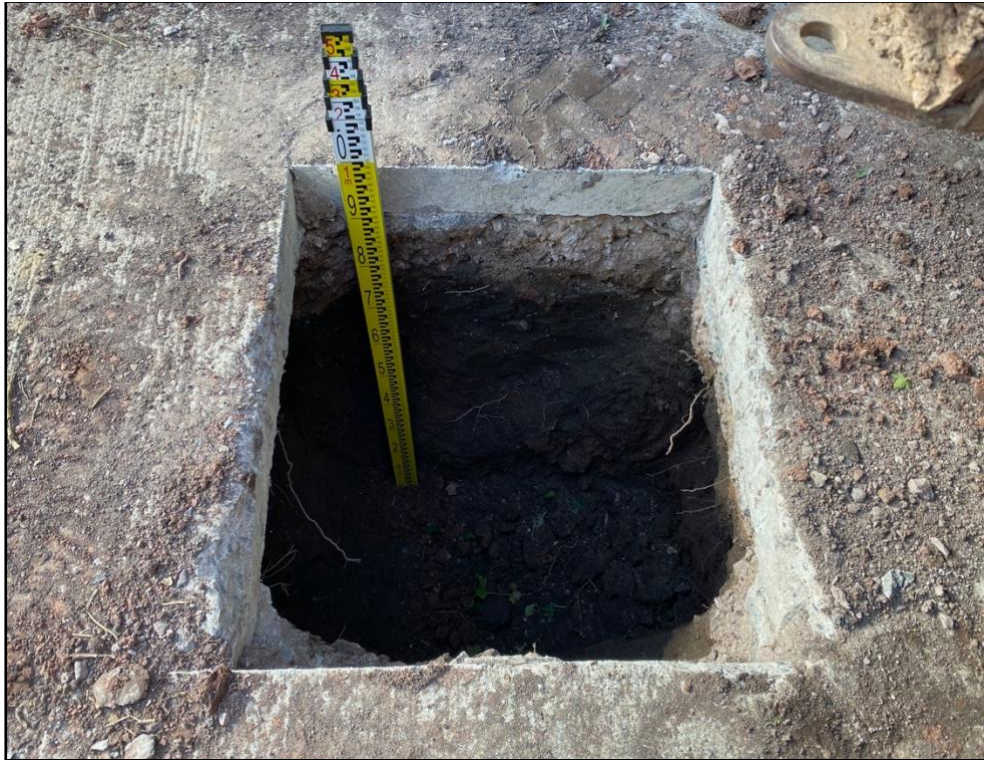
Plate 5. Test Pit 5 (view north)

3.1.11 Test Pit 5 was situated on the eastern edge of the property and measured 0.6m east/west, 0.6m north/south and 0.81m in depth. The level of the ground surface at the top of the test pit was 172.99mOD, while the level at its base was 171.84mOD. The south facing section of the test pit was recorded. The uppermost deposit

encountered within Test Pit 5 was a hardcore layer of gravel and crushed concrete (501), 0–0.15m deep, which comprised the driveway attached to the property. Below (501) was a deposit of dark brown humic silty loam (502) that constituted a build-up of garden soil. Deposit (502) was the lowermost layer encountered within Test Pit 5 and measured 0.15–0.81m+ in depth.

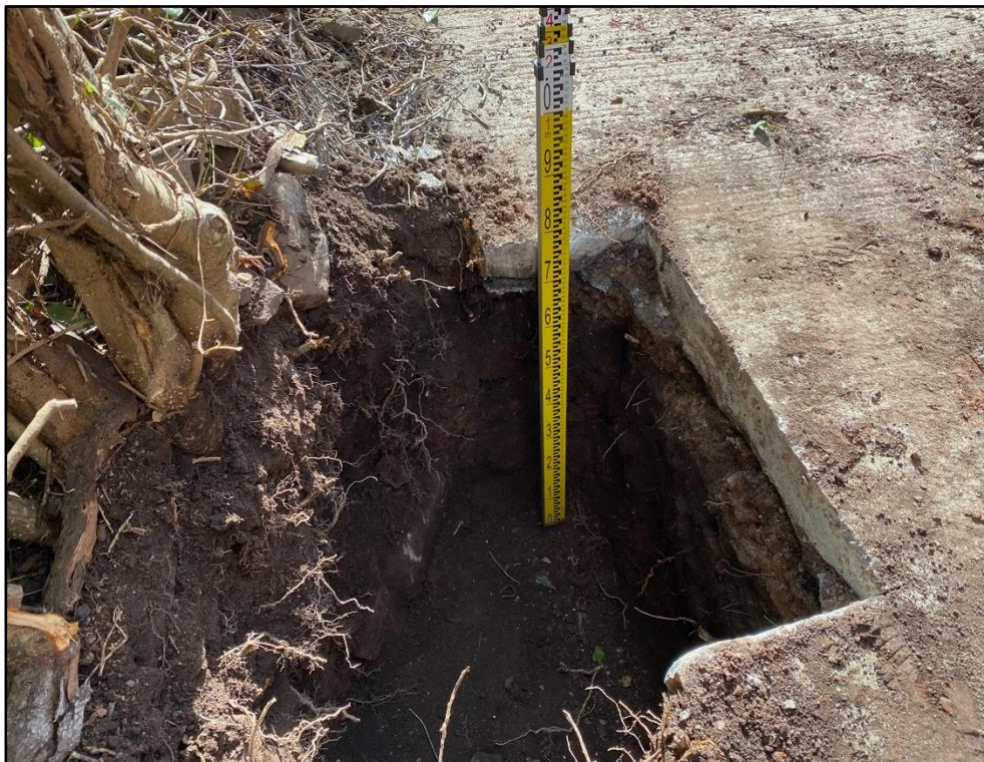
Plate 6. Test Pit 6 (view southwest)

3.1.13 Test Pit 6 was situated on the eastern edge of the property and measured 0.7m east/west, 0.7m north/south and 0.7m in depth. The level of the ground surface at the top of the test pit was 173mOD, while the level at its base was 172.23mOD. The south facing section of the test pit was recorded. The uppermost deposit encountered within Test Pit 6 was a hardcore layer of gravel and crushed concrete (601), 0–0.1m deep, which comprised the driveway attached to the property. Below (601) was a deposit of dark brown humic silty loam (602) that constituted a build-up of garden soil. Deposit (602) was the lowermost layer encountered within Test Pit 6 and measured 0.1–0.7m+ in depth.

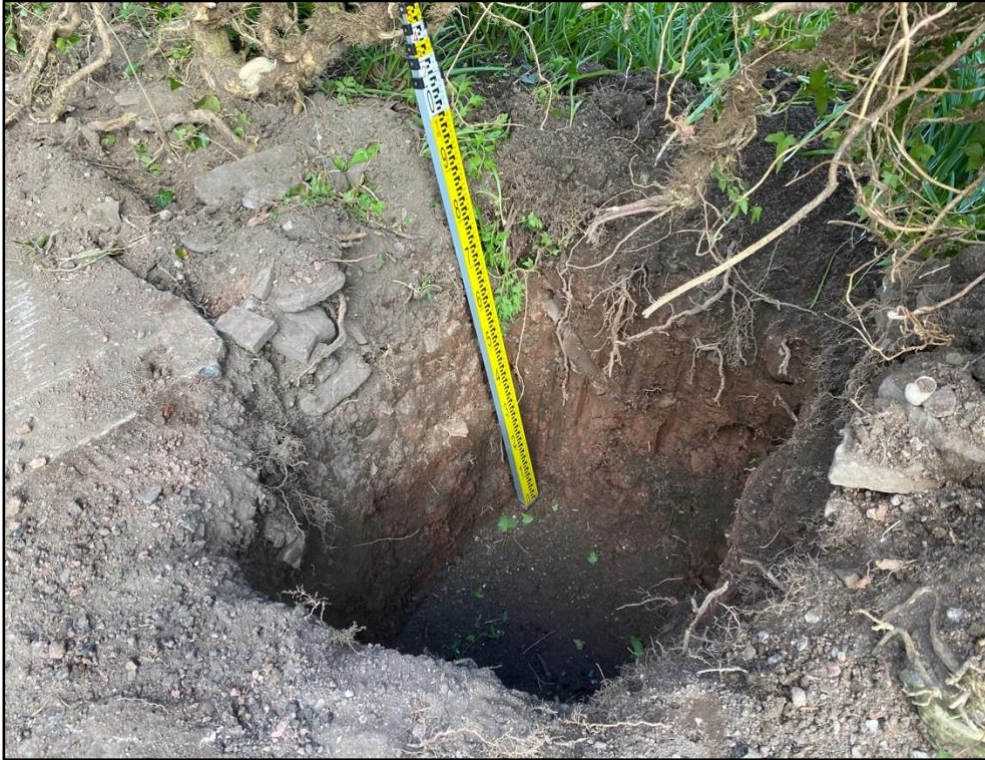
Plate 7. Test Pit 7 (view northeast)

3.1.15 Test Pit 7 was situated on the eastern edge of the property and measured 1m east/west, 1m north/south and 0.7m in depth. The level of the ground surface at the top of the test pit was 173.08mOD, while the level at its base was 172.29mOD. The south facing section of the test pit was recorded. The uppermost deposit encountered within Test Pit 7 was a layer of degraded tarmac (701), 0–0.1m deep, which overlay a thin deposit of dark brown silty clay (702), friable in texture, 0.1–0.2m deep. Tarmac (701) was seen to abut the western edge of a boundary wall [706] that defined the eastern side of the property. Immediately west of deposit (702) was a foundation cut [704], within which [706] was contained, 0.1–0.3m deep, which was filled with a deposit of mortar (705). This foundation cut through deposit (703), which ran directly beneath (702). This deposit comprised a pinkish brown subsoil with frequent small stone inclusions throughout and was encountered at a depth of 0.3–0.7m+. This deposit also comprised a superficial geological layer.
