**Clydach Ironworks,
Monmouthshire
Archaeological Watching Brief**

**Tilhill Forestry
Church Bank,
Llandovery,
Carmarthenshire,
SA20 0BA**

**- BLACK MOUNTAINS ARCHAEOLOGY -
- ARCHAEOLEG MYNYDD DU -**

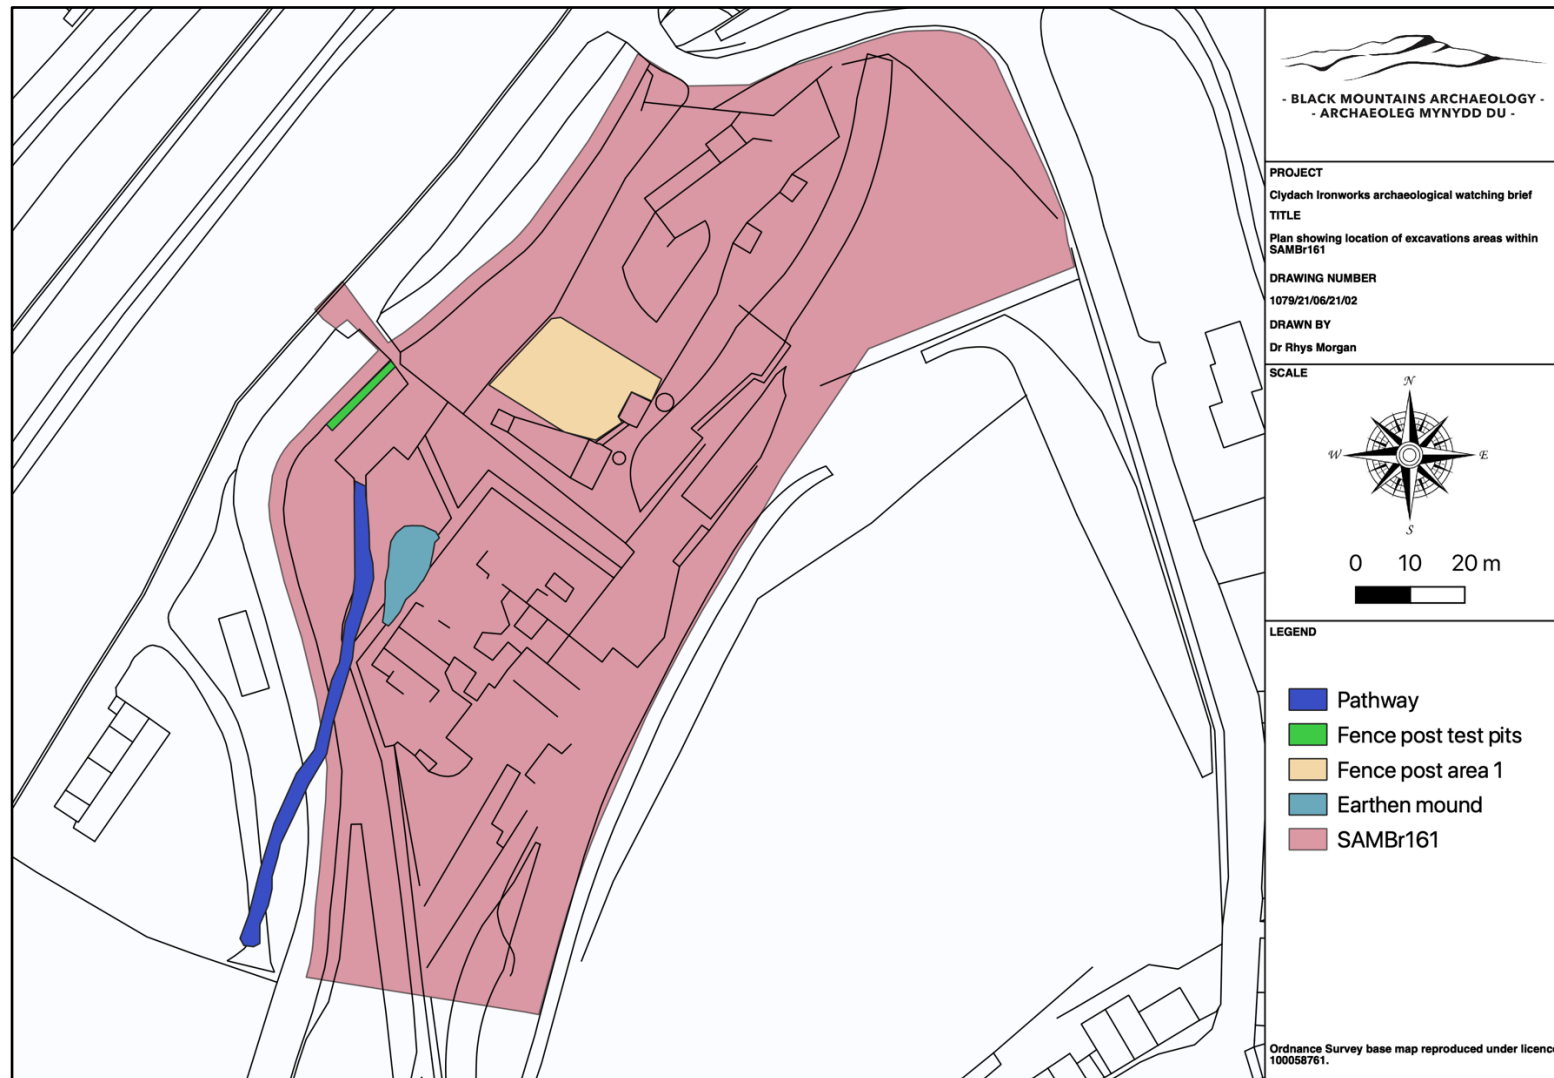
Figure 2. Plan showing location of excavation areas within SAMBr161

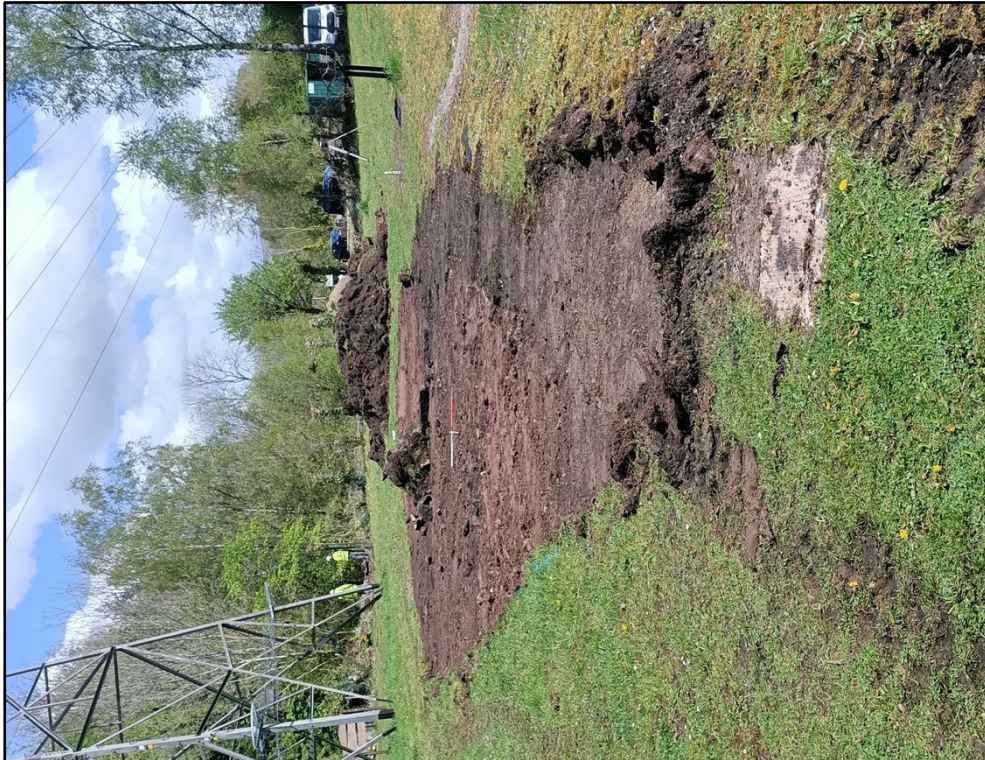
- 3.3.1 The proposed earth banked amphitheatre was situated on the level area immediately to the northwest of the extant ironworks. Groundworks comprised a shallow excavation of an oval-shaped area measuring approximately 19m long x 8m wide.

Spoil was then used to form the earthen mound, which was to be situated directly within the newly excavated area. The maximum depth of excavation was 0.25–0.30m. The level of the present ground surface was 143.58mOD. The level at the base of excavation was 143.28mOD.

- 3.3.2 During excavations, two deposits were encountered. The first (003) comprised a dark brown silty clay topsoil with occasional rooting throughout. This deposit measured approximately 0.15m in depth. The second deposit (004) was seen to underlie (003) and consisted of black or dark brown silty clay with frequent colliery waste and fragments of slag and furnace waste throughout. Deposit (004) was very uneven but was encountered at a depth of 0.15–0.2m+.

Plate 1. Excavation area for earthen mound (view north, scale 2x1m)

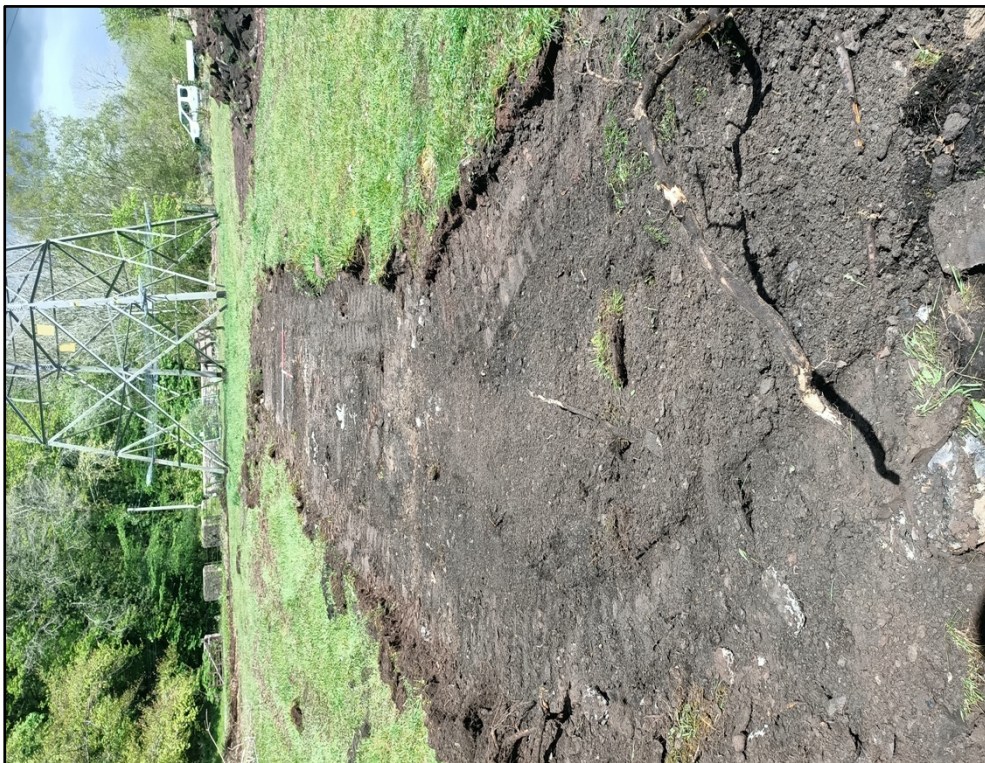
- 3.2.1 The proposed pathway extended for approximately 86m in a broadly NE/SW direction. Excavation for the pathway began in the open area situated towards the eastern edge of the extant structures of the Clydach Ironworks, approximately 22m southwest of Smart's Bridge. Excavations for the pathway extended from this point to the summit of the small hillslope situated on the southwestern edge of the proposed development. The level of the present ground surface varied. The ground surface of the area immediately west of the extant ironworks was 143.59mOD, while the surface of the summit of the hillslope was 165.5mOD. The base of excavation within the former area was 143.35mOD, while in the latter it was 165.25mOD.

- 3.2.2 During excavations, two deposits were encountered. The uppermost deposit (001) comprised a dark brown silty clay topsoil with occasional rooting throughout, 0.24m deep. This deposit was encountered within the level area west of the extant ironworks. Excavations along the hillslope revealed a different deposit (002), which comprised black or dark brown silty clay with frequent colliery waste and fragments of slag and furnace waste throughout, 0.25m+ deep.

Plate 2. North-eastern end of proposed pathway after excavation (view northeast, scale 2x1m)

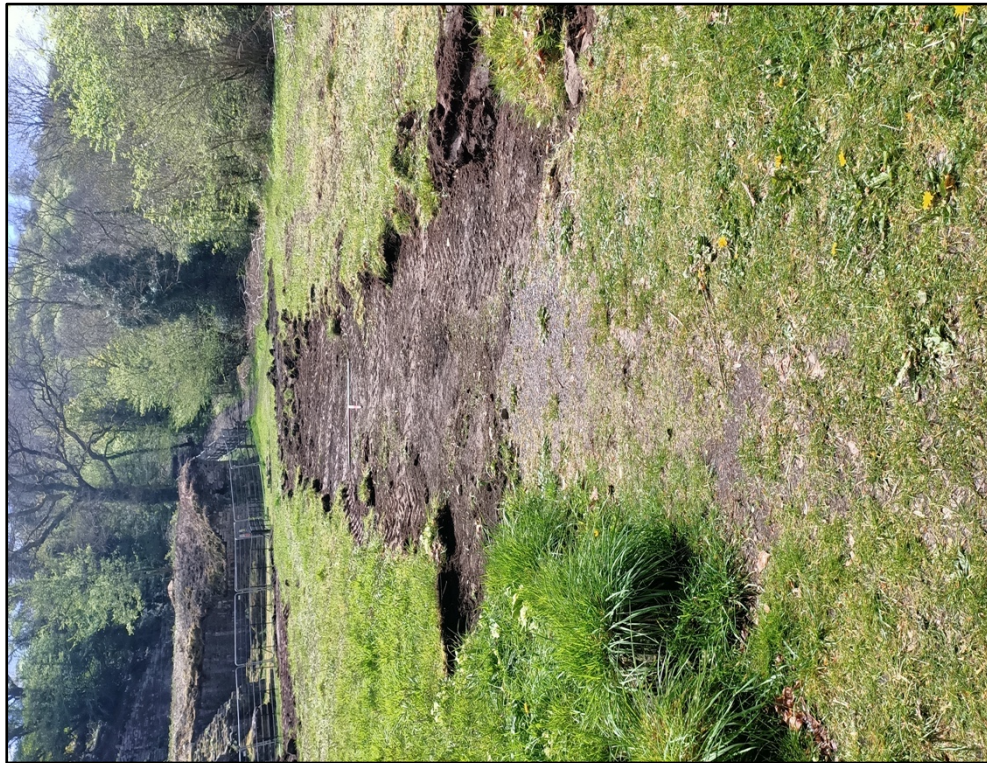
Plate 3. View of proposed pathway after excavation, towards north-eastern end, approaching hillslope to southwest of site (view southwest, scale 2x1m)

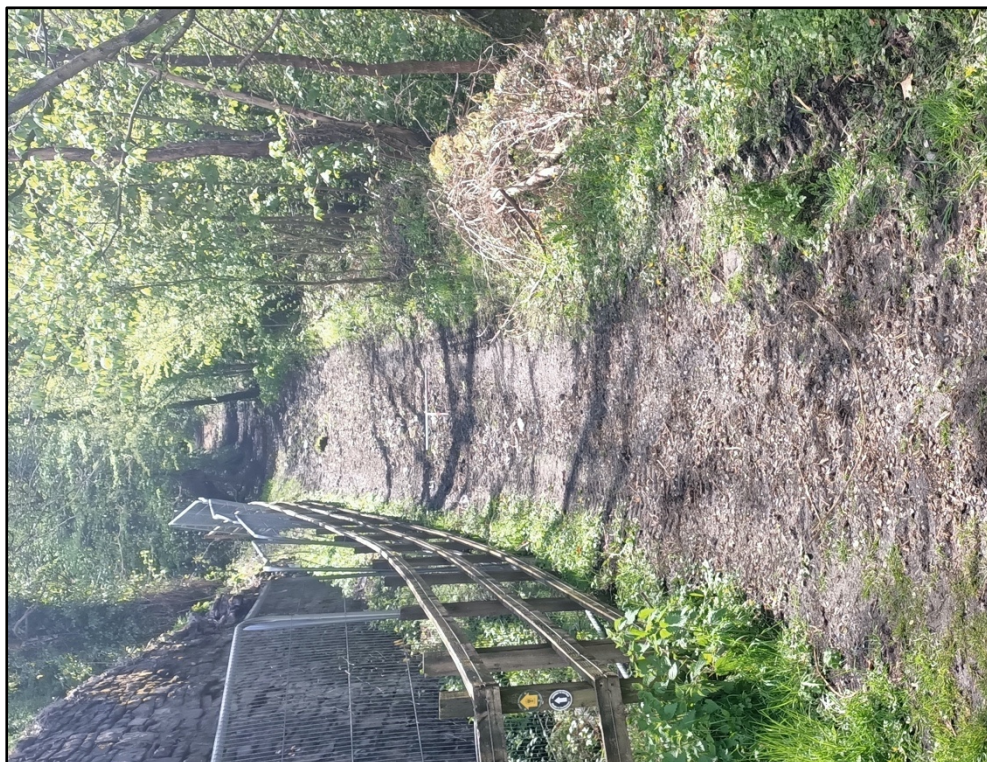
Plate 4. Upslope view of proposed pathway, after excavation, at base of hillslope to southwest of site (view southwest, scale 2x1m)

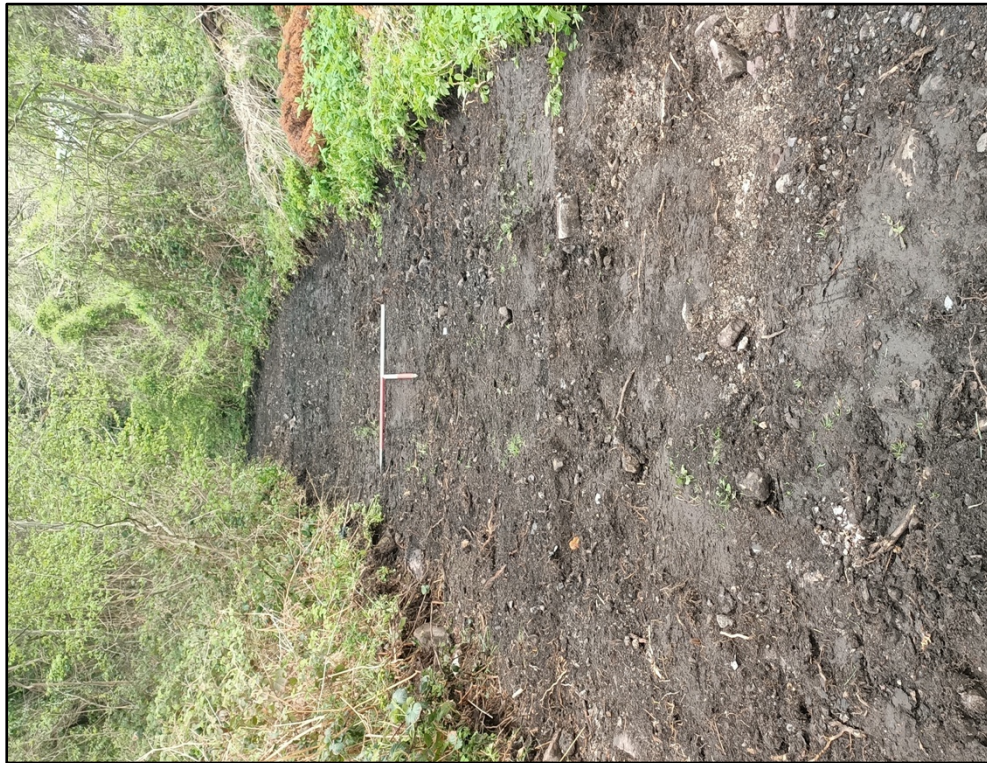
Plate 5. Upslope view of proposed pathway, after excavation, towards middle of hillslope to southwest of site (view southwest, scale 2x1m)

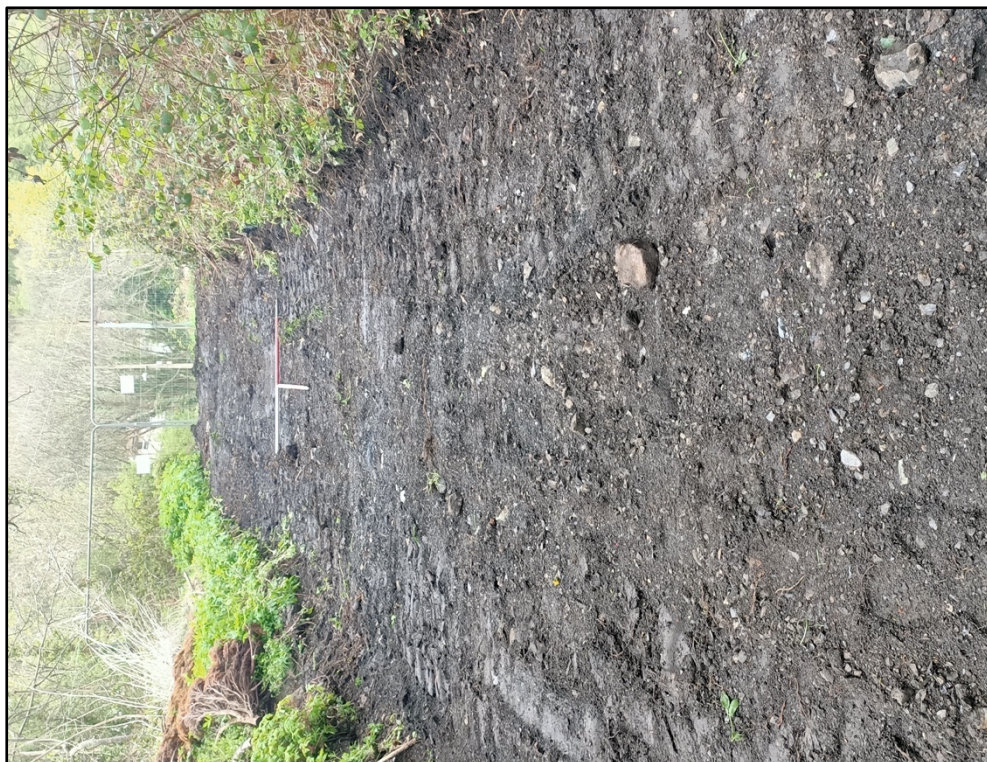
Plate 6. Upslope view of proposed pathway, after excavation, approaching top of hillslope to southwest of site (view southwest, scale 2x1m)

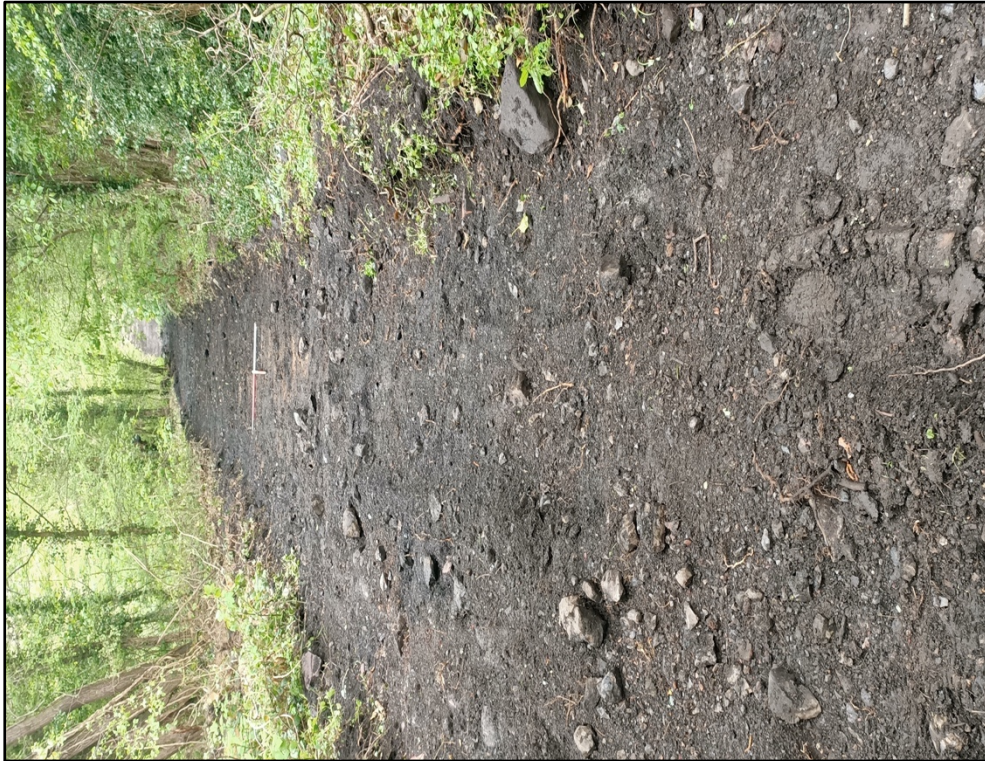
Plate 7. Downslope view of proposed pathway, after excavation, towards middle of hillslope to southwest of site (view northeast, scale 2x1m)

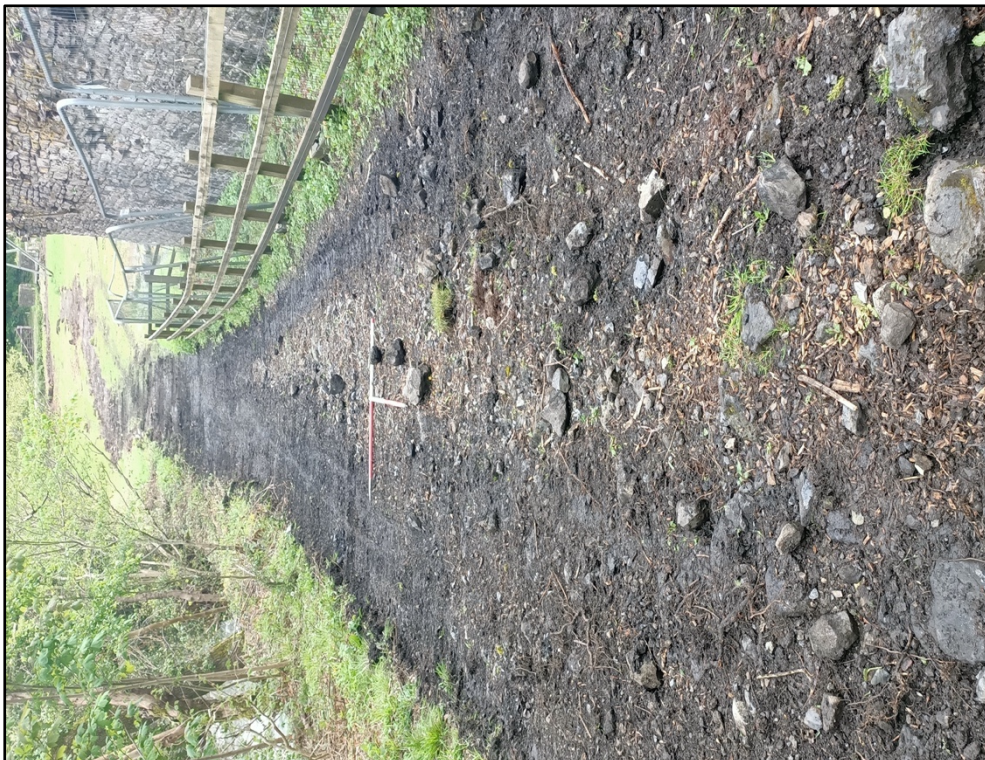
Plate 8. Downslope view of proposed pathway, after excavation, approaching base of hillslope to southwest of site (view northeast, scale 2x1m)

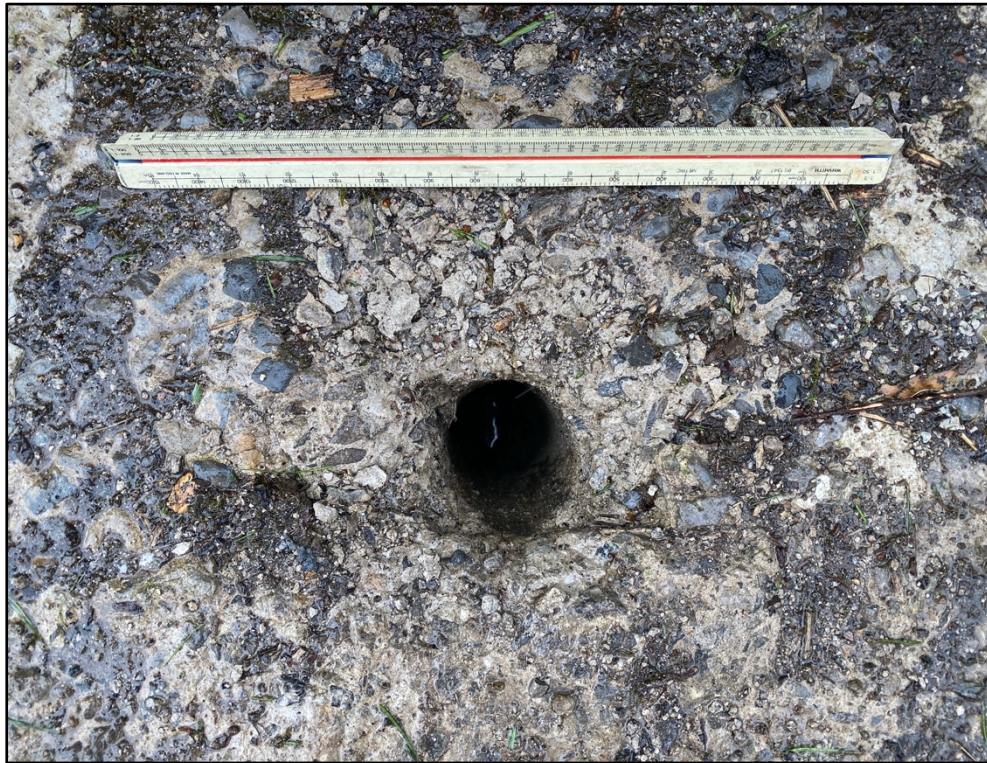
- 3.4.2 Excavations within the first area were achieved using a hydraulic pecker and reached a maximum depth of 0.25m. The area within which these excavations were conducted was covered with a thick surface deposit of concrete (005). During excavations, concrete (005) was not fully penetrated, and no underlying deposits were observed.

Plate 9. Representative photograph of fence posthole within area over former cement works

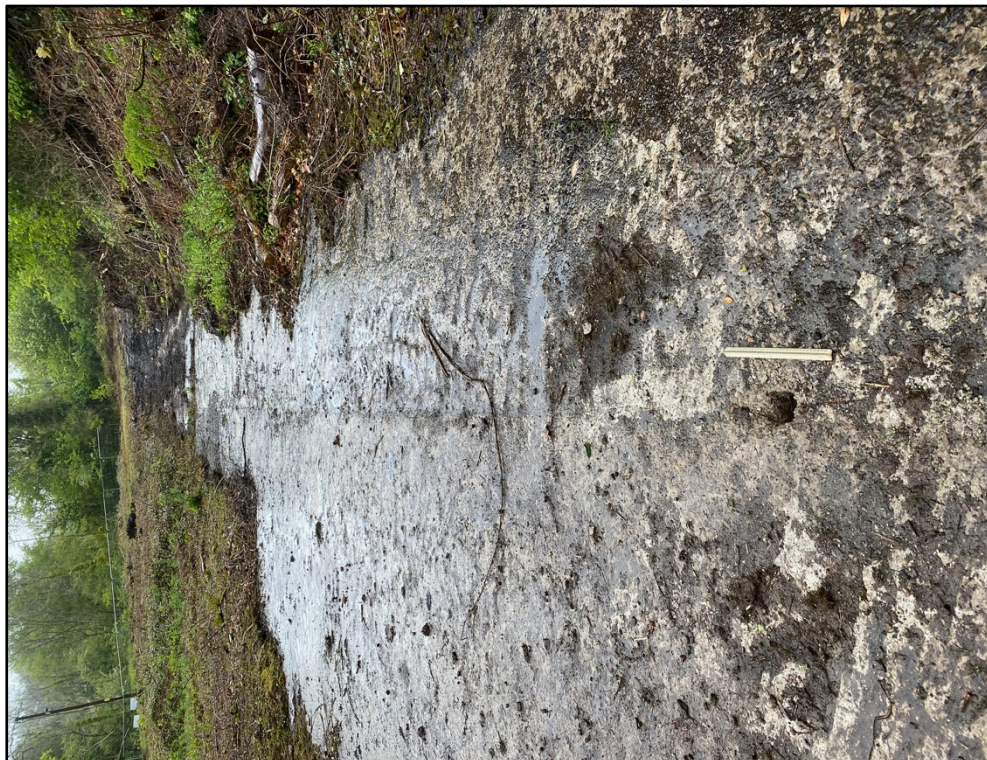
- 3.4.1 Fence posts were excavated in two separate areas of the site. The first area was situated to the northeast of the extant ironworks, within approximately 36m of the north-eastern edge of the proposed earthen mound. This area was small and roughly rectangular shaped. The second area was situated immediately to the southwest of Smart's Bridge and comprised a thin strip running along the south-eastern edge of the River Clydach. The excavation of two test pits were recorded within this second area, the negative results of which indicated that a watching brief on the remainder of the area was not required.

Plate 10. Trajectory of fence postholes within area over former cement works

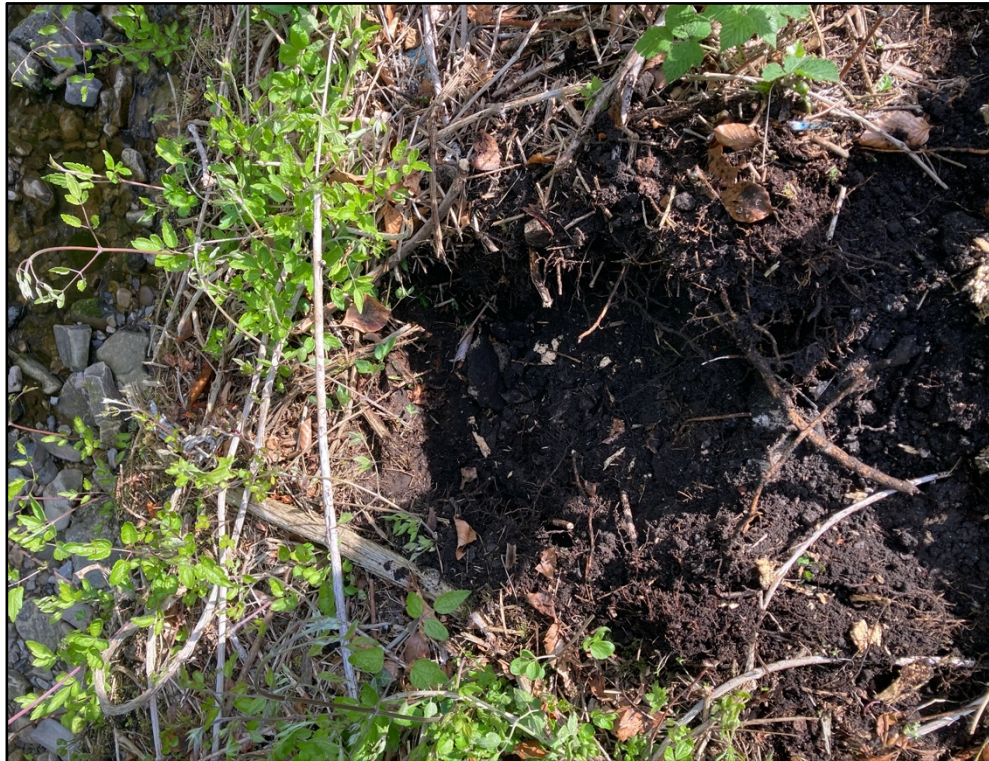
- 3.4.3 Excavations of the two test pits within the second area were conducted to depths of 0.25–0.4m. Both test pits measured 0.3m wide x 0.5m long. The first test pit was situated approximately 8.5m to the southwest of Smart's Bridge. Within this test pit a single deposit was encountered (006), which comprised a dark brown silty clay topsoil with frequent rooting throughout, 0.1m deep. The second test pit was situated approximately 17m to the southwest of Smart's Bridge. Within this test pit three deposits were encountered. The uppermost deposit (007) comprised topsoil identical in composition to (005), 0.1m deep. Underlying topsoil (007) was a mid-brown subsoil comprising very friable silty clay (008), 0.15m deep. The lowermost deposit (009) comprised black loam with fragments of colliery waste and slag throughout, 0.15m+ deep.

Plate 11. First test pit excavated in advance of construction of fence line to southwest of Smart's Bridge

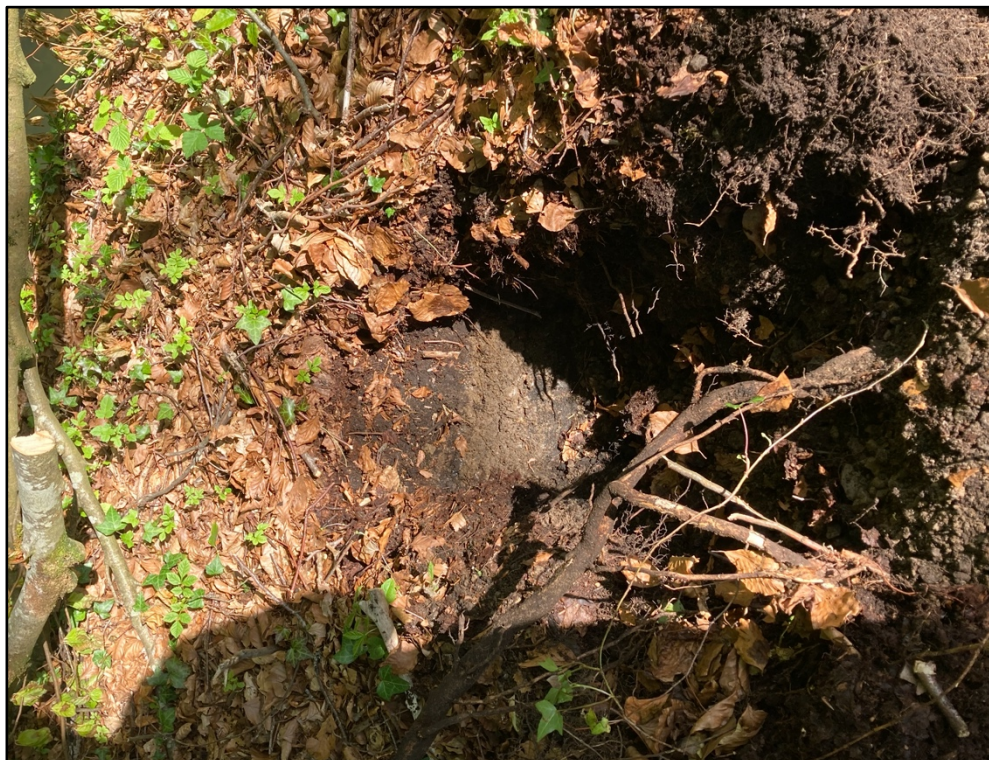
Plate 12. Second test pit excavated in advance of construction of fence line to southwest of Smart's Bridge
