**Additional Land for Plant,
Hafod-Morfa Copperworks
Rapid Assessment**

City and County of Swansea

**- BLACK MOUNTAINS ARCHAEOLOGY -
- ARCHAEOLEG MYNYDD DU -**

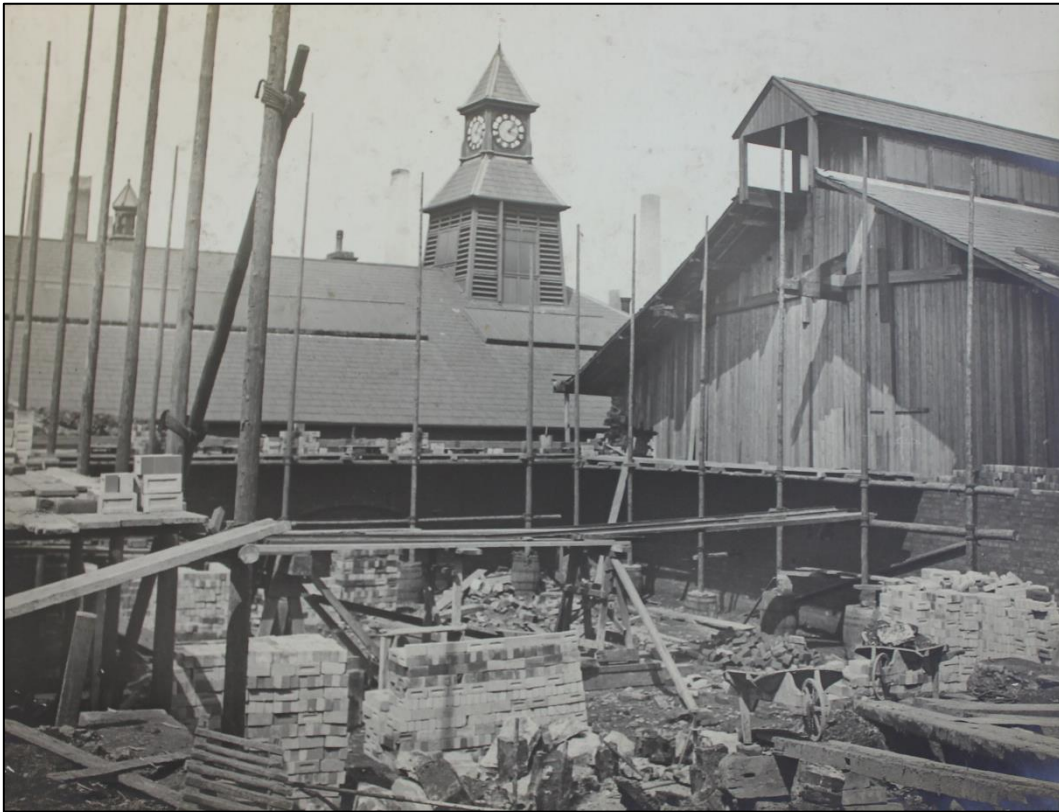
Plate 1. Landore Power Station Building, 1910 © West Glamorgan Archive Service (D/34/5)

East of the basin site are two extensive, discrete areas of tile and concrete surfacing. They clearly represent the floors of YIM36, the powerhouse and boiler house that were established between 1899 and 1919. They were two large, parallel, rectangular N-S buildings, each measuring 20m by 10m, which supplied the works with electricity, and were served by a large chimney stack to the south, for which there is now no physical evidence. Electricity was supplied by two 300kw Sulzer engines and two Mather and Platt 600kw generators; a photo from the 1920s shows both buildings, in steel-frame and brick respectively, and the stack. They were enlarged in the 1930s, apparently at the expense of the stack. In the ramped section to the east can be seen the truncated remains of a brick wall, which appears to represent the end wall of one of the power house lean-tos.”

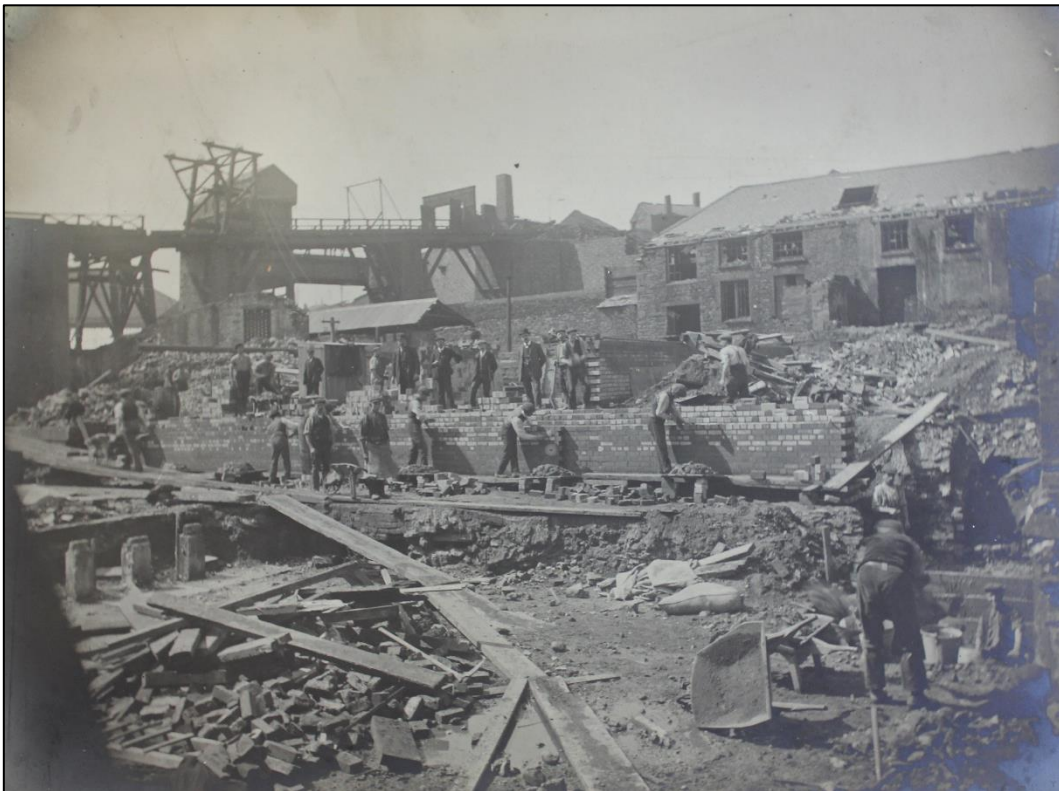
Plate 2. Landore Power Station Building, 1910 © West Glamorgan Archive Service (D/34/5)

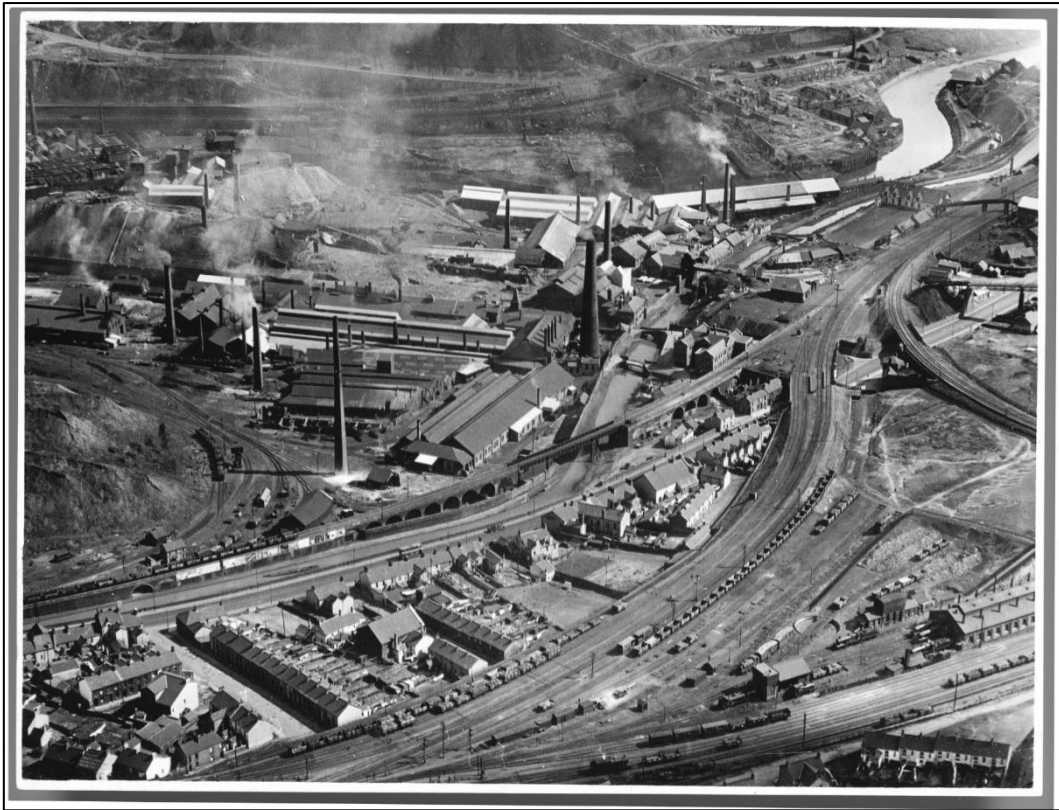
Plate 3. 1920s Aerial photograph of Hafod-Morfa Copperworks, Surrey Flying Services © Swansea Museum Service

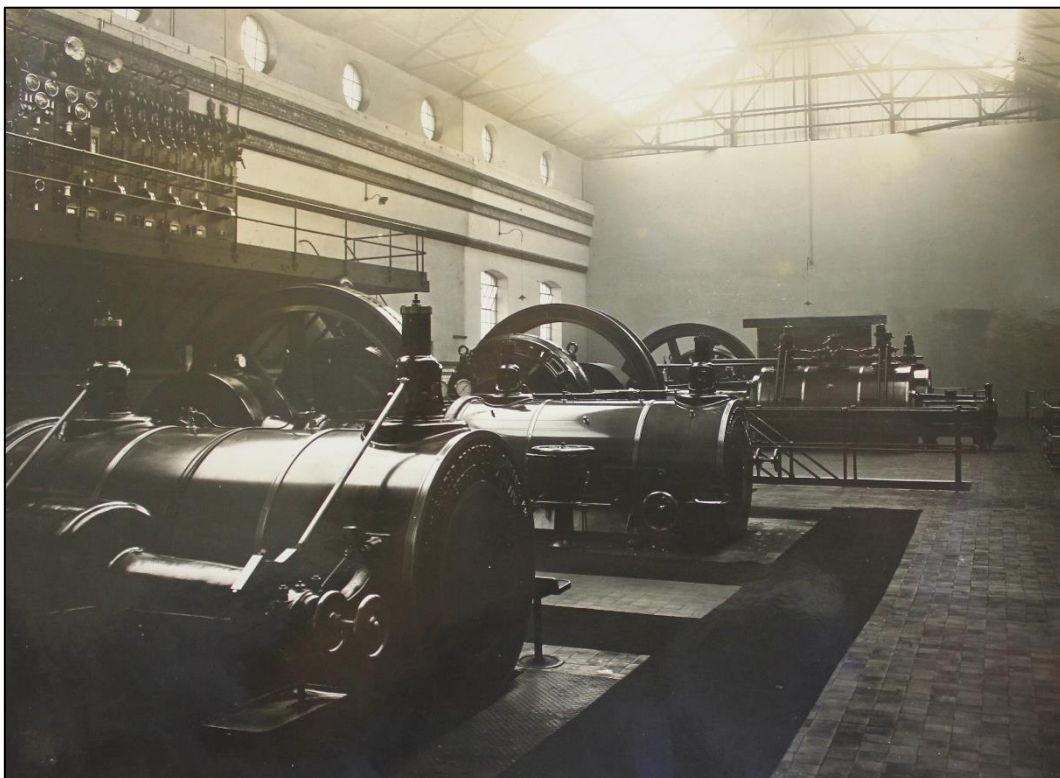
Plate 6. Power Station, Hafod Works. Built 1910, photograph taken 1920. West Glamorgan Archive Service (D/34/5)

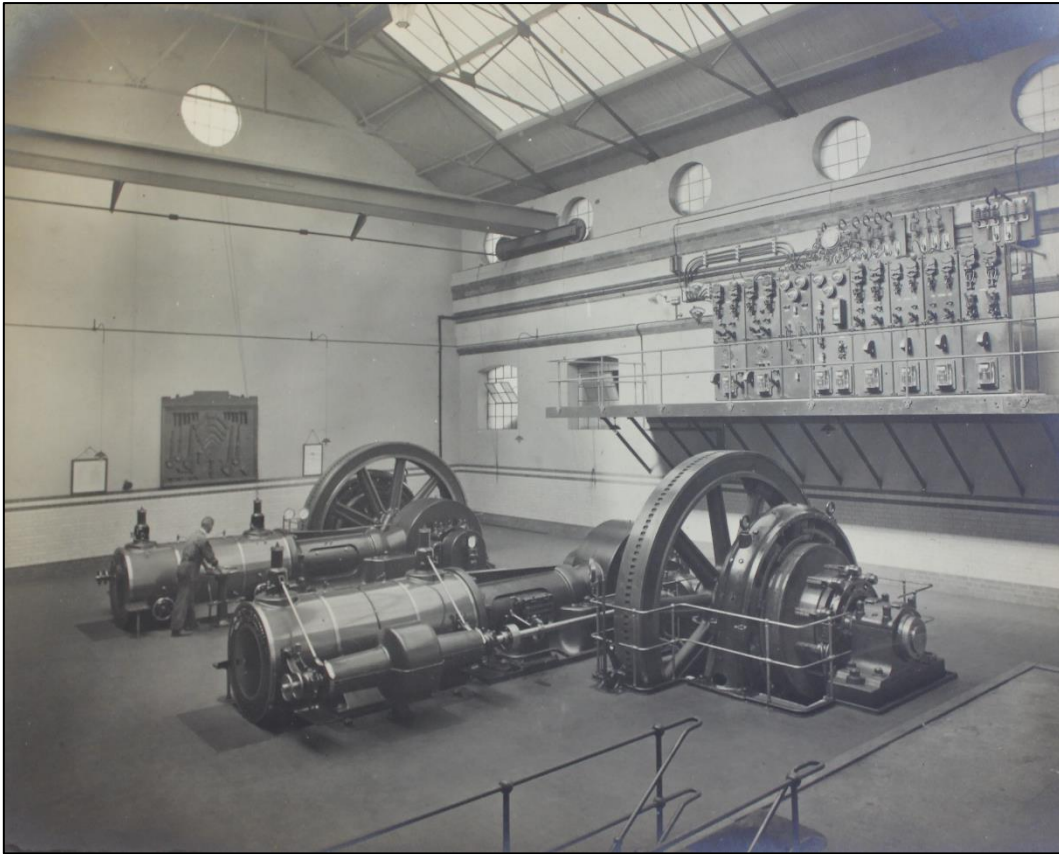
Plate 7. 300KW D.C. Generation 460 volt DC – with Sultzer Uniflow Steam Engine, 1910 installed © West Glamorgan Archive Service D/34/5

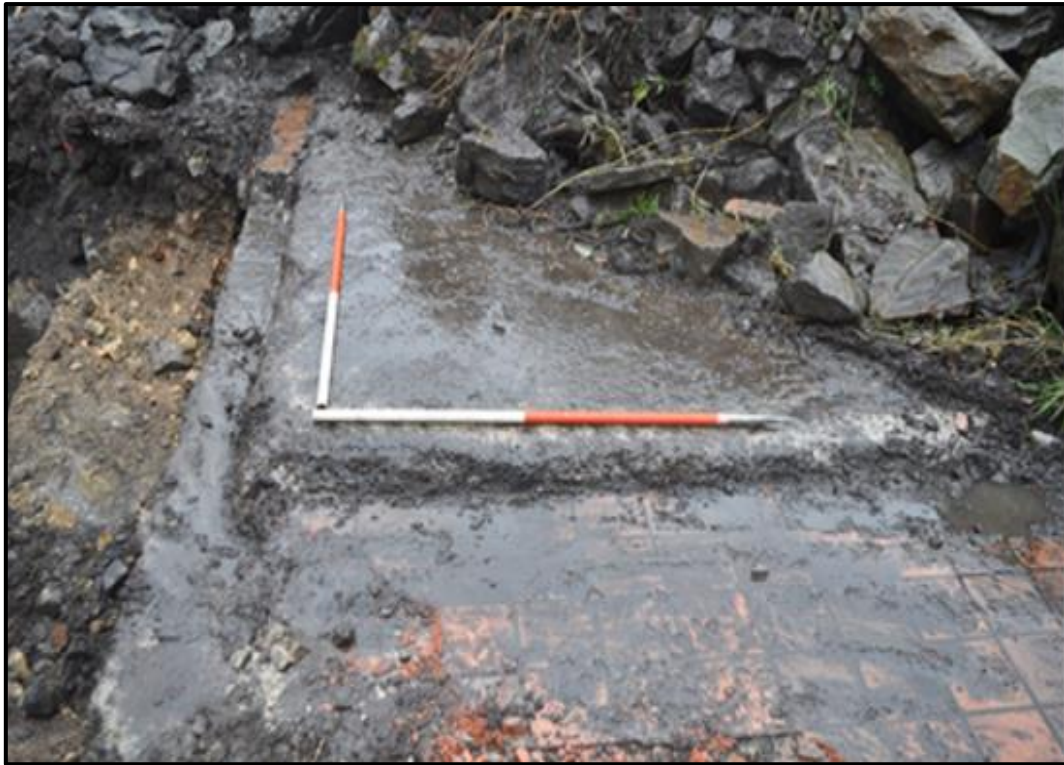
Plate 9. Concrete [101], tiled floor [102] and concrete plinth [104] in Trench 1 (view west) (Eyre-Morgan and Morgan 2021)

3.1.3 Black Mountains Archaeology Ltd/ Archaeoleg Mynydd Du Cyf carried out an archaeological field evaluation in 2018, which included trenches targeting the Hafod Powerhouse Building (Trenches 1-3), in order to assess the extent of archaeological remains in this area (Eyre-Morgan and Morgan 2021). The investigations concluded that the level of survival in this area was high. Quarry tiled floor surfaces, footings and machine bases, as well as a possible coal chute, were discovered just beneath the present ground surface (0.1m deep). Further structures and deposits were found to underlie these later features (Figure 1, Plates 8-12).

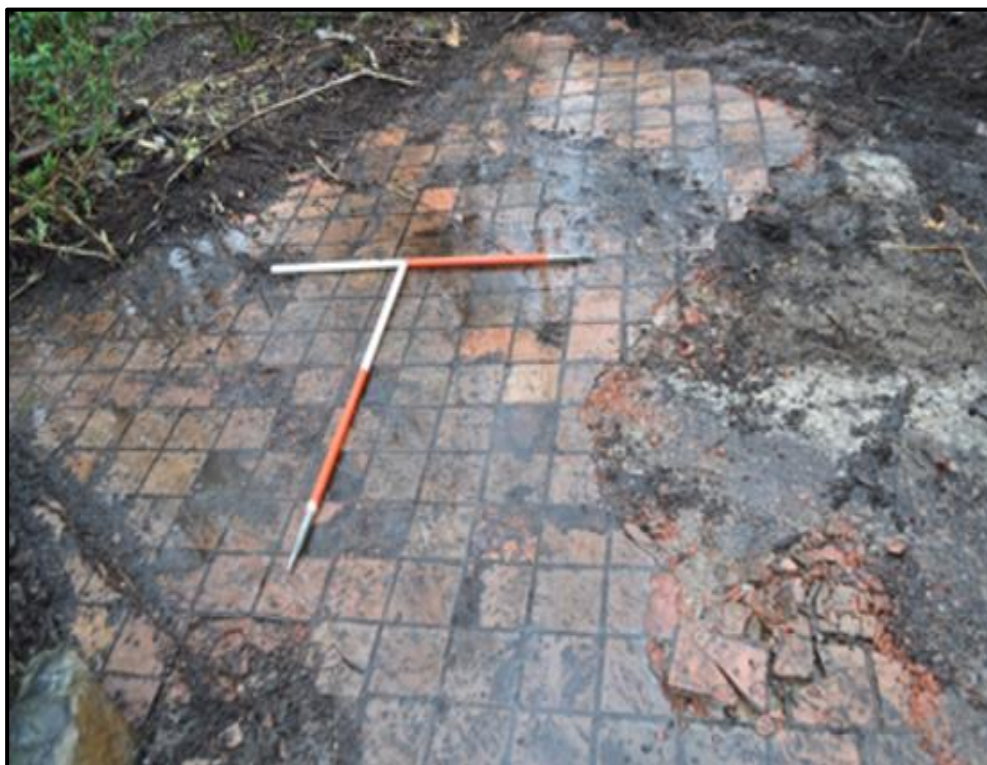
Plate 10. Tiled Floor [102] in Trench 1 (view northeast) (Eyre-Morgan and Morgan 2021)

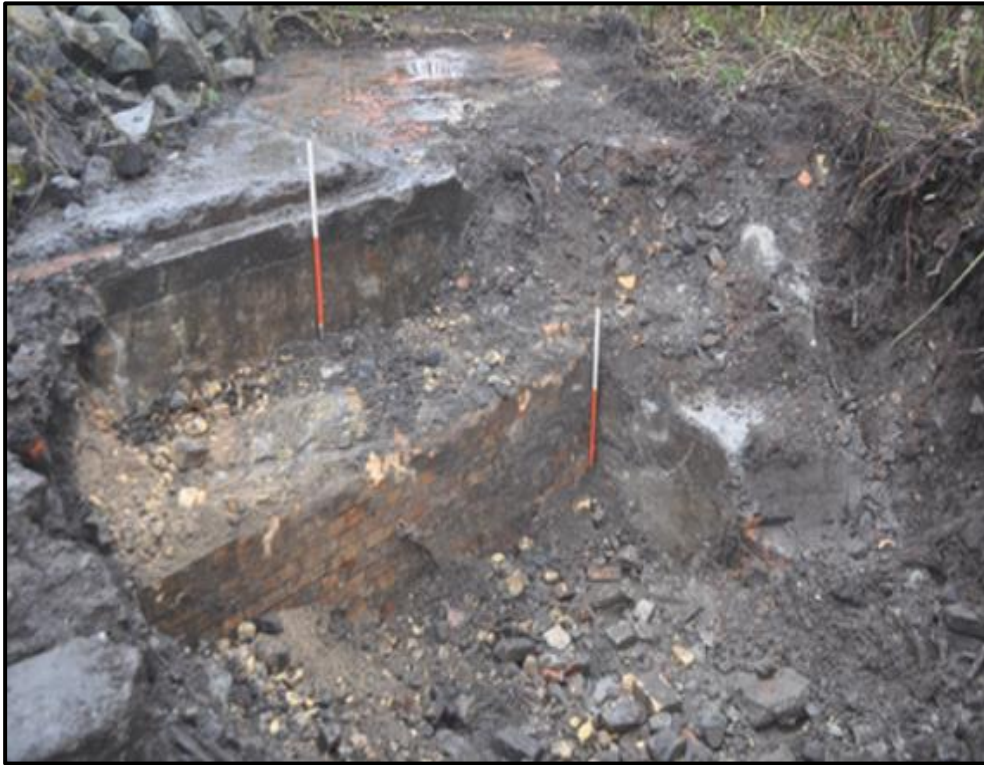
Plate 11. Floors [101] and [102], plinth [104] and walls [108] and [110] in Trench 1 (view north) (Eyre-Morgan and Morgan 2021)

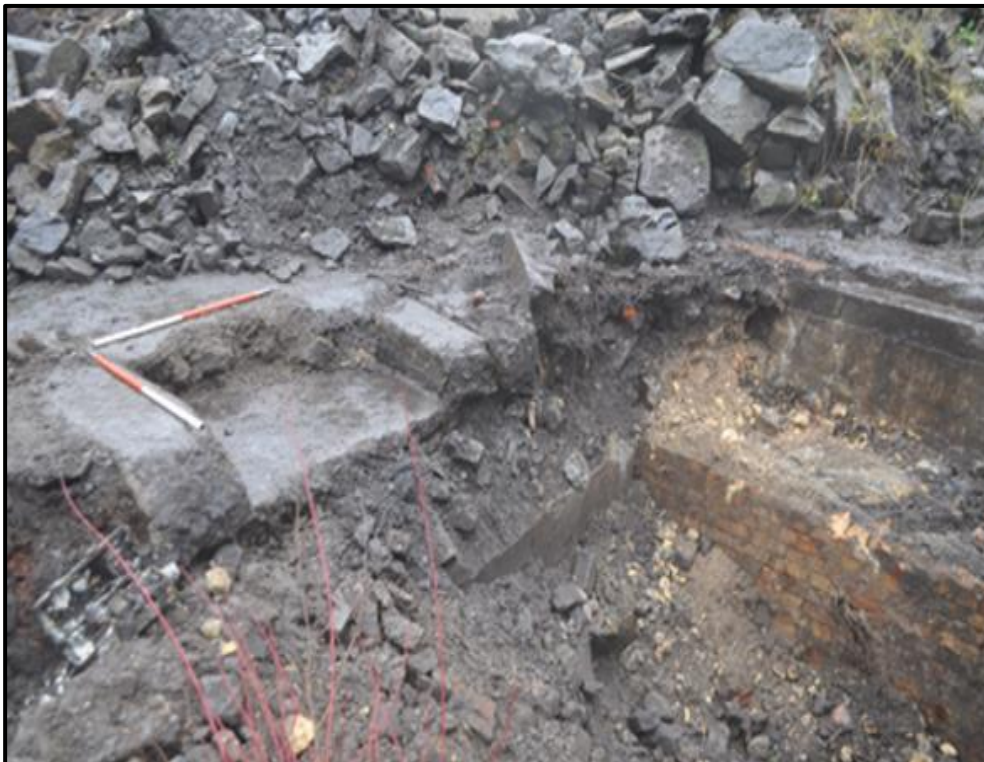
Plate 12. Wall [109] and concrete structure [115] in Trench 1 (view northwest) (Eyre-Morgan and Morgan 2021)

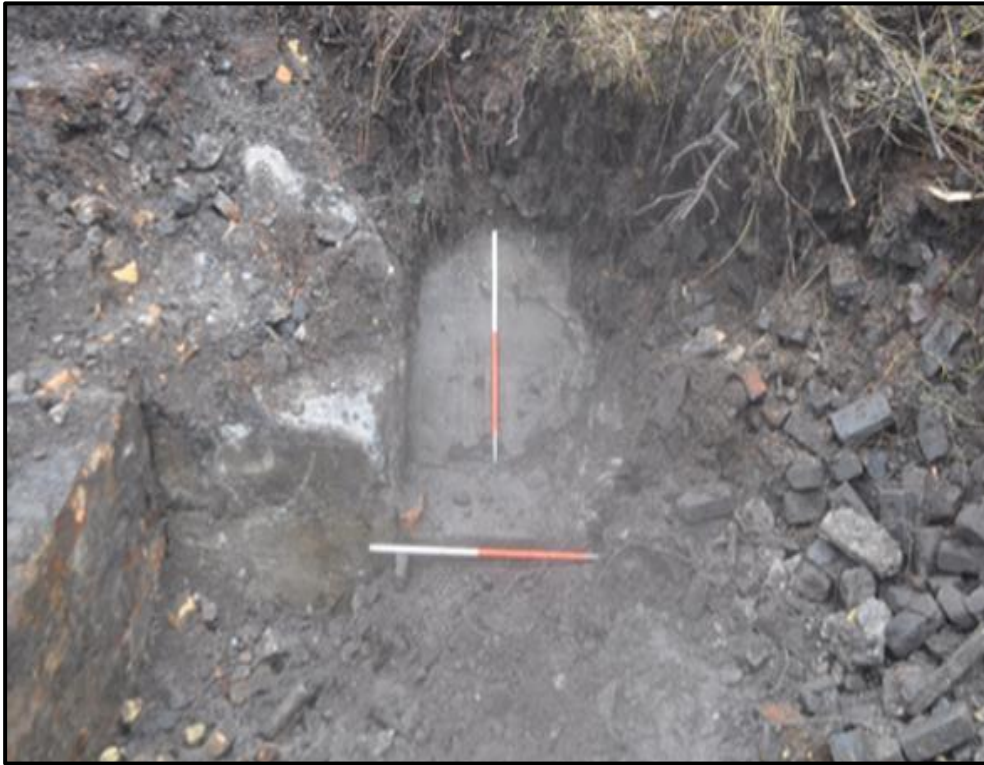
Plate 13. Concrete slab [117], platform [118] and wall [110], forming possible coal chute in Trench 1 (view west) (Eyre-Morgan and Morgan 2021)
