**Penrice Castle Gatehouse**  
**Archaeological Watching Brief Report**

*Black Mountains Archaeology Ltd have been commissioned by Mann Williams on behalf of Mr Thomas Methuen-Campbell of the Penrice Estate to undertake an archaeological watching brief during conservation work on the gatehouse of Penrice Castle (SMGm047m).*

## Archaeological Watching Brief Report

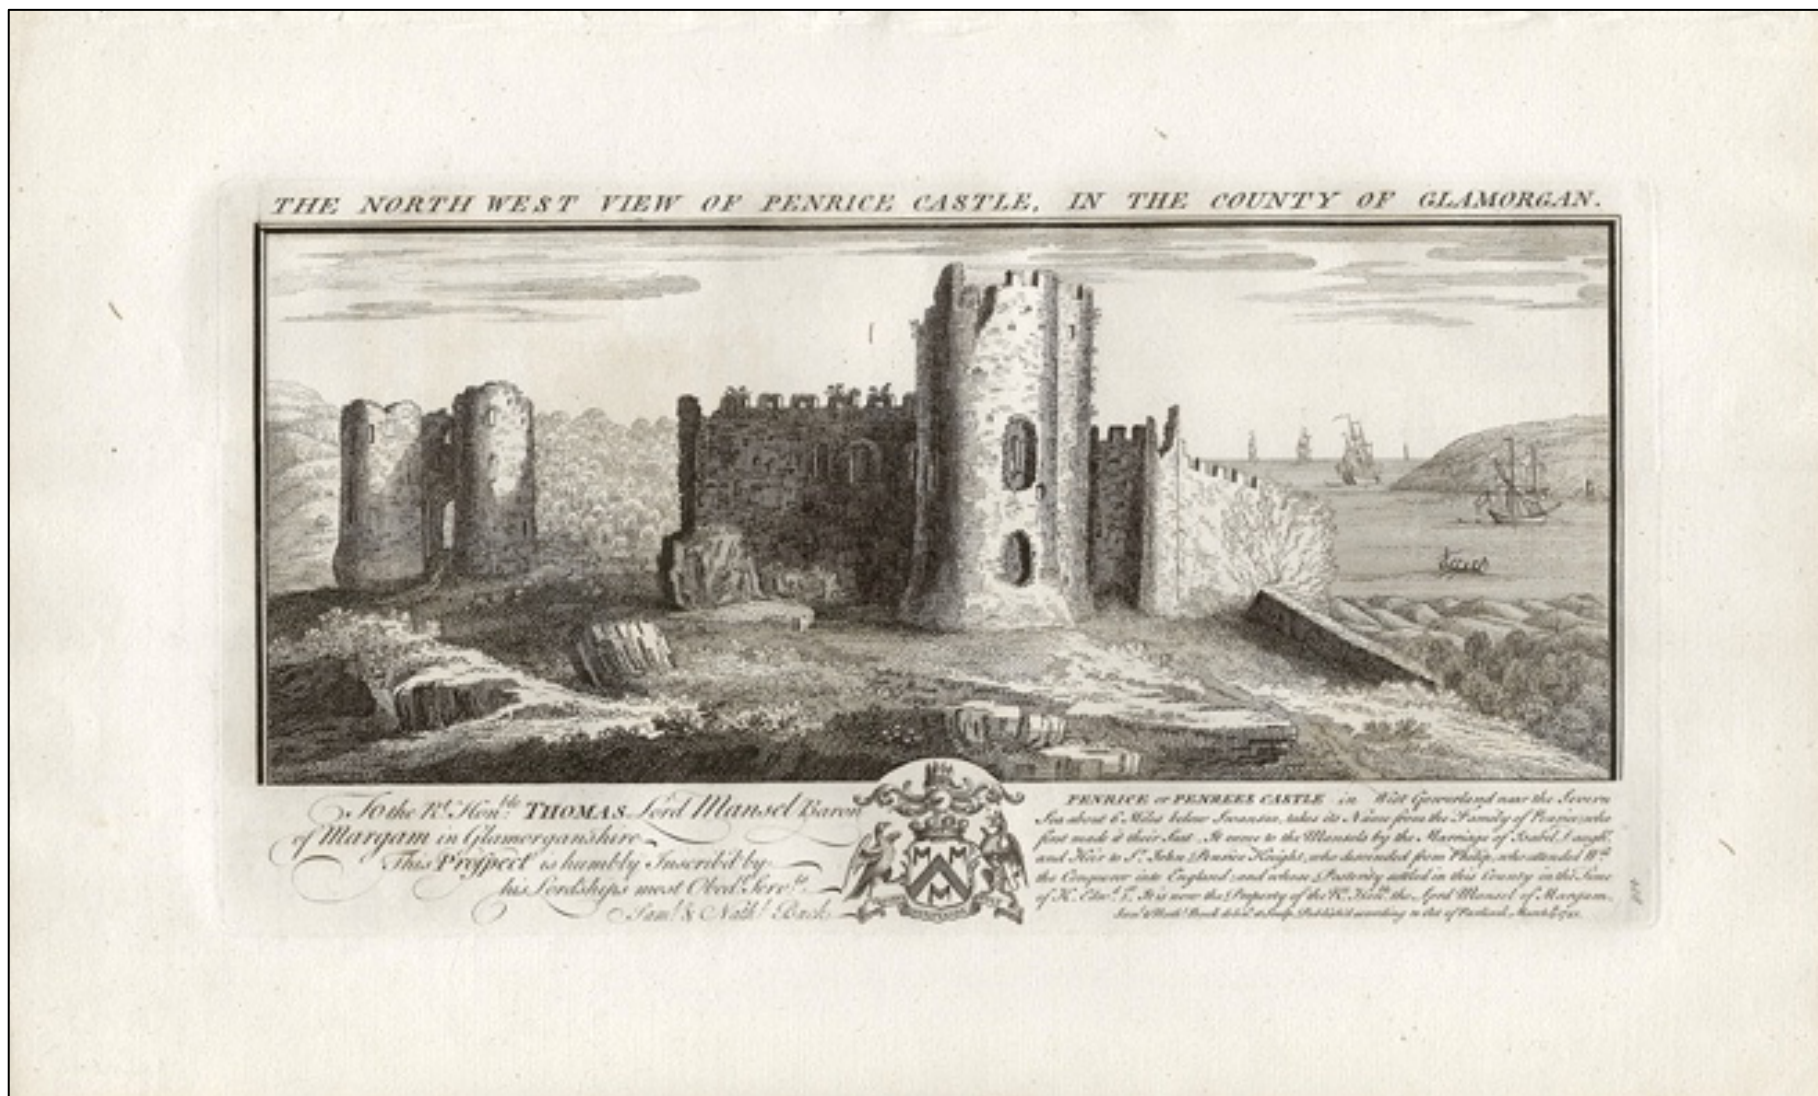
Plate 1. 'The North West View of Penrice Castle, in the County of Glamorgan' by Samuel and Nathaniel Buck (Buck's Antiquities) 1739-42.

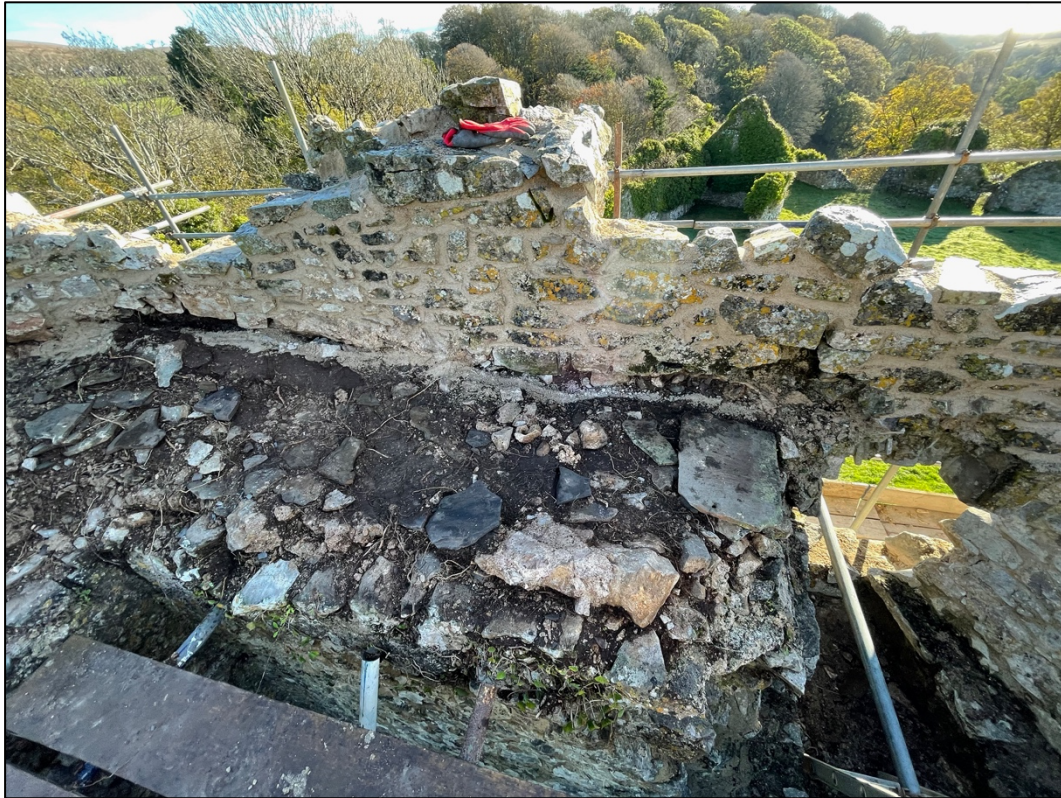
**Plate 2. Wall walk (NE side) along the south eastern internal wall of the gatehouse during masonry conservation and prior to archaeological investigation.**

- 8.1.2 *North Eastern side of the wall walk – Figures 1 and 2; Plates 2, 4-6, 9, 11 and 12*
- 8.1.3 The earliest structural element encountered was the rubble core of the gatehouse, the visible remains of which comprised small limestone stones (<0.1m) held in a hard brownish (sandy) white mortar (Period II). The core of the gatehouse wall directly underlay (and contained) wall walk drain [006], and the very fragmented remains of the wall walk stone surface [004]. The latter being composed of small flat stones (<0.4m) bedded into the core [005] of the gatehouse wall. The Wall Walk Drain 1 [006] was composed of limestone sides and top forming part of the gatehouse wall (exterior 0.25m high x 0.2m wide; interior 0.15m high x 0.39m wide), with a sandstone (Pennant?) stone base. The interior base of the drain was at the level of the of the fragmented remains of the wall walk stone surface [004], with a single small, thin, overlapping sandstone stone surviving before sloping gradually through the gatehouse wall.

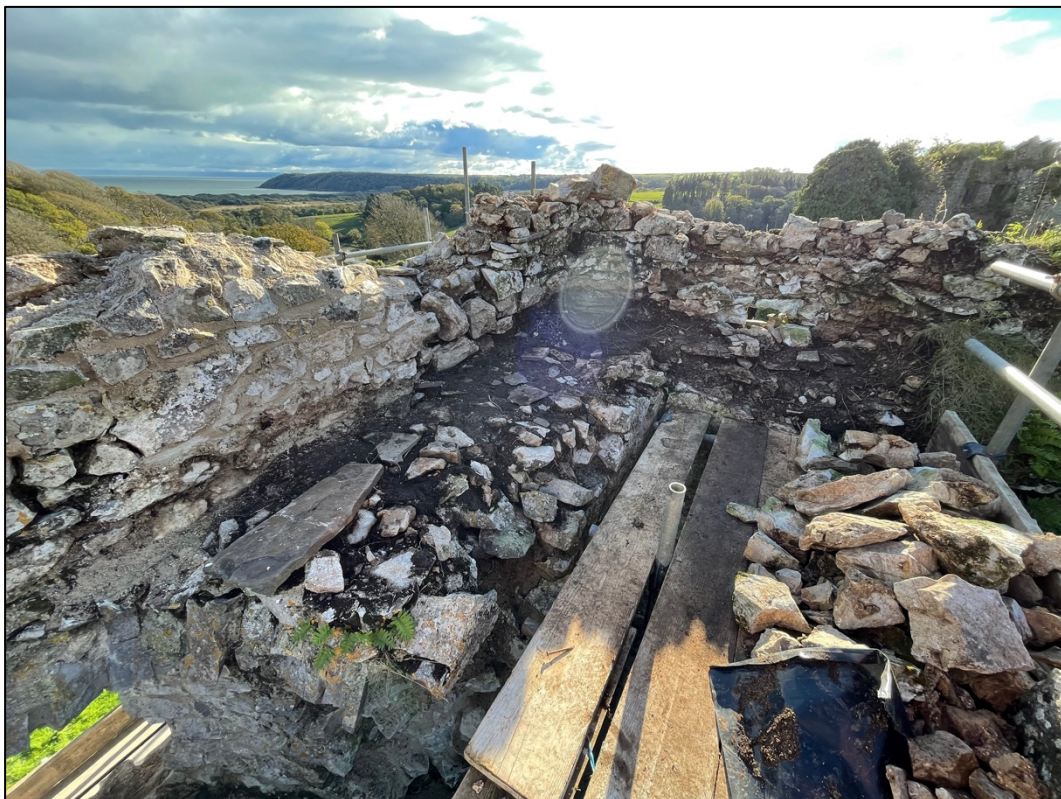
**Plate 3. Wall walk (SW side) along the south eastern internal wall of the gatehouse during masonry conservation and prior to archaeological investigation.**

- 8.1.5 *South Western side of the wall walk – Figures 1 and 2; Plates 3, 7, 8, 11 and 12*
- 8.1.6 The stratigraphy on the SW side of the gatehouse mirrored that on the NE side but with the exception that no formal archaeological excavation was carried out or required. Therefore, a descriptive record was made, including the newly discovered Wall Walk Drain 2 [007].

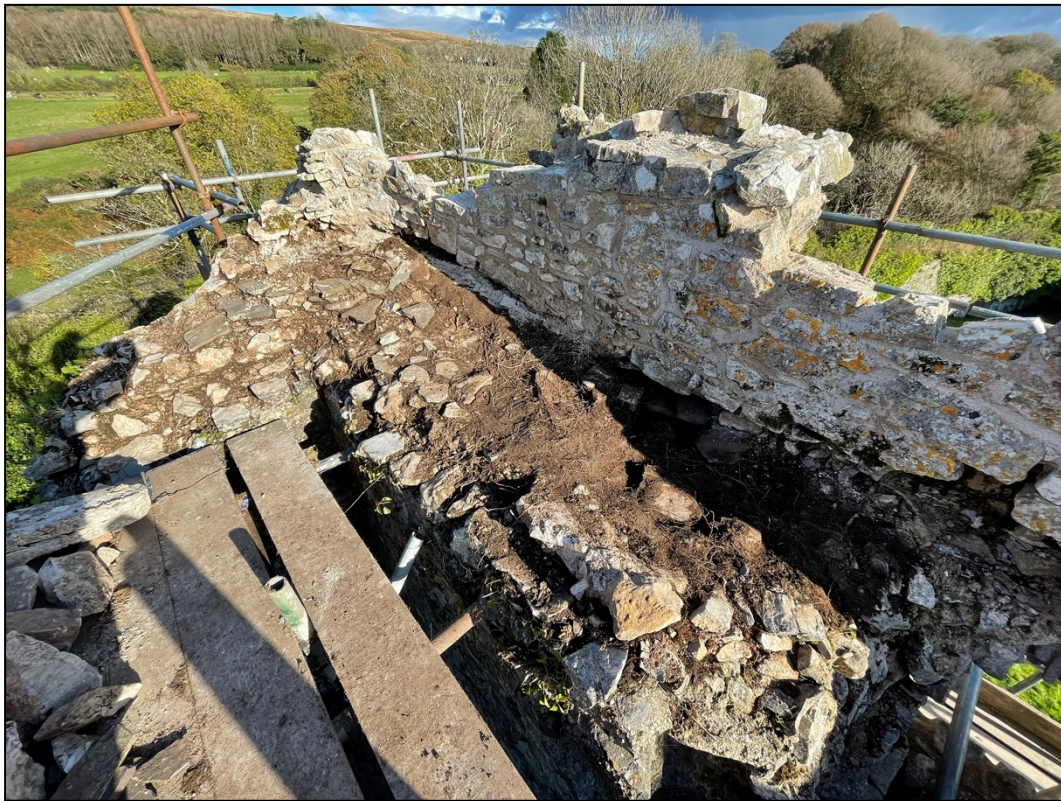
**Plate 4. Wall walk (NE side) along the south eastern internal wall of the gatehouse following archaeological investigation.**

- 8.1.4 The wall walk stone surface [004] was overlaid by a build-up of loose tabular sandstone and limestone held in soft cream coloured lime mortar matrix [002]. The Wall Walk Drain 1 [006] was repurposed and a new walkway drain [003], defined by a narrow limestone channel, inserted into the earlier drain. Both repurposed sandstone roof stones (SF1 and SF2), possibly medieval, and very poor-quality fragments of roof slates (SF03), possibly from Pembrokeshire(?), were used in the construction of the build-up material [002]. A single whole sandstone roof stone (SF01) was recovered from [002], possibly used as a surface (flag) stone for the later, and presumably Post-medieval wall walk. The upper most deposit was a thin (0.04m) covering of dark-brown friable topsoil, with heavy bioturbation (001).

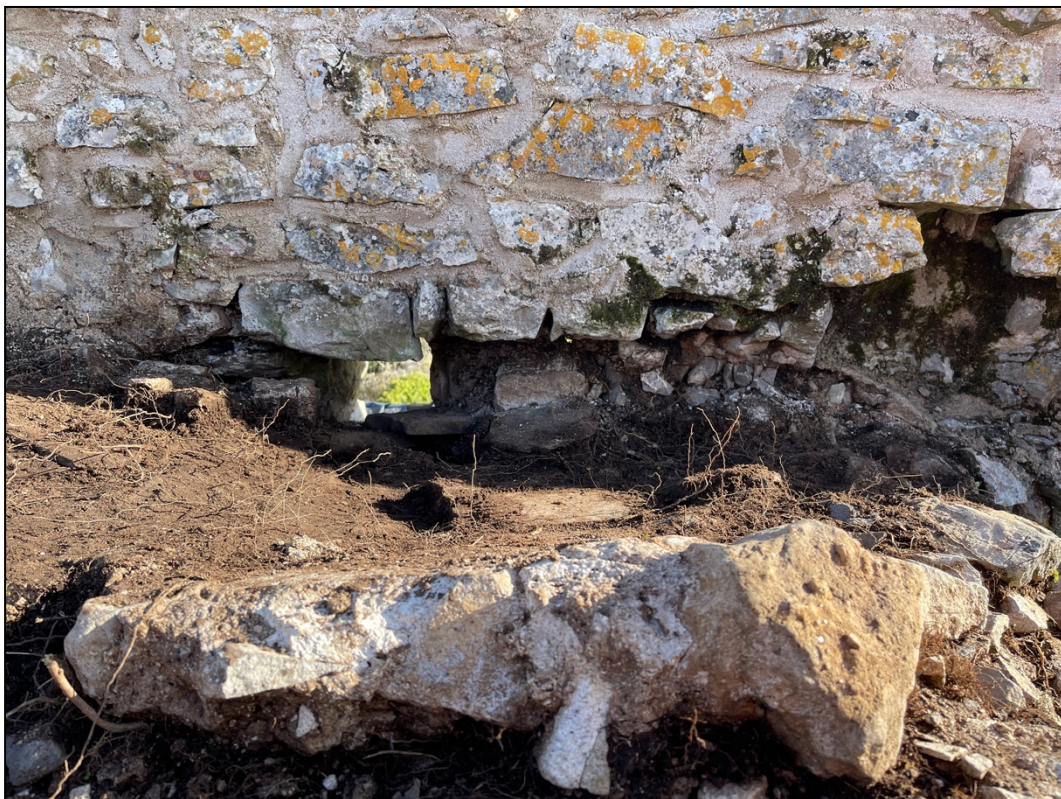
**Plate 5. Wall Walk Drain [006] (NE side), view to SE following archaeological investigation.**

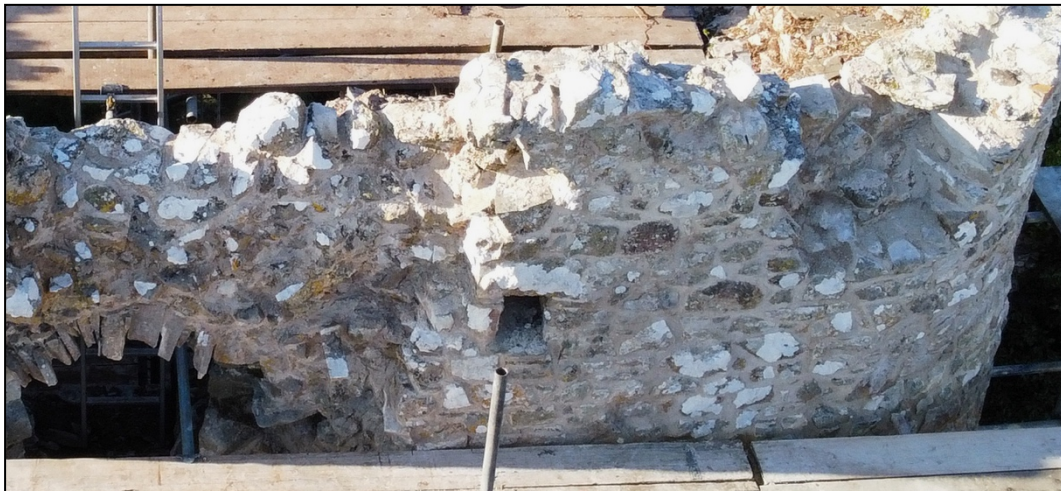
Plate 6. Wall Walk Drain [006] (NE side), view to NW.

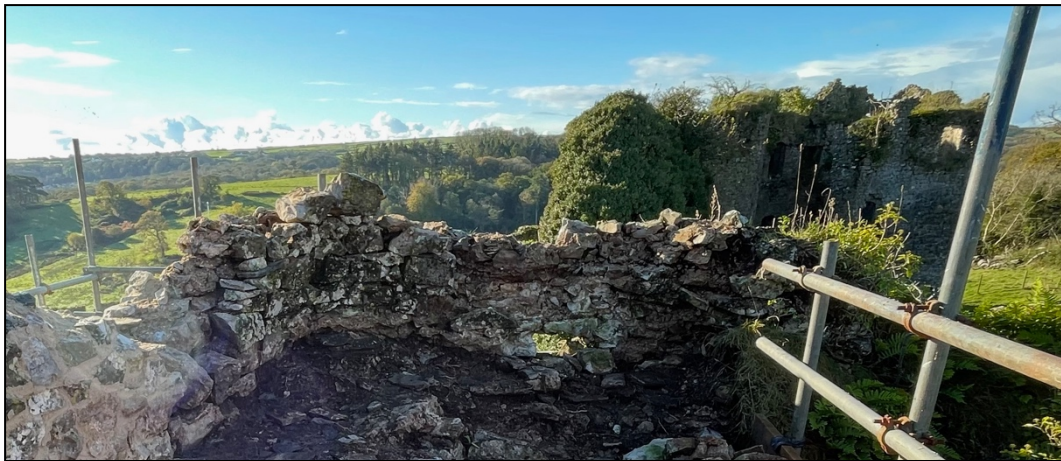
Plate 7. Wall Walk Drain [007] (SW side), view to SW.

- 8.1.7 A poorly surviving wall walk drain [007] was identified in the SW wall of the gatehouse. As far as could be ascertained without formal excavation, the form and extent (0.25m wide x 0.28m high) mirrored the drain recorded in the SE wall of the gatehouse [006]. The presumed sandstone base was missing. No later drains were identifiable, as with the drain [006] to the northeast, due to the poor survival of stonework in this location.

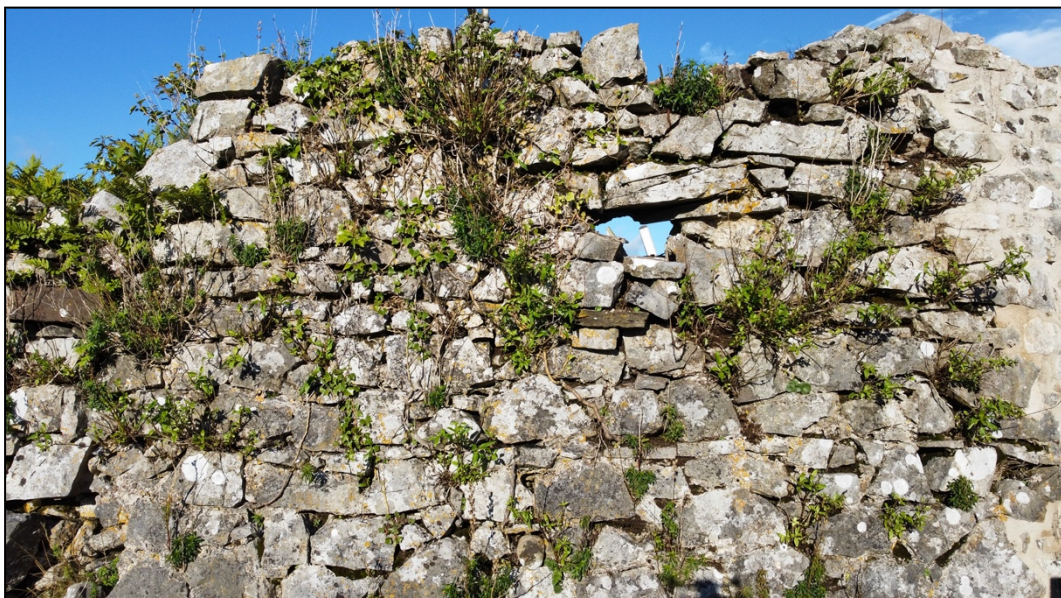
Plate 8. Wall Walk Drain [007] (SW side), view to NE.

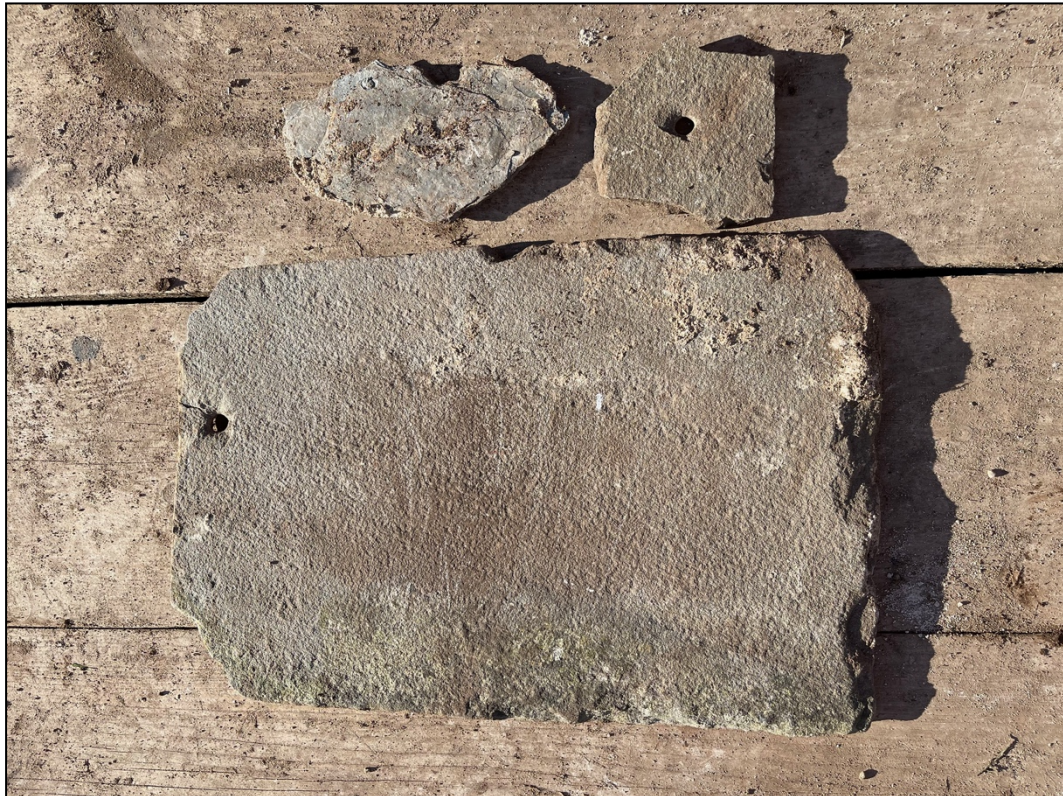
**Plate 9. Roof stones and slate recovered from Post-medieval wall walk [002].**

- 9.1.1 Artefactual evidence included the identification and recording of three roof stones/tiles from the Post-medieval wall walk [002] (Plate 9). SF01 and SF02 were both sandstone roof stones complete with augured peg perforations; the former was complete whilst the latter only a small fragment. SF03 was a fragment of roofing slate, again complete with perforation for the peg or cleat. SF03 comprised of poor-quality slate and visually appeared to resemble Pembrokeshire slate.

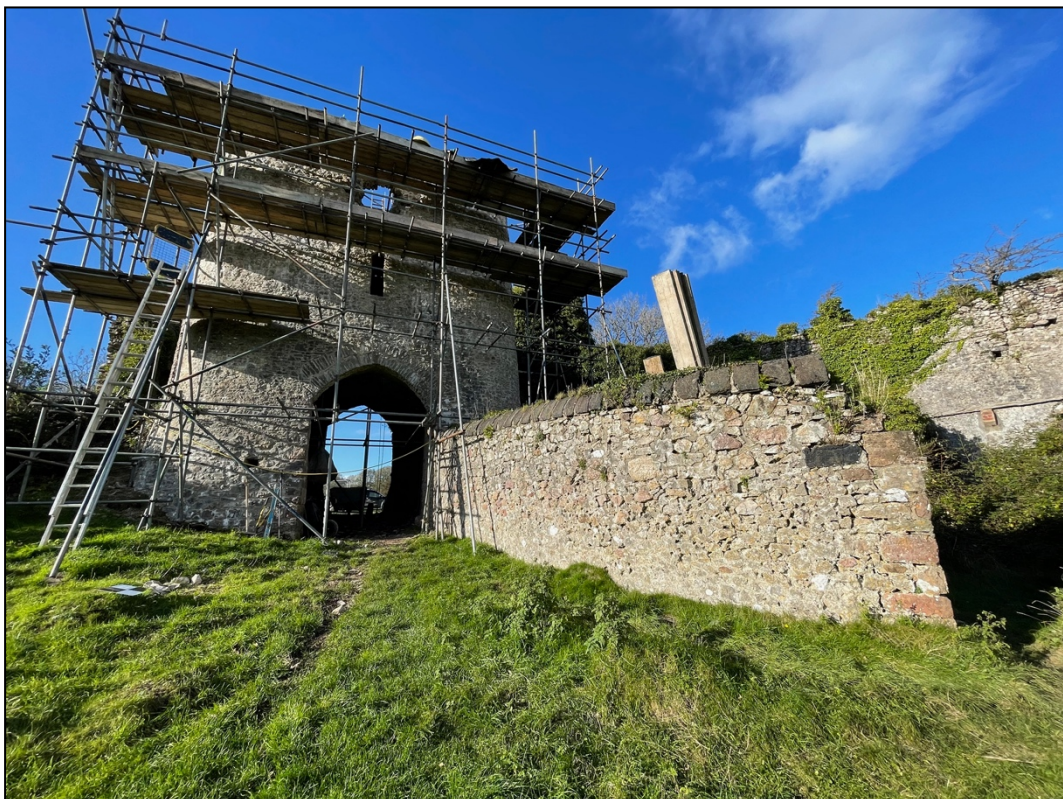
**Plate 10. Inner wall topped with coppers slag coping stones and some copper slag blocks. View to NNW.**

- 9.1.3 It was noted with interest that the fairly recent wall built on the SE side of the gatehouse (Plate 10) was topped with copper slag coping stones and also had several copper slag blocks used in in the wall's construction. Copper slag was a by-product of the copper industry in the Swansea Valley and exemplifies how the industry innovated, turning waste products into by products with value. The copper slag coping stones and block noted in the wall may have come from the Hafod-Morfa Copperworks, Swansea as the Vivians were family friends of the Talbots of Penrice and Margam (*pers. comm.* Mr Thomas Methuen-Campbell).

- 10.1.4 The fairly recent wall built on the SE side of the gatehouse (Plate 10) topped with copper slag coping stones was very interesting to note. Copper slag was a by-product of the copper industry in the Swansea Valley and exemplifies how the industry innovated, turning waste products into by products with value. The copper slag coping stones and block noted in the wall may have come from the Hafod-Morfa Copperworks, Swansea as the Vivians were family friends of the Talbots of Penrice and Margam (*pers. comm.* Mr Thomas Methuen-Campbell).

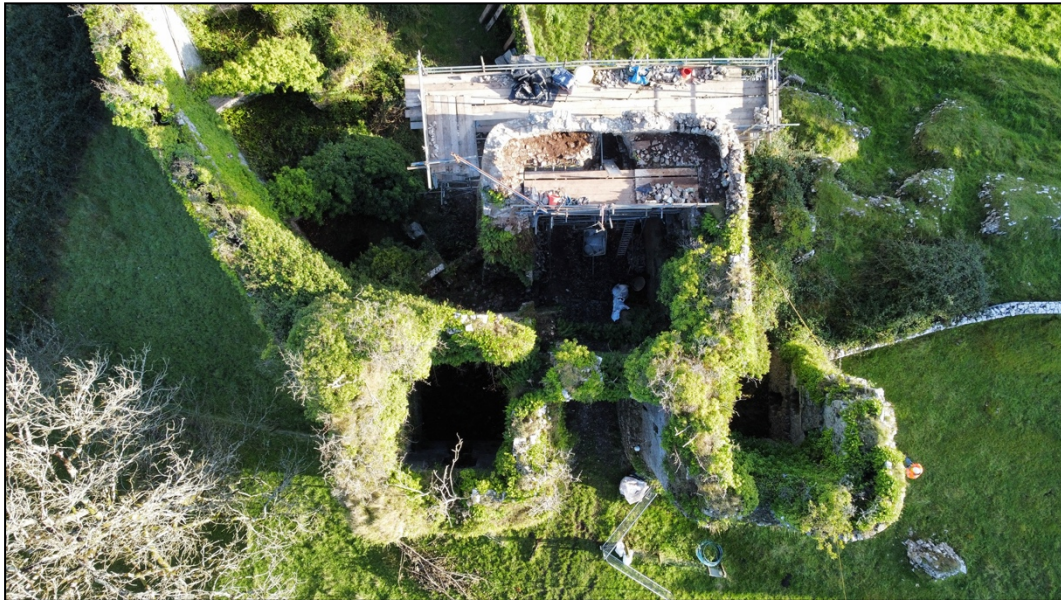
Plate 11. Gatehouse during masonry conservation and following archaeological investigation. Nadir view.

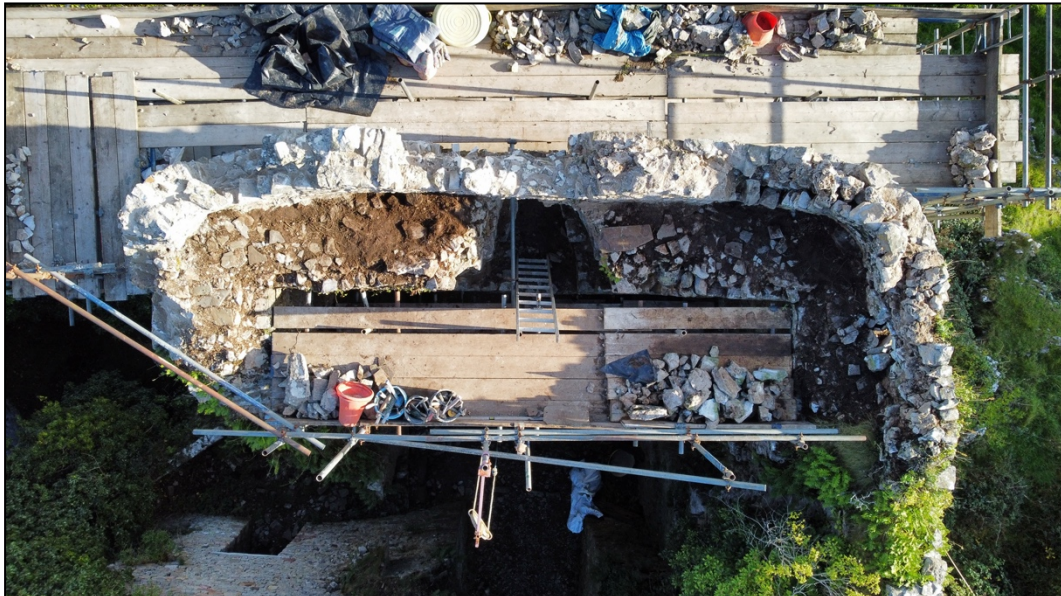
Plate 12. Gatehouse during masonry conservation and following archaeological investigation. Nadir view.

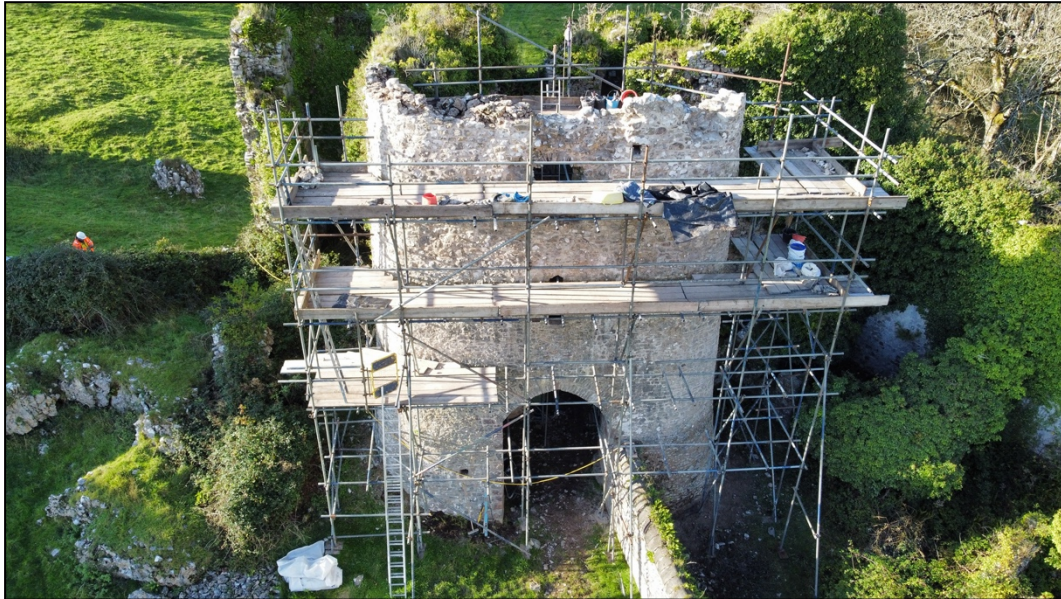
**Plate 13. Gatehouse during masonry conservation and following archaeological investigation. View to NW.**

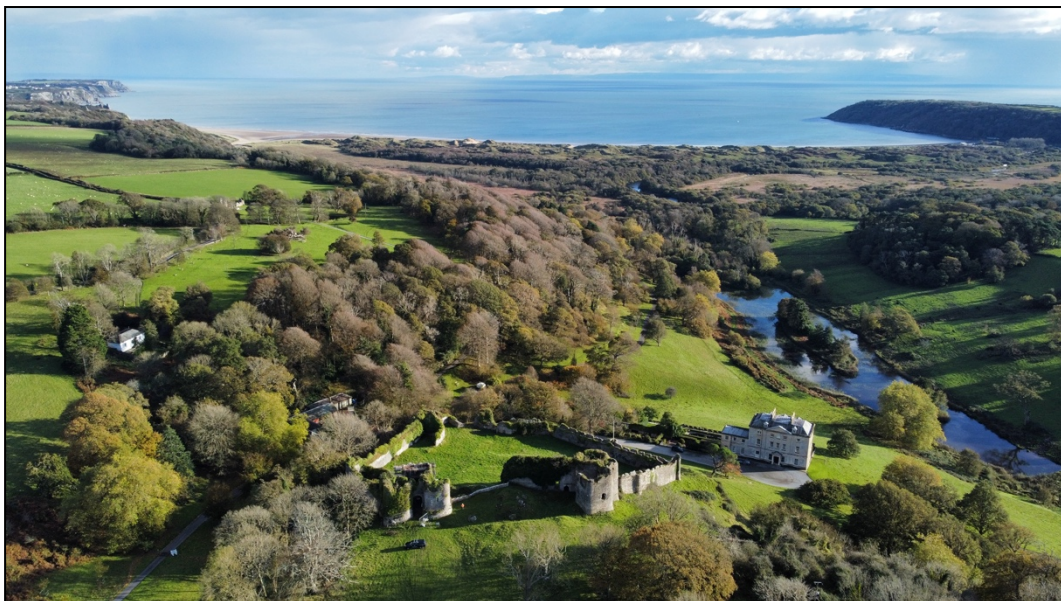
**Plate 14. Penrice Castle (SMGm047). View to SW.**
