Pennard Castle, Gower

Photogrammetric 3D Building Survey

Pennard Castle (SMGm044) Orthographic Photogrammetric Elevation of the north facing Curtain Wall

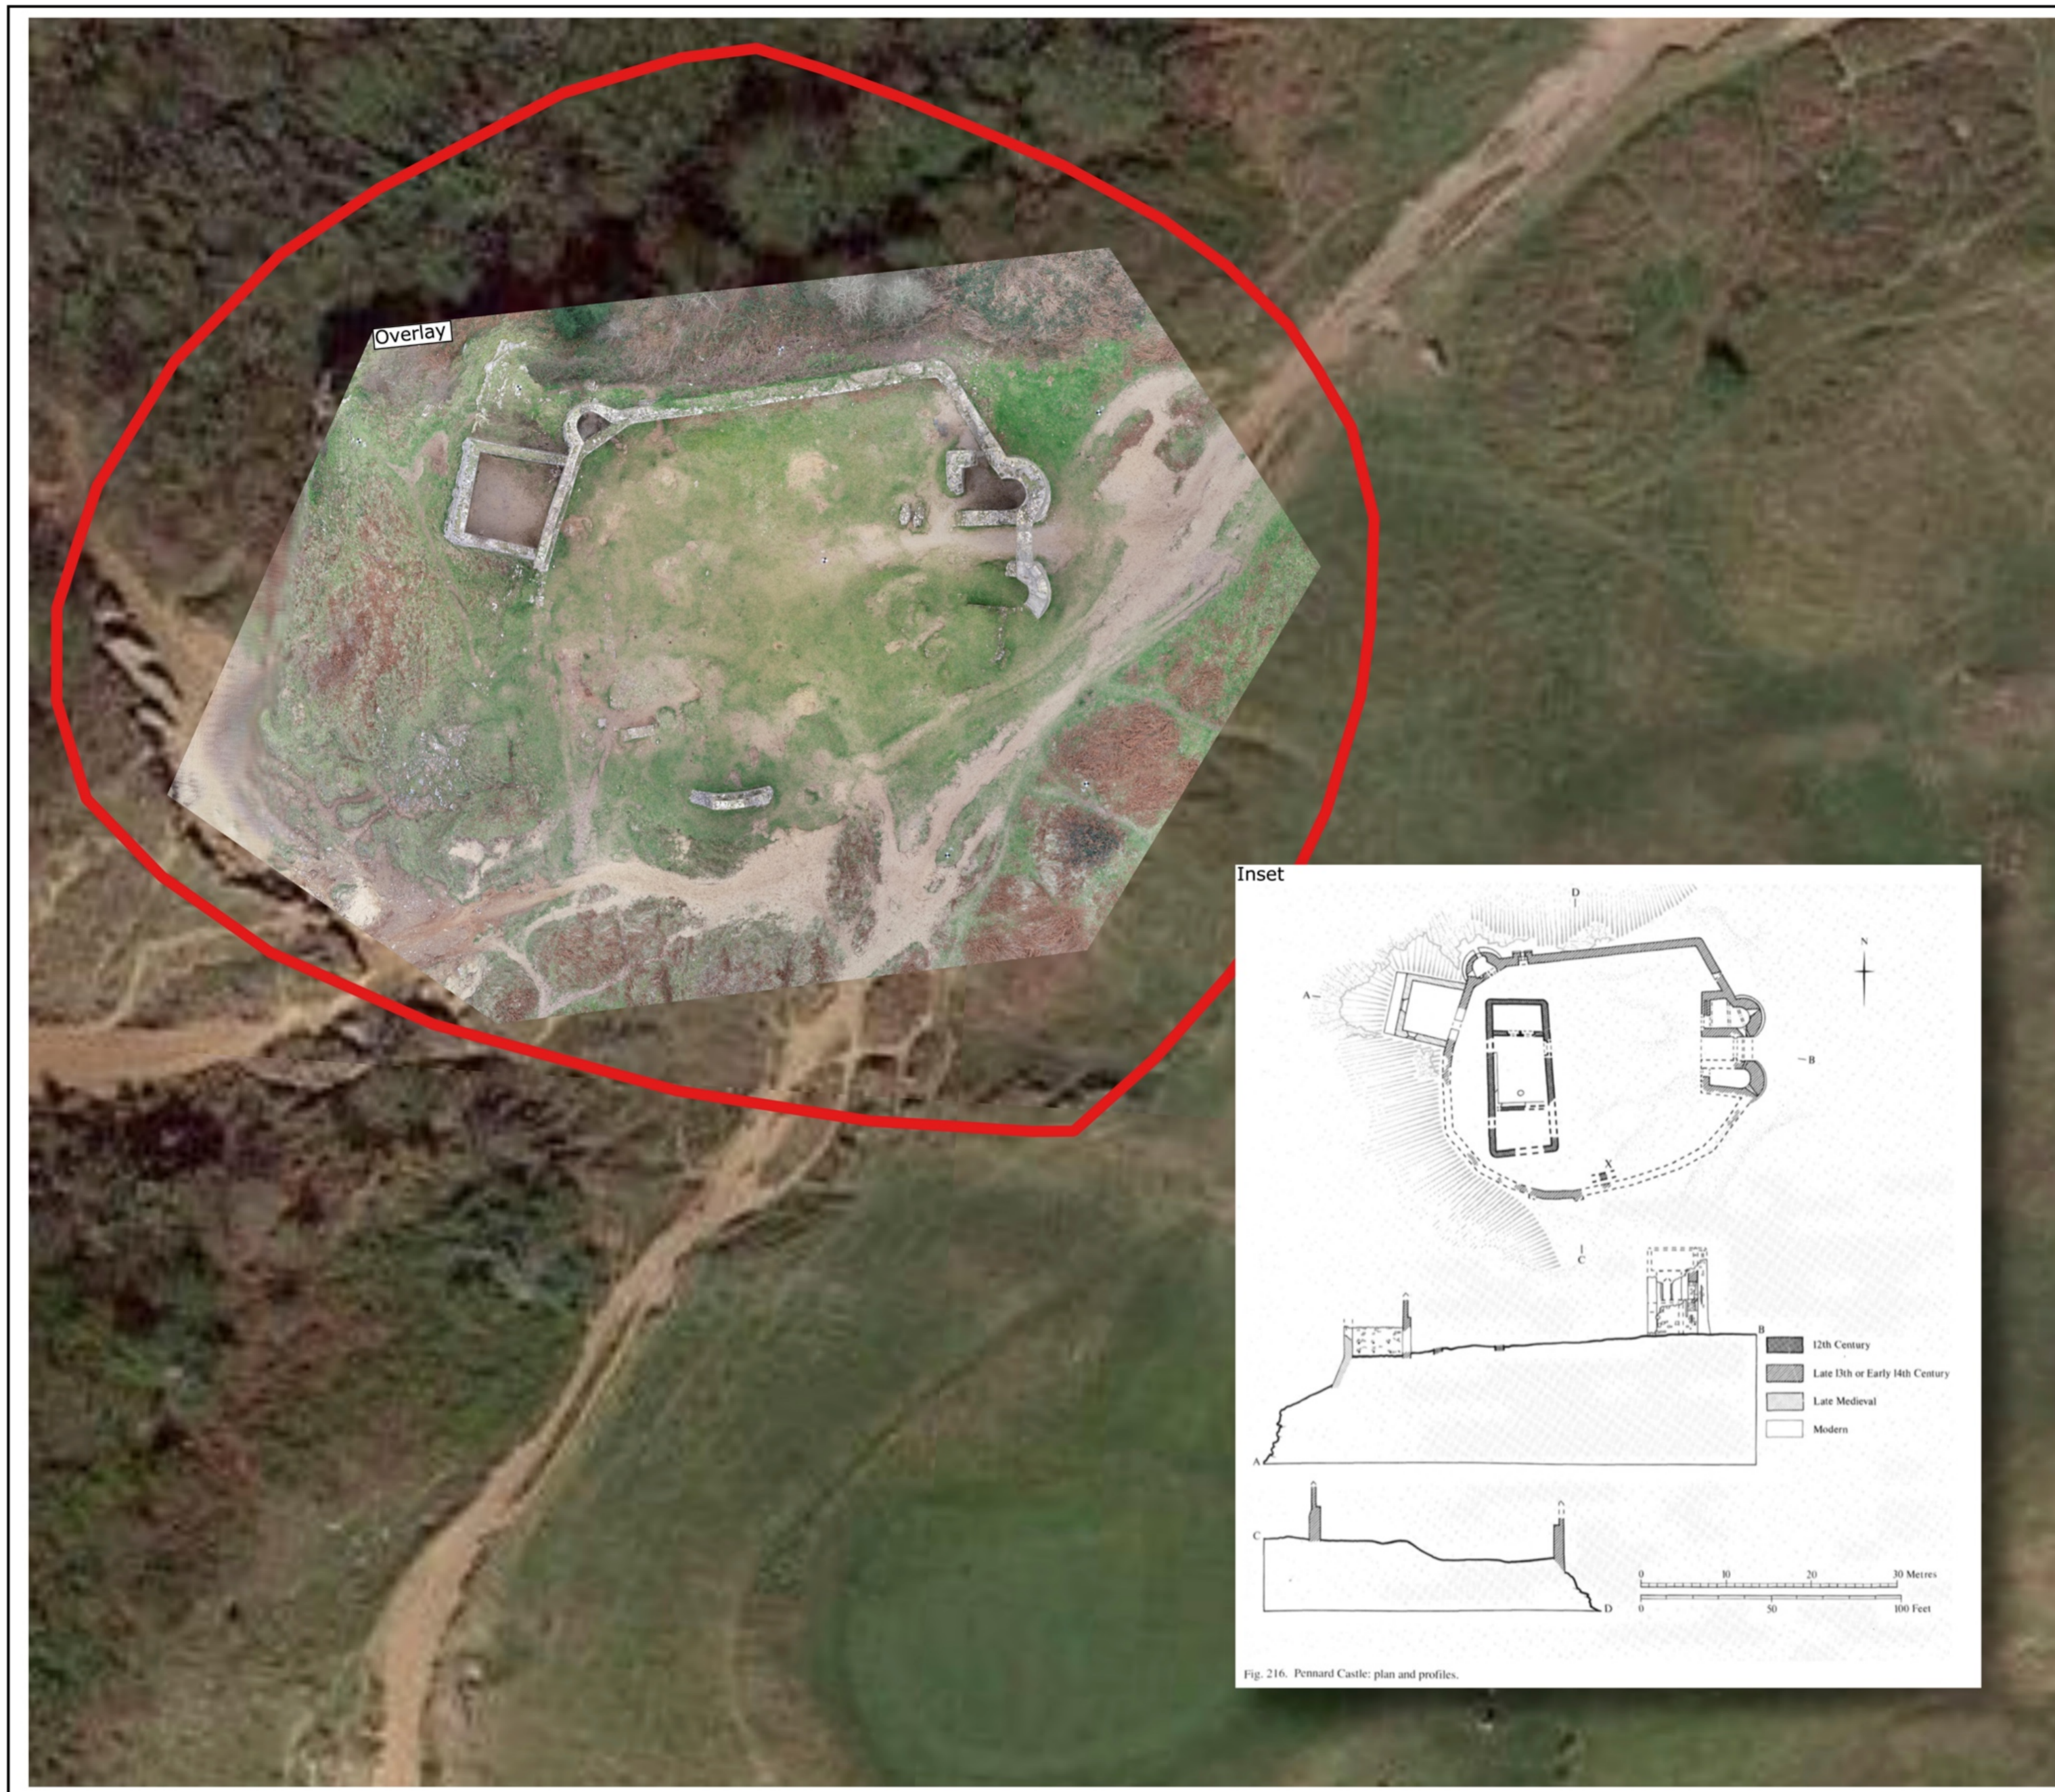
Figure 1. Pennard Castle, Gower (SMGm044), Photogrammetric Orthomosaic Plan. Inset: Fig.216 Pennard Castle plan and profiles © Crown Copyright: Royal Commission on the Ancient and Historical Monuments of Wales.

- 1.1.1 Black Mountains Archaeology Ltd/*Archaeoleg Mynydd Du Cyf* were commissioned by City and County of Swansea to undertake a photogrammetric survey of Pennard Castle, Gower (Figure 1). The aim of the survey to produce accurate, measured 3D photogrammetric modelling of the castle utilising aerial (drone) and terrestrial digital cameras. The outcome a detailed 'digital twin' of the castle. The main focus of the survey was the North Curtain Wall, which has suffered some deterioration in recent years. A review of historic maps and images has been undertaken to inform on the extent of the deterioration of the castle and key dates where elements of the castle have been stabilised with conservation work. Any descriptions of the deterioration of the castle, particularly the north curtain wall, are from a visual archaeological perspective as opposed to structural, as we are not qualified to comment on the structural stability, weakness or otherwise of any part of the castle's standing masonry.

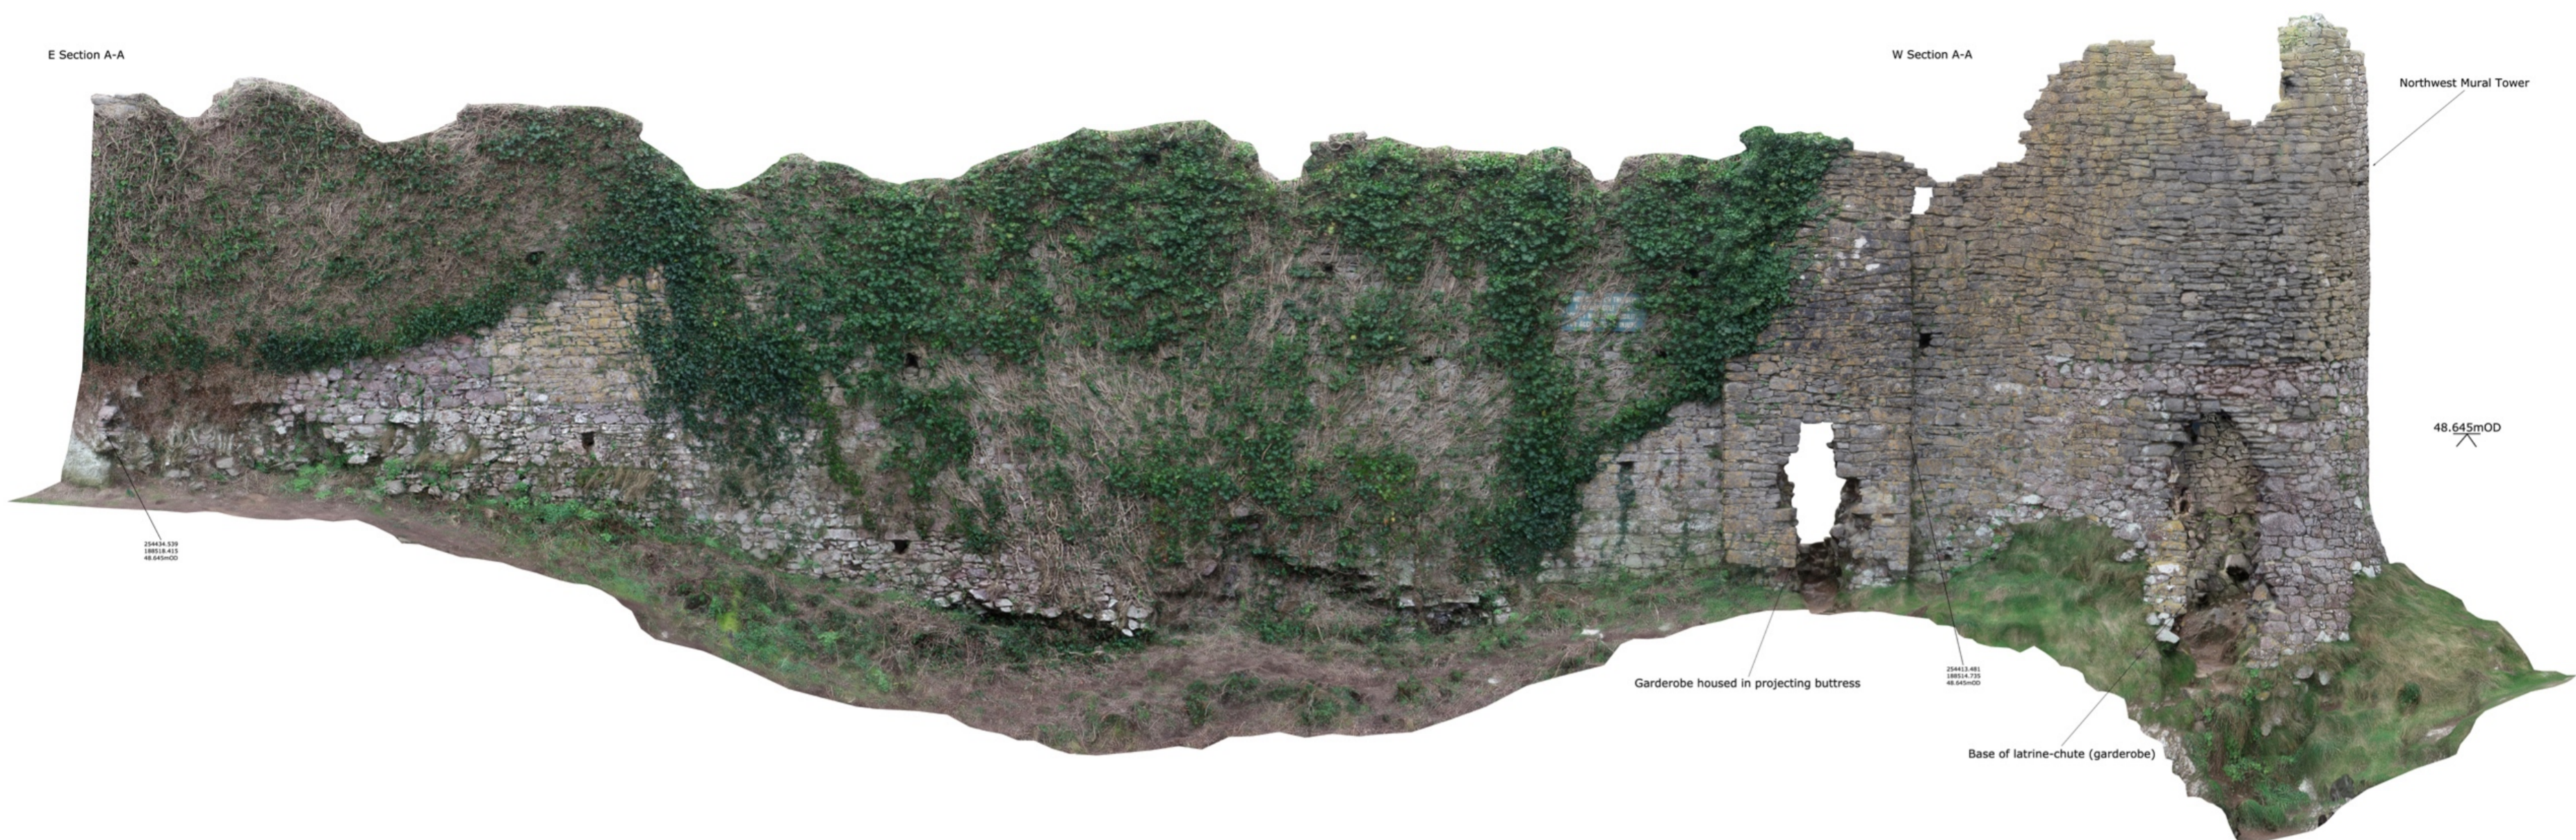
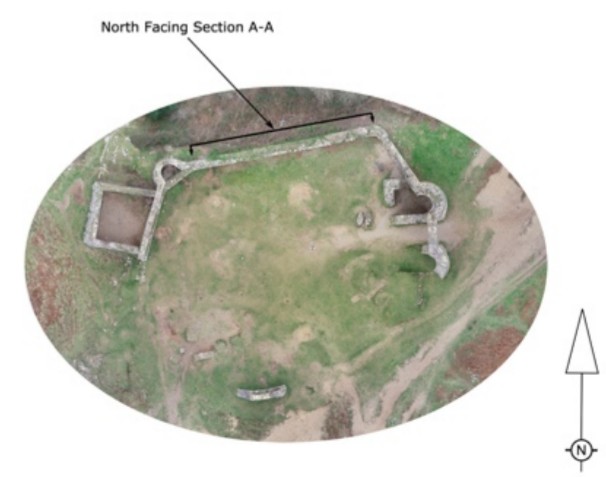
Fig. 218. Pennard Castle: (a) external north front. The crenellation restored in broken lines is based on early photographs, the Buck print, and slight surviving vestiges (RCAHMW 1991, p293).

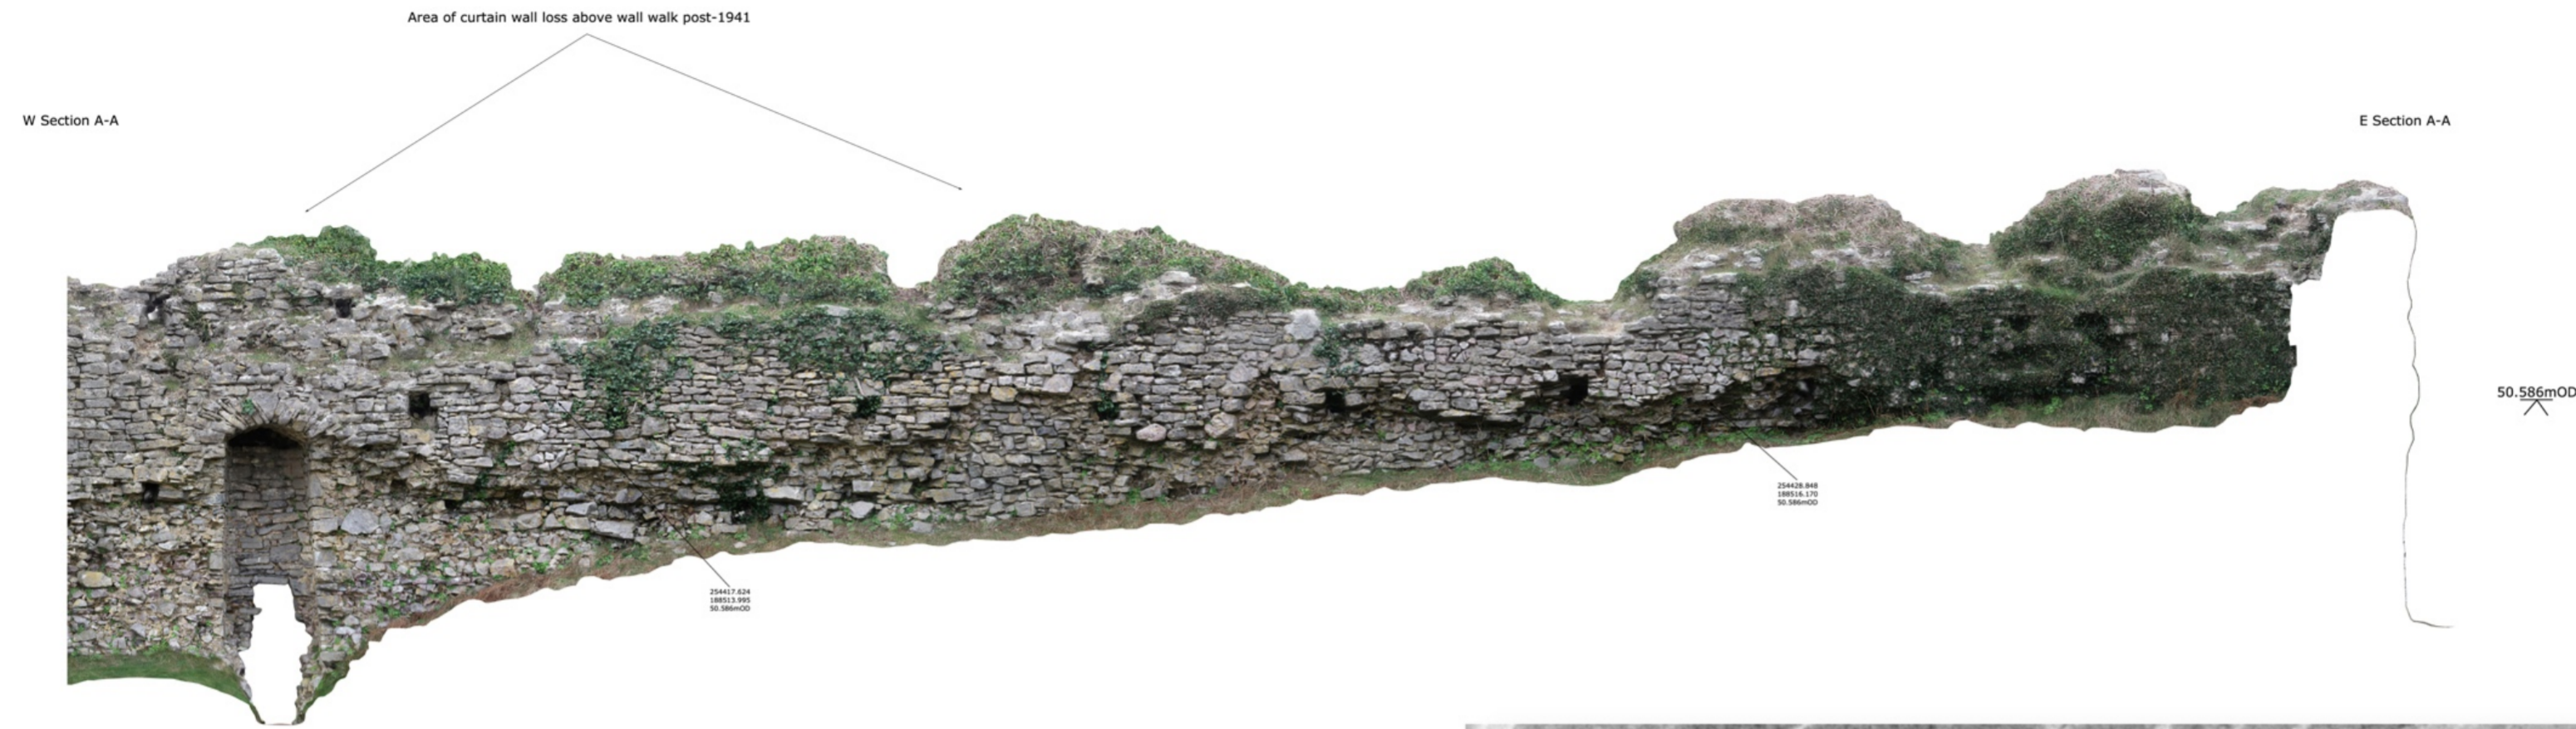
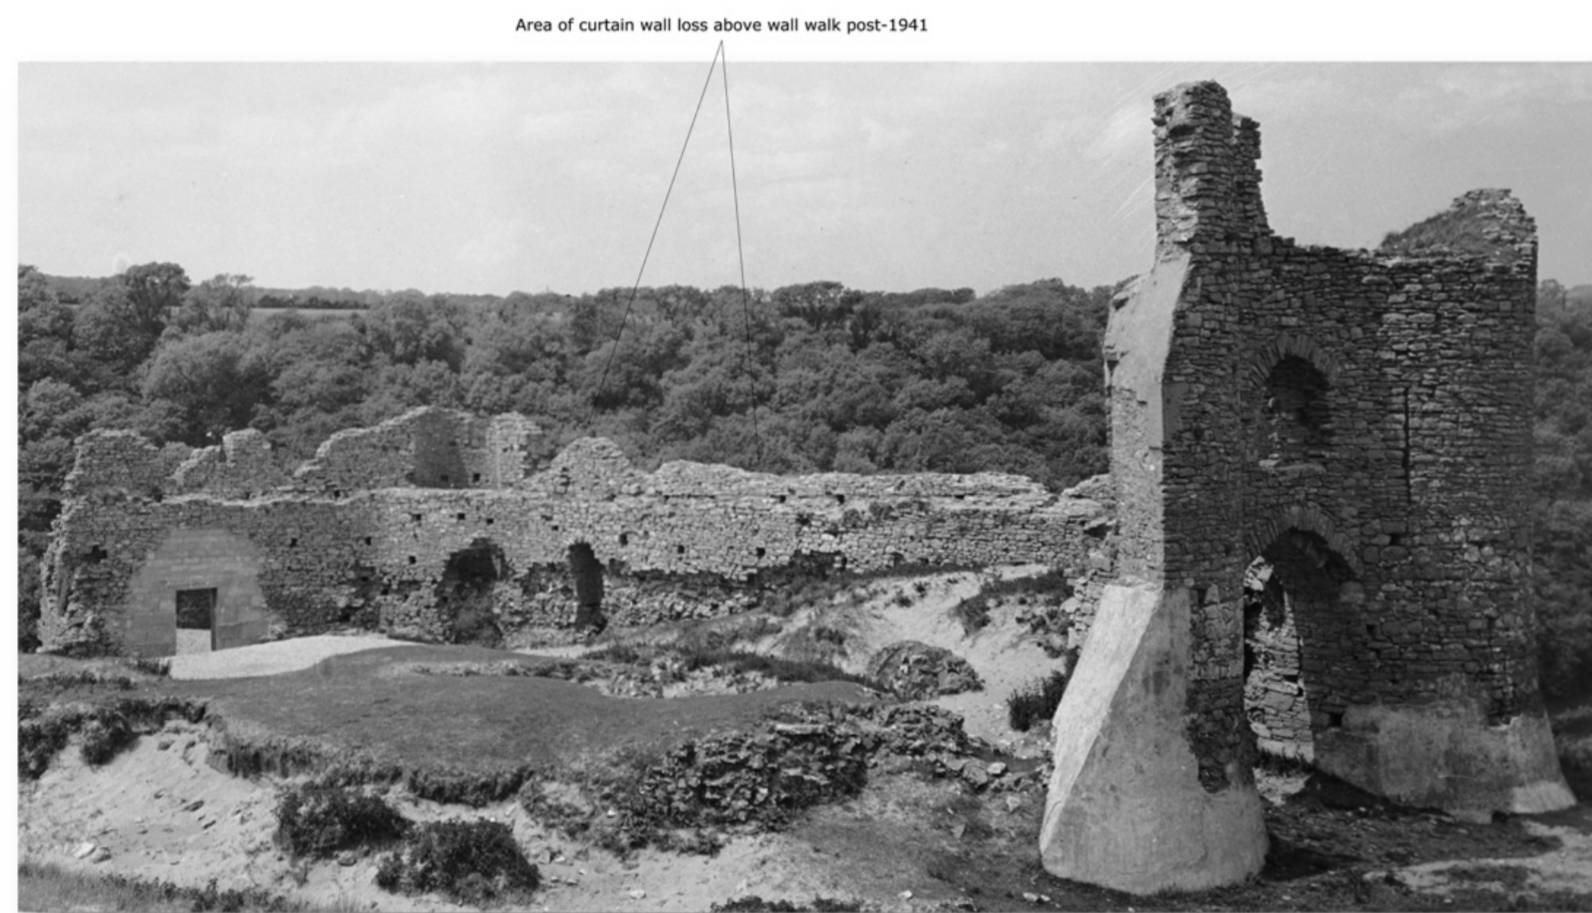
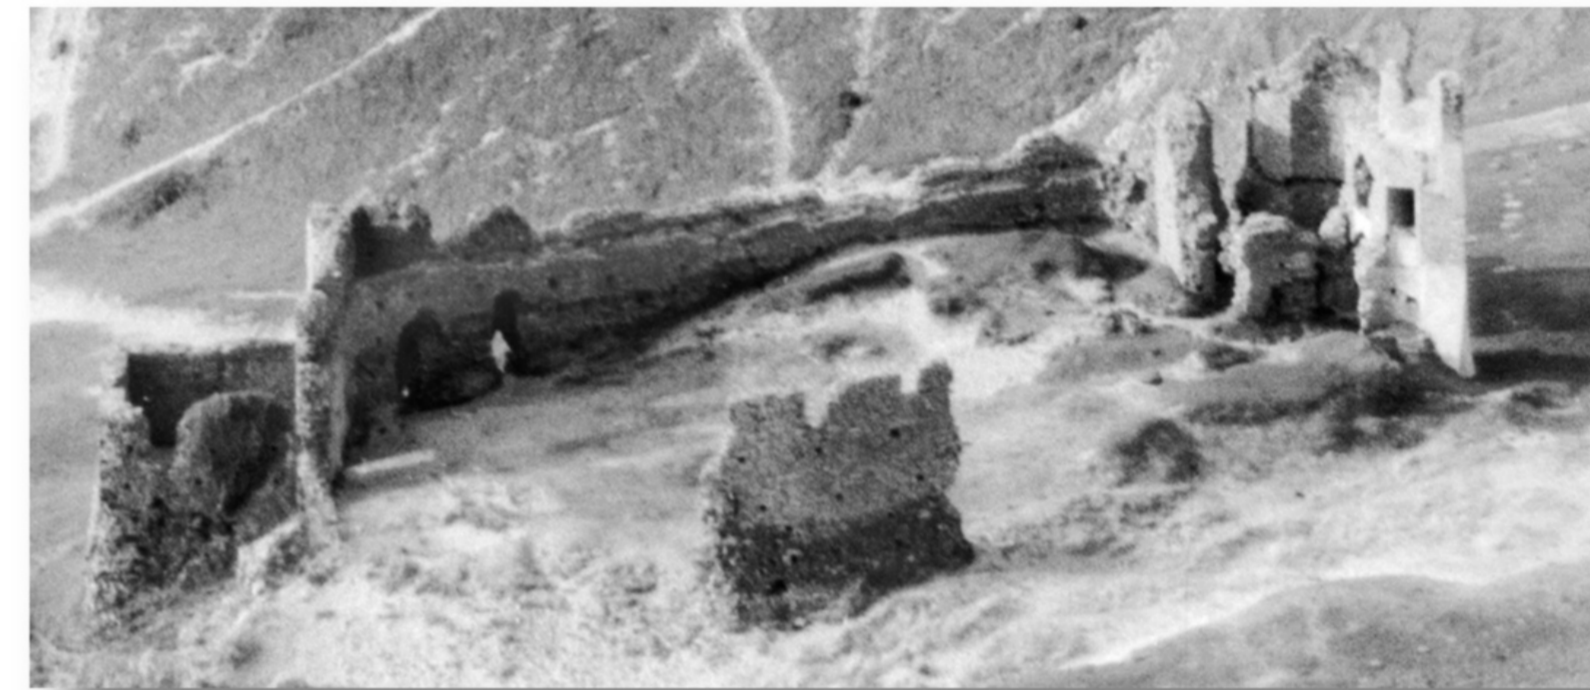
View of the south facing North Curtain wall and interior of Pennard Castle. June 1941
Archive No. 6351169 (c) RCAHMW

View north of Pennard Castle post-1941
Archive No. 6413367 (c) RCAHMW

Figure 4. Orthographic Photogrammetric Elevation of the south facing internal North Curtain Wall. Inset Photographs: 'North Curtain Wall June 1941' (Archive No.6351169) and 'View North post-1941' (Archive No.6413367) © Crown Copyright: Royal Commission on the Ancient and Historical Monuments of Wales.

- 7.3.32 Plates 18-21 (Figures 4 and 5) are images held by the RCAHMW and date to 1941. These images show the 'concrete' conservation works carried out a little under twenty years before. Bernard Morris (1987; 2013, 111-13) helpfully fills in the blanks regarding the conservation work carried out in concrete. The Council of the Royal Institution of South Wales minute books (1923 and 1924) records an agreement with Pennard Golf Club and the Cambrian Archaeological Association to repair the castle "...to organise a scheme whereby the decay of Pennard Castle maybe arrested and the ruins preserved..." (Morris 1987; 2013, 112). The repairs in concrete included stabilising the south tower of the gatehouse after the collapse nearly fifteen years previous, the gatehouse archway and gatehouse wall tops. The perilous collapsing door through the west curtain wall into the square tower was also repaired and a faux doorway left inserted. In addition to the repairs, Plate 18 also shows the arrow loop in the north eastern curtain wall had started to deteriorate with a sizable hole in the wall. But even at this late-stage Plates 20-21 show significant masonry surviving on the north curtain wall, not recognisable as crenelations at this point anymore but still a significant loss of the parapet towards the half-round tower compared with the present survey. Of the two crenels visible on the surviving stub of the south curtain wall in Plate 21, only the eastern eroded crenel now survives. The arrow loop and merlon to the west has not survived. Half of this surviving stub of the south curtain wall collapsed outwards in early 1960 (Morris 2013, 113).

- 7.3.58 **1941:** images held by the RCAHMW (Plates 18-21; Figures 4-5) show the 'concrete' conservation works carried out in 1923-4 in detail. Arrow loop in the northeast curtain wall deteriorated with a sizable hole in the wall. Significant masonry still surviving on the north curtain wall but not recognisable as crenelations.

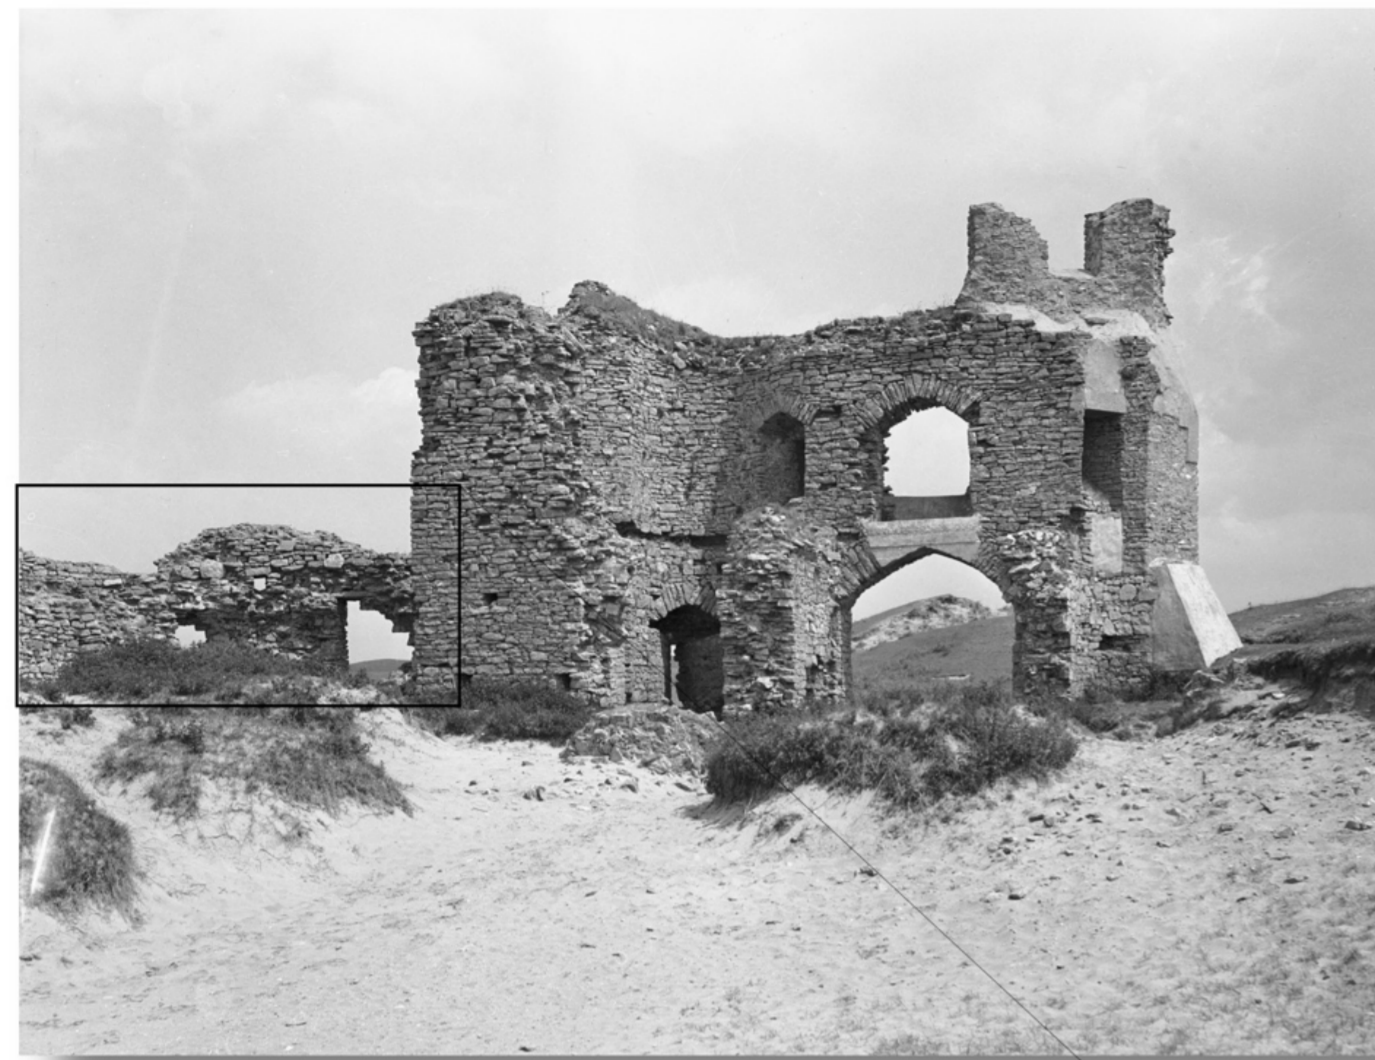
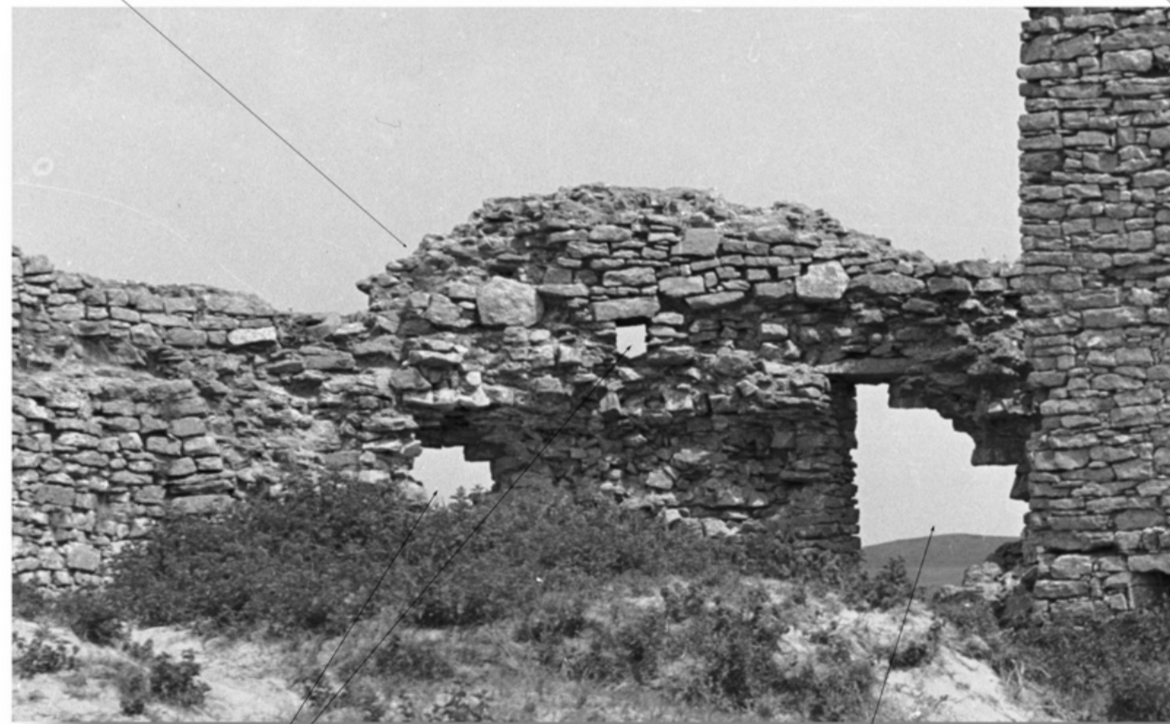
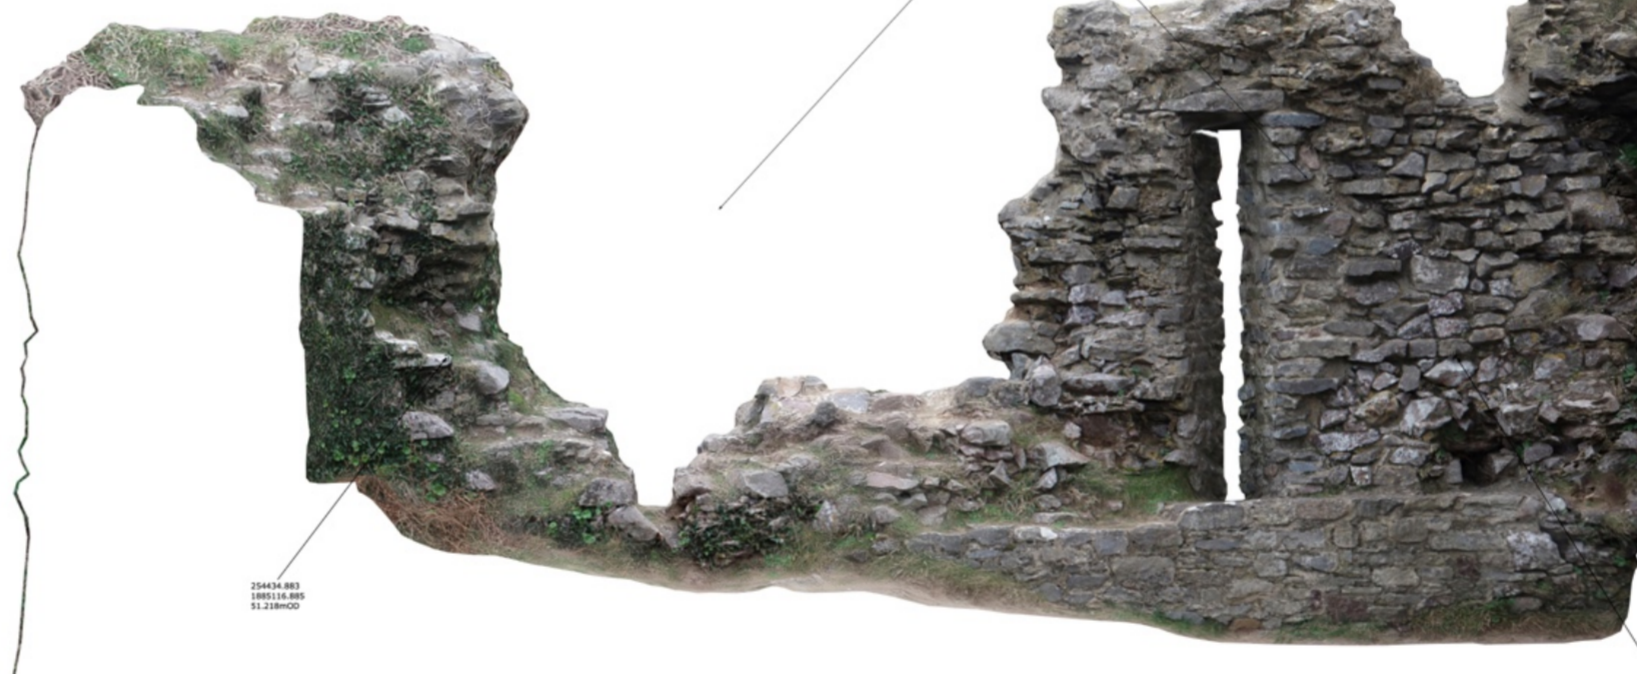
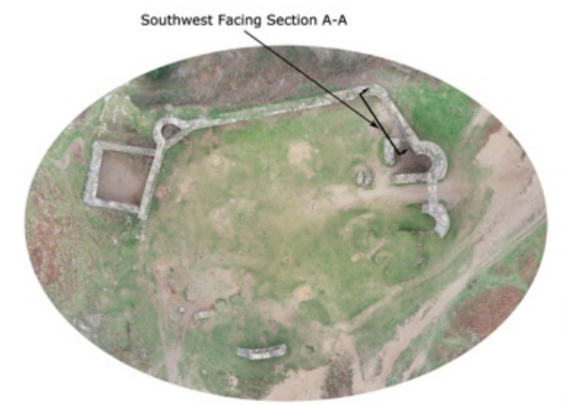
View of the gatehouse at Pennard Castle June 1941. Archive No. 6351162 (c) RCAHMW.

Significant area of curtain wall masonry collapse post-1952.

Put-log hole collapse: Left post-1952. Right post-1991.

Arrow loop repaired after 2010.

Significant area of curtain wall masonry collapse post-1952. Put-log hole collapse after 1991. Arrow loop repaired after 2010.

Figure 5. Orthographic Photogrammetric Elevation of the southwest facing internal North Curtain Wall. Inset Photograph: 'View of Gatehouse June 1941' (Archive No.6351162) © Crown Copyright: Royal Commission on the Ancient and Historical Monuments of Wales.

- 7.3.62 **1991:** Publication of RCAHMW survey. Plate 23 shows the northeast curtain with a large area of masonry collapse but with one putlog hole surviving adjacent to the repaired arrow loop. By the time RCAHMW took an aerial photograph in 2005 the putlog hole and surrounding wall had collapsed.

- 7.3.63 **2010:** Further repairs appear to have been made to the northeast curtain wall and arrow loop after this date. Numerous aerial photographs made by RCAHMW after 2010.

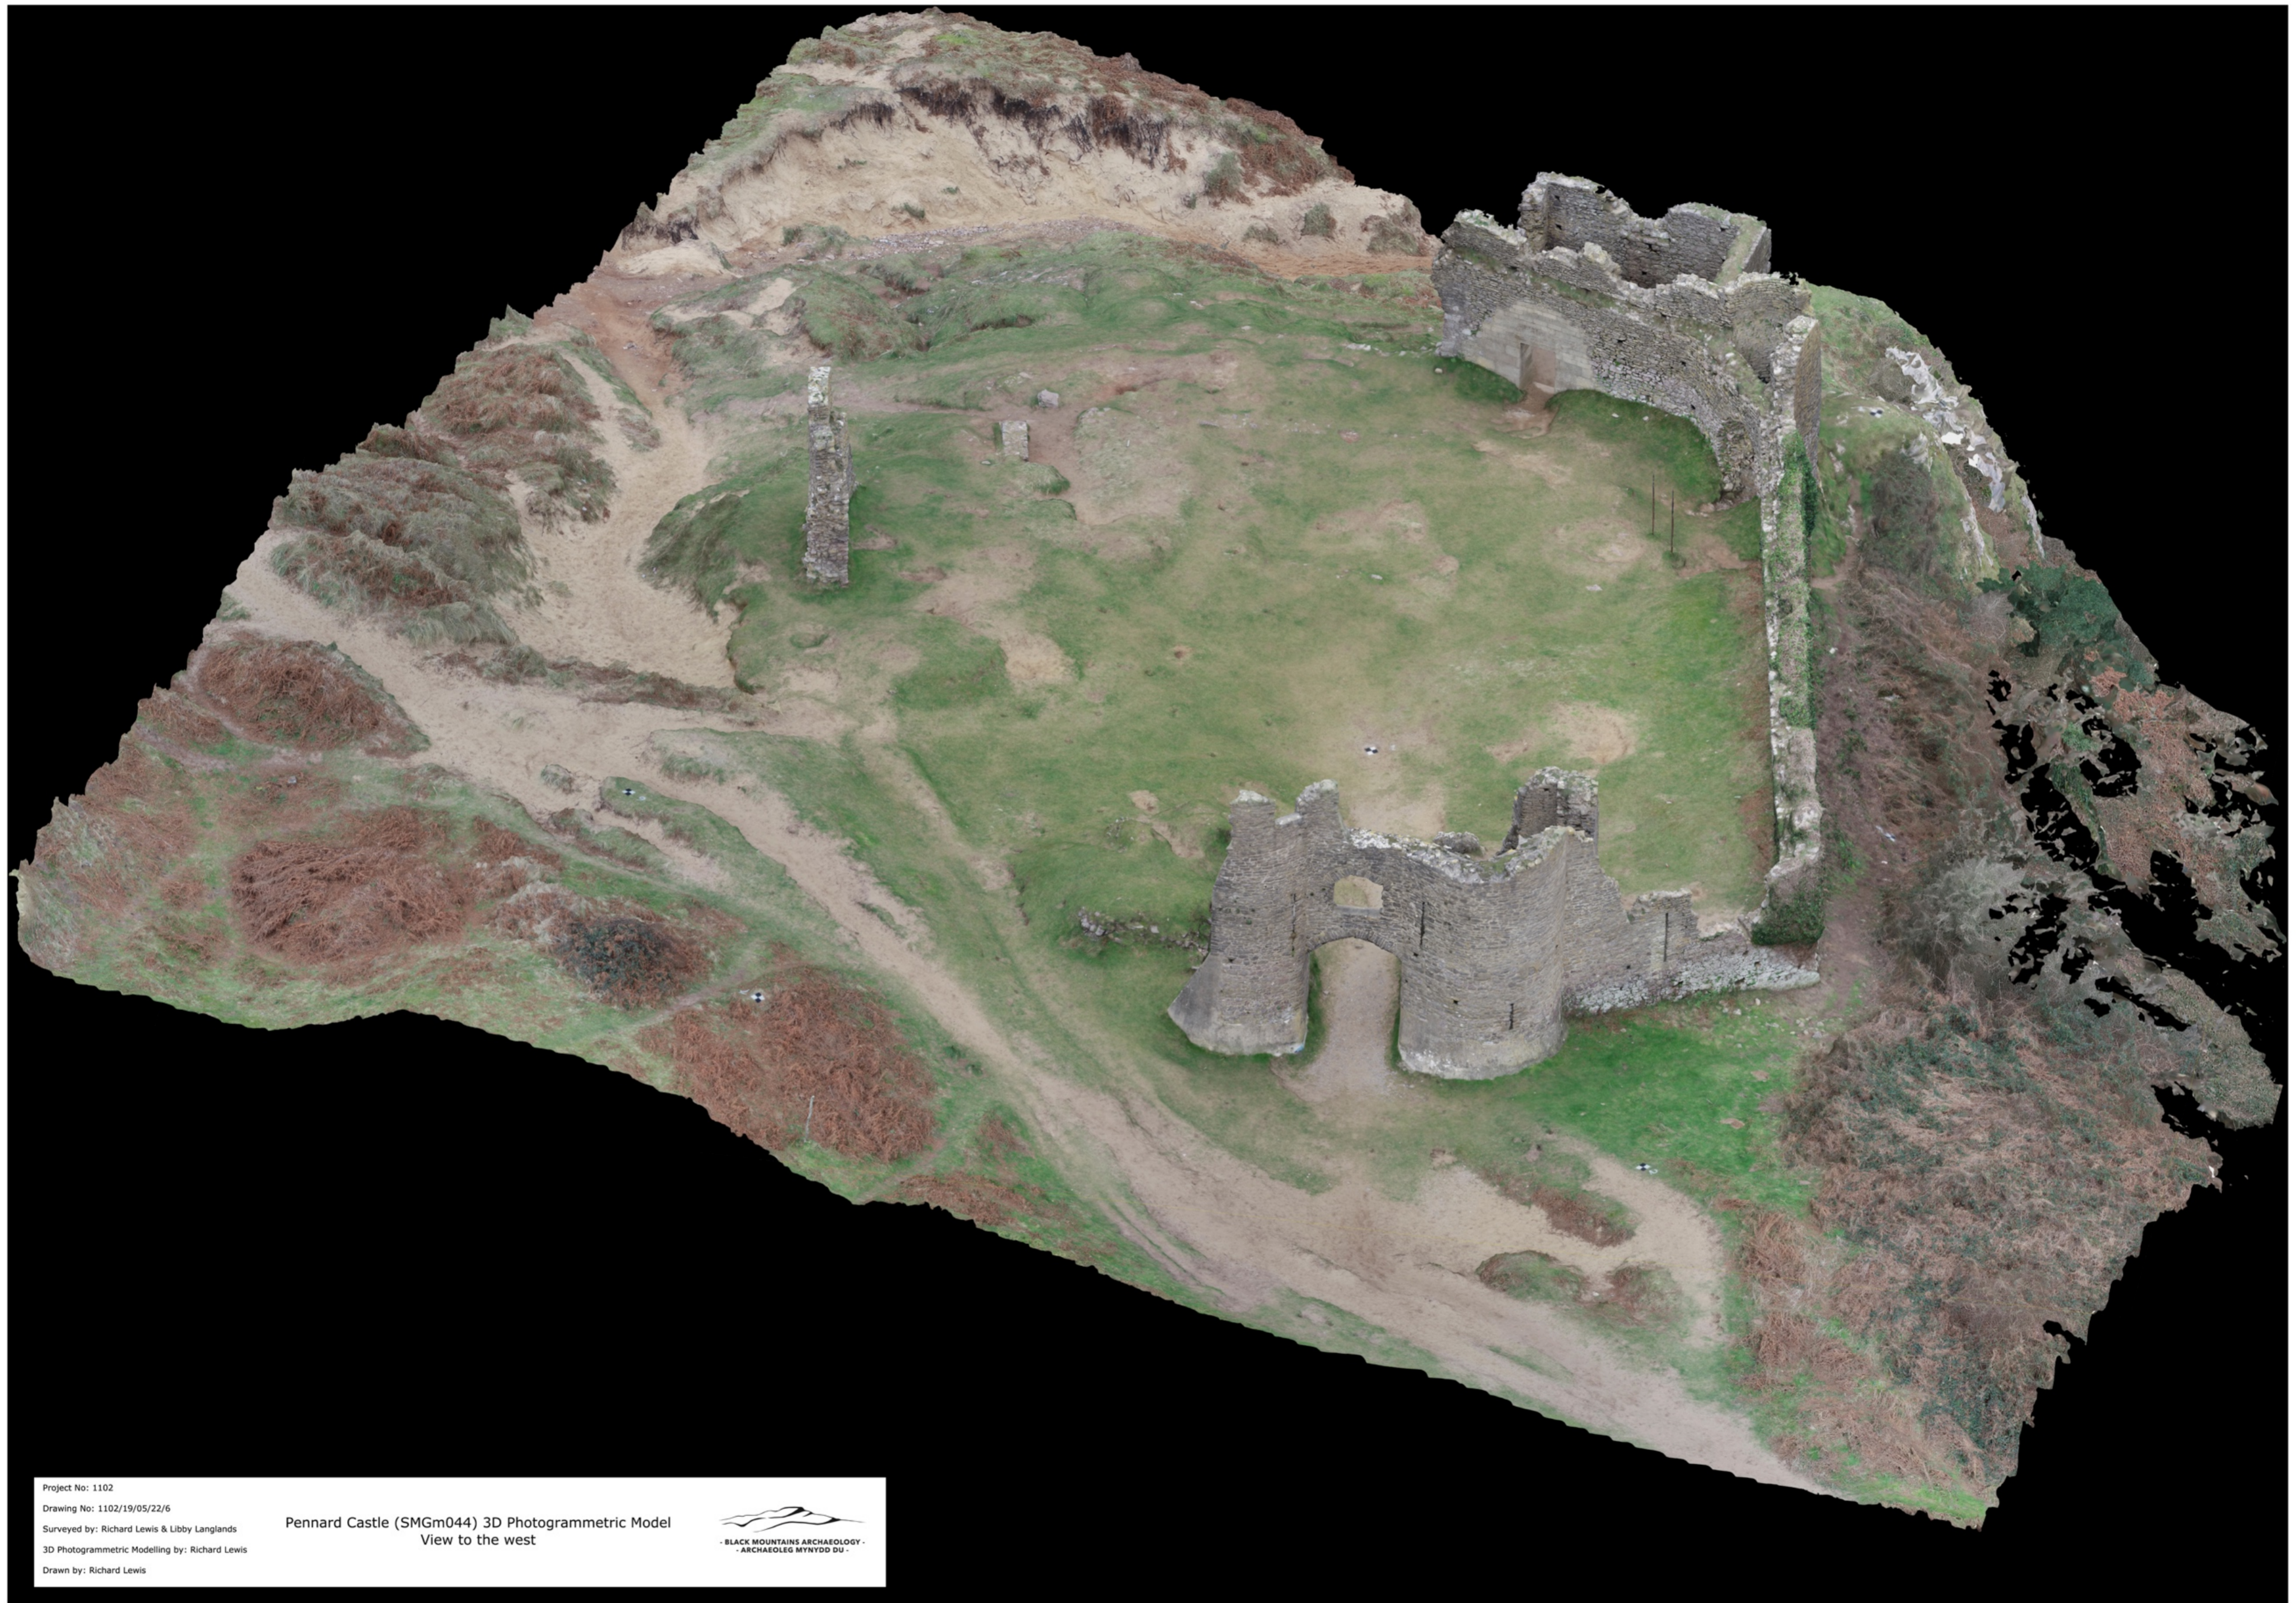
Pennard Castle (SMGm044) 3D Photogrammetric Model
View to the west

Figure 6. Pennard Castle Photogrammetric 3D Model, high mesh count and texture, view to the west.
