Pennard Castle, Gower

Photogrammetric 3D Building Survey

Pennard Castle (SMGm044) Orthographic Photogrammetric Elevation of the north facing Curtain Wall

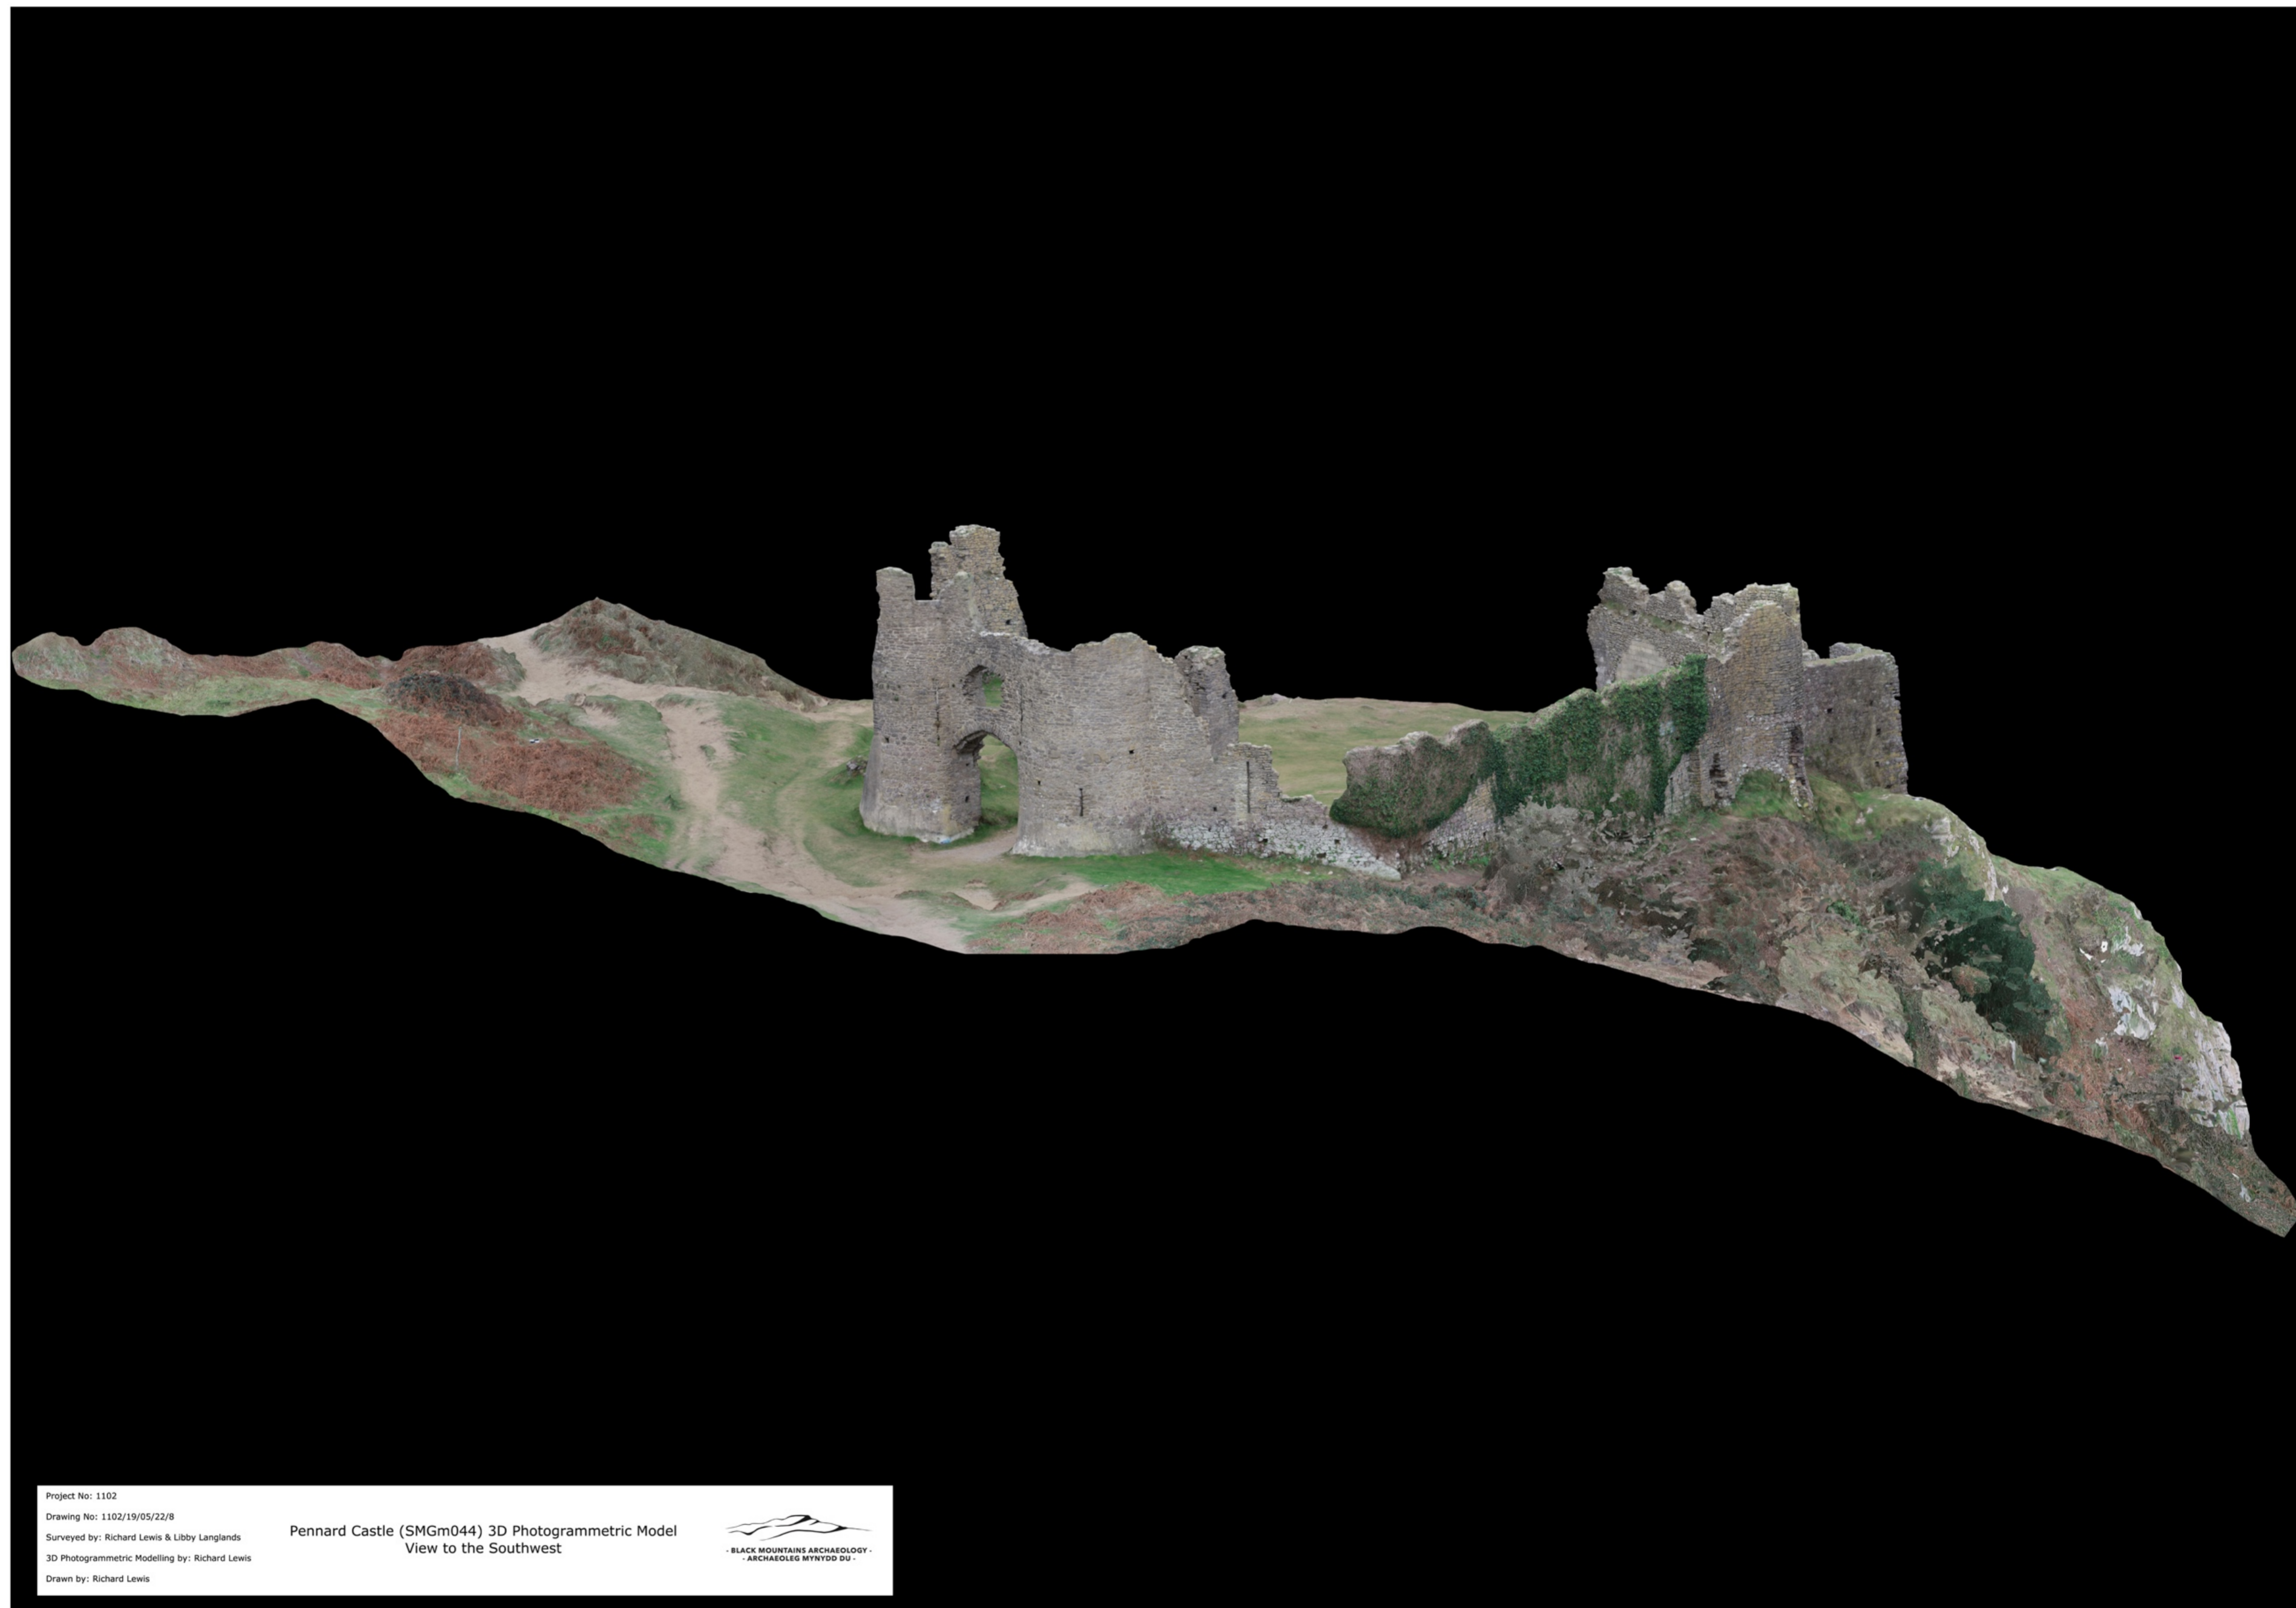
Figure 8. Pennard Castle Photogrammetric 3D Model, high mesh count and texture, view to the southwest.

- 7.3.23 Newman & Co. (London) published an engraving of Pennard Castle and Oxwich Bay in 1850 (Plate 6). The image shows the castle in the middle ground, with small boats in Oxwich Bay and a steamship out in the Bristol Channel. A person with a horse and covered cart on a road in the valley is also visible but this looks peculiar given Pennard Pill should also be in this location. The engraving shows the castle in a state of disrepair. The north drum tower and northeast curtain wall with some significant deterioration of masonry, a large void in the northeast curtain wall in particular. This is odd given later depictions of the northeast curtain do not show this hole until the middle of the 20th century. Putlog holes are again a feature of the north curtain wall and voids in the projected garderobe and mural tower. What is perhaps interesting is an area demarked by shadow on the corner of the northeast and north curtain wall that may show fallen stonework in the location of the masonry deterioration we see today in this position (Figure 2 and 8).

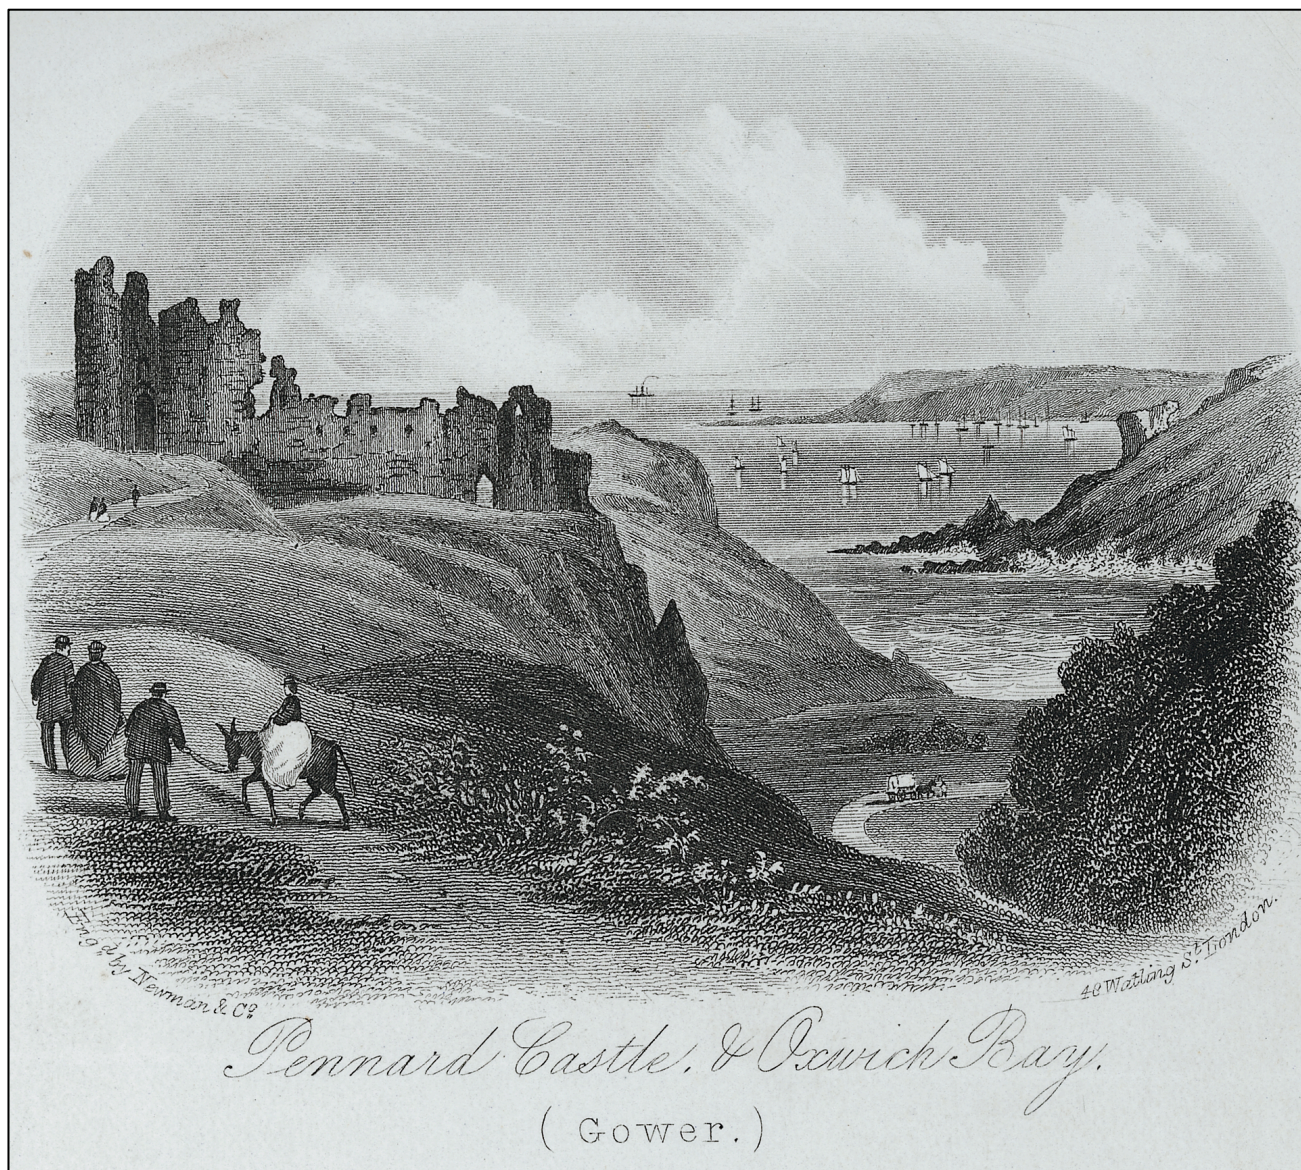
- 7.3.51 **1850**: Newman & Co. (London) engraving (Plate 6) showing the castle in a state of disrepair. The north drum tower and northeast curtain wall with some significant deterioration of masonry, a large void in the northeast curtain wall, which doesn't appear in later images, artistic licence?

Plate 6 – 1850 J Newman & Co Engraving of 'Pennard castle, & Oxwich bay, Gower'. ©National Library of Wales.

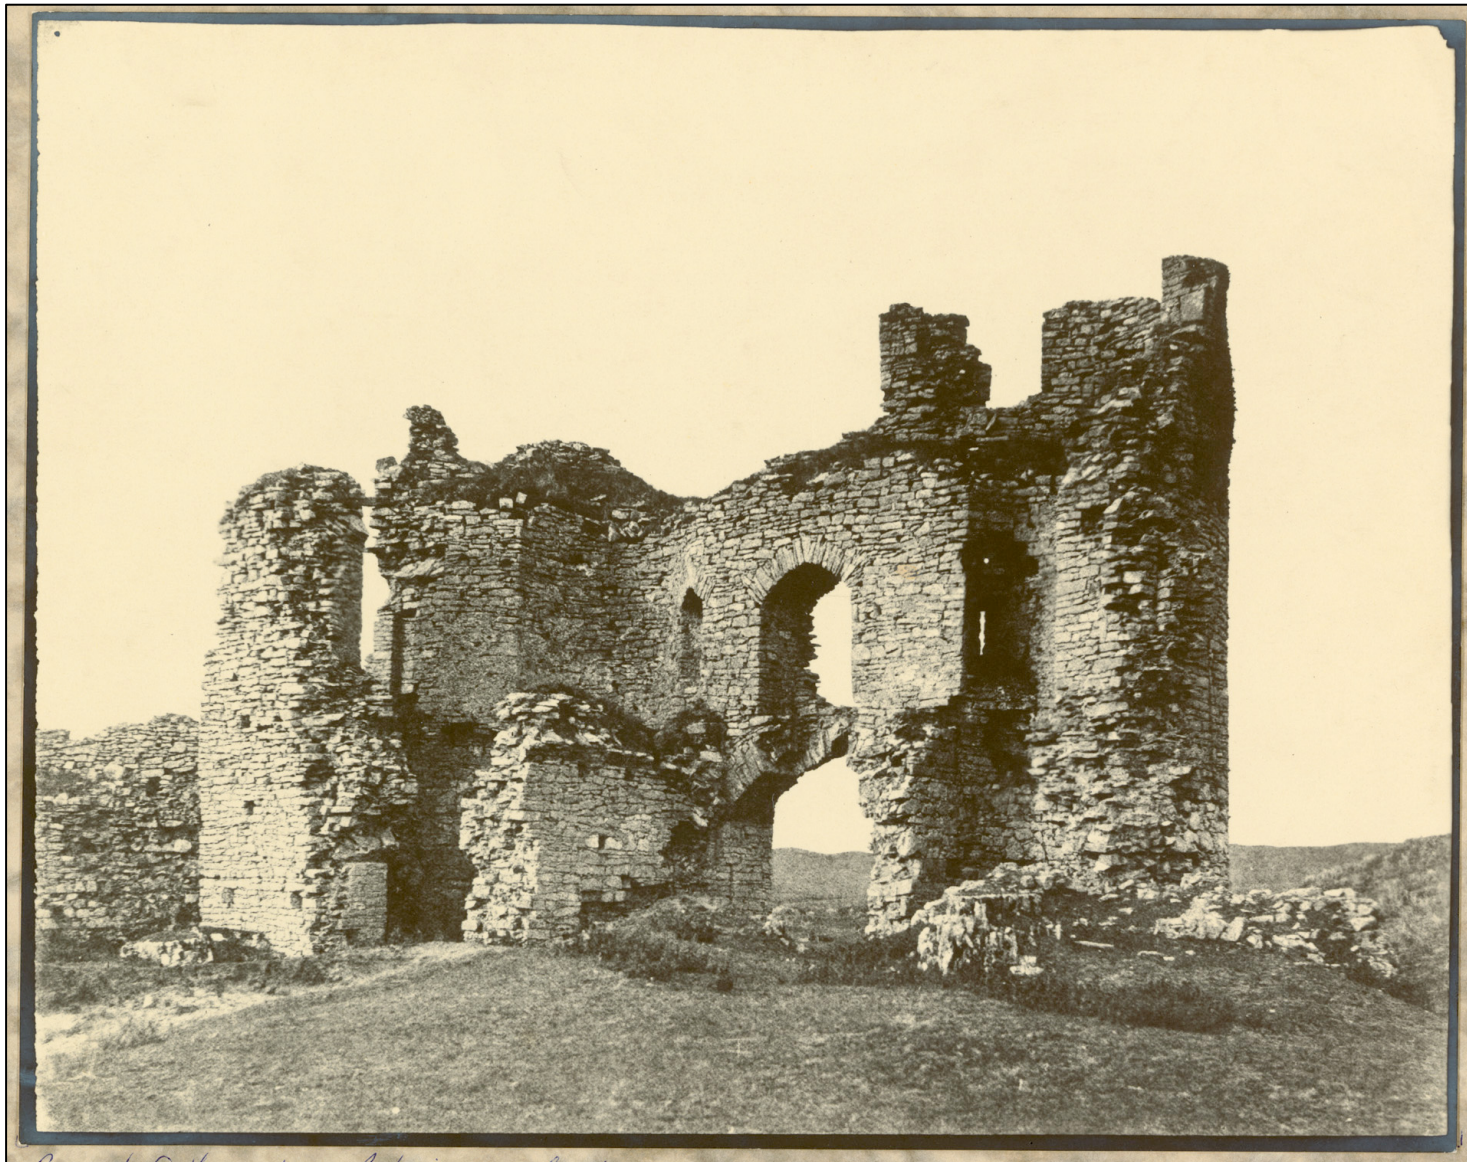
- 7.3.53 **1855-60**: Francis Lockey's calotype negative (Plate 8) showing one of the earliest photographic images of the castle and gatehouse interior before collapse of south tower before 1911. A stub of the south curtain wall standing by the south drum tower. Gatehouse interior pre-concrete repairs (1923-4) shown. Loss of around six courses of masonry on the north drum tower. Northeast curtain wall largely intact.

Plate 8 – 1855-1860 Pennard Castle from interior of court. Print created in 1934 from Francis Lockey's calotype negative. Accession number- 03_Lockey_NMWA24629.

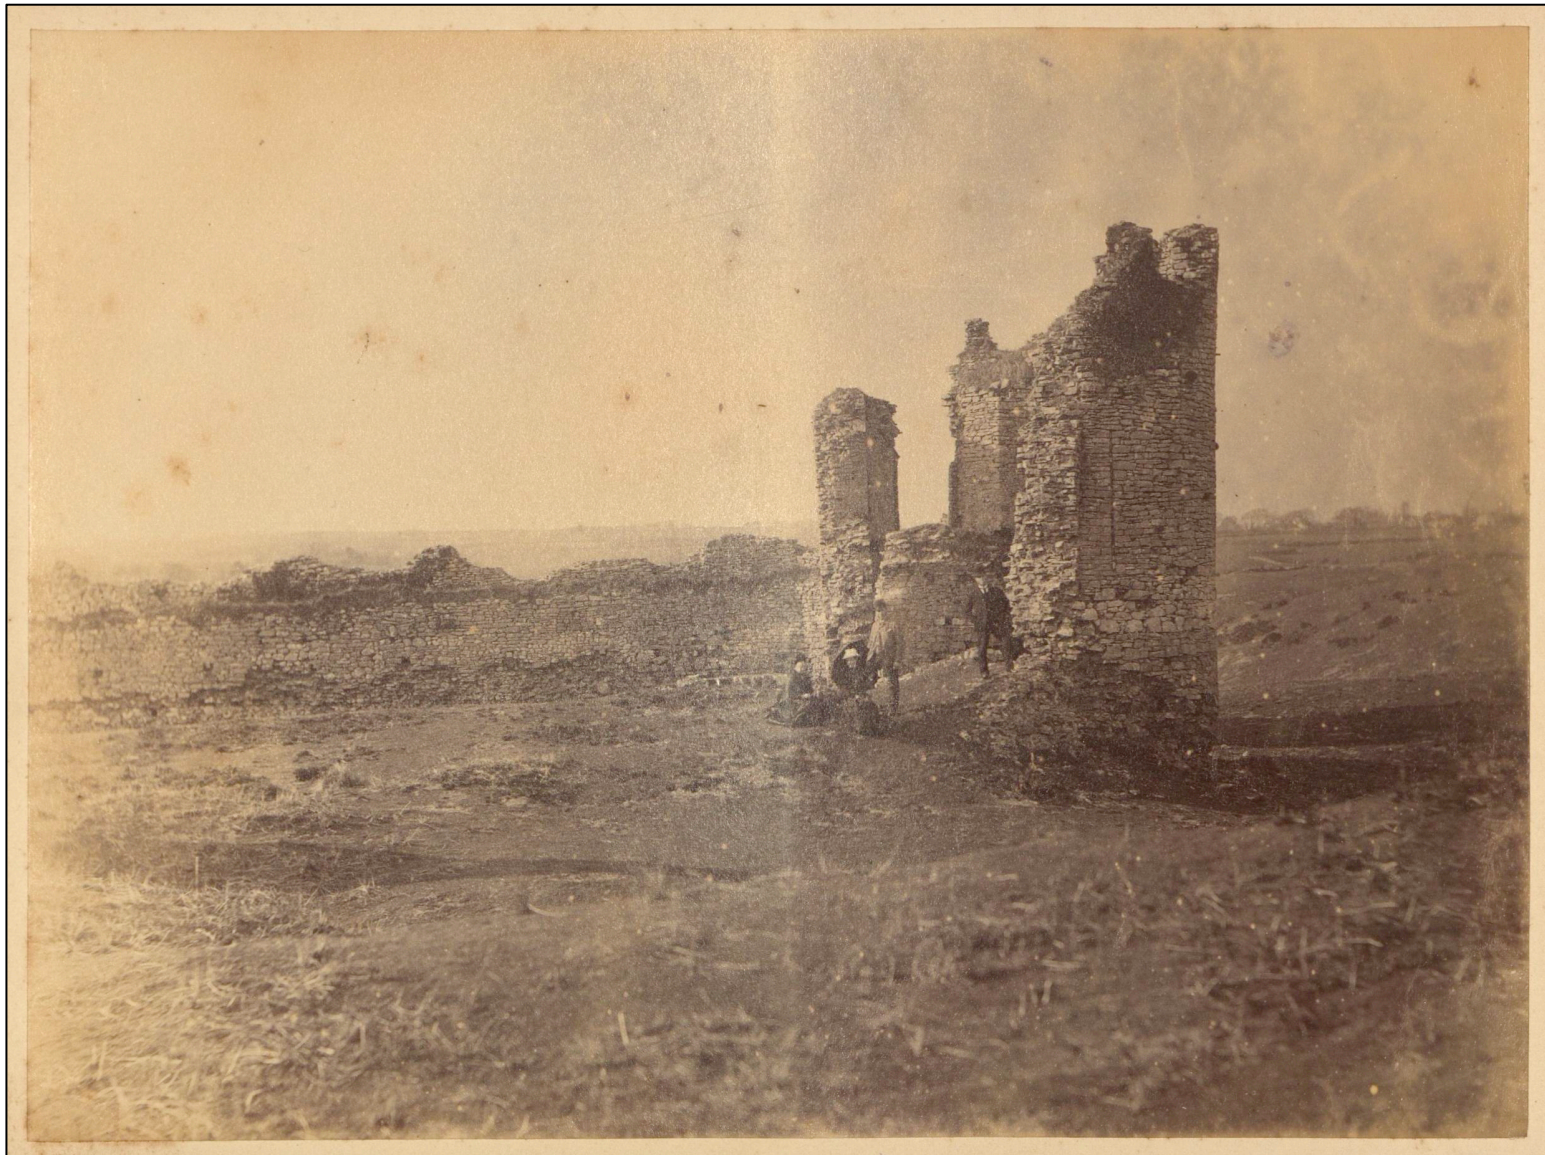
- 7.3.27 Plate 10 shows a very early image of the interior of the north curtain wall from the corner with the northeast section of curtain wall west almost to the projecting garderobe. The image clearly shows the deterioration of the lower courses of the curtain wall and while there has been significant loss of stonework, particularly facing stones, in this area since this photograph was taken the extent is not as great as was first assumed. The general profile of the collapsed masonry today can be loosely aligned with the historic collapse shown in Plate 10 and while in places four or five courses have been lost, these tend to be localised. The greatest loss though is along the wall walk and the crenelations. This is where the parallels between Plate 10 and the present survey divorce. The wall walk has collapsed in several places in the centre of the curtain wall and masonry has been lost along the wall tops, presumably what

- 7.3.54 **1874**: Dillwyn Llewelyn family outing to the castle in 1874 (Plates 9-11). Gatehouse shown in detail with a large crack down the centre of the south drum tower. Deterioration of the lower courses of the north curtain wall. Wall walk has collapsed in several places in the centre of the curtain wall and masonry has been lost along the wall tops. North curtain wall now devoid of crenelations but crenelated defences surviving sweeping around from the half-round mural tower to the western curtain wall above the square tower.

Plate 10 – 1874 Dillwyn Llewelyn family x8 photos during an outing DD Z 368 14 8. © West Glamorgan Archives.

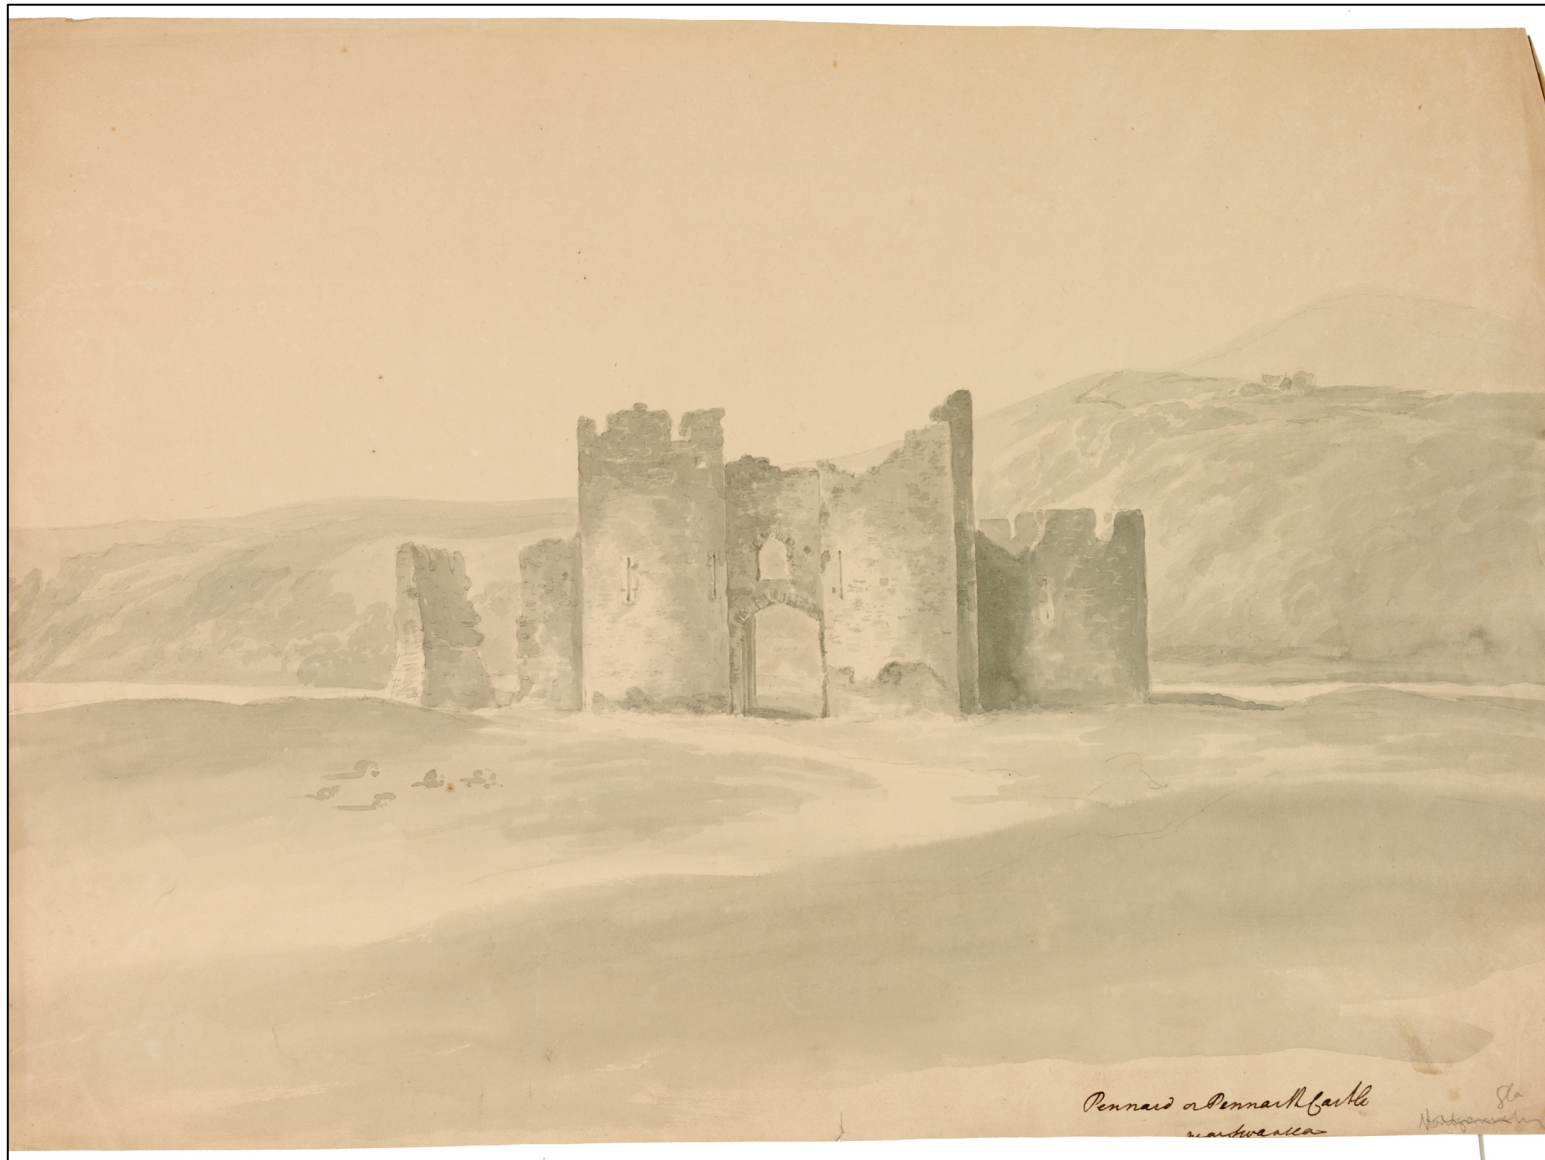
- 7.3.28 Plate 12 is an undated inkwash drawing of Pennard Castle. While broadly 19th century in date it has been included as the image shows an almost full height section of surviving south curtain wall attached to the south tower of the gatehouse. The section of curtain wall has one upper arrow loop, and the width of wall loosely matches the small area or stub of south curtain wall noted in Francis Lockey's calotype negative (Plate 8). Henry Gastineau's engraving (1823) shows this wall section in a much-dilapidated state with a large hole in the wall, presumably the eroding arrow loop. Therefore, this drawing (Plate 12) could predate Henry Gastineau's engraving of 1823. The image also shows missing stonework from the base of the drum towers but otherwise the north curtain wall looks intact, complete with eroding crenelations. This image also truthfully shows the corner of the north curtain wall curving.

Plate 12 – 19th century, possibly pre-1823, Pennard or Pennarth Castle. Ink wash. ©National Library of Wales.

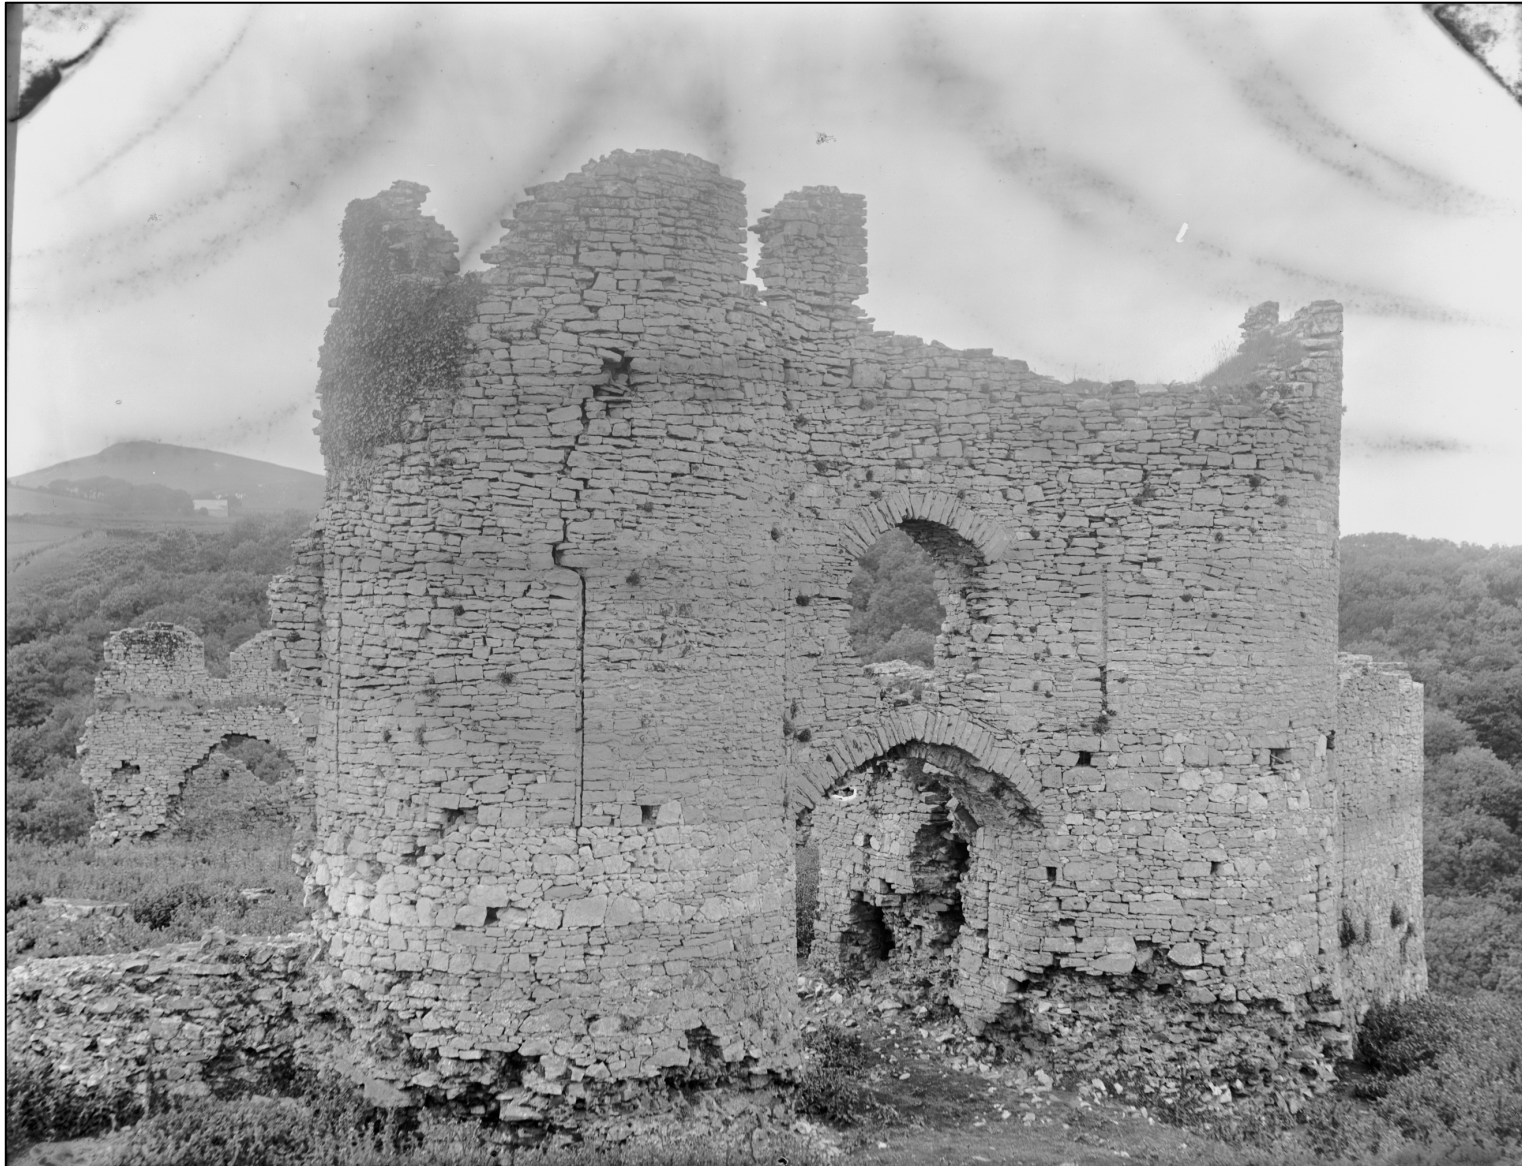
- 7.3.30 Plate 14 shows Aberly's view of the gatehouse again but this time including a much dilapidated west curtain wall where it meets the square tower. The presumed original doorway into the square tower probably acting as a catalyst to the destabilisation of the stonework above. Plate 15 offers a good view of the interior of the north and west curtain walls. Crenelations are visible along the west curtain wall, including an arrow loop in one merlon. These are all now missing except the base of two of the crenels.

The half-round tower's crenel appears together with a surviving merlon on the north curtain wall, the latter now also gone with a significant loss of masonry here. The wall walk along the west curtain wall and the visible section on the north curtain appears to survive relatively well today. The doorways into the half-round tower and project garderobe have survived well since this photograph was taken, however, the latter is now missing much of its eastern jamb and springer. Of interest and shown in the south drum tower is an enfilading arrow loop, which was destroyed when half of this tower (east facing elevation) collapsed before 1911 only a few years after this photograph was taken.

Plate 14 – 1900-1911 Aberly, P. B. (Percy Benzie)1877-1948. ©National Library of Wales.

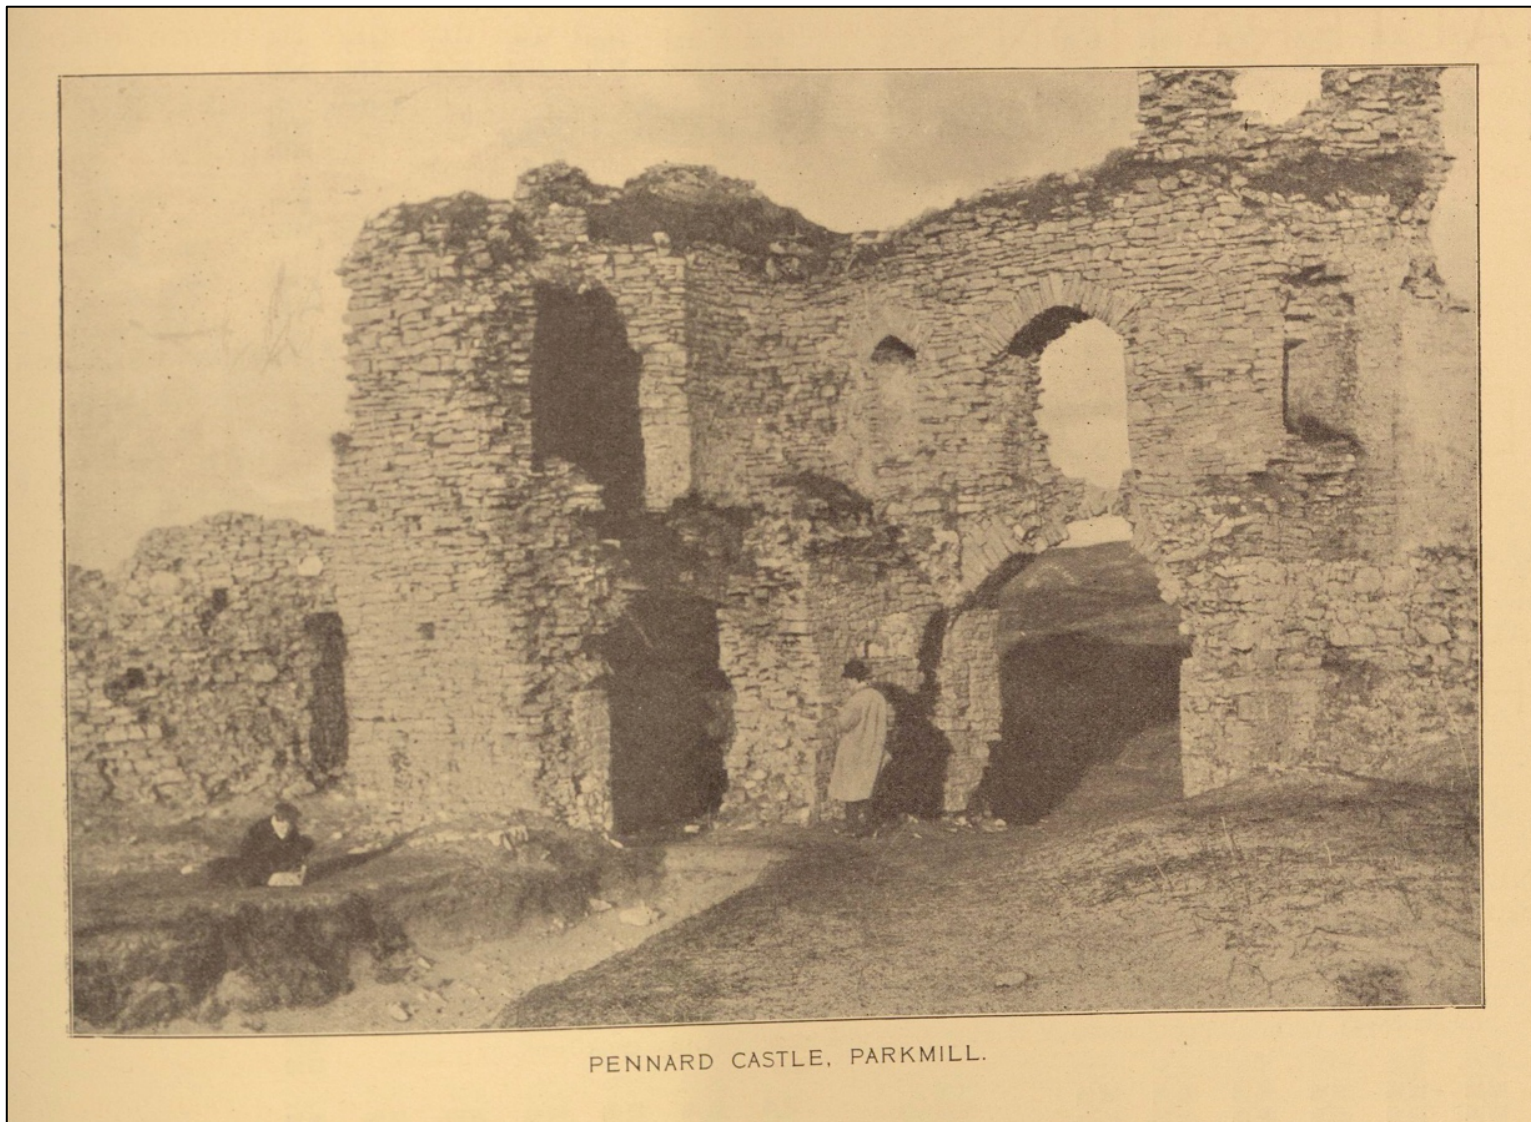
- 7.3.31 The first pictorial evidence for what is arguably one of the most serious structural failures dates to 1911, a souvenir guide to Swansea and district, commemorating the coronation of King George V (Plate 16). This image shows for the first time the collapse of the east facing elevation of the gatehouse's south drum tower along the fault line and arrow loop seen in earlier images. The gatehouse archway is shown in a pretty perilous state with only a few stones holding the arch together. The northeast curtain wall is shown still reasonably intact, although this has now been lost. It is tempting to consider that the gentleman in the photograph in the bowler hat and overcoat may have been surveying the remains for the then Office of Works. A photograph from around this time was used to produce postcards, one with a postal date of 1934 (Plate 17). The photograph must have been taken between 1911 and 1924 when the south drum tower partially collapsed but before the 'concrete' conservation works of 1923-4. The image also shows the northeast curtain relatively intact but the north curtain is in shadow so little can be seen. The west curtain wall's crenels can just be made out.

Plate 16 – 1911 Souvenir guide to Swansea and surrounding district, issued to commemorate the Coronation of King George V. DD JVH 184. © West Glamorgan Archives.

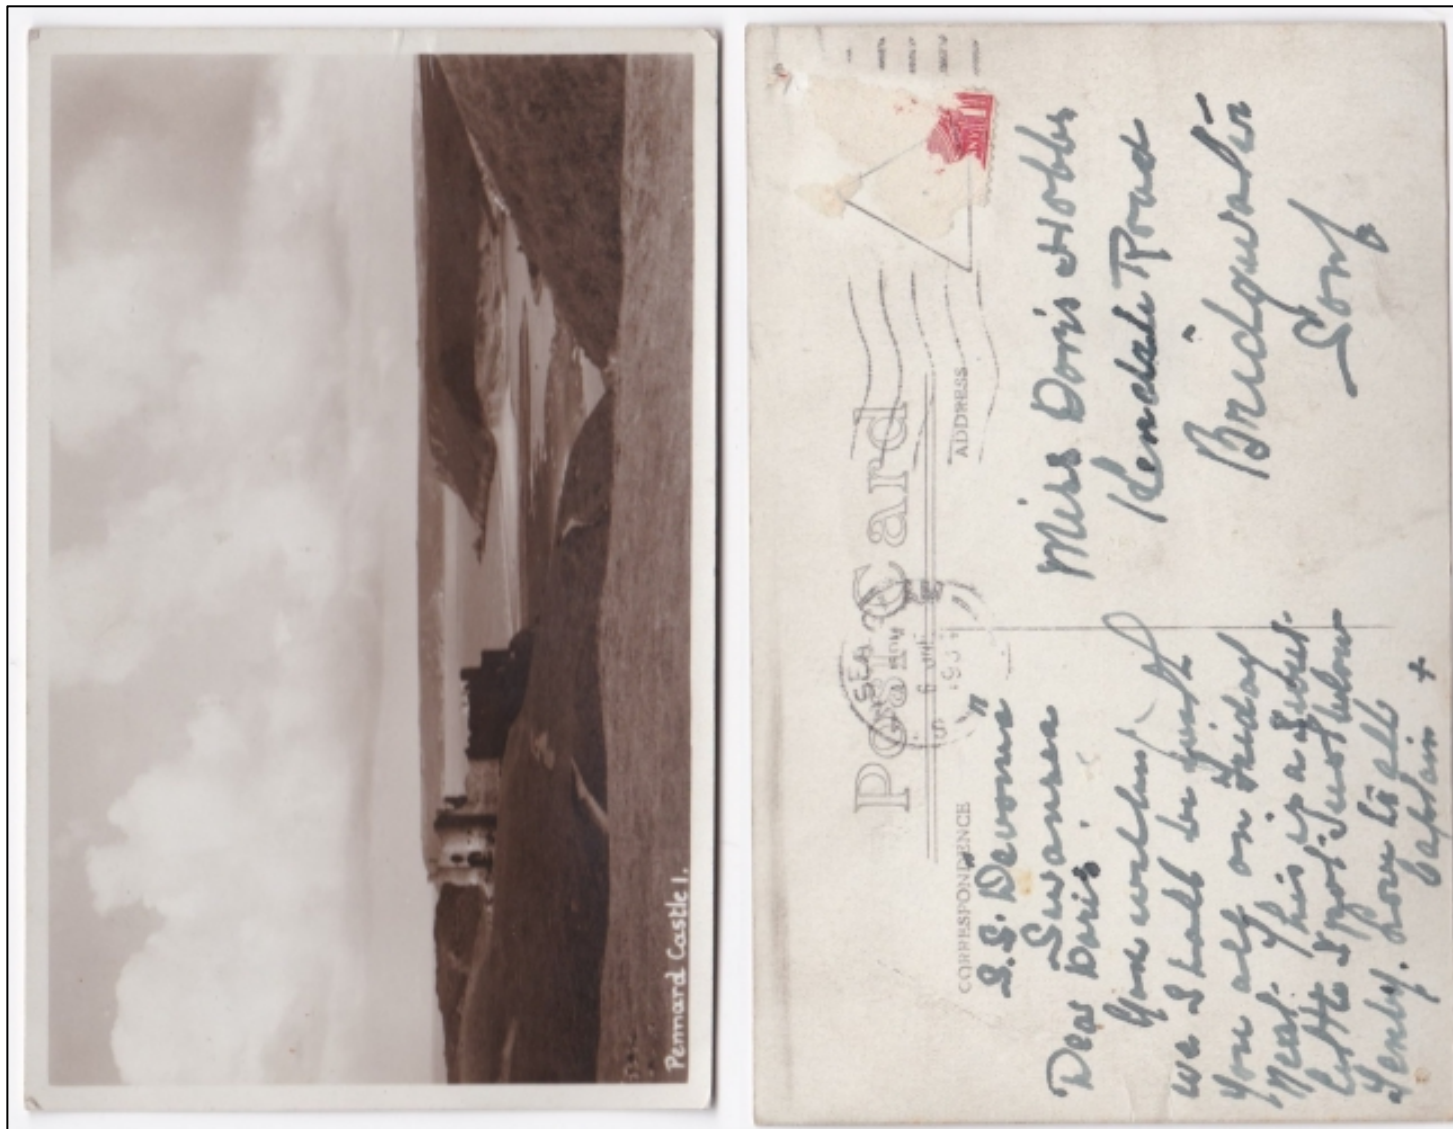
Plate 17 – Postcard of Pennard Castle with postal date of 6th June 1934. Photograph must be dated between 1911-1924 when the south tower had partially collapsed but before the concrete repairs of 1923-1924.
