Pennard Castle, Gower

Photogrammetric 3D Building Survey

Pennard Castle (SMGm044) Orthographic Photogrammetric Elevation of the north facing Curtain Wall

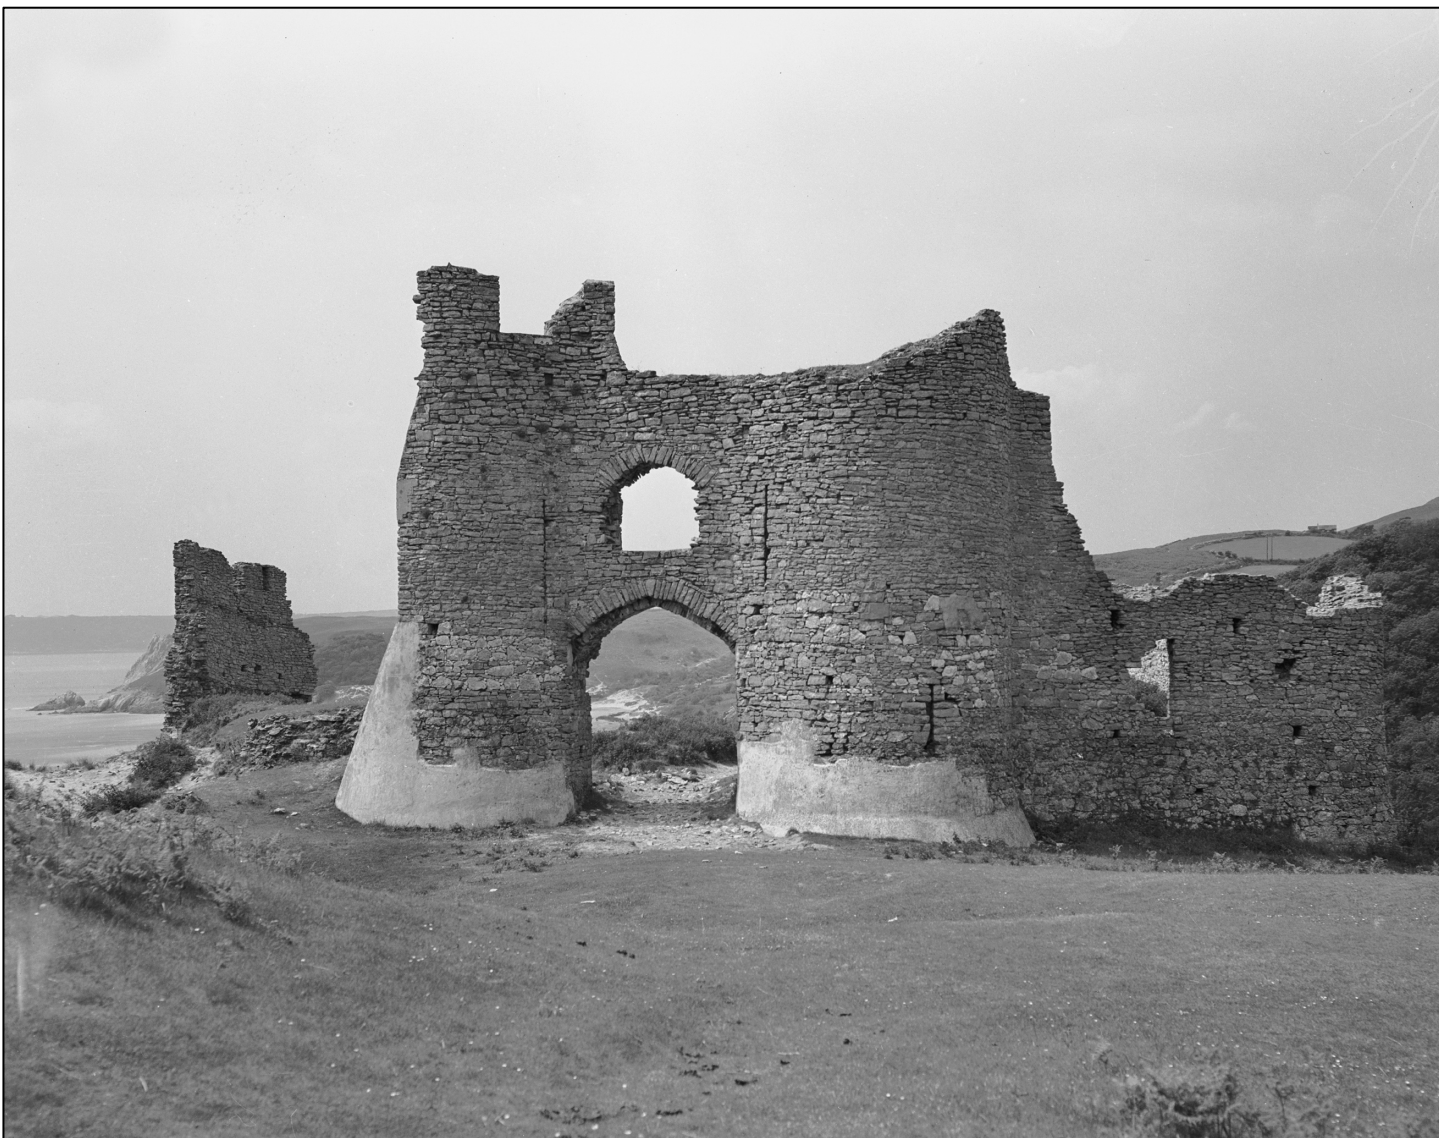
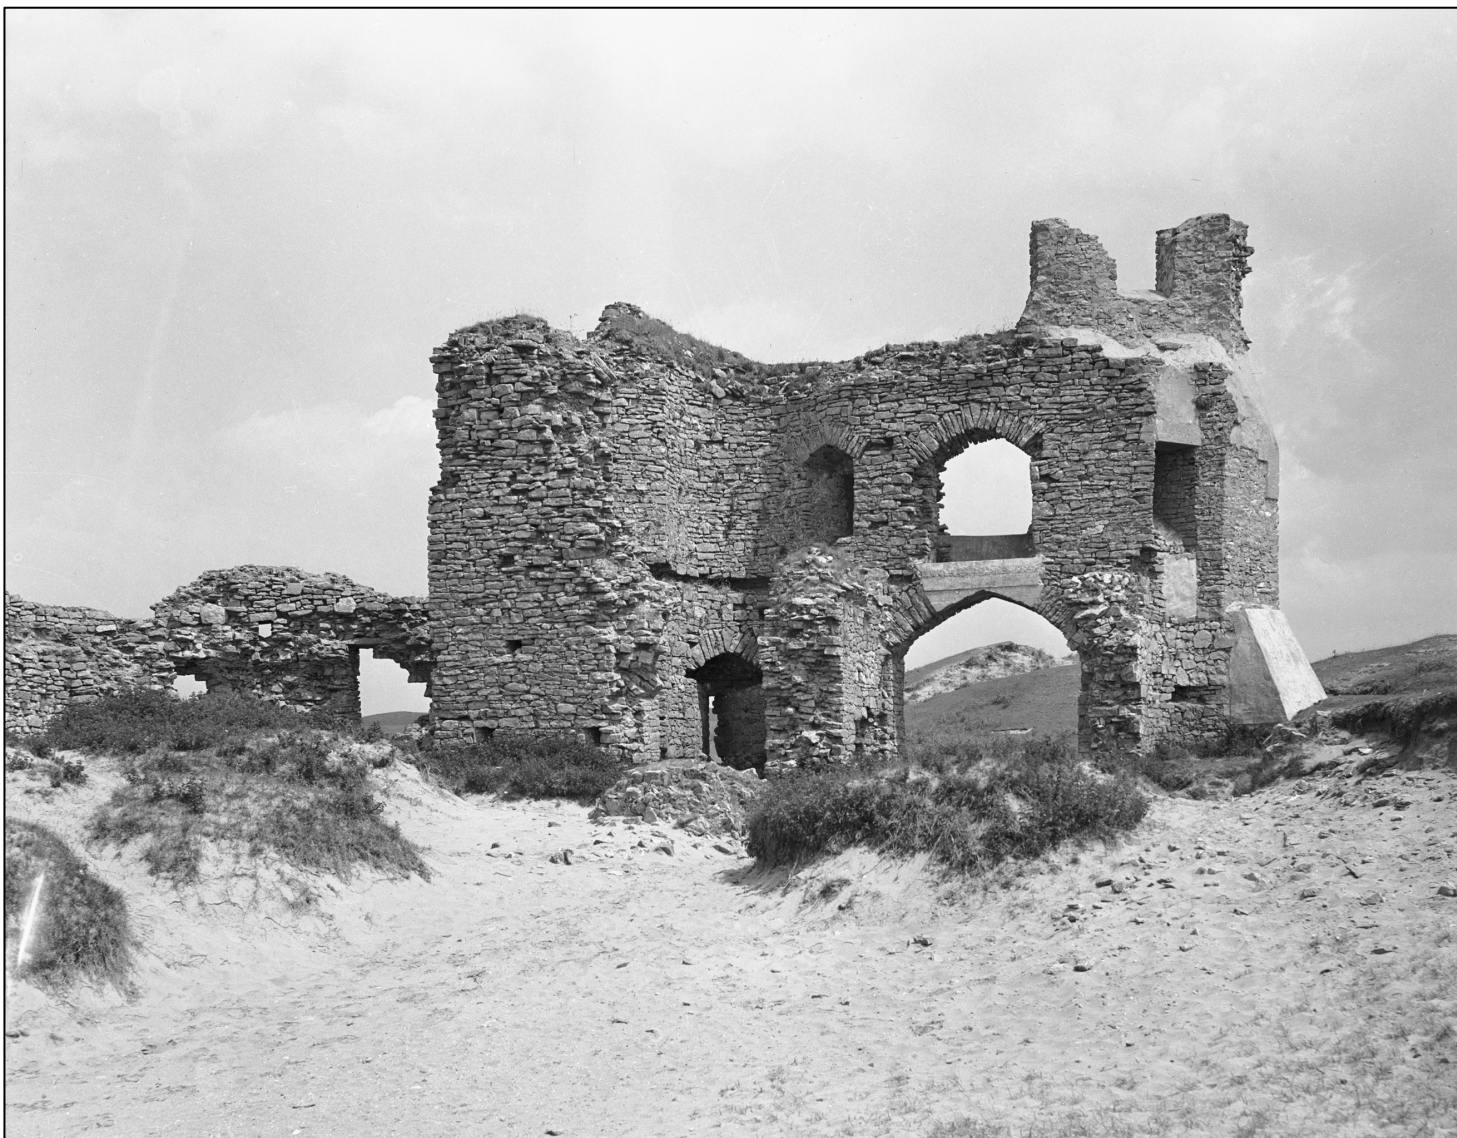
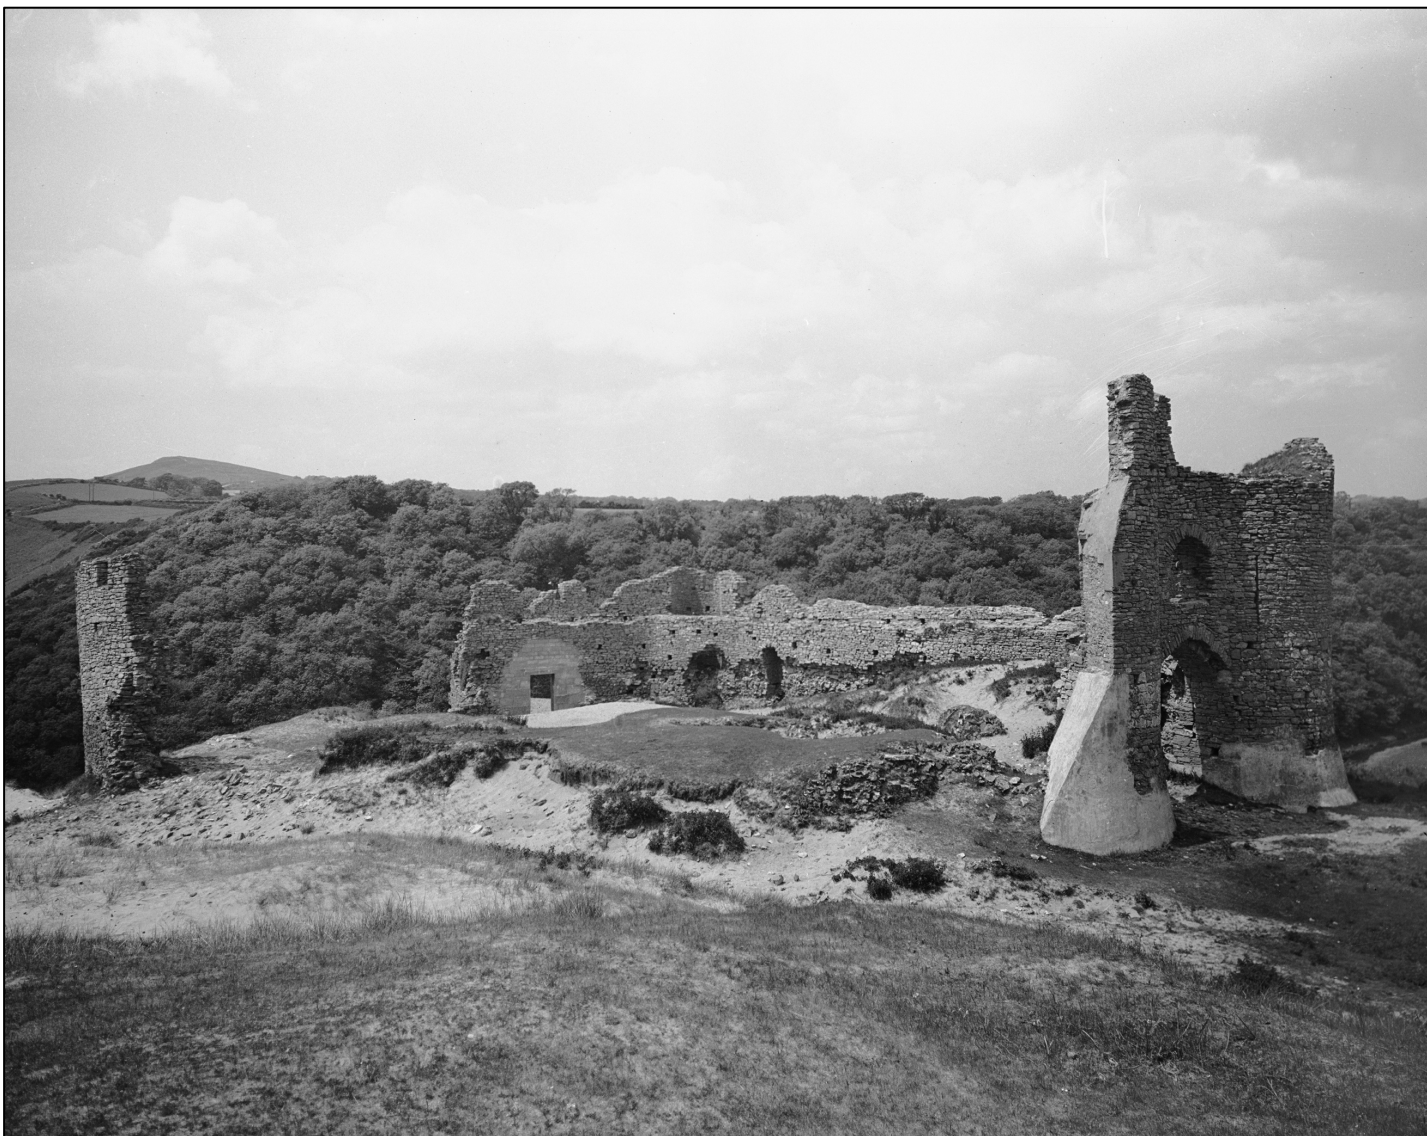
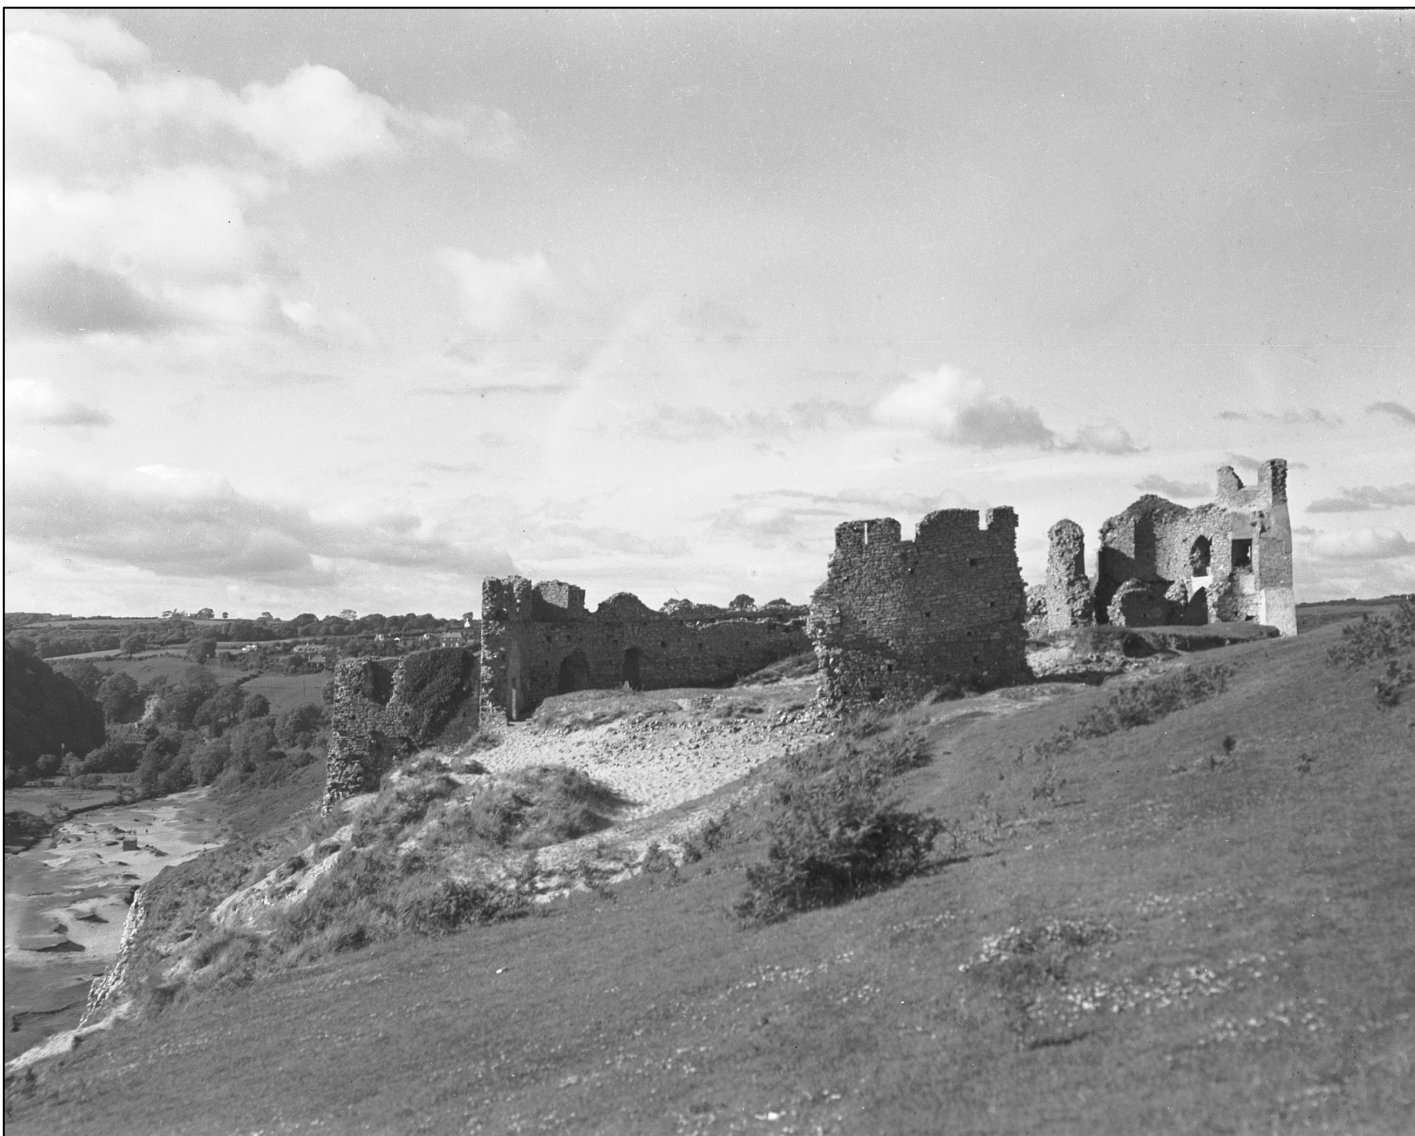
- 7.3.58 **1941:** images held by the RCAHMW (Plates 18-21; Figures 4-5) show the 'concrete' conservation works carried out in 1923-4 in detail. Arrow loop in the northeast curtain wall deteriorated with a sizable hole in the wall. Significant masonry still surviving on the north curtain wall but not recognisable as crenelations.

Plate 18 – View of the Gatehouse June 1941 (Archive No. 6351166) with 1923-4 concrete repairs. © Crown Copyright: Royal Commission on the Ancient and Historical Monuments of Wales.

Plate 19 – View of the Gatehouse interior June 1941 (Archive No. 6351162) with 1923-4 concrete repairs. © Crown Copyright: Royal Commission on the Ancient and Historical Monuments of Wales.

Plate 20 – View of the Pennard Castle, south and north curtain walls and gatehouse June 1941 (Archive No. 6351169) with 1923-4 concrete repairs. © Crown Copyright: Royal Commission on the Ancient and Historical Monuments of Wales.

Plate 21 – View of the Pennard Castle, south and north curtain walls, square tower and gatehouse interior June 1941 (Archive No. 6351170) with 1923-4 concrete repairs. © Crown Copyright: Royal Commission on the Ancient and Historical Monuments of Wales.

- 7.3.57 **1923-4:** Repairs in concrete. Institution of South Wales, Pennard Golf Club and the Cambrian Archaeological Association agree to repair the castle "...to organise a scheme whereby the decay of Pennard Castle maybe arrested and the ruins preserved...". The repairs in concrete included stabilising the south tower of the gatehouse after the collapse nearly fifteen years previous, the gatehouse archway and gatehouse wall tops. The perilous collapsing door through the west curtain wall into the square tower was also repaired in concrete and a faux doorway left inserted.

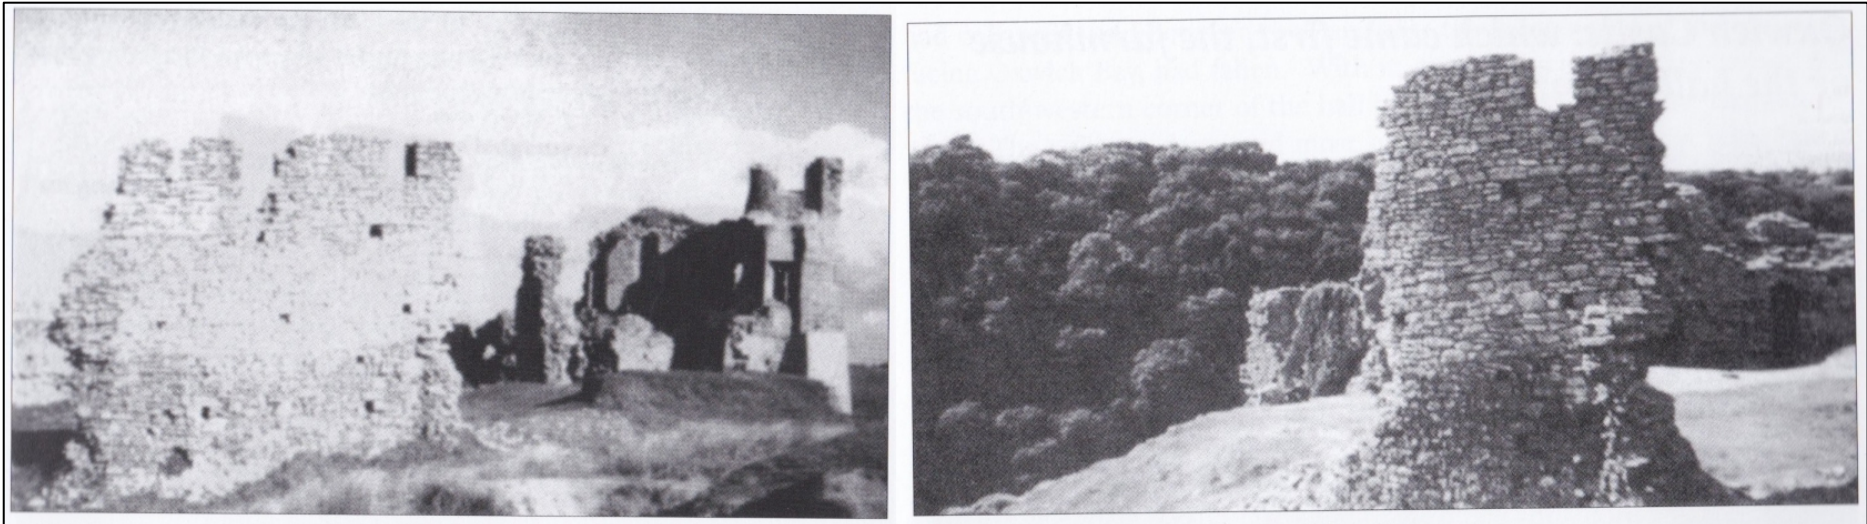
Plate 22 – View of the south curtain wall before (Left: 1952) and after partial collapse (Right: 1960) after Morris 1987, 13-14. © Gower Society.

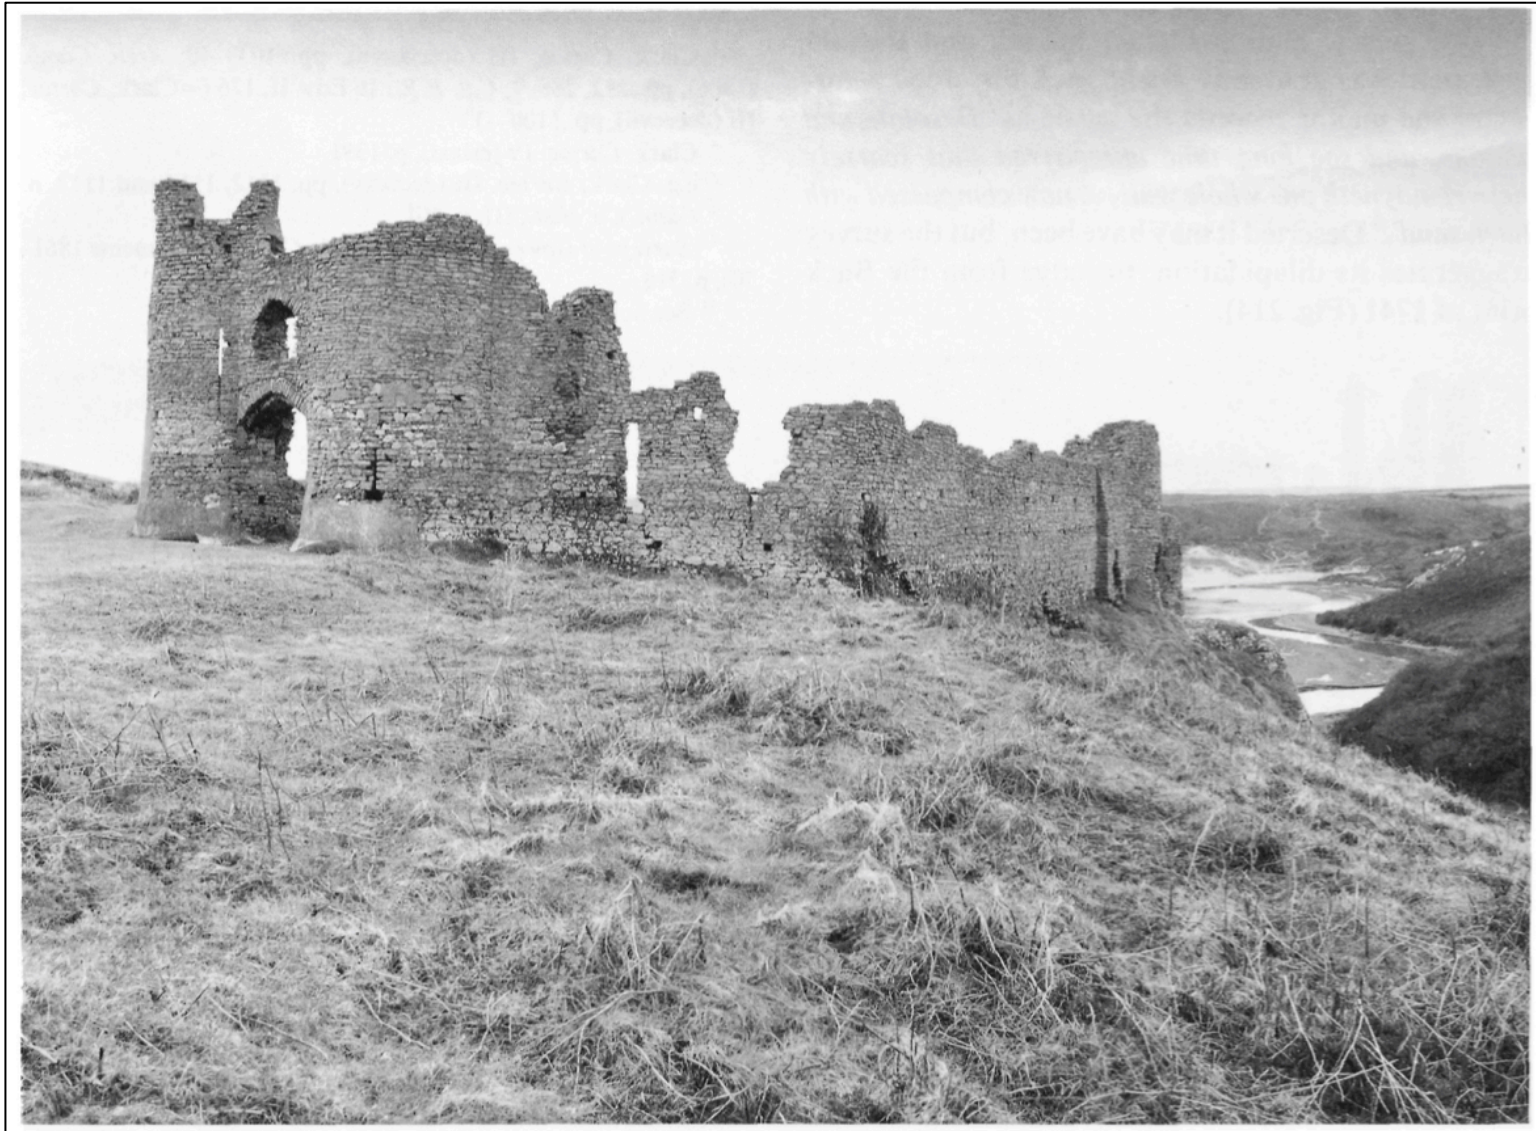
- 7.3.61 **1980s:** RCAHMW surveyed the castle in the 1980s (published 1991), recorded the hole in the northeast curtain as a void on their elevation drawing (Figure 3), however, Plate 23 shows the void repaired indicating that the repair work may not have been carried out in 1963.

- 7.3.62 **1991:** Publication of RCAHMW survey. Plate 23 shows the northeast curtain with a large area of masonry collapse but with one putlog hole surviving adjacent to the repaired arrow loop. By the time RCAHMW took an aerial photograph in 2005 the putlog hole and surrounding wall had collapsed.

Plate 23 – View of the Gatehouse and North Curtain Wall 1991, after RCAHMW 1991, Fig 215, 290. © Crown Copyright: Royal Commission on the Ancient and Historical Monuments of Wales.
