St. Asaph Parish Church, no.1 High Street, St. Asaph, LL17 0RG.

January 2020
V 1.0

Archaeological Watching Brief
Project Code: A0223.1
Report no. 0234

Archaeological Watching Brief

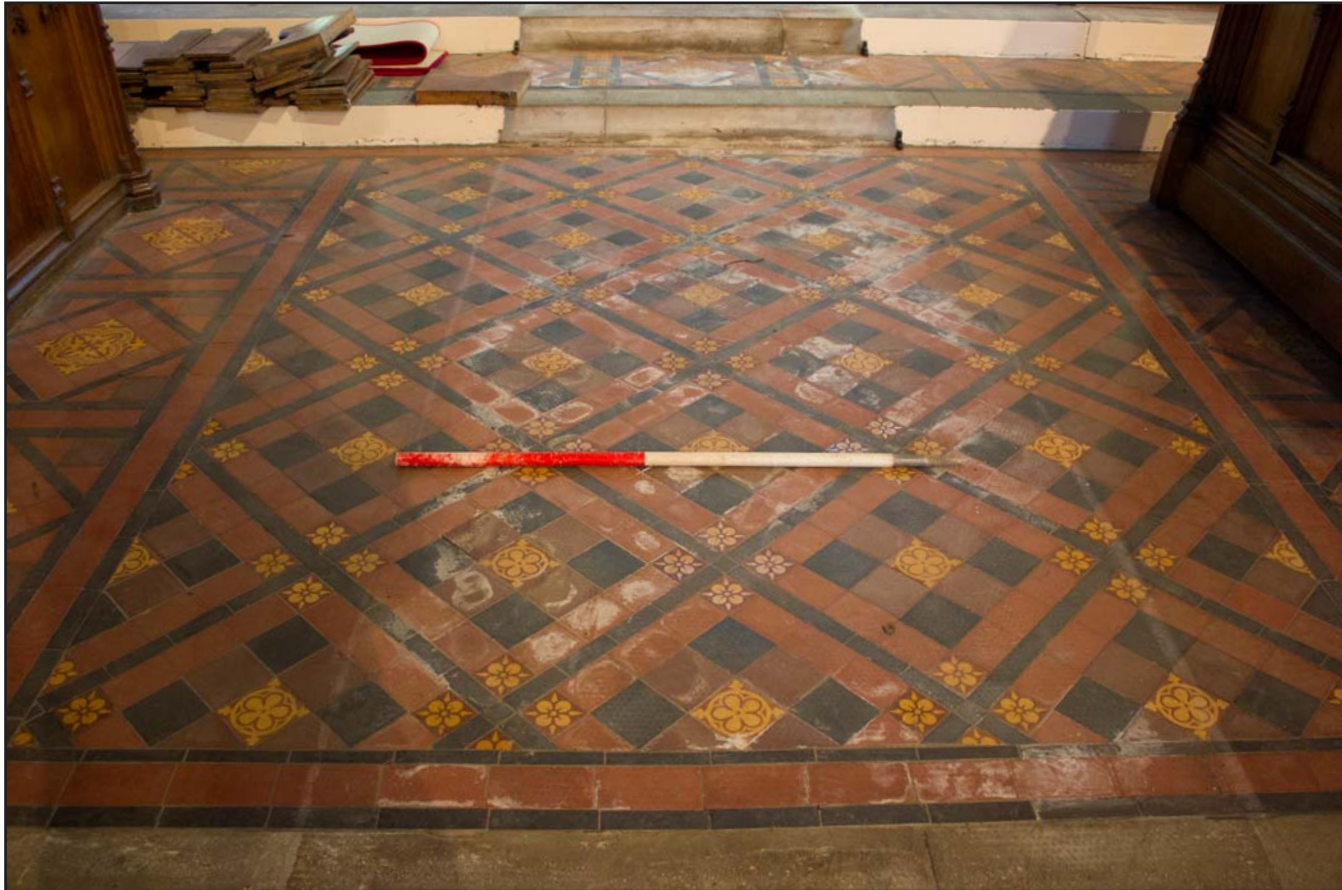
Plate 05: Choir stalls tiled floor at St. Asaph Parish Church, St. Asaph, Denbighshire - from the west - scale 1m

The chancel area had previously been tiled with a geometric pattern with red and black ceramic tiles forming centralised diamond borders with a yellow stamped motif in the centres; these had been removed prior to the arrival of the archaeologist in all of the areas of the chancel except for the uppermost level of the altar. The removal of the floor area around the chancel and the altar also included the removal of three levels of dressed stone kerbs which formed the edging to the altar steps – these were carefully recovered and stored for reuse elsewhere.

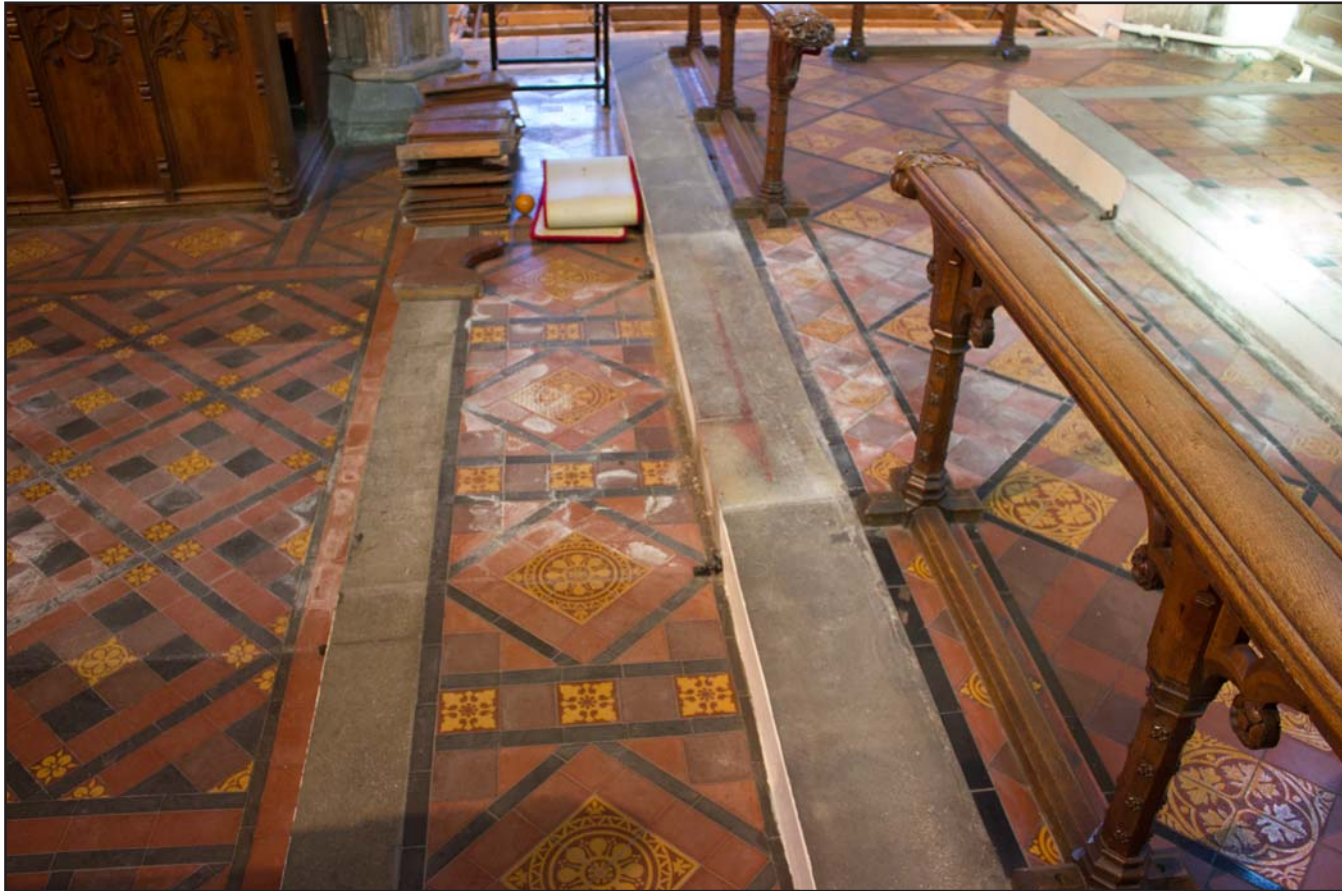
Plate 06: Altar tiled step at St. Asaph Parish Church, St. Asaph, Denbighshire - from the south - scale 1m

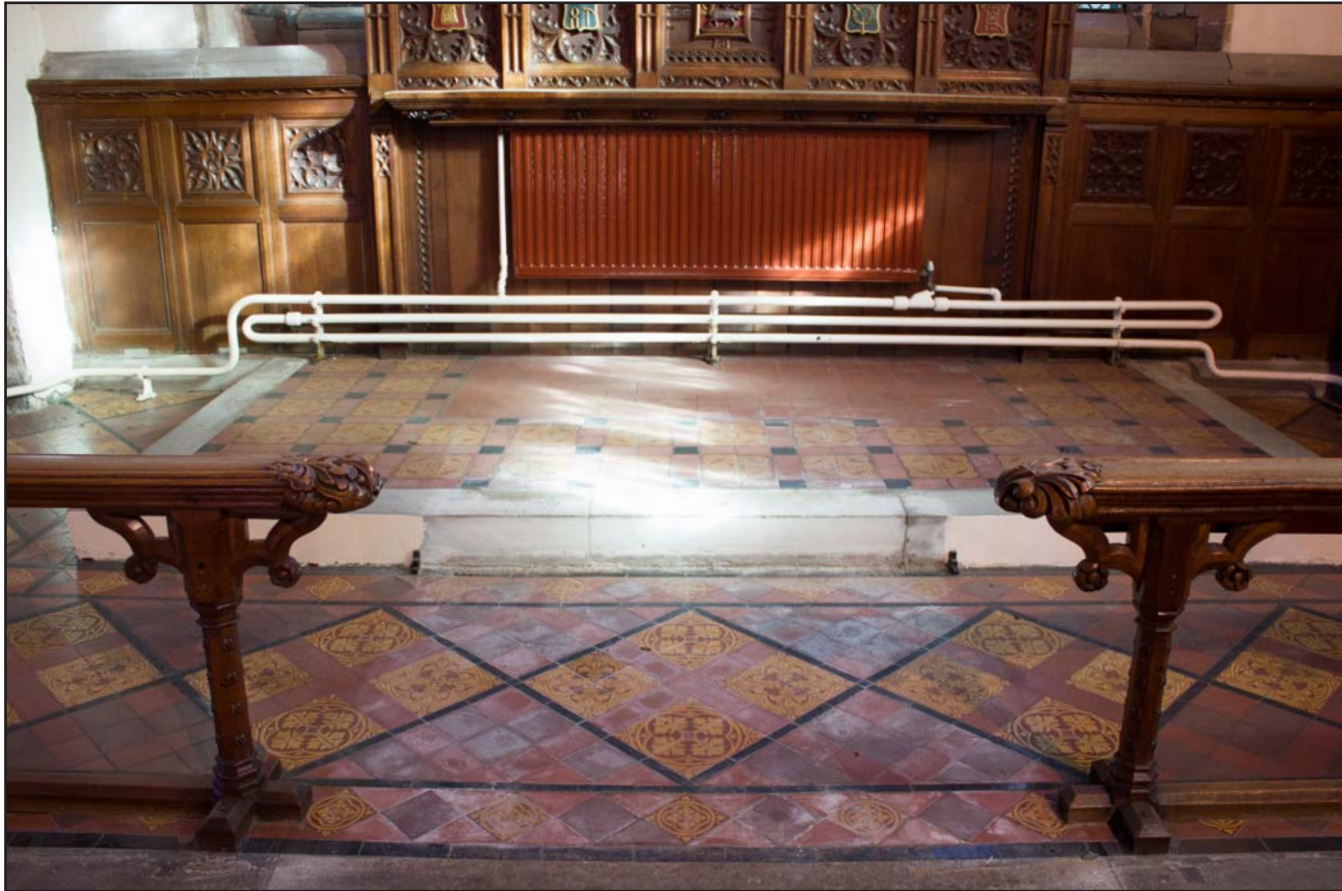
Plate 07: Altar tiles at St. Asaph Parish Church, St. Asaph, Denbighshire - from the west - scale 1m

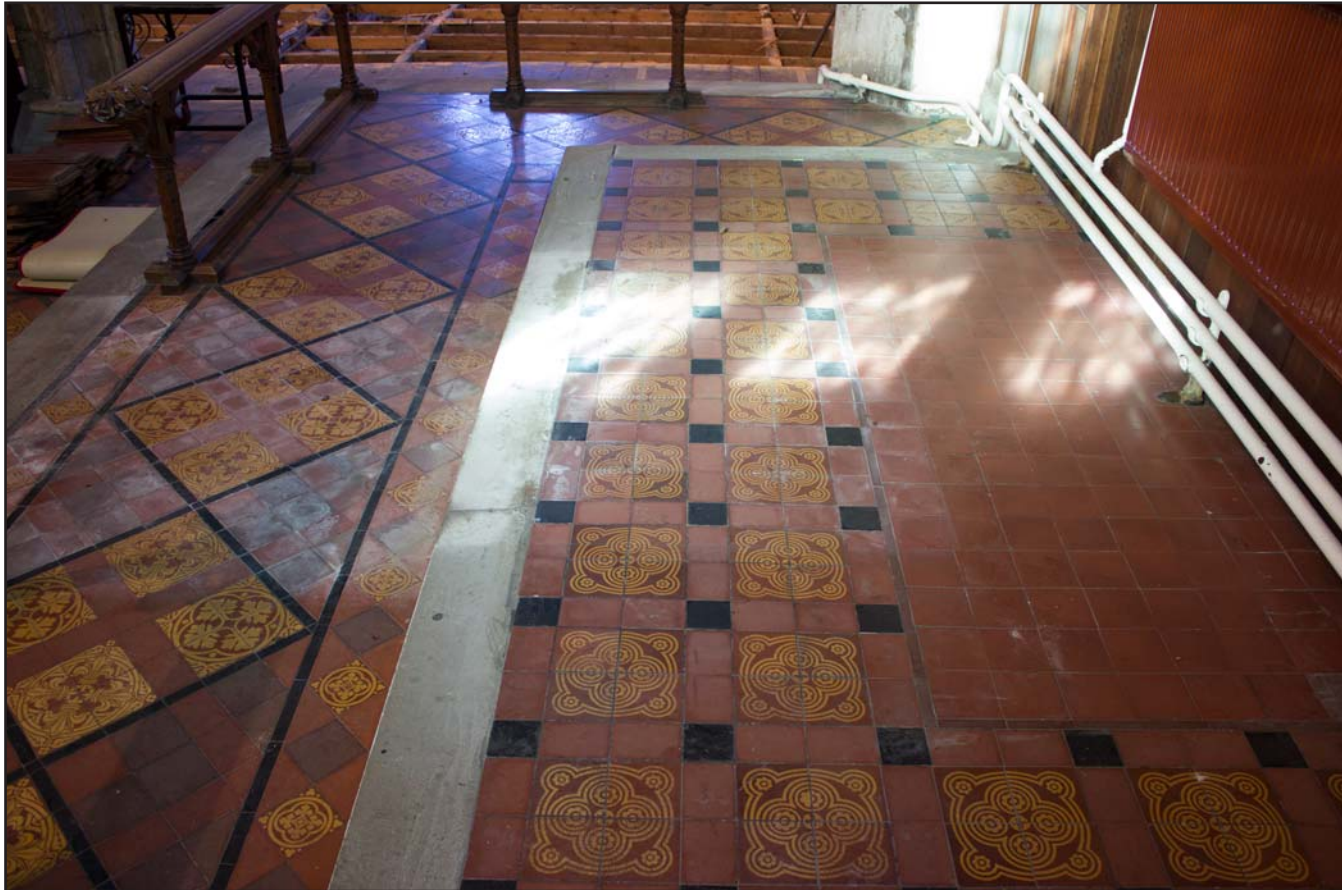
Plate 08: Altar tiles at St. Asaph Parish Church, St. Asaph, Denbighshire - from the west - scale 1m

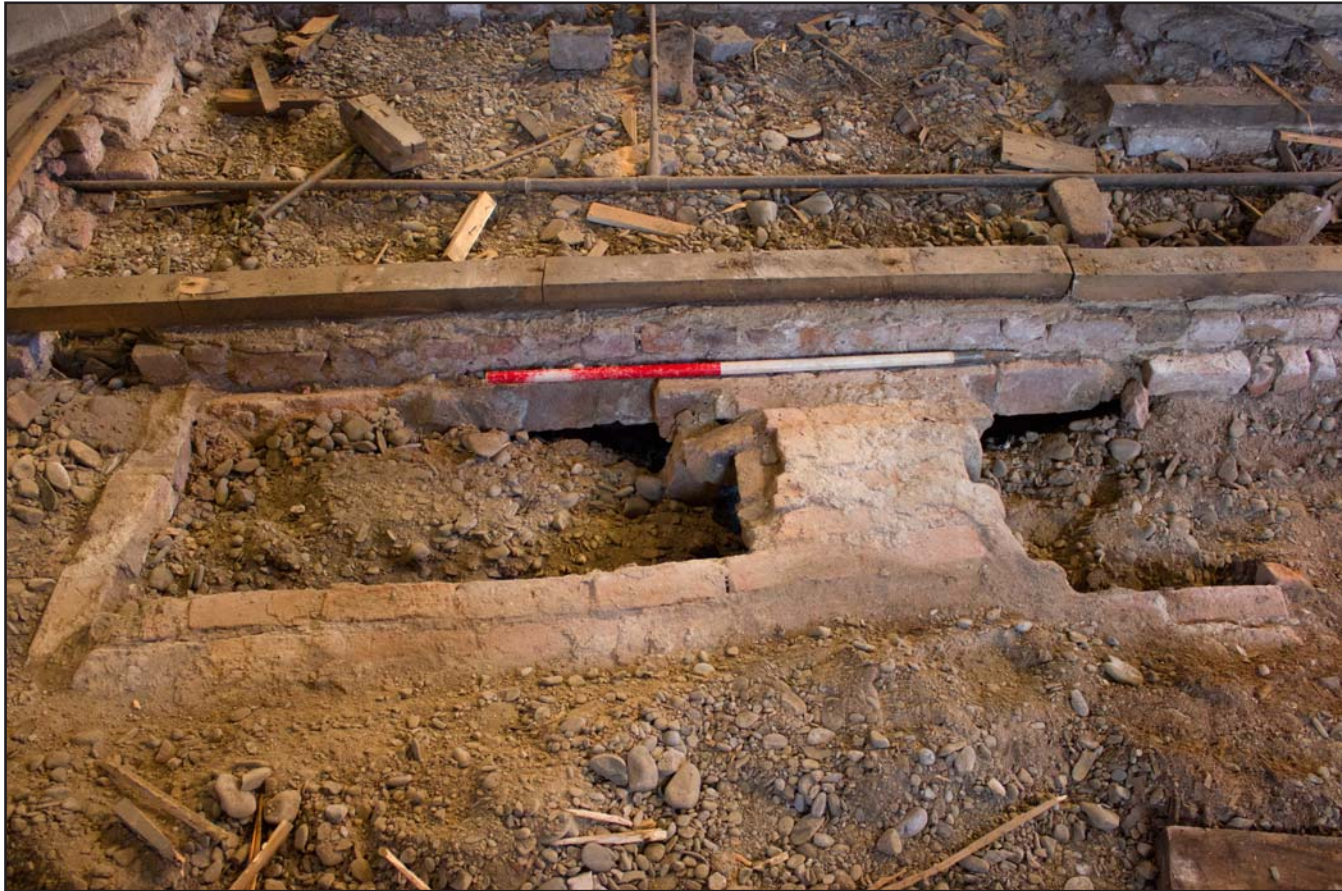
Plate 16: First brick vault found below central floor at St. Asaph Parish Church, St. Asaph, Denbighshire - from the north - scale 1m

To the immediate southeast of the north aisle, between the spans of the central arches a second brick-built barrel-vaulted crypt was found, this one aligned east to west. It had been constructed from handmade unfrosted red-brick bonded by lime mortar; the bricks measured 0.23m in length by 0.12m in width and 0.07m in depth. The barrel vault of the crypt measured 2.30m long by 1.00m wide and extended to a depth >0.30m. The crypt was partially situated below a floor joist which ran east to west across this central area where the wooden floor had been removed; the majority of the northern portion of the crypt had been broken and the interior of the crypt exposed – this had also been infilled with rubble and soil.

Both of the red-brick barrel vaulted crypts pre-date the brick-built piers for the suspended flooring – the vaults were most likely broken and infilled when this floor was installed as both vaults were partially truncated by the piers. Both of the crypts had been cut into the soil below the floor of the church which was a soft, mid brown-grey, silt-sand with frequent small sub-rounded cobbles and pebbles. There were no obvious grave cuts observed for either the vaults or the grave marker as the loose nature of the soil made any such cuts imperceptible.

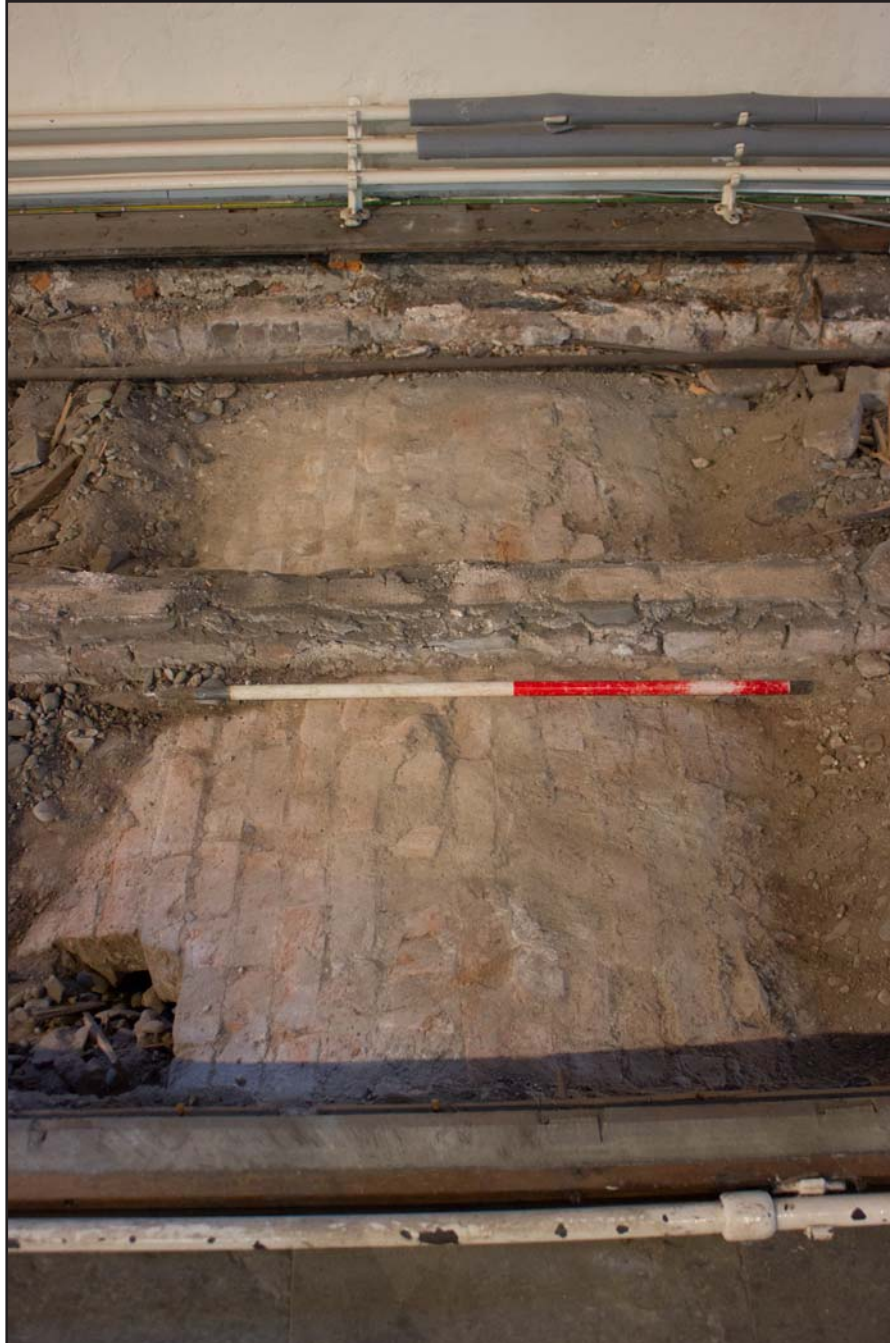
Plate 17: Second brick vault found below northern floor at St. Asaph Parish Church, St. Asaph, Denbighshire - from the south - scale 1m

To the east of this a red-brick barrel vaulted crypt was uncovered in the north aisle aligned north to south. This had been constructed from handmade unfrosted red-brick bonded by lime mortar; the bricks measured 0.22m in length by 0.12m in width and 0.07m in depth. The barrel vault of the crypt measured >2.00m long by 1.14m wide and extended to a depth >0.35m. There was a small break in the south western end of the vault which suggests that it had been previously infilled with rubble and soil. The north to south orientation is unusual but was probably built to be accessed externally from the northern side of the church, with burial perhaps being arranged in the traditional east to west format within the crypt – this was not observed but would explain the anomaly of non-traditional alignment.

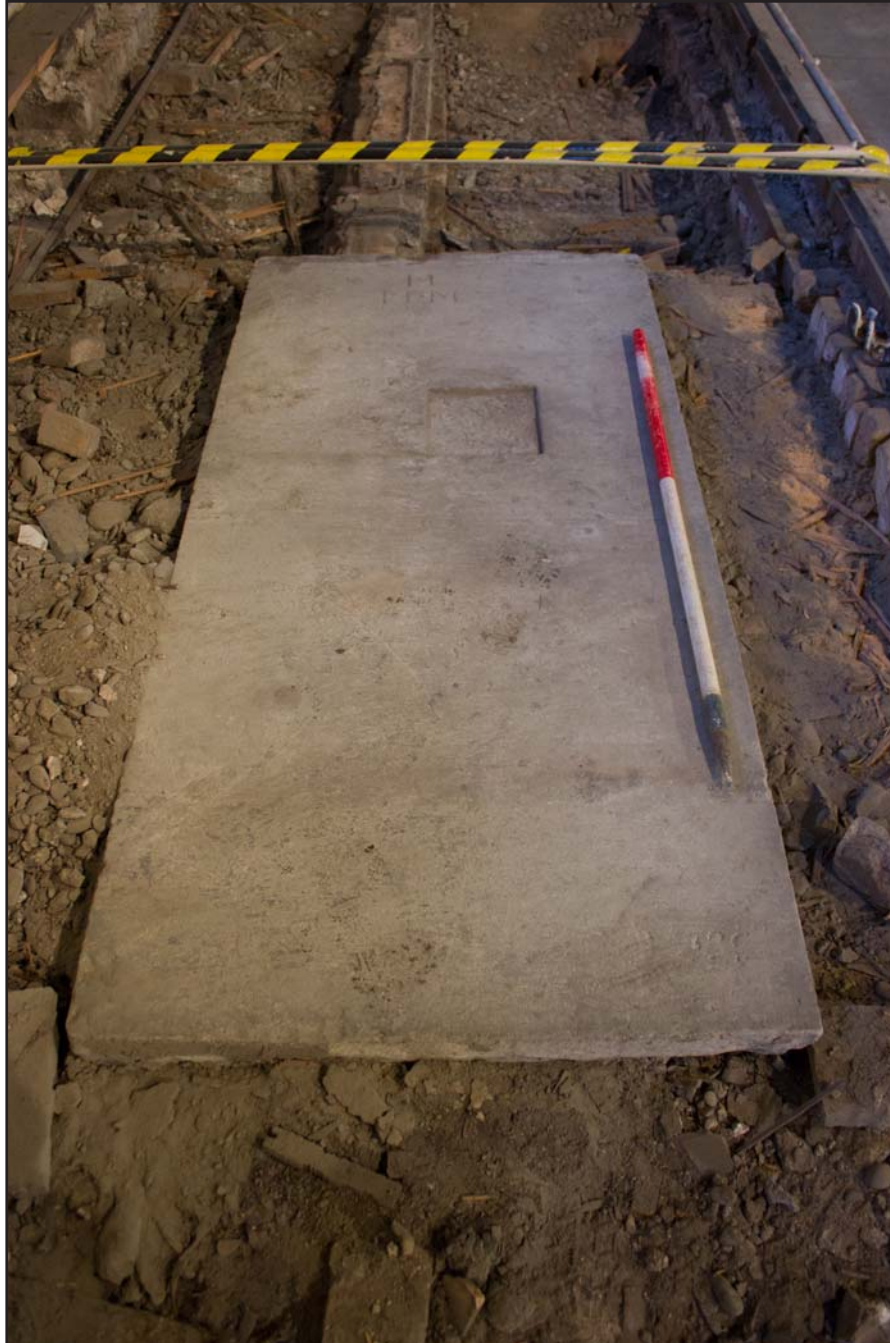
Plate 18: Grave marker found below northern floor at St. Asaph Parish Church, St. Asaph, Denbighshire - from the west - scale 1m

In the northern aisle, towards the western end of the church, there was a rectangular grave marker slab which measured 1.89m long by 0.89m wide by 0.12m deep. This grave slab was orientated east to west and comprised of a single slab of light grey stone. At the eastern end of the grave slab there was a simple inscription in formal script;

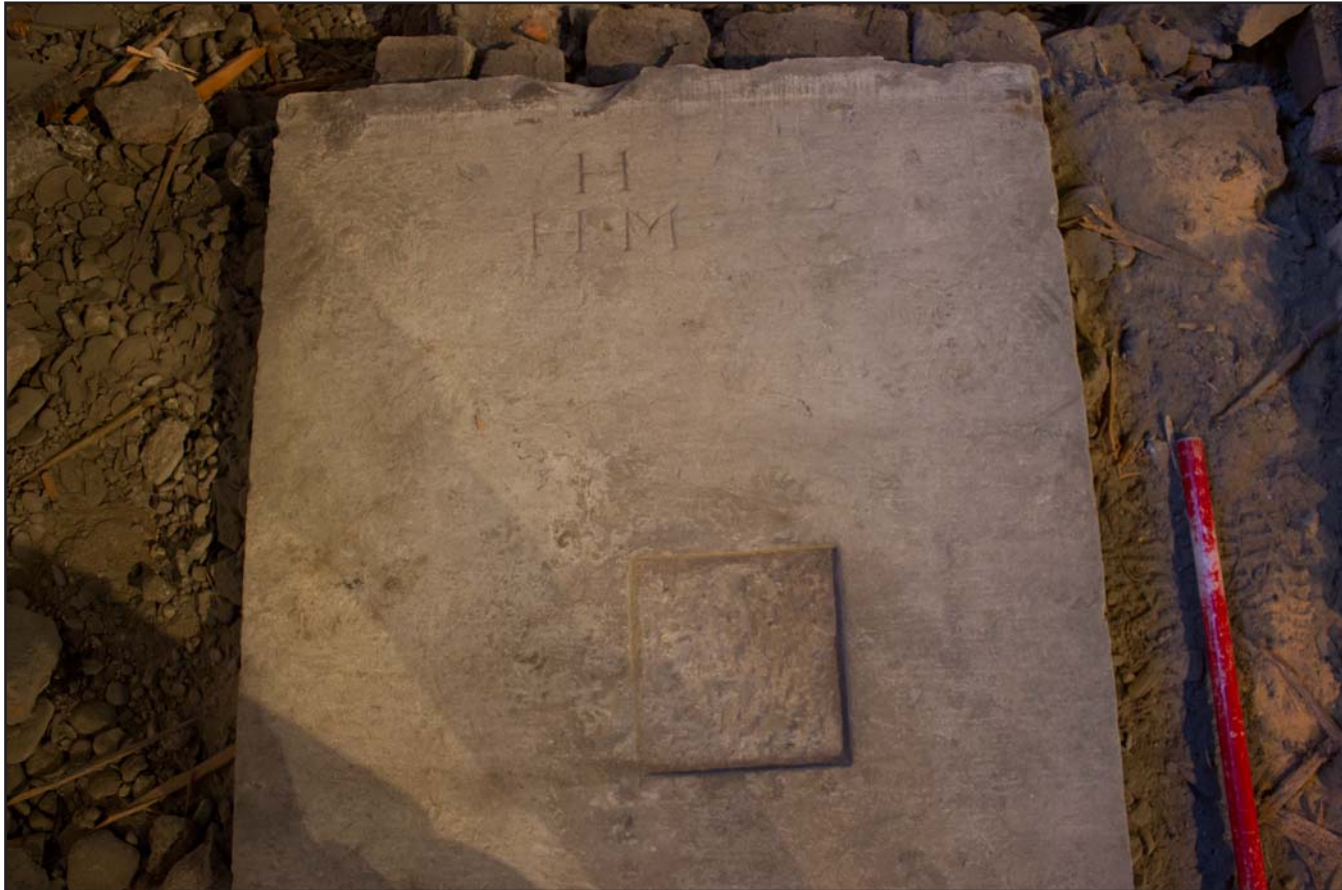
Plate 19: Inscription on grave marker found below northern floor at St. Asaph Parish Church, St. Asaph, Denbighshire - from the west - scale 1m

H
H·M

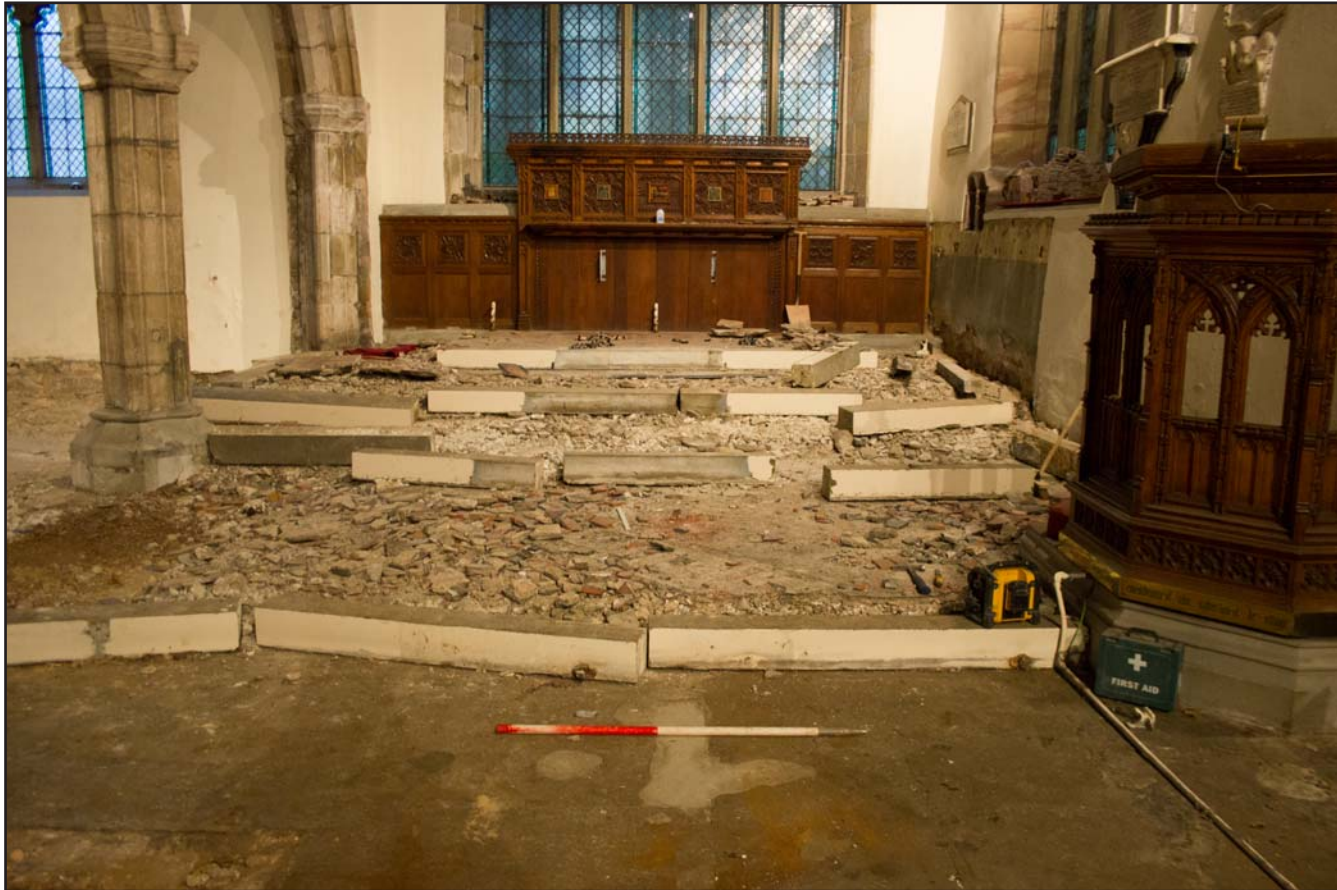
Plate 20: Pre removal of limestone kerbs at St. Asaph Parish Church, St. Asaph, Denbighshire - from the west - scale 1m

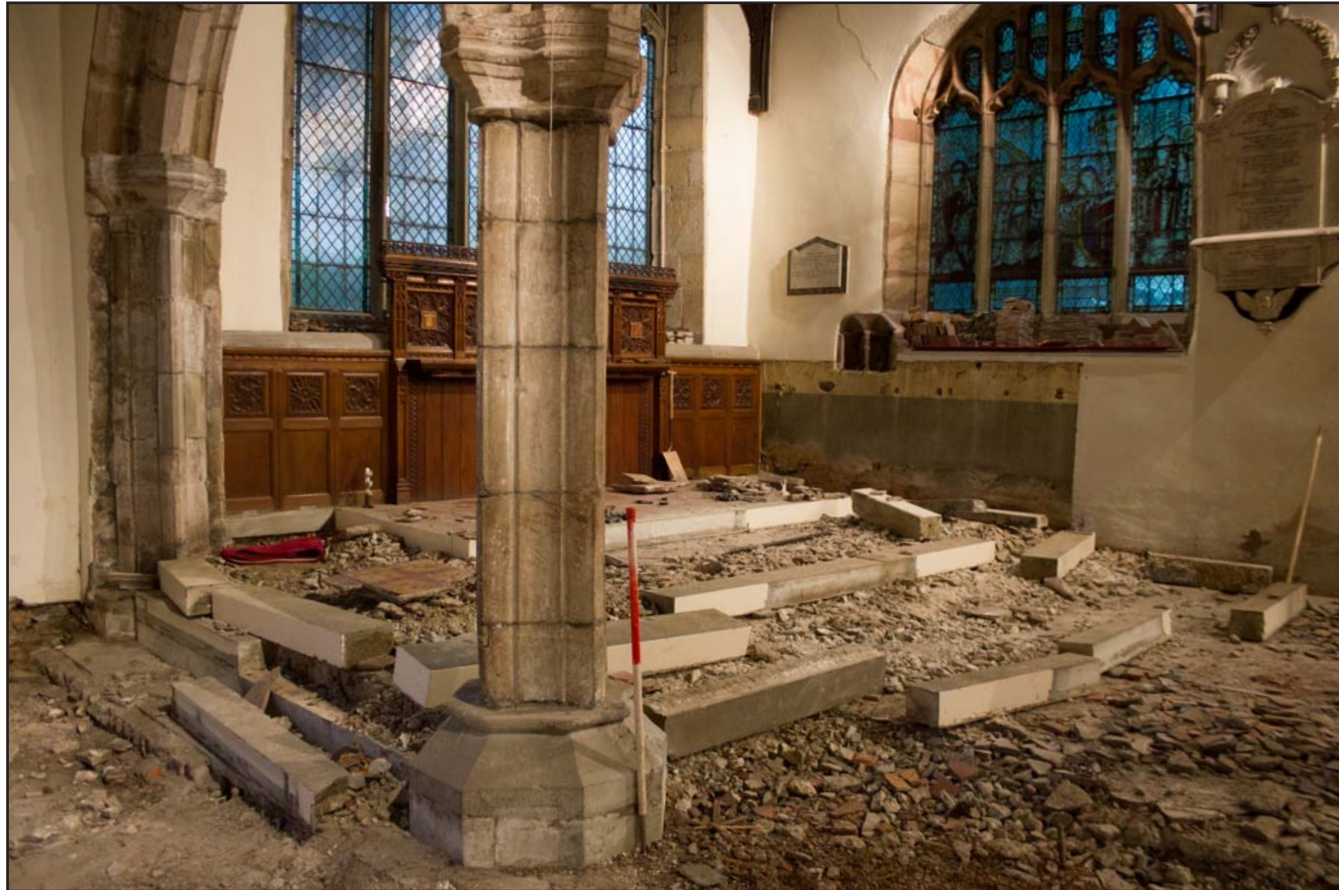
Plate 21: Pre removal of limestone kerbs at St. Asaph Parish Church, St. Asaph, Denbighshire - from the northwest - scale 1m

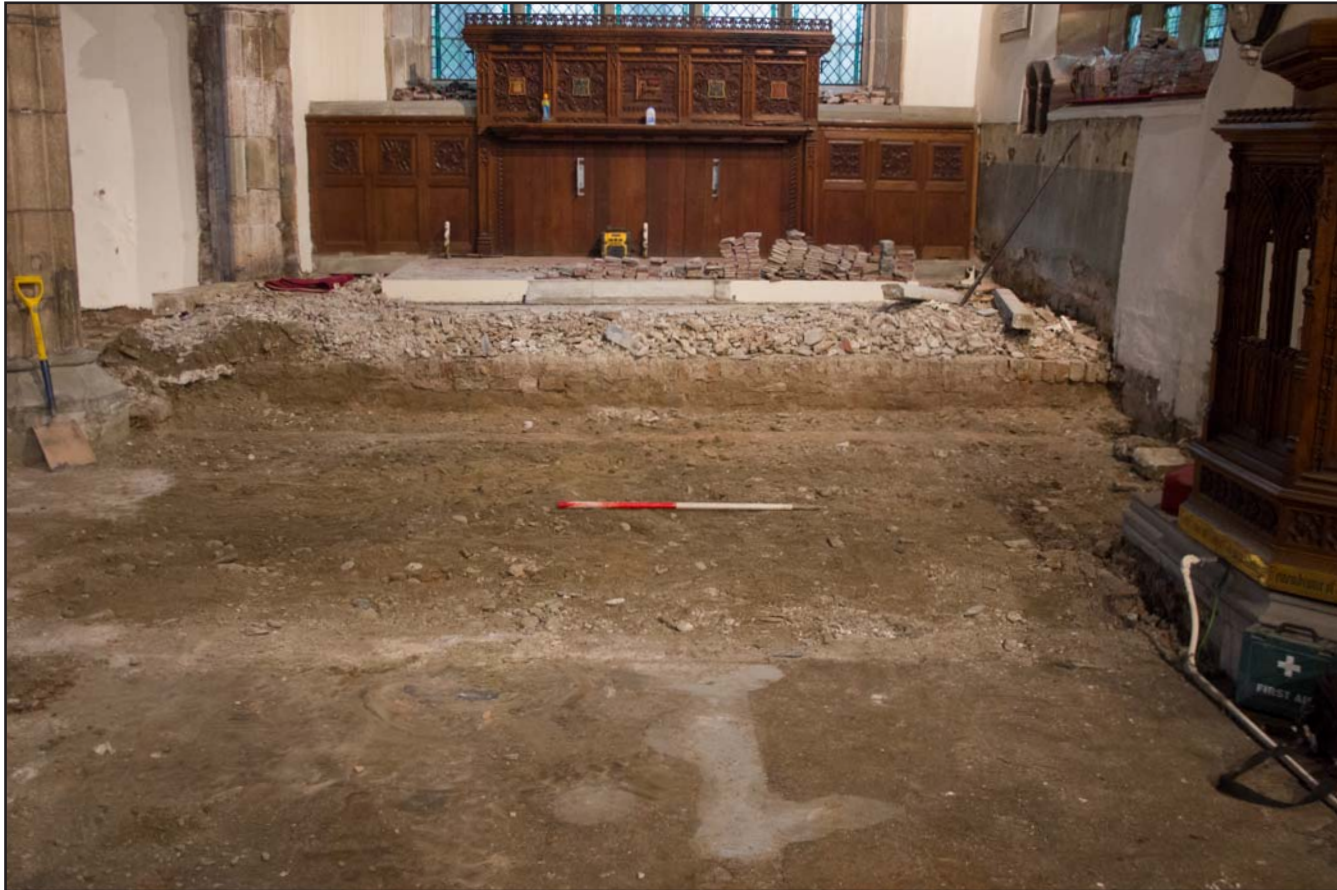
Plate 22: Post removal of limestone kerbs at St. Asaph Parish Church, St. Asaph, Denbighshire - from the west - scale 1m

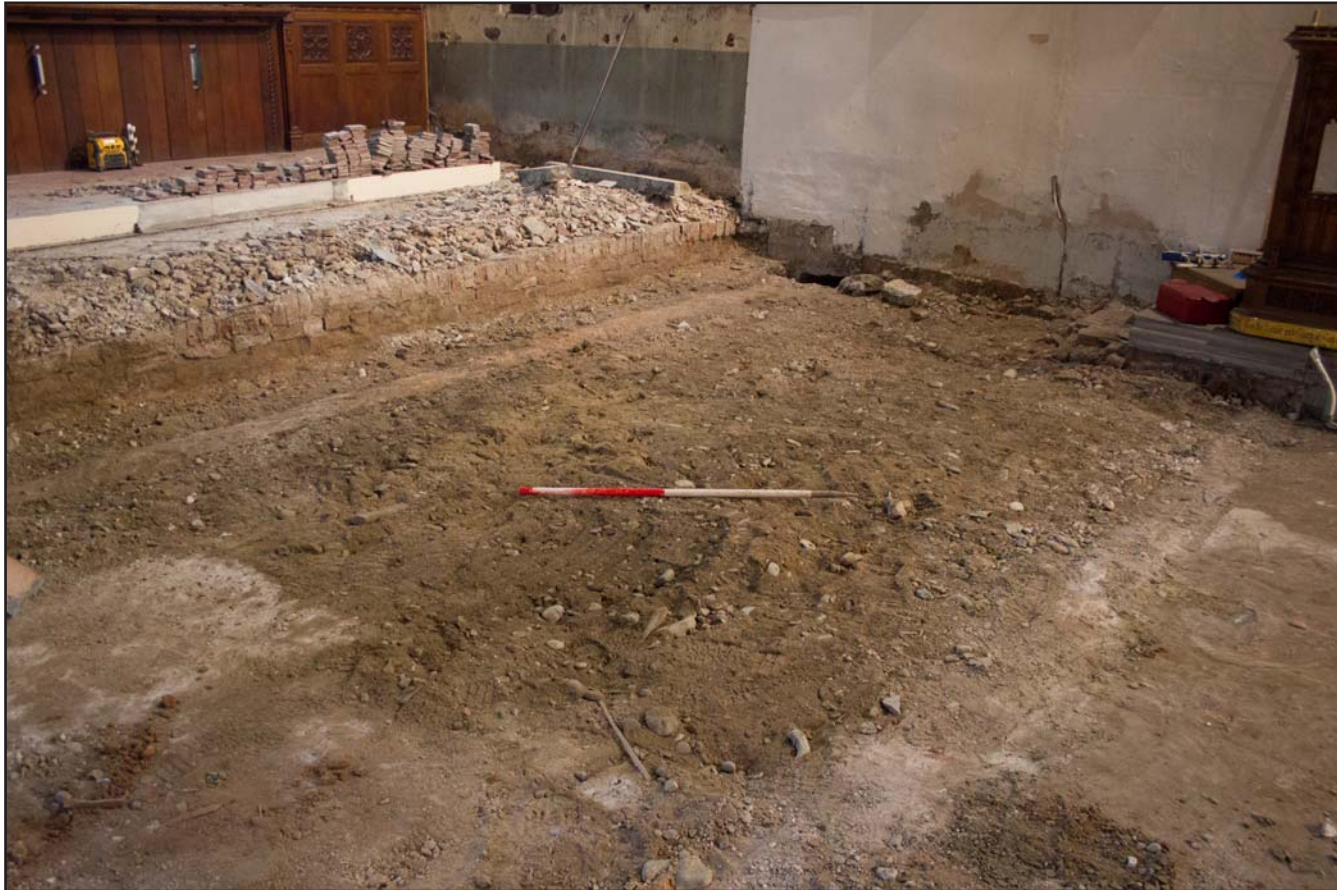
Plate 23: Post removal of limestone kerbs at St. Asaph Parish Church, St. Asaph, Denbighshire - from the northwest - scale 1m

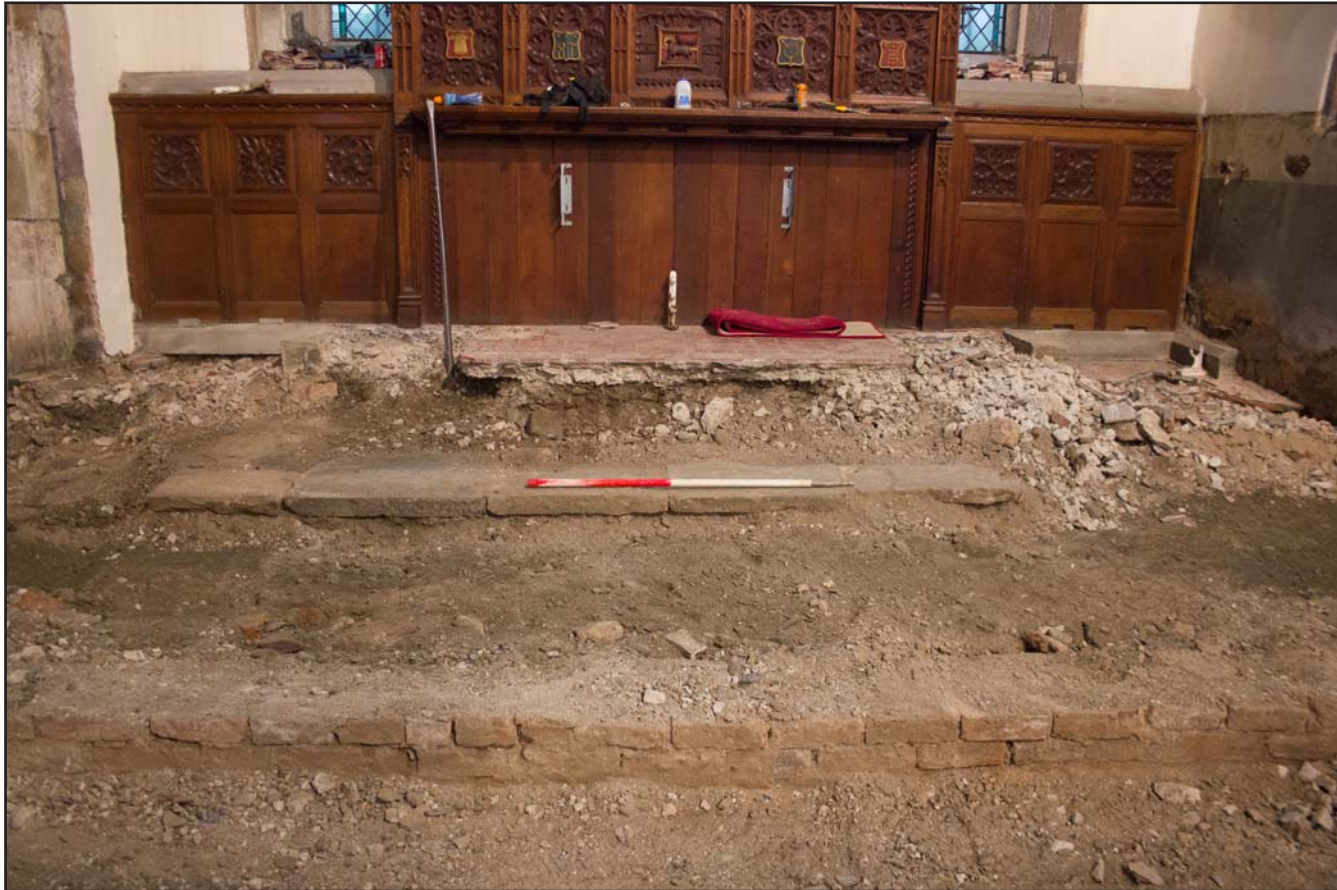
Plate 24: Sandtone slabs foundation footing for altar at St. Asaph Parish Church, St. Asaph, Denbighshire - from the west - scale 0.50m

The sandstone slabs that formed the proto-foundation of the altar were arranged from six slabs that ran north to south and a further two rows of three which formed northern and southern returns, which ran west to east forming a 'C-shape'. Following the removal of the upper step of the altar the timber screen attached to the eastern elevation of the church was removed to reveal a partially mortared wall behind.

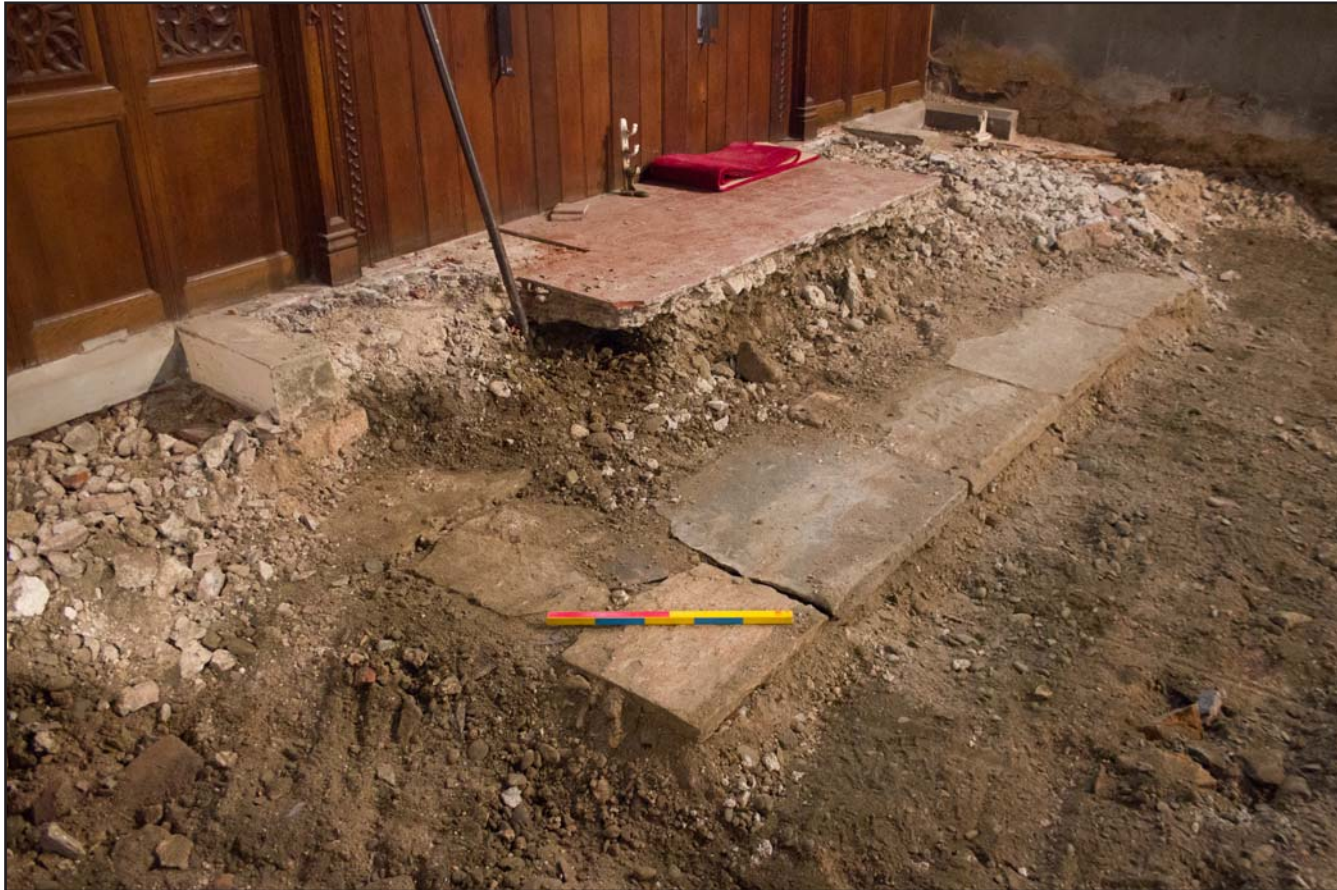
Plate 25: Sandtone slabs foundation footing for altar at St. Asaph Parish Church, St. Asaph, Denbighshire - from the northwest - scale 0.50m

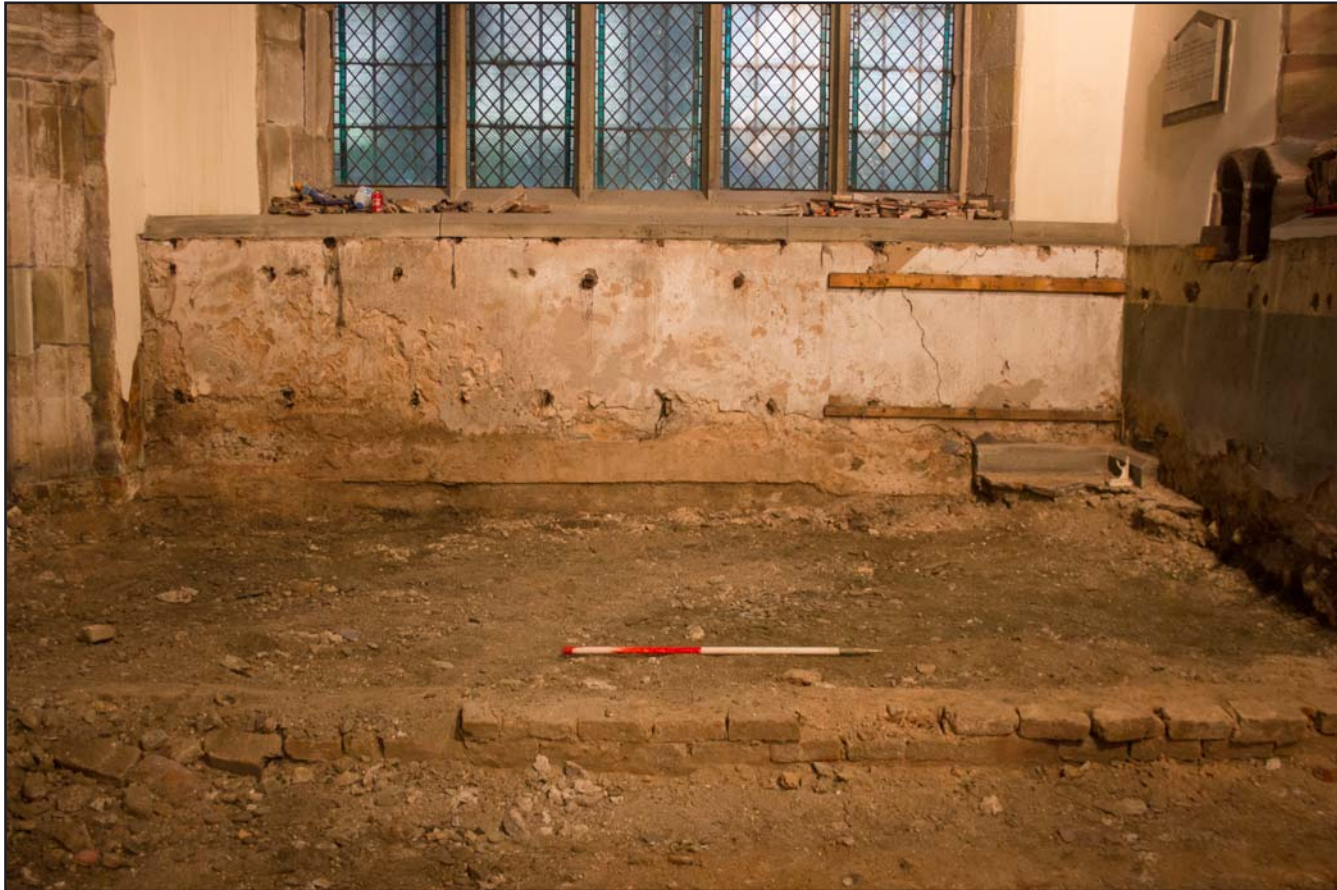
Plate 26: Post removal of carved altar at St. Asaph Parish Church, St. Asaph, Denbighshire - from the west - scale 1m

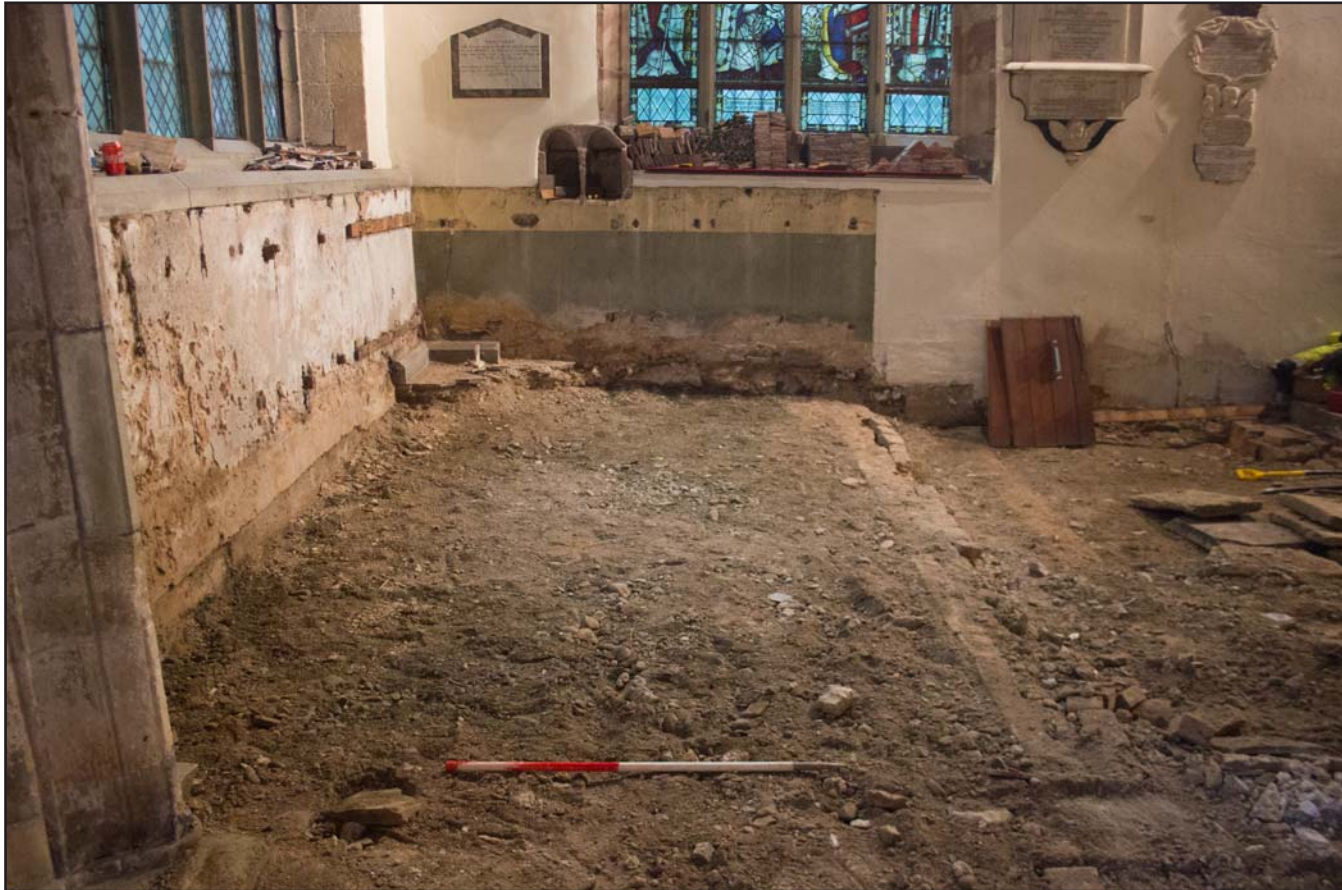
Plate 27: Post removal of carved altar Altar at St. Asaph Parish Church, St. Asaph, Denbighshire - from the north - scale 1m

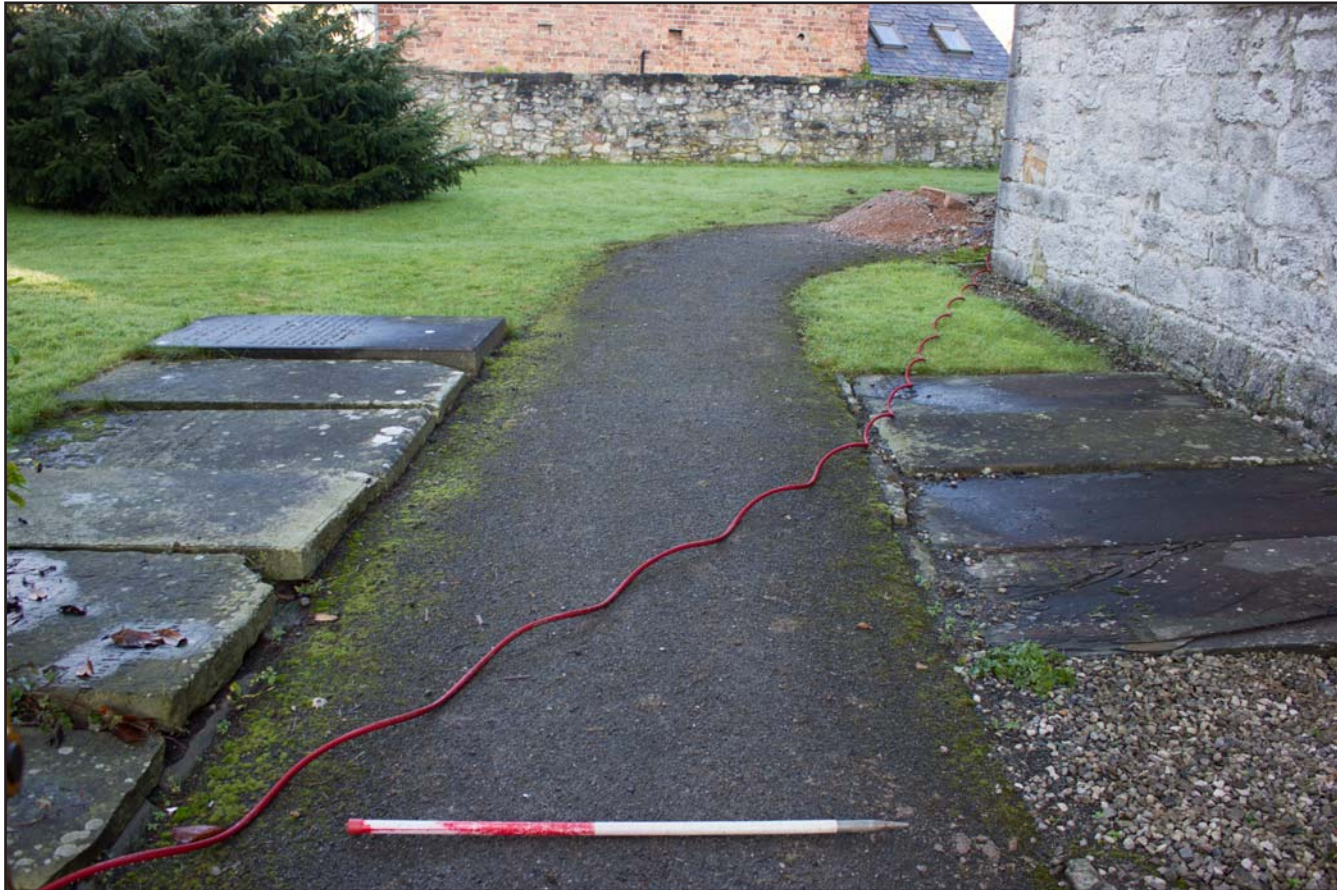
Plate 28: Pre excavation shot of drainage route to the west of St. Asaph Parish Church, St. Asaph, Denbighshire - from the south - scale 1m

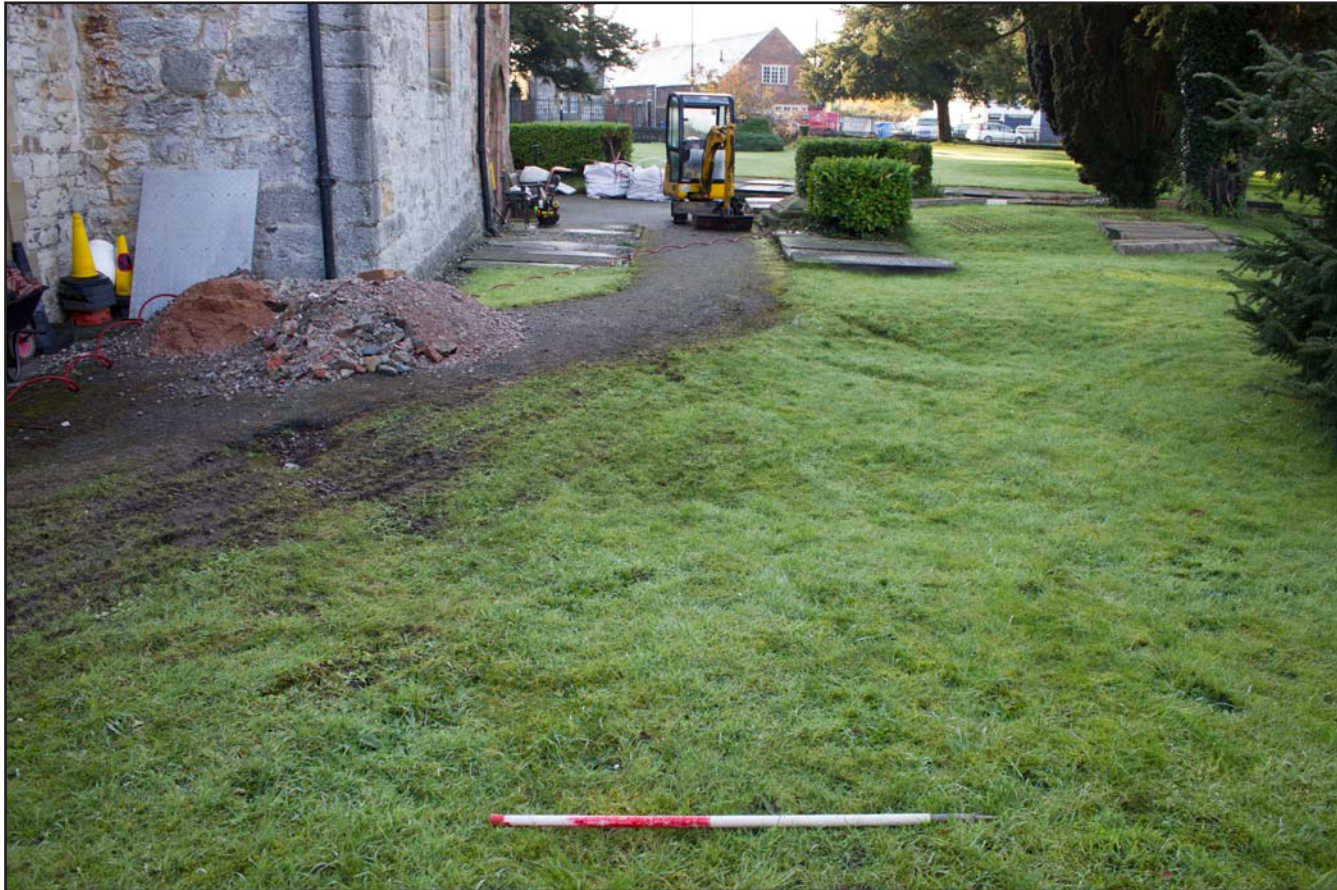
Plate 29: Pre excavation shot of drainage route to the west of St. Asaph Parish Church, St. Asaph, Denbighshire - from the north - scale 1m
