St. Asaph Parish Church, no.1 High Street, St. Asaph, LL17 0RG.

January 2020
V 1.0

Archaeological Watching Brief
Project Code: A0223.1
Report no. 0234

Archaeological Watching Brief

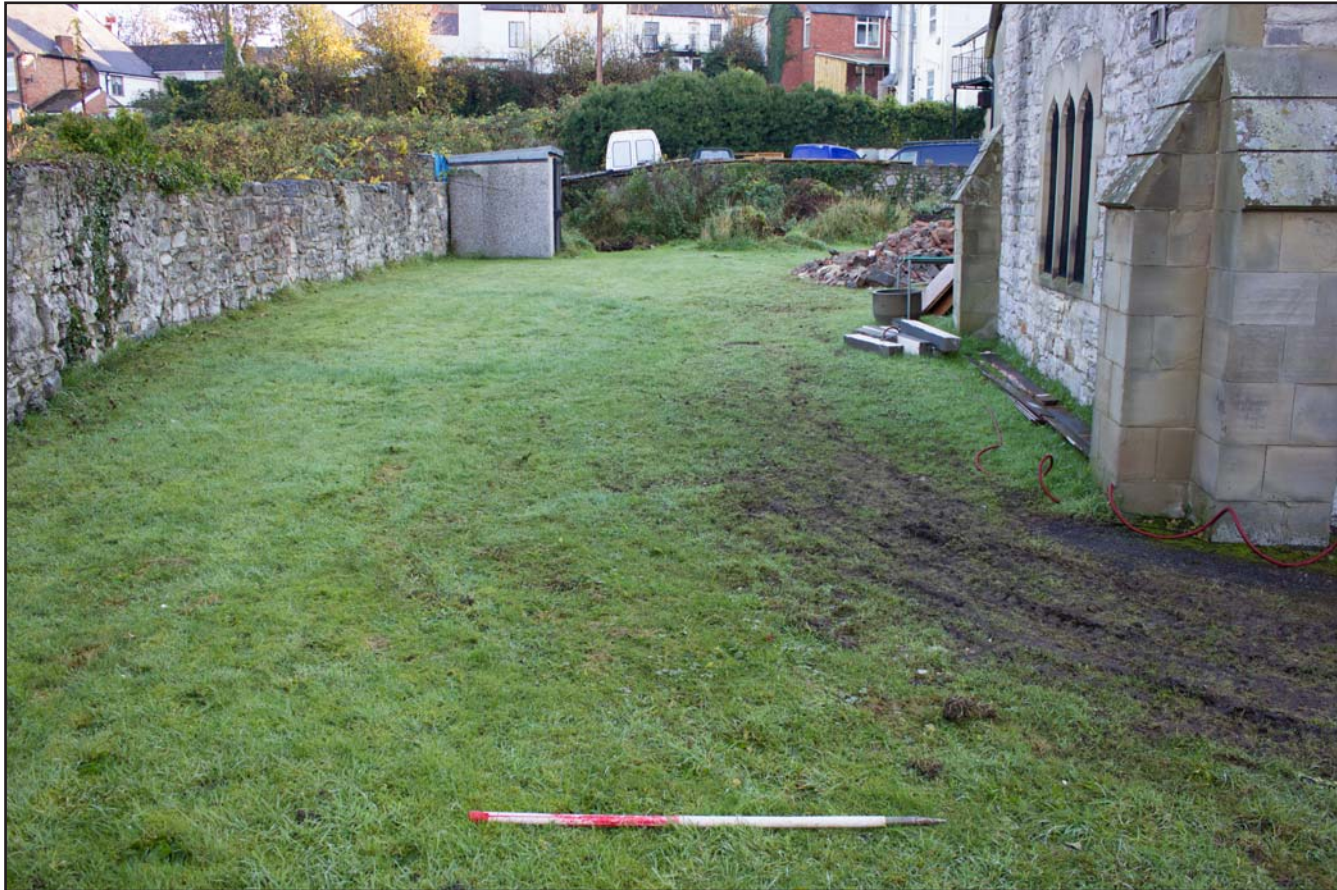
Plate 30: Pre excavation shot of drainage route to the north of St. Asaph Parish Church, St. Asaph, Denbighshire - from the west - scale 1m

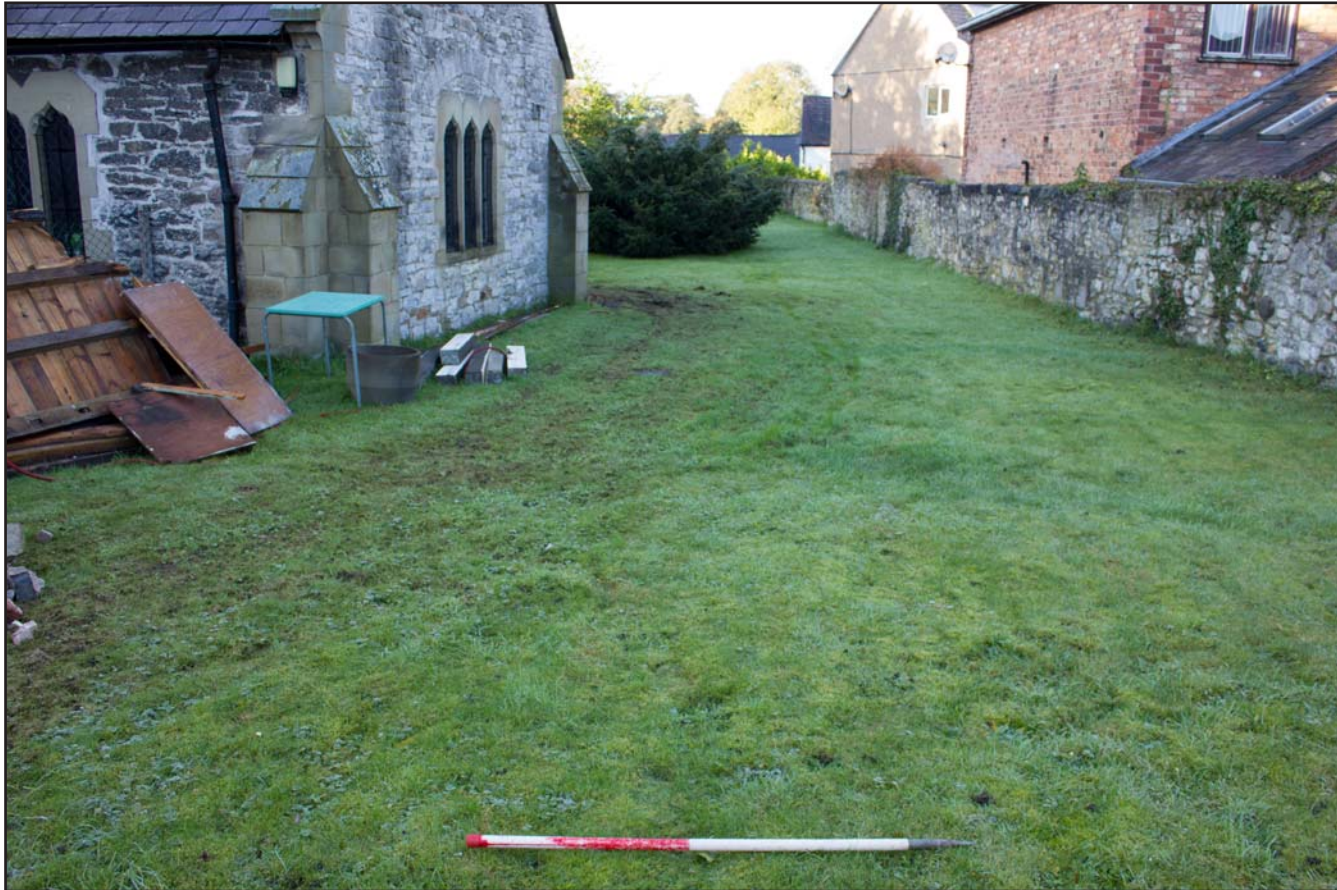
Plate 31: Pre excavation shot of drainage route to the north of St. Asaph Parish Church, St. Asaph, Denbighshire - from the east - scale 1m

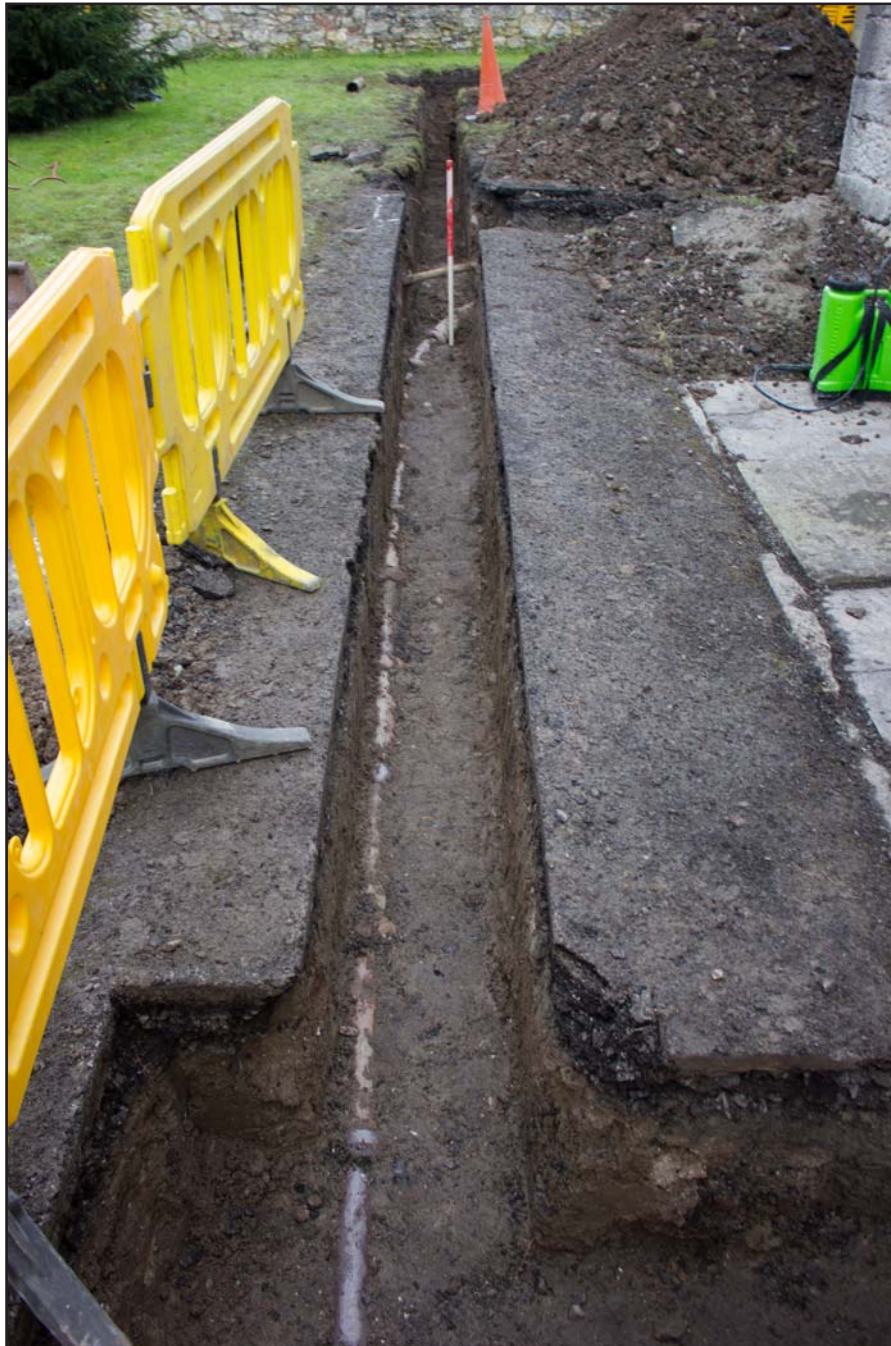
Plate 32: Main drainage trench to the west of St. Asaph Parish Church, St. Asaph, Denbighshire
- from the south - scale 1m

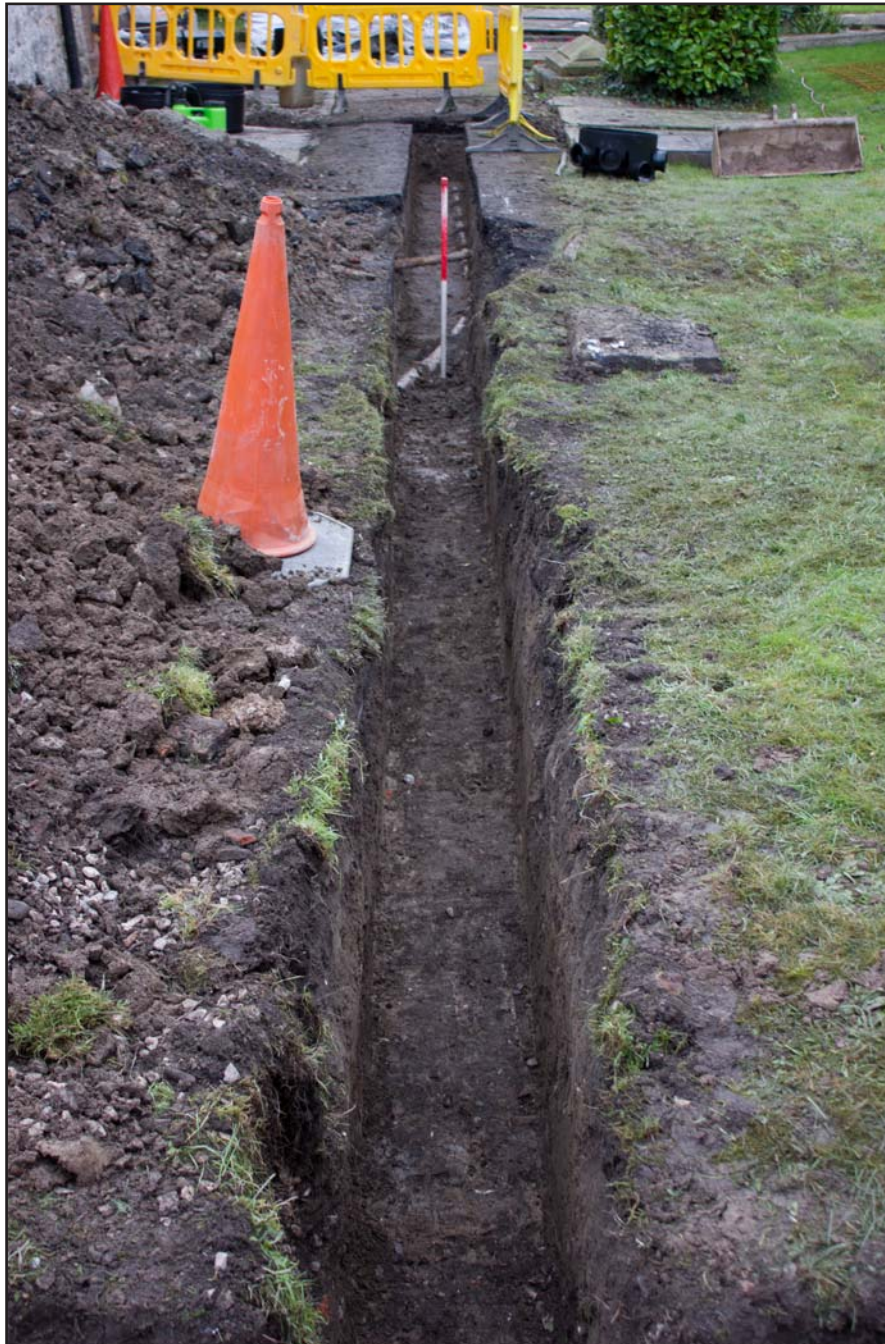
Plate 33: Main drainage trench to the west of St. Asaph Parish Church, St. Asaph, Denbighshire
- from the north - scale 1m

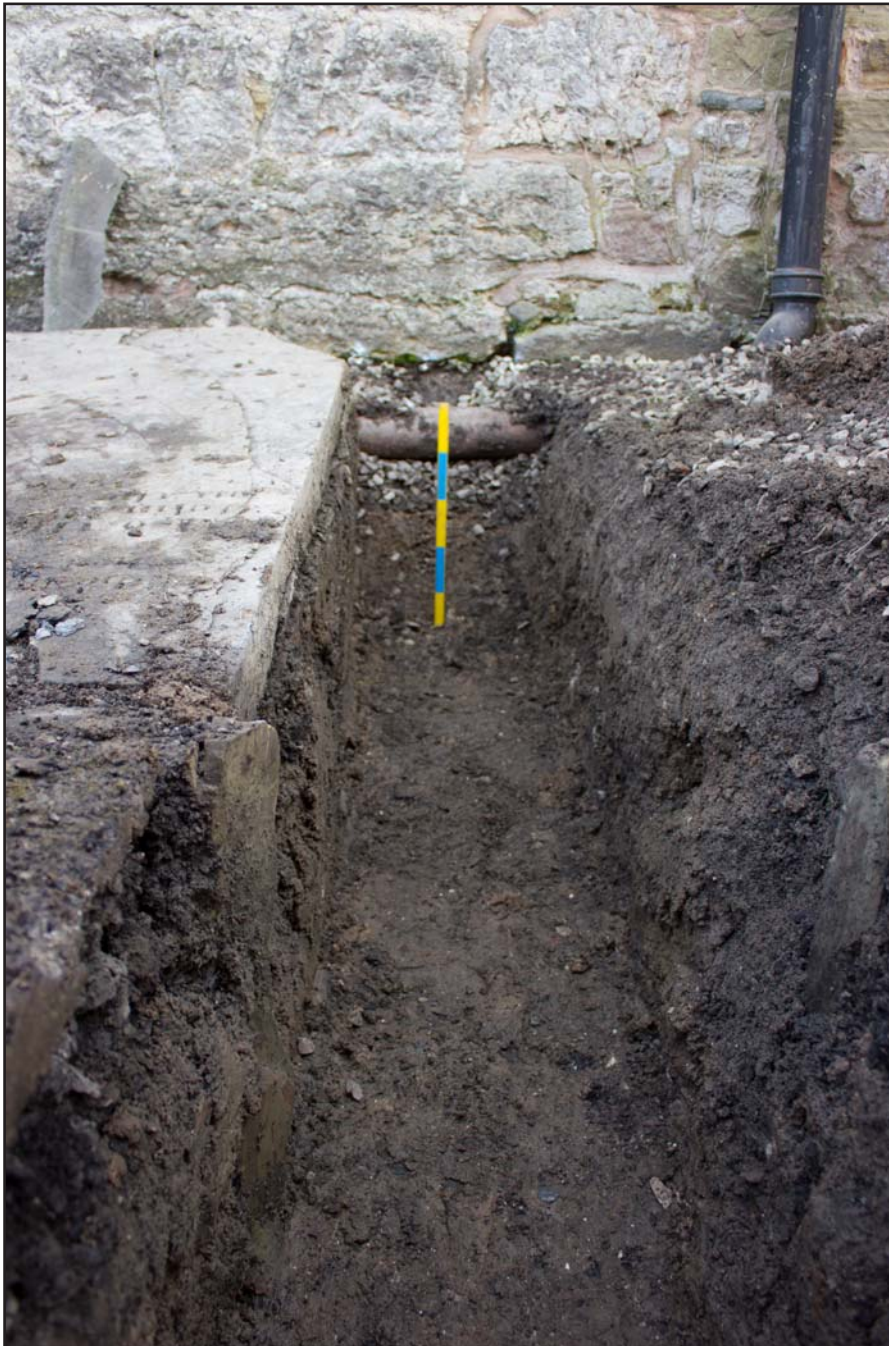
Plate 36: First inlet (southern) to main drainage trench at St. Asaph Parish Church, St. Asaph, Denbighshire
- from the west - scale 0.50m

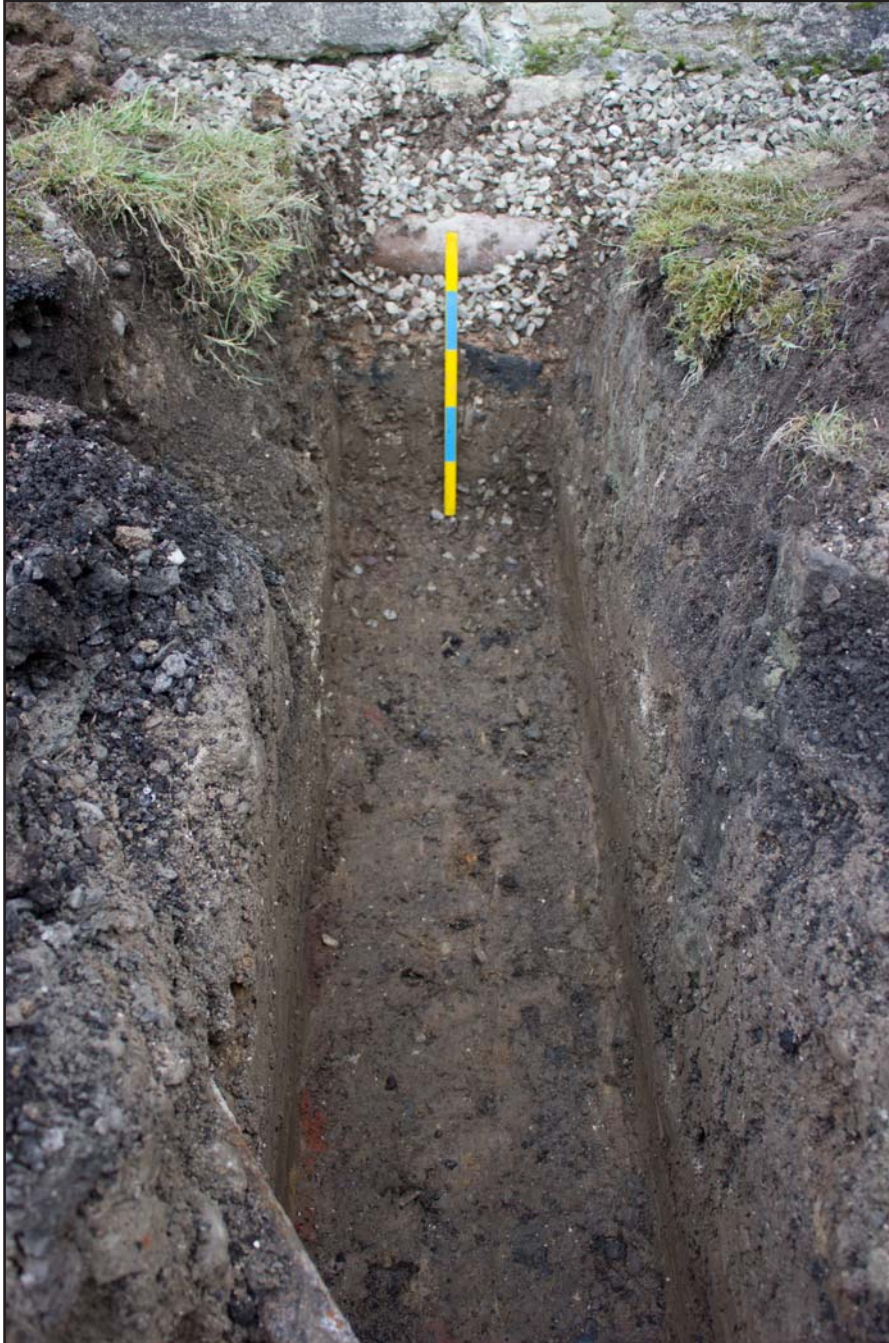
Plate 37: second inlet (northern) to main drainage trench at St. Asaph Parish Church, St. Asaph, Denbighshire
- from the west - scale 0.50m

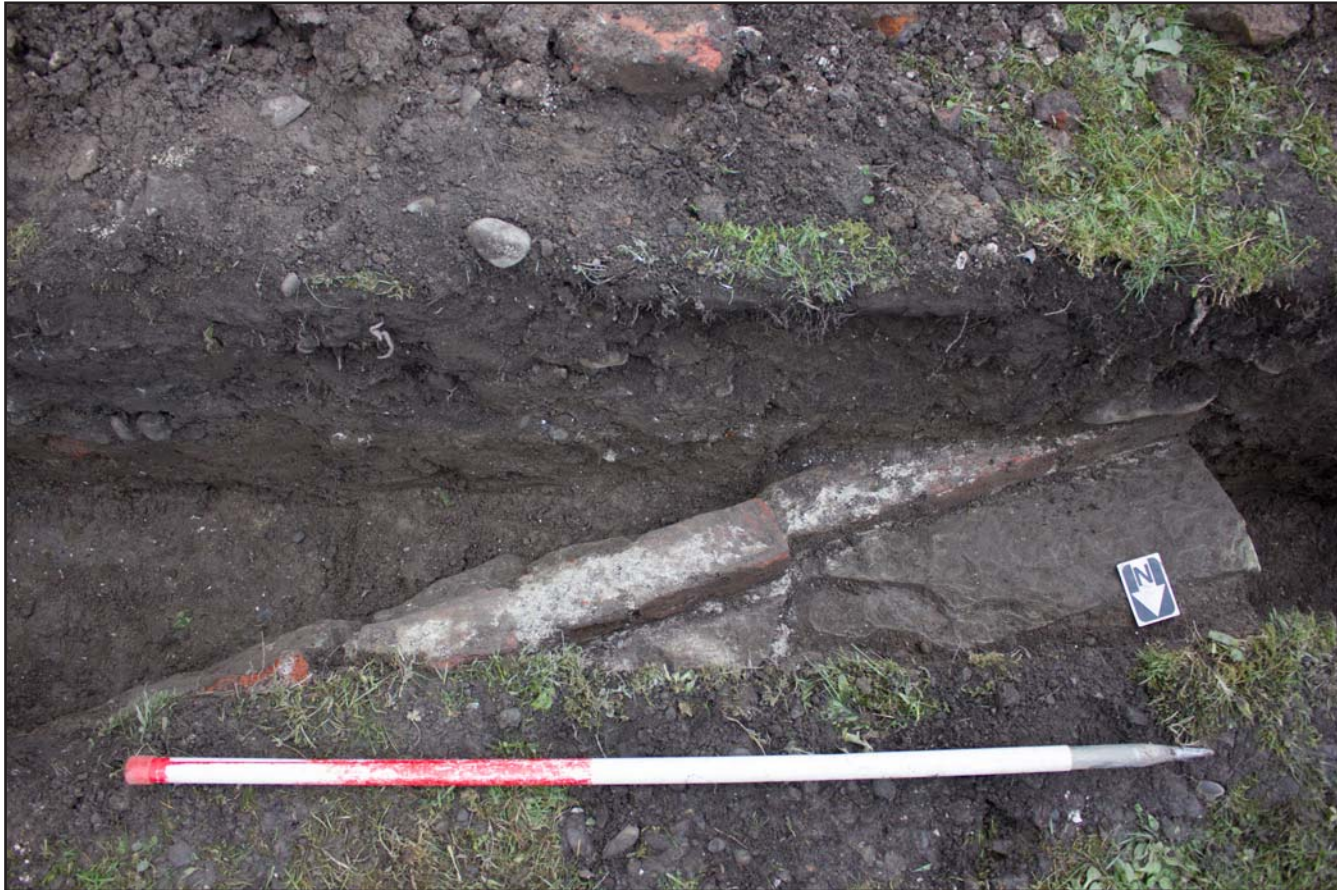
Plate 38: Plan shot of upturned grave marker (105) found in drainage trench to northwest of St. Asaph Parish Church, St. Asaph, Denbighshire
- from the north - scale 1m

Uncovered during excavation of the eastern run of the main drainage trench was a partially destroyed drainage trough or upturned grave marker (105); which measured >2.45m long by 0.21m wide and was 0.12m deep. It was in the form of a linear feature aligned east to west and comprised of a dressed stone trough with a single course of handmade unfrosted bricks attached to its southern edge which had been bonded with lime mortar (brick dimensions: 0.24m x 0.11m x 0.07m). This feature was reminiscent in form of some pre-Victorian drainage troughs which have been seen on country estates elsewhere in North Wales (Aeon report 0185) except for the unfrosted red-bricks bonded by mortar which would appear to be later – perhaps they represent a repair/improvement phase to the drain, furthermore there was a perceptible fall across the feature of 0.06m from east to west. Alternatively, given the context of the feature's presence in the burial ground of St. Asaph Parish Church the feature could represent a portion of a buried grave marker which for some reason had been upturned – with the mortared course of the red-bricks forming the uppermost course of a Victorian tomb which had since been demolished.

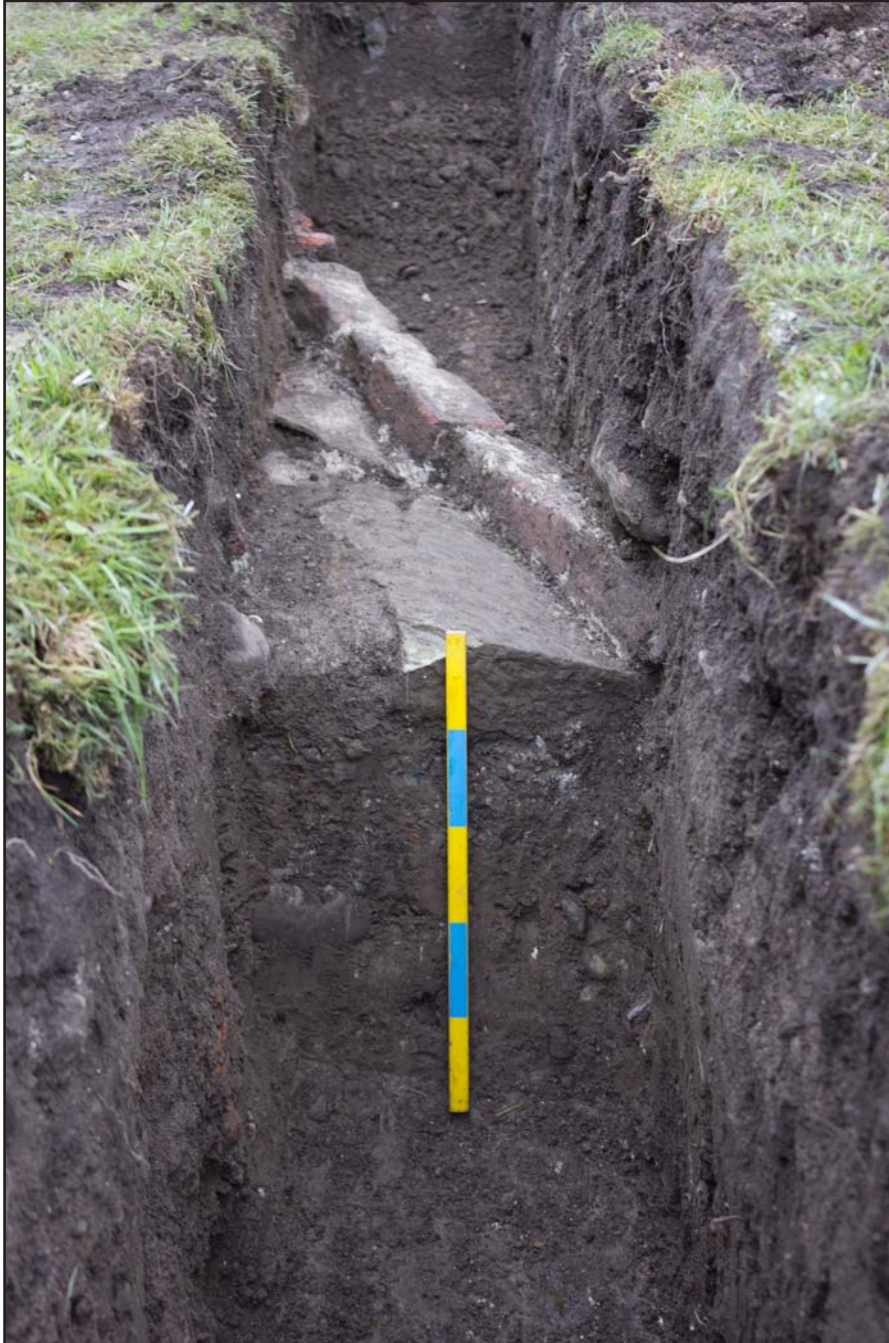
Plate 39: Section shot of upturned grave marker (105) found in drainage trench to northwest of St. Asaph Parish Church, St. Asaph, Denbighshire - from the north - scale 0.50m

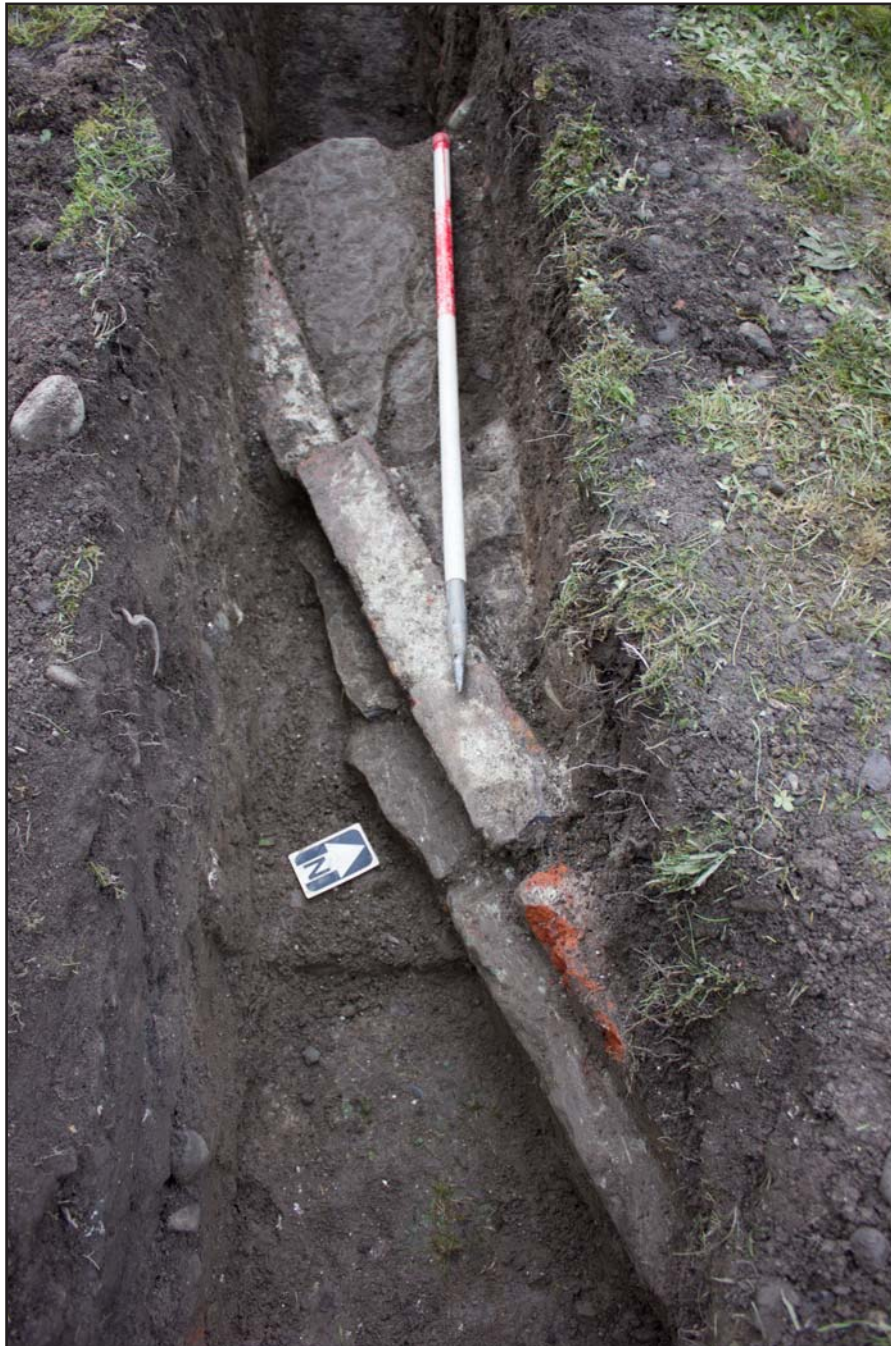
Plate 40: Plan shot of upturned grave marker (105) found in drainage trench to northwest of St. Asaph Parish Church, St. Asaph, Denbighshire - from the north - scale 1m

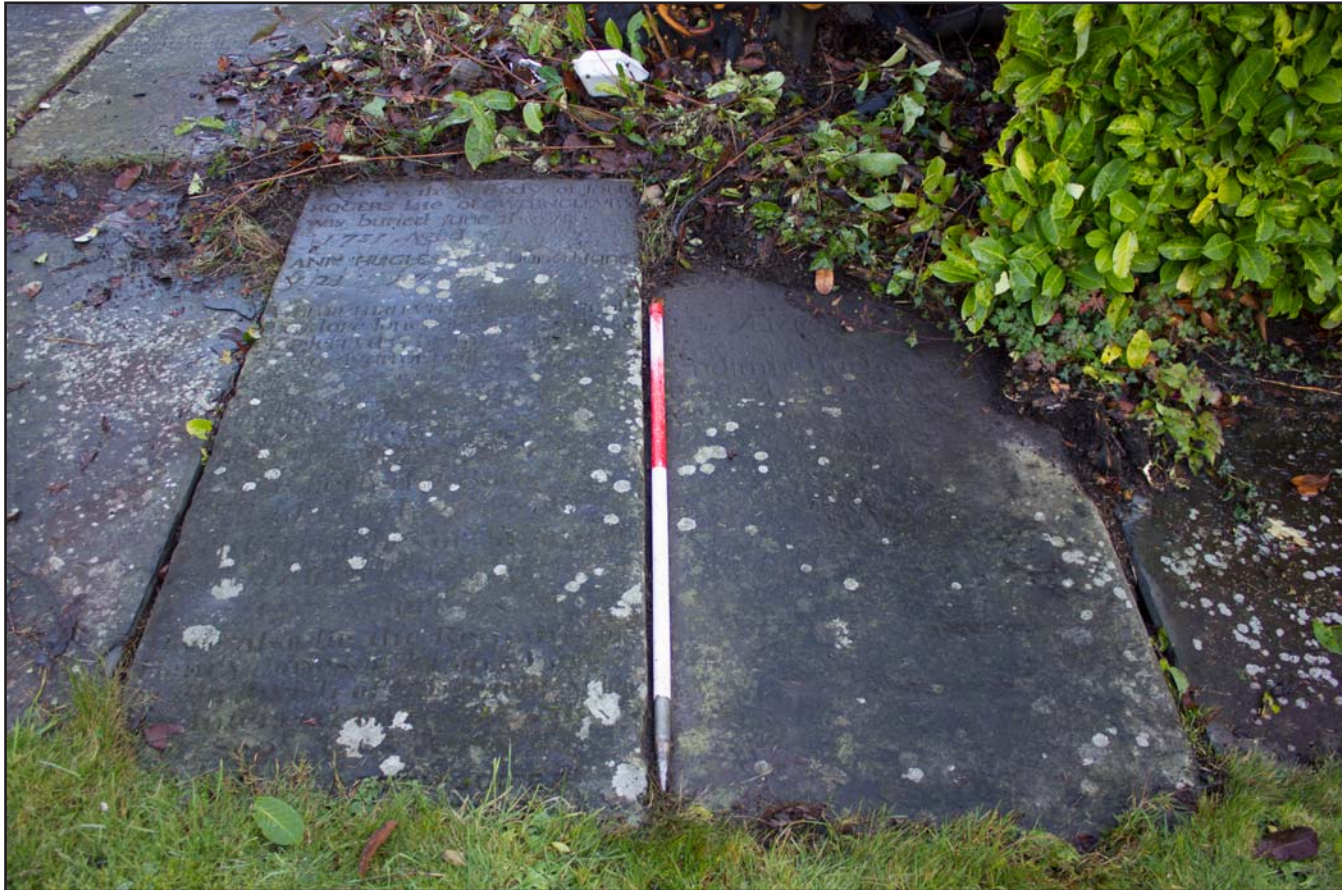
Plate 41: Grave markers pre removal for ramp excavation at St. Asaph Parish Church, St. Asaph, Denbighshire - from the south - scale 1m

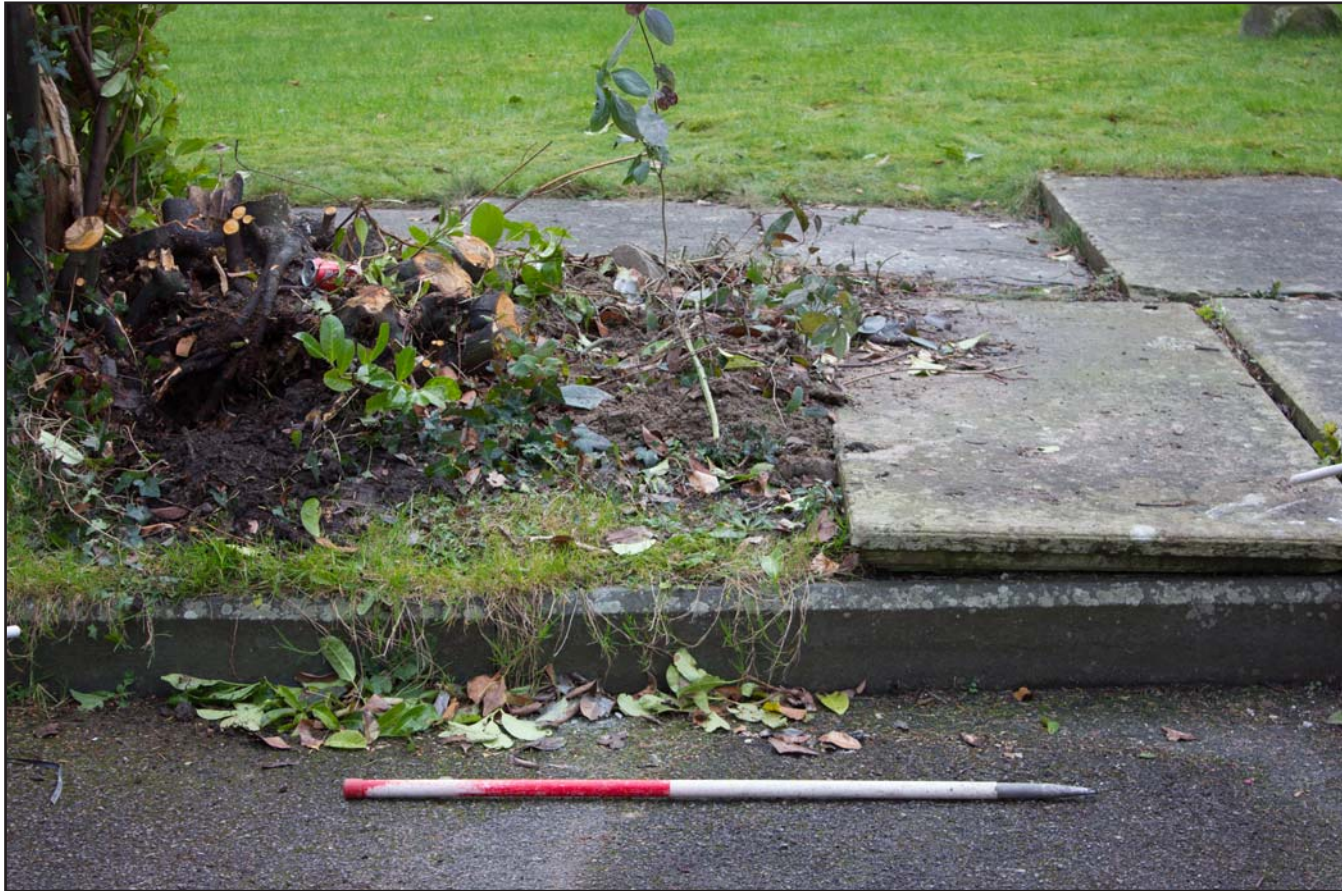
Plate 44: Context shot of grave markers at St. Asaph Parish Church, St. Asaph, Denbighshire - from the north - scale 1m

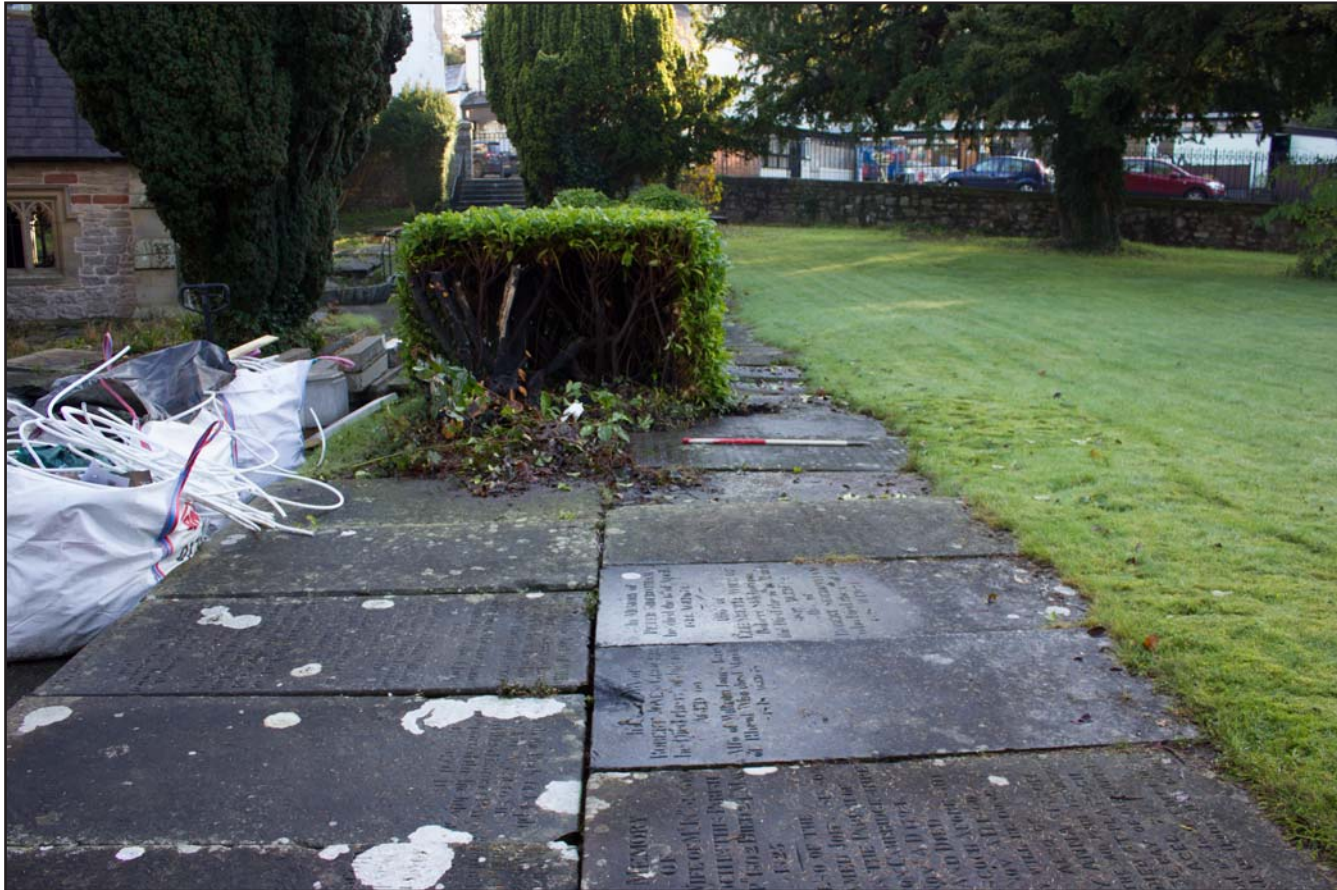
Plate 42: Context shot of grave markers at St. Asaph Parish Church, St. Asaph, Denbighshire - from the west - scale 1m

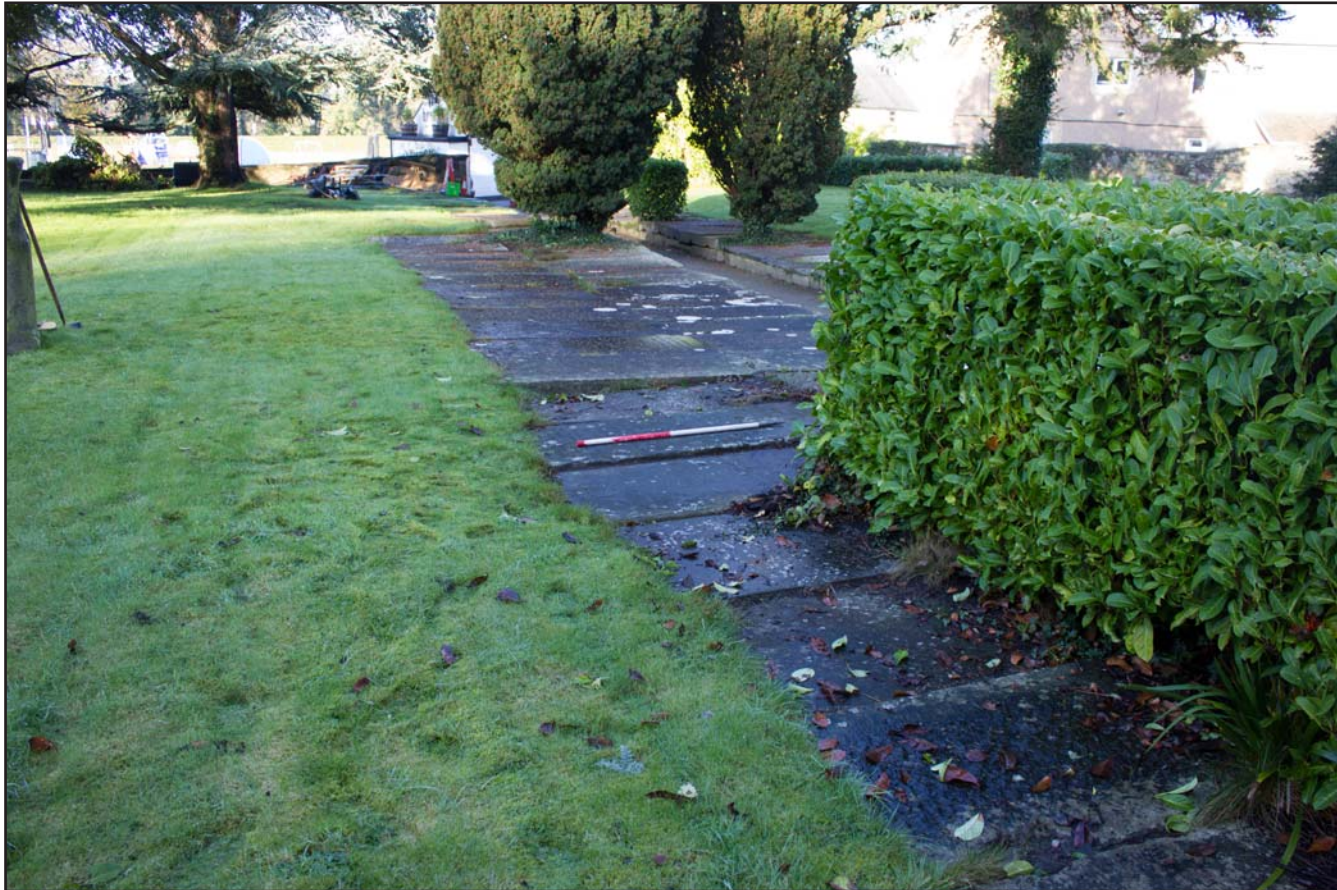
Plate 43: Context shot of grave markers at St. Asaph Parish Church, St. Asaph, Denbighshire - from the southeast - scale 1m

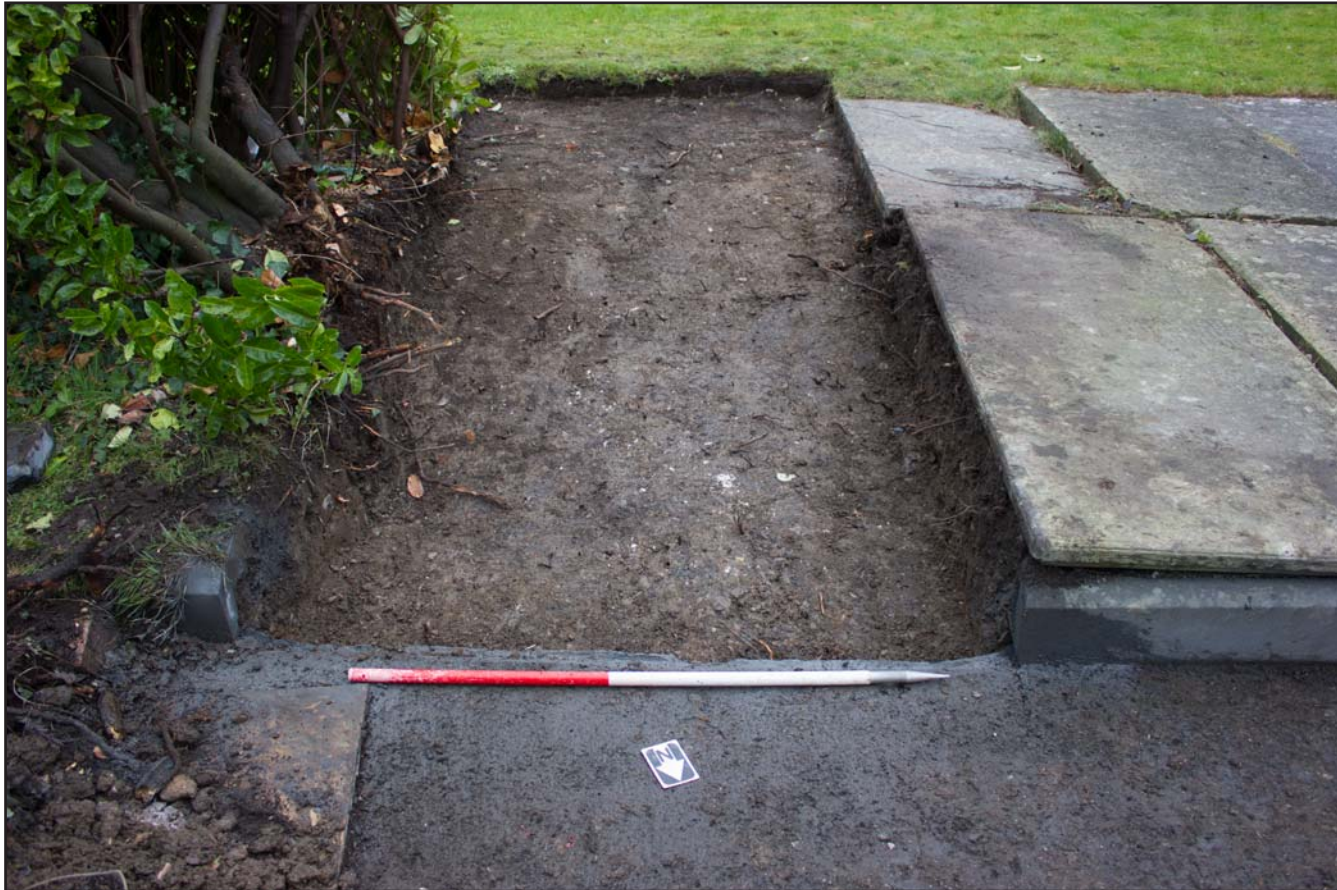
Plate 45: Post excavation shot of the ramp at St. Asaph Parish Church, St. Asaph, Denbighshire - from the north - scale 1m

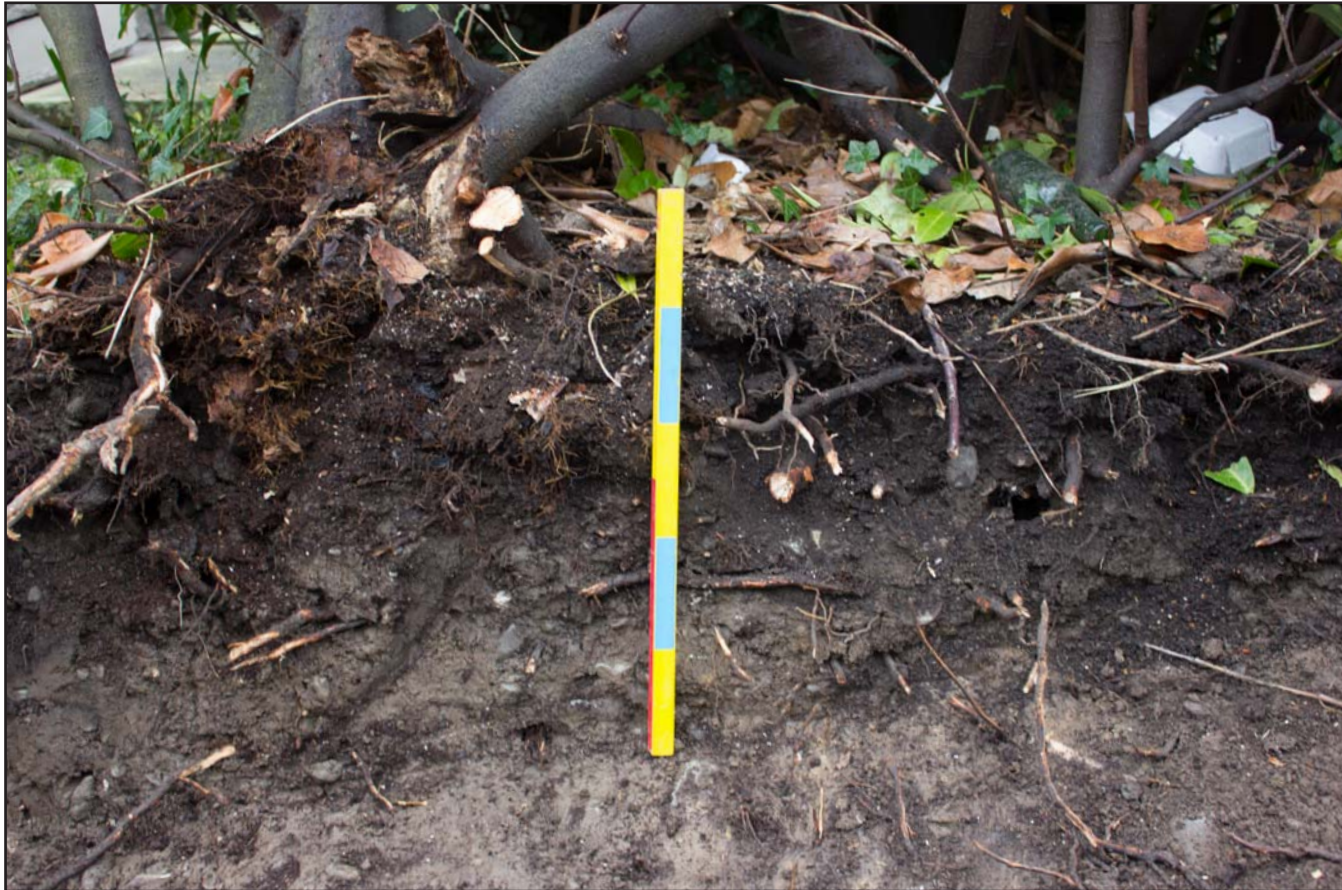
Plate 46: Section shot of the ramp area at St. Asaph Parish Church, St. Asaph, Denbighshire - from the north - scale 0.50m

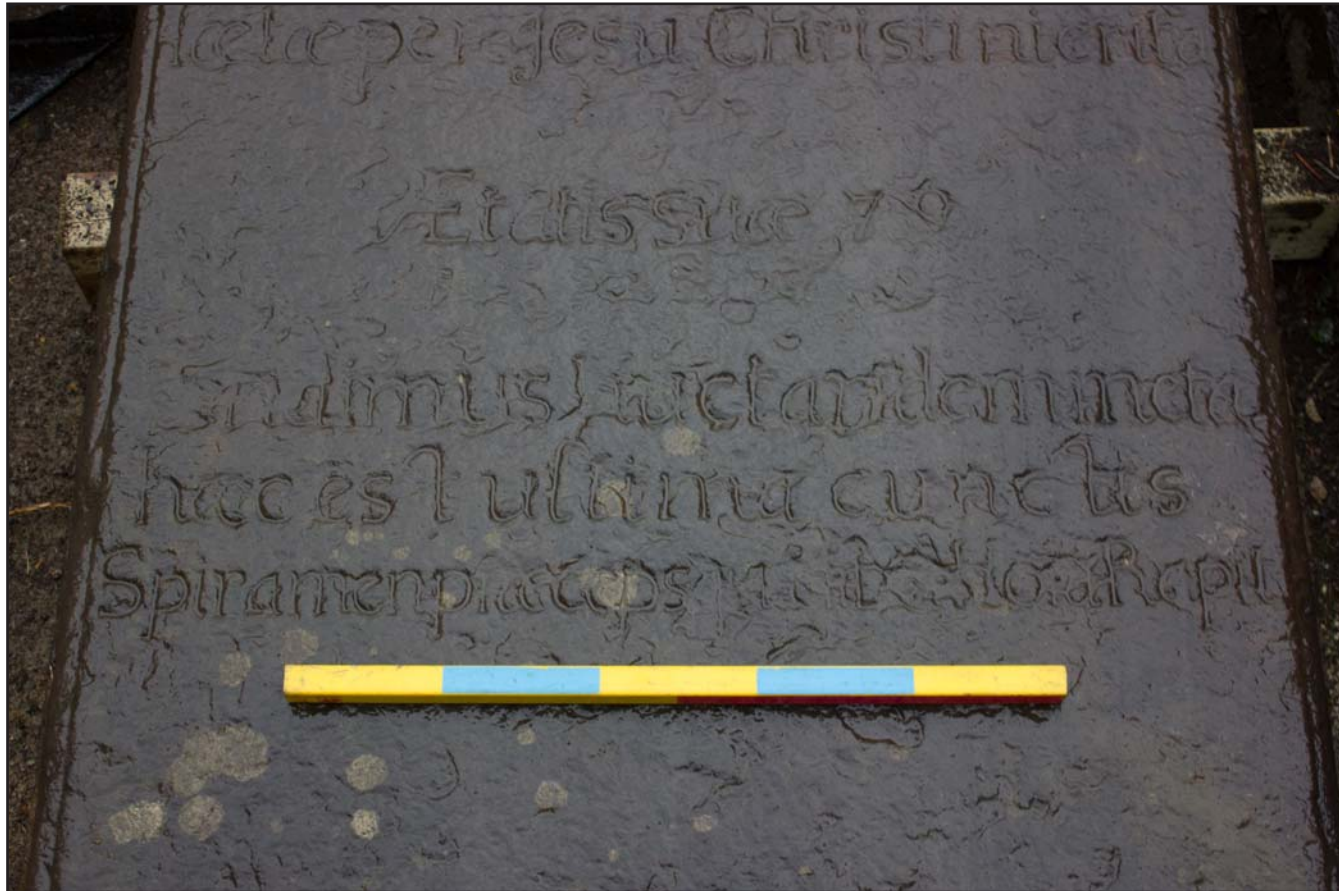
Plate 48: Grave marker (106) inscription Part 2 at St. Asaph Parish Church, St. Asaph, Denbighshire - scale 0.50m

and two large sandstone grave slabs; the eastern grave slab (106) measured 2.22m long by 1.02m wide and was 0.11m deep and was orientated northwest to southeast. Its upward face was found to carry the following Latin inscription:

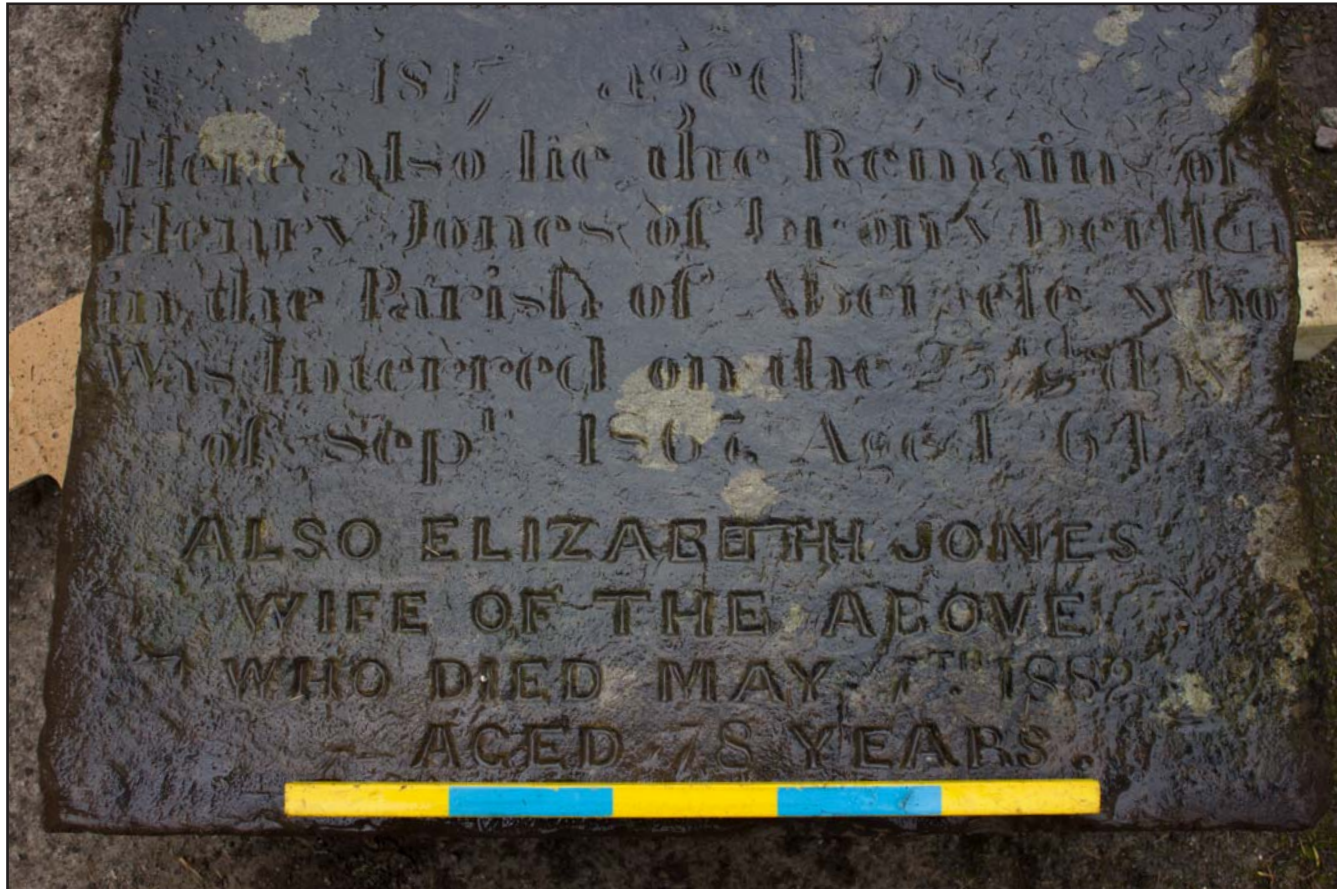
Plate 52: Grave marker (107) inscription Part 4 at St. Asaph Parish Church, St. Asaph, Denbighshire - scale 0.50m

The western grave slab (107) measured 2.20m long by 1.00m wide and was 0.10m deep and was also orientated northwest to southeast. Its upward face was found to carry the following English/Welsh inscription:
