The Strand and Carriers Lane, Cardigan, Wales

Archaeological Watching Brief

on behalf of Welsh Water Capital Delivery Alliance

Draft v.1
27/07/2022

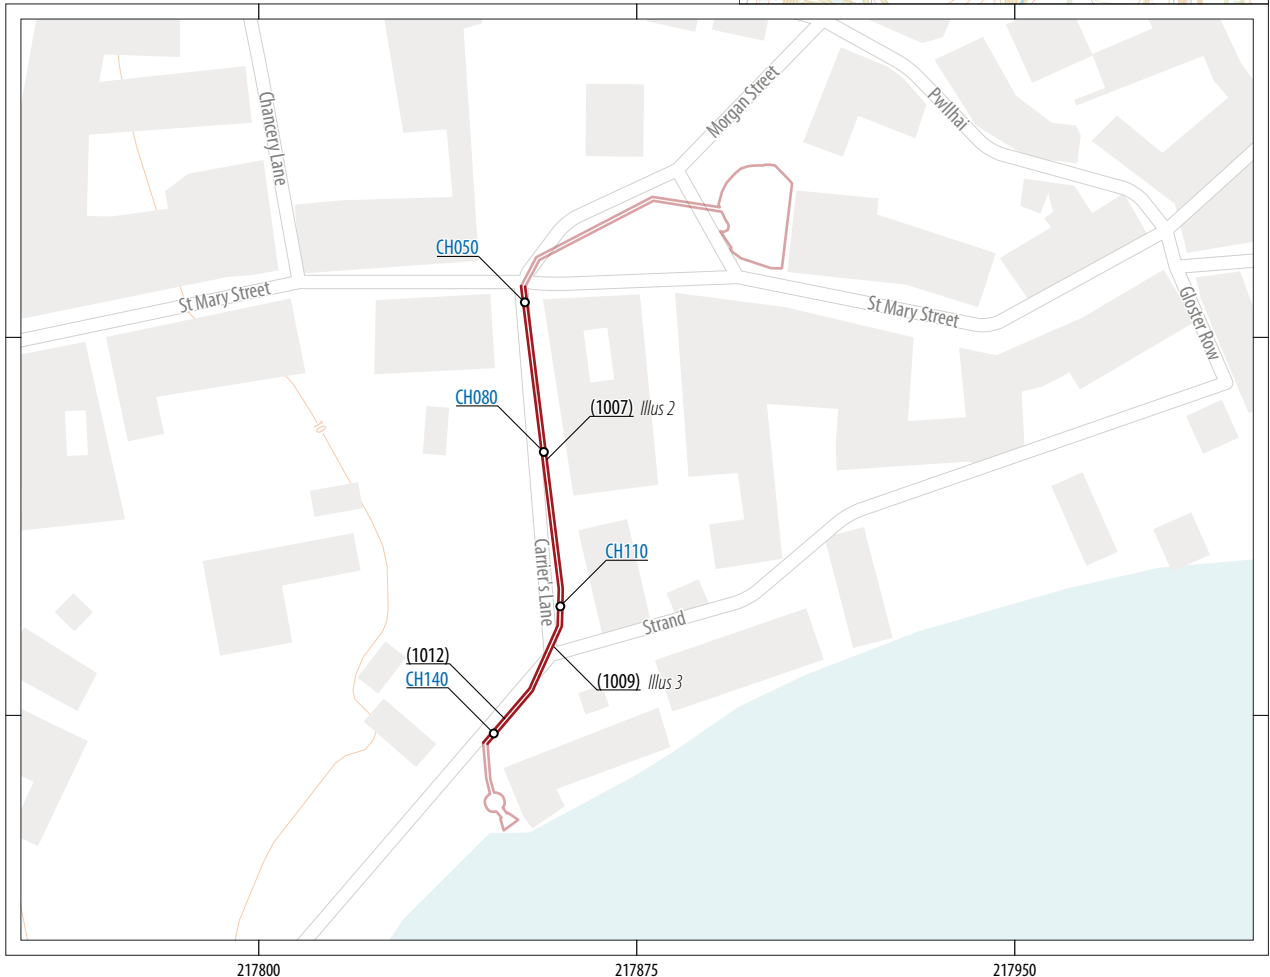
ILLUS 1 Site location

Monitoring of groundworks took place between Chainage 50 in the north and Chainage 140 at the southern end of the scheme (Illus 1). The tarmac road surface (1000) formed the upper deposit (0.2m in depth) for the full length of the trench. This was underlain with its own bedding layer (1001) also 0.2m deep.

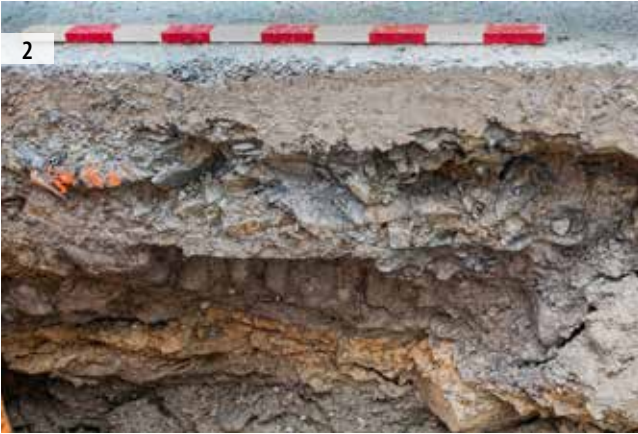
Directly beneath these deposits, at approximately Chainage location 100, was a short length of intact cobbling (1007). This was 7.0m long truncated by a modern service feature. The deposit comprised a single layer of rounded cobbles all measuring approximately 0.12m x 0.07m which lay on their sides within a grey, clayey coarse sand matrix (Illus 2). This deposit was encountered directly underneath the Tarmac and bedding layers and sitting on top of (1006). No finds were recovered from this deposit.

ILLUS 2 Photo showing intact cobbling surface (1007) in west facing section at CH083

One small area of cobbles (1007) was seen directly below the modern tarmac and bedding layer which was only a single course thick and most likely part of a former phase of road construction.
