**CHERISH Report No.**  
CH-RCAHMMW 10

# **Puffin Island / Ynys Seiriol: Archaeological investigation for the CHERISH Project, 2017-18**

## **Landowner's Site Assessment Survey legacy, climate change priorities & recommendations**

## Puffin Island / Ynys Seiriol

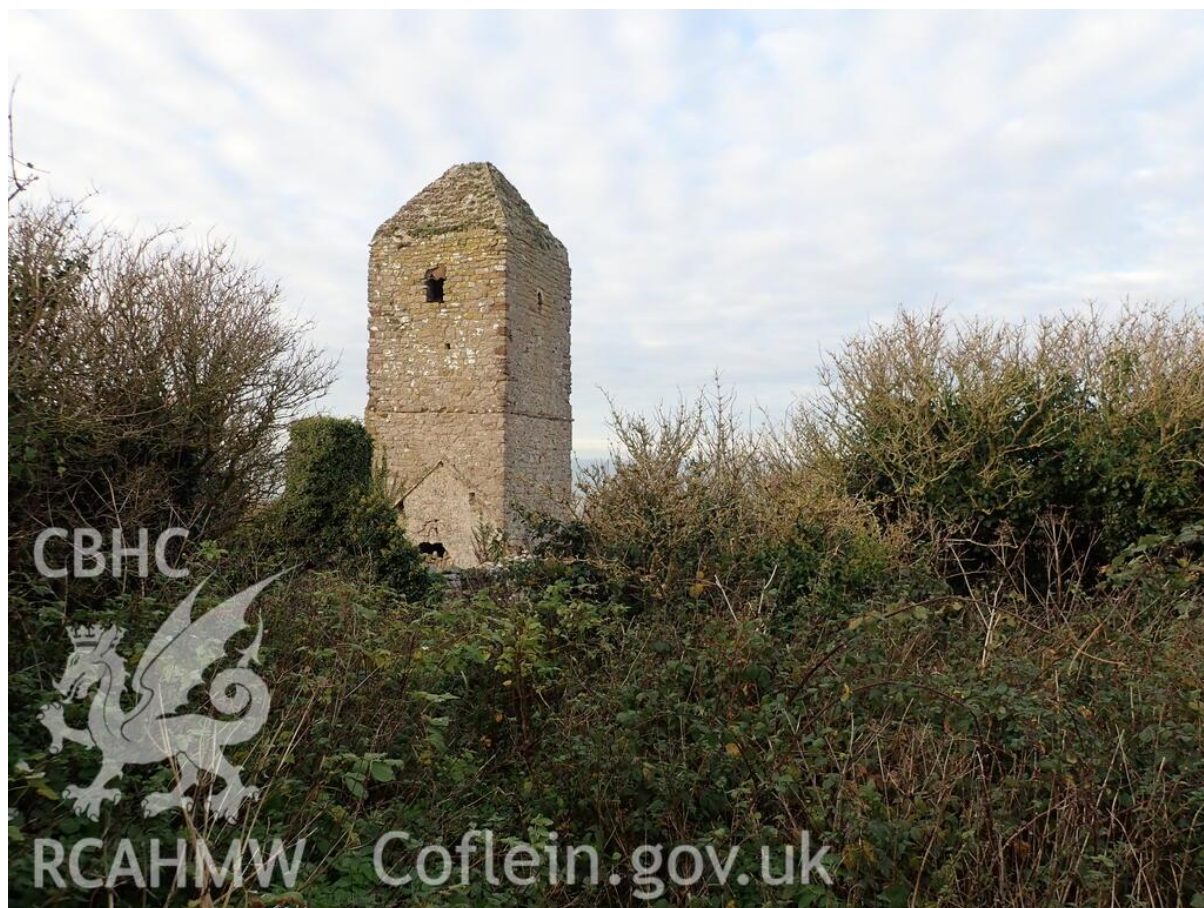
Figure 17 [The church tower in November 2018](#) rising above the local vegetation. (© CHERISH Project. Archive no. 6522905)

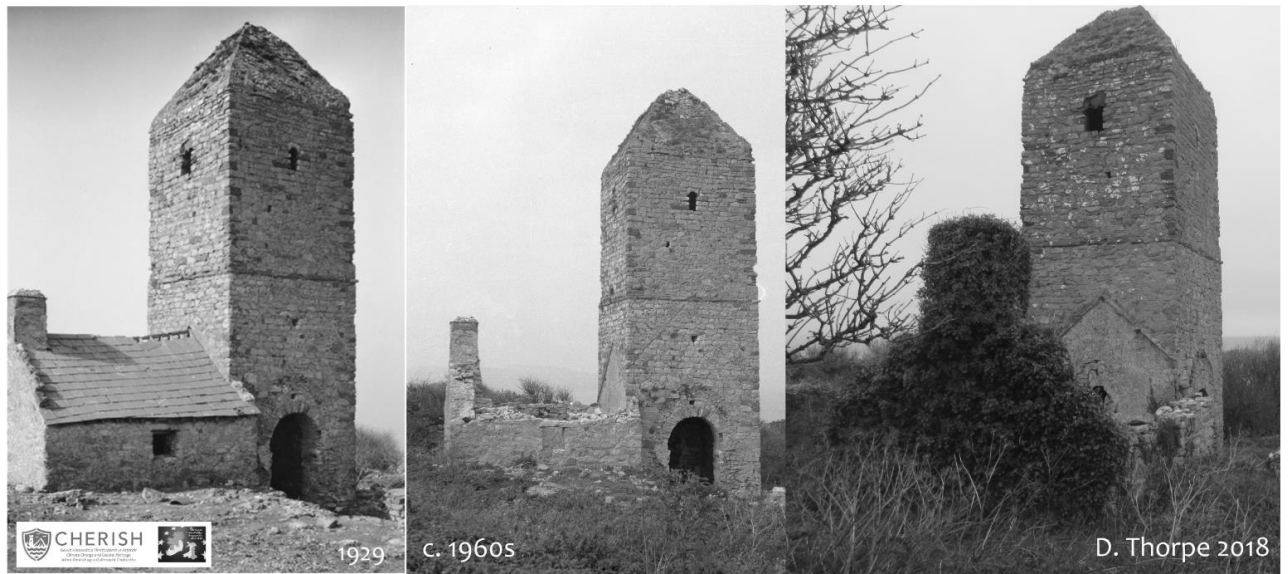
Figure 20 The steady deterioration of the cottage standing on the site of the south chancel can be seen in these three contrasting views of the church from the east (L, 1929; C, 1960s) and southeast (R, 2018). (Crown Copyright RCAHMW (views 1 & 2); View 3 supplied by Dave Thorpe, NRW, copyright reserved).

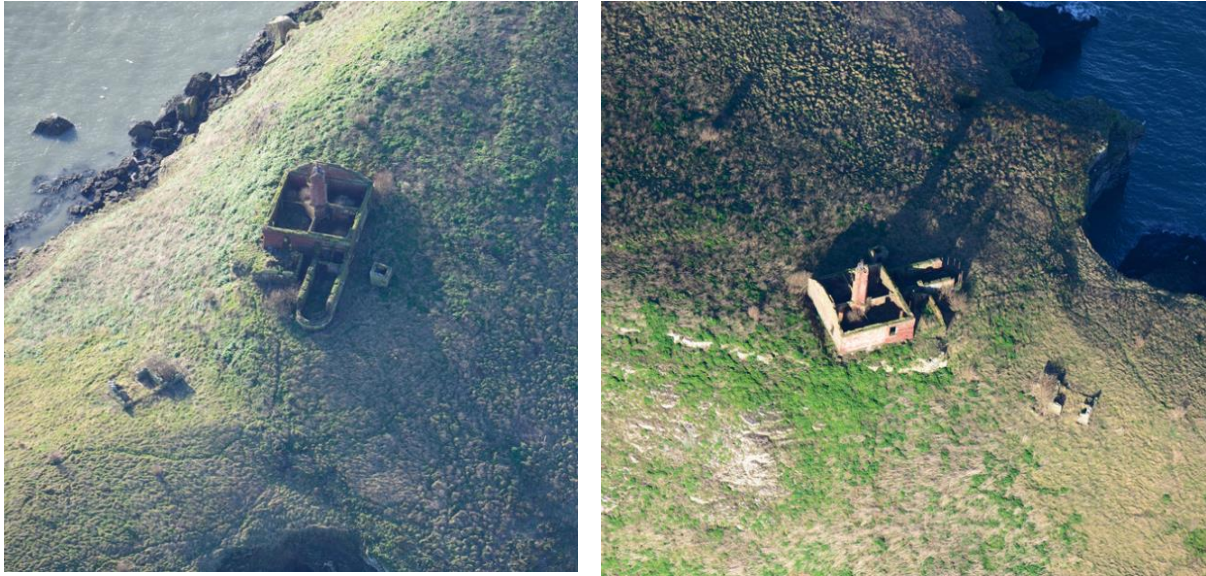
Figure 21 Aerial photographs of the ruins of the Telegraph Station above East Spit, 11<sup>th</sup> Feb 2016 (Crown Copyright RCAHMW, AP\_2016\_0202 (L) and 0203 (R)).

The ruins were visited by Royal Commission survey staff for the EU-funded CHERISH Project on 21 June 2018 accompanied by Jeff Spencer from Cadw. The 1841 remains comprise a square, roofless brick building with four rooms arranged around a central chimney, and fireplaces serving each room. The building is entered by doors on the east and north sides, with steps descending into the ruin on the north side. Extending from the north-west corner of the building is a long observation/signalling room culminating in a panoramic curving window now represented by the rusting remains of vertical frames.

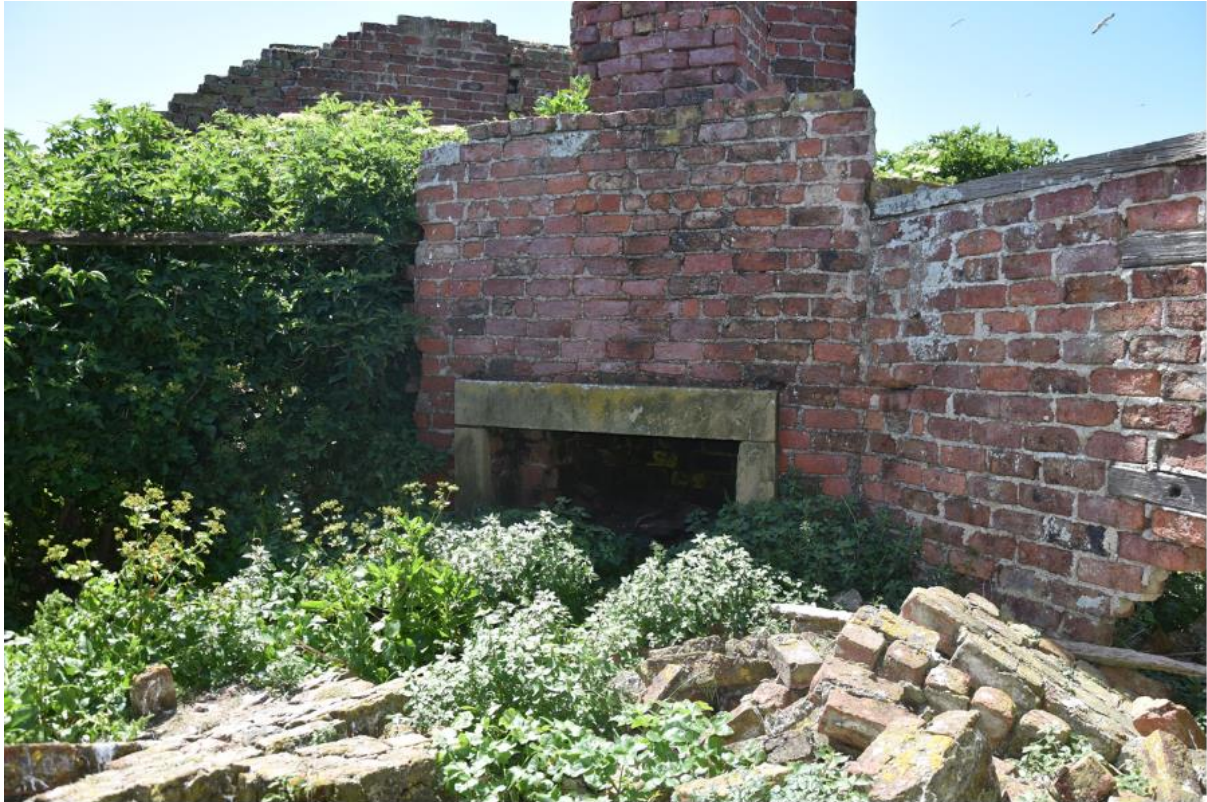
Figure 22 The Telegraph Station: interior view of ruin, June 2018, showing vegetation and elder/buddleia taking hold, and collapsed brickwork (© CHERISH Project: CH2019\_098\_002)

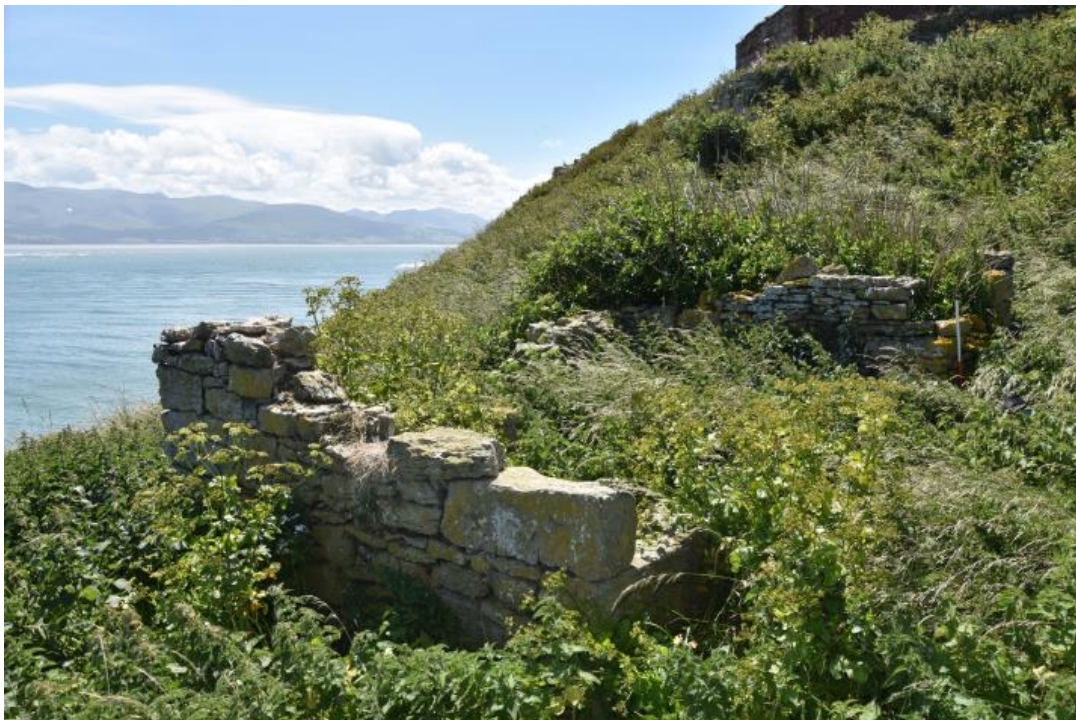
A low stone structure (Figure 24) of rougher stone construction is sited some 10m to the north-east of the telegraph building (NPRN 000, NEW TO THE RECORD). It may be an ancillary structure or store, or the remains of an earlier farm building. See Large (1998).

Figure 25 Puffin Island Telegraph Station, 21 June 2018: low stone structure 10m north-east of the station building, of uncertain function. It may be an ancillary structure or earlier farm building. Scale 1m (CHERISH Project CH2019\_097\_005).

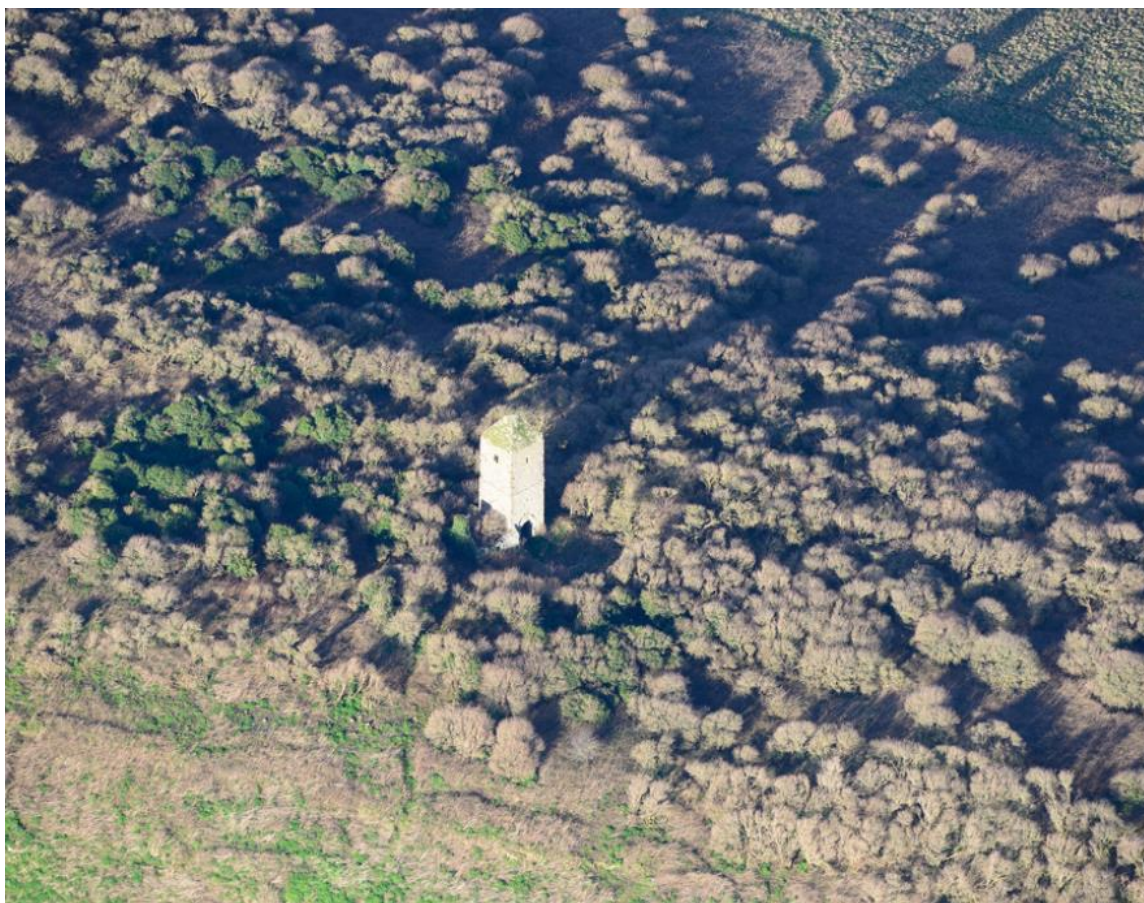
Figure 27 The heavily vegetated surroundings of the church, seen in winter conditions on 11<sup>th</sup> February 2016 (© Crown Copyright RCAHMW, AP\_2016\_0205).

ISSUE	RECOMMENDATIONS:
<p><b>Thick, impenetrable vegetation and woodland on and around the scheduled monument</b></p>	<p><b>All subject to permission of the landowner, and to consent from government agencies.</b></p> <p>Works would need to comply with <a href="#">SSSI procedures</a> in relation to the notifiable operations and observe timing or access protocol to minimise disturbance to breeding seabirds</p> <p>Consider clearance of scrub woodland and vegetation on and around scheduled monument.</p> <p>Consider limited weed killing or vegetation clearance around church.</p> <p>Consider cutting and removing ivy in a two-phase approach – first, by cutting and herbicide treatment of the cut stumps with an appropriate, approved herbicide; then, by return visit to remove the withered vegetation (at least two months after initial treatment). An alternative that may be considered desirable is to treat the ivy with overall foliar application of an appropriate, approved herbicide to which has been added a compatible surfactant or wetting agent to enable the herbicide to penetrate the ‘waxy’ coating of the ivy leaves. This would substitute for phase 1 above. Neither approach can be expected to achieve full control of the ivy growth.</p> <p>Rabbits were recently re-introduced and their presence is being encouraged in the hopes it may reduce the vegetation on the island.</p> <p>Continue regular (2-4 yearly) monitoring of church and scheduled monastic settlement with UAV/drone.</p>

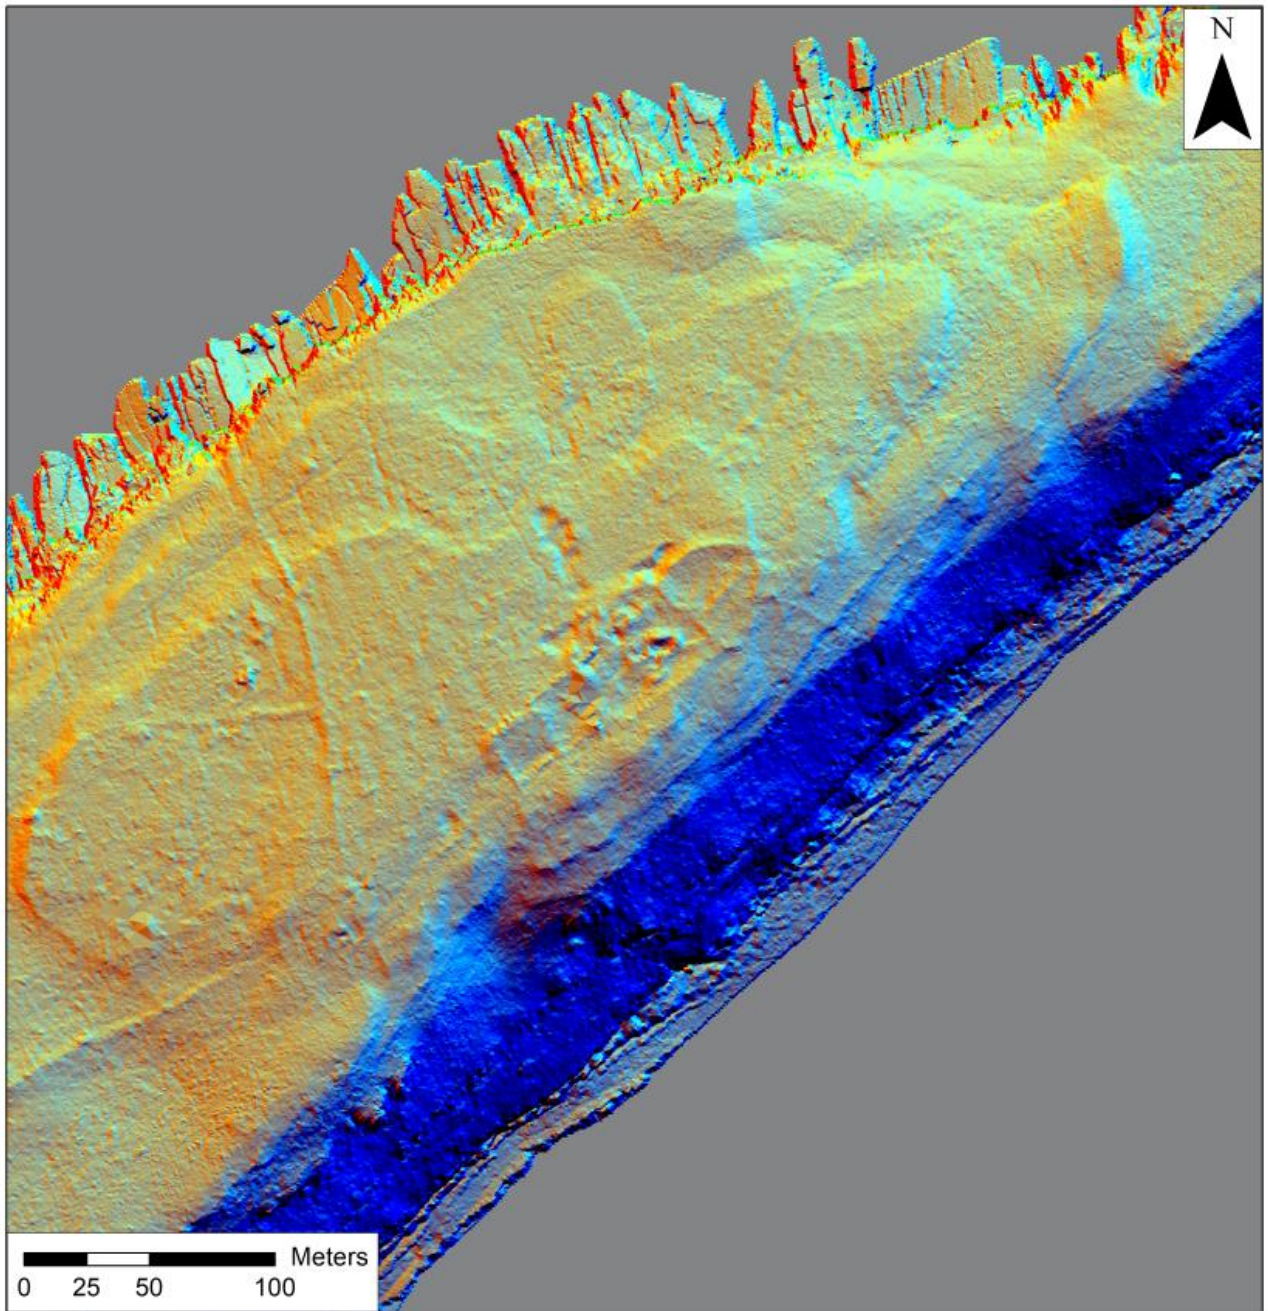
Figure 34 Ynys Seiriol or Puffin Island. 2017 LiDAR DTM view of the central part of the island rendered with a 16-point hillshade, revealing a range of new features and providing a more accurate spatial plan of the monastic enclosures surveyed in 1937 (© CHERISH Project: flown by Bluesky International, 24th February 2017).

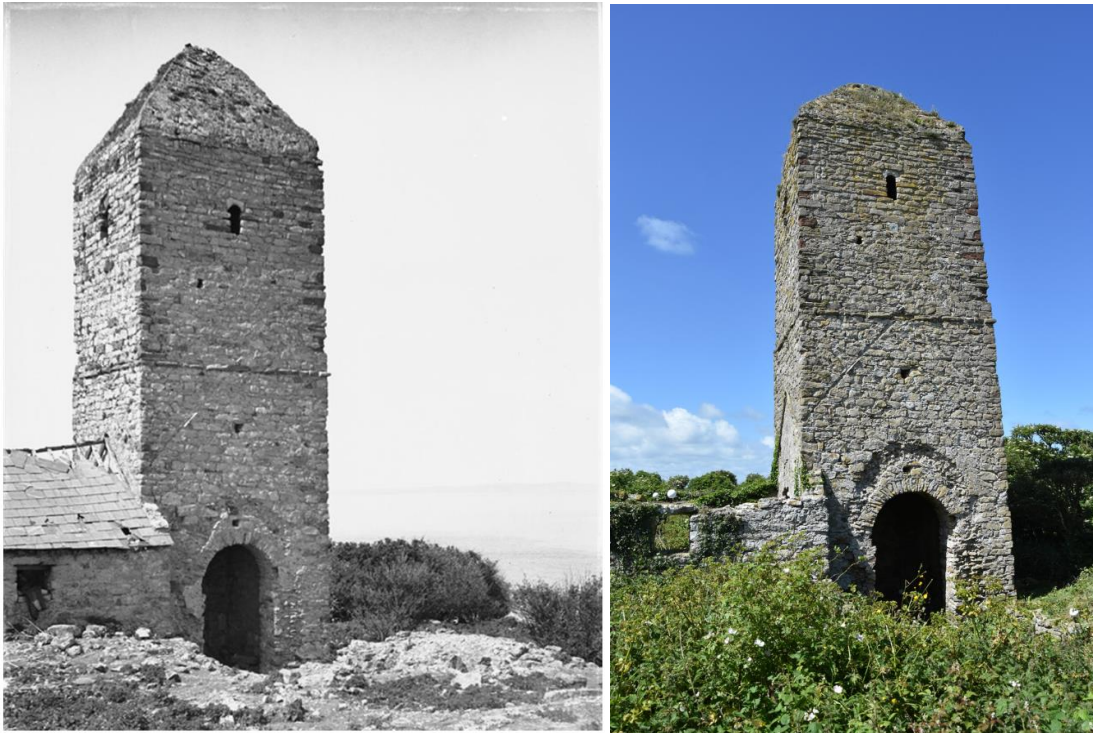
Figure 39 St Seiriol's church from the east. On 17 March 1929 (© Crown Copyright RCAHMW, DL2011\_3905) and on 21 June 2018 (© CHERISH Project, CH2019\_088\_009).

**Condition of the church in 2018:** The church tower and associated buildings stand in a clearing in dense alder woodland. The approaches are overgrown, largely obscuring the wider remains of the monastic enclosure and walls planned by Royal Commission for the 1937 Anglesey Inventory when the island vegetation was open, grazed pasture. The church stands in a clearing due to a previous campaign of clearance, but the stumps had still sprouted waist-high vegetation which was cut and cleared (with permission) on arrival. The walls of the church and cottage on the west and south sides are covered with ivy.

Ruined cottage (south side of tower, site of transept): East and West cottage walls standing 1.8m-1.9m high but heavily grown with ivy with much loose stone at upper levels. East wall has simple central window. The south wall of the cottage preserves a fireplace and chimney breast. The fireplace opening measures 0.83m x 0.90m with a large lintel stone of contrasting red sandstone. Floor littered with tumbled masonry and roof slates. Room adjoining on west side of cottage, accessed through door in west wall. Walls heavily ivy grown, standing internally c. 2m high. Floors infilled with rubble throughout.

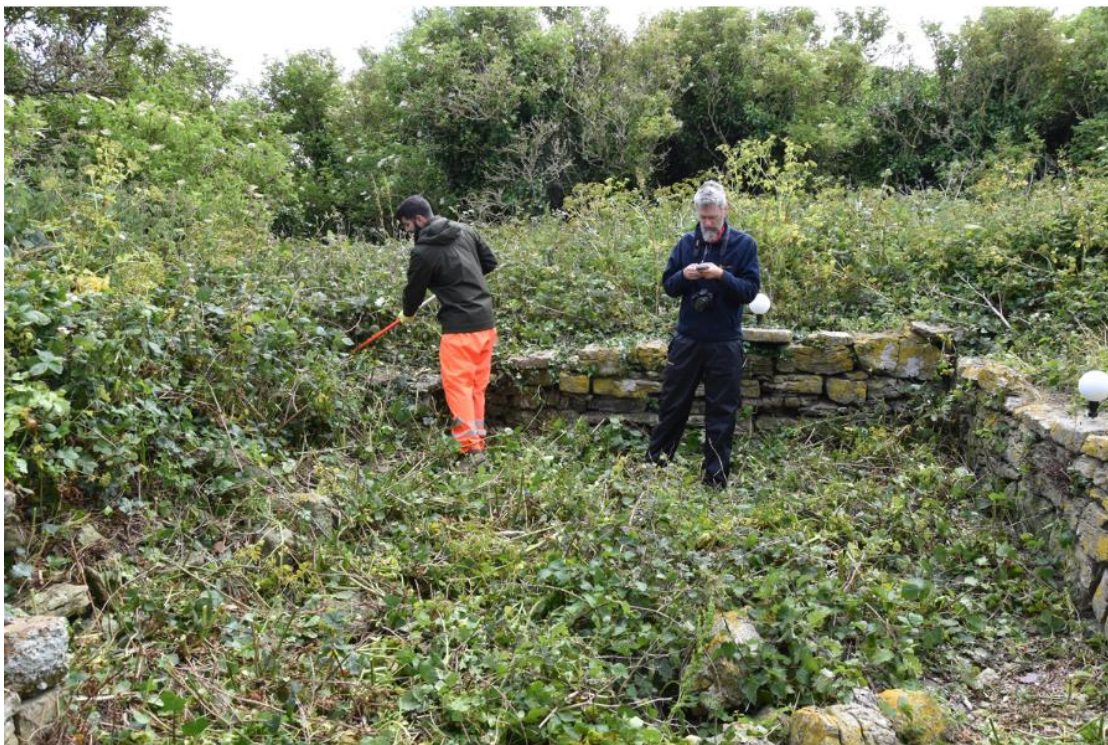
Figure 40 Careful clearance of summer vegetation from the eastern chancel prior to laser scanning, with the permission of NRW and under supervision from the Cadw FMW (© CHERISH Project, CH2019\_090\_005).

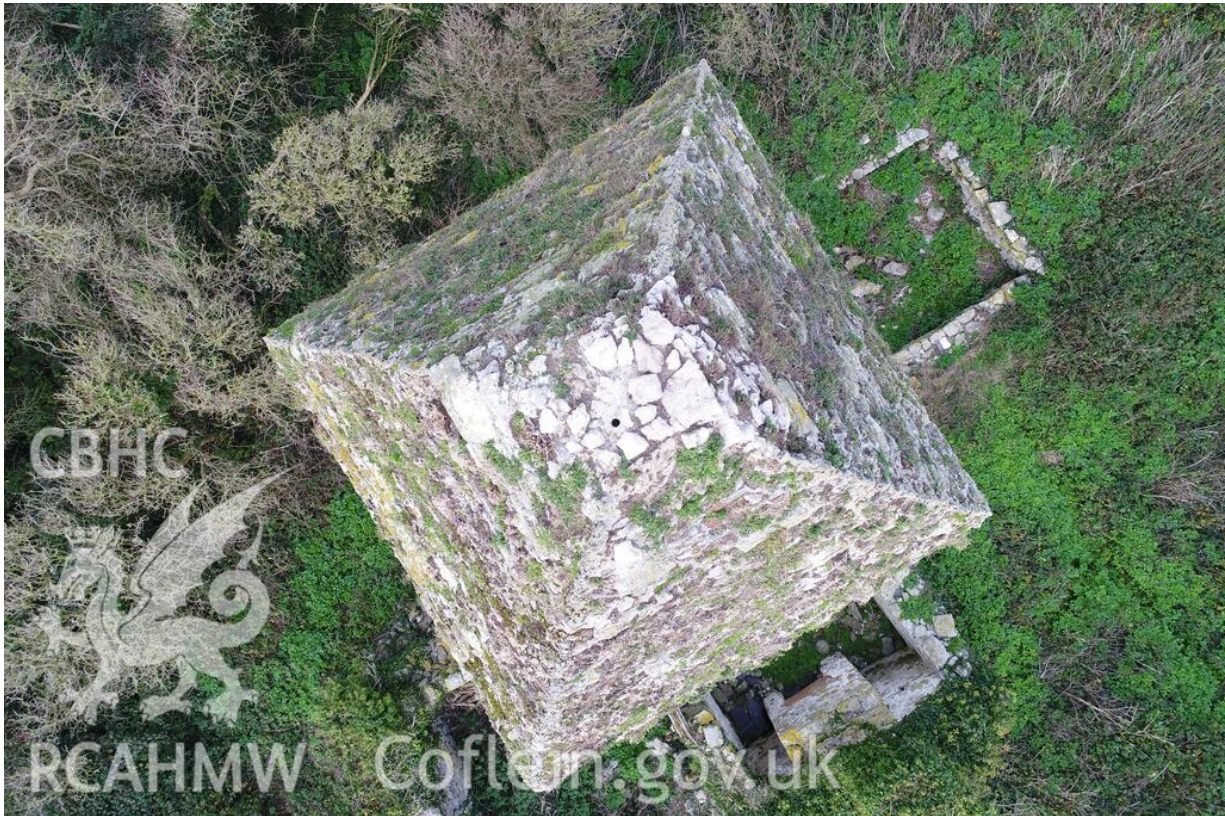
Figure 41 [Vertical UAV view](#) of the tower's roof showing vegetation and weeds taking hold on the pyramidal sides and loose, mortarless stones becoming fragmented at the apex. A small drain hole can be seen in the apex (© CHERISH Project, 26 November 2018. Puffin\_Island\_UAV\_26112018\_0120.TIF).

**Condition of the tower roof, from the 2018 UAV survey (Figures 40 & 41):** while the tower structure is in good condition, the UAV survey from November 2018 showed that the very top of the tower is beginning to fragment with loose, mortarless stones visible at its apex; the corbelled sides of the pyramidal roof have vegetation taking hold in the mortared stone, which it would be good to kill or remove in due course.

<p><b>Deteriorating condition of masonry within scheduled area</b></p>	<p>Assess future need for repointing of loose masonry – currently (2018) loose stones on the tower apex, an area of tumble in the chancel and stonework around the cottage window in the wall of the nave are in need of consolidation.</p> <p>Consider weed prevention on church roof.</p> <p>Continue regular monitoring of church tower and roof with UAV.</p>

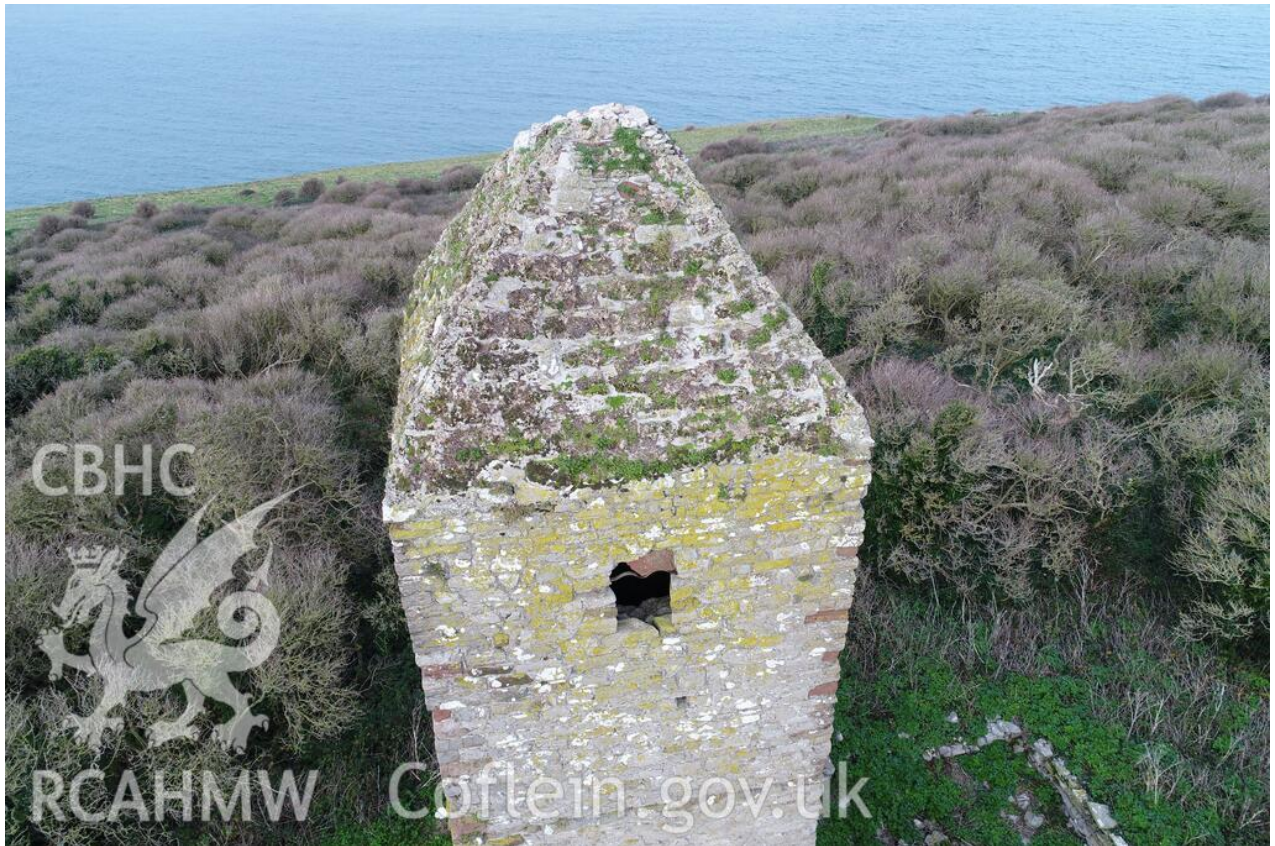
Figure 42 [Oblique UAV view](#) of the tower's roof showing vegetation and weeds taking hold on the pyramidal sides and loose, mortarless stones becoming fragmented at the apex. A small drain hole can be seen in the apex (© CHERISH Project, 26 November 2018. Puffin\_Island\_UAV\_26112018\_0183).

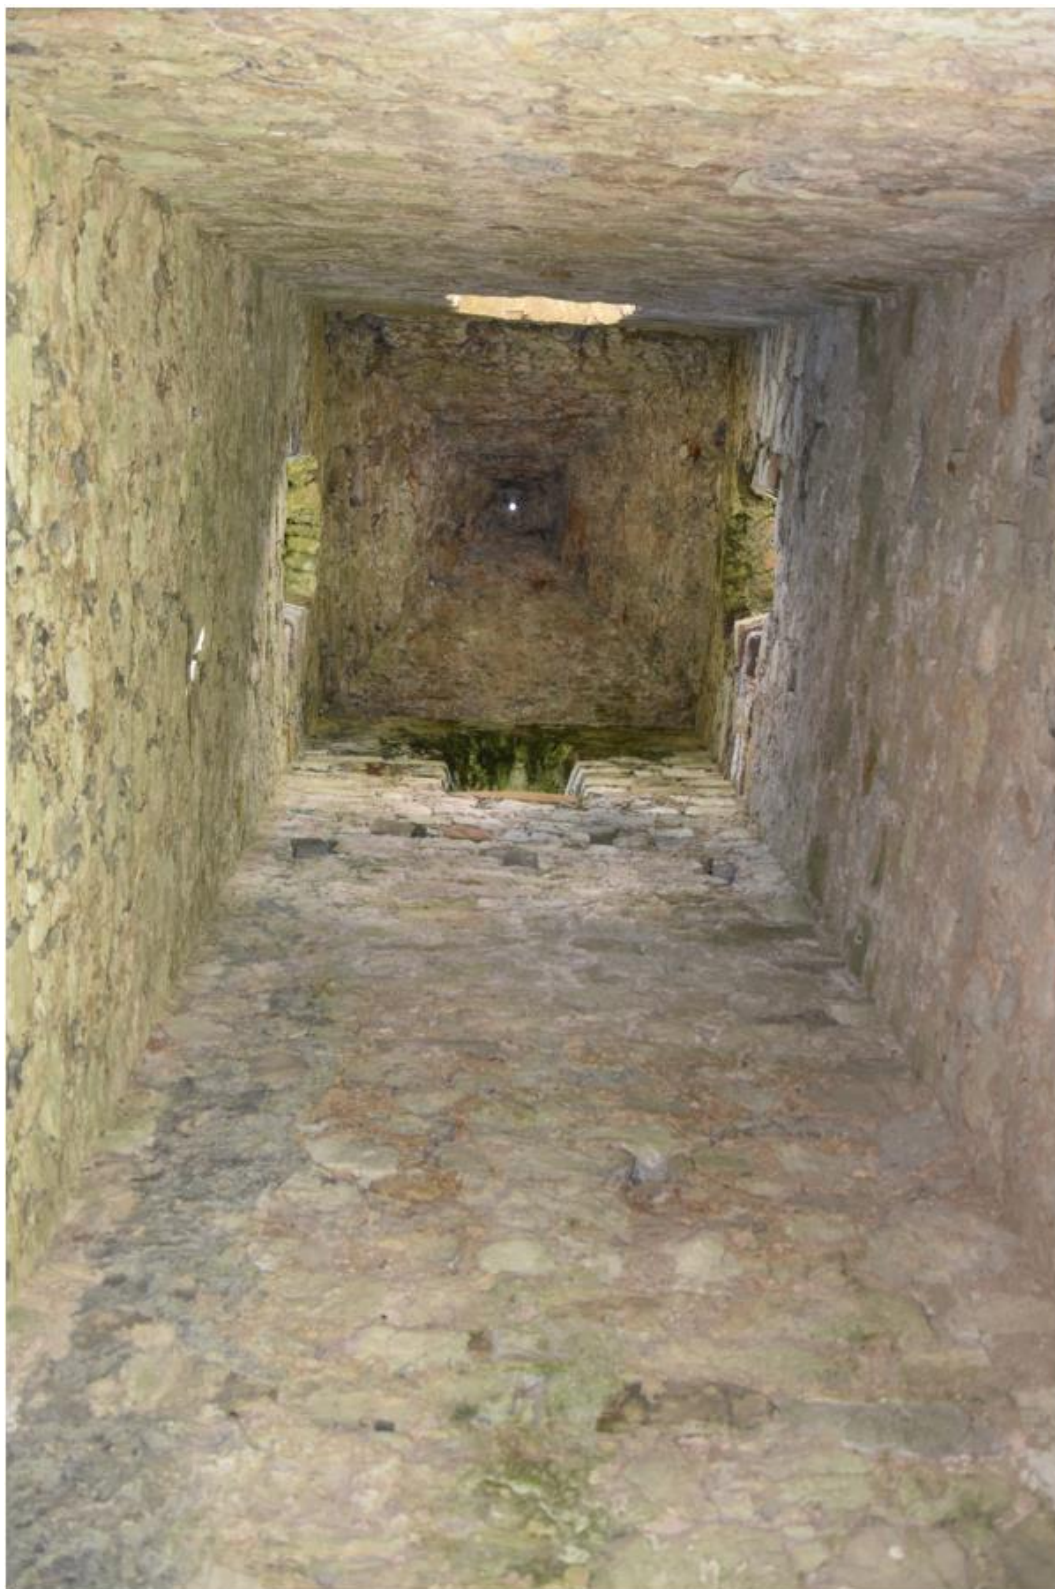
Figure 44 View inside the twelfth century tower; note the small drain hole at the apex of the roof (© CHERISH Project, 21 June 2018 - CH2019\_093\_005).

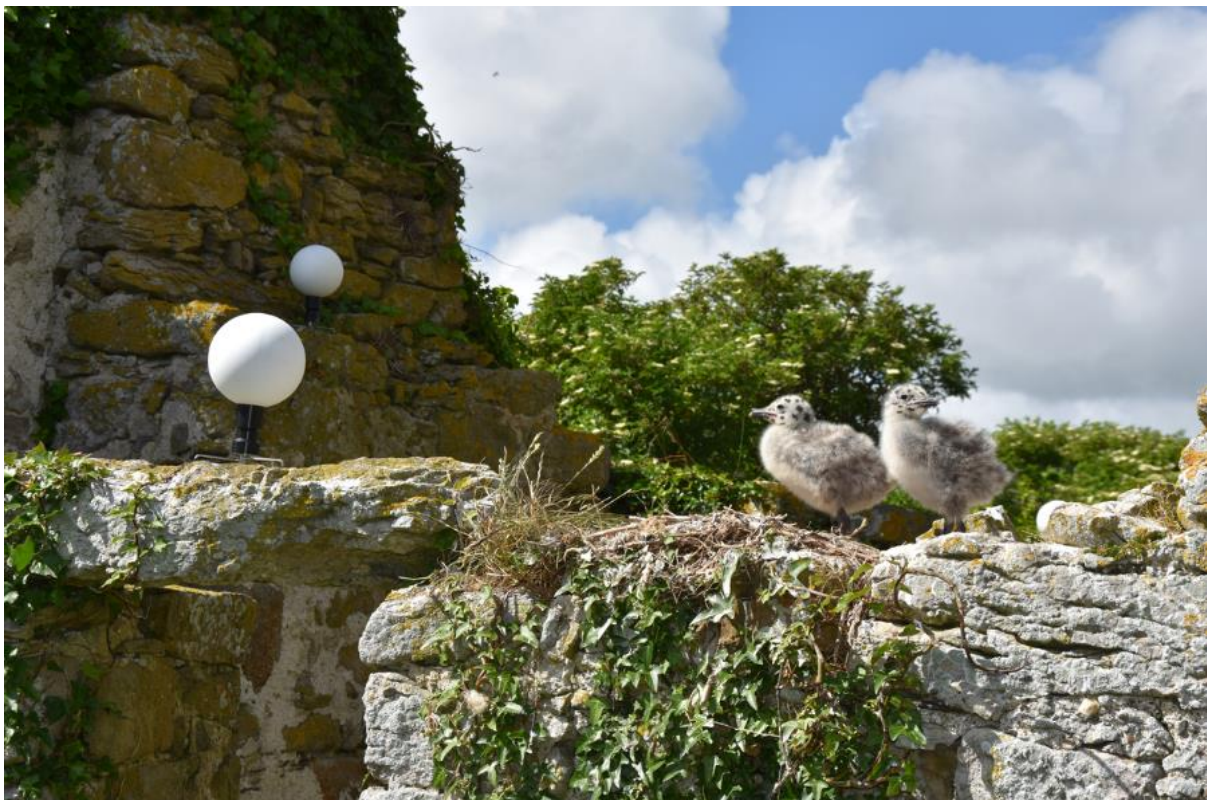
Figure 45 The constraints of working on Puffin Island; a pair of young gull chicks on the cottage wall seem oblivious to the universal reference spheres mounted for laser scanning (© CHERISH Project, CH2019\_092\_009).

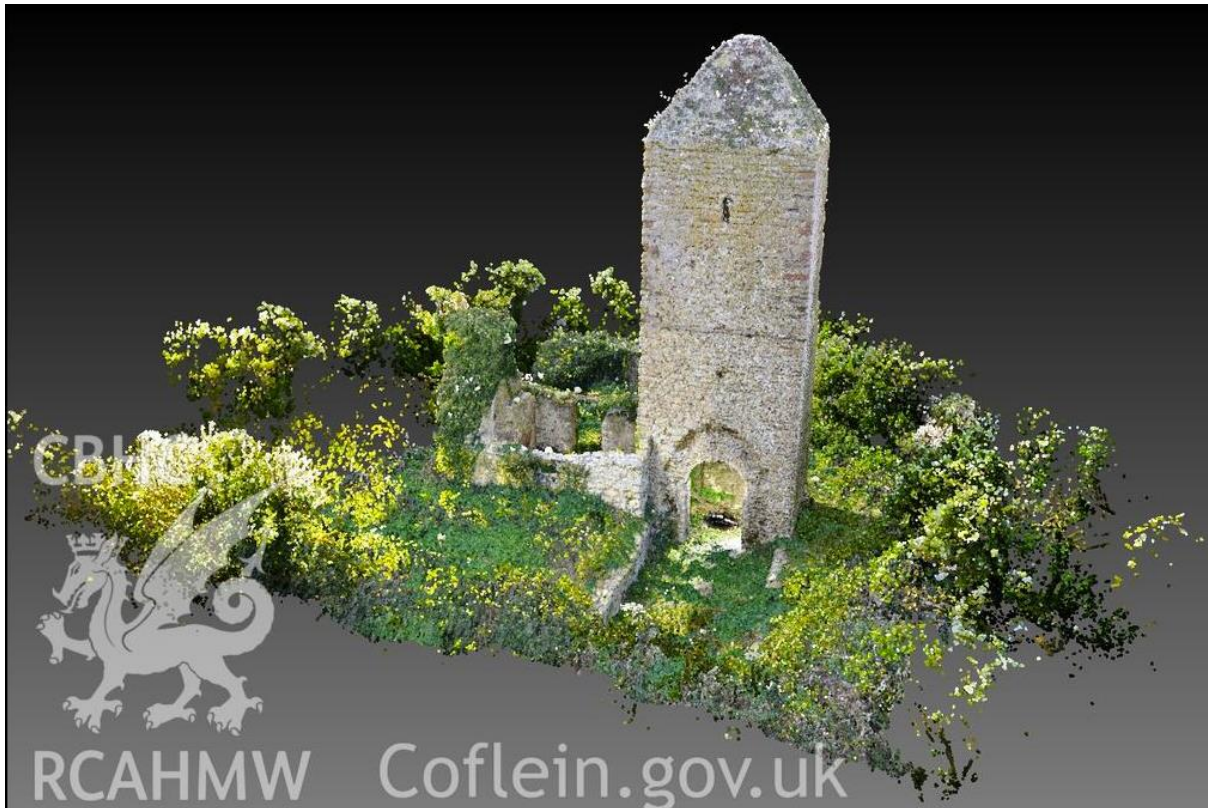
Figure 46 Laser scan of the church tower and surrounding buildings, with summer vegetation. 3D view of the point cloud from the south-west with drone data combined to show tower top ([CHERISH Project: visualisation by Jayne Kamintzis. 2023-03-08\\_5874](#)).

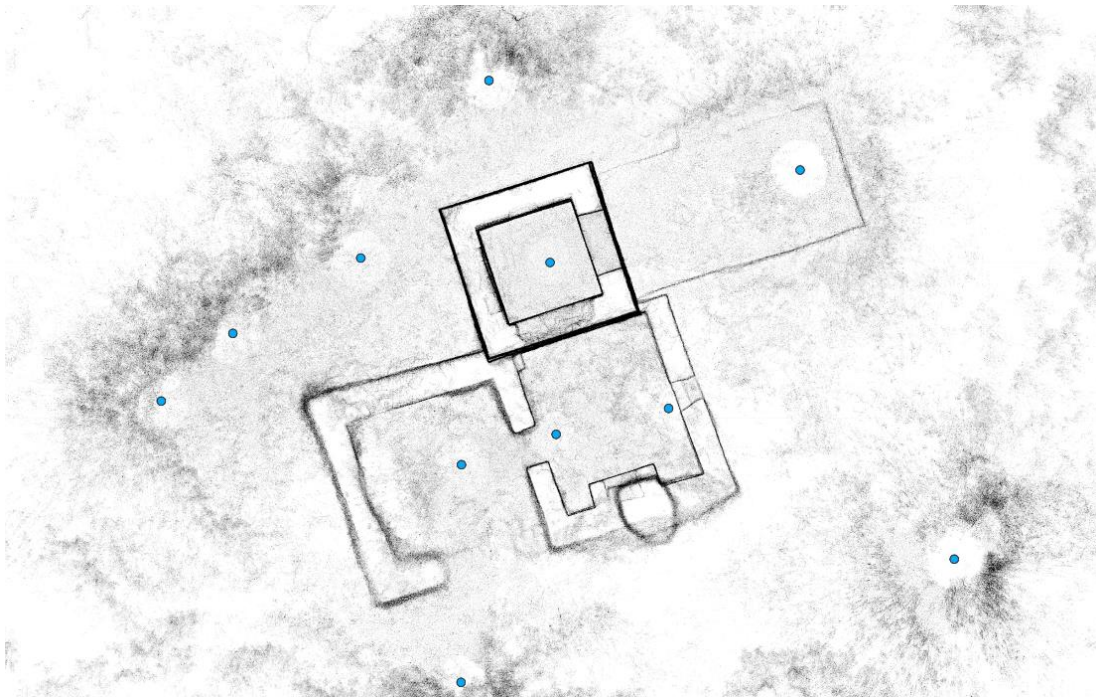
Figure 47 Plan view of the medieval church showing the positions of the 10 scan stations in a clearing around the ruin (© CHERISH Project).

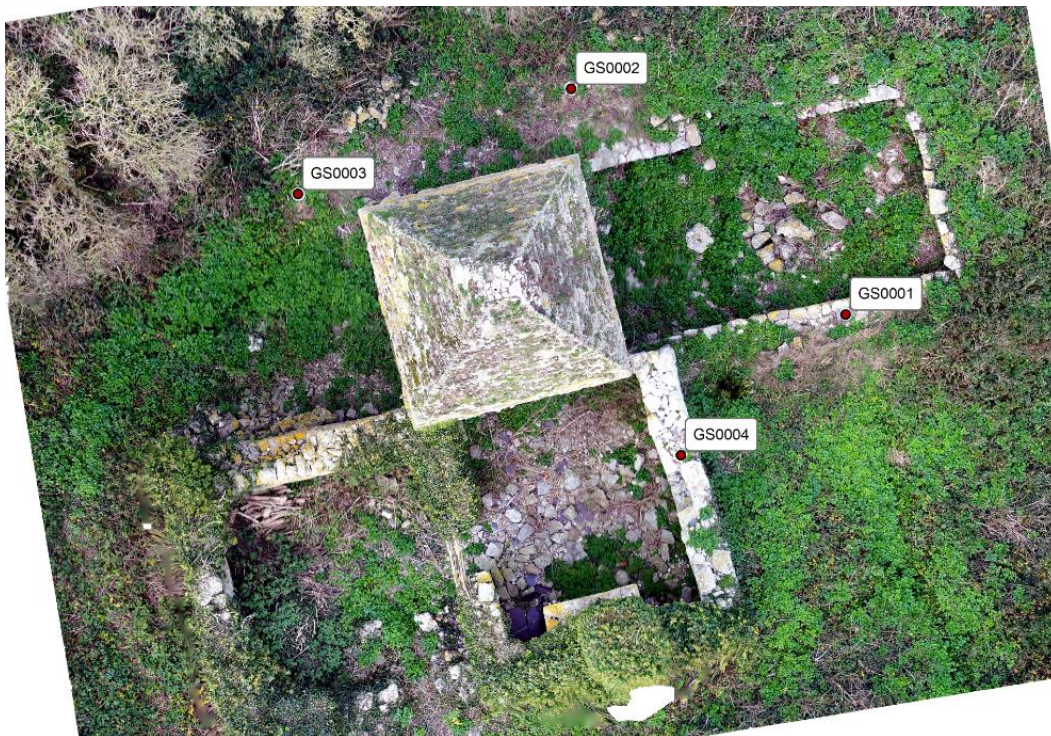
Figure 48 Location of Ground Control Points used during the UAV survey. Points were referenced using ground targets surveyed in using a Leica GS16 in RTK mode (© CHERISH Project; see Hunt 2020).

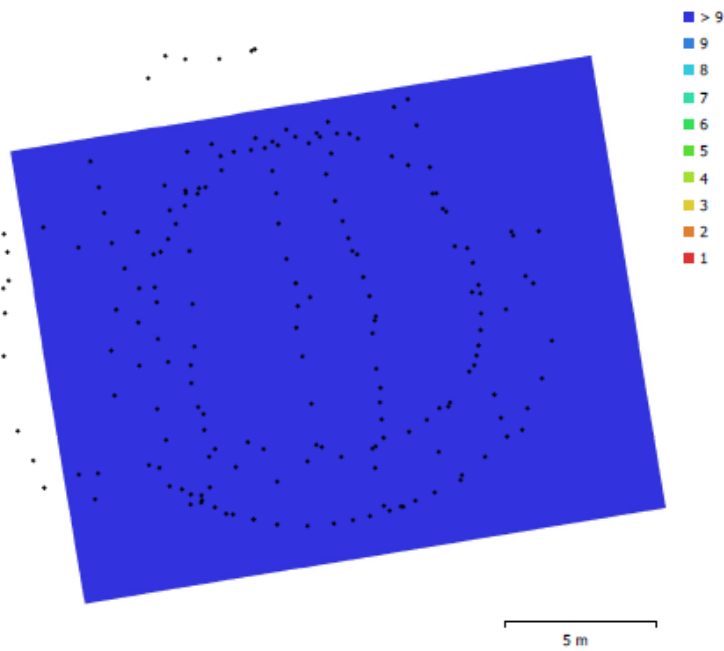
Figure 49 Puffin Island UAV survey: Camera locations for the 186 images flown, and amount of image overlap generated using Agisoft Metashape (CHERISH Project)

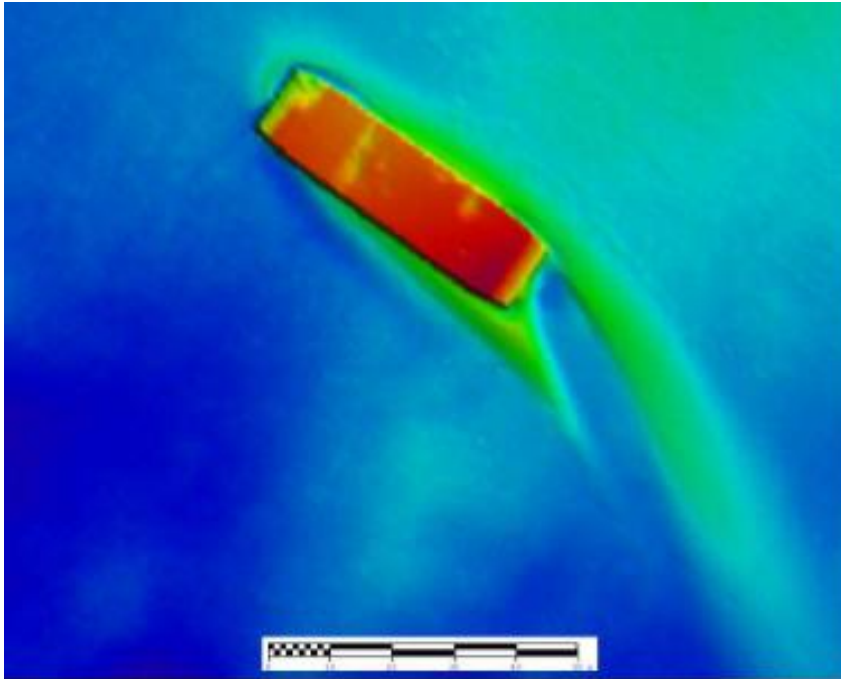
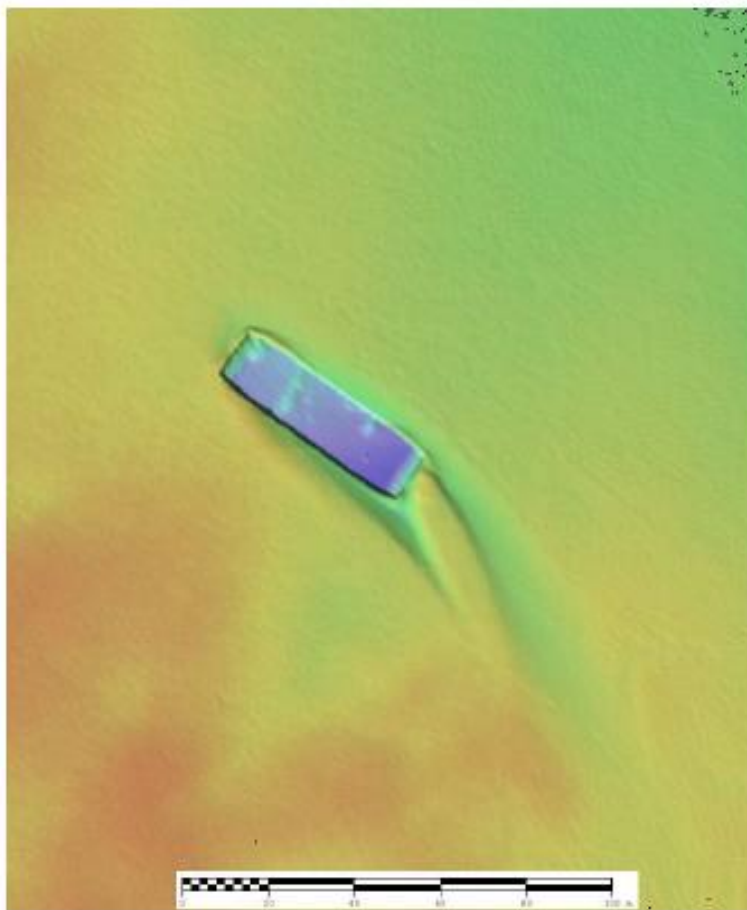
Figure 55 Wreck of the Seahow, lying to the east of Puffin Island, surveyed on 20/08/18. The main structure of the wreck is clearly visible. The wreck is orientated 135/315 with no distinguishing features indicating the bow from the stern. The wreck lies on a sandy bottom and there are some sand waves building from the south-eastern end of the wreck. (© Geological Survey of Ireland for the CHERISH Project; Detailed in Annex 2 of Craven & Barry 2018).
