CPAT Report No. 1837

Alltami Road, Buckley

Archaeological Investigation

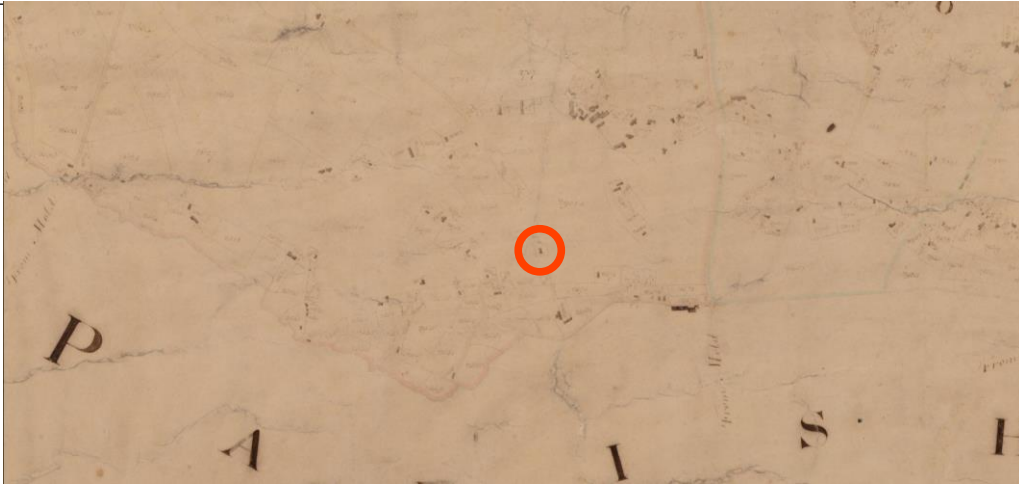
Figure 3 Tithe map (produced 1841) showing "house and garden" at 2585 (red circle), at the approximate location of the modern development plot.

- 2.6. Specific to the site, a structure might have been present in the development plot since the production of the 1841 tithe map (figure 3). The accompanying apportionment for the 1841 tithe map describes the structure present on the plot as a "house and garden". However, the approximate placement of the structure, when compared with the surrounding boundaries and opposite parcels of land, may be to the west of the current plot. The later Ordnance Survey (OS) map of 1871 shows a structure present within the current development plot, but does not identify a building to the immediate west, supporting the possibility that the plot at 2585 on the tithe map could be the same structure identified on the 1871 OS map. The structure identified by the circle in figure 4 agrees with the location of the building that was identified during the watching brief.

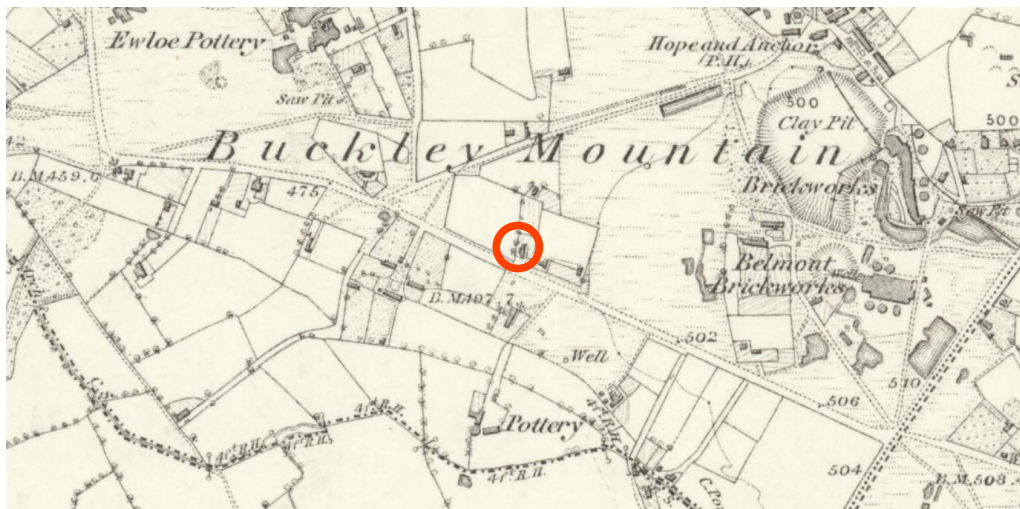
Figure 4 1871 OS map showing the probable building (red circle) identified within the development plot.

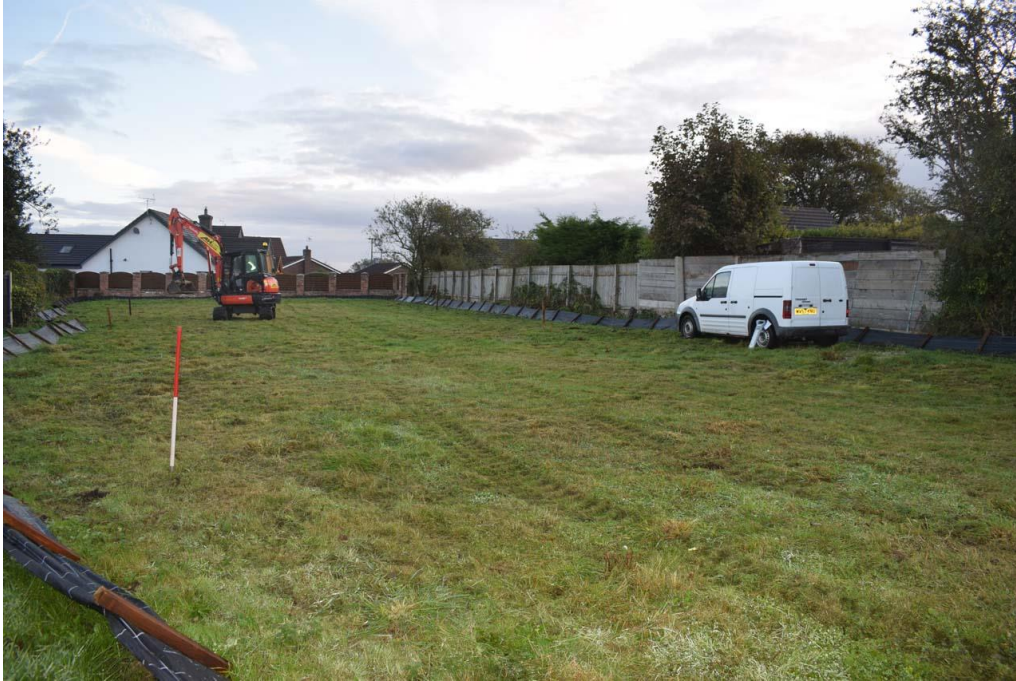
Figure 5 Site of development plot before stripping. Viewed from south. CPAT Photo 4957-0001

- 3.1. The evaluation was conducted on the 25th October 2021 in accordance with the Chartered Institute for Archaeologists' (CIfA) (2014) *Standard and Guidance for an Archaeological Evaluation*. The excavation was mainly undertaken by a mechanical excavator, with additional appropriate hand digging for closer archaeological recording. The development plot in a pre-excavation state can be seen in Figure 5.

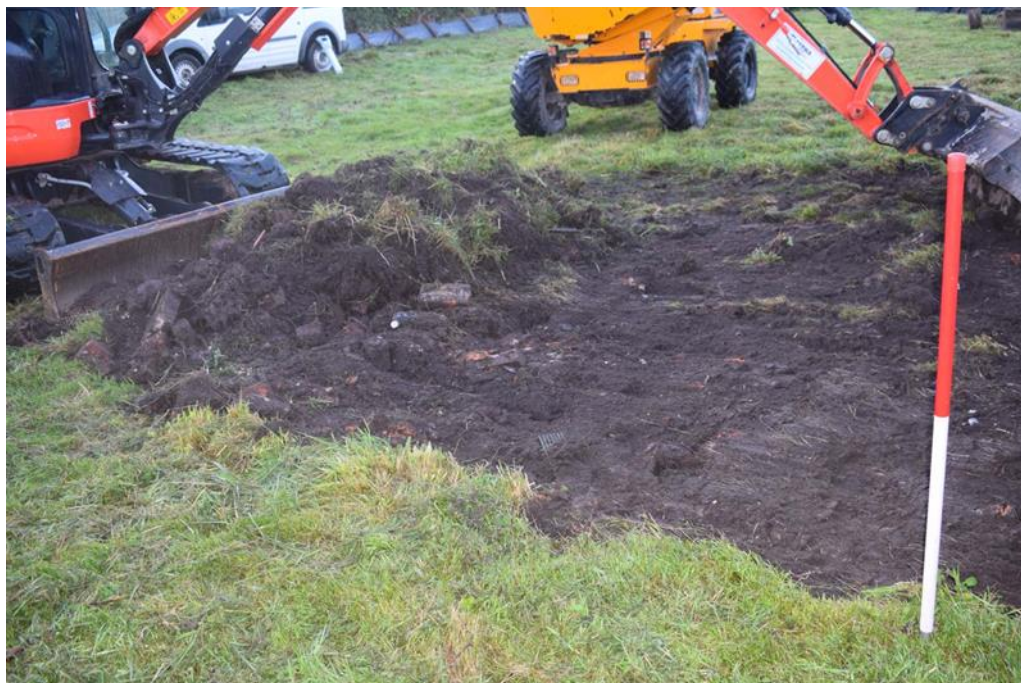
- 3.2. The mechanical stripping of the topsoil identified brickwork and modern waste material. The south-eastern part of the development plot had been used as a work yard into the 21st Century (usage stopped circa 10-20 years before this excavation). The topsoil reached a maximum depth of 0.3m and consisted of a dark greyish brown loamy silt, with minor gravel inclusions less than 0.1m across (see figure 6).

Figure 6 Topsoil stripping, with brick material and waste. Viewed from north west. CPAT Photo 4957-0005

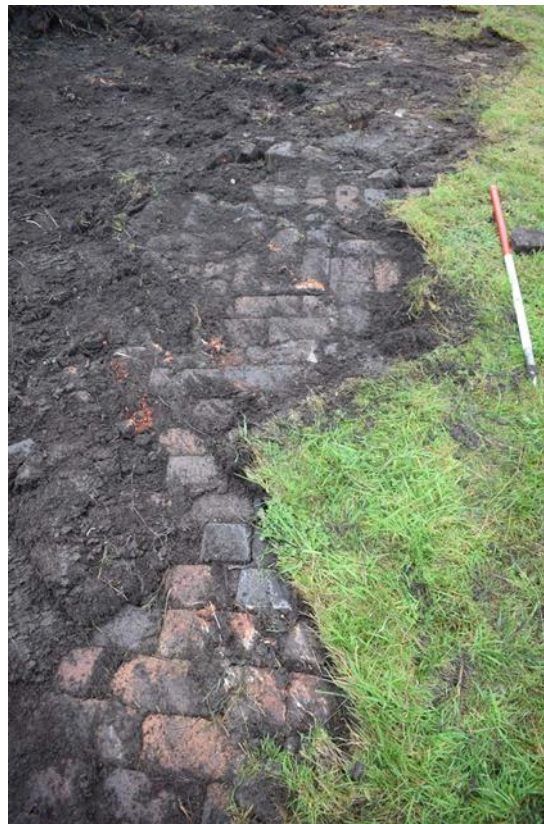
- 3.3. As the area at the northern extent of the projected structure was stripped, it became apparent that the projected size of the structure was an overestimate (see Drawing 1 and Appendix 1, Fig. 3), and the footprint on which the projection was based included a yard surface rather than a roofed structure. As the turf was stripped, a brick and tile path/yard was exposed (figure 7). The fabric consisted of bricks and tiles, likely repurposed as several high temperature kiln bricks and crudely resized tiles were present. A "Metalline" brick within the fabric of the surface (see figure 8) suggests a date within the late 19th Century or later, as the Metalline trademark was first registered in 1885. The surface was spread over a small area, running directly north circa 3.5m from the remains of the building, and never reaching a width over 0.9m, although the outer limits of the surface was not a designed edge and may have been removed in previous years. The surface was dry brick/repurposed ceramic rubble lying directly on the natural dark greyish brown loamy silt subsoil, which itself was rich in fragmentary ceramic building material (CBM) inclusions.

Figure 7 Remnants of brick surface possibly forming a yard/path. Viewed from north. CPAT Photo 4957-0010

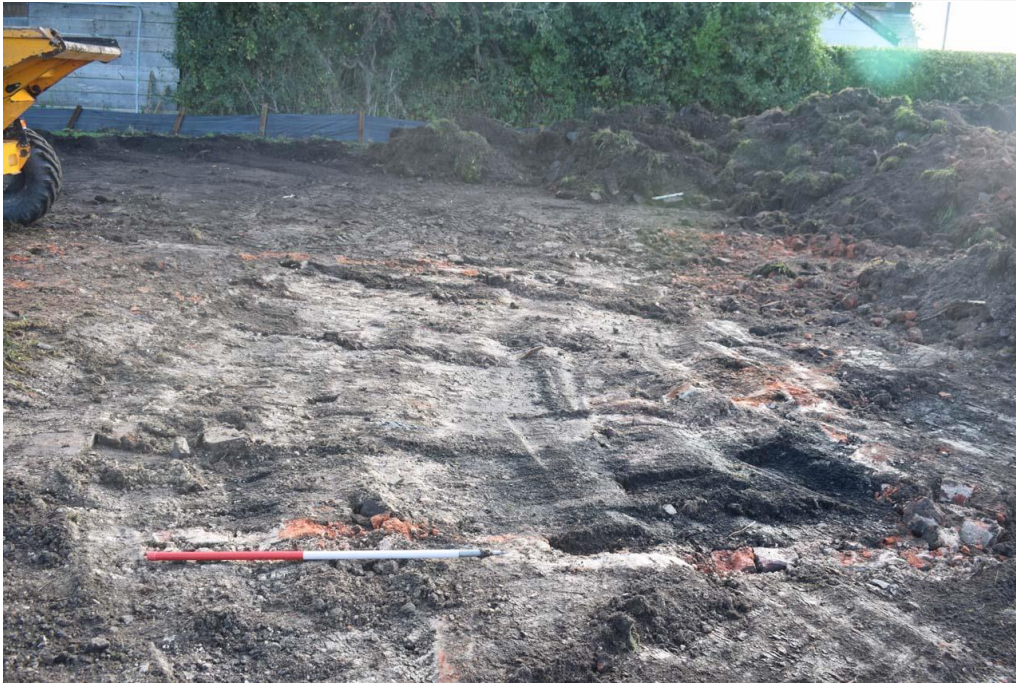
- 3.4. As the stripping continued, the extent of the building became clear, consisting of a primary room 4.8m west – east and 4.4m north-south, with an additional room in the form of a *lean-to*¹ construction to the south 4.6m west – east, and 4.2m north-south (Drawing 1). According to local anecdotal history provided by the neighbour, the southern lean-to was used as a washroom. Evidence of coal storage was visible in the soil within the lean-to (figure 9). The lean-to had brickwork that was not keyed into the primary room brickwork, implying it was a later extension to the primary room.

Figure 9 Lean-to room with coal-rich deposit in south-west corner of room. Viewed from west. CPAT photo 4957-0014

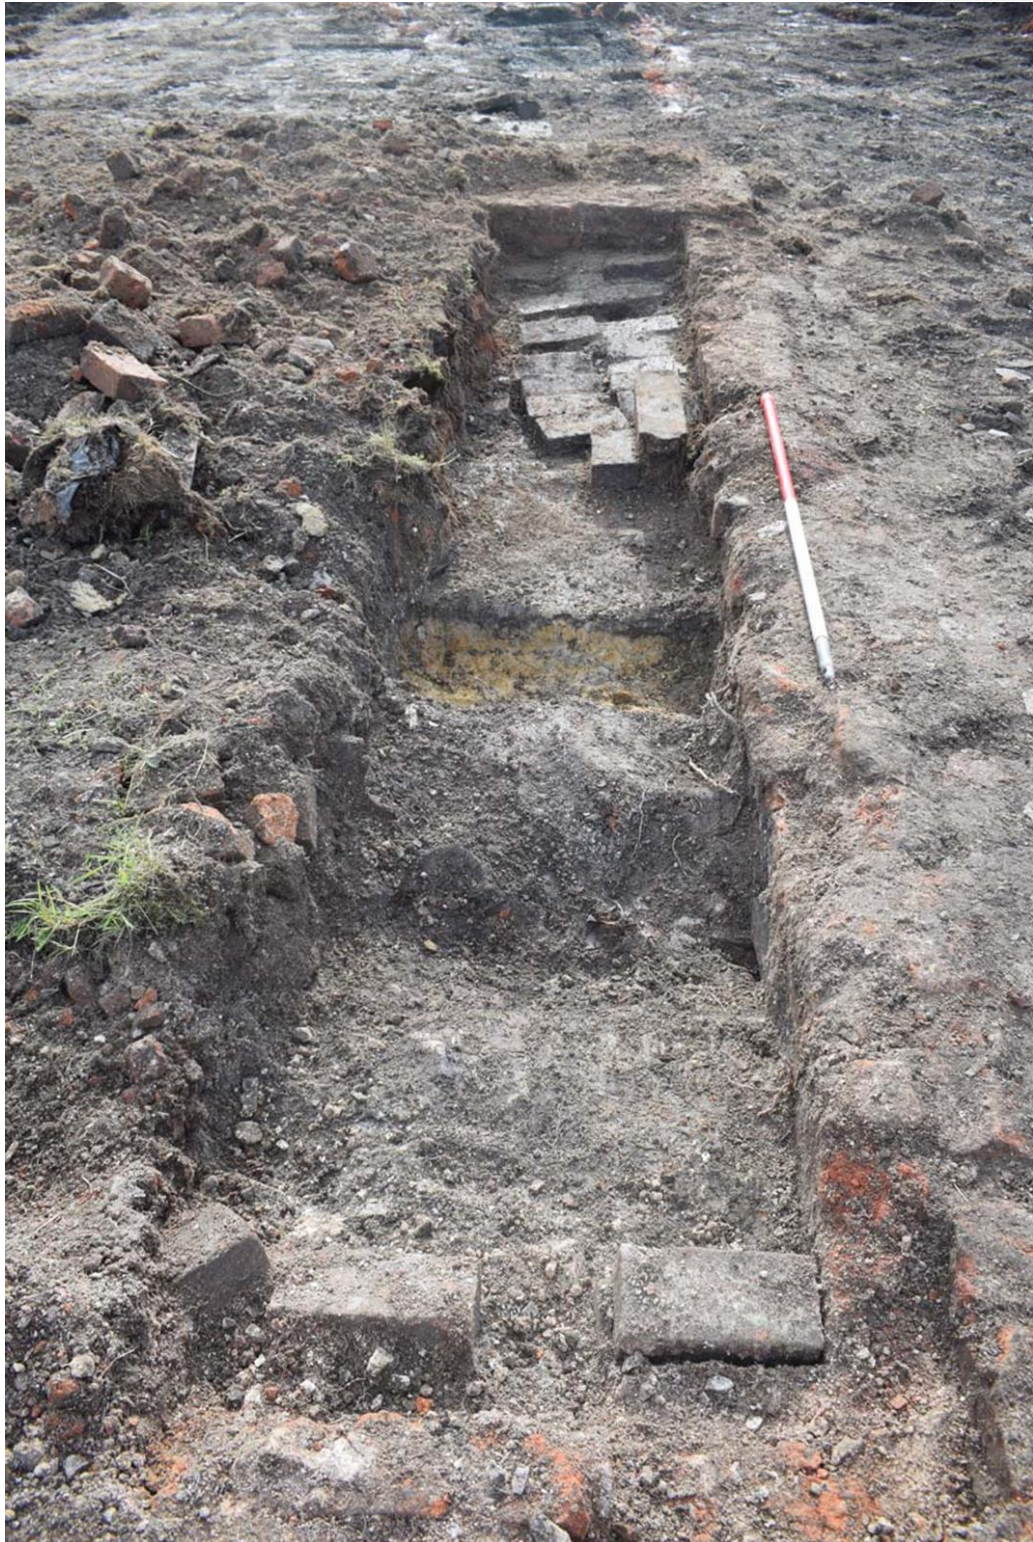
- 3.5. The building's primary room (to which the lean-to room was attached) was investigated archaeologically by excavating a 1 metre slot through its interior and immediate exterior. The slot followed the western wall of the building, and extended a metre to the northern exterior of the building (see Drawing 1 and figure 10). The excavation identified a former floor surface constructed from a linoleum floor placed directly onto a light brownish yellow compacted clay natural base soil (see figure 11). The base soil had been cut by a drain that continued under the brick of the western wall, approximately 1m from the north-west corner of the primary room (figure 13). There was a deposit of dry bricks laid in the south-west corner of the room, possibly to form steps for egress.

Figure 10 Slot oriented north-south through the primary room. Viewed from north. CPAT photo 4957-0020

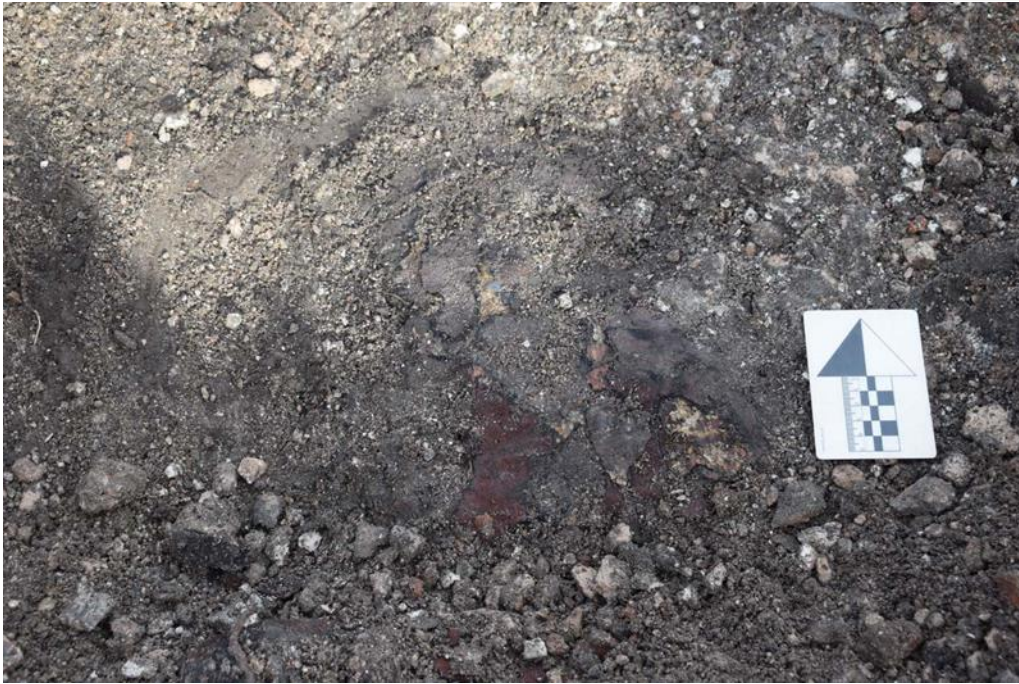
Figure 11 Remains of linoleum surface. CPAT photo 4957-0019

- 3.6. Finds from the soil directly above the linoleum surface were early 20th Century ceramic ware and domestic waste. White china ceramic material and glass dating from the 20th century were found in this deposit, as well as animal bones that had been mechanically cut with a saw. The soil floor surface was tested via a sondage to determine whether archaeological deposits might have continued beneath. The sondage found the light brownish yellow compact clay base soil, with no evidence of a surface beneath the linoleum floor. This would indicate that an earlier floor surface was removed, as the original 19th Century use of the building (as suggested by its presence on the 1841 tithe map) would generate distinct evidence in the archaeological resource, but there was no evidence of material dating to a period earlier than the 20th Century.

- 3.7. The presence of dry bricks forming a step and the placement of the linoleum floor directly onto an earthen surface indicates that the room was crudely repurposed. Oral history provided by the former occupants of the nearby dairy indicate that the early to mid 20th Century occupant of the building moved into this structure after it had seen use as an agricultural building. The floor surface being lower than the surrounding outdoor tiled surface, the basic but functional drainage installation, as well as the dry bricks and linoleum placed to make a floor surface, may indicate an effort of clearing an agricultural floor surface for repurposing into a dwelling. The 1841 tithe map's description of the structure, which is likely to be this building, as a "house and garden" indicates that the structure could have originally been a domestic building.

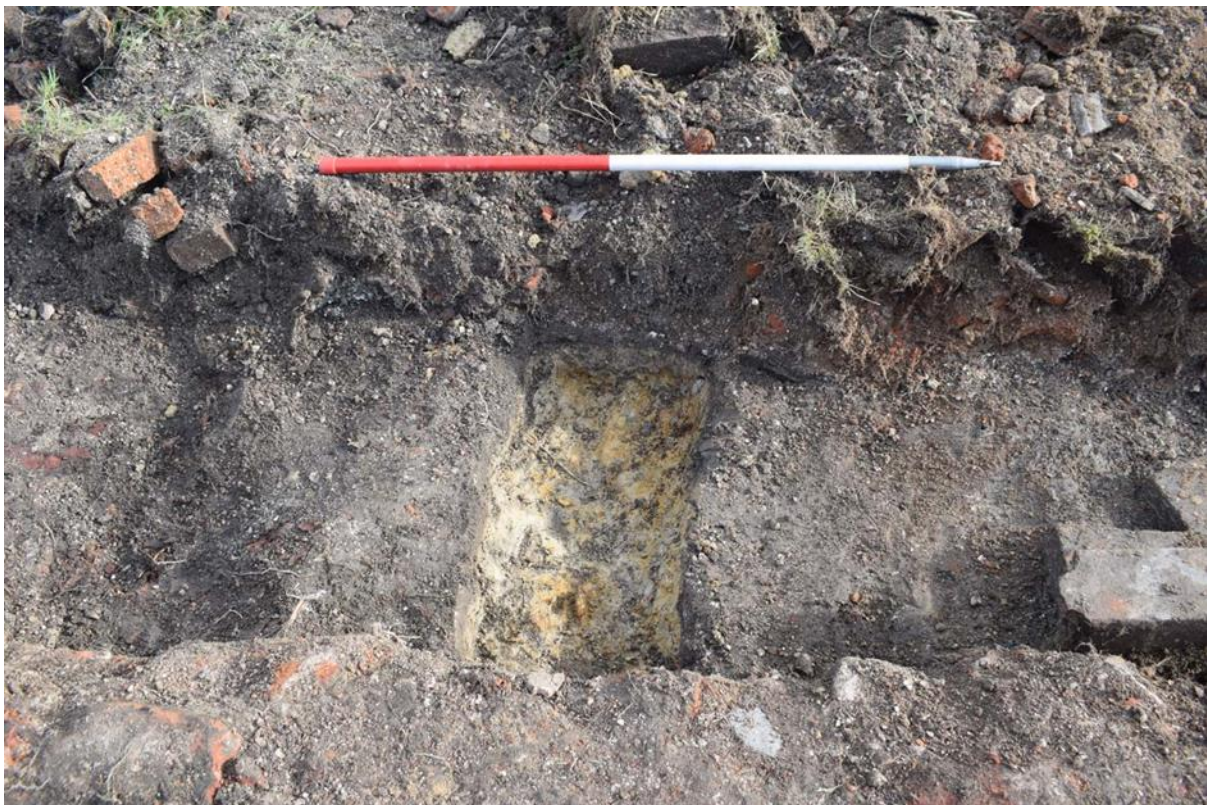
Figure 12 Sondage. CPAT photo 4957-0025

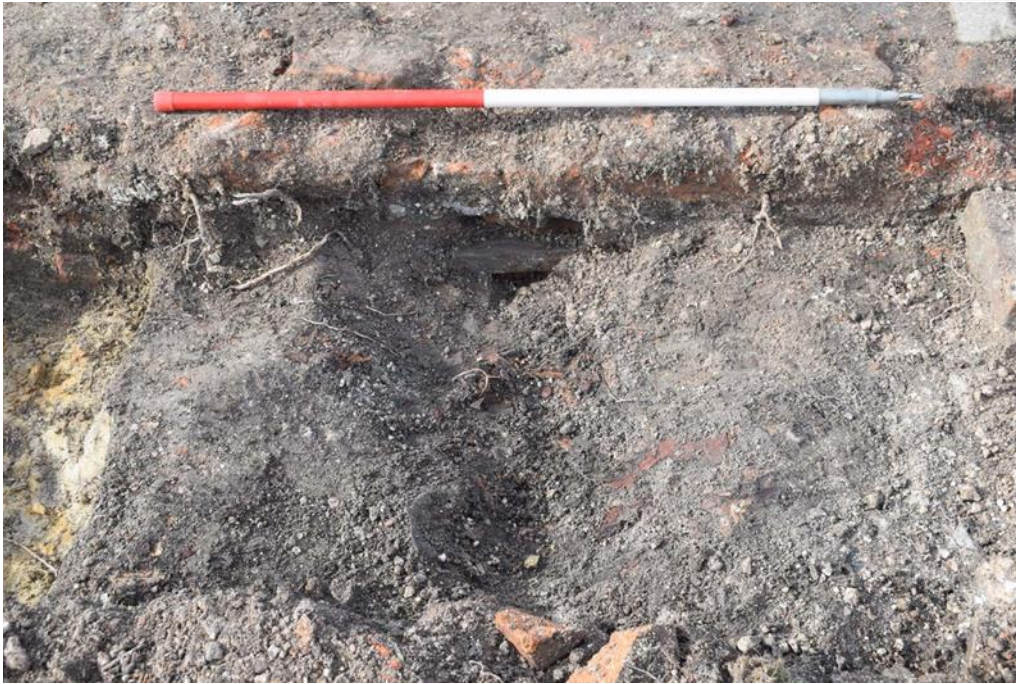
Figure 13 Drain. CPAT photo 4957-0025

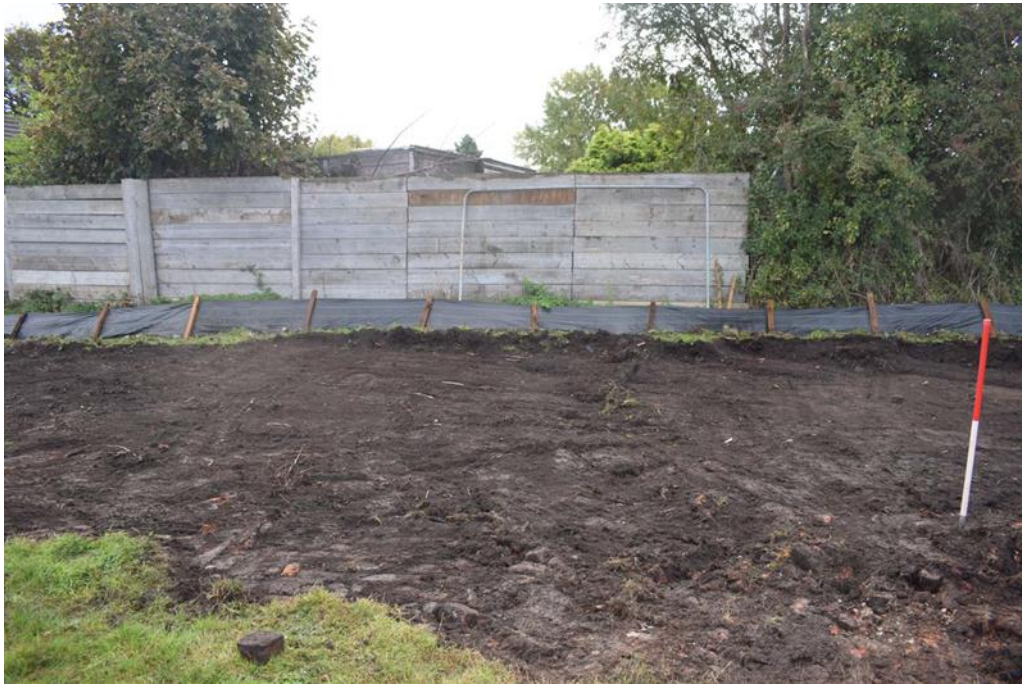
- 3.8. To the east of the remains of the structure (see figure 14), the plot had been used by the immediate eastern neighbour as a yard until 10 to 20 years previous. As the dark greyish brown loamy silt subsoil was removed from this area, 21st Century waste, such as automotive parts and construction equipment, was present throughout the soil. This continued until the natural base soil, which was approximately 0.4m below the surface. The base soil in this area was unchanged from how it appeared under the structure; a light brownish yellow compact clay base soil. Some stratigraphically disturbed remains of guttering and drainage were present in the subsoil, but were out of their original context. The ubiquitous presence of

waste in this area suggests that the original surface of the yard was deeper than the present surface, and soil had been respread over this area to re-establish the turf. This may have been done during an earlier phase of waste removal.

Figure 14 Area of modern interference east of the structure. Viewed from west. CPAT photo 4957-0013

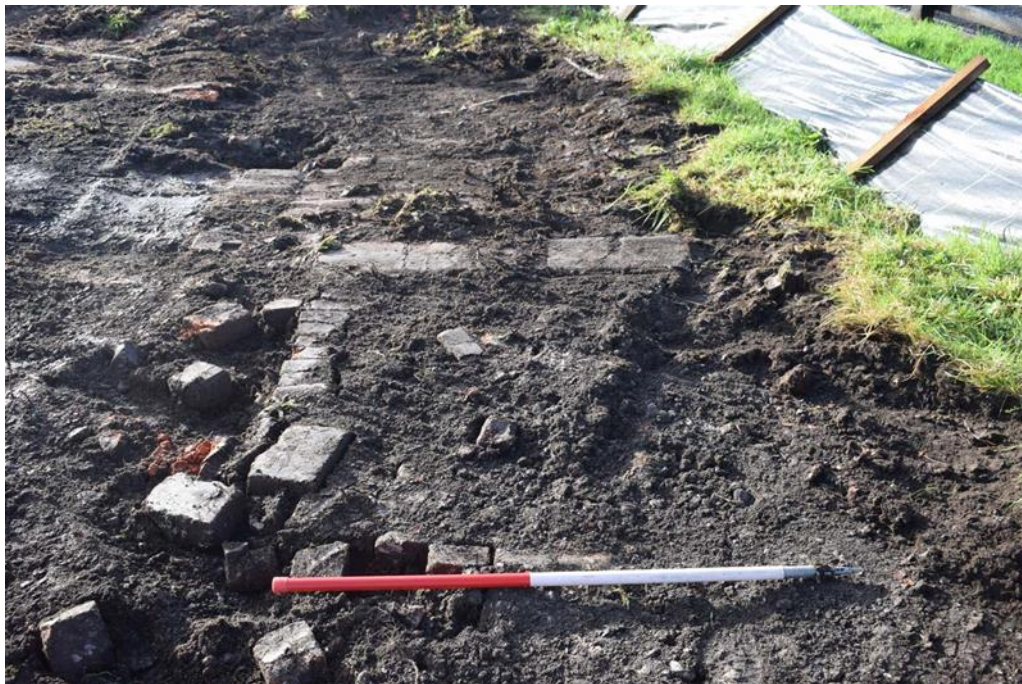
- 3.9. Nearby to the building, there were the remains of a toilet outhouse and a probable coal bunker. The coal bunker was built from dry brick of which only a single course remained (Drawing 1 and figure 15). The toilet block was at the periphery of the development area, and most of the remaining structure went beyond the limit of excavation, so it was not investigated.

Figure 15 Small dry-brick structure, probable coal bunker. Viewed from north. CPAT photo 4957-0018

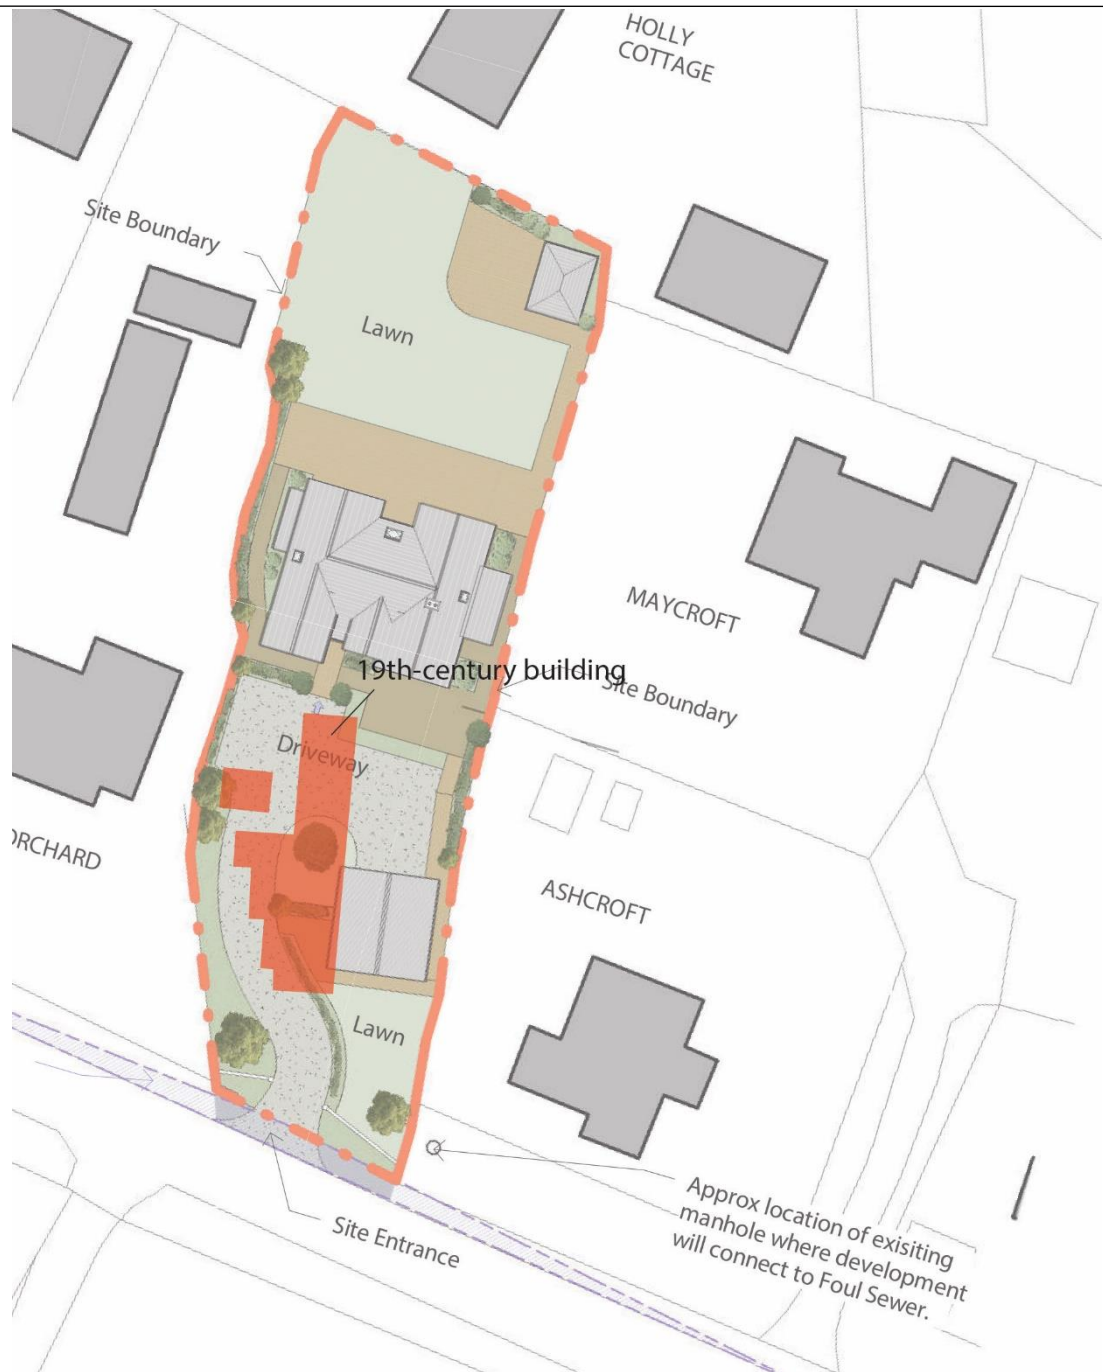
1.3. It had originally been intended that the archaeological works would comprise a watching brief during ground disturbance works associated with the development but during consultation it was revealed that there had been a building within the plot in the late 19th century when the large scale Ordnance Survey mapping was produced. As a result of subsequent discussions with Mark Walters of CPAT, who provides planning advice on archaeological matters to Flintshire Council, it was agreed that the ground occupied by the 19th-century building and its immediate surrounds would be stripped to formation level under archaeological supervision, with any structural remains that were revealed being investigated prior to the commencement of construction work.

Figure 3: 19th-century building overlaid on the development plan
