Revised Route for a CoasterKart Development at Tower Colliery, Rhondda Cynon Taff Historic Environment Desk-Based Assessment

Trysor Project No. 2020/769
GGAT HER Event PRN E006630

For: Zip World

February 2021

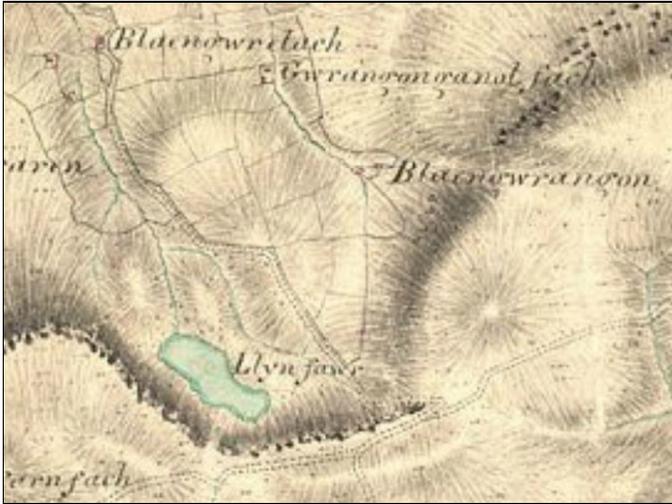
Figure 2; An excerpt from the Ordnance Survey Original Surveyors Drawings Aberdare Sheet of 1814.

8.2 The earliest map showing the property is the Ordnance Survey's Original Surveyors Drawings, Aberdare sheet, surveyed in 1814. The Original Surveyors Drawings represent the first detailed map series of the whole country. They do not generally map field boundaries in detail and the details of the field system which are shown on the map cannot be interpreted as accurate representations of the fieldscape at the time of the survey. The map shows clearly that the area of the proposed development, northeast of Blaengwrangon Farm (ID number 6), was open moorland in the mid-19th century, outside the enclosed field system of the farm.

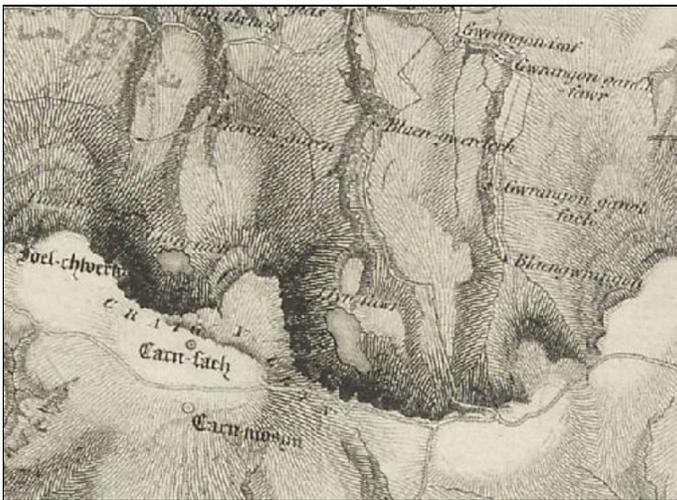
Figure 3; An excerpt from the Ordnance Survey First Series map (Sheet 42) of 1832.

8.3 The 1814 Ordnance Survey map was the basis for the 1 inch to 1 mile scale First Series map of 1832. This map again shows the area to the northeast of Blaengwrangon Farm (ID number 6) to be open moorland.

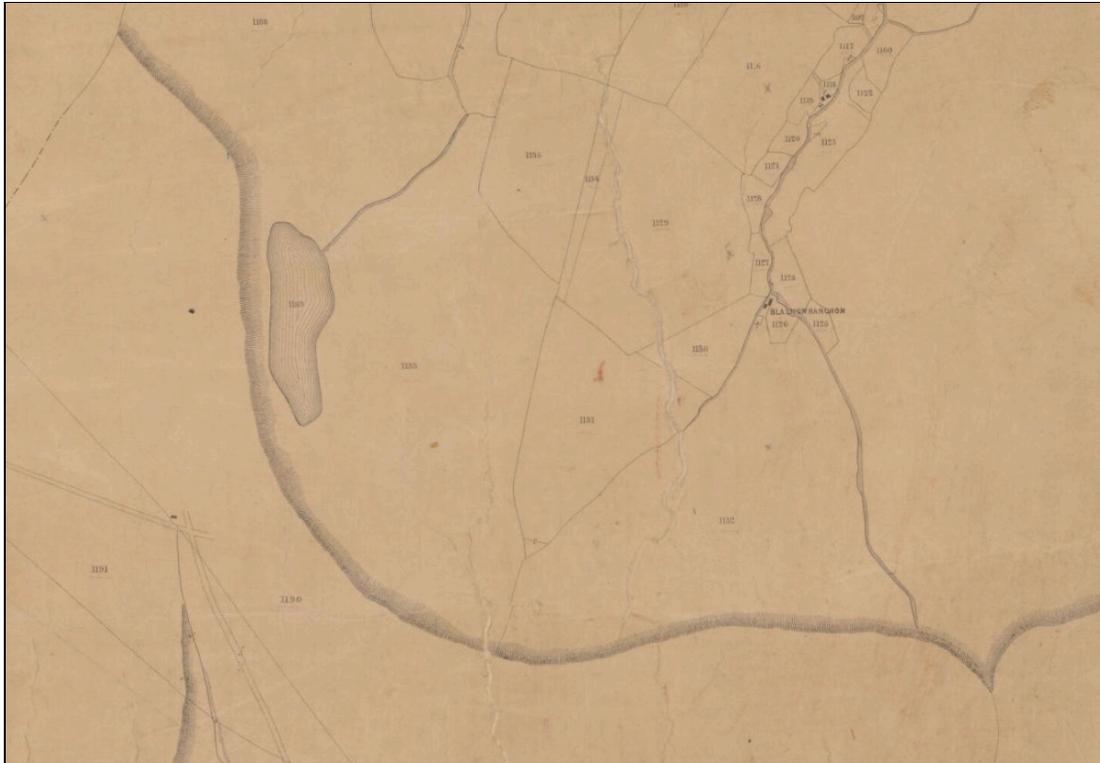
Figure 4; An excerpt from the Ystradyfodwg Parish Tithe Map of 1847.

8.4 The Ystradyfodwg parish tithe map of 1847 provides a much more detailed depiction of the landscape, including the field systems of the day, see Figure 4. It records that the proposed development area still lay outside the field system and on mountain moorland.

8.4.1 This map captures the landscape before it felt the impact of forestry or industry. The fields of the farms of Blaengwrangon (ID number 6) and Gwrangon Ganol Fach (ID number 7) lay within the assessment area.

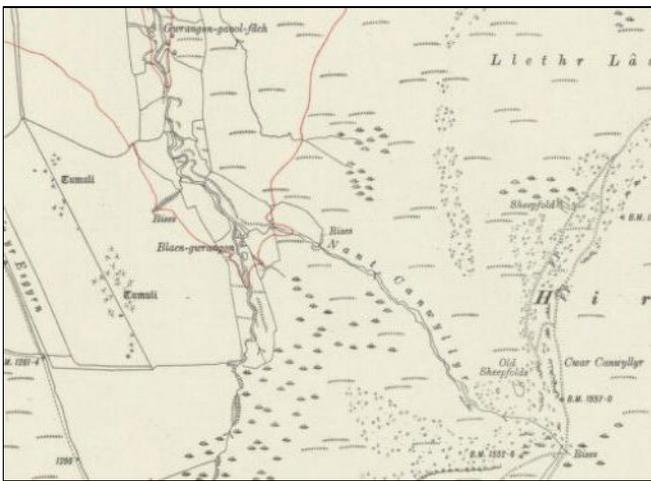
Figure 6; The Ordnance Survey 1:10560 map of 1921. Sheet X.SE

8.5 The 1:10560 Ordnance Survey maps of 1884 and 1921 (Figures 5 & 6 below) show the landscape prior to the development of Tower Colliery and the afforestation of the wider area, which occurred during the 1960s. These maps also show the area before the construction of the A4601 road connecting the Rhondda Fawr and Hirwaun in the 1920s. The Tower Colliery No.4 shaft would not be developed near Blaengwrangon Farm for another two decades after the construction of the road. The area of the proposed development site is shown as unenclosed moorland on both maps.

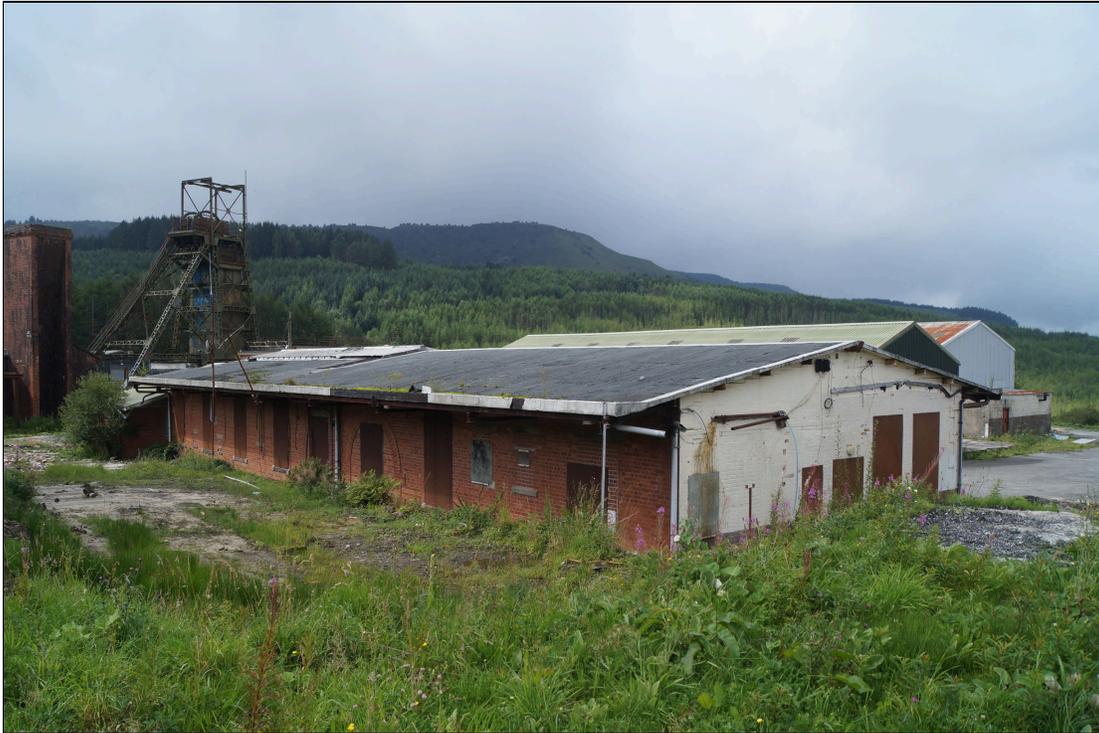
Plate 1: A view of the Tower Colliery lamp room and office building, with the Tower Colliery No.4 shaft headframe to the left. Looking west.

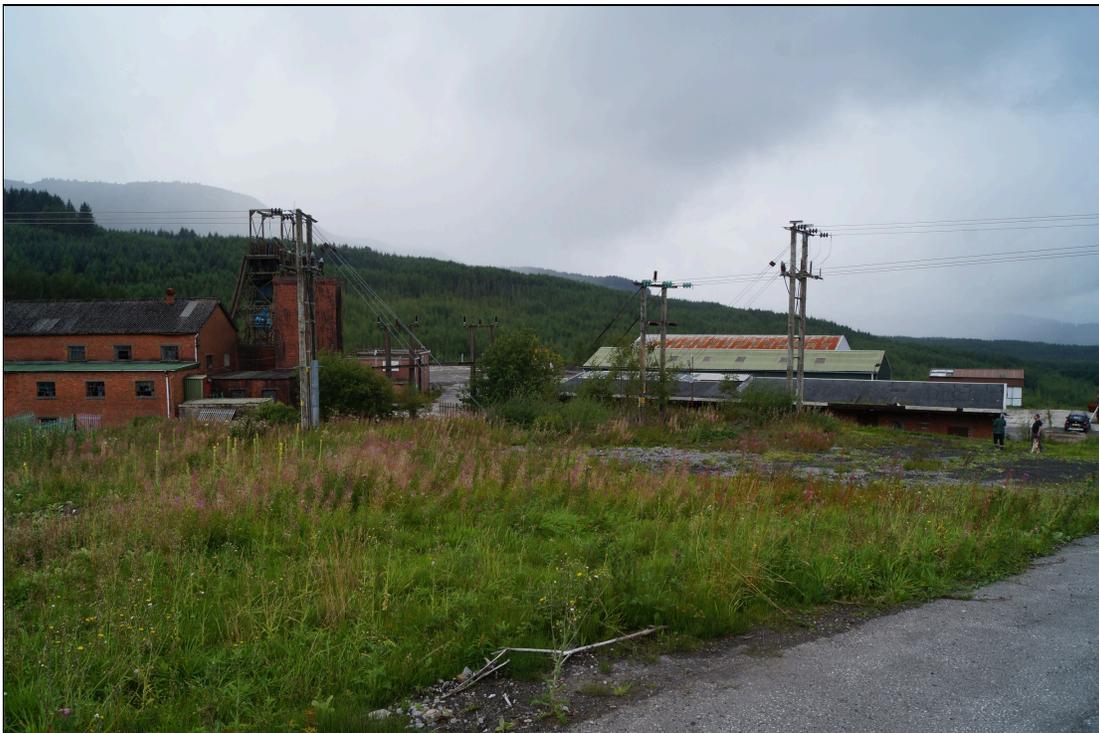
Plate 2: A general view of the Tower Colliery complex, with the engine house and pithead headframe to the left and the lamp room and office building to the right of centre. Part of the CoasterKart ride would pass through the area in the foreground and cross the trackway bottom right which leads to the colliery Magazine building. Looking west.

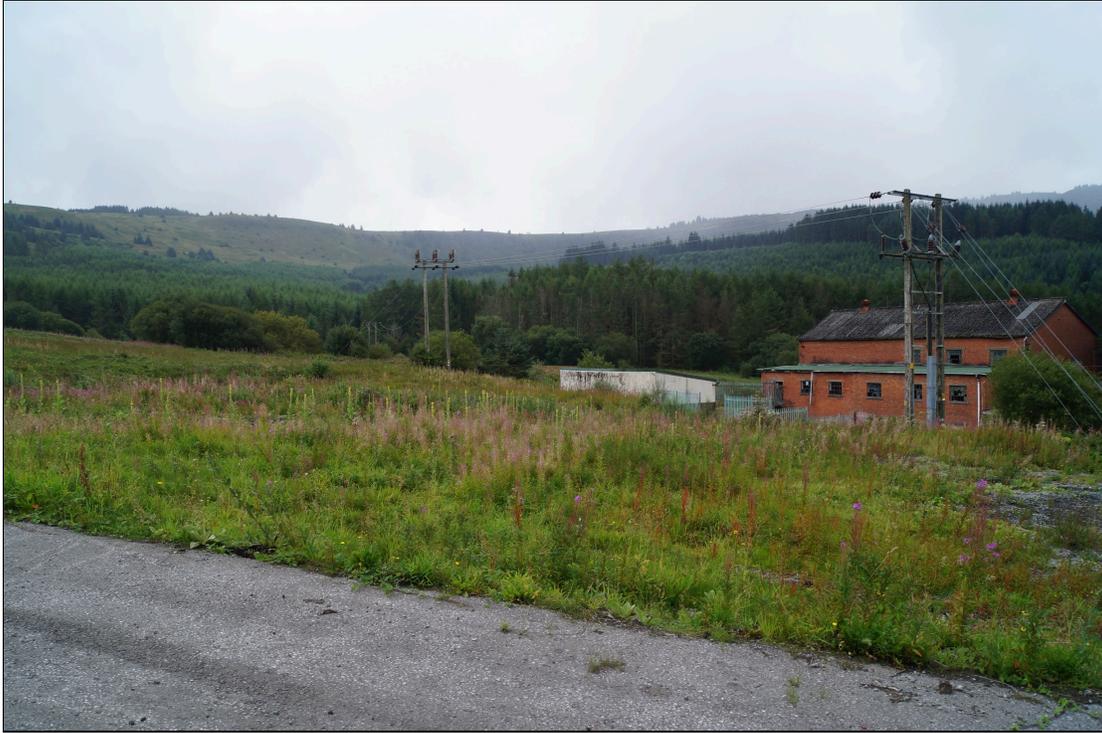
Plate 3: A view of the Tower Colliery engine house. The site of the collapsed Gorllwyn Drift entrance lies behind the white building at the centre of the view. The CoasterKart ride would be located in the area to the left of the buildings. The trackway which leads to the colliery Magazine building is visible in the foreground. Looking southwest.

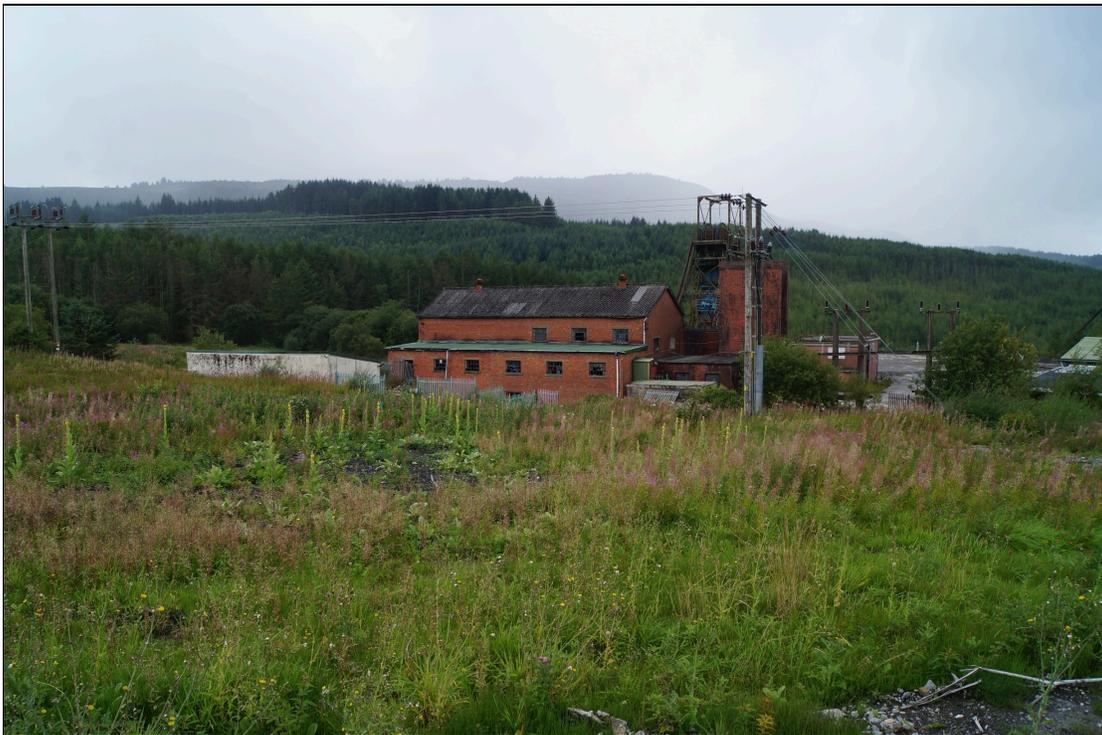
Plate 4: A general view of the Tower Colliery engine house and headframe. The CoasterKart ride would pass through the area in the foreground. Looking west.

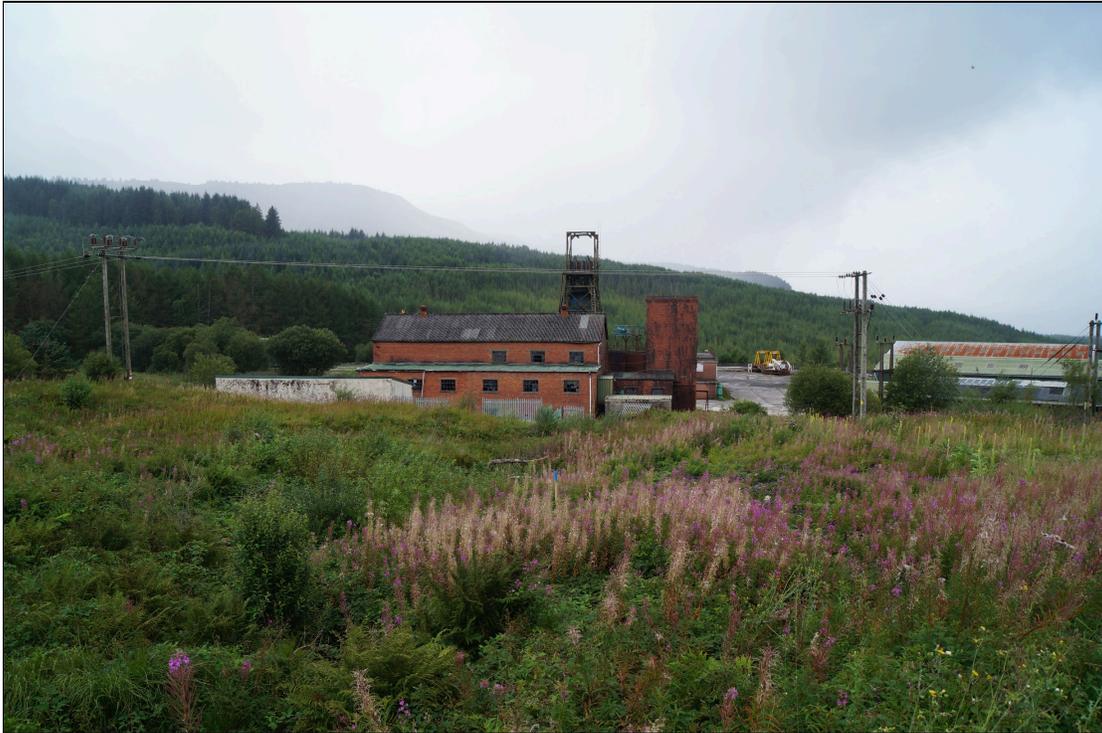
Plate 5: A view of the Tower Colliery engine house and headframe. The CoasterKart ride would pass through the area in the foreground. Looking west.

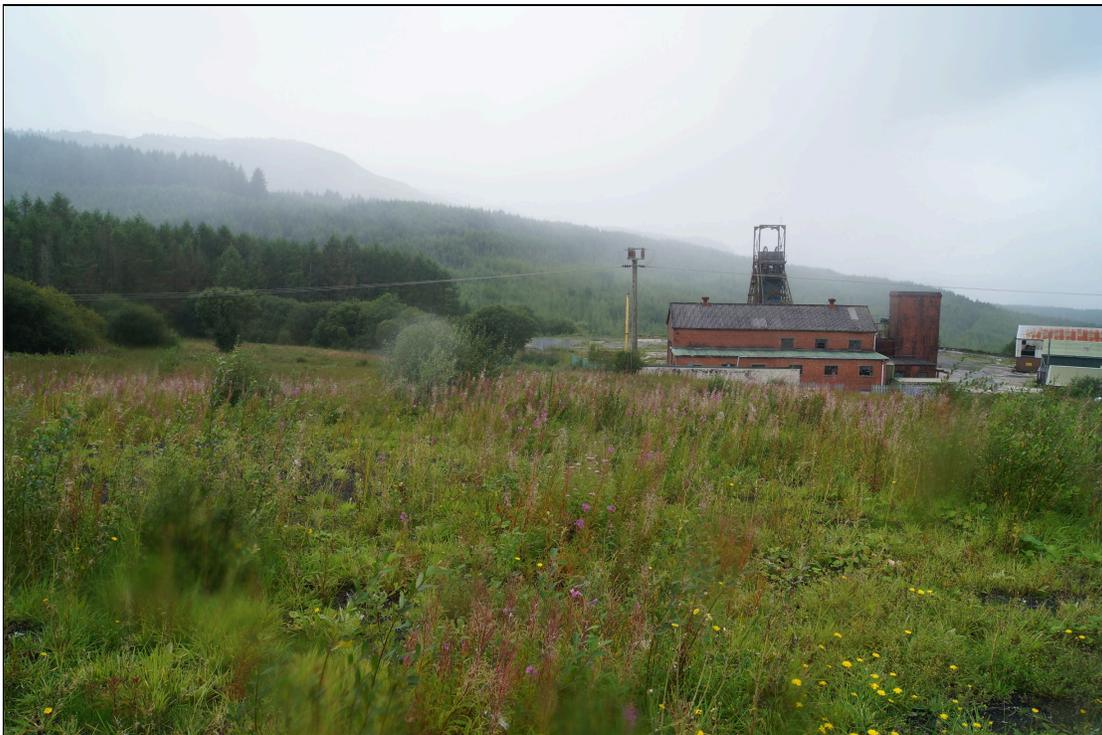
Plate 6: A view of the Tower Colliery engine house and headframe. The CoasterKart ride would pass through the area in the foreground. Looking west.

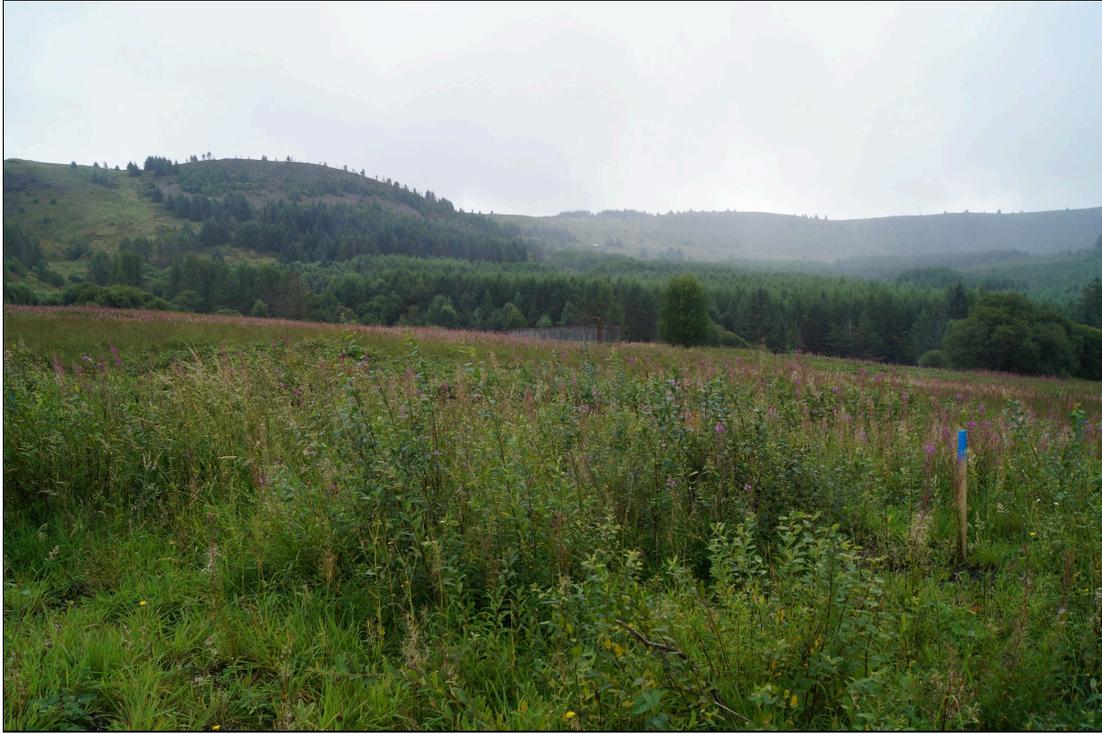
Plate 9: A view of the area to the east and southeast of the colliery complex with water tank (ID number 10). Looking south.

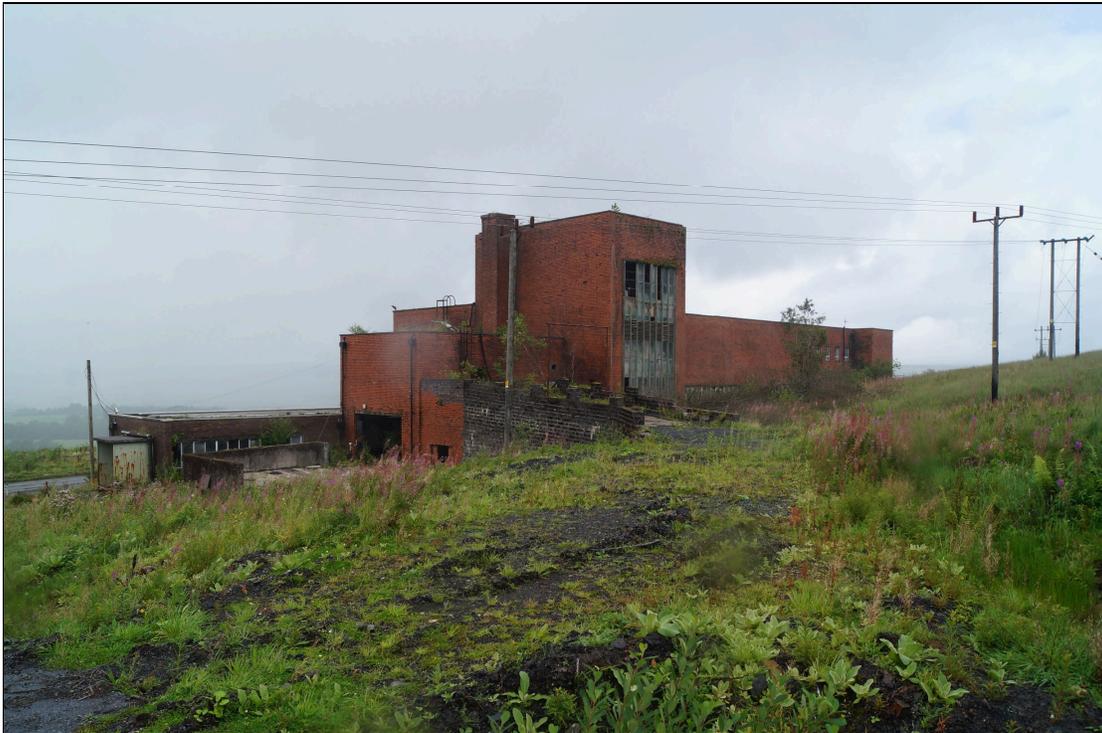
Plate 10: A view of the rear of the Tower Colliery pithead baths building (ID Number 12). The CoasterKart ride would pass to the right of the electricity pylons shown here and would not impact on this view of the pithead baths. Looking northwest.

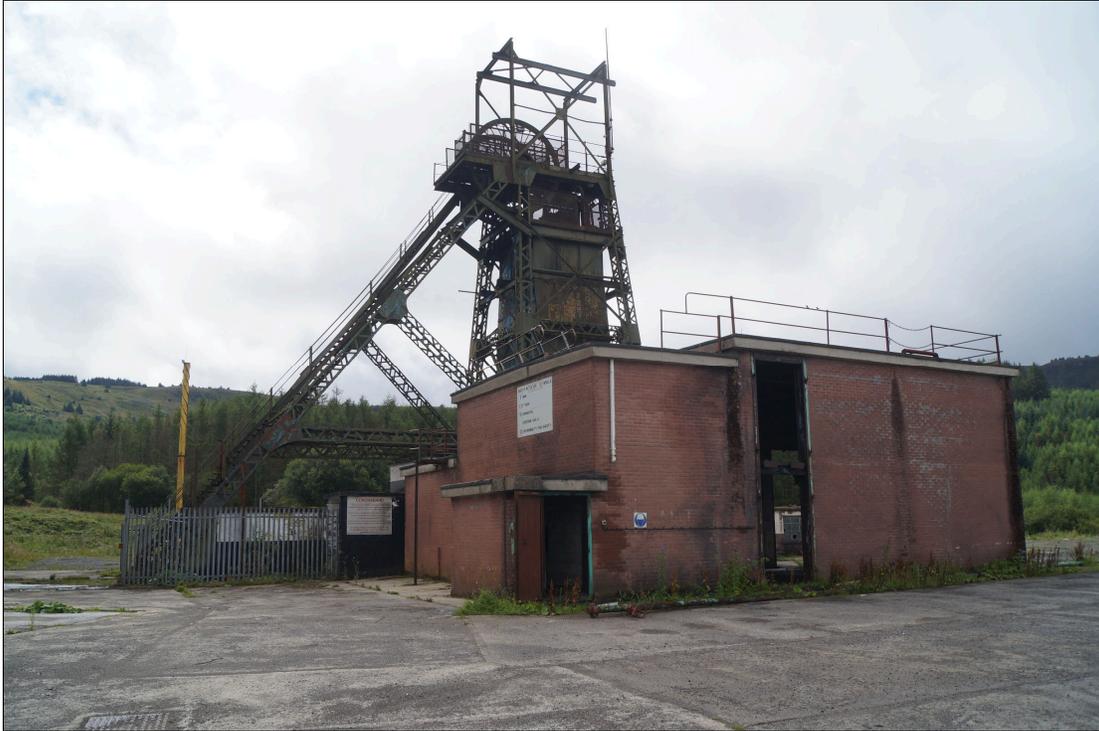
Plate 11: A view of headframe and pithead building at Tower Colliery (ID Numbers 4 and 5). The CoasterKart ride would not impact on key views of these structures. Looking south-southwest.

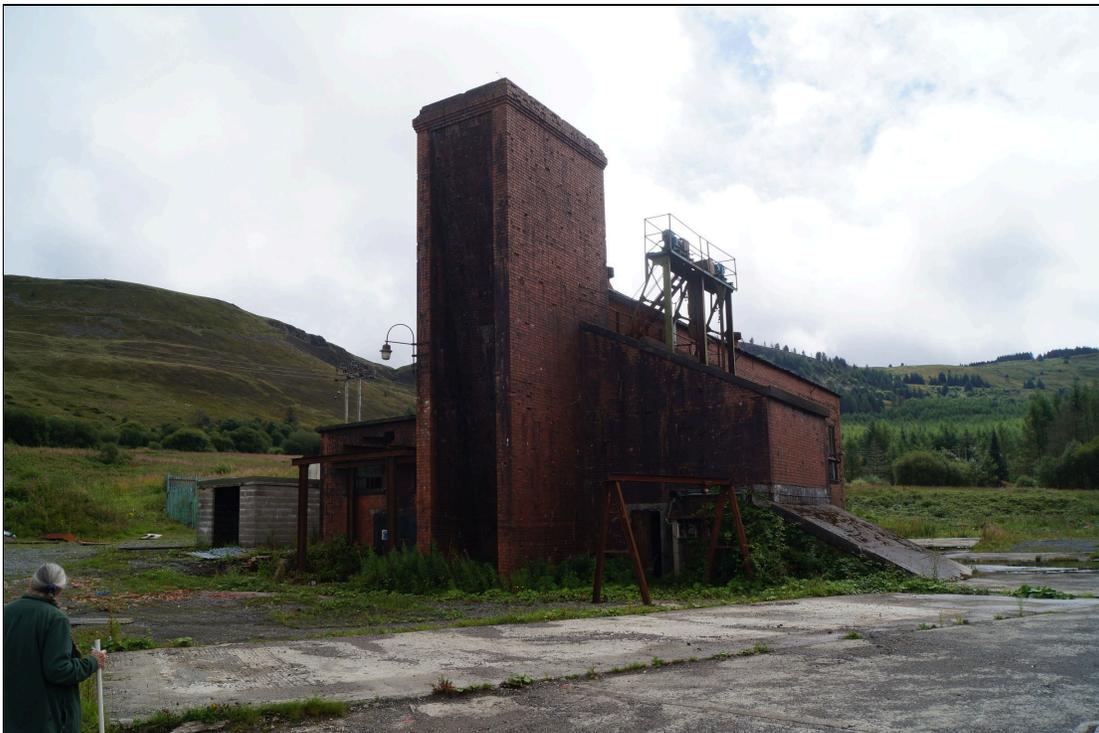
Plate 12: A view of the engine house at Tower Colliery (ID Number 3). The CoasterKart ride would pass across the grassy area visible between the building and the left edge of the photograph and would have some impact on the setting of this listed building. Looking south-southeast.

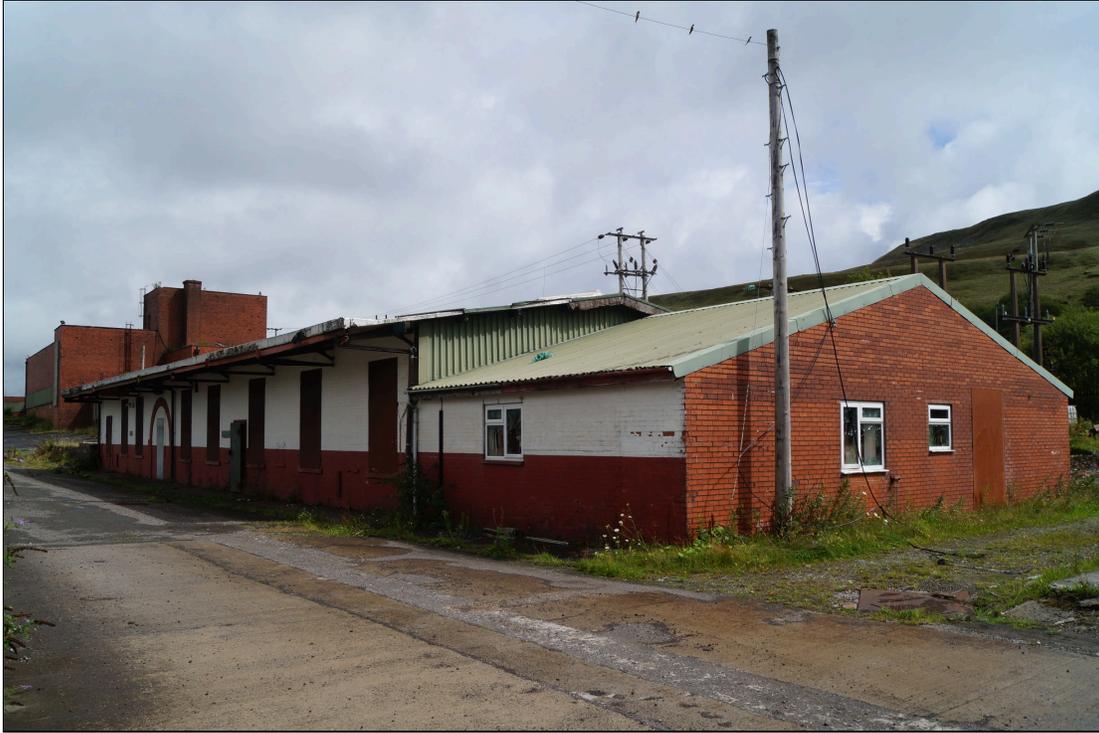
Plate 13: A view of the original lamp room and office building (ID Number 13) at Tower Colliery with the pithead baths beyond. The CoasterKart ride would begin and end within this building but the proposed changes would not affect the elevations of the lamp room shown here. Looking northeast.

- 12.3.2 The start of the CoasterKart ride would be housed within the original lamp room and office building of the colliery. This building dates to the early 1940s and may be a unique survival of its kind, retaining many original features which elevate its historical importance. The reuse of the lamp room building would save it from dereliction and ruin, and the sympathetic conversion proposed is recommended to avoid losing the distinctive architectural features which make this one of the most important surviving buildings at Tower Colliery. In particular, the external walls to the northwest and southeast contain detail that directly relates to the former use of the building. The skylight in the southwestern end of the building was essential to give daylight into the lamp room.

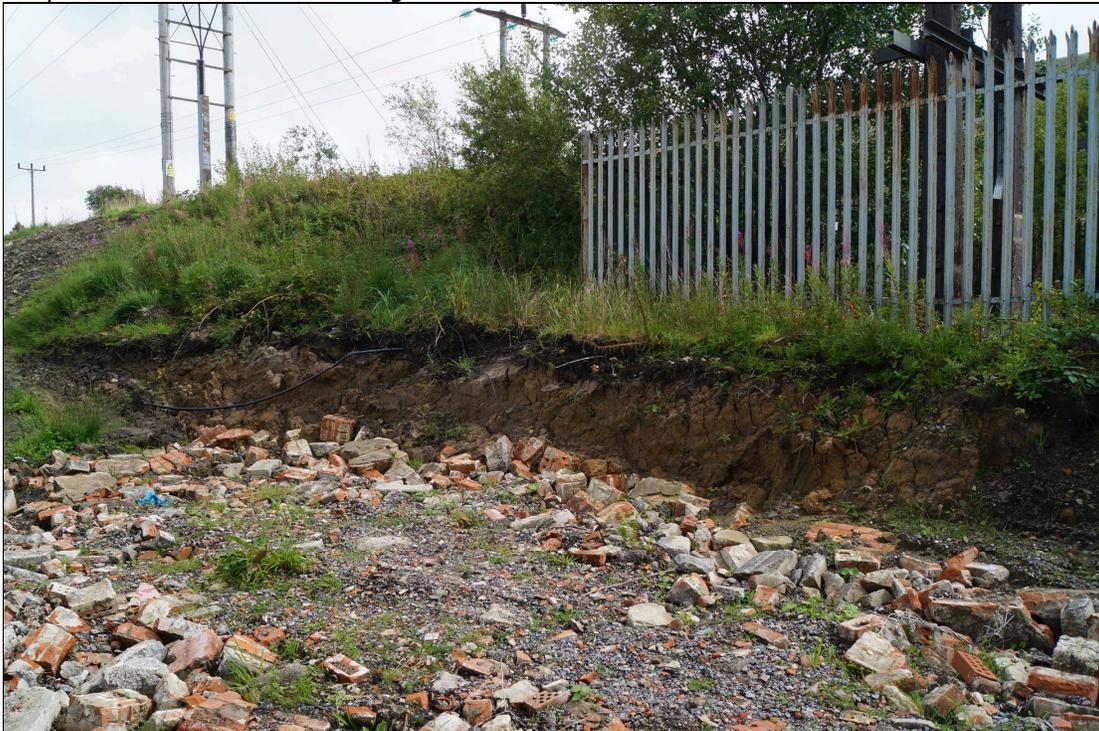
Plate 14: A view of a levelled area between the lamp room building and the electricity substation to its southeastern side. The CoasterKart ride would pass through this area. Looking east.

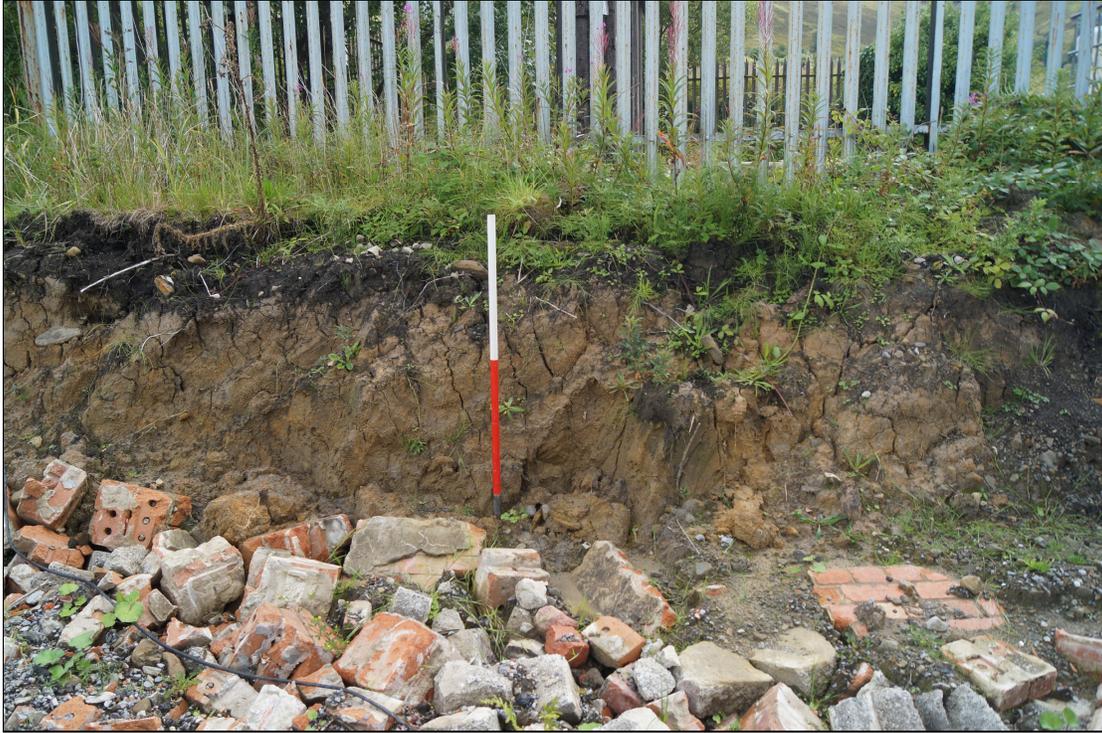
Plate 15: A view of a thin dark peaty soil overlaying boulder clay exposed to the southeast of the lamp room building. Looking southeast.

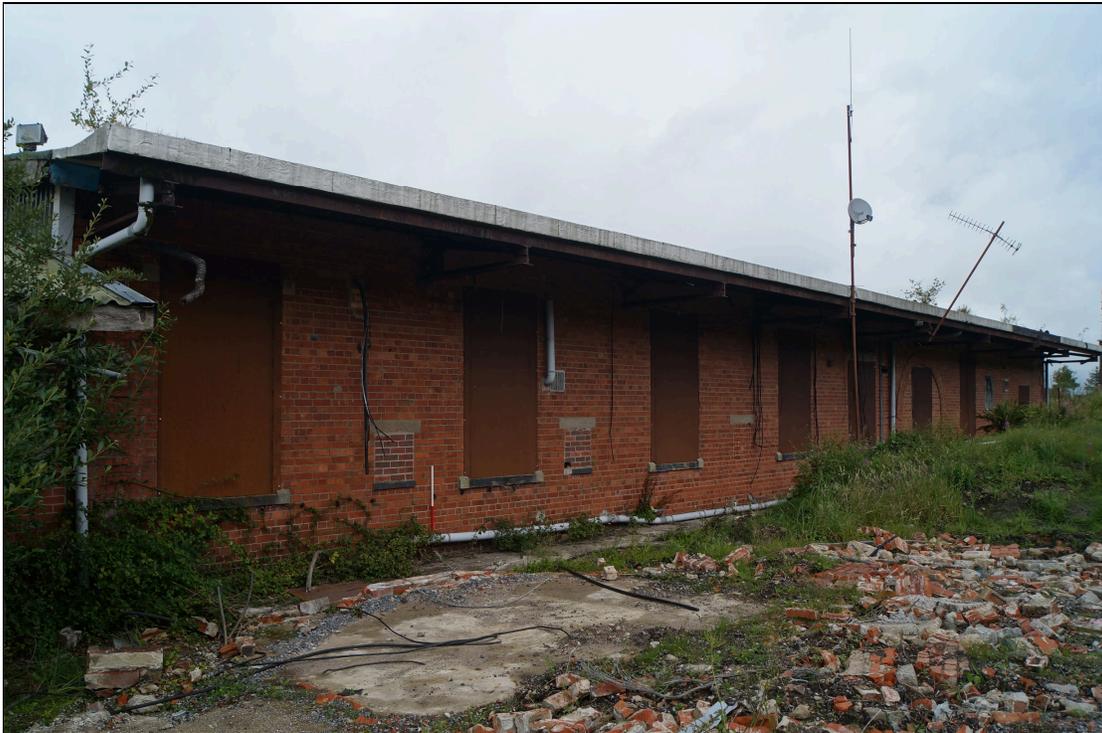
Plate 16: A view of the southeast elevation of the lamp room building (ID Number 13). The three blocked up hatches visible in the wall were the hatches through which the miners returned their safety lamps at the end of a shift, protected by the broad overhang of the roof. The large windows, now shuttered, gave good light inside the building. Looking north.

- 1.8 A Level 2 building recording should be made in advance of any changes to the lamp room and office building to record it in its present condition including any blocked openings.

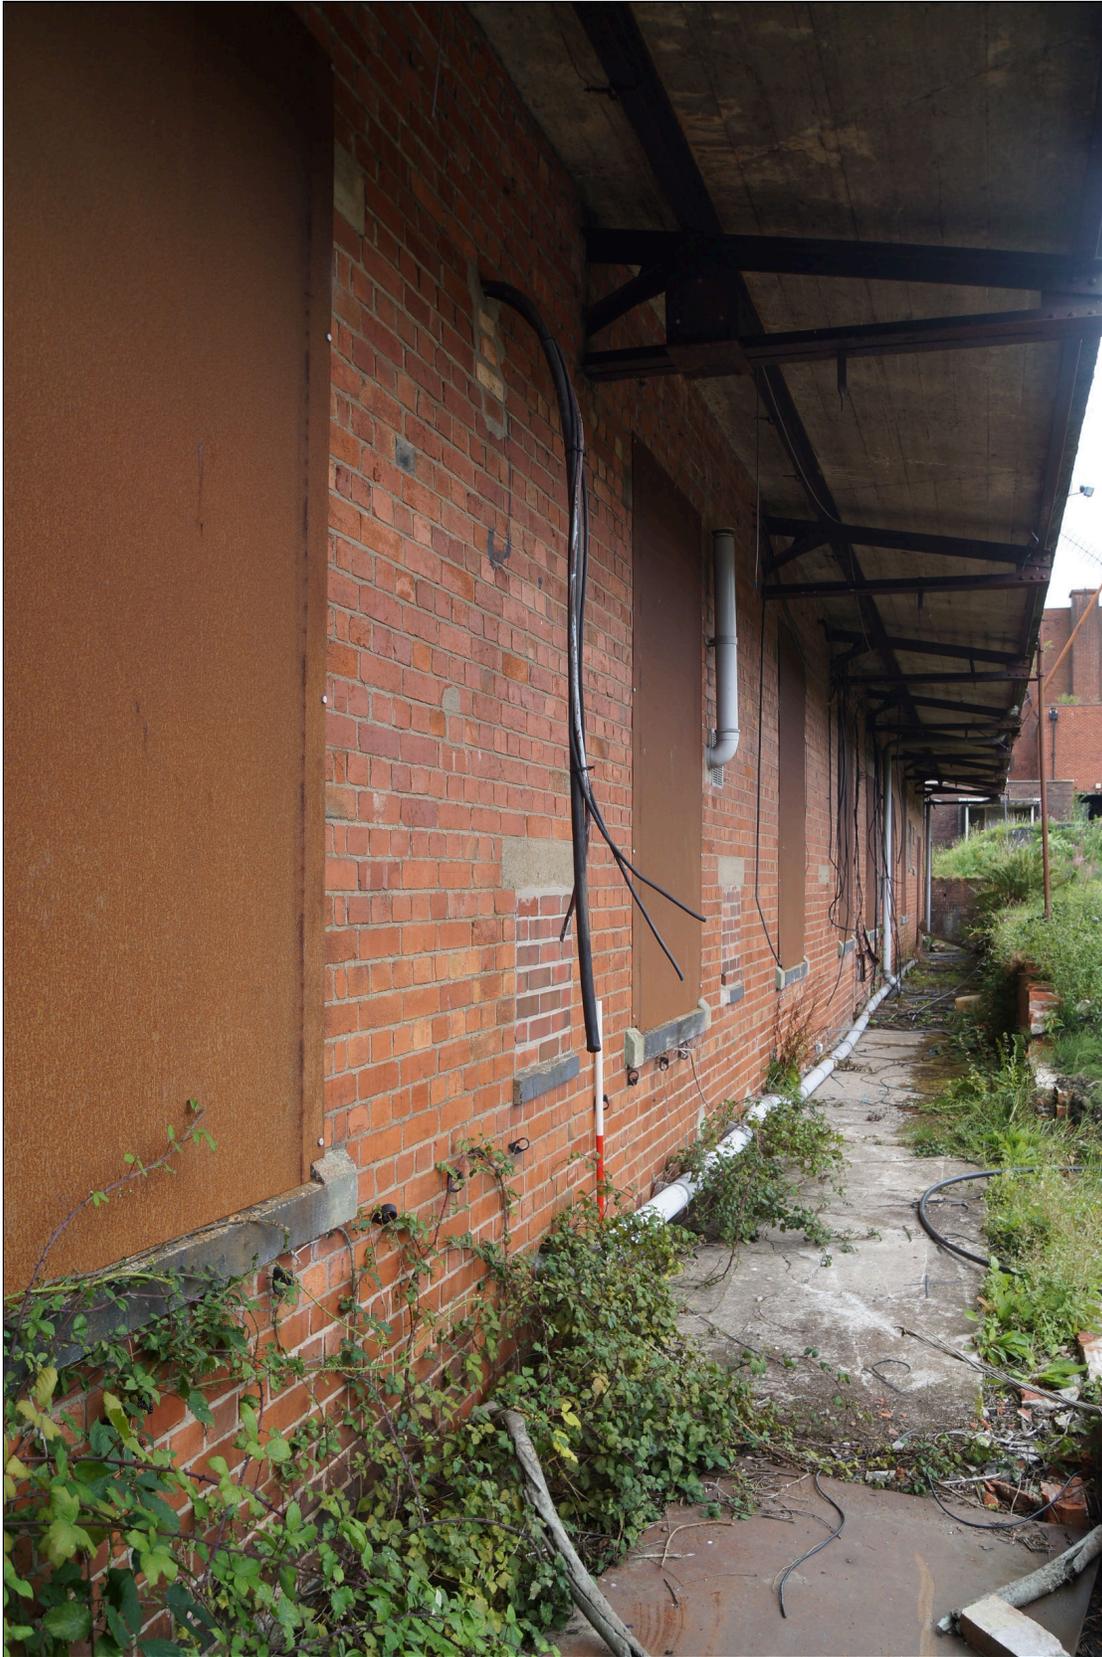
Plate 17: A view along the southeast elevation of the lamp room showing the bricked-up hatches and the broad overhang of the steel-framed roof. Looking north-northeast.

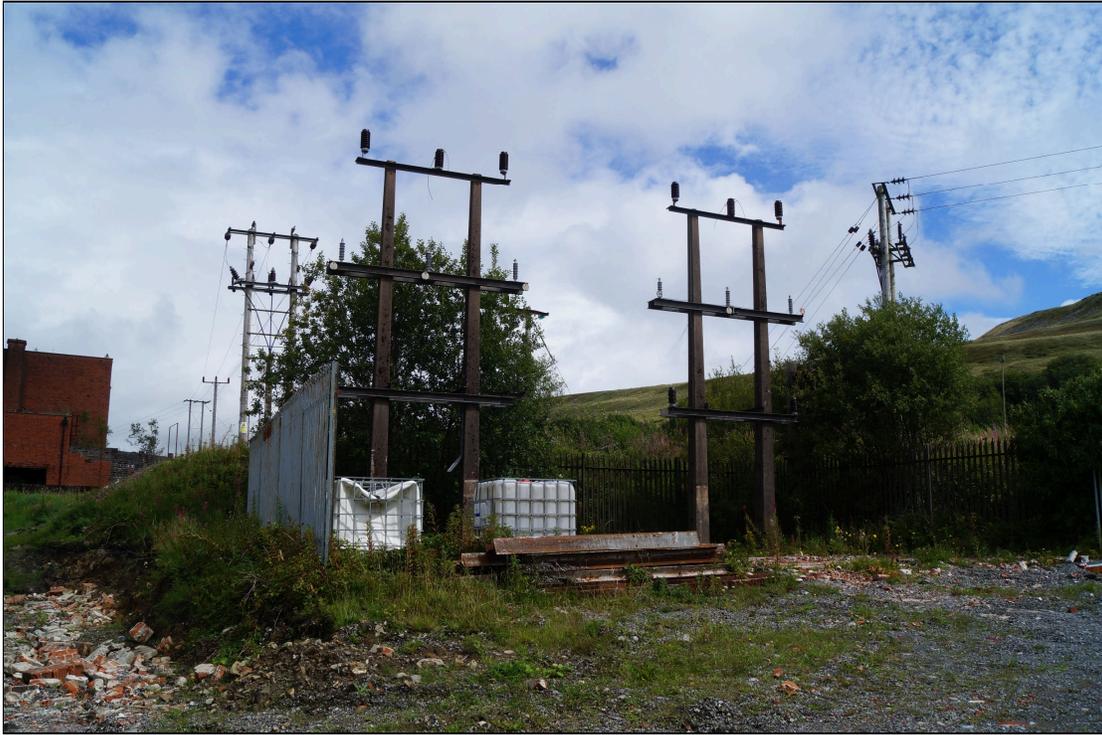
Plate 18: A view of the electricity substation at Tower Colliery. The CoasterKart ride would pass through this site. Looking northeast.

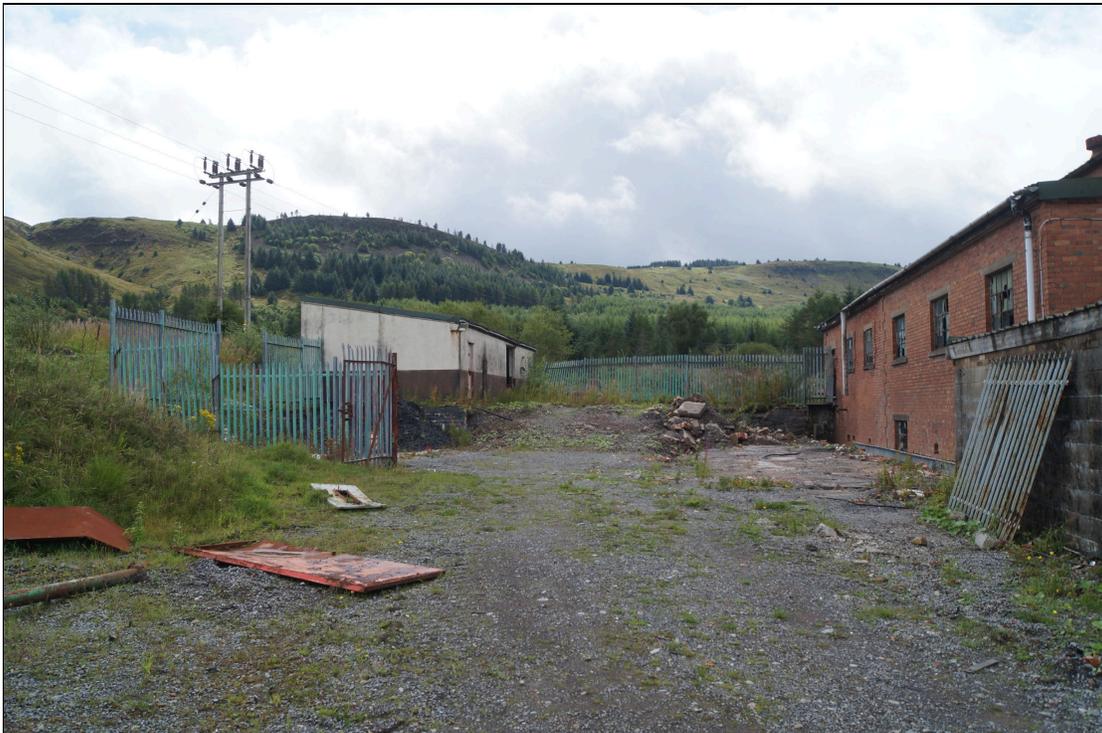
Plate 19: A view of the area to the east of the Tower Colliery engine house. The building left of centre stands in front of the collapsed and infilled Gorllwyn Drift mine entrance. The CoasterKart ride would pass along the bank to the left of this view, through the site of the white building and across the drift entrance. Looking south.

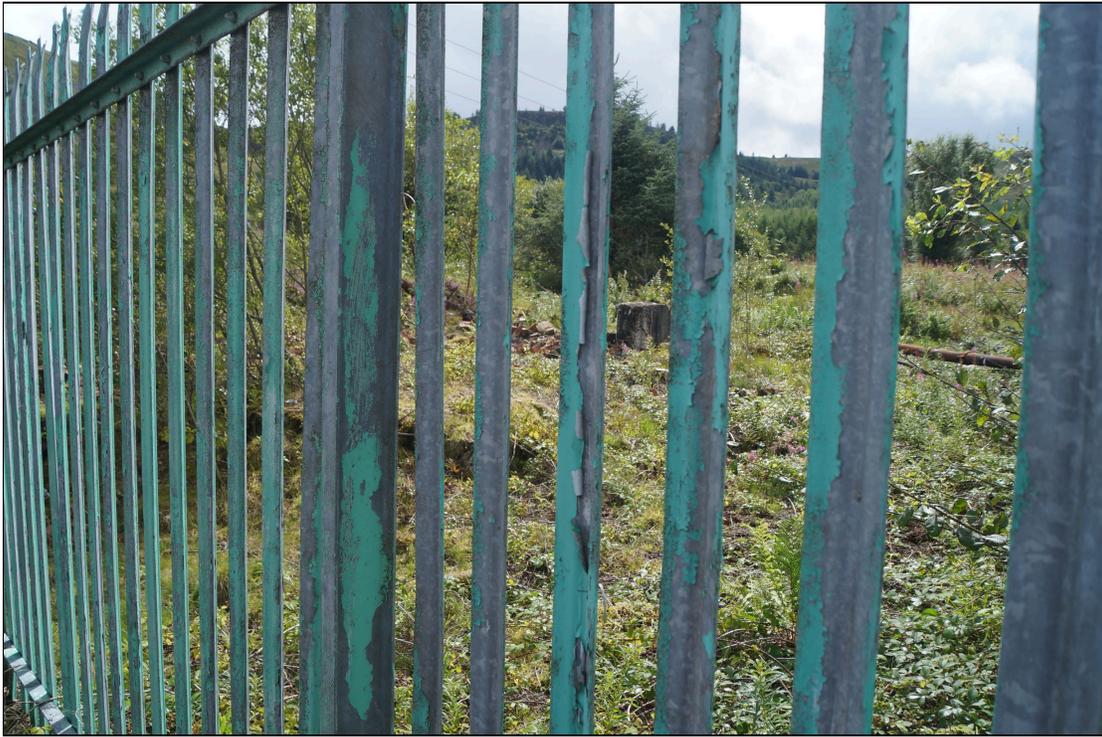
Plate 20: A view of the area of the infilled Gorllwyn drift entrance (ID Number 14), where rubble from an earlier building is scattered around. Looking southeast.

- 11.12 There are no conservation areas within the 500-metre assessment area.
- 11.13 No evidence of non-industrial archaeology was noted during the field visit. A record was, however, made of the collapsed drift (ID number 14) close to the colliery engine house. This feature had not been previously recorded in the archaeological record. The rubble of an associated building was noted across the site of the drift entrance.

- 11.13.1 Overall the buried archaeological potential is assessed as Low, although flints may be present and the foundations of a building connected to the former drift (ID Number 14).

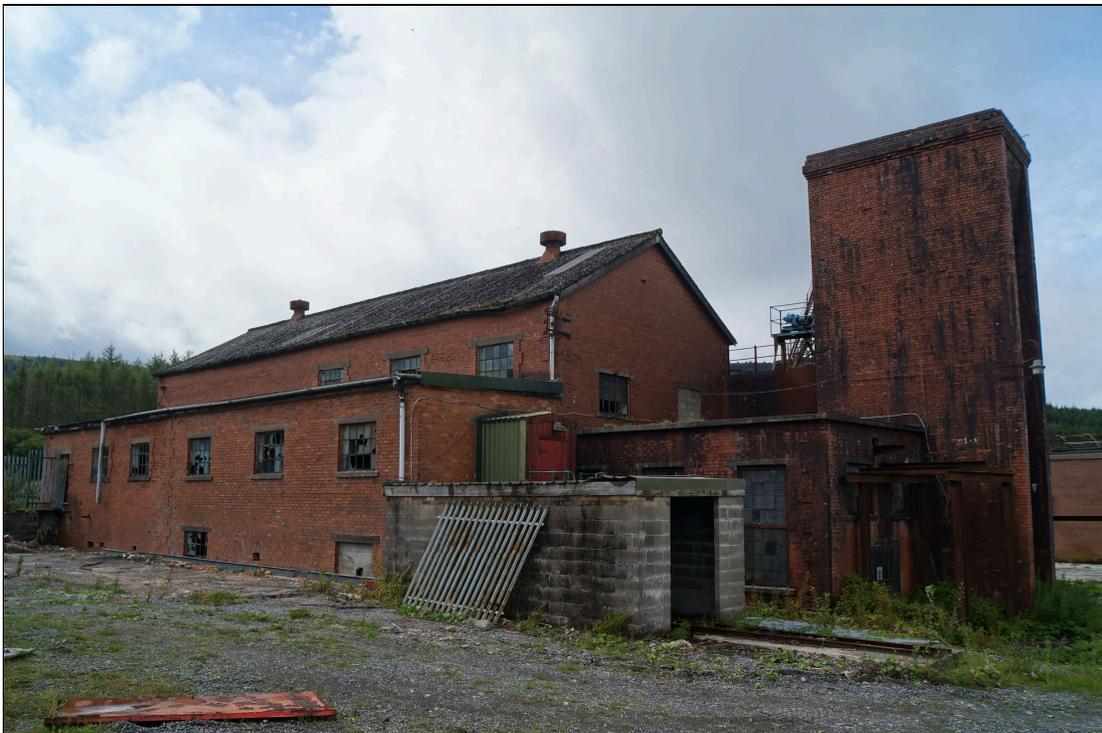
Plate 21: A view of the rear of the Tower Colliery engine house (ID Number 3). The CoasterKart ride would not impede this key view. Looking southwest.

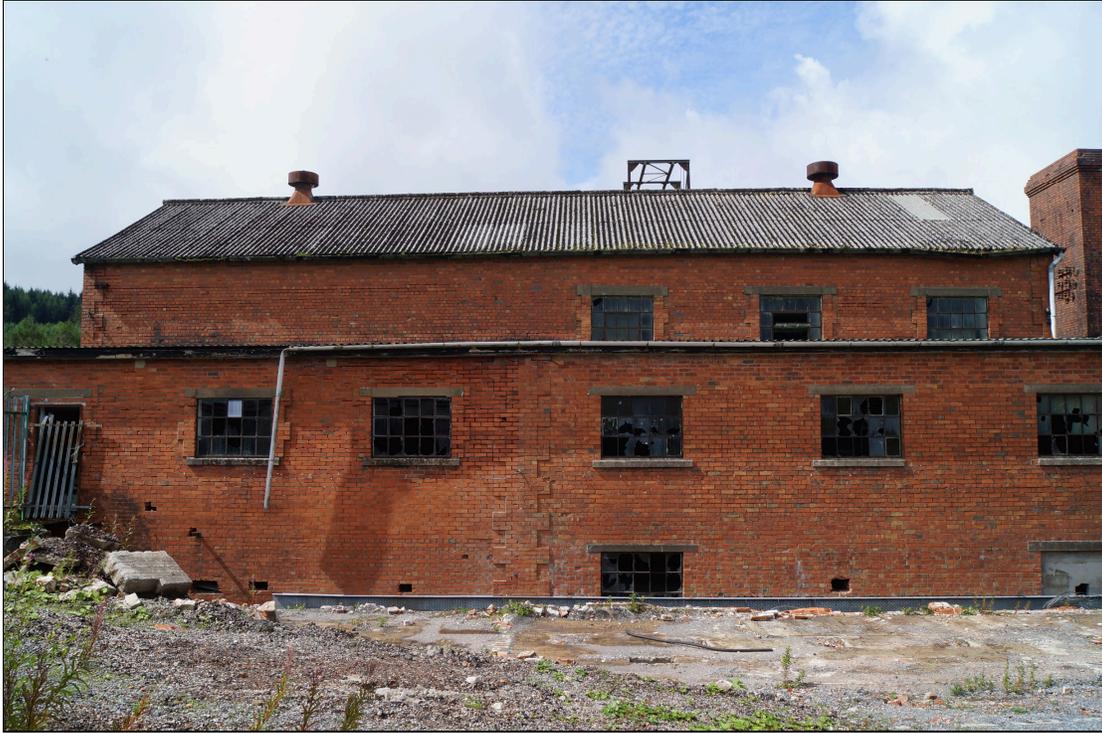
Plate 22: A view of the rear of the Tower Colliery engine house (ID Number 3). The CoasterKart ride would not impede this key view. Looking west.

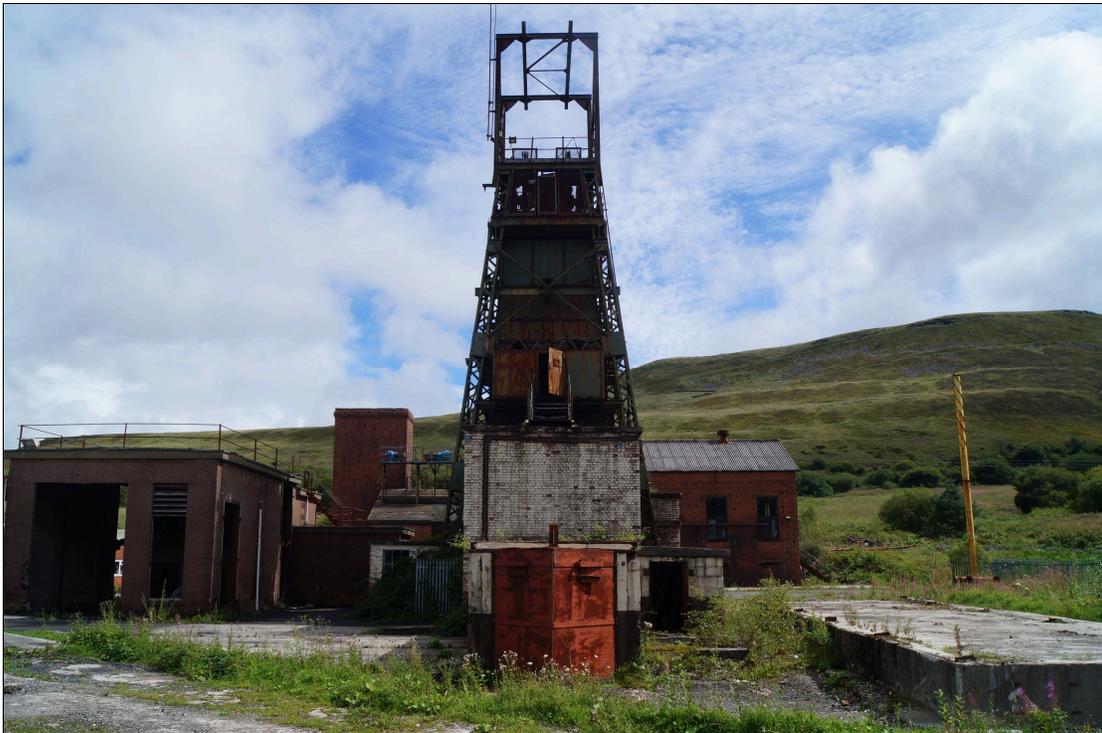
Plate 23: A view of the rear of the Tower Colliery headframe (ID Number 5) with the engine house behind. The CoasterKart ride would be visible in the grassy area to the right of the engine house. Looking east.

- 1.3.3 The proposed development would not cause a direct, physical impact to the headframe or engine house (ID Numbers 4, 5 and 3), see Plates 23, 24, 25, 31, 32 & 37. The impacts the listed buildings were being assessed in a separate report by Cadnant Planning Ltd.

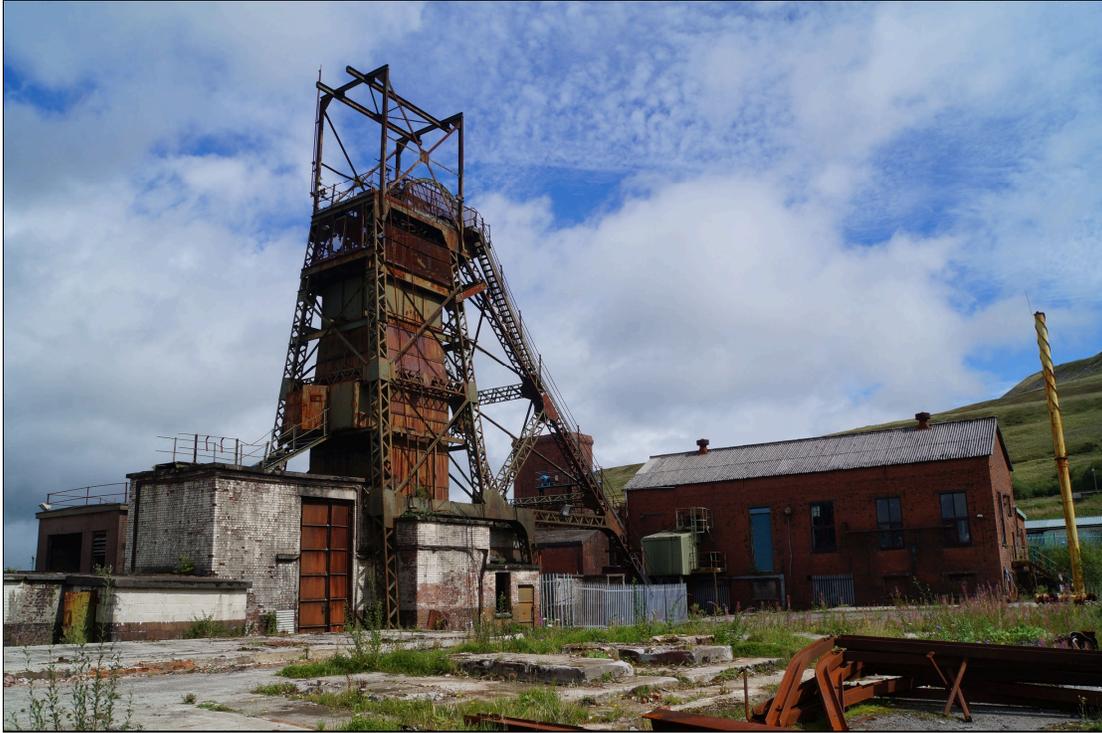
Plate 24: A view of the rear of the Tower Colliery headframe with the engine house behind. The CoasterKart ride would not impede this view. Looking northeast.
