Revised Route for a CoasterKart Development at Tower Colliery, Rhondda Cynon Taff Historic Environment Desk-Based Assessment

Trysor Project No. 2020/769
GGAT HER Event PRN E006630

For: Zip World

February 2021

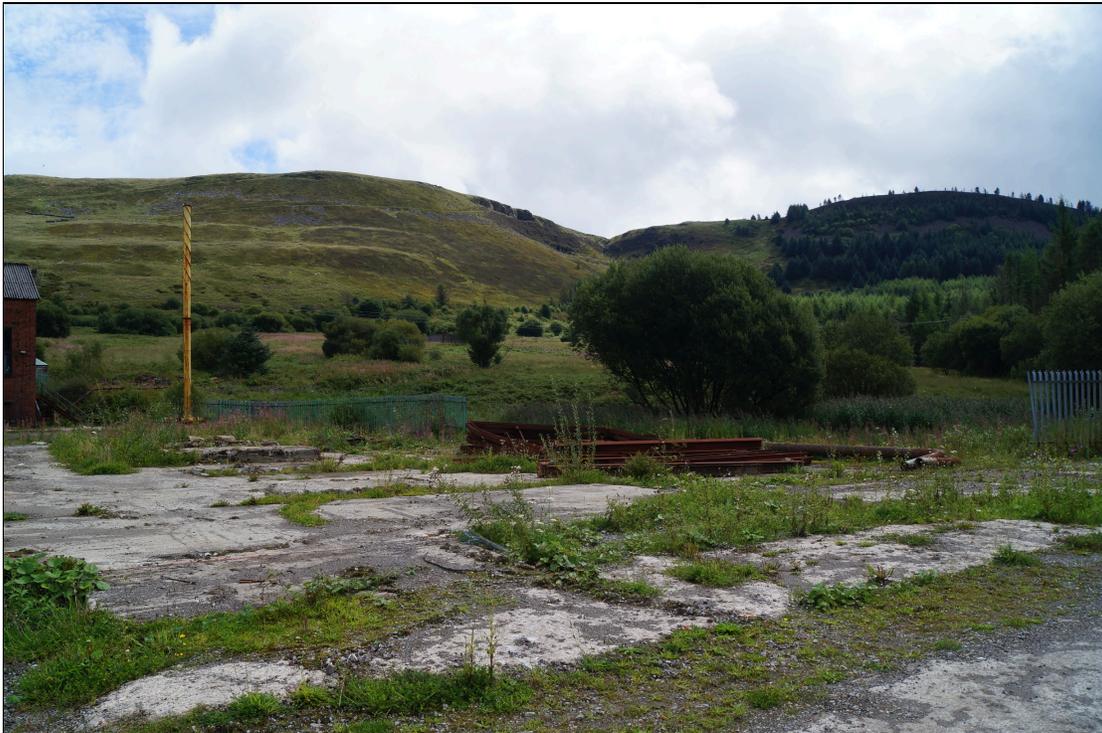
Plate 25: A view of the open area to the south of the Tower Colliery headframe. . The CoasterKart ride would be visible in the grassy area to the left of centre. The southern end of the engine house is just visible to the left. Looking east-southeast.

- 1.3.3 The proposed development would not cause a direct, physical impact to the headframe or engine house (ID Numbers 4, 5 and 3), see Plates 23, 24, 25, 31, 32 & 37. The impacts the listed buildings were being assessed in a separate report by Cadnant Planning Ltd.

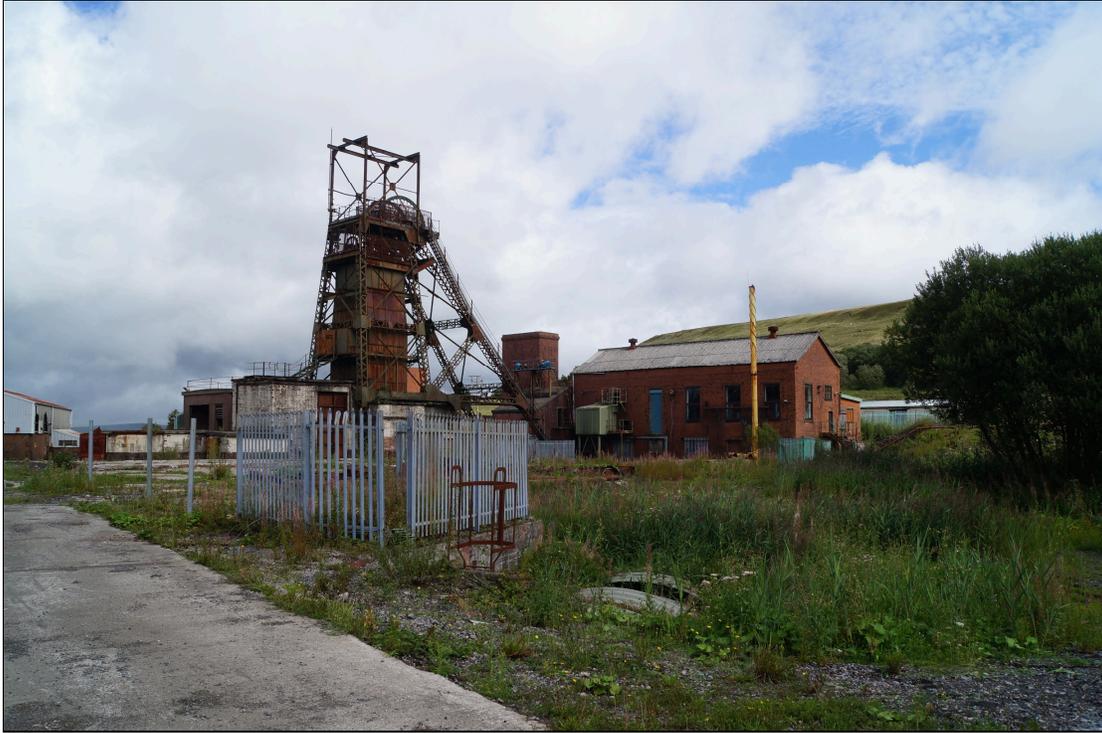
Plate 30: A view of the headframe and engine house Tower Colliery. The CoasterKart ride would not impede this view. Looking northeast.

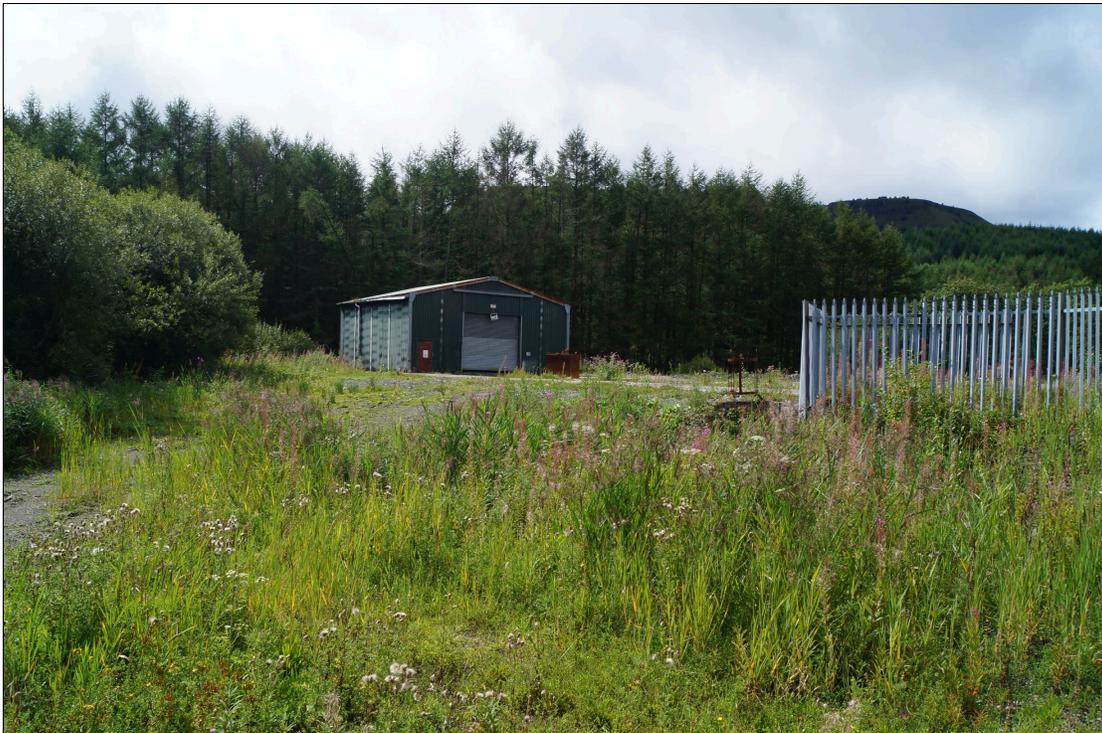
Plate 31: A view of a modern steel-framed building at the southern end of the colliery complex. The ground here is all built up with deposits of waste dating from the early history of the colliery. The CoasterKart ride would not enter this area. Looking southwest.

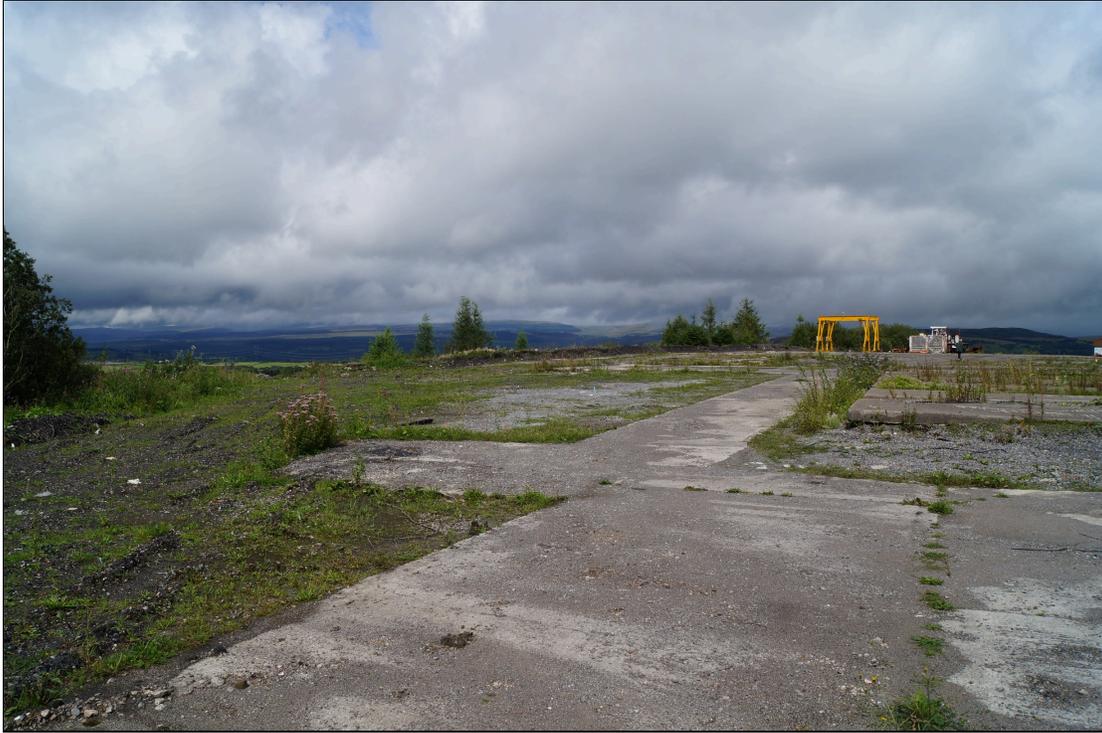
Plate 32: A view of the open area to the southwest of the headframe and engine house at Tower Colliery. The ground here is all built up with deposits of waste dating from the early history of the colliery. Looking north-northwest.

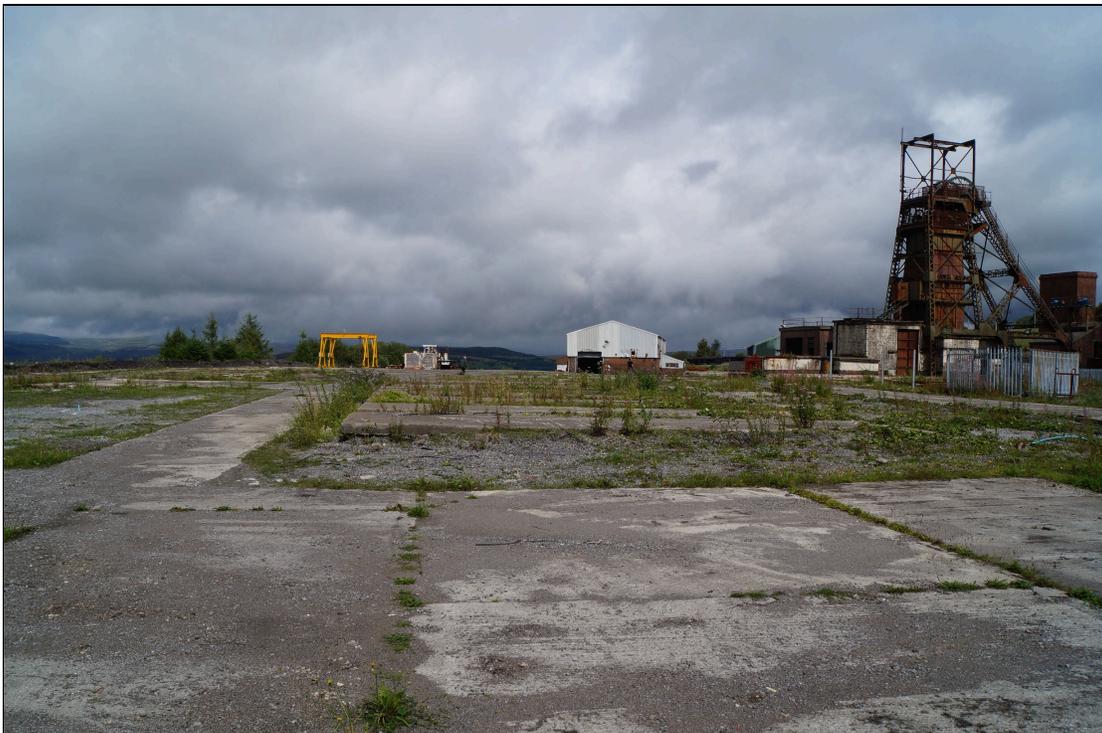
Plate 33: A view of the open area to the southwest of the headframe and engine house at Tower Colliery. The ground here is all built up with deposits of waste dating from the early history of the colliery. Looking north.

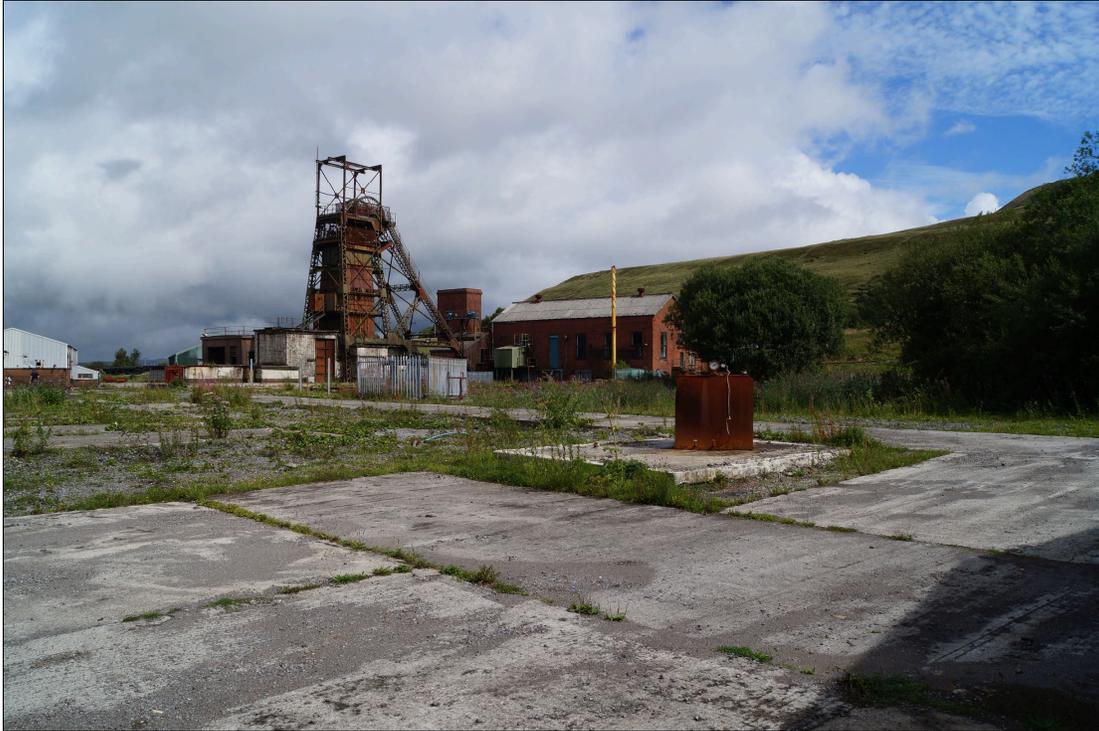
Plate 34: A view of the open area to the southwest of the headframe and engine house at Tower Colliery. The ground here is all built up with deposits of waste dating from the early history of the colliery. Looking northeast.

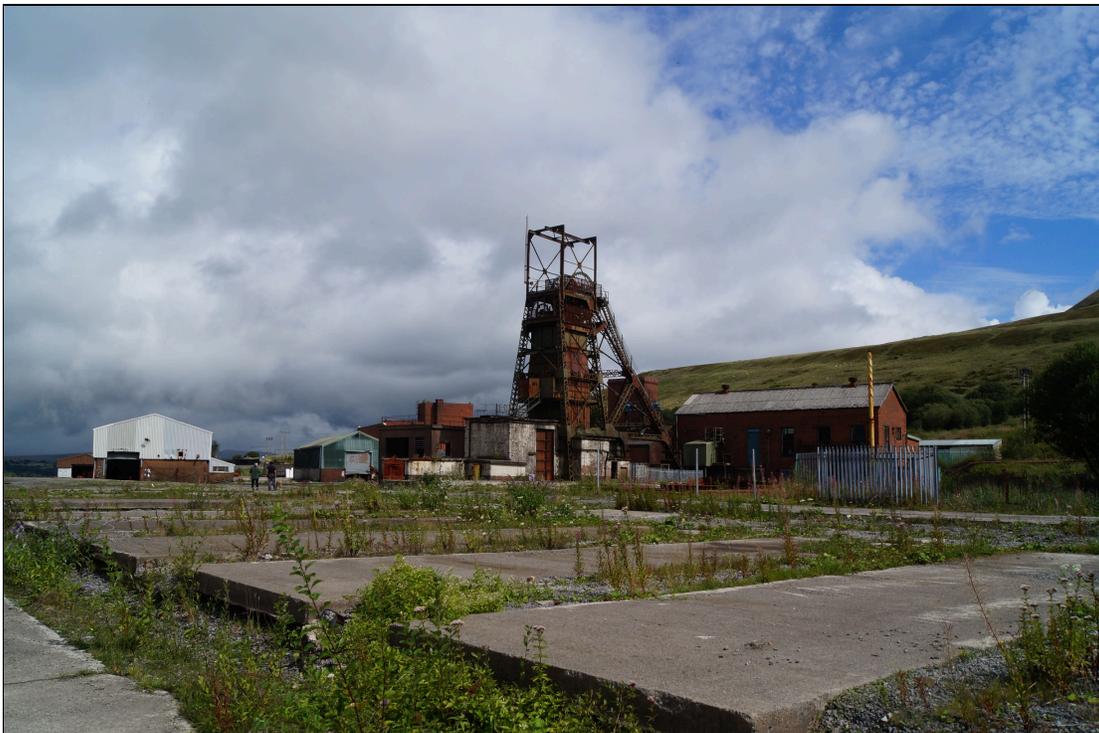
Plate 35: A view of the open area to the southwest of the headframe and engine house at Tower Colliery. The CoasterKart ride would just be visible to the right of the buildings where the light coloured shed can be seen at present. Looking northeast.

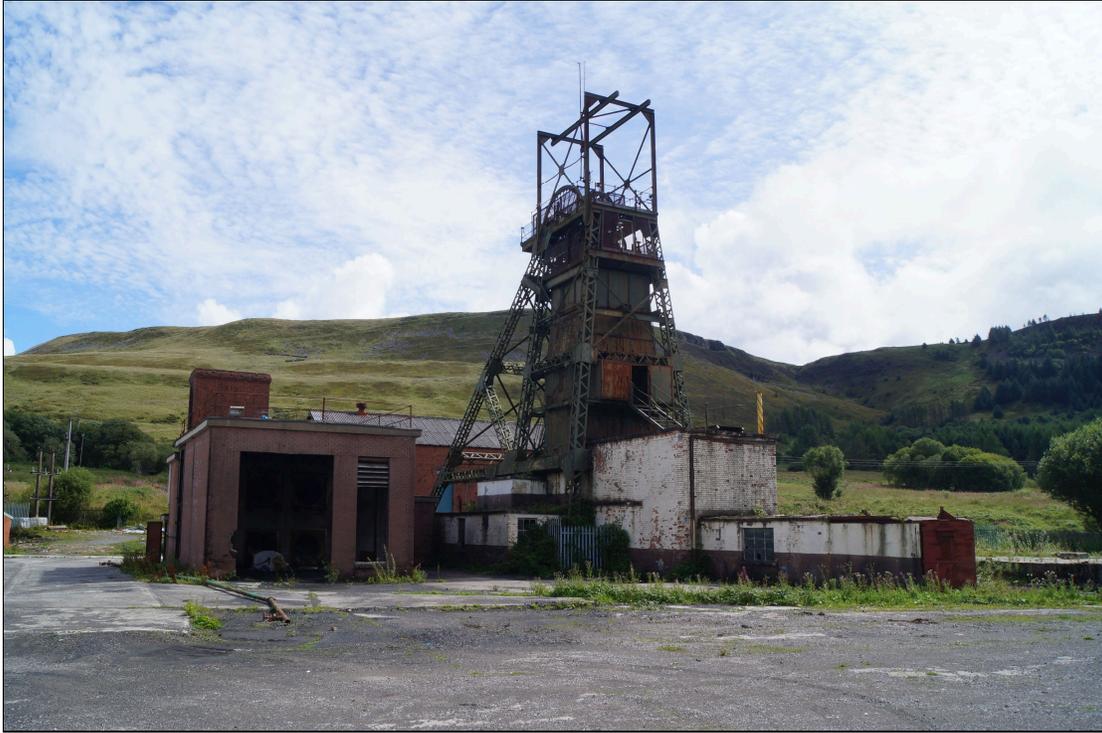
Plate 36: A view of the headframe at Tower Colliery. The CoasterKart ride would be visible to either side of the structures from this direction. Looking east-southeast.

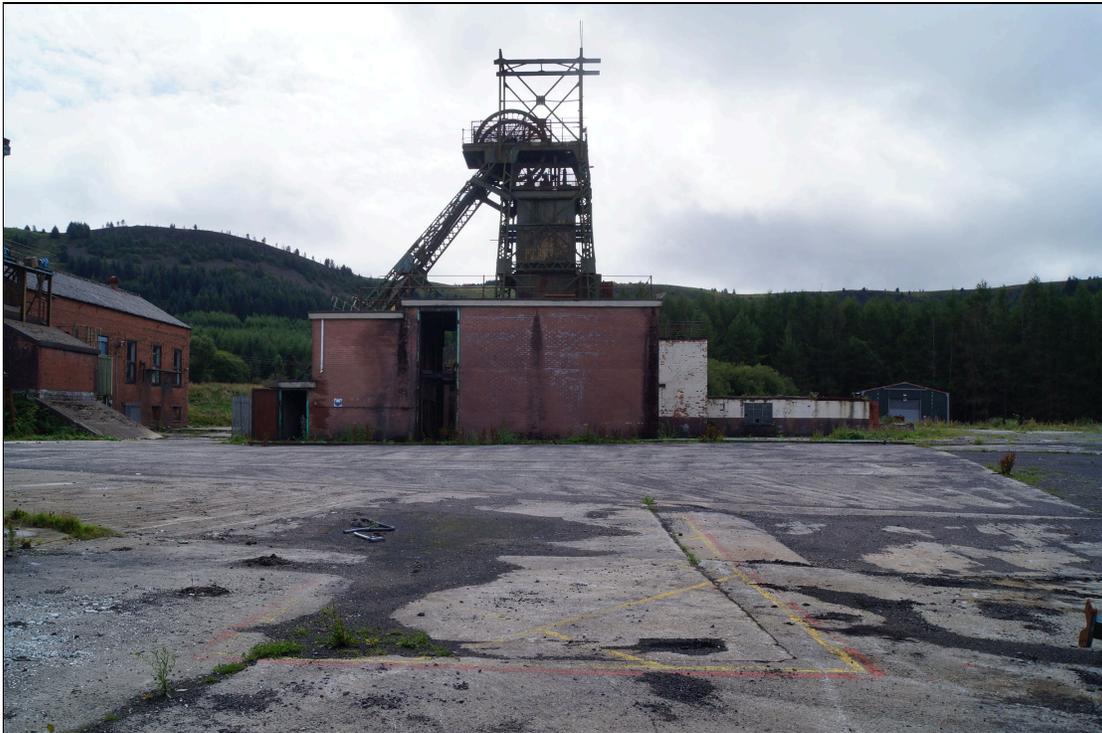
Plate 37: A view of the headframe at Tower Colliery. The CoasterKart ride would not impede this view. Looking south.

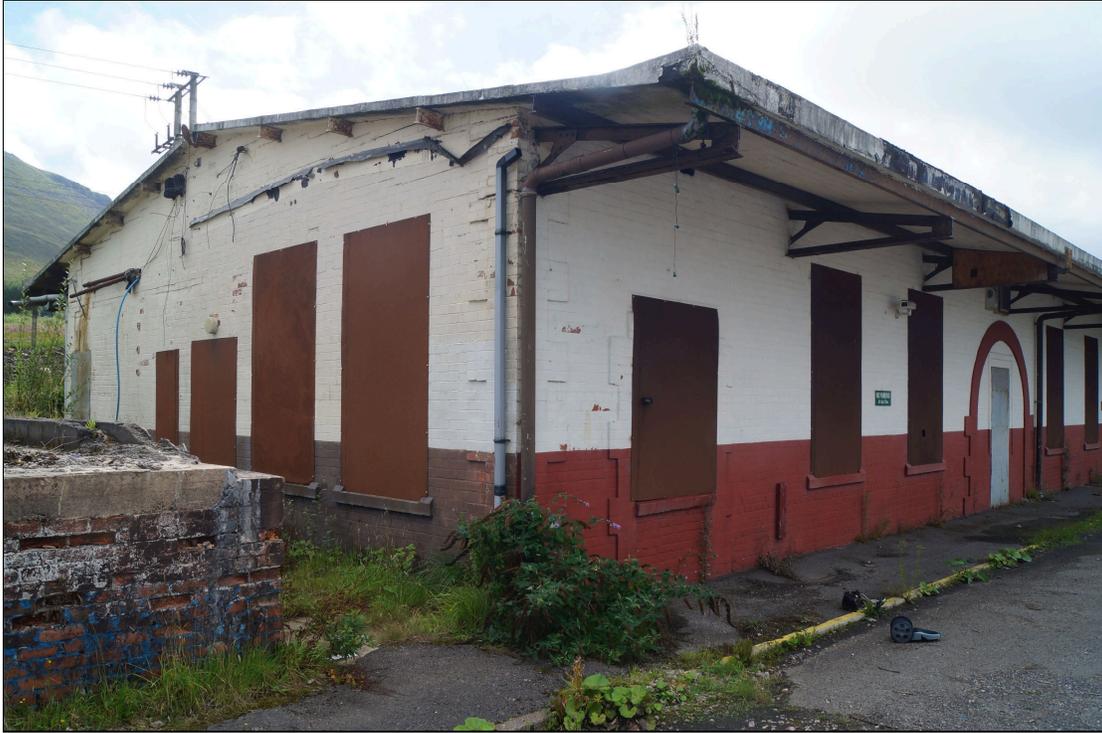
Plate 38: A view of the northeastern end of the original lamproom and office building at Tower Colliery. The small opening to the left in the gable wall was the window of the pay office, where miners collected their pay packets. This end of the building housed the offices of the mine manager and senior staff.

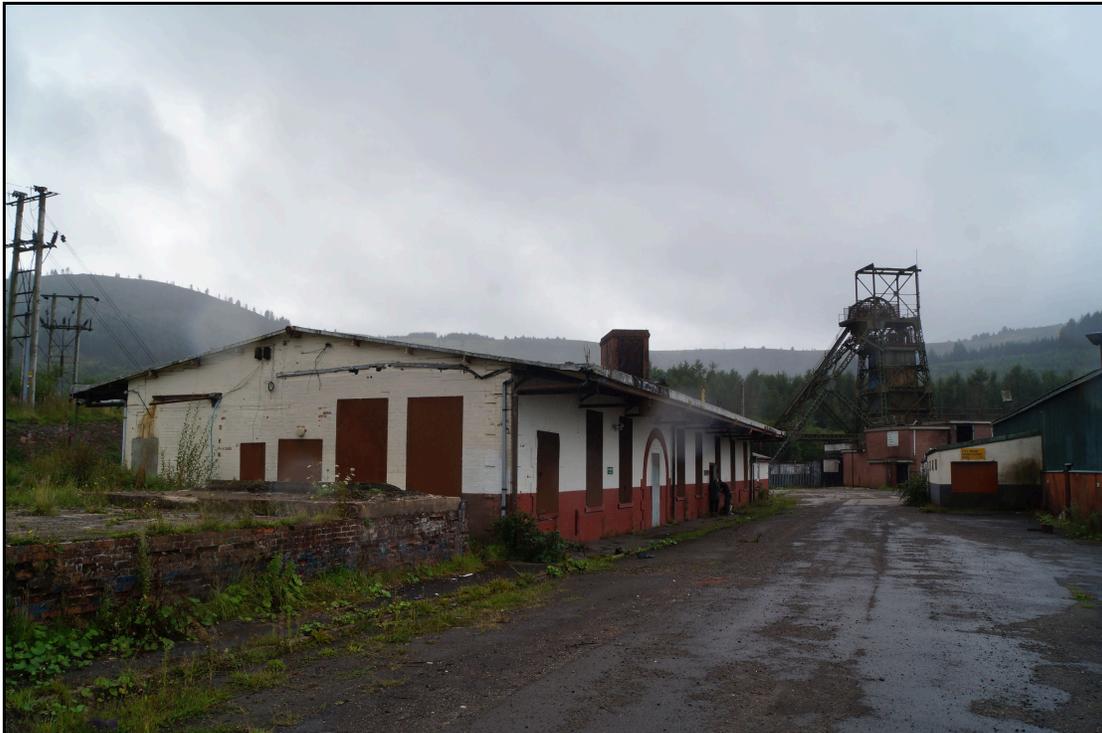
Plate 39: A view of the Tower Colliery lamp room and office building, with the No.4 shaft headframe in the distance. The proposed route of the CoasterKart ride would require an opening be made in the centre of the gable wall of the lamp room building. Looking south.

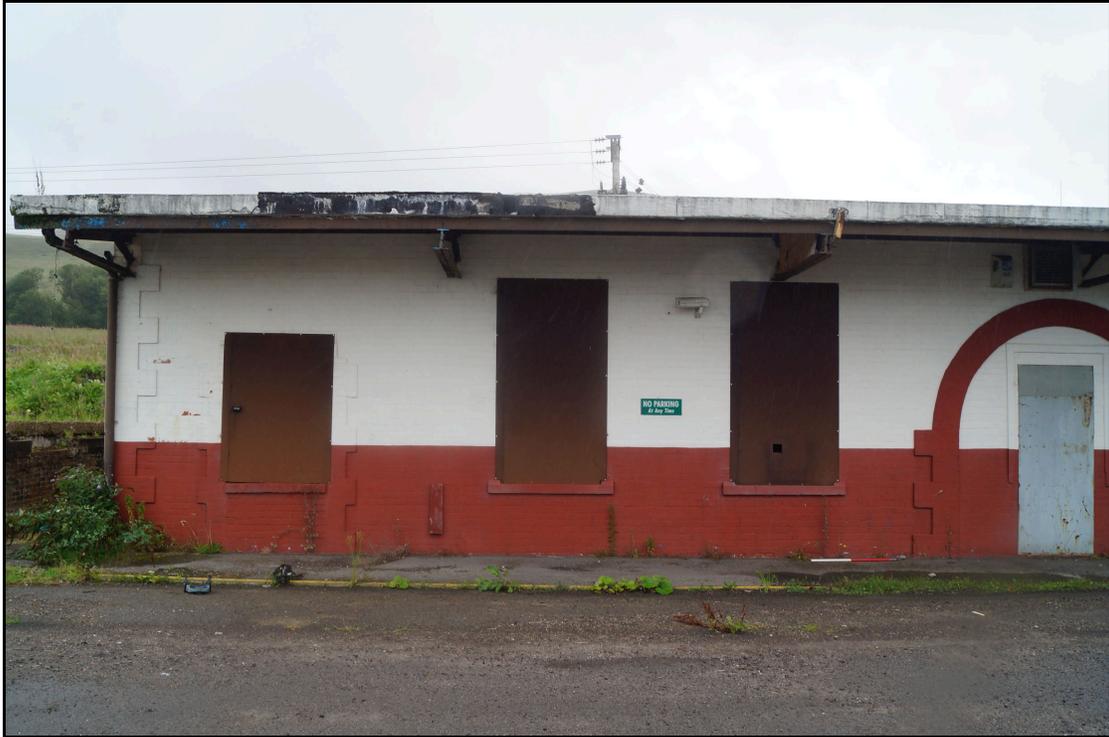
Plate 40: A view of the northern end of the northwest elevation of the lamp room. The large windows of the managers' offices are shuttered. Looking southeast.

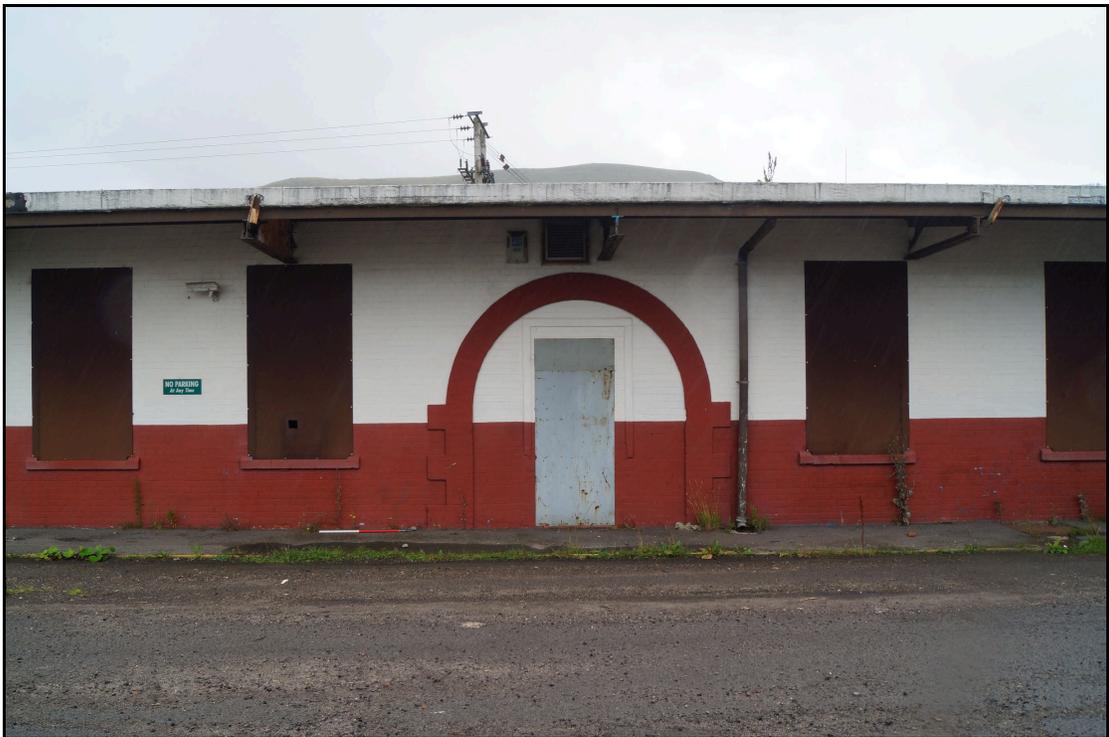
Plate 41: A view of the brick archway in the northwest elevation of the lamp room. An open ended passage ran through the building here, dividing the lamp room to its right from the colliery offices to its right. It was blocked up during the later 20th century when the office space was extended. Looking southeast.

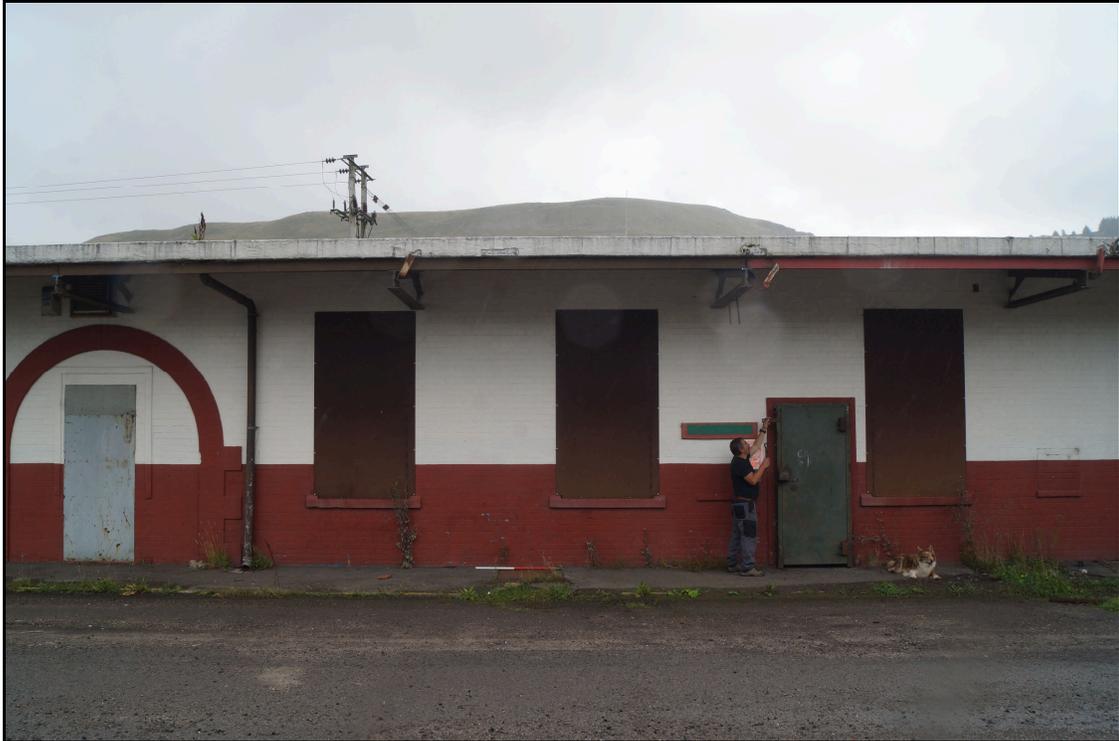
Plate 42: A view of the centre of the northwest elevation of the lamp room. The large windows of the lamp room are shuttered and the small hatches where safety lamps were passed out to miners walking to the pithead at the start of their shift can be seen as bricked-up features between the shuttered windows. Looking southeast.

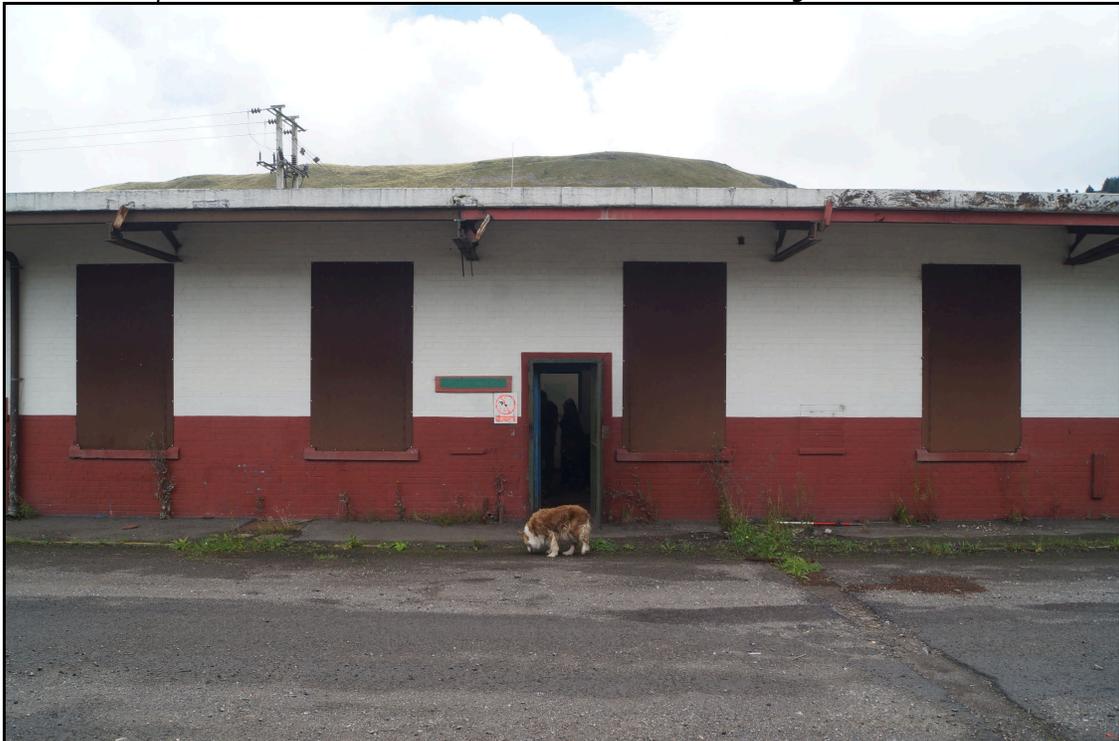
Plate 43: A view of the southern end of the northwest elevation of the lamp room. The large windows of the lamp room are shuttered and the small hatches where safety lamps were passed out to miners walking to the pithead at the start of their shift can be seen as bricked-up features between the shuttered windows. Looking southeast.

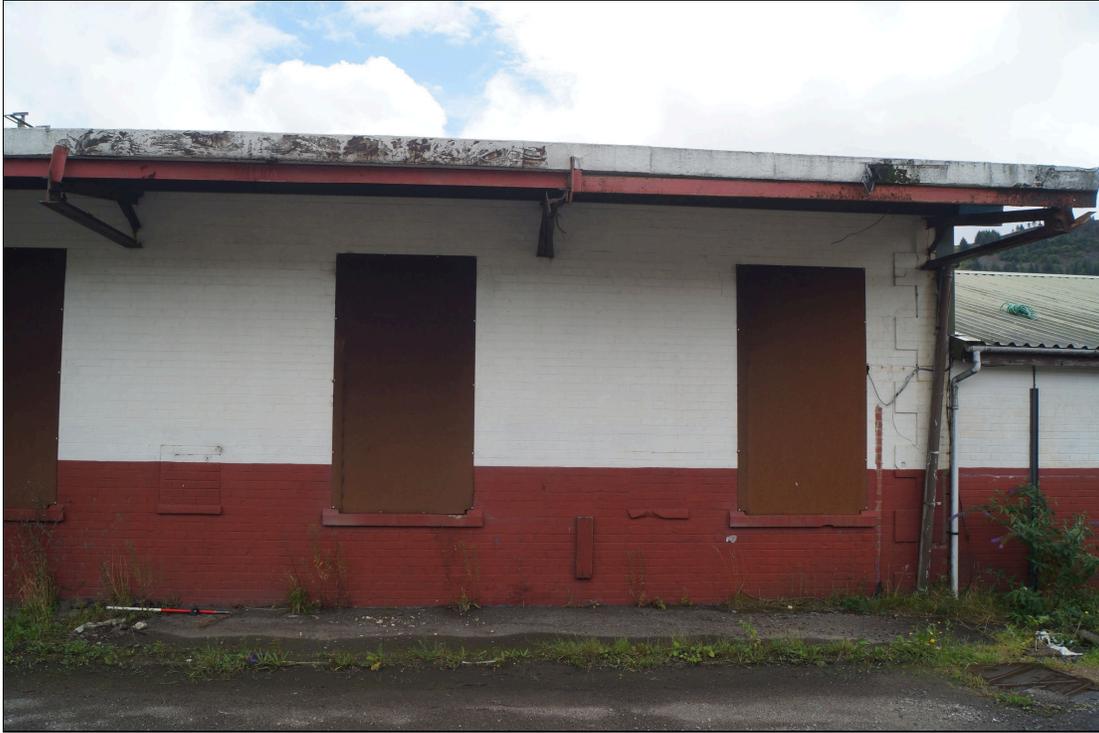
Plate 44: A view of the southern end of the northwest elevation of the lamp room. The large windows of the lamp room are shuttered and the small hatches where safety lamps were passed out to miners walking to the pithead at the start of their shift can be seen as bricked-up features between the shuttered windows. Looking southeast.

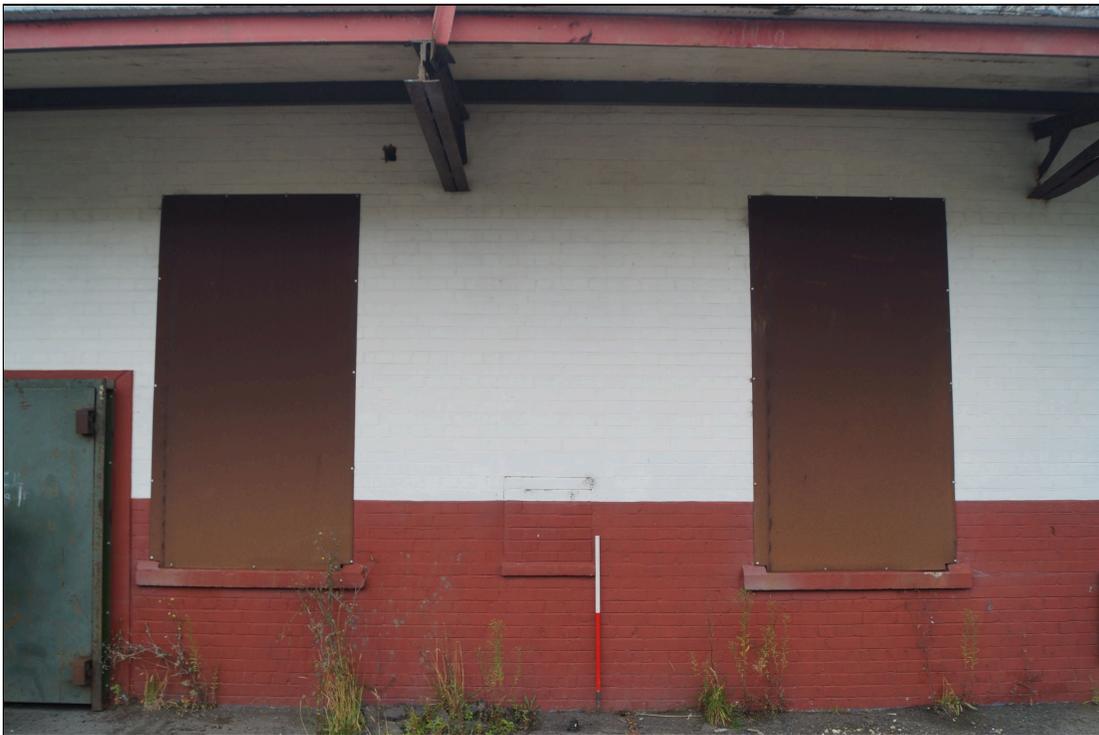
Plate 45: A view of shuttered windows and a bricked-up hatch in the northwest elevation of the lamp room. Looking southeast.

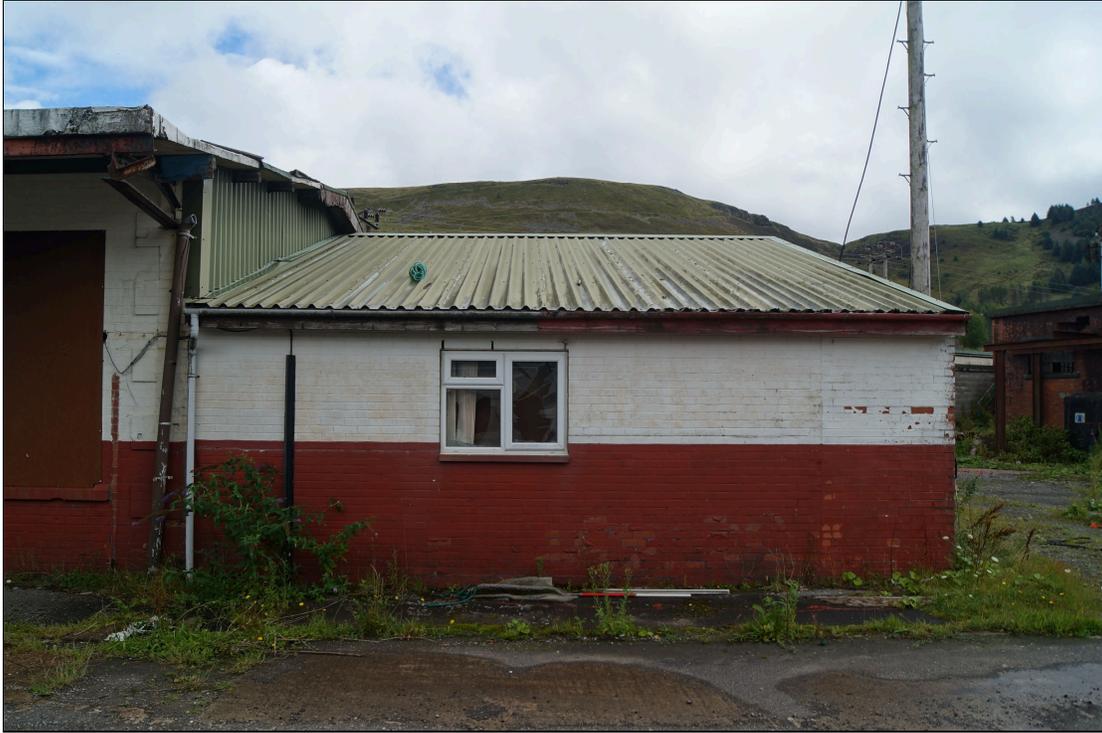
Plate 46: A view of a later 20th century office added to the southwest end of the lamp room. This building dates to the later stages of the mines' history. Looking southeast.

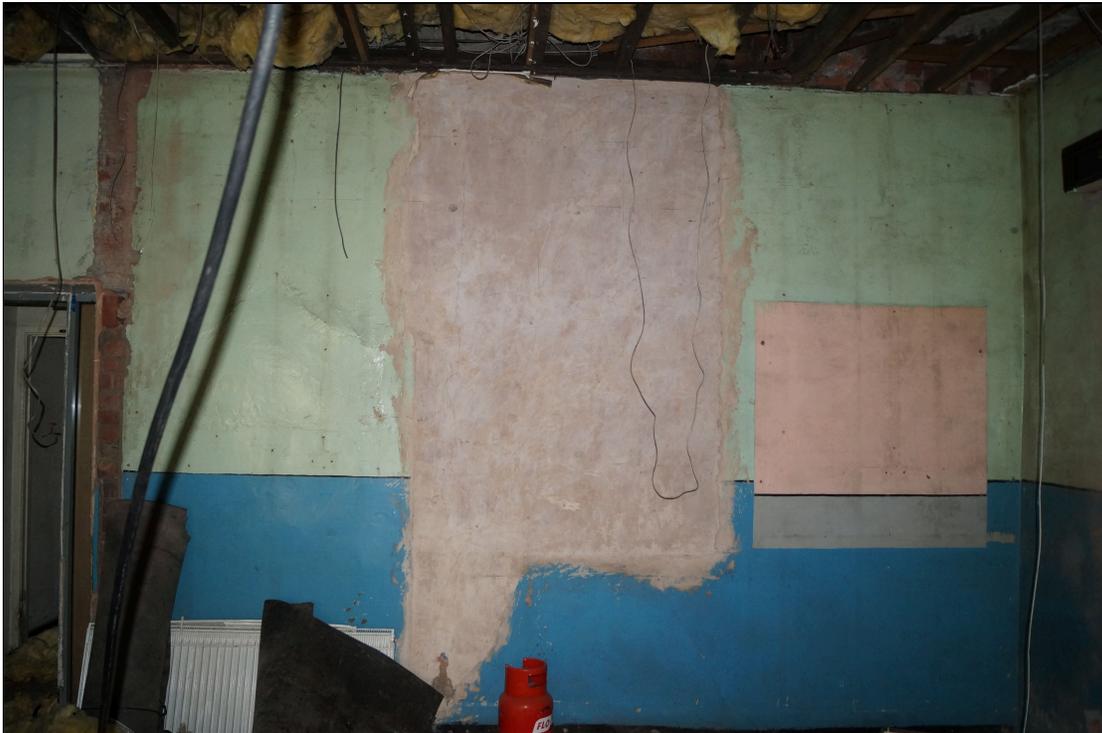
Plate 47: A view inside the lamp room showing later 20th century partitions added when the lamp room was moved to the pithead baths building, allowing for the whole of the original lamp room to be used as office space. Looking northeast.

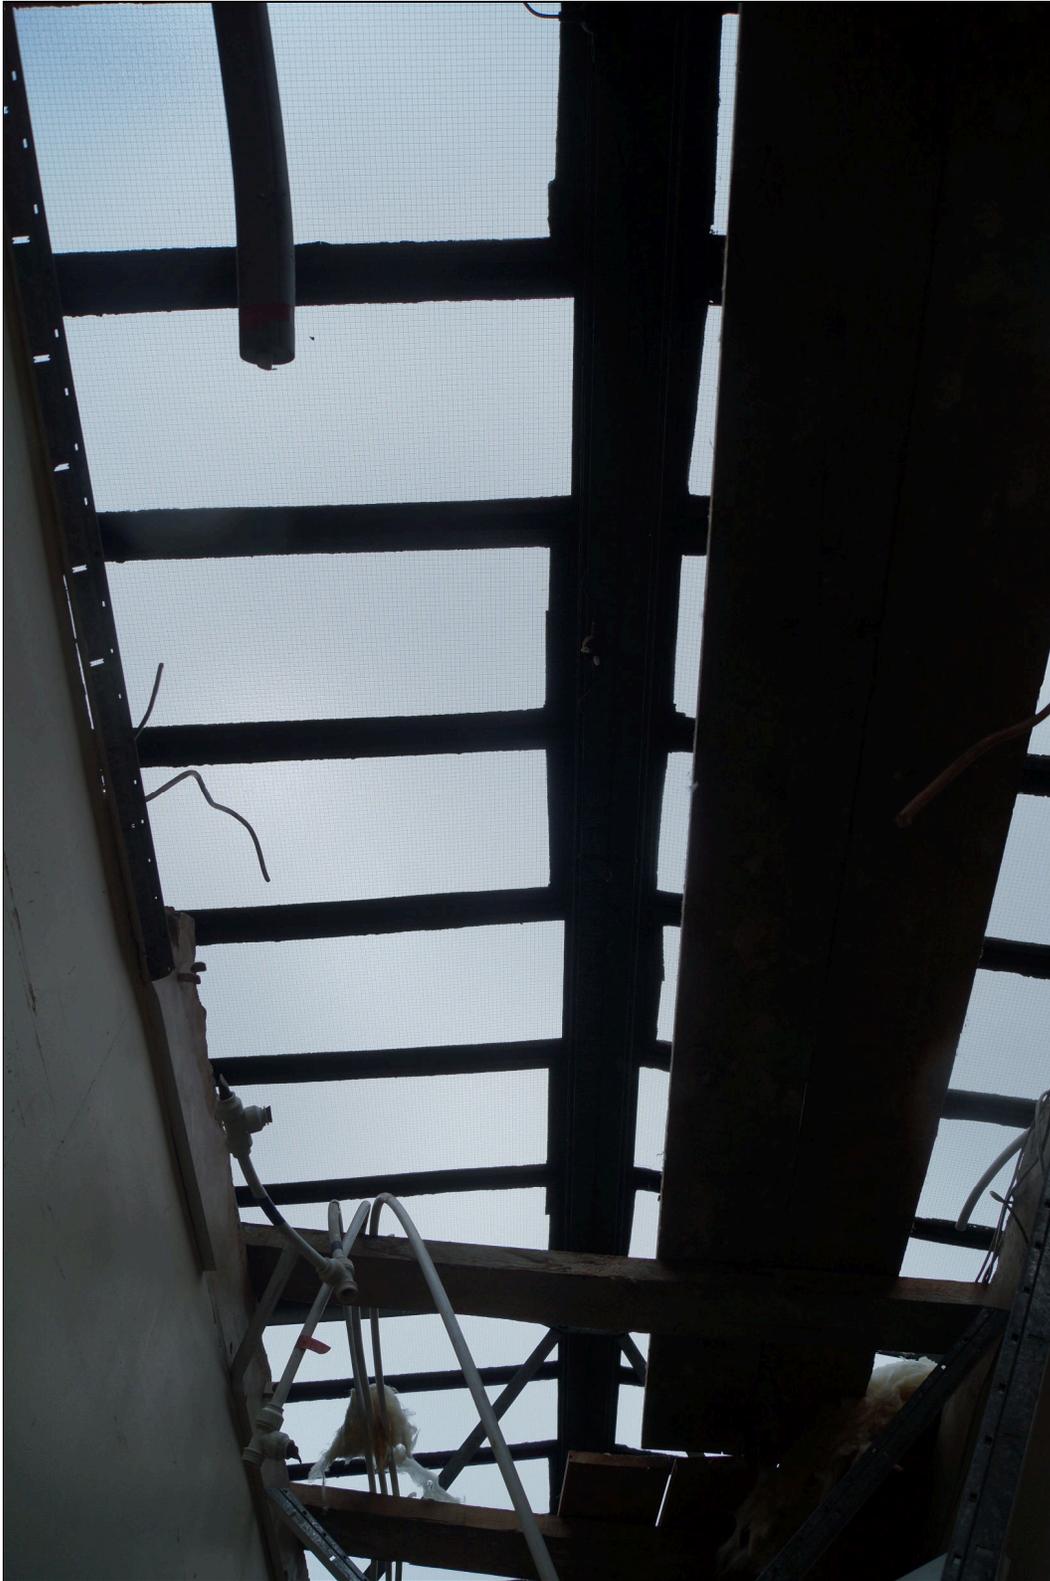
Plate 48: A view of the large skylight taken from inside the lamp room. The glass roof increased the light entering the lamp room, where the important work of preparing safety lamps for miners to take on their underground shift was carried out. Looking southwest.

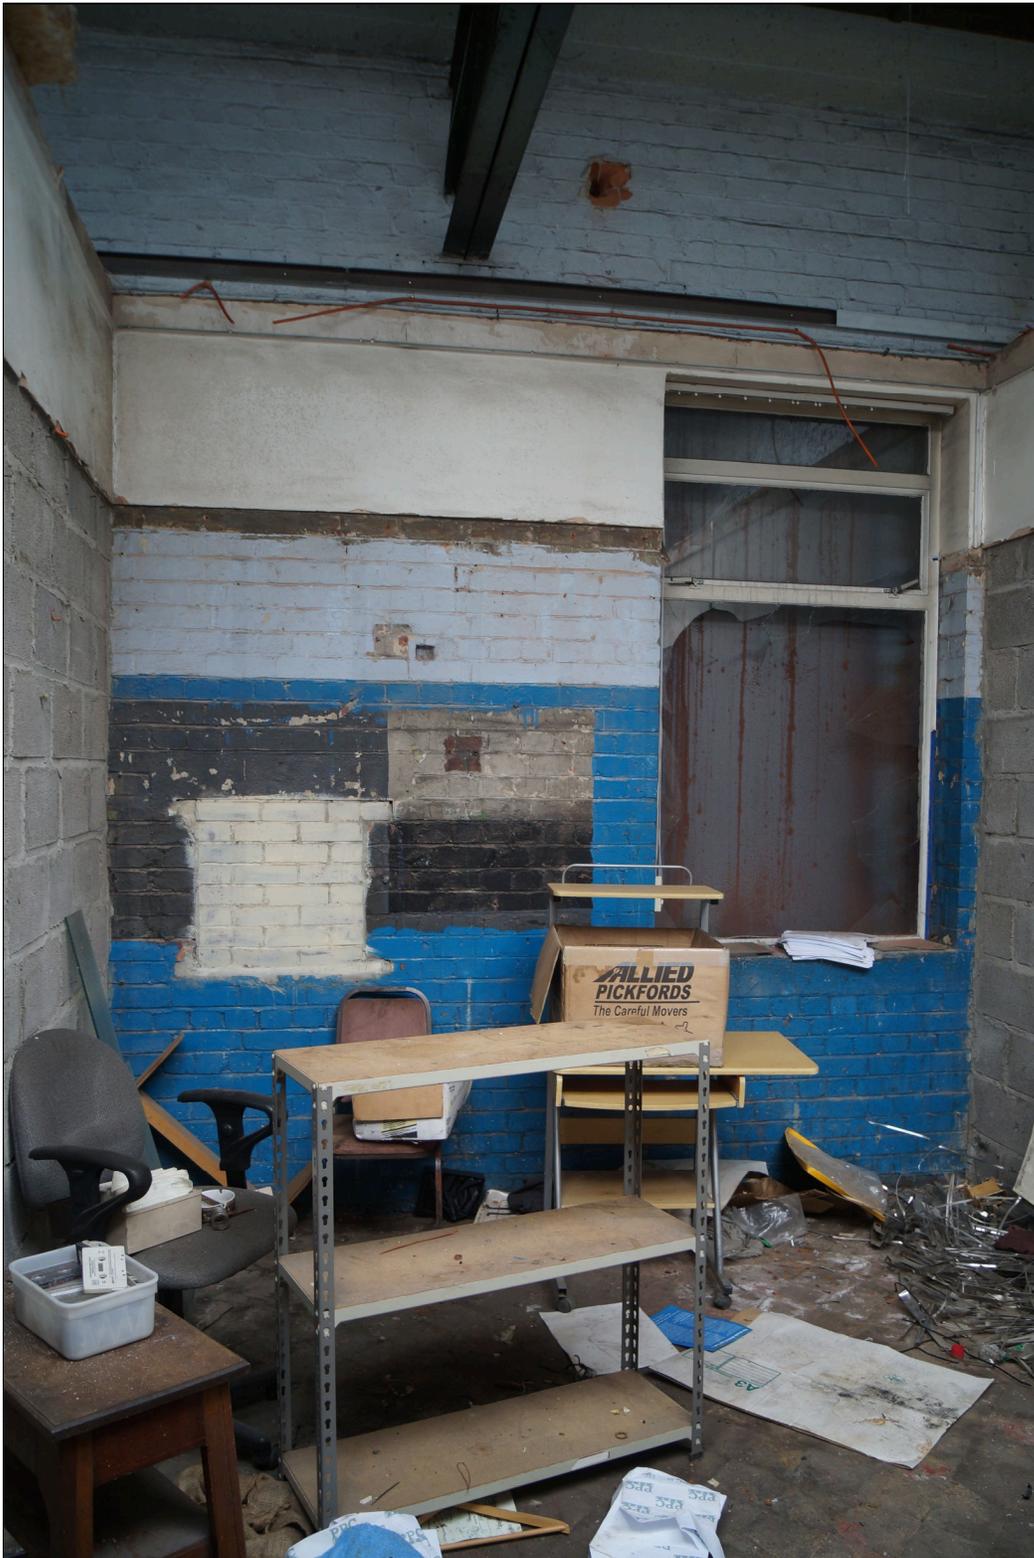
Plate 49: A view of the original lamp room showing a shuttered window and bricked-up hatch from the inside the building. Looking northwest.
