# Masonry Wall Collapse and Repair Neath Castle SAMGm039

## 3D Photogrammetric Survey, Archaeological Watching Brief and Historic Building Record

Prepared for  
**Hurley & Davies Ltd**  
On behalf of  
**Neath Town Council**  
10/12 Orchard Street,  
Neath, SA11 1DU  
By  
**Black Mountains Archaeology Ltd**  
23<sup>rd</sup> February 2023  
Report No.281

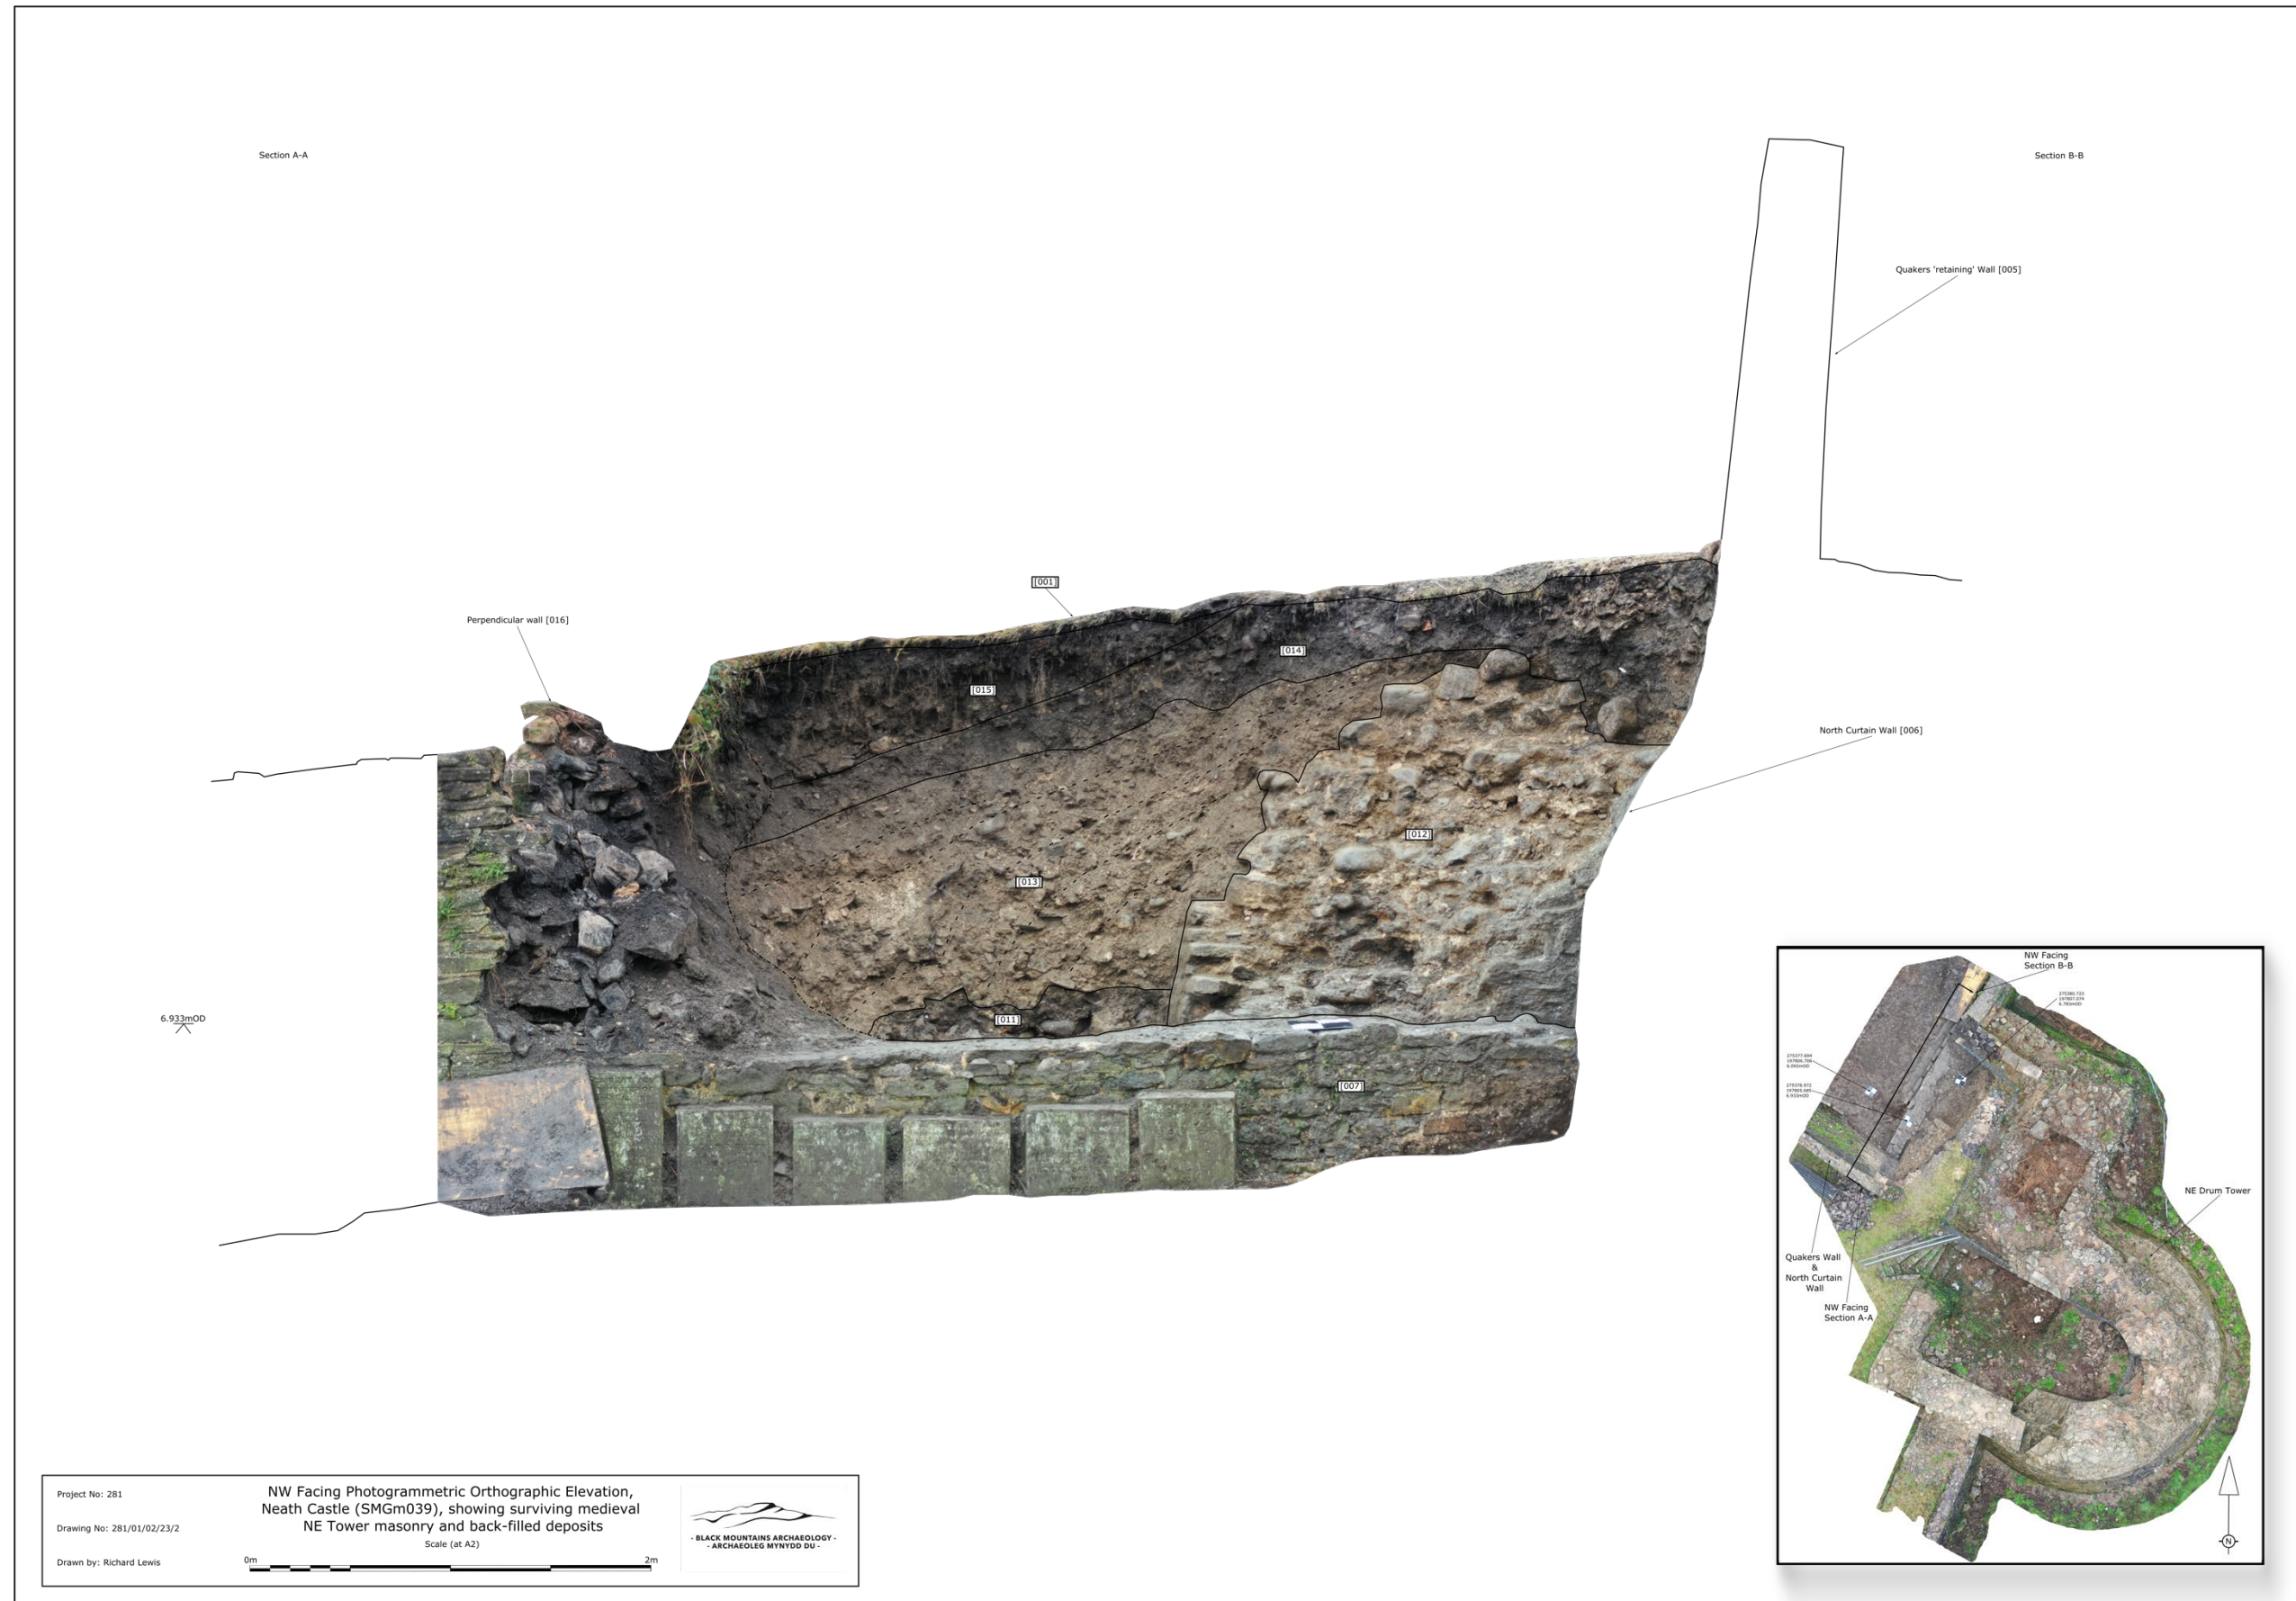
Figure 6. Post-excavation 3D photogrammetric orthographic elevation showing the masonry of the Northeast Tower [012], medieval deposits (011) and later back-filling deposits (013, 014 and 015), Neath Castle (SMGm039).

- 6.5.1 The 5.5m wide section collapsed almost immediately following the dismantling of the Boundary Wall [007] (see above) due to the very soft and friable nature of the back-filled deposits. The section revealed by this collapse was cleaned by hand, and it was noted that further archaeological features and deposits were present. The principal discovery being the previously unrecorded masonry remains of the medieval Northeast Tower and an *in-situ* medieval deposit, possibly a palaeo-horizon (historic ground surface).

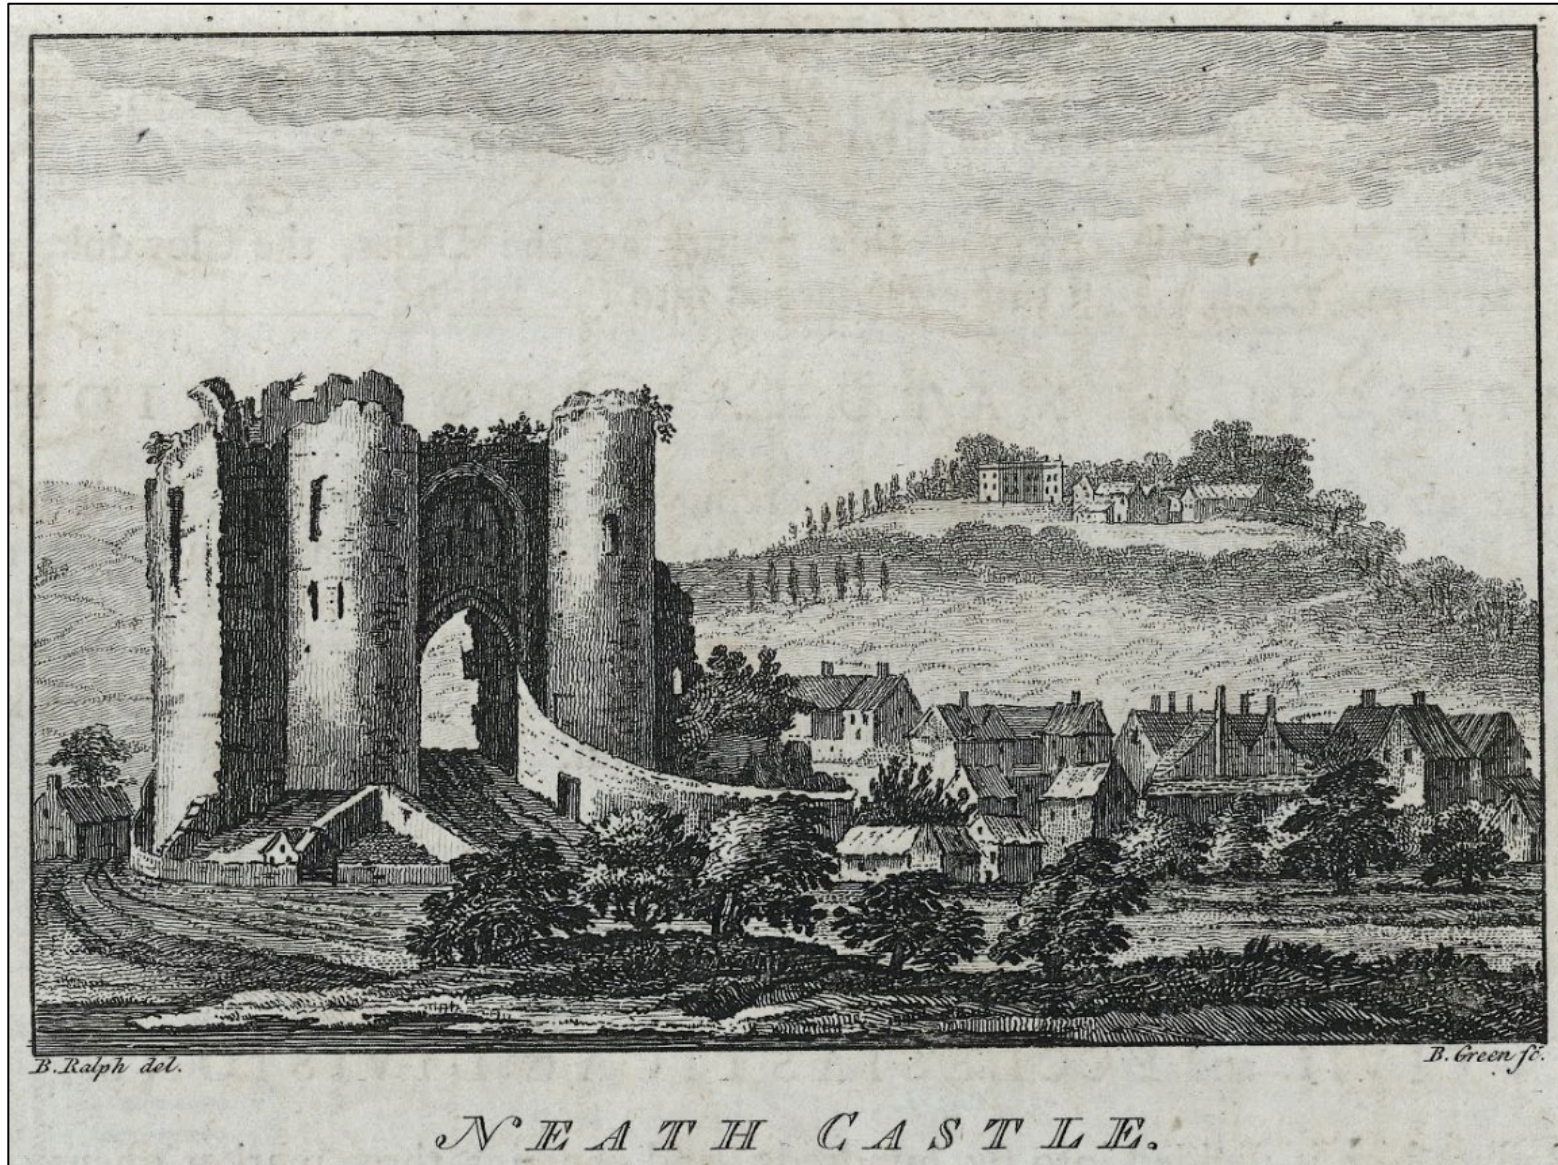
Plate 2. 1760 Neath Castle by Benjamin Ralph. National Library of Wales, Public domain, via Wikimedia Commons.

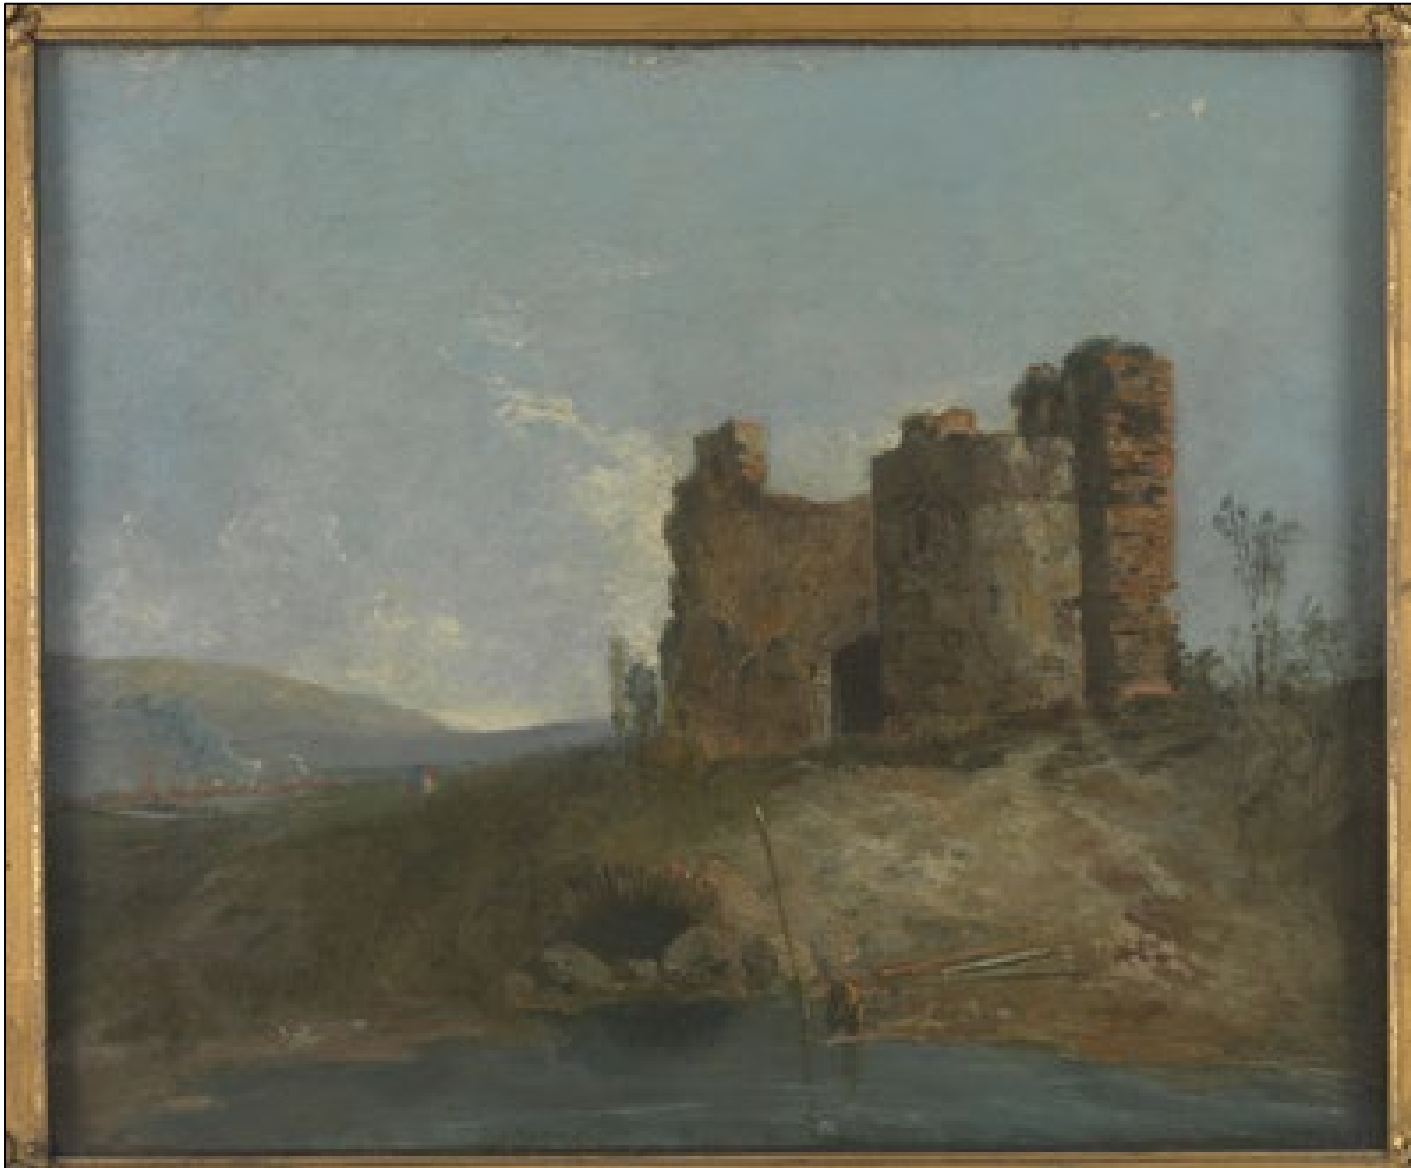
Plate 3. 1765-70 Neath Castle Glamorganshire, by Richard Wilson, Public domain via Wikimedia Commons.

- 2.1.10 Richard Wilson's painting dating to around 1765-70 (Plate 3) shows a view to the northeast of the gatehouse and south curtain wall. An arched culvert is visible on

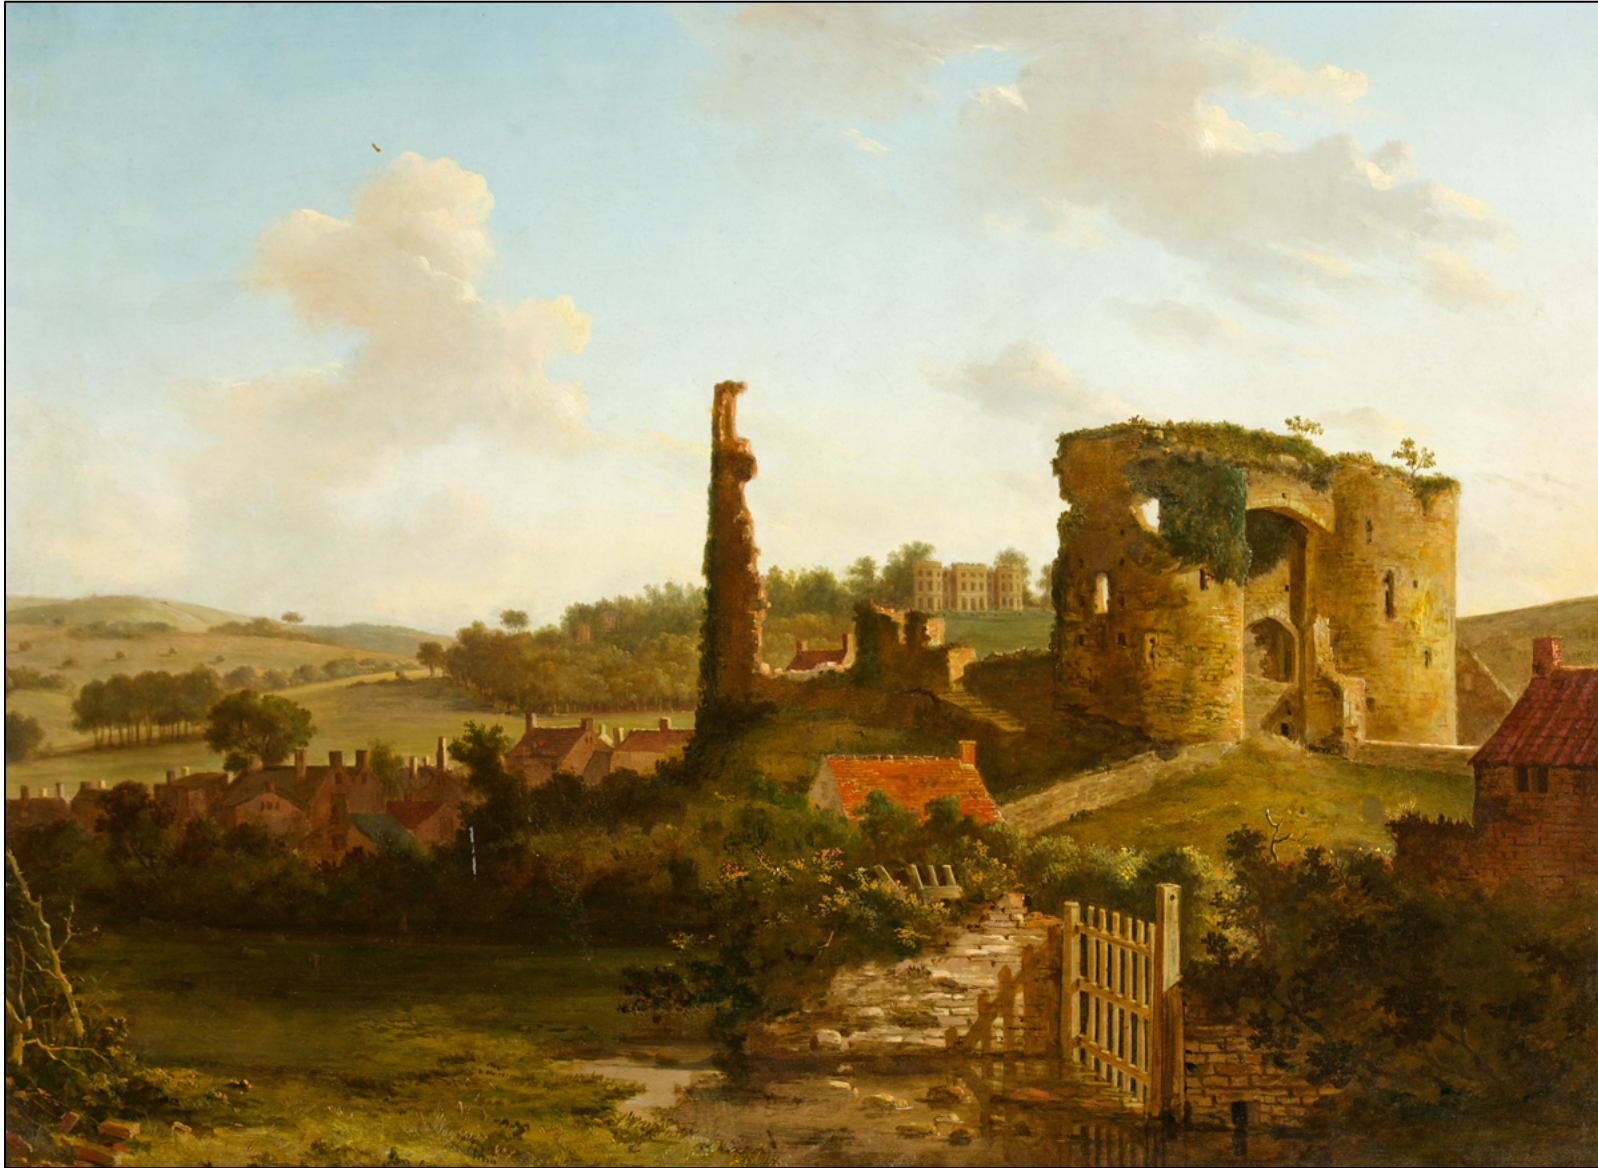
Plate 4. 1790-1810 Neath Castle by Hendrik-Frans De Cort, The Gnoll and Castle at Neath, Public domain, via Wikimedia Commons.

- 2.1.11 Hendrik-Frans De Cort's painting of Neath Castle 1790-1810 (Plate 4) is very detailed, capturing the The Gnoll artistically framed through the north curtain wall of the castle. The square tower against the northwest gatehouse drum tower has disappeared, presumed collapsed at this time. The north curtain wall is shown standing to several metres in height and the northeast drum tower is shown with just one wall standing but this wall is higher than the gatehouse. The small house with a pitched roof is shown here again, with red tiles, close to where the Friends Meeting House Burial Ground is and the end of Castle View.

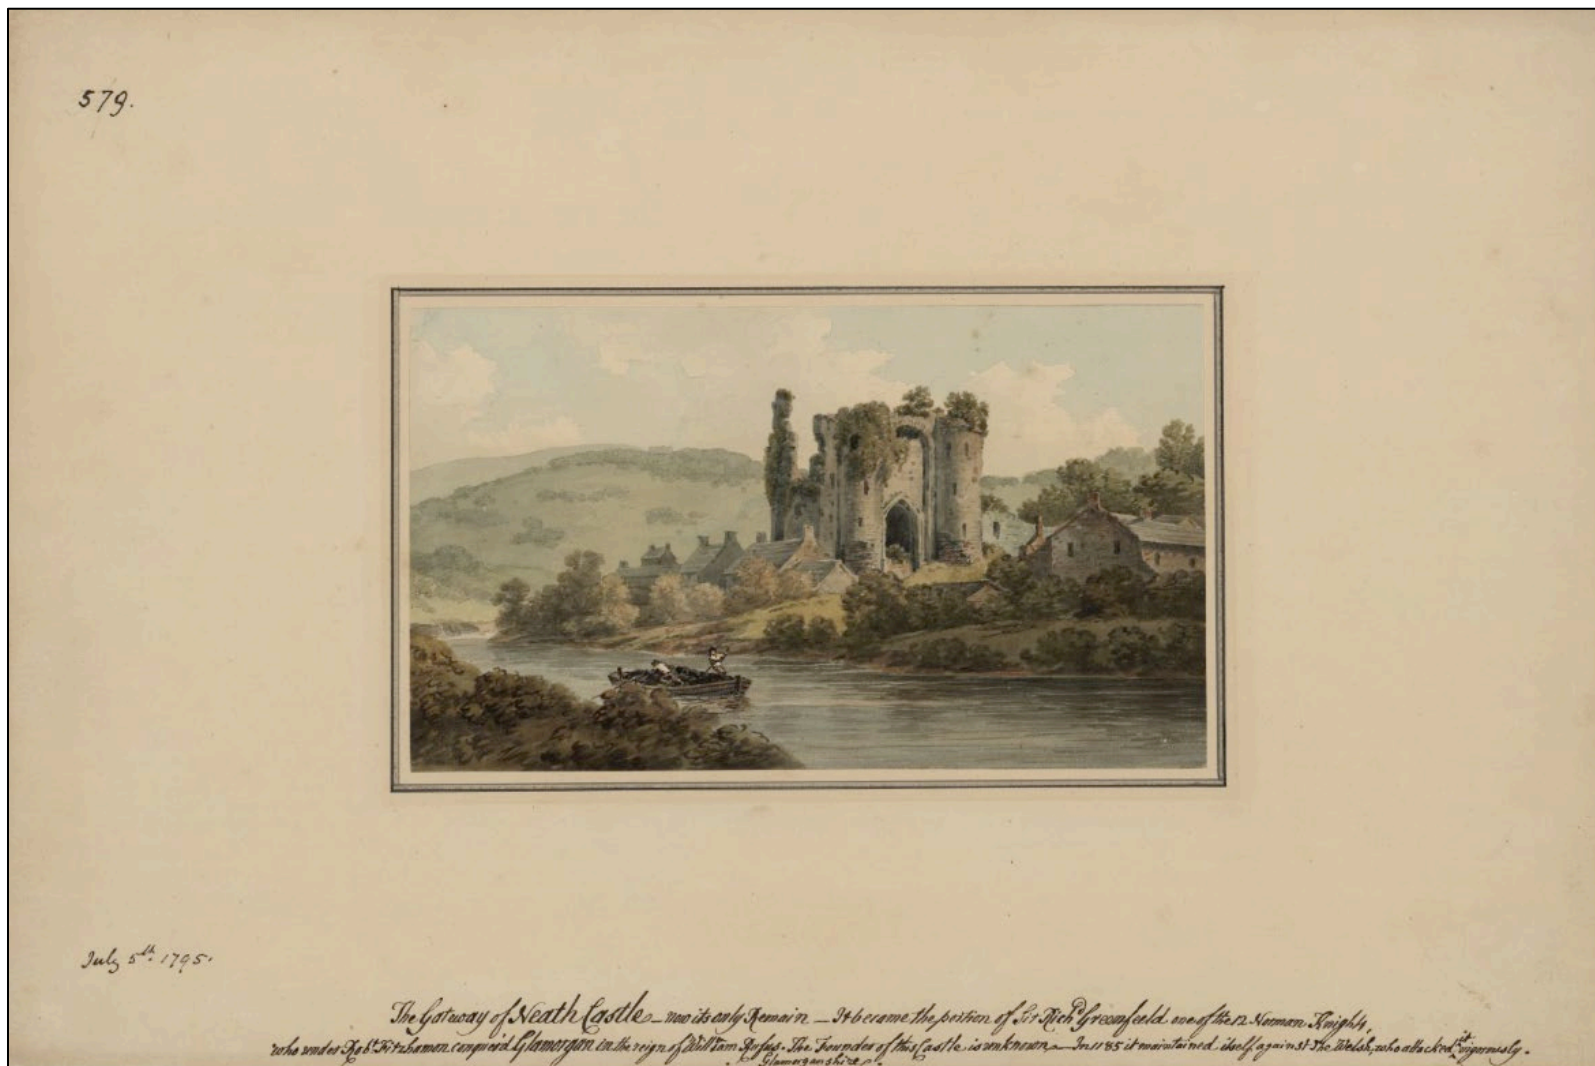
Plate 5. 5<sup>th</sup> July 1795 Neath Castle by Warwick Smith. National Library of Wales, Public domain, via Wikimedia Commons.

- 2.1.12 Warwick Smith, a prolific 18<sup>th</sup> century landscape painter, has dated his painting of Neath Castle to the 5<sup>th</sup> July 1795 (Plate 5). The image is framed towards the southeast and shows what may be the remnants of the square tower against the northwest gatehouse drum tower and also shows the very high wall belonging to the northeast drum tower still standing. It also shows a significant masonry structure in between the northeast drum tower and square tower, which may be the surviving north curtain wall. The image also shows significant vegetation on the walls of the castle.

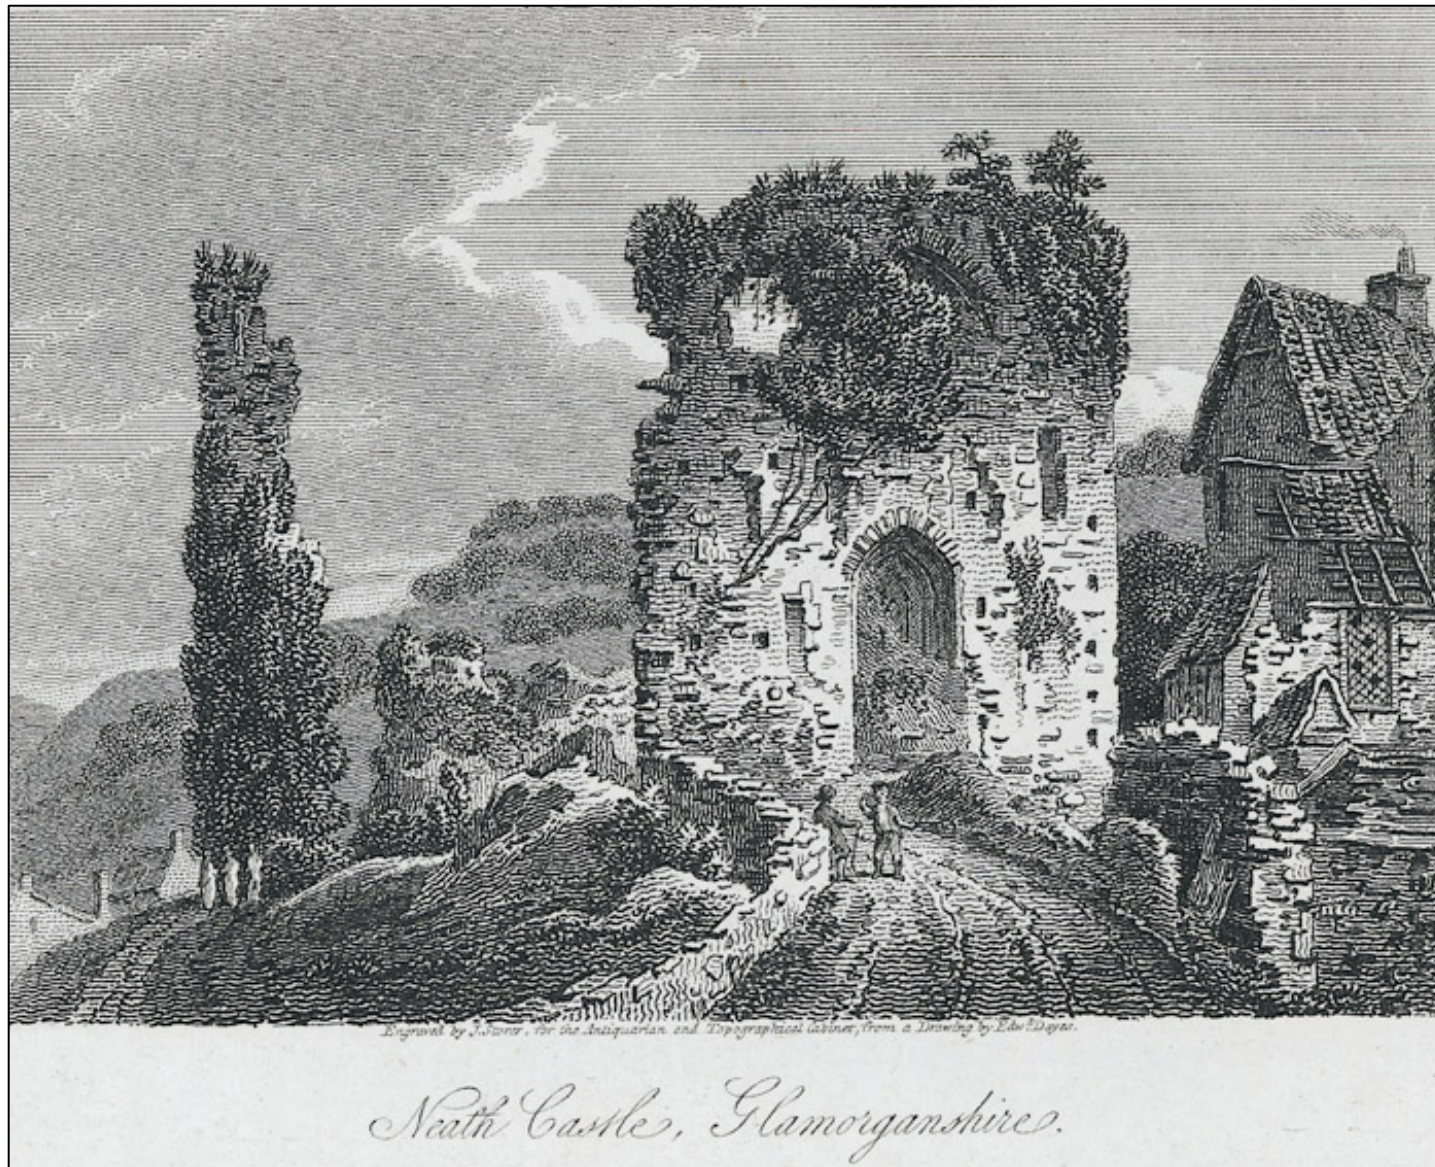
Plate 6. 1807 Neath Castle by Edward Dayes 1763-1804 (artist) and J. Storer 1771-1837 (engraver) National Library of Wales, Public domain, via Wikimedia Commons.

- 2.1.13 Edward Dayes (1763-1804 artist) and J. Storer's (1771-1837 engraver) image of Neath Castle (Plate 6) shows the masonry in a significant state of decay. The square tower and north curtain wall are not shown. The high wall of the northeast drum tower still stands though albeit covered in vegetation. The 1807 date ascribed to the image must be incorrect as the Friends Meeting House was built by 1801 and is not shown.

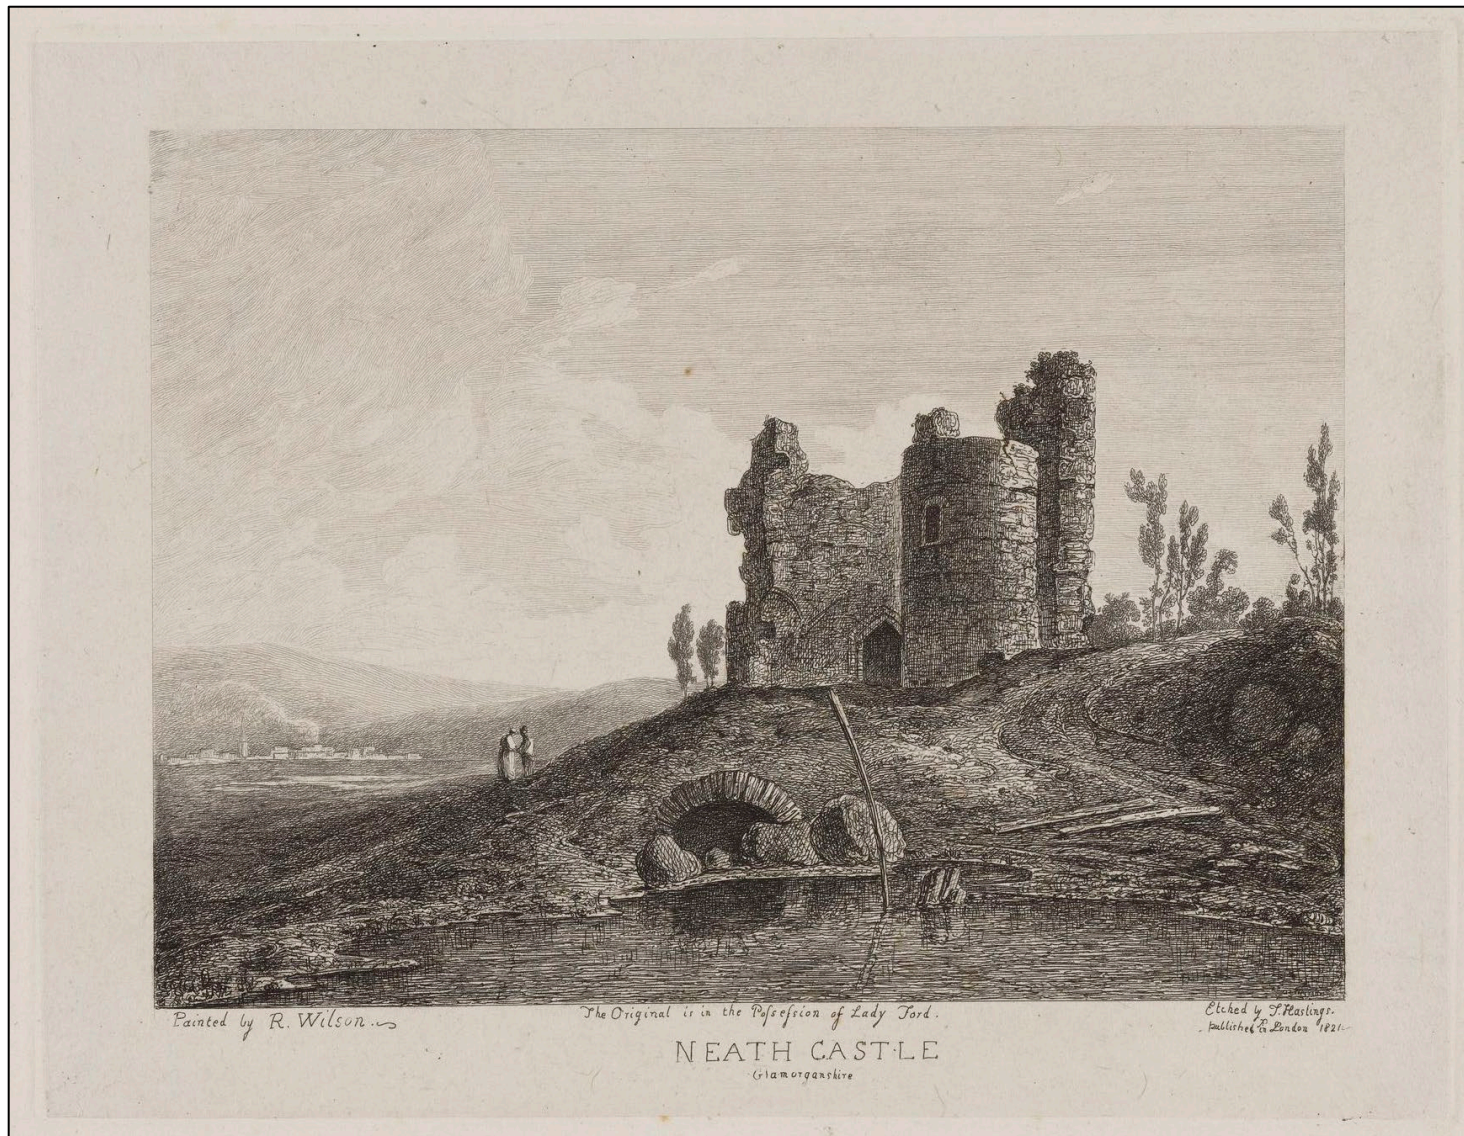
Plate 8. 1821 Neath Castle by Richard Wilson. The 1821 date is erroneous and is a duplicate of his painting dating to 1765-70 (Plate 3). © The Trustees of the British Museum. Creative Commons Attribution-NonCommercial-ShareAlike 4.0 International (CC BY-NC-SA 4.0).

- 2.1.15 The 1821 engraving (Plate 8) by Richard Wilson is almost certainly the same as his painting dated 1765-70 (Plate 3). The 1821 date being erroneous. The engraving shows the castle much as described above but in much more clarity with possibly the Neath Abbey Ironworks in the background. The Friends Meeting House is not shown.

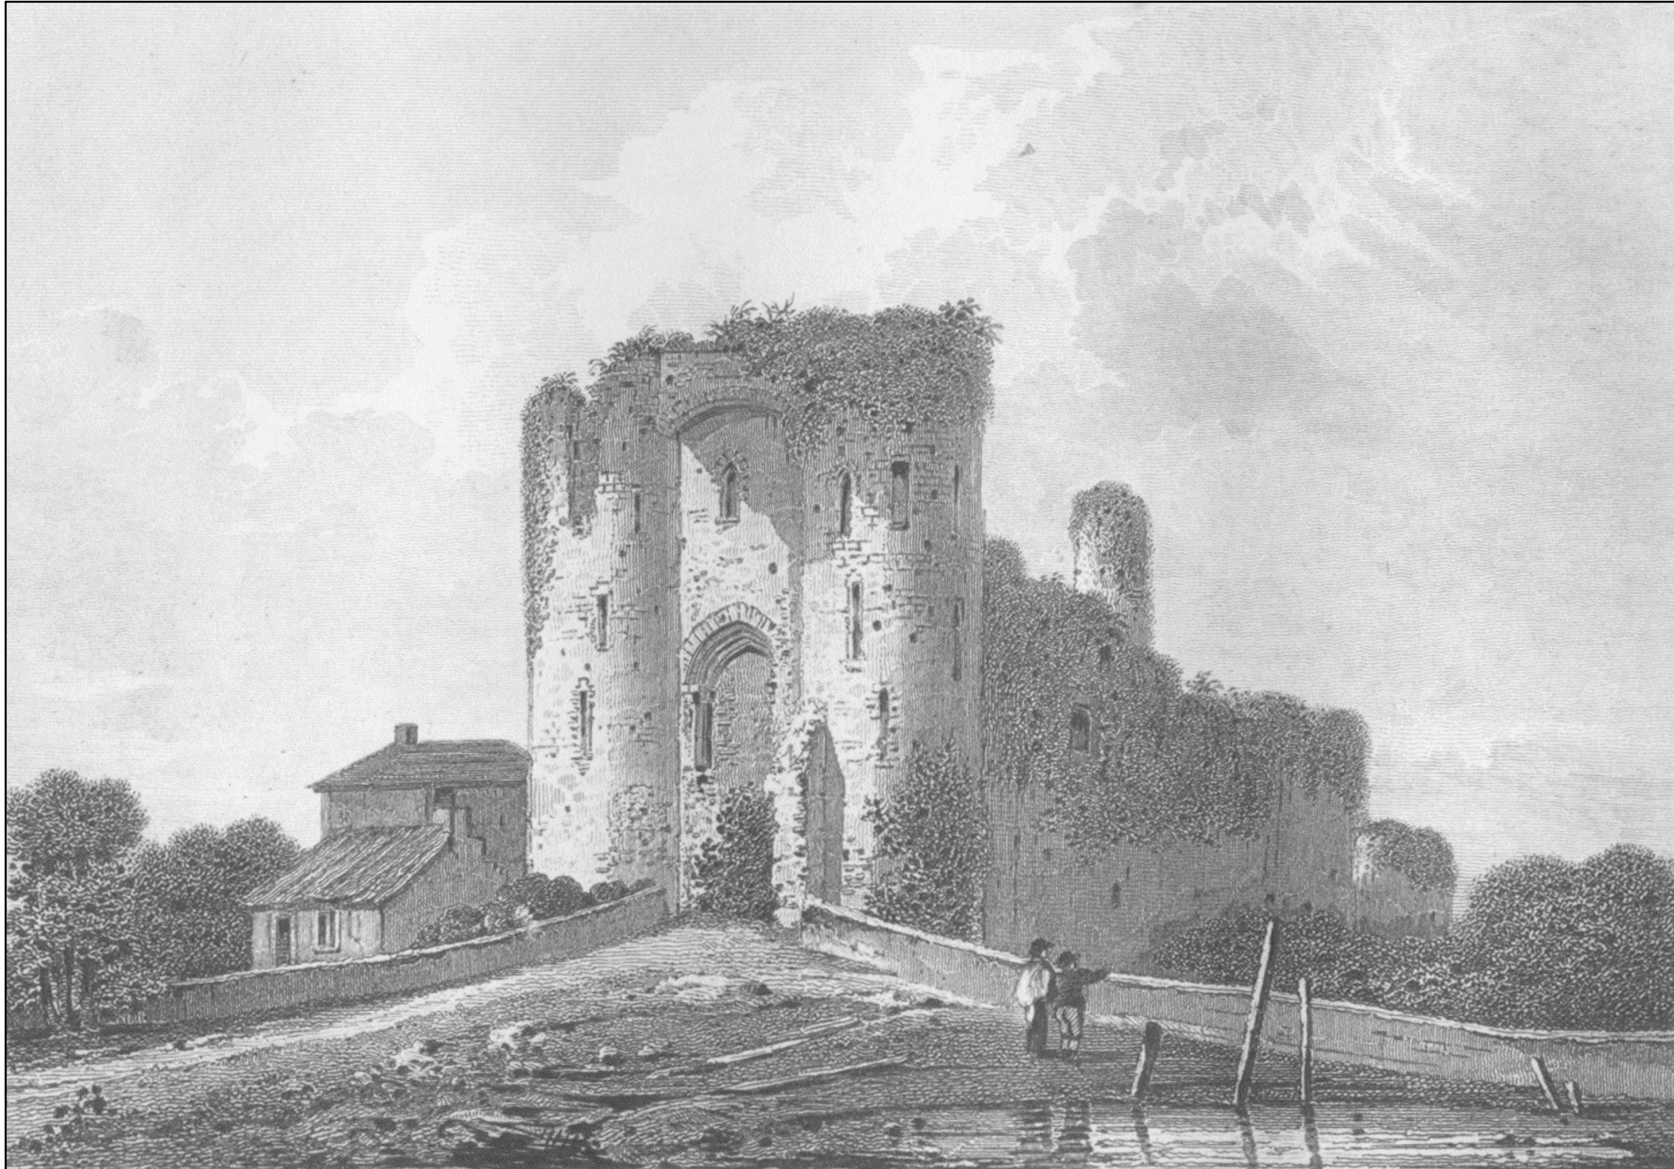
Plate 9. 1845 Neath Castle by Thomas Dugdale and W. Woolnoth, in *Curiosities of Great Britain England and Wales, Historical, Entertaining, and Commercial*. © Alamy.

- 2.1.16 Neath Castle is depicted by Thomas Dugdale and W. Woolnoth, in *Curiosities of Great Britain England and Wales, Historical, Entertaining, and Commercial* 1845 (Plate 9). The image clearly shows both the small house with a pitched roof shown in earlier images and the Friends Meeting House. The north curtain wall is shown standing to a significant height and the tall masonry remains of the northeast drum tower is also still standing.

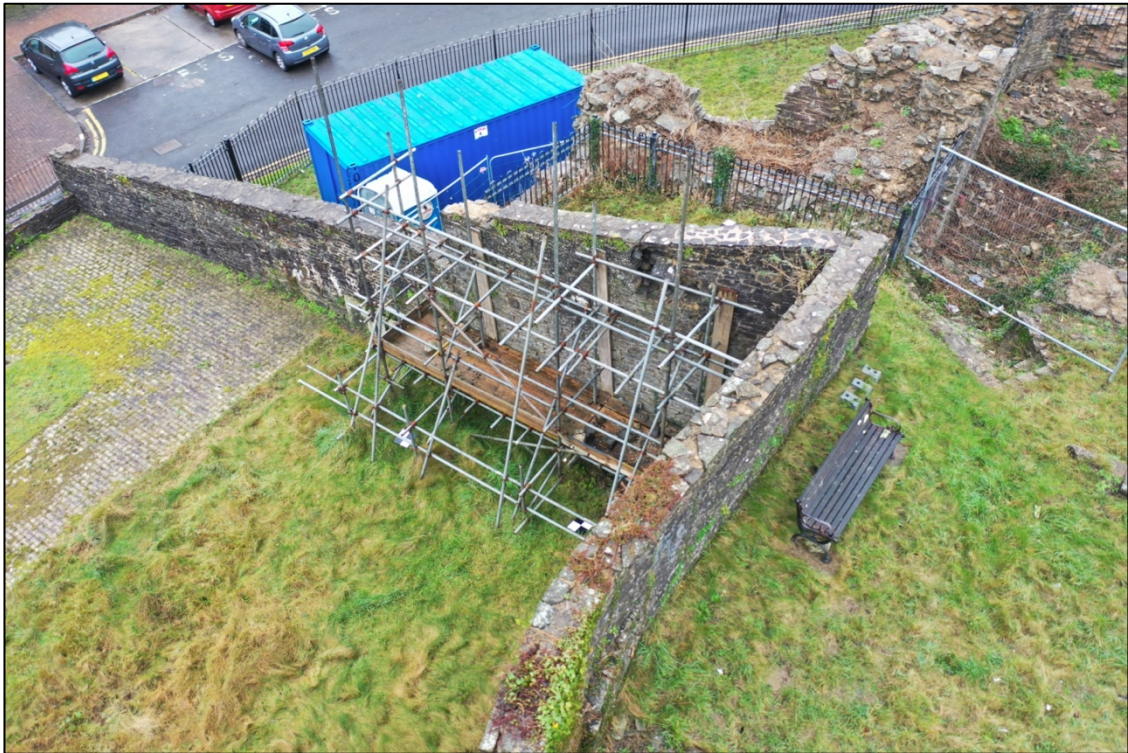
Plate 11. Oblique view to NE of the collapsing Boundary Wall and Quakers Wall atop the North Curtain Wall.

- 6.3.1 The collapsing northeast/southwest aligned Boundary Wall [007] was situated towards the western edge of the castle's northeast drum tower. Access to the wall was provided by scaffolding attached to its outer (western) face. In terms of function, the wall served to retain a large amount of soil and other built-up materials that accumulated in and around the remains of the castle's northeast drum tower [012]. A large section of the wall had sustained significant damage, where a quantity of masonry had fallen. This area measured approximately 0.8m x 0.9m and extended downwards from the top of the wall. Immediately below this area a sizeable crack also existed on the exterior wall face, which extended approximately 2.3m below the top of the wall. Together, this area of fallen masonry and sizeable crack meant that the wall required imminent repair work.

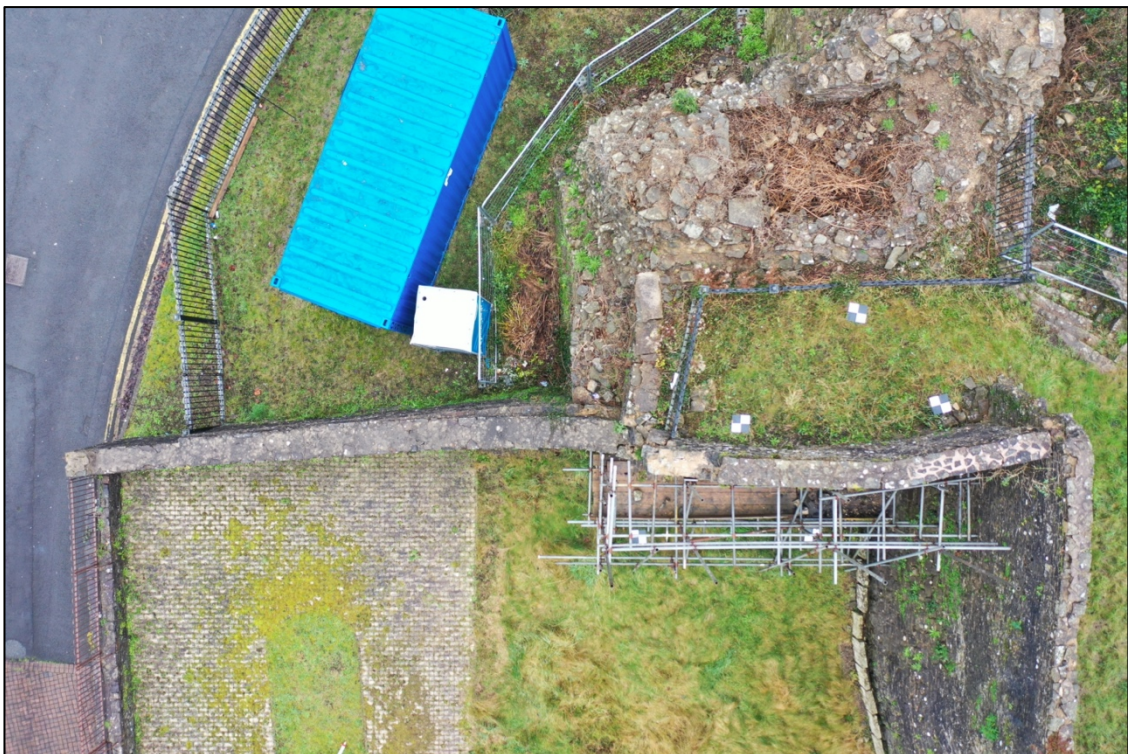
Plate 12. Nadir view of the collapsing Boundary Wall and Quakers Wall atop the North Curtain Wall.

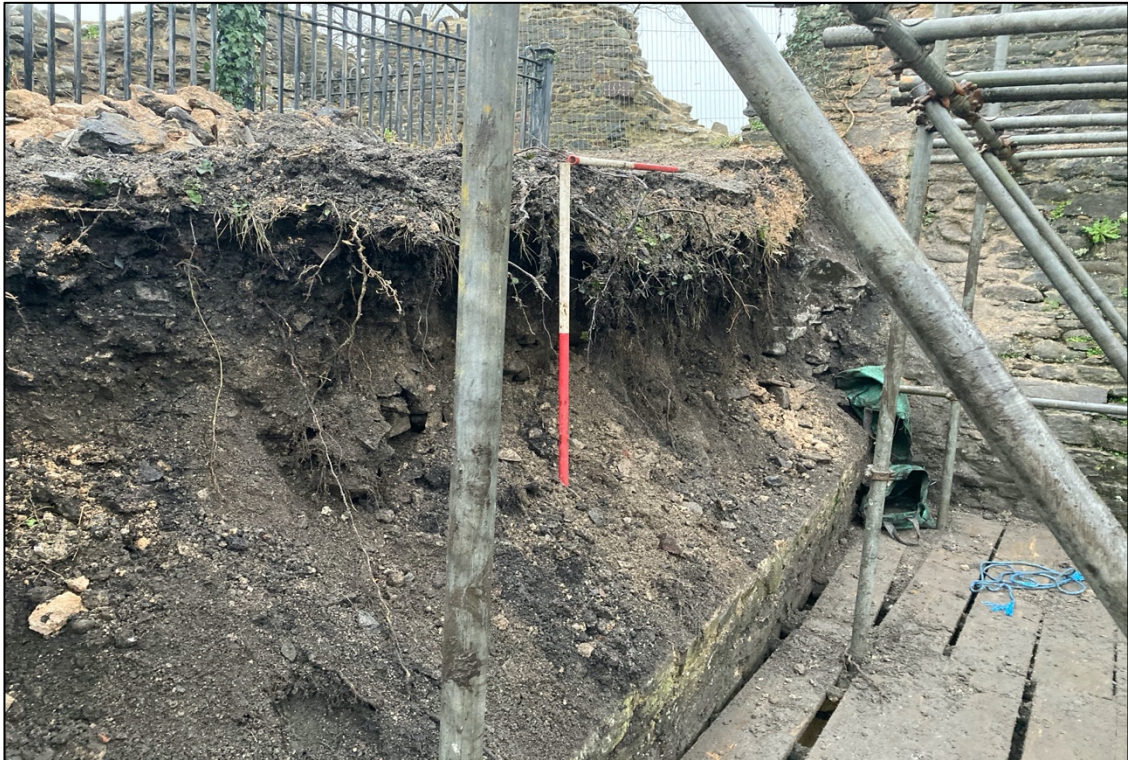
Plate 13. Oblique view of stratigraphical deposits during dismantling of the Boundary Wall [007] prior to the section collapsing (view south).

6.4.1 The archaeological watching brief observed the dismantling by hand of around 5.5m of the collapsing Boundary Wall [007], as well as limited excavations into the material it retained. Several deposits were encountered and were recording in section. These deposits represented Post-medieval back-filling or tipping events behind the Boundary Wall [007]. The section collapsed almost immediately following the dismantling of the Boundary Wall [007] due to the very soft and friable nature of the back-filled deposits. However, prior to collapse a record was made of the stratigraphy but the section collapsed before any photogrammetric or drawn record could be made. The uppermost deposit within the section (001) comprised dark brown silty clay-loam topsoil with frequent rooting throughout (001). The depth at which this topsoil was encountered varied between 0.05m – 0.15m. The deposit situated below this topsoil (002) comprised a highly friable silty clay, mid-brown in colour, which contained frequent demolition material throughout, most notably in the form of masonry and patches of ashy lime mortar. In total, deposit (002) measured 0.45m in overall thickness. Deposit (002) also contained within it a significant number of ceramic sherds and shards of glass, mostly of Post-medieval and modern date. These included ceramic sherds of Bristol glazed stoneware, North Devon gravel-tempered ware and white earthenware, and fragments of glass beer and mineral water bottles as well as and a glass jar (see Section 6.6 below). Underlying deposit (002) was a layer of dark brown silty clay, very friable, with fragments of ashy lime mortar throughout. In terms of depth, deposit (003) was not bottomed, but was seen to measure >0.73m. It was also observed that deposits (002) and (003) abutted an earlier deposit (004), which was itself seen to abut both the Quakers Wall [005], along with the castle's north curtain wall [006]. Deposit (004) was deliberately tipped northward, over the northern edge of the Quakers Wall. Compositionally, this deposit comprised dark brown silty clay with frequent sandstone cobbles throughout, ranging in size from 0.15–0.4m. In terms of depth, deposit (004) was again not bottomed, but was seen to measure >1.25m in depth.

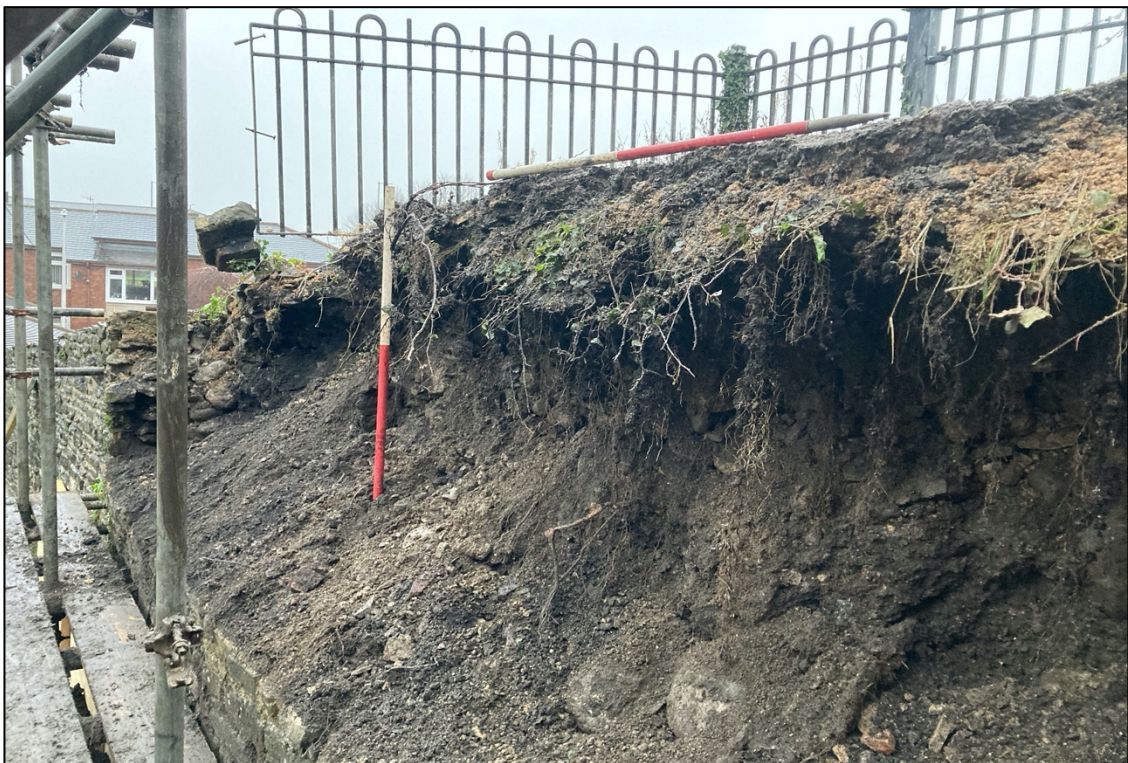
Plate 14. Oblique view of stratigraphical deposits during dismantling of the Boundary Wall [007] prior to the section collapsing (view northeast)

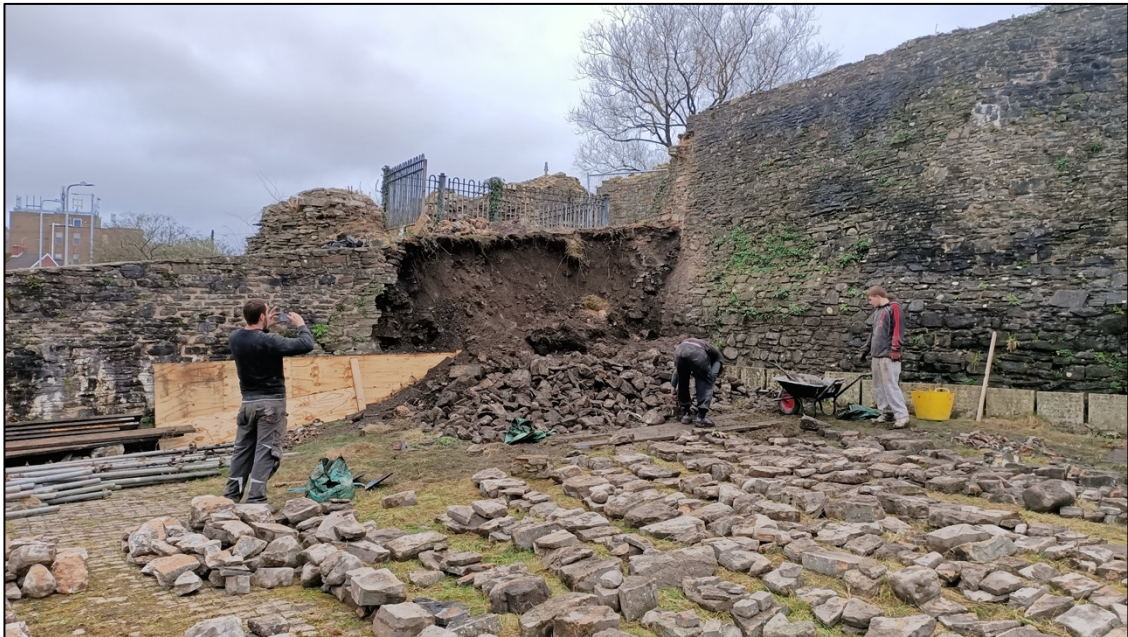
Plate 15. View to southeast of controlled demolition of the Boundary Wall [007] following the collapse of the section.
