# Masonry Wall Collapse and Repair Neath Castle SAMGm039

## 3D Photogrammetric Survey, Archaeological Watching Brief and Historic Building Record

Prepared for  
**Hurley & Davies Ltd**  
On behalf of  
**Neath Town Council**  
10/12 Orchard Street,  
Neath, SA11 1DU  
By  
**Black Mountains Archaeology Ltd**  
23<sup>rd</sup> February 2023  
Report No.281

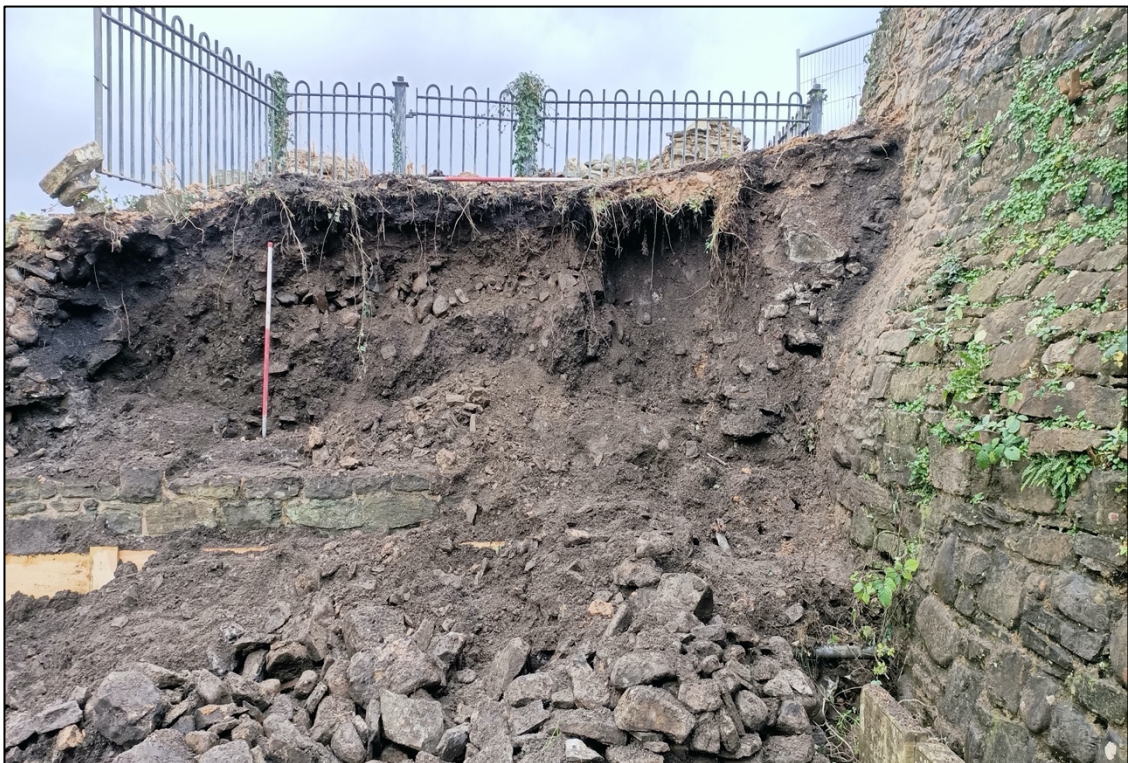
Plate 16. View to east of controlled demolition of the Boundary Wall [007] following the collapse of the section.

- 6.5.1 The 5.5m wide section collapsed almost immediately following the dismantling of the Boundary Wall [007] (see above) due to the very soft and friable nature of the back-filled deposits. The section revealed by this collapse was cleaned by hand, and it was noted that further archaeological features and deposits were present. The principal discovery being the previously unrecorded masonry remains of the medieval Northeast Tower and an *in-situ* medieval deposit, possibly a palaeo-horizon (historic ground surface).

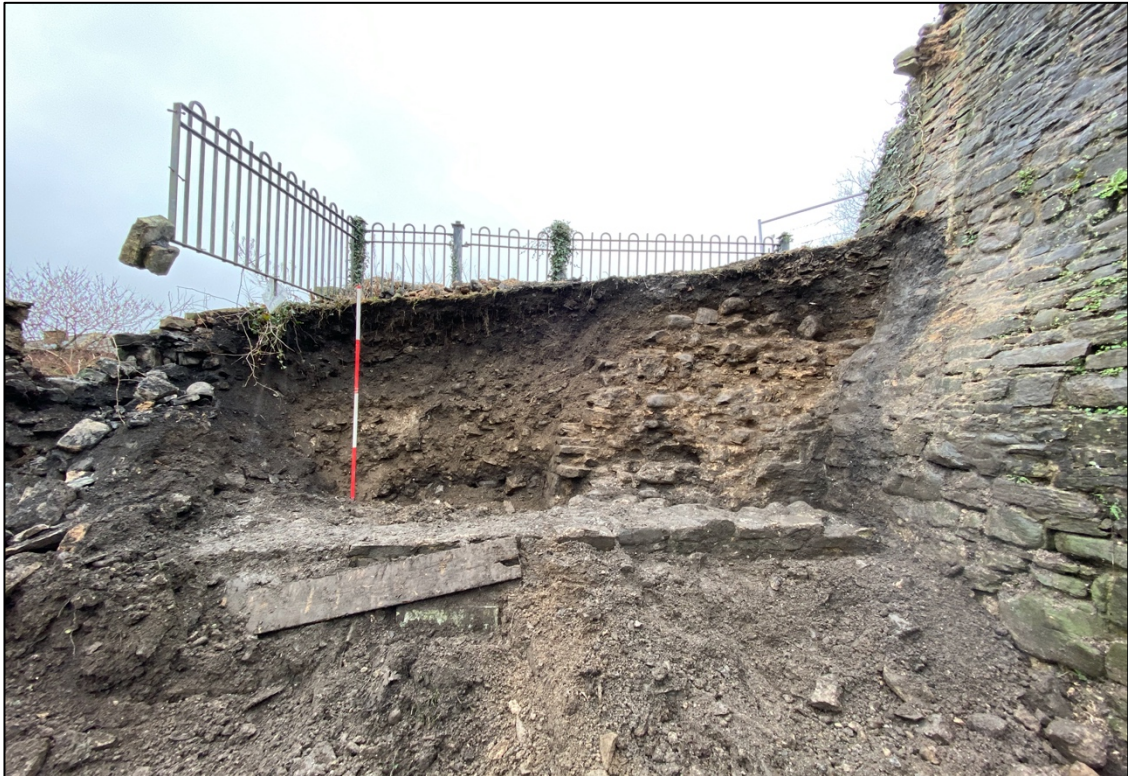
Plate 17. View to the east of the excavated and cleaned section (following the collapse) showing the masonry of the Northeast Tower [012], medieval deposits (011) and later back-filling deposits (013, 014 and 015).

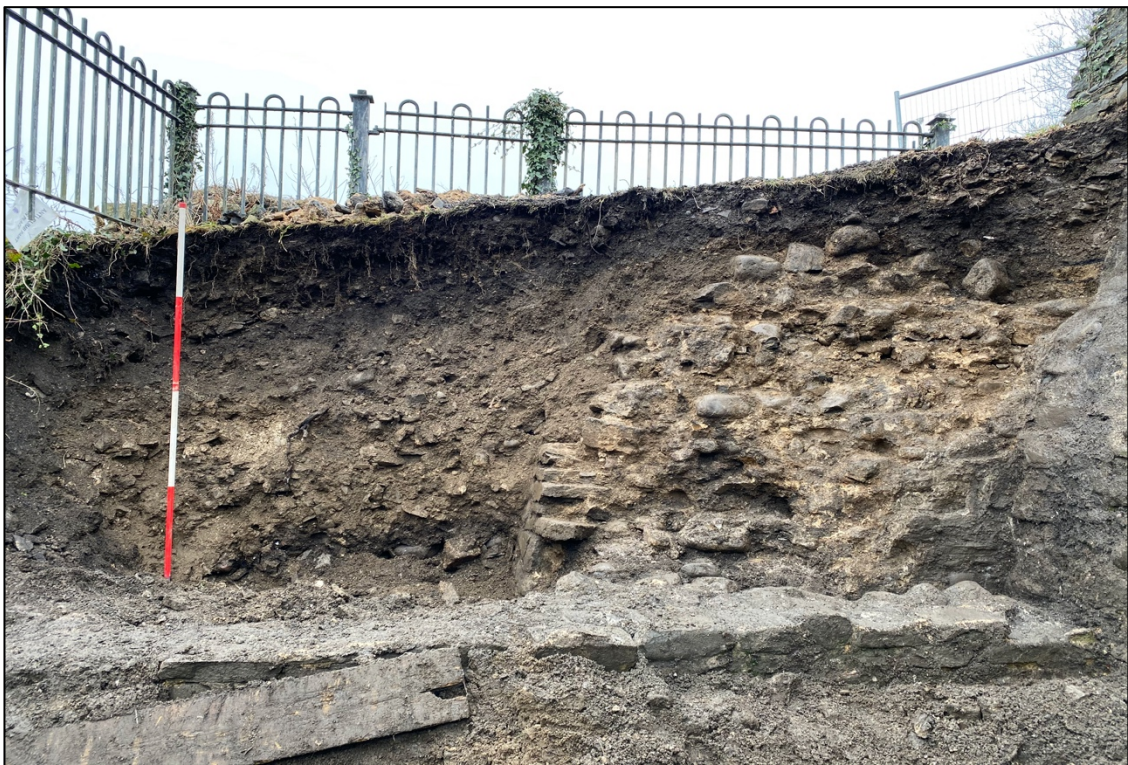
Plate 18. View to the east of the excavated and cleaned section (following the collapse) showing the masonry of the Northeast Tower [012], medieval deposits (011) and later back-filling deposits (013, 014 and 015).

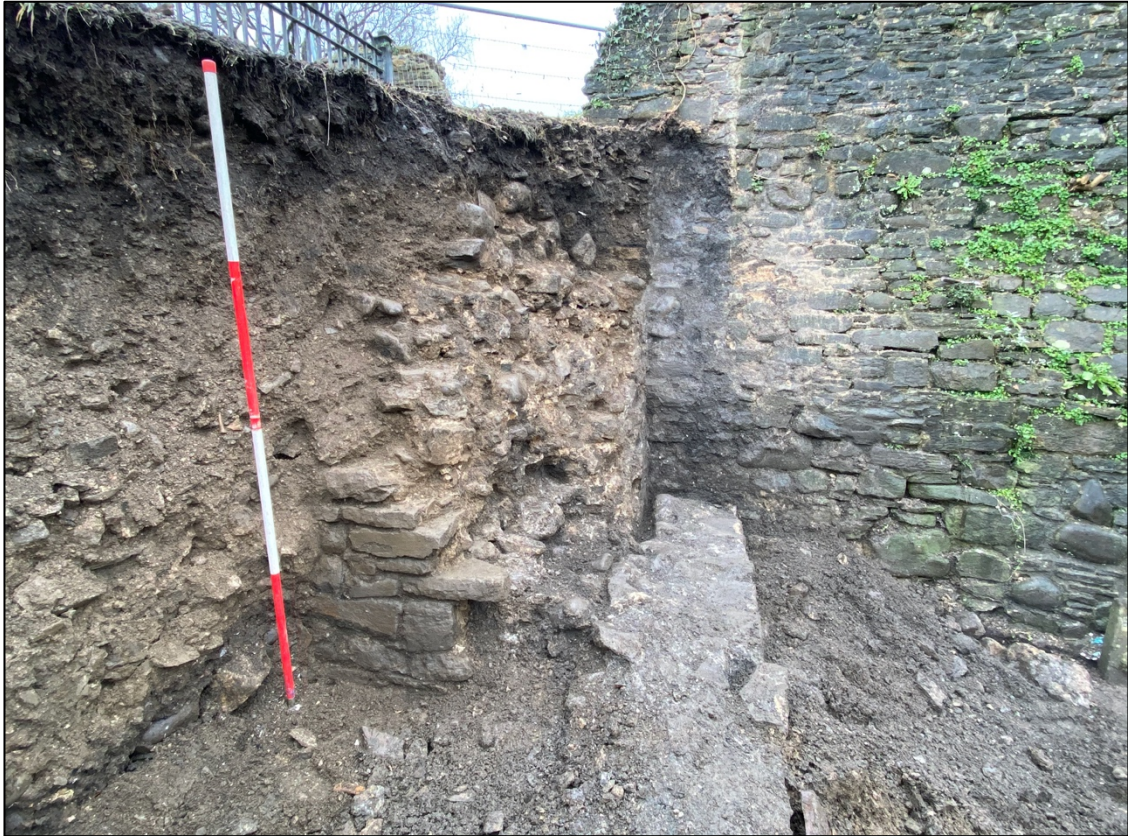
Plate 19. View to the south showing the masonry of the Northeast Tower [012], including surviving facing stones, medieval deposits (011) and later back-filling deposits (013, 014 and 015).

- 7.1.2 As a result of the collapse of the modern deposits detailed above, older medieval structural remains were revealed beyond the eastern edge of the collapsing wall. These remains formed part of the Northeast Drum Tower of Neath Castle. The structural remains, which comprised the foundation of a north/south aligned wall [012], indicated that the northern range attached to the northeast drum tower possessed a form entirely different to that which has traditionally been suggested (see RCAHMW 2000b, 229). Rather than being simply apsidal in form, this northern range of the drum tower was apsidal towards its southern end and was squared off towards its northern.

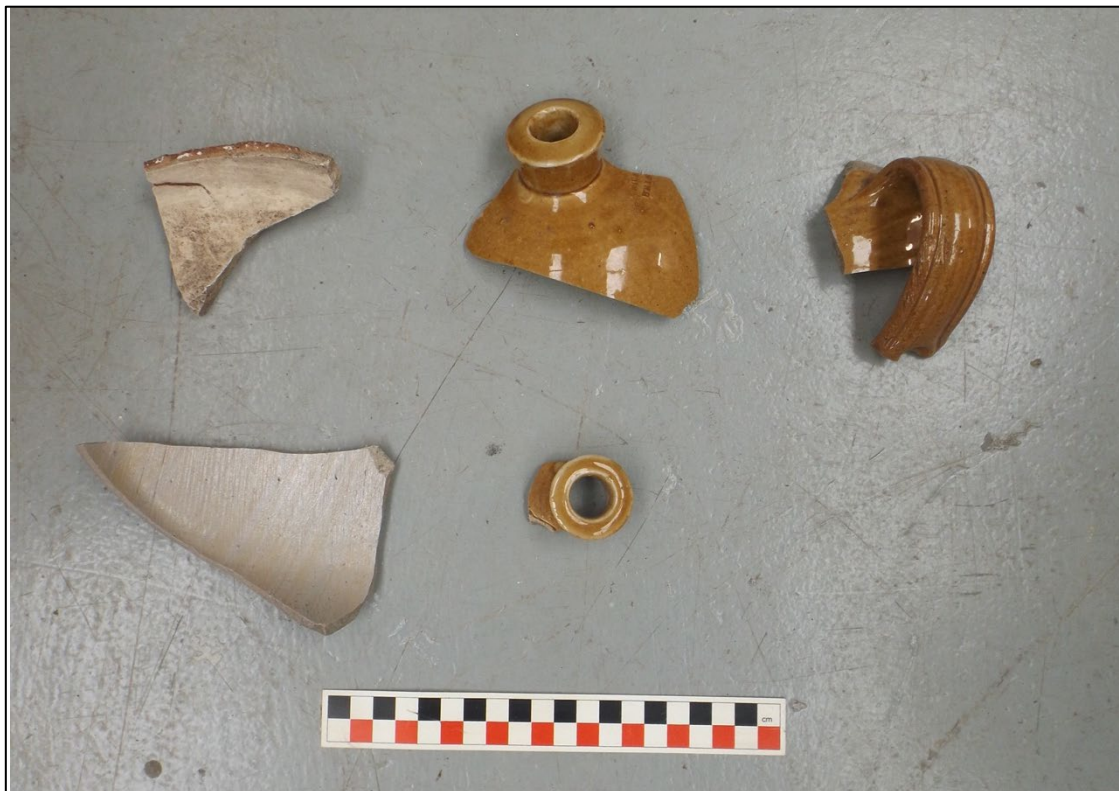
Plate 20. Sherds of modern stoneware from deposit (002)

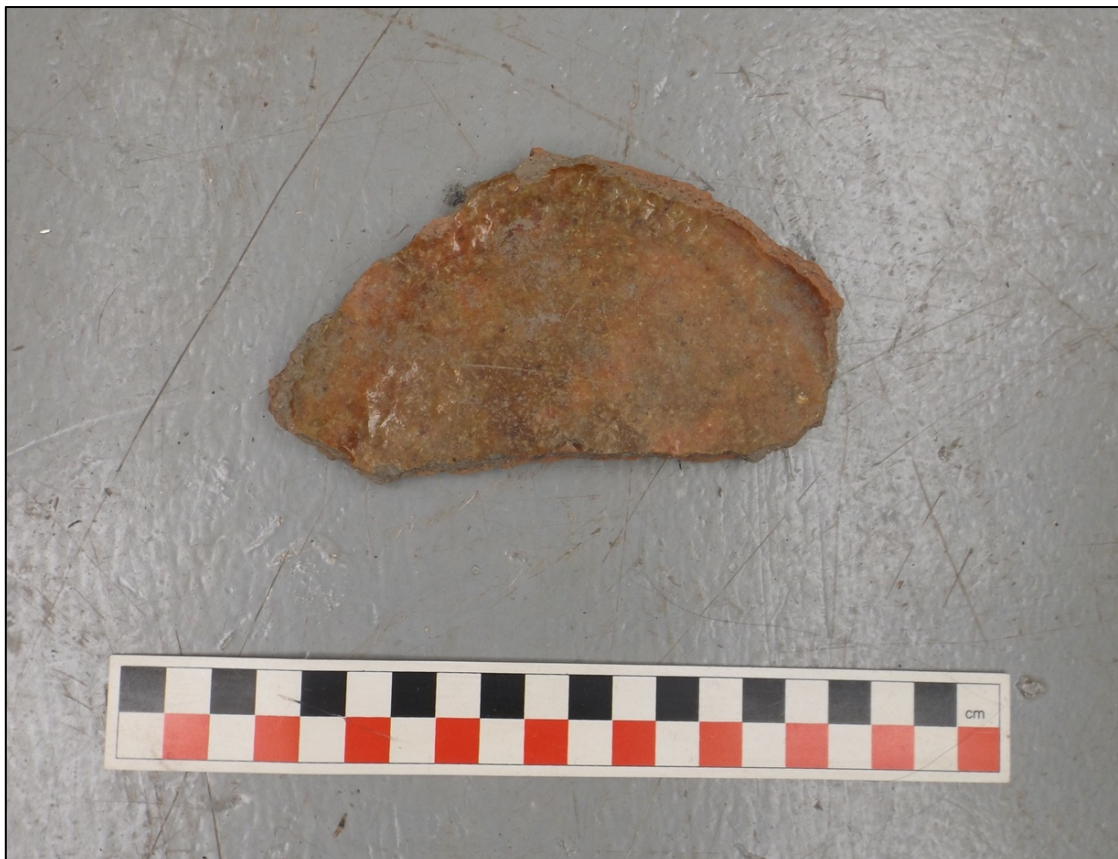
Plate 22. Sherd of North Devon Gravel-tempered ware (Post-medieval) from deposit (002)

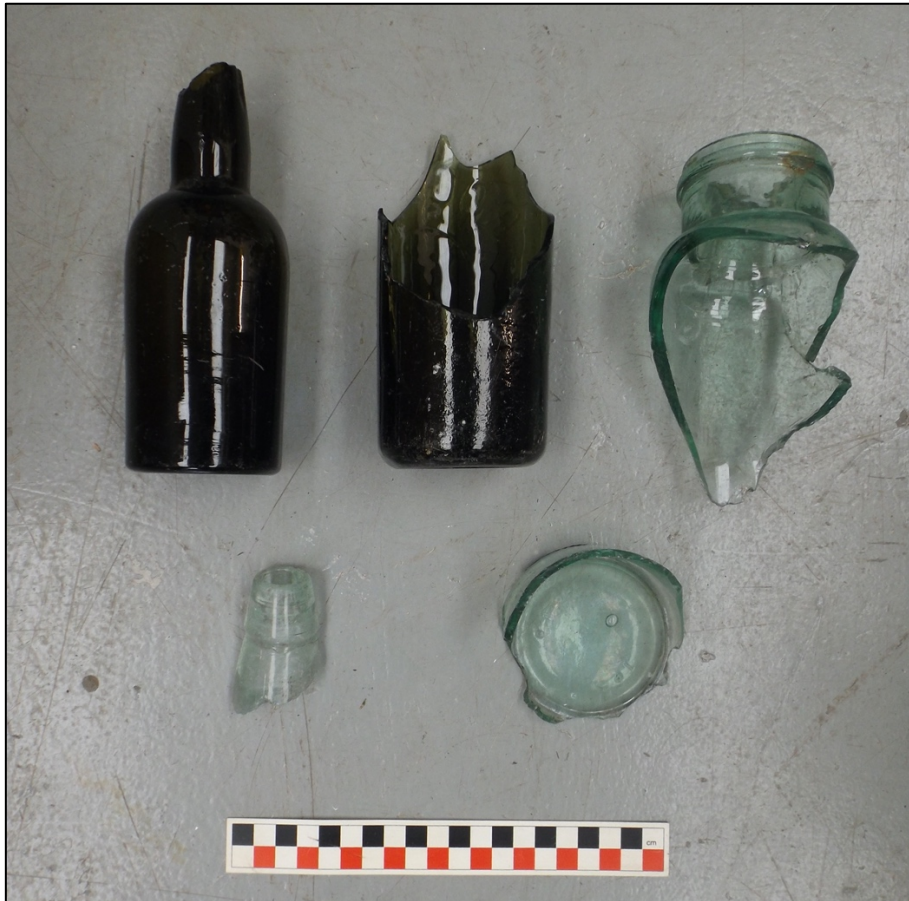
Plate 23. Modern glass finds from deposit (002)

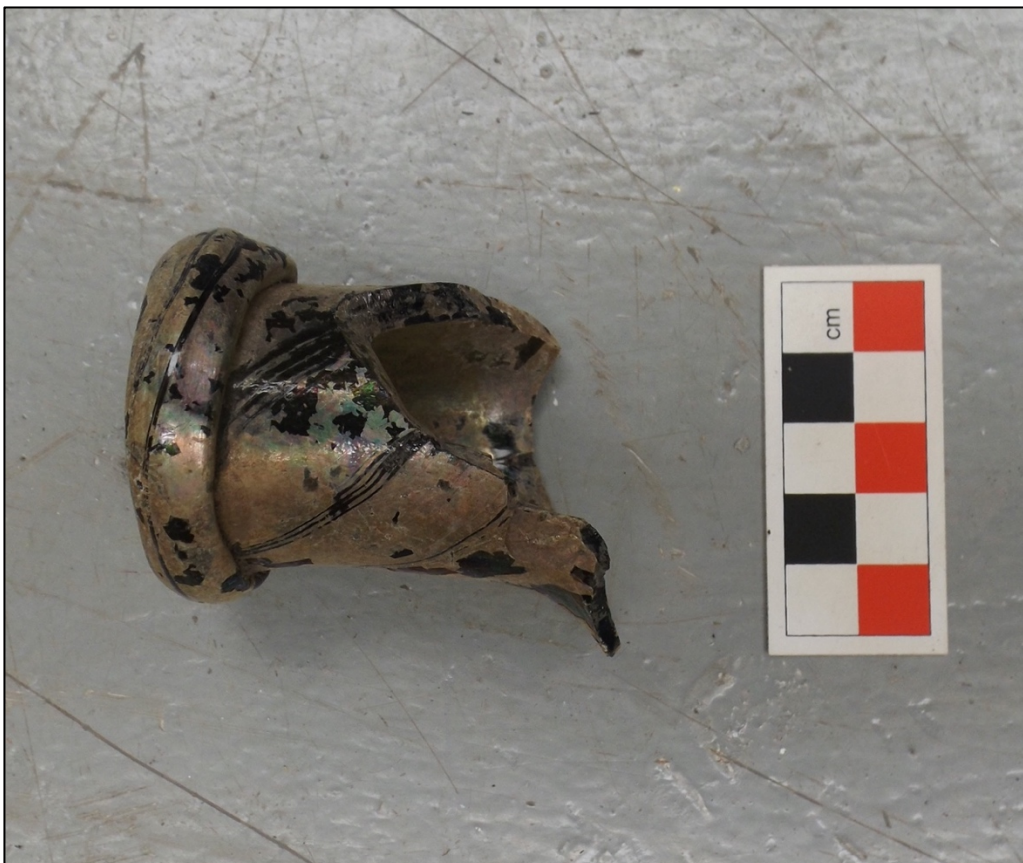
Plate 24. Spout of Post-medieval flask from deposit (002)
