Llysun Motte and Bailey

Scheduled Ancient Monument MG072

Completion Report

This Completion Report describes repair works undertaken between Monday 22 June and Friday 26 June 2015 to fulfil Mr Tudor's obligations under the Scheduled Ancient Monument Management Plan and his Glastir Advanced agreement.

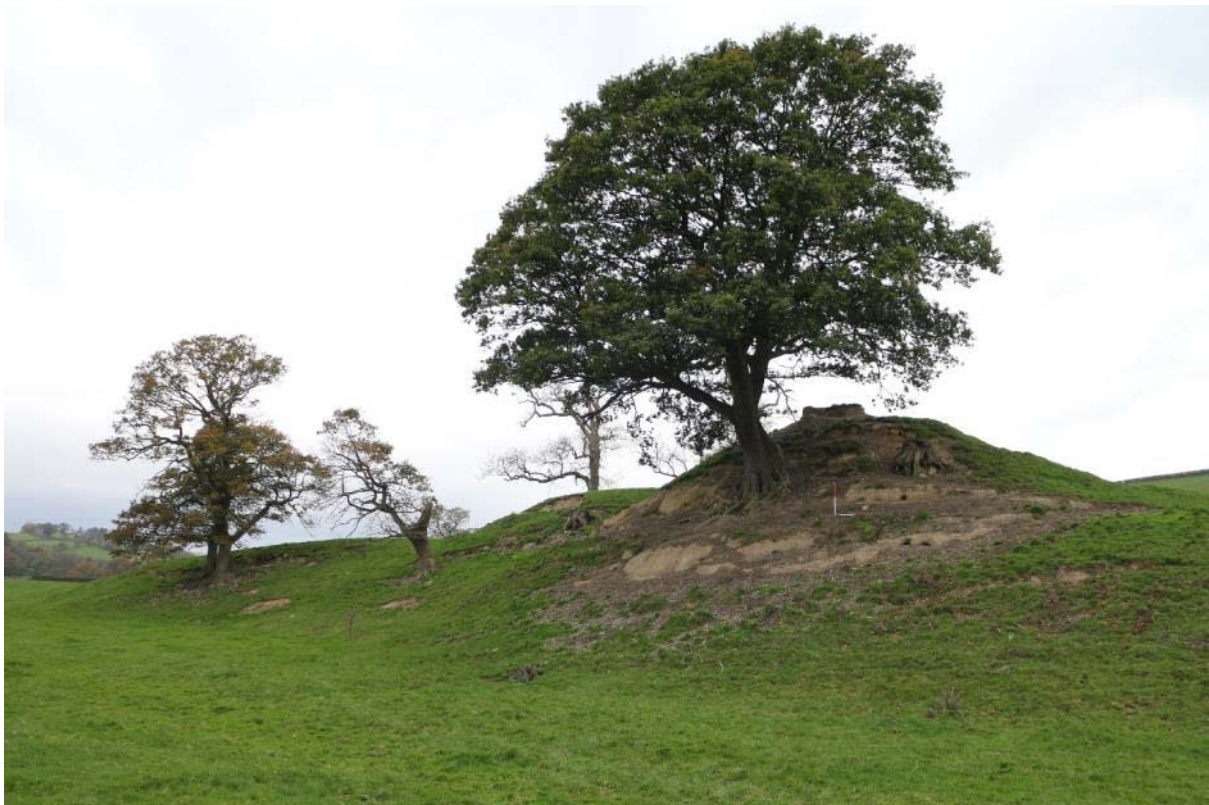
22 October 2014, IMG_2563 ©AQB Historic Landscapes

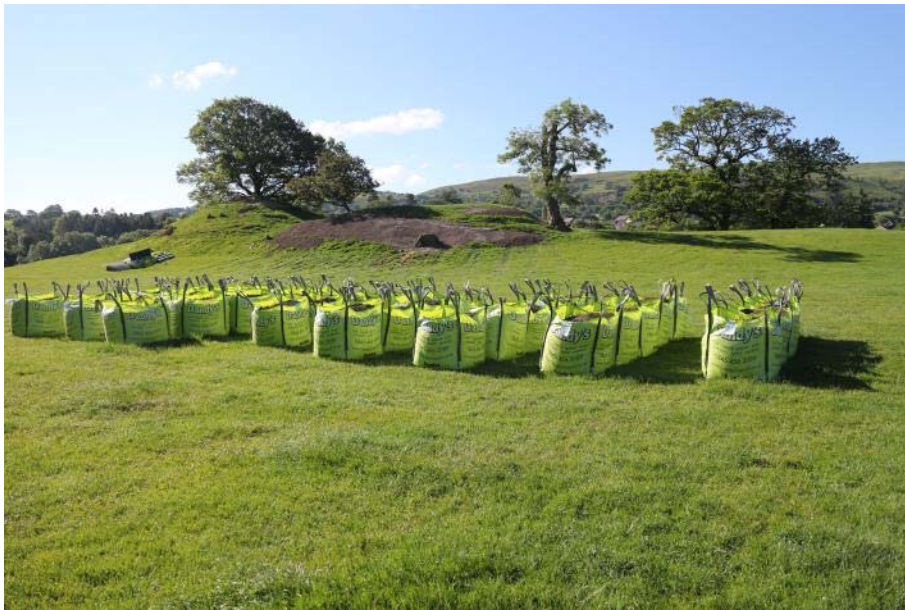
Topsoil base location B1, IMG_6984, 23.06.2015

125 bags were delivered to site by articulated lorry on 18 June 2015, with a further 25 bags delivered on 24 June 2015 – a total of 150 bags or 112.5 tonnes (see images below). The topsoil was stored in two base locations away from the Monument, but sufficiently close to minimise subsequent vehicle movements in transporting bulk bags to work areas.

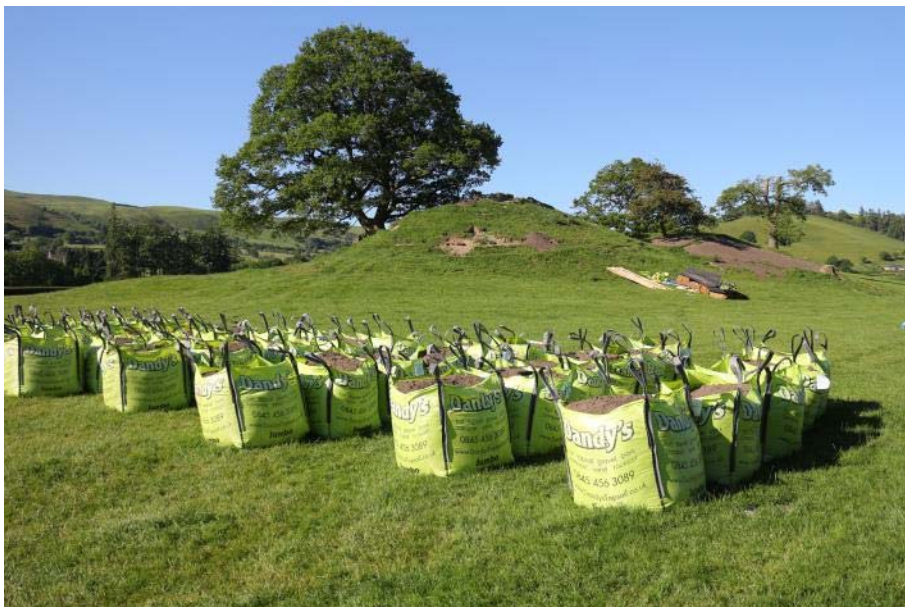
Topsoil base location B2, IMG_6983, 23.06.2015

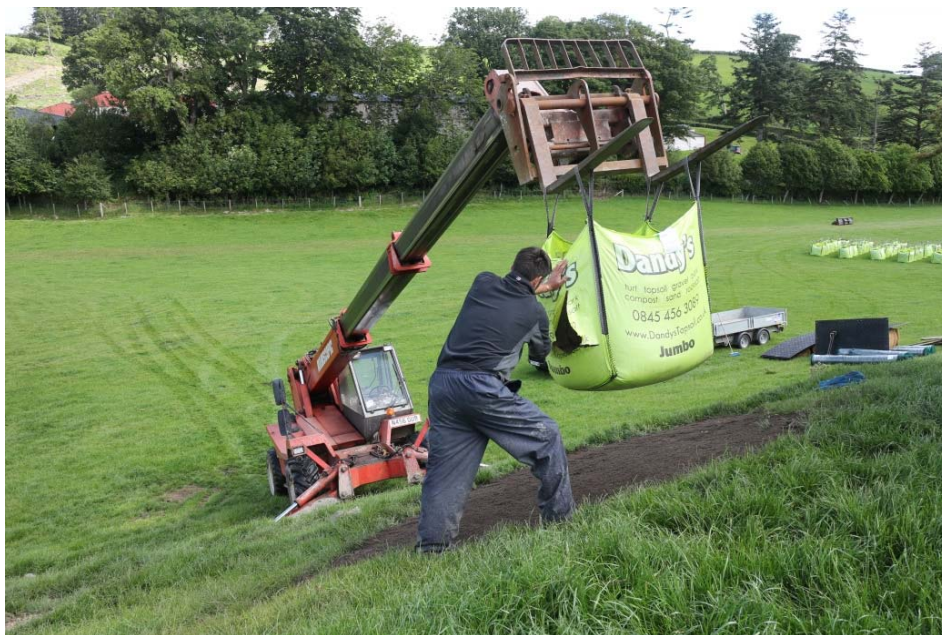
Manitou Maniscopic Serie C telehandler, IMG_6931, 22.06.2015

Lorries were offloaded by Manitou Maniscopic Serie C 9 metres reach telehandler, fitted with pallet forks, at two base locations situated to the north of the Scheduled Ancient Monument.

The telehandler was used to move individual bulk bags to accessible repair areas where the bags, still suspended from the telehandler's pallet forks by their lifting loops, were slit open to enable soil discharge (see image below).

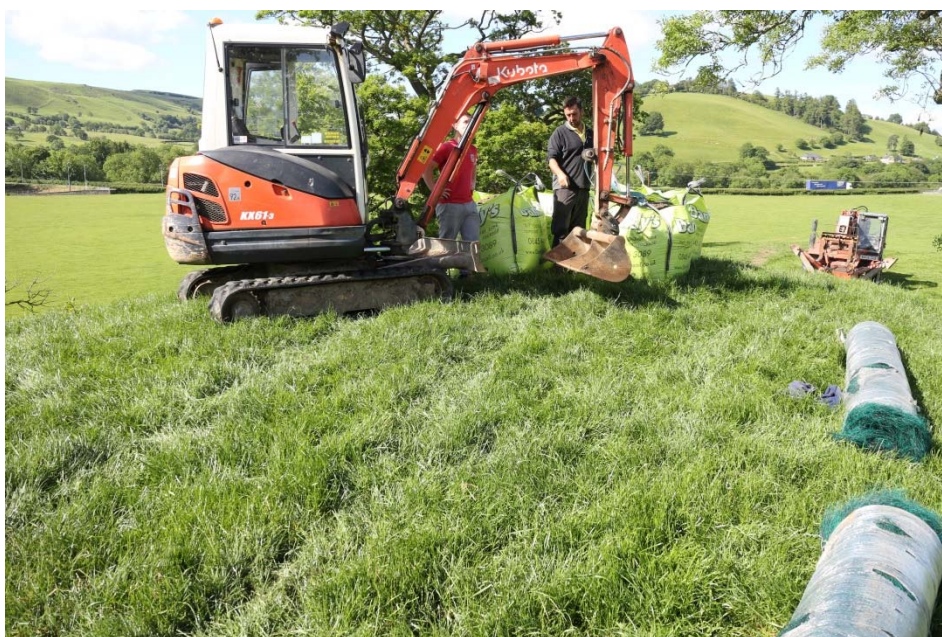
Kubota KX61-3, 2.6 tonnes, 360°, skid-steer mini excavator, IMG_7000, 23.06.2015

Limited use was also made of a Kubota KX61-3, 2.6 tonnes, 360°, skid-steer mini excavator to move topsoil on the 'platform' to the west of the motte (see image below)

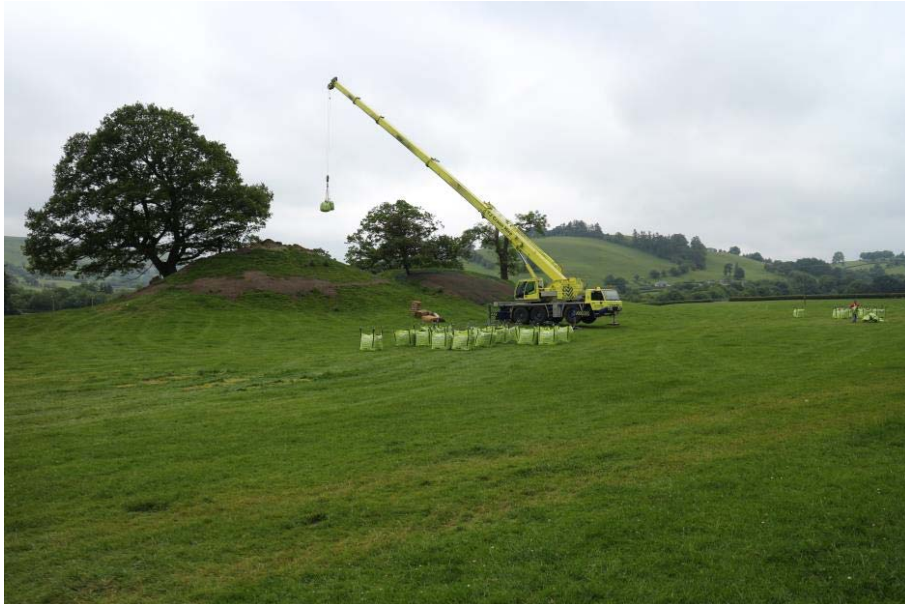
Faun ATF 60-3 Crane, IMG_ 7171, 25.06.2015

For less accessible erosion scars on the south of the Monument and around the crest of the Motte, a Faun ATF 60-3, 47 tonne all-terrain crane was used to lift bulk bags to their discharge locations (see image below). The crane was capable of lifting two 750 Kilograms bulk bags at a time at 75% boom extension.

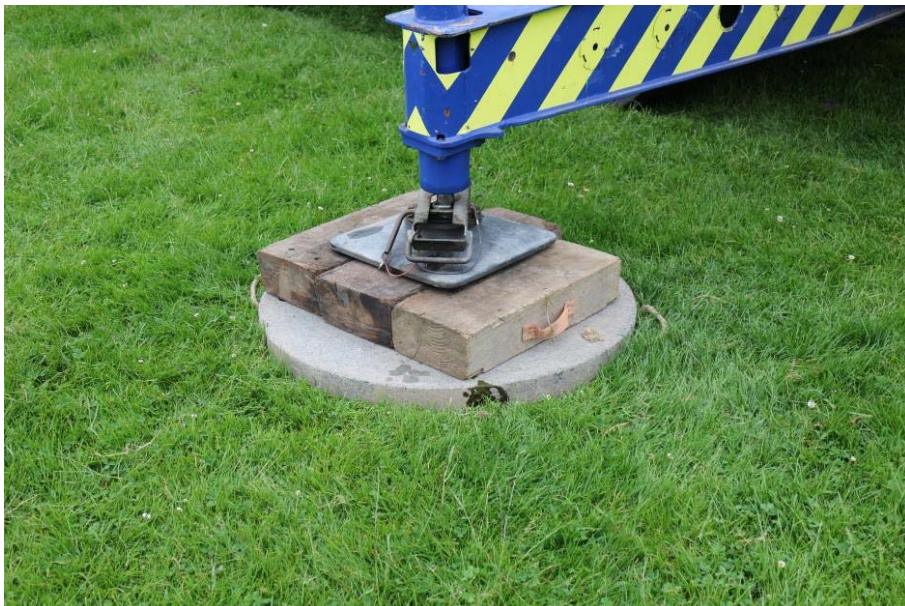
Crane stabiliser jack and load-spreading plate, IMG_7138, 25.06.2015

The crane was levelled on stabiliser jacks using load- spreading plates (see image below).

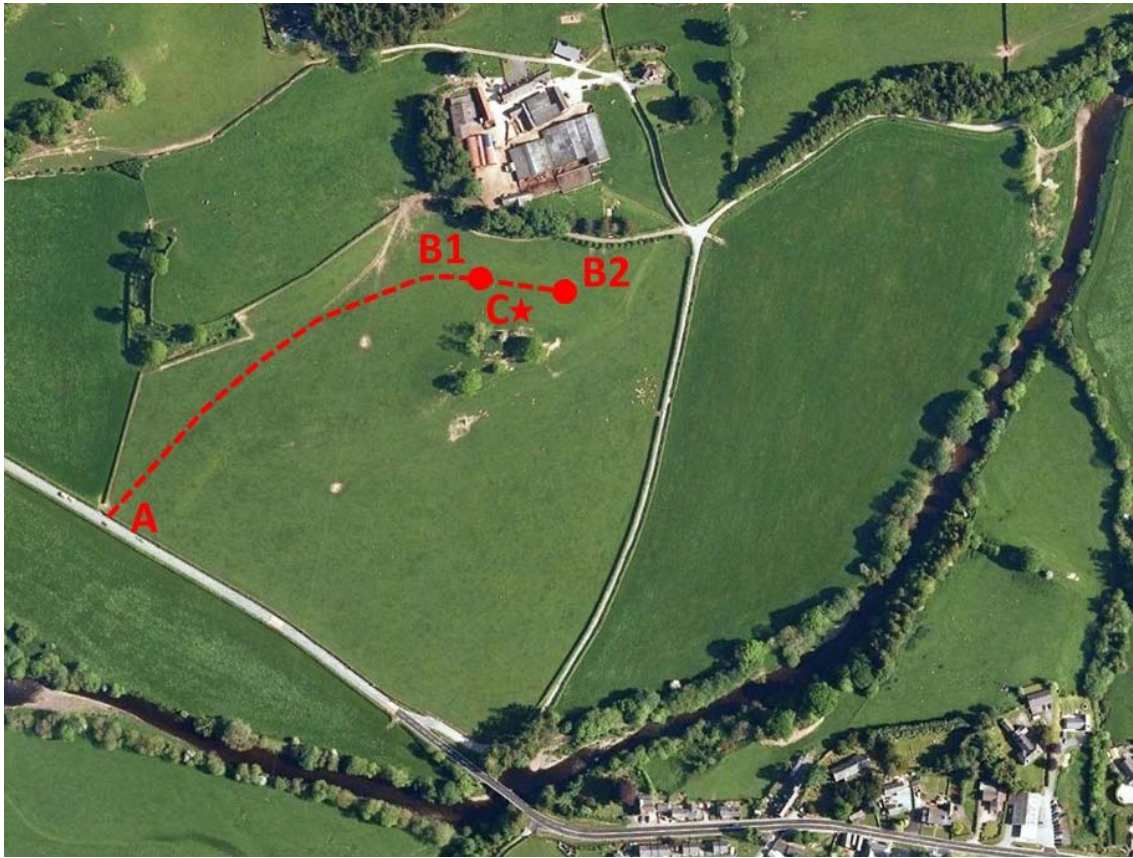
*Access route (A), topsoil base locations (B1 & B2), crane operating location (C)
Base Image © 2015 Getmapping plc and Google Earth*

The access route for lorries and crane (A), topsoil base storage locations (B1 and B2) and crane operating location (C) are indicated on the plan below.

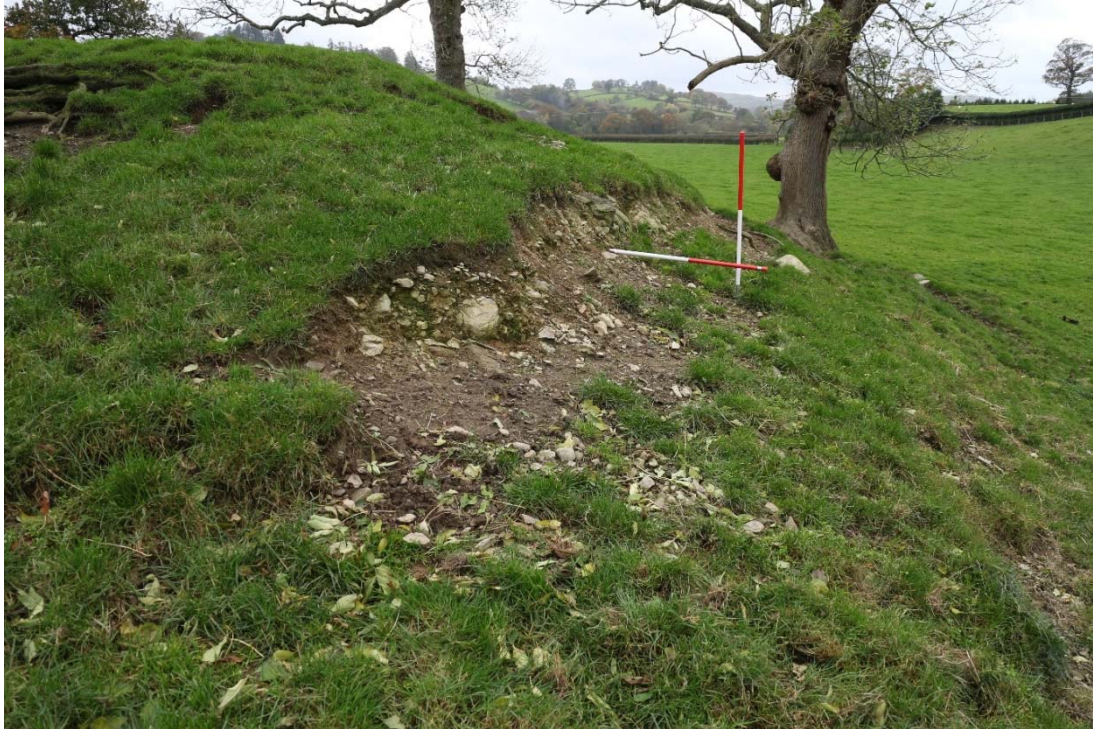
1. Grass cover on much of the monument has been entirely removed by stock wear, and there are significant areas of bare earth, erosion and scrapes. These include vertical erosion scars over 1m in height, and an entire lack of ground cover on the southern side of the motte. Vertical erosion scars are unlikely to recover naturally (due to the combination of gravity, wind, rain and stock). The motte summit has been much reduced in area, and archaeologically significant material has been exposed, and undoubtedly destroyed, by the erosion.

Prior to repair, IMG_2517, 22.10.2014

At all erosion scar locations where repair was undertaken by infilling (except for the summit of the motte) work was undertaken to the following specification. Scars along the north flank of the 'platform' lying to the west of the motte are used to illustrate the sequence:

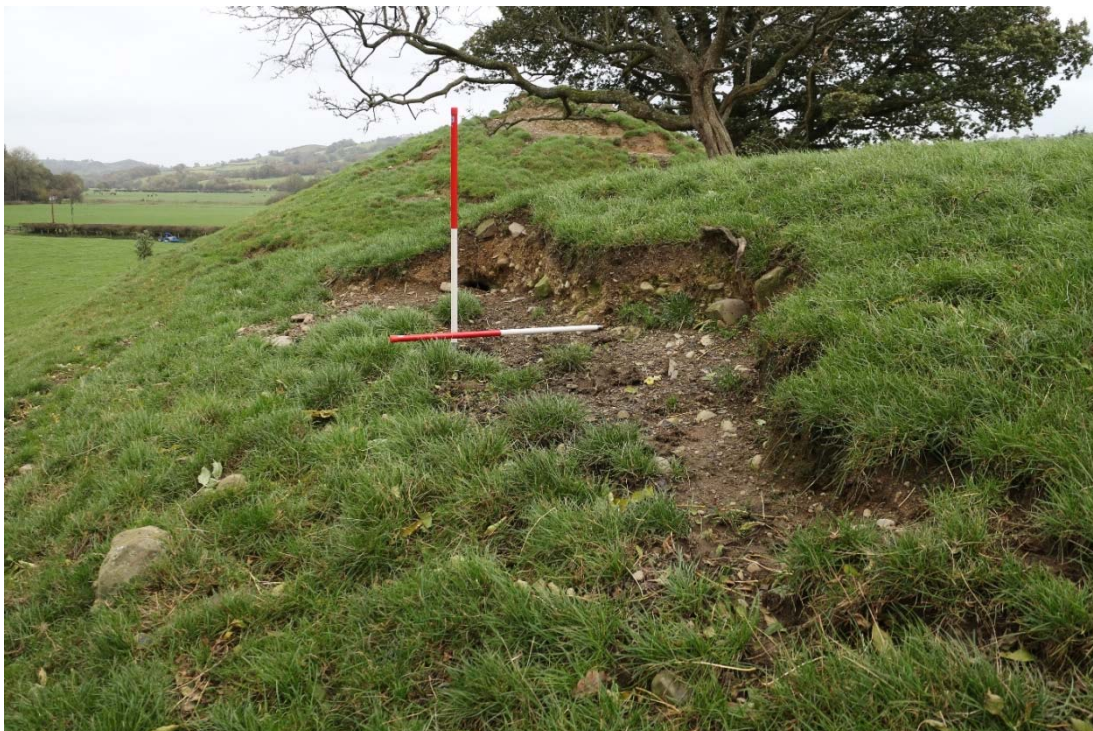
Prior to repair, IMG_2520, 22.10.2014

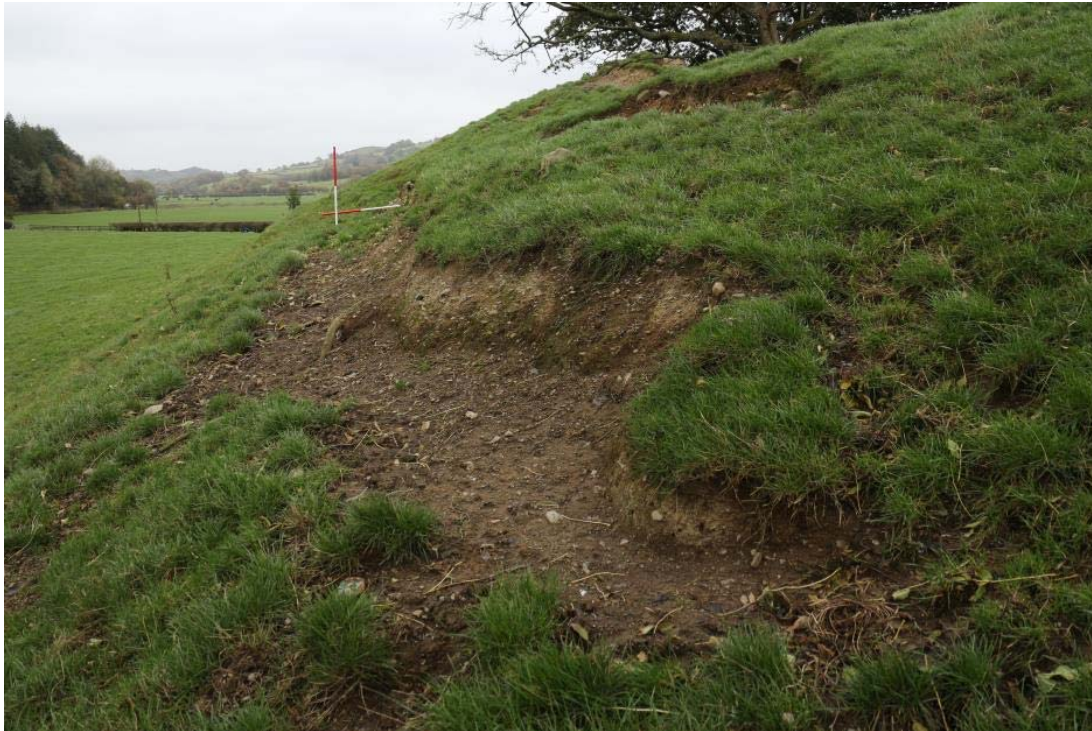
Prior to repair, IMG_2518, 22.10.2014

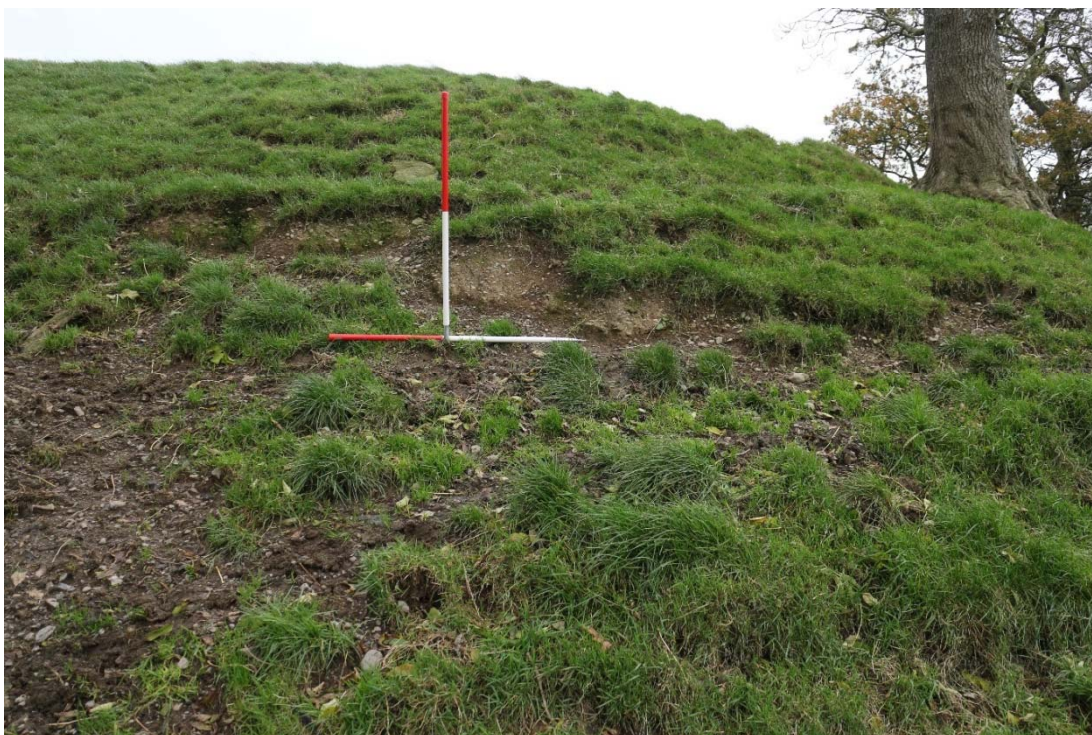
Prior to repair, IMG_2523, 22.10.2014

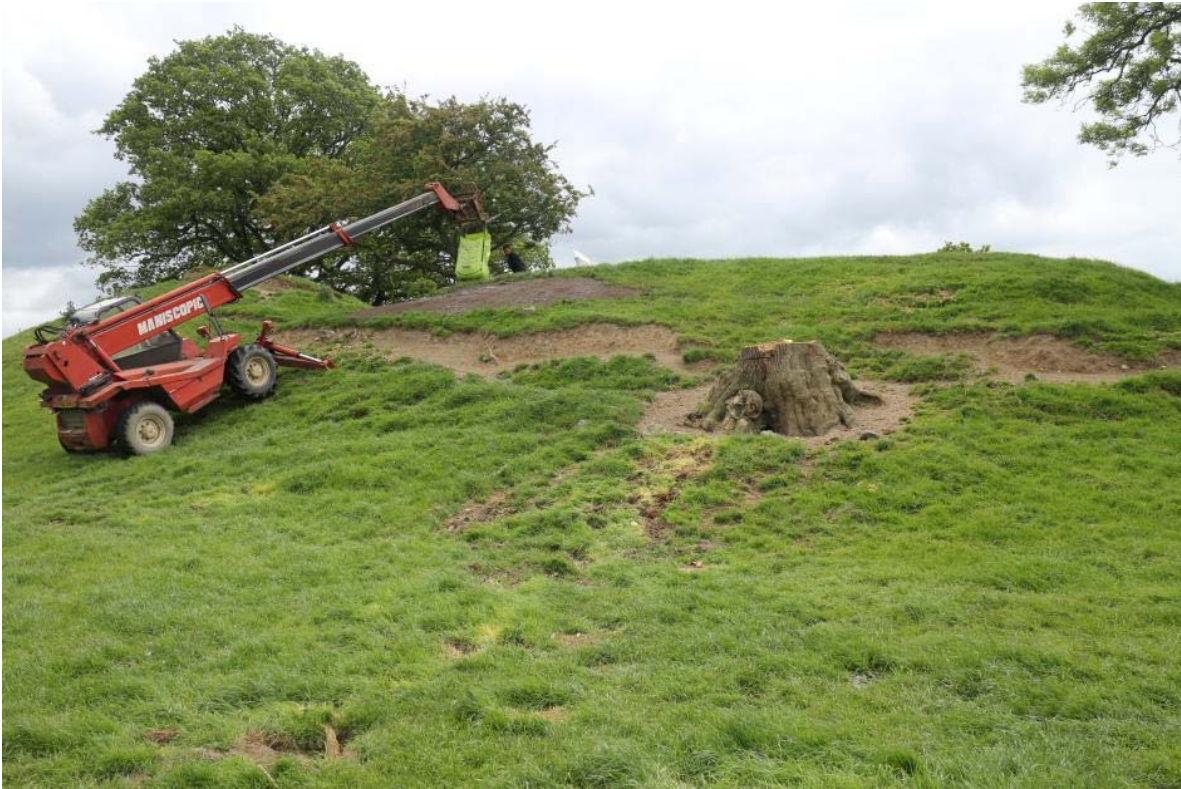
Commencing infilling of scars, IMG_6938, 22.06.2015

Scars were first infilled with topsoil, the infill material being partially compacted by treading and raking, the final, profiled surface being finished level with the surrounding ground surface. Infill soil was mixed with Broadleaf 4 (see Appendix 1) at a rate not exceeding one Kilogram per cubic metre.

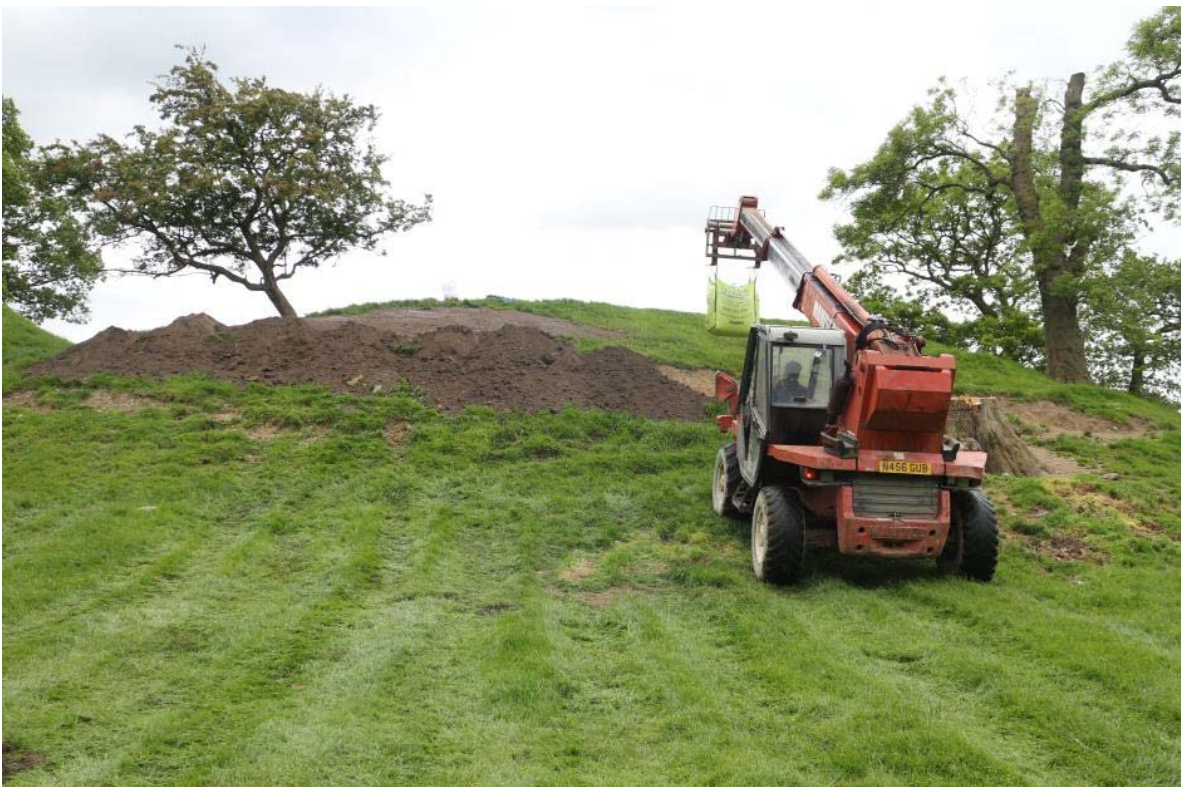
Infilling of scars in progress, IMG_6946, 22.06.2015

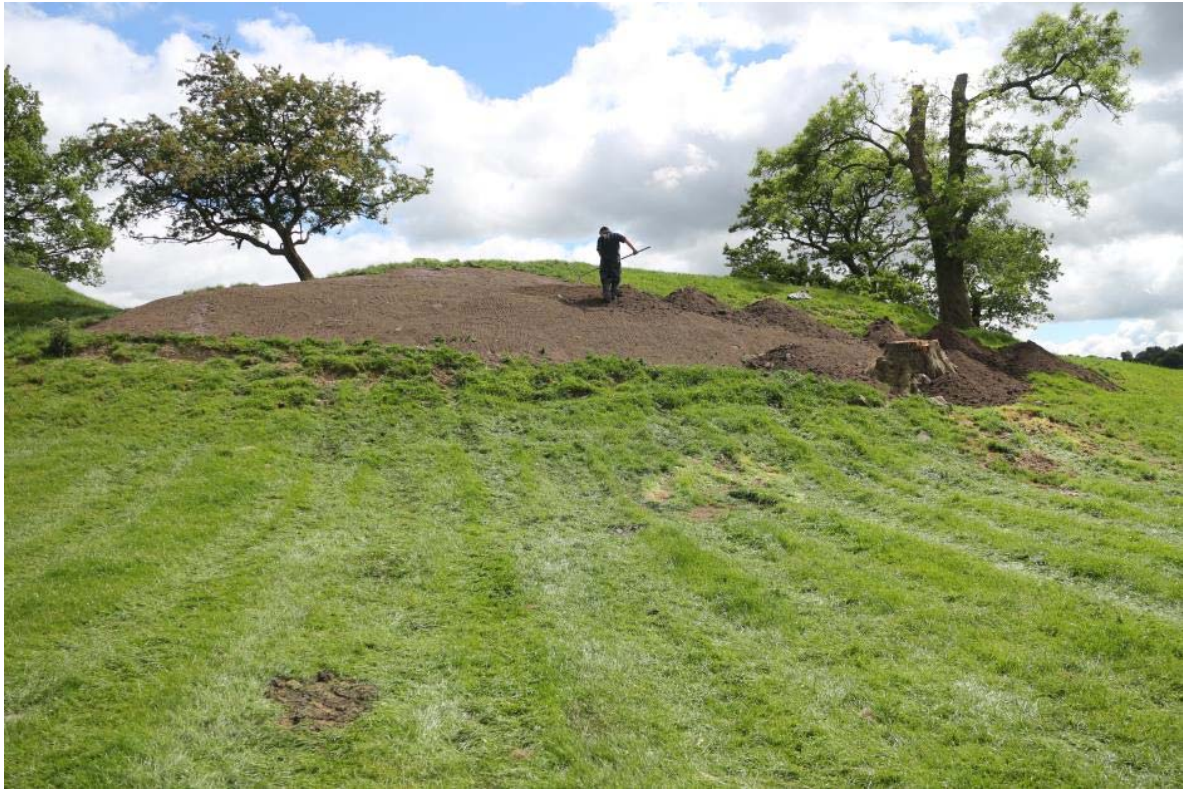
Compacting and profiling infill topsoil, IMG_6949, 22.06.2015

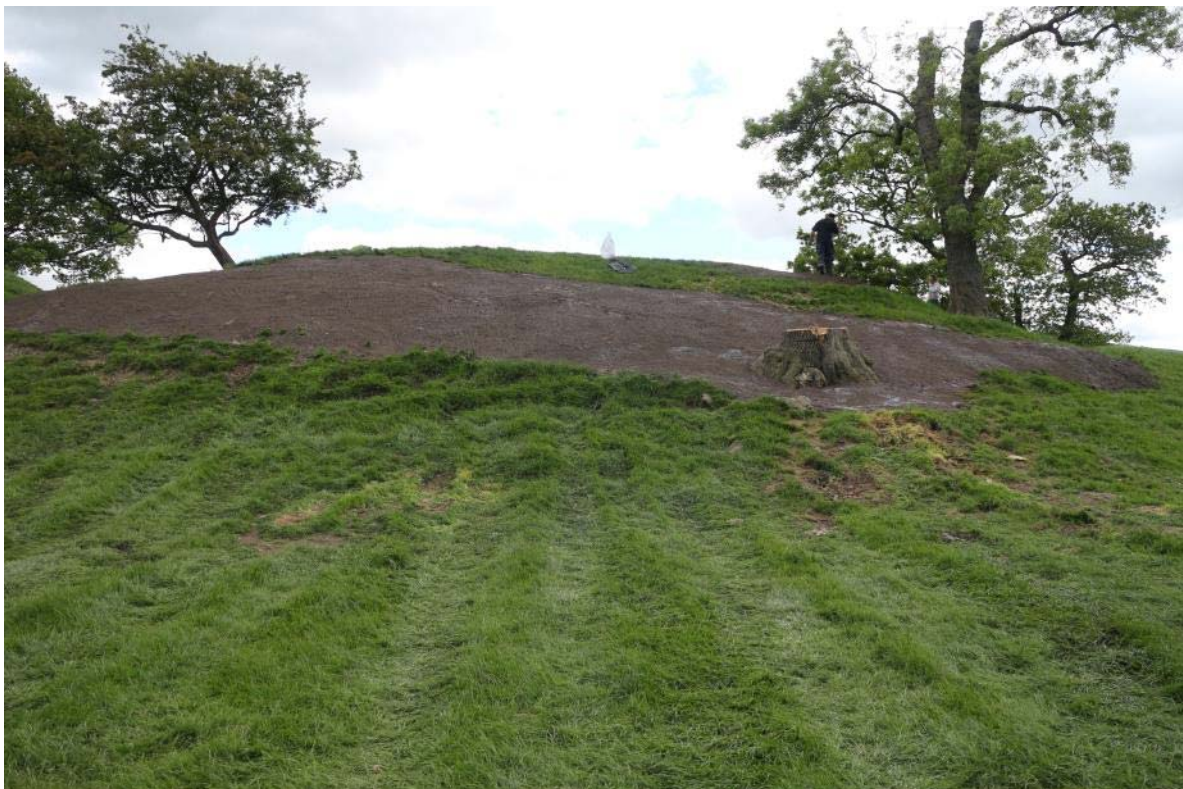
Infilling and profiling completed, IMG_6960, 22.06.2015

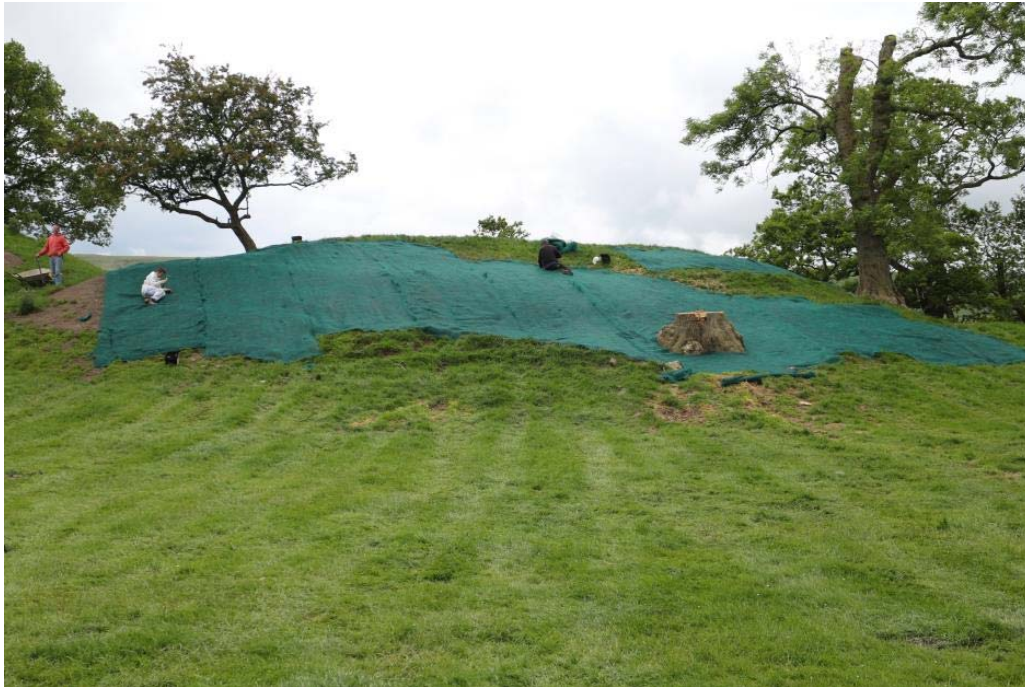
Installing Western Excelsior Excel PP5-12 Turf Reinforcement Matting, IMG_7070, 24.06.2015

Scars were then seeded with a drought-tolerant grass seed mix comprising 35% tall fescue *Festuca arundinacea*, 35% rhizomatous tall fescue and 30% topgun dwarf perennial ryegrass *Lolium perenne* at a rate of 35 grams per square metre. The repair was then covered with Western Excelsior Turf Reinforcement Matting PP5-12, secured to the substrate using a mix of 200 mm and 300 mm crimped steel pins, at a density not exceeding six per square metre.

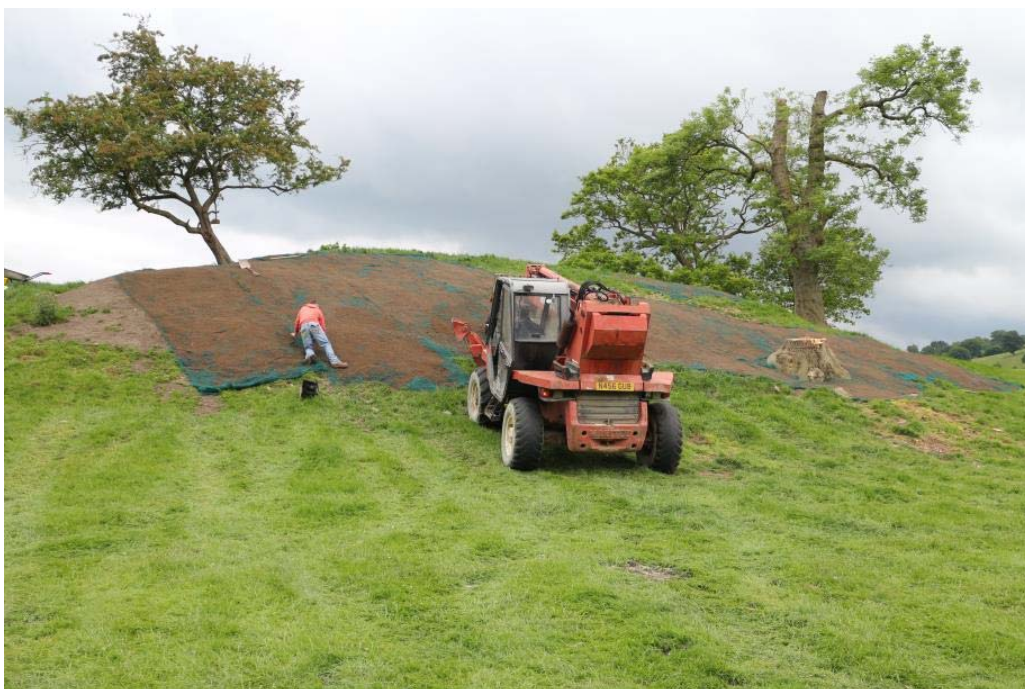
Top-dressing installed Western Excelsior Excel PP5-12 TRM, IMG_7097, 24.06.2015

Finally, the Turf Reinforcement Matting was top-dressed with a thin layer of topsoil, lightly brushed into the matrix of the matting.

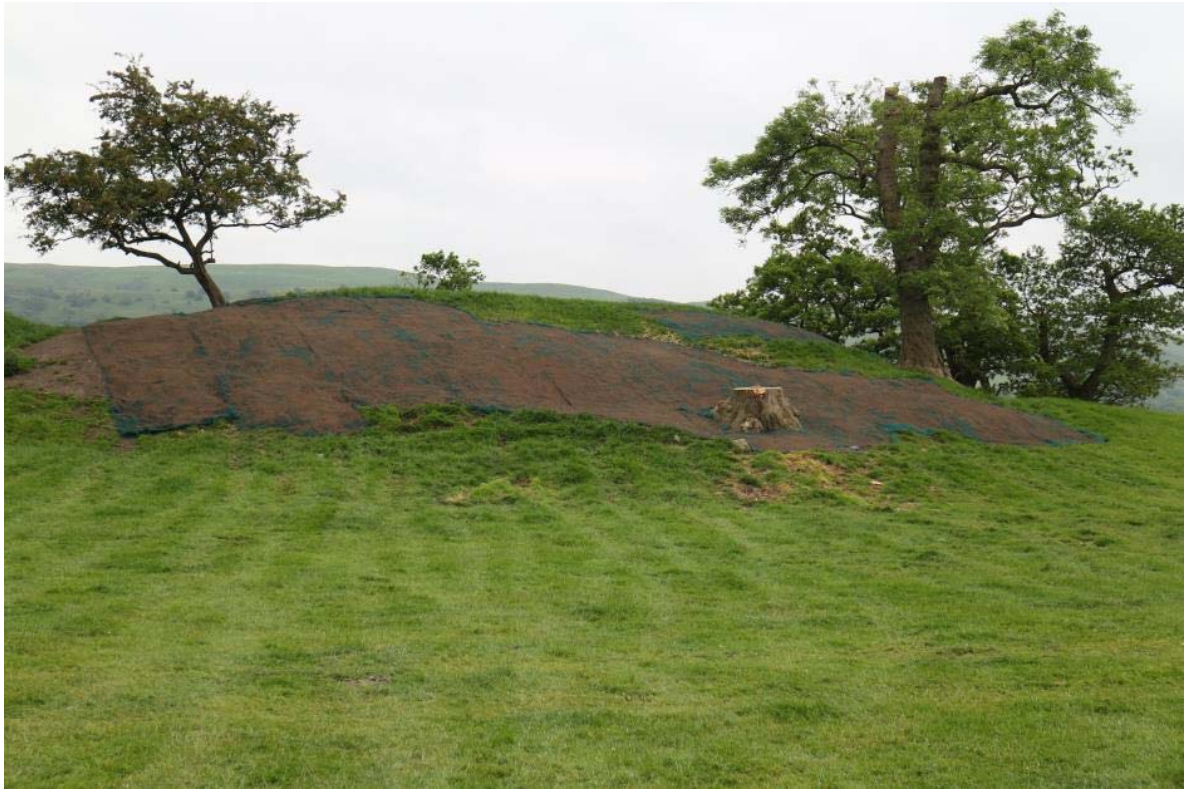
Completed repair, IMG_7108, 25.06.2015

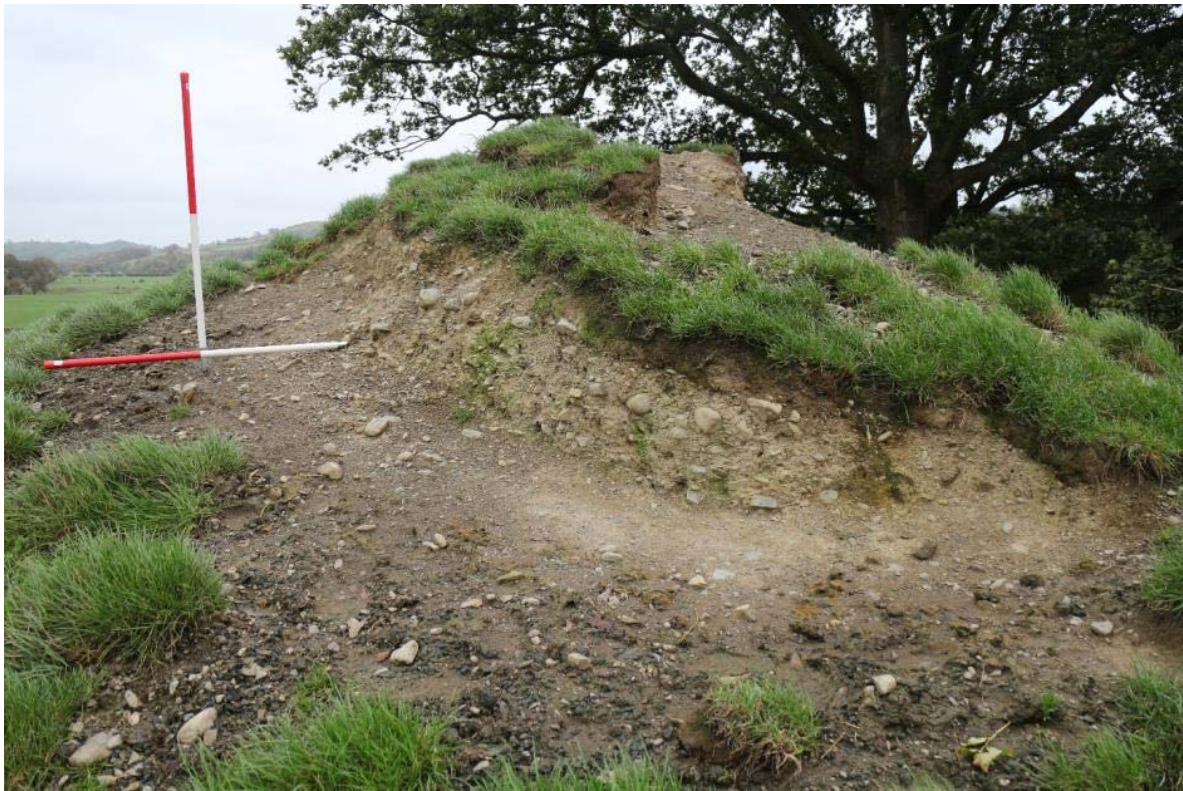
The motte summit, prior to repair, IMG_2524, 22.10.2014

The summit of the motte was similarly treated, but a bespoke, interlocking timber crib (see Appendix 4) was first constructed to help retain the topsoil infill. This was held in place by 1000 mm long by 20 mm diameter steel pins (see images below).

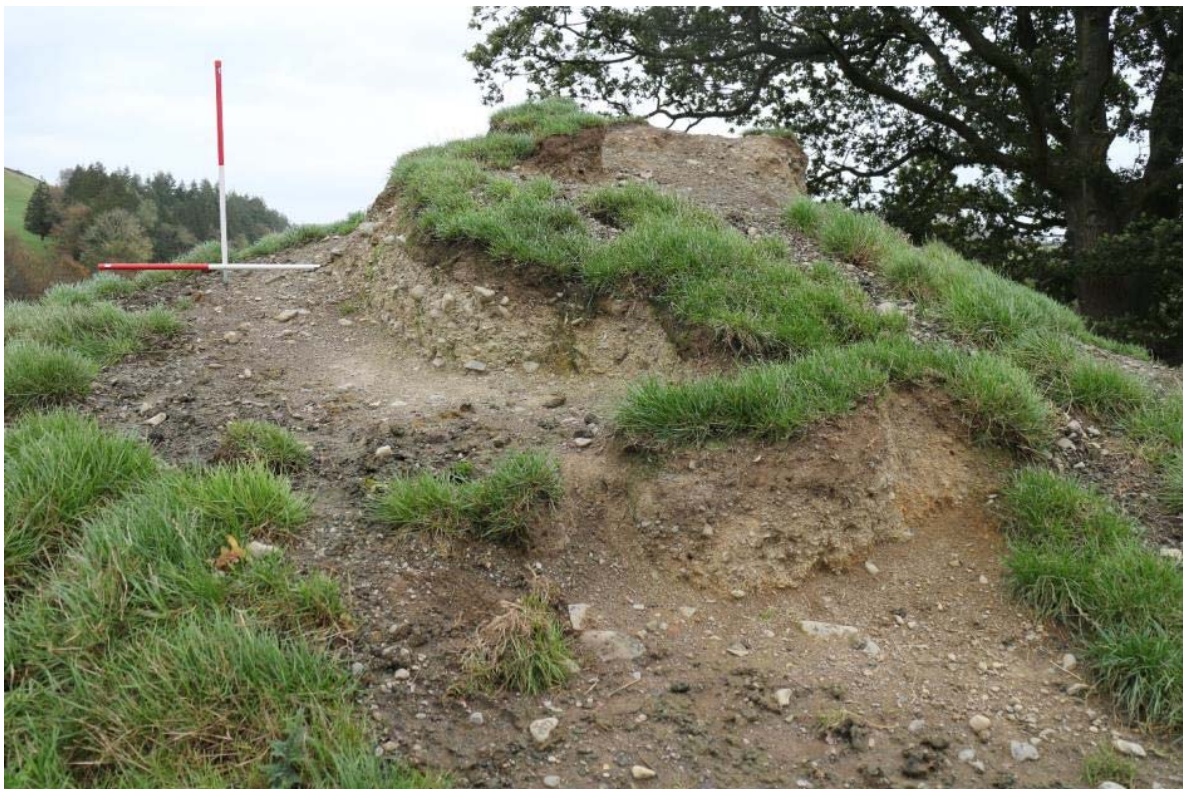
The motte summit, prior to repair, IMG_2525, 22.10.2014

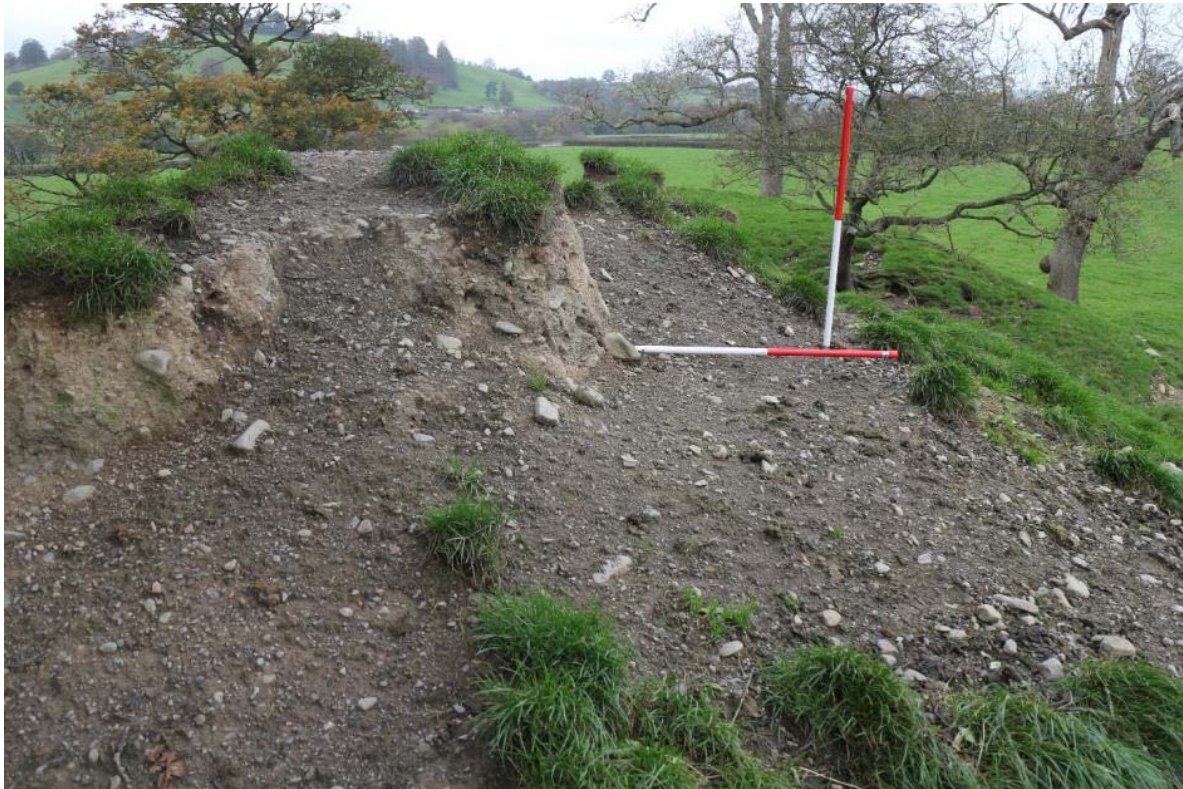
The motte summit, prior to repair, IMG_2526, 22.10.2014

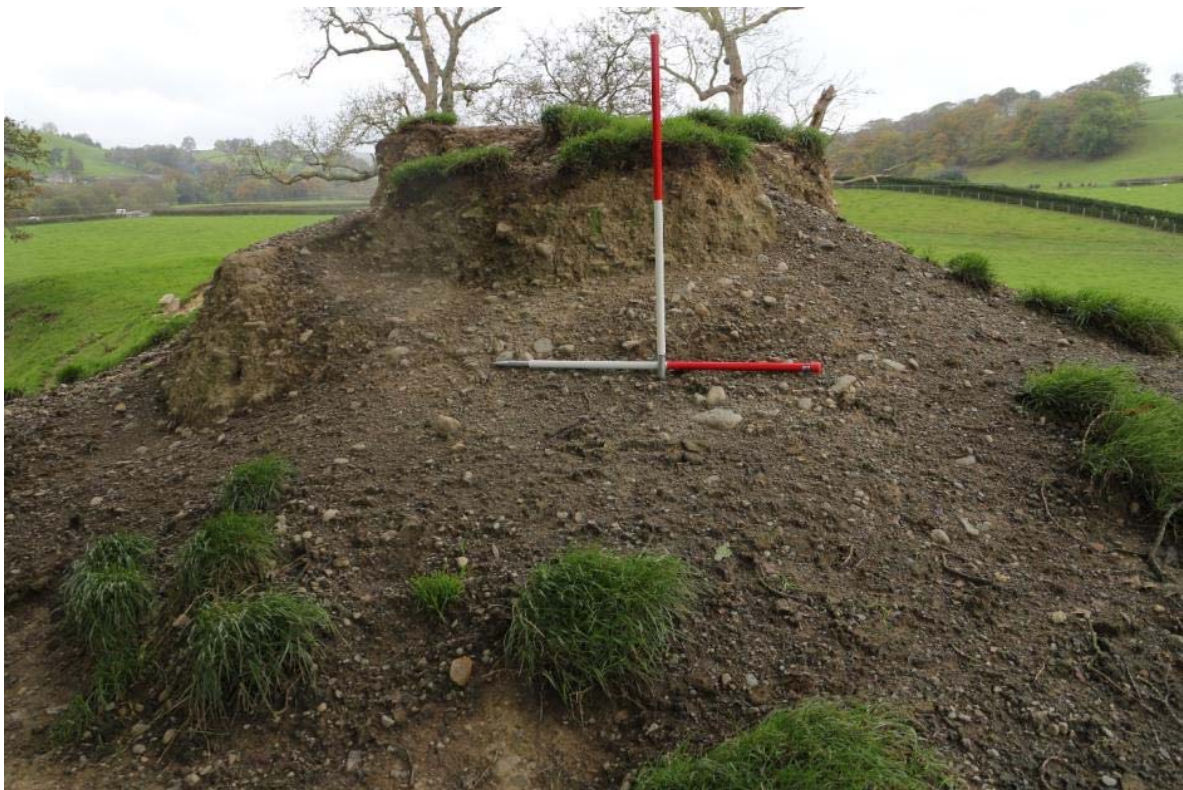
The motte summit, prior to repair, IMG_2527, 22.10.2014

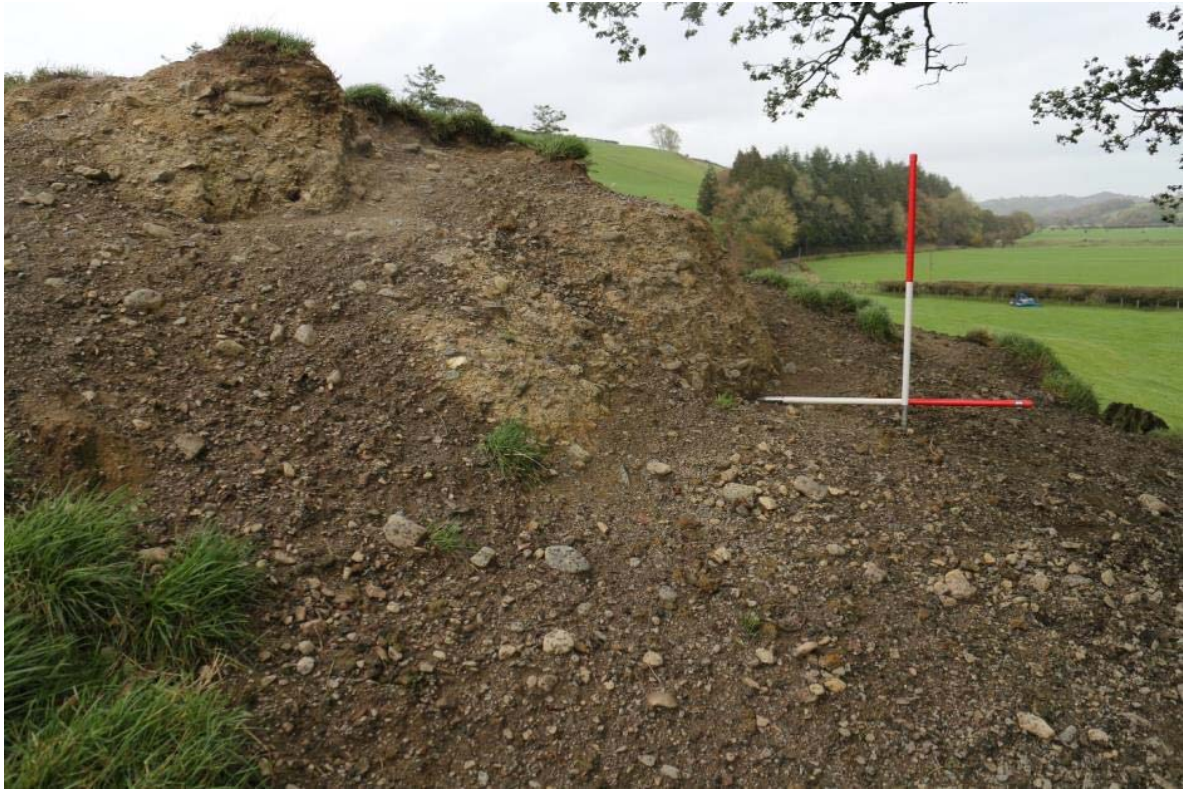
The motte summit, prior to repair, IMG_2529, 22.10.2014

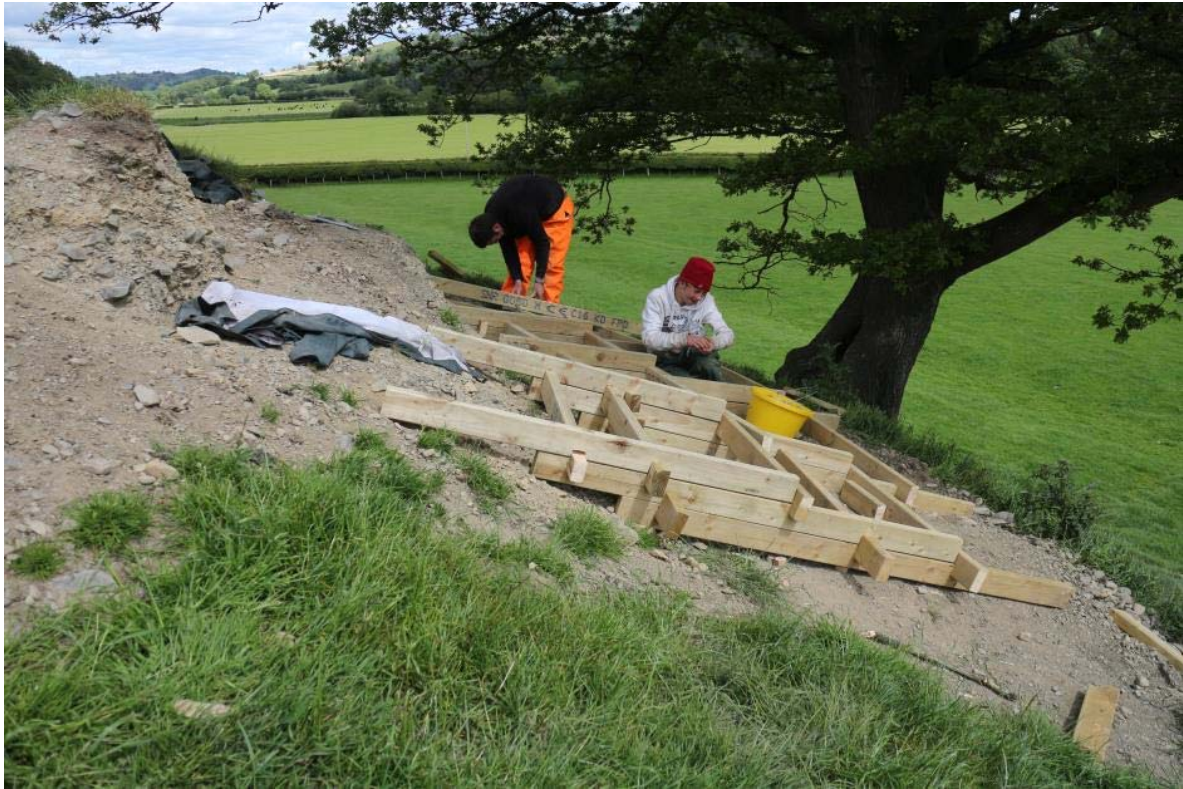
Commencing construction of timber crib, IMG_6956, 22.06.2015

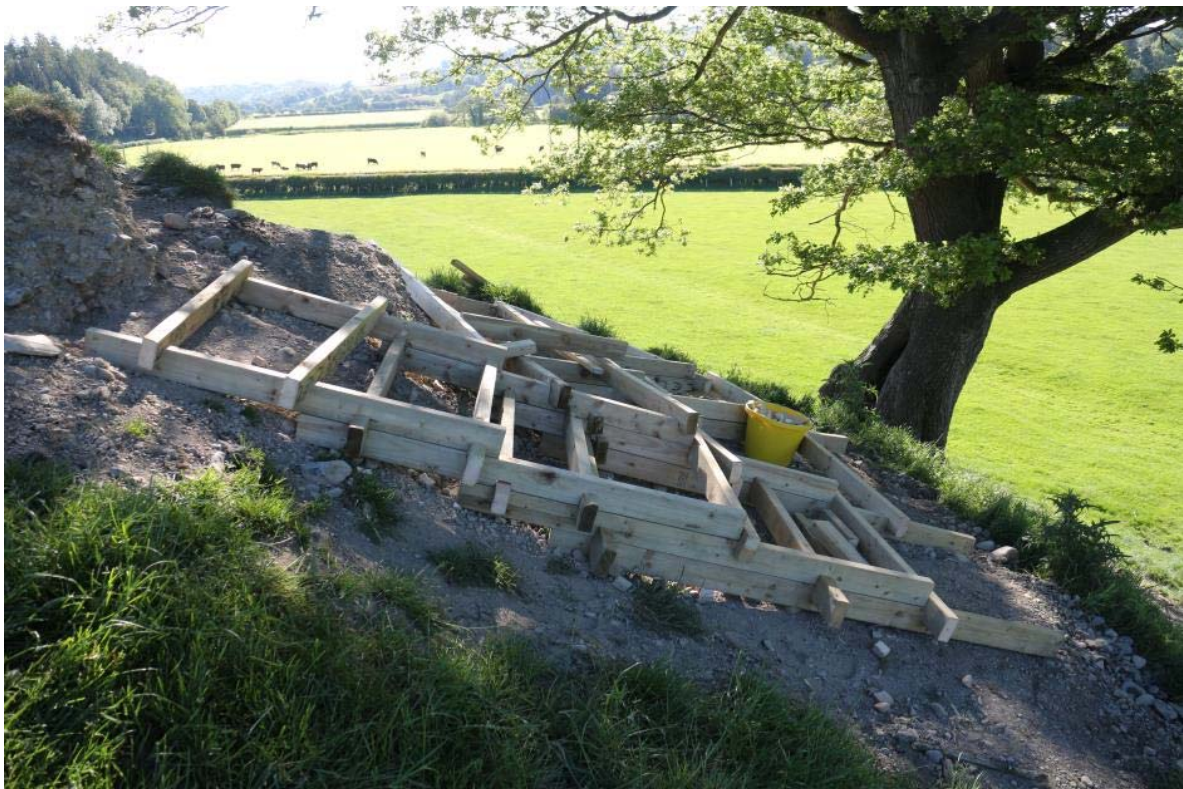
Midway through construction of timber crib, IMG_6979, 23.06.2015
