Llysun Motte and Bailey

Scheduled Ancient Monument MG072

Completion Report

This Completion Report describes repair works undertaken between Monday 22 June and Friday 26 June 2015 to fulfil Mr Tudor's obligations under the Scheduled Ancient Monument Management Plan and his Glastir Advanced agreement.

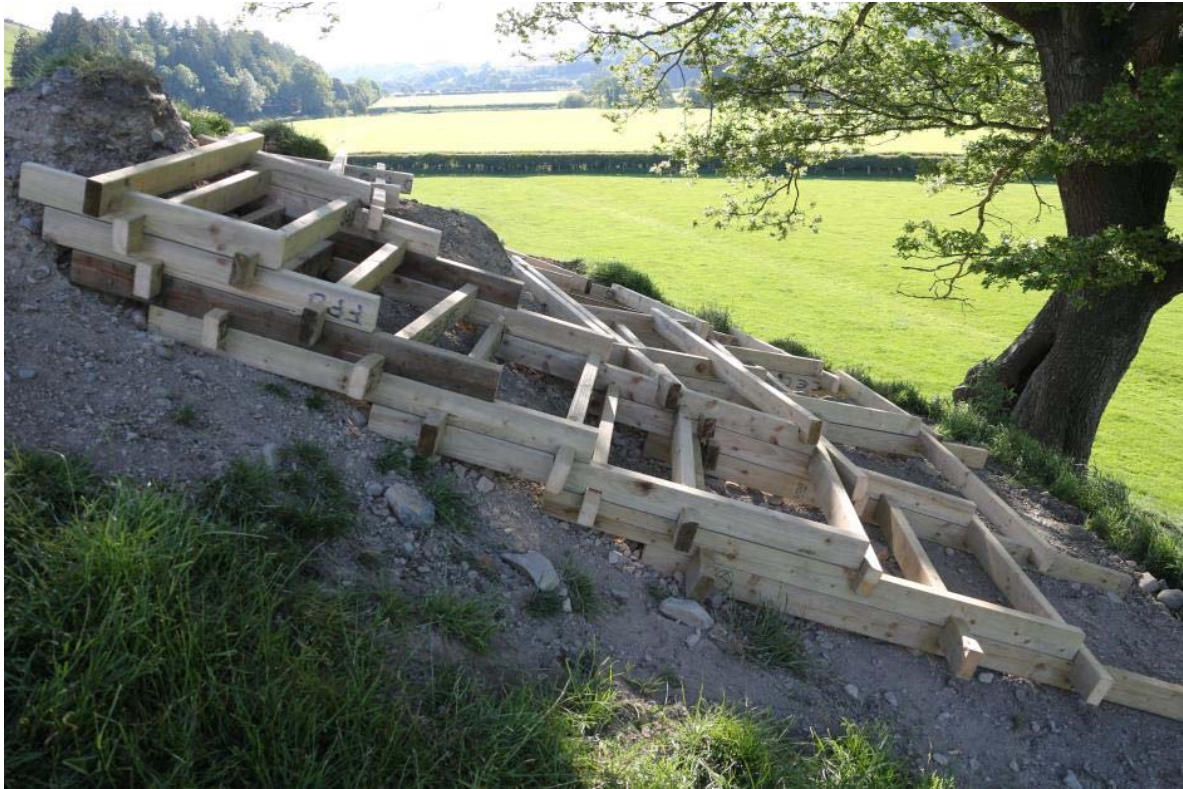
Completed timber crib, IMG_7032, 24.06.2015

The summit of the motte was similarly treated, but a bespoke, interlocking timber crib (see Appendix 4) was first constructed to help retain the topsoil infill. This was held in place by 1000 mm long by 20 mm diameter steel pins (see images below).

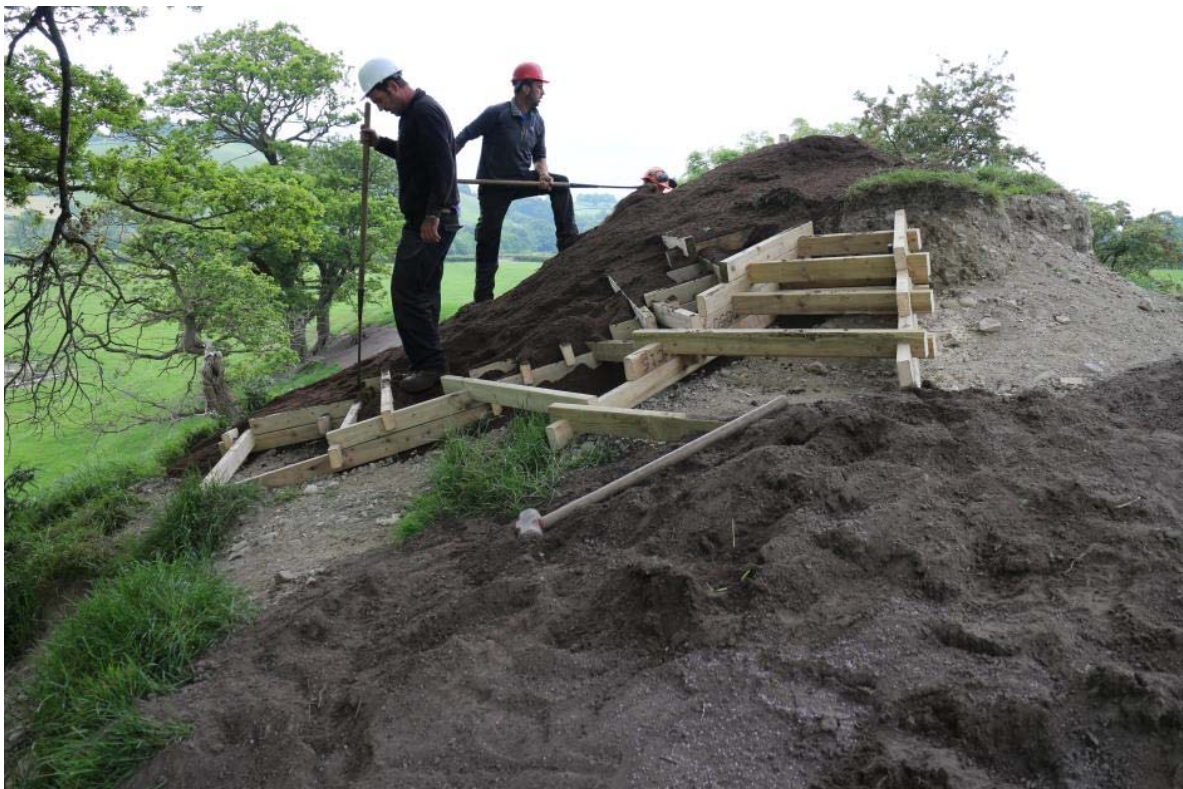
Commencing infilling timber crib, IMG_7173, 25.06.2015

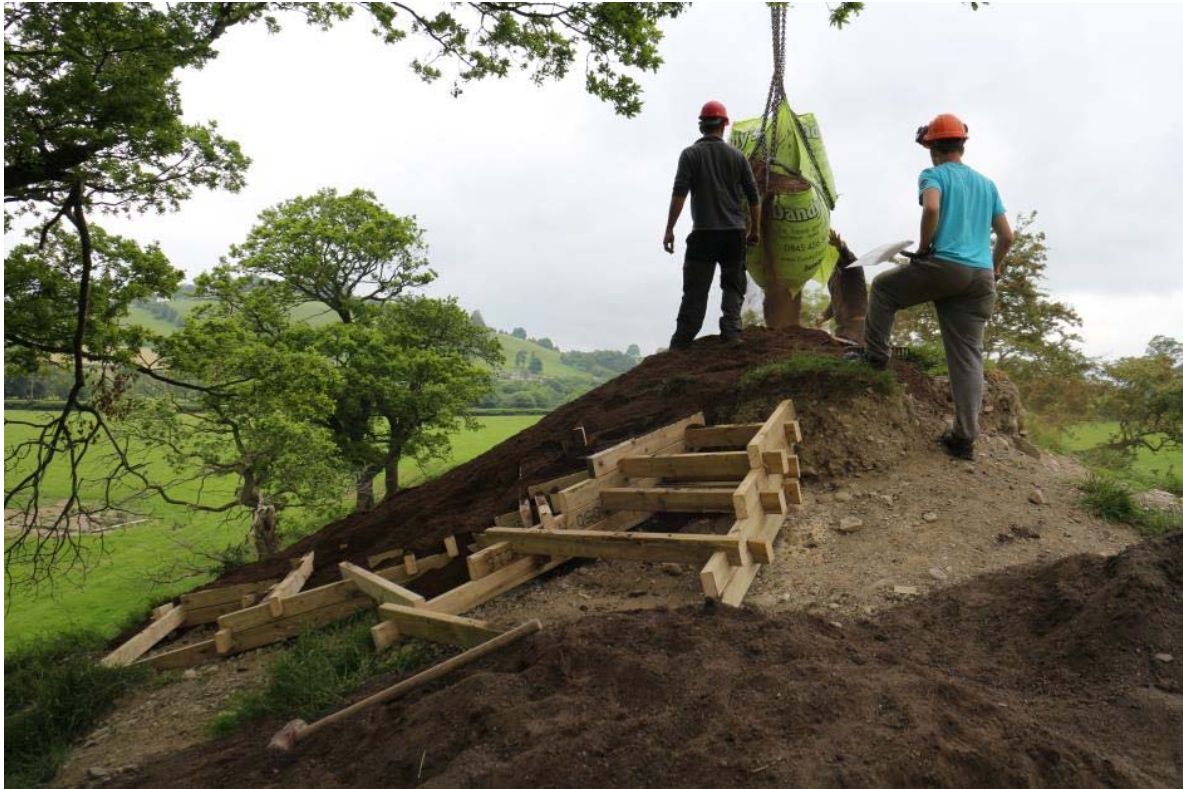
Topsoil delivery by crane to timber crib, IMG_7178, 25.06.2015

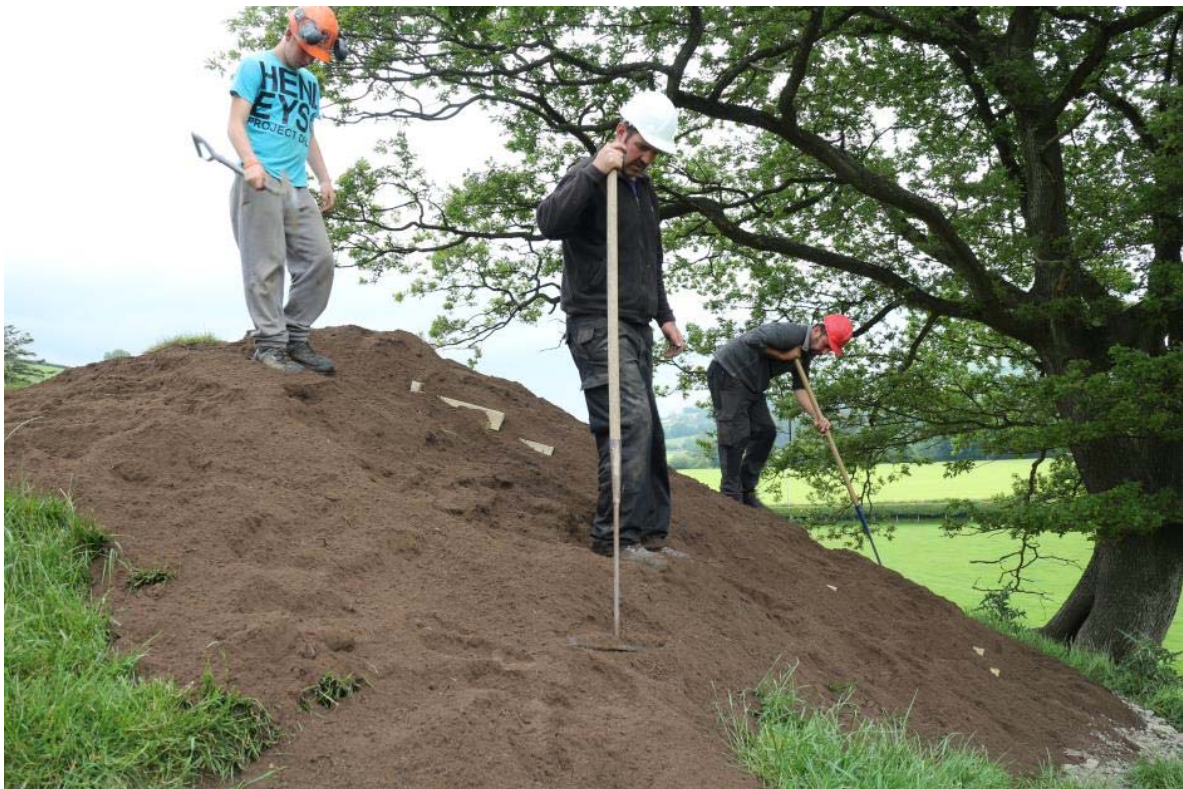
Compacting infill topsoil, IMG_7185, 25.06.2015

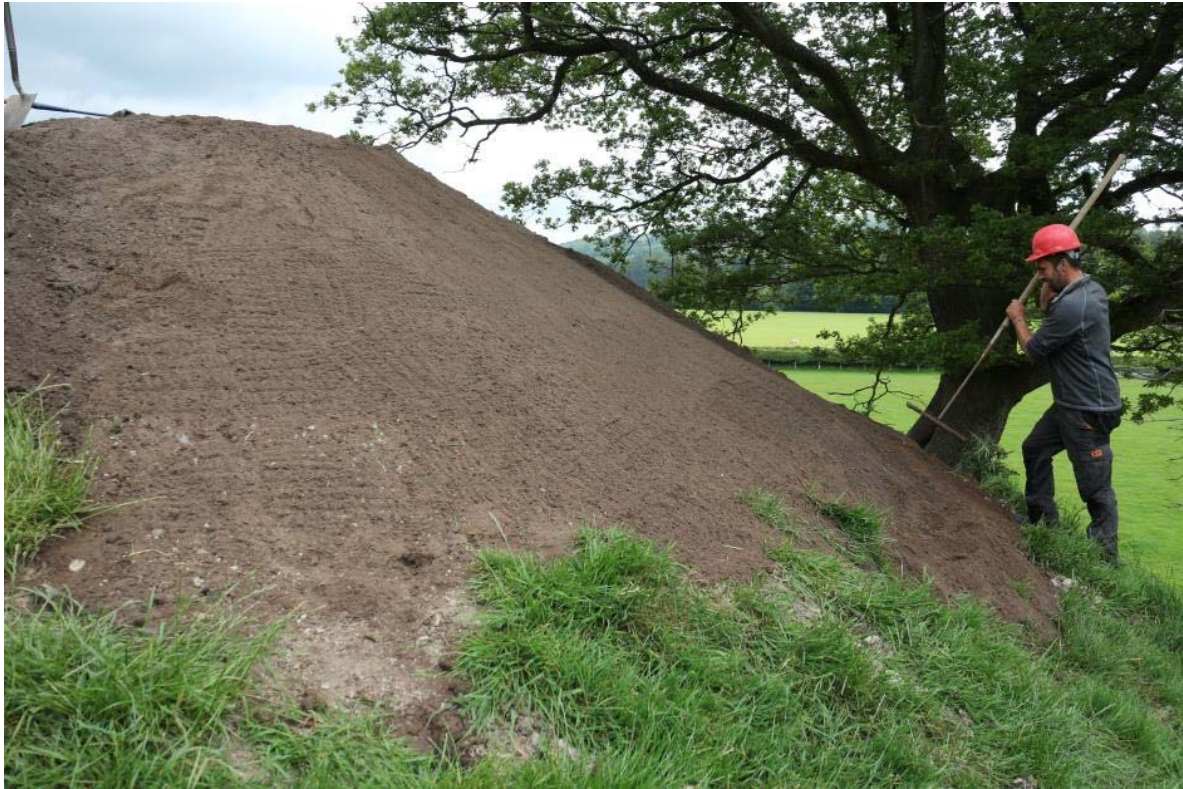
Final profiling of infill topsoil, IMG_7205, 25.06.2015

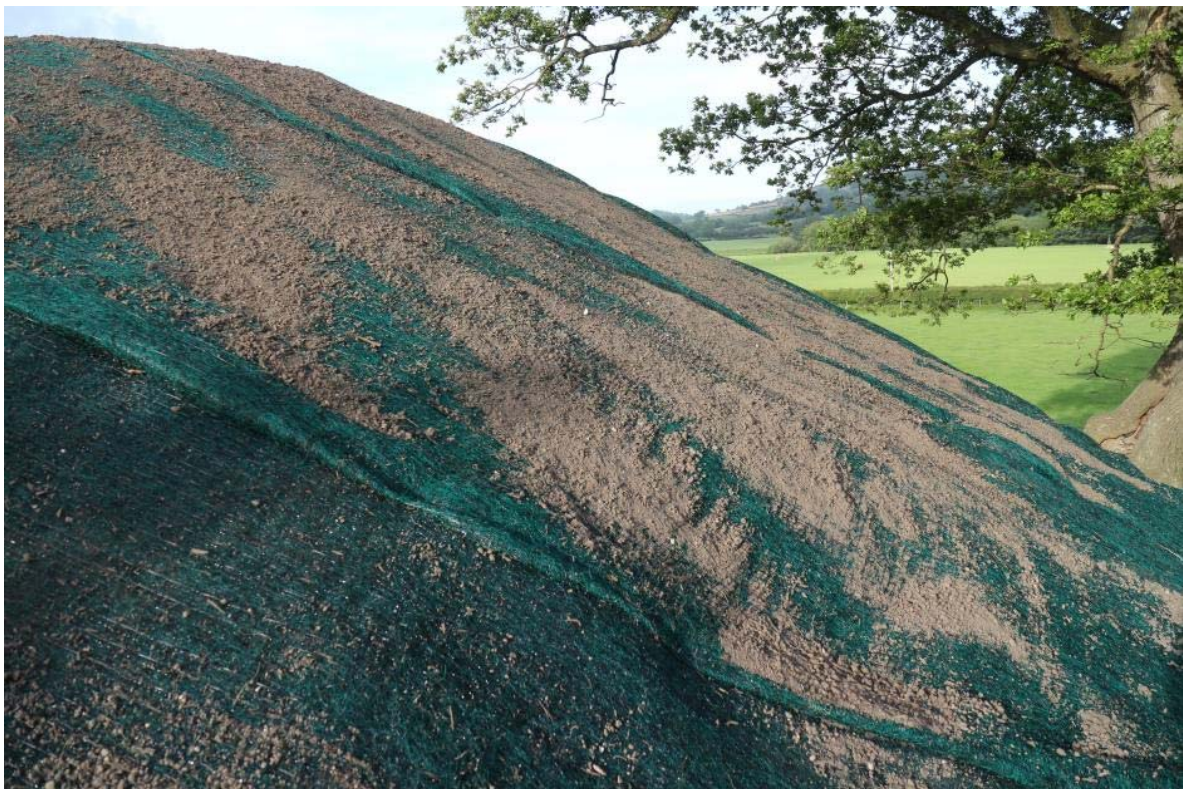
Western Excelsior Excel PP5-12 Turf Reinforcement Matting installed, top dressing with topsoil in progress, IMG_7288, 26.06,2015

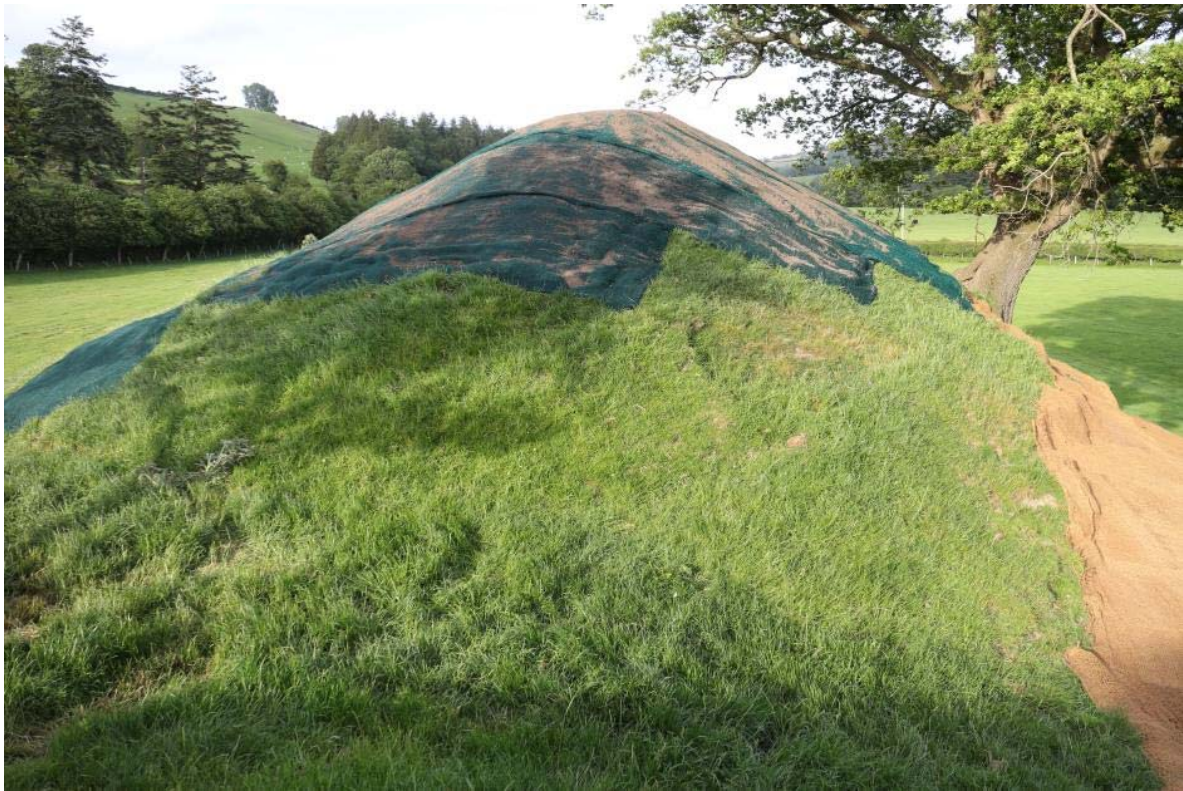
Completed repair to motte, looking east, IMG_7287, 26.06.2015

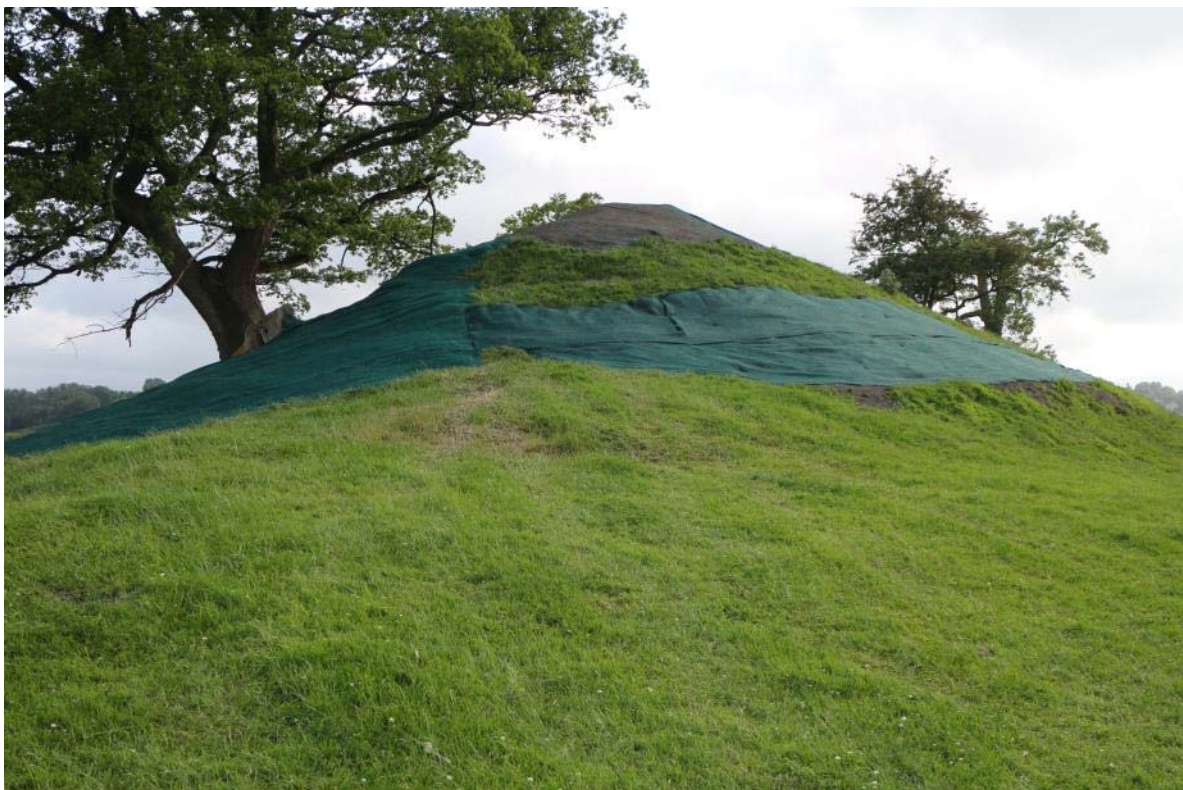
Completed repair to motte, looking west, IMG_7272, 26.06.2015

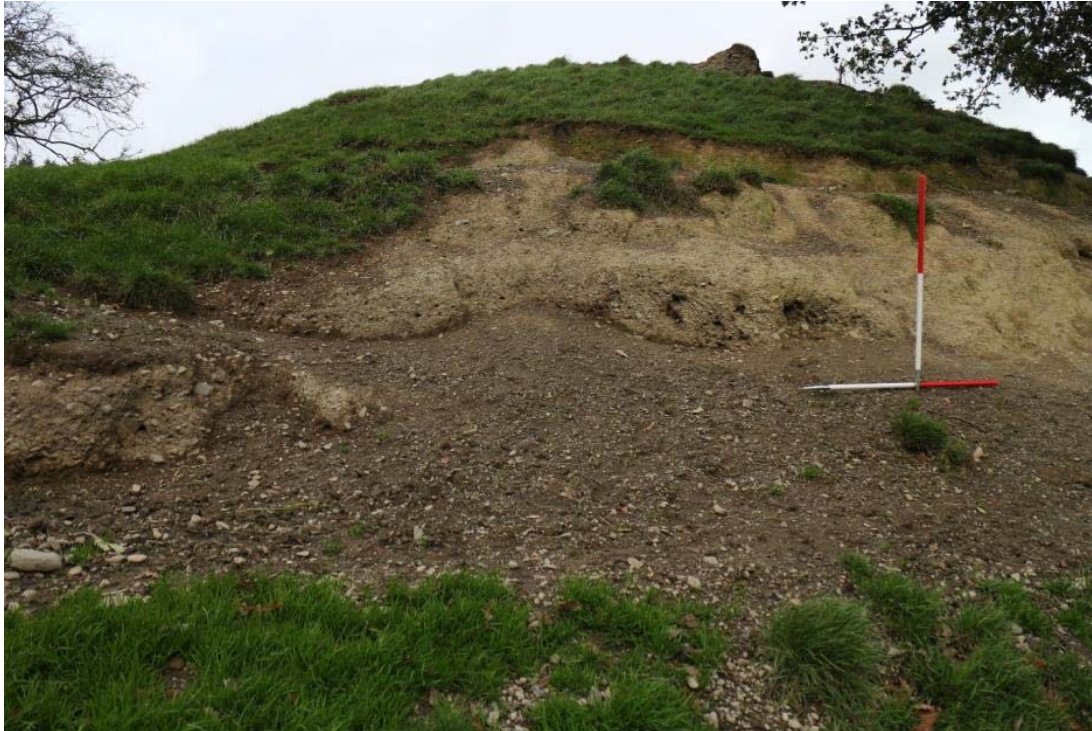
Prior to repair, IMG_2534, 22.10.2014

Areas on the south side of the Monument, perceived to be eroded natural substrate, were more simply treated (see images below). The areas were first sown by hand broadcasting with the drought tolerant grass seed mix at a rate of 35 grams per square metre. The extent of these areas was then covered with Greenfix Geocoir 900 Matting (see Appendix 3), the matting secured to the substrate using a combination of 200mm and 300mm long steel pins, at a density not exceeding six per square metre.

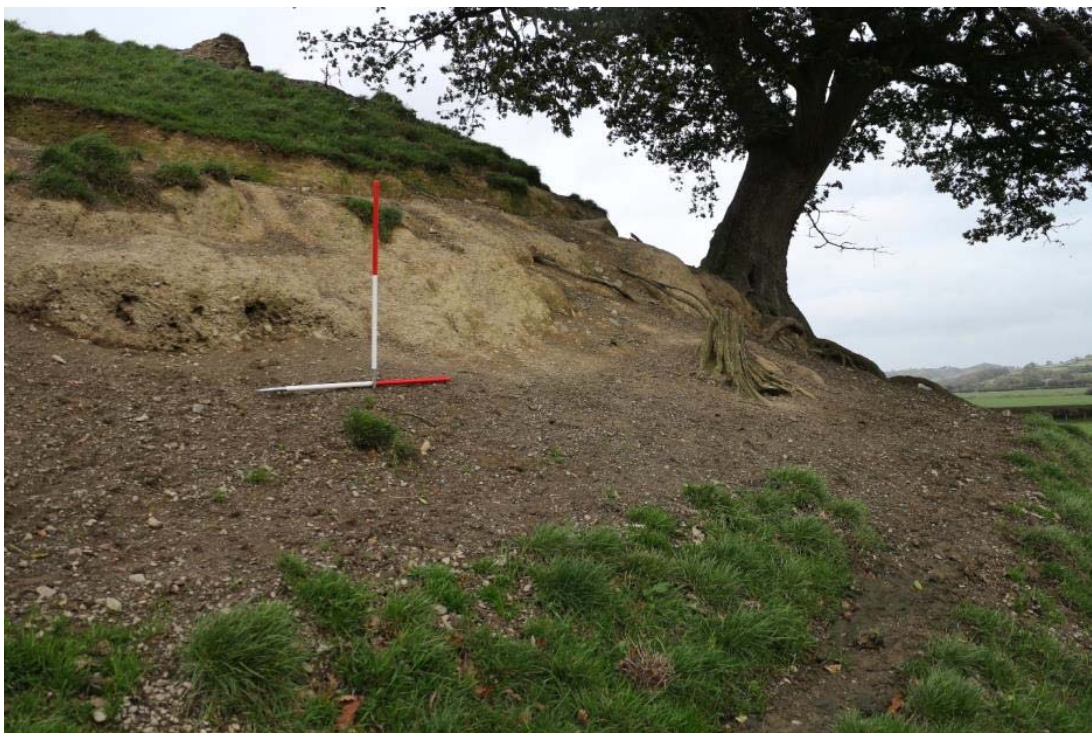
Prior to repair, IMG_2535, 22.10.2014

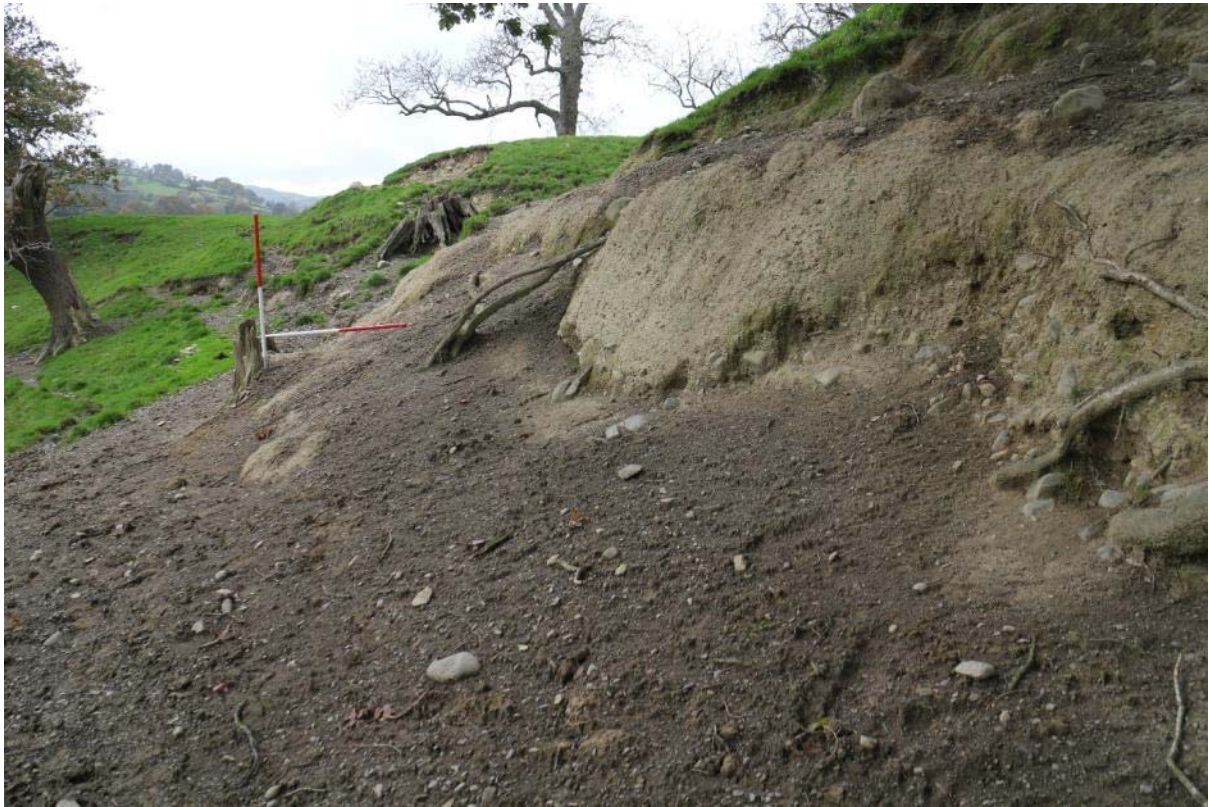
Prior to repair, IMG_2538, 22.10.2014

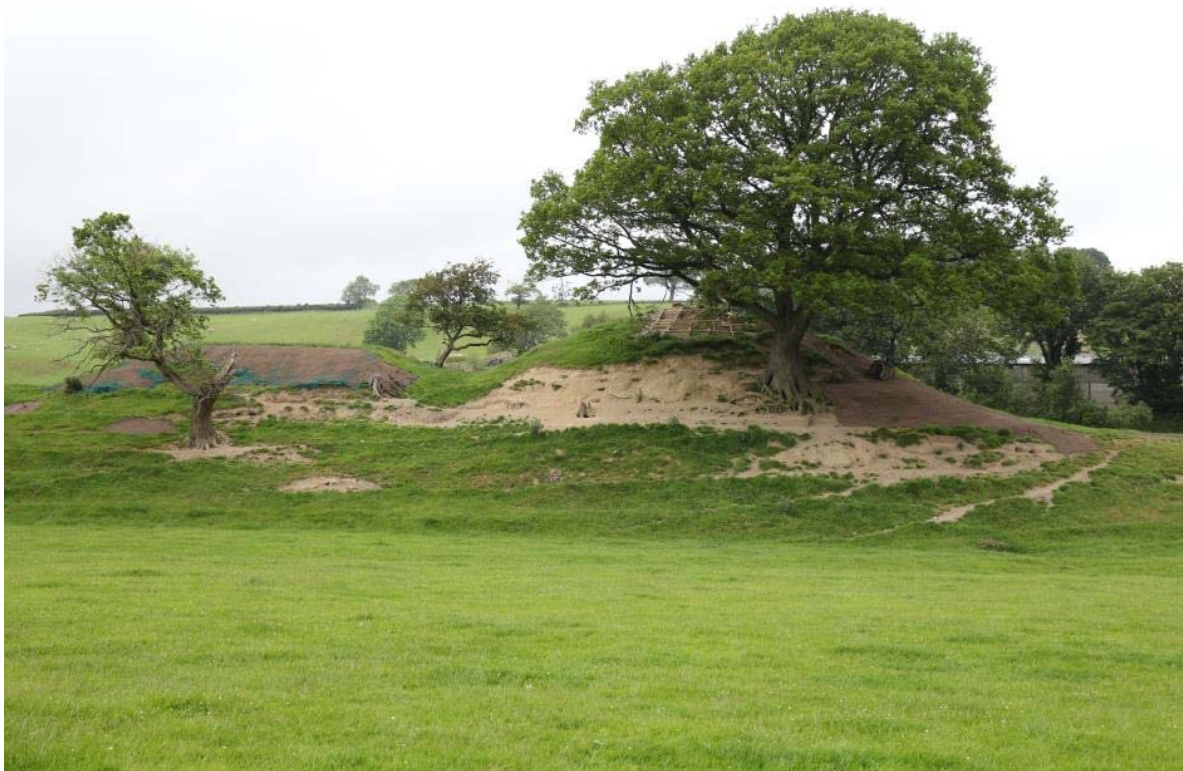
Immediately prior to repair, IMG_7114, 25.06.2015

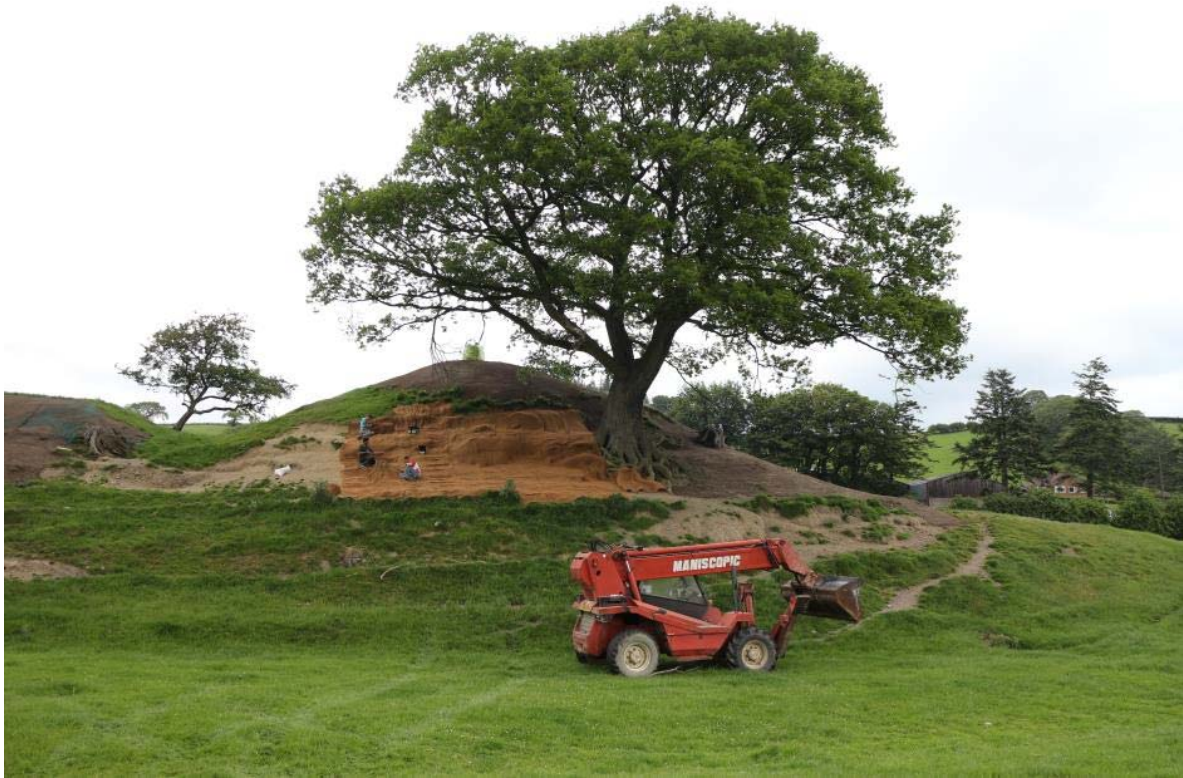
During repair, IMG_7214, 25.06.2015

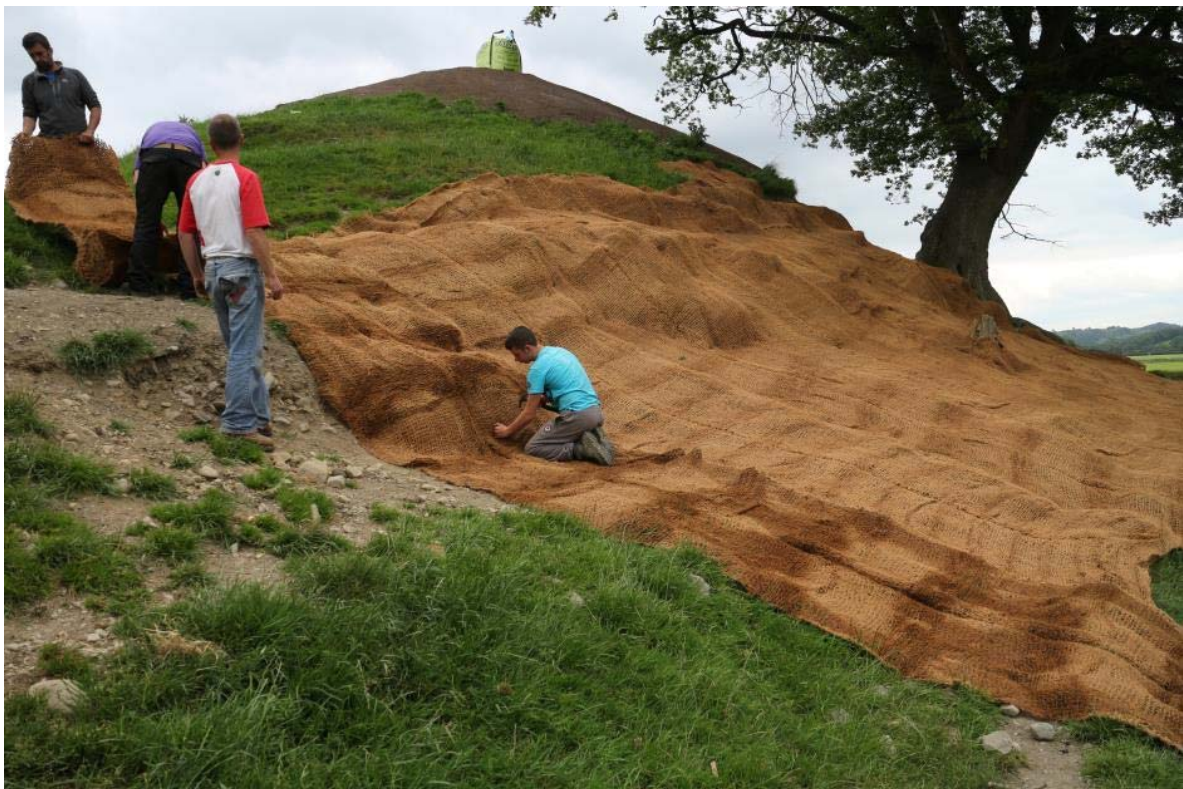
During repair, IMG_7222, 25.06.2015

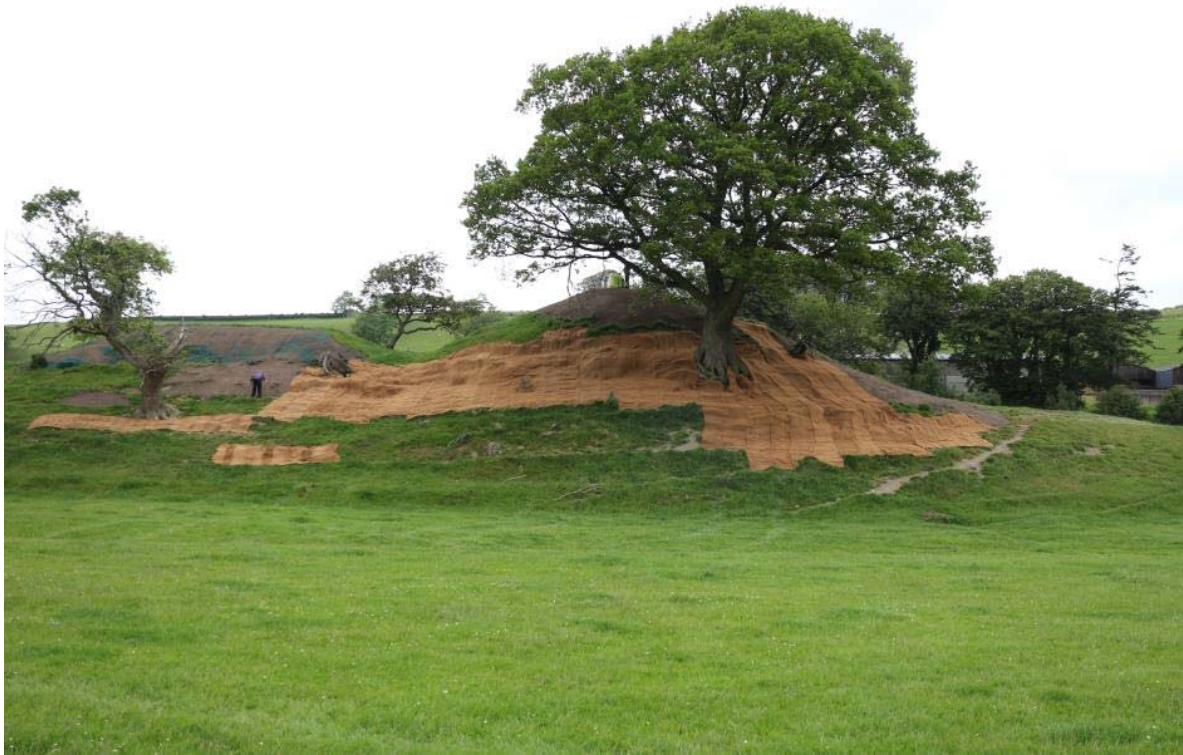
Completed repair, IMG_7236, 25.06.2015

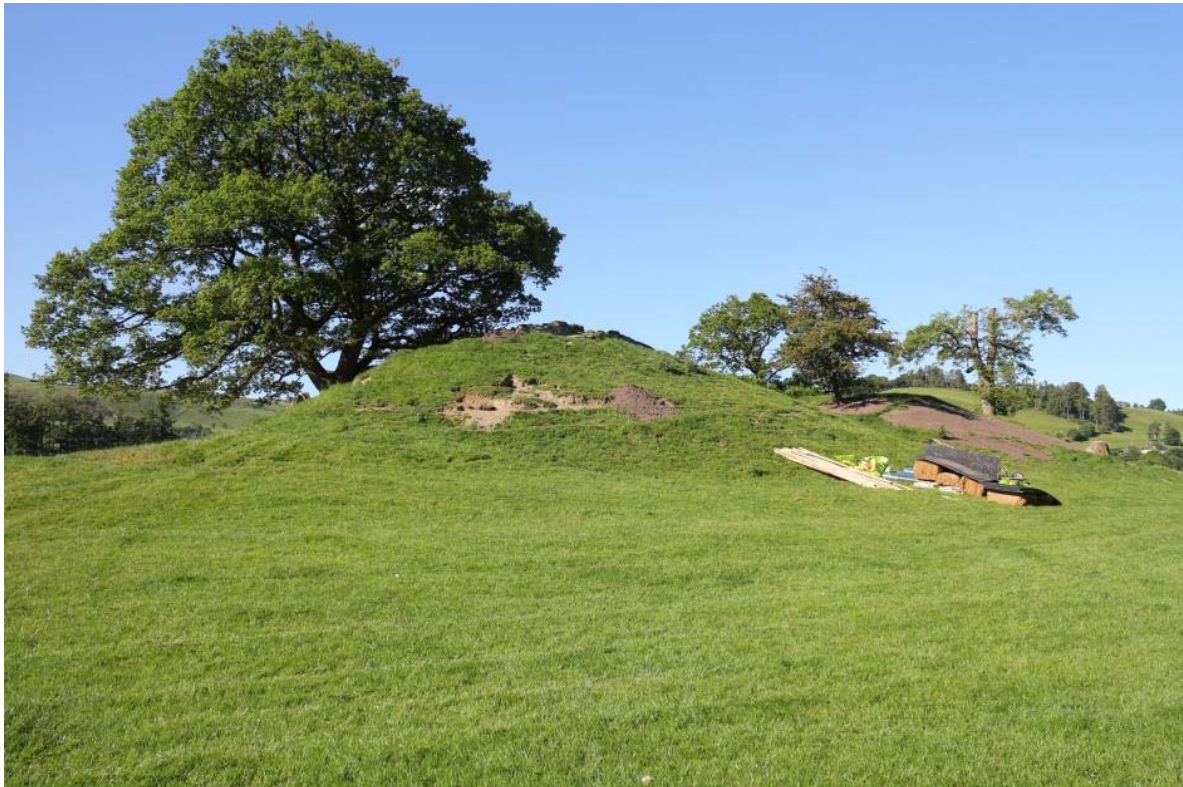
North side, early stages of repair, IMG_6989, 23.06.2015

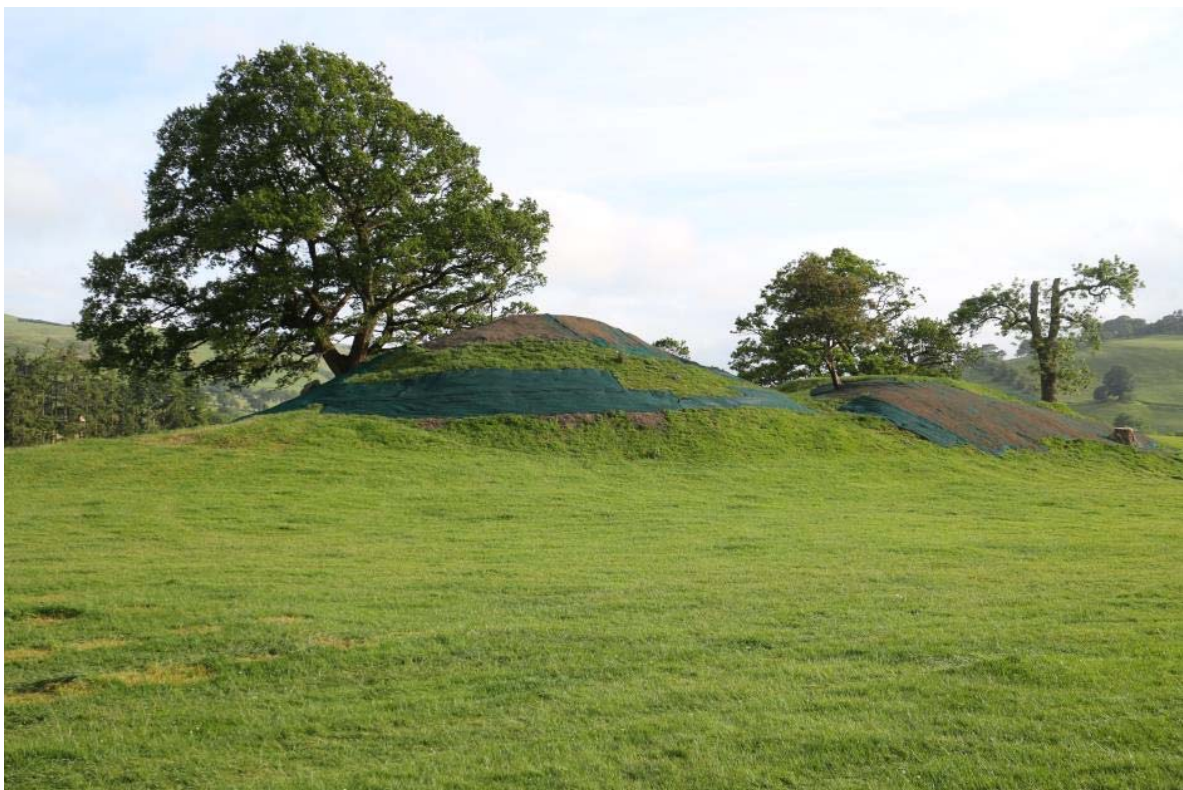
North side, immediately after completed repairs, IMG_7301, 26.06.2015

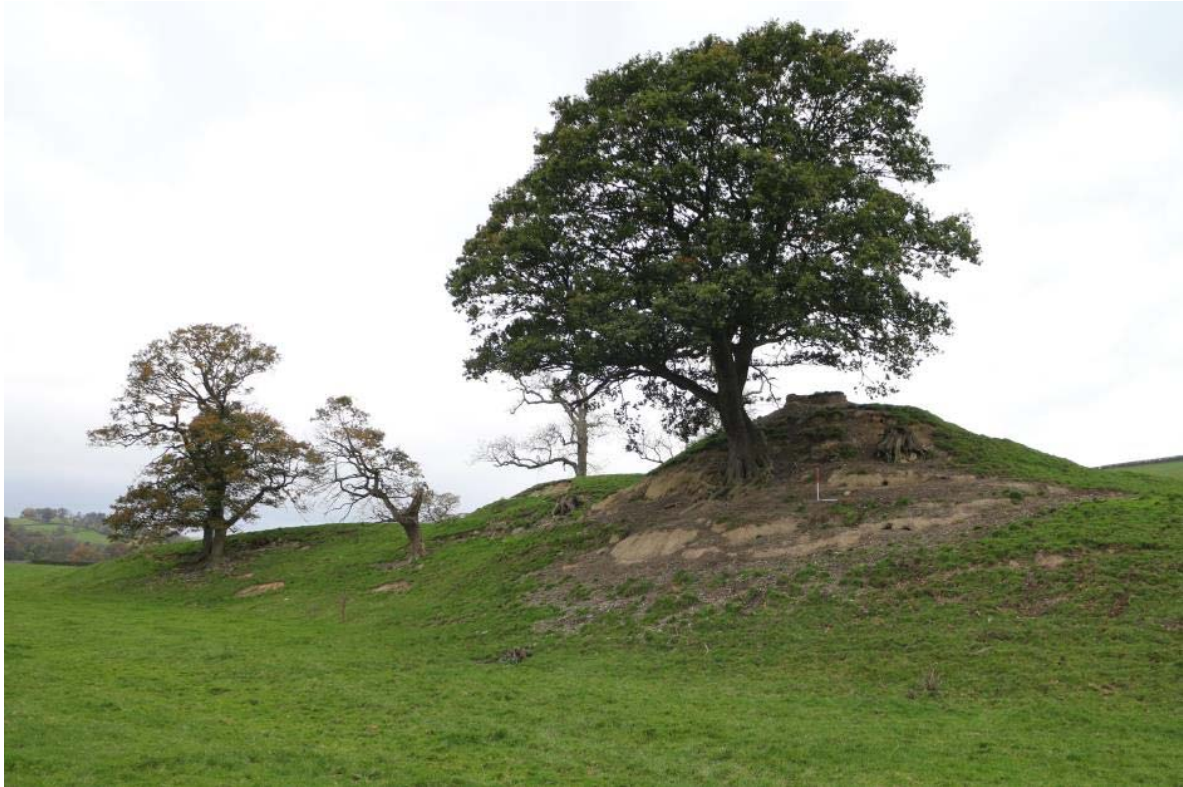
South side, prior to repair, IMG_2563, 22.10.2014

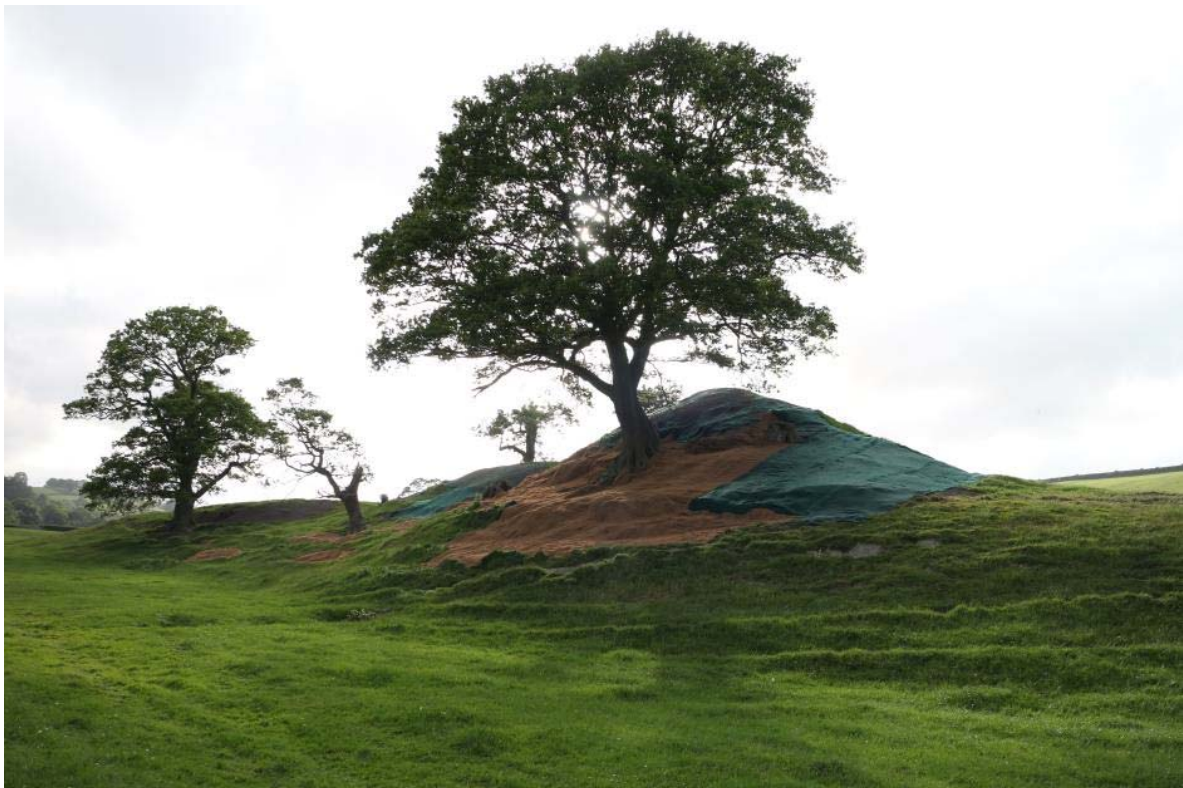
South side, immediately after completed repairs, IMG_7274, 26.06.2015

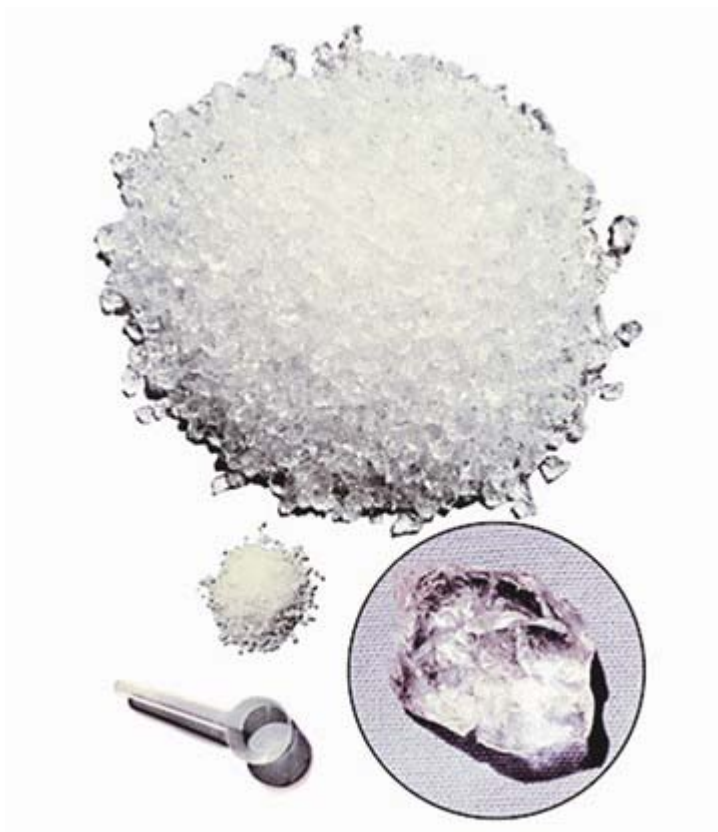
Broadleaf P4 is a high performance, long lasting, hydrophilic (water and nutrient storing) cross-linked copolymer polyacrylamide which has been specifically developed for agricultural and horticultural applications. It is an environmentally safe, non-toxic organic compound that has been 'engineered' to store extremely large quantities of water and nutrients.

Broadleaf P4 absorbs 100-200 times its weight in water in soil, giving back over 95% of the water stored within it directly to plants as they need it via its reservoir-action. In dry form, P4 takes on water and swells to form odourless, colourless hydrogel particles which plant roots grow through.

*Broadleaf P4. Image source:
www.baldur-nederland.nl*

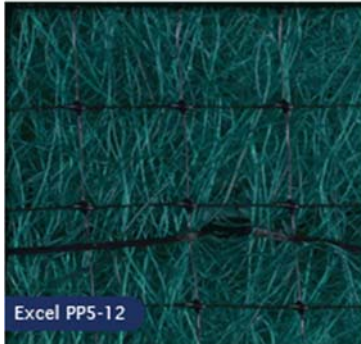
Western Excelsior Excel PP5-12 Turf Reinforcement Mat (TRM) is composed of 100% synthetic components. A matrix of green polypropylene fibres is mechanically (stitch) bound between two UV stabilised, heavy duty synthetic nets. Stitching is secured on 50 mm centres using UV stabilised, heavy duty polypropylene thread.

Western Excelsior Excel PP5-12 TRM is a permanent, three dimensional, Turf Reinforcement Mat that provides immediate erosion protection and long term turf reinforcement; and, is intended for slope applications requiring erosion protection for greater than thirty-six months.

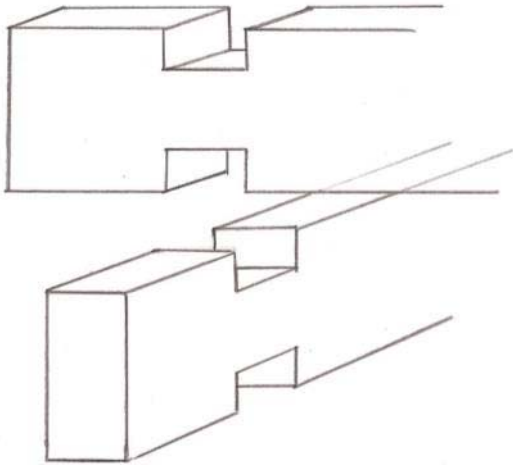
Detail of interlocking

100 mm x 50 mm cross-section (4 inches x 2 inches) rails, cut to length on-site, as necessary.

Rails bespoke 'notched' on-site to create interlocking sections, as required, avoiding the need to use nails or screws to achieve fixing.

Timber crib in sections, four in number, each section resting on the substrate surface and retained in place using 20 mm x 1000 mm round steel pins, hammered into the substrate to a maximum depth of 600 millimetres.
