Bute Dry Dock, Cardiff

Level 3 Historic Building Record

Project no. 70043727

Date: July 2023

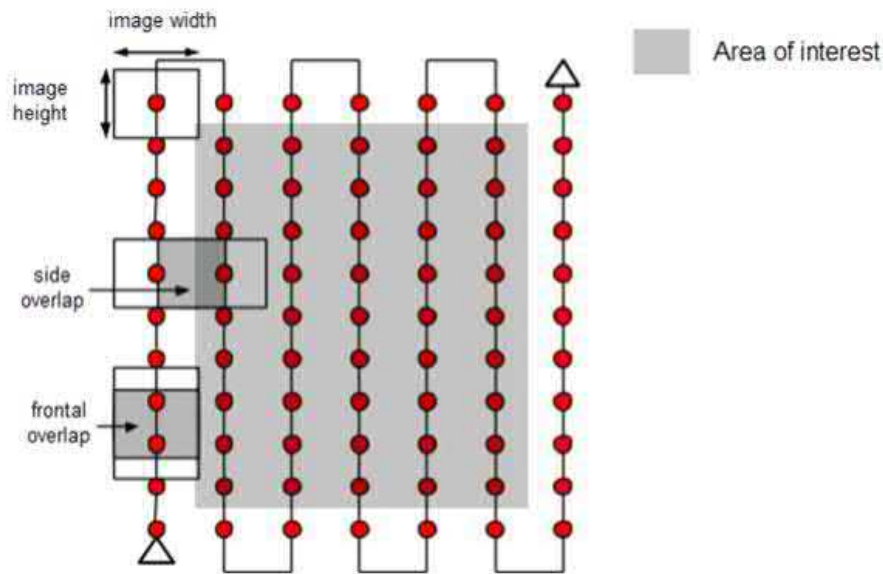
Figure 2- Photogrammetry employed on site

1.7.9. The photogrammetry was carried out by flying the UAV over the site in a systematic fashion, capturing numerous overlapping oblique and nadir (vertical downwards) images (Figure 2).

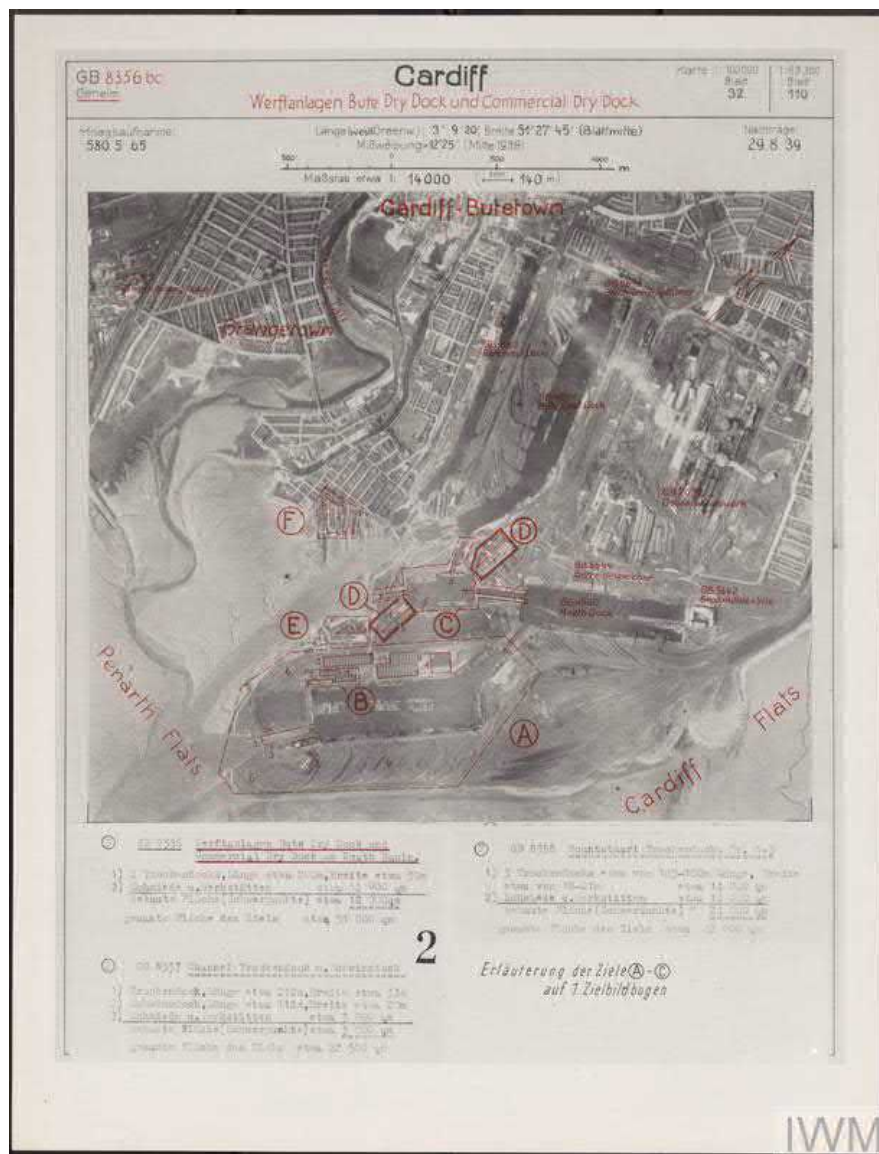
2.1.41. These developments and technological upgrades were likely needed, as perhaps a result of the increased demands placed upon the dry dock following the onset of the Second World War. Alongside the other dry docks, as well as Cardiff Docks rival ports at Barry and Bristol, the dry dock was in near constant use for wartime services. As during the previous war, Cardiff became a nexus for US aid and military deployment; Bute Dry Dock and other docks regularly became witness to the ‘Liberty Ships’ which moved vehicles, men and their munitions from Britain to Normandy following Operation Neptune in June 1944 (Richards, 2008). Its importance was also recognised by the German Luftwaffe, who produced preparatory reconnaissance plans on 29th August 1939, five days prior to British declaration of war, which directly highlighted Bute Dry Dock (labelled as ‘D’; Figure 9) as an important bombing target (Imperial War Museum, ref: LBY LUFT 1925).

Figure 9– Luftwaffe reconnaissance of Cardiff Docks, August 1939 (Imperial War Museum, 2023)

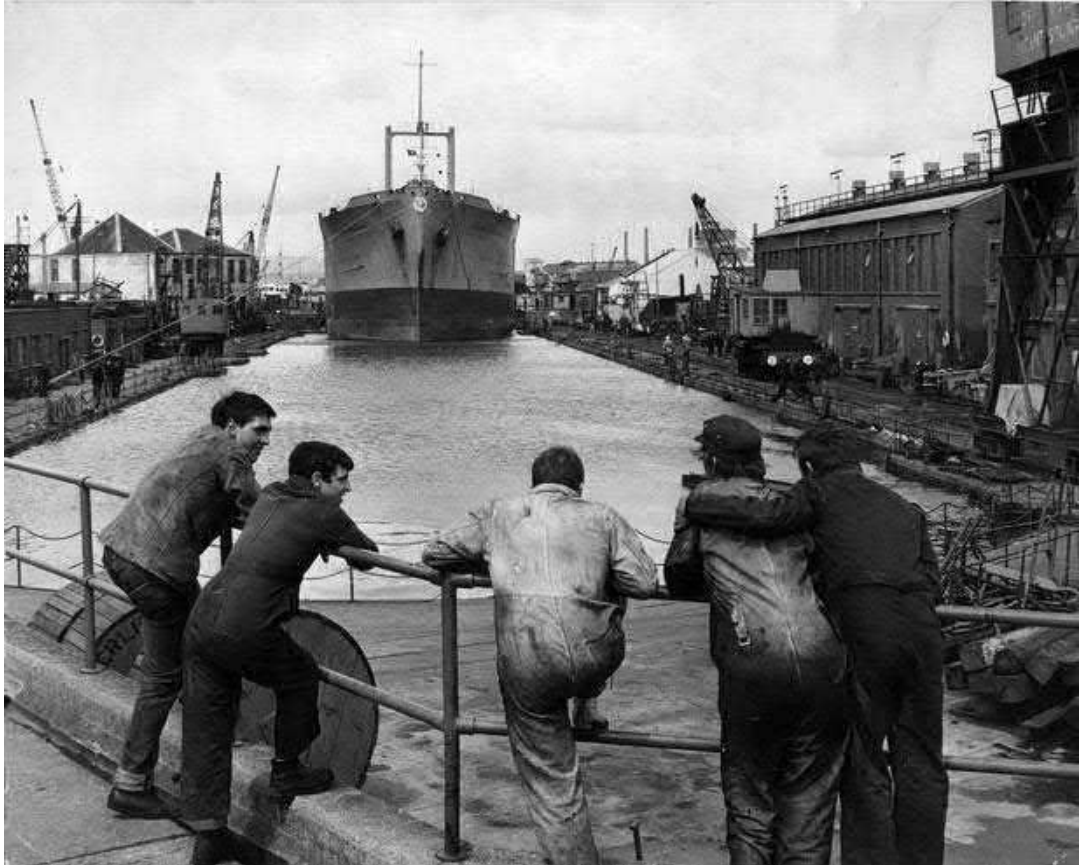
Figure 11– Workers watching the Cape Nelson in Bute Dry Dock in May 1967, looking north (O'Neill, 2001)

- 2.1.46. A photograph dated to 1967 (Figure 11) shows the historic dockyard whilst still in use. Although dated nearly a century after the construction of the Bute Dry Dock, the photograph shows a number of buildings around the site which were only present in the form of remains of footings at the time of the site visit. The photograph shows five workers at the dock, four of which wear overalls, and leaning on a steel tubular railing. The photo is taken at the south of the site and looking north, where a large vessel is moored. On the east side a large brick building is present and displays large warehouse-style doors to ground level. Above a series of large windows are present across the elevation. It appears that the building has a fairly shallow pitched roof and possibly a skylight by the apex running north south. At the north end of the dock on both the east and west extents, the buildings have a pitched roof. At the western extent these appear to have possibly been weatherboarded elevations. At the south end of the western extent the building is a single storey brick construction with a flat roof and small regularly spaced windows, possibly representing more of an administrative building. The majority of the industrial activity appears to be taking place along the eastern extent, as was suggested by the number of bollards shown on the 1951 map.

- 2.1.47. The photograph also shows the cranes on both sides of the dock having been formed of a fairly short lattice-work jib with a simple glazed cab.

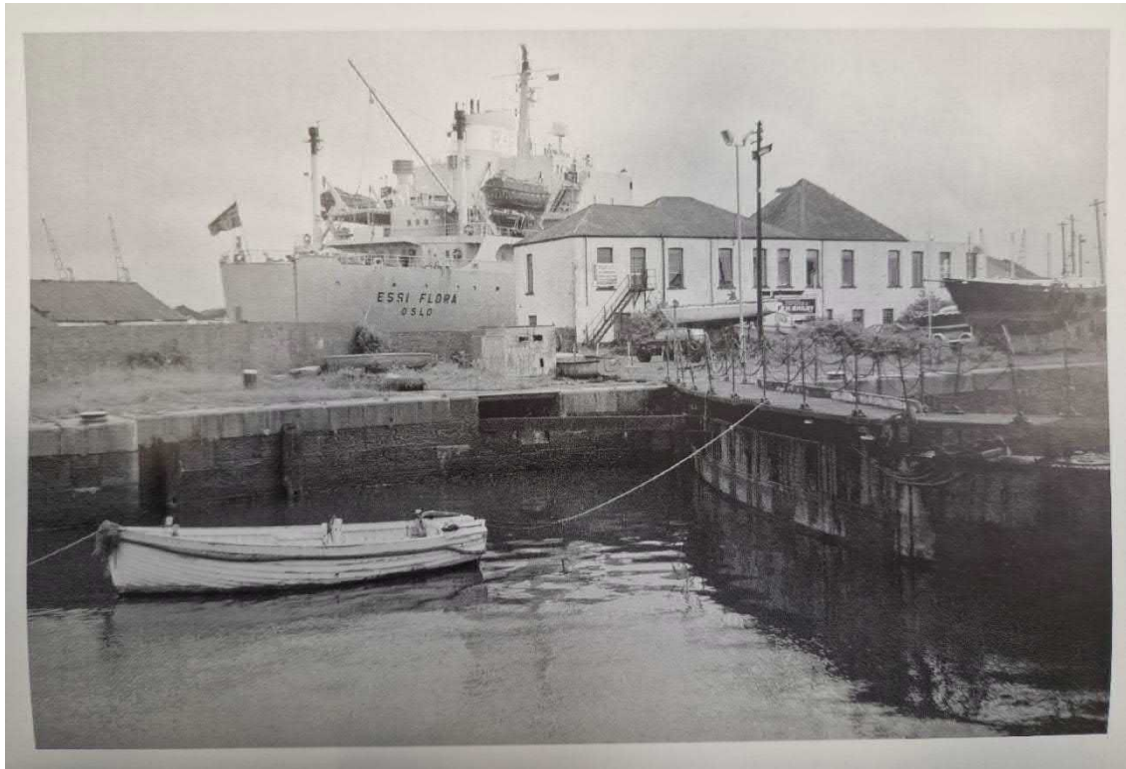
dry docks north-west labelled with their owners ‘C. H. Bailey’ banner. The buildings environs are shown to have become increasingly overgrown and unkempt, although the buildings still seem to be remaining in operation with placards and advertisements over windows. Looming behind can be seen the large Essi Flora Oslo, a Norwegian owned chemical tanker and bulk carrier ship which had a gross tonnage of 12,056, which is docked in Bute Dry Dock (Bekkevold, 2006).

Figure 13– Bute Dry Dock with the ESSI Flora Oslo chemical tanker, viewed from Roath lock in the 1970s, looking south-east (Briggs, 2002)

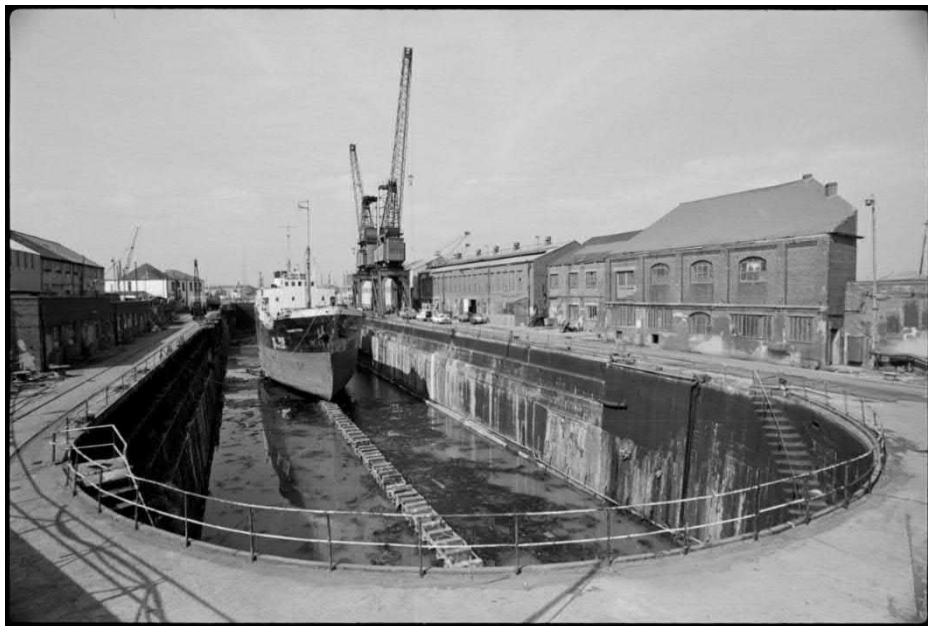
Figure 15– Bute Dry Dock with M.V. Ouraniotoxo docked in 1979, looking north (National Museum of Wales, 2023)

2.1.51. A photograph dated to 1979 depicts the buildings alongside the dock in operation and the ship M. V. Ouraniotoxo docked during her year-long stay (Figure 15). The northernmost eastern warehouse building is two-storey appears to have a shallow gradient metal

corrugated gabled roof with skylights and a railed gangway, that is surmounted by multiple circular vents. Its lower storey has a wide doorway and a small shed on its southern end, and its upper storey is penetrated by numerous vertical windows. More widely, the photograph also shows us a glimpse southernmost building at the eastern extent, that was obscured by a travelling crane in the photograph from 1967 above (Figure 11). This building can be seen to have been constructed of brick and comprised large windows on the upper storey with warehouse style openings beneath. The building is typical of late 19th century warehouses and likely dated to the original phase of construction. In addition, we get a closer look at the condition of the single-storey brick buildings west of the building, which are situated directly ahead of a two-storey corrugated warehouse (labelled as 'Bute Building Works' on the 1979 OS Maps; Figure 14), all of which are seemingly still in operation. It also provides a clear glimpse into the dry dock when not filled with water. It clearly shows the stepped ledge on the inside of the dock wall (known as an altar) which line the upper third of the dry docks western and eastern edges and shows their abrupt ending upon reaching the flat edges of the southern end of the dry dock and stairways. It also gives an idea of how would ships would operate and manoeuvre within the dry dock, seemingly being moved by a linear system of elevated wooden rollers which runs central within the docks base. In addition, the travelling cranes have seemingly been upgraded to larger modern versions.

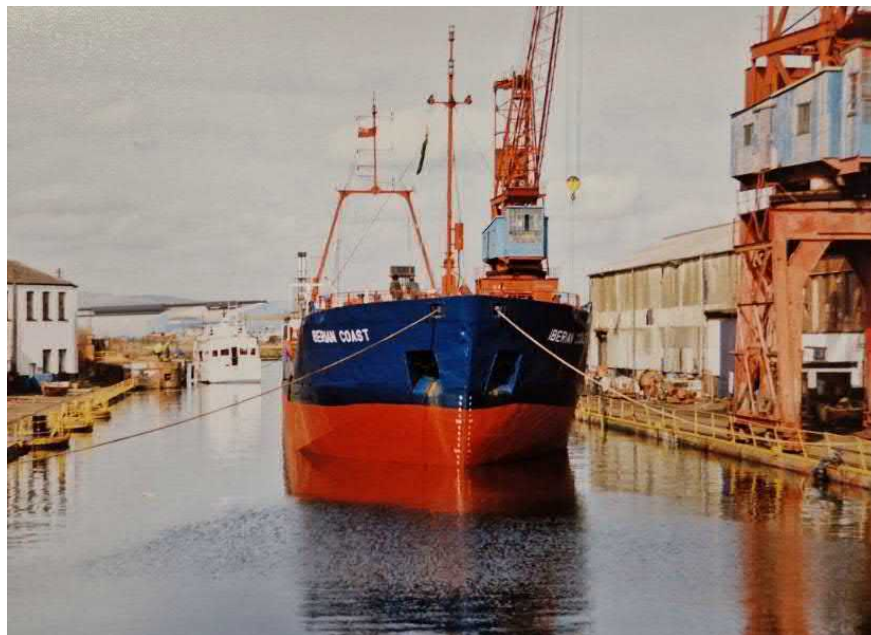
Figure 16– 'Iberian Coast' in Bute Dry Dock in 1987, looking north (Glamorgan Archive, ref. D788/1/5)

of the buildings on the western side of the dock, as well as showing the still operational travelling crane, previously illustrated in 1967 (Figure 11). The 1987 (Figure 16) image gives us a closer insight into warehouse in the sites north-eastern corner, which consists of a two-storey building, with a corrugated low gradient roof. It has a large door on northern end of its western face and like its neighbouring warehouse, its first storey is rendered in white paint.

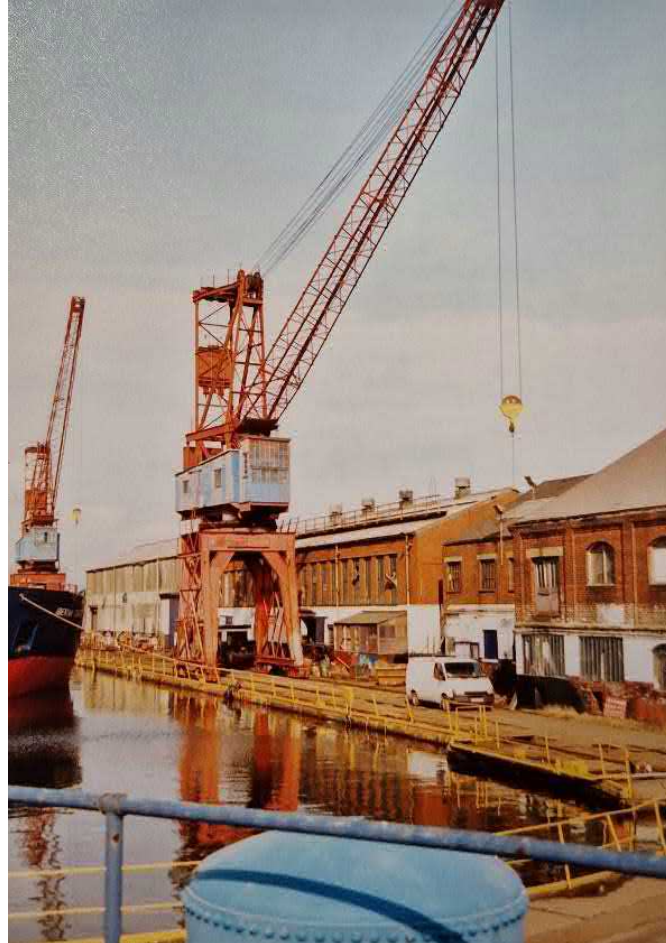
Figure 17– Photo showing ‘Iberian Coast’ docked in 1987, with mobile crane and buildings east of dock, looking north-west (Glamorgan Archive, ref: D788/1/6)

2.1.53. This warehouse and its southern neighbours, as is illustrated in the second photograph, now also have a white rendering on their first storey (Figure 17). Besides the greater amount of detritus and overgrowth along the base of the buildings, very little has changed since the previous illustration and, according to the reverse of the second image, the functions of this buildings still remained industrial in nature. The caption reads ‘5. 3. 92 / Bute Dry Dock, Cardiff / on the right’ and then list of functions reads as ‘storer, fitting shop, plumber’ and a ‘boilermakers’ (Glamorgan Archives, ref. D788/1/6). Although it is unclear in which order these should be read, it is most logical to apply the headings in a left to right direction. With the largest warehouse on the left, it is most likely that was intended for

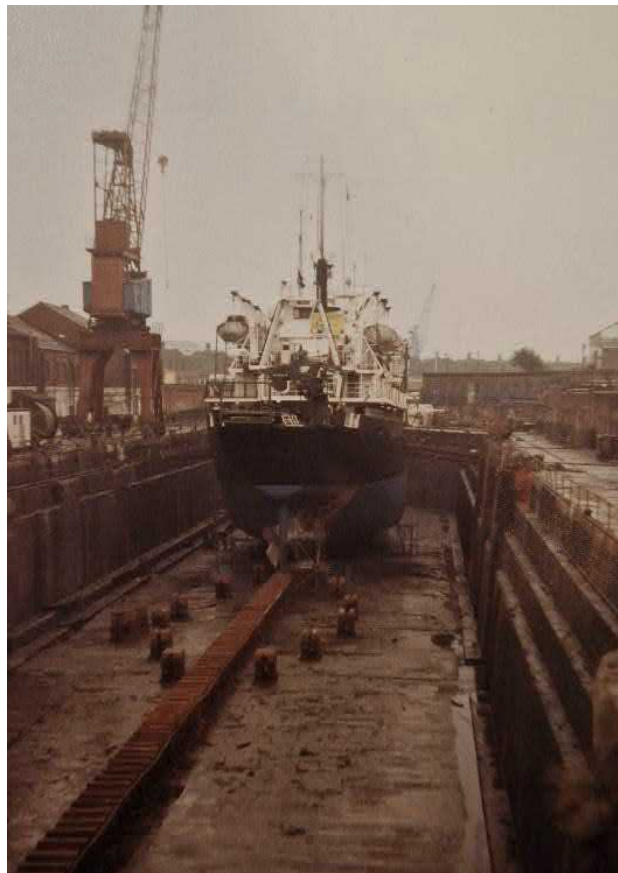
Figure 18– Bute Dry Dock with unknown ship in 1987, looking south (Glamorgan Archive, ref. D788/1/2)

2.1.54. Another photograph in 1987 with an unknown ship (Figure 18) give further detailed insights into the dry dock when drained. It shows an unknown ship at the docks southern end, again mounted upon the same wooden rolling platform as last seen in 1979, but this time surrounding by an arrangement of wooden blocks. These are presumably employed for hold the ship steady and elevated for works on their hulls. This image also gives a clearer indication of the altars, a set of which can also now be seen lining the western and eastern walls of the docks base. This image also us our first close look at the three internal projecting columns, intended to hold the caisson at the dry docks centre (McConnochie, 1884). The three on the western wall project outward and appear fully intact, whereas, in contrast, the three on the eastern wall are less prominent, with their projections only appearing up the first upper altar. This aligns with the historic OS Maps, particularly before 1941 (Figure 8), which show altars extending out beyond the projecting columns. This photograph also gives us our first glimpse of the rectangular structure to the dry docks south-west, which appears to be a single storey structure with multiple blue doors, presumably for storage.

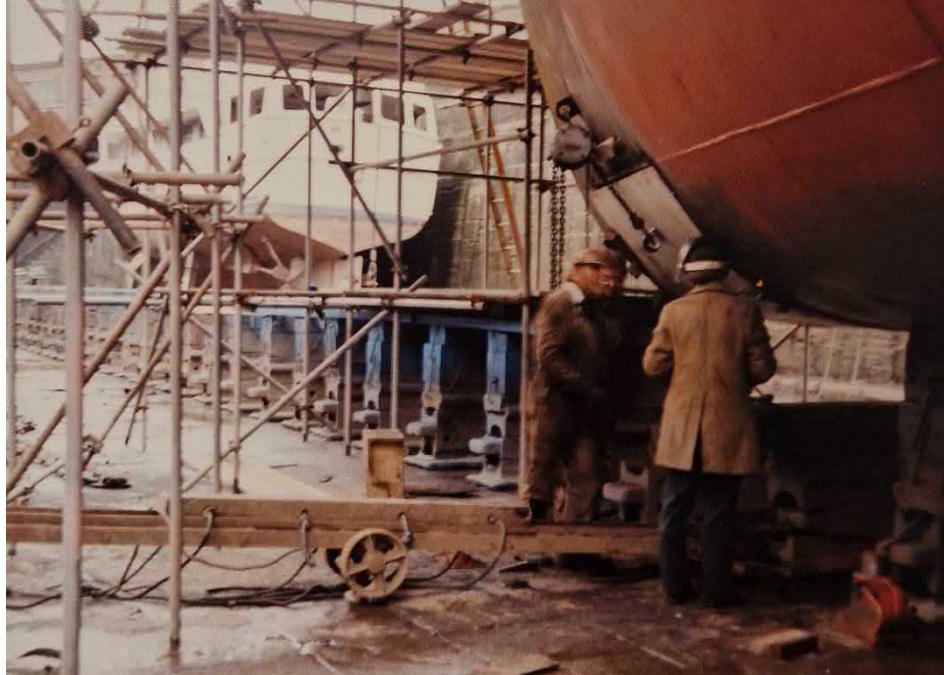
Figure 19– Workers in Bute Dry Dock, working on the ‘Otto Danielson’ vessel in 1989 (Glamorgan Archive, ref. D788/1/4)

2.1.55. An additional photograph taken in 1989 (Figure 19) gives us an interior view of the dry dock with several workers working on a docked vessel. To their left is the now the visibly large wooden roller system, given scale when compared to the size of the workers. It was evidently capable of being disassembled as two legs and a set of rollers have been removed immediately in front of the workers, seemingly to allow fixtures to be mounted onto the ship’s hull with ease. Image also shows a brightly coloured ship positioned against the western wall (as surmised from the western stairway in the photographs back left). Although somewhat obscured by scaffolding, it would appear that it is held in an off-set position by a wooden beam, giving an insight into the multi-ship capabilities of the dry dock even into its later life. This close insight all illustrates how the dock walls are comprised of the original stop blocks, with the dock floor being covered by possible square tiles.

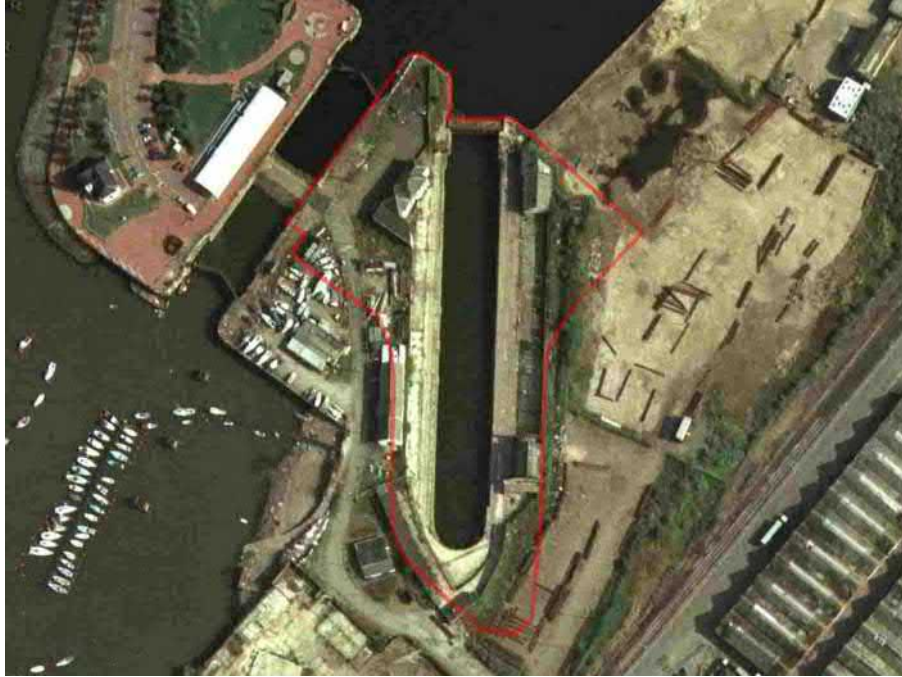
2.1.57. The Ordnance Survey 1:2,000 map of 1992 (Figure 20) shows the site relatively unchanged from its last cartographic iteration, although a has now small rectangular ‘hopper’ has been constructed within the north-east of the site. Very little changes around the site until the early 2000s, when aerial photography shows significant changes around the dock. Despite attempts to open negotiations, it would appear operations continued whilst residential and commercial redevelopment began around the site. On the north-western side of the Roath Lock, a new rectangular building was constructed, earthen bank now forming a crossing.

Figure 21- Aerial photograph taken in 2000. Image: Groundsure

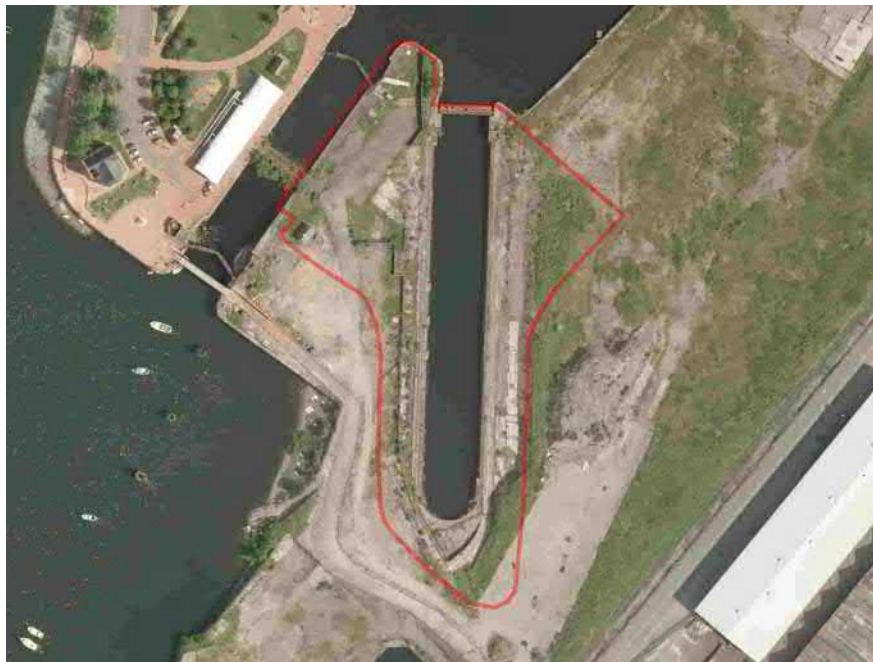
2.1.59. By 2008 (Figure 23) aerial imagery shows that, for the most part, all remaining buildings associated with Bute Dry Dock have been removed with the exception of partial remains of the buildings walls and there appears to be some of the original footings from the dock's ancillary buildings which remain *in situ* below ground level. The angular exterior walls of the building to the west remain extant and are lined with shrubs. To the east, the varying levels of the docksides remain intact as they do to the west and the south where the ramp is located. To the south and the east of the site area the sidings and built-up areas have been cleared and given over to patchy grassland. However, industrial warehouses remain to the south-east lining Queen Alexandra Dock.

Figure 23- Aerial photograph taken in 2008. Image: Groundsure.

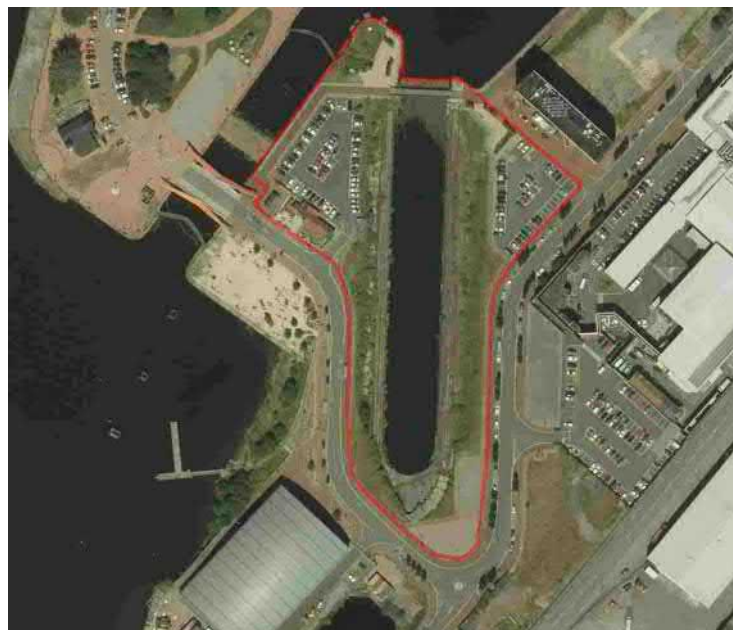
2.1.61. Aerial imagery from 2017 (Figure 25) shows further development of the site area with paved carparks constructed to the east and west of the dock and a new public footbridge at the north of the dock, above and separate to the caisson. The site appears as it does today.

Figure 25- Aerial imagery taken in 2017. Image: Groundsure

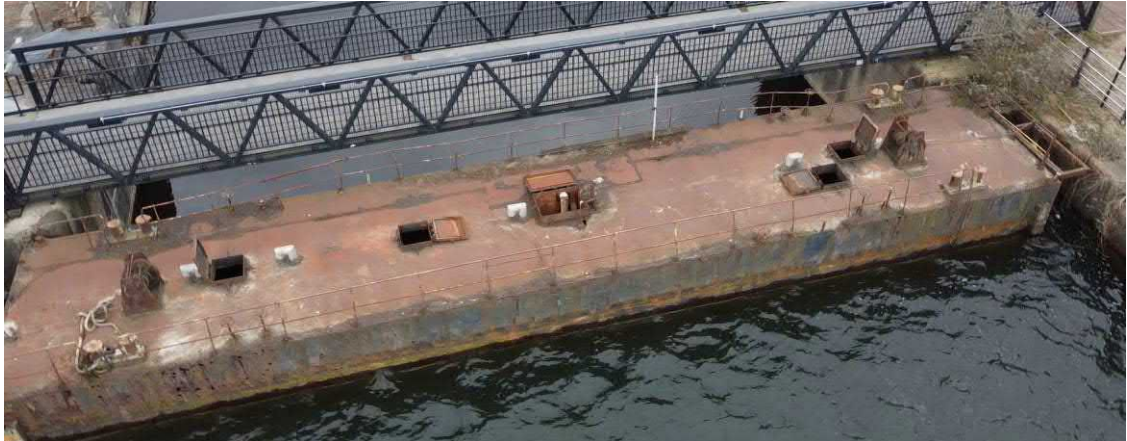
Figure 29– The Bute Dry Dock Caisson, looking south south-west.

- 3.1.4. The water levels at the caisson measured approximately 2m higher outside the dock in Roath Basin to the north, than inside the dock itself. An inspection of the caisson below the water line (Kaymak Marine and Civil Engineering, 2018) revealed that there was extensive corrosion and pitting to the north and south of the structure, with additional delamination to the south.

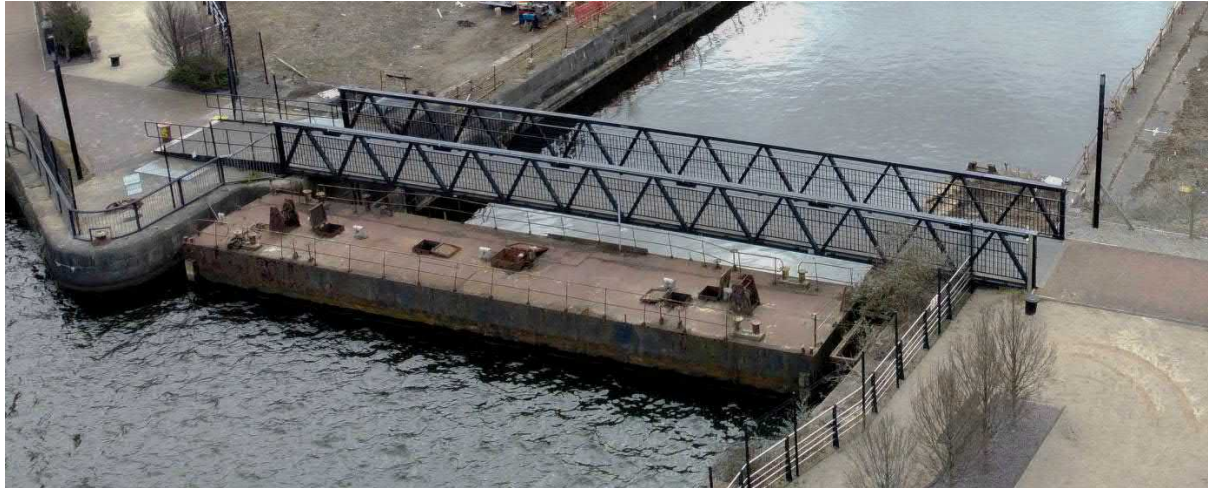
Figure 31– The caisson and footbridge, looking west.

- 3.1.5. The footbridge over the Bute Dry Dock and caisson was constructed sometime between 2013 and 2017. It comprises a beam bridge that's structurally separate from the caisson and links the carparks to the west and east of the dock (Figure 31).

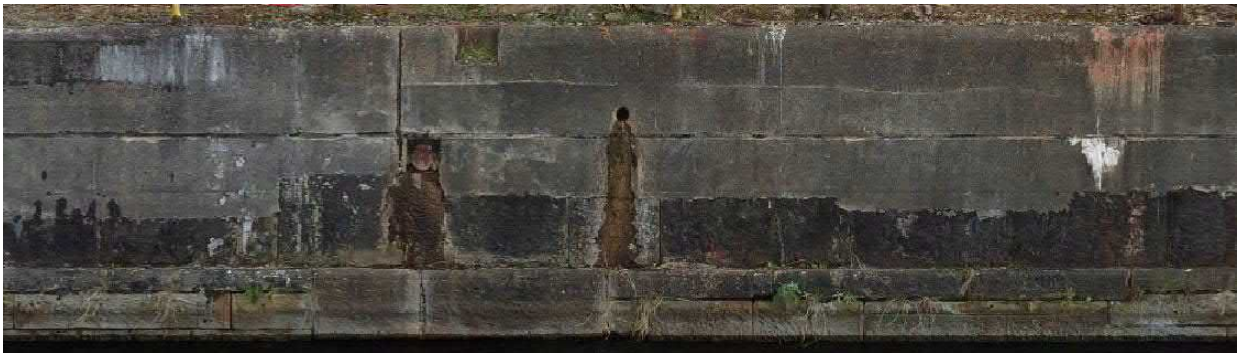
- 3.1.6. The east wall of the dock comprised a straight dock edge measuring approximately 170m in length from the caisson to the curved south wall. Exposed above the water line the dock wall comprised an ashlar masonry construction clad in cement render sometime in the 20th century, presumably for repair and maintenance (Figure 32). The cement render was formed in courses of shuttering, which near the top of the dock, contained horizontal sections measuring 600-670mm high and 15m long. Below this, intermittent areas of cement render covered the original masonry which otherwise remained visible near the water level. The original masonry was most clearly visible in an altar exposed above the water line to be 400m wide and 1.5m down from the dock edge (Figure 32).

Figure 32- The east wall exposed above the water line showing services within a cement render cladding (20th century) and ashlar masonry exposed at the altar (original), looking east.

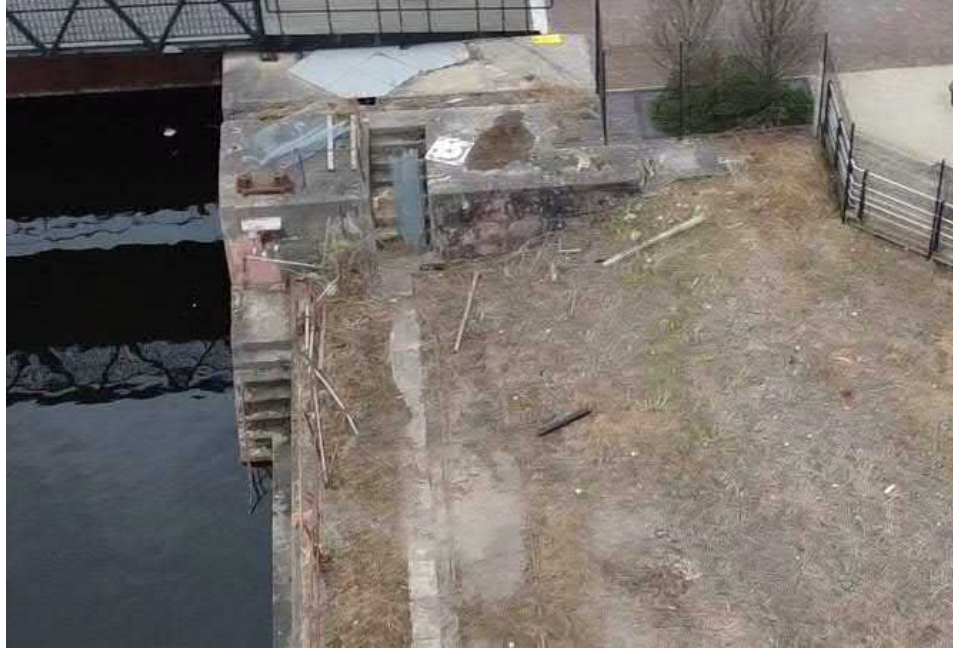
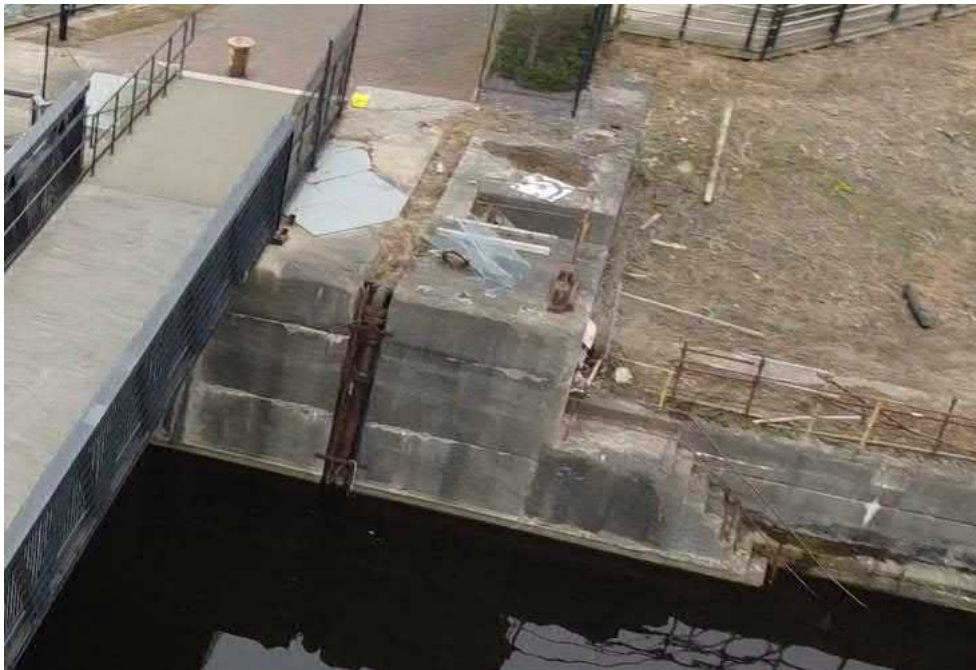
dockside which contained a large supporting abutment for the caisson immediately adjacent (Figure 33 and Figure 34). This abutment measured 8m across from east-west and was comprised by large concrete blocks with two sets of stairs: one leading southward from the level of the caisson to the dockside, and another leading southward the top of the dock to the base. This was reconstructed was reclad in concrete sometime in the 20th century, most likely between 1941 and 1951 which the original iron gates to Bute Dry Dock were replaced by the current caisson (Phase 2). Set within the top of the concrete supports was a double bitt bollard to the south-west which would have been used to moor vessels within the dock. Recessed within the structure was a steel pipe which extended east west and then down the east wall. A scar is present on the eastern-most abutment which suggests the presence of a large feature, likely associated with infrastructure. It is possible that a large mooring post or small immobile crane was mounted here, but no evidence could be found to confirm.

- 3.1.9. Recessed elsewhere along the east wall of the abutment were services comprising drainage pipes (Figure 33 and Figure 34).

Figure 33- The northern supports of the east dock wall, looking north.

Figure 34- The northern supports to the east dock wall, looking north-east.

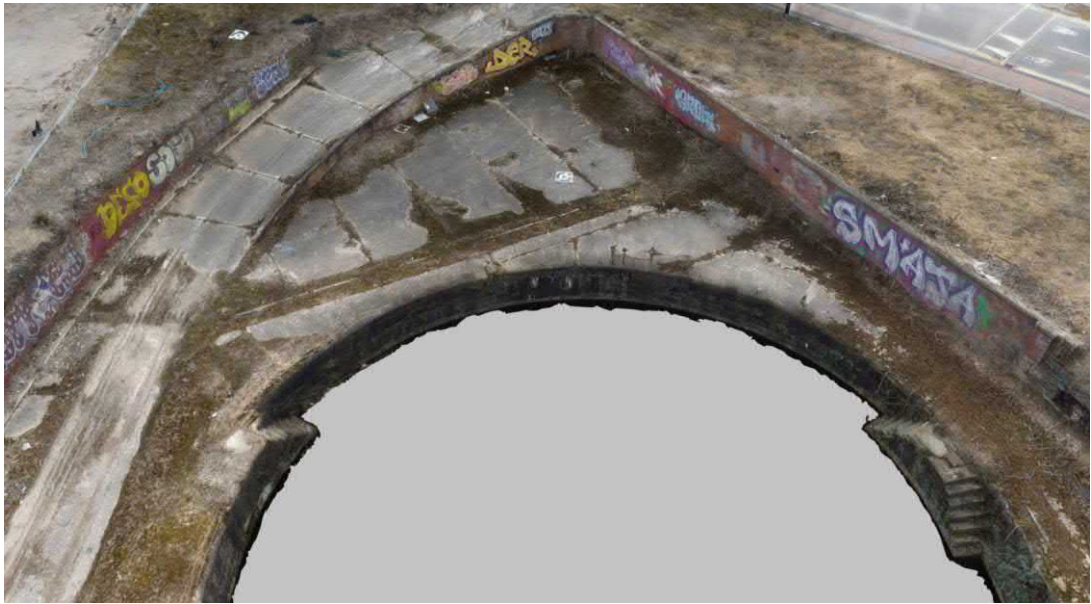
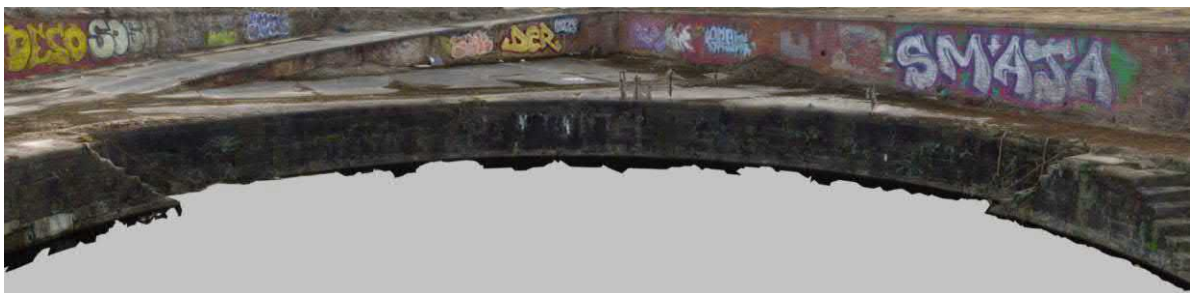
3.1.11. The south wall of the dock was formed in ashlar masonry and was semi-circular in plan (Figure 35 and Figure 36). Two sets of staircases were built into the curving walls to the east and west, which led southwards to the bottom of the dock. An intact section of masonry was observed to the south of the dock on a section of the east wall containing stairs leading south to the bottom of the dock (Figure 35). Both the sides of the dock and the stairs were partially lined by railings approximately 1m high. Figure 35 shows the southern end of the dock and the masonry construction. Vegetation has grown from the walls of the dock and the remaining railings are visible along the dockside.

Figure 35- The southern end of the dock, looking south.

Figure 36- The southern end of the dock, looking south.

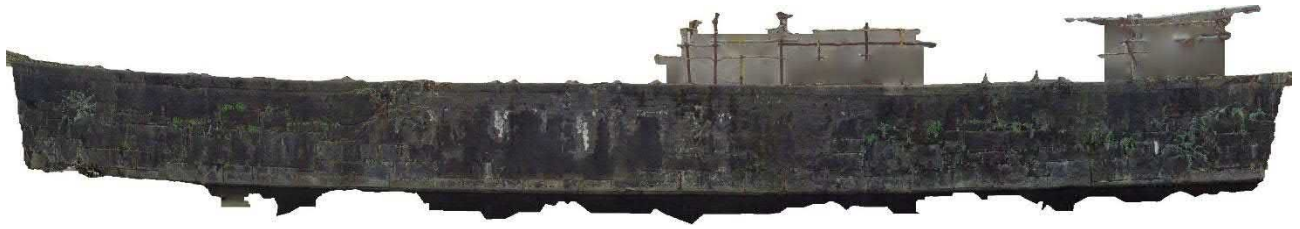
Figure 37– Orthomosaic showing the southern end of the dock, looking south. Note: the slight curvature is indicative of the curved dock walls

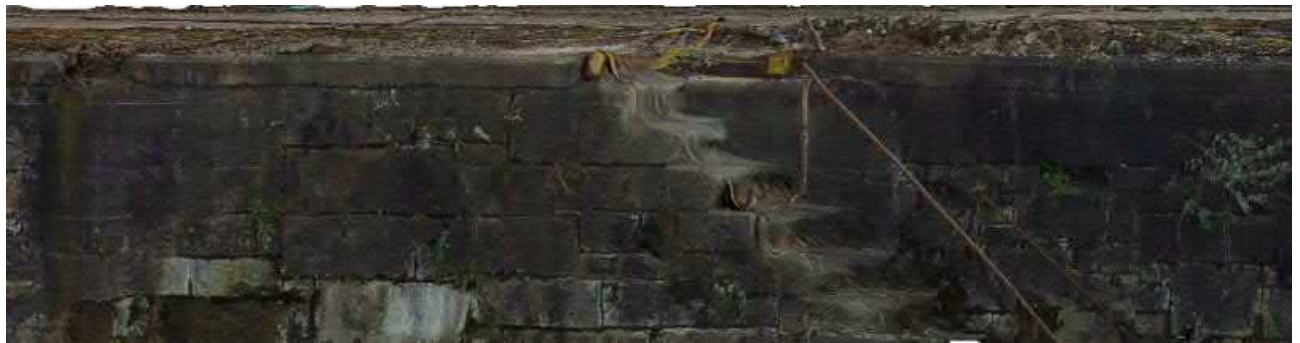
Figure 38- Ashlar masonry forming the staircase supports to the south of the dock, looking east.

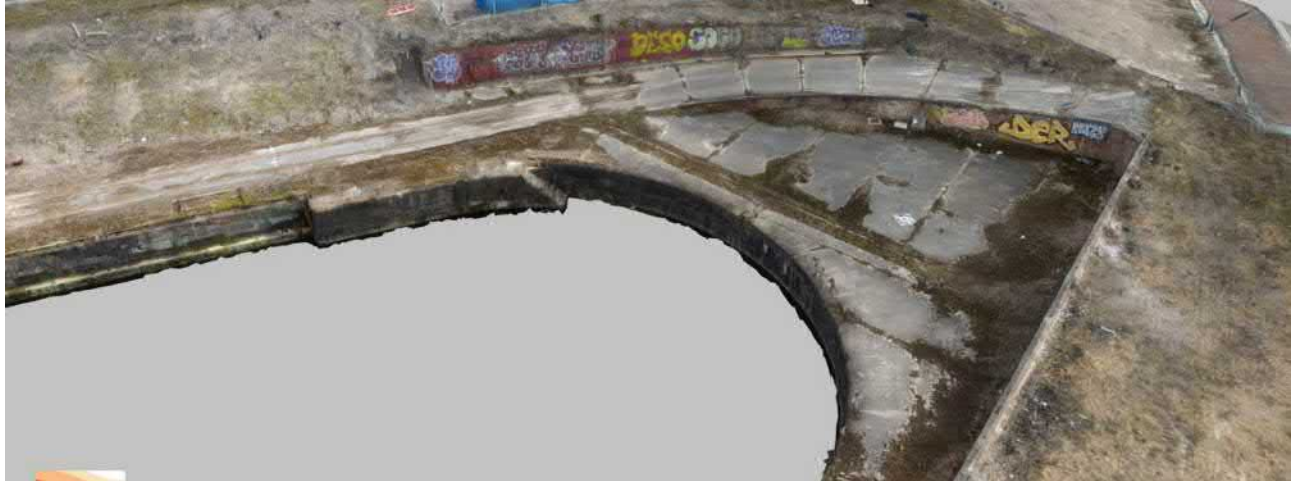
- 3.1.12. Beyond the dry dock, the compound to the south comprised two levelled terraces separated with an angular red brick retaining wall (Figure 39). This contained an access ramp to the east which led down from the upper terrace to the lower terrace nearest to the dockside in a north-easterly direction. The southern approach to the dock was reconstructed sometime between 1954 and 1969 when a ramp to the north-west of the dock was removed. This reconstruction involved the reconfiguration of the upper terrace, which was previously semi-circular, to an angular design, coinciding with the removal of the extensive rail sidings east of the dock, and a new ancillary building to the south-west which lined the dock in a north-west to south-east direction (now removed). The ramp and lower terrace were paved in large concrete slabs and the red brick retaining walls contained graffiti.

Figure 39- The southern end of the dock showing the ramp, looking south-east.

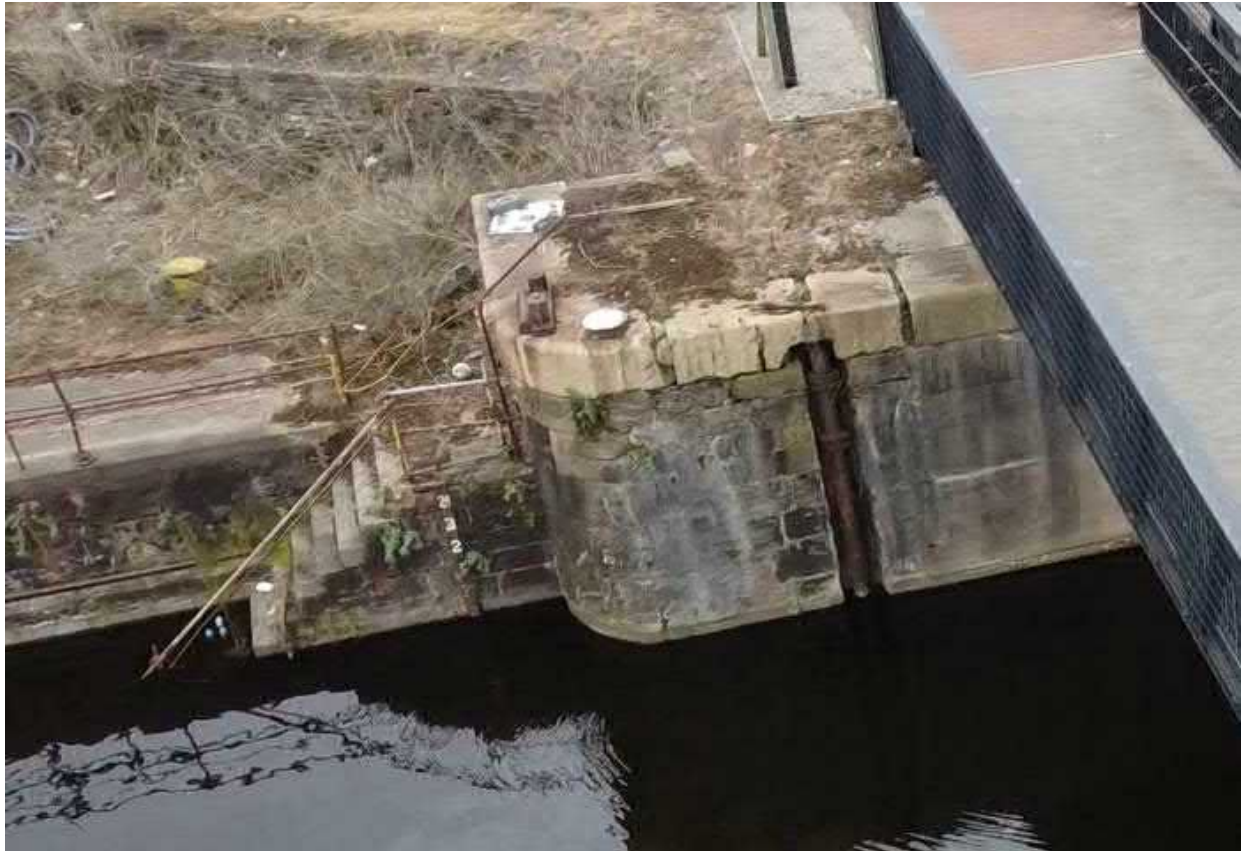
Figure 40- The northern abutment on the west wall, looking west.

- 3.1.13. The west wall of the dock was formed in ashlar masonry and comprised a straight dock edge measuring approximately 170m in length from the caisson to the curved south wall (Drawing 4). This was formed over a single uniform level except for the northern-most 10m of the dockside which contained a large supporting abutment for the caisson immediately to the north (Figure 40). The abutment was formed in large stone blocks with cement render cladding the western face underneath the footbridge. Unlike the abutment to the east, this was 5m across from east to west and was capped by sandstone blocks. The abutment had a curved south-east corner where a double bit bollard was located, and this would have been used to moor vessels within the dock. These supports contained two sets of stairs: one leading southward from the level of the caisson to the dockside, and another leading southward the top of the dock to the base.

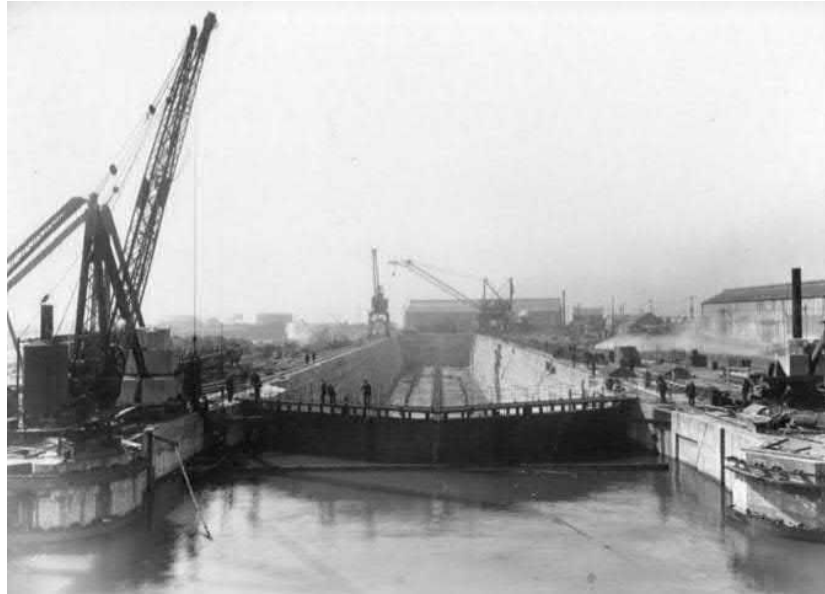
Figure 41 - View of Palmers Dry Dock gates from the Kings Dock, Swansea, circa 1924 (Swansea and Port Talbot Docks History, 2023)

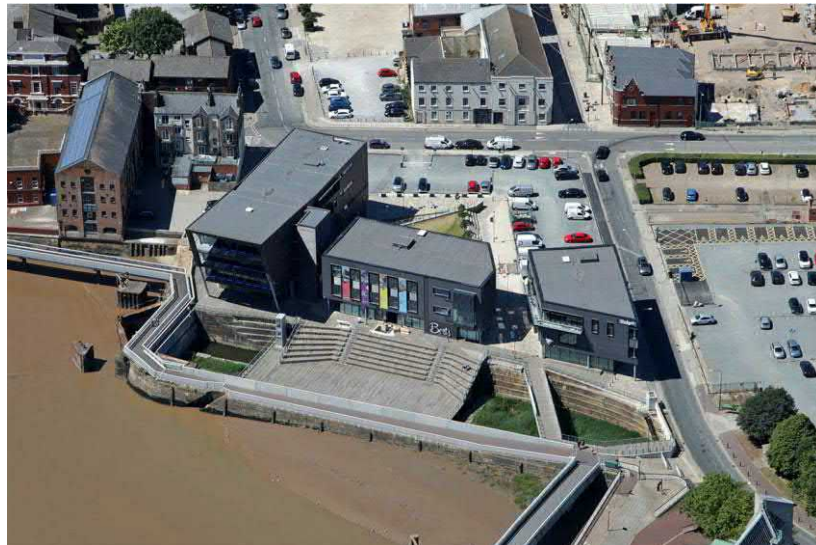
Figure 42 - Hull Central Dry Dock (Historic England, 2023)

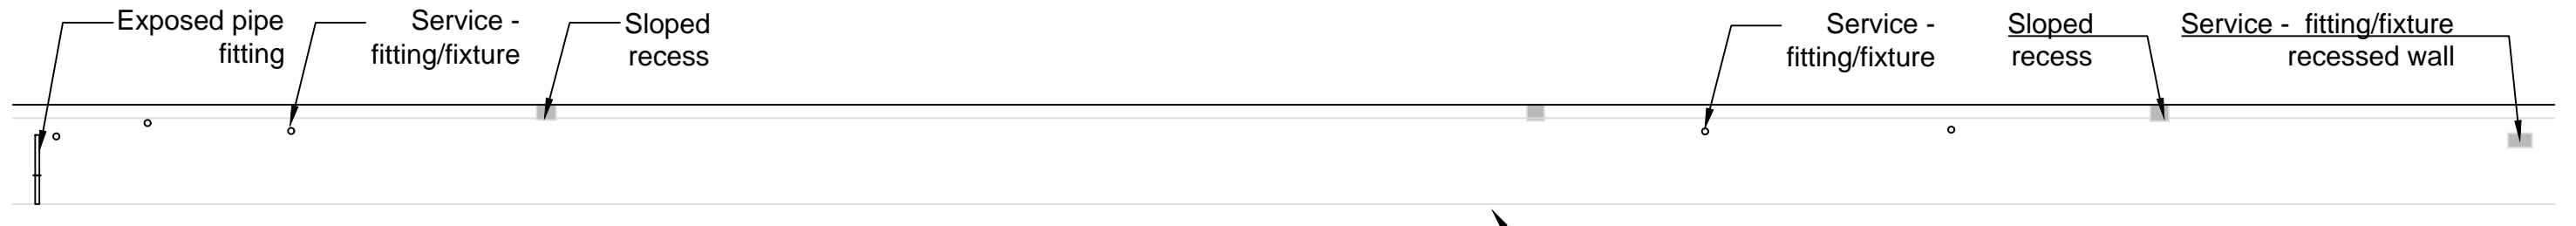
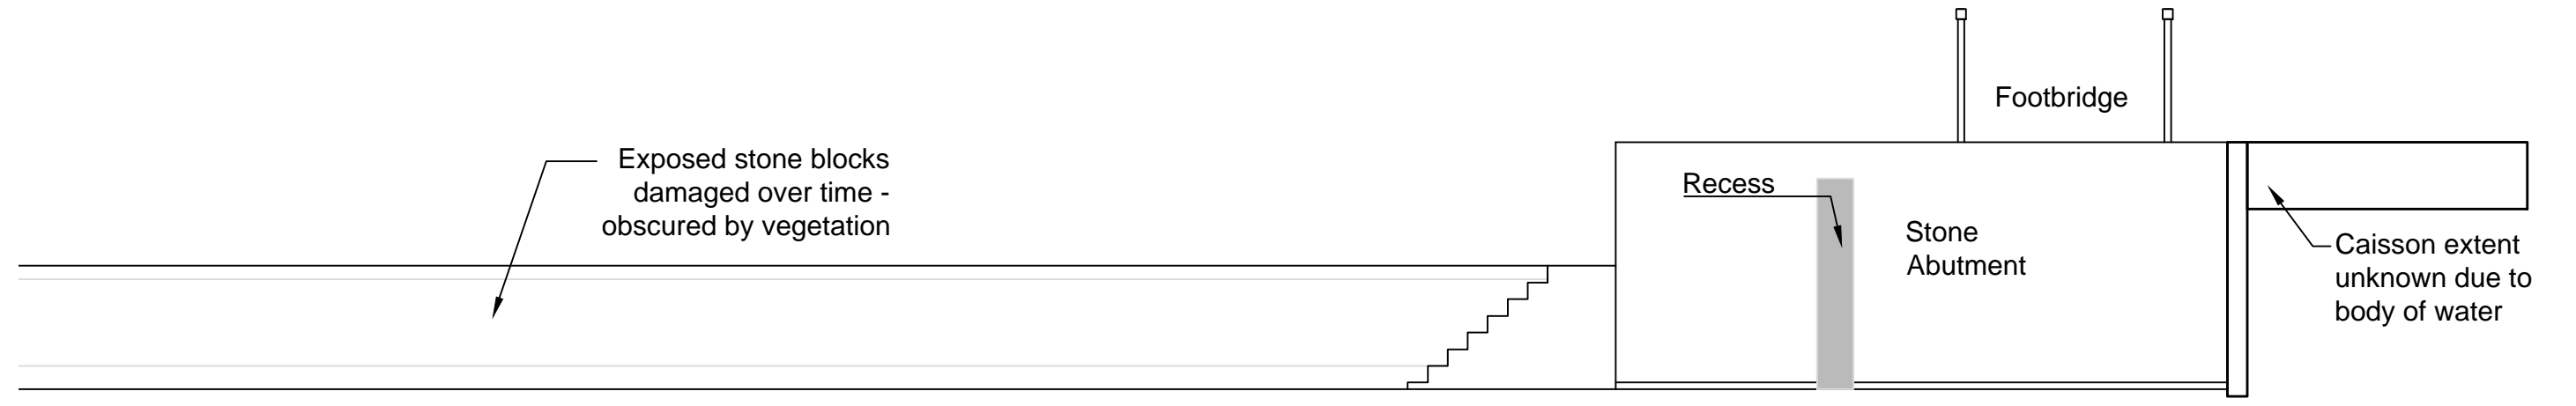
PART D — Exposed stone blocks (inner plinth)
