Bute Dry Dock, Cardiff

Level 3 Historic Building Record

Project no. 70043727

Date: July 2023

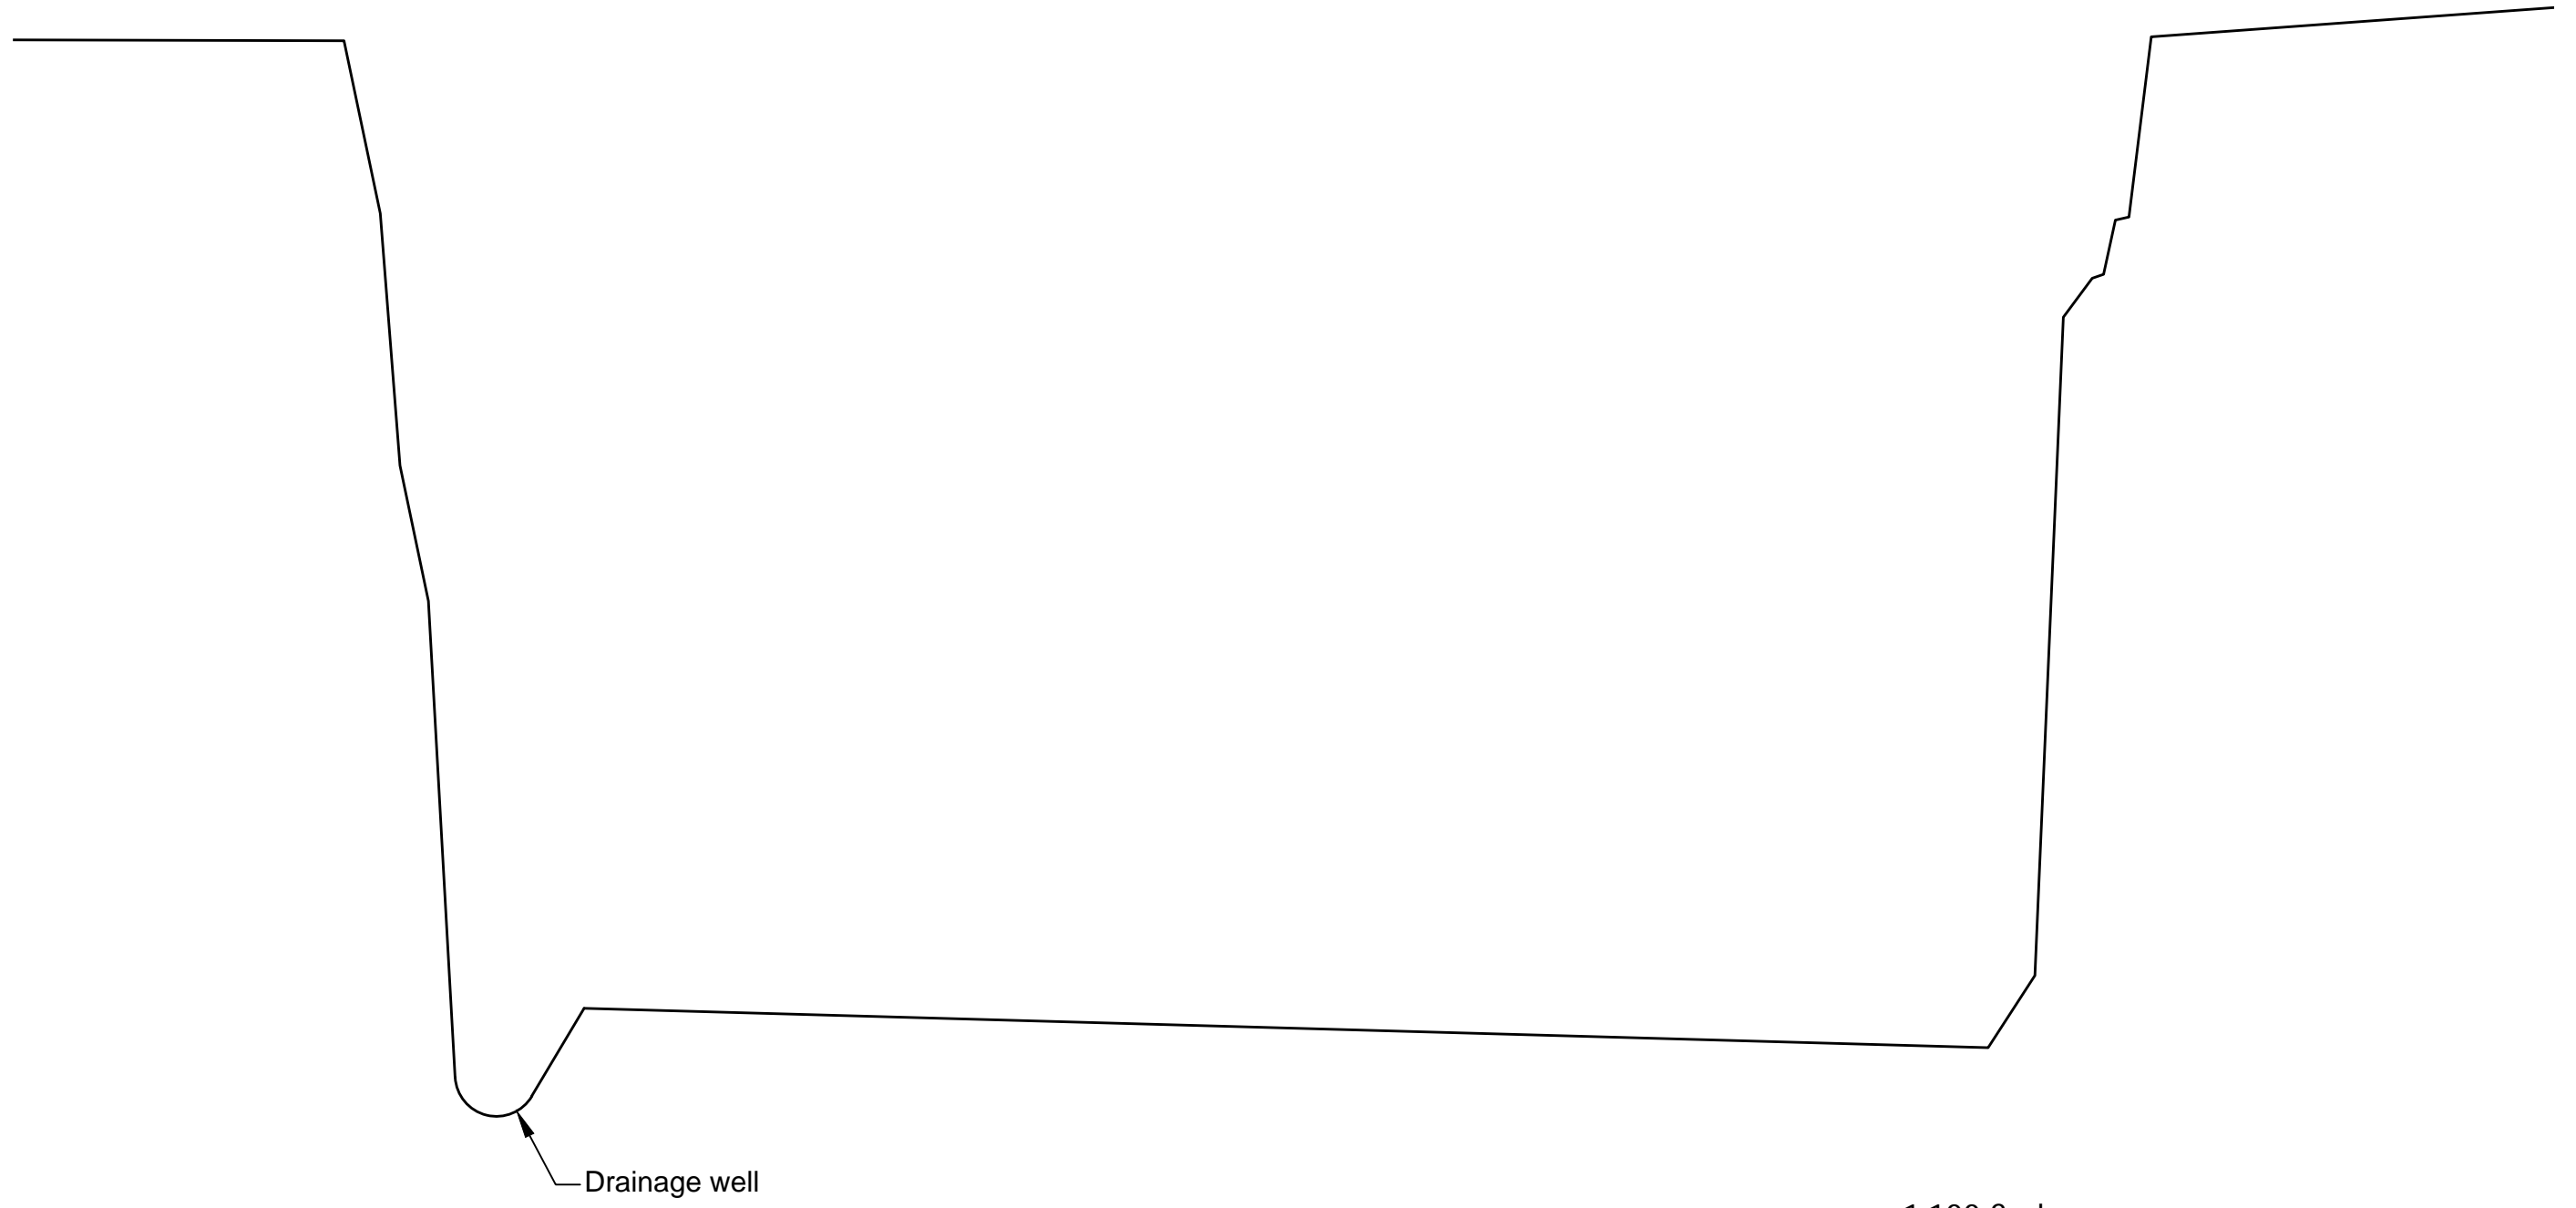
Drainage well

- 3.1.16. The MBES LiDAR survey showed the presence of two wells positioned along the west wall at the base of the dock. The historic accounts of the dock from 1884 describe these as pumping wells which were associated with two centrifugal pumps on vertical shafts 4ft in diameter, powered by two horizontal non-condensing engines that would have drained the north or south parts of the dock when the (now removed) central caisson was in position.
