**Former Estate Offices and Stables,
Trevor Row, Trevor Road, Chirk,
Wrexham, LL14 5HE**

Historic Building Record Level 2

Project Code: A0447.1

Report no. 0423

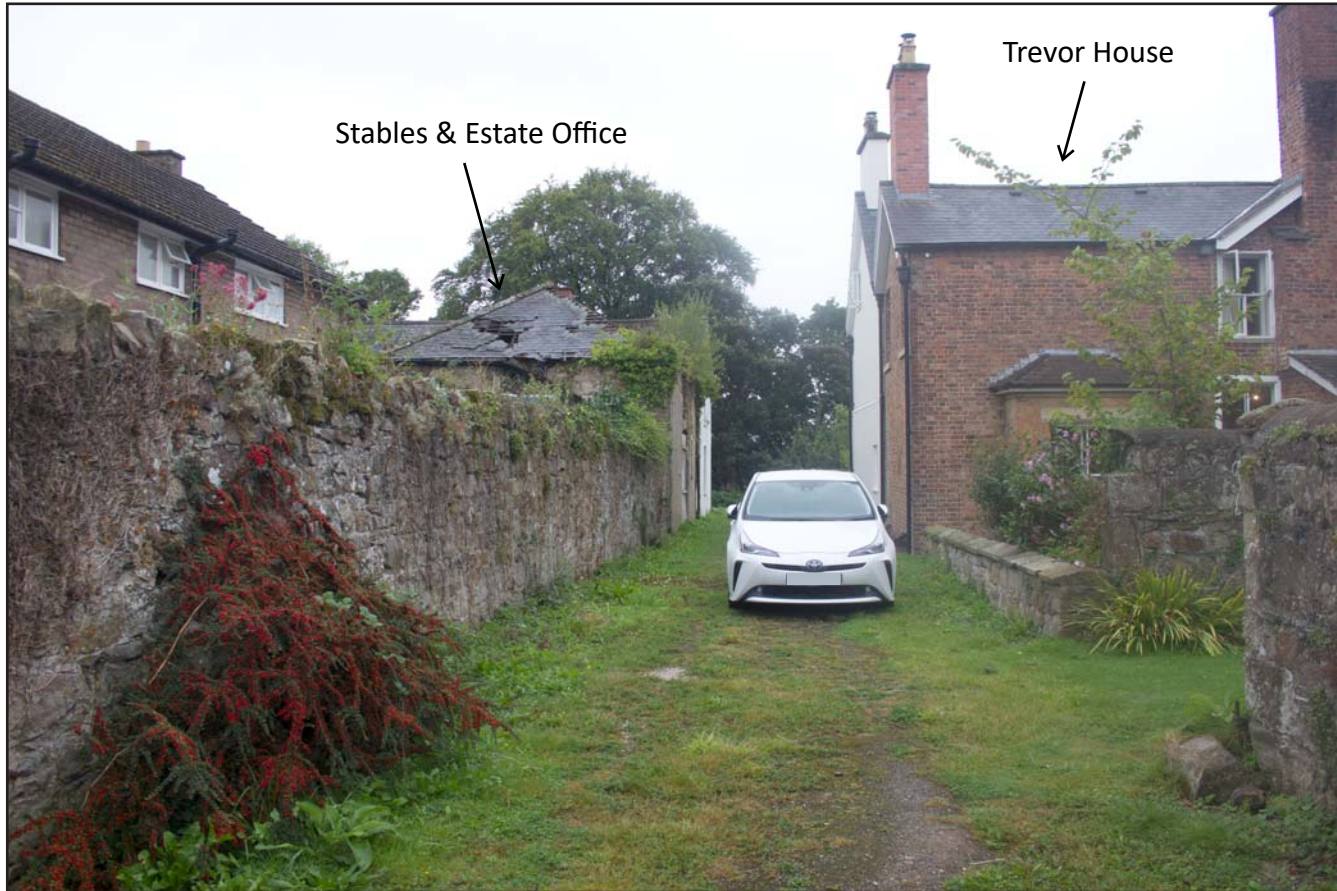
Plate 01: Northern driveway, context shot, former Estate Offices & Stables, Trevor Road, Chirk - from the north - no scale

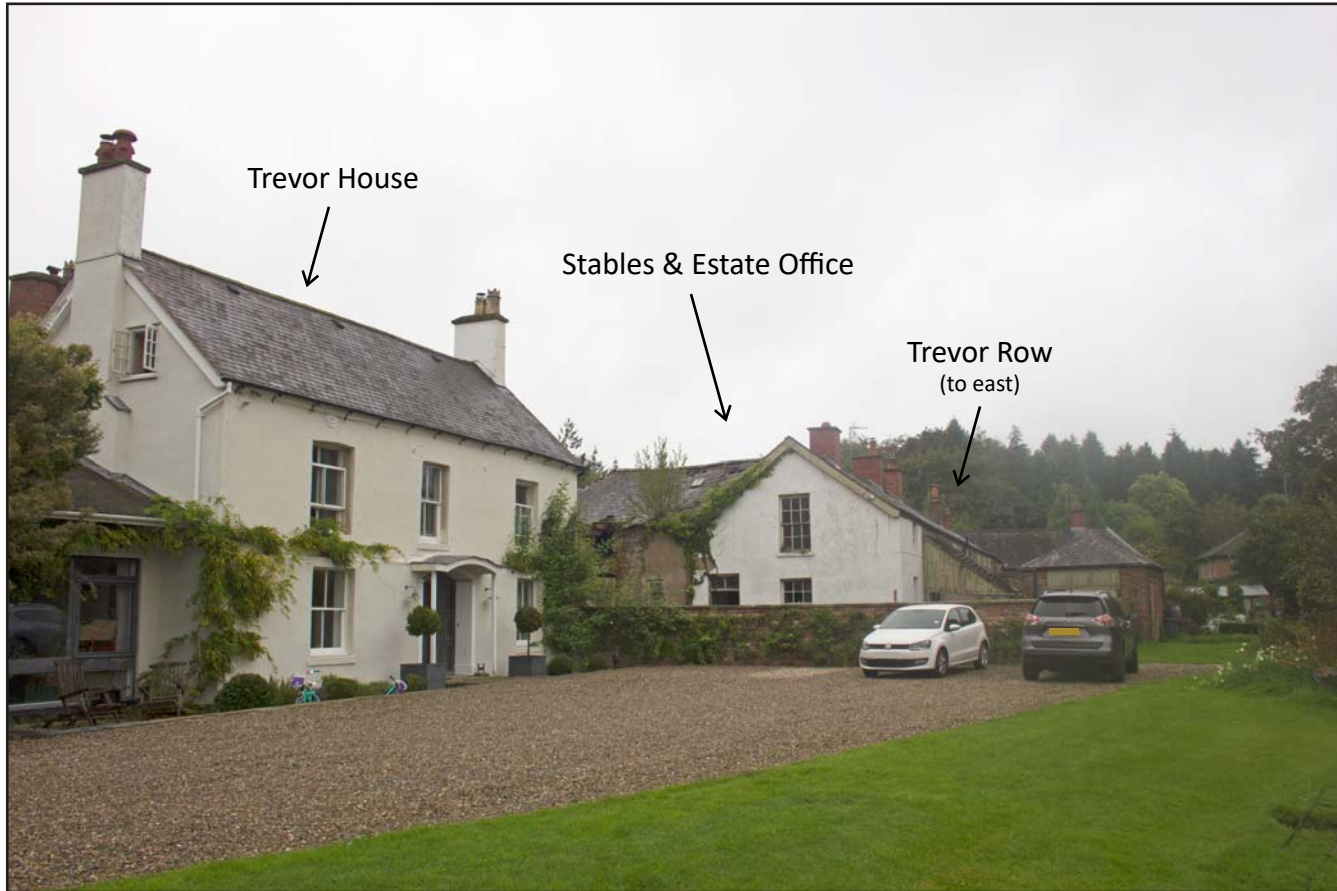
Plate 02: From Trevor House, context shot, former Estate Offices & Stables, Trevor Road, Chirk - from the west/southwest - no scale

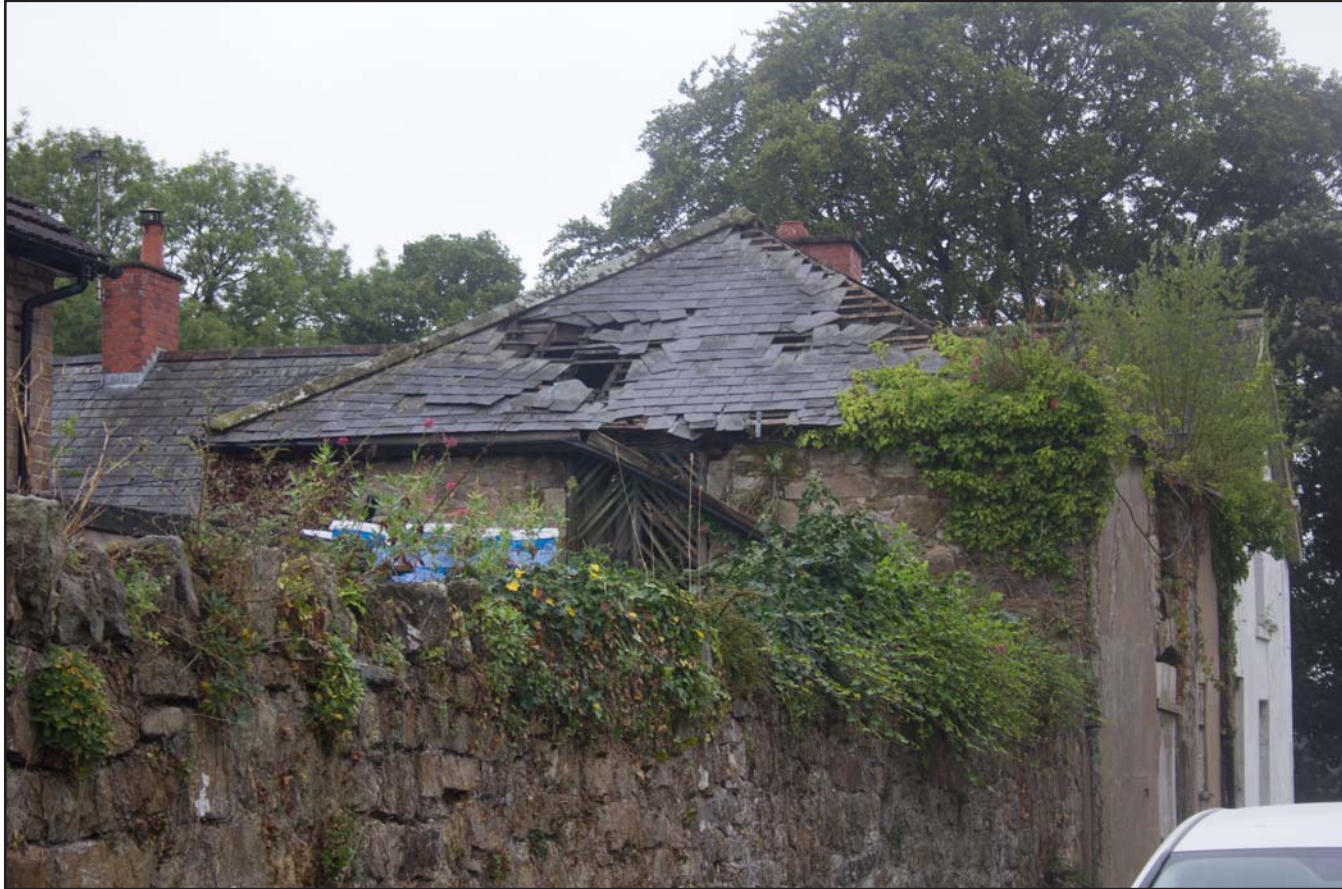
Plate 03: Northern elevation, stables, former Estate Offices & Stables, Trevor Road, Chirk - from the north - no scale

This elevation is largely obscured by the rear garden of no 7. Trevor Row and the large north to south aligned, masonry wall, which bounds the northern approach to the estate offices and stables. The hipped roof construction is visible showing that the ridges have concrete tiles. Although the roof is in a poor state of repair with holes in the slate, showing the roof construction bare to the elements beneath.

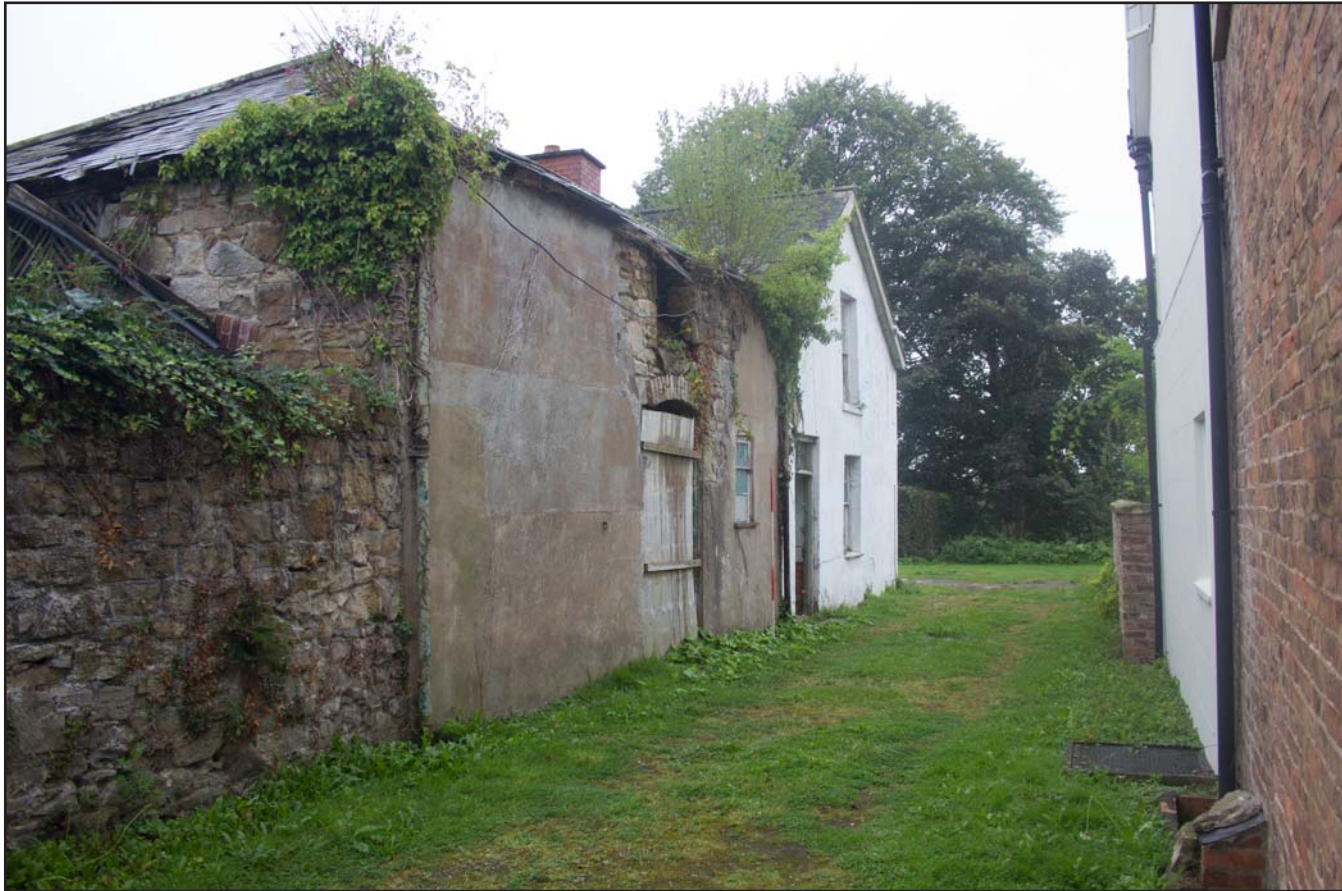
Plate 04: Western elevation, oblique shot, former Estate Offices & Stables, Trevor Road, Chirk - from the northwest - 2.00m scale

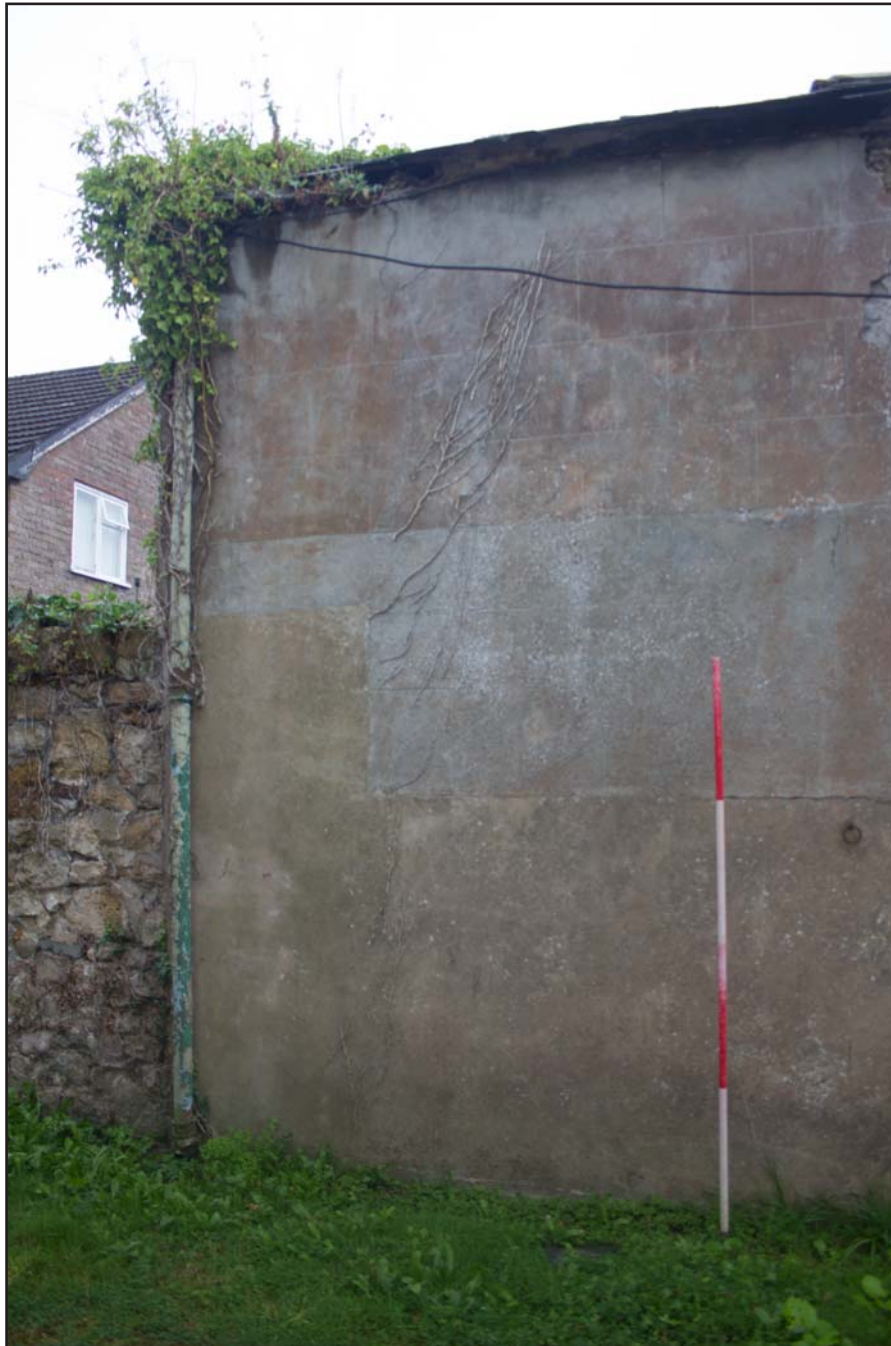
Centralised within the elevation at ground floor level, there is a wide, double height, stable door, which appears to have been inserted and/or widened within the elevation, as evidenced by the supporting segmented arch above. This arch is of red bricks placed on end, and has not been implemented properly; although it meets the elevation on the right-hand side, it fails to do so on the left hand, meaning the elevation above has dropped, allowing the elevation to subside at first floor level above the doorway. The door has green painted wooden frames, but is now boarded up with chipboard and batons. To the right of the doorway is a three-pane fixed window in metal frames with modesty glass. To the left of the doorway, there is a small cast iron ring which has been fixed to the wall, presumably once for hitching a horse.

Plate 05: Western elevation (left), stables, former Estate Offices & Stables,
Trevor Road, Chirk - from the west - 2.00m scale

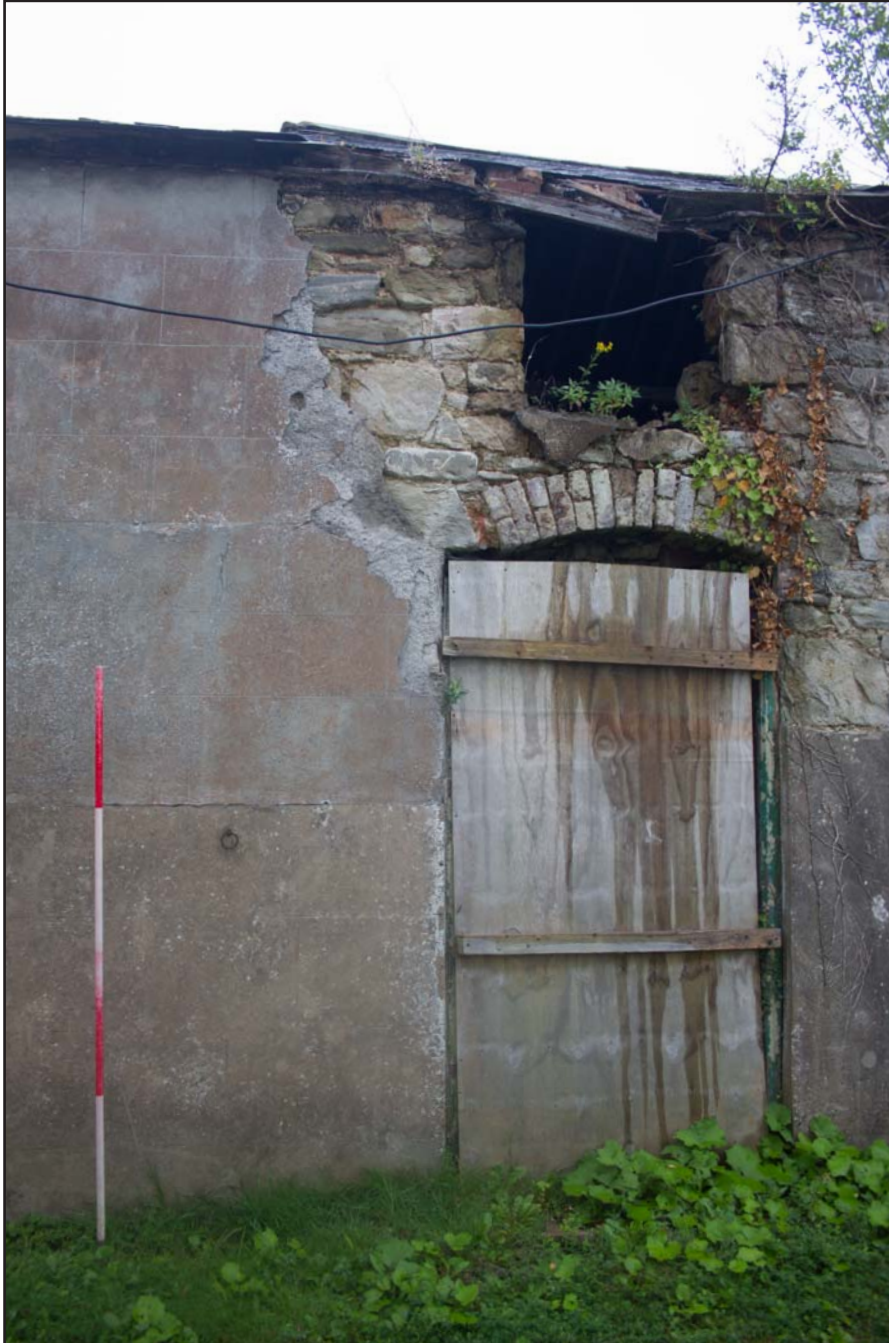
Plate 06: Western elevation (centre), stables, former Estate Offices & Stables, Trevor Road, Chirk - from the west - 2.00m scale

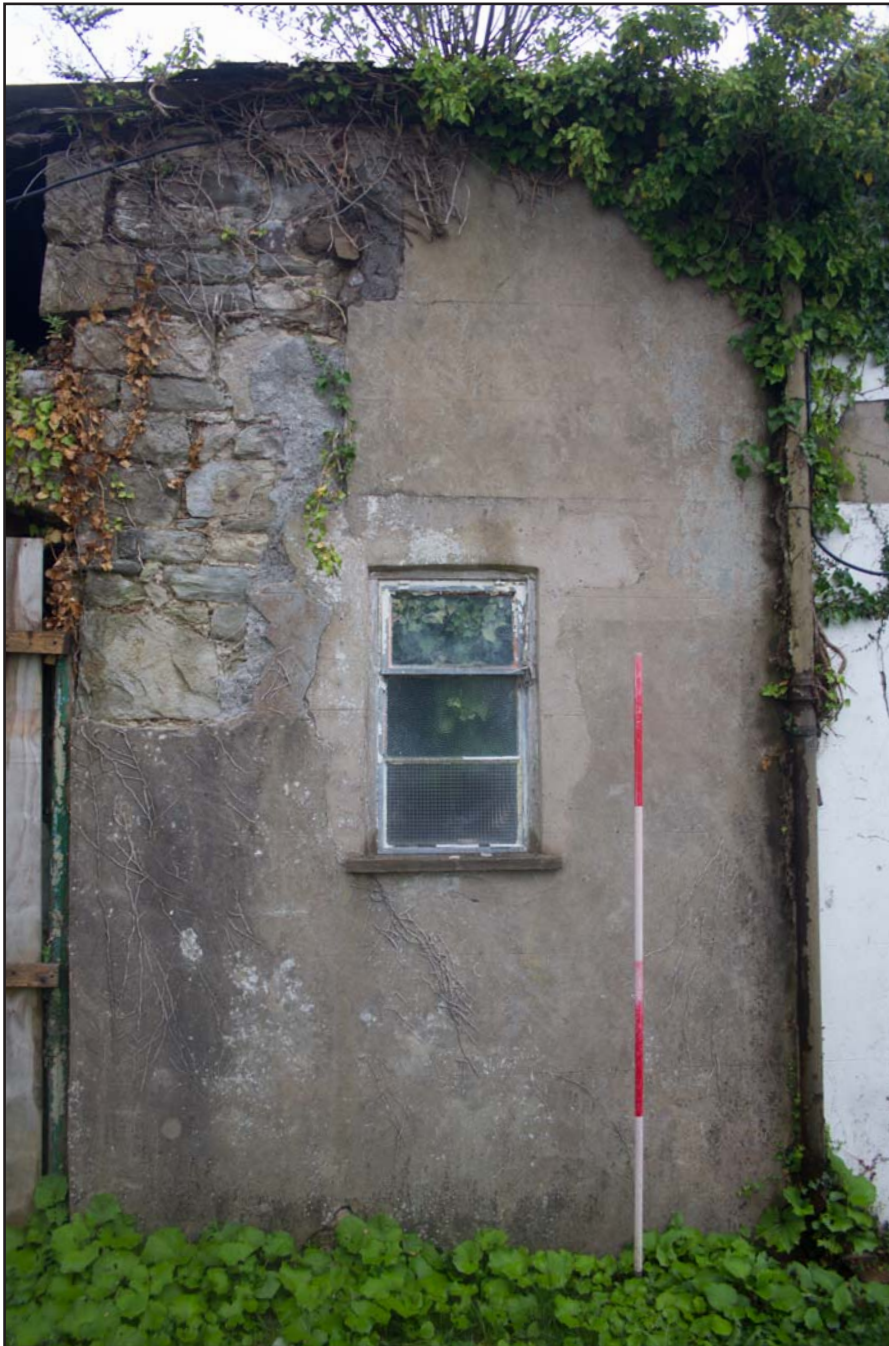
Plate 07: Western elevation (right), stables, former Estate Offices & Stables, Trevor Road, Chirk - from the west - 2.00m scale

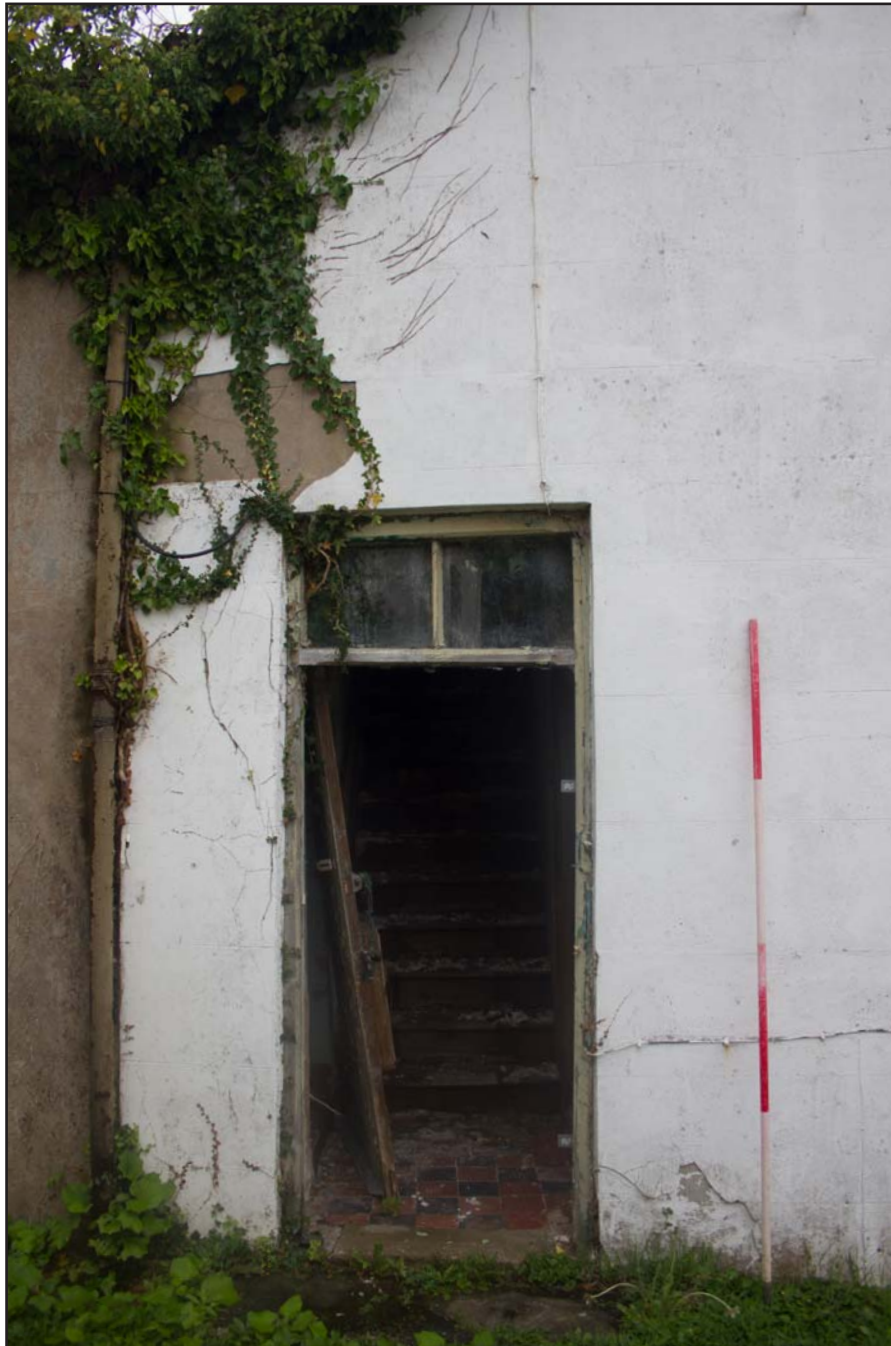
To the left of the ground floor window there is a doorway entrance, which permits access to the stairwell, enquiries office, and downstairs toilet. This doorway has a green painted wooden frame with a two pane, transom window light above, but now with door missing. However, the door stands just inside the building and is of vertical wooden boards and has also been painted green with brass letterbox. Immediately to the left of this is the stable extension. Running north to south and located immediately to the west of the building, is the driveway, which is accessed from the north and is bounded by a large estate wall (with cock and hen coping) to the east and the eastern elevations of Trevor House to the west.

Plate 08: Western elevation (left), Office Entrance, former Estate Offices & Stables, Trevor Road, Chirk - from the west - 2.00m scale

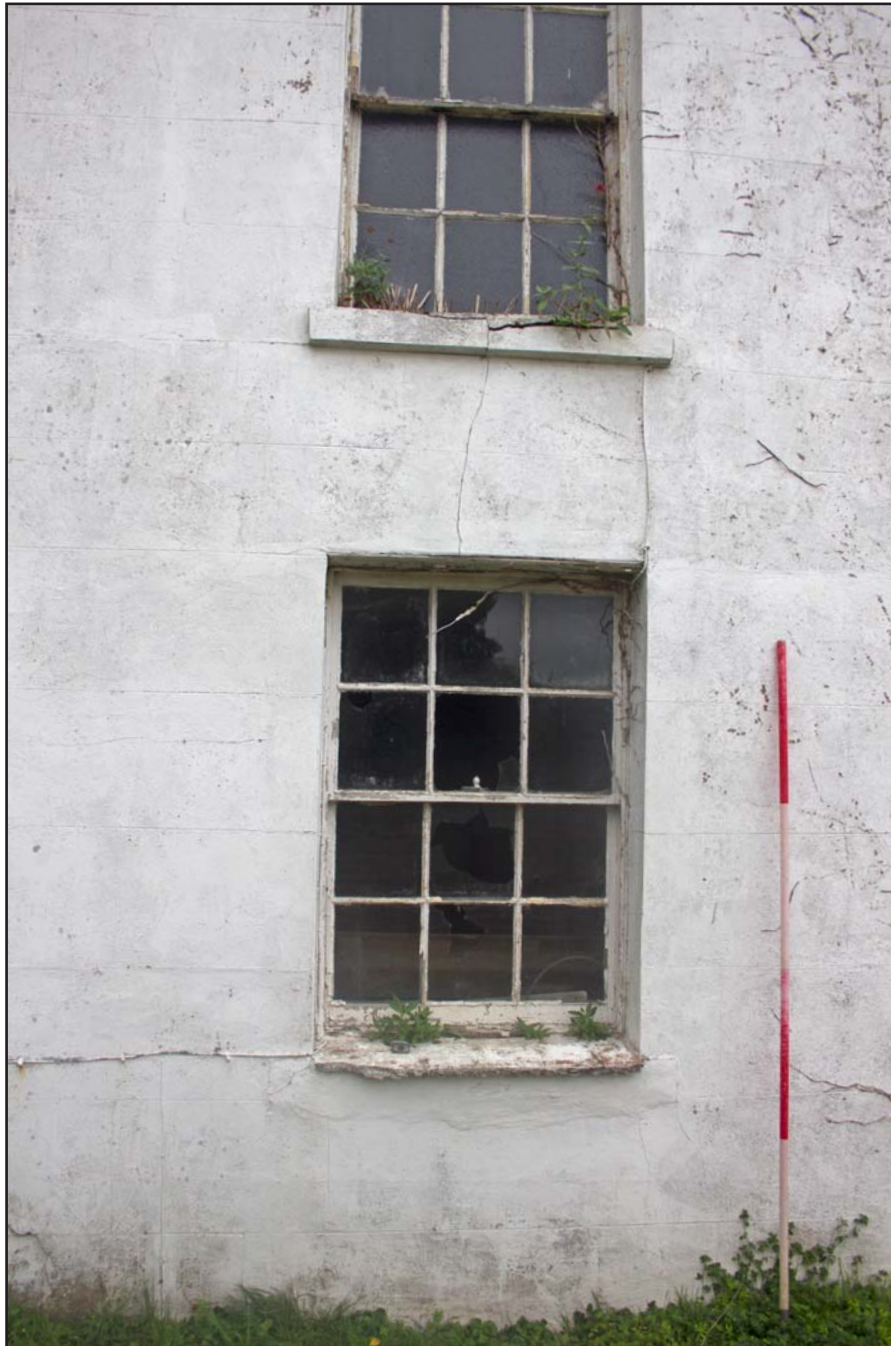
Plate 09: Western elevation (centre), Office Windows, former Estate Offices & Stables, Trevor Road, Chirk - from the west - 2.00m scale

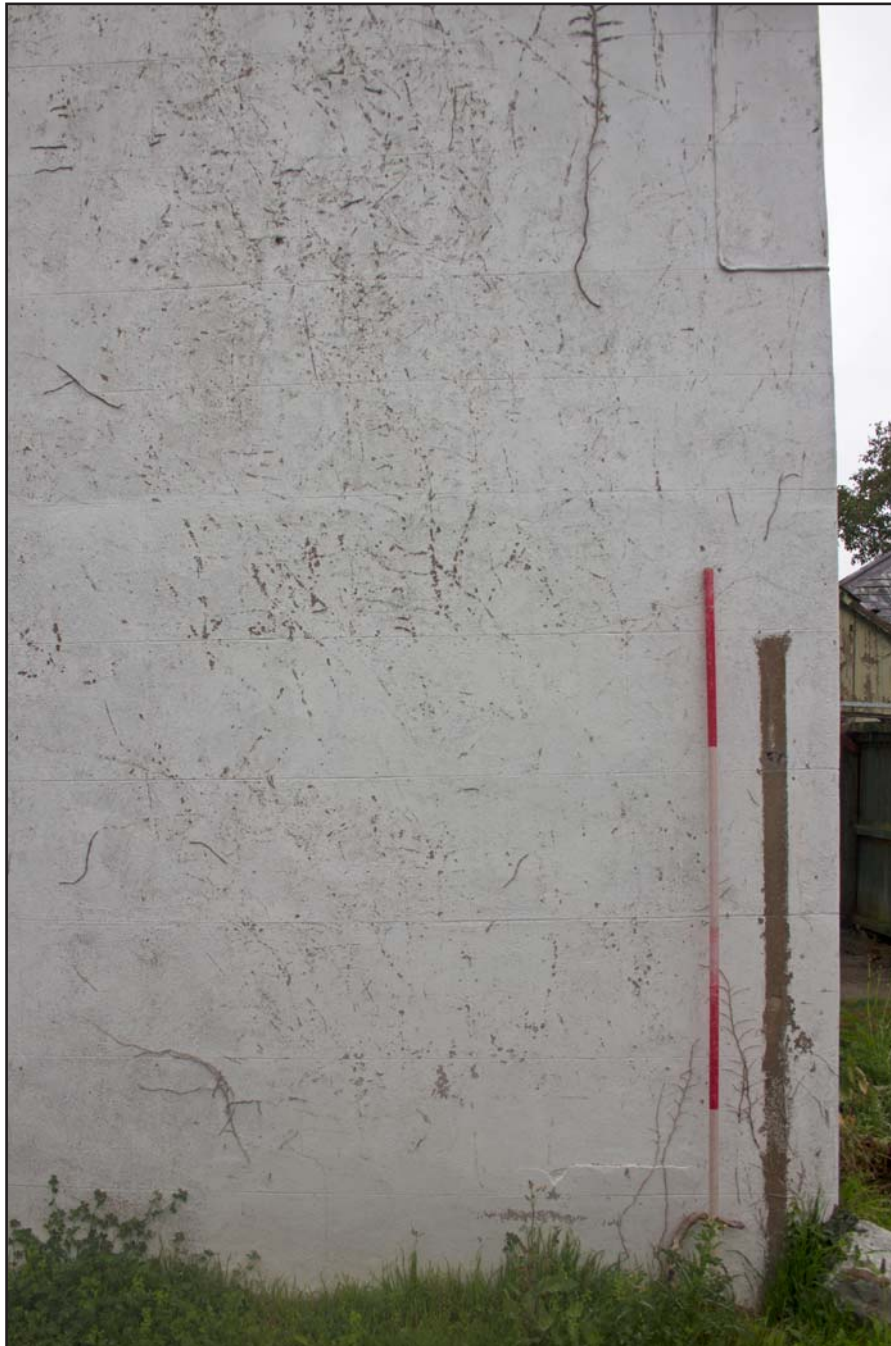
Plate 10: Western elevation (right), Estate Office, former Estate Offices & Stables, Trevor Road, Chirk - from the west - 2.00m scale

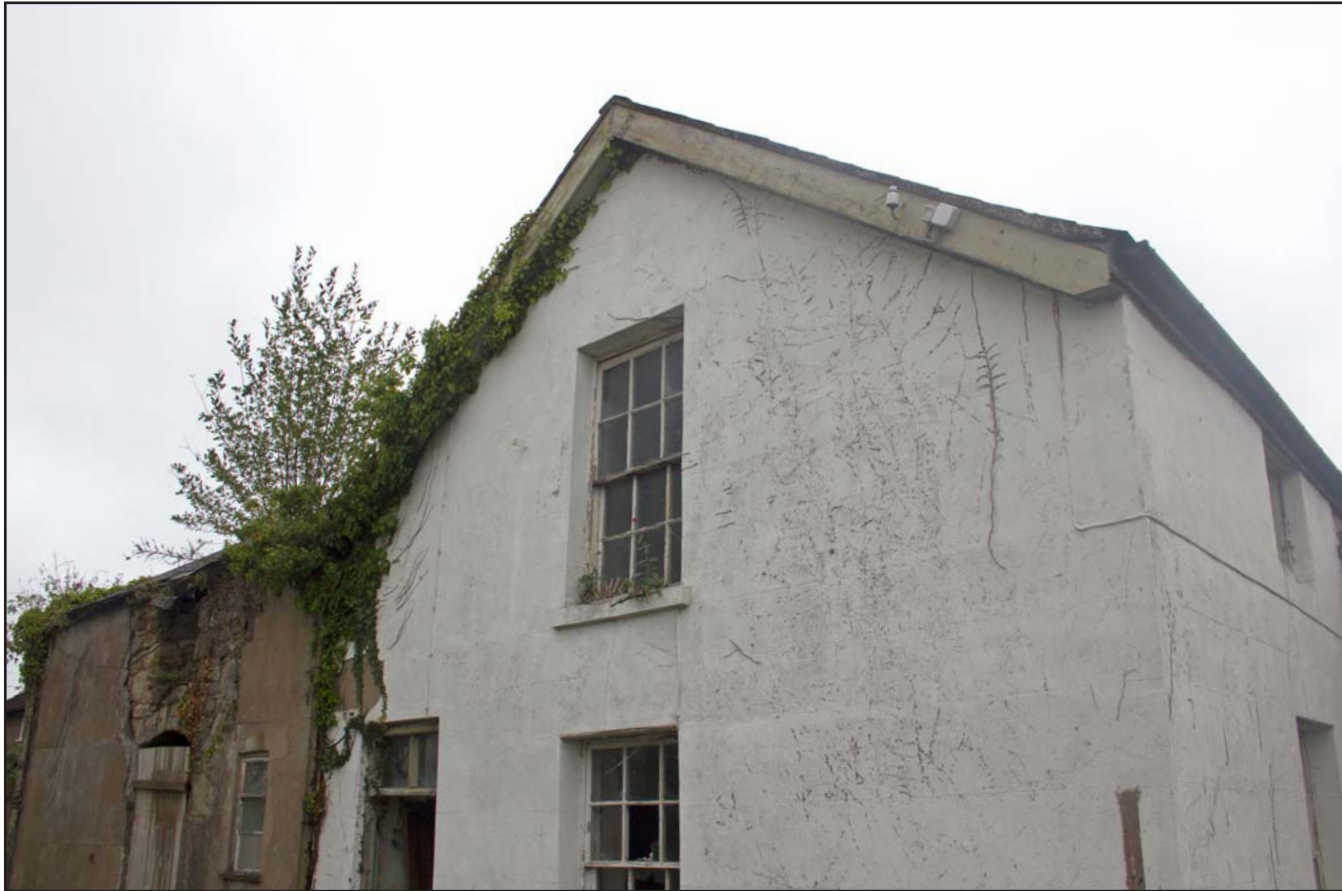
Plate 11: Western elevation, First Floor , former Estate Offices & Stables, Trevor Road, Chirk - from the west - no scale

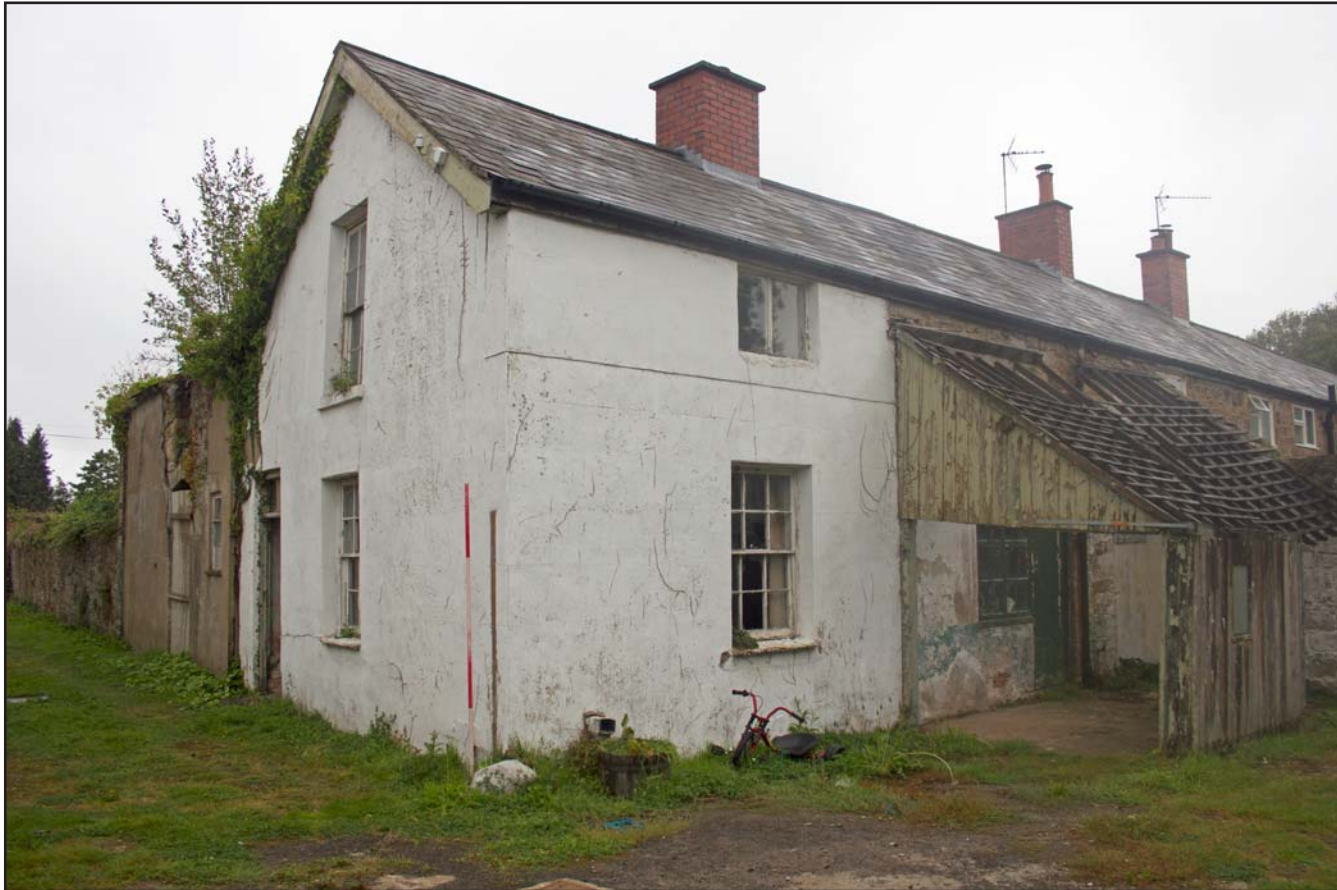
Plate 12: Western/southern elevations, oblique shot, former Estate Offices & Stables, Trevor Road, Chirk - from the southwest - 2.00m scale

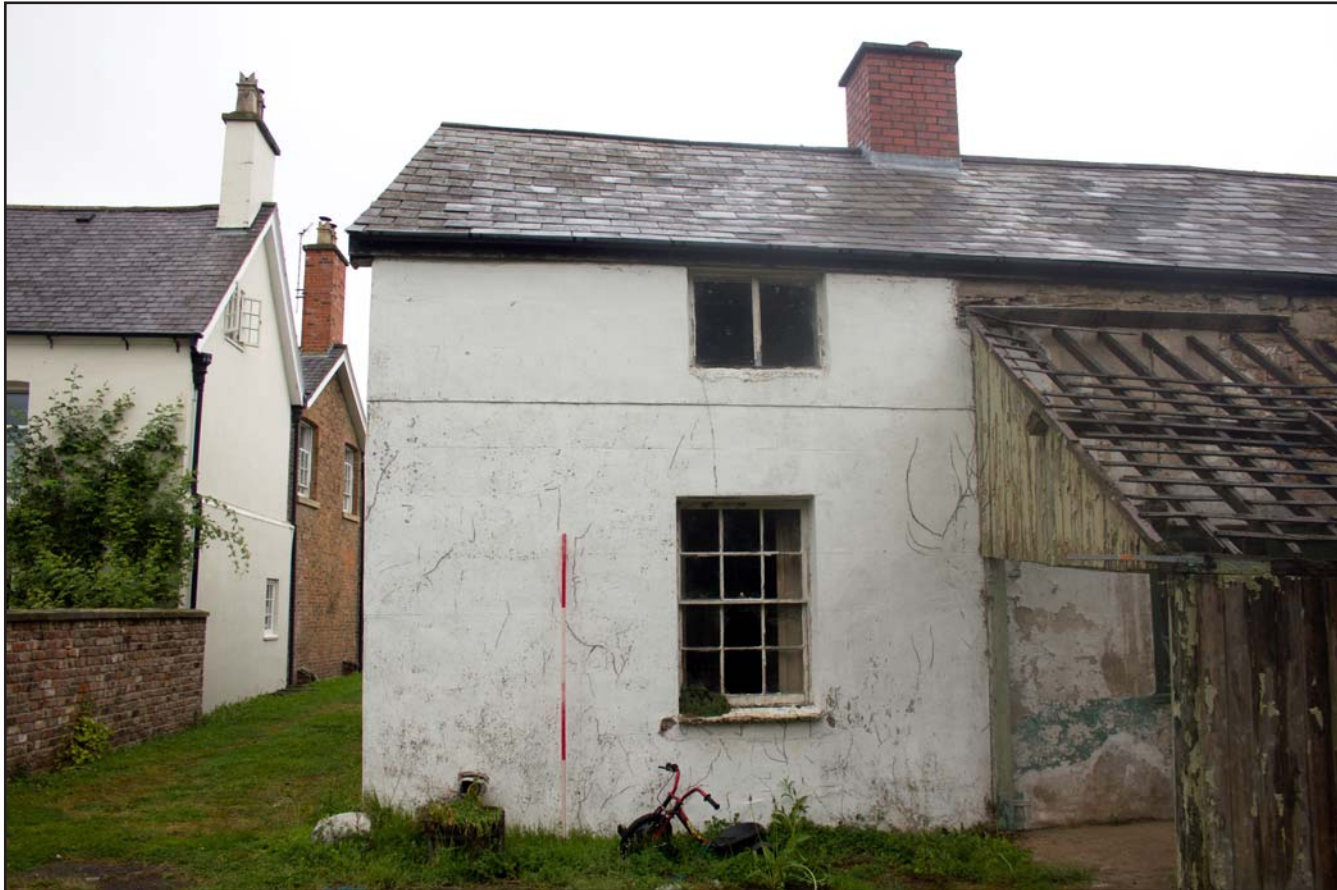
Plate 13: Southern elevation (left), Estate Office, former Estate Offices & Stables, Trevor Road, Chirk - from the south - 2.00m scale

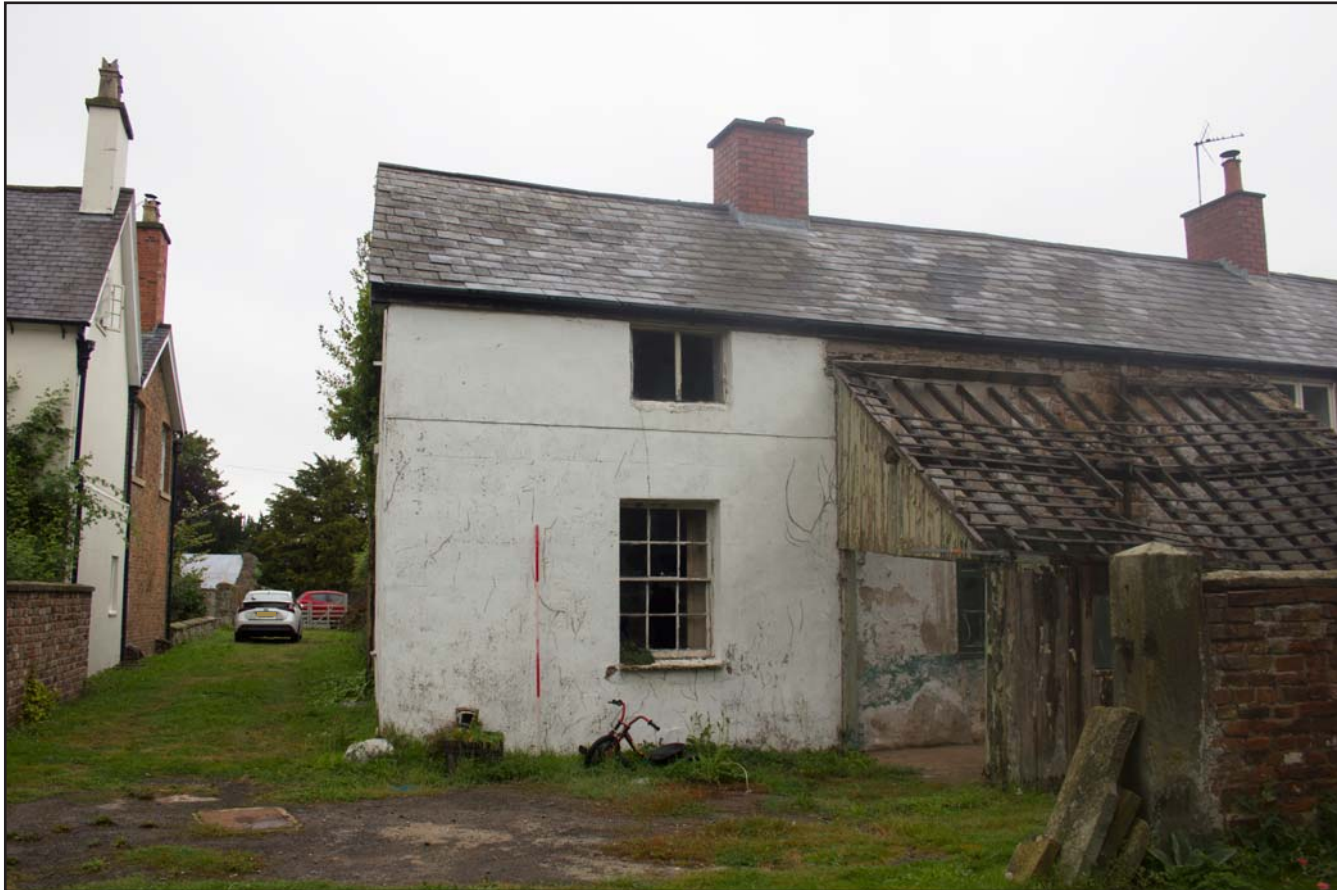
Plate 14: Southern elevation (wide), former Estate Offices & Workshop, Trevor Road, Chirk - from the south - 2.00m scale

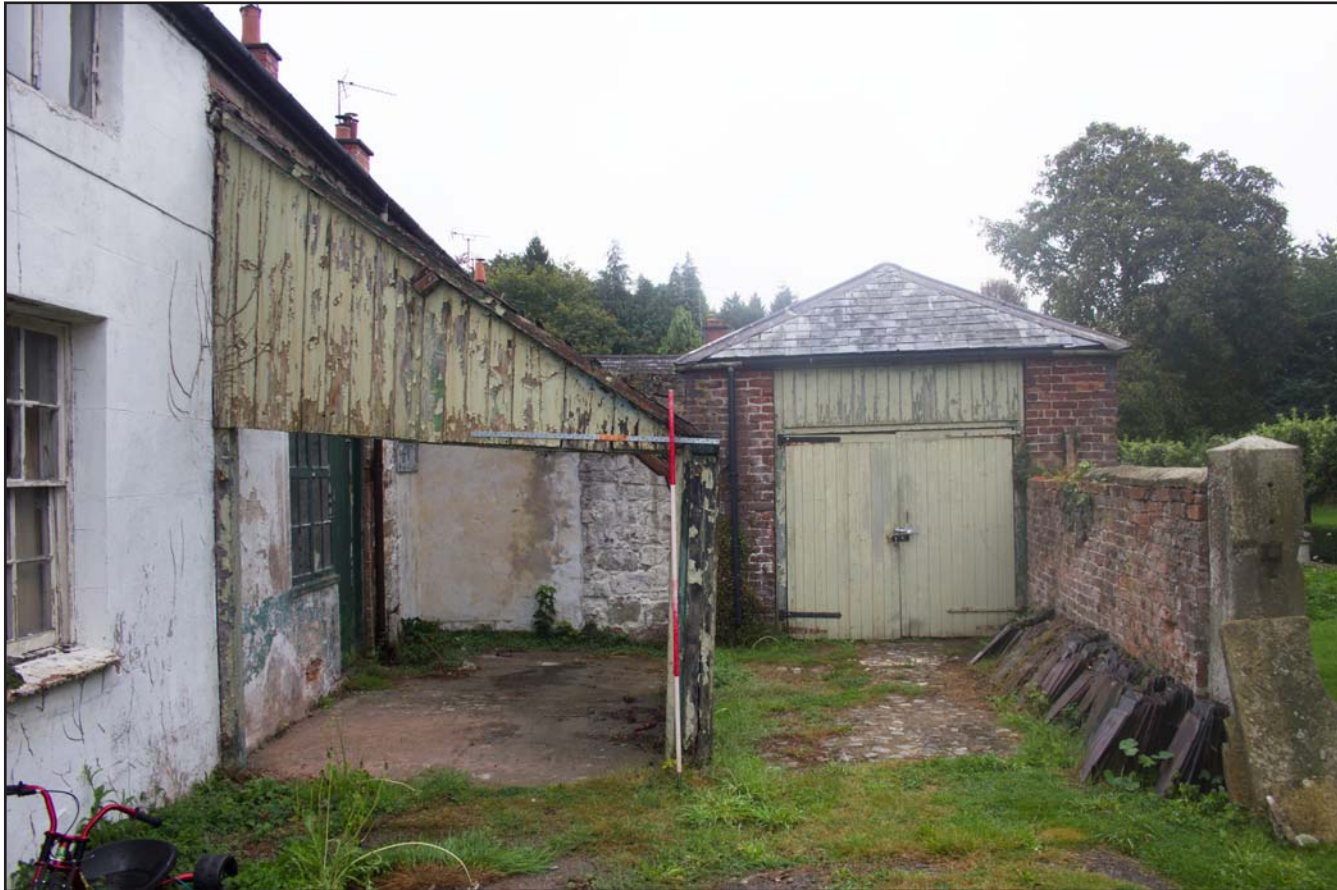
Plate 15: Wooden lean-to & garage, at former Estate Offices & Stables, Trevor Road, Chirk - from the south - 2.00m scale

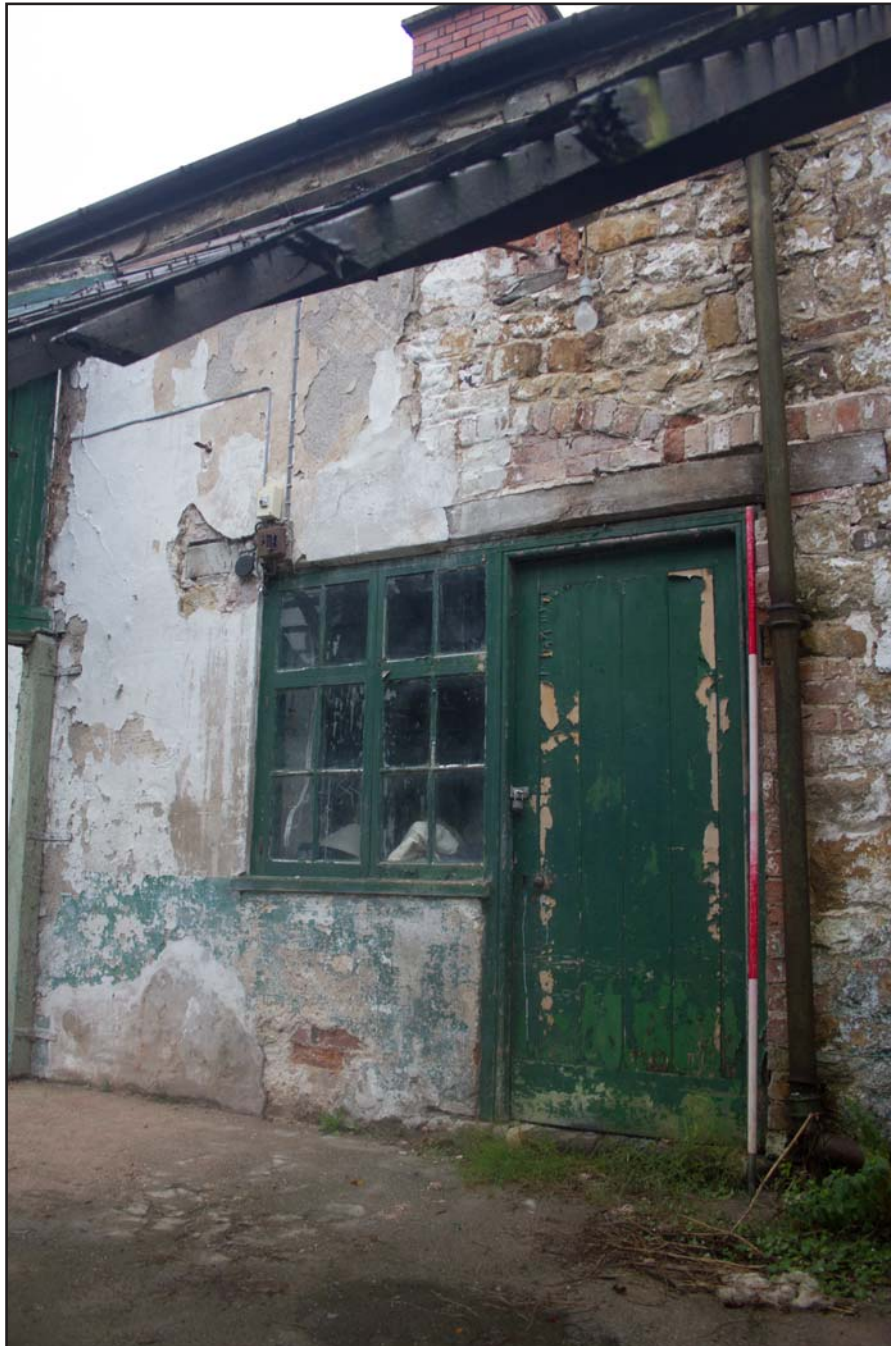
Plate 16: Workshop elevation (left), former Estate Offices & Stables, Trevor Road, Chirk - from the southeast - 2.00m scale

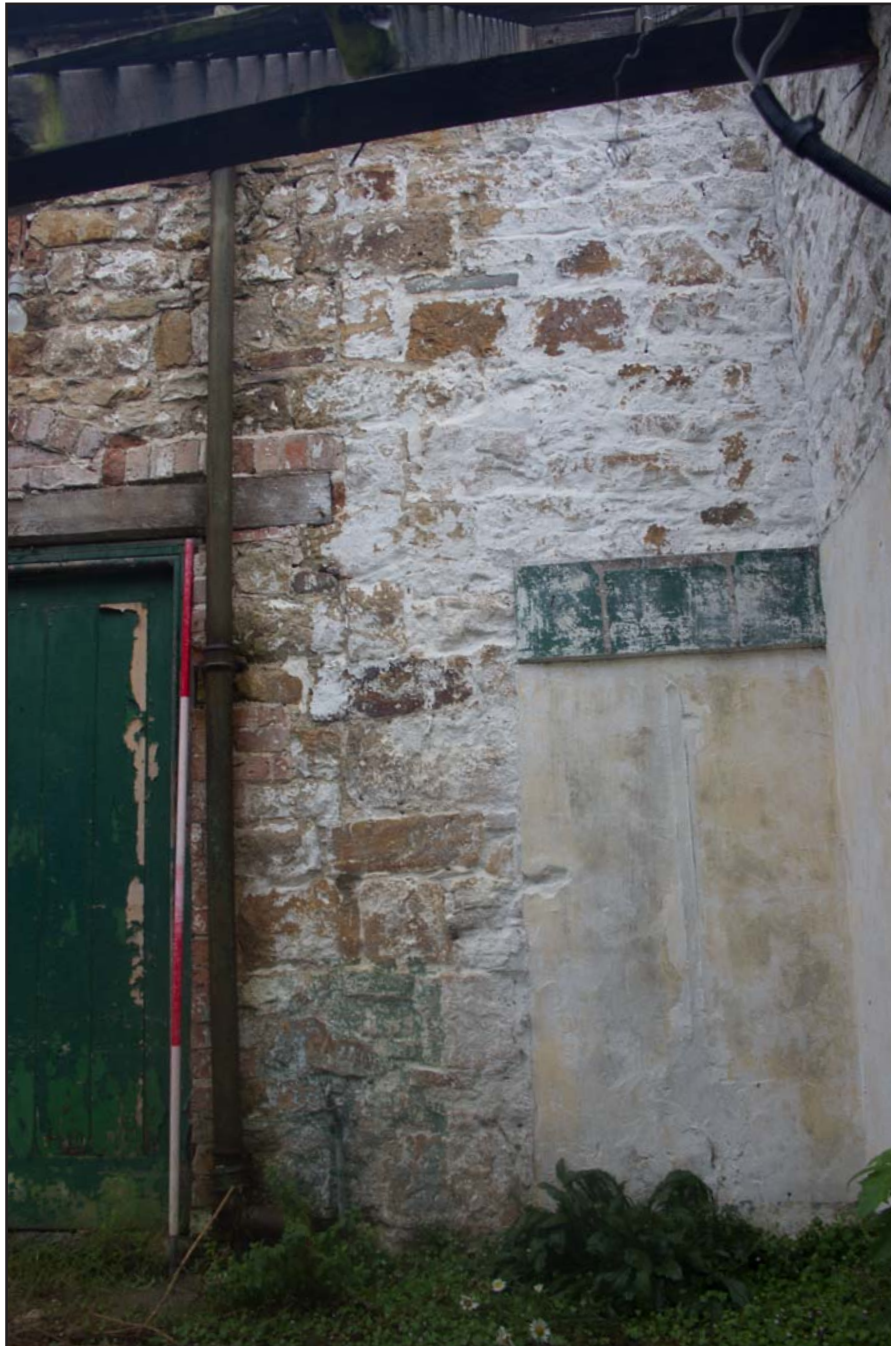
Plate 17: Workshop elevation (right), former Estate Offices & Stables, Trevor Road, Chirk - from the south - 2.00m scale

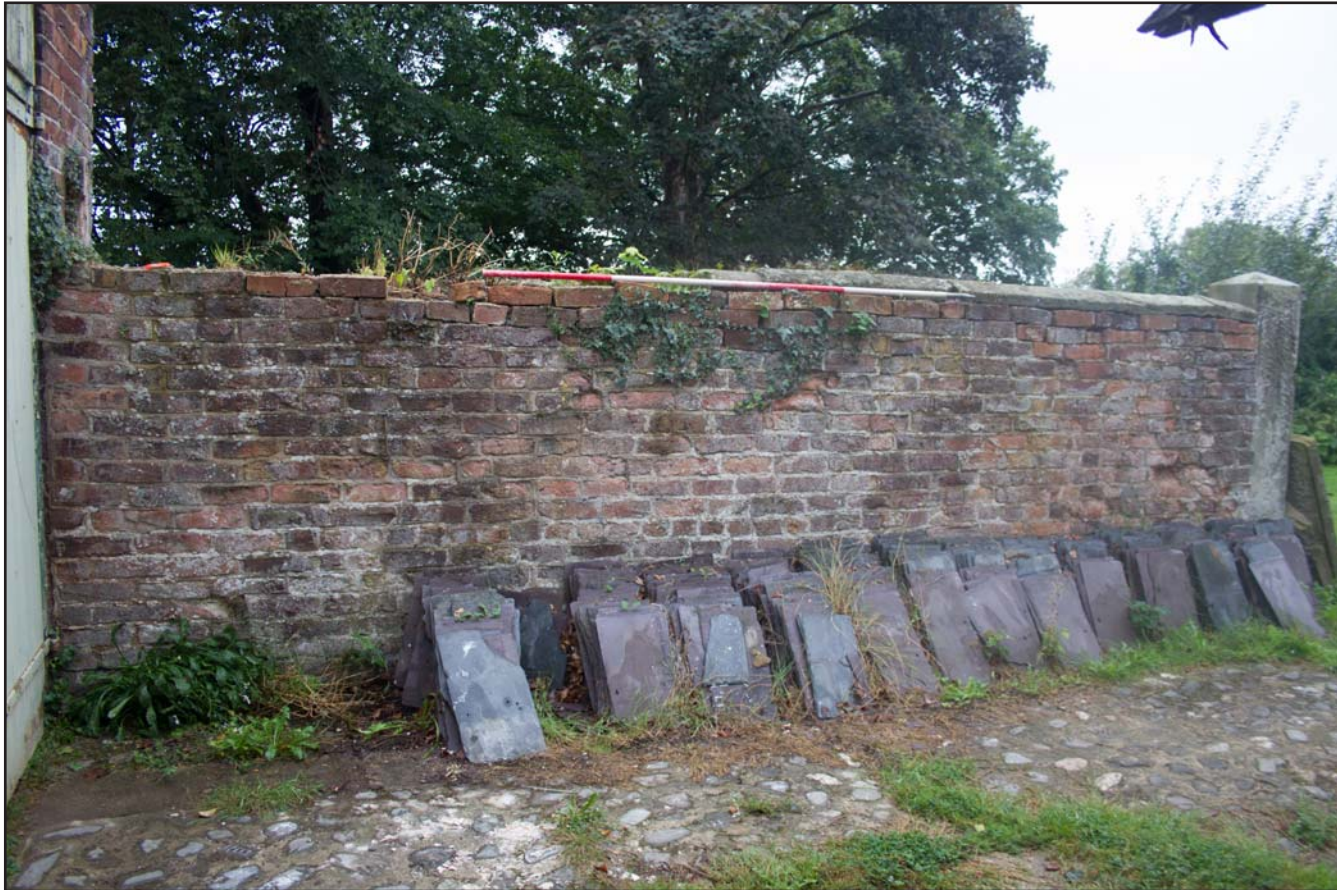
Plate 18: Garden Wall, former Estate Offices & Stables, Trevor Road, Chirk - from the northeast - 2.00m scale
