**Former Estate Offices and Stables,
Trevor Row, Trevor Road, Chirk,
Wrexham, LL14 5HE**

Historic Building Record Level 2

Project Code: A0447.1

Report no. 0423

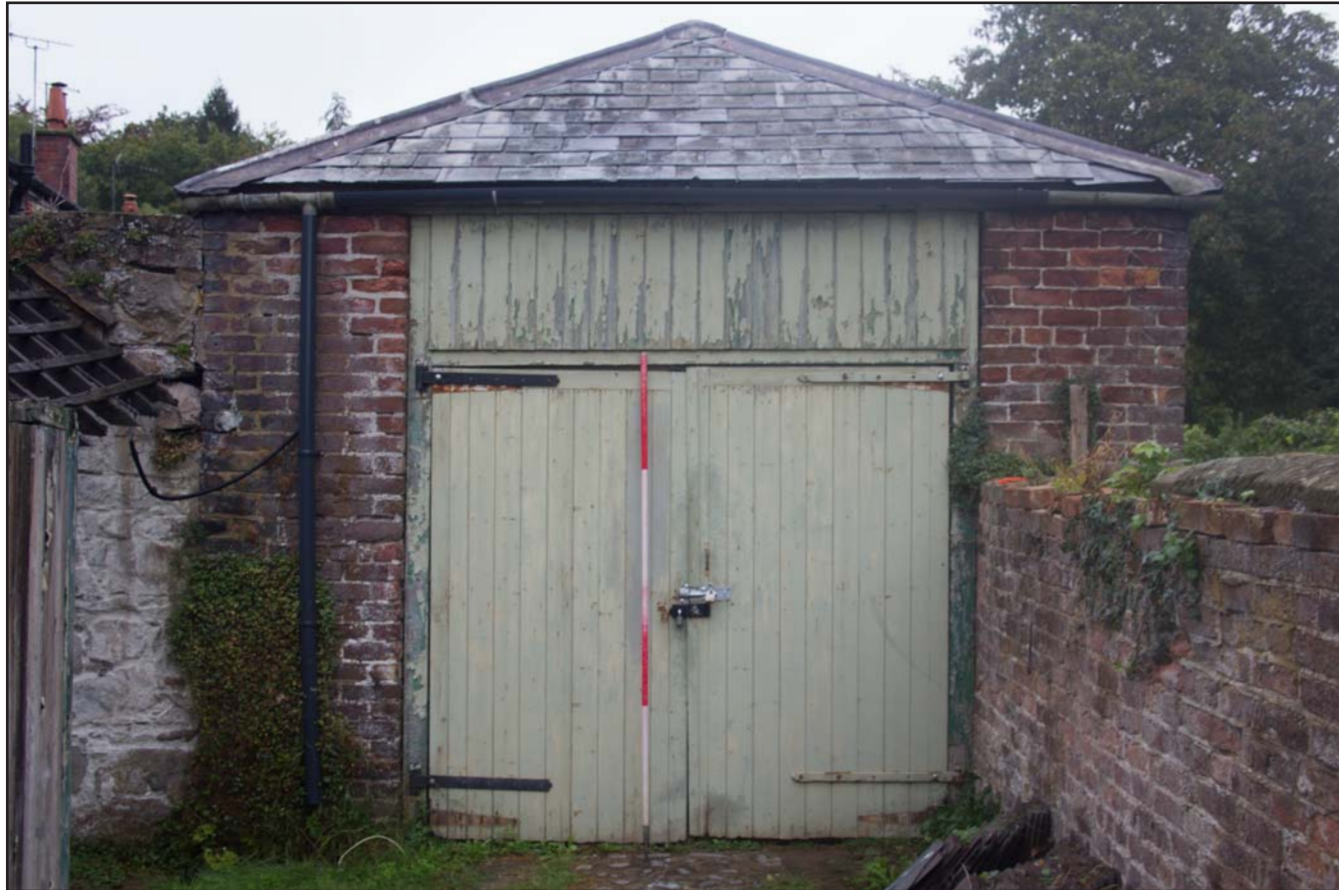
The western elevation has a large double garage door entrance constructed from timber and which has been painted green. The southern elevation is largely featureless, although there is an area of the wall which appears to have once been painted white, and to the right of this there is a blocked-up doorway, which is now evidenced by a segmented Arch. The eastern elevation is featureless.

Plate 19: Garage, former Estate Offices & Stables, Trevor Road, Chirk - from the west - 2.00m scale

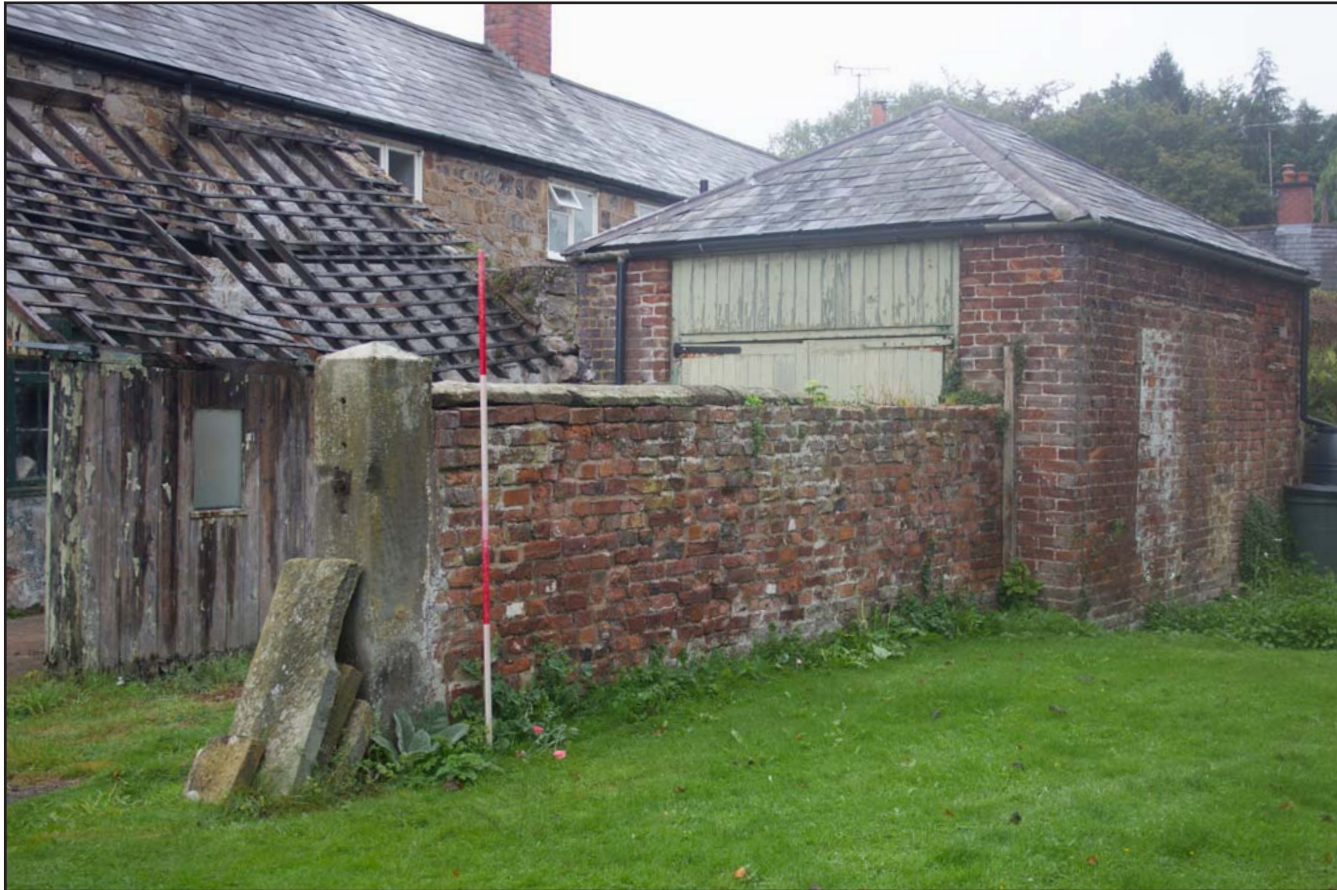
Plate 20: Garden Wall & Garage, former Estate Offices & Stables, Trevor Road, Chirk - from the northeast - 2.00m scale

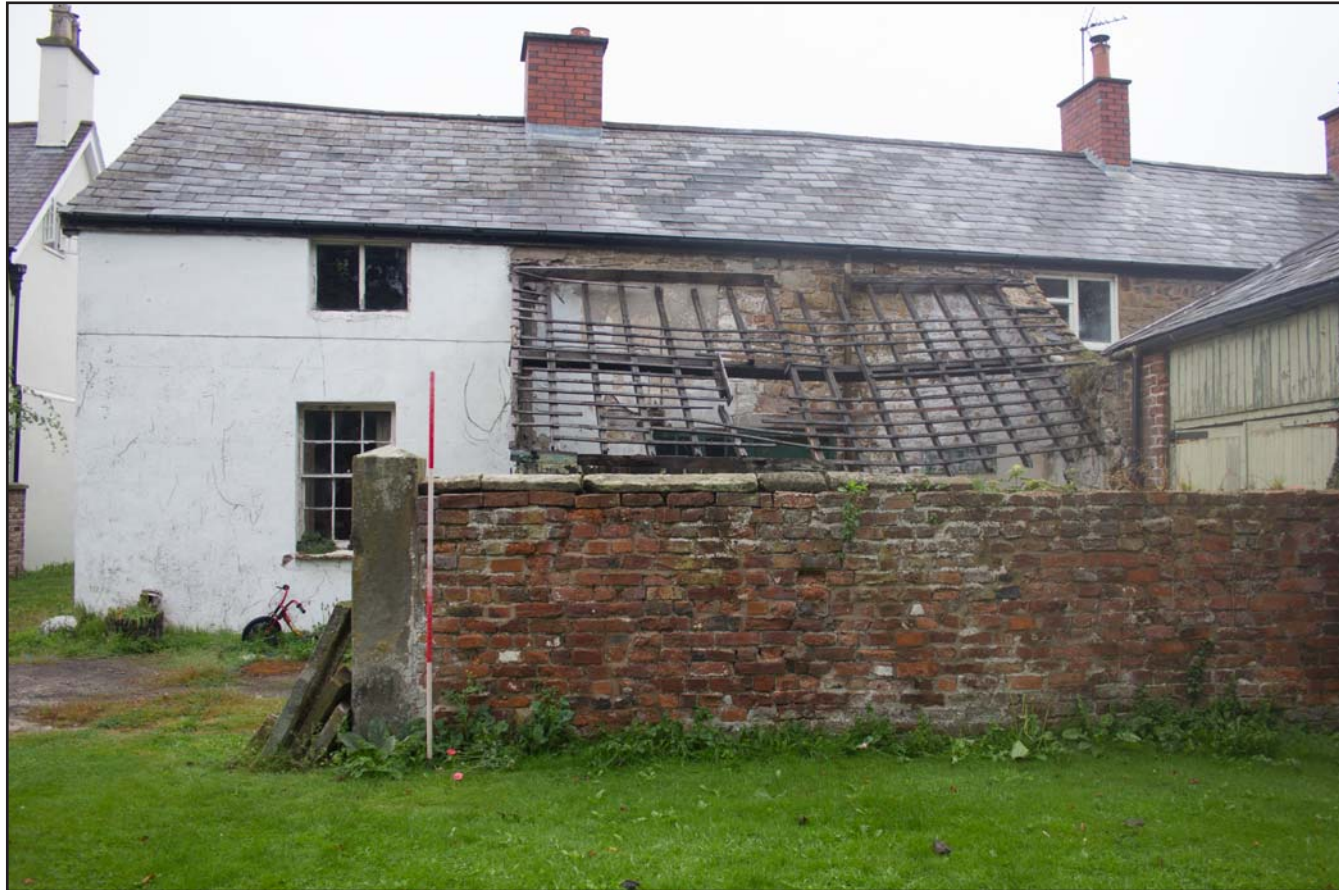
Plate 21: Southern elevation garden wall, Estate Office & workshop in background, former Estate Offices & Stables, Trevor Road, Chirk - from the south - 2.00m scale

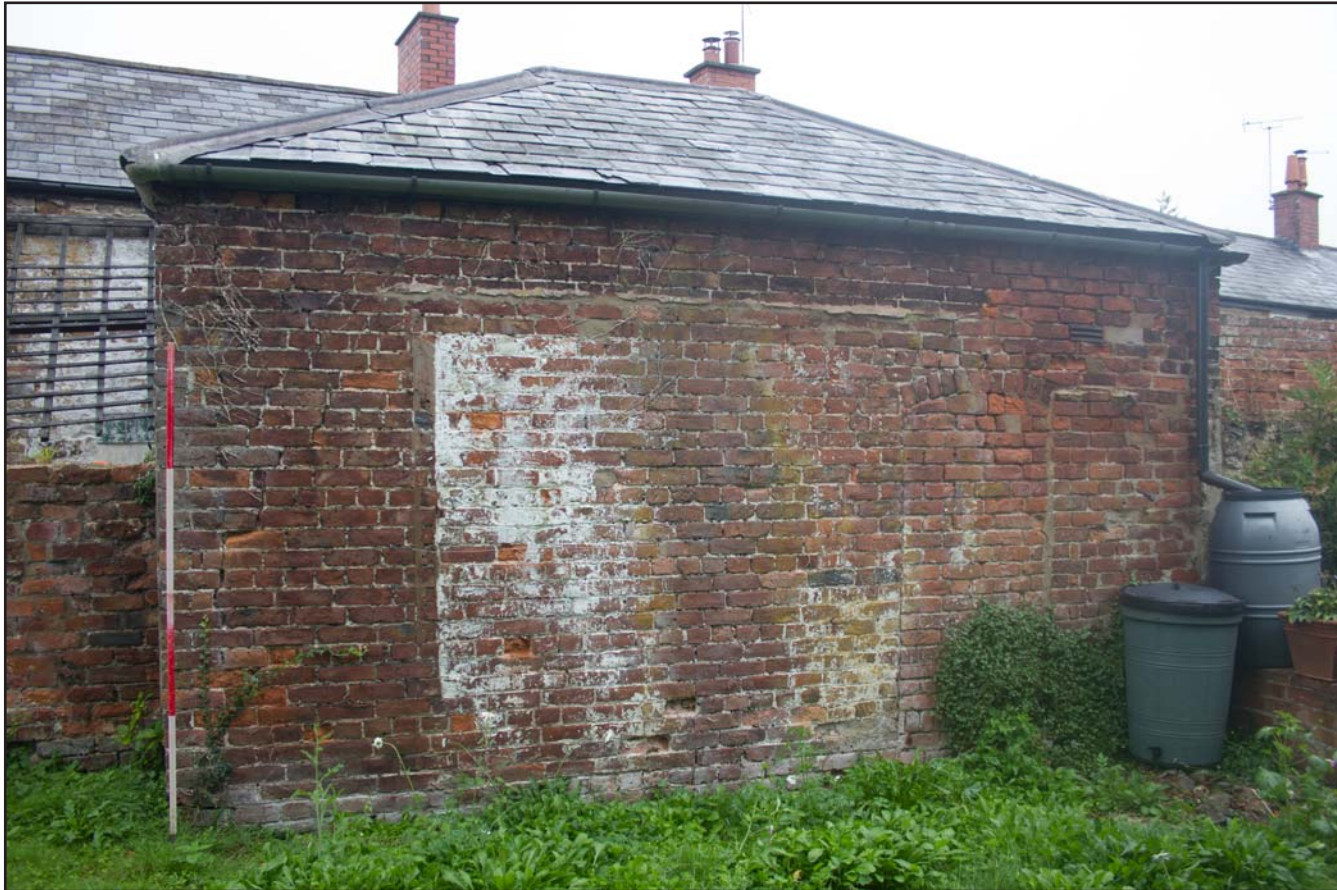
Plate 22: Southern elevation Garage, former Estate Offices & Stables, Trevor Road, Chirk - from the south - 2.00m scale

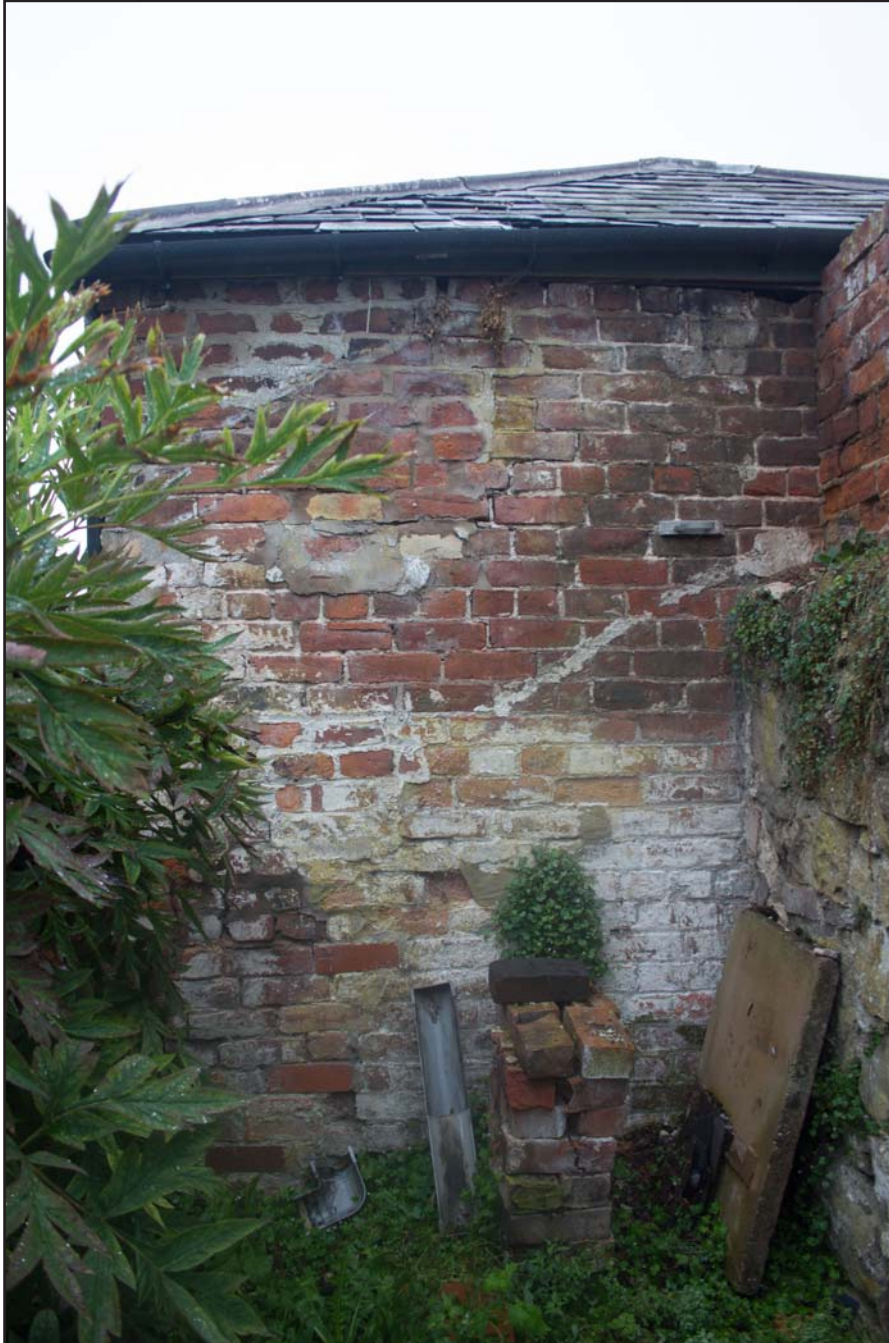
Plate 23: Eastern elevation Garage, former Estate Offices & Stables,
Trevor Road, Chirk - from the east - 2.00m scale

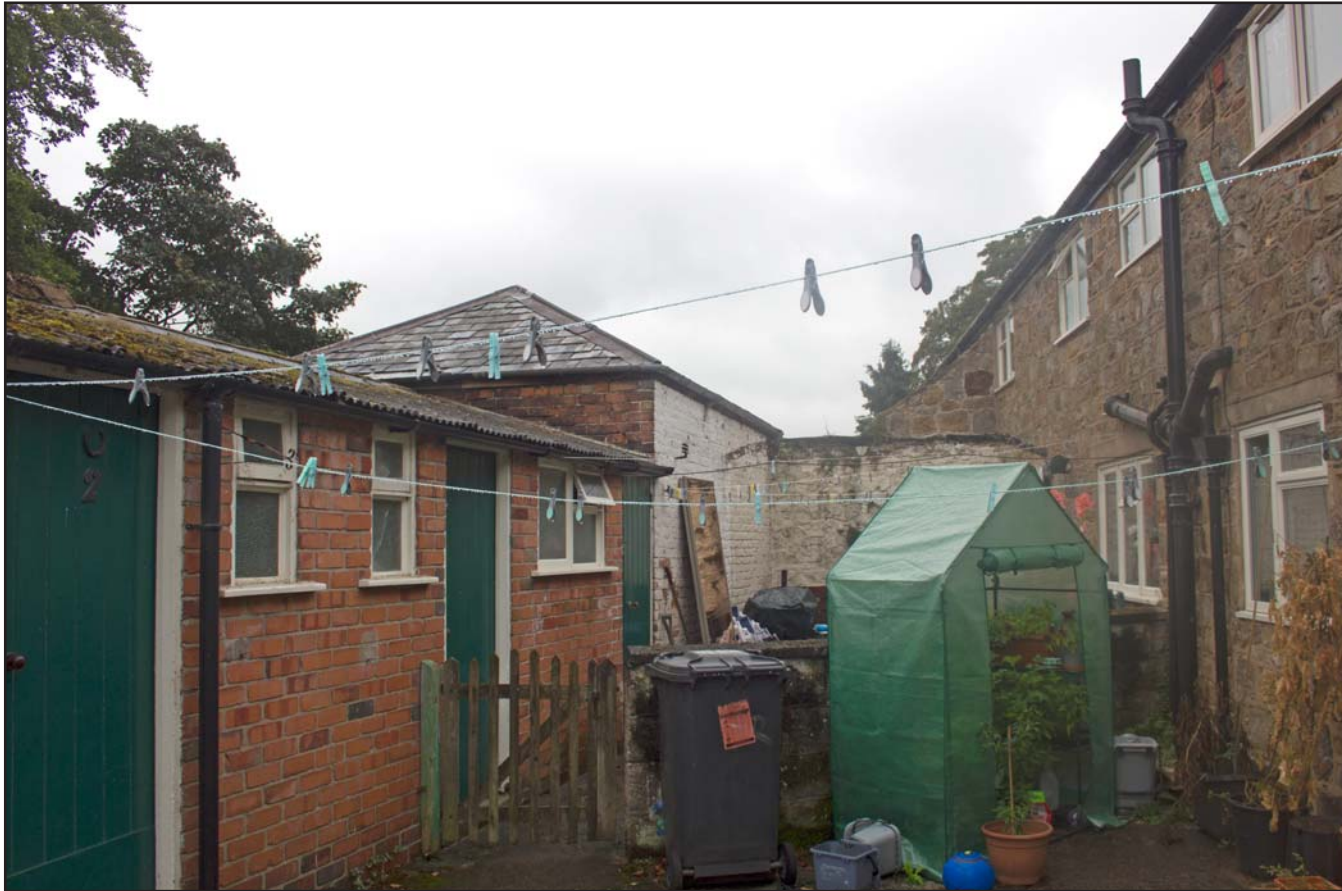
Plate 24: Garage & Wall, from rear of Trevor Row, Estate Offices & Stables, Trevor Road, Chirk - from the east - no scale

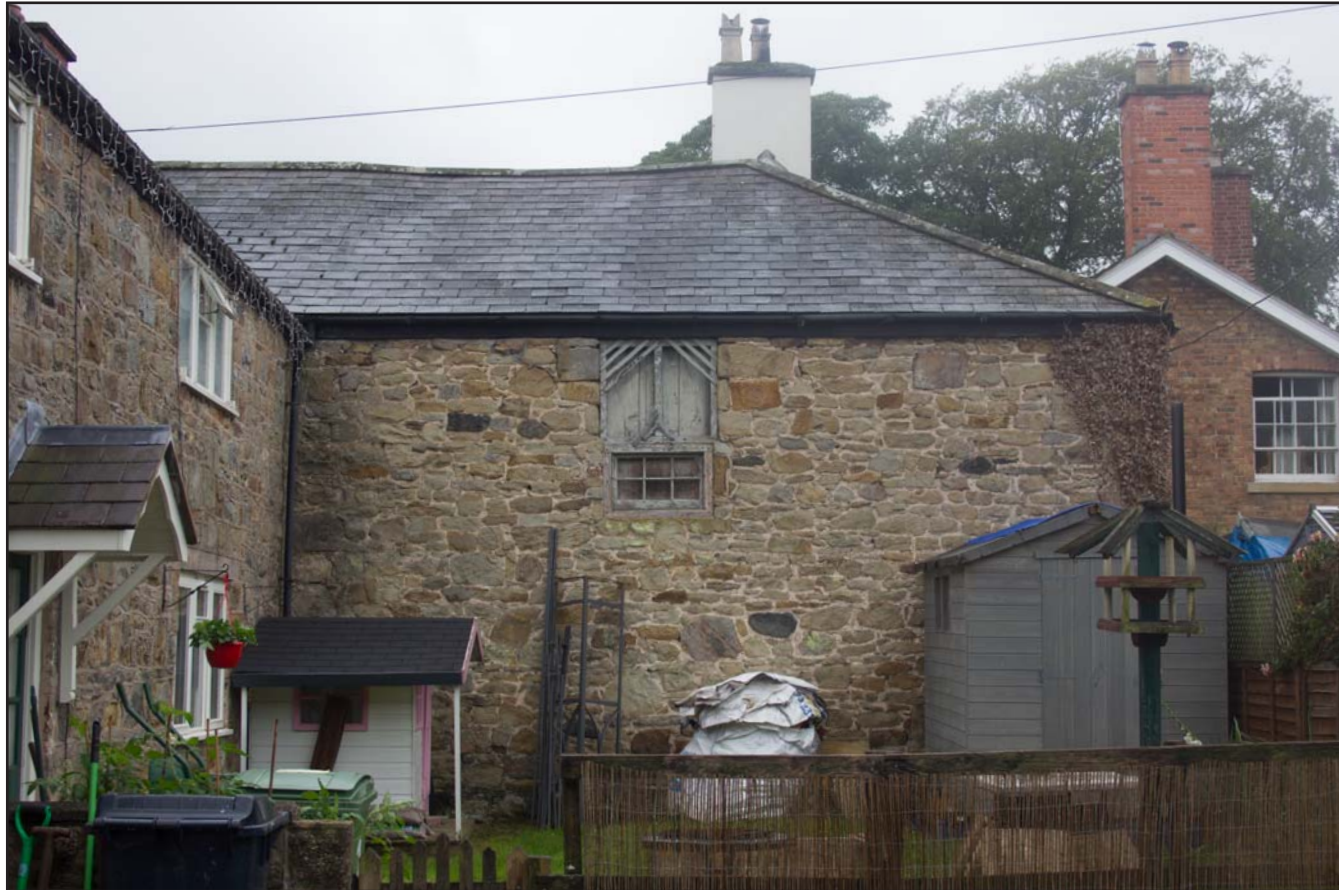
Plate 25: Stables, from Trevor Row, Estate Offices & Stables, Trevor Road, Chirk - from the east - no scale

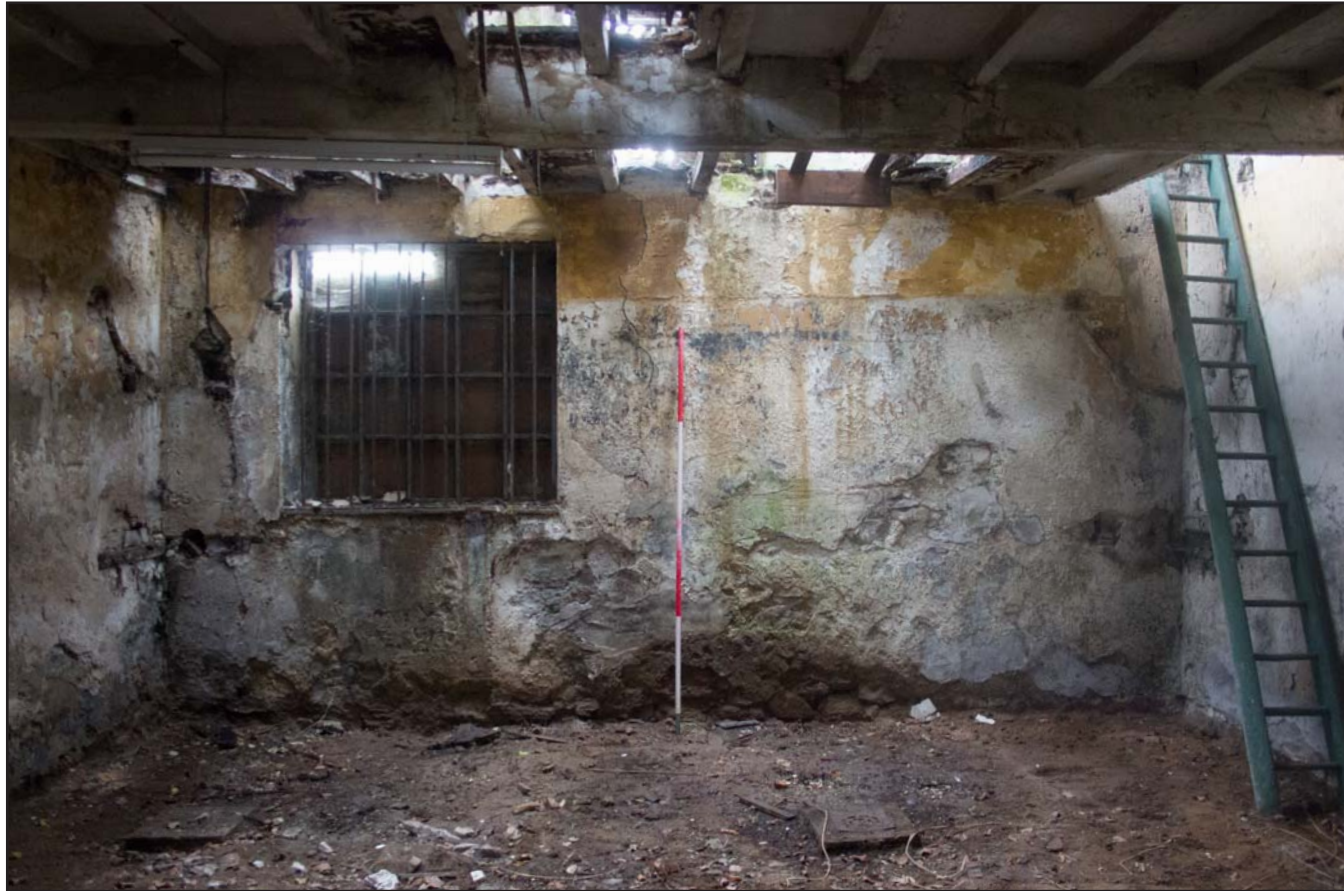
This is a rectangular room, which is orientated north/northeast to south/southwest, and which measures 6.45m in length by 5.54m in width. The ceiling is formed from two large, sawn and chamfered floor beams, which support 12 (remaining) sawn timber joists. The ceiling has suffered from an abundance of water ingress and is entirely unsafe to walk on (this was confirmed by the client).

Plate 26: Internal shot of stables, Estate Offices & Stables, Trevor Road, Chirk - from the south - 2.00m scale

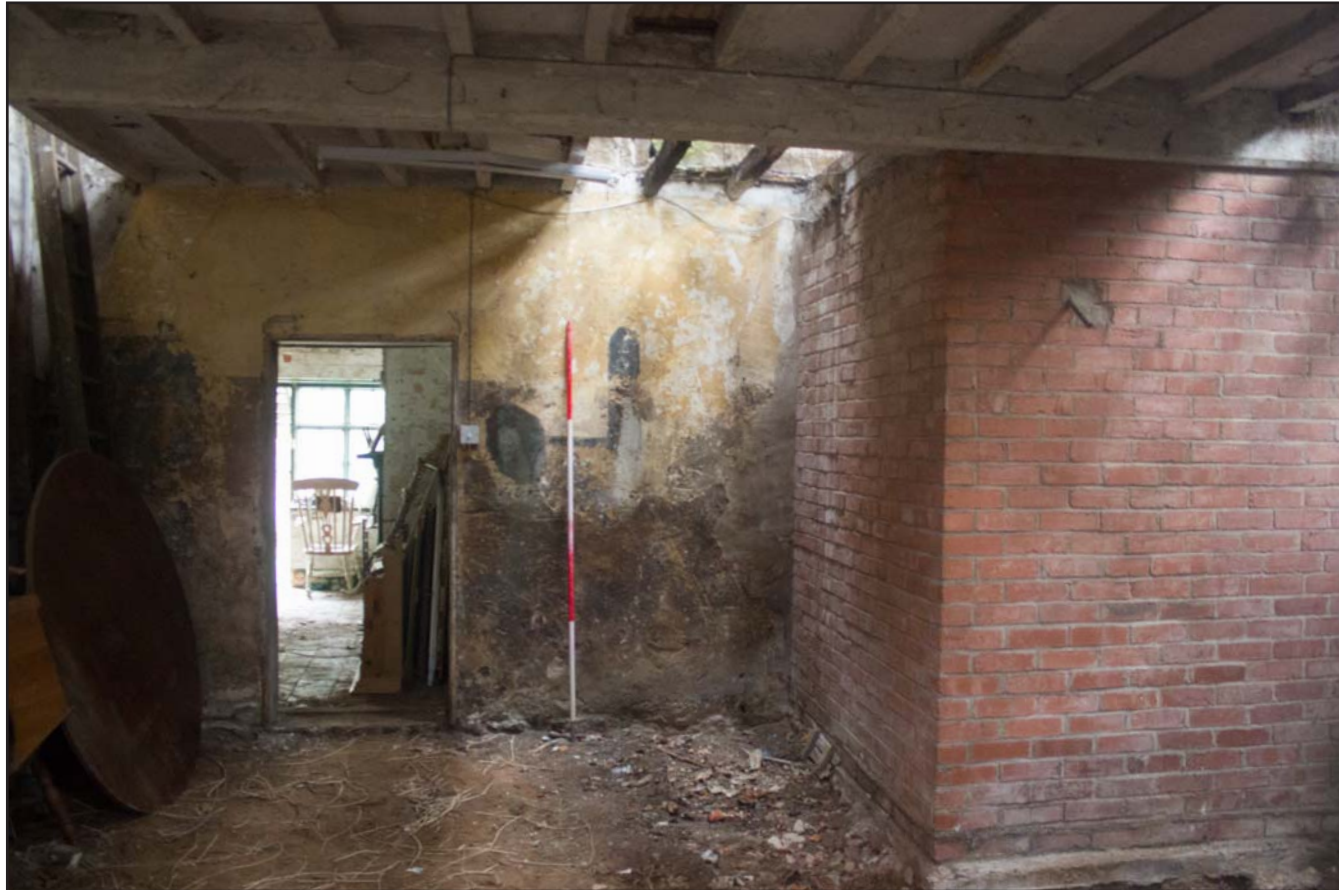
Plate 27: Internal shot of stables, Estate Offices & Stables, Trevor Road, Chirk - from the north - 2.00m scale

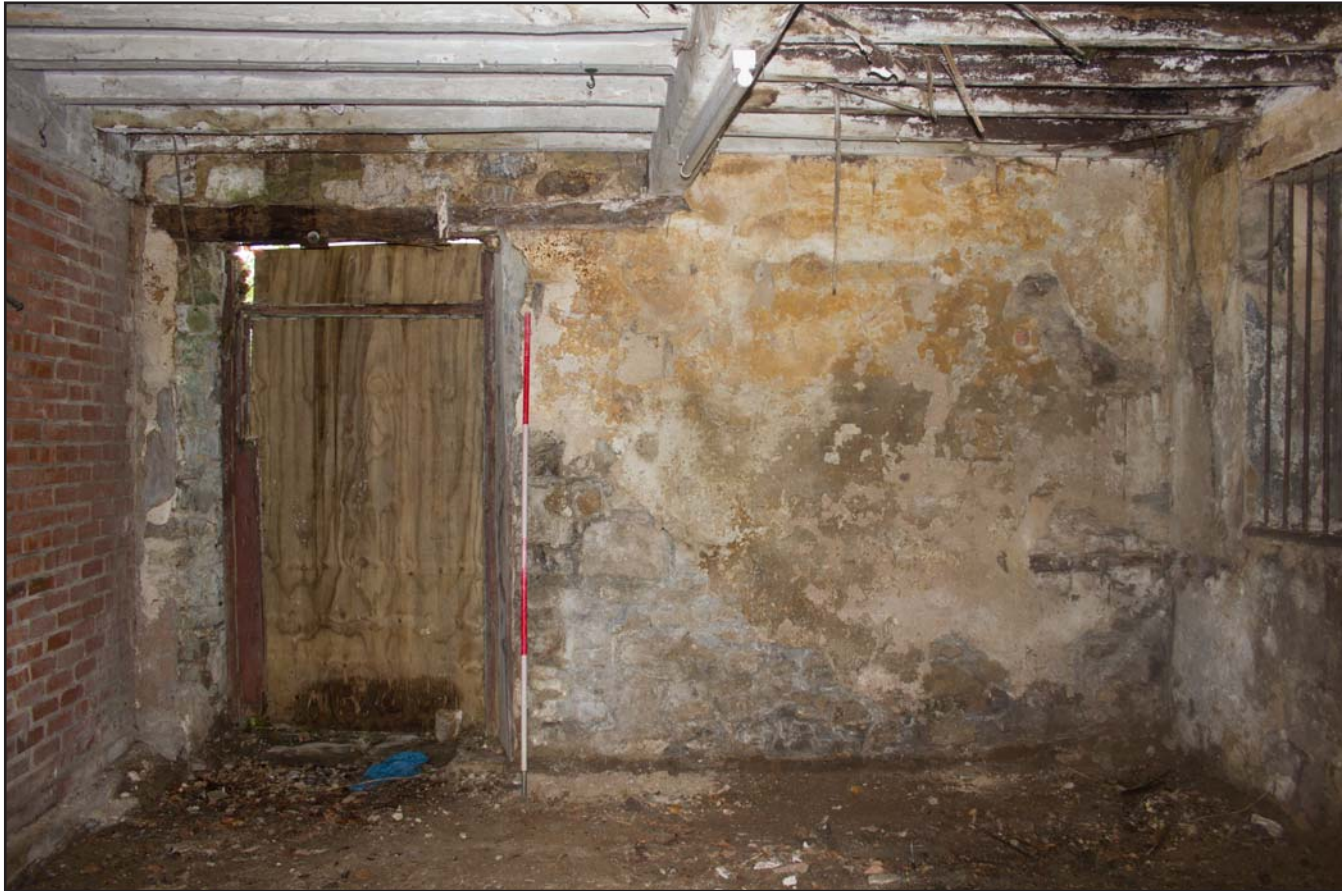
Plate 28: Internal shot of stables, Estate Offices & Stables, Trevor Road, Chirk - from the east - 2.00m scale

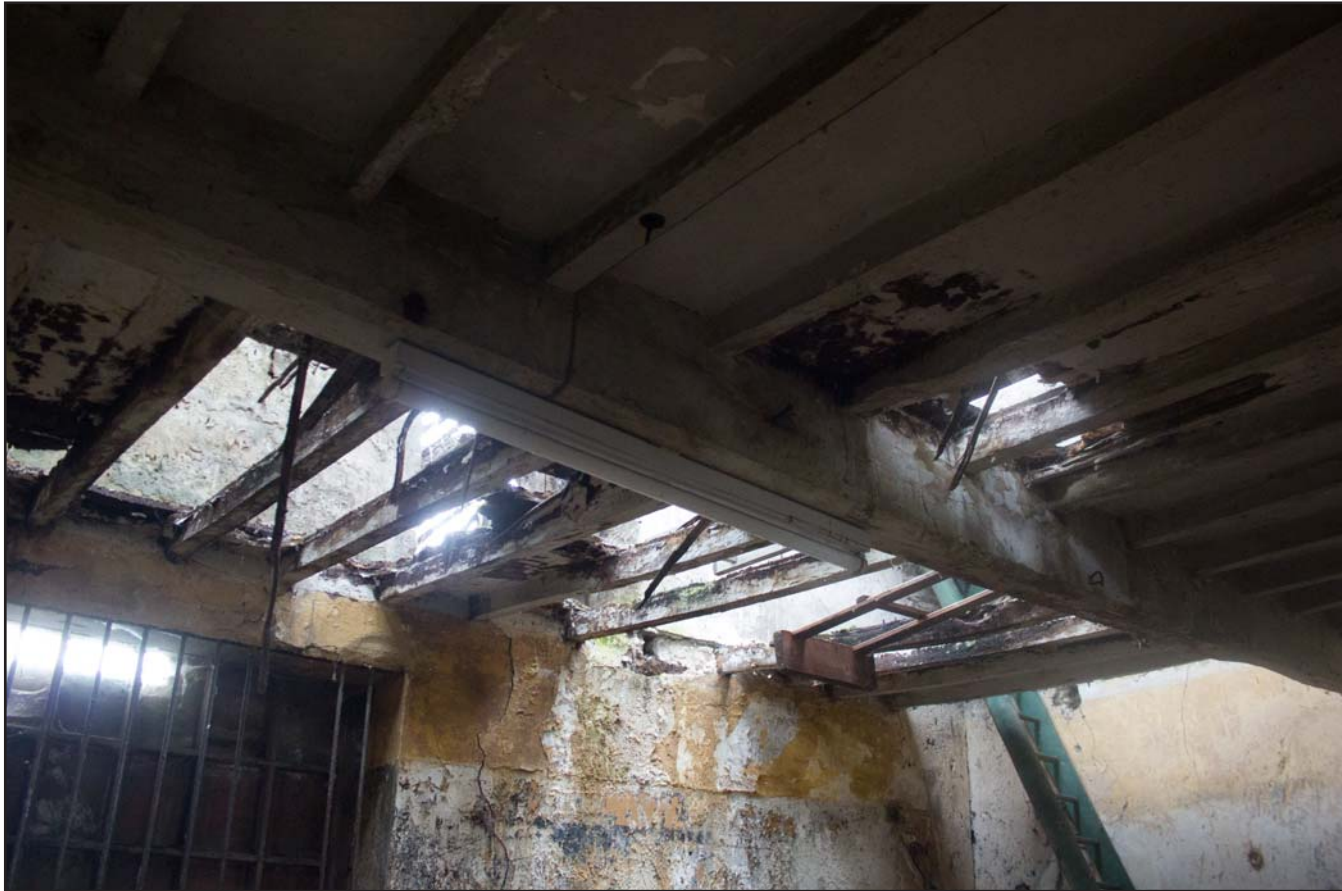
Plate 29: Internal shot of stables ceiling, Estate Offices & Stables, Trevor Road, Chirk - from the southwest - 2.00m scale

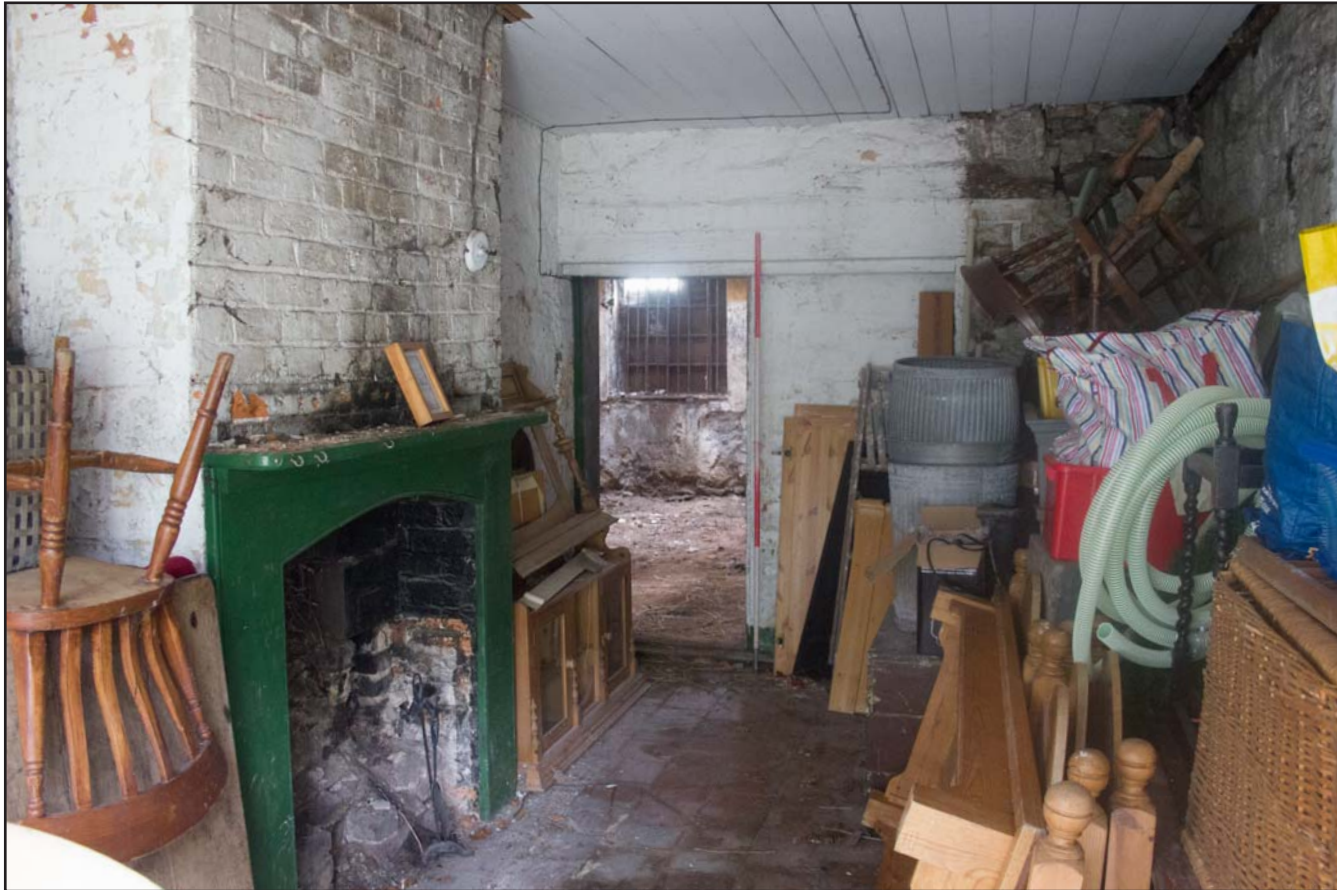
Plate 30: Internal shot of workshop, Estate Offices & Stables, Trevor Road, Chirk - from the south - 2.00m scale

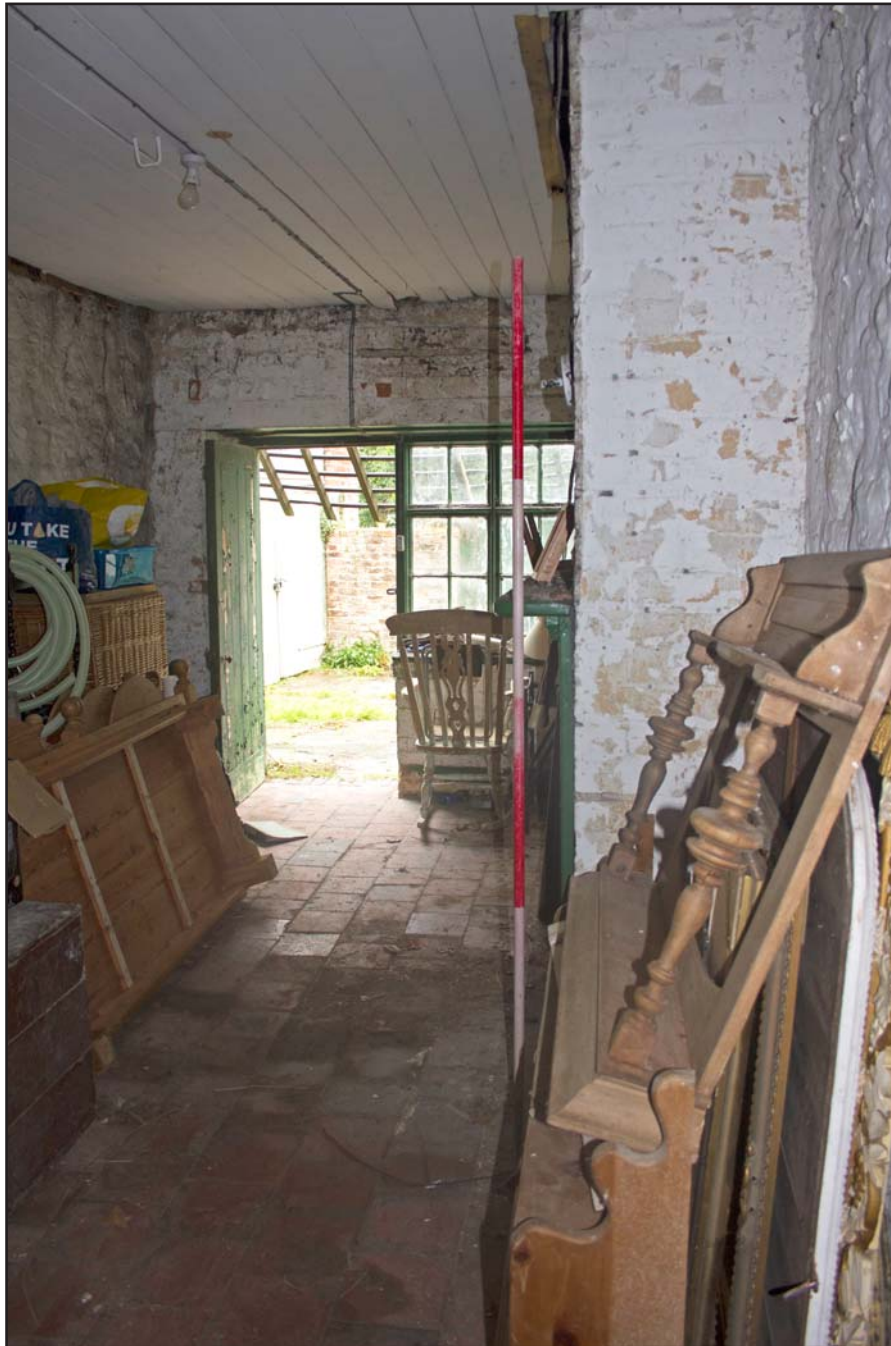
Plate 31: Internal shot of workshop, Estate Offices & Stables, Trevor Road, Chirk - from the north - 2.00m scale

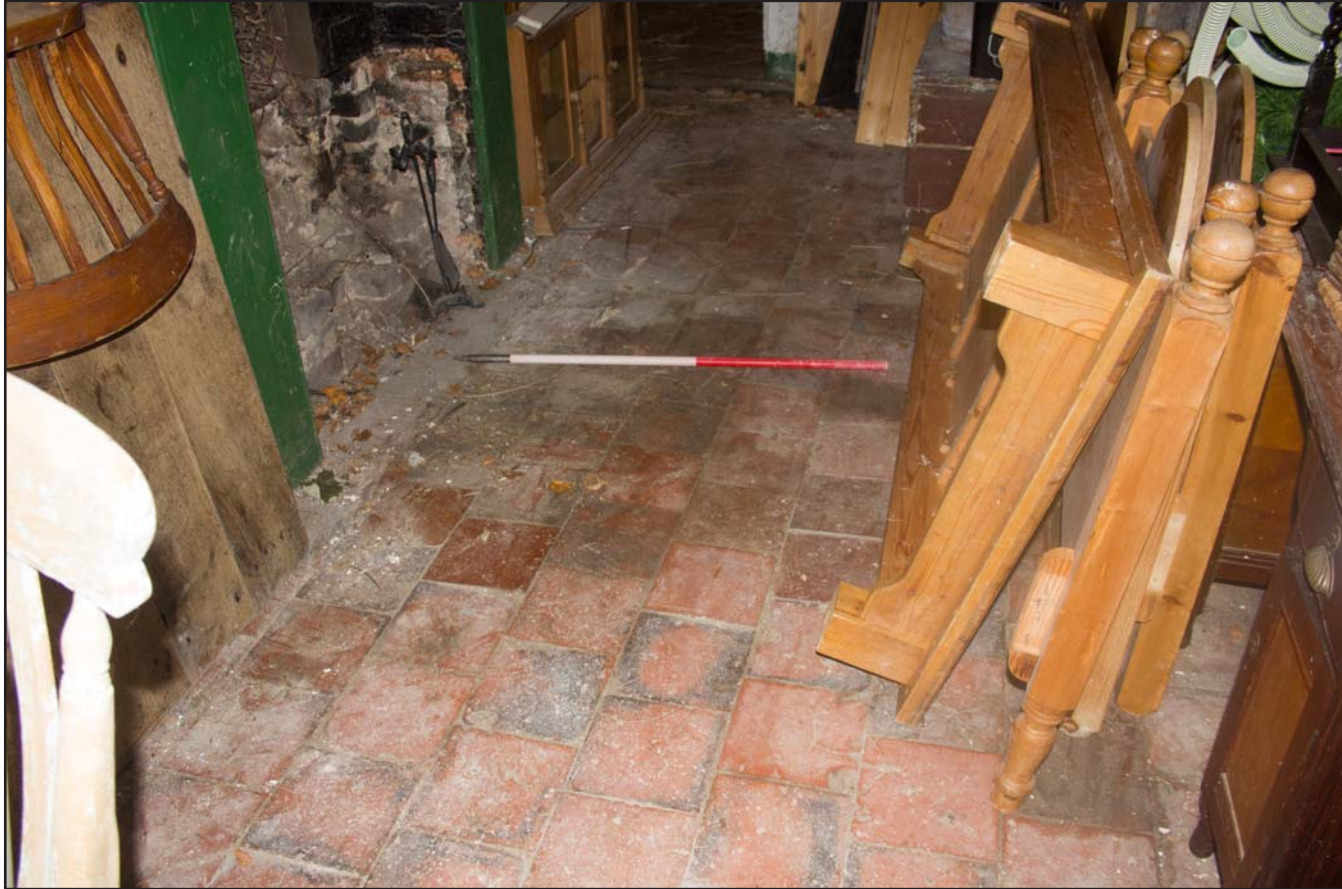
The floor is of laid wooden hardboard, which is in a poor state of preservation. Presumably from dry rot and in places this has fallen away, revealing that this is a floating floor above a beaten earth surface beneath.

Plate 32: Internal shot of workshop floor, Estate Offices & Stables, Trevor Road, Chirk - from the north - 2.00m scale

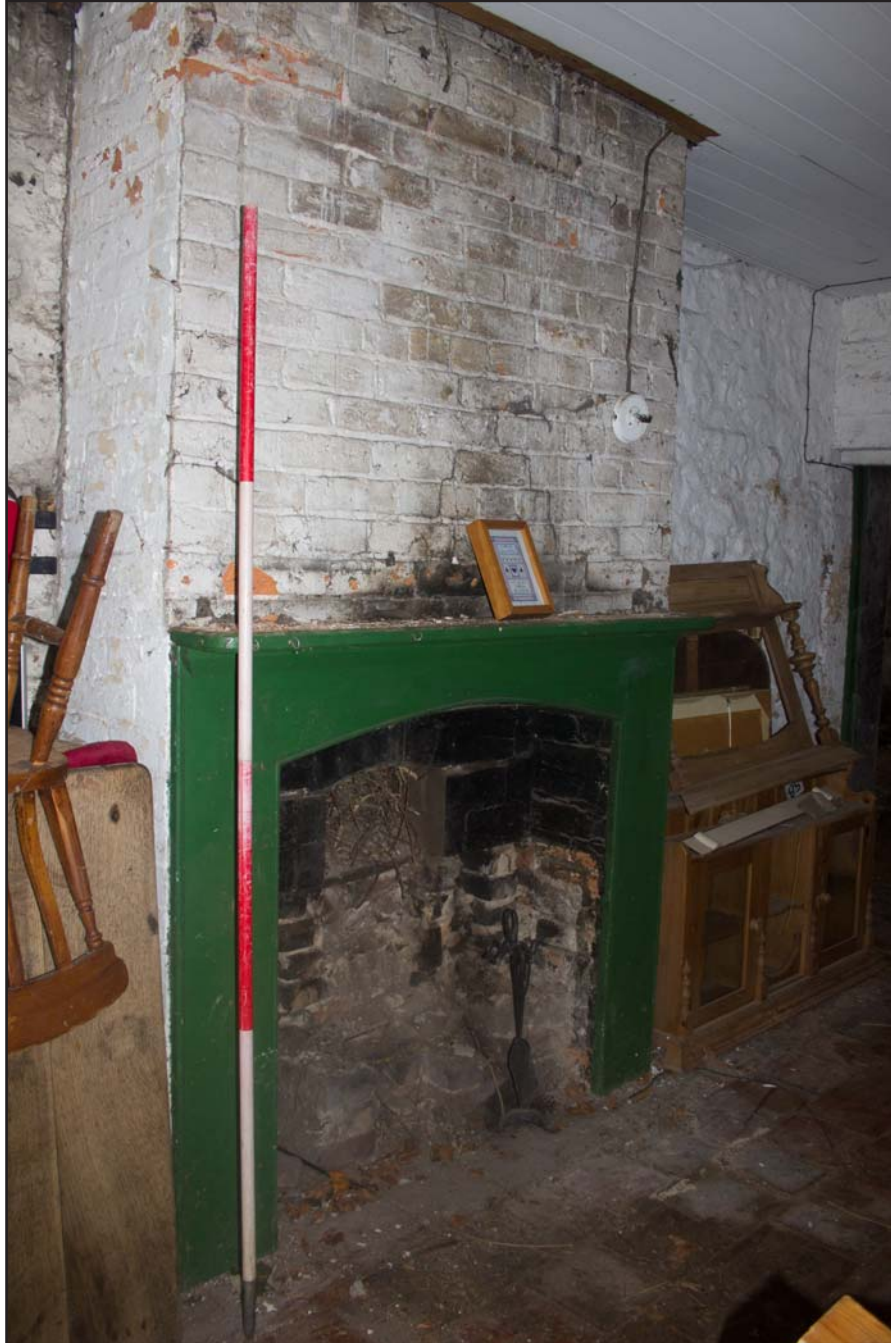
The western elevation has been constructed from stone rubble bonded by lime mortar and which has been painted white. However, within the centre of the elevation and dominating it is a red brick chimney construction which has been painted white, this is formed from a red brick hearth and forms a small inglenook. Above this, and mounted on the brickwork is a single gas fired light fitting with a metal feed which traces along the elevation to the north. Gas fired lighting appears as early as the 1820's and was considered popular by the 1850/60s before being replaced with electricity in the early 19th century (Nead 2000).

Furthermore, there is a green painted wooden mantle and surround which finish the fireplace. Inscribed into the left-hand side of the fireplace are various initials "A.D.," "P. S." and "F.S." The floor of the room is of red and black quarry tiles. As alluded to in the previous section, the room above the workshop is inaccessible, this is due to the only access being across the first floor in the stable, and this is unsafe for transit due to water ingress and a severe deterioration in the timbers which support the floor.

Plate 33: Internal shot of workshop fireplace, Estate Offices & Stables, Trevor Road, Chirk - from the southeast - 2.00m scale

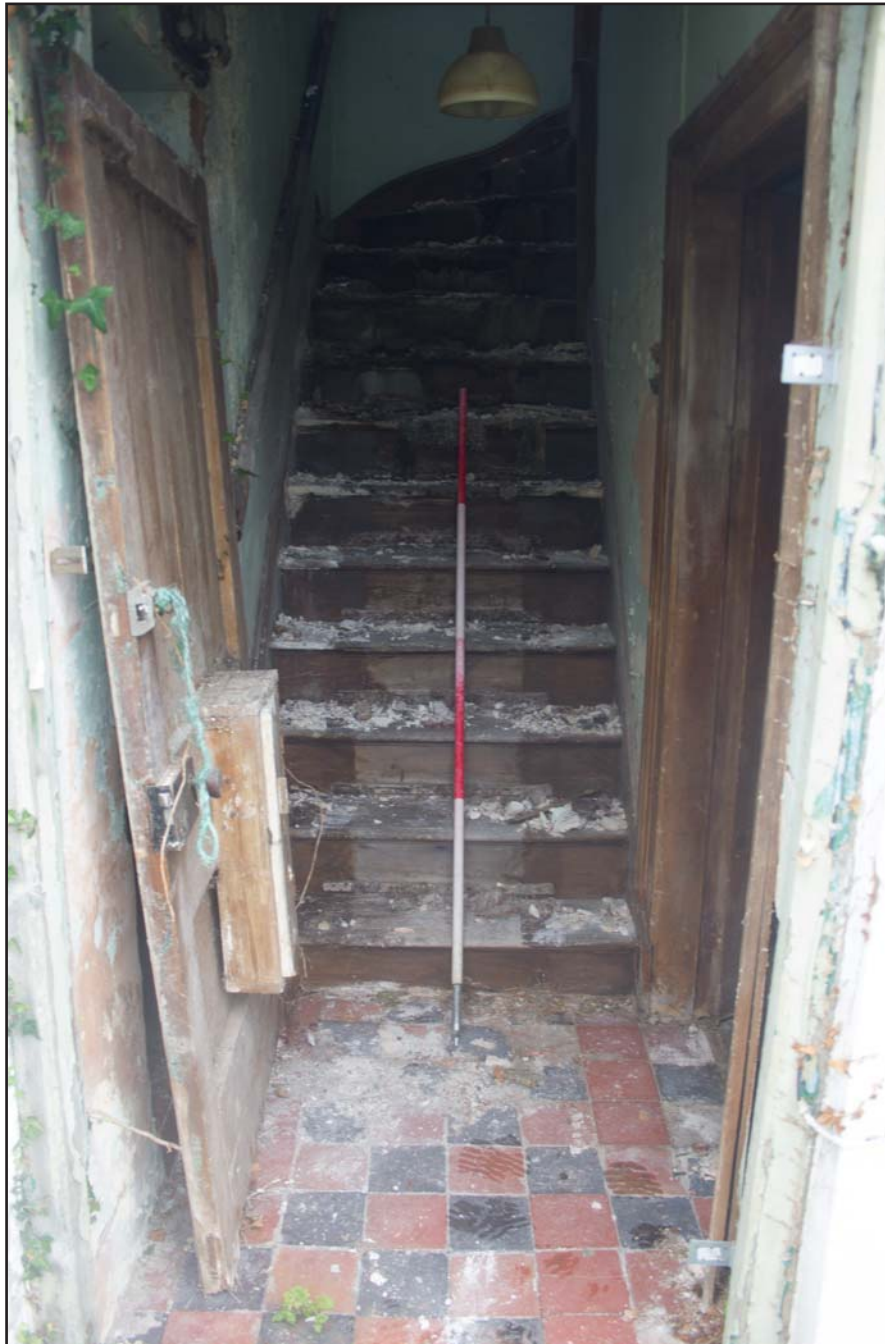
Plate 34: Entrance to Offices , Estate Offices & Stables, Trevor Road, Chirk - from the west - 2.00m scale

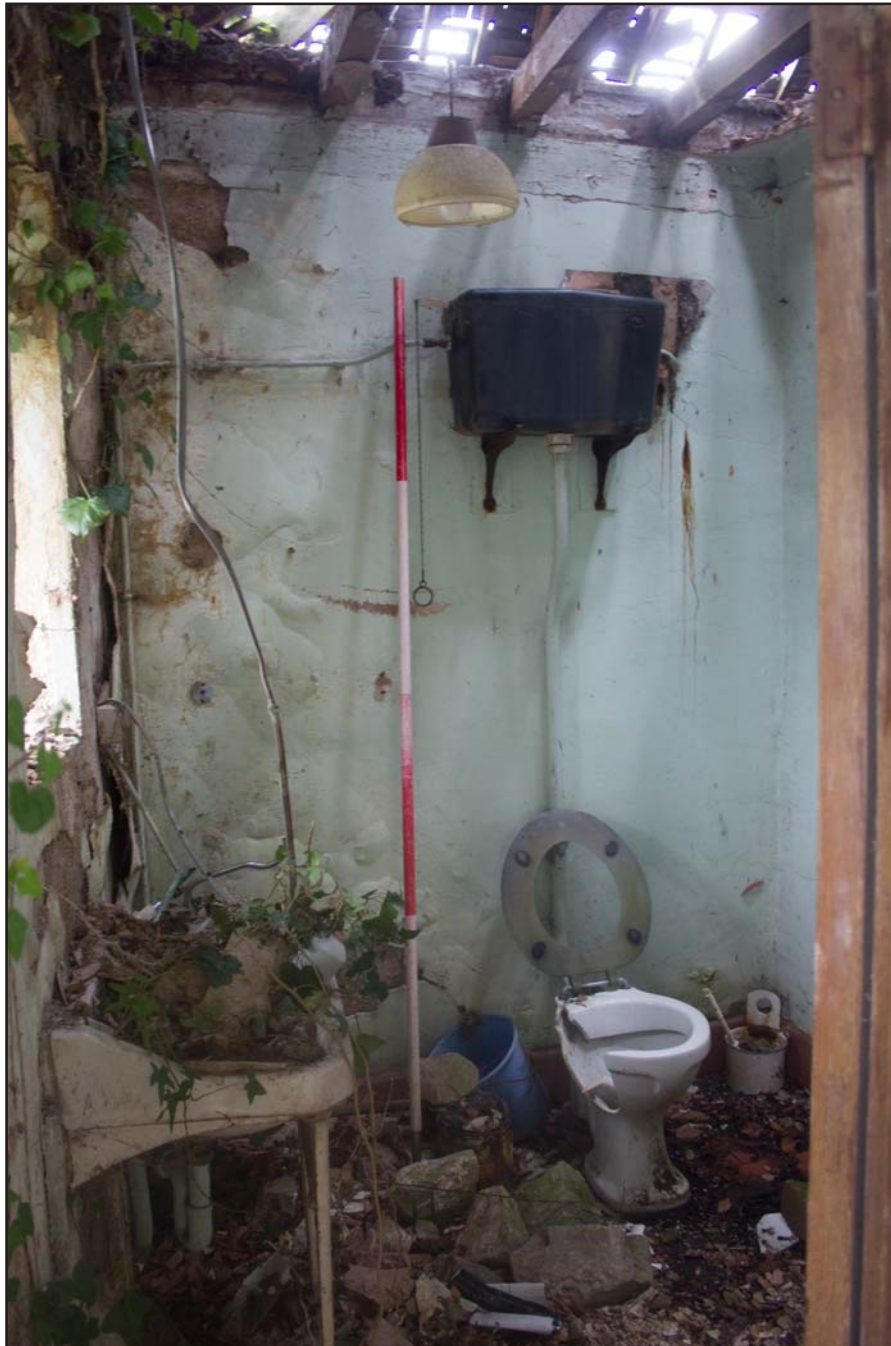
This is a roughly square room with walls, which have been rendered and wallpapered green. The ceiling is now missing, revealing the sawn timber joists which once supported it, demonstrating that it has been constructed within the stable. The northern elevation has a centralised ceramic toilet with suspended cistern above, whereas the eastern elevation is featureless.

Plate 35: Office Toilet , Estate Offices & Stables, Trevor Road, Chirk -
from the south - 2.00m scale

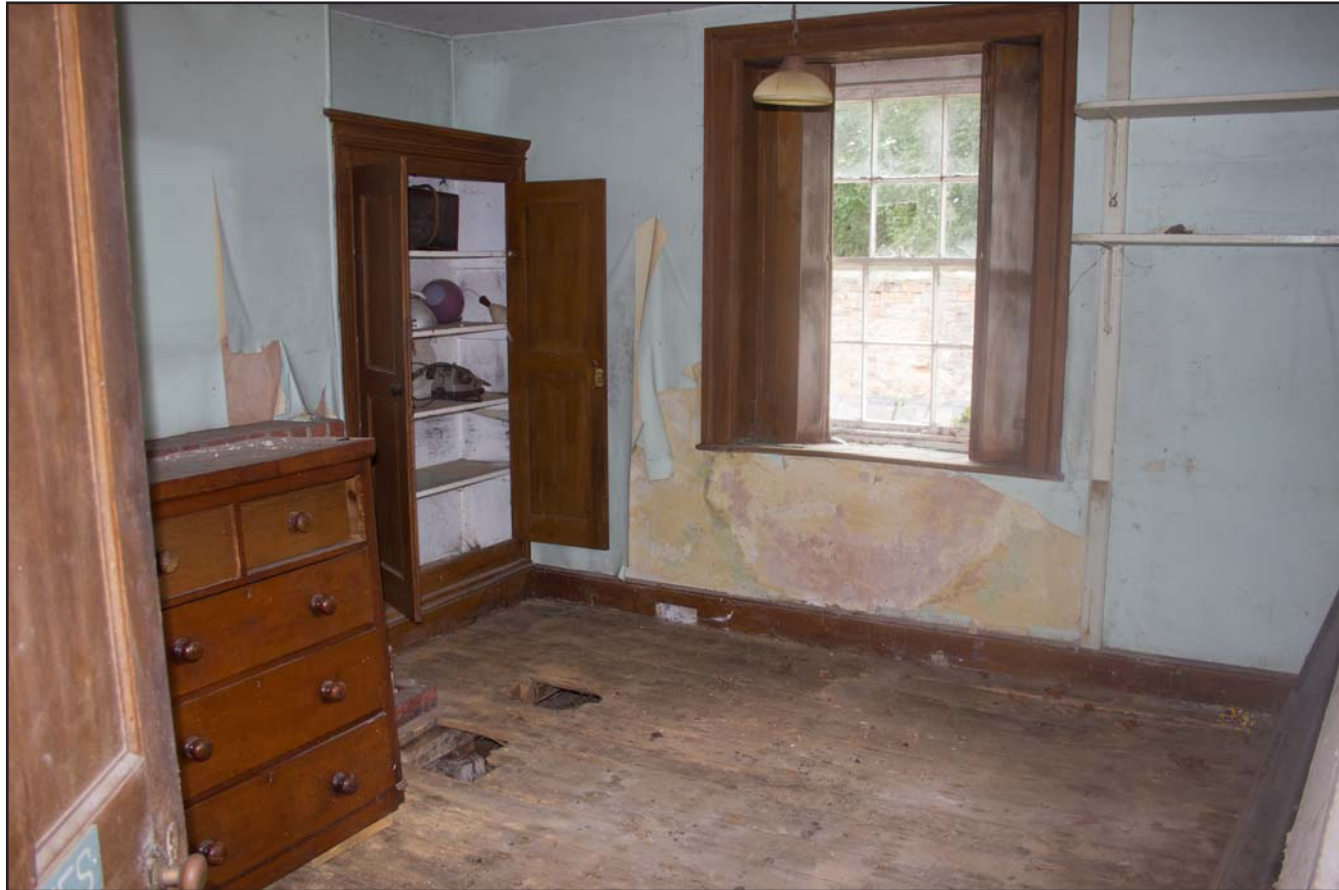
Plate 36: Internal shot of Enquiries Office, Estate Offices & Stables, Trevor Road, Chirk - from the northwest - no scale
