**Former Estate Offices and Stables,
Trevor Row, Trevor Road, Chirk,
Wrexham, LL14 5HE**

Historic Building Record Level 2

Project Code: A0447.1

Report no. 0423

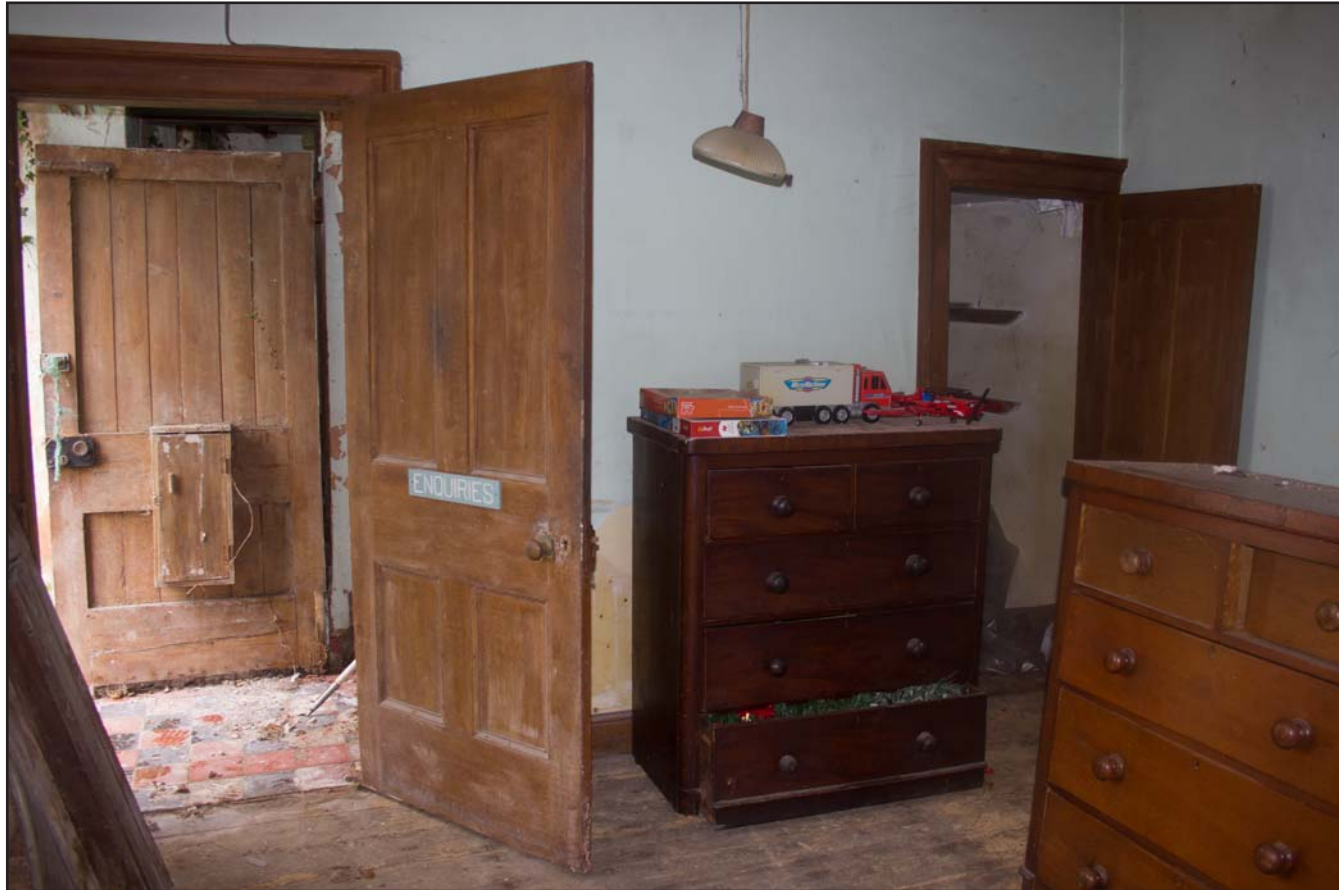
Plate 37: Internal shot of Enquiries Office, Estate Offices & Stables, Trevor Road, Chirk - from the southwest - no scale

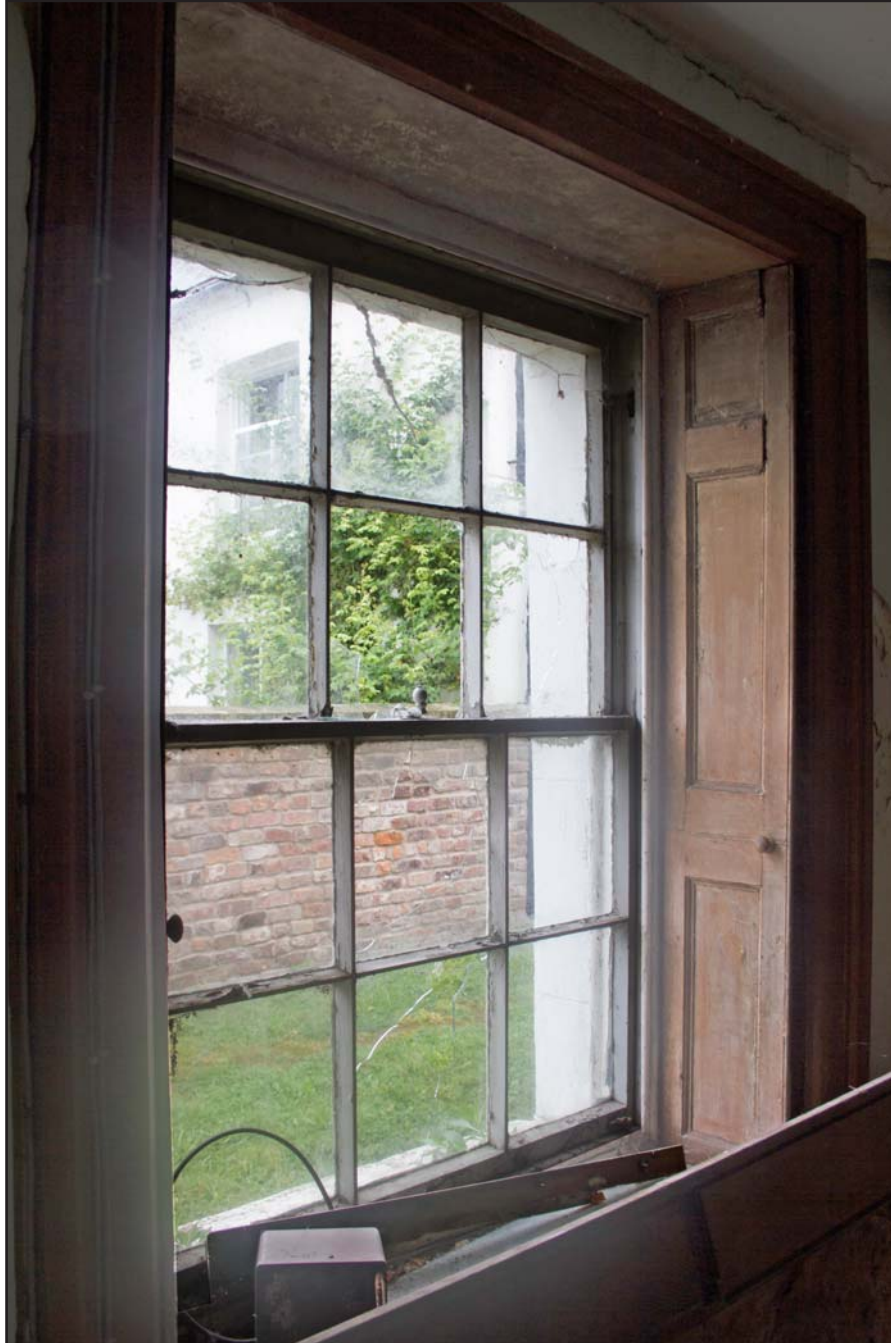
Plate 38: Internal shot of Enquiries Office - sash window, Estate Offices & Stables, Trevor Road, Chirk - from the southeast - no scale

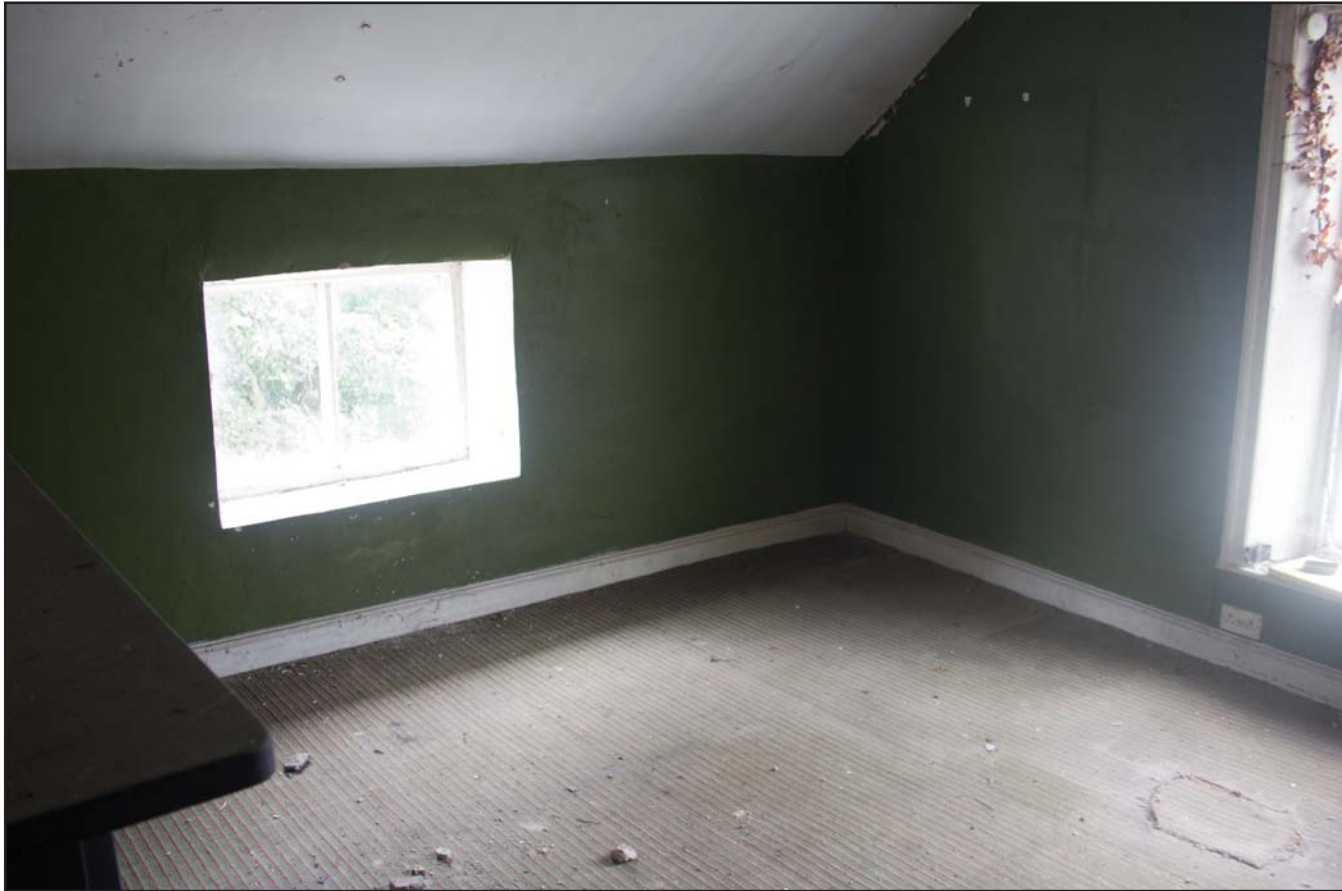
Plate 39: Internal shot of First Floor Office, Estate Offices & Stables, Trevor Road, Chirk - from the northeast - no scale

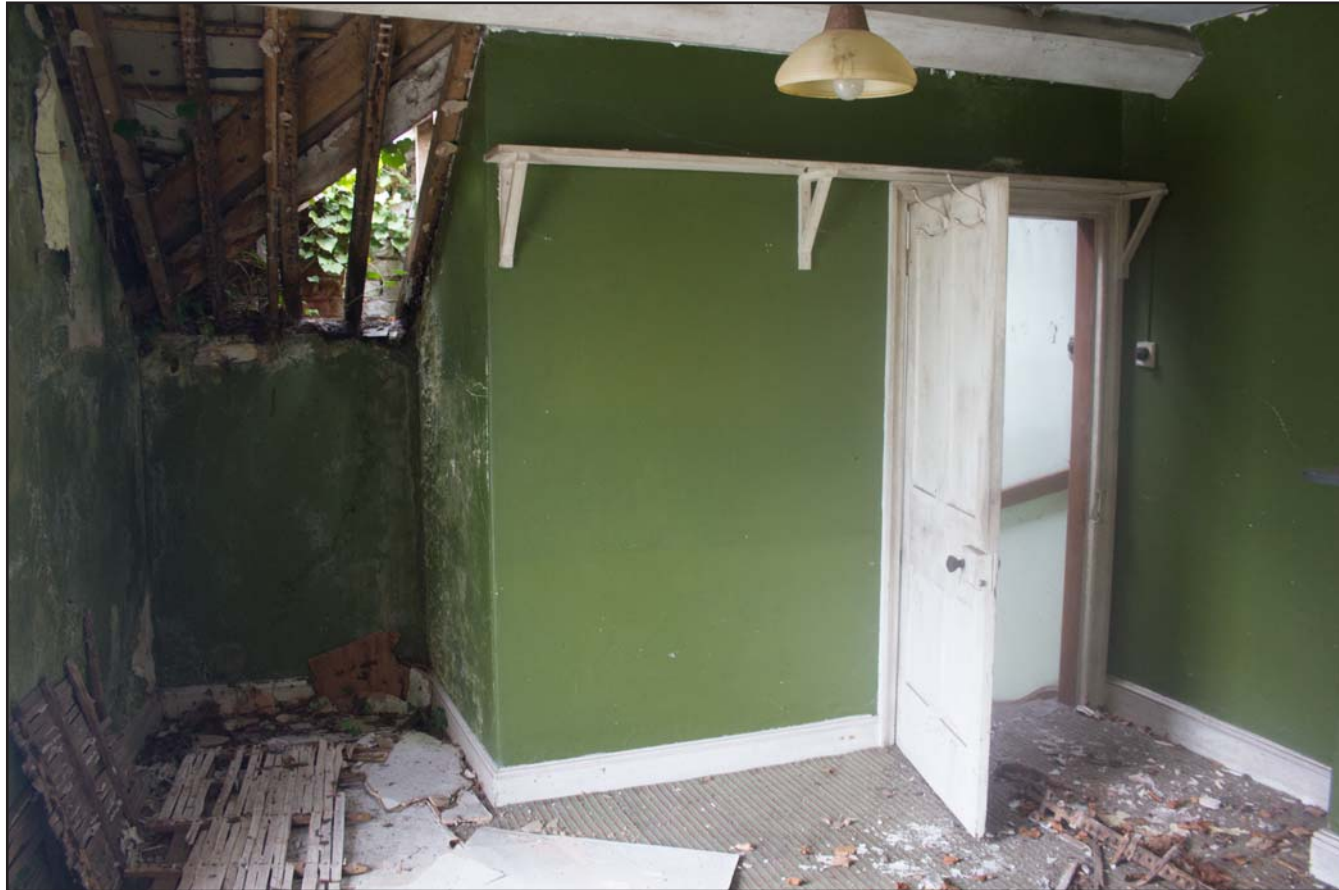
Plate 40: Internal shot of First Floor Office, Estate Offices & Stables, Trevor Road, Chirk - from the southwest - no scale

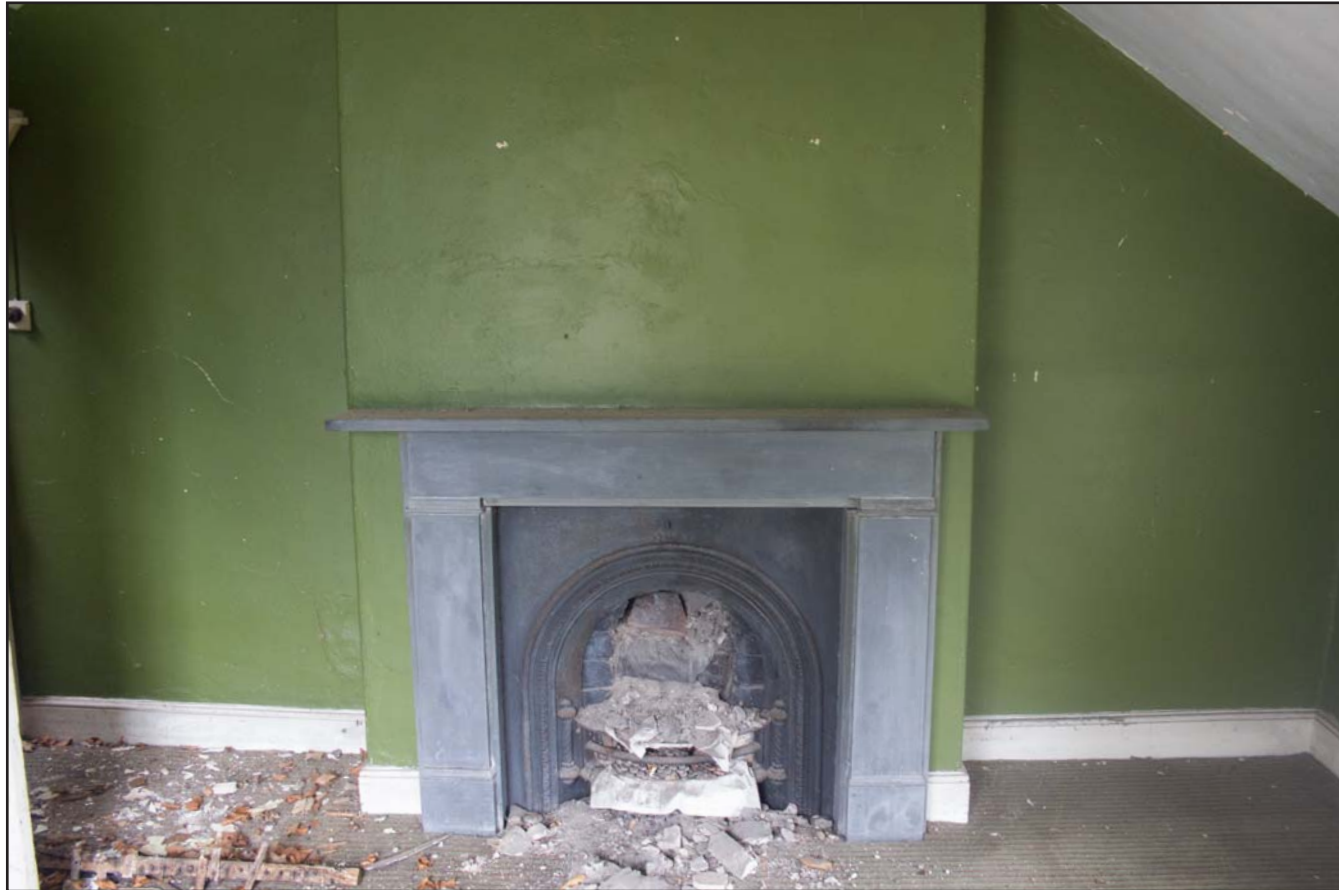
descending a staircase and the ground floor. The eastern elevation is dominated by a projecting chimney breast, which is finished by a decorative slate mantle and which is surrounded with a cast iron guard fireplace. The southern elevation has a single fixed window with two glass panes set within white painted wooden frame. The western elevation is dominated by a 12-glass pane sash window in white painted wooden frame with modesty glass. The floor has been carpeted with green carpet.

Plate 41: Internal shot of First Floor Office - Fireplace, Estate Offices & Stables, Trevor Road, Chirk - from the west - no scale

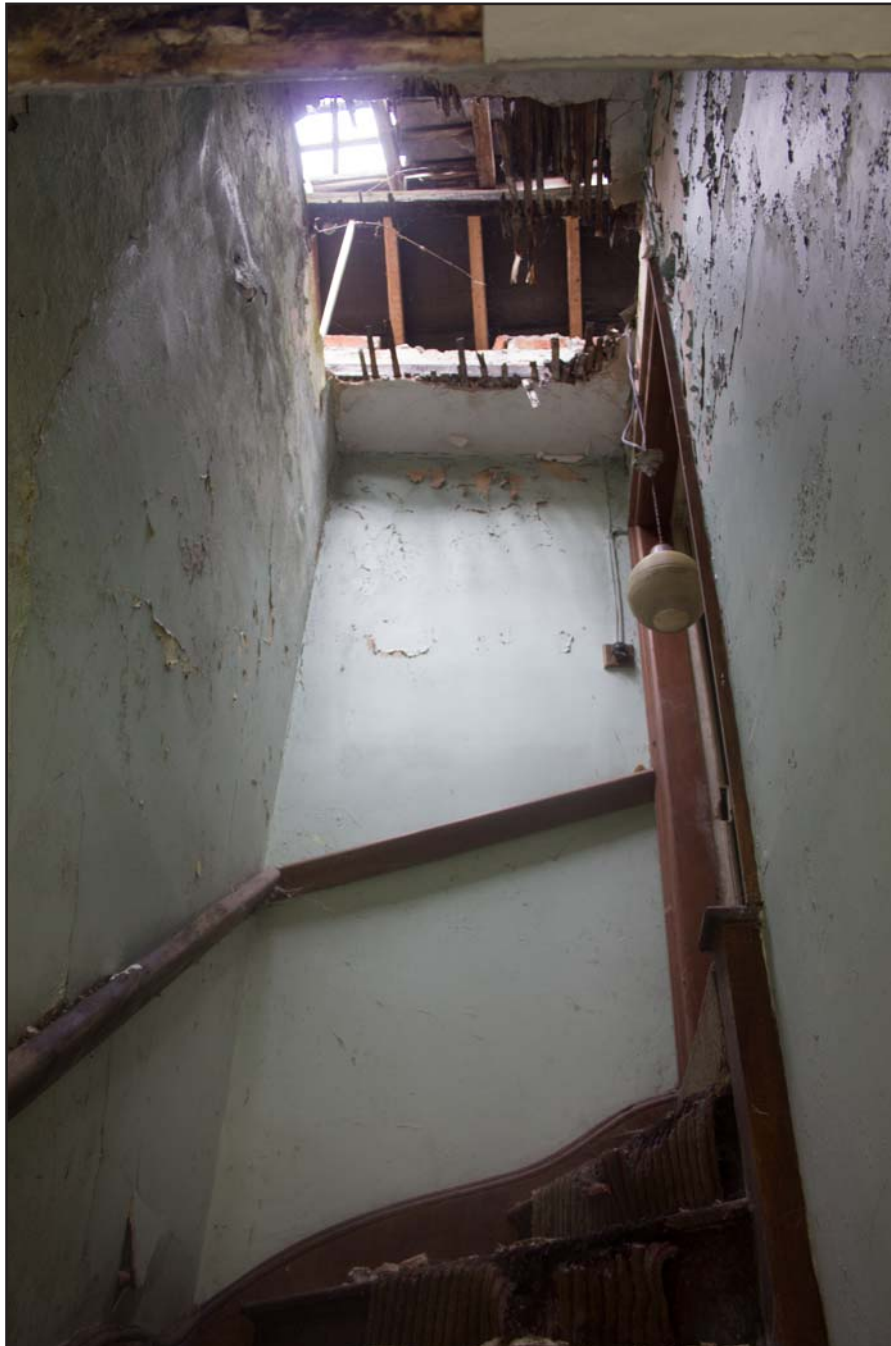
Furthermore, directly ahead, and to the east is the ascending staircase which leads to the room above the "*Enquiries Office*." As with the stable, a large hole in the roof has made access to the first floor, very difficult due to water ingress and the severe deterioration of the staircase itself.

Plate 42: Staircase to First Floor Office - Fireplace, Estate Offices & Stables,
Trevor Road, Chirk - from the west - no scale

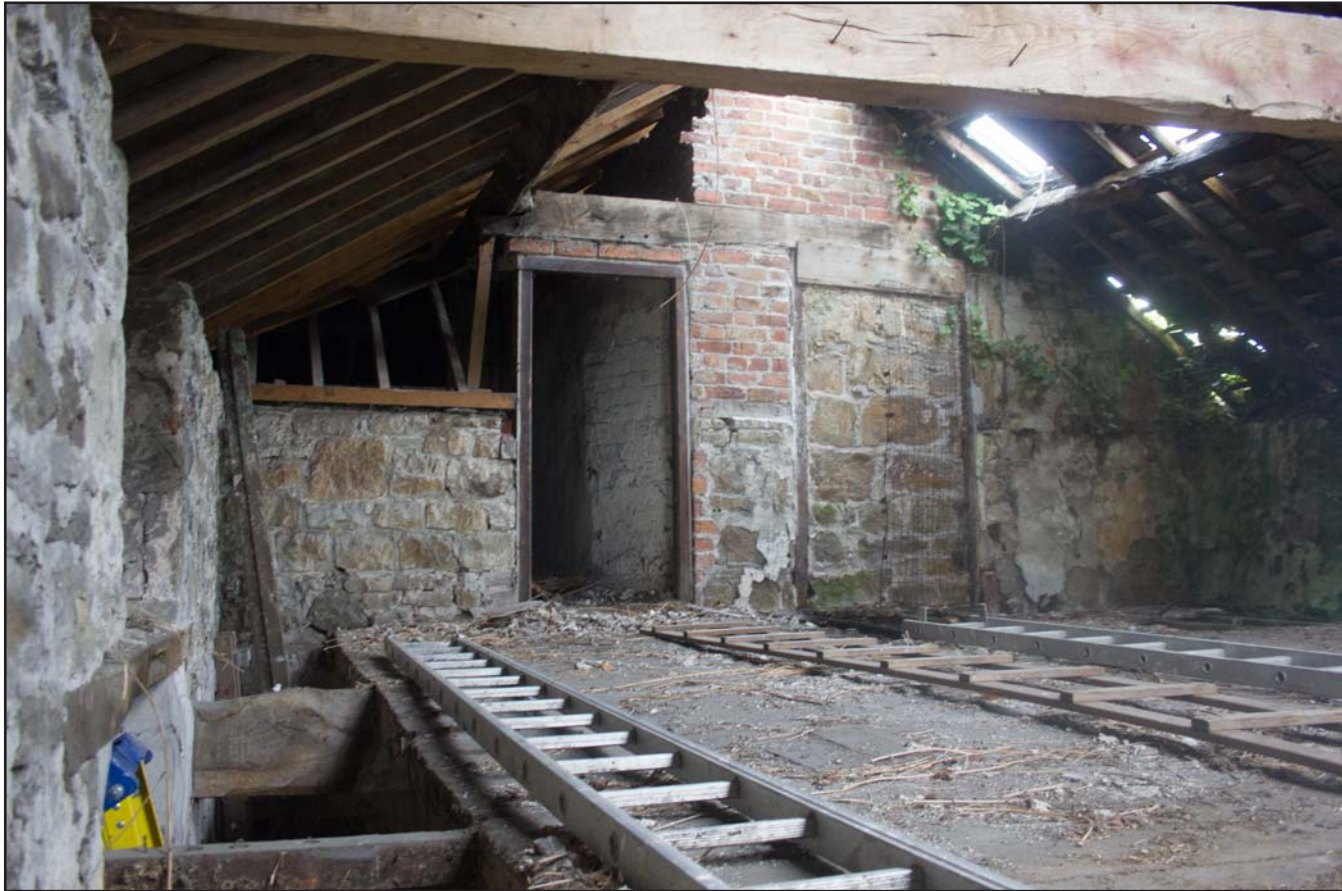
The first floor, hayloft above the stables could only be accessed via a set of ladders in the north eastern corner of the room below. The room is open to the roof pitch, demonstrating the hipped roof construction where purlins form onto two ridge beams, which are in turn supported with a sawn timber, Kings post, "A-frame Truss." However, the roof is in a poor state of repair and water ingress has severely damaged the floor of this room.

Plate 43: Internal shot of Hayloft, Estate Offices & Stables, Trevor Road, Chirk - from the northeast - no scale

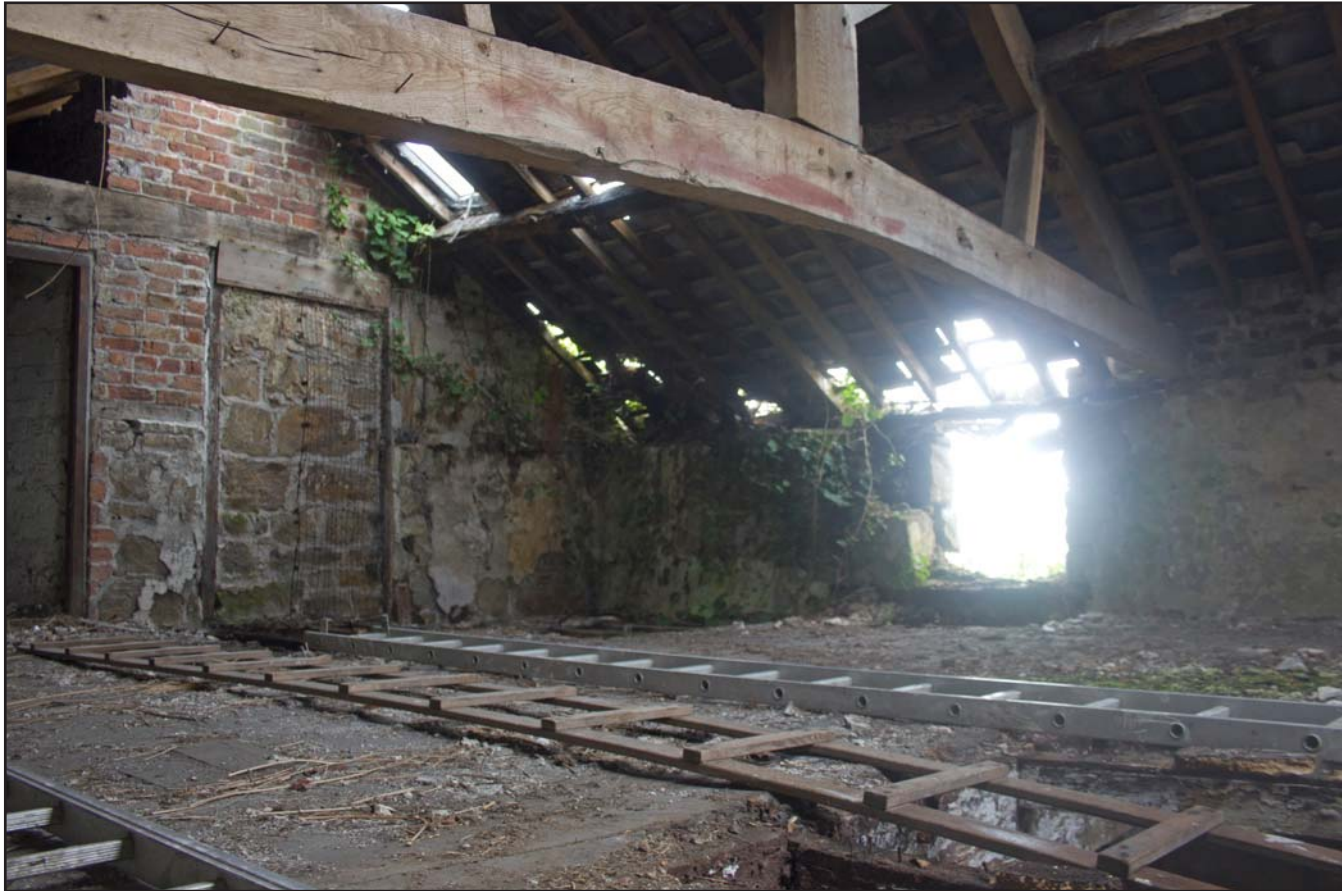
Plate 44: Internal shot of Hayloft, Estate Offices & Stables, Trevor Road, Chirk - from the northeast - no scale

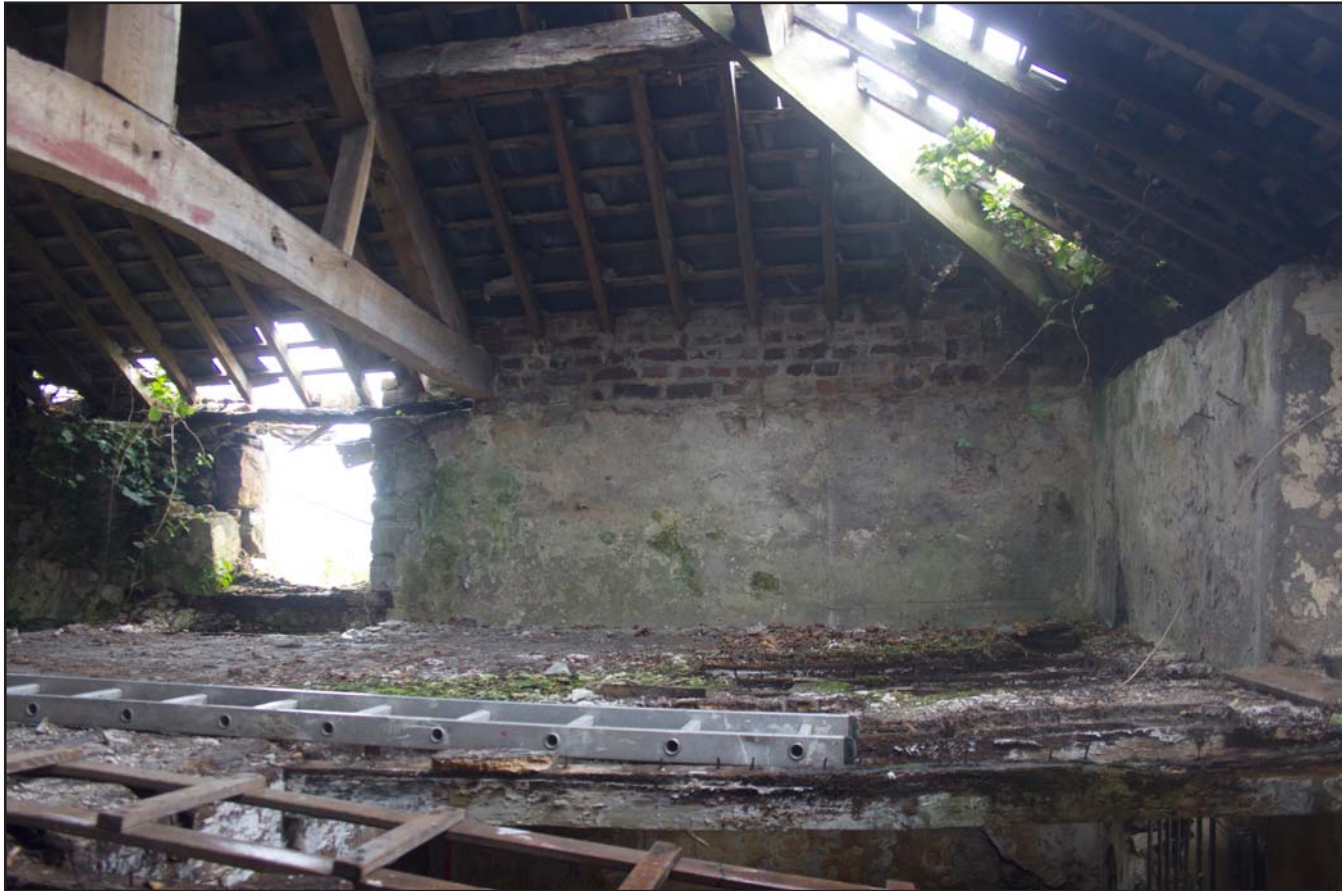
Plate 45: Internal shot of Hayloft, Estate Offices & Stables, Trevor Road, Chirk - from the east - no scale

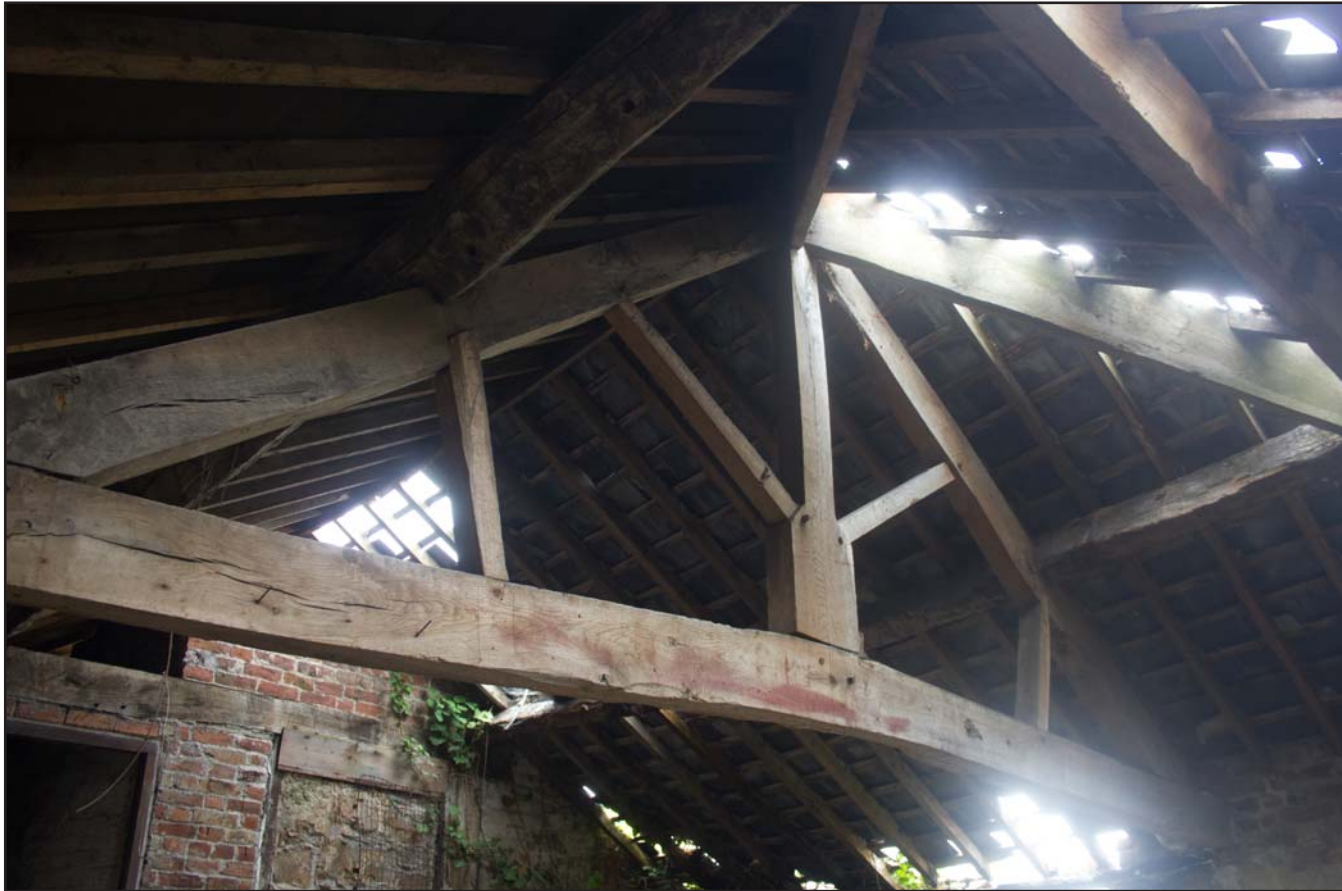
Plate 46: Internal shot of Hayloft, King's Post Truss, Estate Offices & Stables, Trevor Road, Chirk - from the northeast - no scale
