**CHERISH**

# Report of Survey

Geological Survey Ireland  
Anglesey, Wales 2018

Project title: Report of Survey – CHERISH: Wales Marine Survey 2018

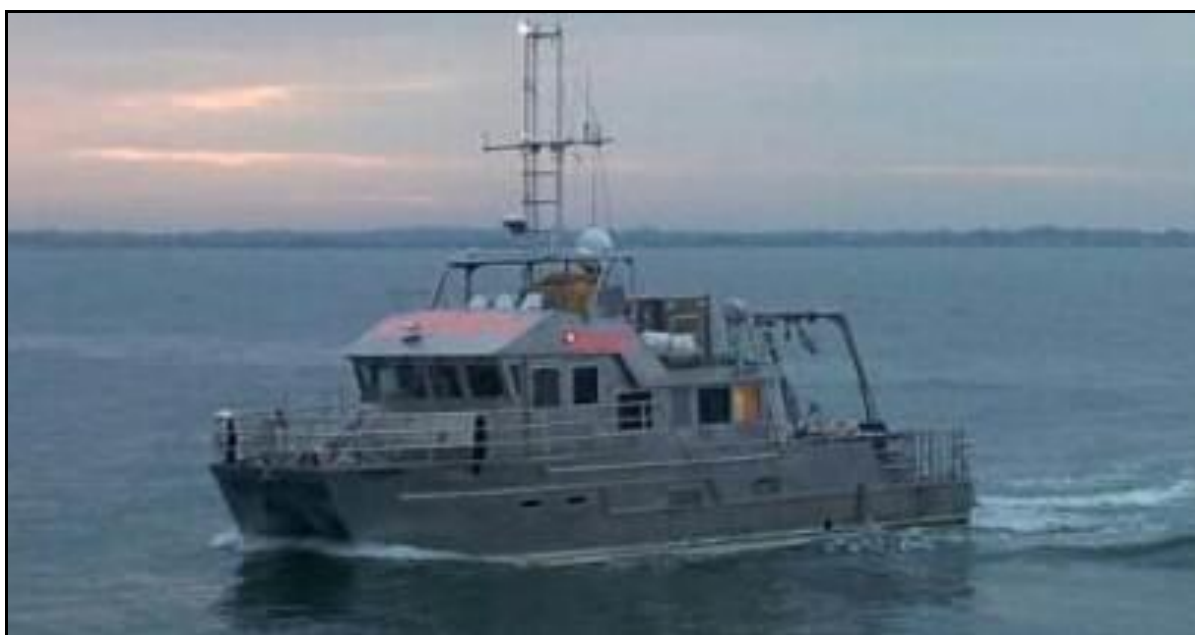
Figure 5: R.V. Keary

The Irish state research vessel R.V. Keary is an aluminium catamaran designed for near shore survey work. She is ideally suited in this role due to her stable twin hull construction, shallow draft, retractable equipment pod and hydraulically operated A-Frame and winch. The R.V. Keary is typically crewed by a team of 3 individuals. Table 7 provides information on her design specifications and survey equipment on board.

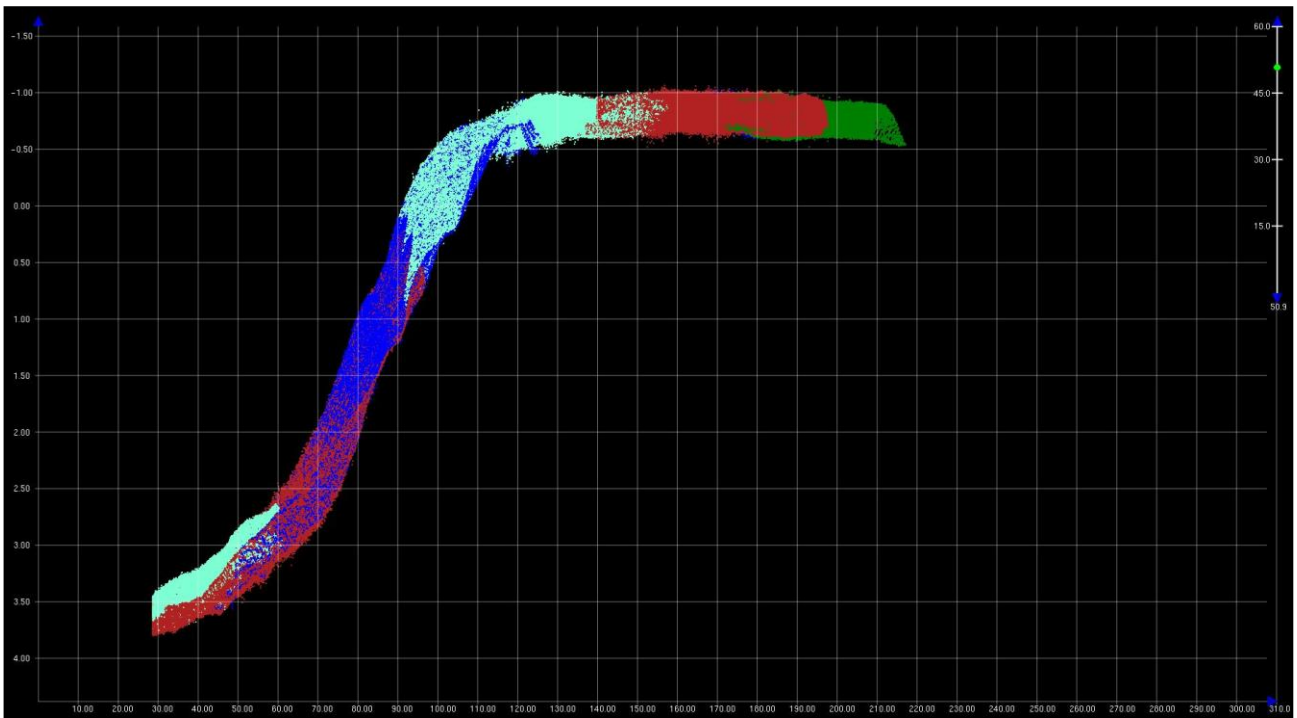
Sand bank rising to -1 m LAT observed (drying) outside 1 m contour. There is a drying area marked on the chart south east of the sand bank so the bank may have moved. Shoalest point occurs at 53-19-00.29 N 004-01-23.72 W. The contour is incorrect all along the sand bank as I will illustrate with a series of images showing the subsets location and then the subset view.

Figure 18 Image showing the chart details in the location of the sand bank and the incorrect contour

Figure 19 Sand bank that rises to -1 m LAT observed. Subset box is located on the shoalest point along the bank

Figure 20 Subset view showing shoalest point along the sand bank

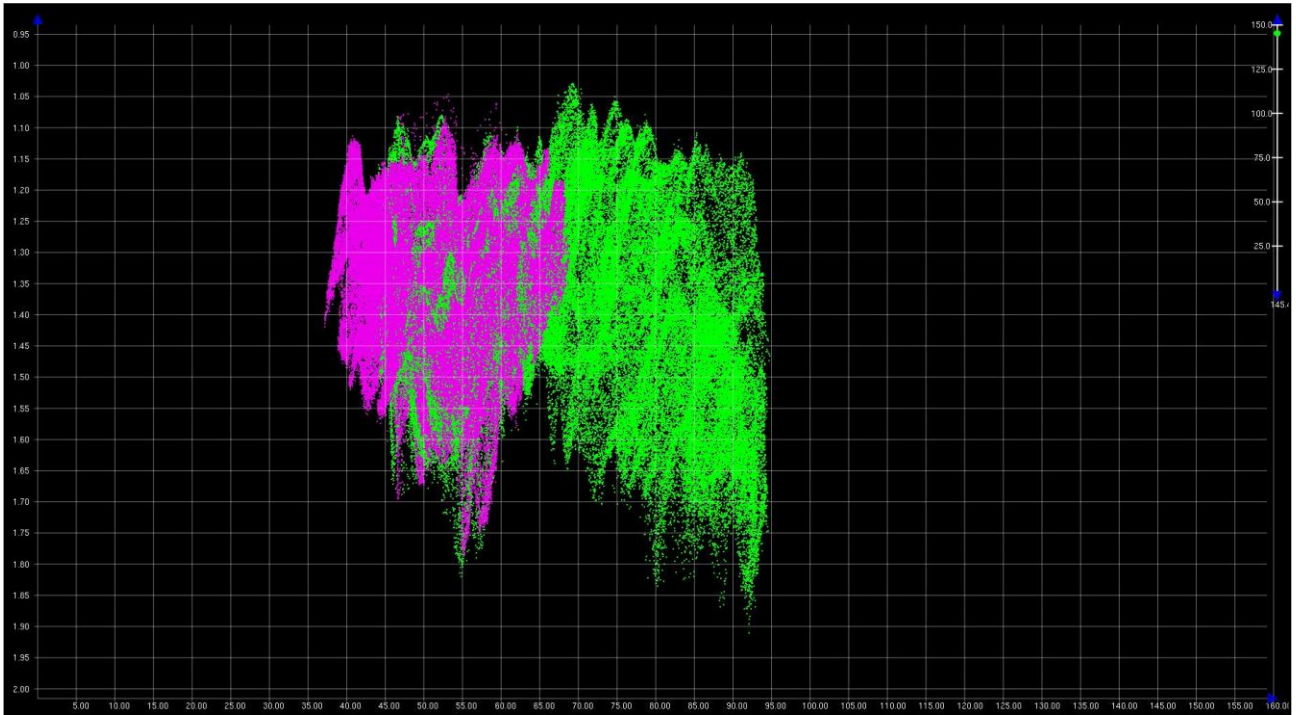
Sand bank rising to 1.0 m LAT observed in an area charted at 5 m. Occurs at 53-10-25.38 N 004-14-52.00 W.

Figure 49 Chart details in the area containing the sand bank which rises to 1 m LAT observed

Figure 3 Image showing the subset rectangle over an area where bank rises to 1 m LAT observed

Figure 4 Subset view showing sand bank rising to 1 m LAT observed

Almost all of the area within the subset box is less than 5 m. I will include a number of images with the subset yellow rectangle in a number of areas.

Figure 5 Image of the sandbank with the yellow rectangle located where the 51 sounding is on the chart

Figure 6 Subset view of the sand bank rising to 1.4 m LAT observed directly over 51 sounding on chart

Figure 7 Image with yellow subset rectangle in a different location

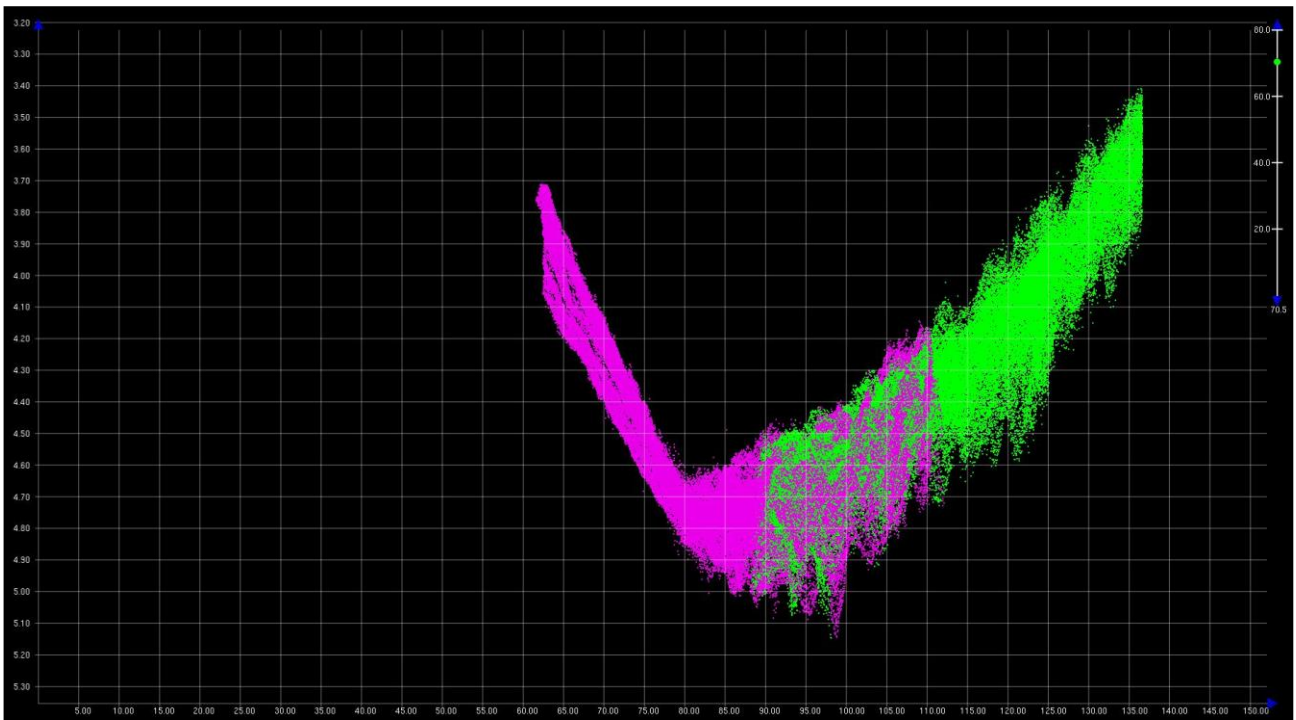
Sandbank rising to 3.7 m LAT observed inside 5 m contour. Occurs at 53-10-16.06 N 004-15-24.32 W. This is located in an area bounded by a 5 m contour beside the coast. The sand bank rises to less than 5 m all along the contour line.

Figure 9 Chart details in area where sand bank rises to 3.7 m LAT observed

Figure 10 Image showing sand bank which rises to 3.7 m LAT observed inside 5 m contour

Figure 11 Subset view showing sand bank rising to 3.7 m LAT observed

The sand bank rises to less than 5 m all along this contour.

Figure 12 Image showing the subset rectangle in a different location along the bank

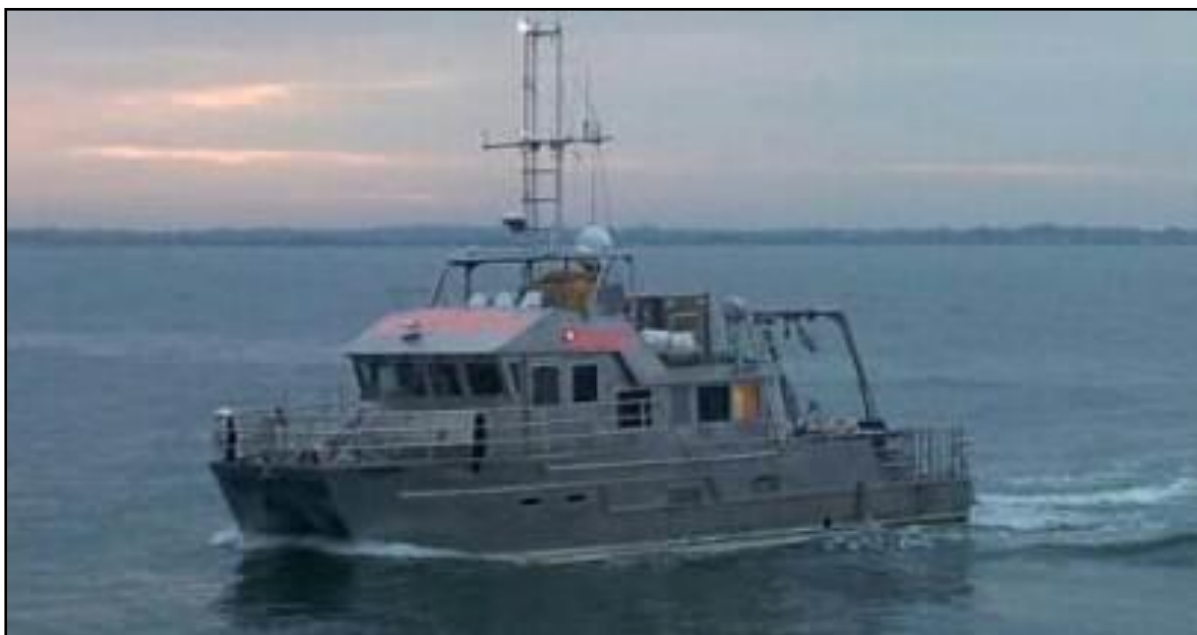
**Figure 1: R.V. Keary**

The Irish state research vessel R.V. Keary is an aluminium catamaran designed for near shore survey work. She is ideally suited in this role due to her stable twin hull construction, shallow draft, retractable equipment pod and hydraulically operated A-Frame and winch. The R.V. Keary is typically crewed by a team of 3 individuals. Table 7 provides information on her design specifications and survey equipment on board.
