Site of the former King Hotel, Somerton Road, Newport

Archaeological Watching Brief

Report No. 1834

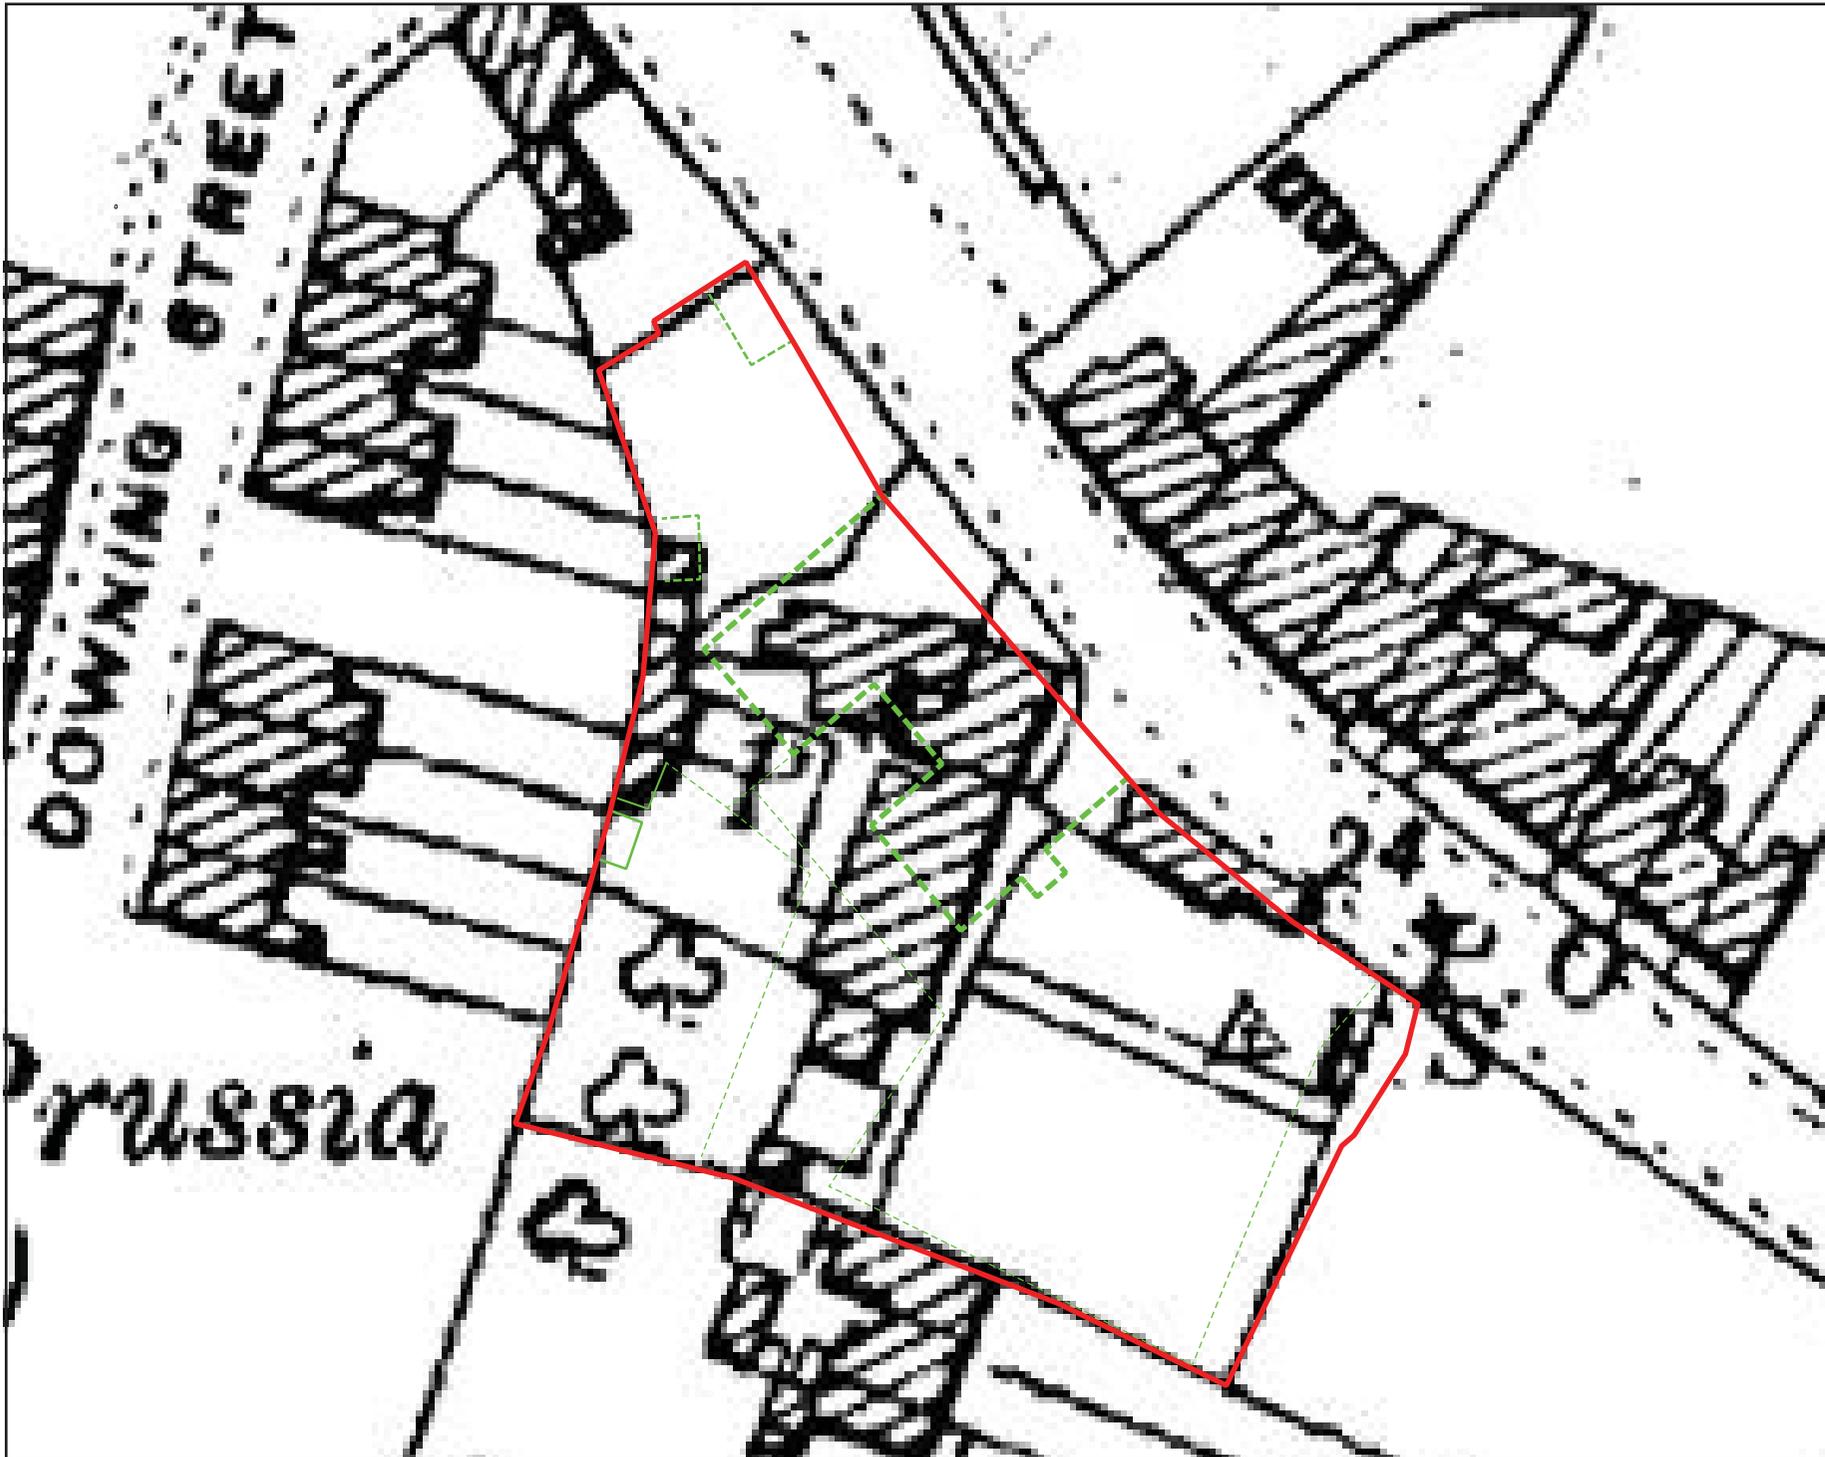
Figure 3: Extract from the Ordnance Survey map of 1901 showing the location and layout of the former King of Prussia public house. Overlaid with the development area outline (in red) and the outline of the King Hotel (in green), built in the early 20th century.

The development is located on the site of the former King Hotel, Somerton Road. The hotel lay on the site of the former King of Prussia public house. The name is thought to refer to Frederick the Great, a popular name to give to public houses in the mid-18th century, which may date the origins of the site. There is little recorded history of this building, but a building is possibly shown here on an early Ordnance Survey drawing of 1811. The earliest detailed map to show Somerton Road, the 1848 Tithe Map of the Parish of Christchurch in the County of Monmouth, would appear to show the public house on the location of the development area. A rectangular building orientated north-east – south-west, apportionment 1013, is designated as a beer house and garden. A small square structure also associated with the apportionment is located to the east. The apportionment immediately to the north, 1014, is described as a smith shop, cottage and garden. It contained a smaller rectangular building orientated east – west, which also appears to be within the bounds of the development area. These buildings appear to still be present in both the 1883 and 1902 Ordnance Survey Maps, with the main building labelled as the King of Prussia public house. The smith shop building is still present, but is not individually labelled any more. It was around this time in the early 20th century that the pub was apparently used as a changing room by Newport County football club, prior to training on Somerton Park and later on the Cromwell Road ground. The King of Prussia is still listed in street directories up until 1914, but by the time of the 1921 Third Edition Ordnance Survey map these buildings have been replaced by a U-shaped building fronting onto Somerton Road, now called the King George public house. This is the same building that became the King Hotel.

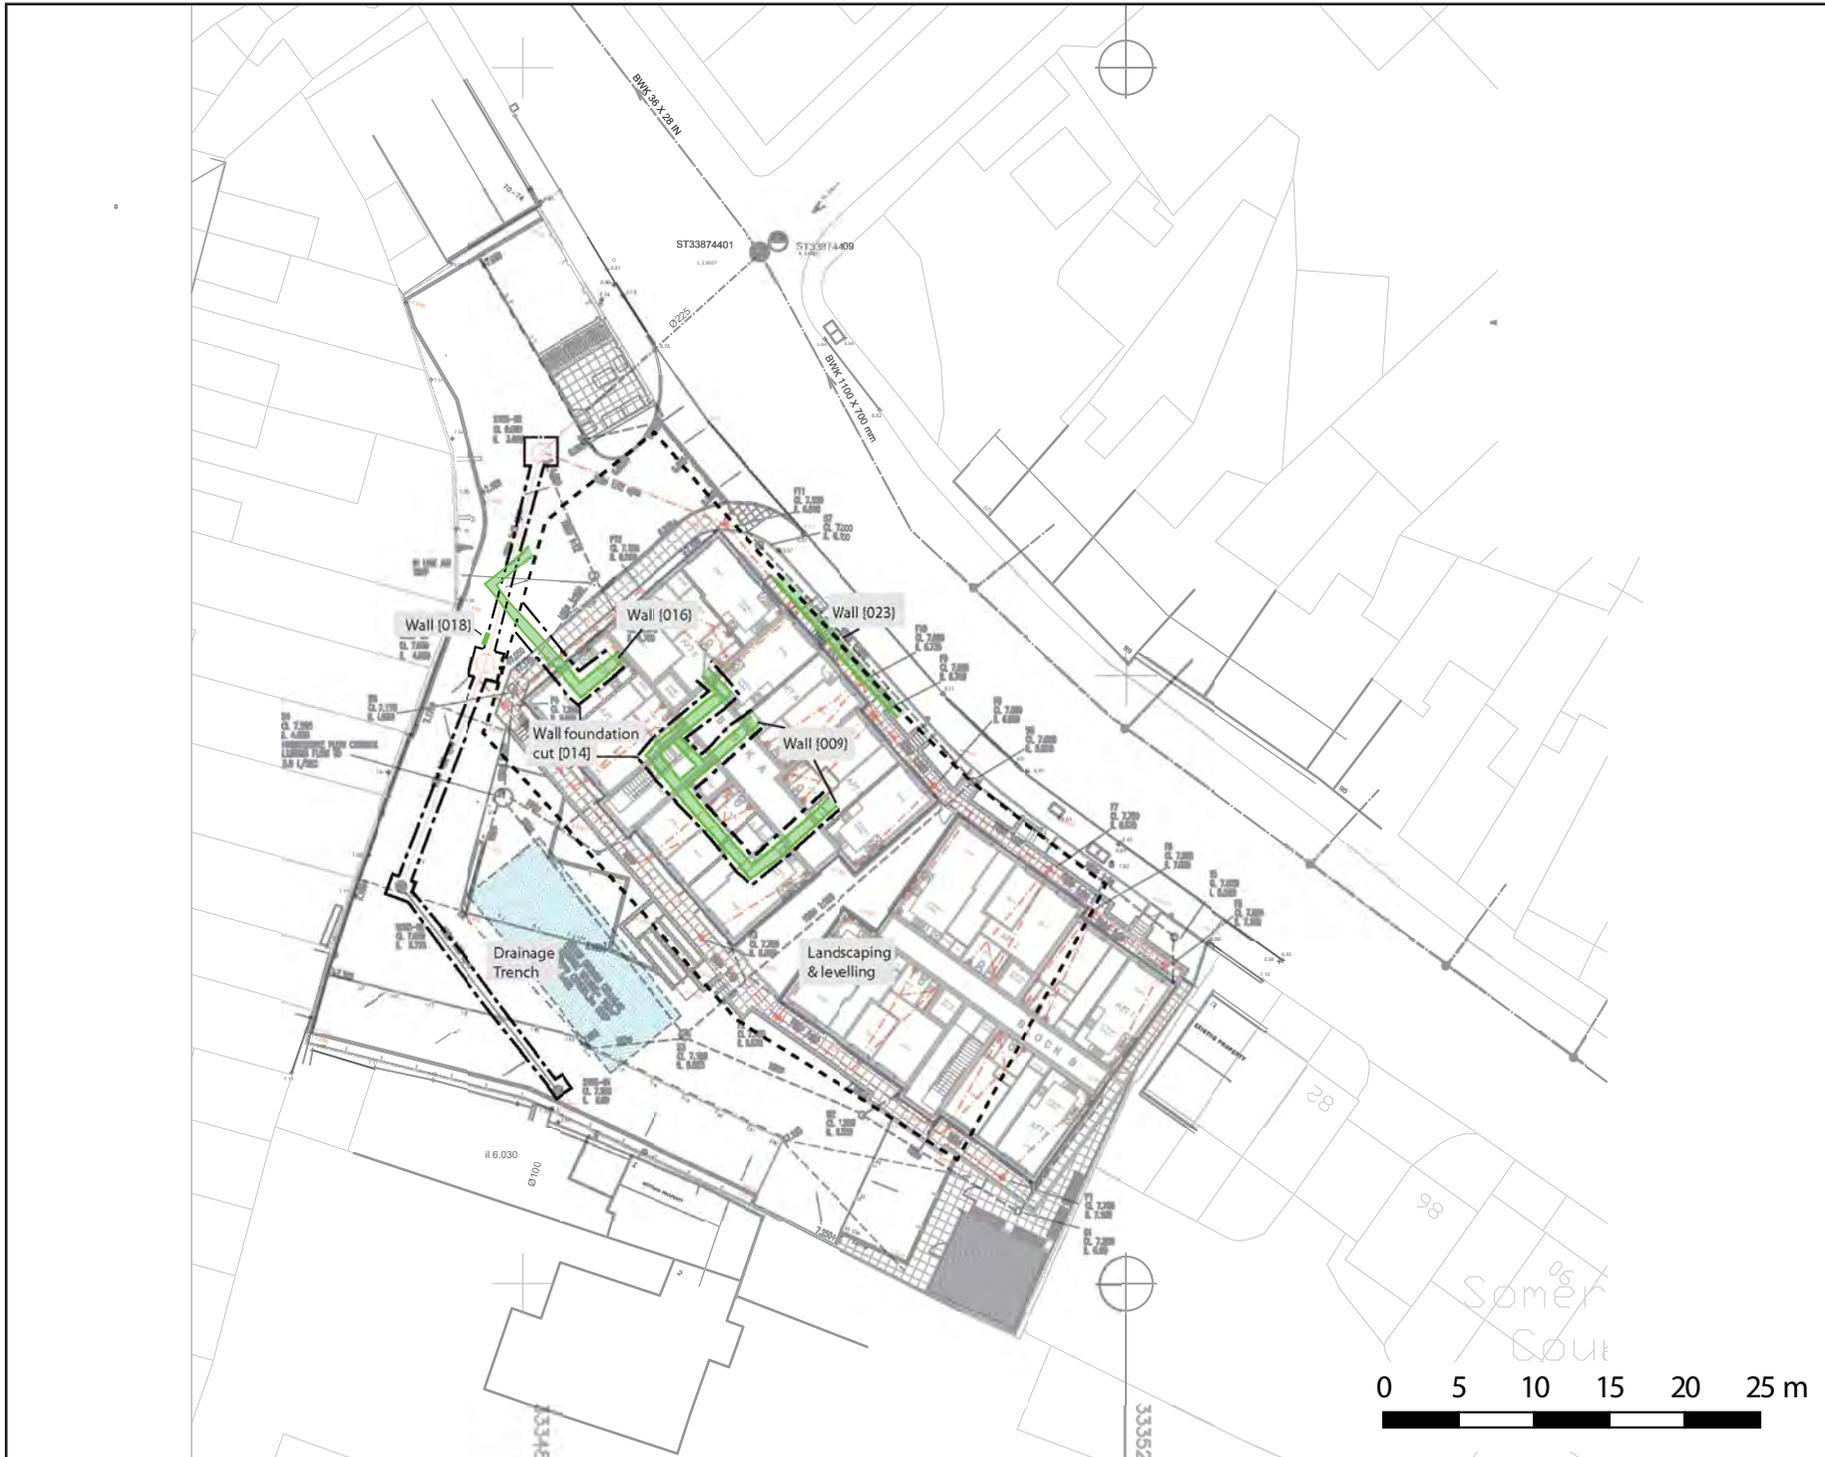
Figure 4: Areas of archaeological observation, and recorded features (in green) overlaid on development plans.

Original development plan produced by NJP Consulting Engineers Ltd, drawing No. 10241-500 C3, May 2018

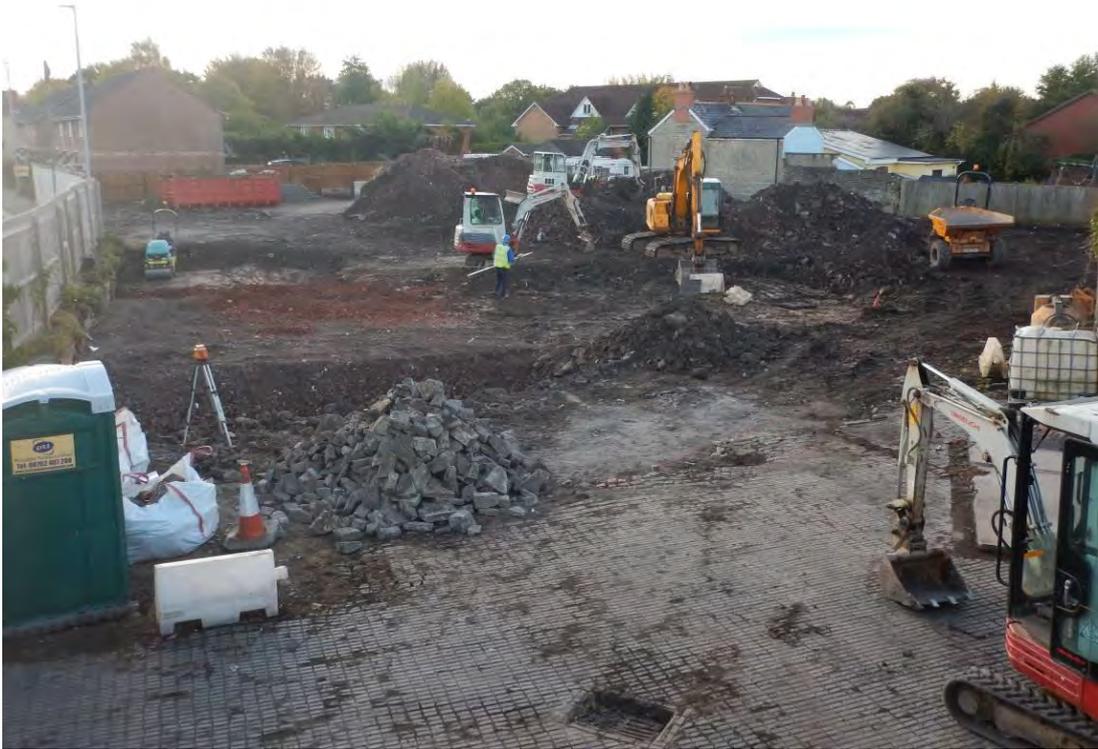
Photo 1: General shot looking southeast across the site during levelling and landscaping work. External yard surface (001) to former King Hotel visible in the foreground.

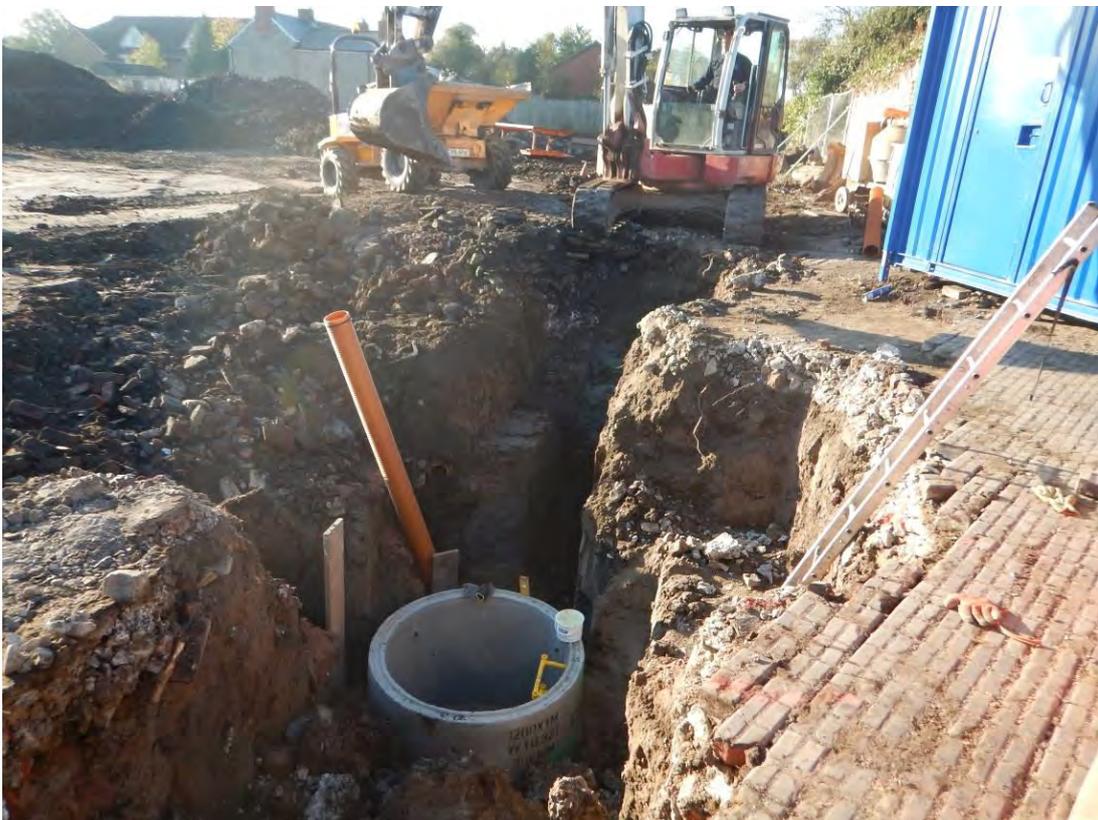
Photo 2: General shot looking SSW along the drainage excavation.

Naturally deposited layers were revealed in areas across the site, their presence confirmed in trenched excavations across the western part of the site, which comprised the excavation for a main drainage/sewerage trench along the western side of the site, and the removal of the foundations of the previous structure (King Hotel) on the site. Landscaping and levelling activity on the site did not uniformly reach natural deposits across the site, some modern overburden, infill and disturbed ground remained, which was subsequently compacted and covered by imported material.

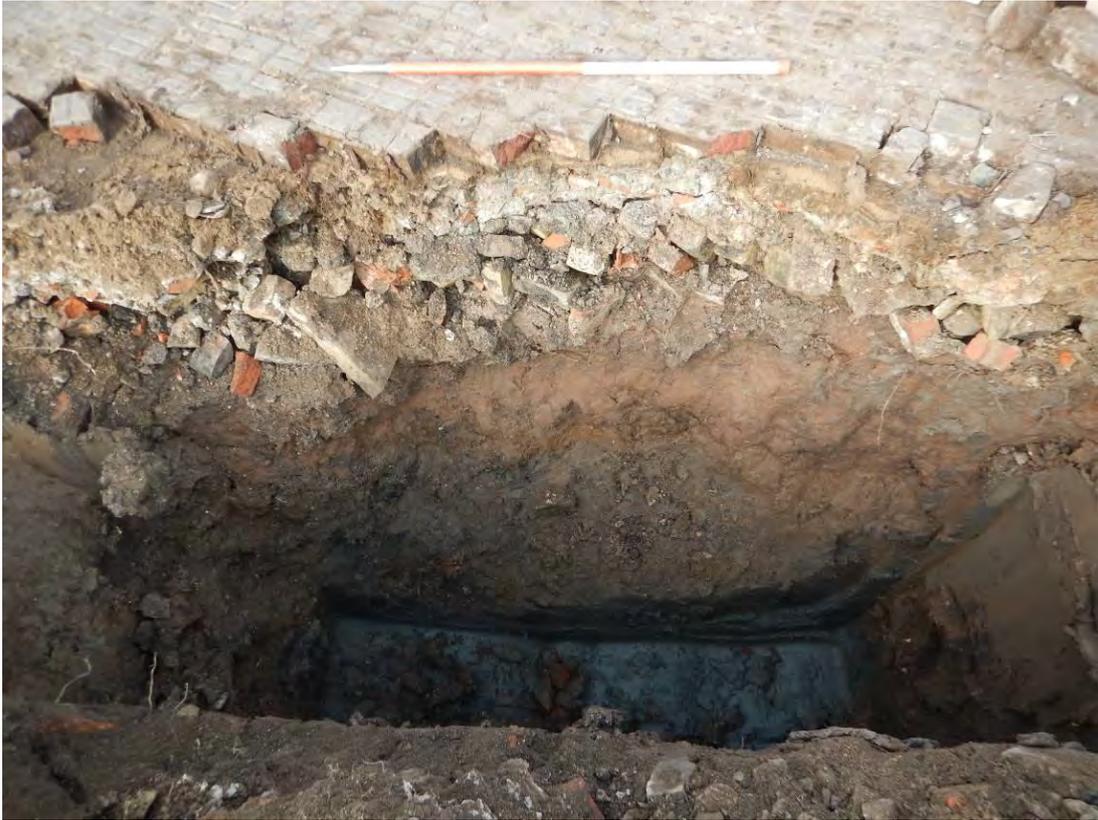
Photo 3: West facing section of the drainage trench excavation, showing the lower natural deposits (021) and (020), overlain by modern deposits (003), (002) and (001). 1m scale.

The stratigraphically earliest deposit revealed comprised a mid blue-grey alluvial clay deposit (021). This was largely revealed within the deeper drainage trench excavations, although it was also apparent at the base of some of the foundation removal trenches. This deposit became apparent at a depth of between 0.9m and 1.5m below the pre-existing ground levels. No archaeological material was visible within this deposit. A similar deposit (007) was revealed at the western end of the site within the drainage trench excavations, although this deposit contained modern pipework, along with a distinctive oil-rich aroma. It is possible the services were moled into this deposit, or it may be redeposited within cut [006] (see below). The depth and dimensions of the excavations prevented closer inspection.

Deposit (021) was overlaid by a mid orange-brown alluvial clay (020), visible at depths of between 0.3m to 0.8m below pre-existing ground levels, and varying from 1m to 2m thick. This deposit was revealed within all trenched excavations and was variously recorded as deposit (015) and (012), but was identical in nature and appeared consistent across the site. The deposit was also revealed in the general ground landscaping and levelling activity, within the southern part of the footprint of the former King Hotel structure. There was a relatively gradual transition from the underlying darker grey clays of (021) into the orange-brown clays of (020).

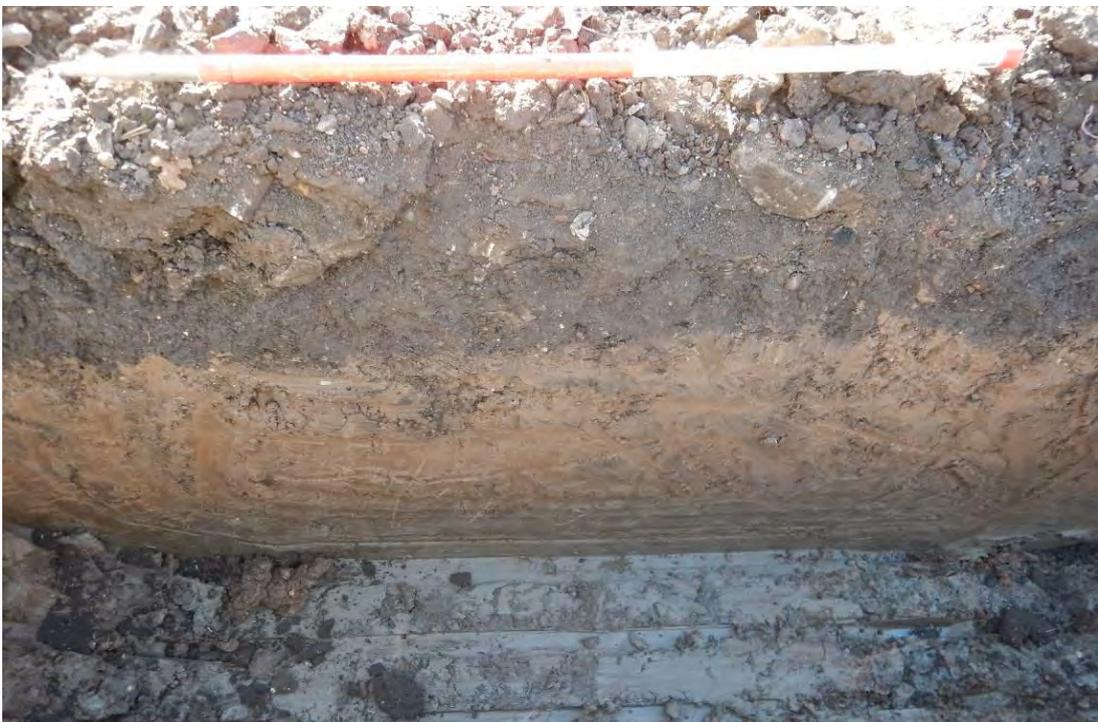
Photo 4: East facing section of drainage trench showing deposit (021) at the base, overlaid by (020), with modern deposit (003) above. 1m scale.

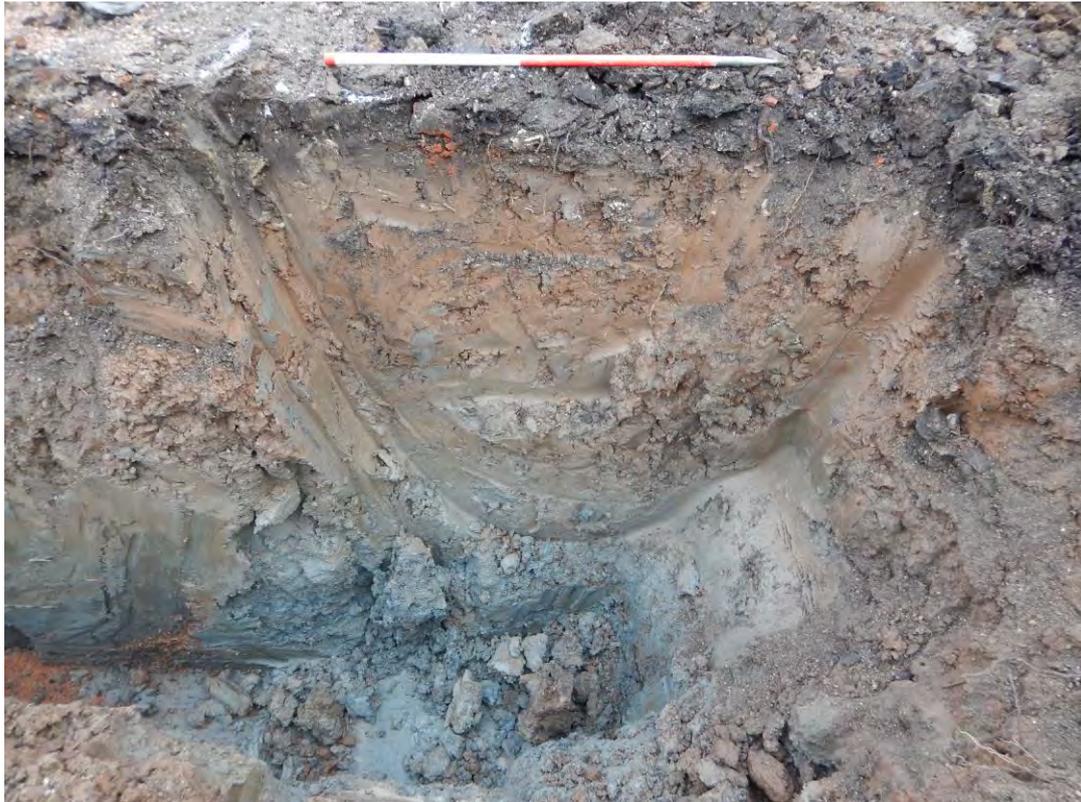
Photo 5: Deeper drainage trench excavations revealing deposit (021) at the base, looking west. 1m scale.

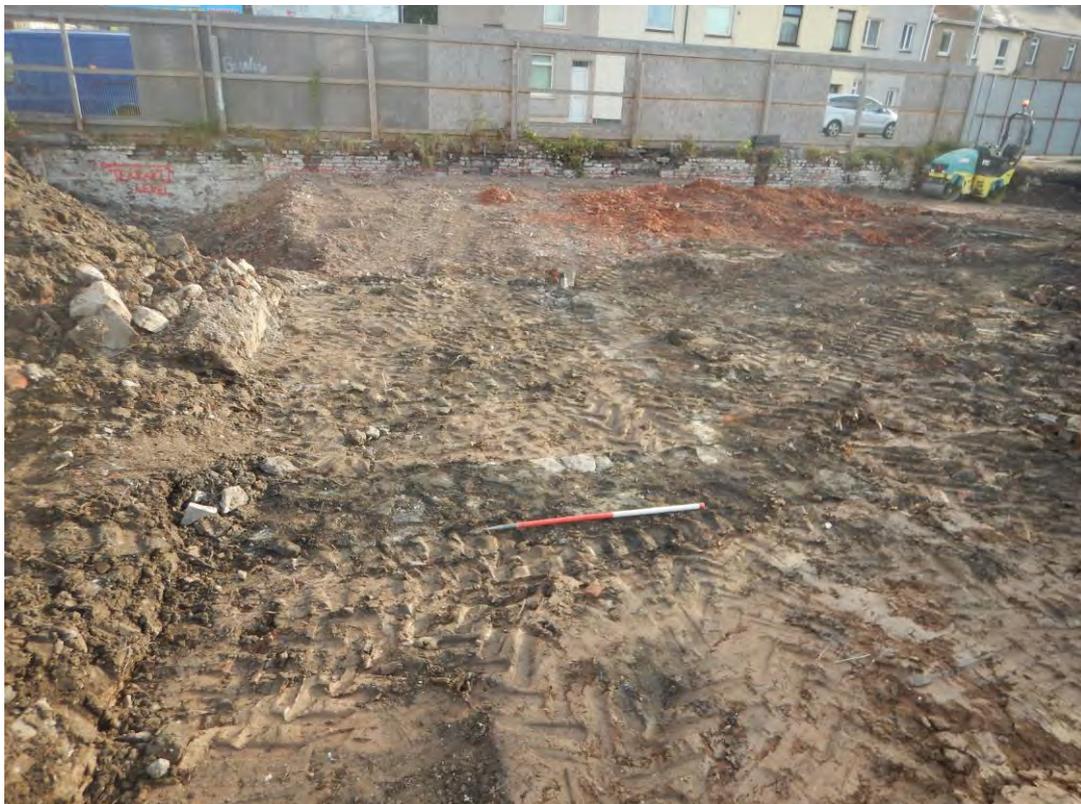
Photo 6: Wall {009} becoming visible at the base of the cleared area. Also note wall {023} along the roadside to the rear. 1m scale.

The outline of the rear wall foundations and partial side wall foundations of the former King Hotel were also revealed, recorded as walls {016} and {009}. These foundations were removed by machine in plan. The walls themselves were approximately 0.7m wide, surviving to a depth of between 0.5m to 0.8m deep. As with the section exposed within the drainage trench, they comprised mixed brick and roughly squared stonework, laid in random coursing, capped in concrete, and sat upon a wide concrete pad, 1.5m wide and 0.3m thick. One internal wall

The front wall {023} of the King Hotel was still visible along the street frontage, comprising a brick wall in a stretcher bond, with internal white paint. This wall continued to a depth of at least 1.8m below the road surface level, suggesting it may form the face of a cellar wall associated with the hotel. The internal area in front of this wall was not excavated however, it was merely compacted in situ and covered over, therefore the internal arrangements along the street frontage were not investigated.

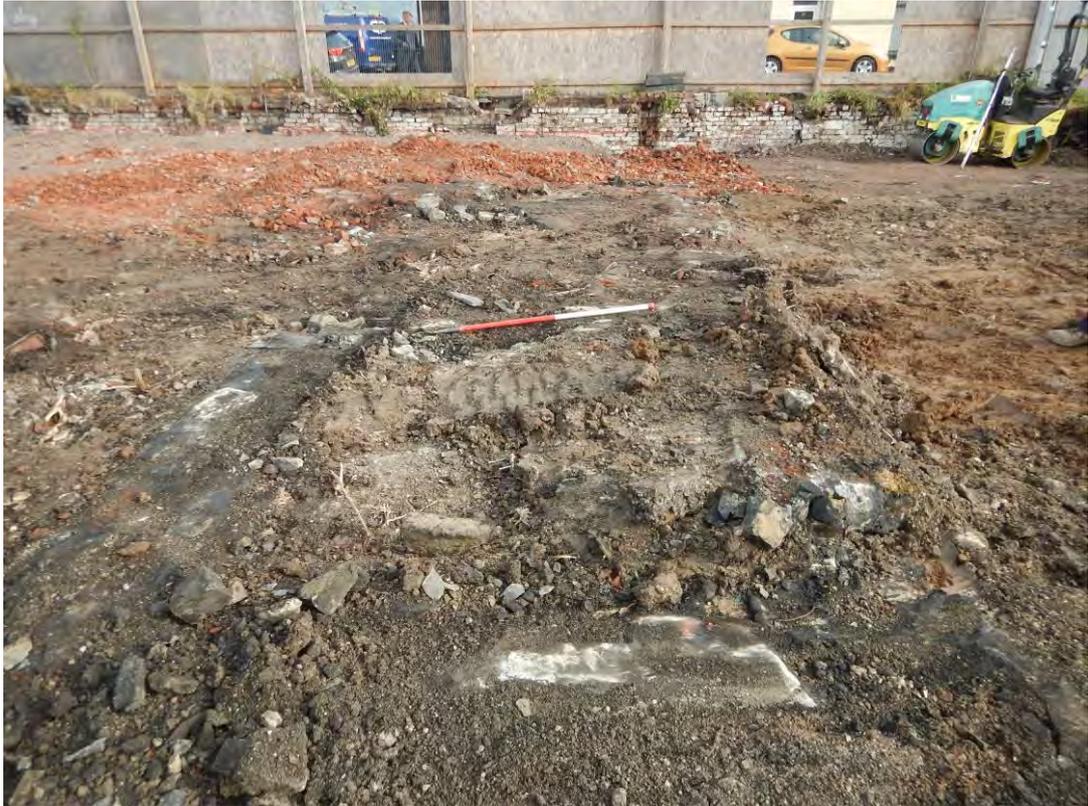
Photo 7: Further remains of wall {009/016} revealed at the base of the levelled area, looking northeast. 1m scale.

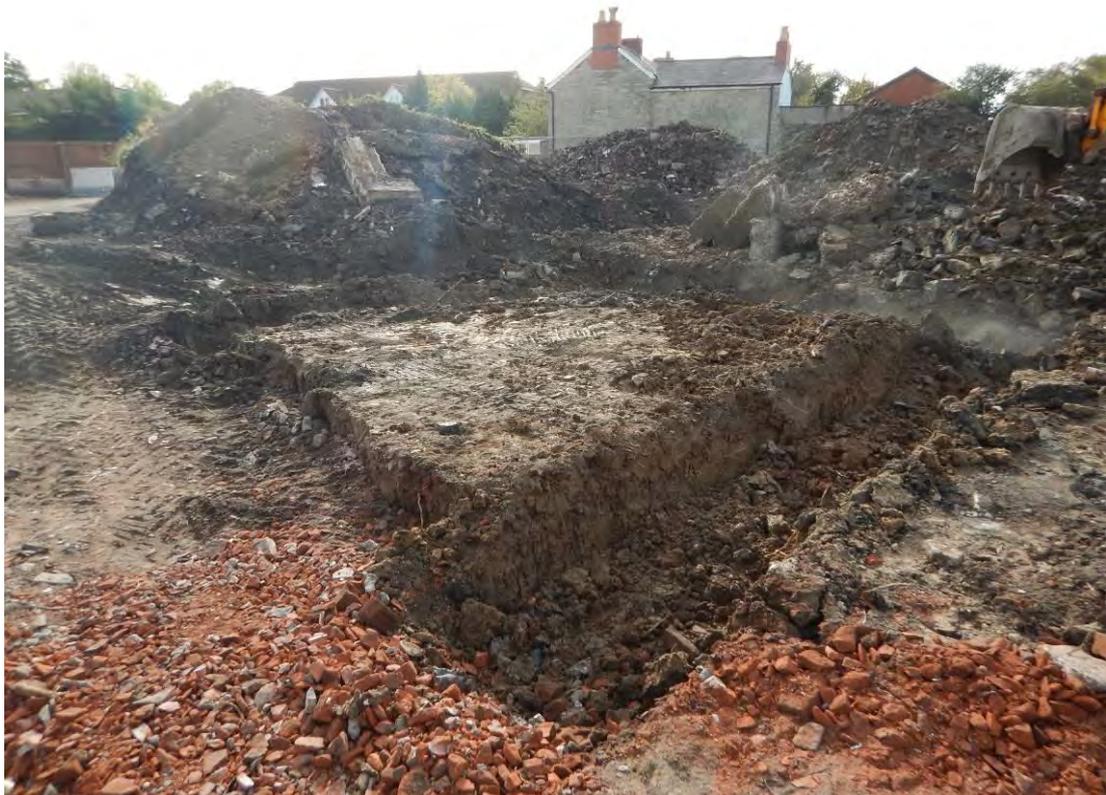
Photo 8: Removed foundations of wall {009/016}, looking north.

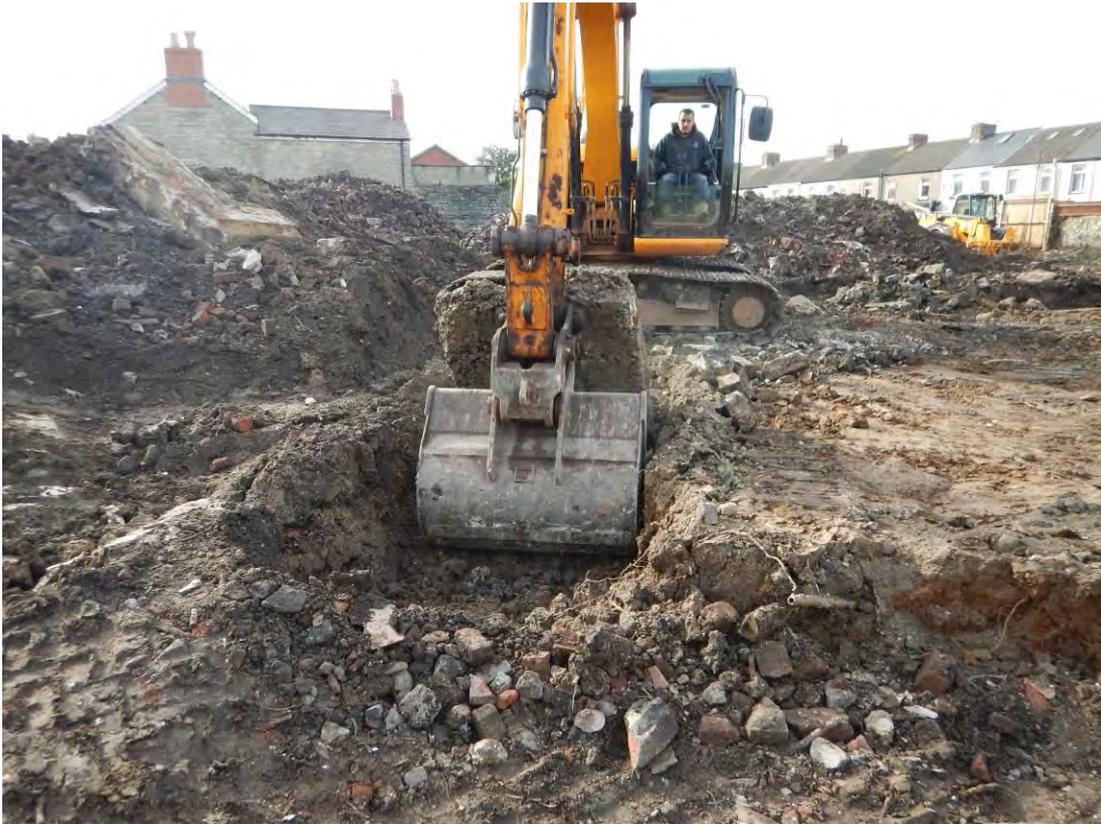
Photo 9: Concrete foundation of wall {009/016} during removal, looking north.

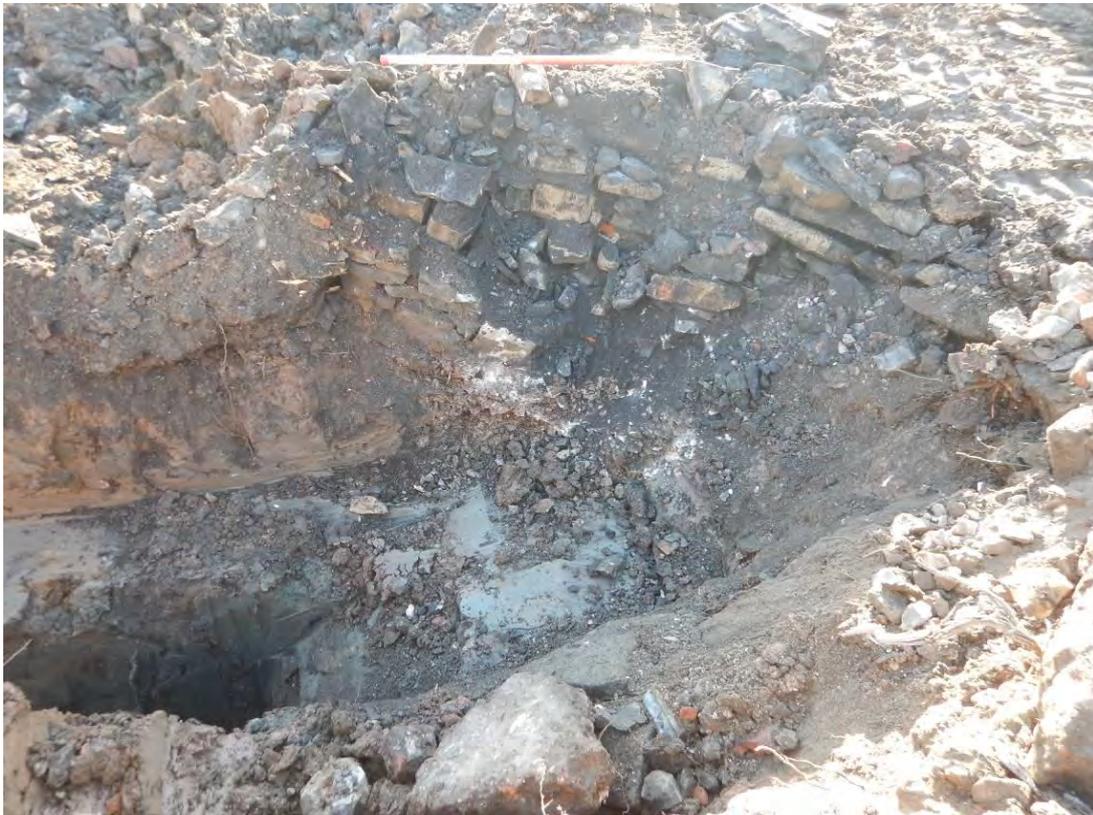
Photo 10: Fragmentary remains of wall {016} revealed during drainage trench excavations, looking southeast. 1m scale.

The drainage trench exposed the northwest corner of the building. The wall foundation cut [014] was 1.6m deep, and 1.5m wide, with steep sides and a flat base. This contained wall {016}, which was difficult to examine in detail but comprised a linear structure built of mixed brick and roughly squared stone bonded with a dark grey mortar. This appeared to sit upon a concrete foundation base.

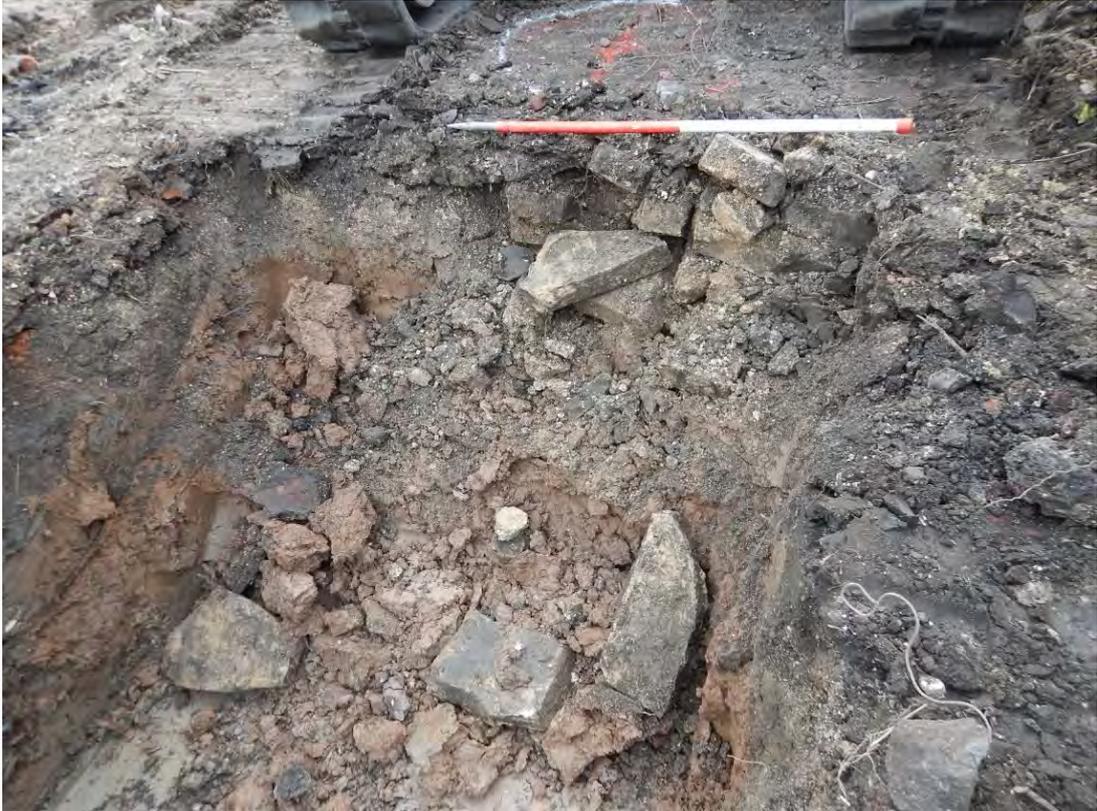
Photo 11: Remains of wall {018} revealed during drainage trench excavations, looking southwest. 1m scale.

Outside the footprint of the former King Hotel another fragment of walling was revealed within the drainage trench to the west. Approximately 1.5m further south from the western corner of the King Hotel another wall was encountered from a different structure {018}, constructed from roughly dressed stone bonded by a loose yellowish mortar. This was only revealed along the west side of the trench excavations and was approximately 1m wide x 4m long. It would appear to be a modern structure however, as it cut into (004), the fill of a modern service trench.

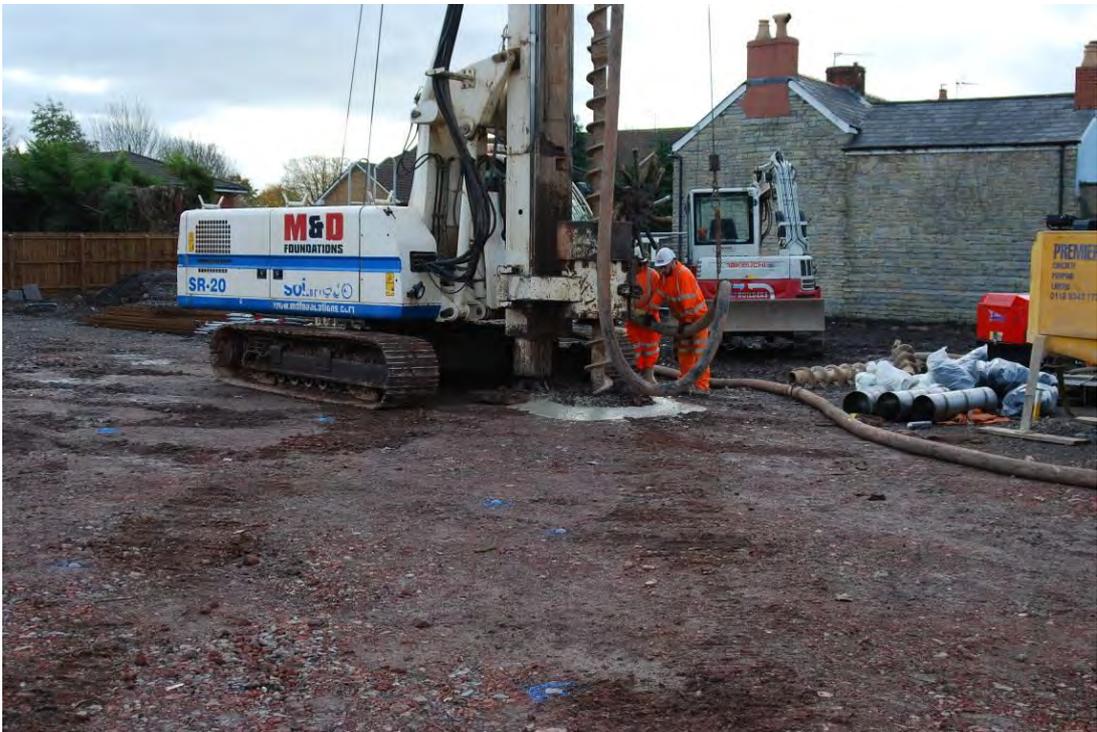
Photo 12: Foundation piling underway.
