Tredeggar House Museum, Duffryn, Newport

Archaeological Watching Brief

Report No. 1729

Prepared For: The National Trust

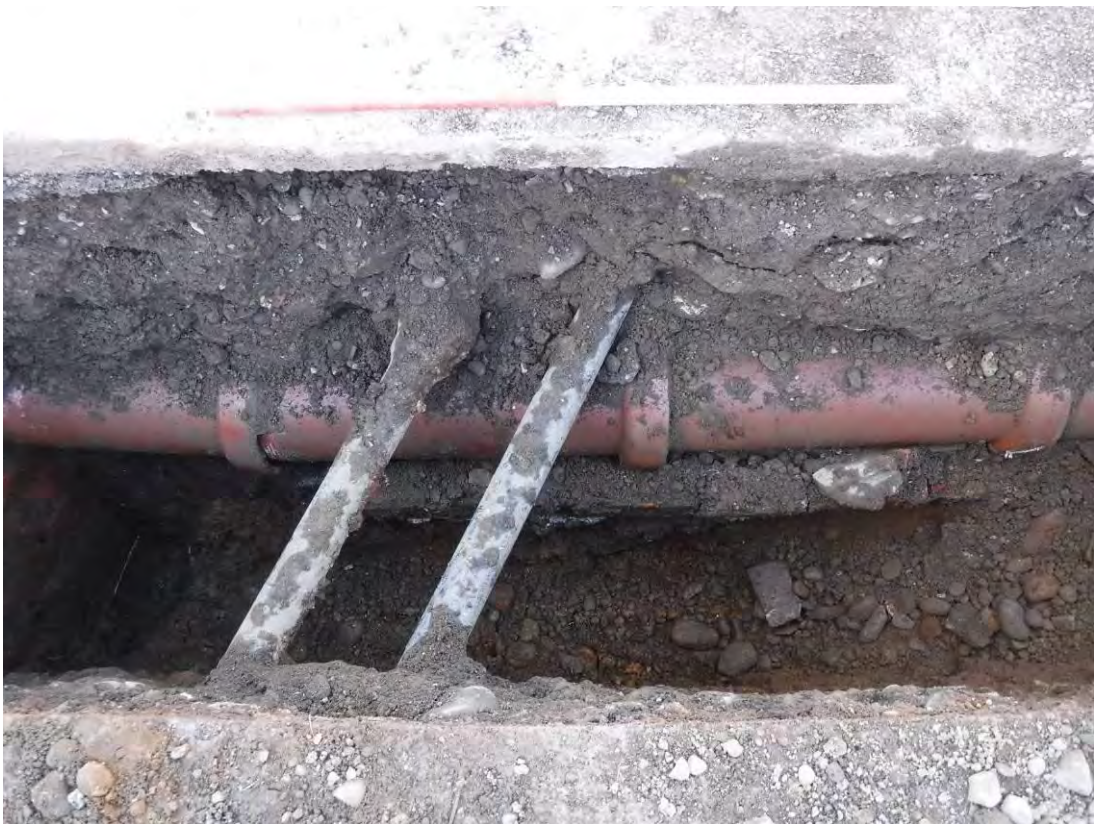
Photo 4: Trench 1, shot facing northwest showing ceramic drainpipe 107. 1m scale.

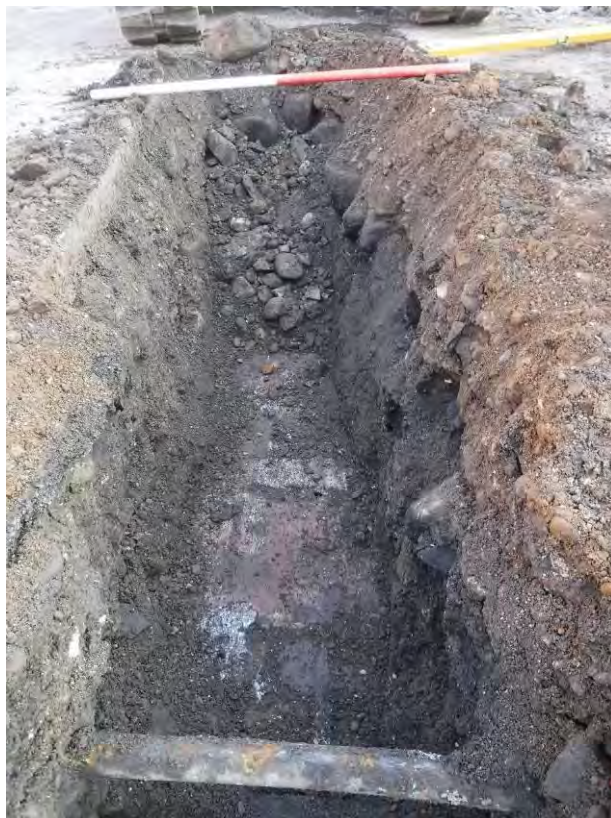
Photo 6: Trench 1, shot facing northeast showing Drain/Culvert 122 crossing the base of the trench. 1m scale.

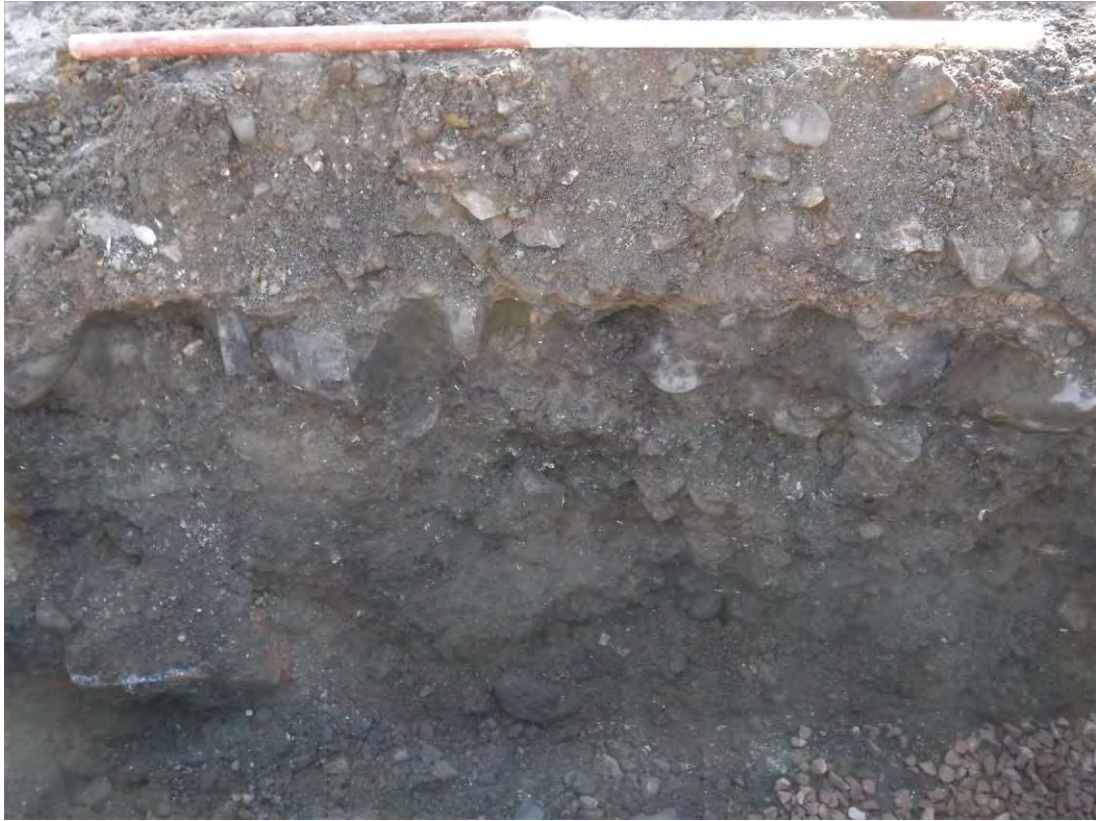
Photo 7: Trench 1, shot facing southeast, showing layer containing large stones (128), used as a bedding deposit for the re-laid cobbled surface above. 1m scale.

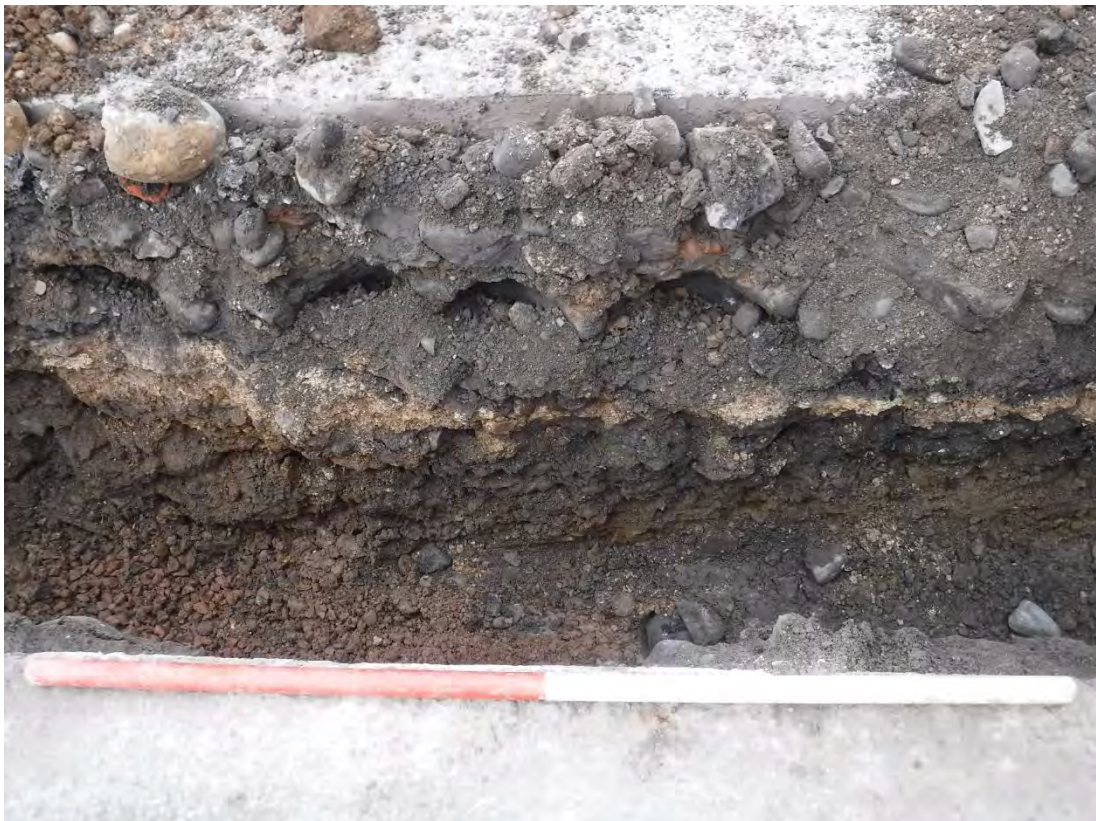
Photo 8: Trench 2, shot facing southeast showing the continuation of the large stone layer (128) above mortar layer (124). 1m scale.

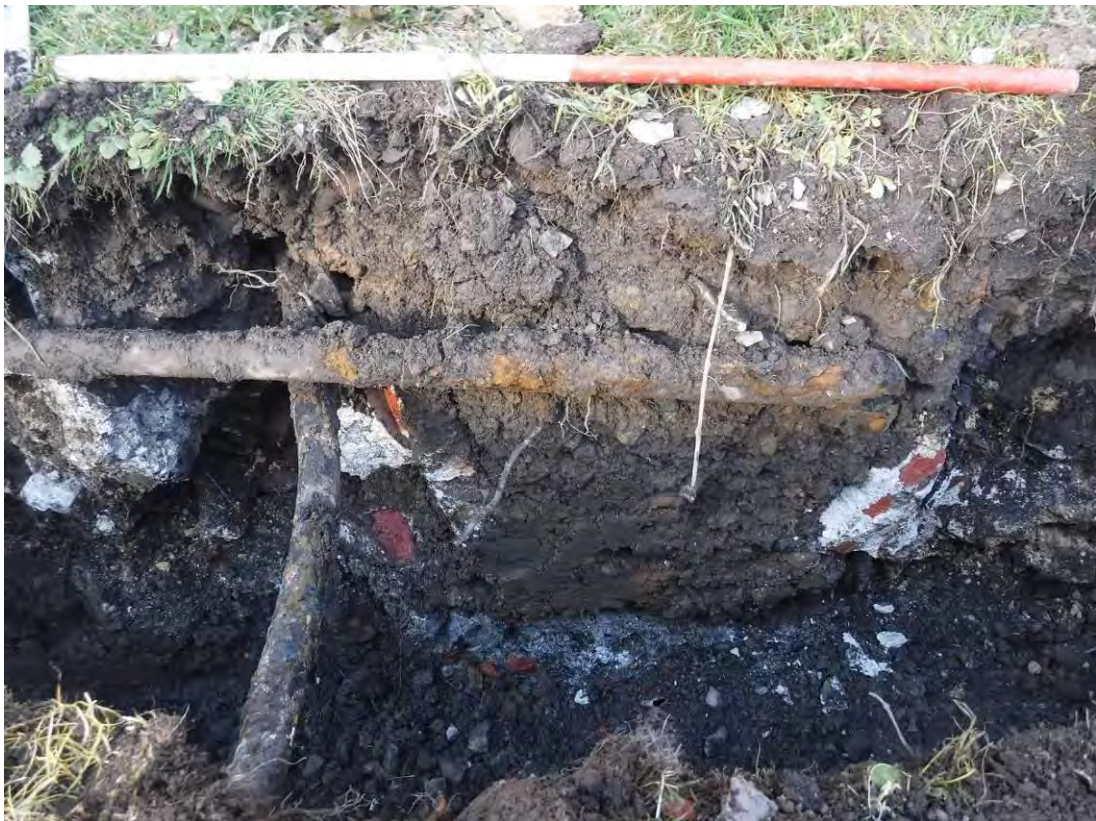
The foundations of a brick wall (140) running north-south were encountered approximately 58.4m from the start of trench 1, also about 26m east of the start of the laundry building. The wall ran perpendicular to the building, and was approximately 0.60m wide (Photo 12). The bricks were set within a hard lime-mortar, and ceramic drains were also set within this mortar towards the base of the wall. The wall sat below topsoil deposits but had been so heavily truncated by subsequent services the relationship to surrounding deposits and levels was obscured.

Photo 12: Trench 1, shot facing north, showing the disturbed remnants of brick structure (140). 1m scale.

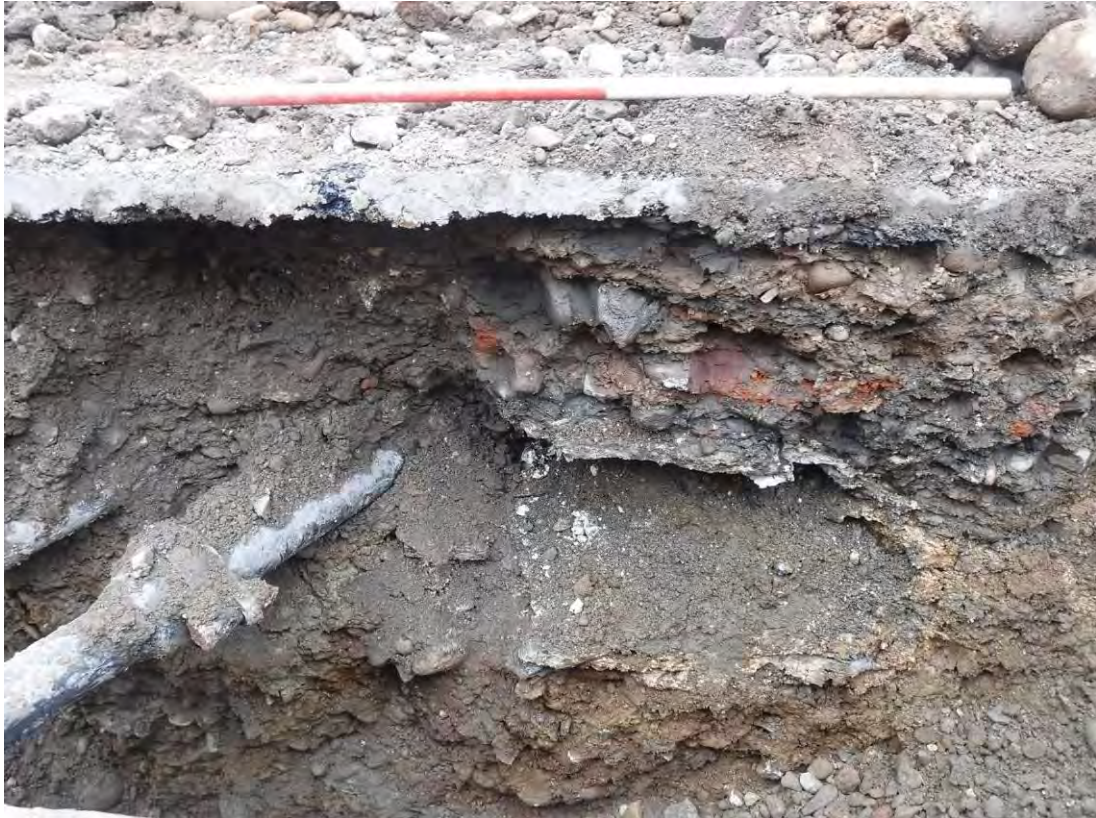
Photo 13: Trench 2, shot facing southeast showing the possible stone drain/culvert 116, and modern services. 1m scale.

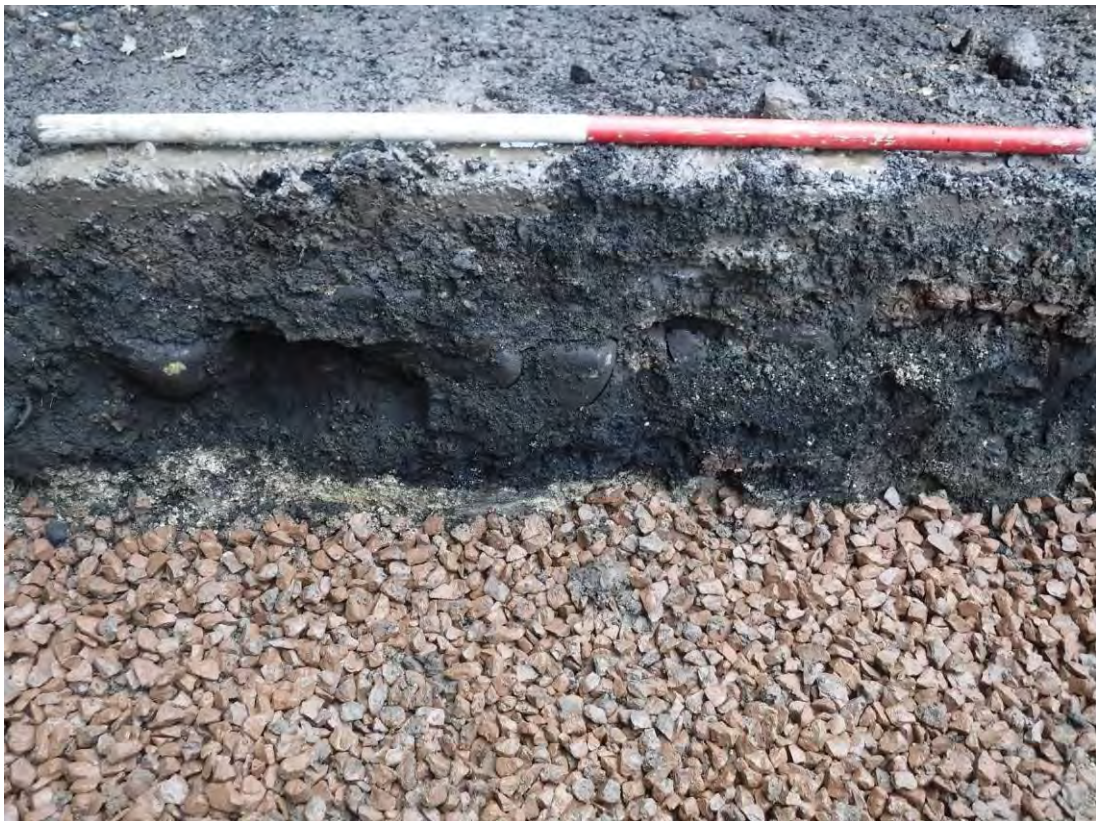
Photo 14: Trench 3, shot facing west showing cobbled surface (142) directly below current surface. 1m scale.

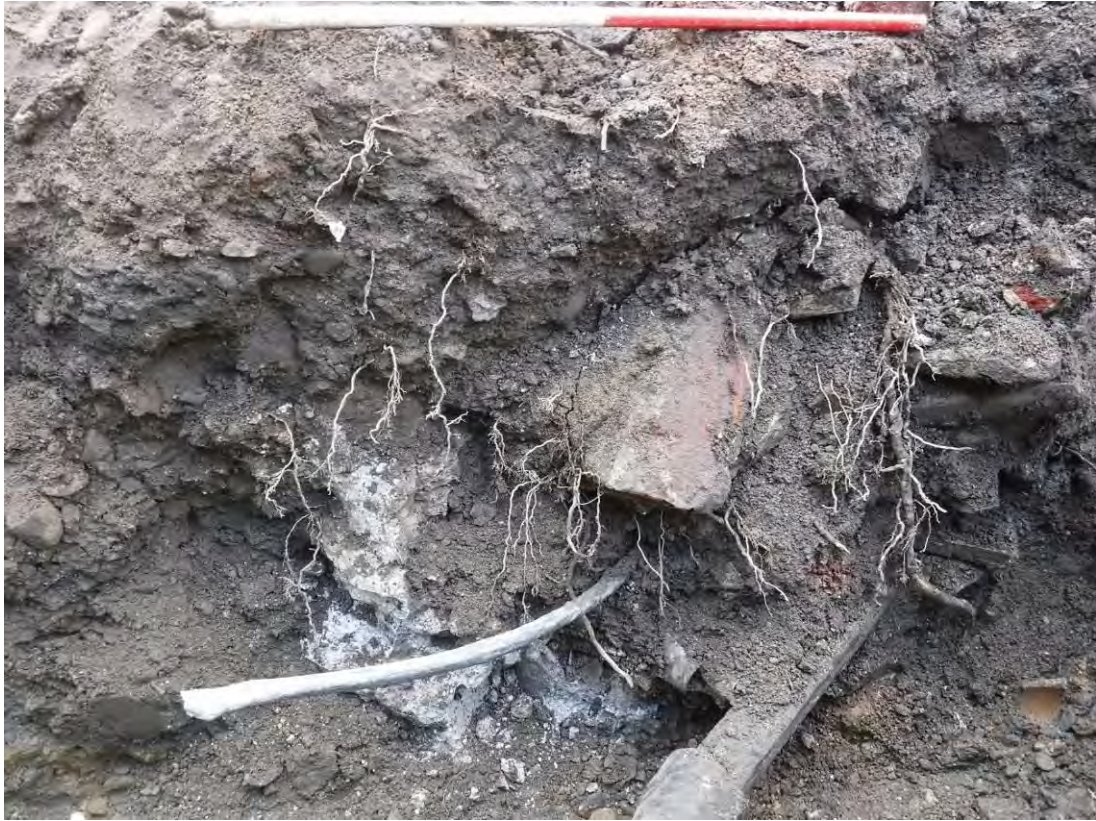
Photo 15: Trench 3, shot facing east showing the heavily disturbed remains of a brick and stone structure (150). 1m scale.

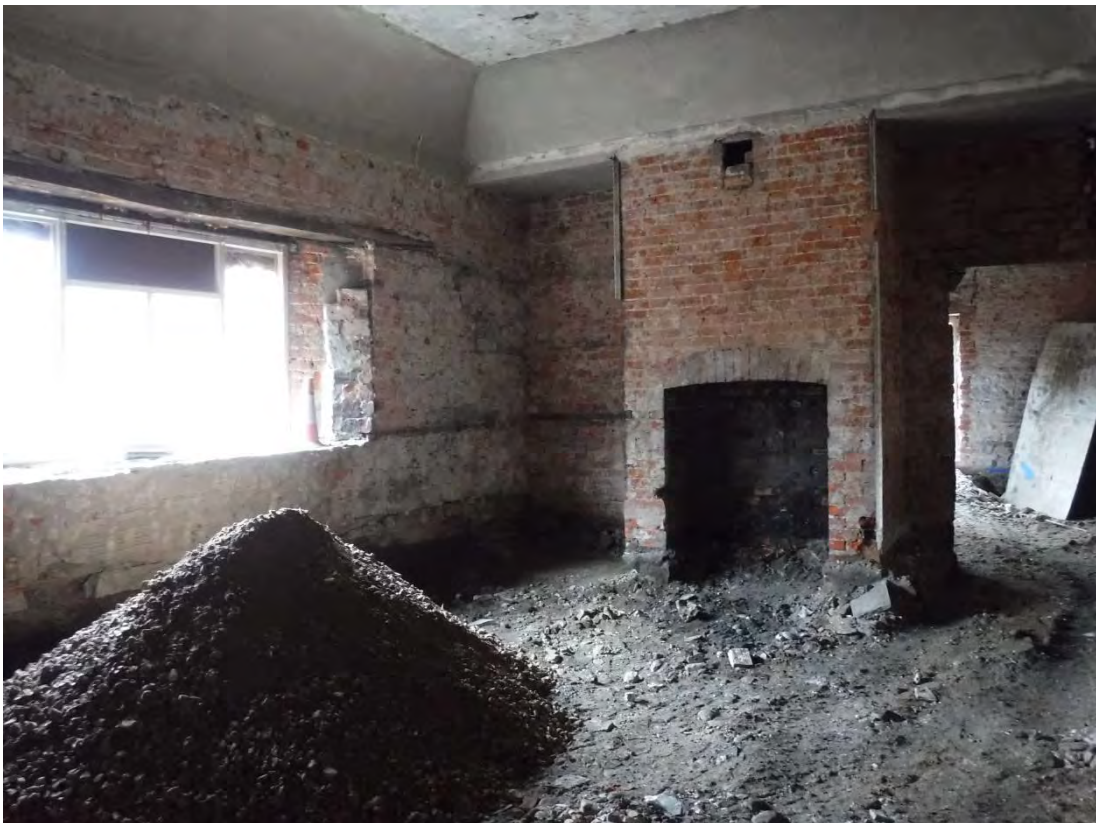
This was the next room to the west of room 1, also identified as a drying room within the former Laundry. The basal deposit in Room 2 was the same (176) (Photo 20), overlain by a deposit of mortar (218) about 0.03m deep, identified in the centre of the room close to the northern window, potentially representing the remains of an earlier floor foundation. This was overlaid by a mid-brown layer of sandy silt (217) containing shards of slate, mortar, bricks and broken wood (Photo 21). This layer was about 0.08m deep. Overlying this was the general upper mixed deposit (172), 0.20m deep, which contained a clay pipe bowl, a horse shoe and a metal brick bolster, of a general 19th to 20th century date. Above this was a light orangey-red aggregate (175), approximately 0.07m deep, underlying the concrete floor on the surface (163).

Photo 20: Laundry Building, Room 2. Shot facing ENE, showing deposit (176) and eastern wall.

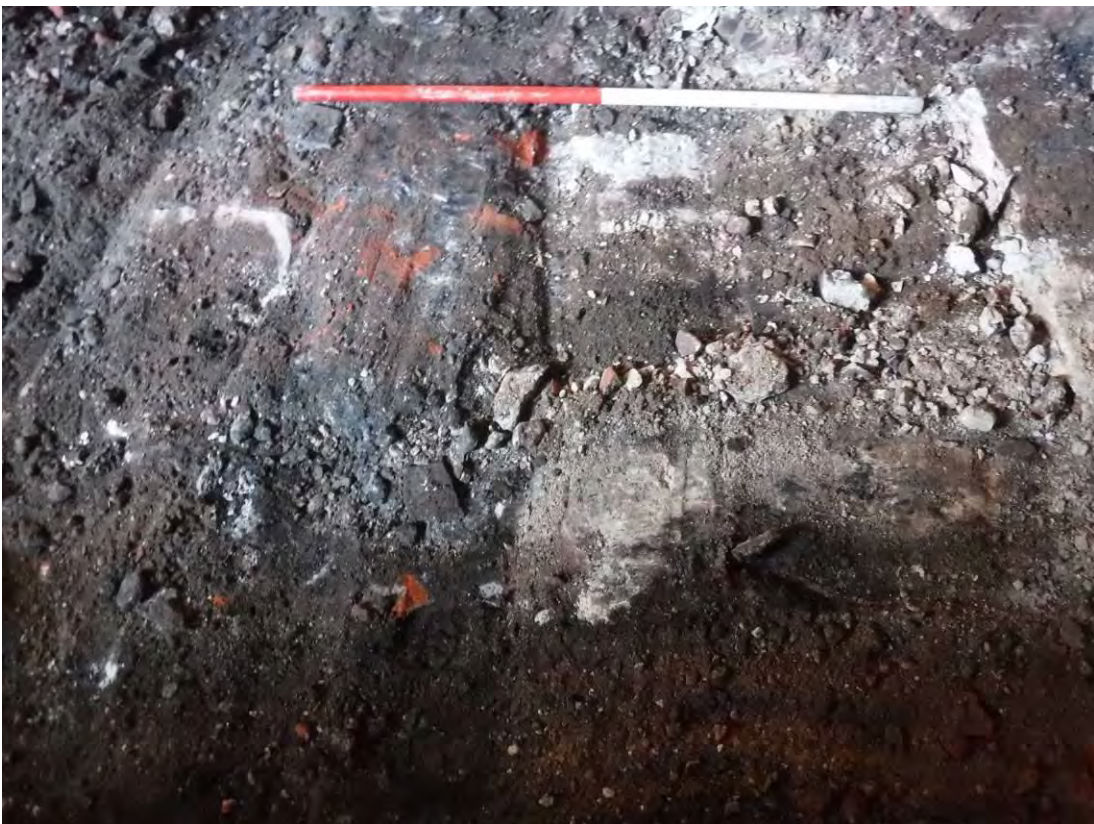
Photo 24: Laundry Building, Room 3. Shot facing north showing drain structure (177). 1m scale.

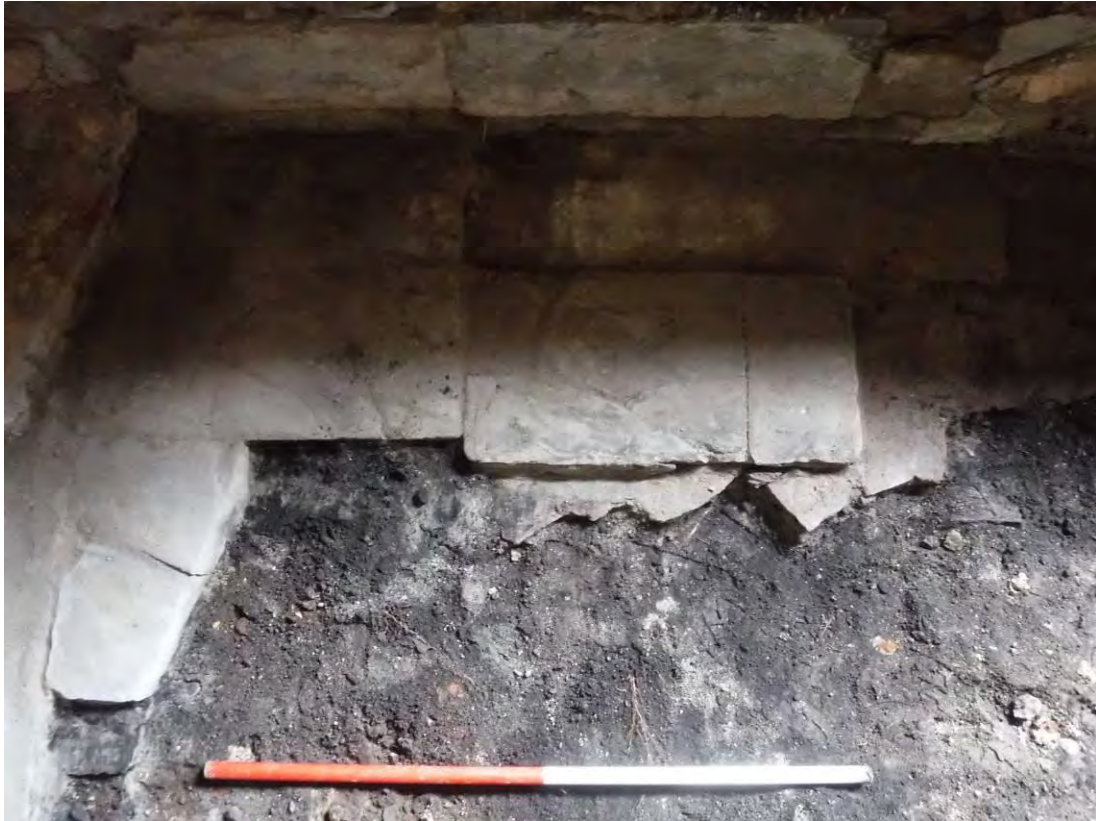
Photo 25: Laundry Building, Room 3. Shot facing north, showing stone slab flooring (166 & 167). 1m scale.

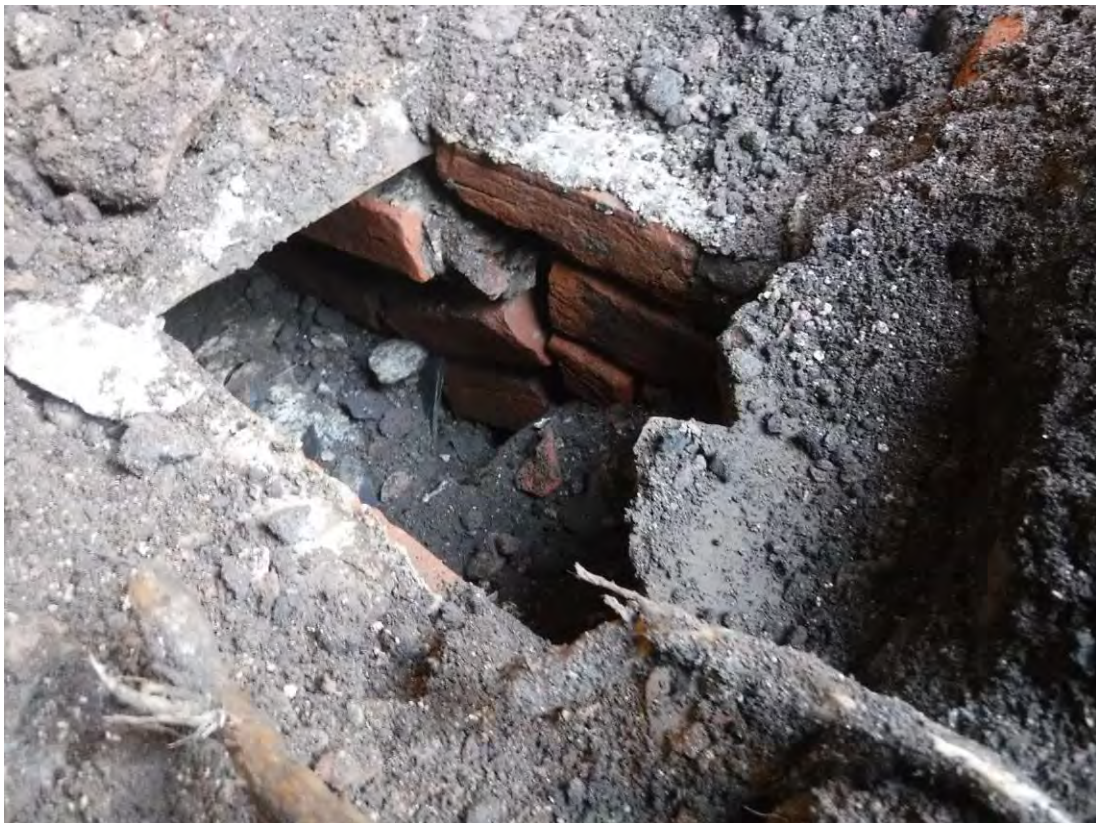
Photo 26: Laundry Building, Entranceway. Shot facing northeast, showing the partial revealed remains of drain (179).

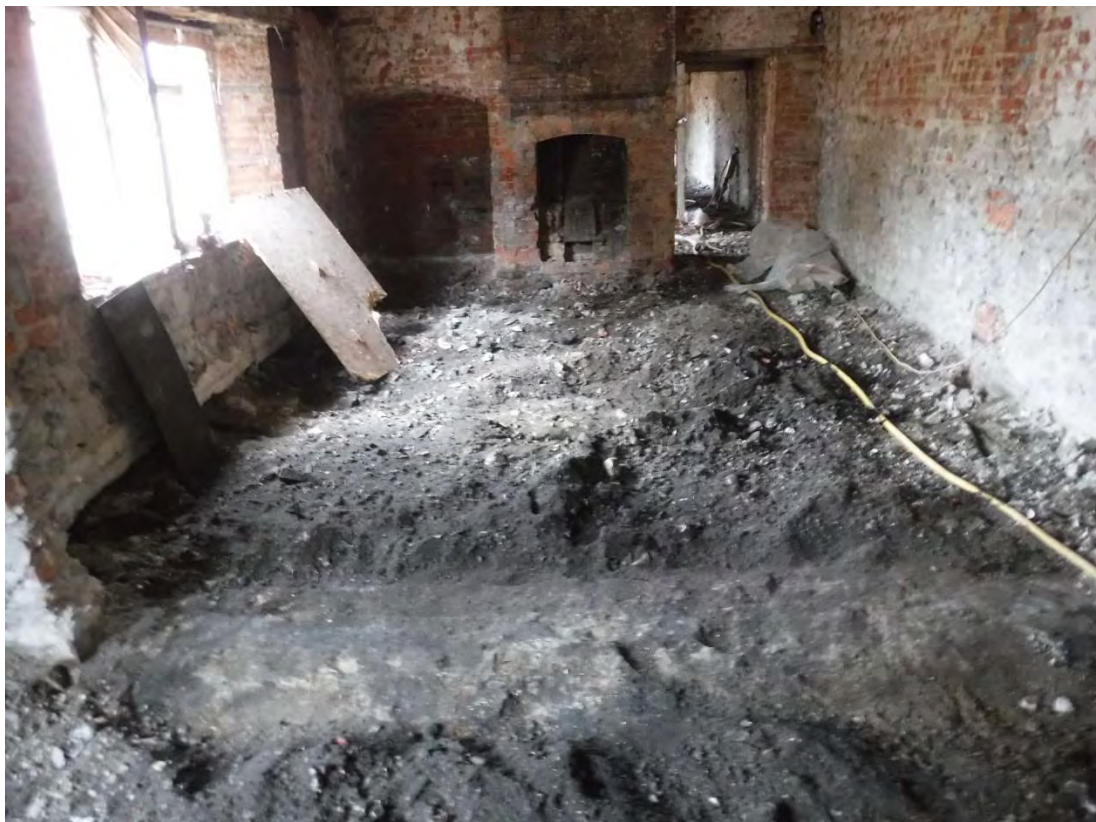
This room lay immediately to the west of the main entranceway, identified as the ironing room in the former Laundry (Photo 28). Approximately 3.45m west of the hearth (set into the eastern wall) in Room 4 were the foundations of a wall {171} running north/south, 0.73m

Photo 28: Laundry Building, Room 4. Shot facing east, showing wall foundation (174) in the foreground, deposit (176) beyond.

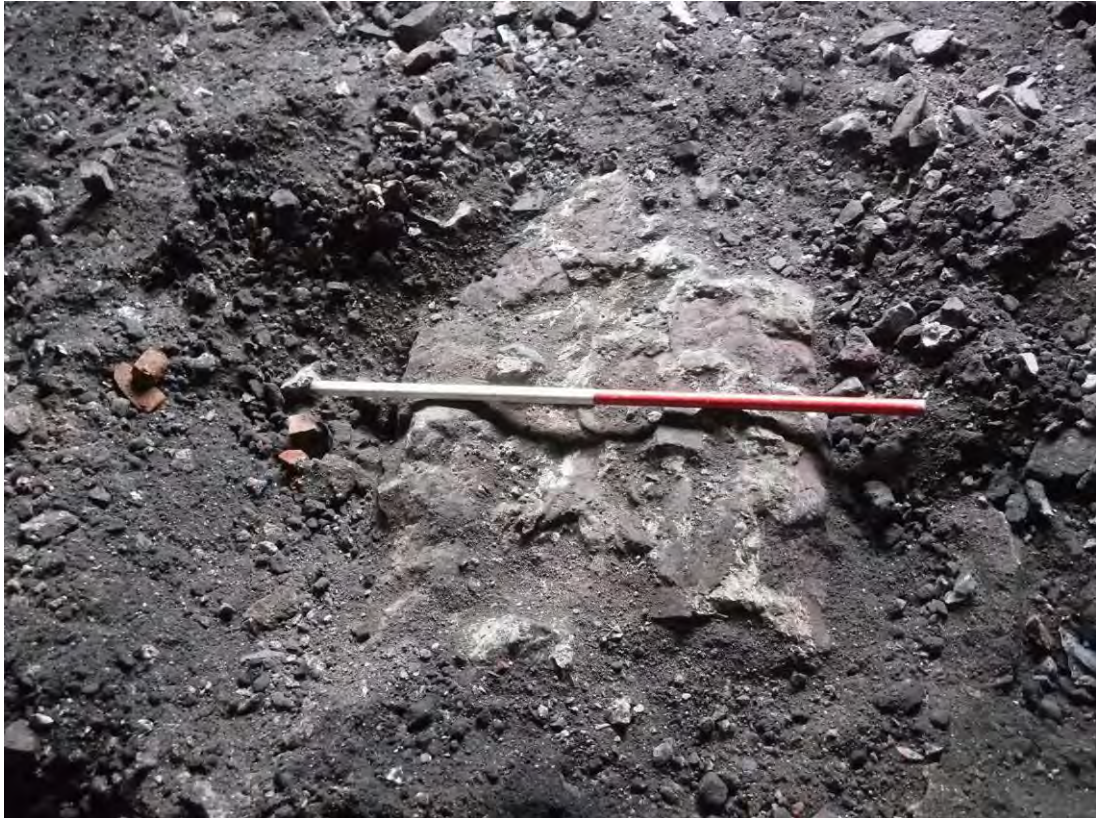
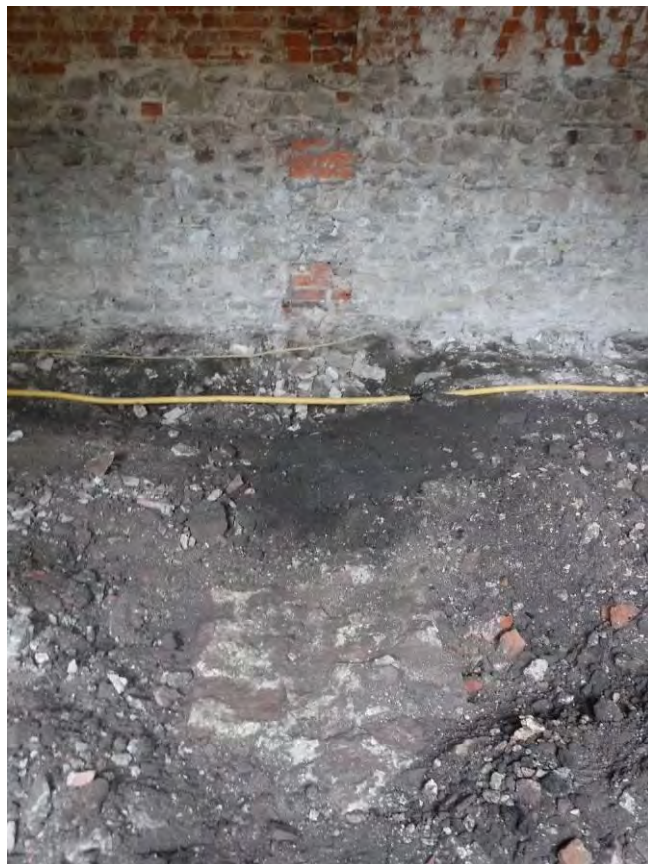
wide and approximately 3.4m long (Photos 29 & 30). It left a gap on the south side of the room of approximately 1.4m wide, presumably as this was a former doorway. Consequently, the wall was in line with the metal joist in the ceiling of the room. On the west side of this wall foundation, a flagstone and brick drain construction {180} similar to {179} was uncovered (Photo 31). The main difference was the dark grey mortar holding the bricks together. This was revealed about 1m west of {171} and 0.35m north of the south wall. Only a small section of this feature was uncovered, and therefore its full extent is unknown. The chamber underneath was at least 0.44m deep filled with a silty soil, although this may have fallen in during the excavation. The soil sequence above {180} contained the reddish-brown sandy deposit (176) approximately 0.15m deep, overlain by (172) at a depth of about 0.28m. Finds included fragments of china, brick, glass and animal bones within this layer. The pottery fragments would appear to be of 19th century to early 20th century date.

Photo 29: Laundry Building, Room 4. Shot facing north, showing wall remains (171). 1m scale.

Photo 30; Laundry Building, Room 4. Shot facing south, showing wall remains (171), the former doorway gap beyond, and remnants of the internal wall attachment to the southern wall beyond.

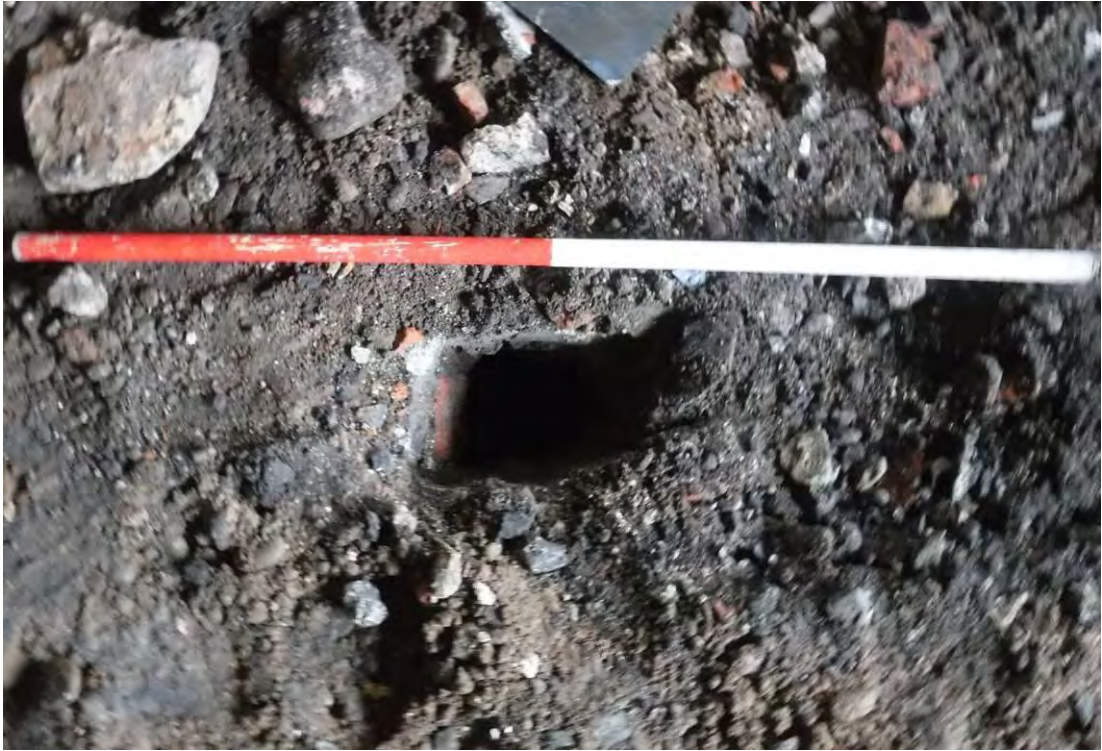
Photo 31: Laundry Building, Room 4. Partially revealed remnants of drain structure 180. 1m scale.

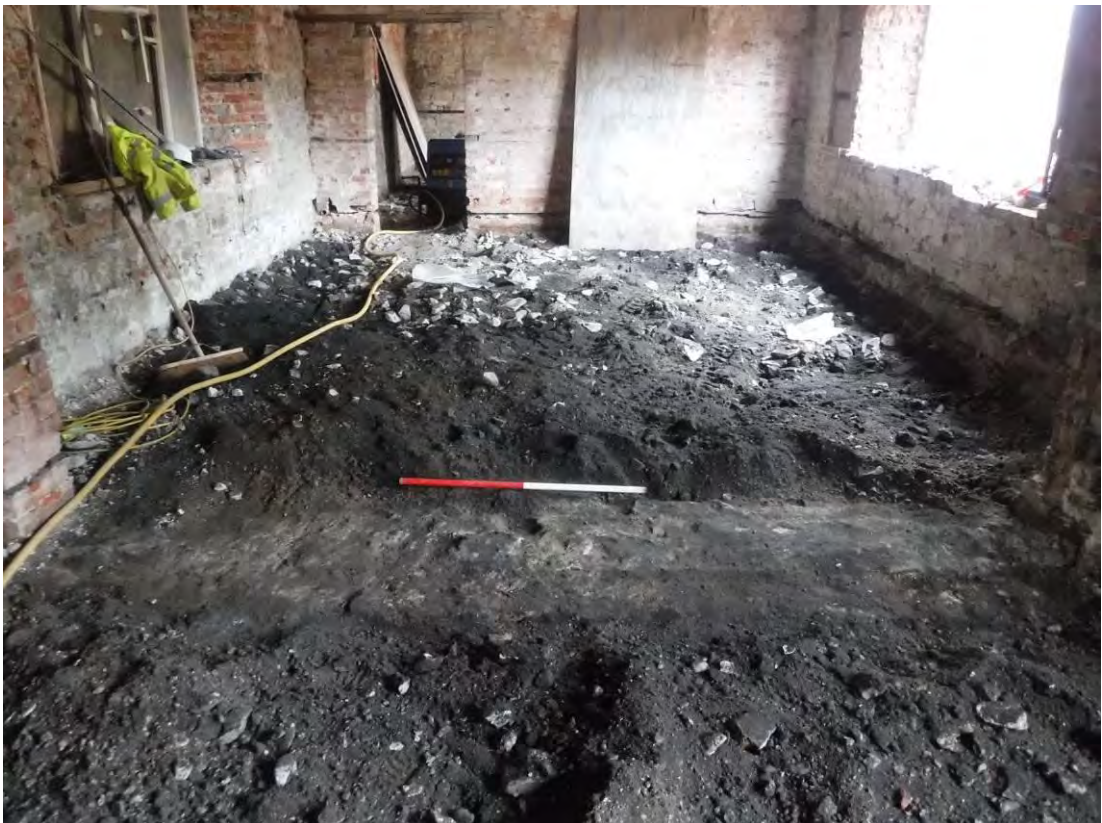
The adjacent room is largely open to Room 4, in between the two lies the foundation of a wall {174} running north/south, in which only the north and south ends still existed (Photo 32). This room has been identified as part of the former dairy. The room also contained a 0.70m x 0.75m square drain {181} built up against the north wall, about 0.50m west of the inner wall {174} (Photo 33). The structure was made of mortared brick and stone, and it appeared that the stone inside of it angled downwards toward the interior of the building (south - unless it just settled). The soil sequence contained (176) covering {181}, 0.08m thick; then a heavy mortar layer (219) about 0.1m deep; covered by a red-brown sand (220) approximately 0.05m deep and with no inclusions; and then (172), which contained animal bones, fragments of pottery of general late post-medieval date, and a clay pipe bowl. Within this room (172) was about 0.25m deep.

Photo 32: Laundry Building, Room 5, viewed from Room 4. Shot facing west, showing wall foundations (174) in the foreground. 1m scale.

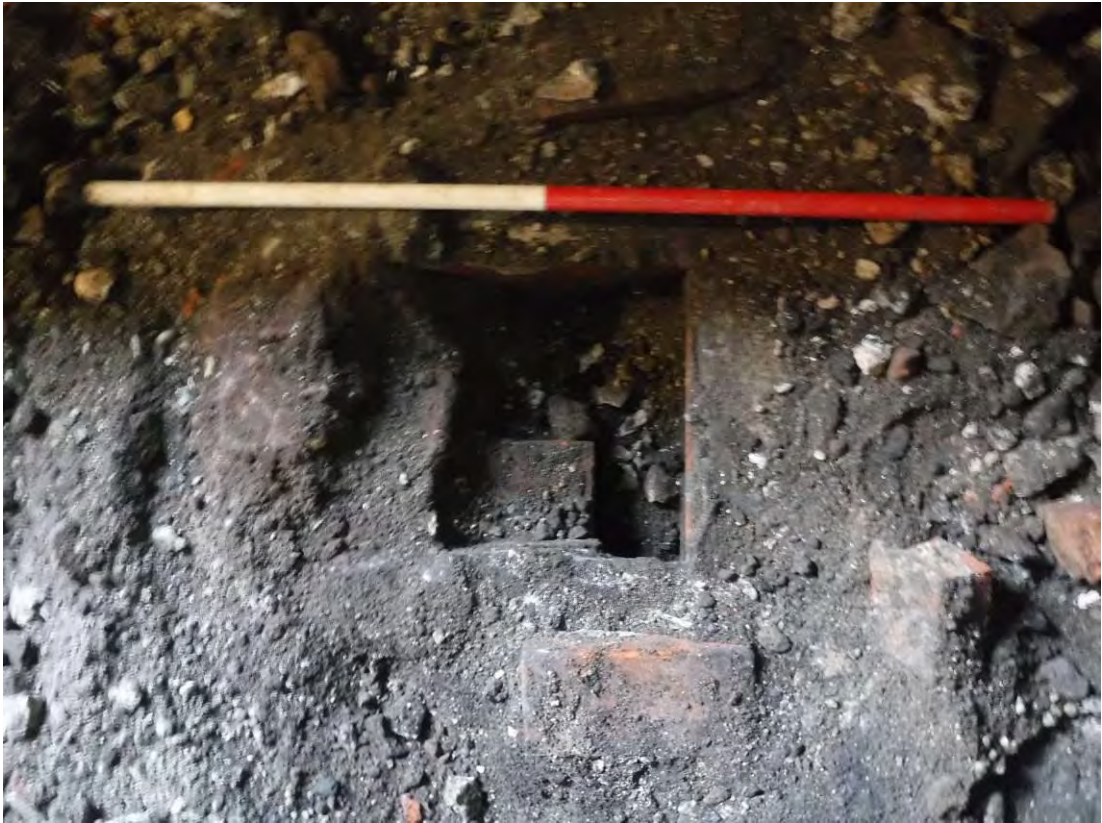
Photo 33: Laundry Building, Room 5. Shot facing east, showing drain 181. 1m scale.

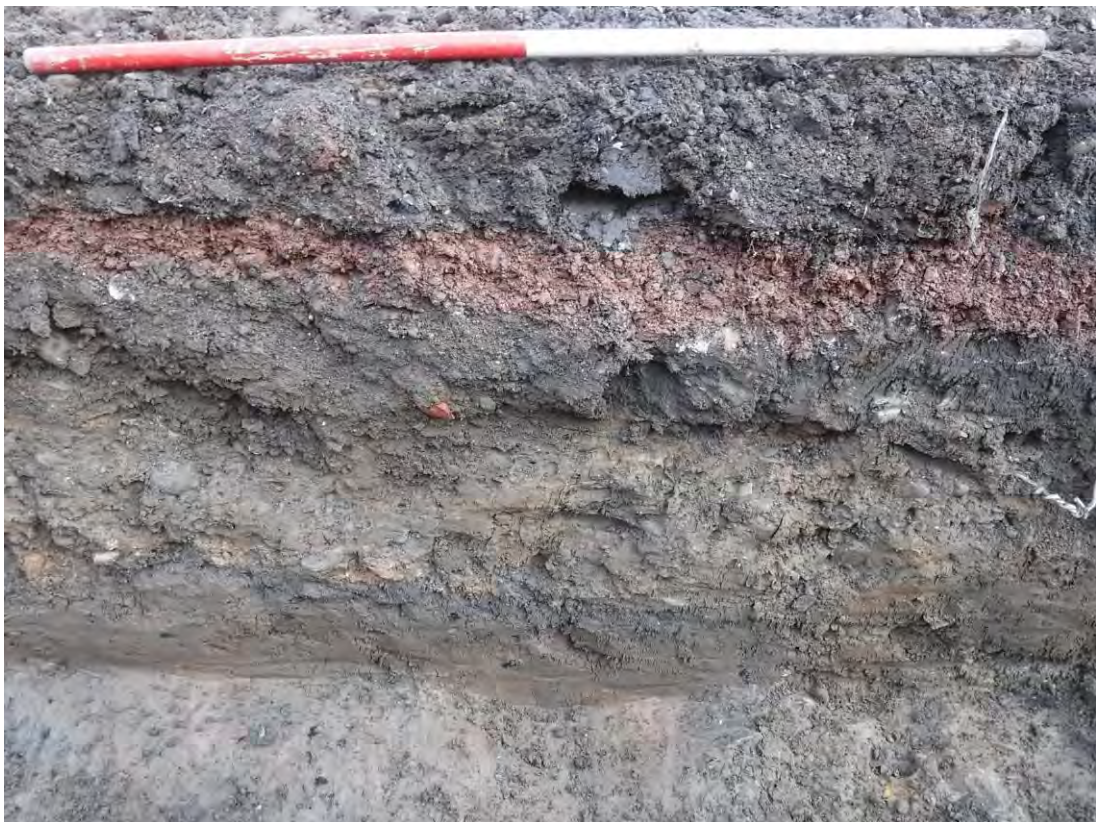
In front of the laundry building, the soil sequence revealed a basal deposit (186) of firm, mid greyish-yellow silty clay about 0.25m deep (extending beyond depth of excavation). Overlying this was (185), a firm, mid greyish-yellow silty clay, about 0.5m thick, containing modern CBM and a thin cable. This deposit appeared heavily disturbed. Above this was (184), a moderately firm, mid greyish-brown deposit of silt with frequent sub-angular stones and approximately 0.16m thick. Overlying (184) was (183), a loose, mid brownish-pink mix of aggregate and sandy clay about 0.1m thick. This was possibly a layer deposited for levelling the ground, as it sat directly under the topsoil (182). The topsoil (182), with a thickness of 0.15m, was heavily disturbed and contained modern CBM (Photo 36).

Photo 36: Trench 4, shot facing north. Showing base deposit (186), overlaid by (185), (184), (183) & (182). 1m scale.

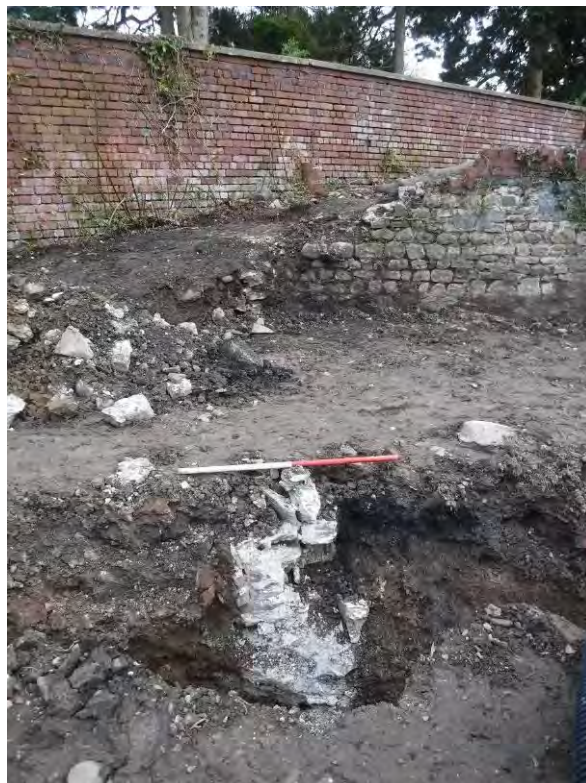
Photo 38: Trench 4, shot facing north. Showing the remains of wall (193), and its alignment with the existing stone boundary wall to the rear. 1m scale.

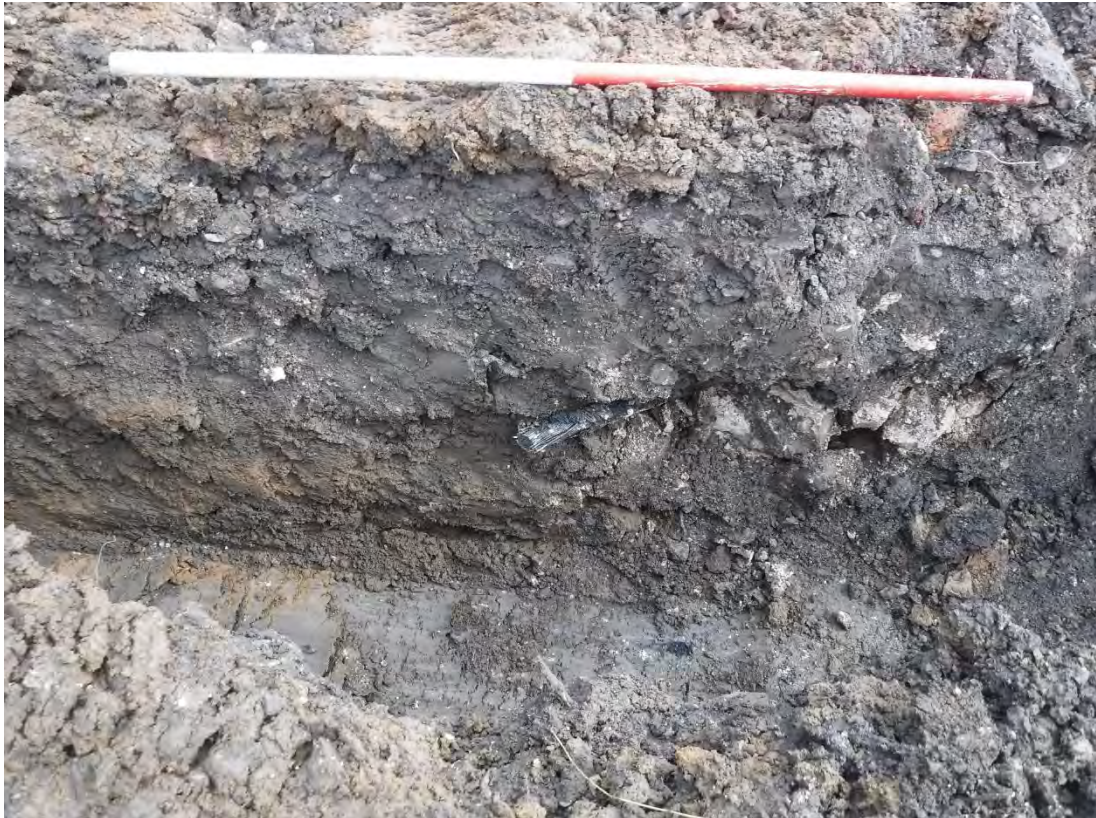
Trench 5 was approximately 13m long, 0.30m wide, and 0.80m deep. It was orientated northwest/southeast from the wall opening to the yard of the laundry building and extended to the centre of the former outbuilding along the northern boundary wall, in which new foundations were being dug (Trench 7). The deposits here were again mixed and modern, with modern CBM as well as disarticulated animal bones. The topsoil had already been removed before the watching brief when demolition of modern outbuildings took place. The basal deposit (200) of firm, mid orange-brown silty clay, was approximately 0.1m thick, though it extended beyond the depth reached by the trench. The upper layer (199) was a firm, mid grey-brown silty clay full of sub-angular stones, modern CBM and animal bones. This layer varied in depth from 0.2 – 0.7m (Photo 39).

Photo 39: Trench 5, shot facing north, showing deposits (200) and (199). 1m scale.

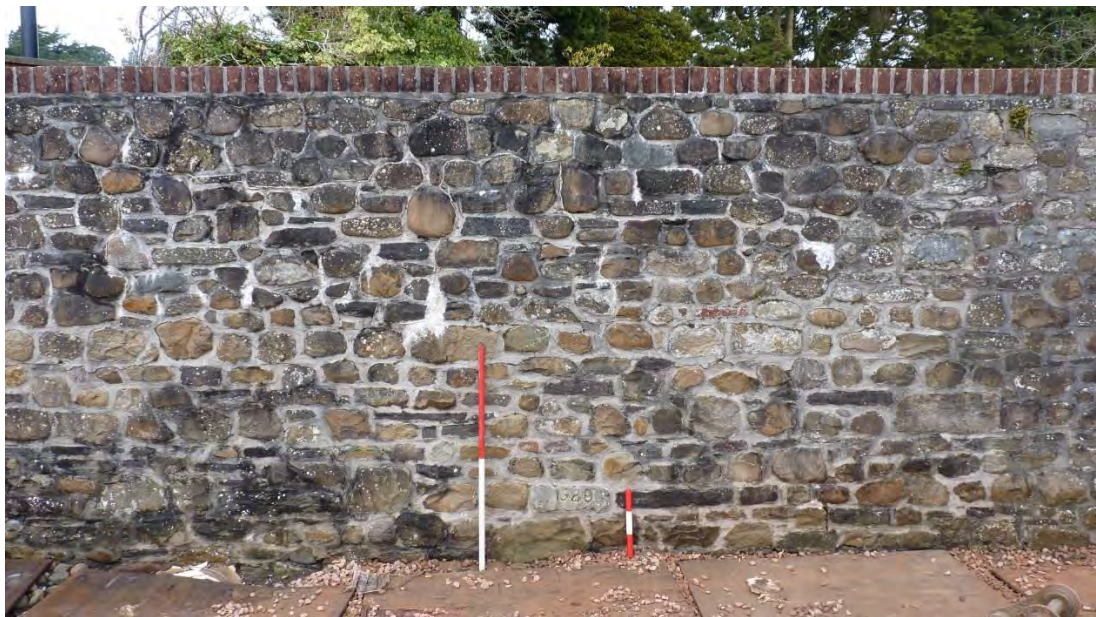
Photo 42: Boundary wall between the main yard to the south, and the Laundry Building yard to the north, shot facing north. Date stone '1928' at base of wall between scales. 1m & 0.3m scales.

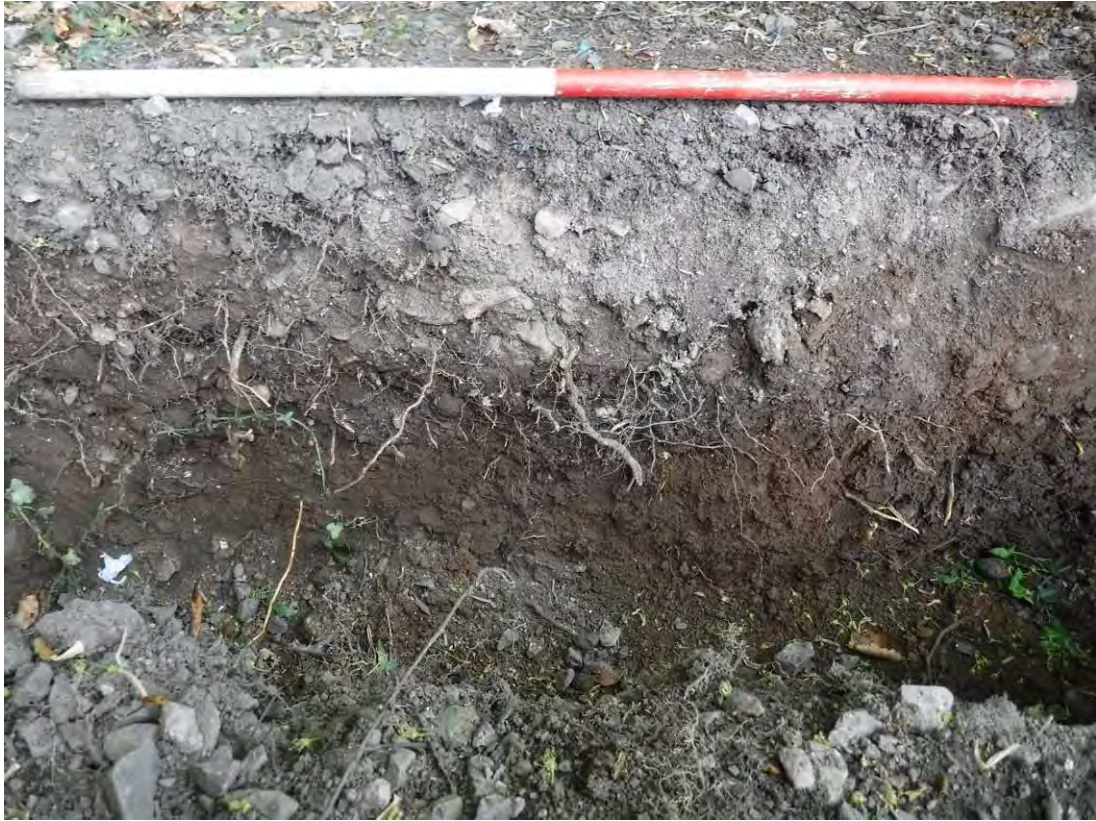
The southern end's basal deposit (211) was a firm, mid-orangepy brown, silty clay with rooting. It was 0.21m thick. This was overlaid by a loose, light orangey-brown subsoil (210) with small, sub-angular stones and rooting at the bottom. This layer was 0.22m thick. Overlying this was the current surface comprised of packed earth and aggregate (209), approximately 0.08m thick (Photo 45).

Photo 45: Trench 8, shot facing east showing deposits (211), (210) and (209). 1m scale.
