CPAT Project 2740

CPAT Report 1982

Old Market Hall, Llanidloes, Powys

Photographic Survey

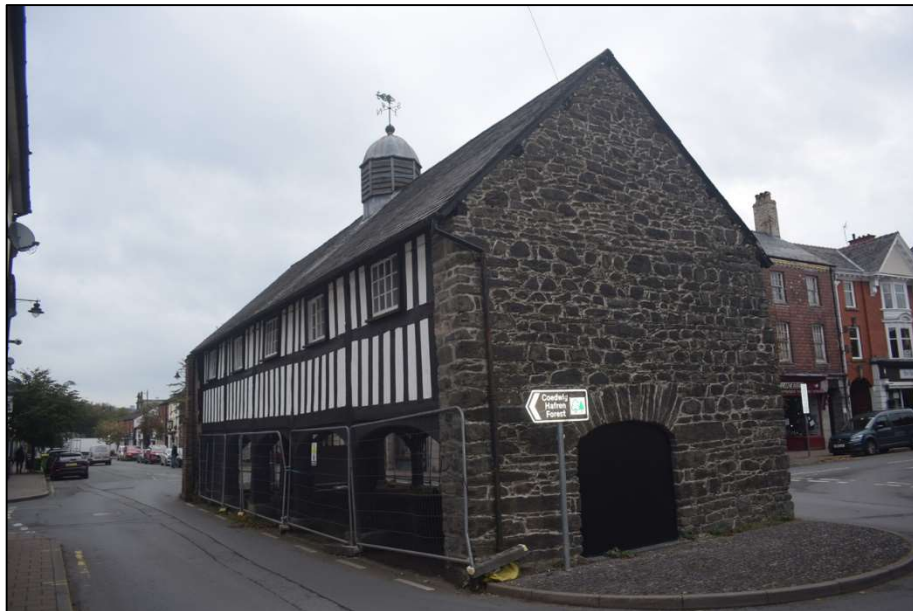
Fig. 2 South and west elevation of the hall looking north along Long Bridge Street. Photo CPAT 5096-002

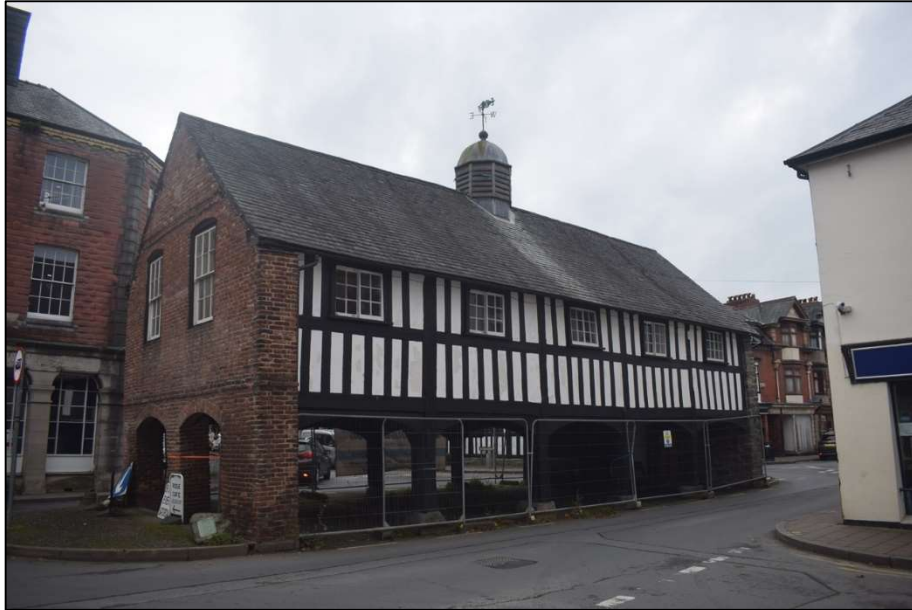
Fig. 3 North and west elevations of the hall viewed from the west. Photo CPAT 5096-001

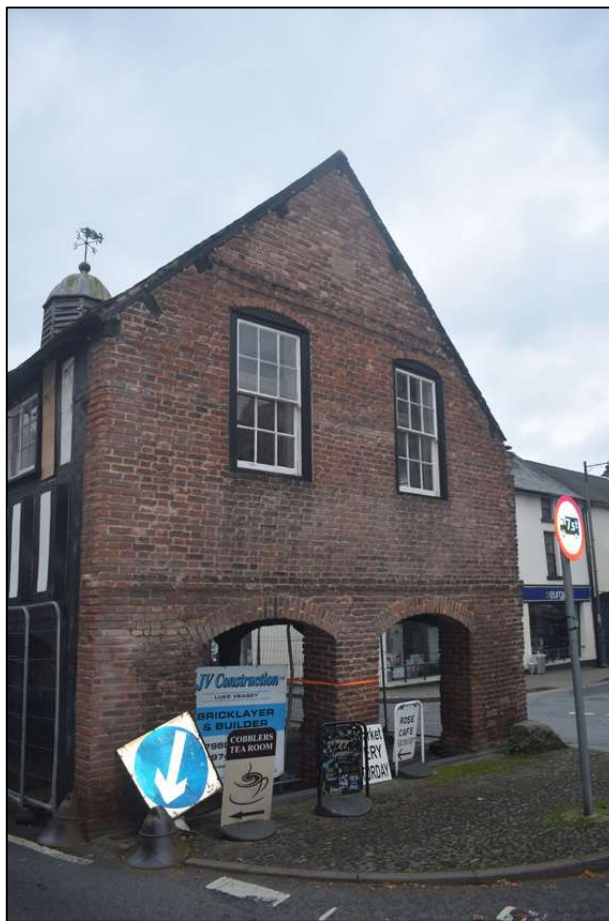
- 3.3. The northern gable end of the hall was rebuilt in 1765, using brick laid to a Flemish bond with string courses (Fig. 4). The date of this work is recorded by a stone inset in the upper elevation.

Fig. 4 North elevation of the hall viewed from the north Photo CPAT 5096-006

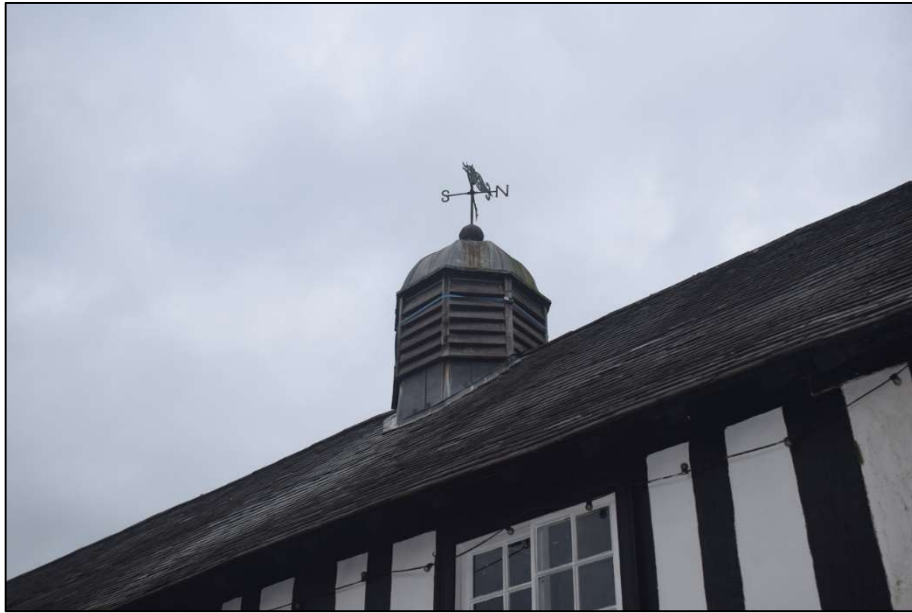
- 3.4. The bell cupola was built in 1838 and rebuilt with slating during the early 19th century (Fig. 5). The stone roof slabs were replaced with slate during the same phase of renovations.

Fig. 5 Bell cupola viewed from the north-east Photo CPAT 5096-007

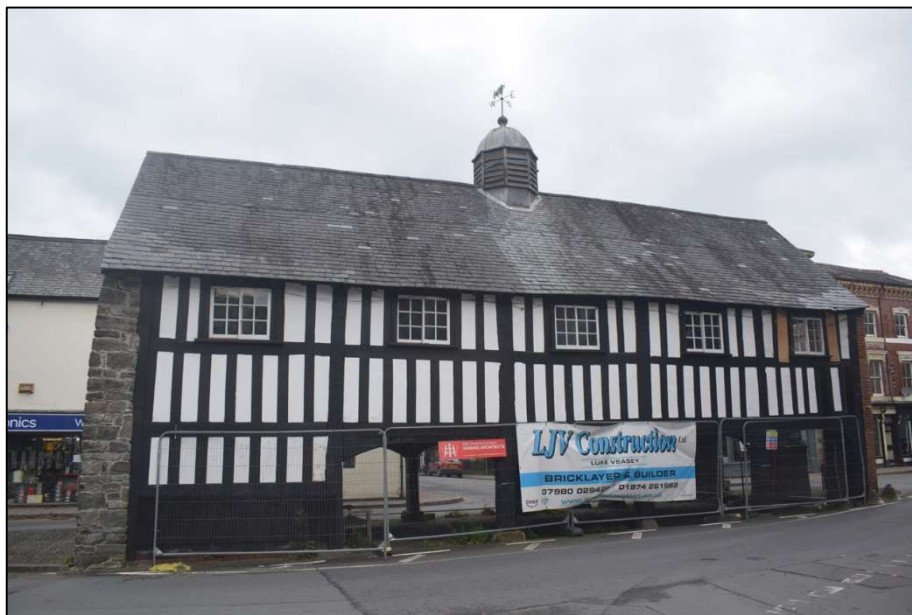
Fig. 6 Hall viewed from the east Photo CPAT 5096-004

- 3.5. The windows in the east and west elevations are of a similar type with protruding framework comprising a mixture of fixed and horizontally sliding frames (Fig. 6). The two windows in the north elevation are larger sash type windows (Fig. 4). The close framed timber superstructure is largely original and tar painted with white infill panels.

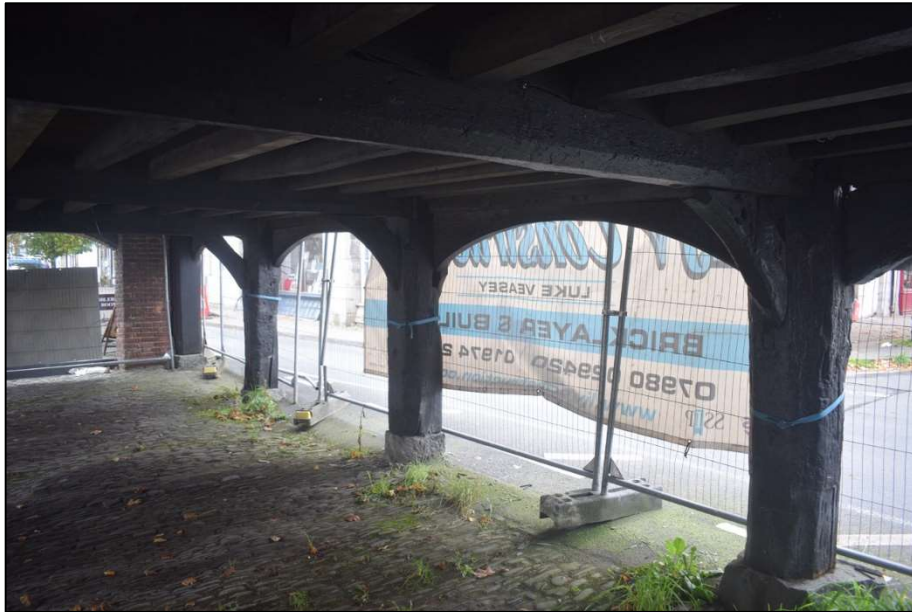
Fig. 7 View north-east across the covered market. Photo CPAT 5096-014

- 3.6. The covered market place was laid with cobbled flooring and accessed from the north, east and west via wide arched openings. The timber vertical posts along the east and west elevations had rotted at the bases, so the affected material had been cut away and the shortened posts mounted on stone blocks. The posts, support members for the ceiling beams and the archways were massive and hand cut and likely original in date, the joists for the upper floor were machine cut and probably modern (Fig. 7).
- 3.7. There was little evidence relating to the use of the area as a market. A single large hanging hook was located on a ceiling beam towards the southern end of the building (Fig. 8).

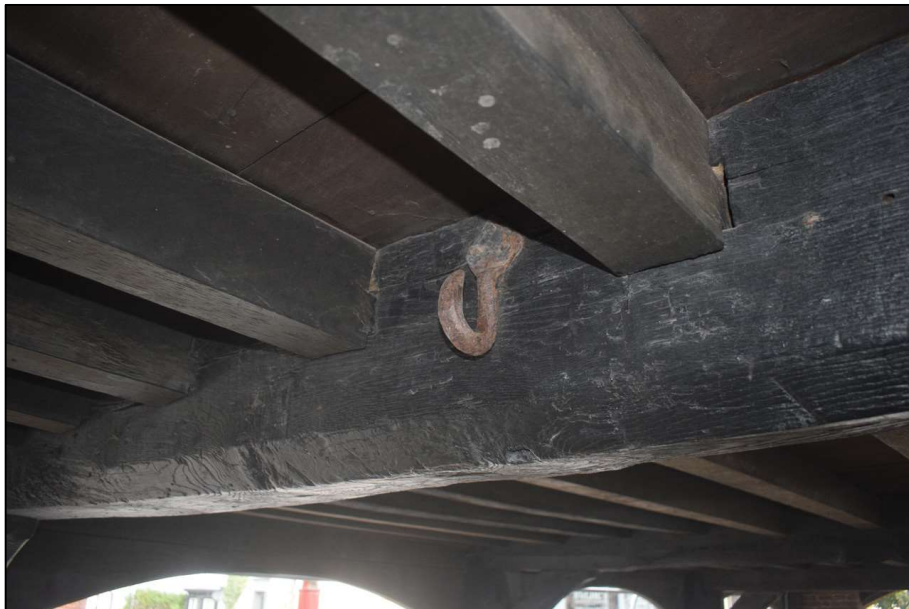
Fig. 8 Hook attached to beam at southern end of covered market. Photo CPAT 5096-019

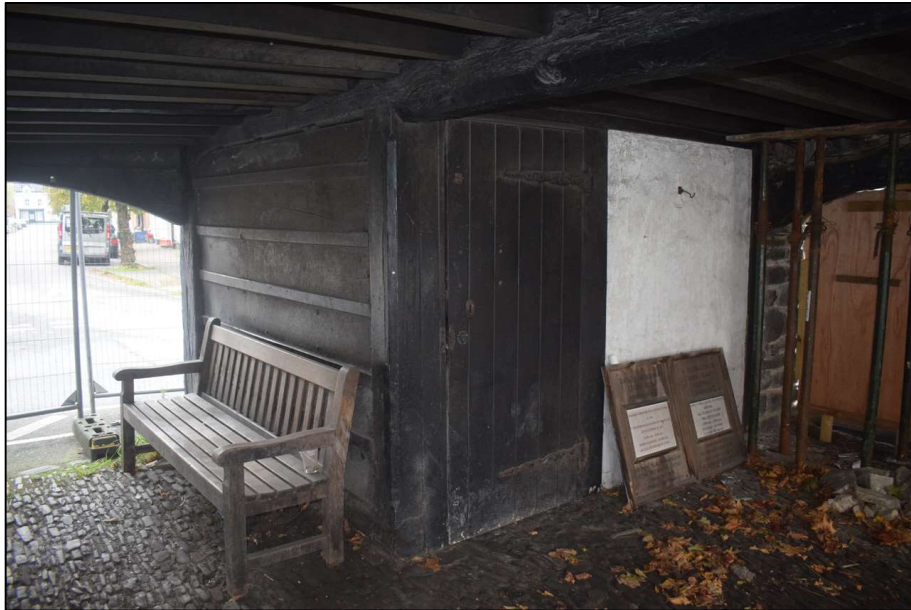
- 3.8. At the southern end of the covered market was an enclosed staircase to the upper floor, accessed via a doorway on the internal facing side (Fig. 9). This had been inset into the earlier fabric and was probably constructed as part of the early 19th century remodelling of the

building. The staircase itself was modern and was rebuilt during the mid-20th century renovations.

Fig. 9 View east towards enclosed staircase. Photo CPAT 5096-020

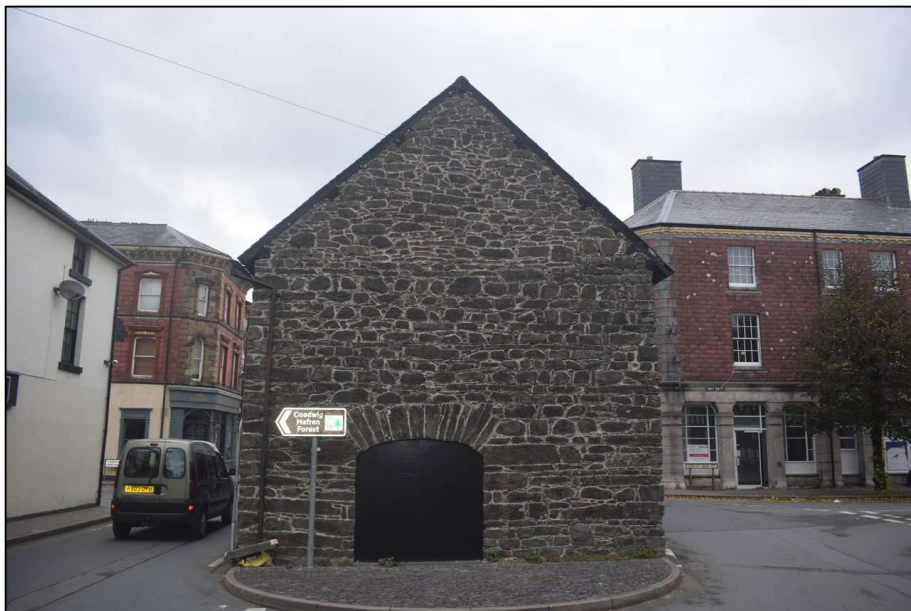
- 3.9. The stone built southern gable end of the building was of uncertain date. It was constructed from random rubble stone blocks laid to courses with quoins at the corners. A wide arched doorway with a stone arch was set somewhat asymmetrically in the elevation. On the internal facing side of the doorway was a hand worked timber lintel. The door itself was no longer present and had been boarded over (Fig. 10).

Fig. 10 South facing elevation of the Hall Photo CPAT 5096-003

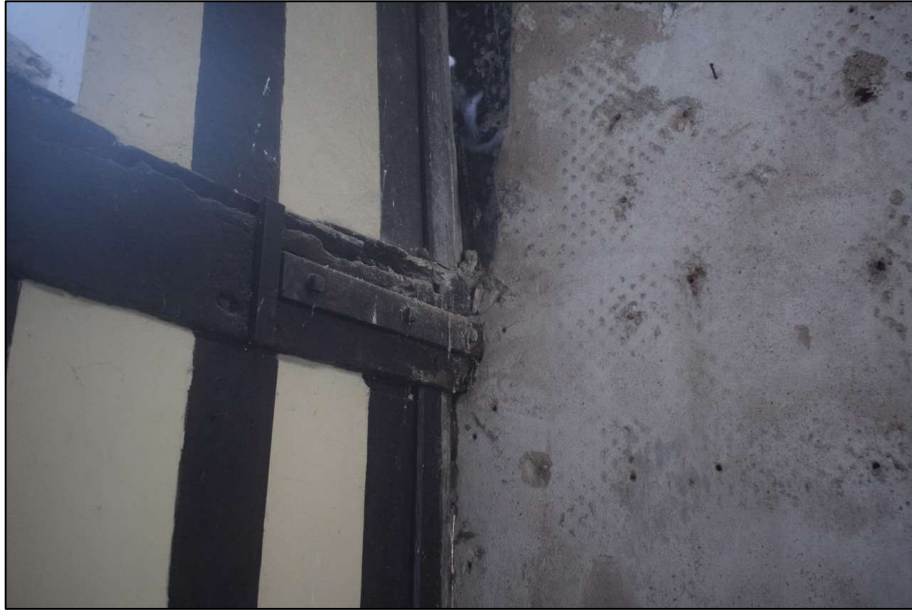
- 3.10. The gable end was attached to the timber framing via large metal brackets (Fig. 11).

Fig. 11 Bracket attaching stonework of the south elevation to the timber frame Photo CPAT 5096-048

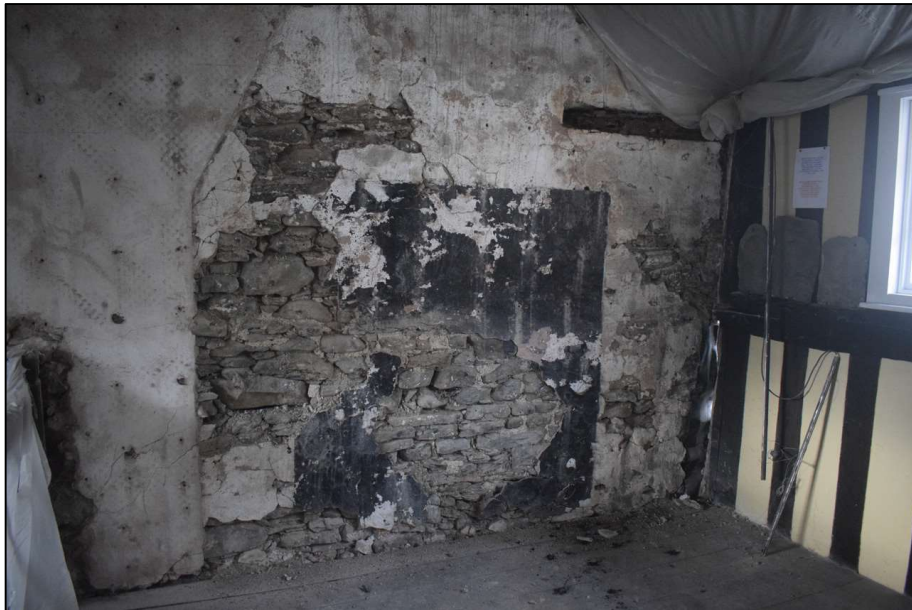
3.11. The upper floor of the hall comprised a large open plan area open to the roof across the south four bays. The northernmost bay had been formed into a separate ceilinged room or office. The internal plasterwork or rendering on the southern gable had blown and the mortaring on the stonework was friable and had fallen out from between the stones (Fig. 12).

Fig. 12 Internal face of the south gable. Photo CPAT 5096-039

In October 2023 the Field Services Section of the Clwyd Powys Archaeological Trust conducted a photographic survey of the Old Market Hall, Llanidloes, in advance of proposed stabilisation and repair works to the south wall,

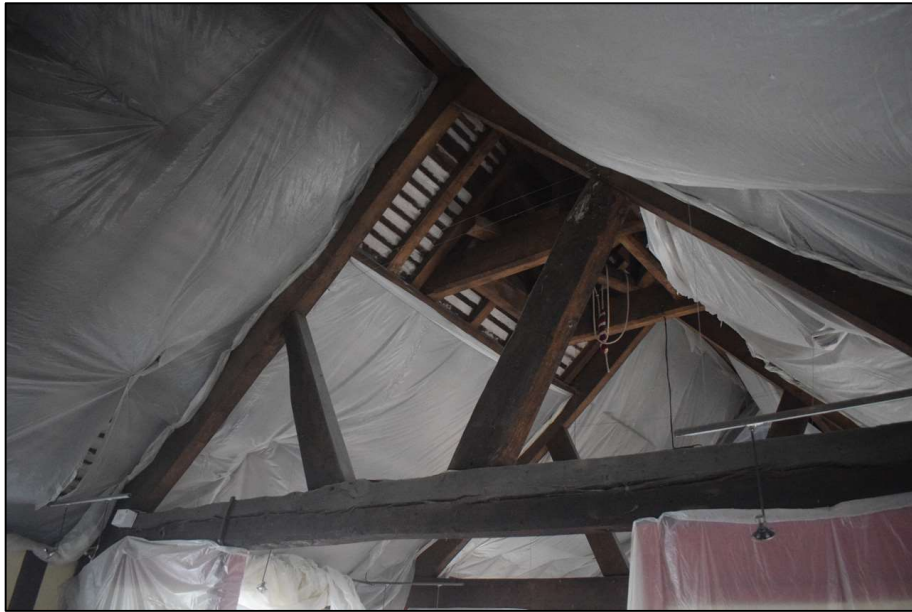
3.12. The roof frame and probably the infill panelling in the wall frames was modern, although one of the struts in Roof Truss 2 (Dwg. 1, Fig. 13) was hand cut and presumably a reuse. Roof Truss 1 was of the queen strut type (Fig. 14), Roof Trusses 2, 3 and 4 were common with angled struts. The roof was open with visible battening which had been torched, presumably with lime render. The flooring was hardwood and also dated to the 20th century reconstruction. The interior framework of the bell cupola and bell rope were visible in the upper roof structure.

Fig. 13 View north of Roof Truss 2 Photo CPAT 5096-027

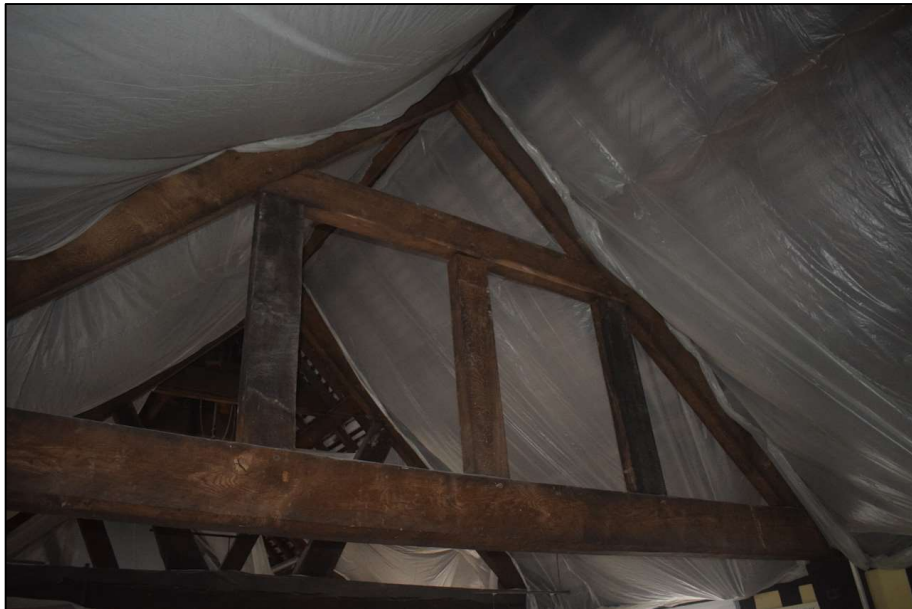
Fig. 14 View south of Roof Truss 1 Photo CPAT 5096-026

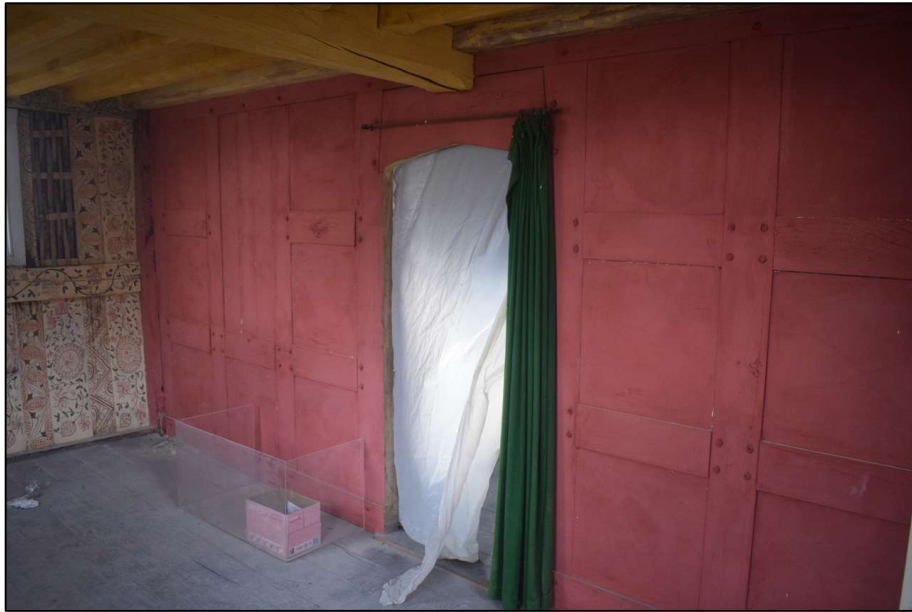
3.13. The room at the north end of the building was separated from the hall via an infilled wooden partition wall (Fig. 15). The door aperture was characteristically pre classical in form with a gently peaked jamb. The ceiling and walls had been painted in various colours and designs presumably during the 20th century. The ceiling beam looked like an original feature but the joists were later replacements.

Fig. 15 View south of the doorway and timber framed partition between the room at the north end of the building and the main hall Photo CPAT 5096-033
