## **Chapel Cottage, Kemeys Inferior, Gwent**

Archaeological Watching Brief

Report No. 1069

Date: **July 2012**

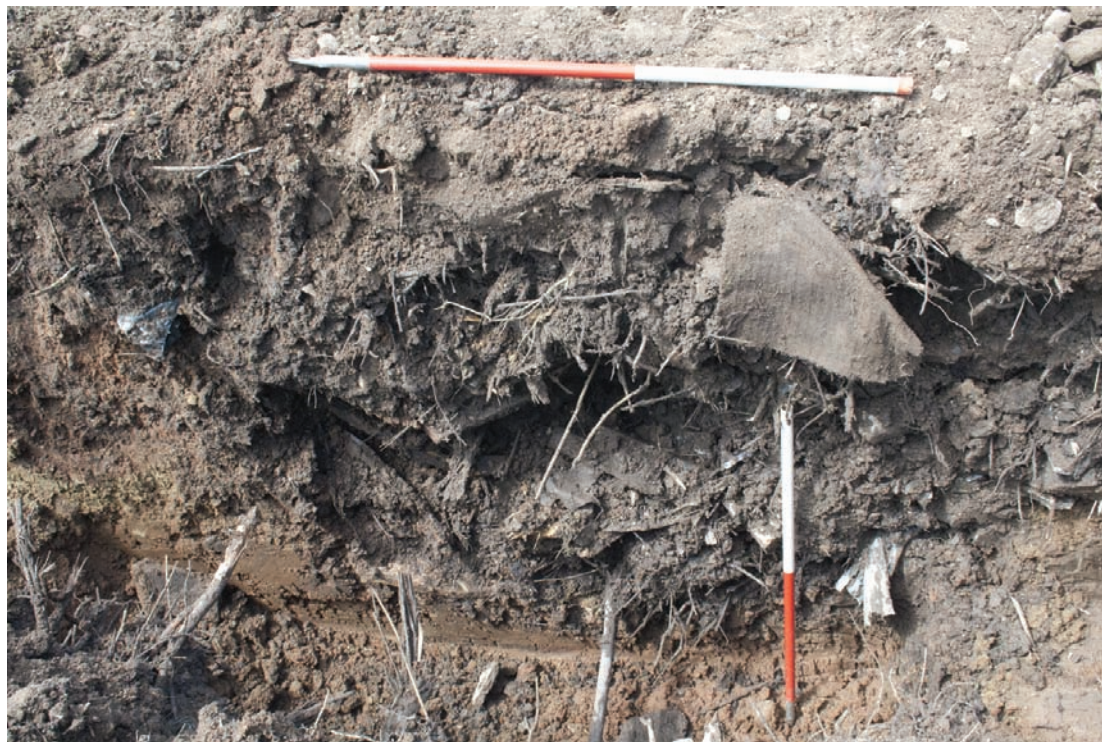
Fig. 4  
Pit filled with modern  
materials at the  
southern end of  
Trench 1

Looking E  
Scale = 1m

**Trench 1** marked the eastern extent of the new building. It was 0.9 to 1.0m wide, 13.4m long, north to south, and ran from the rock outcrop at the north of the site towards the hedgerow forming the southern boundary at Coed y Caerau Lane (fig. 2 and 3). The depth of the trench varied as the underlying geology dictated. The northern most extent comprised shallow bedrock that had to be partially cleared in order to facilitate excavation. The remainder of the trench was approximately 1.1m deep, although a section 1.5m from the southern end was excavated to a depth of 1.7m to remove a pit containing burnt modern building material, a plastic water pipe and tree roots (figs. 3 and 4). The uppermost context of this trench in section comprised 0.45m of a grey-brown silt comprising fragments of demolition debris. Underlying this was 0.75m-0.9m of a mid-brown gritty clay which did not contain any archaeological material. This clay deposit overlay the bedrock.

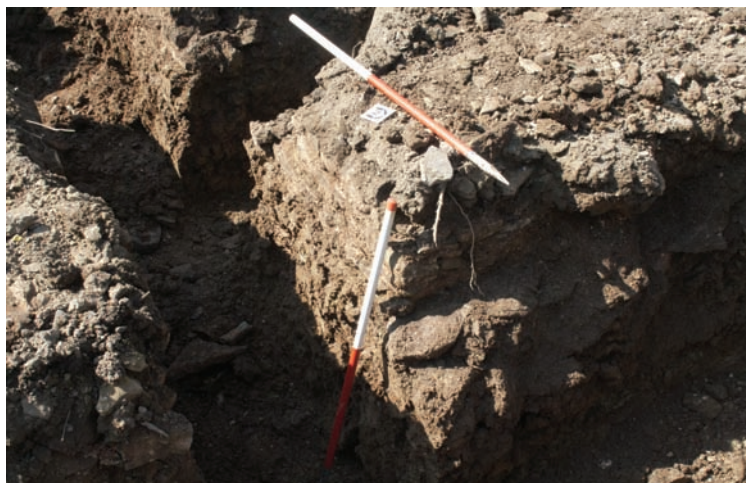
Corner wall section A  
(Intersection of trench 6  
and 4). Looking SW

Fig. 5  
Wall sections A and  
B in trenches 4 and  
6.

**Trench 4** was located north of trench 3 and also ran east to west from trench 1 for a length of 15m, parallel with and 10m north of trench 2 (fig. 3). After the bedrock encountered in the west end of this trench was broken the trench was 1.1m-1.3m deep throughout its length. A 0.5m corner section of stone-wall (fig. 3) was observed in the north facing section, where the trench forms a junction with trench 6 (see below). The return was observed in trench 6. The 0.45m wide wall, comprising five courses of stone (0.06m-0.1m wide and 0.15m-0.2m long) was 0.4m deep and bonded by white/yellow lime mortar (see fig. 5). The base rested on flatter stones 0.4m below the prepared ground level. No further foundation levels were observed below this level. The fact that this wall was so near the current ground surface suggests that they must be associated with a phase of the previous house.

**Trench 6** which ran parallel with trench 1 (fig. 3), was 13.5m long, 1.1m deep, 0.8-0.9m wide and extended north to south from the rock face (trench 5) towards Coed y Caerau Lane (trench 2). It was intersected along its length by trenches 3, 4 and 7. A section of the stone wall (see above) was discovered at its junction with trench 4. The wall could be clearly seen along the east-facing section of this trench, especially between its junctions with trenches 4 and 7 (fig. 5). The wall was as described above. Less clearly preserved wall remains were observed along the southernmost 5m of trench 6.

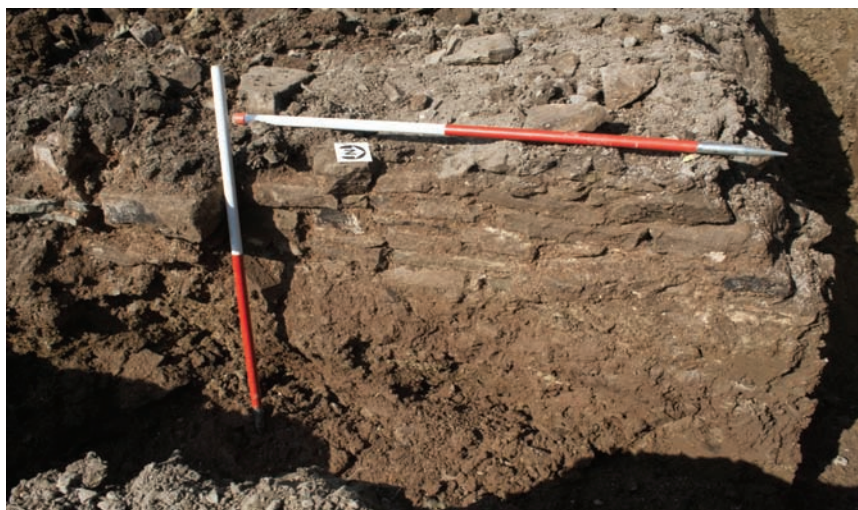
Wall section B (trench 6).  
Looking W

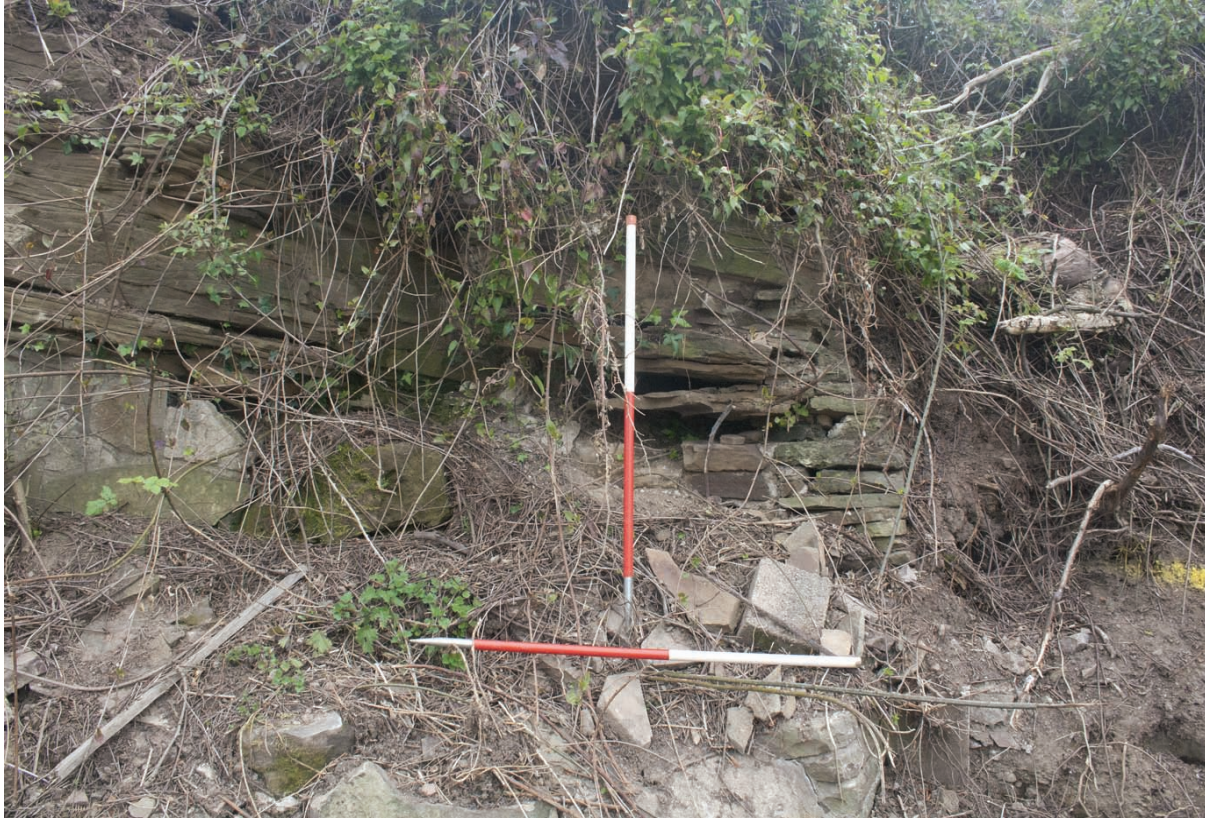
Fig. 6  
Rock outcrop north  
of the dwelling with  
sections of  
incorporated walls

Looking N  
Scale = 1m

A number of north to south and east to west trenches were excavated to provide footings for the new dwelling, which is to be larger than the previous (demolished) building. Sections of bonded and dry stone walls were identified, incorporated into

the quarried rock face at the northern end of the site, presumably an attempt to avoid flooding and slippage in the past (fig. 6).
