Letterston School, Pembrokeshire

Archaeological Watching Brief

Report No. 1014

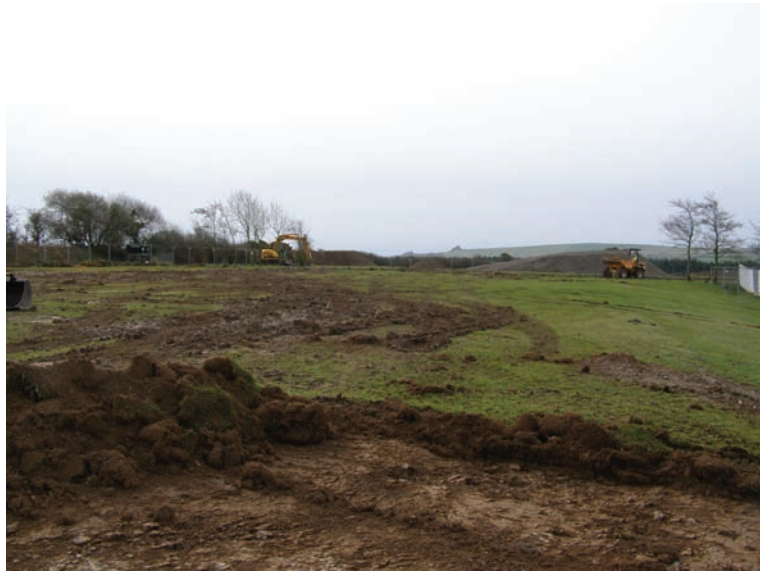
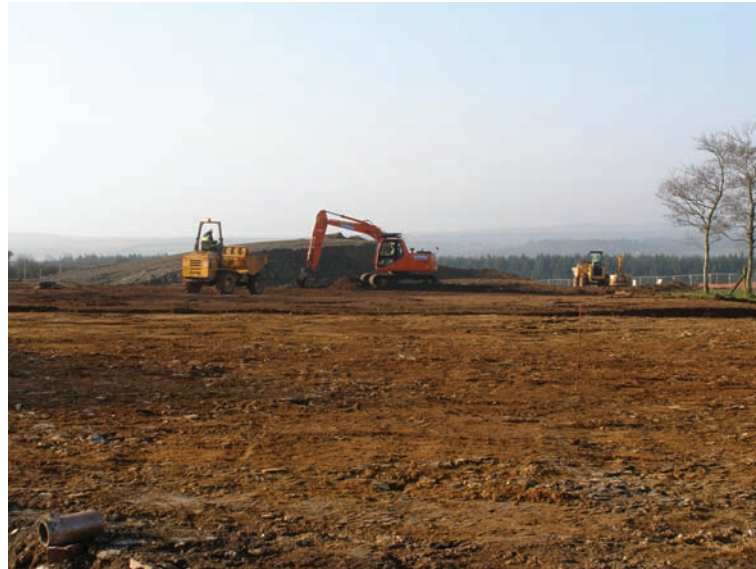
Fig. 3
The site prior to and
during the topsoil
strip
