## **West Lodge, Bute Park, Cardiff**

Archaeological Watching Brief

Report No. 1042

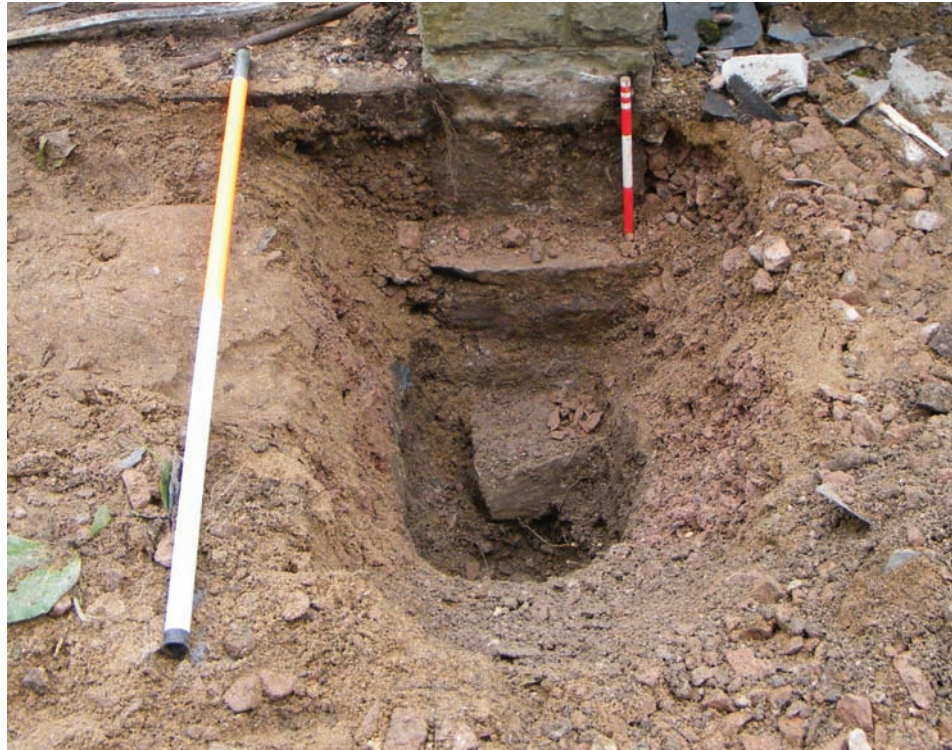
Fig. 3  
Trial pit 1

Trial Pit 1 was located towards the centre of the courtyard to the east of the Lodge (fig. 2). It measured 1m in length, 0.75m wide and was excavated by hand to a depth of 0.9m. The upper 0.4m of the trial pit comprised modern scalpings, which overlay a thick layer of twentieth century rubble (fig. 3). This was excavated to a depth of 0.5m. On the western side of the trial pit, within the rubble layer, the footings for the adjacent wall were identified. No features of archaeological significance were revealed.

North-facing Section through Trial Pit 1

Trial Pit 1 looking west. Scale = 1m and 0.5m

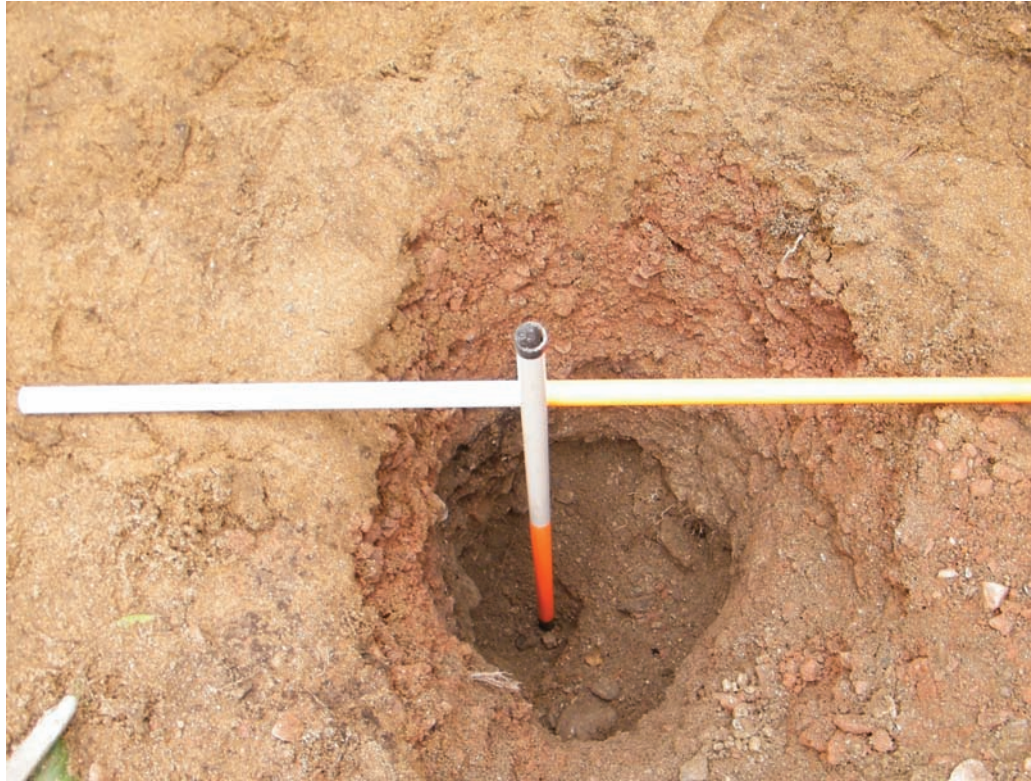
Fig. 4  
Trial pit 2

Trial Pit 2 was also located in the courtyard, 5m to the south of Trial Pit 1 (fig. 2). It measured 0.8m long by 0.55m wide and was excavated by hand to a depth of 0.9m (fig. 4). The upper 0.3m of the trial pit comprised modern scalpings, with a thick deposit of twentieth century rubble below. This was excavated to a depth of 0.6m. No features of archaeological significance were identified.

North-facing Section through Trial Pit 2

Trial Pit 2 looking west. Scale = 1m

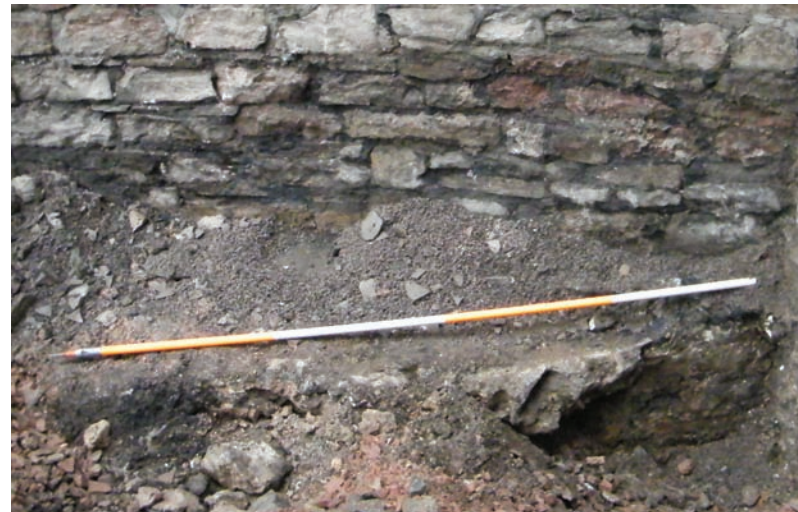
Fig. 5  
Trial pit 3

Trial Pit 3 was located on the southern side of the courtyard, adjacent to the eastern wall of the Lodge (fig. 2). It measured 2m long, 0.5m wide and was excavated to a depth of 0.5m. The upper 0.2m comprised modern scalpings, which overlay a thick deposit of twentieth century rubble. This was excavated to a depth of 0.3m. No features of archaeological significance were revealed.

Trial Pit 3 looking west. Scale = 1m

West-facing Section through Trial Pit 3

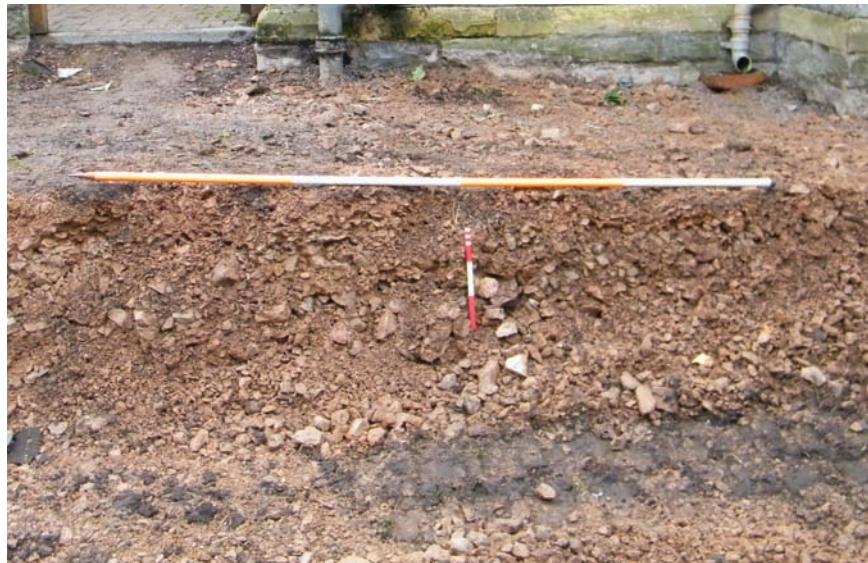
Fig. 6  
Section 1

A trench was dug through an area of hardstanding, immediately to the north of the Lodge, from which a 2m length of section was recorded. The trench was orientated east/west and cut through the original paved surface. Below the paving was a thick deposit of modern scalpings. This was excavated to a depth of 0.65m. No features of archaeological significance were identified.

North-facing Section through Section 1

Section 1 looking east. Scale = 1m

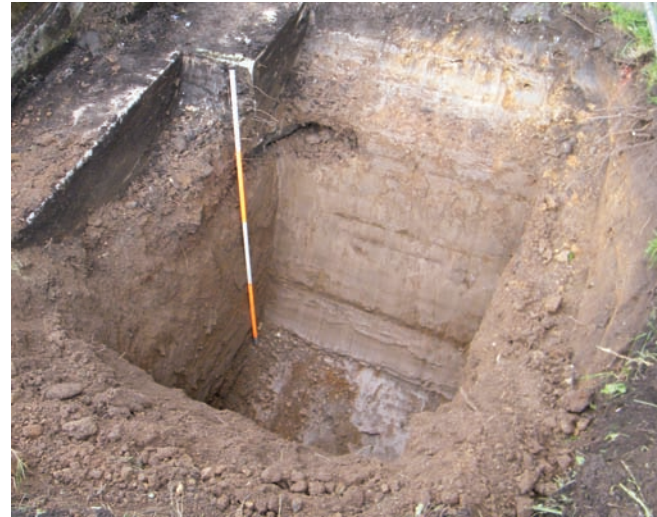
Fig. 7  
Soakaway trench

Soakaway trench 1 was located on the north-eastern edge of the Lodge site (fig. 2). It measured 2.3m long by 2.1m wide and was excavated to a depth of 2m (fig. 7). Below the topsoil was a thin deposit of orange brown silty clay, 0.2m deep, which overlay the grey/brown silty clay natural. This was excavated to a depth of 1.8m. No features of archaeological significance were identified.

West-facing section through soakaway trench

Soakaway trench looking south-east. Scale = 2m
