Medieval Town Defences (MG023) Tan-y-Mur, Montgomery, Powys

Archaeological Watching Brief & Evaluation

Report No. 1279

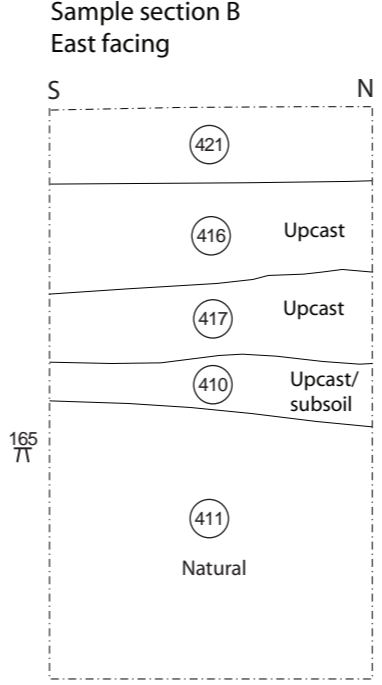
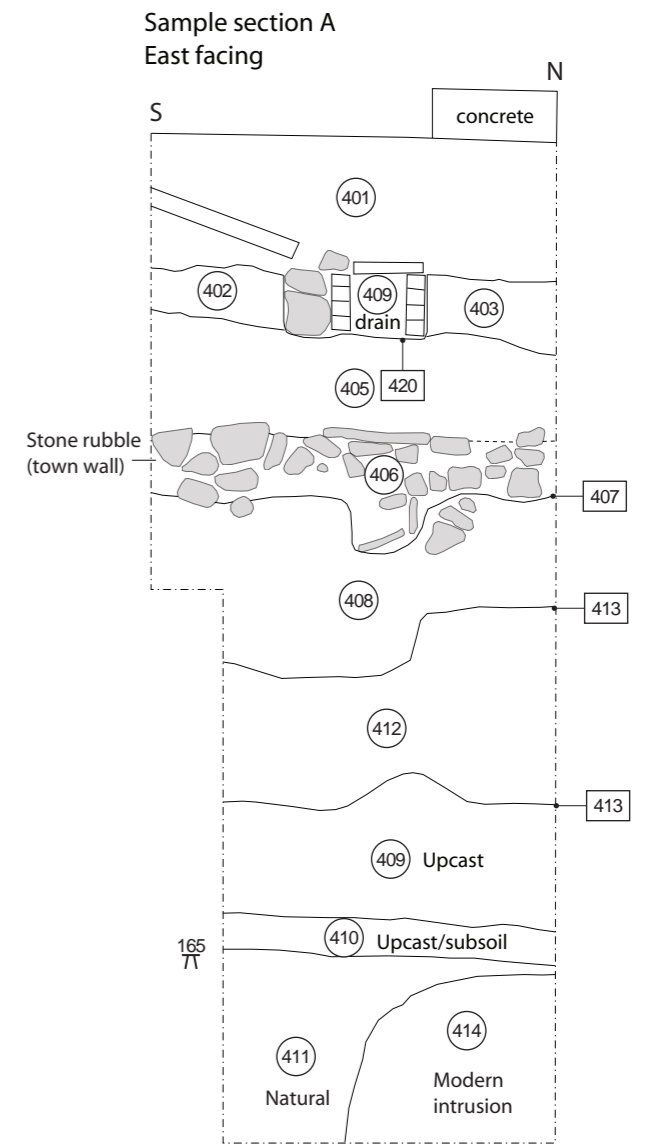
Montgomery town ramparts
East facing section

Fig 6: Illustrations showing face of town bank after topsoil/overburden removal as well as detail of sondages A-D

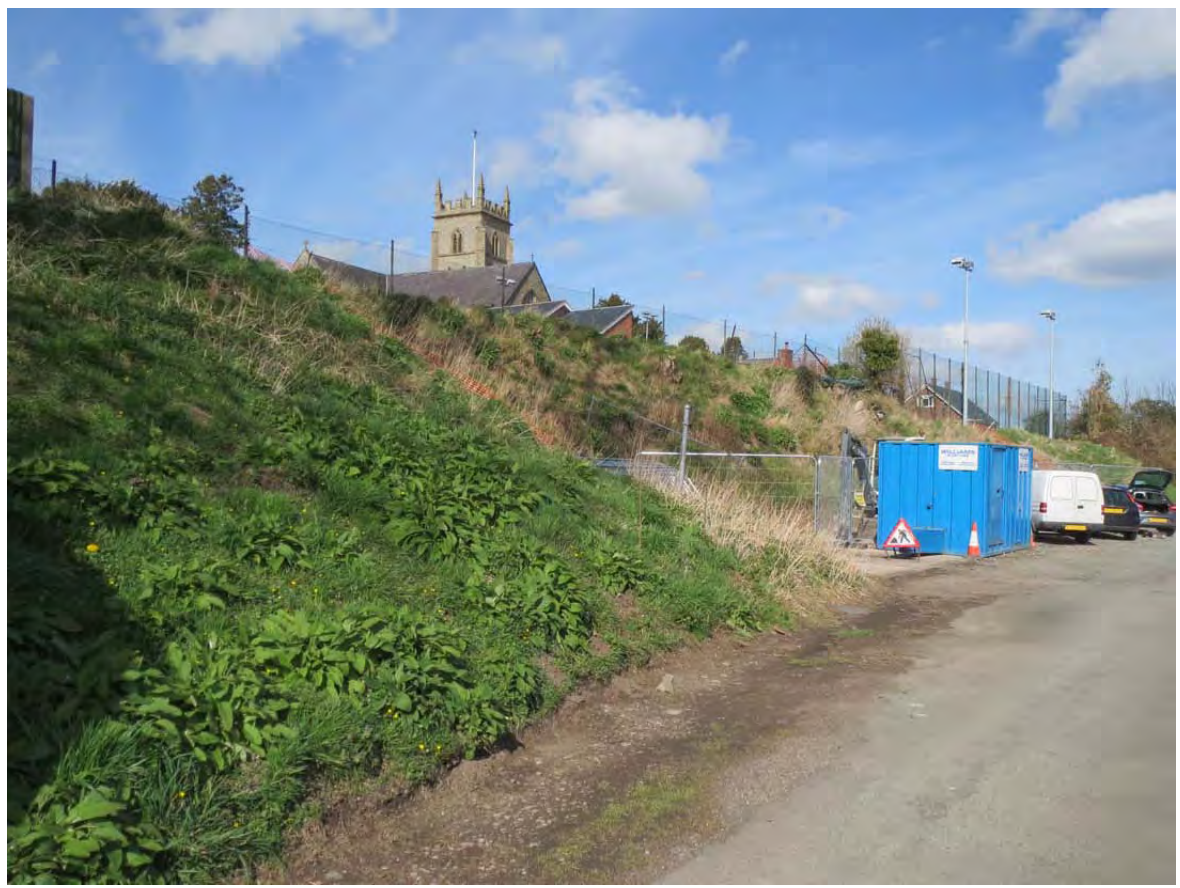
Plate 1: General view of medieval town bank. Looking north north west

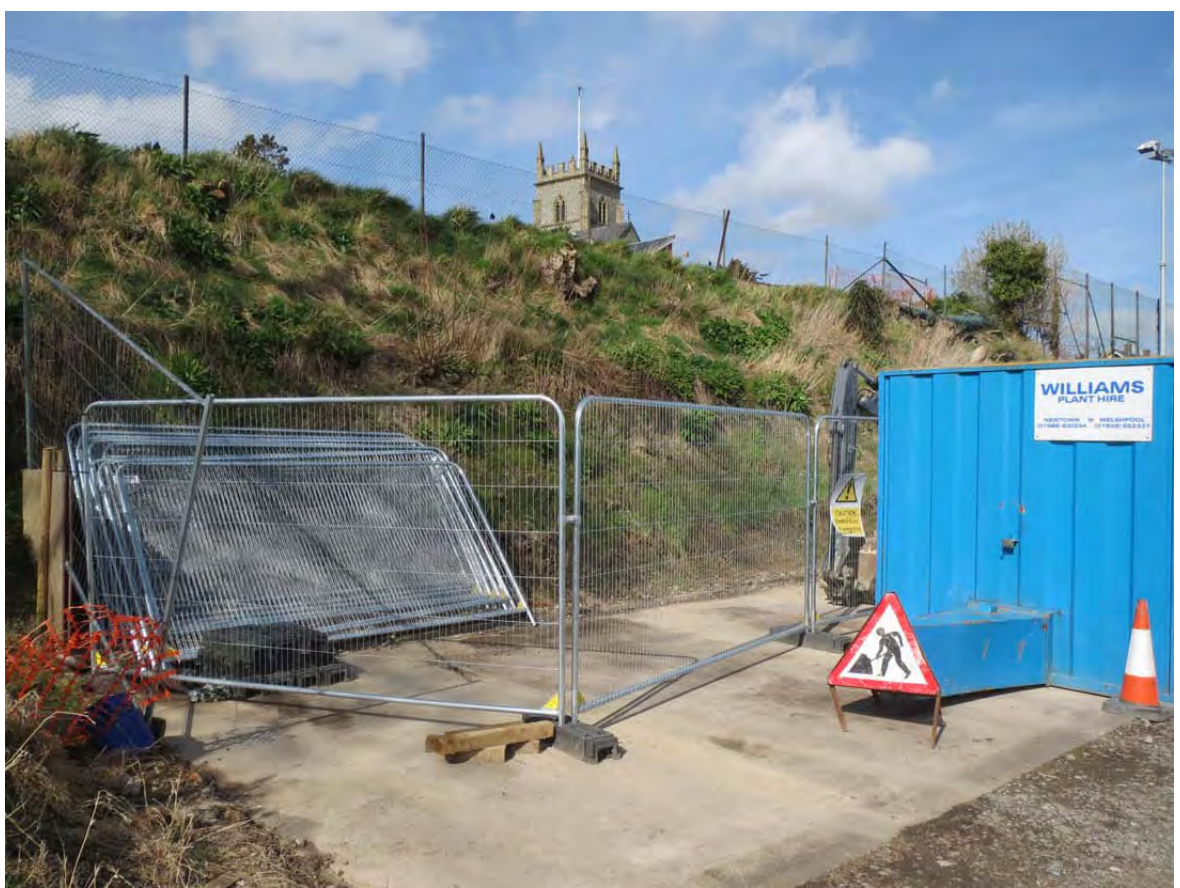
Plate 2: View of cutting into medieval bank for garages (demolished). Looking north north west

- 1.1.2 The work was undertaken after a section of the medieval town defences slumped following the failure of a land drain. The slumping of bank material resulted in damage to a garage structure at the base of the bank. In order to make the area safe, the garages were to be removed and the bank restored to its original profile.

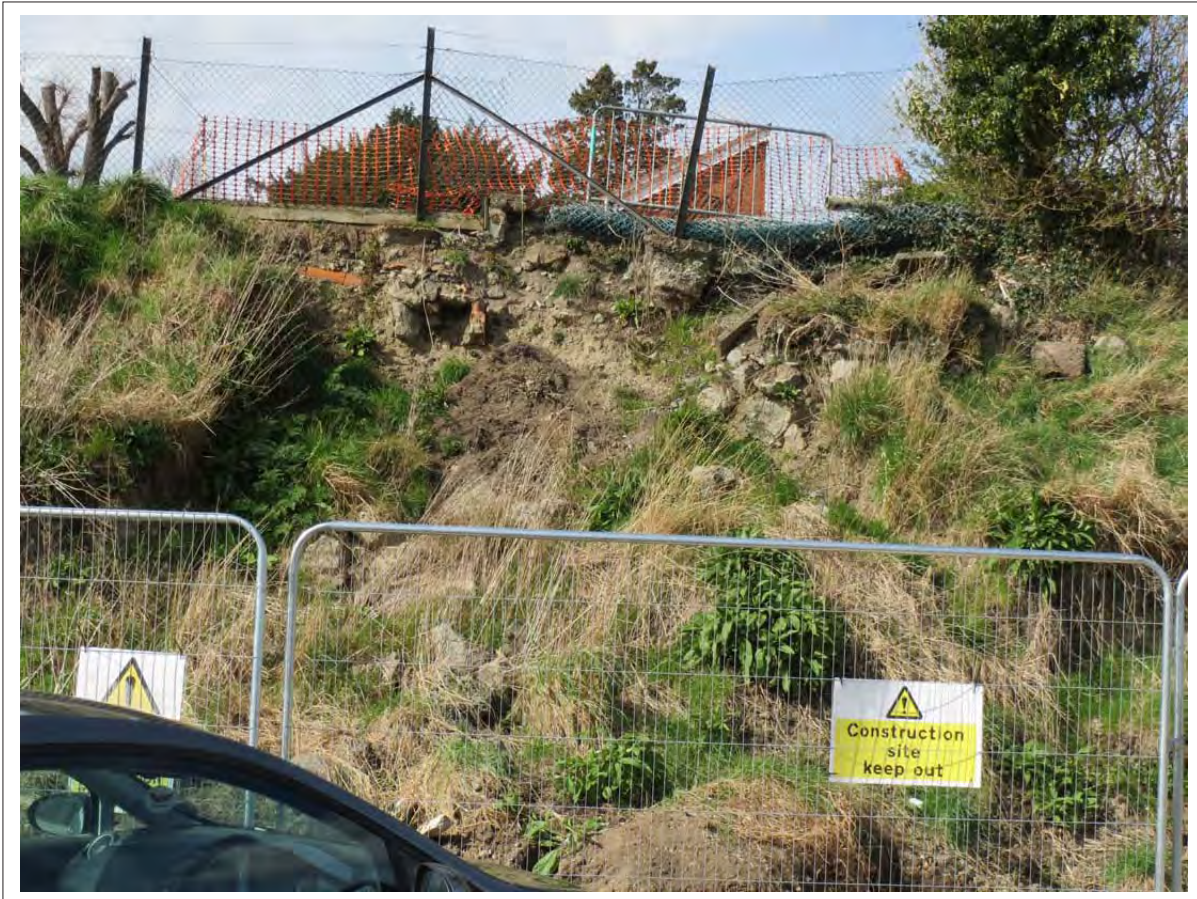
Plate 3: Area of landslip/slumping at the top of the bank, below the eastern edge of the bowling green. Looking west

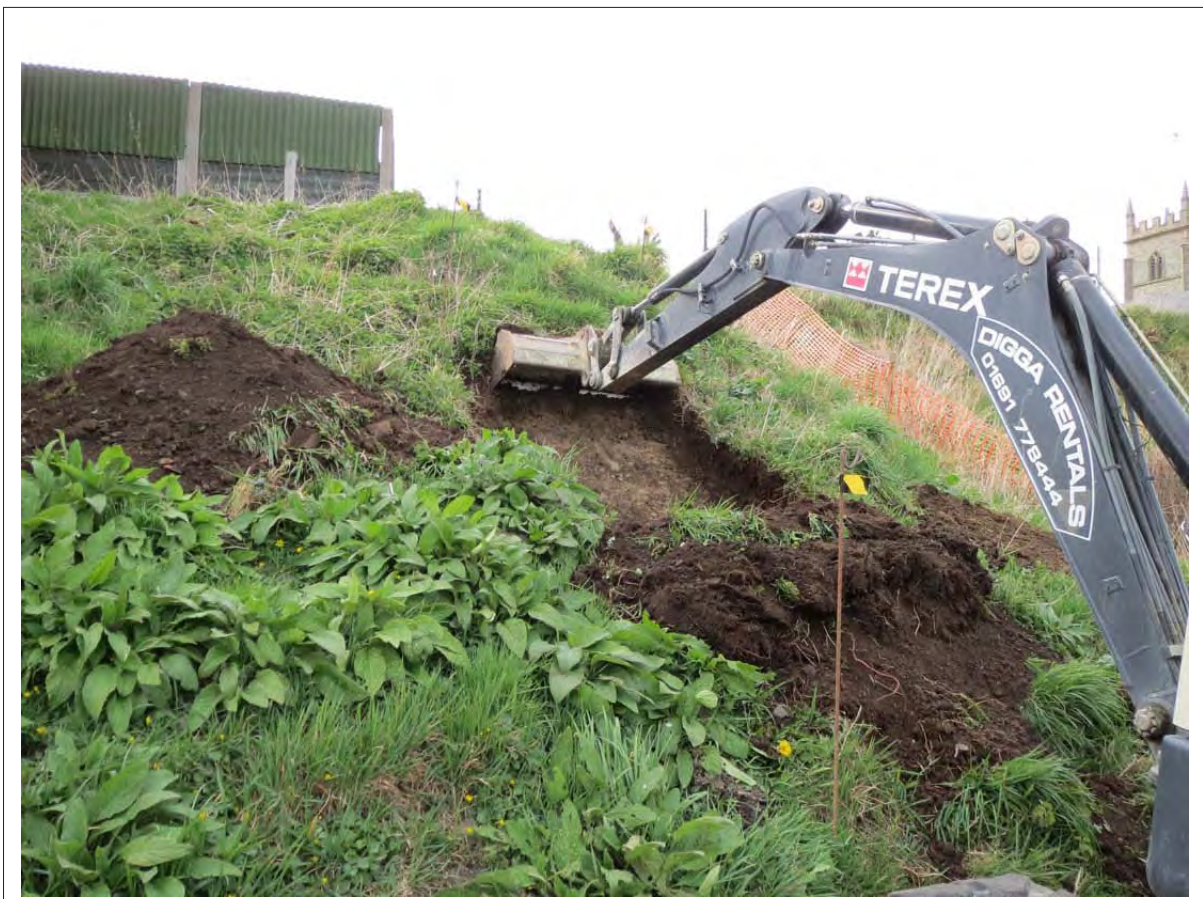
Plate 4: Working shot of excavation of trench 1. Looking west north west

- 4.2.1 Trench 1 (Figs 3, 3a&4, Plates 4-6) was located to the south of the former garage block. This was aligned east-west. The trial trench was approximately 3.9m long and 1.6m wide. The excavation depth was between 0.9m and 1.4m.
- 4.2.2 The deposits recorded within Trench 1 consisted of redeposited topsoil (101) (104) and redeposited (natural) subsoil (102) (103) (105) above a layer of disturbed or redeposited natural (106). The five layers of redeposited soil all contained modern material.

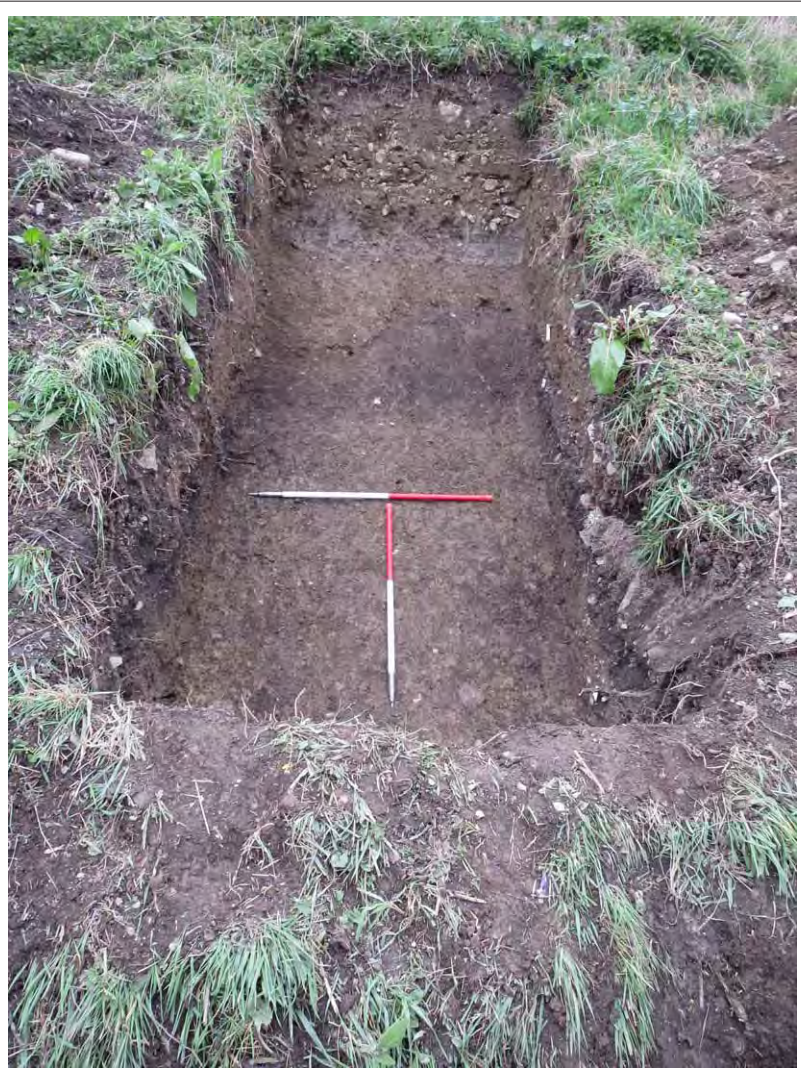
Plate 5: Post-excitation shot of trench 1. Scales 2x1m
Looking west

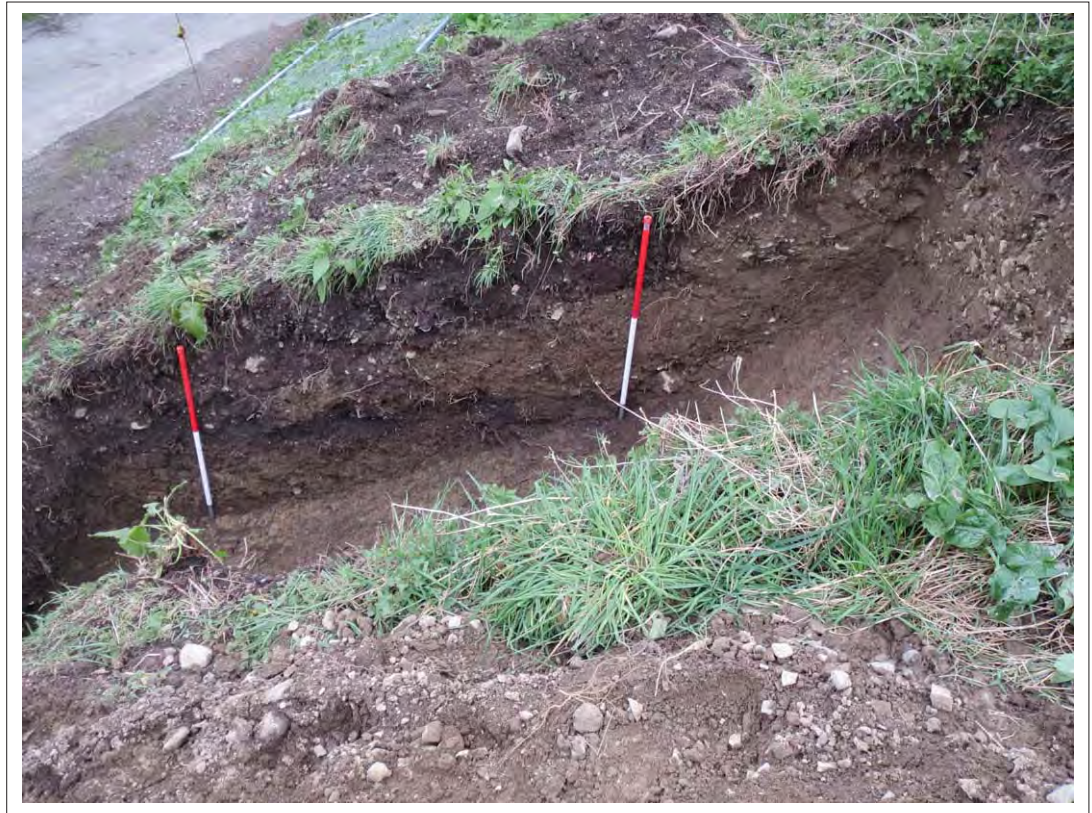
Plate 6: North facing section of trench 1, Scales 2x1m. Looking south

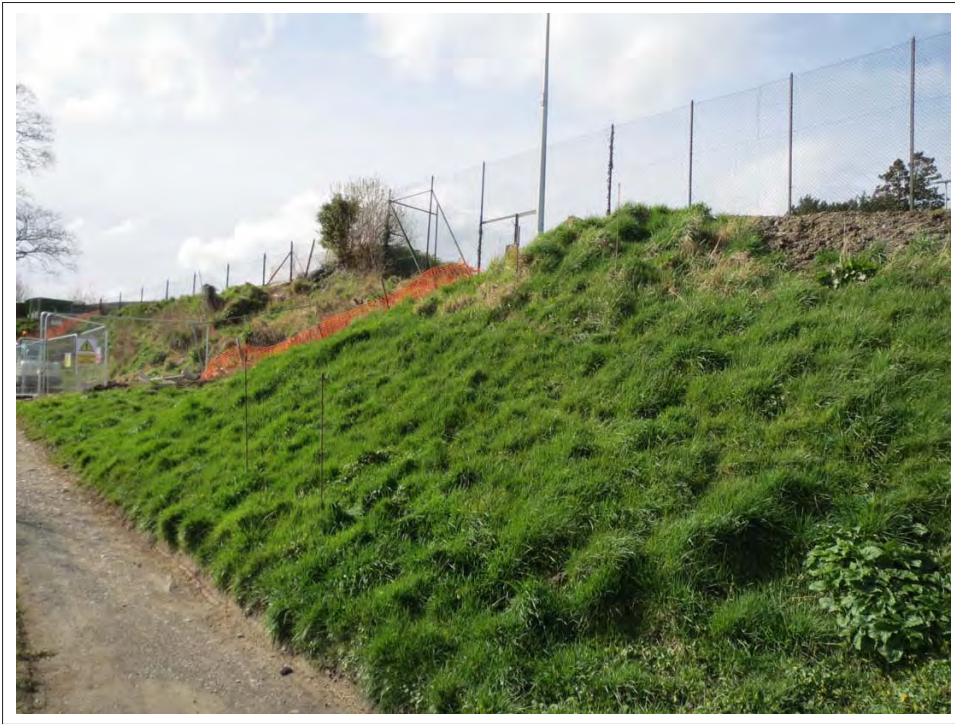
Plate 7: Pre-excitation shot of trench 2. Looking south west

- 4.3.1 Trench 2 (Figs 3, 3a&4, Plates 7-9) was located to the north of the former garage block. This was aligned east-west. The trial trench was approximately 3.6m long and 1.6m wide. The excavation depth was between 0.6m and 1.5m.
- 4.3.2 The deposits recorded within Trench 2 consisted of redeposited topsoil (201) and redeposited (natural) subsoil (202) (203) (204) (205) above a buried topsoil (206). All six layers of redeposited or disturbed soil contained modern material.
- 4.3.3 The deposit encountered at surface (201) comprised a dark brown gravelly silty clay

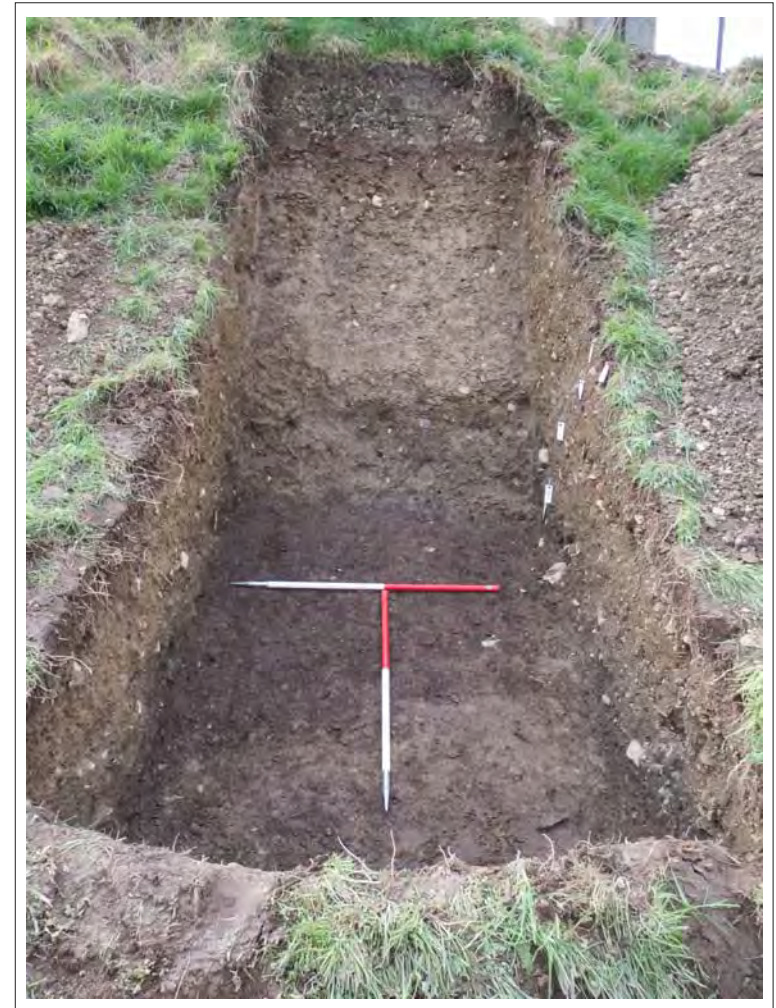
Plate 8: Post-excitation shot of trench 2
Scales 2x1m, Looking west

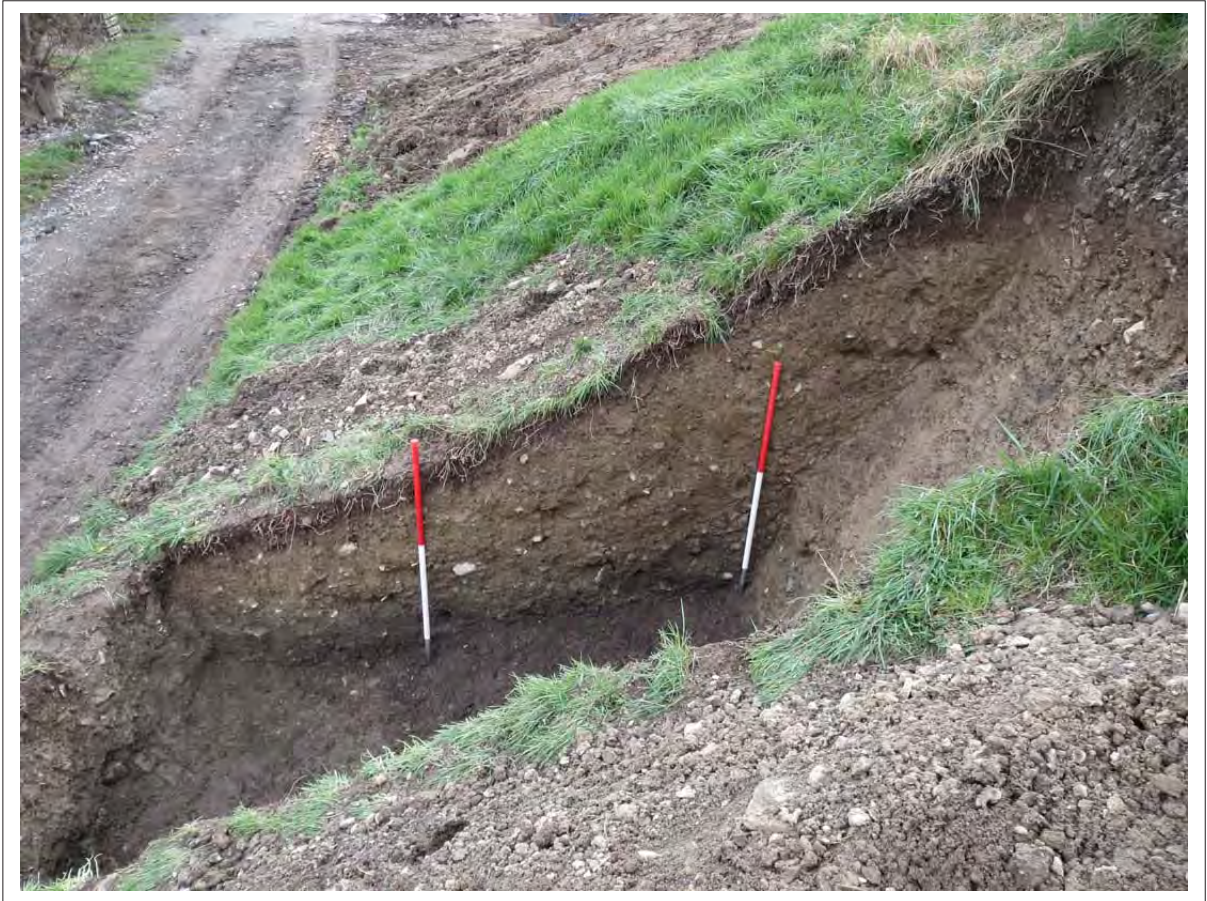
Plate 9. North facing section of Trial Trench 2. Scale 2x1m. Looking South.

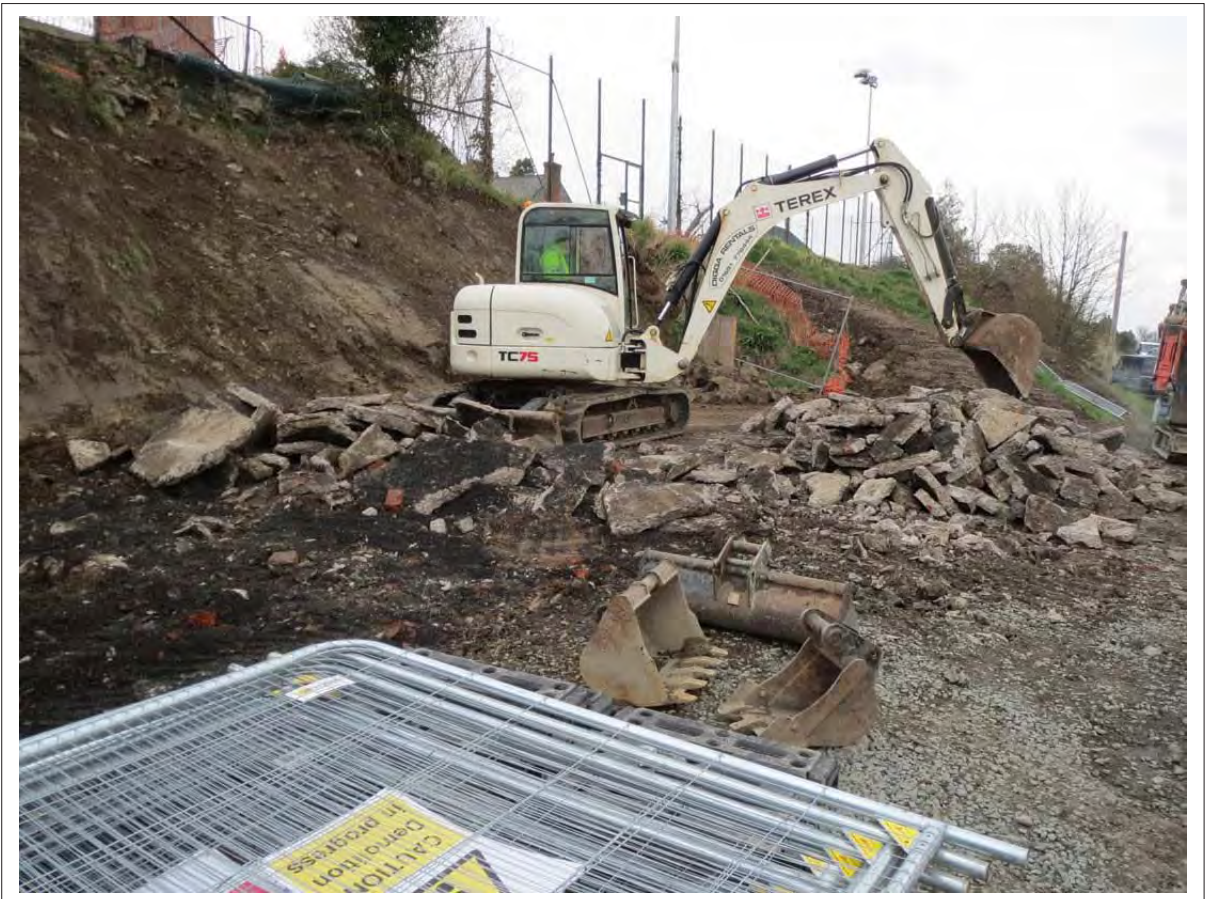
Plate 10. Removal of concrete slab at location of former garages. Looking North-North-West.

Removal of the garage foundation slab revealed the surface of the silted-up medieval town ditch, which ran parallel with the town bank. The upper fills appeared to be late 19th or early 20th century in date.

5.2 Slab Removal and Soil Strip (Figs 3, 3a&5, Plates 10-31)

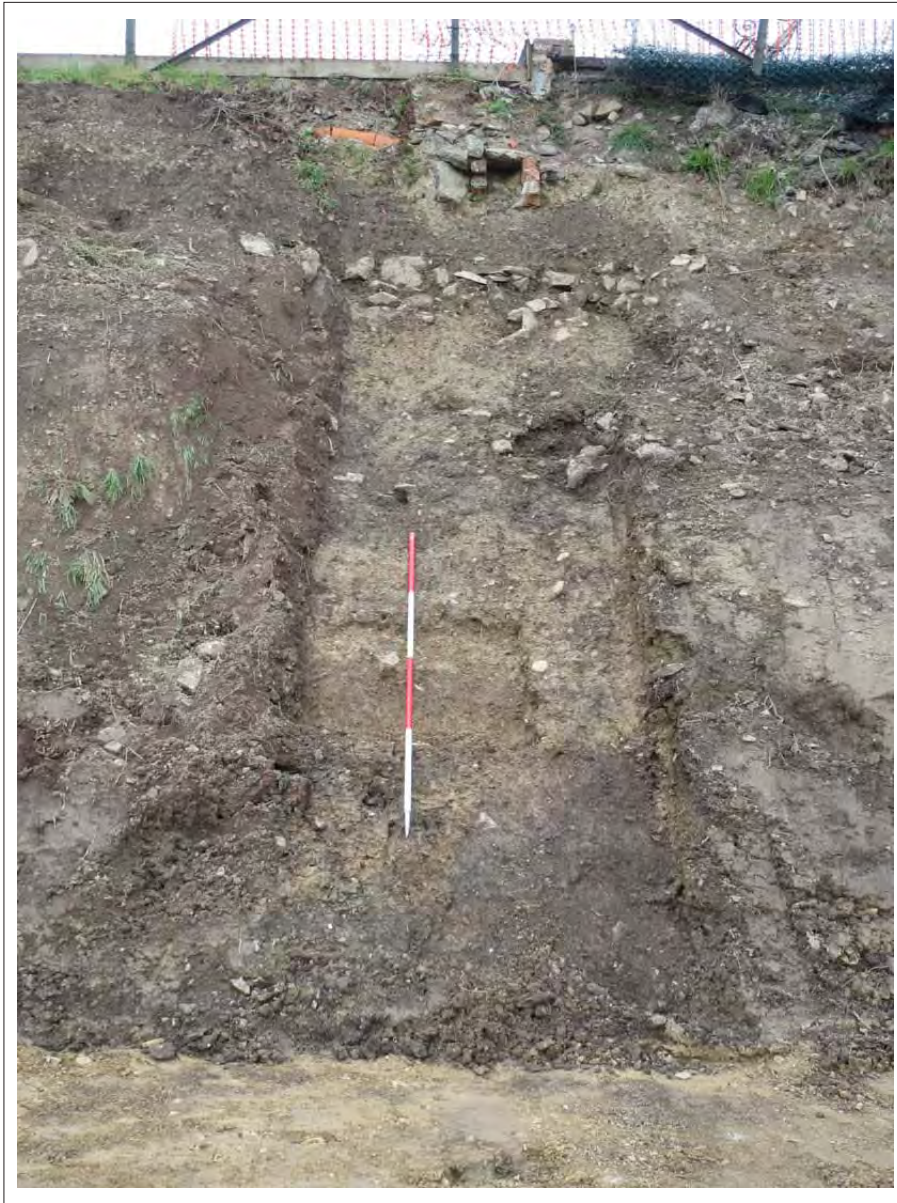
Plate 11. East facing section of medieval bank (Sample Section A). Scale 1x2m (laid flat on sloping section). Looking West.

- 6.2.1 The exposed section of the bank, resulting from a failed drain, formed the upper part of Sample Section A. The bank below the landslip was machine excavated to remove loose overburden and subsequently cleaned by hand to expose the construction of the medieval town defences. The overall height of this section was 5.3m.

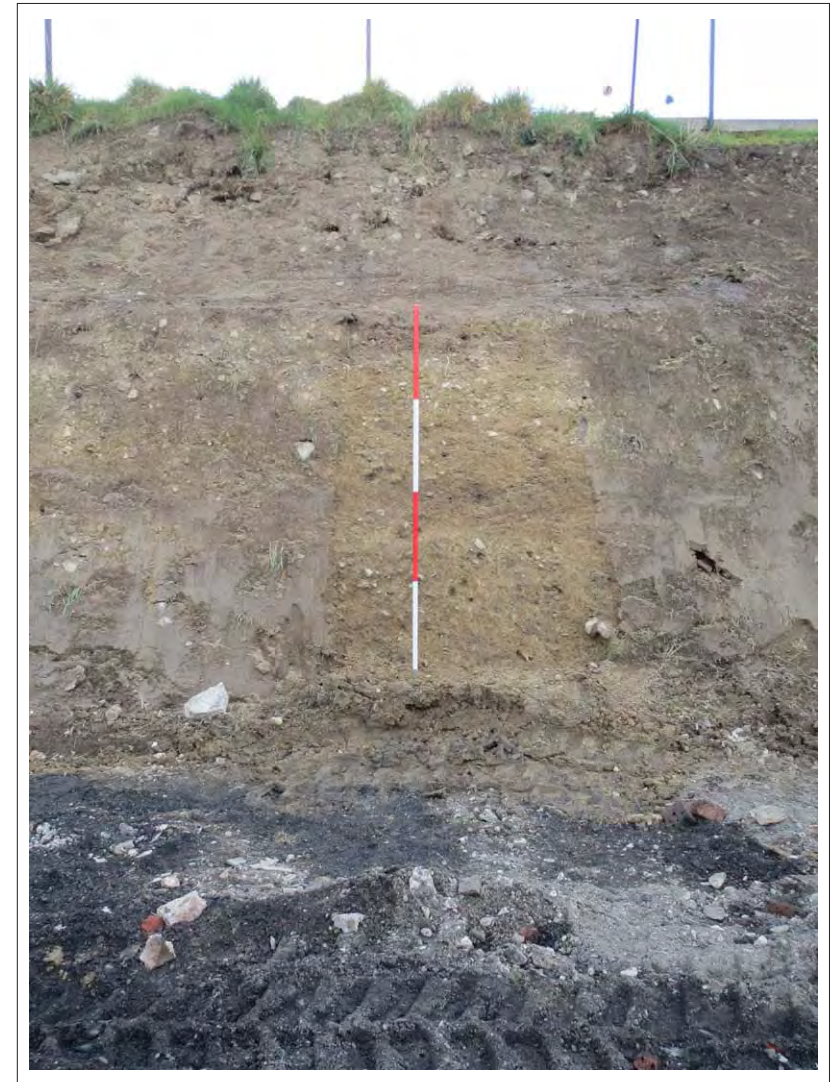
Plate 14. East facing section of medieval bank (Sample Section B). Scale 1x2m. Looking West.

- 6.1.1 Modern overburden on the bank to the rear of the former garage block was stripped by machine. Four areas were hand cleaned to create sample sections (A-D) along this truncated (29m long) part of the medieval bank (Figs 3, 3a&6, Plates 10-31). The upper part of Section A was located within an eroded part of the bank. This section was extended down the bank to expose the entire escarpment that formed part of the medieval town defences. The upper part of the bank had elsewhere been severely truncated when the garages were constructed; these areas had been backfilled with redeposited topsoil (421), as recorded in Sample Sections B-D.

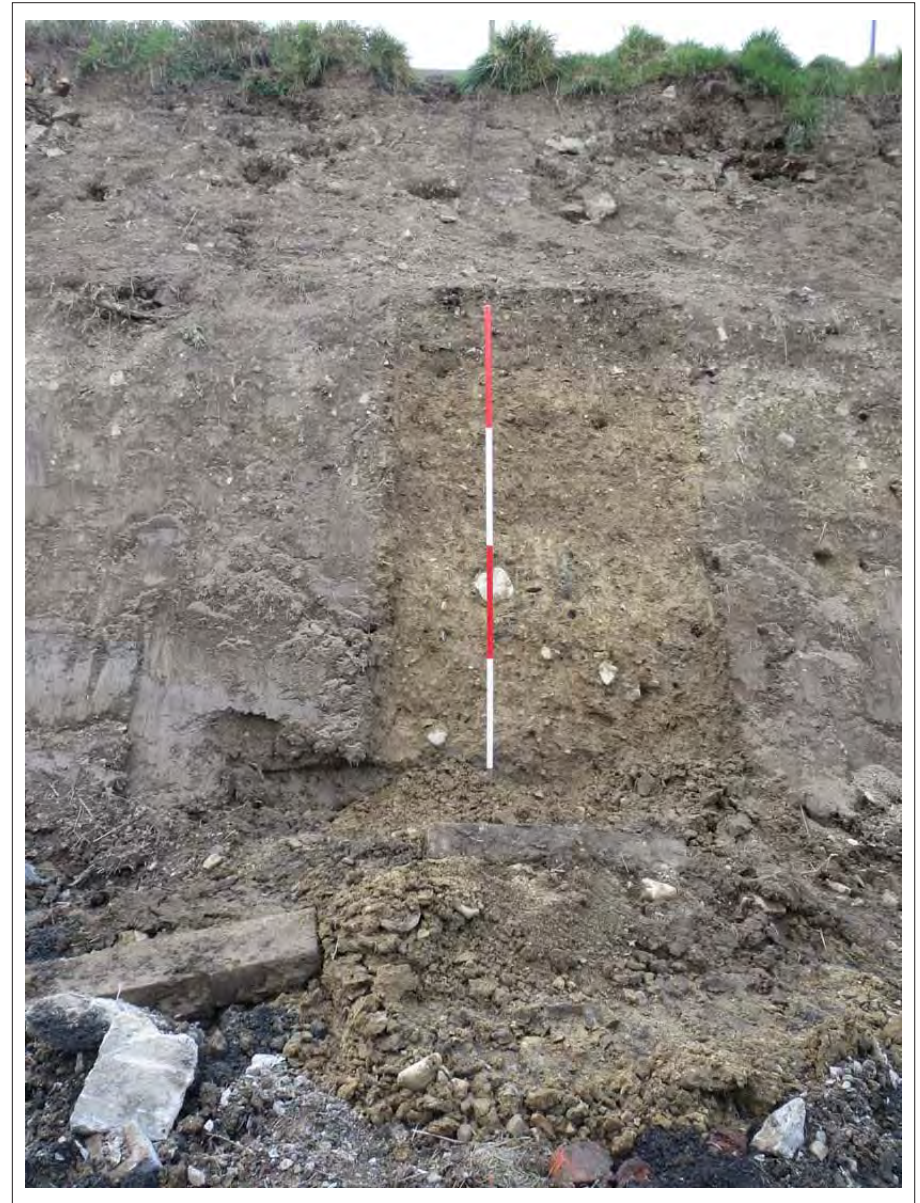
Plate 16. East facing section of medieval rampart (Sample Section C). Scale 1x2m. Looking West.

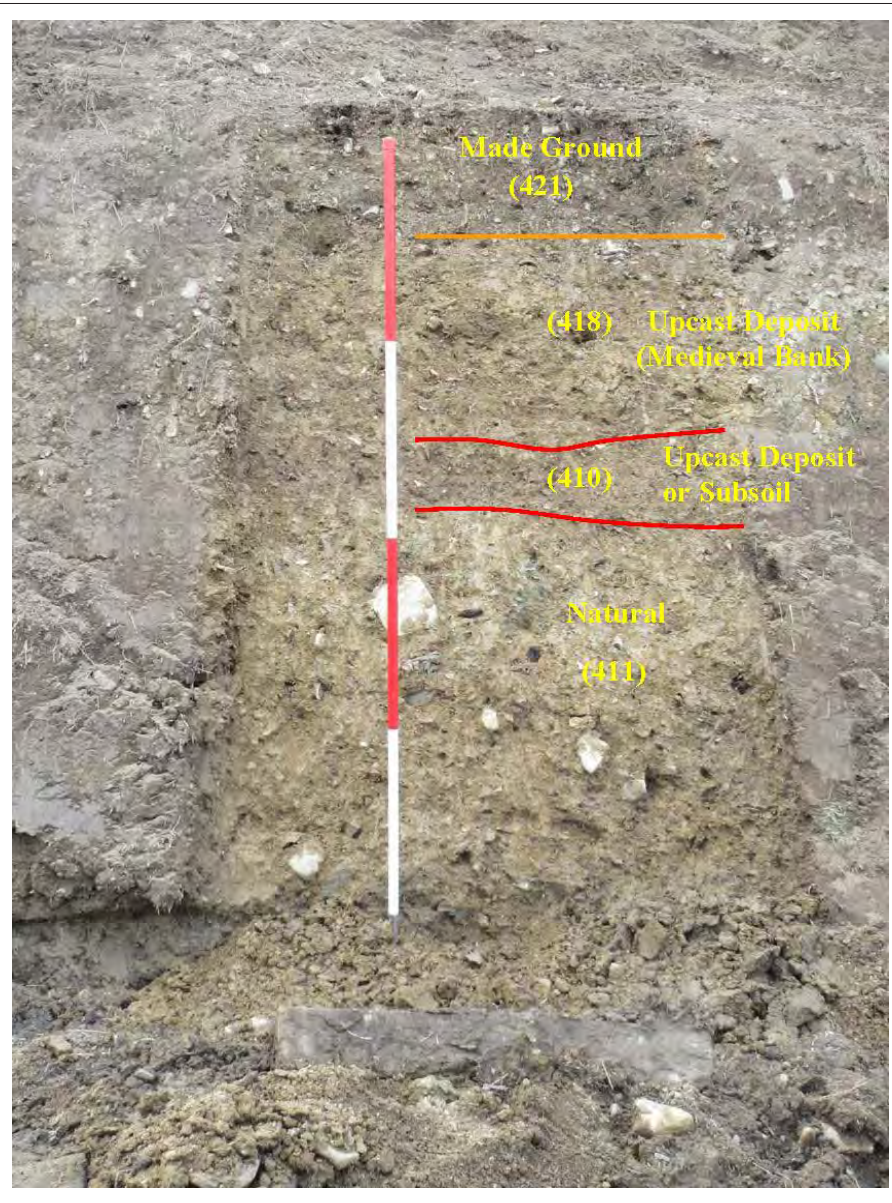
Plate 17. Annotated photograph of Sample Section C, showing medieval upcast layer (418) above further upcast or disturbed subsoil (410) and natural clay (411). Scale 1x2m. Looking West.

- 6.4.3 Redeposited natural (418) was encountered at 166.42m OD, where the bank has been truncated (during the construction of the garage block). The deposit was 0.73m-0.8m thick. This layer appears to be part of the medieval defensive bank. It was noted that layer (418) is similar to deposit (417) identified in Section B.

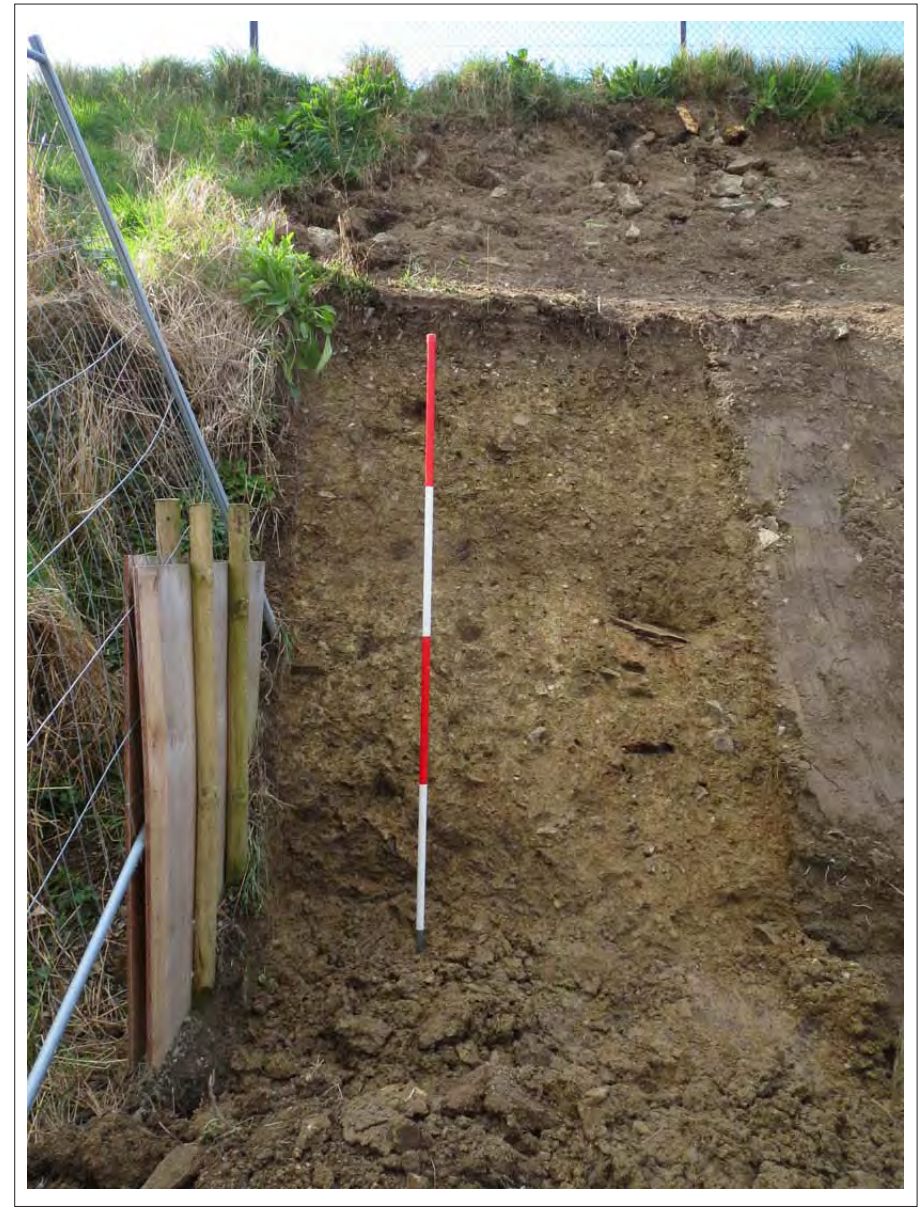
Plate 18. East facing section of medieval bank (Sample Section D). Scale 1x2m. Looking West.

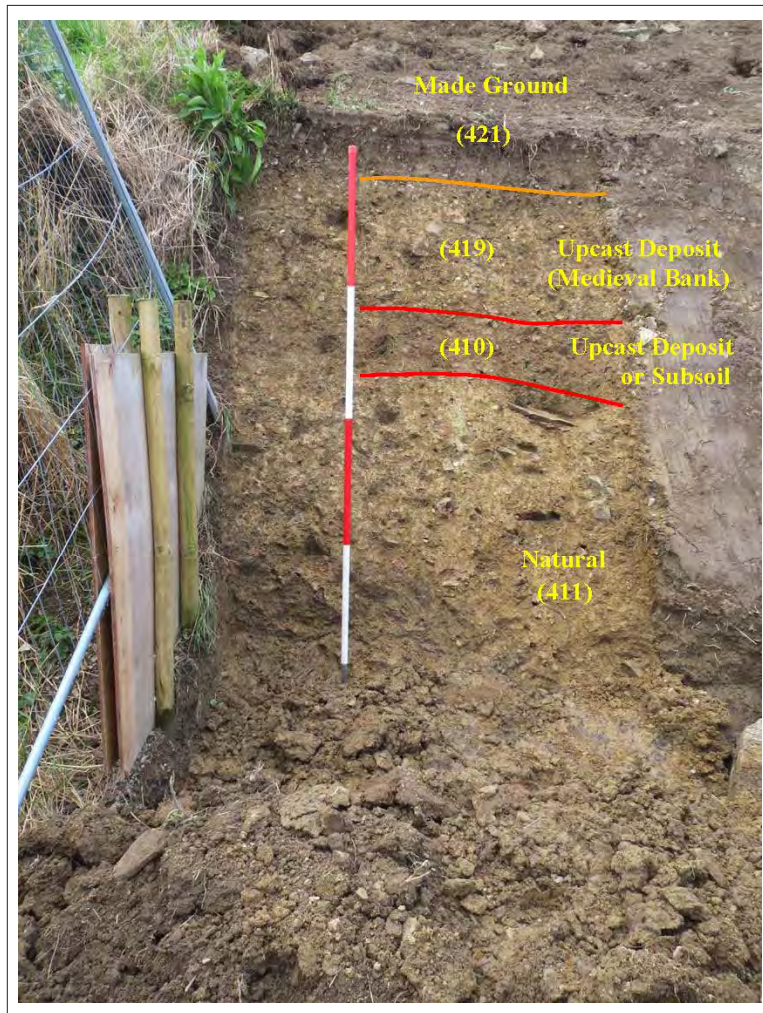
Plate 19. Annotated photograph of Sample Section D, showing medieval upcast layer (419) above further upcast or disturbed subsoil (410) and natural clay (411). Scale 1x2m. Looking West.

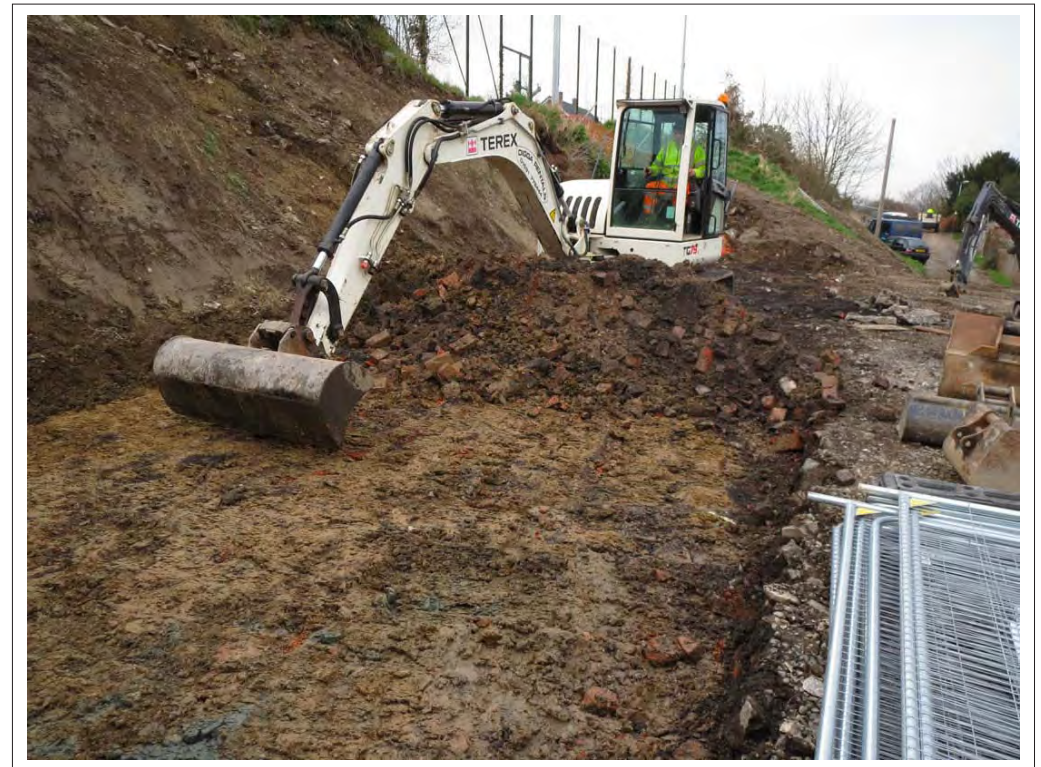
Plate 20. Working shot of soil strip within area of former garages. Looking North-North-West.

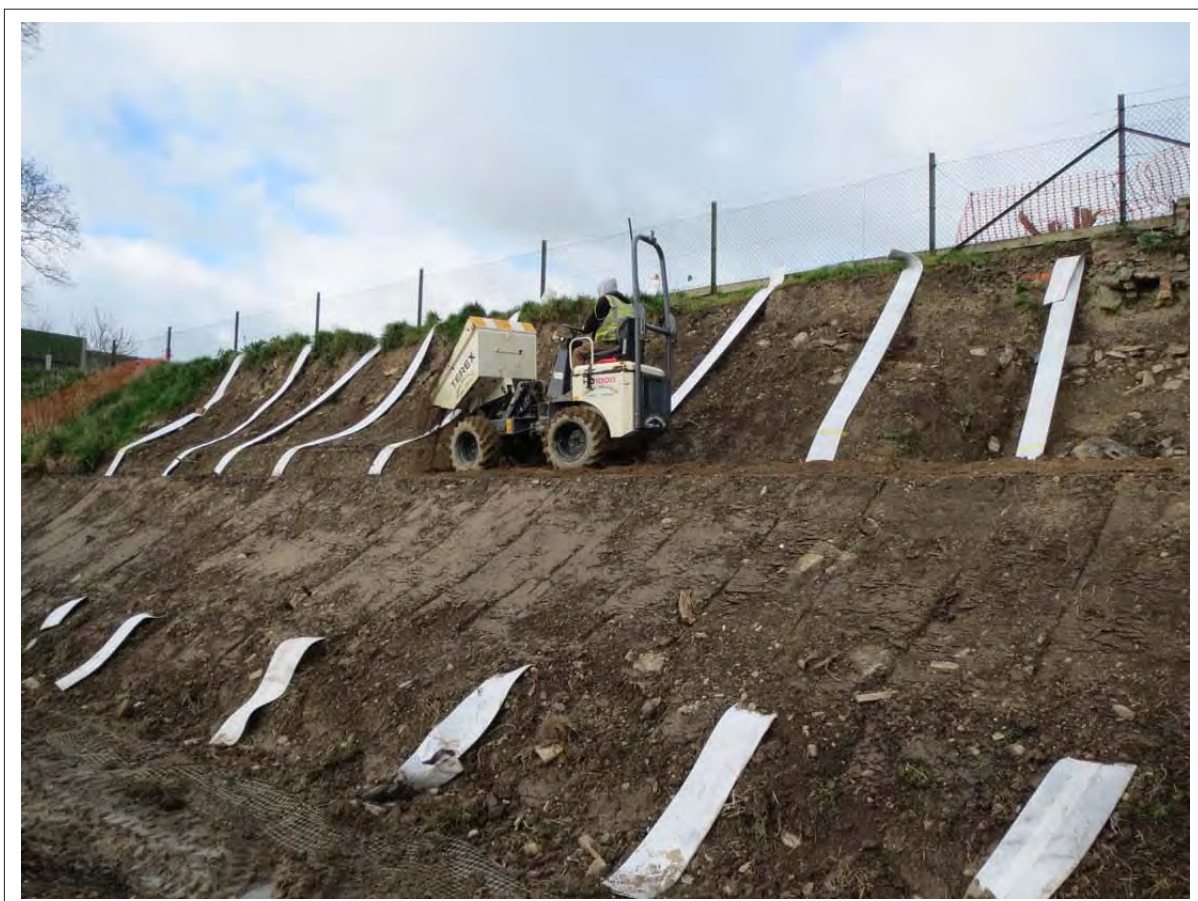
Plate 26. Working shot of the restoration work showing soil infill (over geo-textile strips pinned to the truncated bank). Looking South-South-West.

- The landslip will be backfilled with soil and a pinned geo-textile and the failed land drain reinstated. There will be further limited excavation (0.25m deep) to create a 'toe' to prevent slippage at the base of the bank and the slight cutting back of the bank slope to create an even surface for the new fill material, some of which will potentially be taken from the possible spoil tips to either side of the garages, the rest being imported (See 3.3.5).

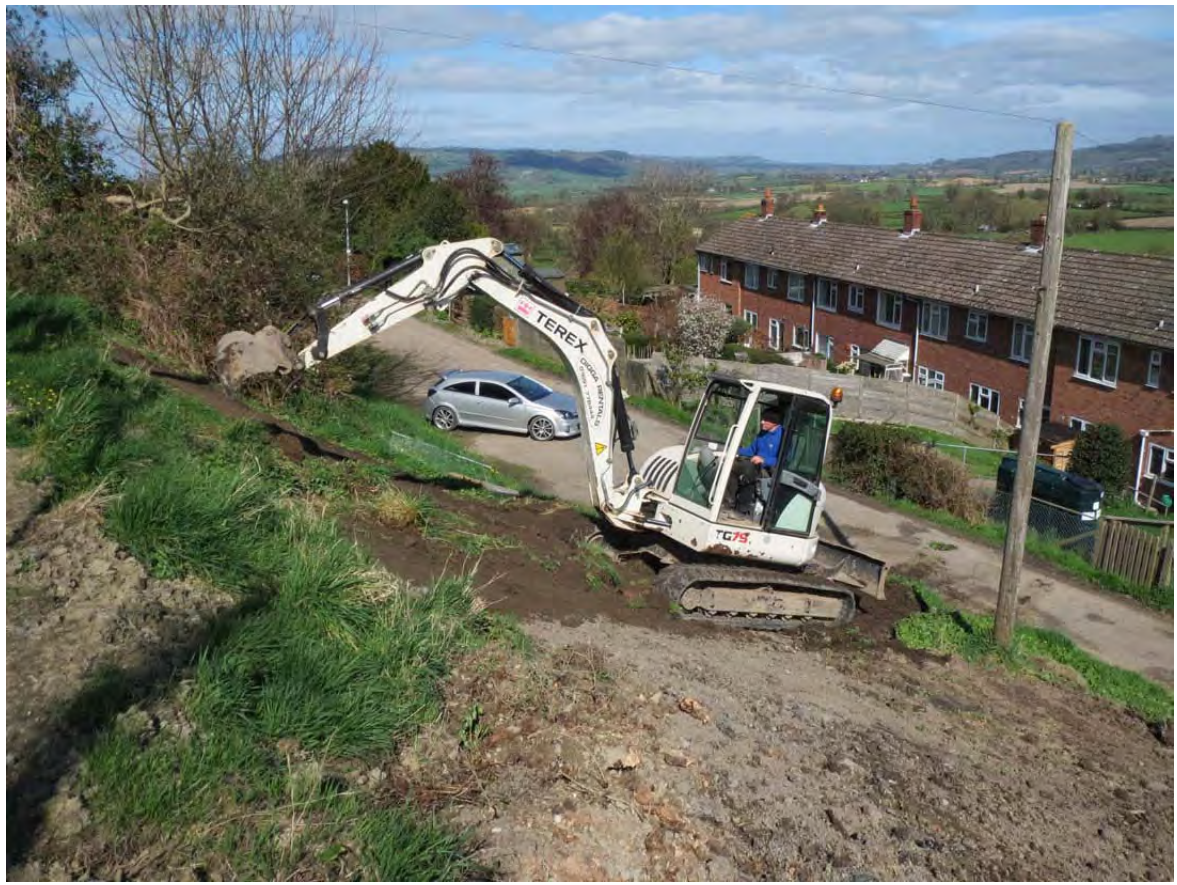
Plate 27. Working shot of the soil strip to the north of the former garages. Looking North-North-East.

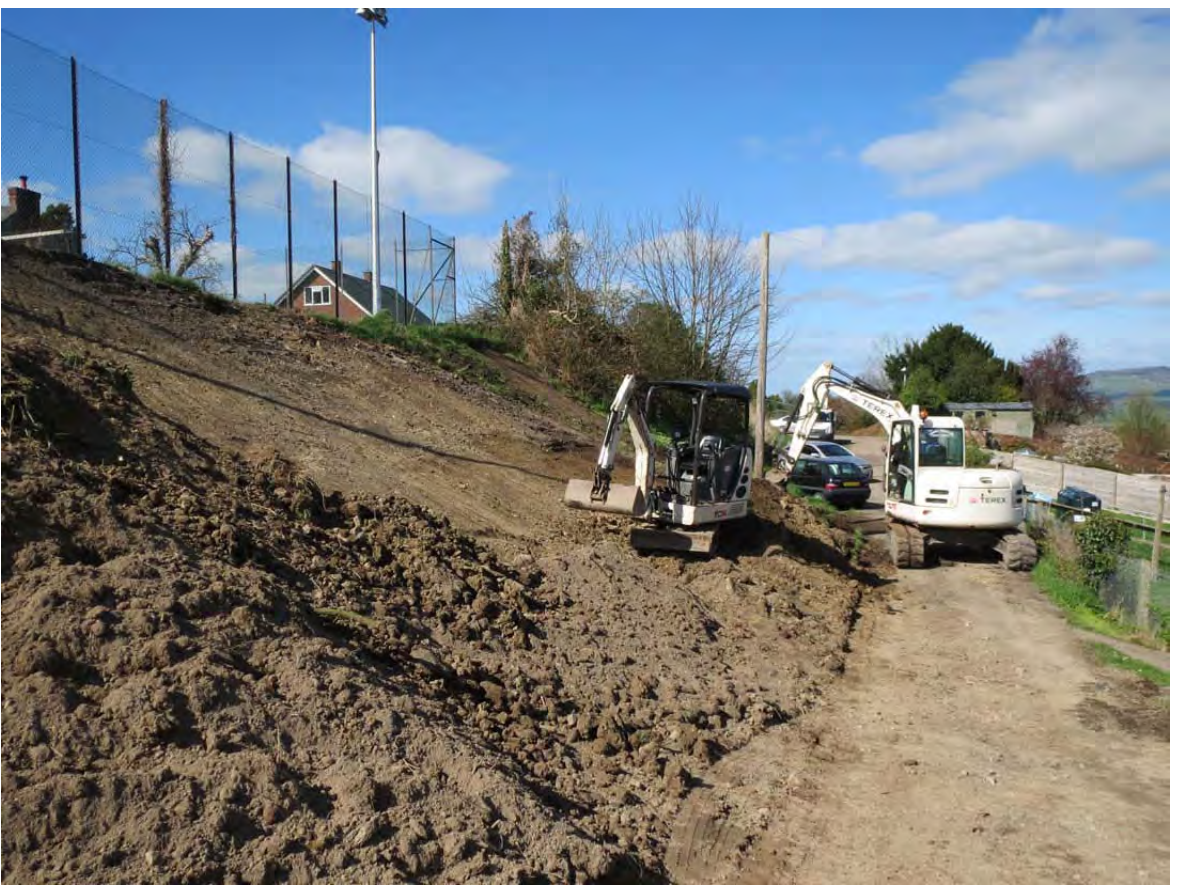
Plate 28. Post-excitation shot of the soil strip of modern deposits to the north of former garages (below tennis courts). Looking North-North-West.
