Medieval Town Defences (MG023) Tan-y-Mur, Montgomery, Powys

Archaeological Watching Brief & Evaluation

Report No. 1279

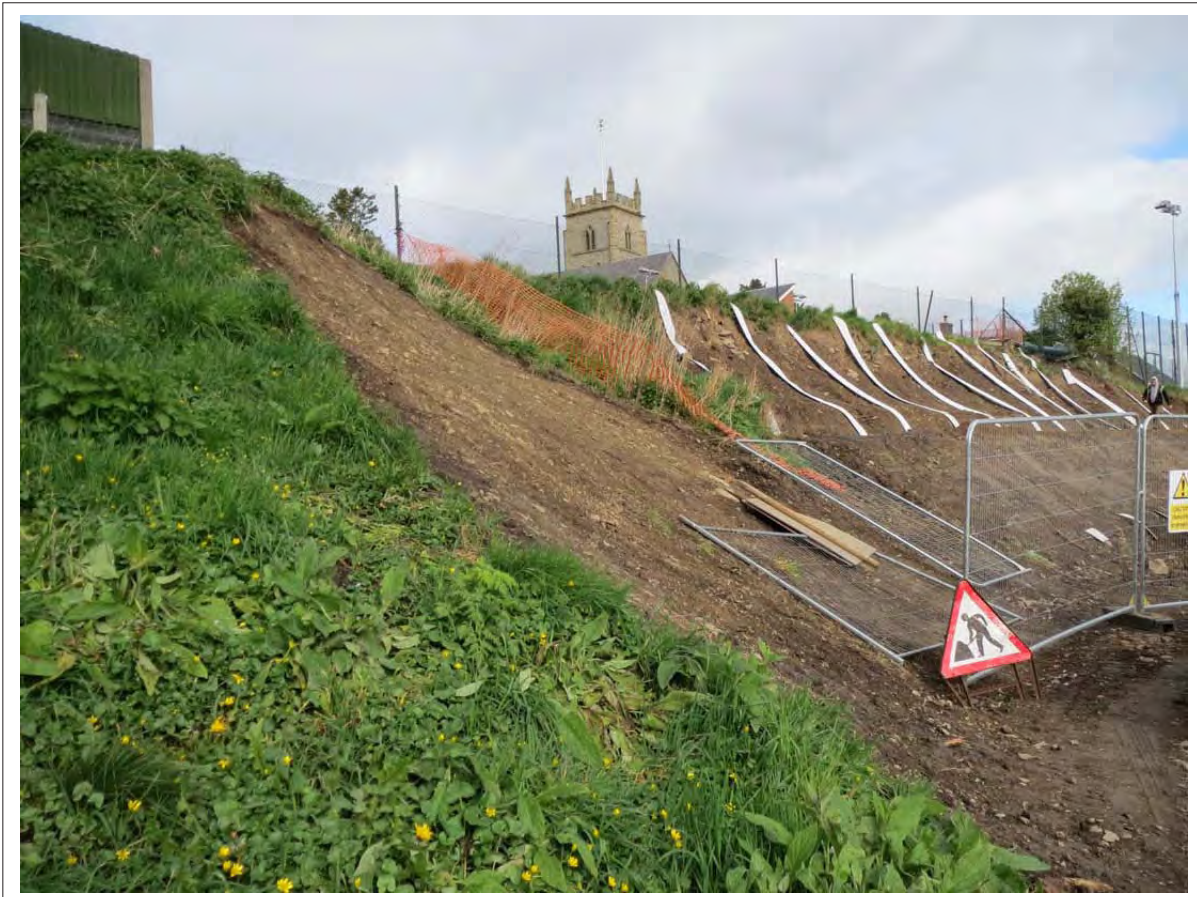
Plate 29. Post-excitation shot of the soil strip of modern deposits to the south of former garages (below bowling green). Looking North-West.

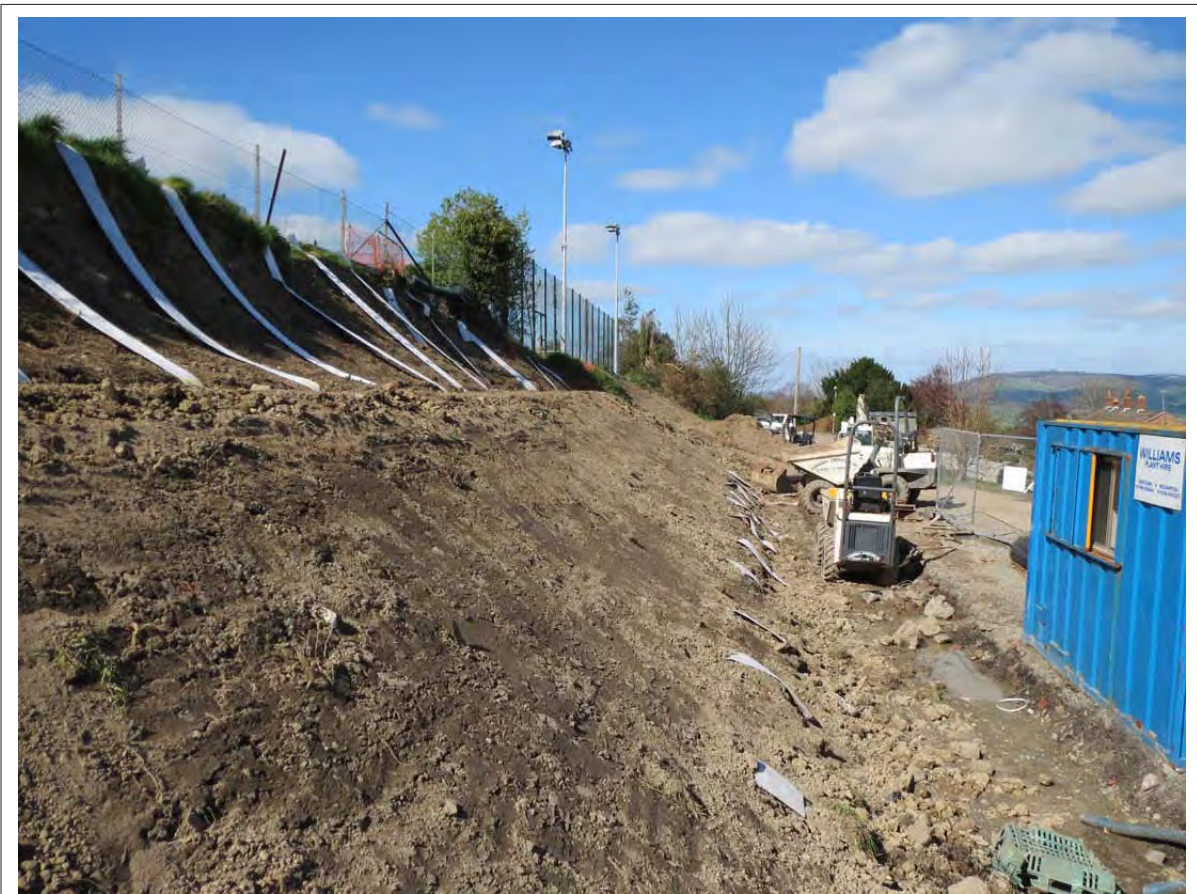
Plate 30. Profile of original bank after removal of modern deposits (the bank has been partly reinstated in the area of the former garages). Looking North.

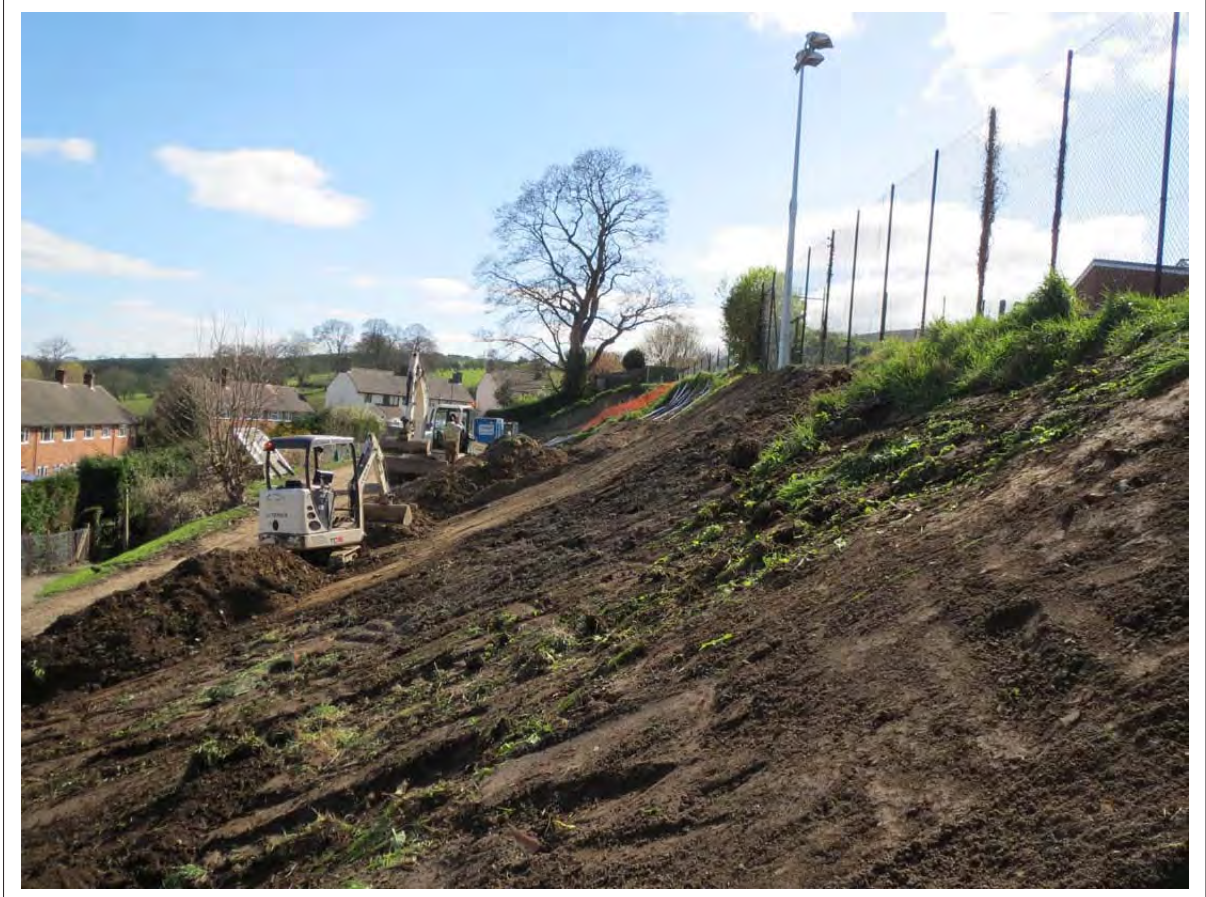
Plate 31. Profile of original bank after removal of modern deposits (the bank has been partly reinstated in the area of the former garages). Looking South.
