**Glan yr Afon Gas Works  
Ystalyfera  
Neath, Port Talbot**

Archaeological Watching Brief

# Glan yr Afon Gas Main Replacement Ystalyfera Neath, Port Talbot

## Archaeological Watching Brief

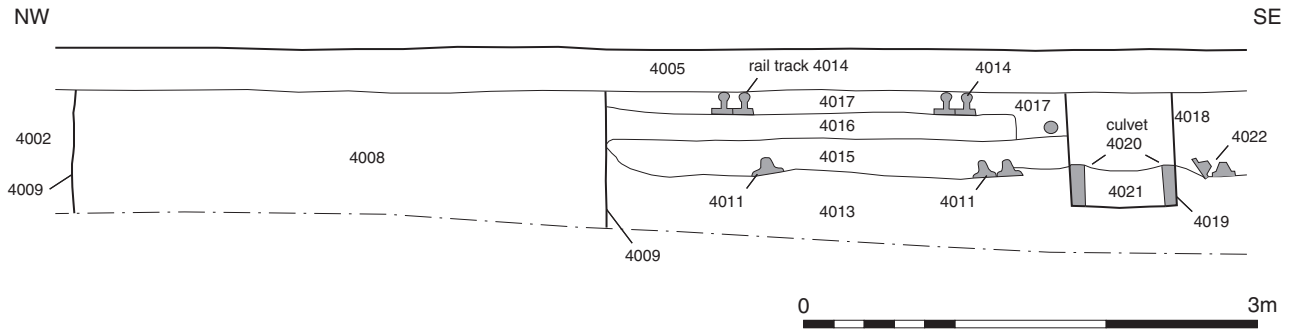
Section AA

- 2.10 Two phase of iron tracks were also recorded (Section AA) near the concrete foundations both orientated northeast-southwest. The first (4011 and 4022) were set into a layer of cinder and slag (4012) which may have been deposited to provide a firm base, consisted of four iron rails 3m apart and may represent two parallel lines. Into this was also cut a stone lined culvert (4019) which was probably used for drainage associated with the second phase of tracks. The rails were covered by a layer 4015 of slag gravel and concrete which formed a base for the second phase of tracks 4014. These were laid on a timber sleeper (4016) and consisted of two sets of rails set approximately 1.2m apart. The tracks were then overlain by 4017 a concrete and gravel layer and then sealed by the tarmac road.

- 3.2 The rail tracks recorded in Trench 4 align with a still extant bridge crossing the Tawe and were probably part of the extensive network of tramways and train tracks that were used to move materials around the iron works. The earlier phase of tracks appear to correspond to those illustrated on a map from the 1870s produced by the Midland railway Company (Midland railway company 1870s), and may be evidence for a tram way or railway. The later phase appear to be railway tracks. This may coincide with the arrival of the railway in the 1860s which partly replaced the canal (DAT *forthcoming*). The concrete foundations observed may be part of the still surviving bridges spanning the river Tawe however little further interpretation can be made.

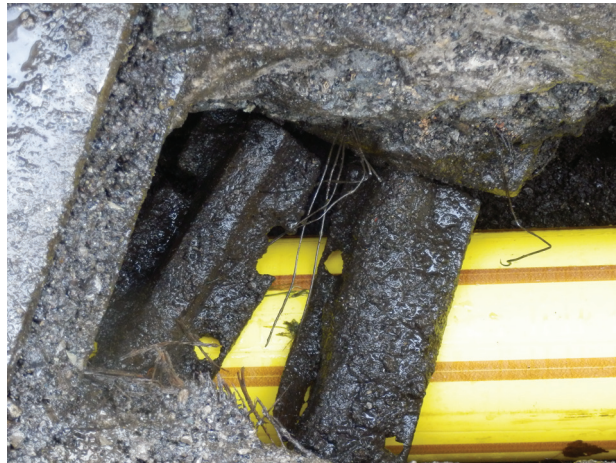
Southern rails of earlier rail track 4011

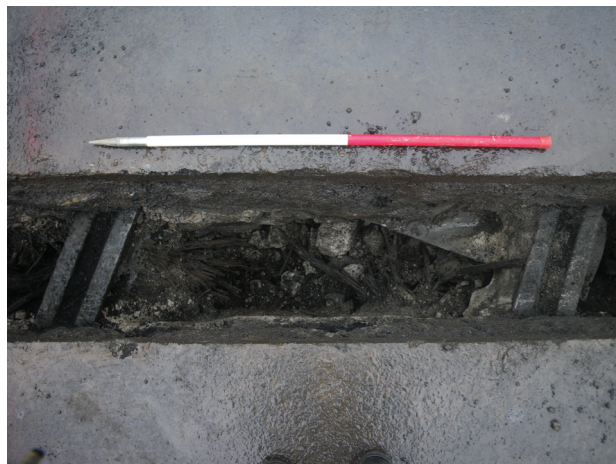
Rail track 4014, looking north-east
