Llandaff Cathedral Cardiff Wales

Archaeological Watching Brief

CA Project: 5318
CA Report: 15163

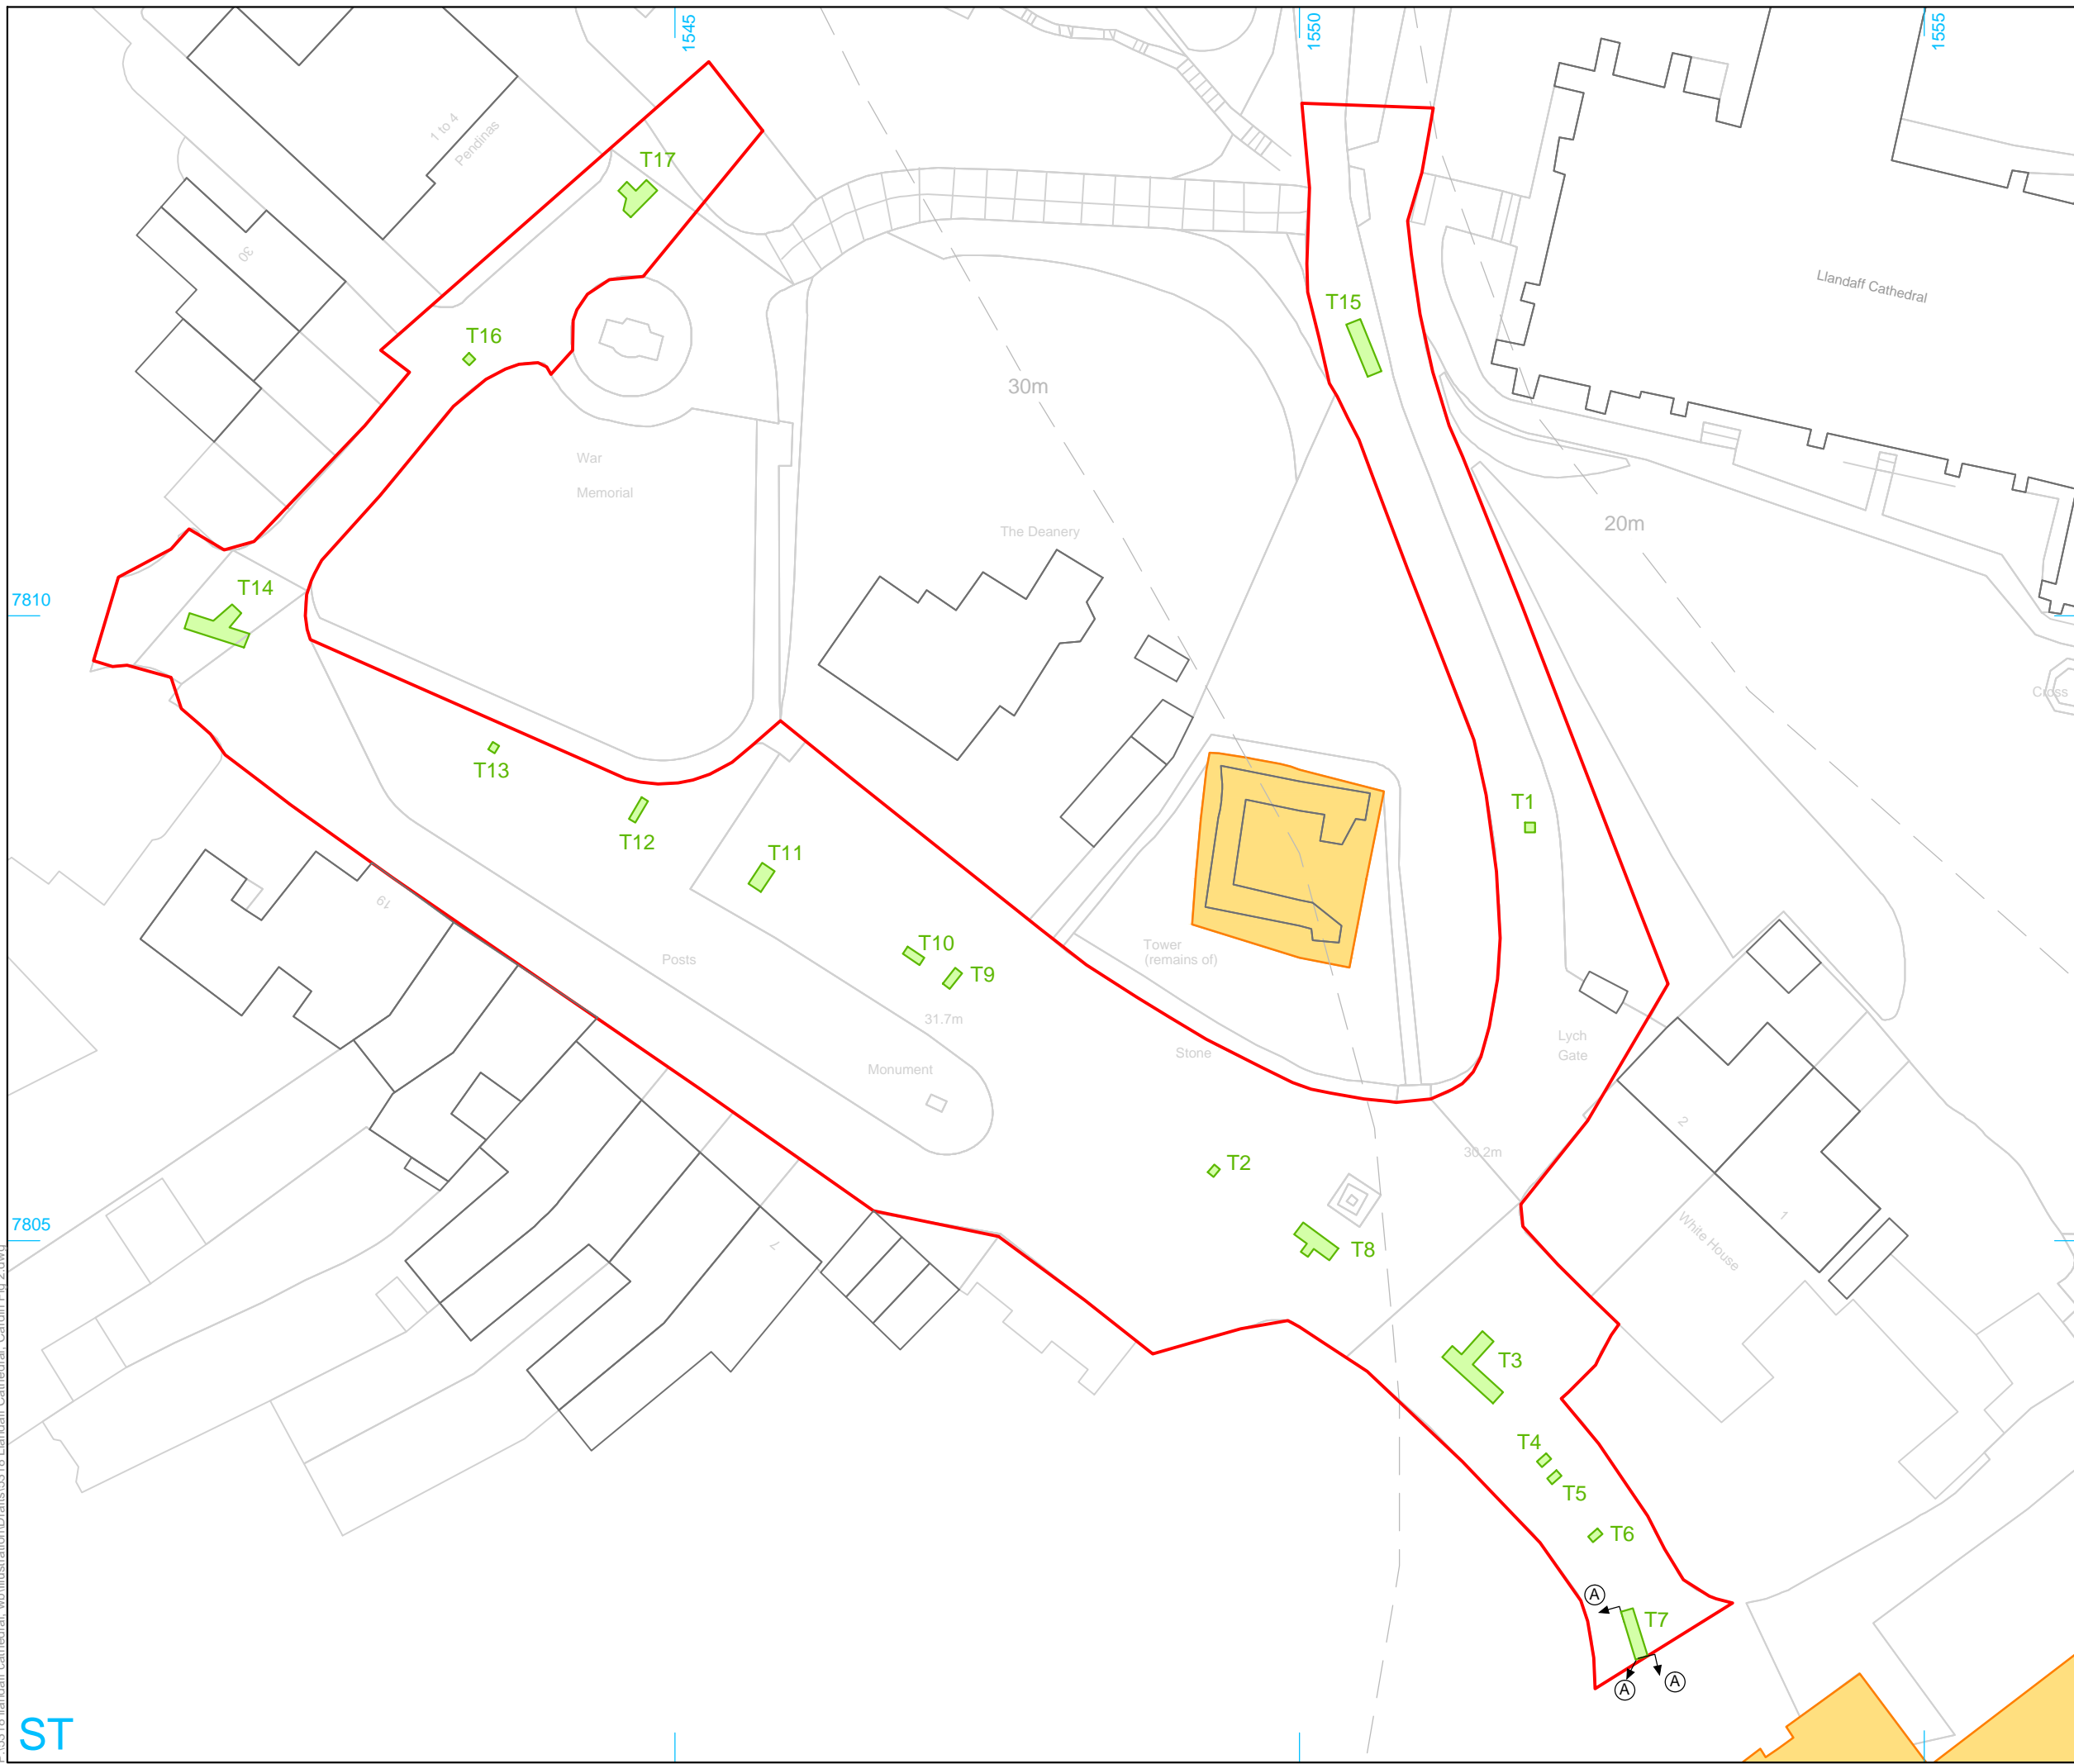
FIGURE TITLE
 The site showing location of groundworks

4.1 The fieldwork followed the methodology set out within the WSI (CA 2015). An archaeologist was present during intrusive groundworks comprising excavation of 17 trenches for the insertion of the new gas main into the existing gas main and connections to the adjacent properties (see Fig. 2 for location and extent).

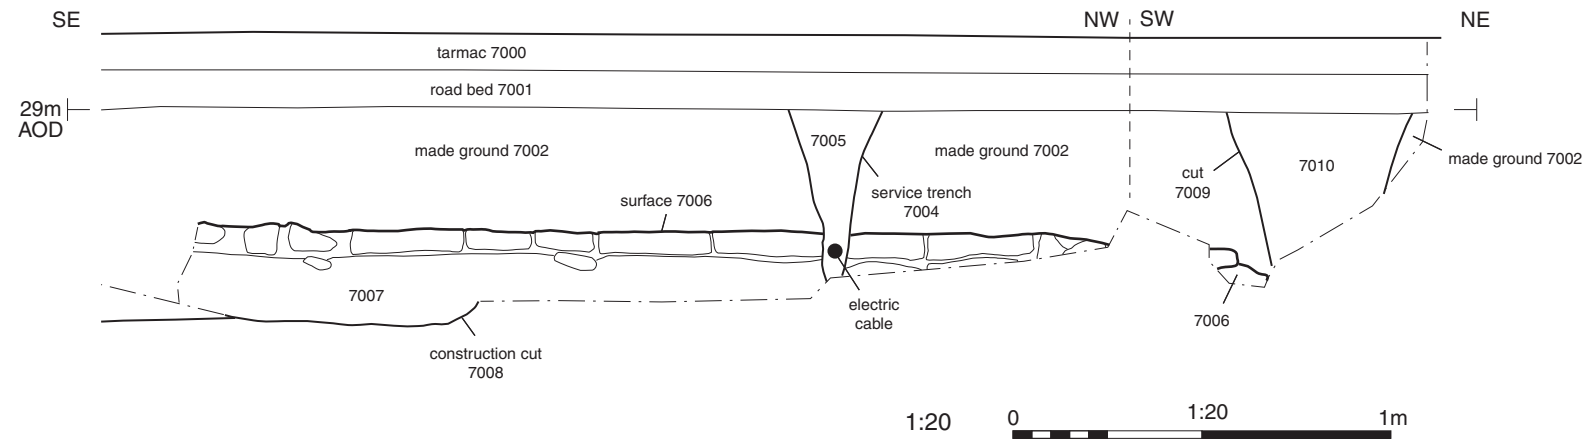
Section AA

- 5.2 In Trenches 3, 4, 5, 6 and 8 the made ground was sealed by a probable former road surface, 3002, 4002, 5002, 6002 and 8002, respectively. This surface was 0.1m in thickness and comprised cobbles in red clay. It was overlain by the gravel/clay make-up layer for the modern road surface.
- 5.3 In Trench 7 the natural clay was cut by probable construction cut 7008. This was filled by an undated clay, 7007, which was in turn overlain by a probable stone surface, 7006 (Fig 3, section AA). The structural remains comprised a single layer of roughly dressed stone blocks in a lime mortar.

- 6.1 Despite the archaeological potential of the application area (see archaeological background above), the watching brief identified limited archaeological remains within the area of observed groundworks and no artefactual material was recovered.
- 6.2 Stratigraphic evidence suggests that the cobbled surface observed in Trenches 3-6 inclusive and 8 is likely to comprise the pre-modern precursor of the existing road. The structural remains identified in Trench 7 appear to represent the remains of a probable exterior surface, possibly associated with the Bishop's Castle (RCHMW ref. no 96079) located to the south-east. However no further interpretation is possible given the limited exposure of the remains.

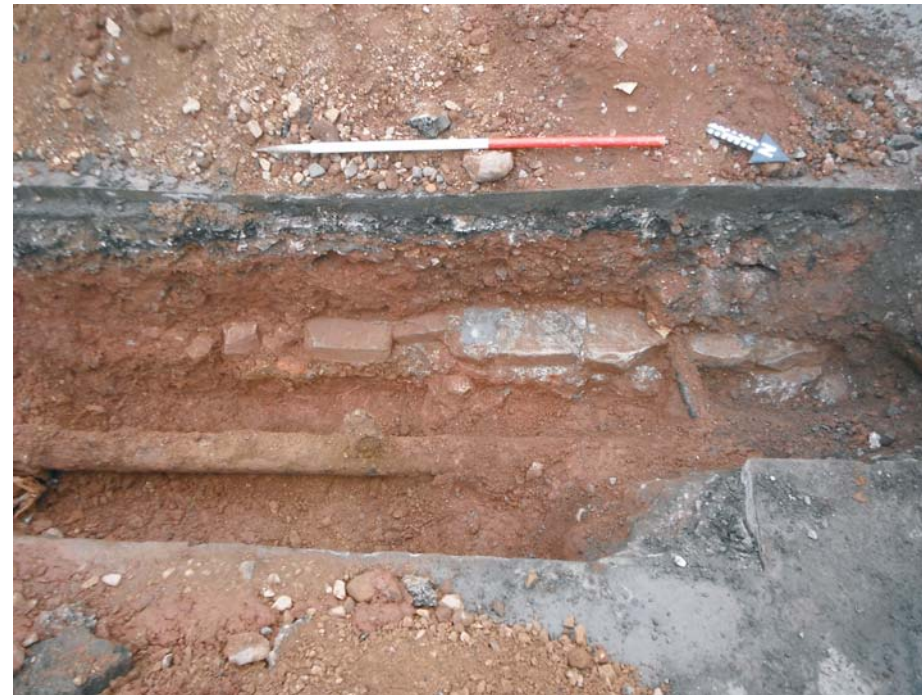
Trench 7, looking south-west (scale 1m)
