**HISTORIC ENVIRONMENT
DESK-BASED ASSESSMENT
FOR A RESIDENTIAL SCHEME
ON LAND OFF TUDOR ROAD,
WYESHAM, MONMOUTHSHIRE
NGR: SO5215012230**

March 2024

Trysor Project No. 2024/930
HER Event Record PRN GGAT E007862

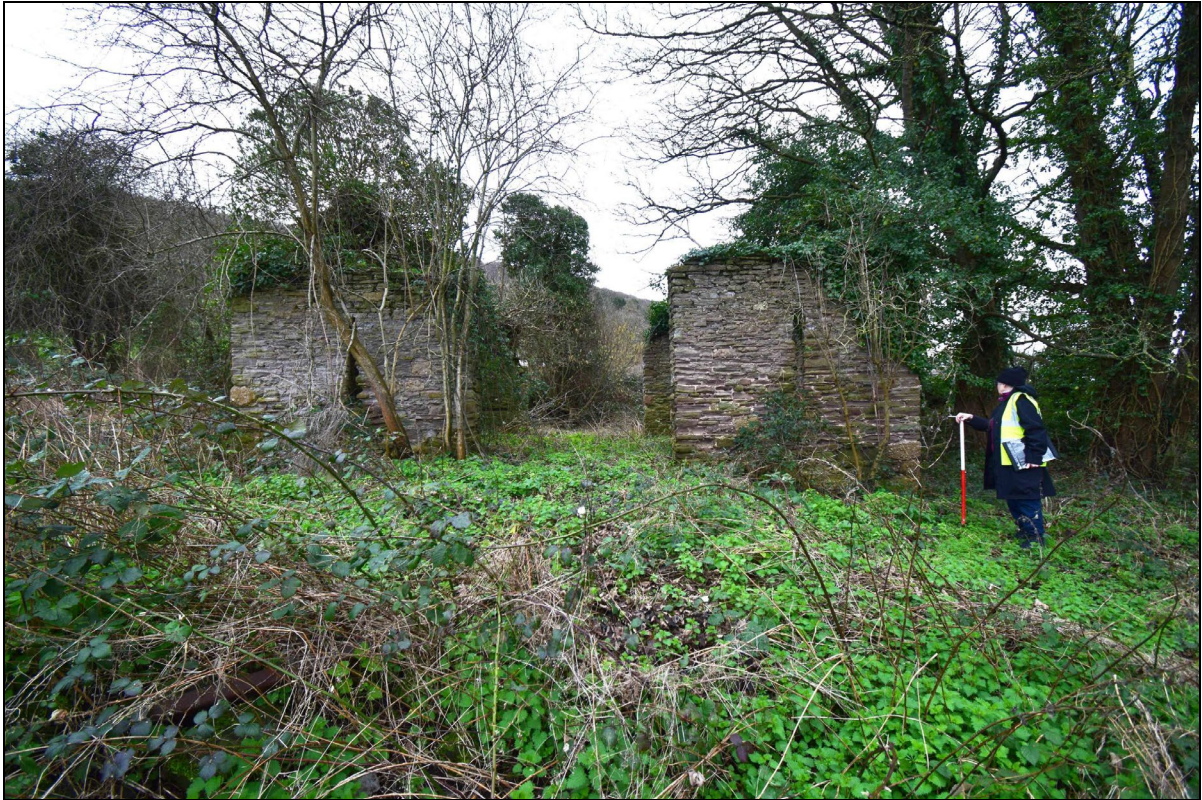
Cover photograph: The remains of a former barn, Project ID 22, in the southern part of the proposed development site, looking west.

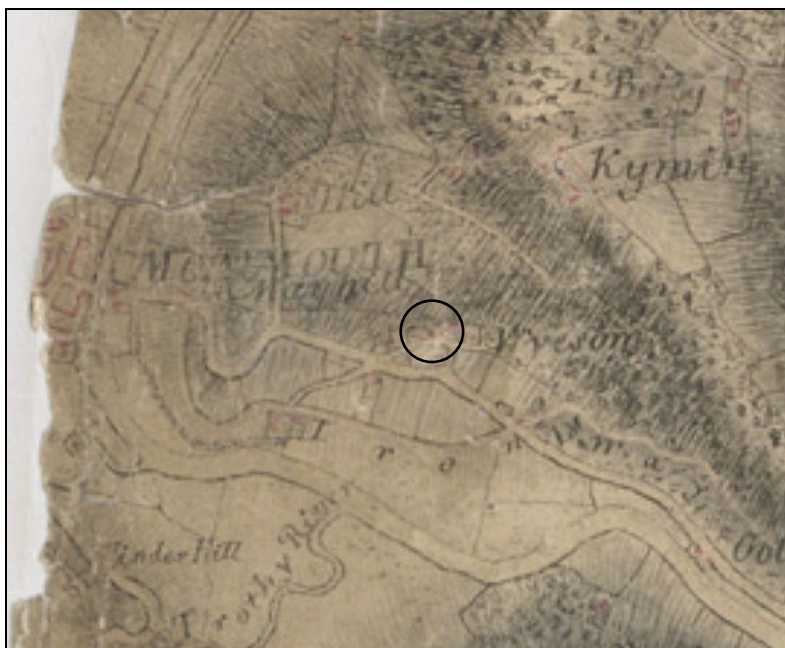
Figure 2: The Ordnance Survey Original Surveyors Drawing of 1812 (Chepstow Sheet) is indistinct. Houses are shown in red and the red mark circled appears to be at the location of barn ID number 22, to the north side of road ID number 17. This may indicate that there was a house near the barn, on the tenement purchased by Thomas Tudor by 1830. Source: British Library.

- 7.3.5 It is possible that the tenement that Tudor bought at Wyesham included an earlier house at a different location to that of Tudor House. The 1812 Original Surveyors Drawing, see figure 2, produced by the Ordnance Survey appears to show a dwelling in the approximate area of the barn, ID number 22.

11.1.1 It should be noted that the 1812 Ordnance Survey Original Surveyors Drawings appear to show that there was a dwelling in the vicinity of the surviving barn. It is possible that it was associated with the existing tenement purchased by Thomas Tudor around 1830, before he built Tudor House nearby. This possibility elevates the archaeological potential of this group of former farmstead buildings.

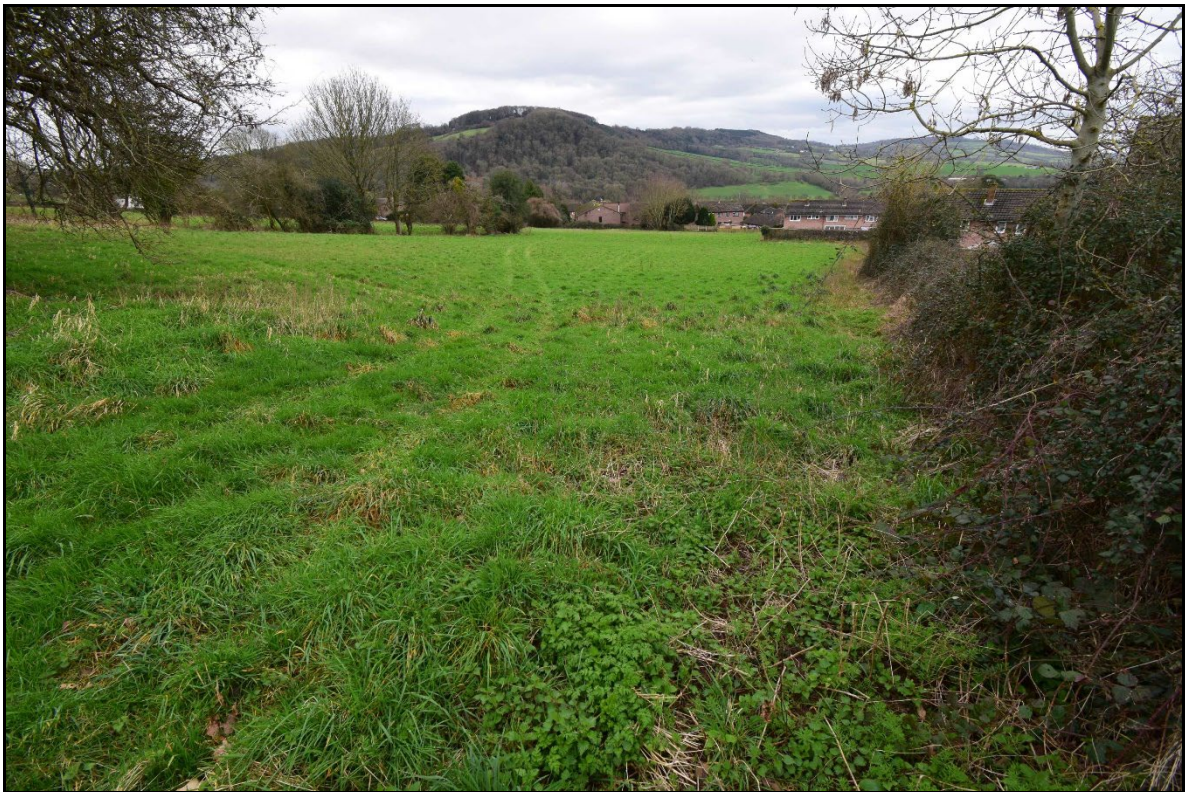
Plate 1- TRW2024_001: A view of the proposed development site from its northern corner. Looking south-southwest.

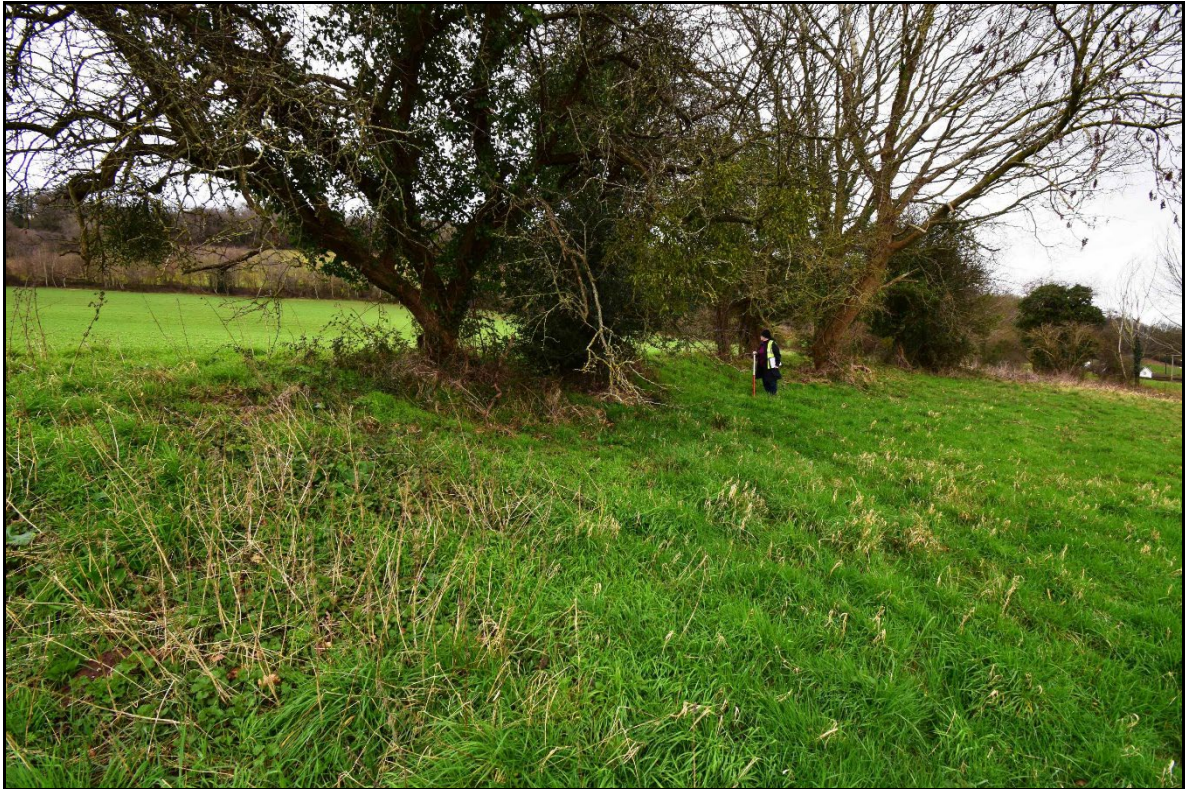
Plate 2 - TRW2024_002: A view across the very denuded boundary bank or lynchet at the northern side of the proposed development site. Looking east.

10.10 The field boundaries within the proposed development site and along its northern edge are denuded post medieval boundaries which are not considered to be of archaeological or historical significance. The proposal does not include any plan to remove these boundaries but rather to strengthen them with new tree or hedge planting.

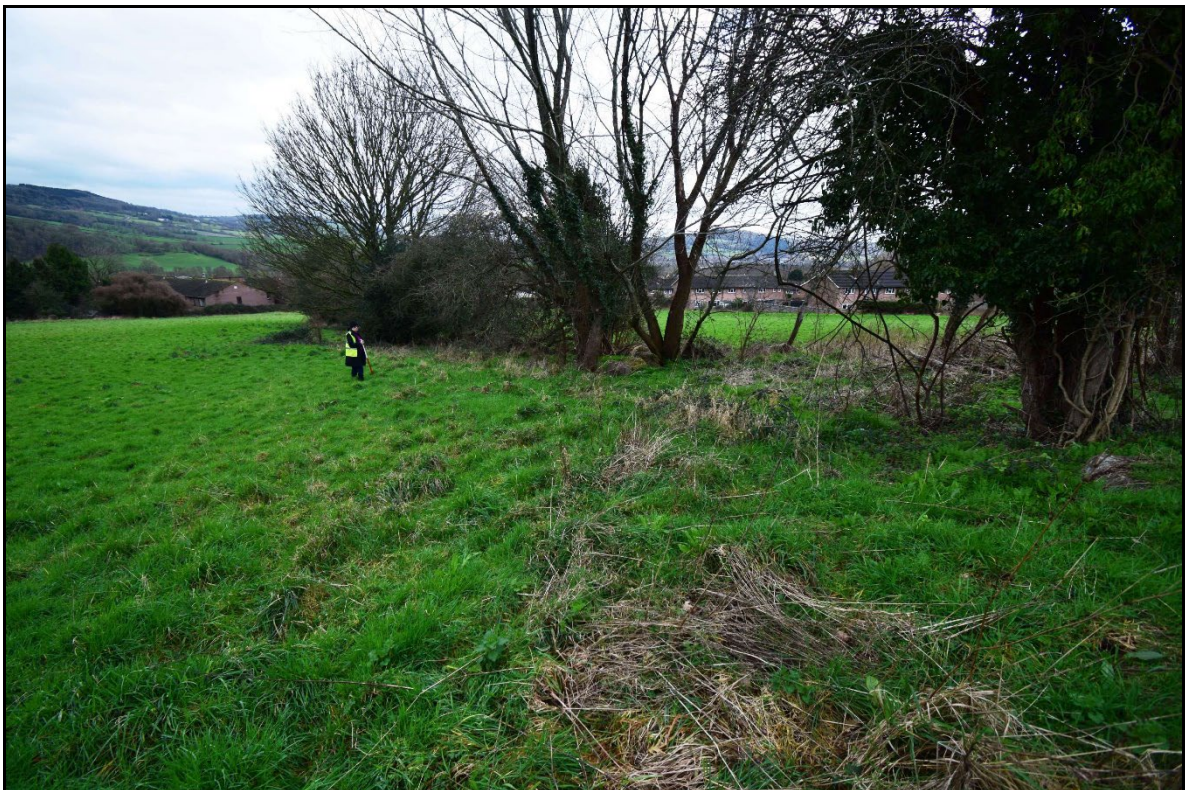
Plate 3 - TRW2024_003: A view of the remains of the boundary which separated the two western fields in the proposed development area. This boundary may have been a hedged or tree-lined drainage course. No bank was seen here. Looking southwest.

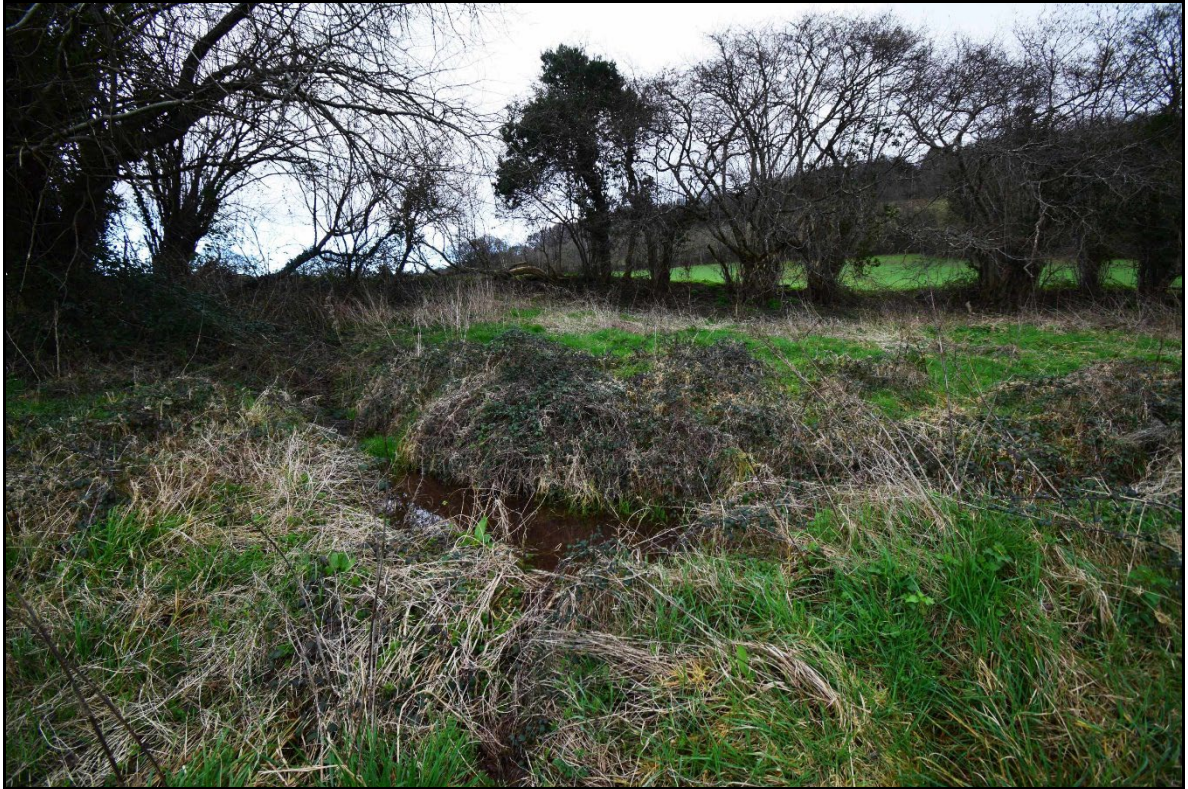
Plate 4 - TRW2024_004: A view of a wet area inside the northern boundary of the central field in the proposed development area showing why there may have been a central drainage channel through the site. Looking northeast.

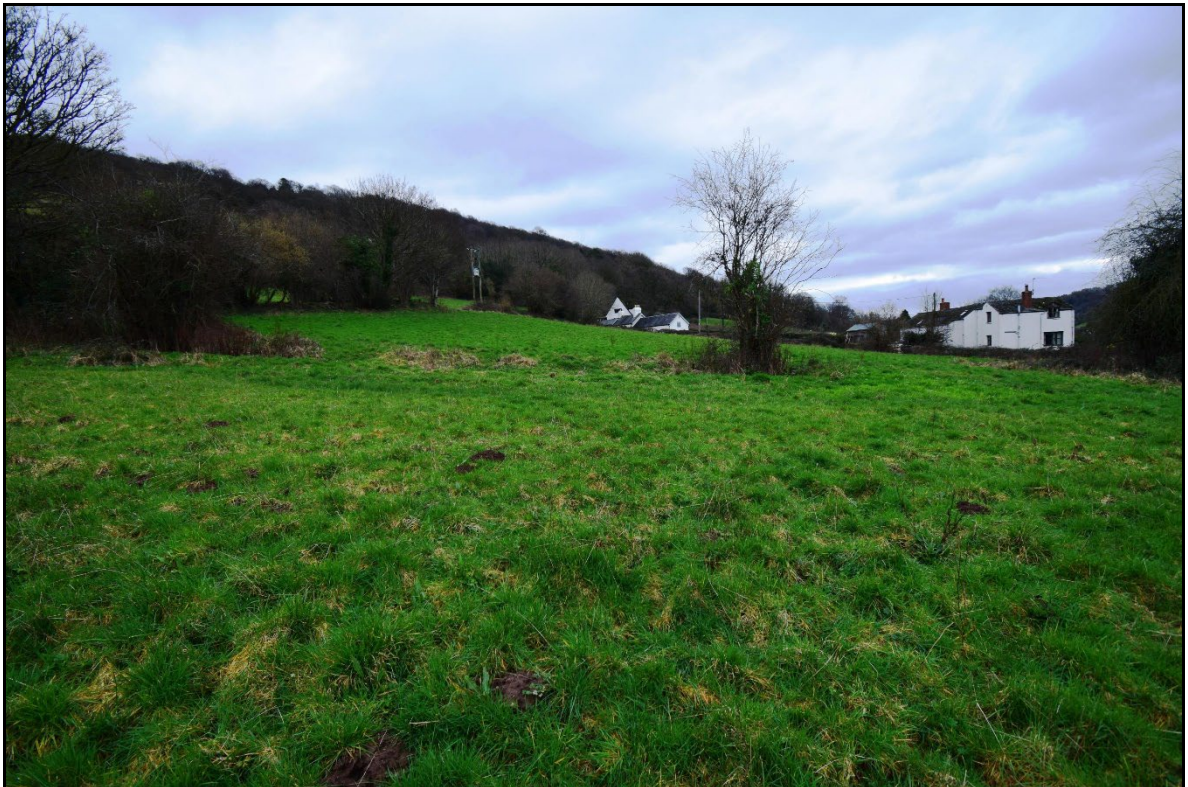
Plate 5 - TRW2024_005: A view towards the now intermittent boundary between the central and eastern fields in the proposed development area. Looking southeast.

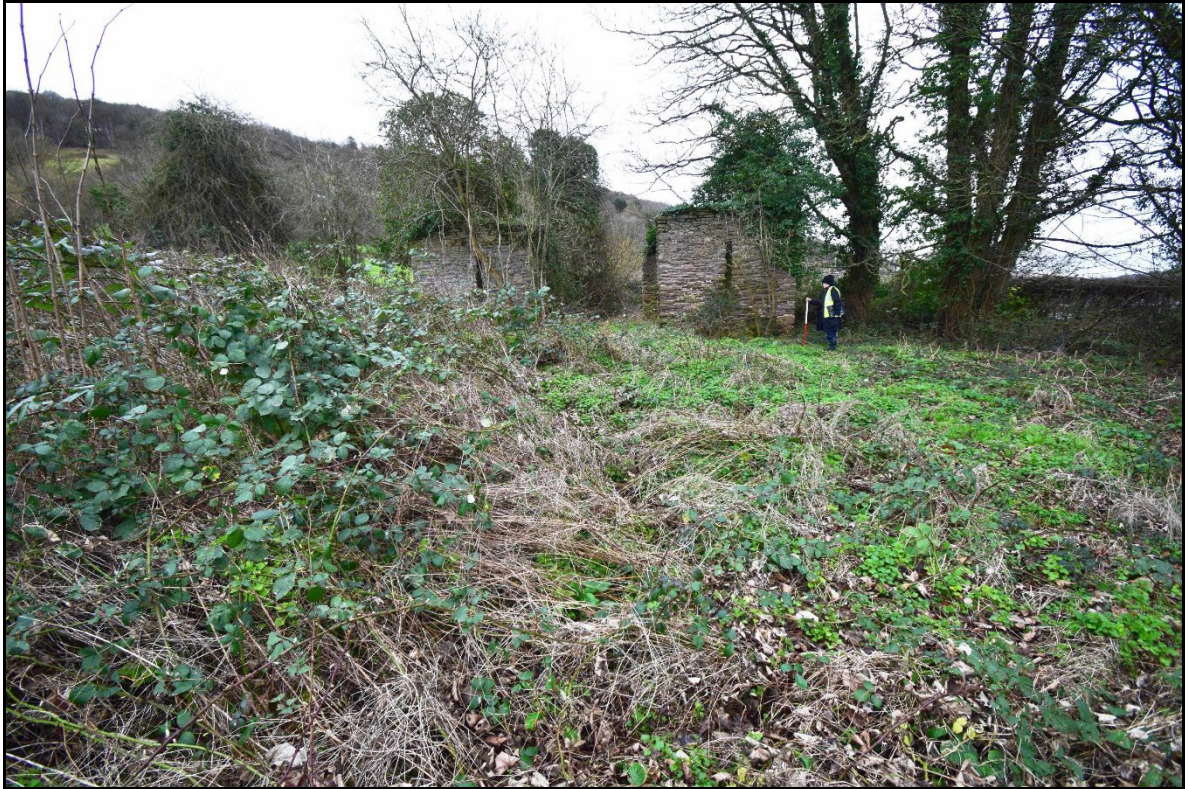
Plate 6 - TRW2024_006: A view of the now derelict barn (ID number 22) which once belonged to Tudor House. Mature deciduous trees are still present close to the building, on the south boundary of the proposed development site. Looking east.

It remained in use until the second half of the 20th century, but was disused and derelict by the 21st century. When visited in 2024 it was found to be roofless, but otherwise in good condition, with its mortared, sandstone walls standing to wallplate and gable height. 19th century maps show that there was another building or section attached to the north gable wall of the barn, but there is now no surface evidence for this structure.

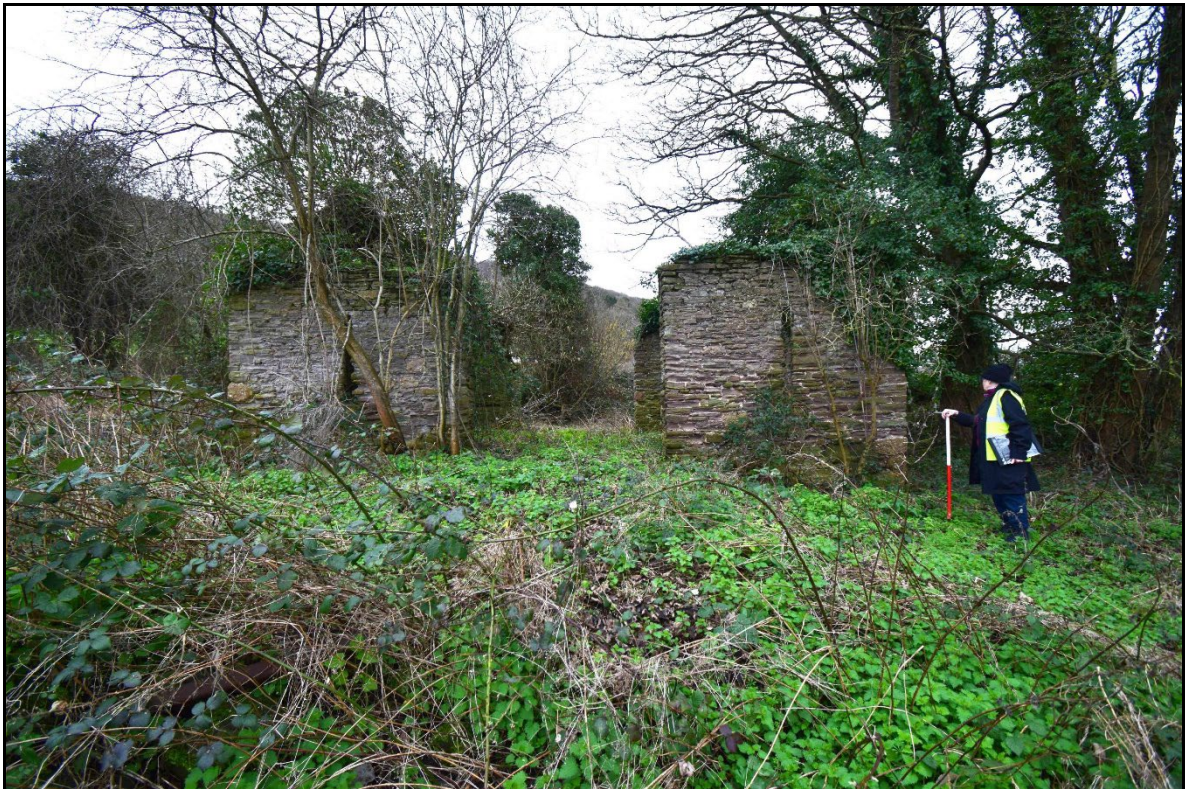
Plate 7 - TRW2024_007: A closer view of the now derelict barn (ID number 22) which once belonged to Tudor House. Note the wide, opposed doorways, suggesting it may have been used for threshing originally. There are narrow ventilation openings in the walls either side of the doorways. Looking east.

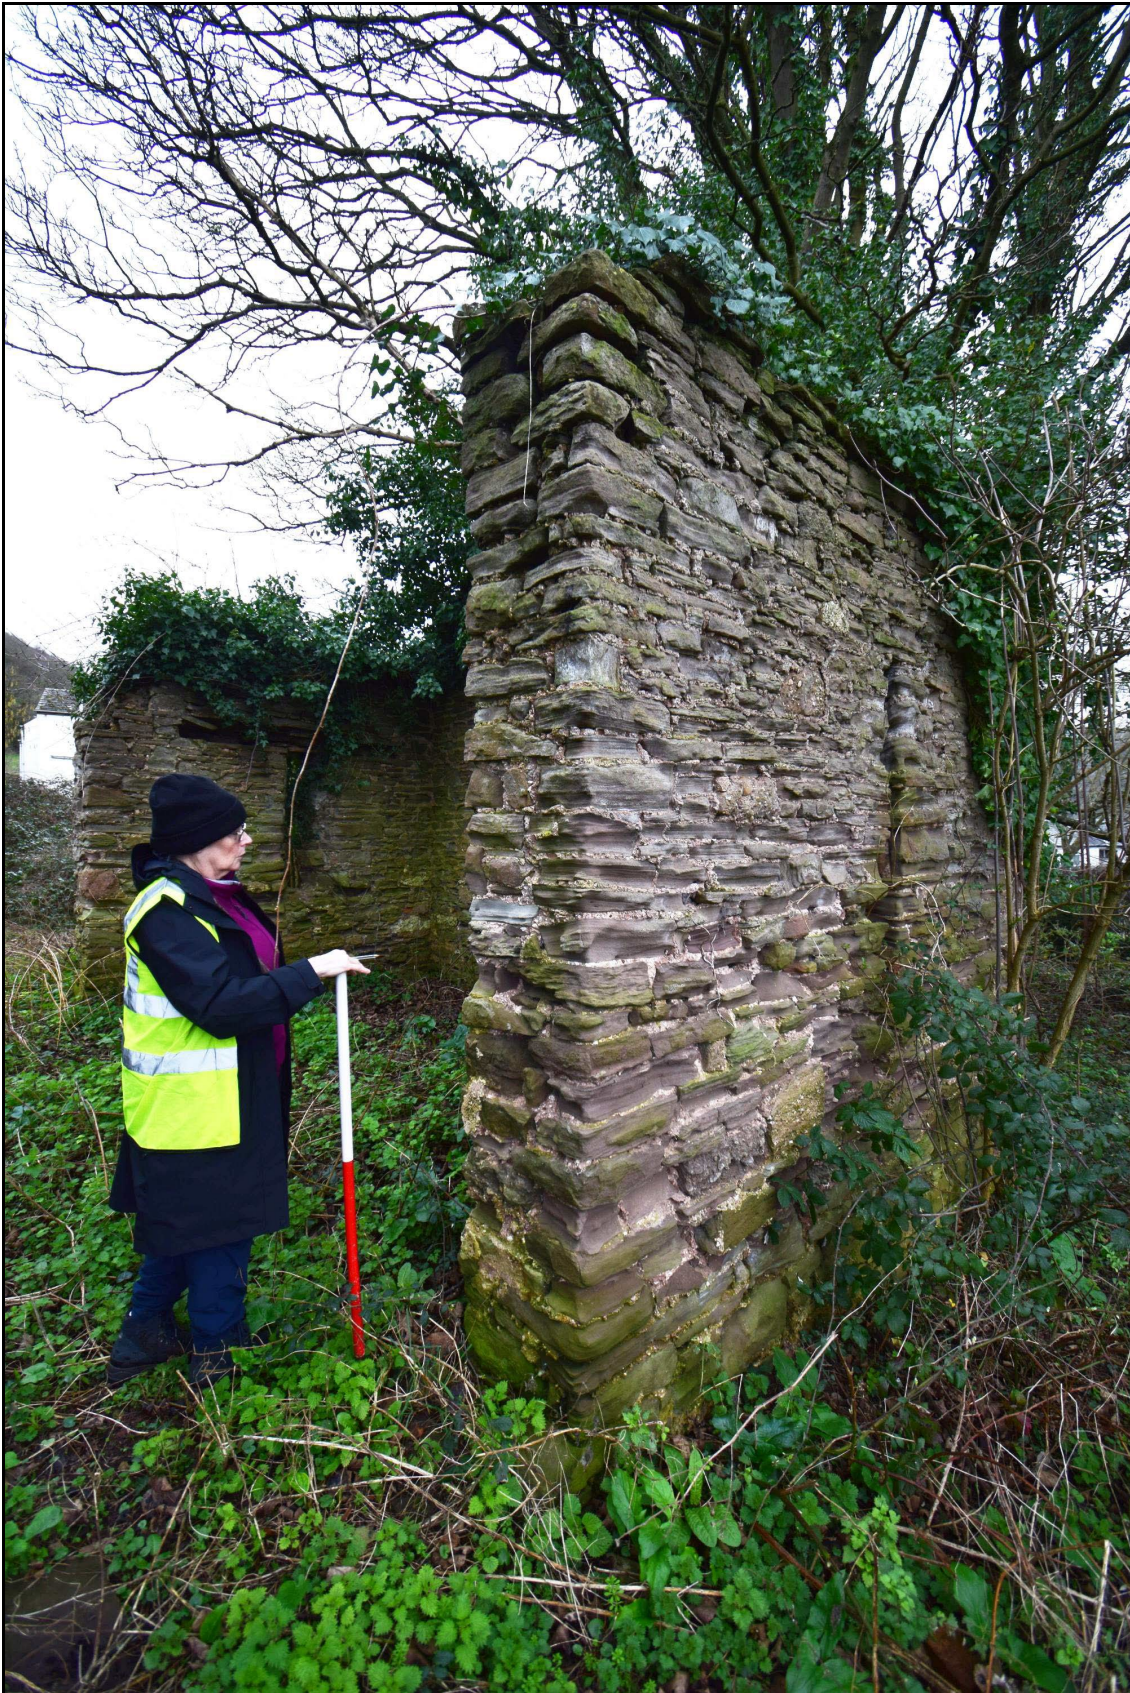
Plate 8 - TRW2024_008: A view of the lateral wall to the south of the west-facing doorway of the barn (ID number 22). Note the white lime mortar bonding the now heavily eroded sandstone masonry. Looking southeast.

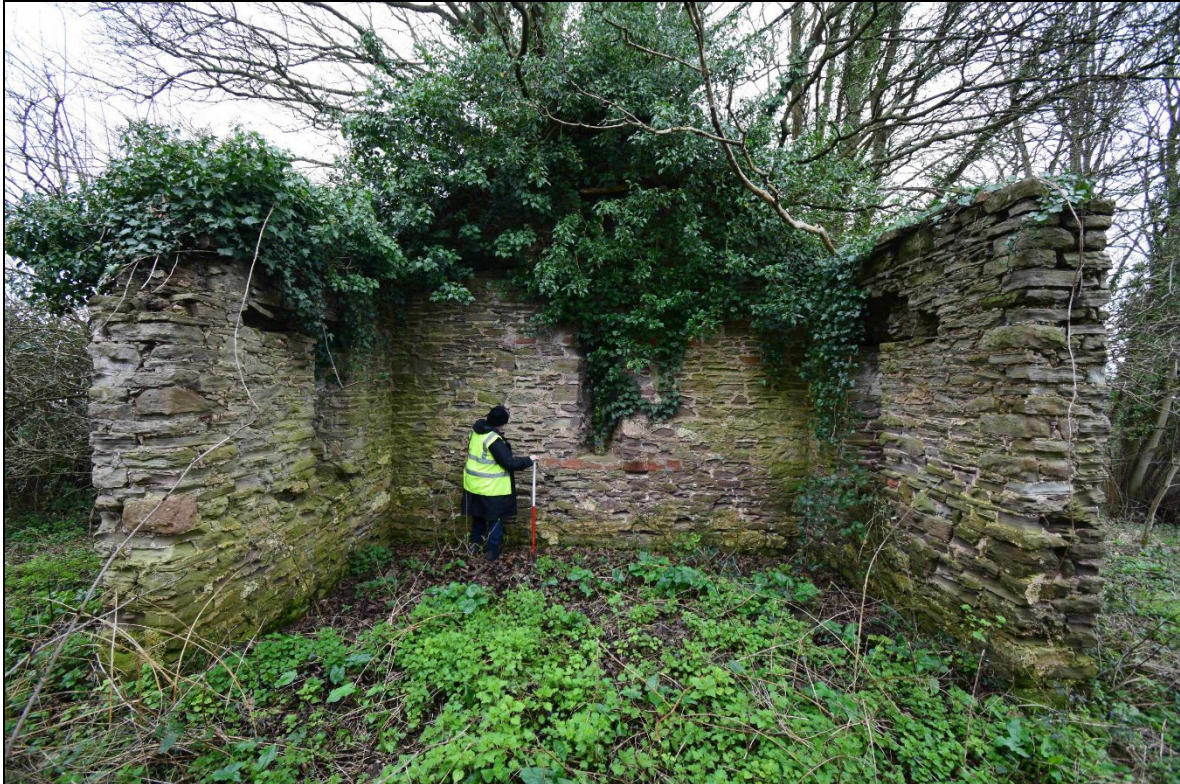
Plate 9 - TRW2024_009: A view inside the barn (ID number 22), showing a ventilation opening in the southwest gable end. The gable is fairly complete to ridge height and the lateral walls are largely intact to wallplate level. Looking south.

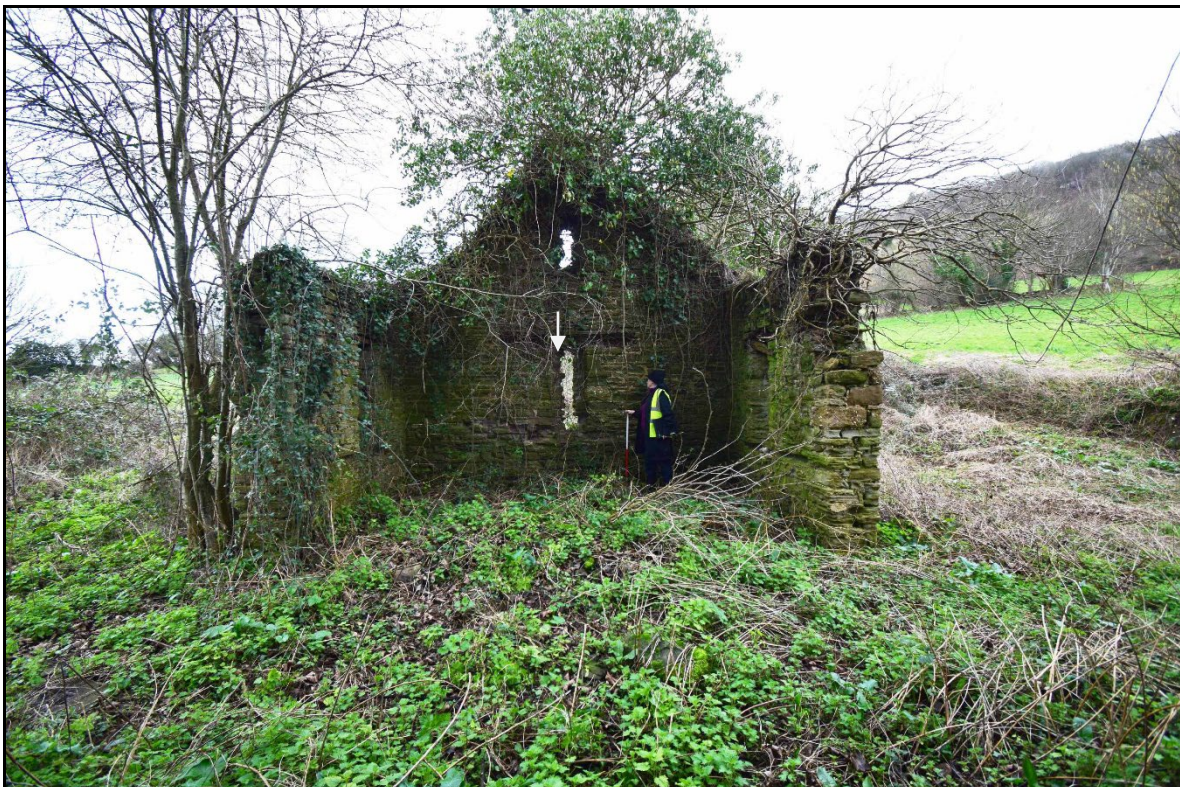
Plate 10 - TRW2024_010: A view inside the barn, showing the ventilation openings in the northeast gable end. This gable is also fairly complete to ridge height and the lateral walls are largely intact to wallplate level. Looking north.

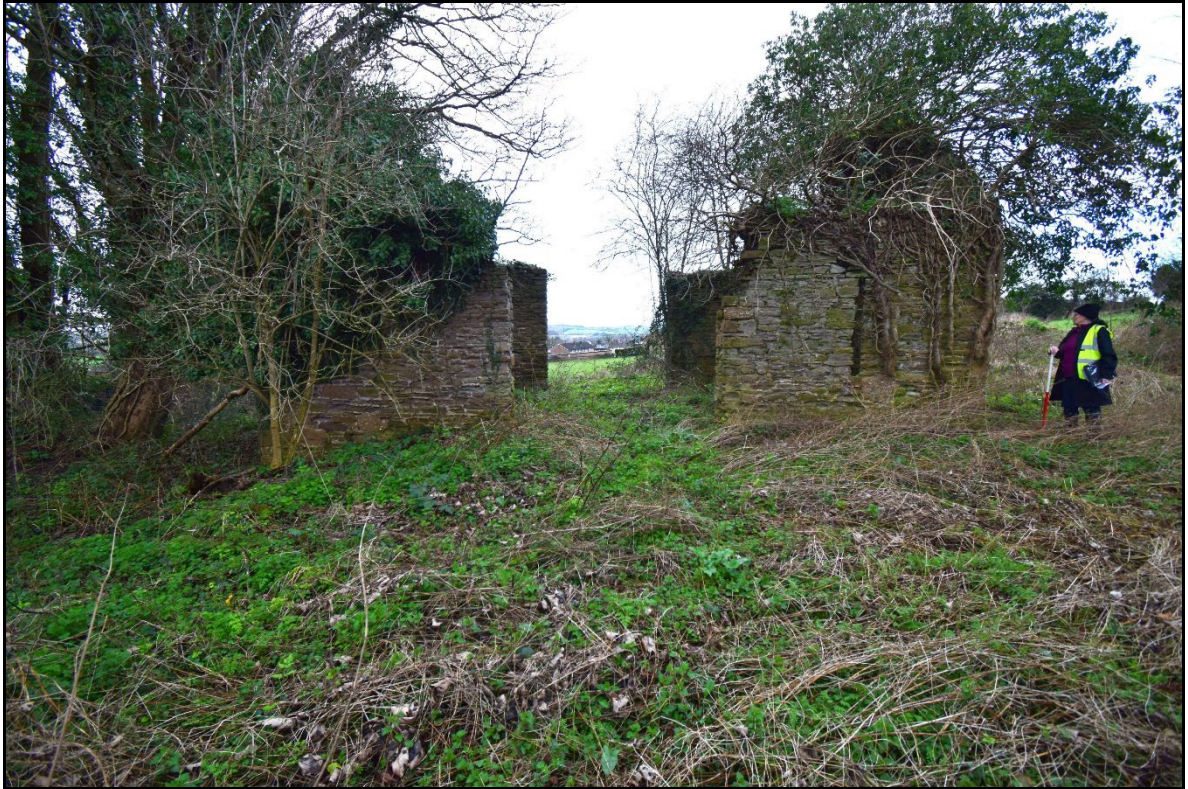
Plate 11 - TRW2024_011: A view of the now derelict barn (ID number 22). Looking west.

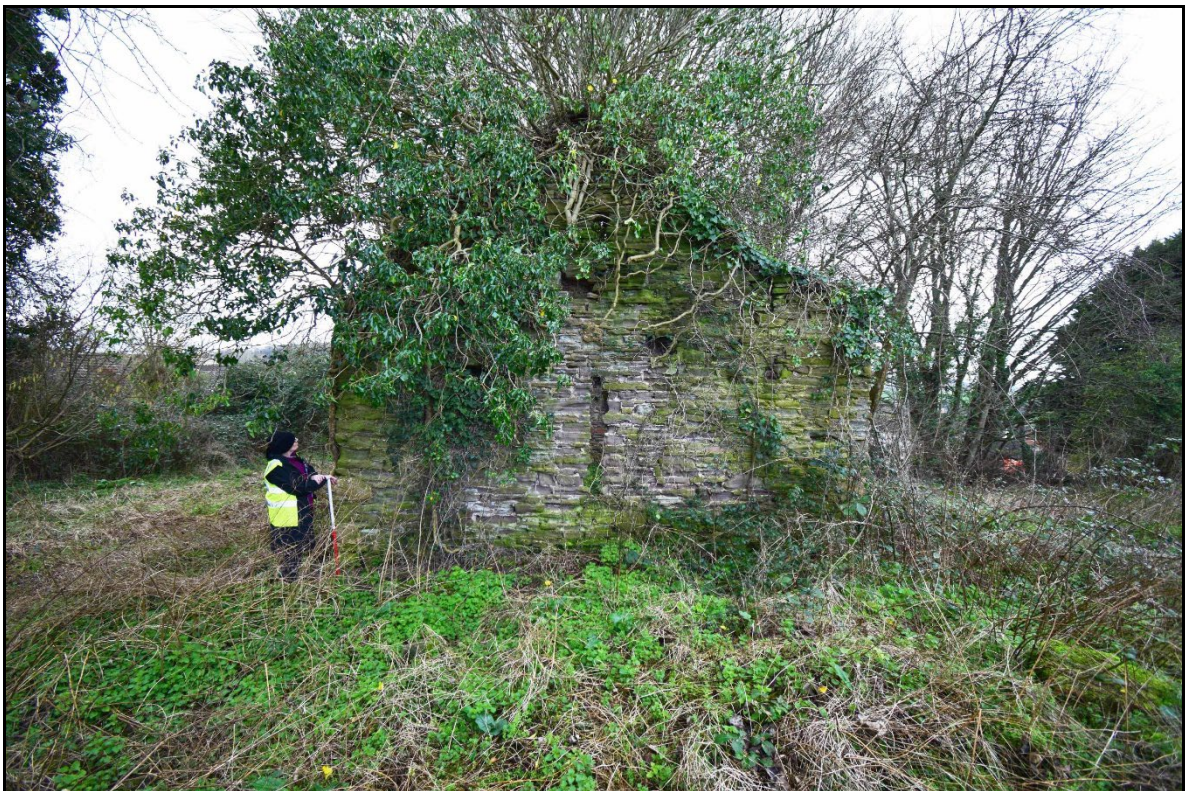
Plate 12 - TRW2024_012: A view of the northern gable wall of the now derelict barn (ID number 22). Looking south.

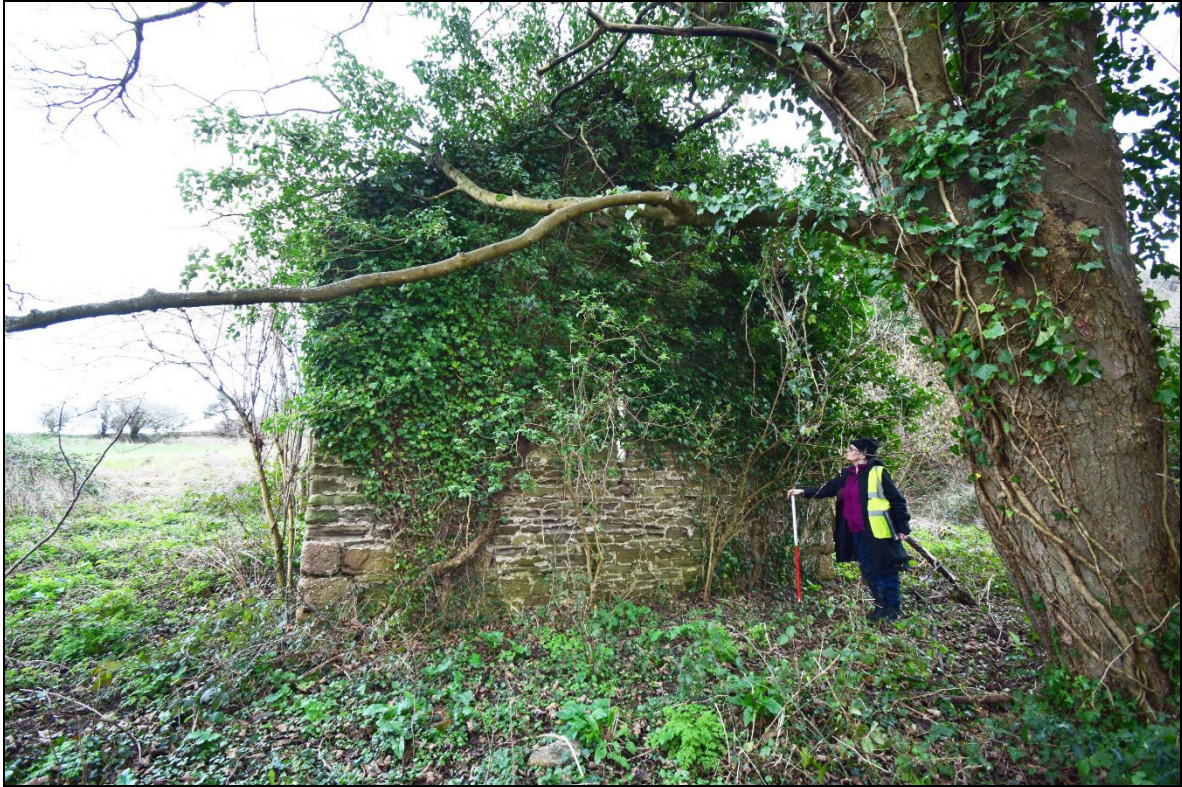
Plate 13 - TRW2024_013: A view of the southern gable wall of the now derelict barn (ID number 22). Looking north.

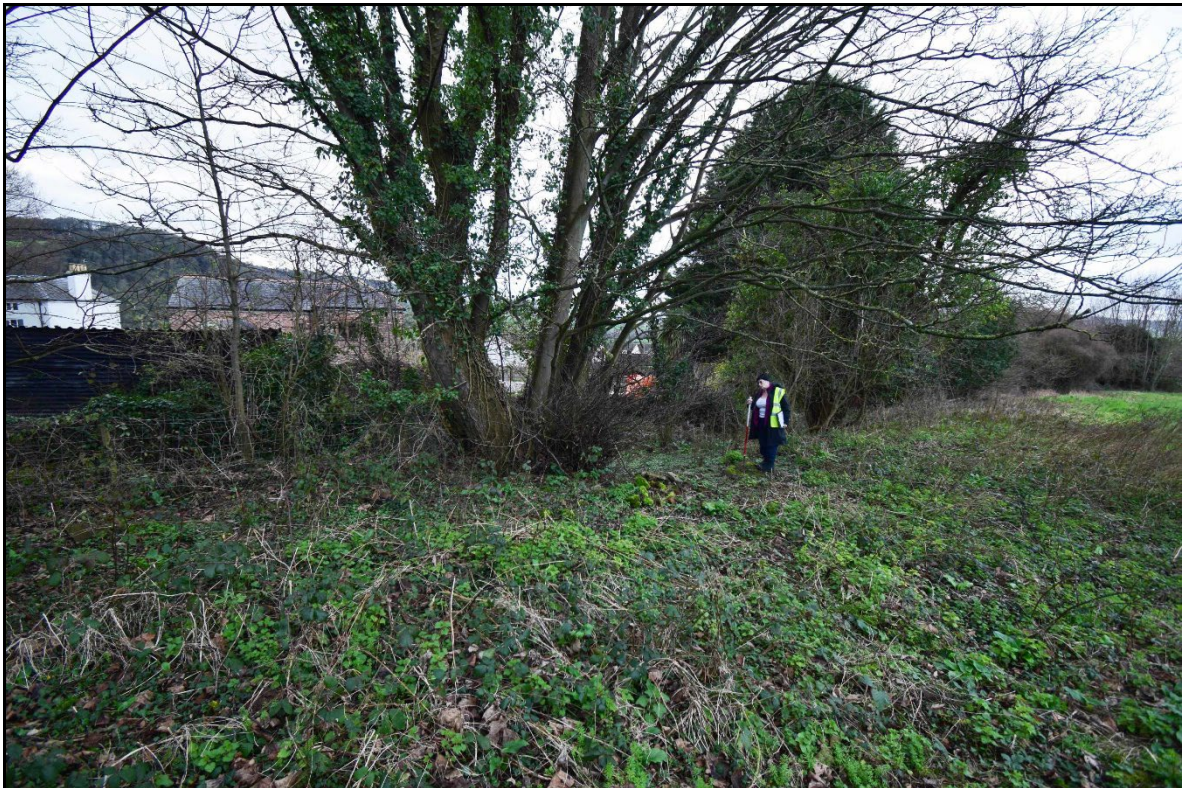
Plate 14 - TRW2024_014: A view of the southern boundary of the proposed development site, showing how trees have grown along the former road (ID number 17). Looking west-southwest.

10.2.3 A disused section of historic road (ID number 17) running southwest from Wyesham Lane lies outside the area of the development but could be directly or indirectly impacted upon by groundworks for landscaping drainage or utilities along its northern edge.

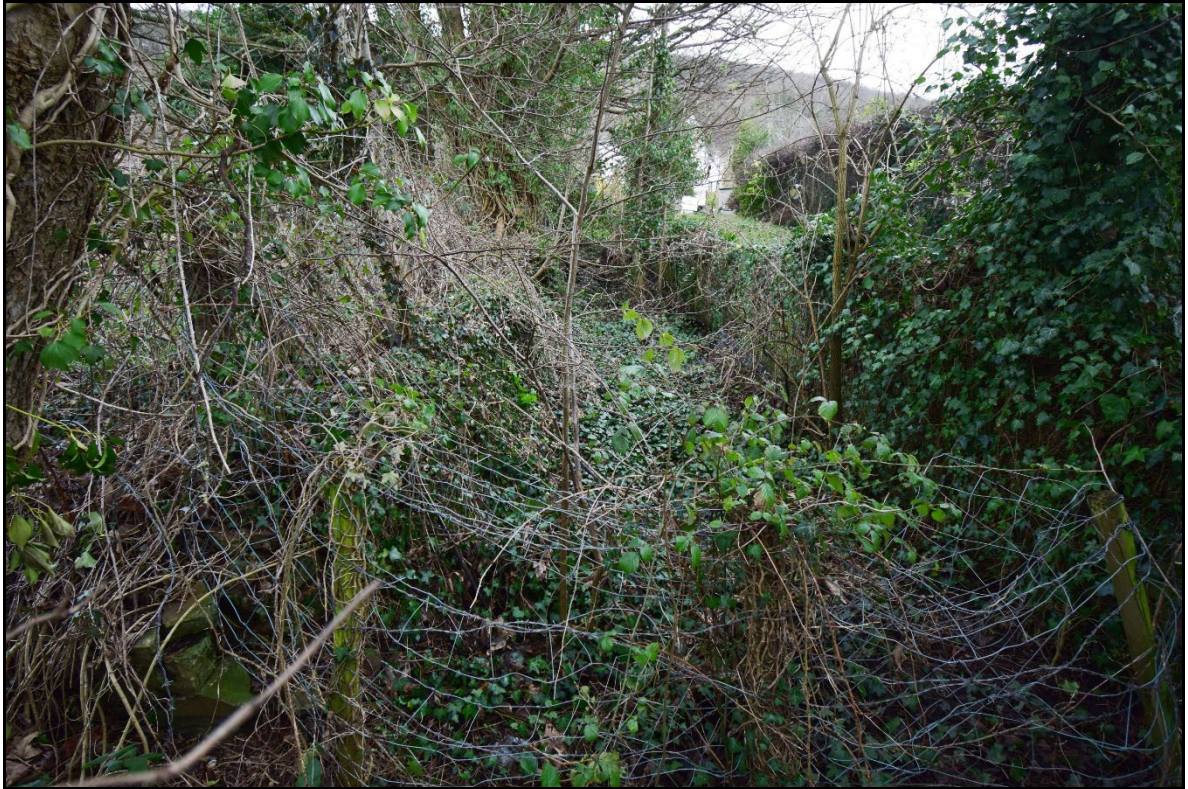
Plate 15 - TRW2024_015: A view of the now vegetation-choked roadway ID number 17, as it passes south of barn ID number 22. Looking east-southeast.

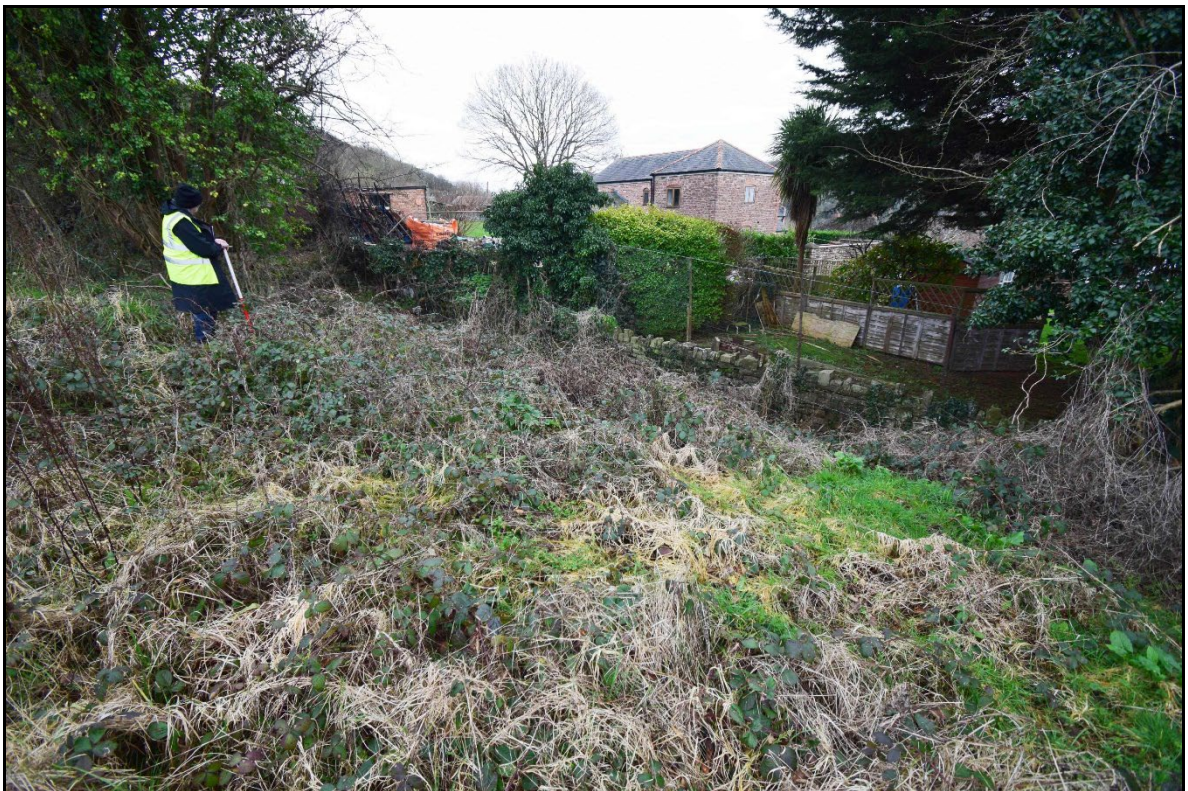
Plate 16 - TRW2024_016: A view of the now vegetation-choked roadway ID number 17, as it passes south of barn ID number 22. Looking southeast.

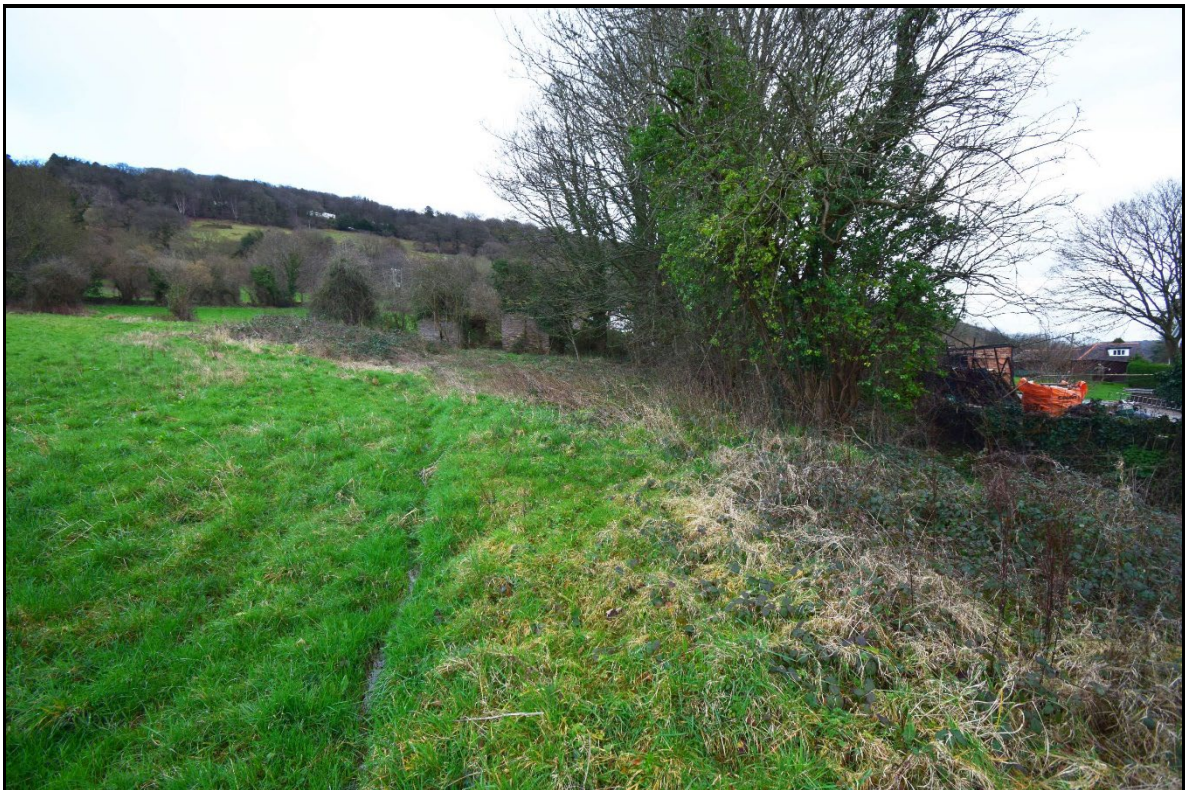
Plate 20 - TRW2024_020: A view towards barn ID number 22 with roadway ID number 17 to the right side of the image. Looking east.

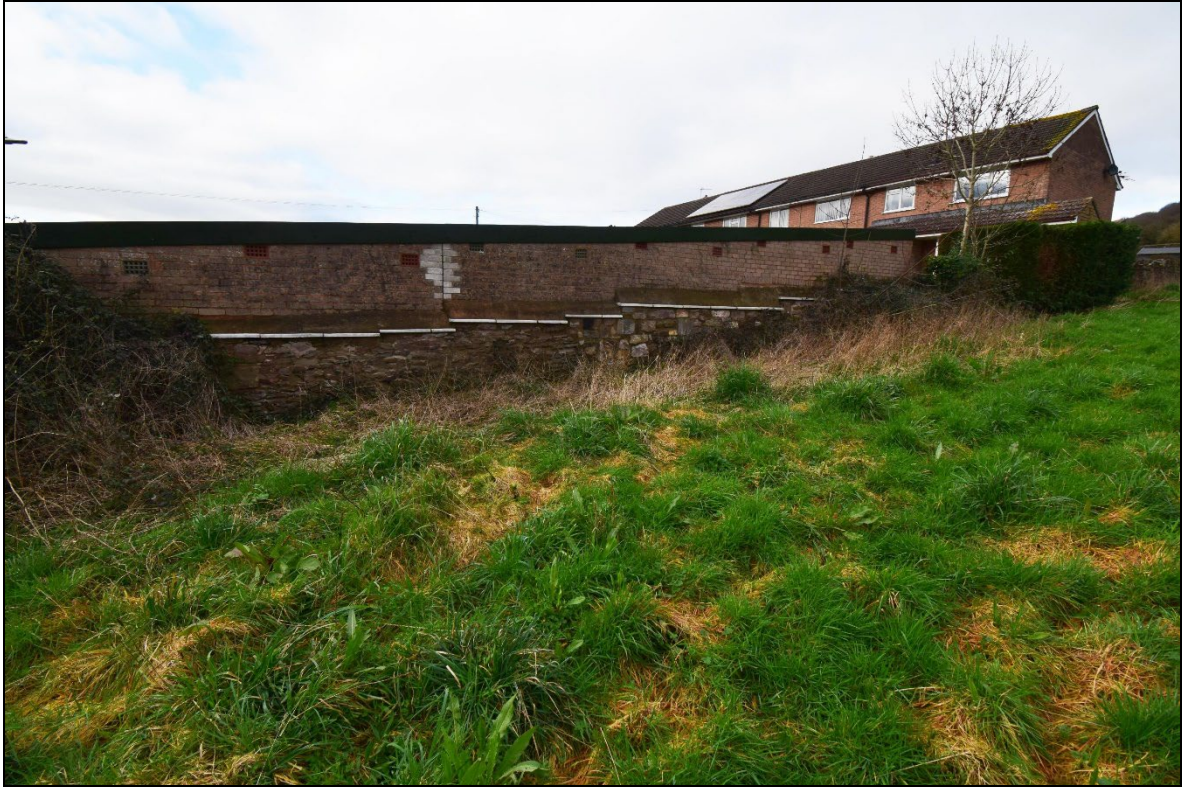
Plate 23 - TRW2024_023: A view of the rear of the Tudor Road garages along the west boundary of the proposed development site. The stone wall contains some fragments of the Tudor House garden wall (ID number 18). The garage will be removed for the development. Looking west-northwest.

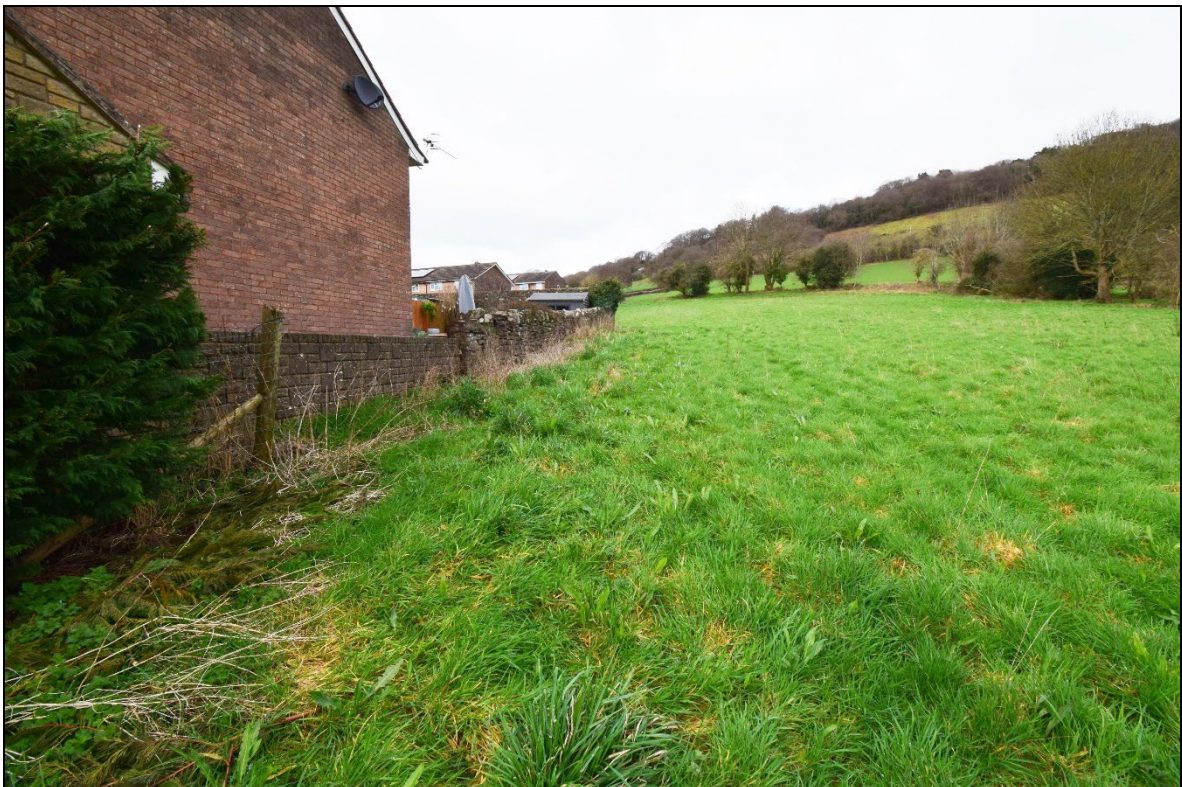
Plate 24 - TRW2024_024: A view along the western side of the proposed development site showing the preserved section of the Tudor House garden wall (ID number 18) left of centre. Looking north.

Any Direct Impact?: Yes
Moderate
New dwellings and roads will be created under the proposed development. This may cause the loss of some of the wall to its south end.

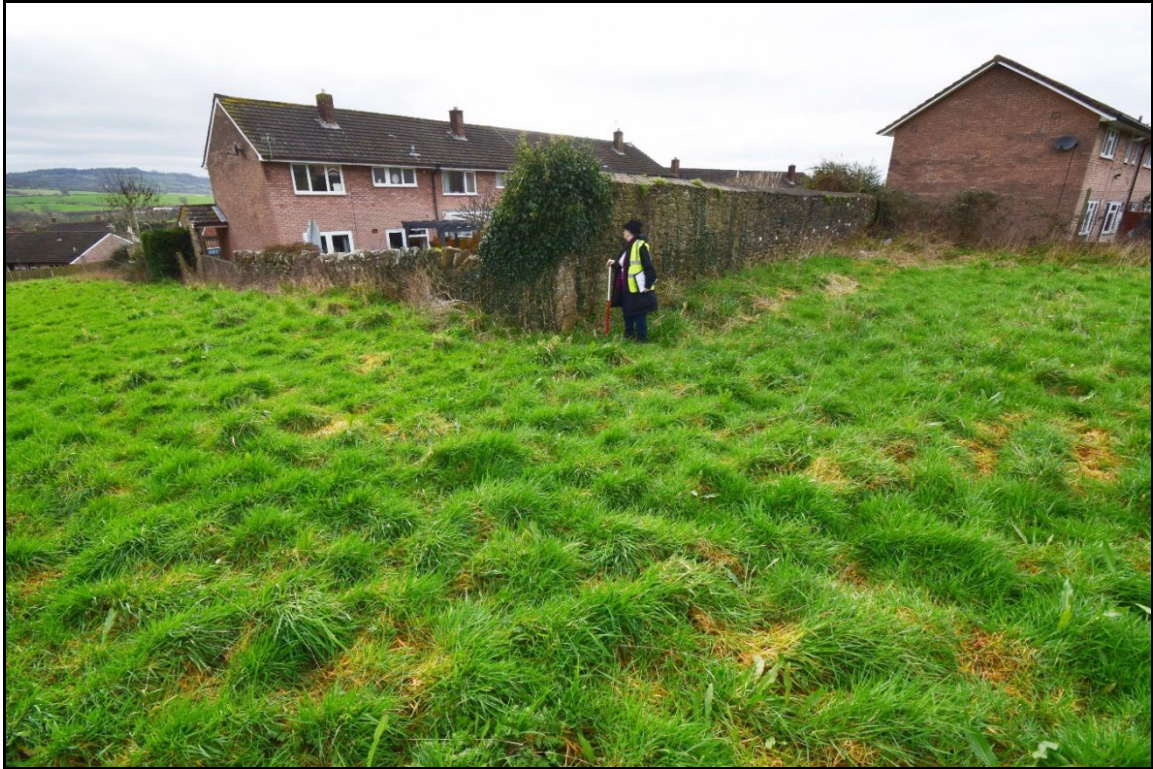
Plate 25 - TRW2024_025: A view of the best-preserved section of the former Tudor House garden wall ID number 18. Looking west.

NGR: SO5206912269 **Feature Centred**
Period: Post Medieval **Broadclass:** Monument (By Form)
Form: Structure **Condition:** Fair **Survival:** Damaged
Site Status:

Trysor Description: A section of the former garden wall of Tudor House still stands at the eastern edge of the housing development along the eastern side of Tudor Road. This wall was probably erected circa 1830 when Thomas Tudor built a new residence here. It was part of the garden wall to the north of his house, possibly defining the kitchen garden. The housing estate was built during the 1960s and this caused the removal of the house and its outbuildings, as well as the southern and western side of the garden wall. The eastern and northern walls were retained as the site boundary however, and largely remained intact when seen in 2024.
