**HISTORIC ENVIRONMENT
DESK-BASED ASSESSMENT
FOR A RESIDENTIAL SCHEME
ON LAND OFF TUDOR ROAD,
WYESHAM, MONMOUTHSHIRE
NGR: SO5215012230**

March 2024

Trysor Project No. 2024/930
HER Event Record PRN GGAT E007862

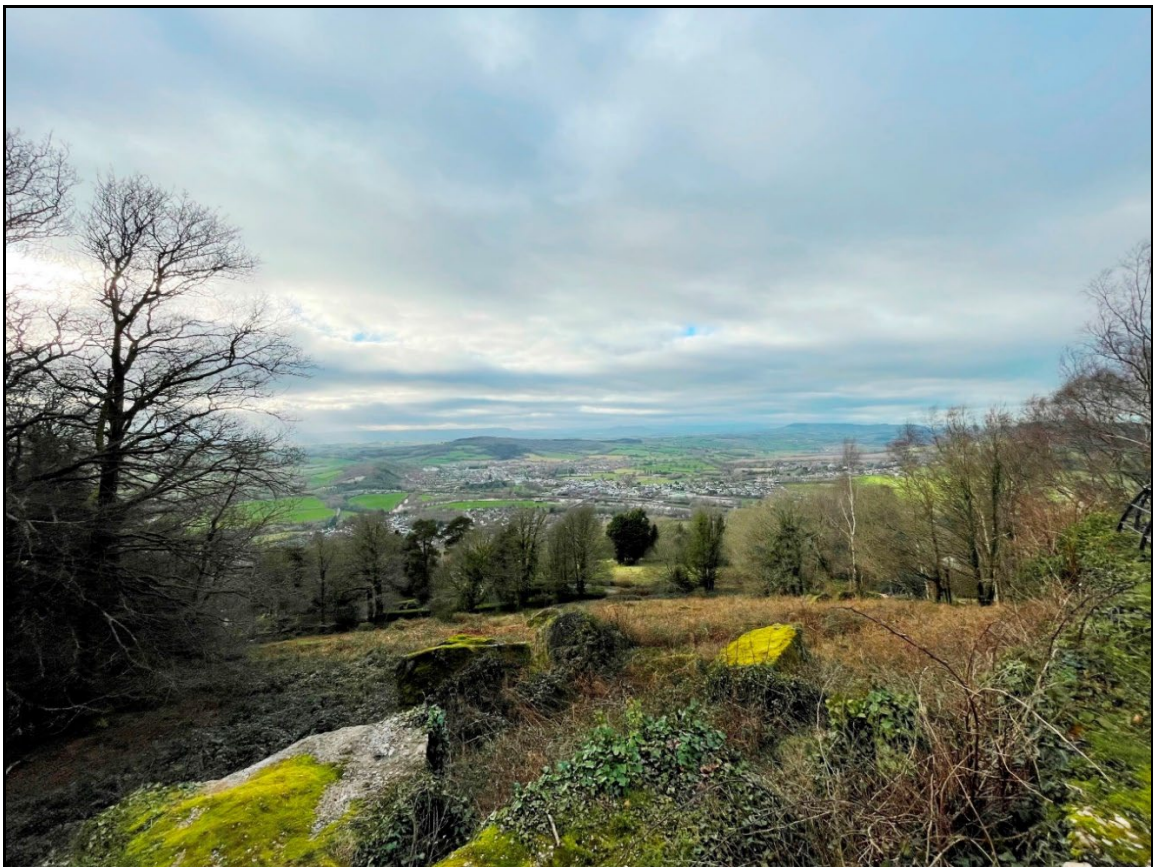
Plate 26 - TRW2024_026: A view towards Wyesham from The Kymin (taken from SO5275912507). There is no intervisibility between the proposed development site at the foot of the hill and this Registered Park and Garden or its listed buildings. Looking west.

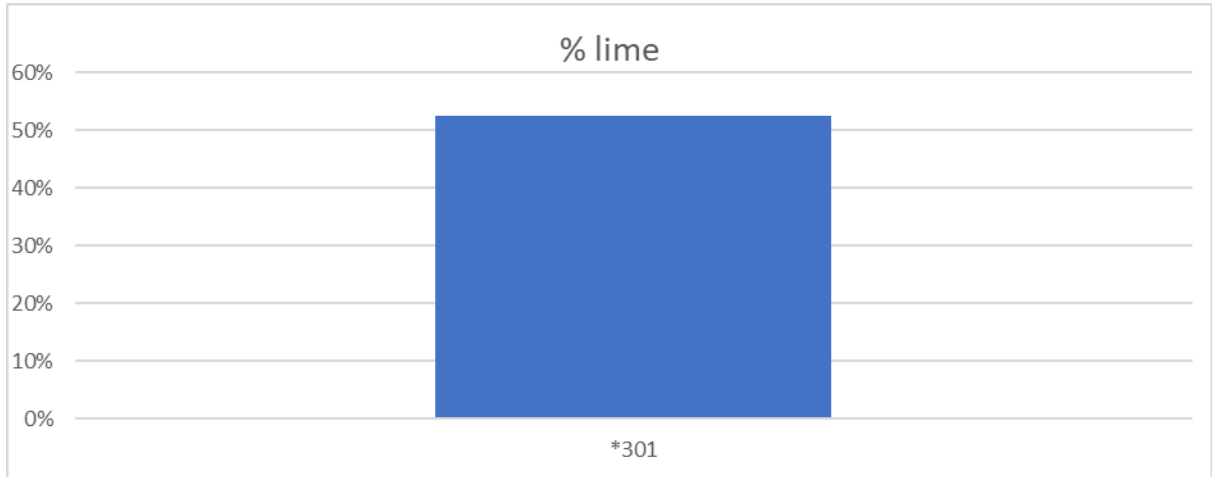
% lime

A single aliquot (subsample) from each sample was dried and crushed and analysed by the acid digestion method (dissolved in dilute hydrochloric acid) as recommended by Cadw (2004, 2); the residue was filtered and dried by gentle heating, and weighed. Overall composition of the mortar was calculated from the aggregate and soluble (Calcium Chloride) components.

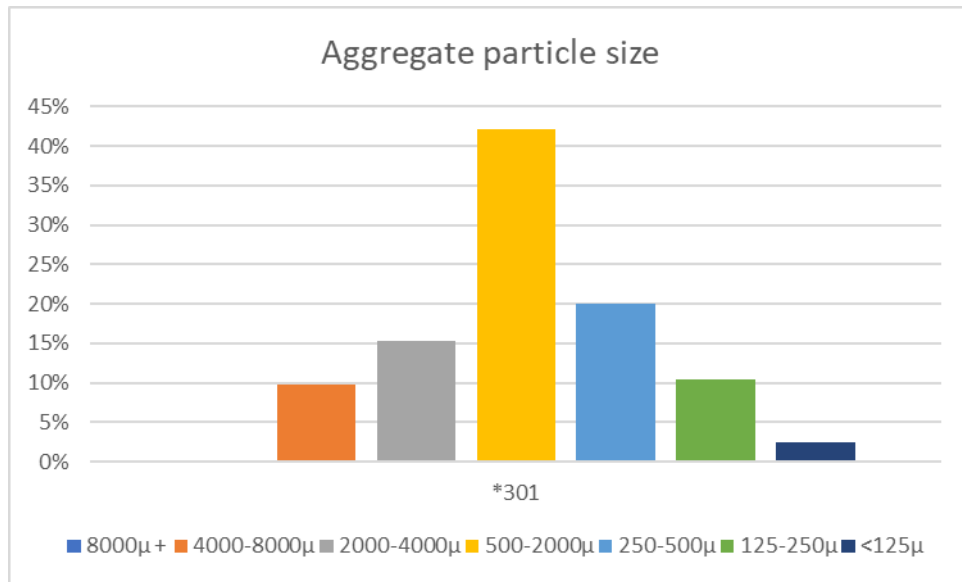
Particle size analysis of aggregate

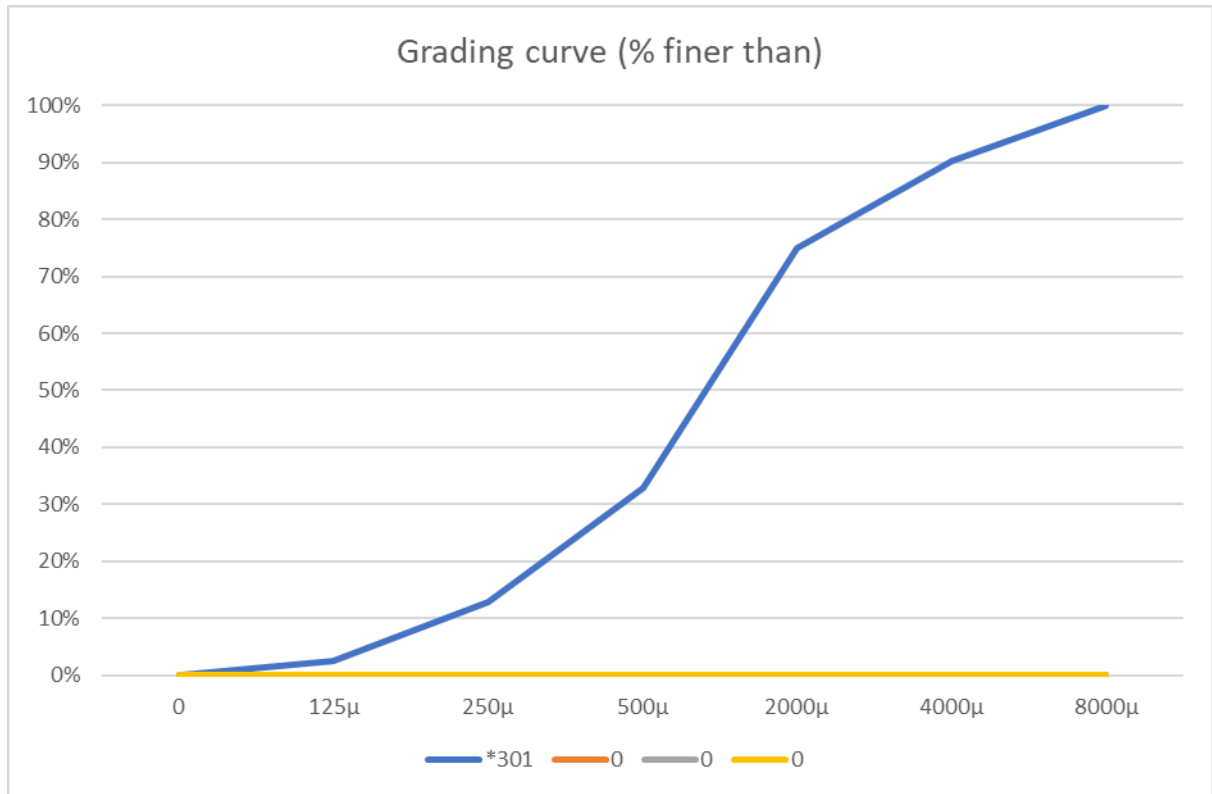
Grading curve of aggregate (% finer than)
