Game keepers lodge, Llandefalle

Level 2 Building Survey

Report No . 1957

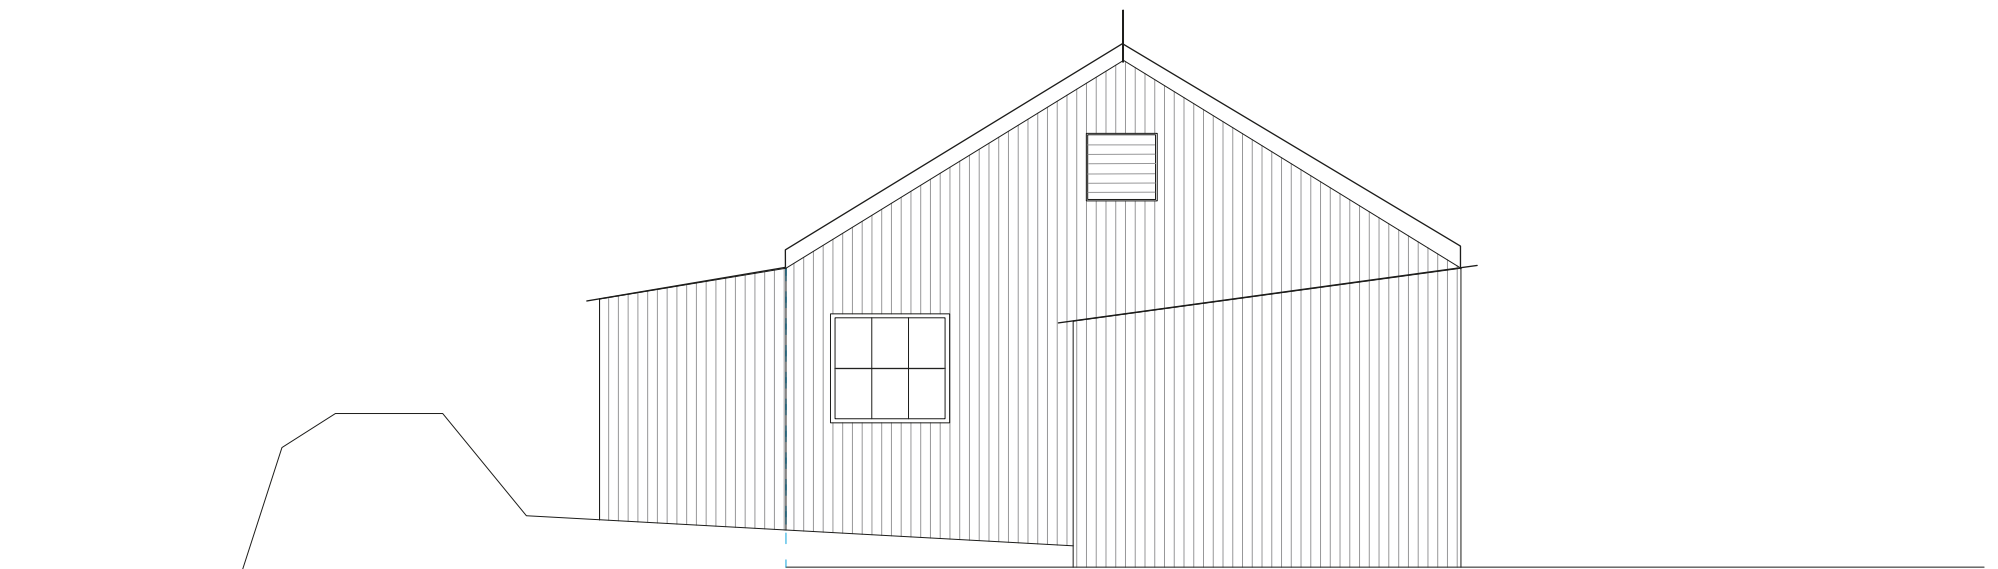
Figure 2.1. Exiting plan and elevations.

East Elevation

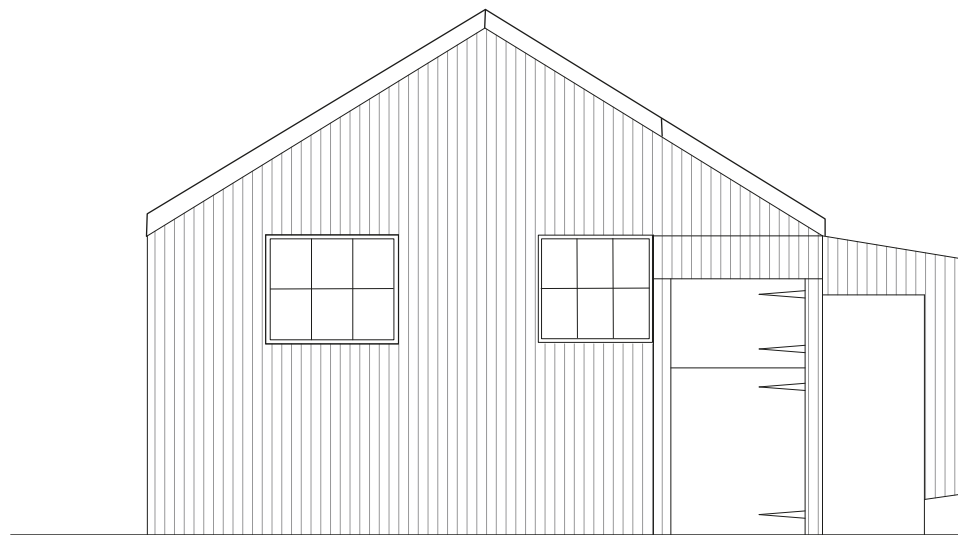
Figure 2.2. Existing plan and elevations.

West Elevation

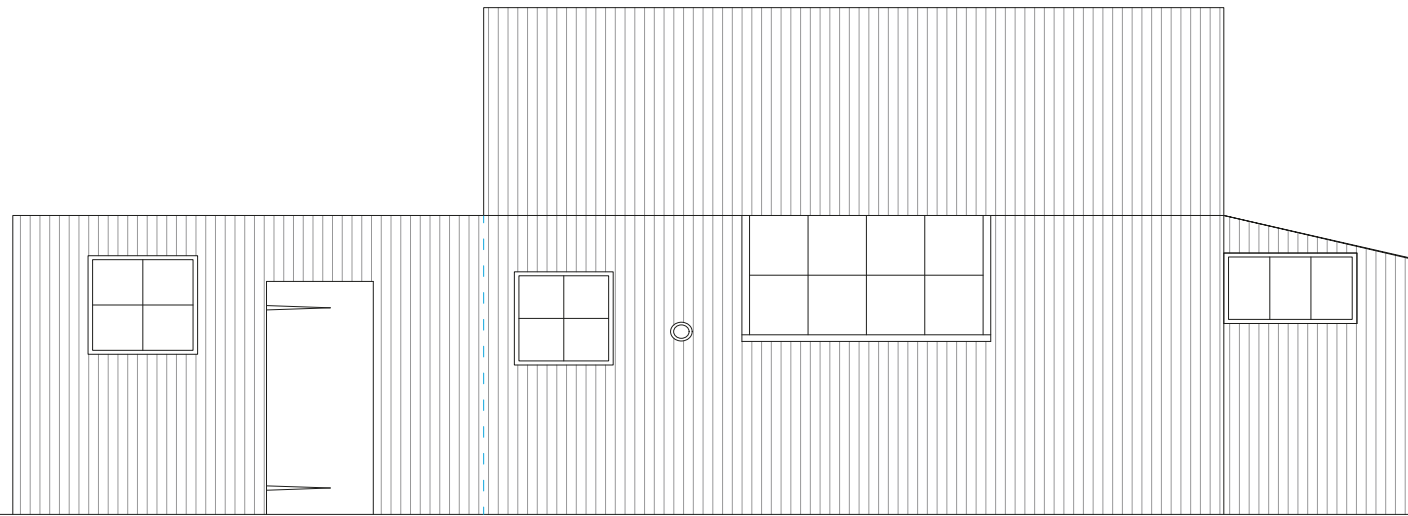
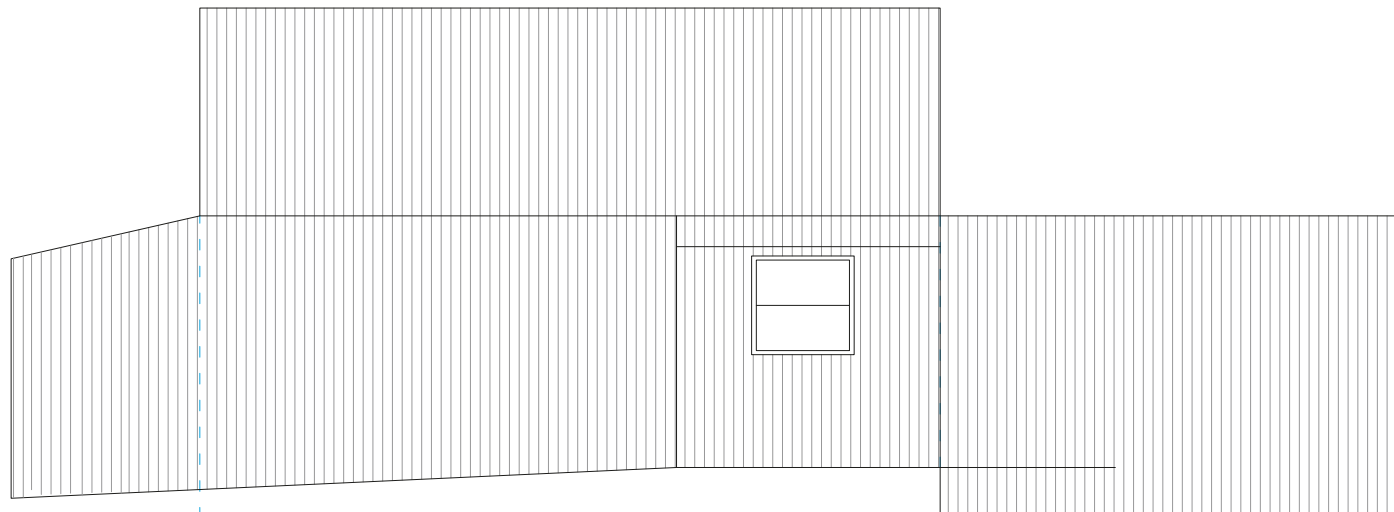
Figure 2.3. Exiting plan and elevations.

North Elevation

South Elevation

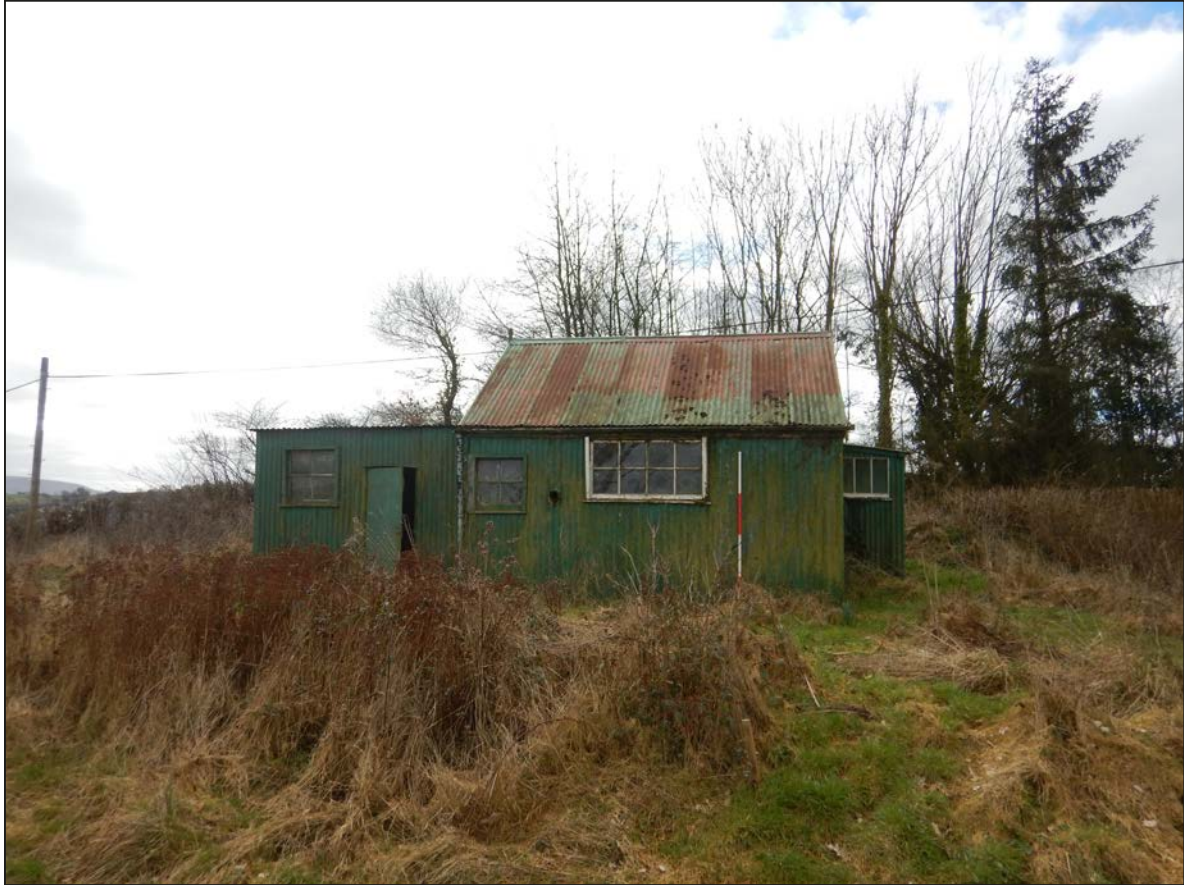
1. View of N facing elevation, looking S.

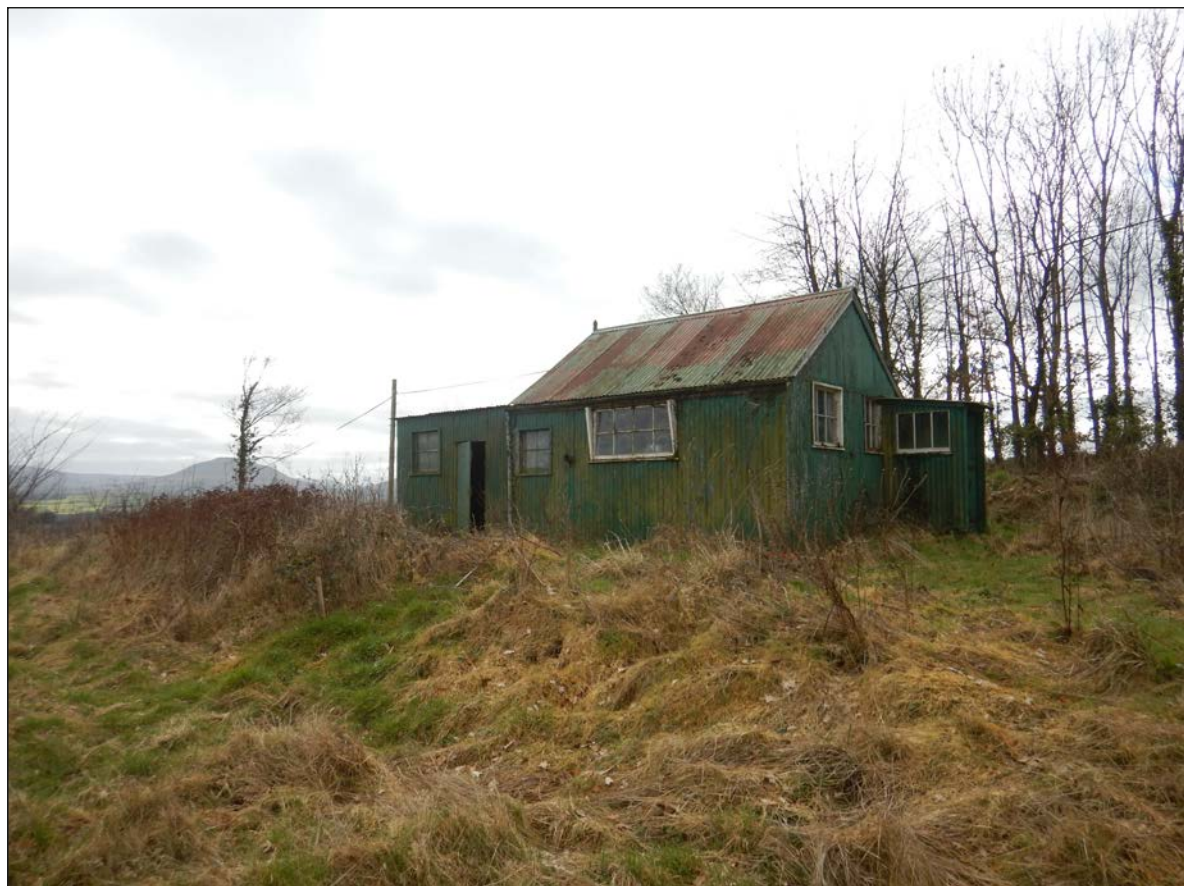
2. View of N elevation, oblique.

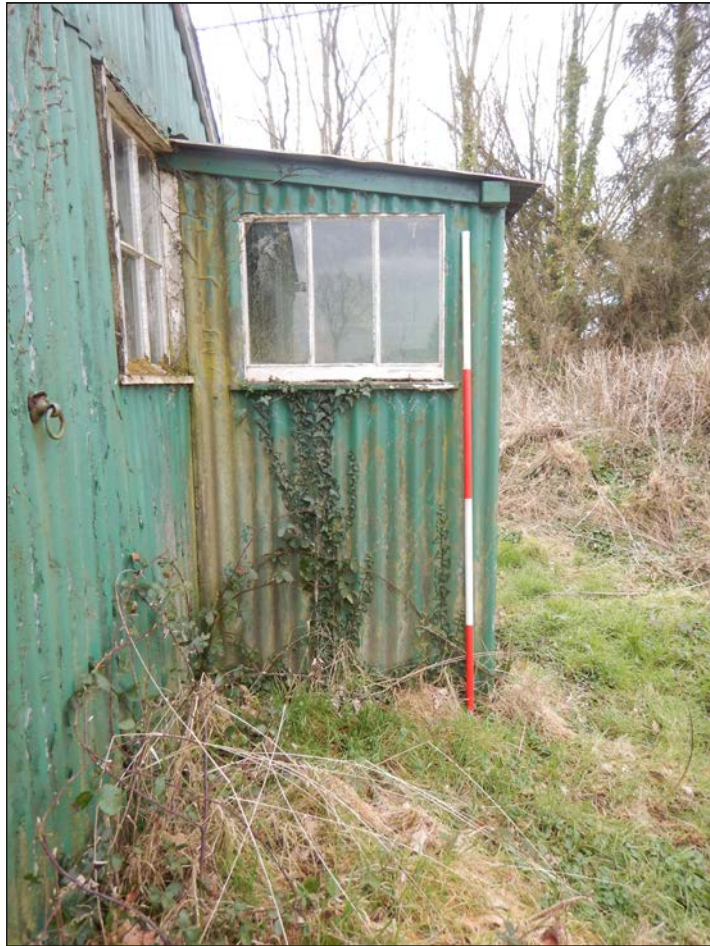
- 5.4 The porch measures 2.20m in height and c 1.20m in length. Structurally is made of square cut timber (0.1m) slotted together to form the main frame from which the galvanised corrugated sheets stand as well as the main door. The latter is defined by a panelled stable door held by four T hinges. All timber and galvanised corrugated sheets are painted green.

3. Porch S facing elevation, looking N.

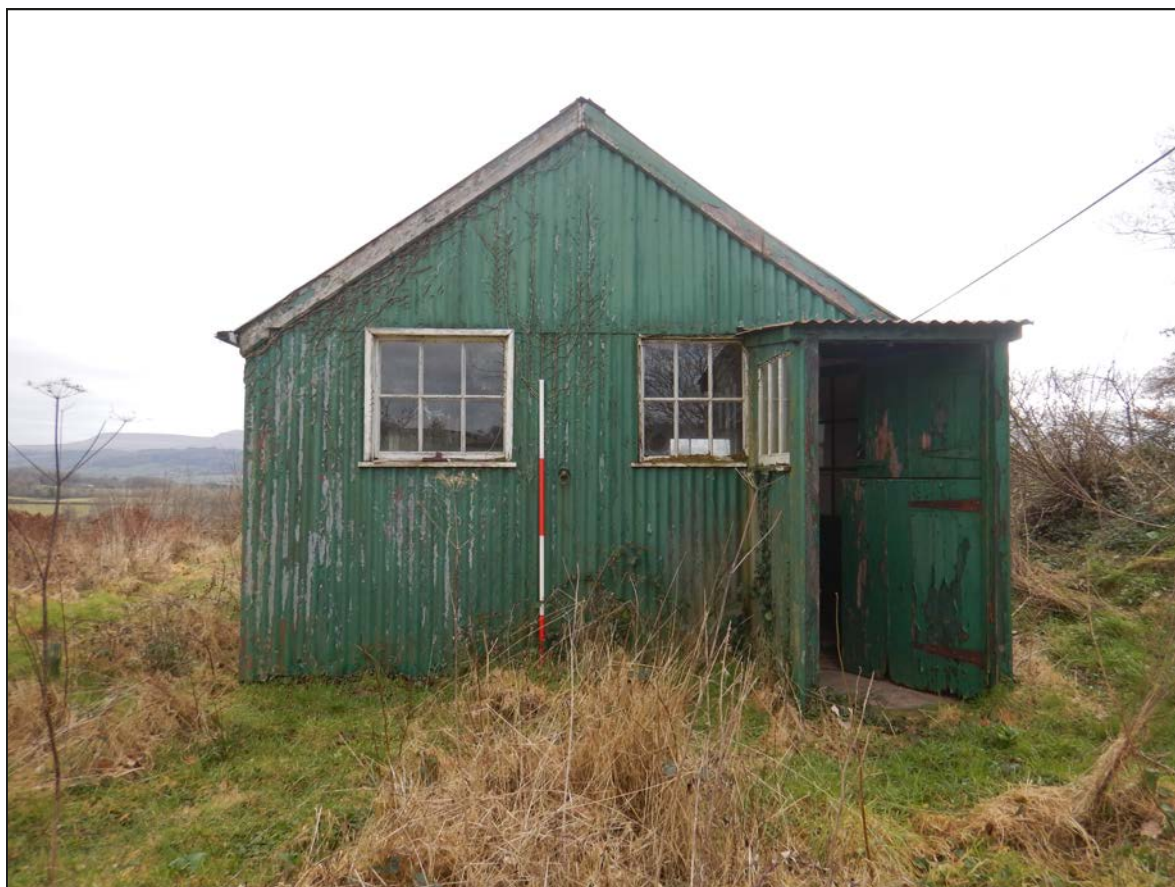
- 5.3 This elevation is 5m wide with every wall is constituted with galvanised corrugated sheets with rivets, painted green. Two rectangular windows are located on this elevation. The northernmost window measures 1m in length and 0.8m in width. The space holds a timber framed window occupied with six panels of single glazed glass. The timber is currently painted white. The southernmost window is of the same characteristics than the opening described above, however, it is of smaller size (approximately 0.8m x 0.7m) probably to accommodate the entrance porch.

8. View of W facing elevation, looking E.

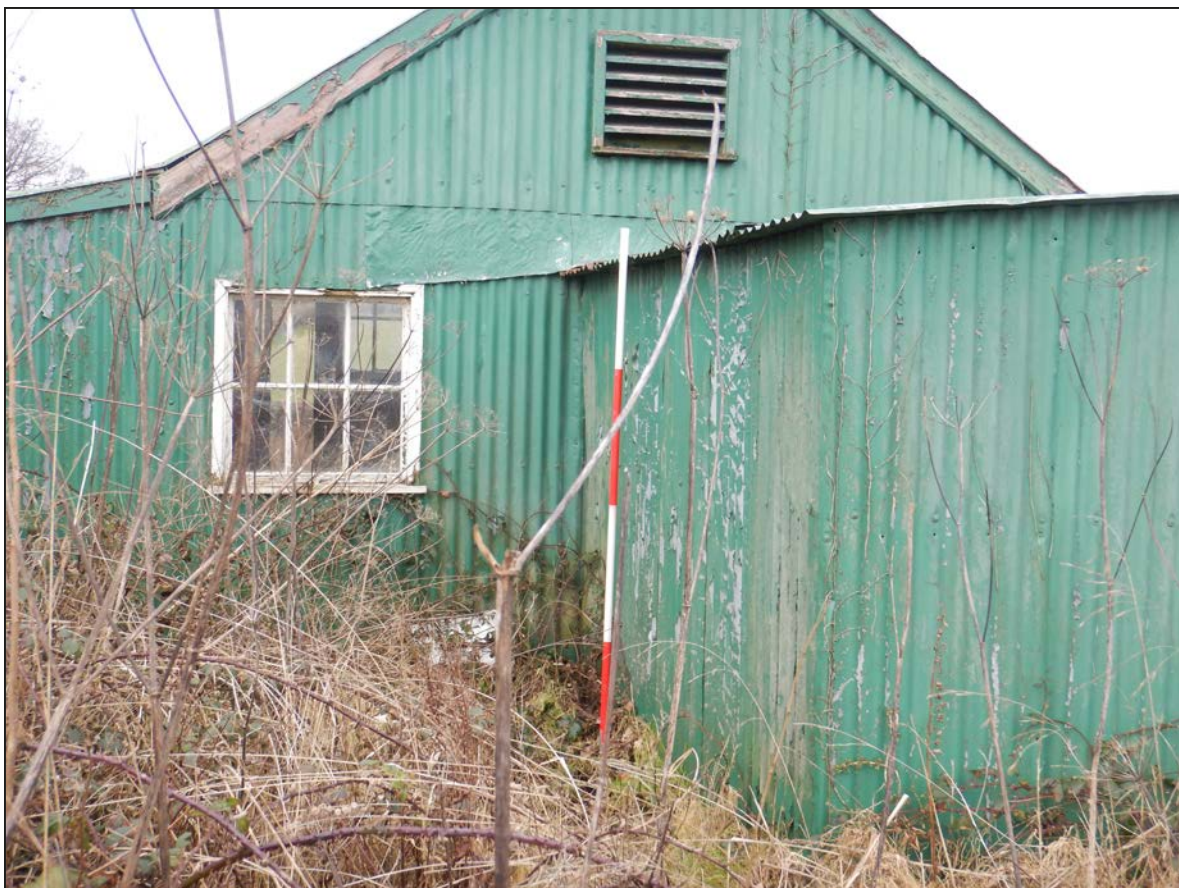
10. E facing elevation looking NW.

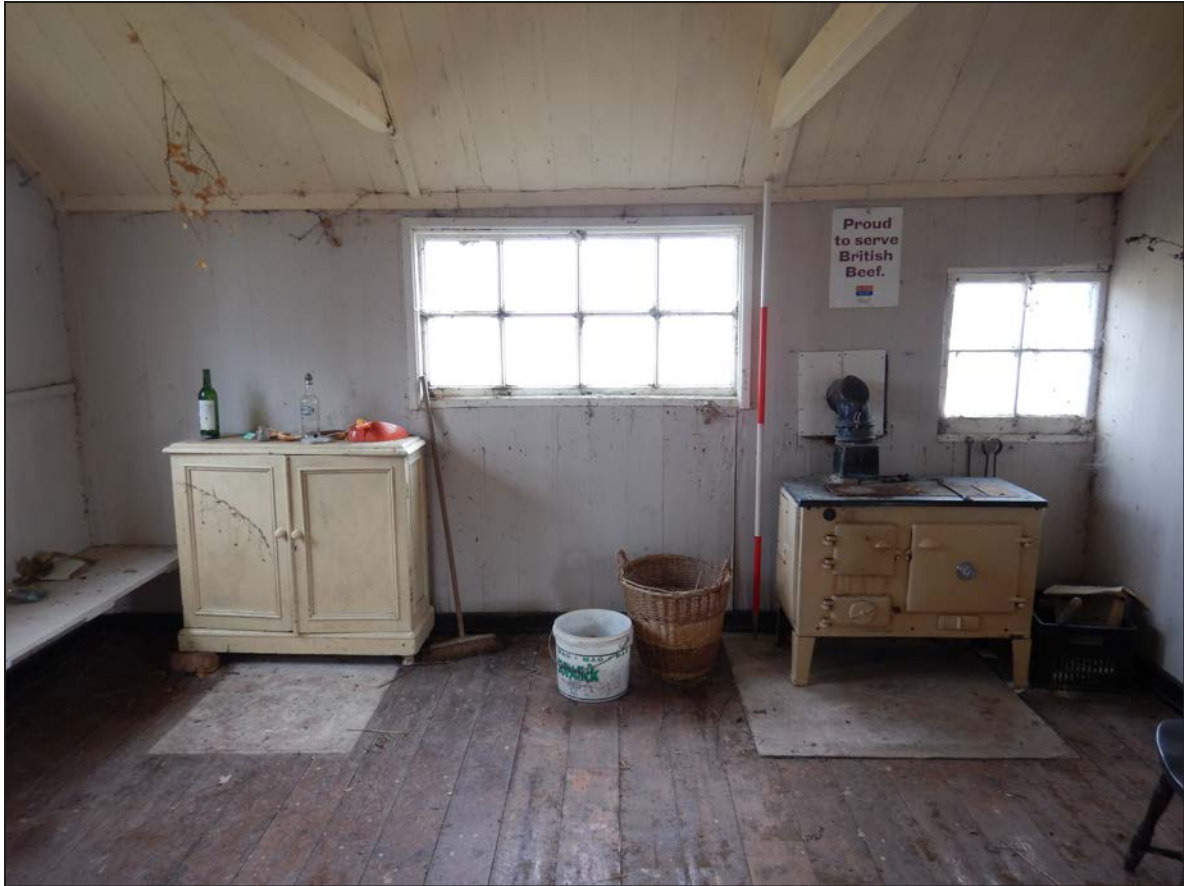
5.17 This space is floored with floorboards possibly dating to the construction of the structure. While some wood treatment is evidenced (polish), the boards are currently heavily worn out exposing the bare timber. Furthermore, two areas concreted over exist, one beneath the hob, and one adjacent to it, probably indicating the position of an earlier hob or a similar source of heat.

20. View of S facing elevation looking N.

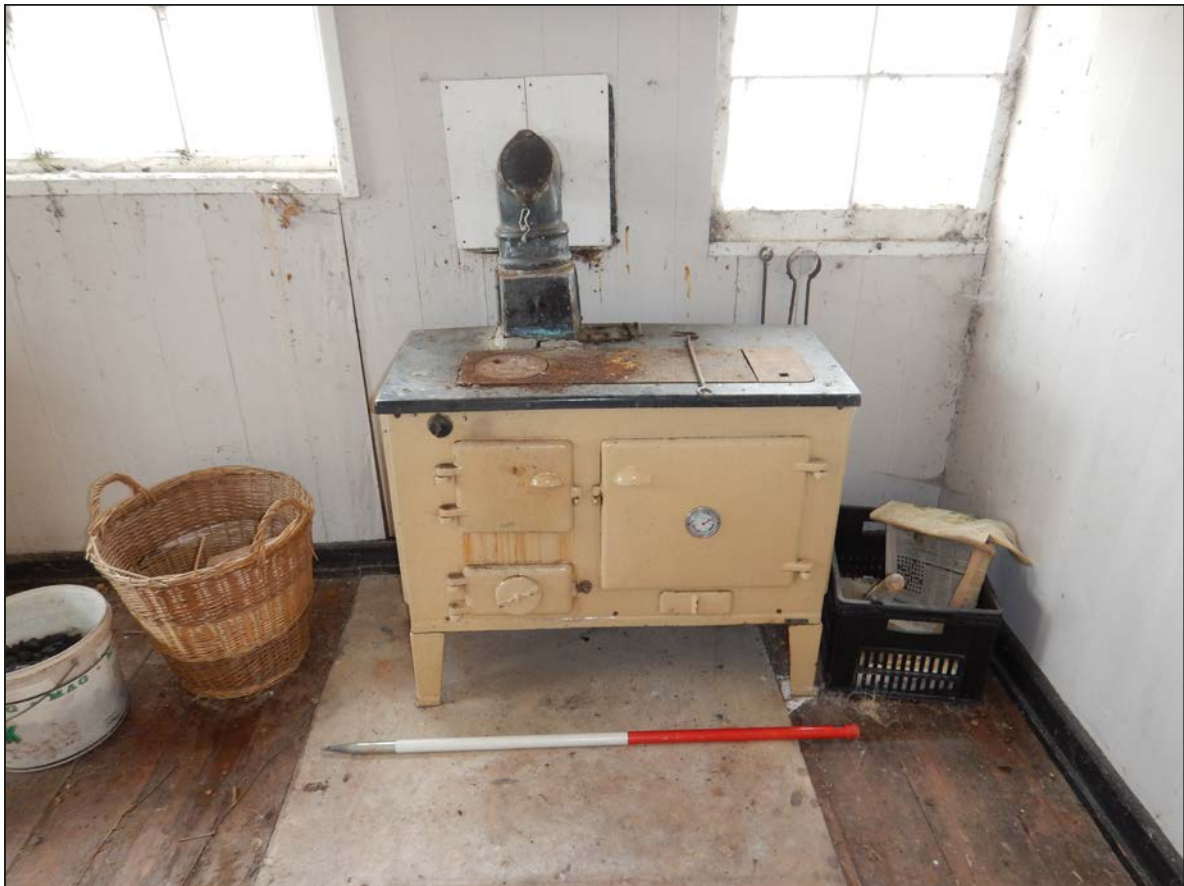
21. View of S facing elevation looking N - hob.

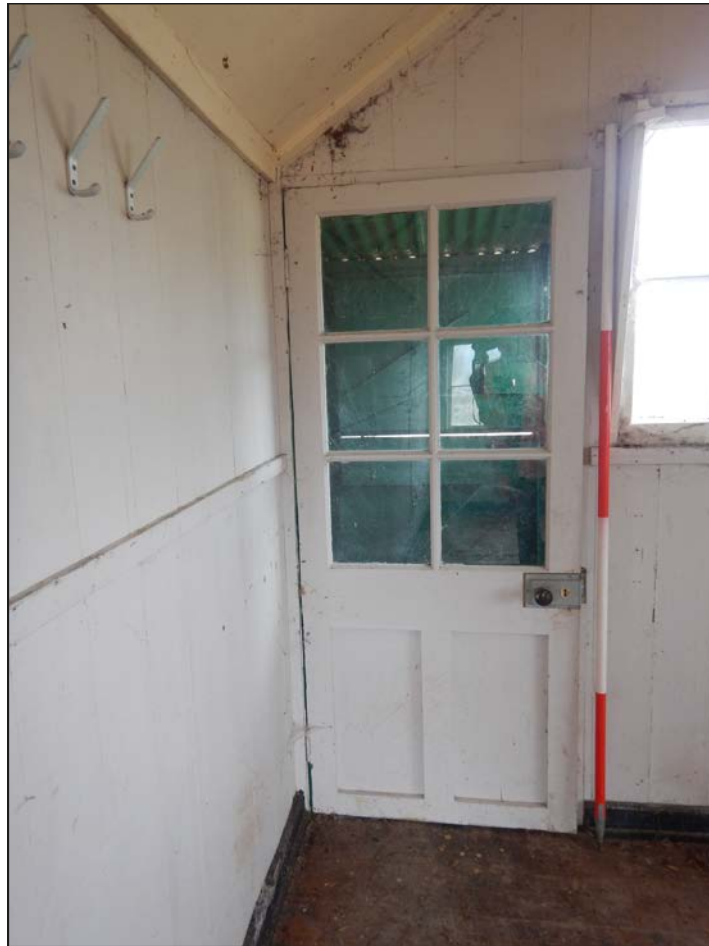
5.20 The interior door - as opposed to the porch door - is made of wood with fielded panels to the lower half, and with six light panels above. The doorknob is made of metal.

22. Door detail, E elevation looking W.

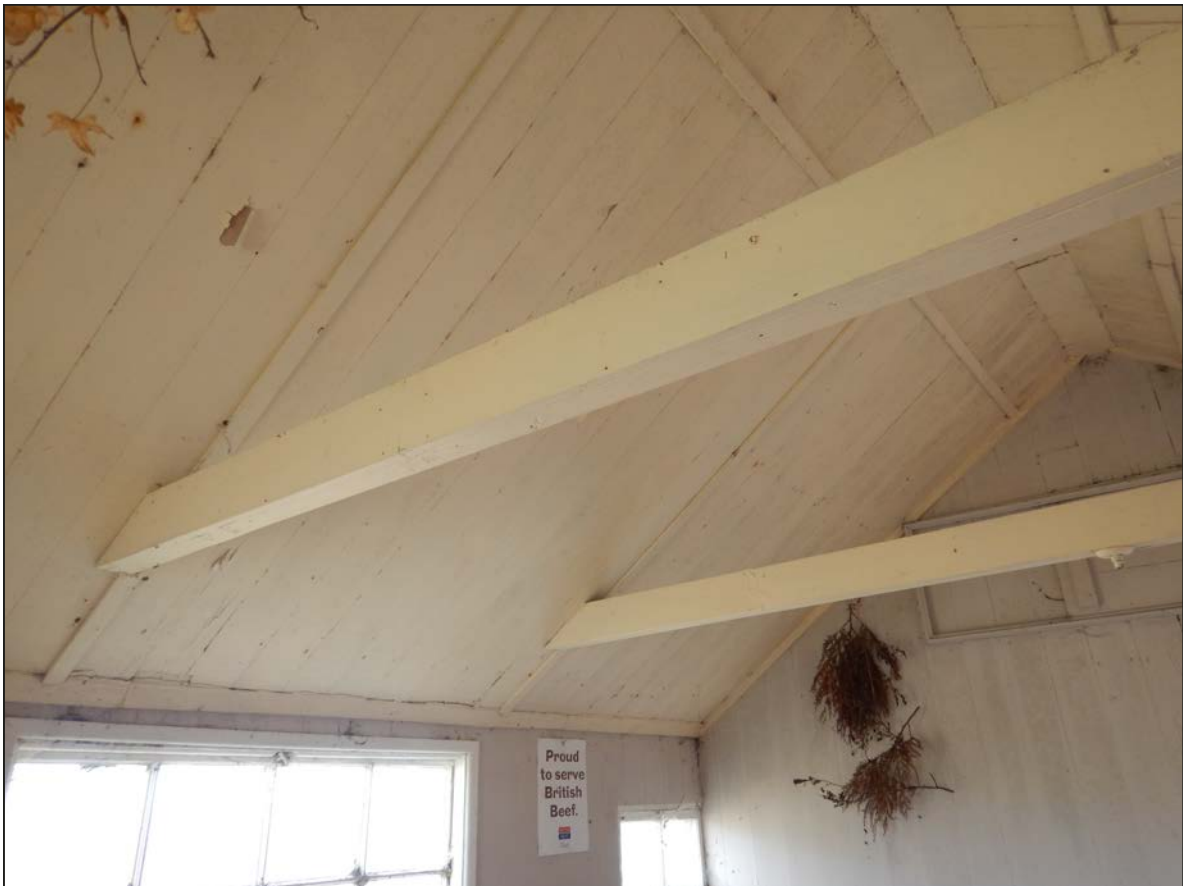
- 5.6 The gable end has the timber trusses exposed and are situated immediately below the roof made of galvanised corrugated sheets. The truss is made of two main beams running down at 45° angles, however, the southernmost one is defined by two adjoined beams. While there are no other sources of evidence to support the following interpretation, the two-beam element described above might be understood as proof for an event of alteration defined by the creation of the porch.

25. Detail of roof trusses.

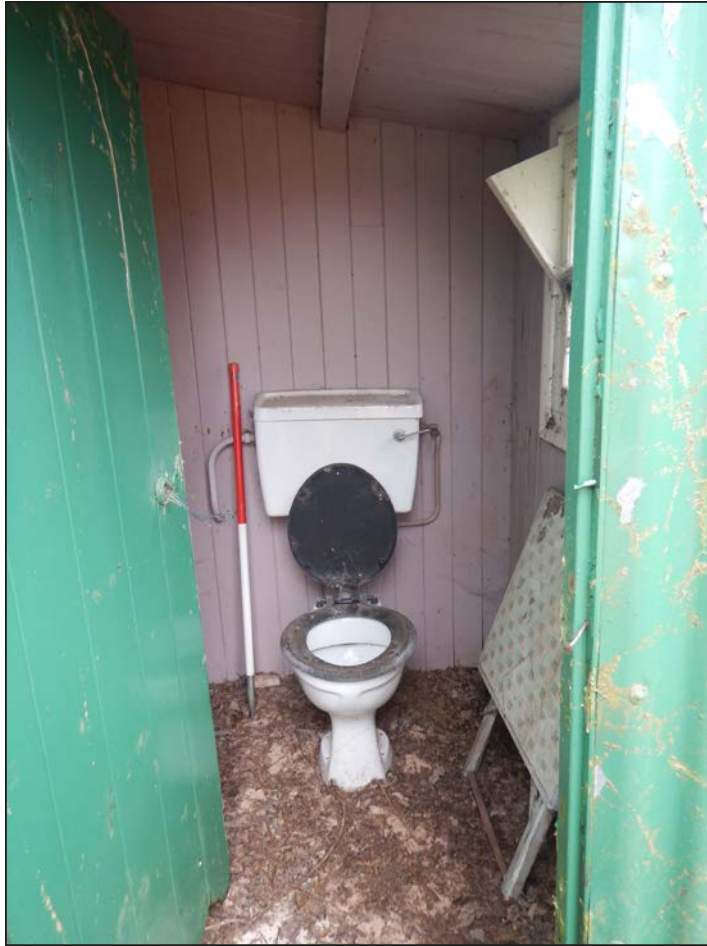
- 5.23 This space shares a number of traits with the living area, and it is therefore possible to suggest that it may also be an element corresponding to the original layout of the building. The toilet block floor is concreted, however the walls and ceiling are constructed with wooden panels painted white. The toilet unit may be dated to around the 1960s.
- 5.24 A small rectangular window cuts through the S elevation. The latter is a two light hopper PVC window.

26. View into toilet block looking E.

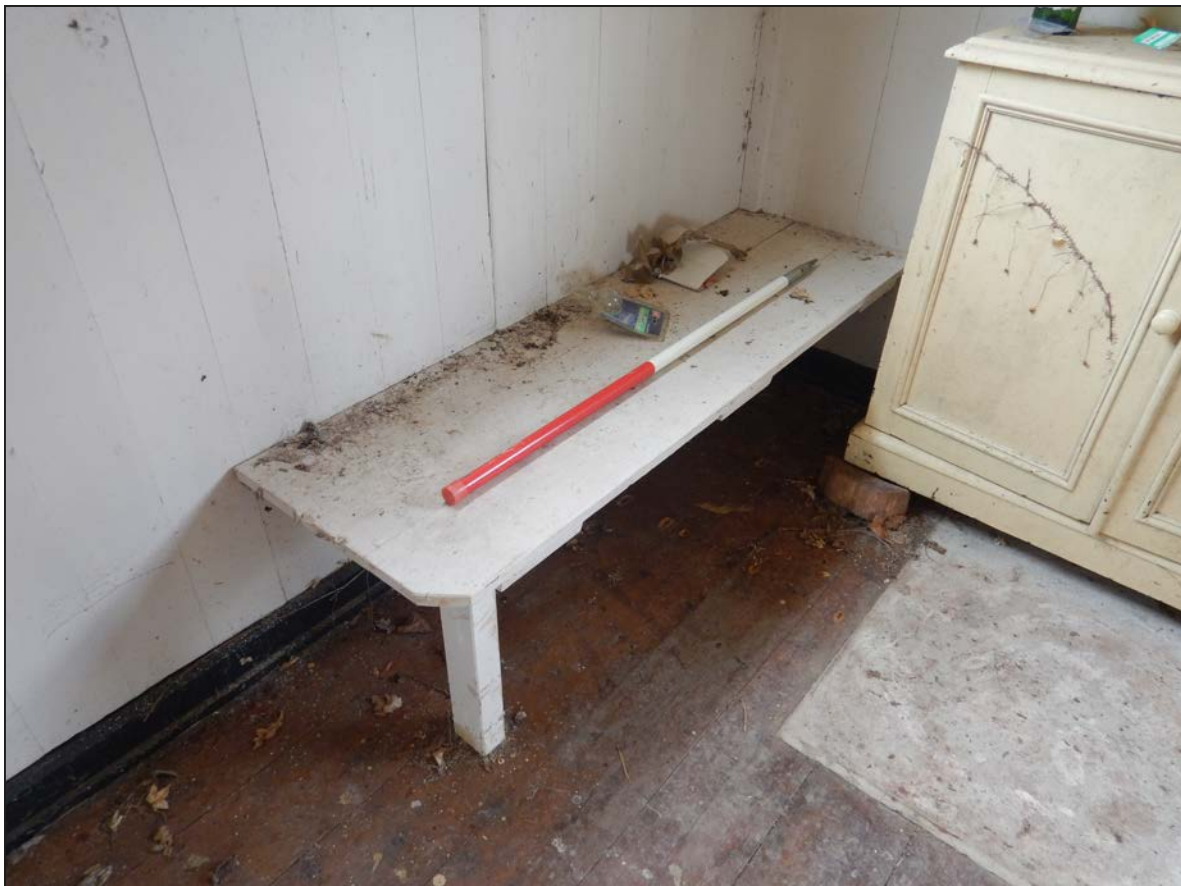
5.19 A wooden bench also painted white is located in the NW corner of the room. This is attached to the boarded wall, with a supportive post in the SW corner. Evidence suggests that the original layout would have contained a further bench on the SE corner of the room.

27. View of bench, interior looking NW.

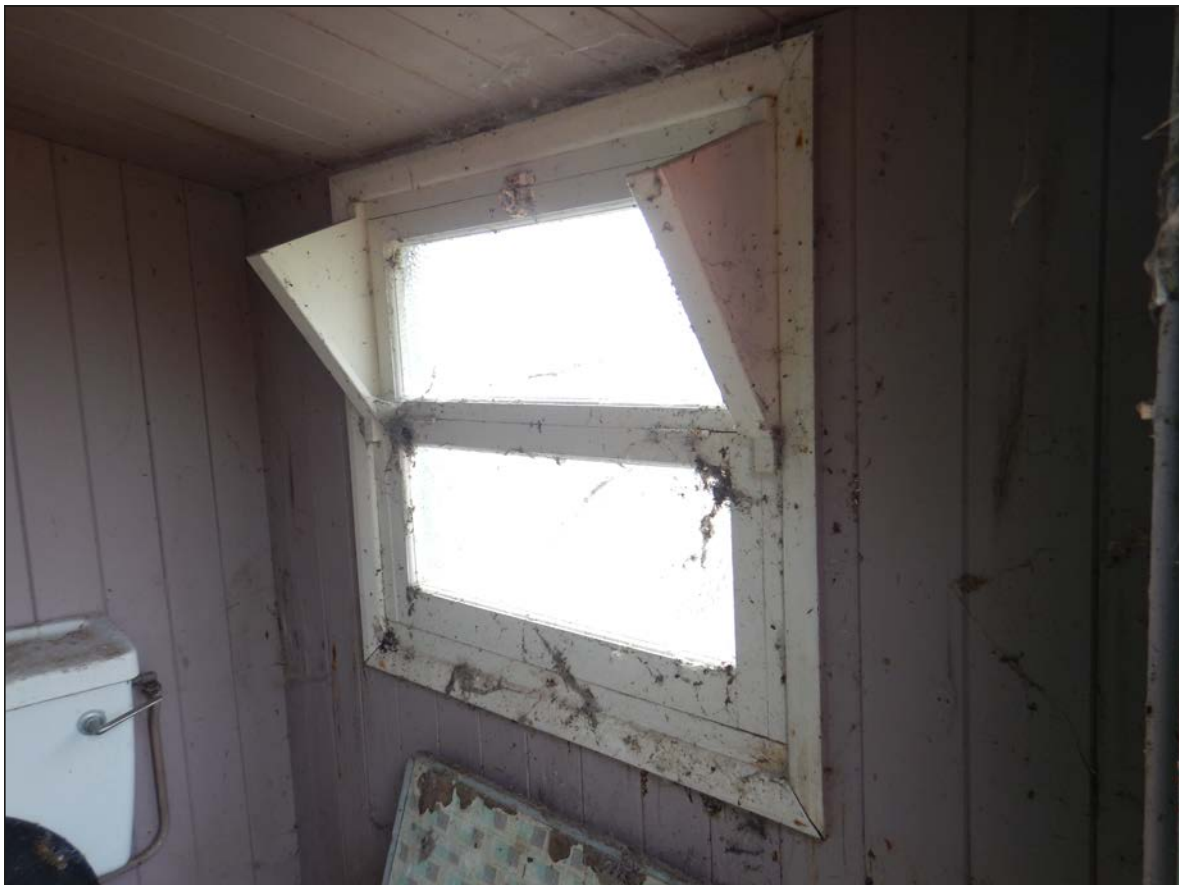
29. View of window, toilet block looking W.

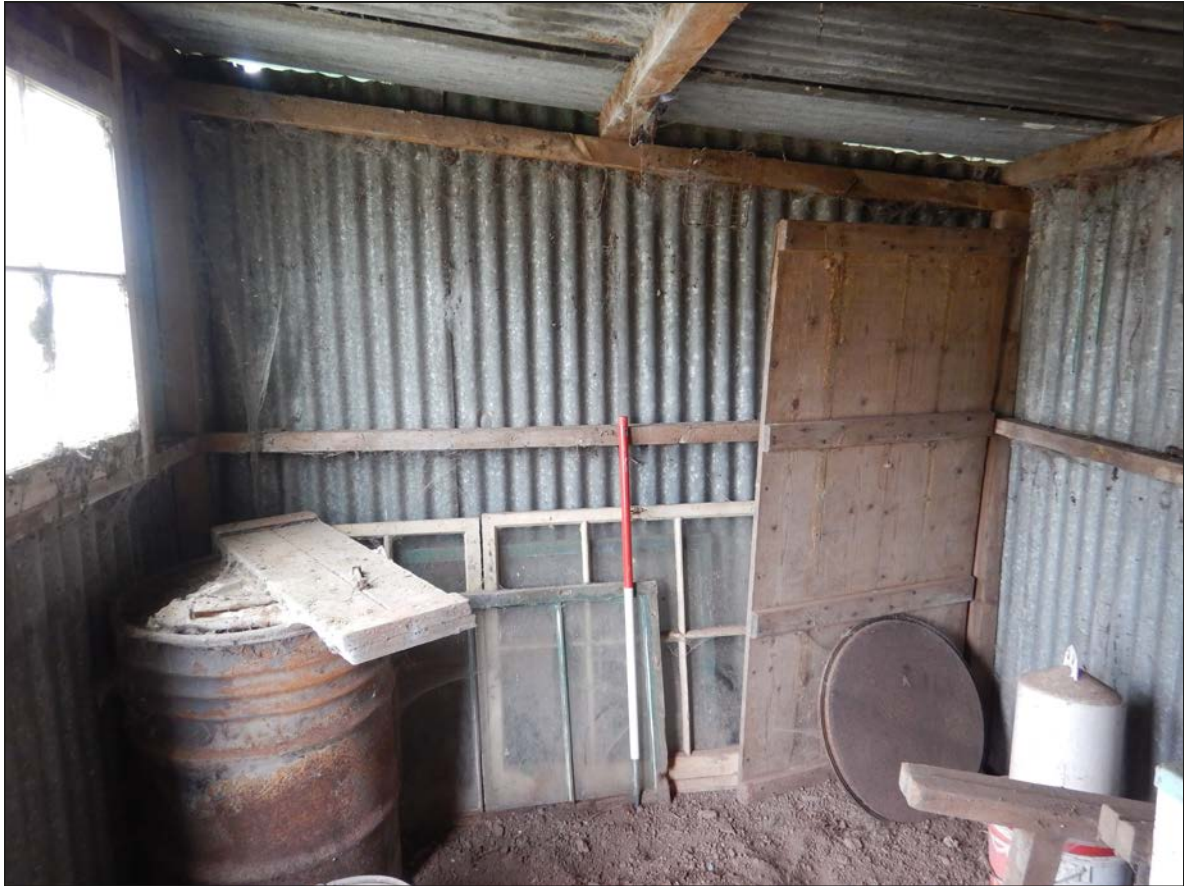
- 5.25 This space is floored with concrete although the latter is currently covered with soil. Both the ceiling and the walls are constructed with square cut frame covered with galvanised steel sheets painted in green. There is no detail on the elevations other than the changing height corresponding to the profile of the shed roof.

30. View into shed looking E.
