DYLASAU-UCHAF, PADOG, BETWS-Y-COED, CONWY

[NPRN 26416]

Architectural Record

Document Title: Architectural Record
Issue No.: v.02 **FINAL**

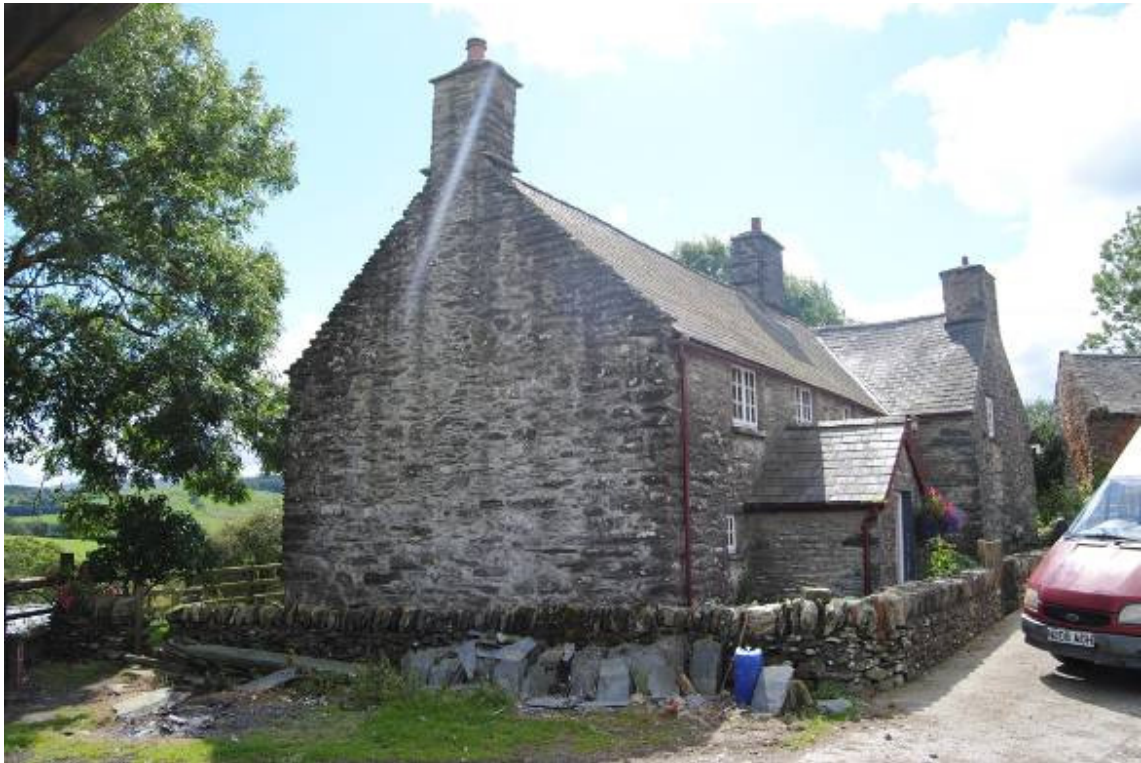
Plate 1: General view of farmhouse from the north-west.

4.1.1 The farmhouse at Dylasau-uchaf (Plates 1/2) can be broken down into two principal elements (see sketch plan overleaf); the earliest element is located to the south, comprising a stone-built range on a compact, rectangular plan aligned east-west, rising to 1½ storeys beneath a pitched, slate-clad roof, gabled to east and west with a ridge stack rising above the western gable. Appended at the north-east of this range, a further, longer range is aligned north-south with its principal elevation facing onto the main farmyard which

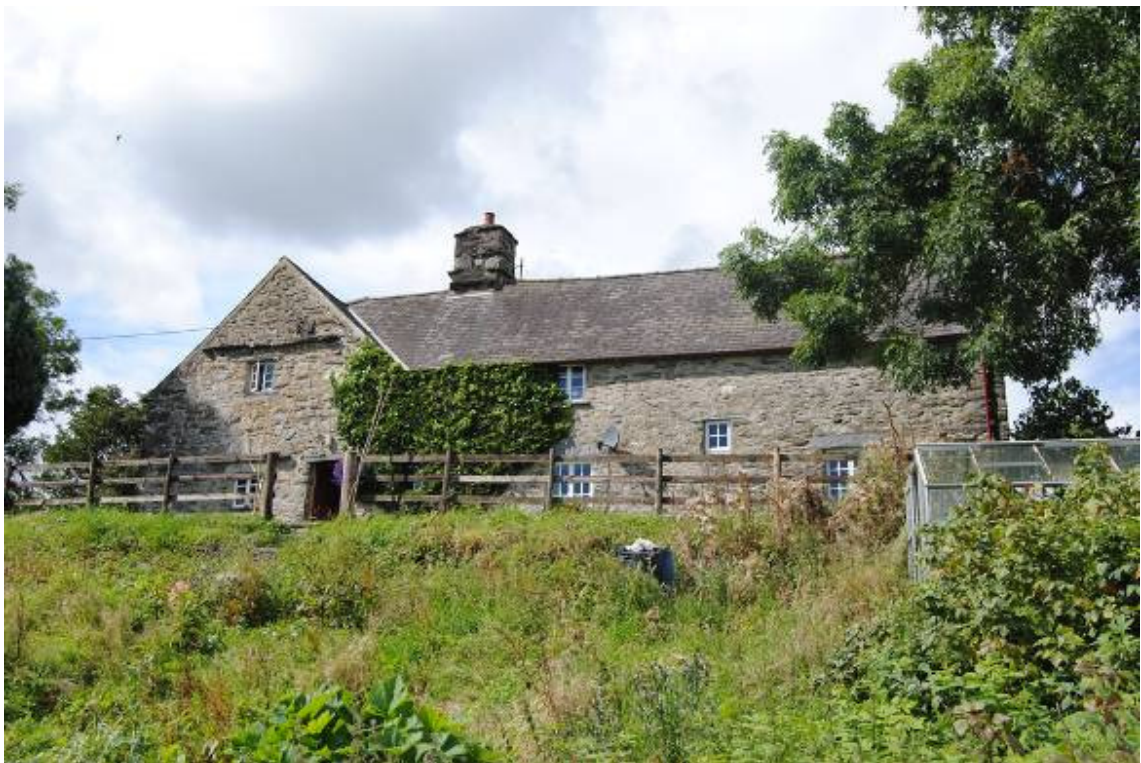
Plate 2: General view of farmhouse from the east (south range to left, north range to right).

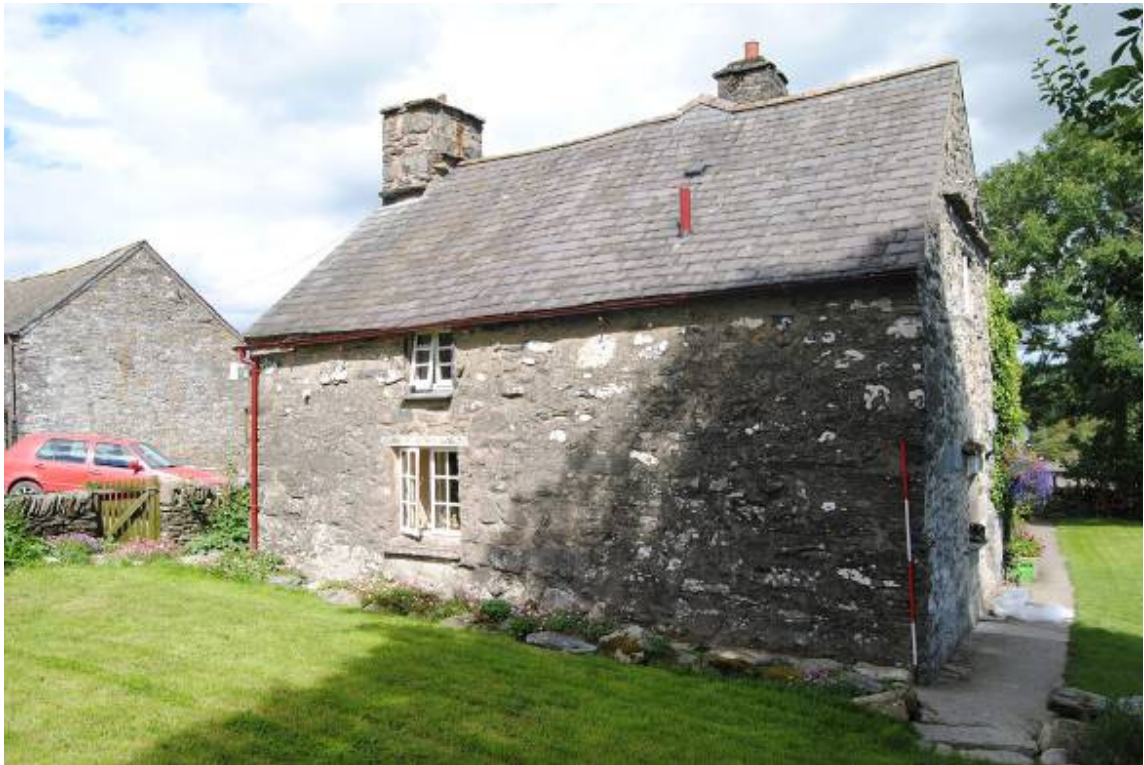
Plate 3: South range, south elevation.

- 4.2.2 The **south elevation** (Plate 3) is stone-built rising through 1 ½ storeys to a pitched, slate-clad roof, gabled to east and west with plain verges; a short ridge stack rises above the western gable with tabling to ridge and base. Superimposed window openings towards the western end of the elevation light ground and first floor levels, both house timber casements, the upper window with top-hinged opening light and jambs of vertical slate blocks.

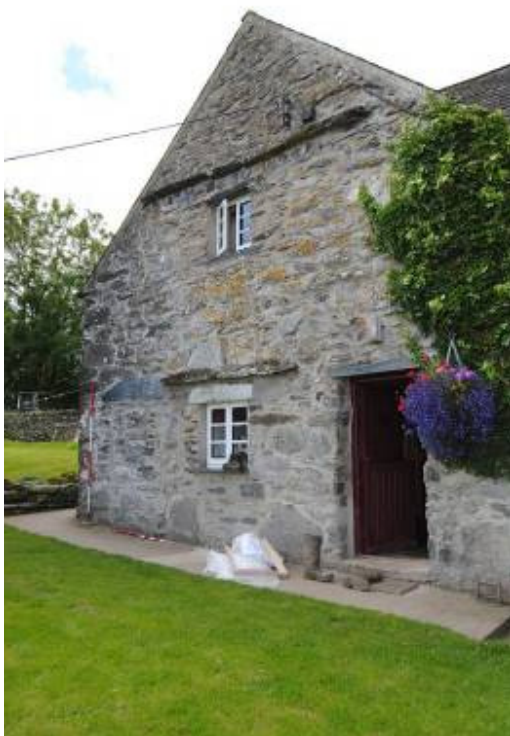
Plate 4: South range, east elevation.

- 4.2.3 The **east elevation** (Plate 4) presents a stone-built, asymmetrical gable⁴ with plain verges, the southern eaves line being set lower than to the north where the block is abutted in a clear straight joint by the secondary, northern range (Plate 19). To the south end of the ground floor a 1m wide doorway with monolithic head has been blocked (Plate 5) while to the centre of the elevation, a two-light timber casement has been inserted into a further former doorway opening, the latter being furnished with projecting horizontal slabs or dripstones over, and with opposing 'boulders' defining its lower jambs (Plate 6). The inserted window itself has a secondary slate head and cill and would appear to have been reduced in width to the south. The present doorway has been inserted to the north side of the elevation. At first floor level a window opening, located slightly off-centre to the south and housing a two-light timber

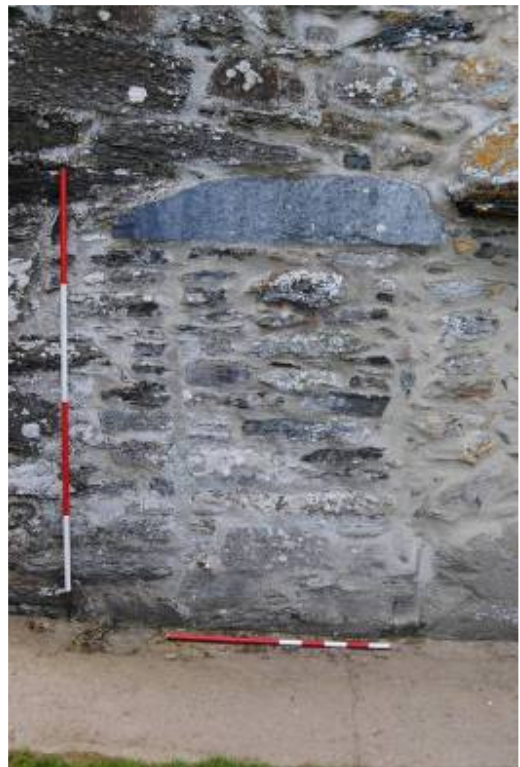
Plate 5: Blocked door at south end, east elevation.

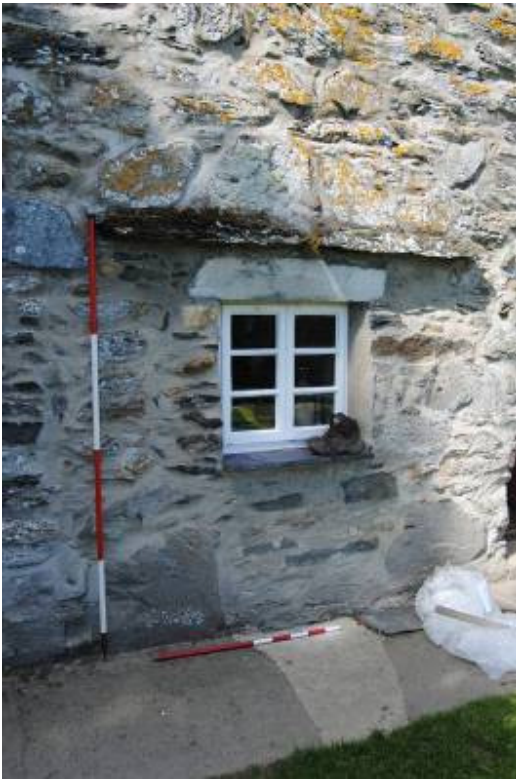
Plate 6: Former door converted to window at centre of south elevation.

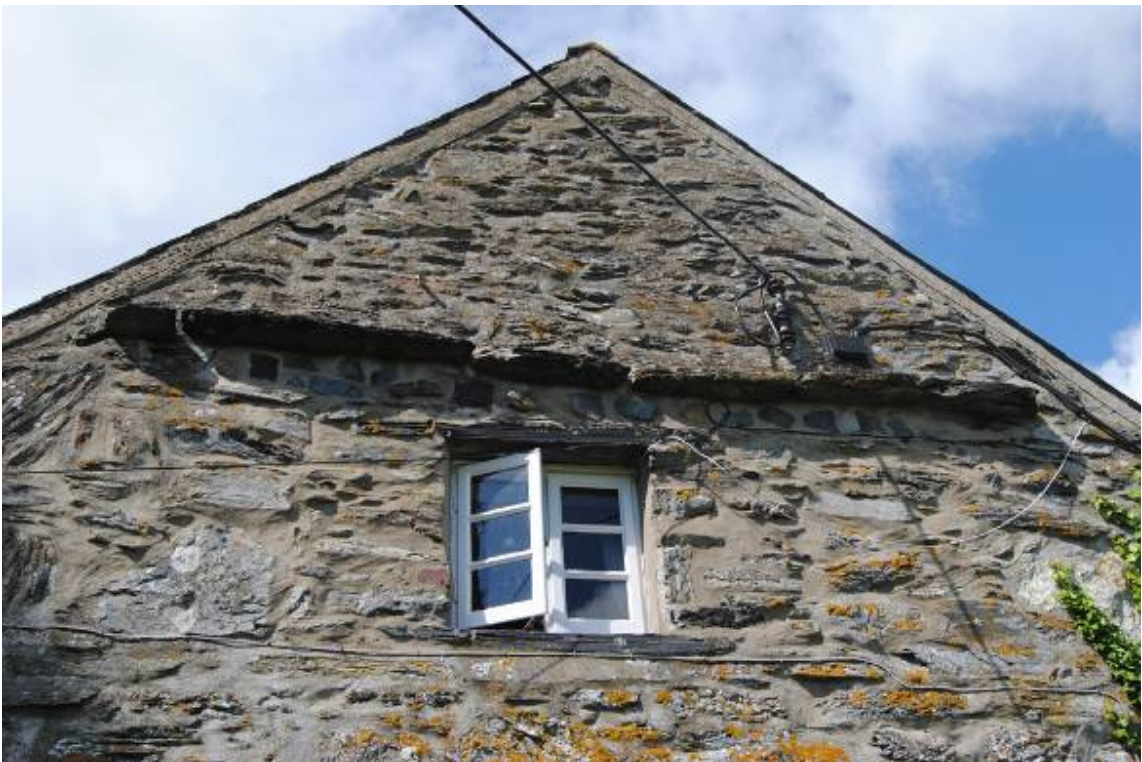
Plate 7: Reduced window opening within east gable.

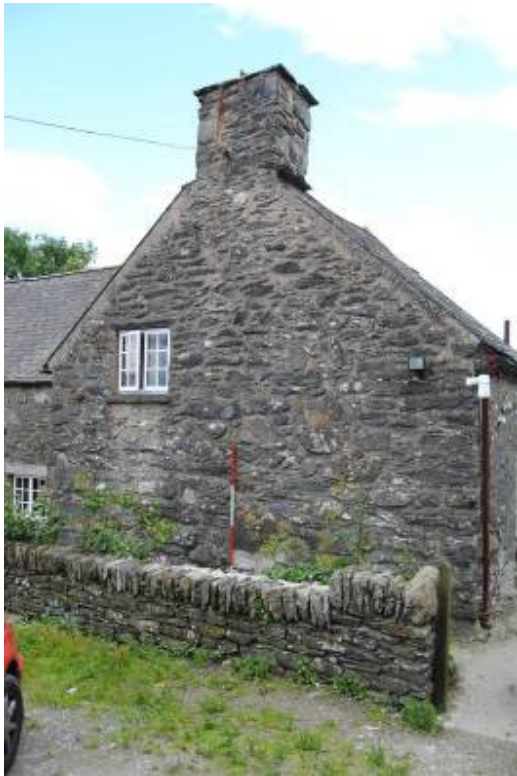
Plate 8: South range, west elevation.

- 4.2.4 The **west elevation** (Plate 8) again presents a stone-built, asymmetrical gable with plain verges, the gable topped by a rectangular stone ridge stack (possibly rebuilt) with tabling to the base to both north and south. The elevation is pierced by a single window opening, at first floor level to the north of the stack, housing a standard two-light timber casement. The **north elevation** is mainly obscured by the north range which abuts to the east, though a short length of the western return is visible (Plate 9), which includes a single, two-light casement at ground floor level beneath a heavily weathered timber lintel; a possible straight joint beneath the western jamb of this window may indicate an original doorway.

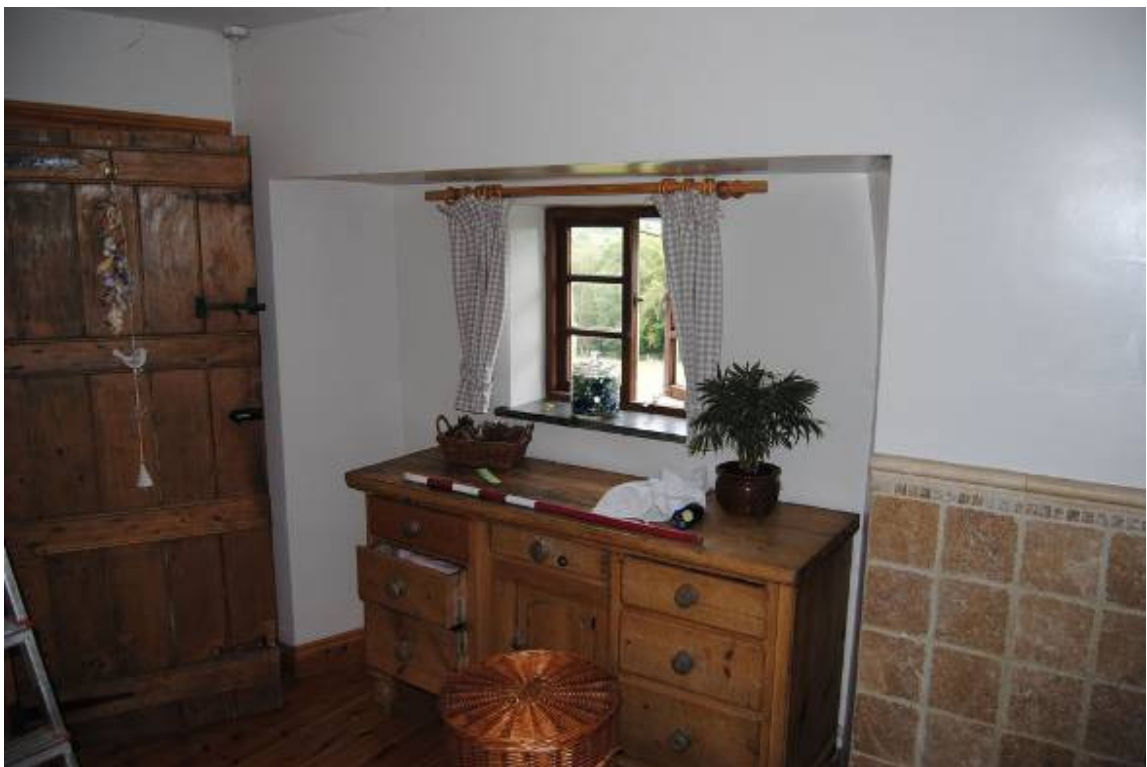
Plate 12: South range, Room [1F02], reduced window opening of east gable (see Plate 7).

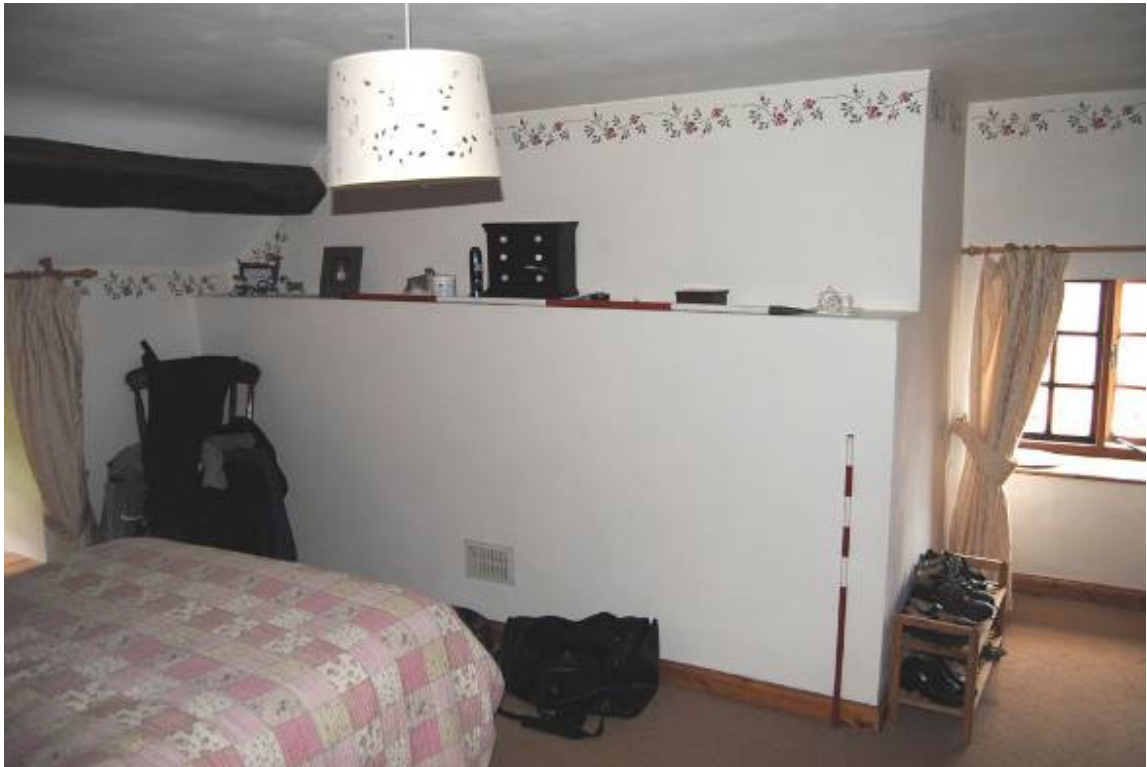
Plate 13: South range, Room [1F01]; stack at SW angle (fireplace blocked; note vent).

west angle of the room is the massive projection of the gable stack (Plate 13); Hughes records a fireplace here in 1983 though this has subsequently been blocked in / covered over and is evidenced only by a small vent above floor level.

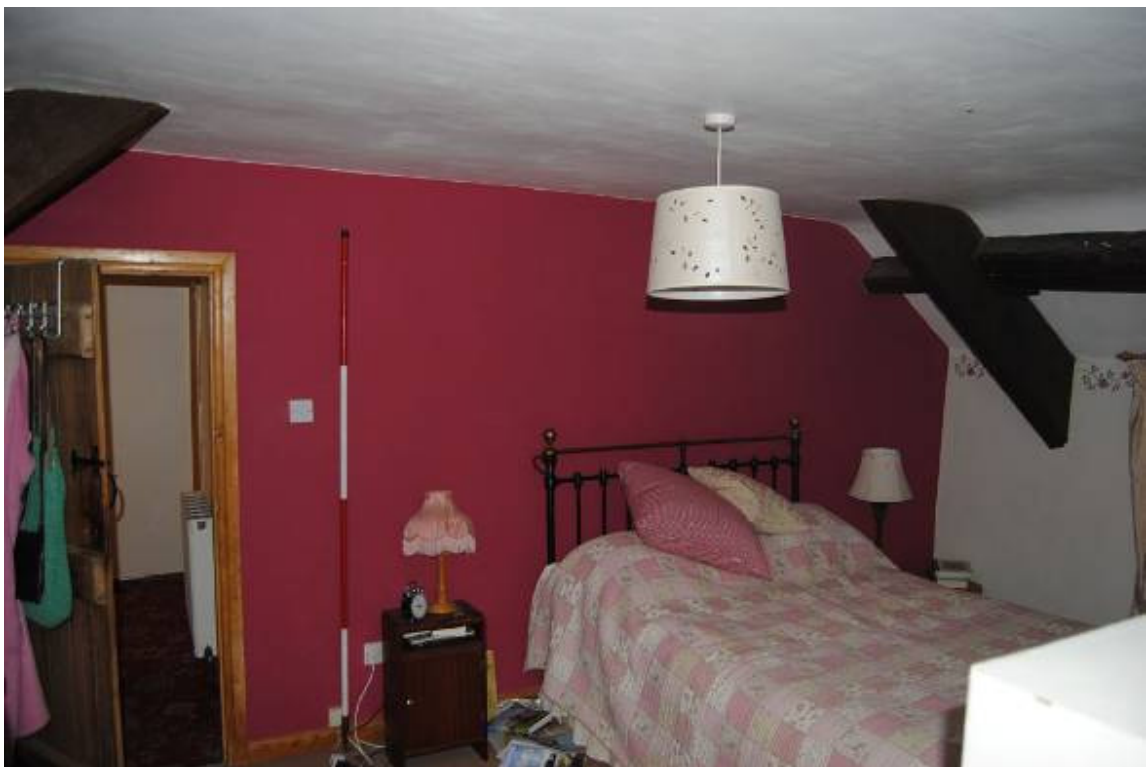
Plate 14: South range, Room [1F01] looking east with exposed principals and lower side purlins of T1.

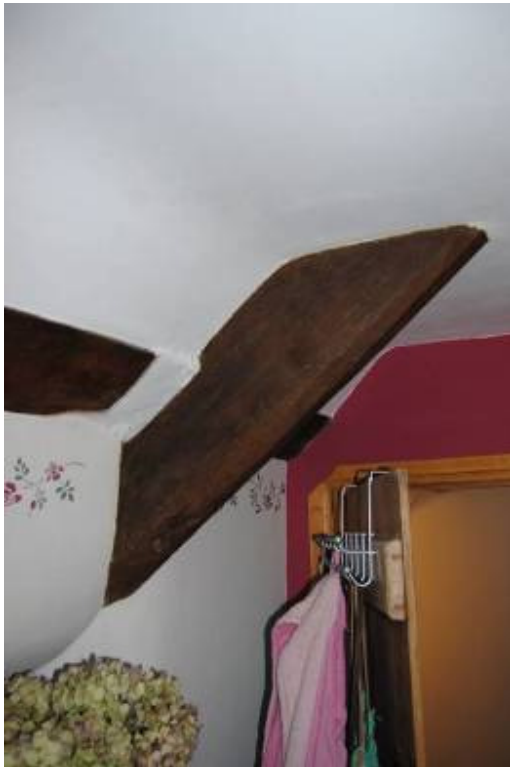
Plate 15: Southern principal, T1.

- 4.2.8 At **first floor** level, the range is again subdivided by modern partitions to form a series of three rooms. To the south, lobby [**1F03**] opens off a passage leading from the north range and gives access to bathroom [**1F02**] to the east and bedroom [**1F01**] to the west. Bathroom [**1F02**] retains evidence for the original wide gable window (see §.4.2.3; fn.5) in the form of a wide embrasure within the east wall (Plate 12). The principal room [**1F01**] (Plates 13/14) is located to the west, where the feet of the principal rafters of the central truss (**T1**) and the lower side purlins of the roof structure are exposed (Plate 15/16). At the south-

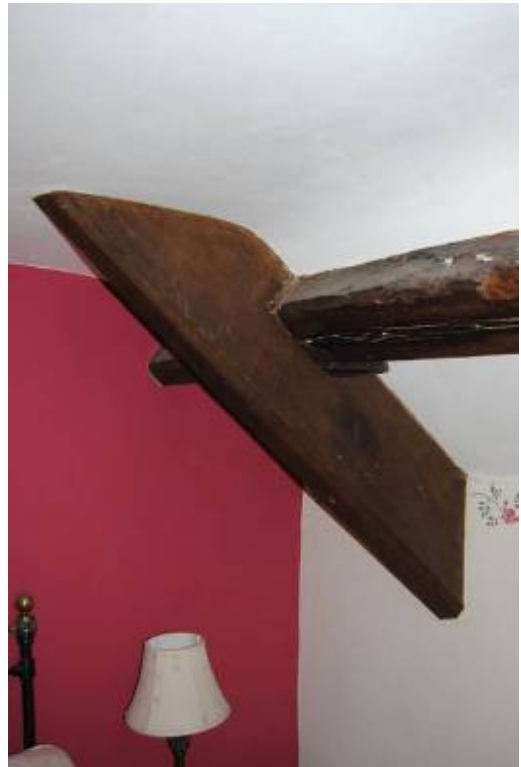
Plate 16: Northern principal, T1.

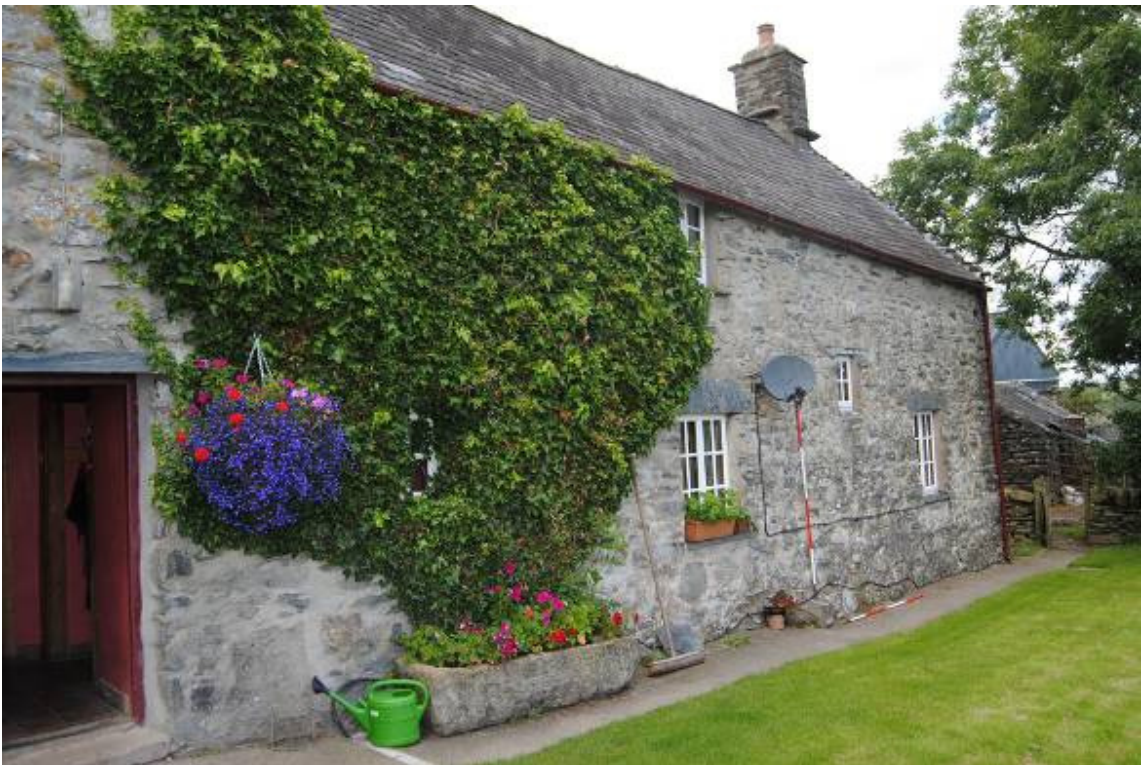
Plate 19: North range, east elevation oblique, looking north-west, note straight joint to right of door.

- 4.3.2 The **east elevation** (Plate 19) is again of 1½ storeys, stone-built beneath a pitched roof, gabled to the north; it abuts the south range in a straight joint, clearly visible at ground floor though obscured by vegetation at higher level. Two widely spaced casements light ground floor rooms [**GF04**] and [**GF06**] to south and north, while a further small, 4-pane fixed-light window to the far south lights a small passage connecting the two ranges internally; the latter window is unfortunately obscured by vegetation which negates close examination, though it is possible that it may represent a former doorway (see §.6 below). A second, small fixed-light window lights the interior stairwell; windows have renewed slate heads and cills. A single window opening at first floor level lights passage [**1F04**] internally, the upper window being set hard beneath the eaves.

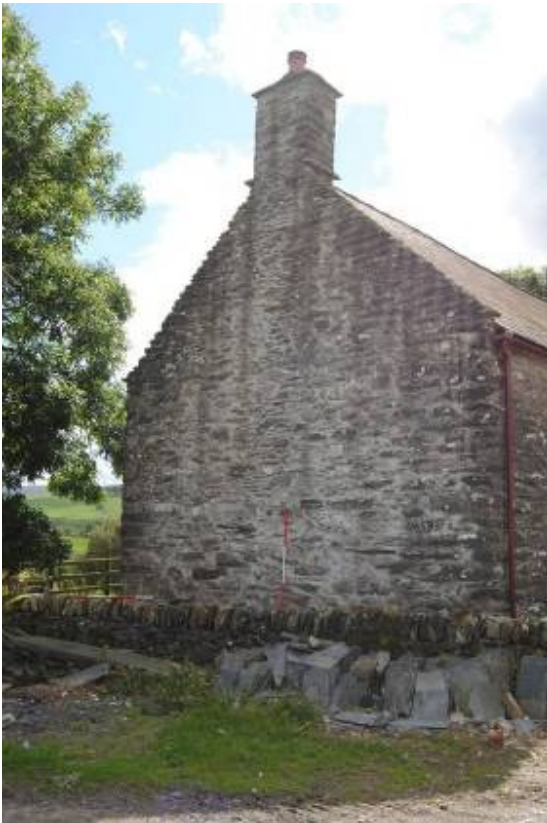
Plate 20: North range, north gable.

- 4.3.3 The **north elevation** (Plate 20) presents a blind gable end with a coping of horizontally set stones and is capped by a tall chimney, with projecting stone tabling to east and west.

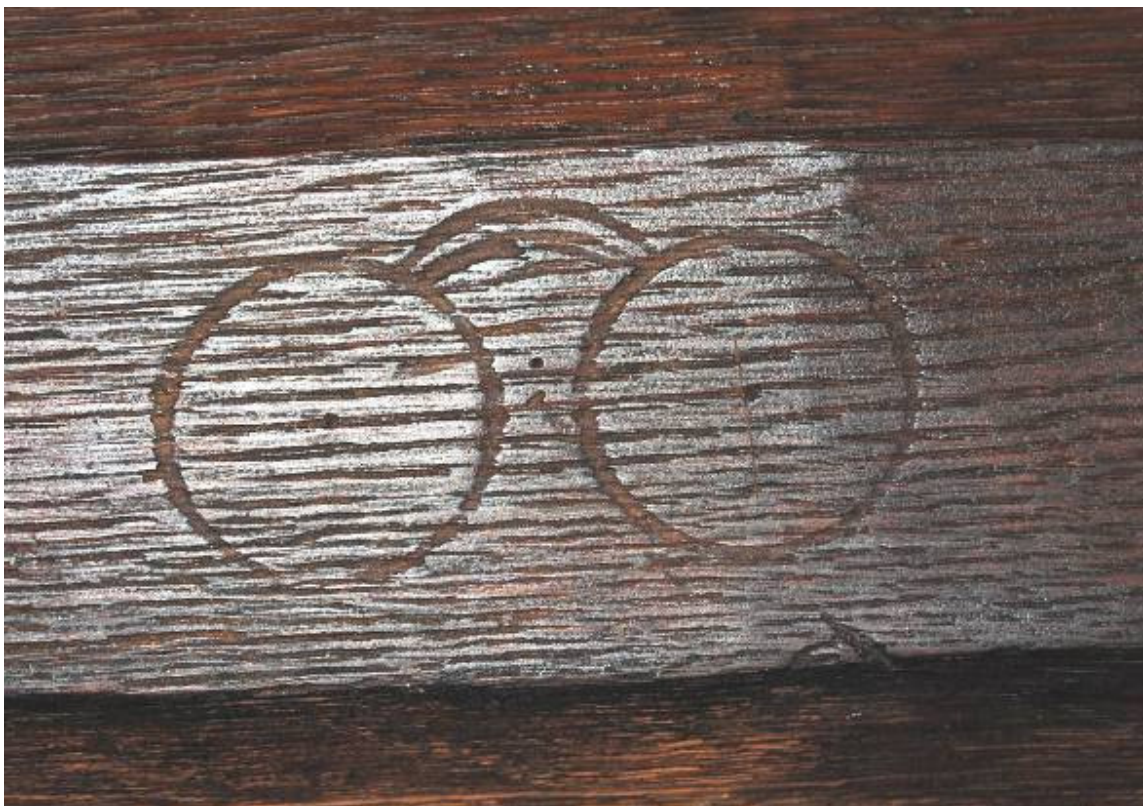
Plate 23: Incised 'spectacles' on fireplace bressumer, [GF04].

¹¹ ‘Spectacles’ marks are one of a number of motifs commonly found in the properties, particularly of the 17th century; they are interpreted as apotropaic or ‘evil-averting’ marks, often referred to as ‘witch marks’, and were believed to protect a building from the influence of evil spirits, preventing their entry via available openings. Doorways, windows and especially fireplaces were thus seen as key points of entry and are often the focus for concentrations of such marks (Hall 2005, 150-51; fig. 5.33). Recent recording work at nearby Dylasau Isaf on the Ysbyty Ifan Estate (Tyler 2011) recorded a concentration of such ‘spectacles’ motifs in association with incised circles, daisy wheels and a rudimentary/stylised ‘M’ (‘Mary’).

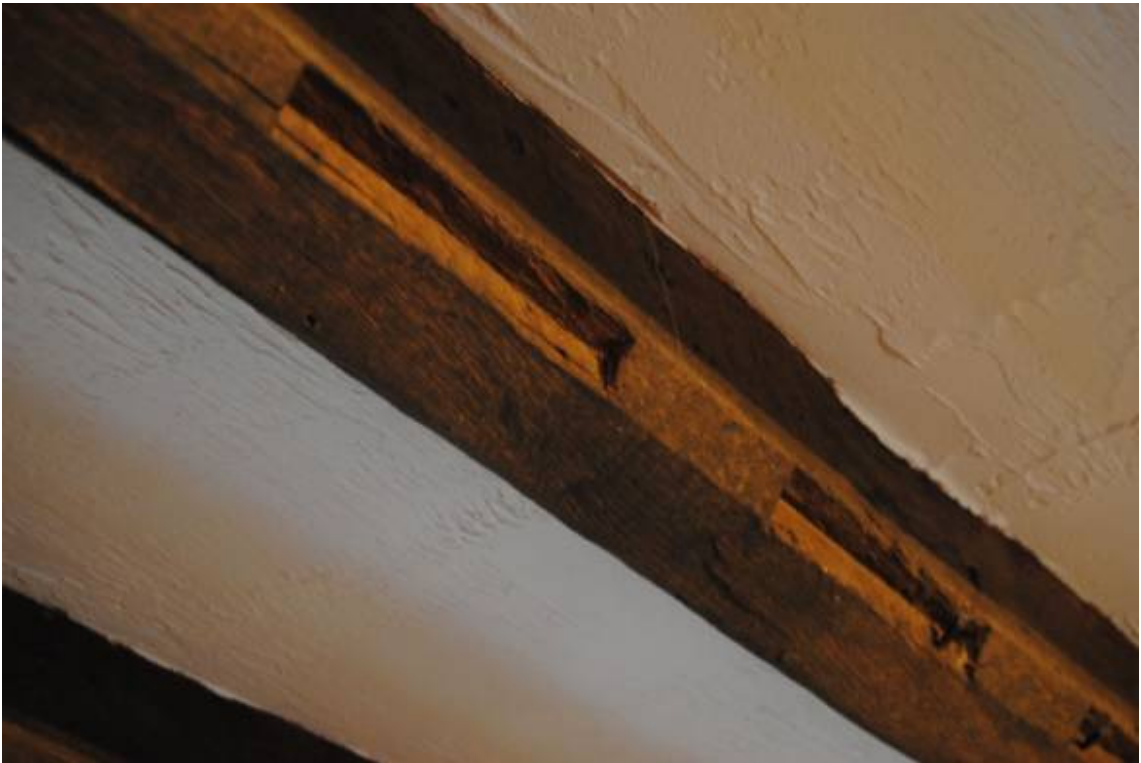
Plate 27: Room [GF06]; evidence for former partition.

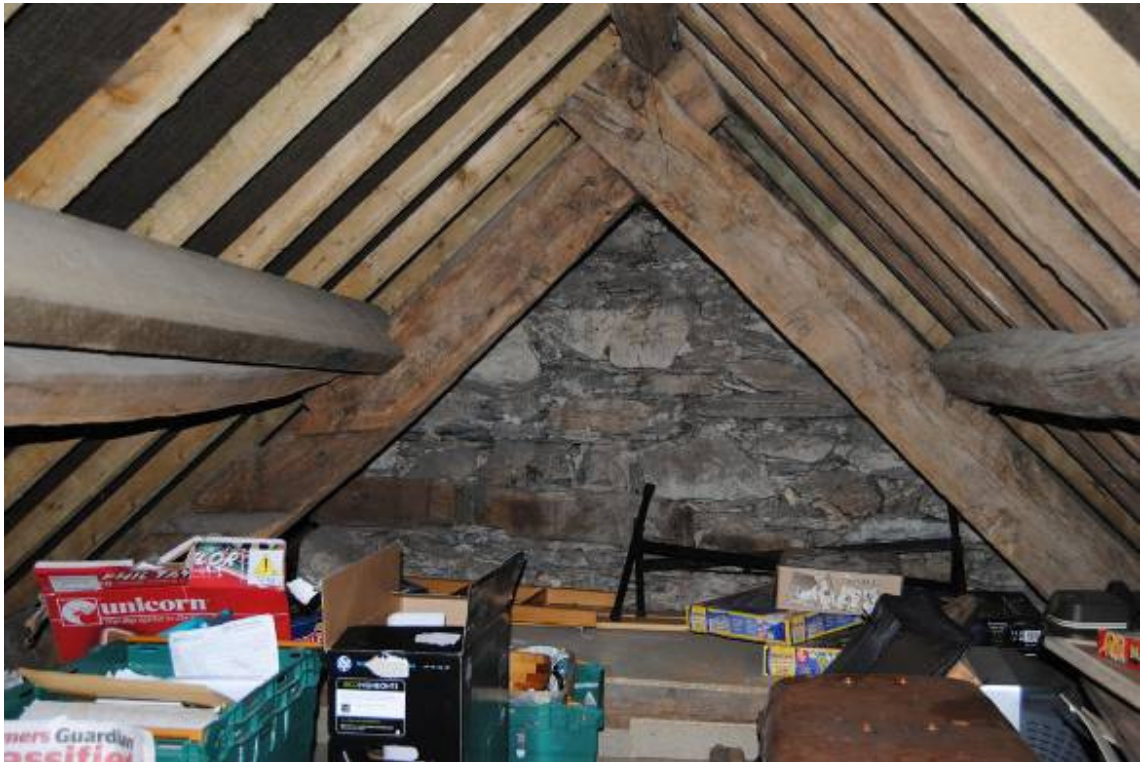
Plate 30: North range, Truss T2 looking north.

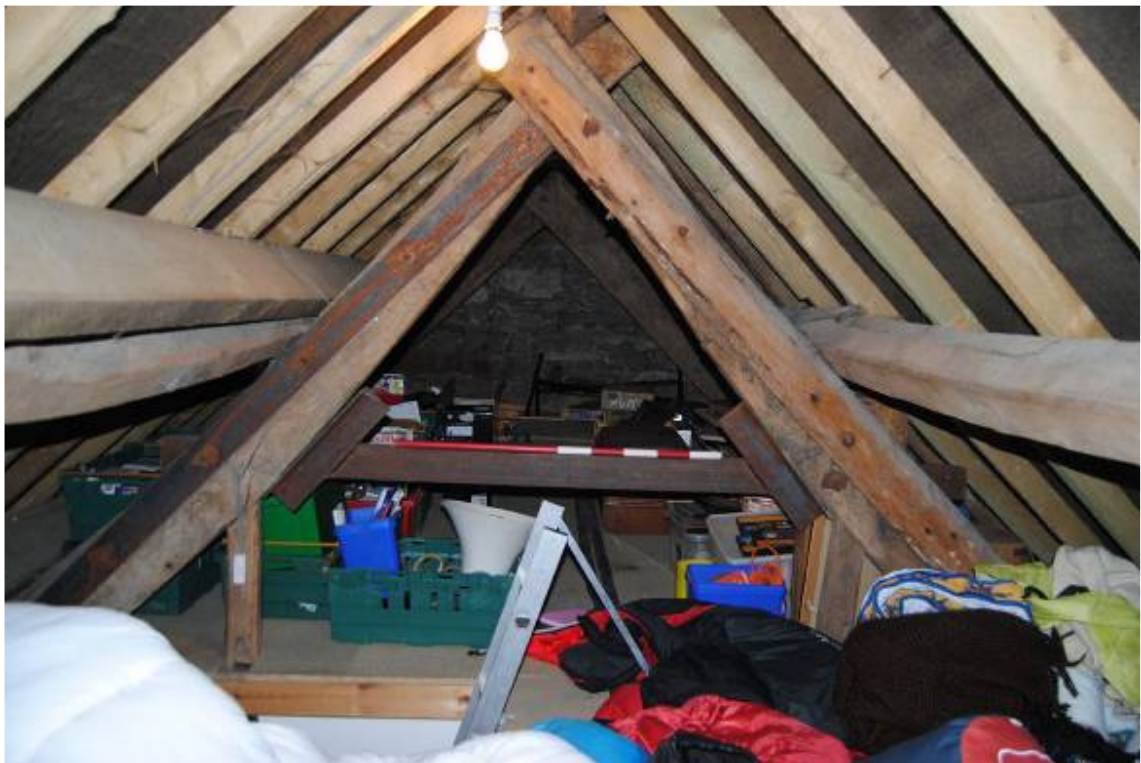
Plate 31: North range, T3 looking north, note vertical struts.

- 4.3.10 Fairly extensive repairs have been undertaken to the roof, with **T2** in particular having been strengthened by the introduction of steel plates and a secondary steel 'collar' (Plate 31), presumably to prevent spreading; common rafters have been renewed throughout and a secondary upper purlin inserted to the eastern roofslope (Plates 30/31). The eastern principal of **T5** displays a number of discrepancies (eg. unchamfered, redundant lap joint to north face) and may have been renewed.

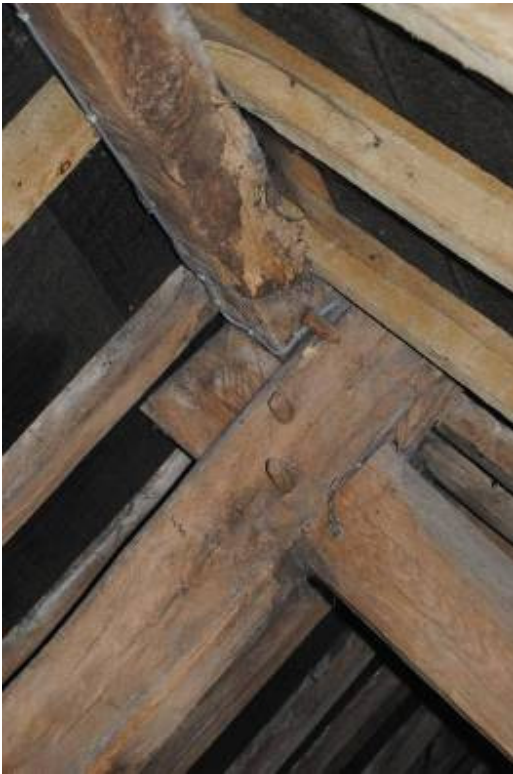
Plate 32: Apex detail (T4).

- 4.3.9 The roof of the north range is of three bays (here numbered 1 to 3 from south to north) defined by three collar beam trusses (**T2** to **T4**), here with a markedly low collar, exposed at first floor level in the case of **T3** (Plate 28) and **T4**, and with vertical struts extending from collar to principal (Plate 31). Principals are plain chamfered to their lower arisses, as are the vertical struts between collar and principal, indicating that the trusses were originally exposed to first floor level. Principals are lap jointed at the apex (Plate 32), double pegged with square-section pegs driven through the timbers at divergent angles in a manner similar to that employed in cruck construction, where they are employed to create a secure joint. The roof is carried by two tiers of through purlins and a square section ridge piece; side purlins are shallowly trenched over the outer faces of the principals, where they are scarfed with simple splayed joints, single pegged (Plate 33); likewise the ridge piece is scarfed at each truss (Plate 32).

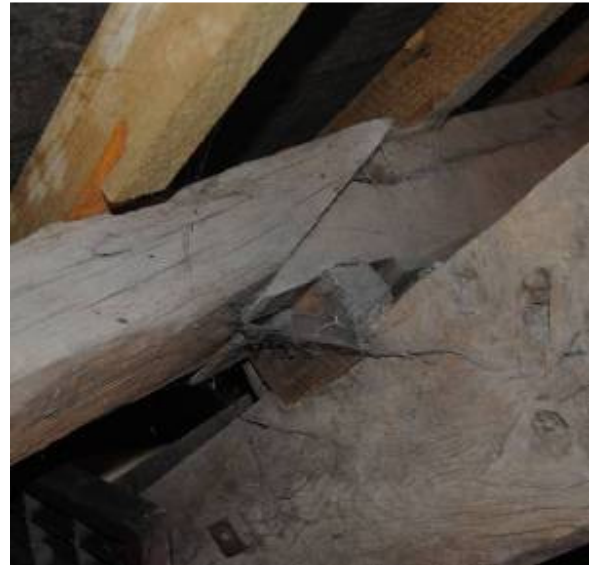
Plate 33: Purlin scarf detail (T3, west).
