# BODLOESGOD, FFESTINIOG, GWYNEDD

## Architectural Record

### FINAL REPORT

January 2012

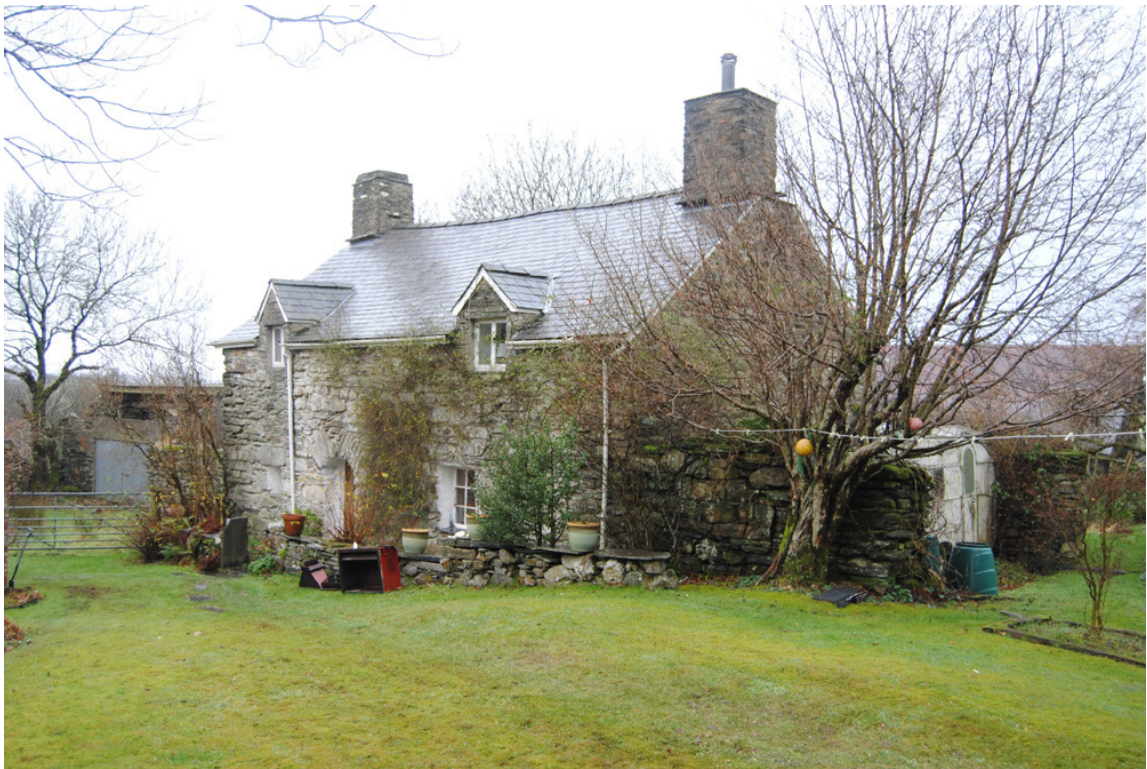
Plate 1: General view from north-east.

- 4.1.1 Bodllosged is essentially of a single phase with limited modifications. The house is built on a rectangular plan aligned approximately NE-SW, though this has been simplified for the purposes of the following description and discussion such that the range is assumed to be aligned north-south, with the principal entry via the east elevation (see Figure 4). It is stone built of 1½ storeys beneath a pitched, slate-clad roof, gabled to north and south with ridge stacks above the end gables (Plate 1).

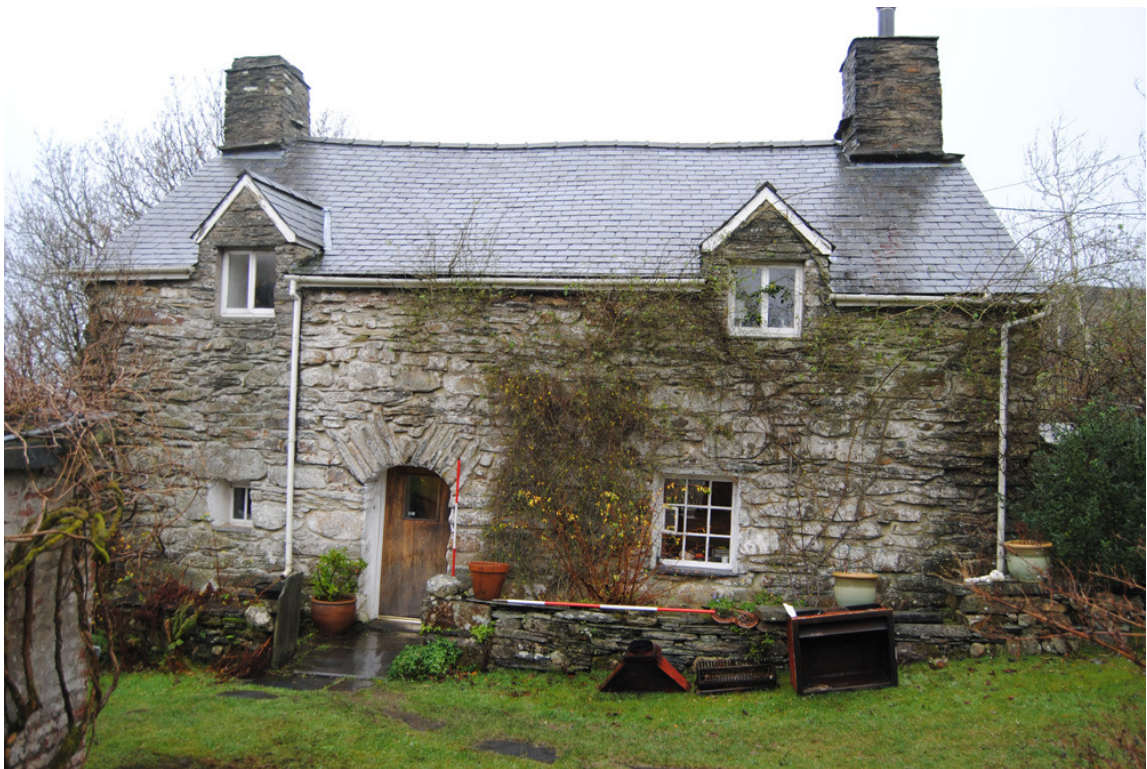
Plate 2: East elevation.

- 4.2.1 The house is built on a rectangular plan with exterior measurements of 11.25m (37ft) north-south x 7.5m (24½ ft) east-west and standing 7m tall from interior floor level to ridge. The **east elevation** (Plate 2) is stone-built of rubble construction, rising to 1½ storeys above an offset boulder footing beneath a pitched, slate-clad roof, gabled to north and south; ridge stacks rise above the northern and southern gables, that to the north being the larger, principal stack serving the ground floor fireplace. The principal doorway (Plate 3) is offset towards the south end of the range, and is furnished with a roughly semi-circular head of stone voussoirs of a type similar to nearby Bryn Yr Odyn<sup>5</sup> of c.1557 and Cwm Farm.<sup>6</sup> Ground floor fenestration comprises a small, square opening to the south with monolithic stone head (Plate 4), while a larger window to the north of the door houses a 9-pane fixed light with a single opening panel; the first floor is lit by two inserted, gabled semi-dormers housing two-light timber casements. While the windows have been renewed throughout, it would appear that all openings reflect primary locations.

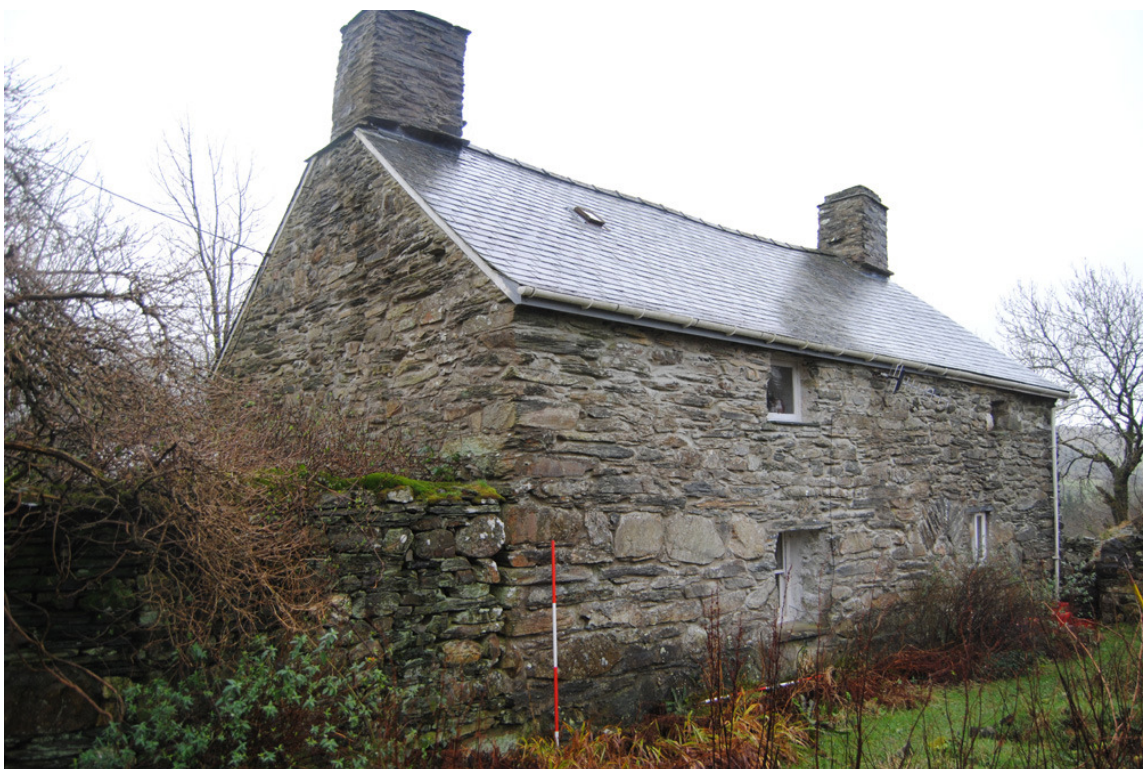
Plate 5: West elevation (oblique).

- 4.2.2 The **west elevation** (Plate 5) closely reflects the arrangements of the east front. It is again stone-built of rubble construction, rising to 1½ storeys above an offset boulder footing (Plate 6) to a pitched, slate-clad roof, gabled to north and south and with ridge stacks rising above the gable ends. A former doorway, offset towards the south of the elevation, and opposing the principal doorway to the east, has been blocked (Plate 7); it is of smaller dimensions than the eastern door though it displays the same distinctive

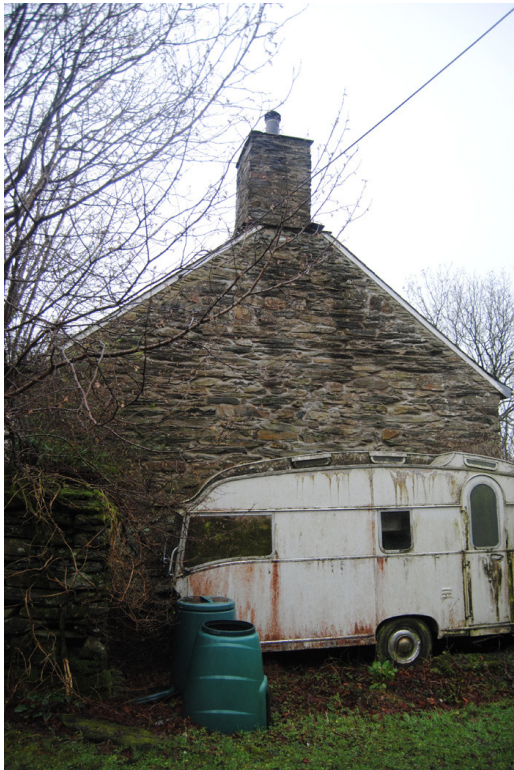
Plate 9: North elevation.

- 4.2.3 The **north** and **south elevations** (Plates 9 and 10) present blind gables of stone rubble construction above projecting boulder footings, capped by square ridge stacks.

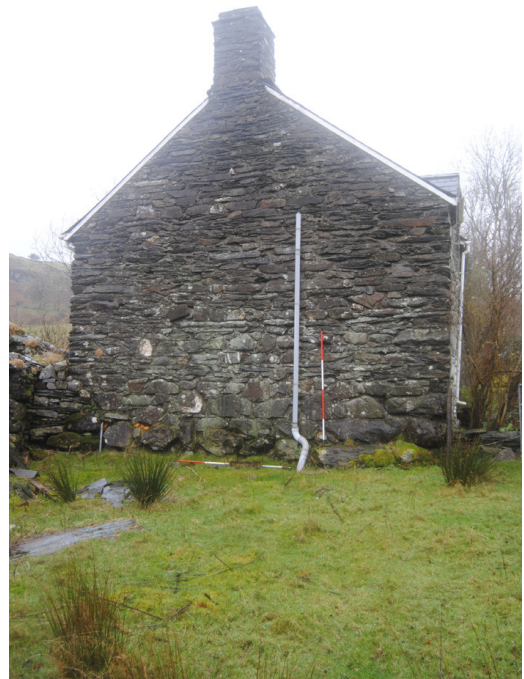
Plate 10: South elevation.

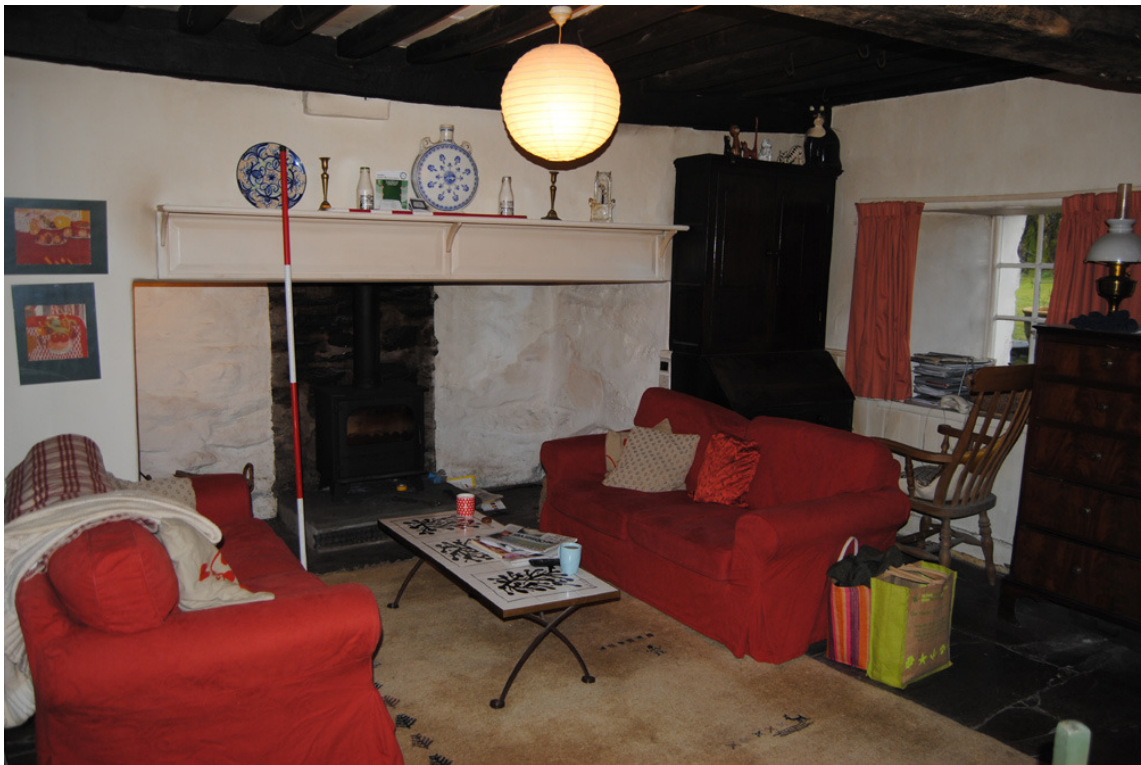
Plate 13: Room [GF02] looking north-east.

- 4.3.2 To the north side of the transverse post and panel partition, Bays 2 and 3 originally comprised a single space [GF02] (Plate 13) constituting the main hall, though this has been encroached upon at the south-east by the introduction of walls forming lobby [GF01], previously noted. The main hall of the house was lit by windows in the lateral walls at Bay 3 and heated by the wide mural fireplace in the north gable wall, to the west of which an integral stone winder-stair rises to first floor level (Plate 16). The ceiling over the hall is carried on a massive central transverse beam (1ft wide x 14 in. deep; Plate 17), plain chamfered with stepped run-outs, by a plain chamfered beam (11 x 6in.) above the fireplace and by a moulded beam (10 x 4in.) at the head of the southern screen wall. The upper floor is carried by a total of 16 common joists, 4½ x 3½ in. scantling at 1ft centres with moulded soffits matching the detailing of the partition posts (Plate 18; see Figure 4 inset profile **A**).

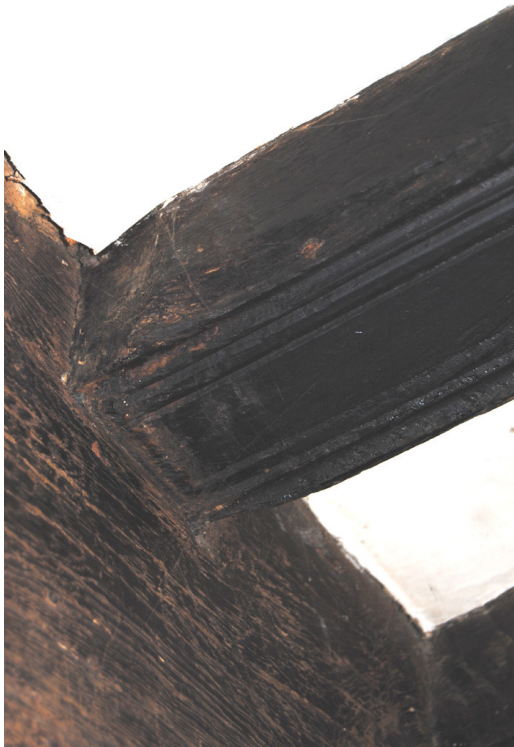
Plate 18: Detail of moulded common joist, [GF02].

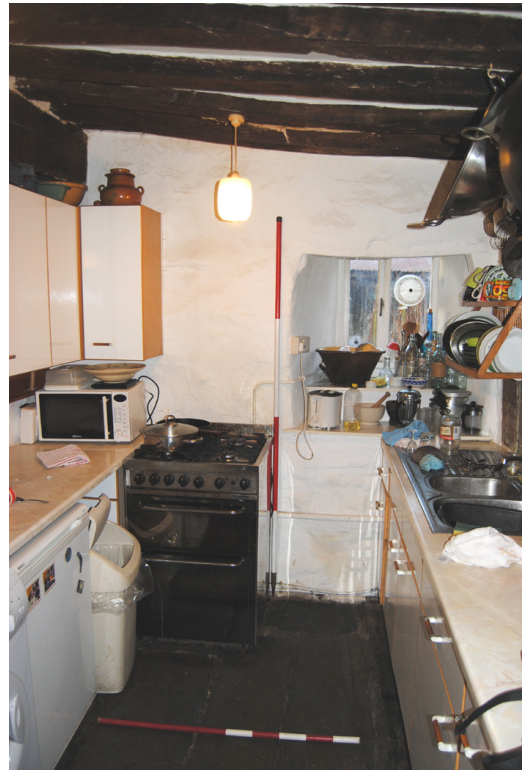
Plate 19: Kitchen [GF03] looking west.

- 4.3.3 Beyond the post and panel partition to the south, Bay 1 is currently occupied by two rooms, kitchen [GF03] (Plate 19) and bathroom [GF04]; this bi-partite plan reflects a historic division, though the original partition was located 1m to the west on the axis of the range, where pegged mortices and a groove within the soffit of an axial ceiling beam (Plate 21) evidence a former post and panel partition. Each primary room would thus originally have been served by one of the paired doorways in the screen wall. The posts of the transverse partition and ceiling joists of the original south-west room are plain (Plate 20) while to the south-east, all are moulded reflecting a distinction in status between the two rooms, presumably service to west, parlour to east.

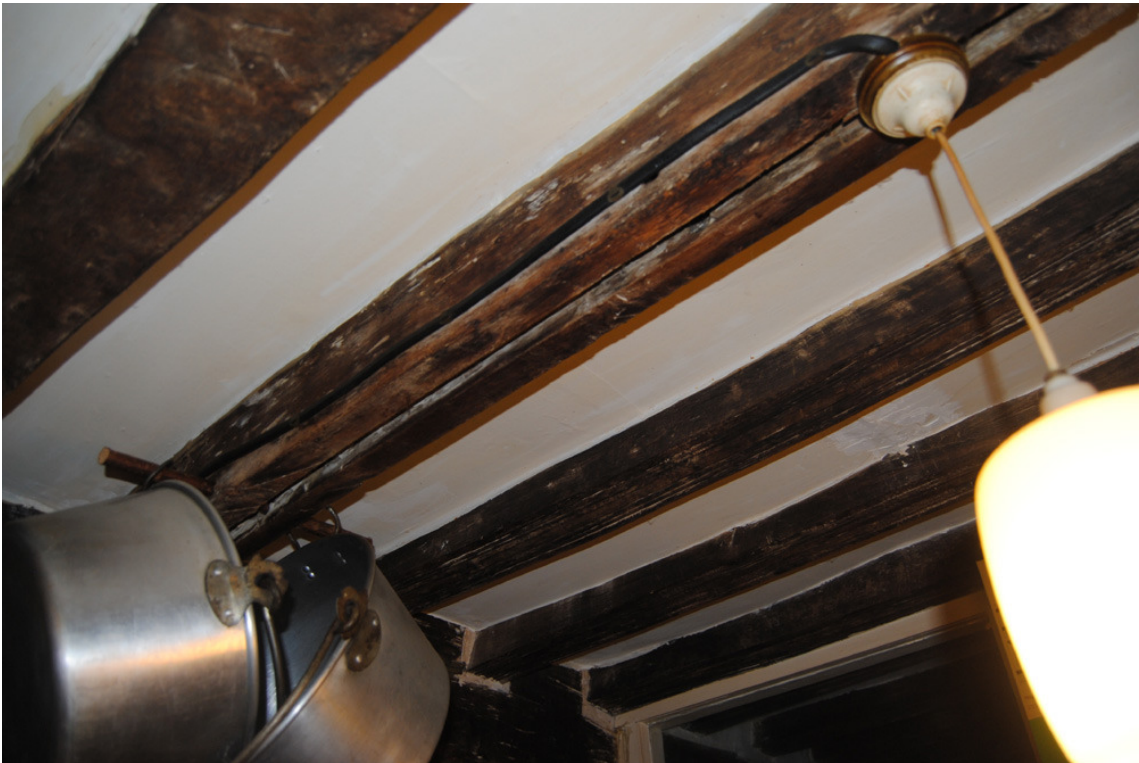
**Plate 21:** Ceiling structure of [GF03] with redundant mortices and groove indicating former lateral partition; NB: common joists to east are moulded, those to west are plain.

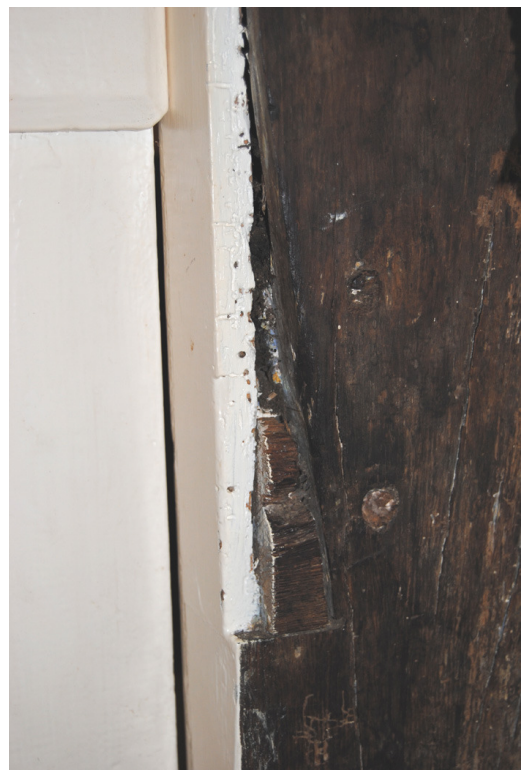
**Plate 23:** Notched joint evidences original door head location (see Figure 6).

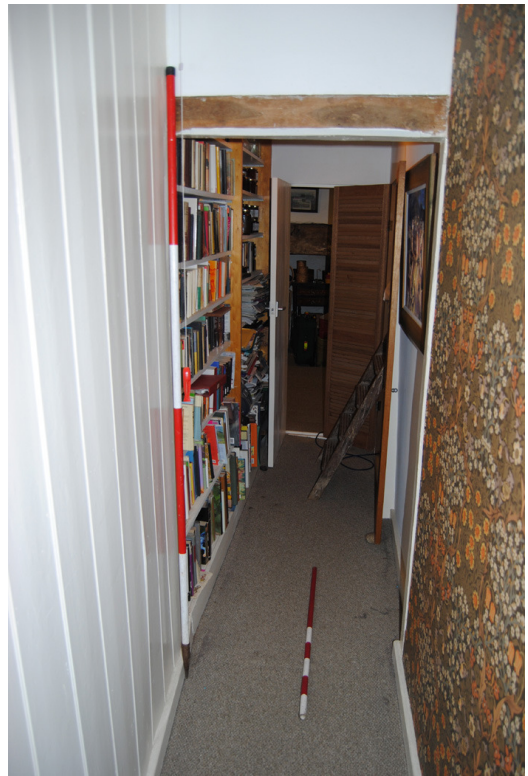
Plate 25: Central passage [1F01] including primary doorframe beneath T2.

- 4.3.4 **First floor** level is accessed via the winder stair adjacent to the northern mural fireplace (Plates 16 and 24) which rises to a first floor axial passage [1F01] (Plate 25). In its present state, the first floor is divided to

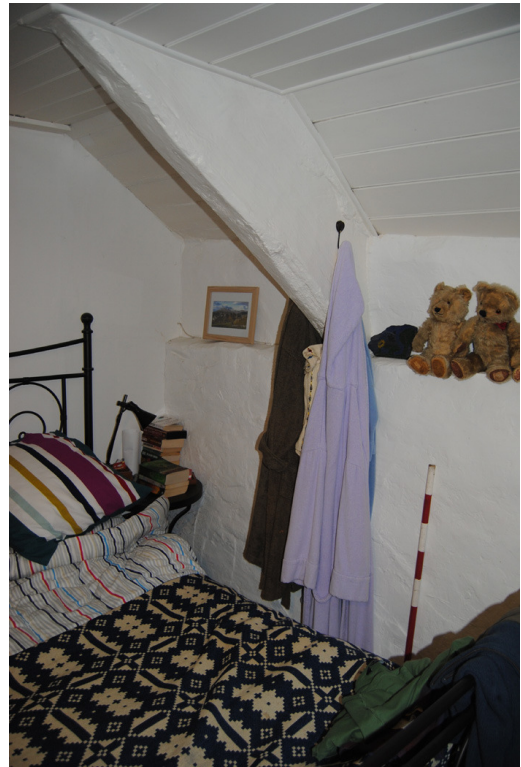
Plate 29: Room [1F02], east principal of truss T1.

- 4.3.5 The principal bedroom [1F02] is located within Bay 1 to the south of the range, lit by windows within the lateral walls and heated by a projecting mural fireplace within the south gable wall (Figure 6; Plate 27). The eastern widow is an insertion, forming a gabled semi-dormer, though that to the west, small and square set hard beneath the eaves, represents an original opening (Plate 28). To the east, the foot of the eastern principal rafter of truss **T1** is exposed, the lower arrises being here plain chamfered (Plate 29).<sup>7</sup>

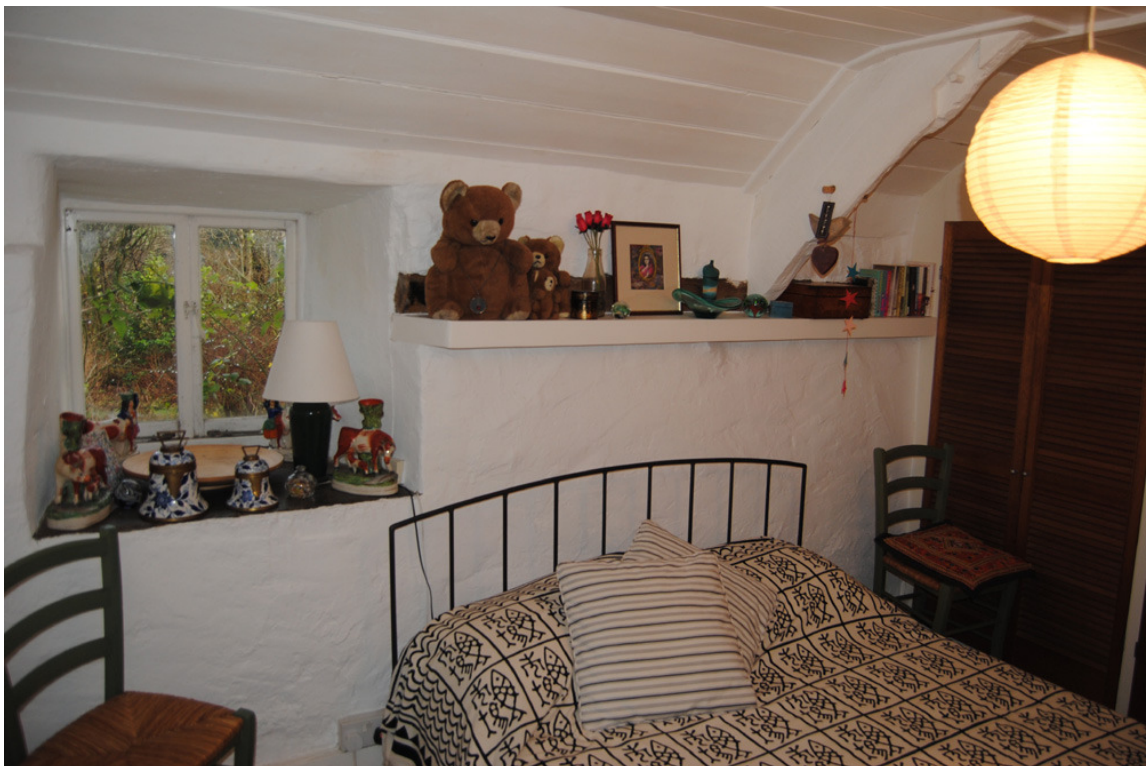
Plate 30: Room [1F03] looking east; note east principal of truss T2 with lap joints for former vertical studs.

- 4.3.6 The lower principals of **T2** are exposed within [1F03] and [1F04] to east and west respectively (Plates 30/31), again plain-chamfered and each including two halved joints to their northern face formerly receiving vertical studwork infill (implied 6in. studs at 18in. to 2ft centres, halved and lapped, single-pegged).<sup>8</sup> Exposed to the west, south and east walls of bedroom [1F04] are a number of decorated planks with stencilled paintwork and borders in imitation of wallpaper (Plate 32), probably of 18<sup>th</sup> or early 19<sup>th</sup>-century date (Suggett R, *pers. comm.*; see Kightly 2005, 61);<sup>9</sup> to the west, the decorated planks extend onto the soffit of the roofslope.

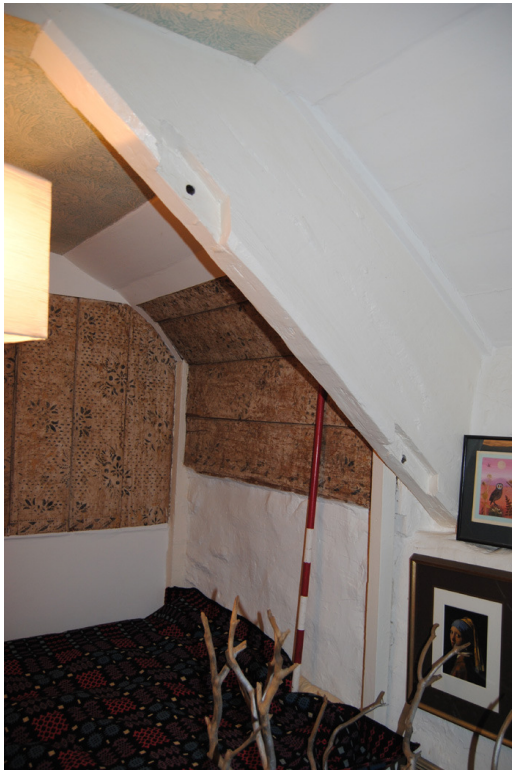
Plate 31: [1F04], west principal of T2 displaying lap joints for former vertical studs.

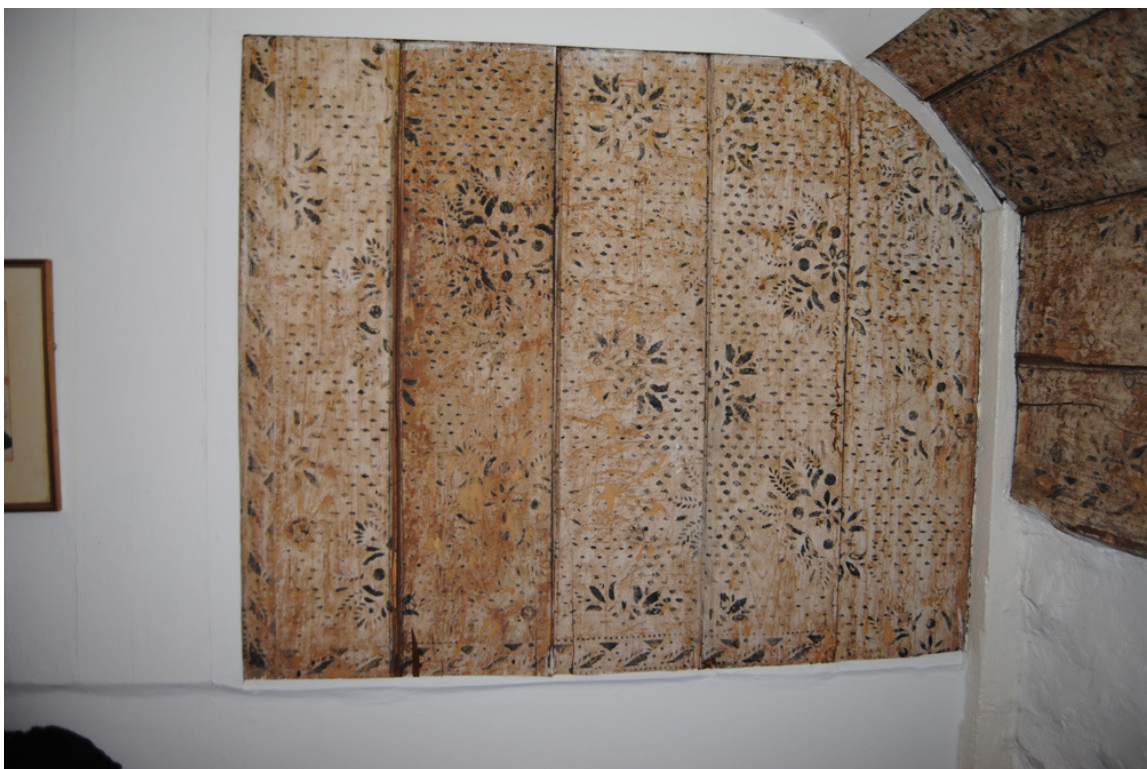
Plate 32: [1F04]; detail of stencilled painting to boards.

- 6.2.2 None of the modifications can be securely dated though the presence of stencilled panels to the west wall of the first floor axial passage (visible within [1F04]) suggests an 18<sup>th</sup>-/early 19<sup>th</sup>-century date for the rearrangement of this level.

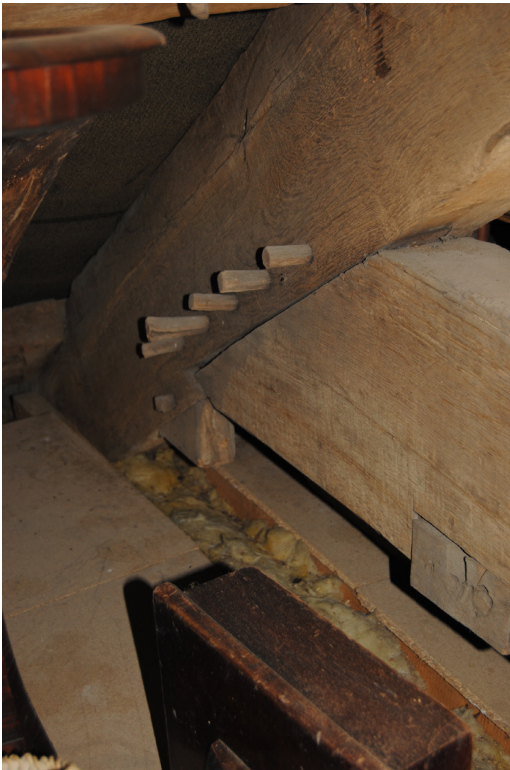
Plate 36: Truss T2; collar joint, NB. cut off studs.

<sup>8</sup> Further halved and lapped joints and cut-off studs survive at attic level (see Figure 7; Plate 36/7; section §.4.3.8 below)

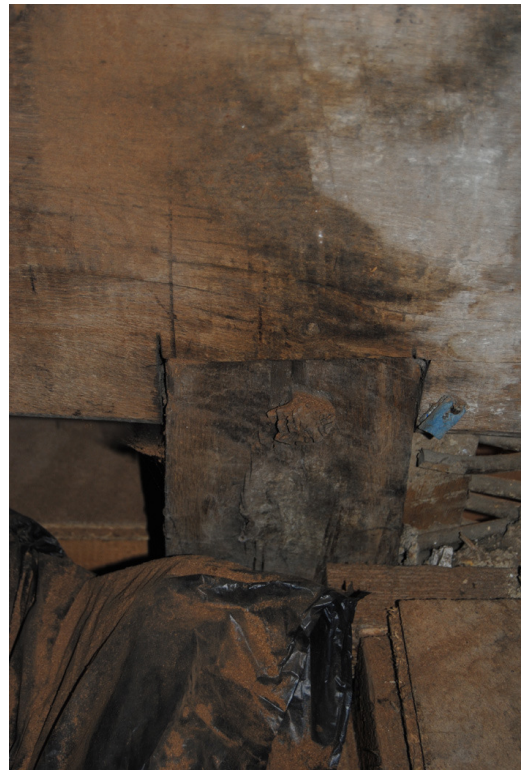
Plate 37: Truss T2, halved and lapped stud.

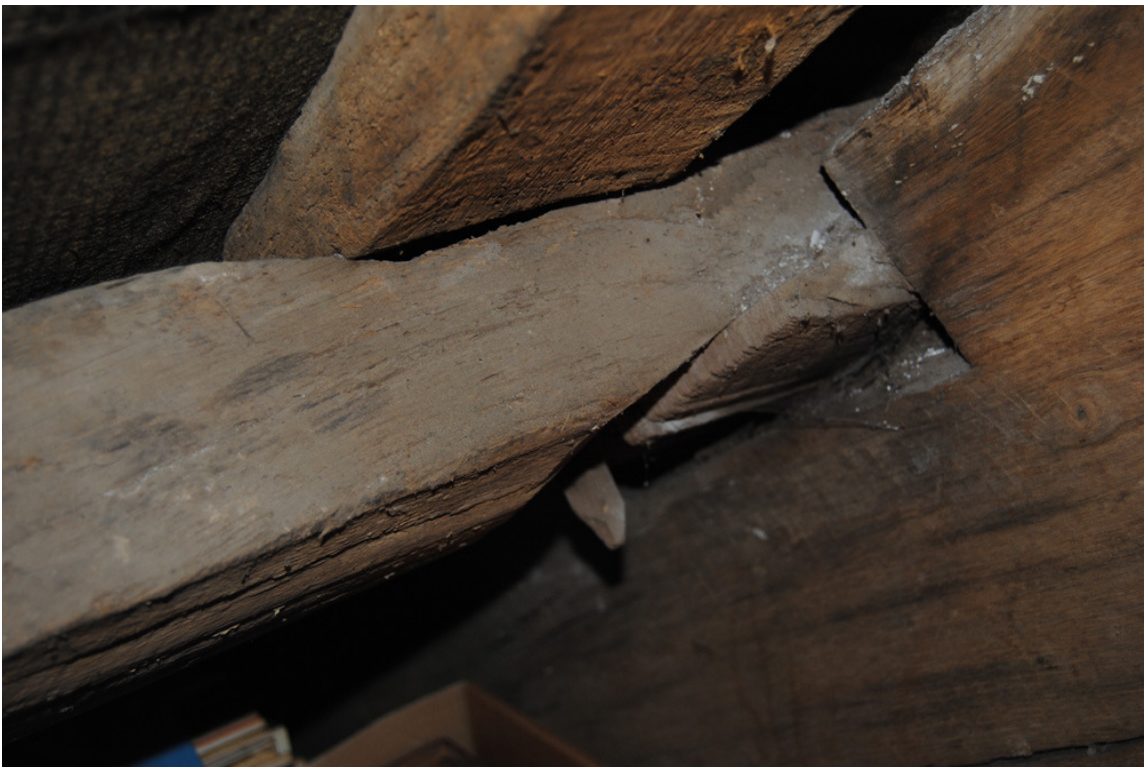
Plate 38: Detail of splayed scarf at T2 (W).
