PENLAN FAWR, PWLLHELI, GWYNEDD

[NPRN 16676]

Architectural Record

DRAFT REPORT
December 2011

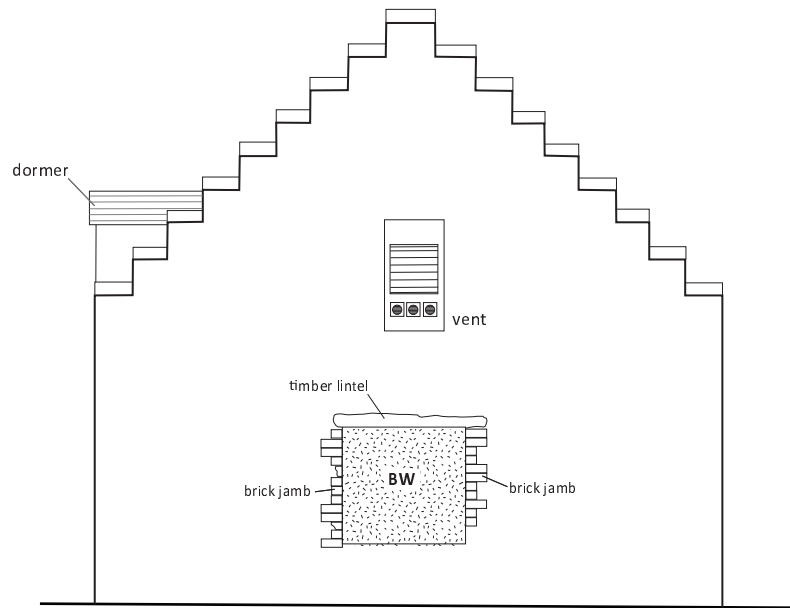
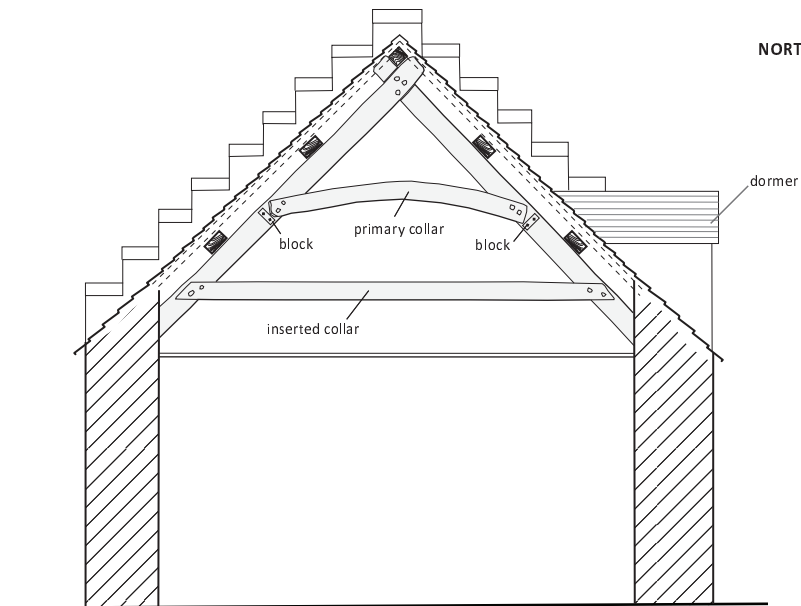
(a) Western stepped gable

(b) Transverse cross-section at A-A

- 4.4.2 The outbuilding comprises a compact range on a rectangular plan (Figure 10) with overall dimensions of 9m (E/W) x 6.25m (N/S), stone-built of a single storey beneath a pitched, slate-clad roof, gabled to east and west. The south elevation includes three evenly-spaced blocked openings comprising, from west to east, a door, door/window and window (Plate 31). The western elevation has a blocked window with brick jambs to ground floor level and a narrow opening within the stepped gable, reused for modern ducting (Figure 11a; Plate 30). A gabled dormer rises above the west end of the north elevation (Plate 30).

- 4.4.3 Internally, the range has been refurbished in recent years to house a kitchen and toilet facilities and retains nothing of note at ground floor level. The roof is of four bays, defined by three collar beam trusses (Figure 11b; Plate 32), the principals of which are carried by timber pads set within the masonry of the northern and southern walls (Plate 34). Principals are halved/lapped and triple pegged to the apex while cranked collars are simply lapped onto the eastern face of the principals, secured by double pegs of square section with additional support provided by small timber blocks bolted to the face of the principals. Secondary raised ties are bolted to the principals below the level of the primary collars with, in places, shallowly raking struts extending between tie and principal (Plate 32). The roof is carried on two tiers of through purlins and a square-section ridge piece.

6.3.1 The roof structure of the outbuilding is indicative of a probable 18th-century date, though the stylistically earlier, Renaissance crow-stepped western gable may indicate that the roof has been renewed and the present structure inserted into an earlier building. It is commonly held that the stepped gable was introduced into Wales by Sir Richard Clough, agent of Sir Thomas Gresham in Antwerp, in c.1567; Smith (1988, 519; Map 45) records a number of late 16th- and 17th-century stepped gables in northern Wales with a particular concentration in northern Denbighshire and Flintshire, a high status example survives at Plas Mawr of 1577-95 in Conwy, while a more local example is to be found at Plas Gwyn (NRRN 16746)¹⁸ of

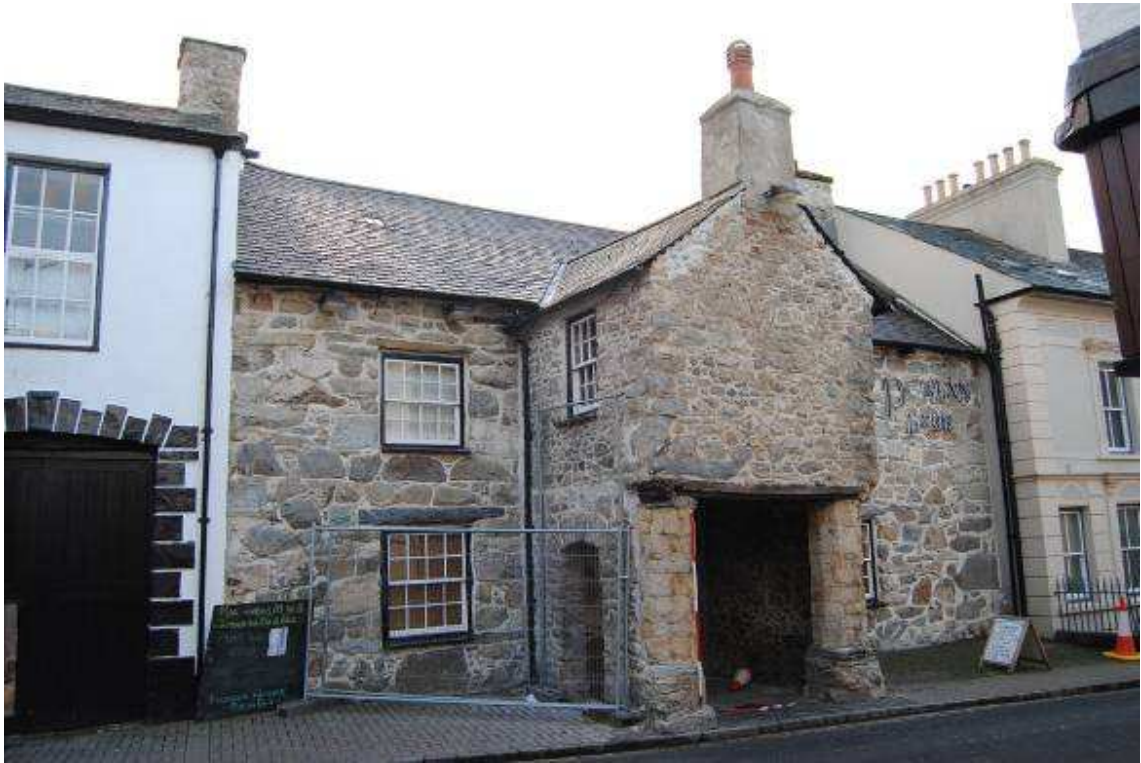
Plate 1: North (street) elevation looking south-west.

4.2.1 The **principal elevation** (Figure 5; Plates 1 and 2) faces to the north onto Stryd Penlan; of two full storeys beneath a pitched, slate-clad roof with gable stacks rising to east and west, the building is abutted at either end by later structures.⁵ The elevation, recently stripped on concrete render,⁶ is of stone rubble construction utilising large boulders of Llanbedrog stone, roughly coursed, with a mix of locally quarried material and with window lintels of distinctive Maentwrog stone. A two-storey, gabled porch (a secondary addition), partly open at street level, projects northwards over the pavement slightly off-centre towards the eastern end of the elevation (Plate 3), protecting the principal access doorway, with flat monolithic head, opening onto Bay 2 of the interior via a small internal lobby.

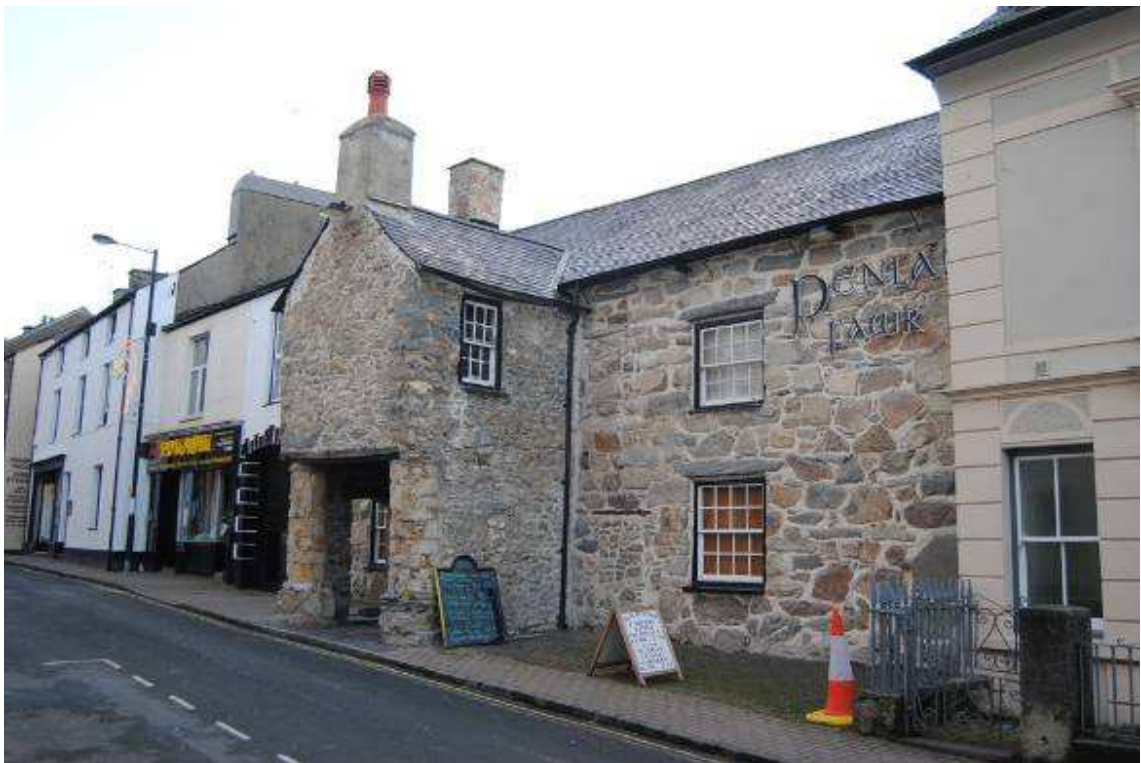
Plate 2: General North (street) elevation looking south-east.

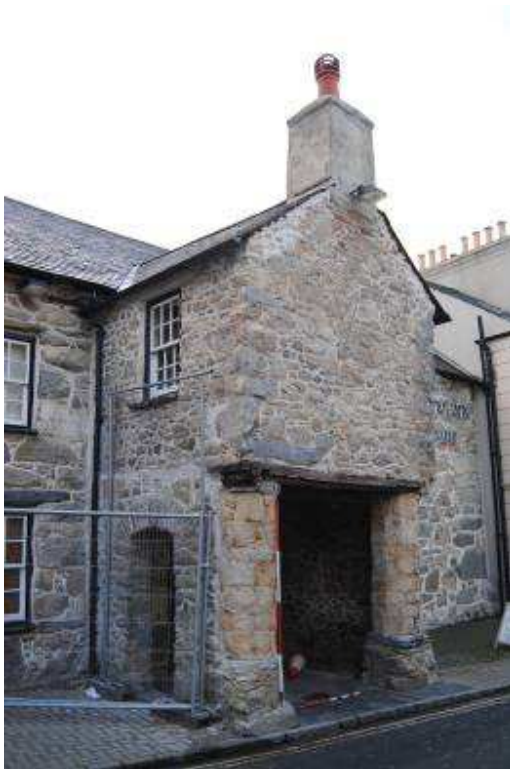
Plate 3: Secondary porch.

4.2.3 The two-storey **porch** (Plate 3) clearly represents a secondary feature, evidenced by the distinct nature of its masonry (smaller rounded stone) and by the fact that it abuts primary features of the principal range. Originally open at street level, with the north gable carried on a substantial timber bresummer supported by two octagonal pillars of a yellow coloured sandstone (?Egryn freestone), the eastern and western flanking walls have subsequently been (partly) infilled, leaving only the north side fully open. A segmental arched doorway survives within the eastern flanking wall while a small blocked window within the west wall has been exposed during recent work. The western pillar supporting the north gable (Plate 4) retains incised graffiti 'R.V.' part-way up its western facet (Plate 5), probably relating to Richard Vaughan (see §.6.1 below). The upper room of the porch is lit by single 6/6 double-hung sashes in the east and west walls; the north gable is blind though a small area of possible blocking may indicate a further former small window opening to the left (east) of the central flue serving the square ridge stack (rendered though visible internally to be rebuilt in brick).⁷

6.2.1 The two-storey porch of the north elevation, originally fully open at street level, is clearly a secondary introduction and its erection necessitated the blocking of a small first floor window within Bay 3, offset slightly to the west of the principal doorway, which it clearly abuts. A possible historical context for the addition of the porch is provided by the documentary record. When William Vaughan, High Sheriff of Caernarfonshire in 1613 and 1632, died in 1633 his property passed to his son, another Richard Vaughan (great-grandson of the Richard Vaughan recorded in Pwllheli in 1578), a former MP for Merioneth (1628-9).¹⁵ William Vaughan had undertaken significant work at Cors-y-gedol (NPRN 18242) in 1630, including the construction of the gatehouse, and it is possible that it was his son Richard Vaughan who was responsible for the introduction of the porch at Penlan Fawr at some point between his inheritance in 1633 and his own untimely death at the age of 30 in 1636, and that it is he who is commemorated by the incised 'R.V.' recently exposed on the western pillar.

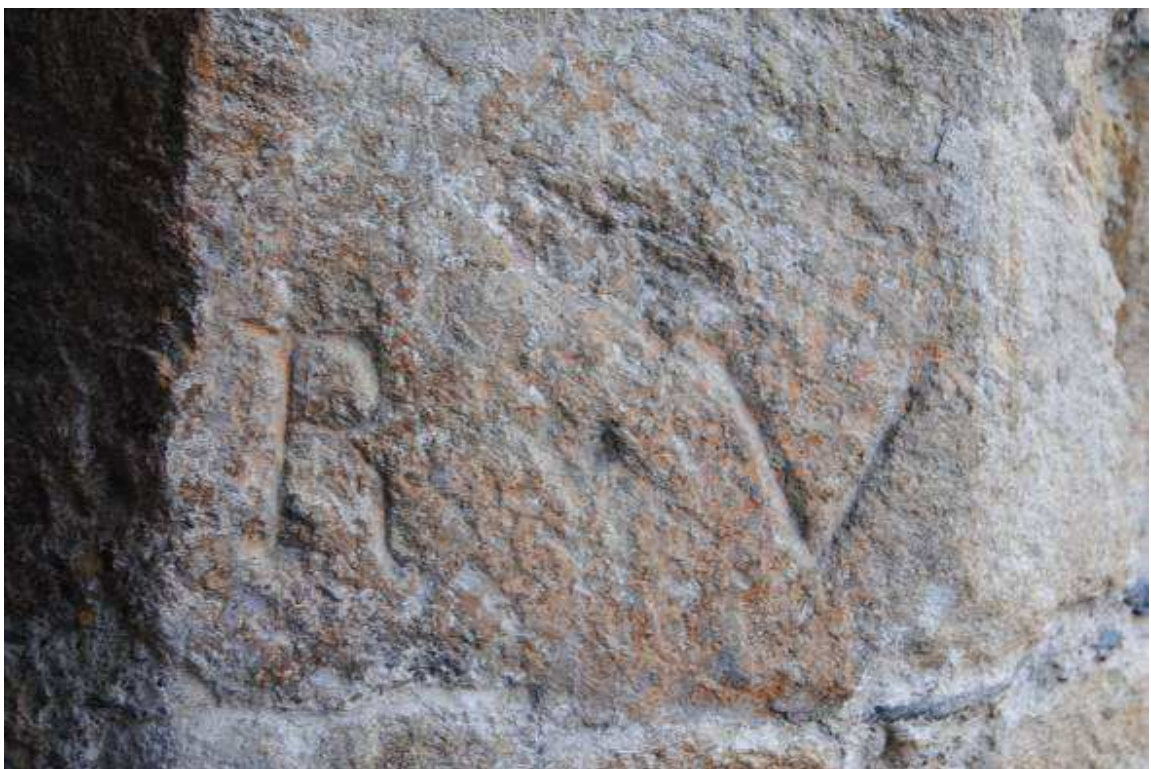
Plate 5: Graffiti 'R.V.' (Richard Vaughan?) on western pillar of porch.

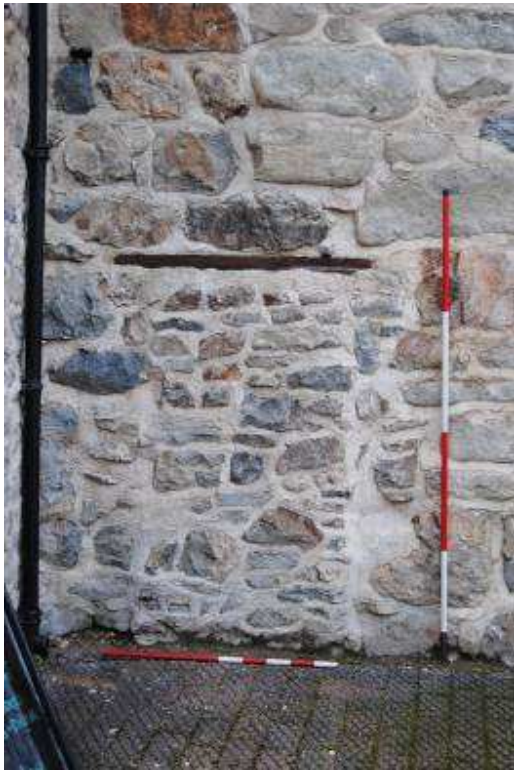
Plate 6: Blocked doorway to west of porch.

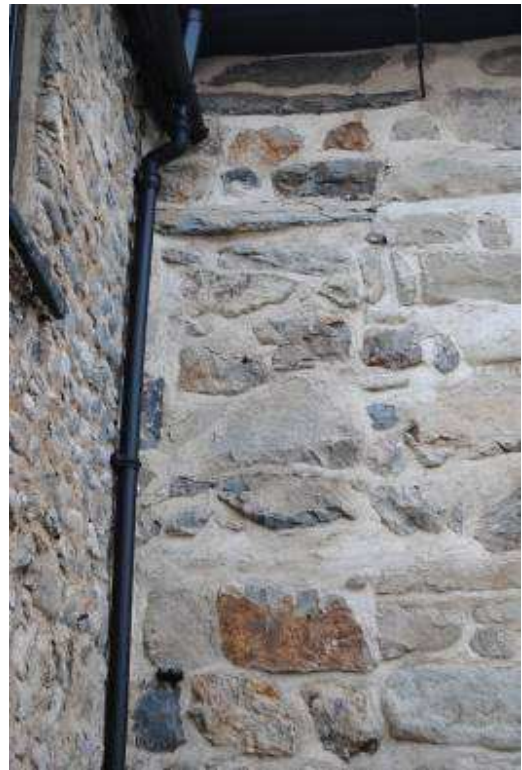
Plate 7: Blocked window at 1F level (infill abutted by west wall of porch).

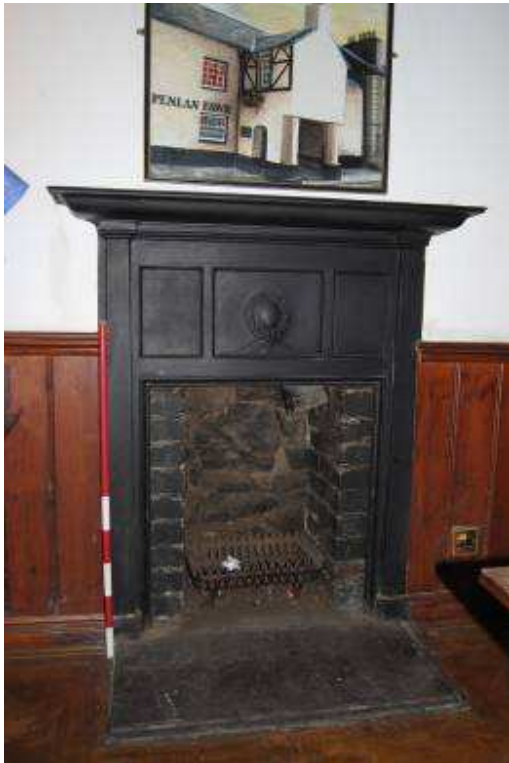
Plate 11: Inserted FP, east wall.

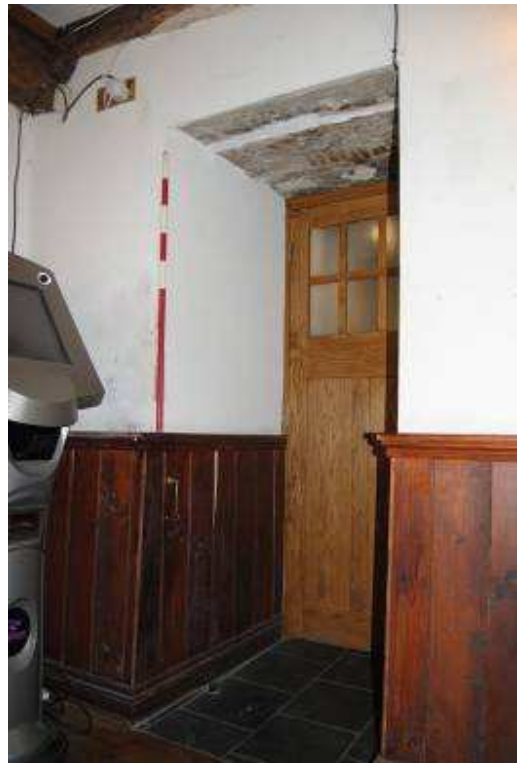
Plate 12: Primary opening (former window?), south-east angle ([GF01a]).

4.3.1 The interior is accessed via a principal doorway, located beneath the secondary porch, opening onto a small lobby, [GF02], inserted at the north side of Bay 2 with internal doorways opening to the south and east. In its current form, the **ground floor** level of the principal range essentially forms a single open space [GF01] (Plates 8/9), with the exception of lobby [GF02] previously noted, though an associated, inserted stair at the east side of Bay 2 partly screens off the east end of the range (Plate 9), with through access to the south, the space being thus partitioned into [GF01a] to the east and [GF01b] to the west. [GF01a] (Plate 10) occupies Bay 1 (with cellar under) forming a small discrete area furnished with a herring-bone woodblock floor, heated by a 19th-century fireplace (Plate 11) inserted centrally to the east wall and lit by a single 8/8 double-hung sash within the north wall set within slightly splayed reveals. A doorway at the east end of the south wall, spanned by three timber lintels (Plate 12), arguably represents a modified original window opening.

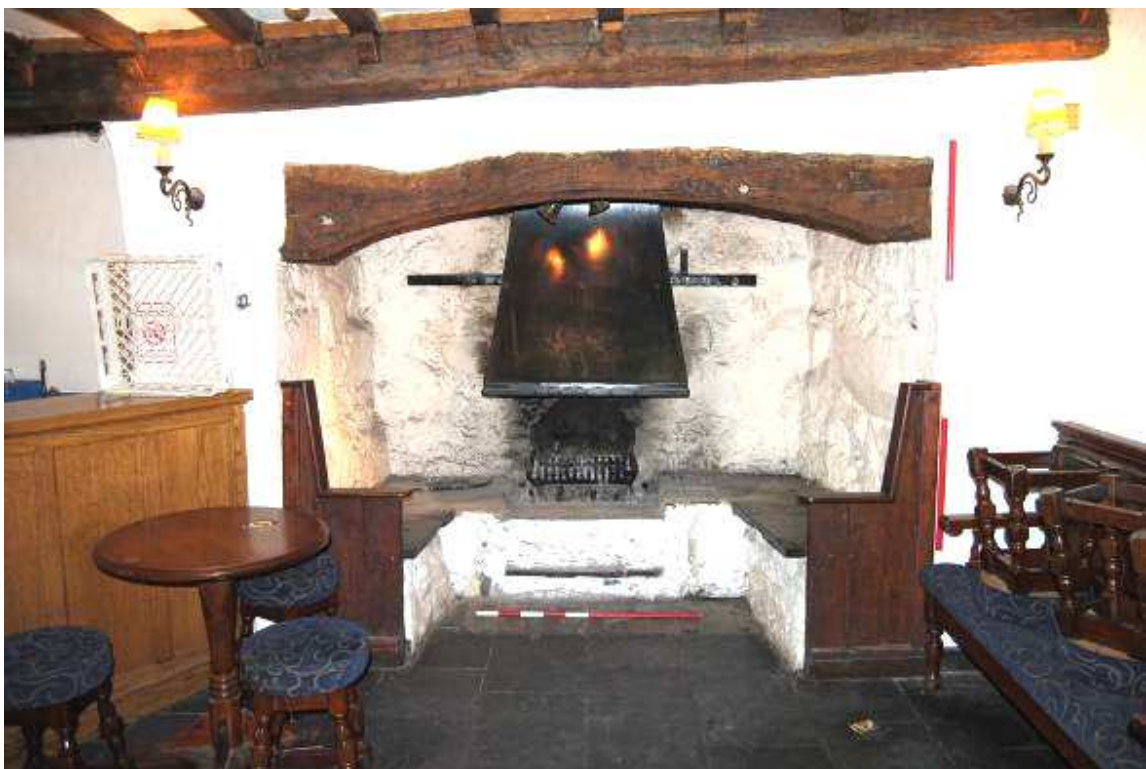
Plate 13: [GF01b], detail of FP to west wall.

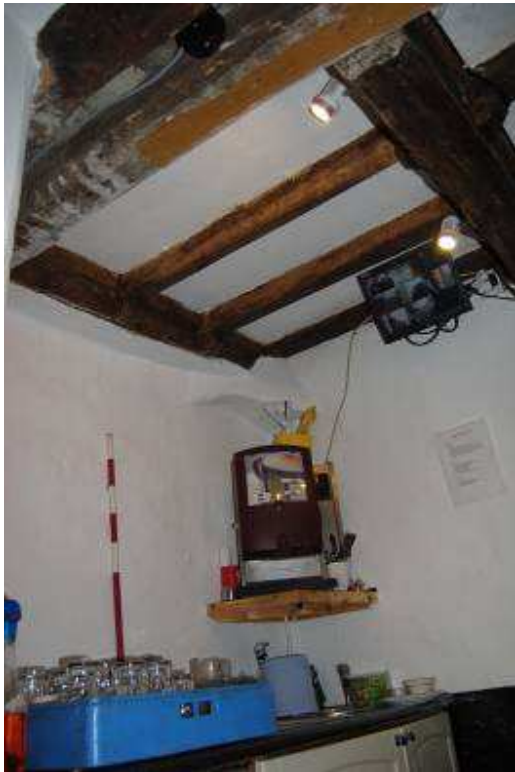
Plate 14: Site of primary stair to south of FP.

4.3.2 [GF01b] occupies Bays 2 to 4 and is lit by a second 8/8 sash within the north wall at Bay 4, matching that at Bay 1. A further doorway within the south wall of Bay 2 is located directly opposite the main street entrance and again arguably represents a primary feature, while a wide opening spanning Bays 3 and 4 is a modern insertion (the published RCAHMW plan of 1964⁸ indicates a small doorway only within Bay 3). A further doorway survives to the far west in modified form. The west wall is dominated by a wide fireplace (Plate 13), offset to the north of the range and furnished with integral stone benches to north and south. The fireplace recess is spanned by a heavy, cambered bresummer, plain-chamfered to its lower, eastern arris and stopped with ogee-stops. Flanking the fireplace to the south, a recess reasonably represents the site of an original winder-stair rising to first floor level, the ceiling joists here being obvious replacements (Plate 14).

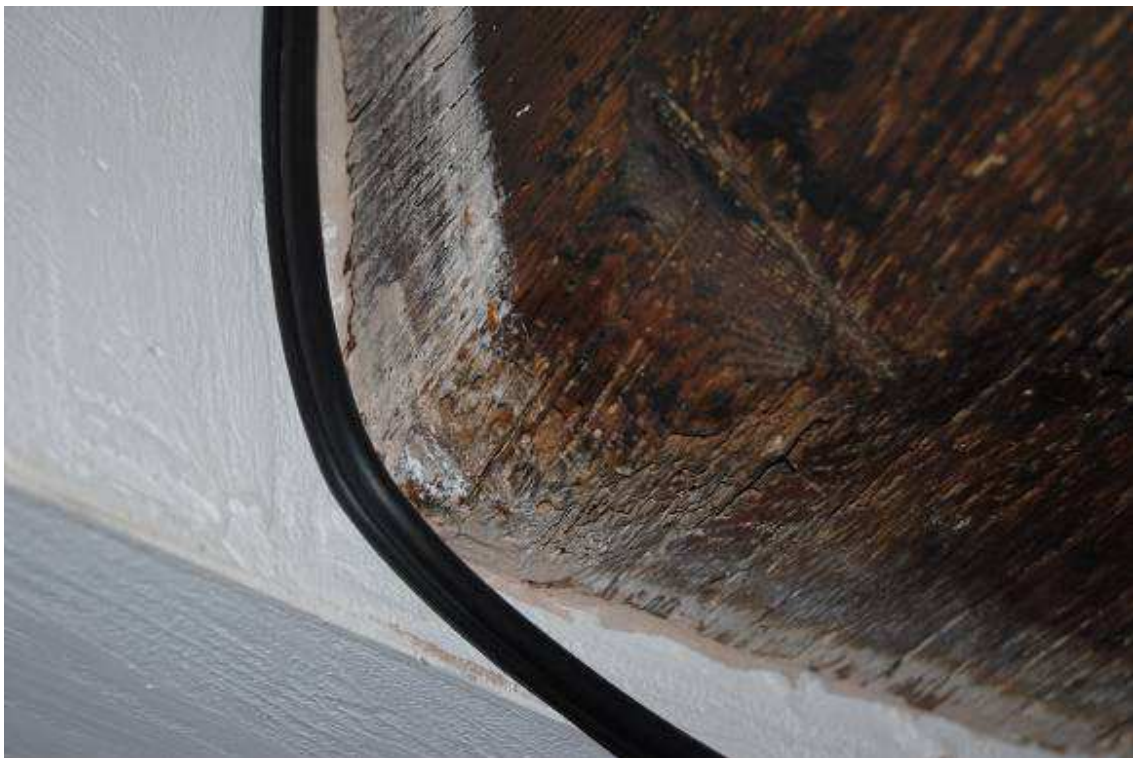
Plate 15: Ogee chamfer-stop of ceiling beam at Bay 2/3 (S); [GF01].

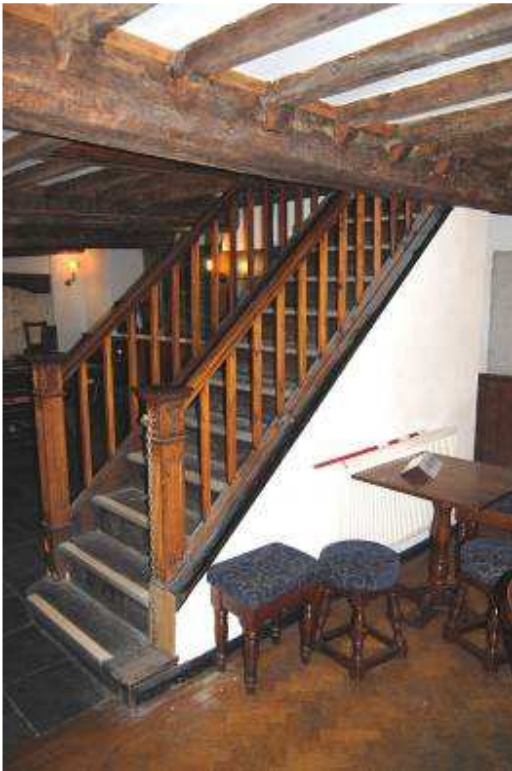
Plate 16: Inserted stair at Bay 2.

- 4.3.4 **First floor** level is accessed via the inserted straight-flight stair (Plate 16), rising from south to north and flanked at first floor level by a ½-glazed stud partition where it opens onto landing [1F02] (Plate 17). Landing and stair together occupy the whole of Bay 2, extending to the full width of the range and lit by a single, small casement window with splayed reveals within the south wall. To the west end of the range, room [1F01] (Plate 18) occupies the whole of Bay 4 and the northern part of Bay 3, the southern section of the latter bay being partitioned off and housing a stair, accessed from [1F02] only (see below). Room [1F01] is lit by a single 8/8 sash window in the north wall, while a plan of 1979¹⁰ indicates a former, small window in the south wall, now blocked. A small fireplace has been inserted into western stack while the recess to the south of the stack again retains evidence suggesting a primary stair.

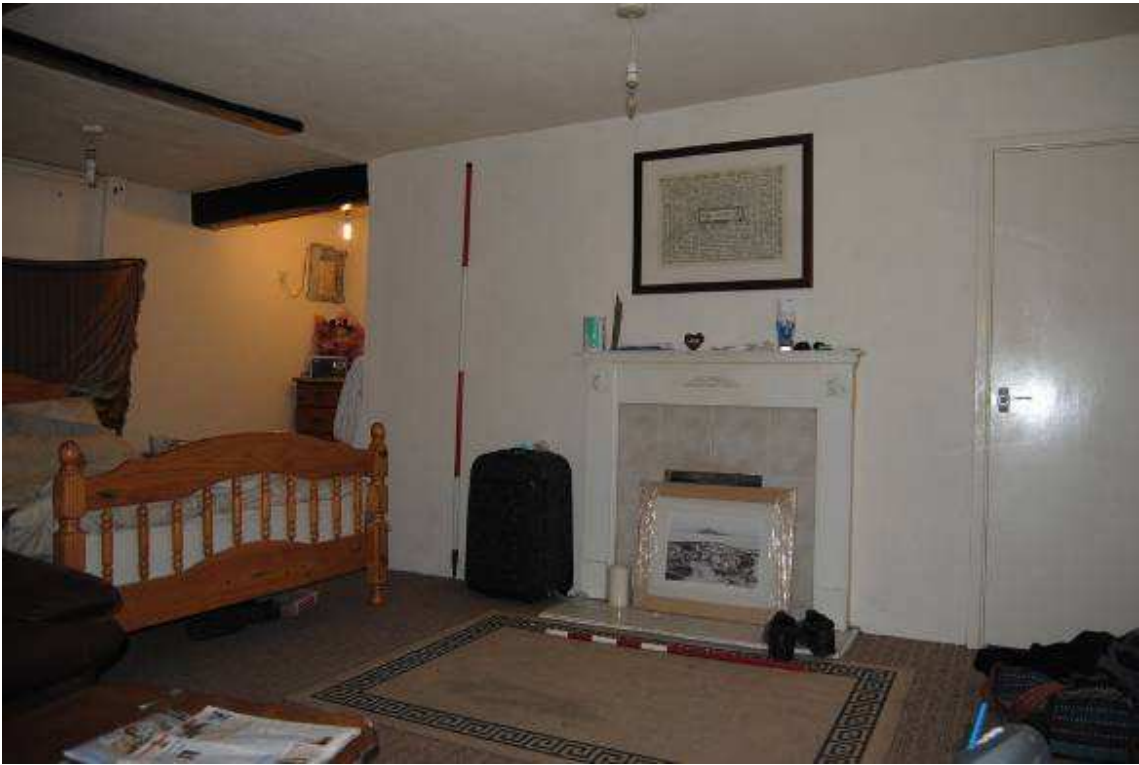
Plate 18: [1F01], looking south-west; note recess to south (left) of stack for ?primary stair.

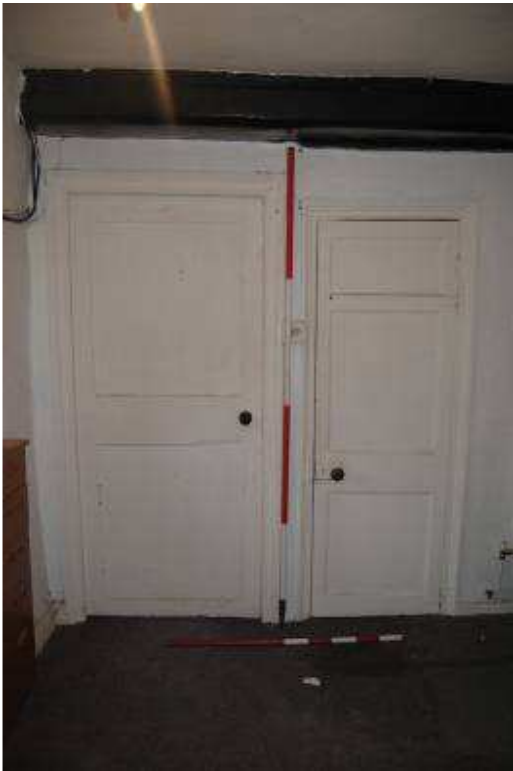
Plate 19: Paired doors to [1F02], south wall.

- 4.3.5 Paired, panelled doors at the south end of landing [1F02] (Plate 19), stylistically (?)18th-century in date, open to the west onto a stair and small understair cupboard. The southern door, hung to the south on plain L-hinges, opens onto a small chamber [1F04] (Plate 20) occupying the southern part of Bay 2, formed by vertical plank walls and housing the stair, straight-flight with lower ¼-turn, rising from west to east to attic level.

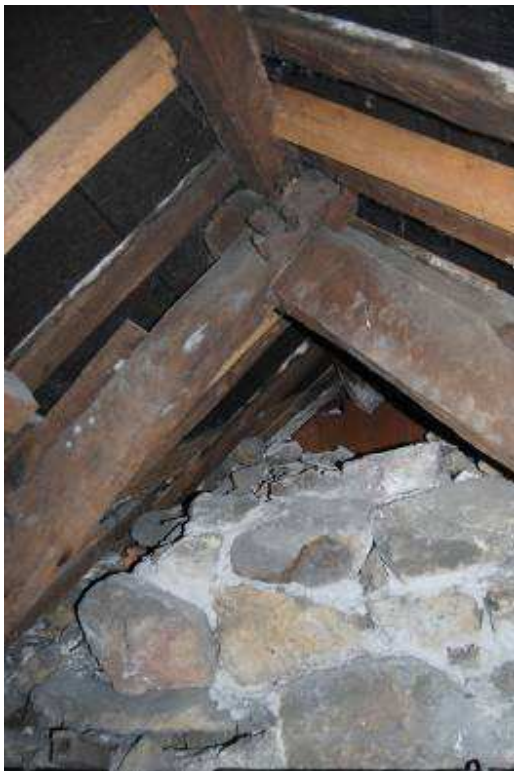
Plate 22: Roof structure over porch.

- 4.3.8 At the north end of landing [1F02], room [1F06] occupies the first floor level of the secondary porch (Plate 21); it is lit to east and west by 6/6 double hung sash windows and is heated by a small fireplace, with plain timber bresummer, set centrally to the north gable wall. A possible window, traceable externally to the east of the stack, is not visible internally.¹¹ The roof structure of the porch was inspected visually from an access hatch in the first floor ceiling and was noted to be of common rafter type on a single tier of side purlins and square section ridge piece. A single truss, coincident with the north wall of the main range, comprises stout principals, lapped and triple pegged at the apex (Plate 22).

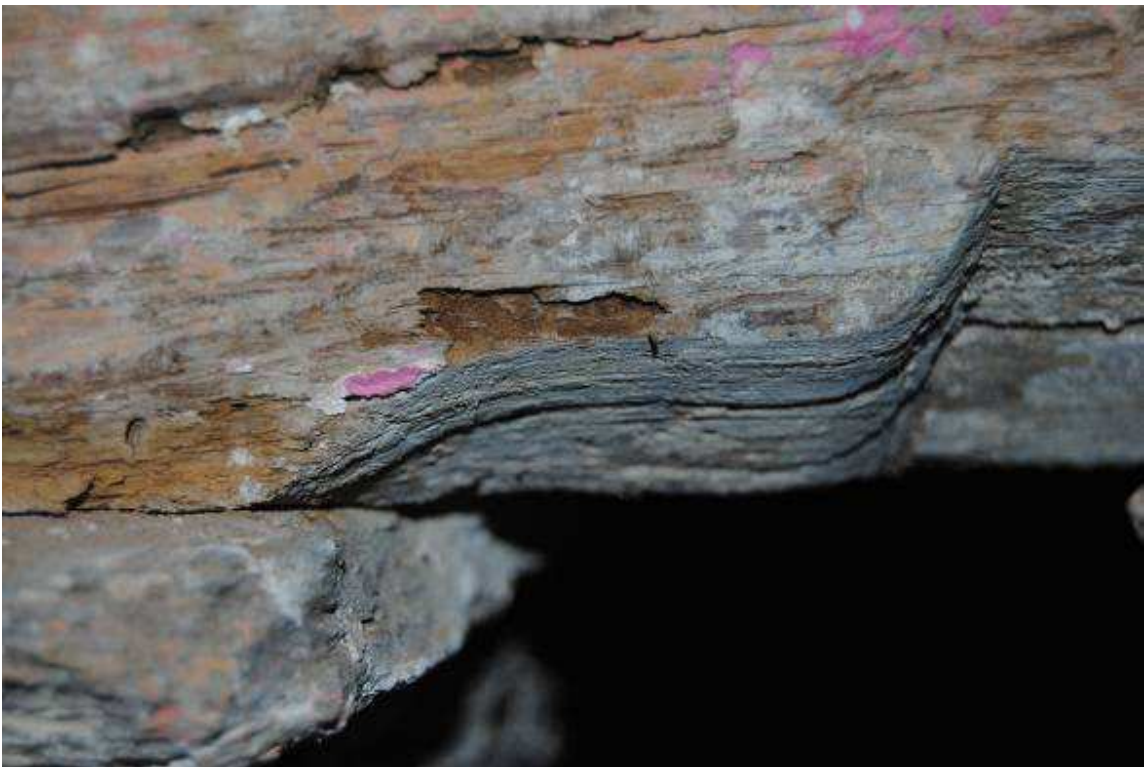
Plate 25: [2F01]; ogee stop to FP bresummer in west wall

- 4.3.9 **Attic** level is accessed via a stair rising west to east from [1F04] (Plate 20/23). The attic is divided by a tongue and groove partition wall, inserted within Bay 2 to form two unequal rooms, [2F01] to the west and [2F02] to the east. [2F01] is heated by a small fireplace (Plate 24) within the western stack, spanned by a ogee-stopped chamfered bresummer (Plate 25) while [2F02] is unheated.

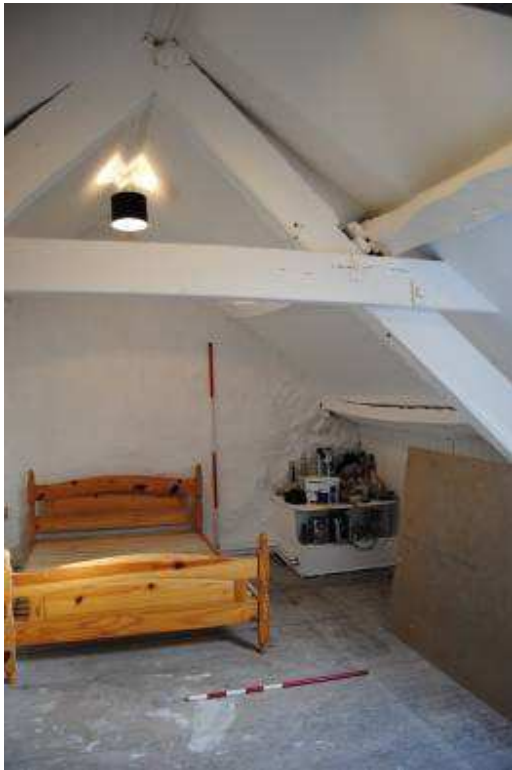
Plate 26: [2F02], truss T1.

- 4.3.10 The **roof structure** of the main range (Plates 26-9) is of four bays (here numbered 1 to 4 from east to west) defined by three trusses (**T1** to **T3** from east to west), originally of collar-beam form though each now lacking their primary collar. In each truss, secondary collars have been lapped onto the west face of the principals (Plate 26), where they are secured by paired iron bolts just above the level of the original collars which are evidenced by mortices housing cut-off tenons, triple pegged (Figure 8; Plate 27): original collars were set at a level of c.1.75m above the attic floor level, creating a utilisable roofspace. Principals of **T3** are

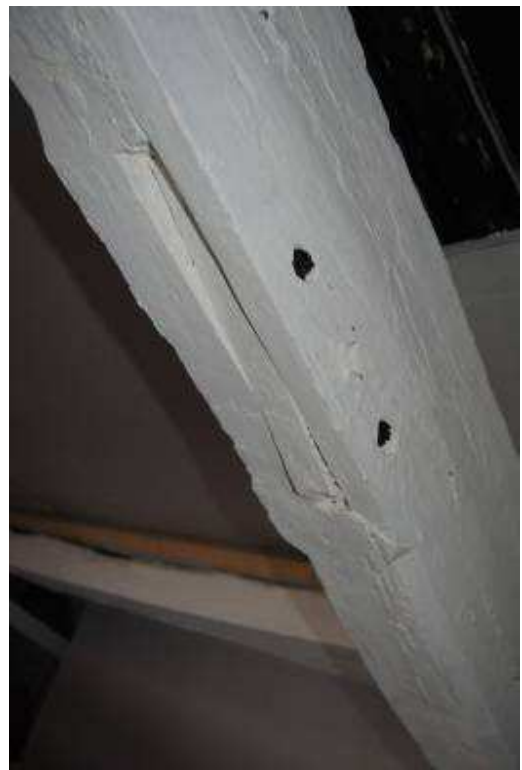
Plate 27: Truss T2; sawn off primary collar

chamfer-stopped (ogee-stops) on each face to respect the location of the original collar (Plate 27), while **T1** and **T2** are chamfered and stopped (plain run-outs) to the west face only.

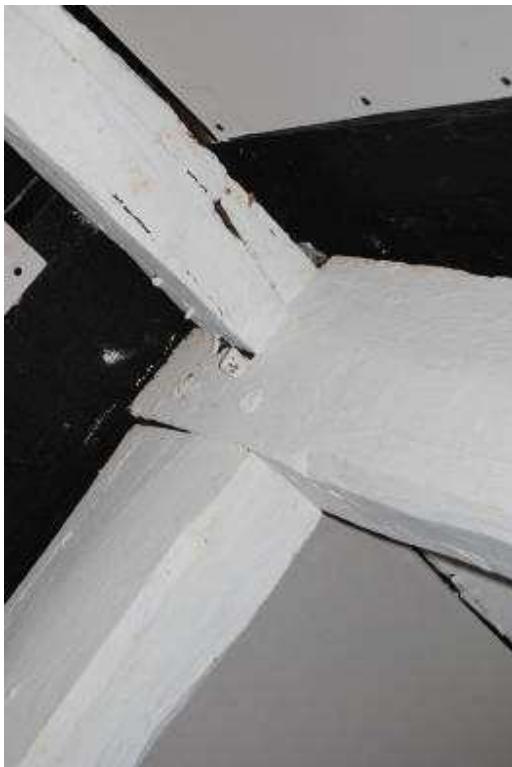
Plate 28: Apex detail

- 4.3.11 Principals support two tiers of side purlins (4 x 9in.), jointed at each truss with stop-splayed scarfs (Plate 29), and square section ridge piece (Plate 28) carried in notched principals; upper purlins are trenched shallowly into the outer face of the principals (Plate 29) while lower purlins are carried by packing pieces and/or timber cleats. At the west end of the range, purlins are supported by short rafters extending from the exterior walls to the masonry of the principal stack. No evidence was recorded to indicate original longitudinal wind bracing. The lower purlin within Bay 4 has been truncated to east and west, suggestive of a former dormer; the presence of a scarf joint immediately west of **T3** indicates that any former dormer was not primary. Common rafters have been renewed throughout.

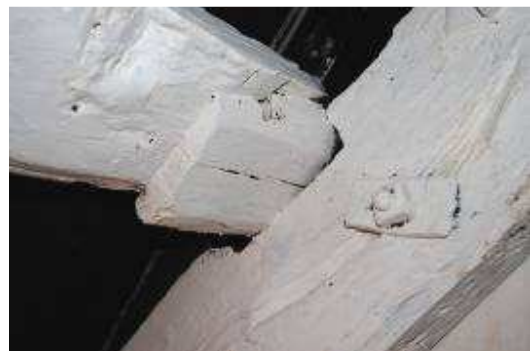
Plate 29: Detail of purlin scarf

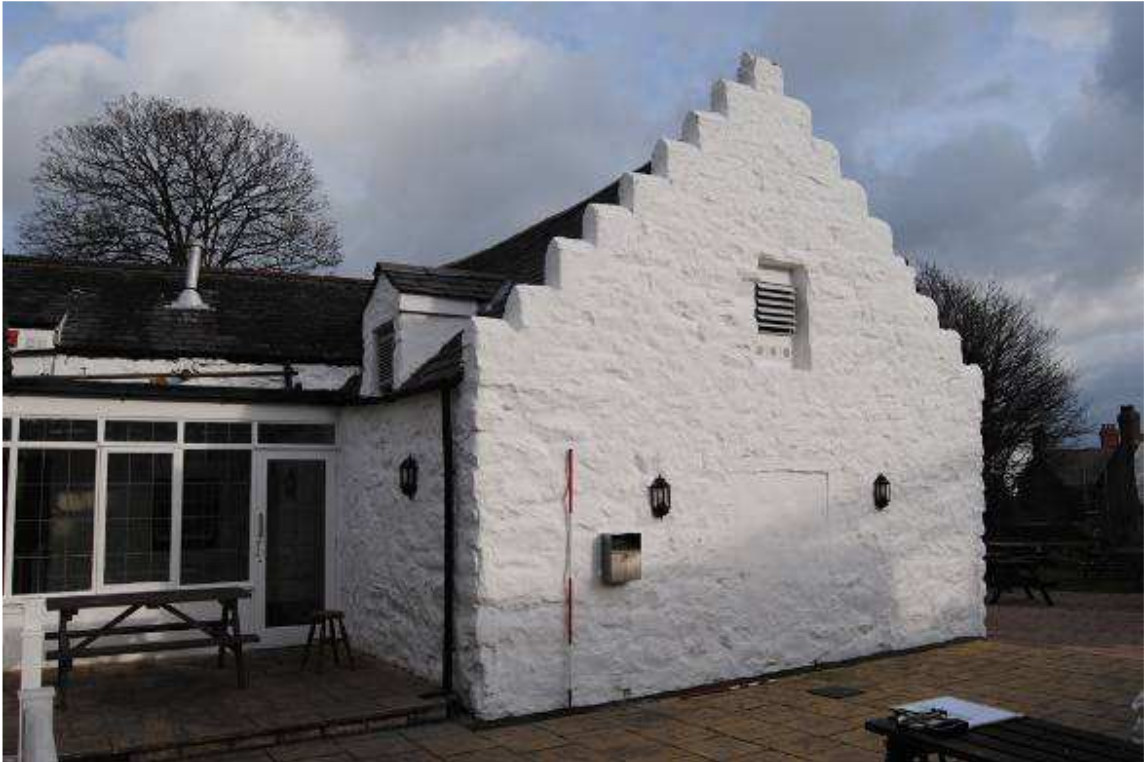
Plate 30: Outbuilding; western stepped-gable end, note dormer to north elevation.

- 4.4.1 The opportunity was taken during the course of site survey, to make a rapid record of a small outbuilding to the south of Penlan Fawr (Figure 4; Plates 30/31) incorporating an interesting crow-stepped western gable, stylistically of 17th-century date.¹²

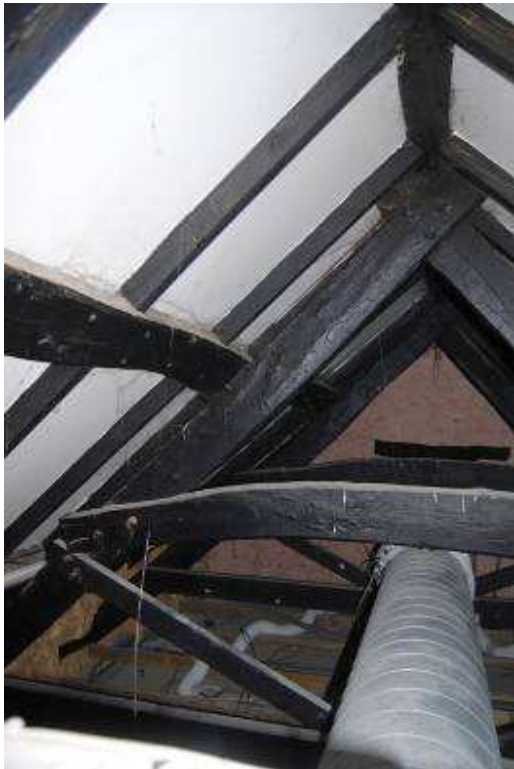
Plate 32: Outbuilding roof structure.

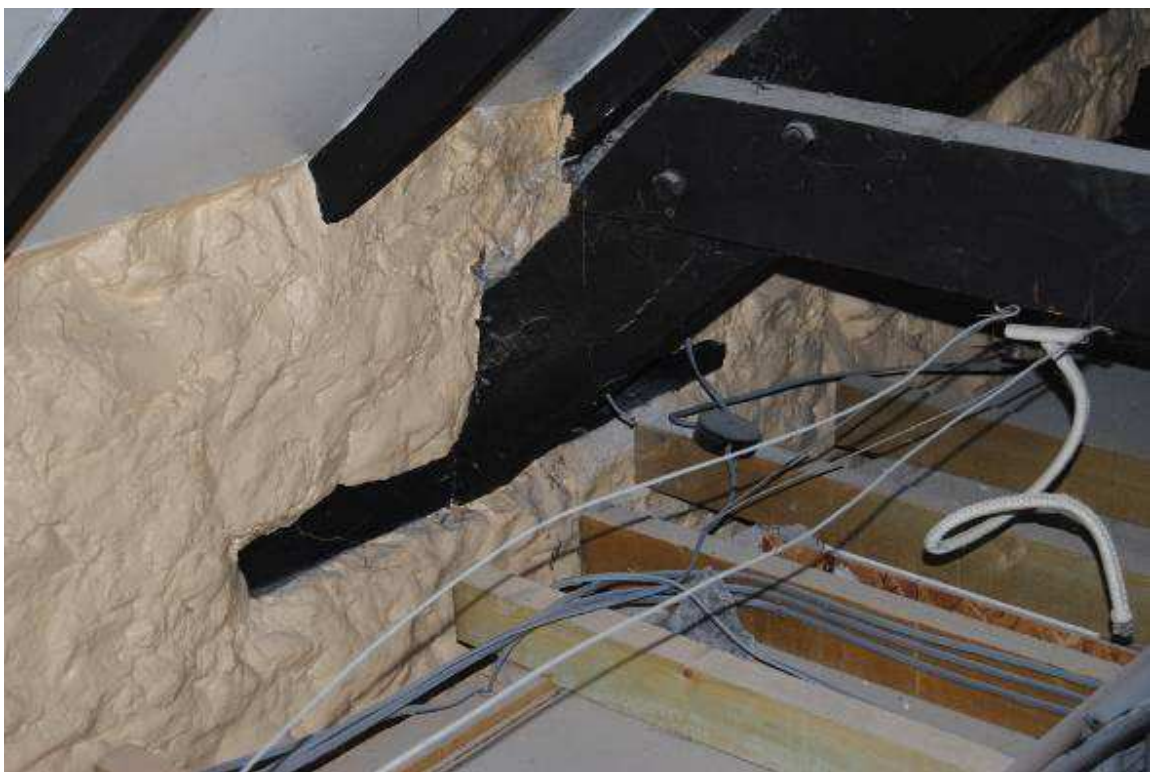
Plate 34: Outbuilding; principal rafter resting on timber pad set into stonework.
