# North West Wales Dendrochronology Project Pen-y-bryn, Abergwyngregyn, Gwynedd

**EAS Client Report 2010/02  
February 2010**

**North West Wales Dendrochronology Project  
Pen-y-bryn, Abergwyngregyn,  
Gwynedd**

**EAS Client Report 2010/02**

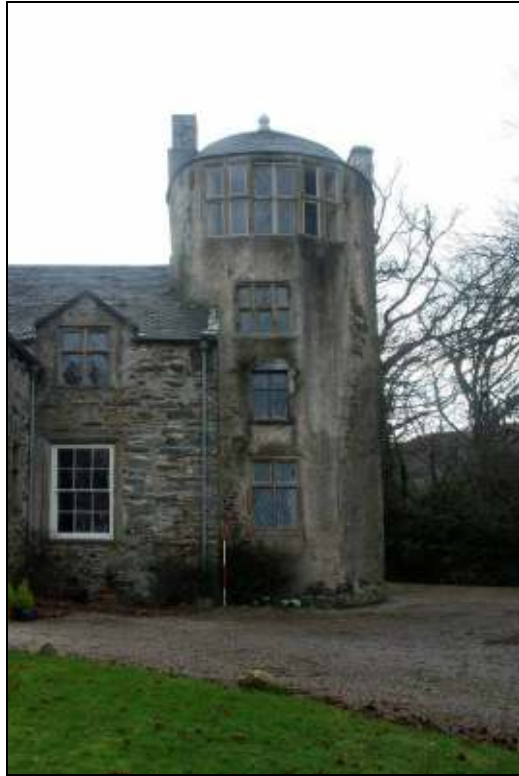
Plate 3: Front elevation of tower

The tower (Plates 3 and 4) is a four storey structure, roughly circular in plan with a conical (slightly domed) slate roof. Two chimney stacks protrude from the roof. The north east chimney serves the fireplaces in the south west gable end of the central range. The south western chimney is no longer active, but is presumably associated with the brick flue recorded on the second floor of the tower (see later). The front face is slightly flattened, presumably with the addition of the windows on this side of the structure. Each of the windows is slightly different. Those on the ground and first floors have four paned windows with mullions and transoms, although of different designs. The second floor has a six paned window with mullions and a transom, whilst the third floor window is much larger with a twelve pane window wrapped around the front face of the tower. The ground, second and third floor windows are in sandstone, whilst the first floor window is in wood.

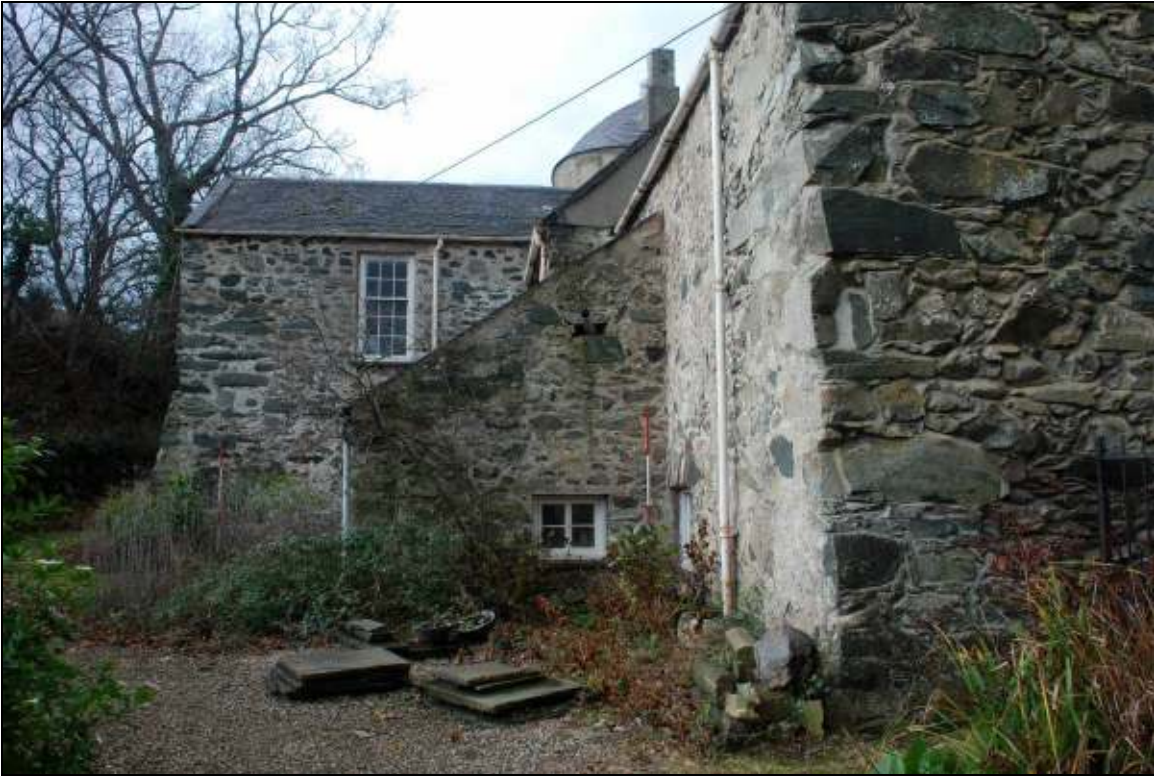
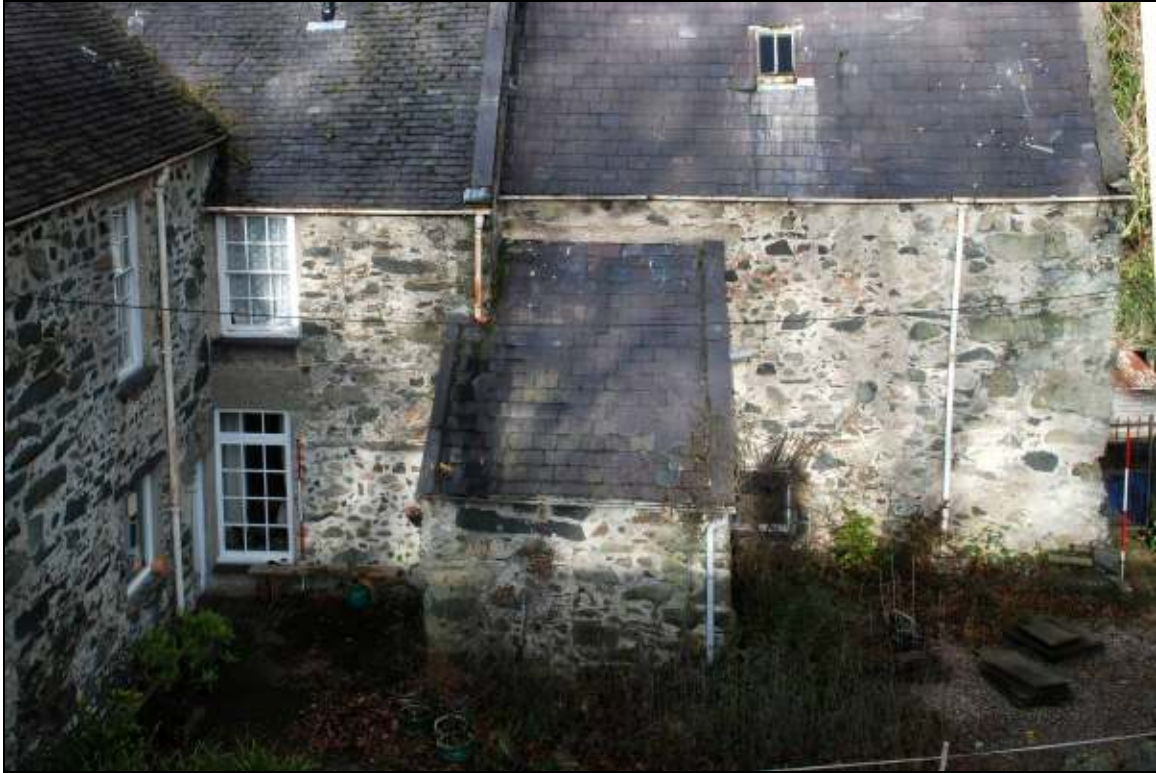
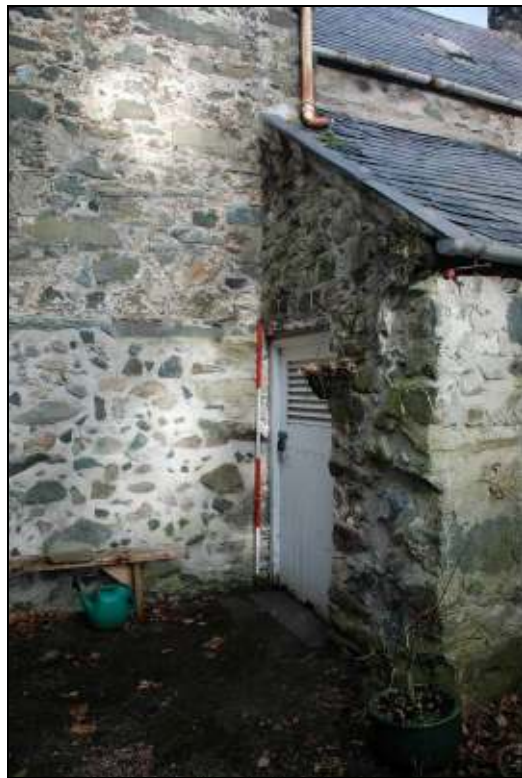
The northern wing is set at right angles to the north eastern range, is single storey, lean-to structure with a slate roof (Plate 24, 25, 26) and is clearly a late addition. Whilst the existing door way is in the south western wall there is a blocked opening in the south eastern wall of the wing. This doorway must predate the corner fireplace in this wing.

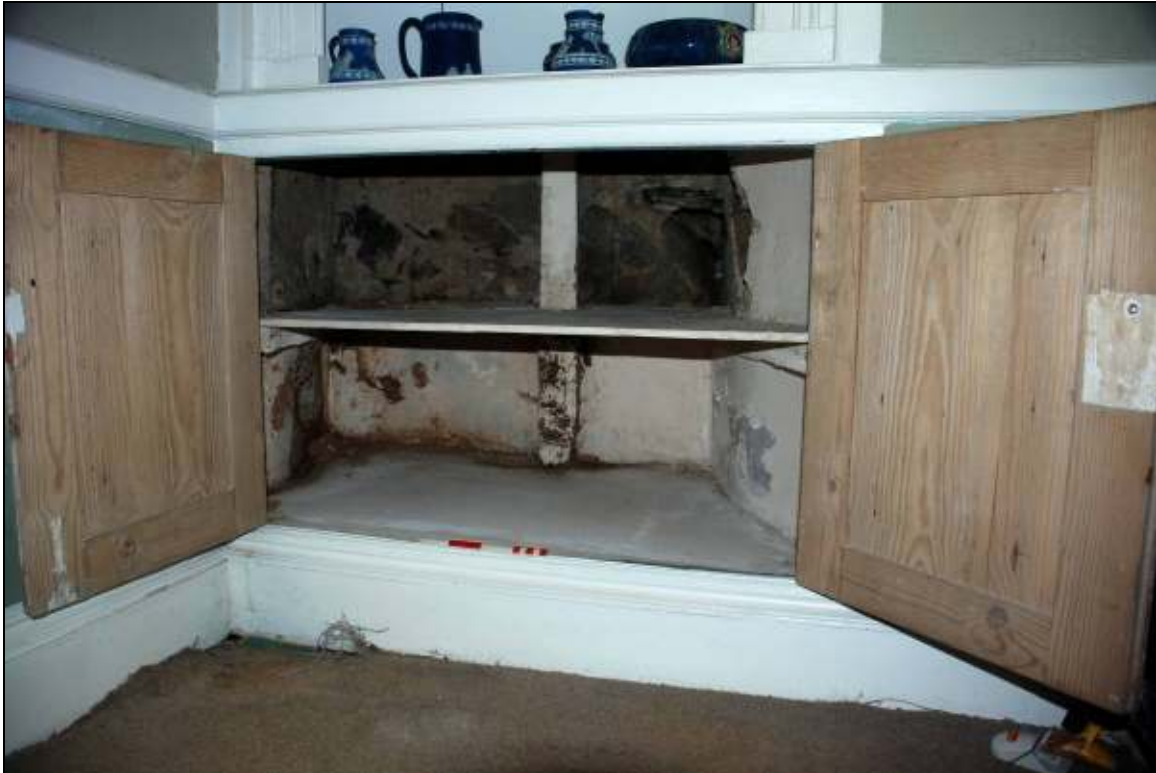
Plate 27: Curved outer wall of the tower in cupboard in central range, looking SW

tower can be seen (Plate 27) extending the line of the tower wall through the structure of the central range. The full curve of the tower wall, however, has been cut suggesting that it predates the construction of the central range. Also within this cupboard, the other lateral wall curves away from the line of the wall and the back wall appears to have straight joints. Linking this with the possible evidence for a blocking on the outside wall (see above) it seems likely that there was a doorway in this corner of the central range.

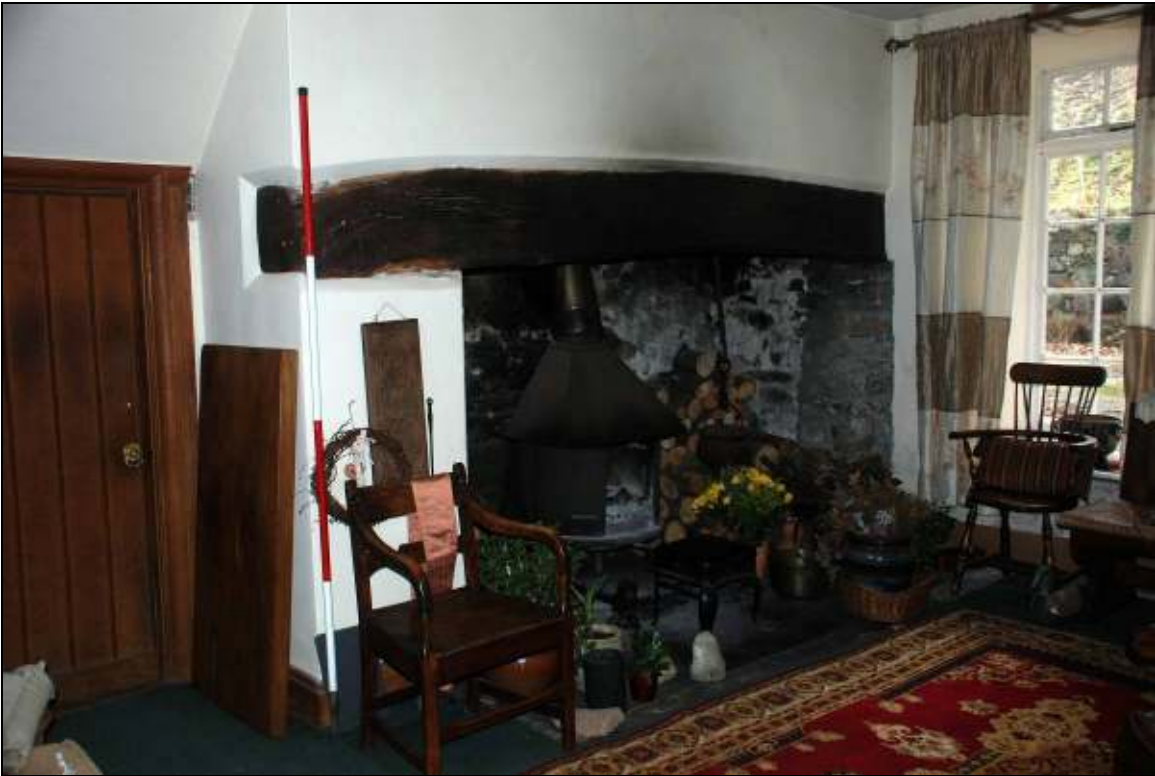
Plate 35: Central range fireplace, looking SE

On the ground floor the central range has a large fireplace with a wooden bressumer on what would be its north eastern gable wall (Plate 35). Adjacent to this is the main staircase with massive moulded and swept handrail, turned balusters to lower flight, and double-square newels with capping (Plate 36). Room for the staircase was provided by replacing the dividing wall between the Central and North Eastern ranges with a thin, timber and brick wall (Plate 37 and

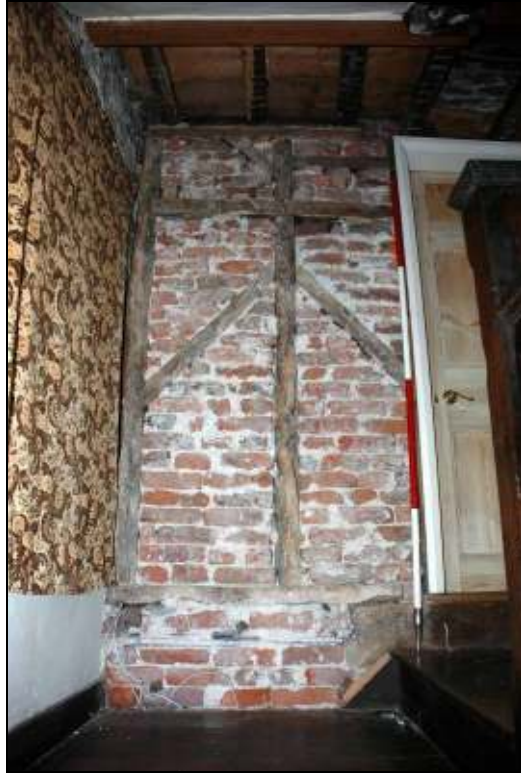
Plate 37: Brick and timber wall in staircase, between ground and first floors

38). This wall was constructed of a timber frame with rails and studs with some diagonal bracing filled with hand made brick of eighteenth century type. There are three tie beams visible on the first floor, the two outer of which have the feet of trusses 5 and 6 adjacent (Figure 5, Plate 39). The exposed tie beams have been roughened to take a plaster coat, however they were originally chamfered with straight stops (Plate 40). The trusses for this range are largely hidden as they are used as the dividing walls between the rooms on the second floor. The bases of the trusses are exposed in the attic space between the walls of the second floor rooms and the roof structures (Plates 41 and 42), unfortunately any collars or other reinforcement are hidden. Truss 4 survives only on the north western side of the chimney breast. A raking strut runs from the principal rafter to the chimney breast and two purlins are trenched into the principal rafter (Figure 8, Plate 43).

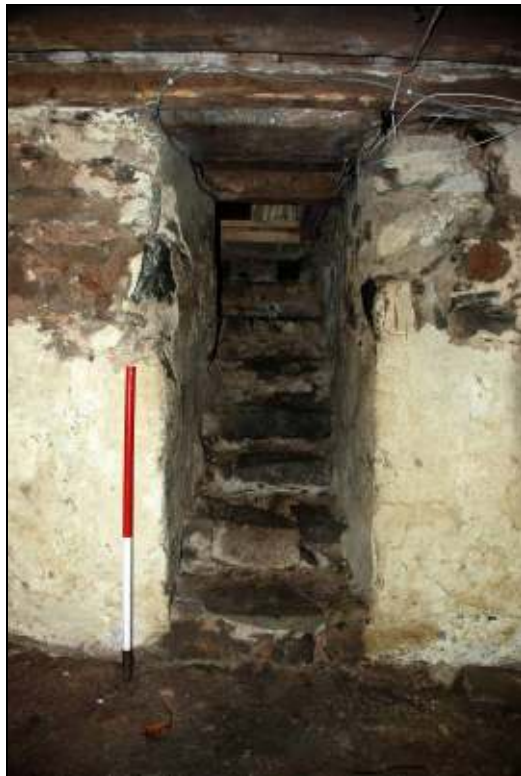
Plate 44: Stone stairs between the cellar and the tower

Below the front section of the central range is the cellar or undercroft (Figure 4). Access is via a flight of stone steps from beneath the tower (Plate 44). This relationship would suggest that the cellar predates the central range. There has been a link between the central range and the cellar with the remains of a dog-legged staircase (Plate 45) which would have exited in the space now occupied by the main staircase. There are a series of small niches cut into the cellar wall (Plates 46 – 50), one of which extends behind the dividing wall of the cellar (Plate 47) possibly suggesting this wall was from a secondary phase. To the north east of the dividing wall is an area of cobbling (Plate 52) which leads to a door frame and head of late sixteenth or early seventeenth century type (Alcock and Hall 1994, 20) (Figure 10, Plate 51). The door frame and head would appear to be of relatively high quality work, possibly suggesting that they have been moved from elsewhere in the house. The doorway leads to a short passage below the current porch; some work has broken through the end wall of the passage revealing the northern wall of the passage extending beyond its current extent.

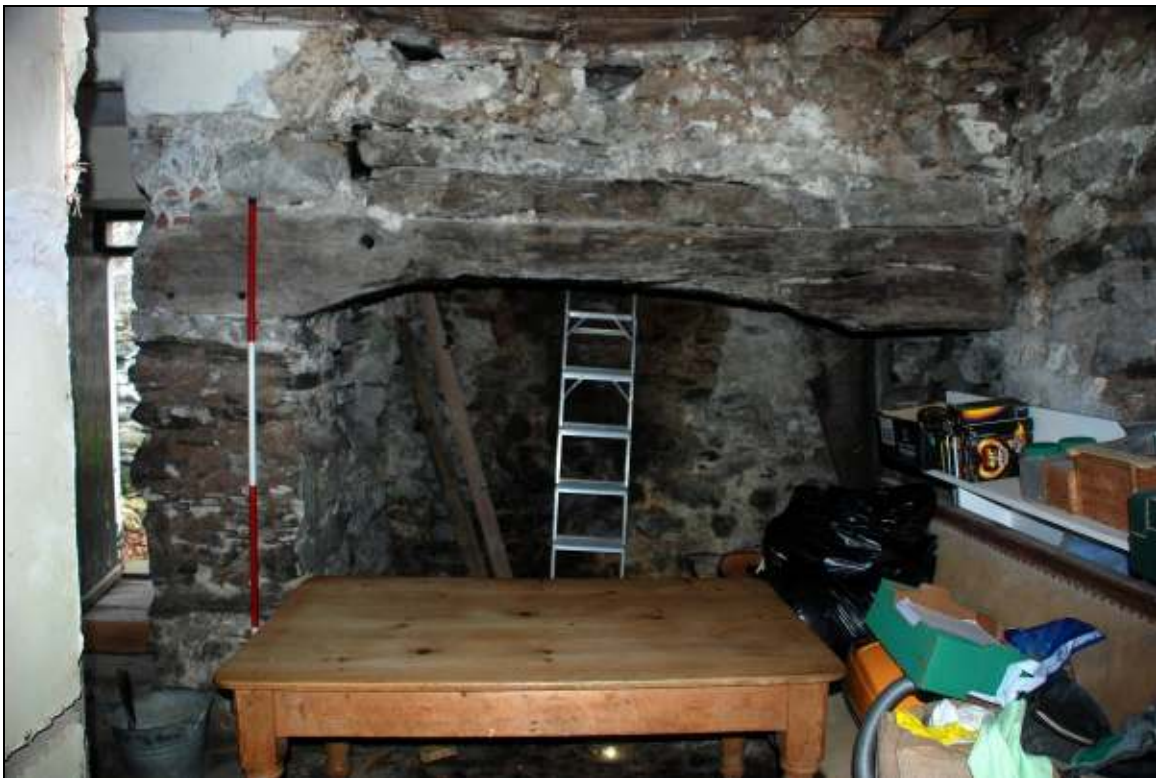
Plate 53: Fireplace in north eastern range, looking NE

The north eastern range has a large fireplace at the north eastern end (Plate 53) with a wooden bressumer and recesses on each side suggesting the possible locations of ovens. Truss 1 is disrupted by the chimney breast (Figure 9, Plate 52) with only a short length of principal rafter surviving on the north western side running between the eaves and the chimney breast. The purlins sit on the principal rafter and are supported by cleats both on this truss and Truss 2. Truss 2 is the most exposed truss in the house. It has a slightly curved collar with dove tailed lap joints linking it to the principal rafters (Figure 9.2, Plate 54). At the north eastern end of the collar is a clear carpenter's mark of "VIII" in chisel mark. There is also the same number in scratch marks slightly above the chisel marks in larger figures (Plate 55). Below the collar are two mortice holes in the principal rafters suggesting the position of a lower collar, now lost. The principal rafters are crossed, with a notched joint, to house the ridge purlin.

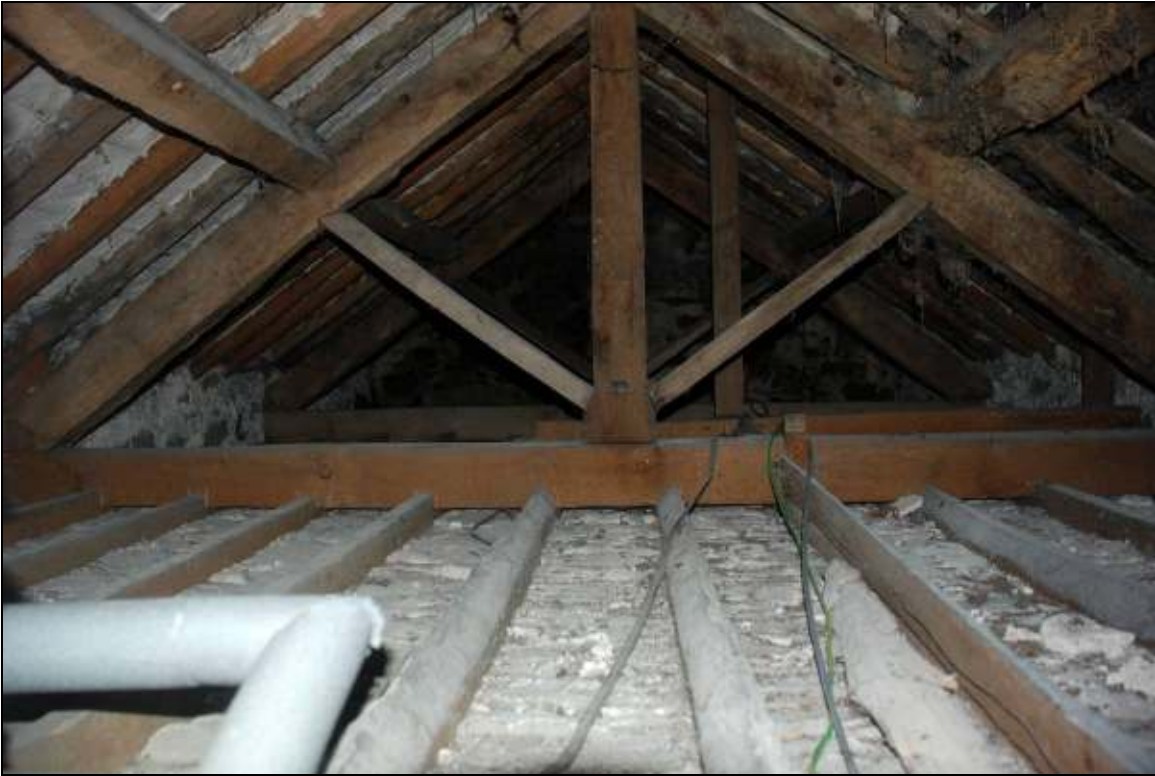
Plate 56: The roof structure for the south wing, looking SE

The south wing has a modern replacement roof structure (Plate 56) with a king post and racking struts. On the first floor the plaster has been removed from the south western wall, revealing the heightening of the wing observed on the outside wall (Plate 57). The removal of the plaster also revealed a niche cut into the wall (Plate 58).
