# DUGOED, PENMACHNO, BETWS-Y-COED, CONWY

[NPRN 26415]

## Architectural Record

**August 2011**

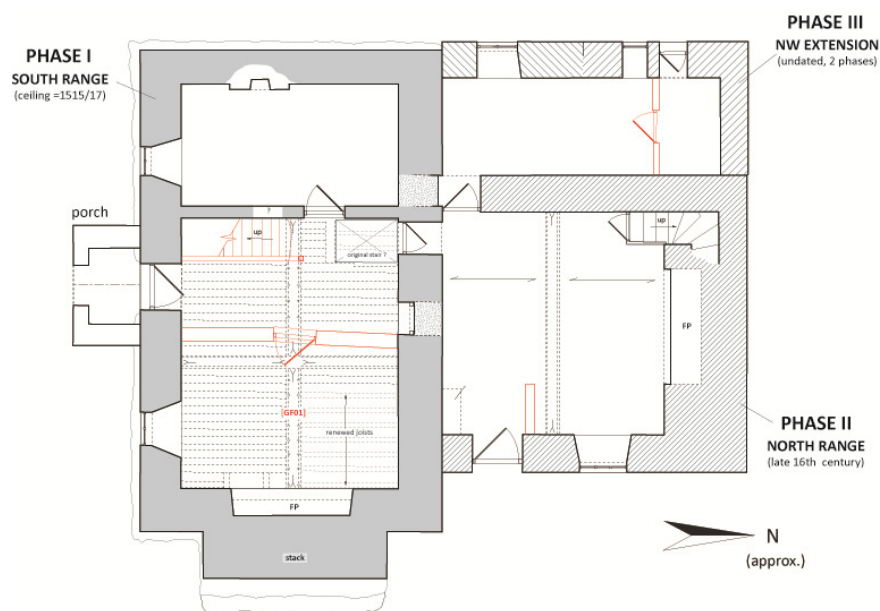
*Dugoed: Sketch plan showing principal features described in text (see also Figures 4-6)*

- 4.1.1 The extant farmhouse at Dugoed can be split into three principal elements (see sketch plan overleaf). The earliest part lies to the south, a stone-built range on a two-unit plan aligned approximately east-west with projecting end chimney stack to the east and rising to two full storeys beneath a pitched slate-clad roof, gabled to east and west. A perpendicular range extending to the north of the north elevation represents a secondary addition; again of two storeys beneath a pitched roof, the range opens to the east via a characteristic 'cyclopean' doorway and is cut into the natural bedrock to the north. A pent-roofed extension has been appended, in two phases, to the western side of the northern range.

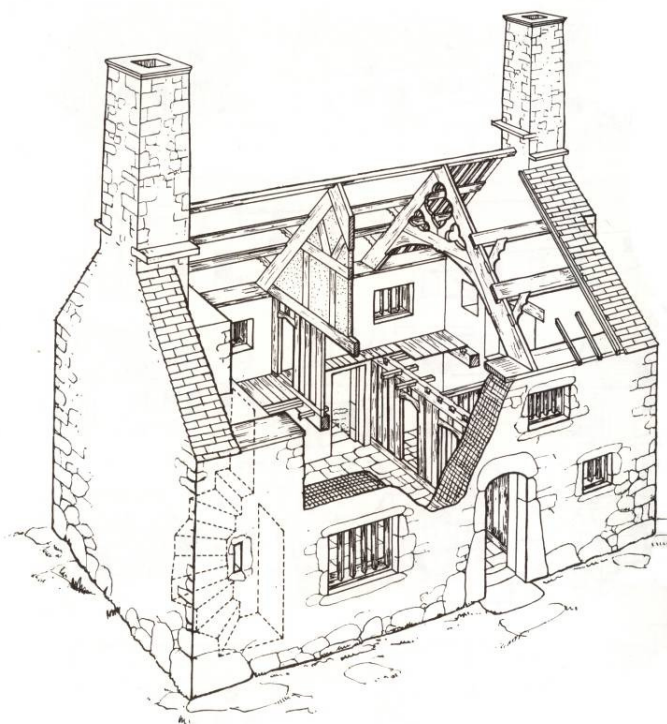
Cut-way projection of a 'typical' Snowdonia plan house (from Smith 1988, fig. 81).

- 6.1.4 The process of conversion from open-hall to storeyed house involved the insertion of both a ceiling and chimney into an existing building, the latter being necessary to supersede the former open hearth. The normal location for an inserted stack was either within the body of the hall, or within the entrance passage, the latter resulting in a classic lobby-entry plan, in both cases the secondary ceiling frame would retain evidence for a former stack location. At Dugoed, the ceiling frame displays no such evidence and the extant, stone built stack is located within the eastern gable end, external to the area of any early, open hall.

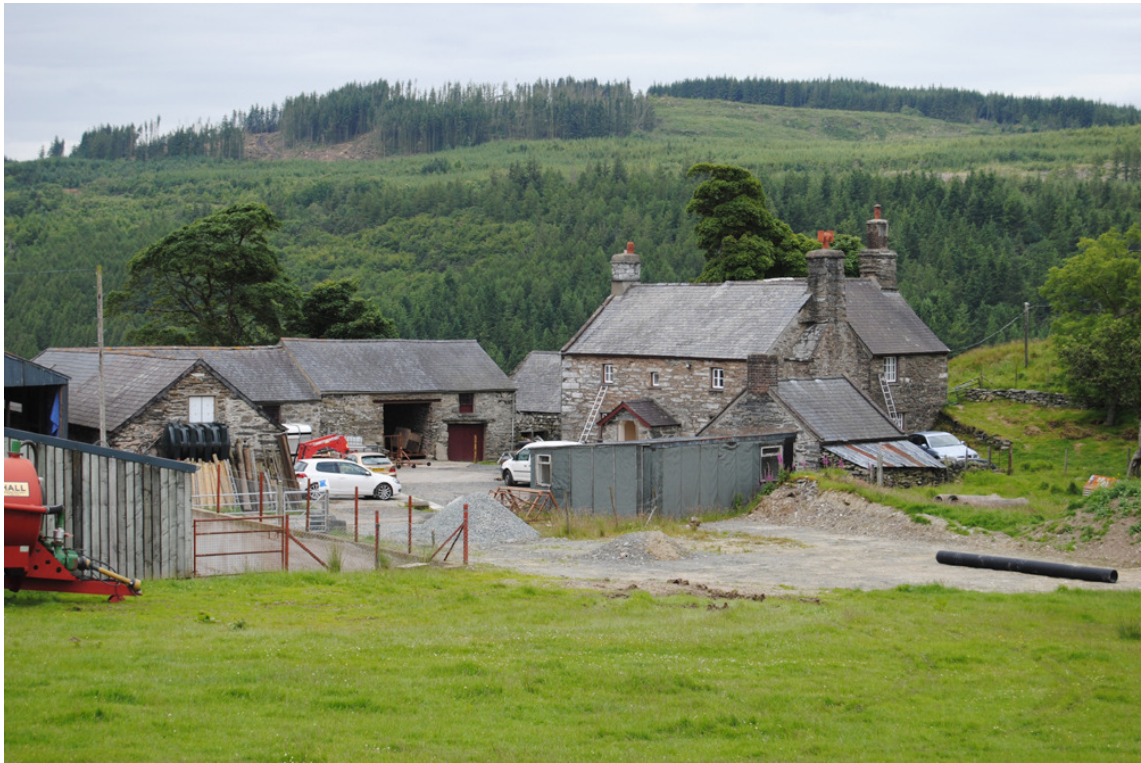
**Plate 1:** Dugoed in context, long view of farmstead looking north-west with Machno Valley beyond, note early outbuildings to west and south of farmhouse.

- 4.1.2 A series of stone-built agricultural outbuildings including cow stalls, piggeries and a two-storey barn,<sup>4</sup> together with a number of late 20<sup>th</sup>-century steel sheds, are arranged around the southern and western sides of the main yard (Plate 1) located immediately to the south of the farmhouse, the whole being partially enclosed by a curving stone wall and tree planting (Figure 3).

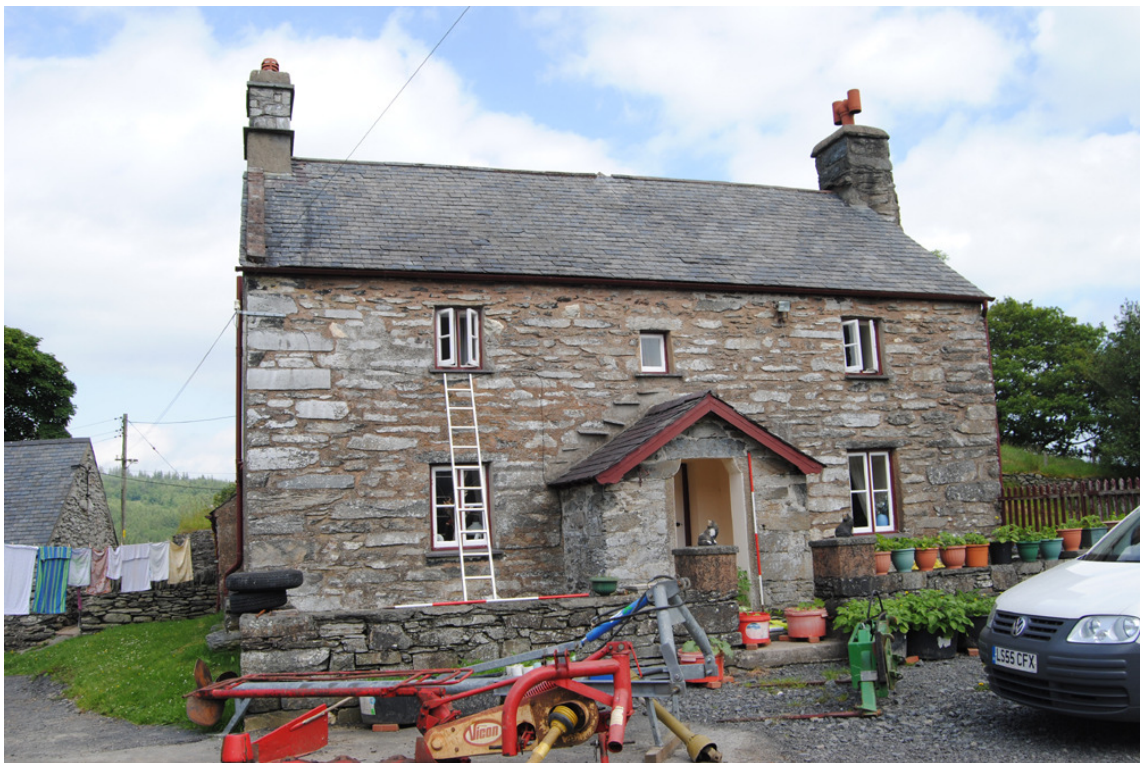
**Plate 2:** South range, principal (south) elevation.

- 4.2.1 The south range is built on a rectangular plan with external measurements of c.11m (36ft) east-west x 7m (23ft) north-south. The principal **south elevation** (Plate 2) of the farmhouse is of stone construction rising to two full storeys above an offset, rough stone-rubble plinth (Plate 6) beneath a pitched, slate-clad roof, gabled to east and west. A projecting, shouldered stack is located to the east (Plate 5), while a plain ridge stack rises above the western gable. The principal doorway is set centrally to the elevation, protected by a secondary, gabled porch the doorway of which displays a 'Caernarfon' arch with convex corbels supporting a monolithic slate lintel (Plate 3). Fenestration is of single, symmetrically opposed, two-light timber casements at ground and first floor level to east and west, the upper windows being of smaller dimensions than those at ground floor level. An additional, single-light opening casement is located directly above the ridge of the central porch.

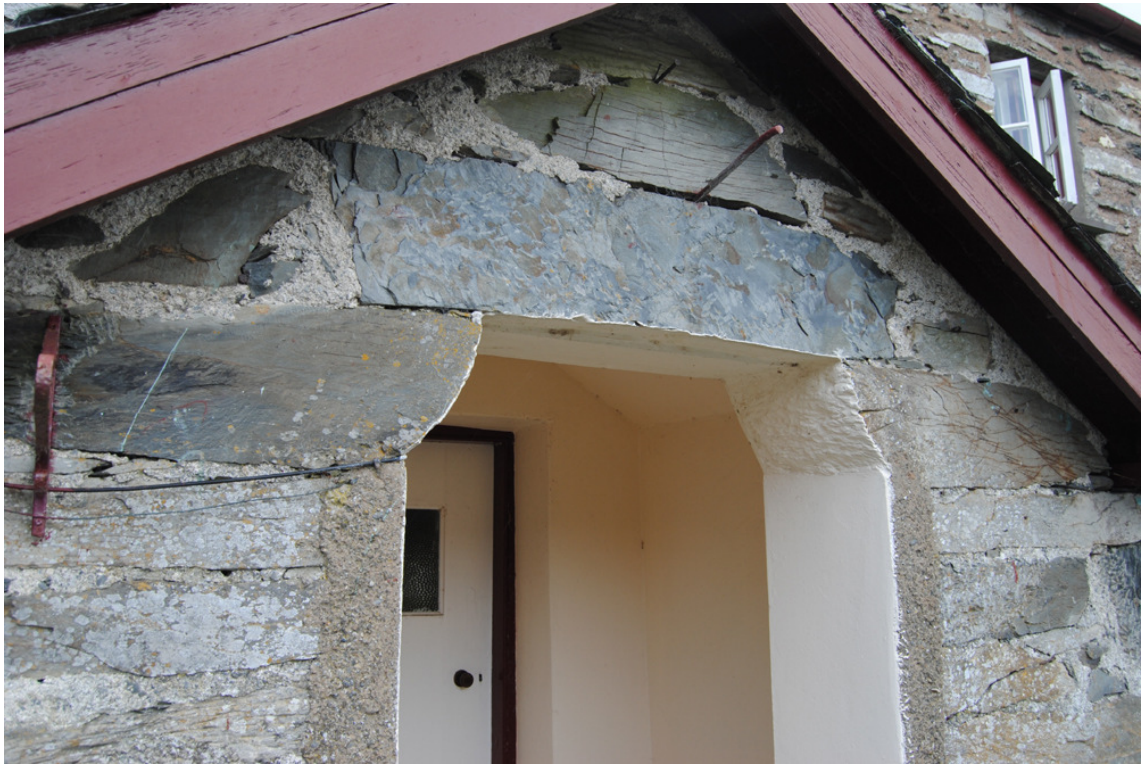
Plate 3: South elevation, detail of porch doorhead.

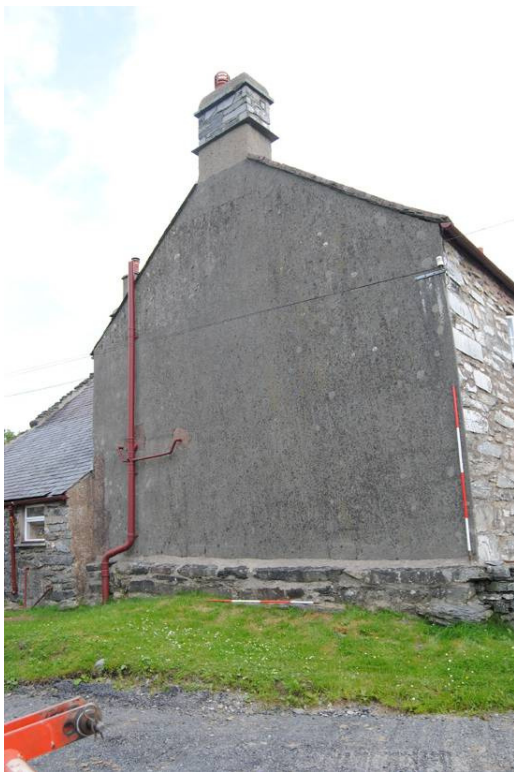
Plate 4: Cement rendered west elevation with ridge stack.

- 4.2.2 The **west elevation** (Plate 4) presents a blind gable end, cement rendered above a projecting stone rubble plinth and with plain ridge stack; the **east elevation** (Plate 5) is again blind and is dominated by a massive projecting, shouldered stone stack rising to a square chimney. The offset stone plinth of the south elevation continues around the base of the stack. The **north elevation** is for the most part obscured by secondary work, namely the north range and north-west extension, though small, square casement windows are located at first floor level to east and west, the latter opening above the pent roof of the north-west extension.

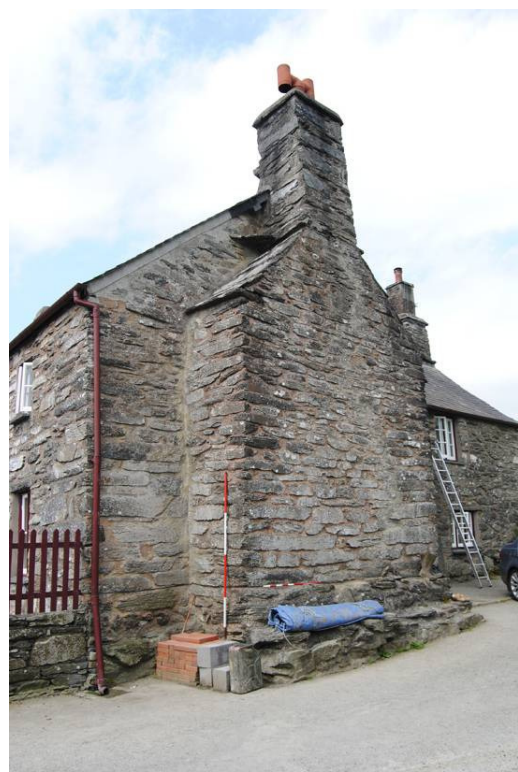
Plate 5: Projecting shouldered stack to east.

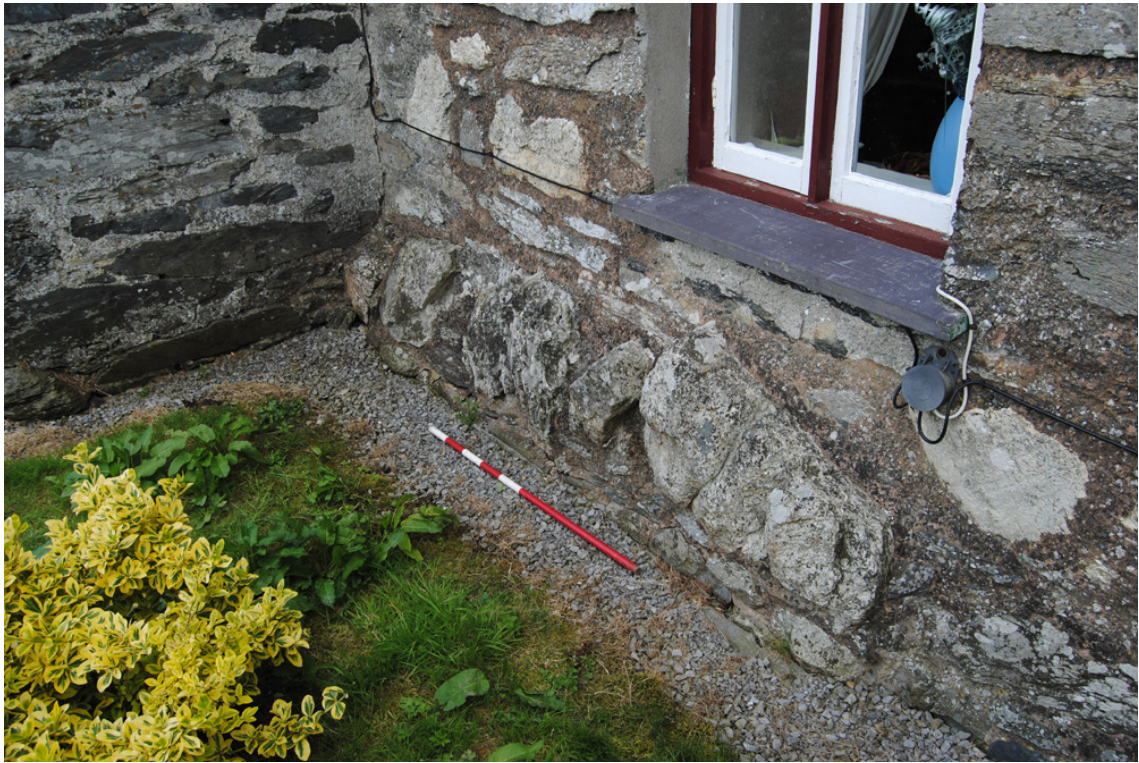
Plate 6: Offset rough stone plinth at base of primary range, south elevation.

- 6.1.3 An alternative interpretation is that Dugood may represent an updated open-hall house, perhaps of medieval origin. The presence of an offset, rough stonework plinth to the exterior of the south range has been proposed as evidence that this may be the case (Suggett, *pers. comm.*), though no other unambiguous, supporting evidence for this assertion has been recorded as part of the current study. At Tŷ-Mawr, Wybrnant,<sup>12</sup> cut-off cruck blades were revealed within the lateral walls during refurbishment work, indicating the reworking of an early open hall (Suggett and Stevenson 2010, 72), though it should be noted

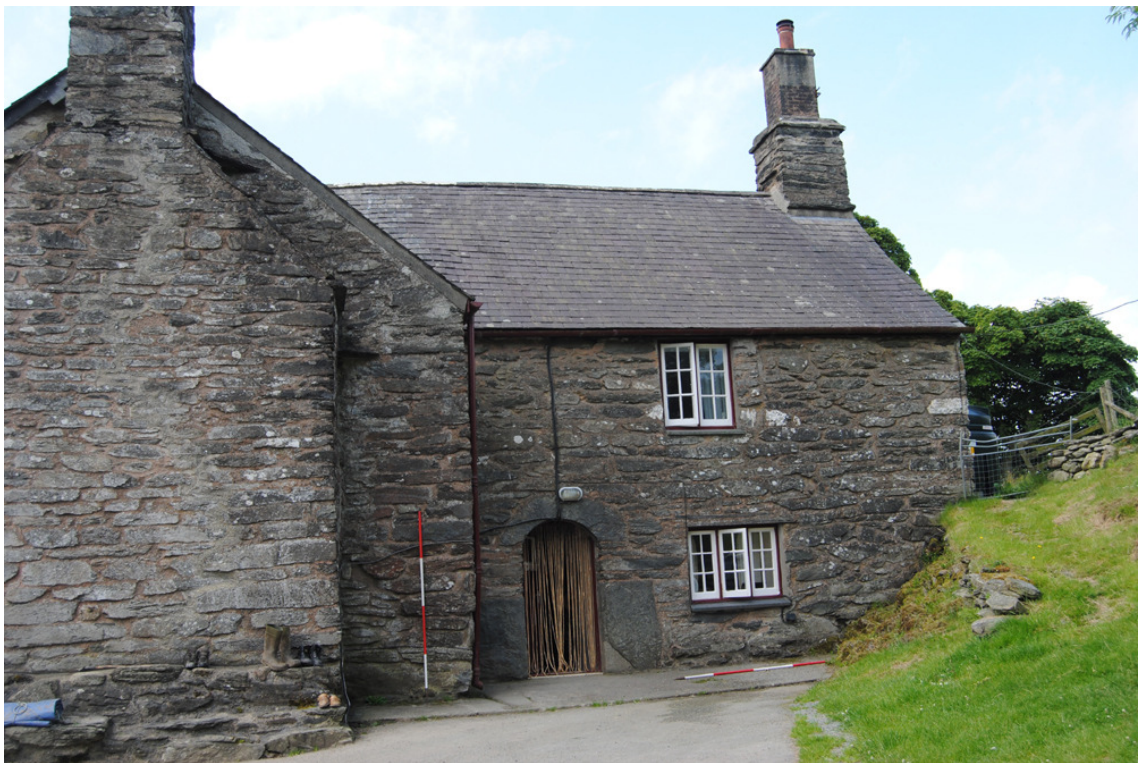
Plate 7: South range, east gable (left) and secondary north range; east elevation (right).

4.3.1 The north range (Plate 7) is built on a square plan 7m (23ft square) and is appended to the north side of the earlier southern range, set slightly off-centre to the east; at the northern gable, the range is cut into the natural bedrock of a pronounced knoll (Plate 9). The principal **east elevation** (Plate 7) is stone-built rising to two full storeys beneath a pitched, slate-clad roof, gabled to the north and abutting the earlier range to the south. Entry is gained via a doorway of 'Cyclopean' form<sup>8</sup> with monolithic, arched lintel and jambs of massive upright slabs (Plate 8); to the north, superimposed window openings at ground and first floor level house timber casements, of three-lights to ground floor and two-lights to first floor, the first floor opening having been reduced to the north, evidenced by a clear area of blocking. The **north elevation** presents a blind gable rising to a square ridge stack, the exterior ground level is here raised, corresponding approximately to the interior first floor level, due to the 'terracing' of the range into a natural rock outcrop (Plates 7/9). The western eaves includes a corbelled stone kneeler beneath which a straight joint denotes the junction with the north-west extension.

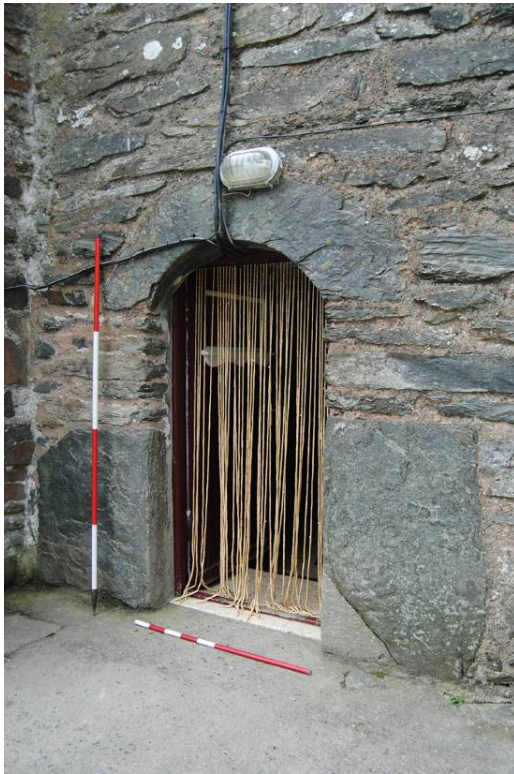
Plate 8: Cyclopean doorway to secondary range.

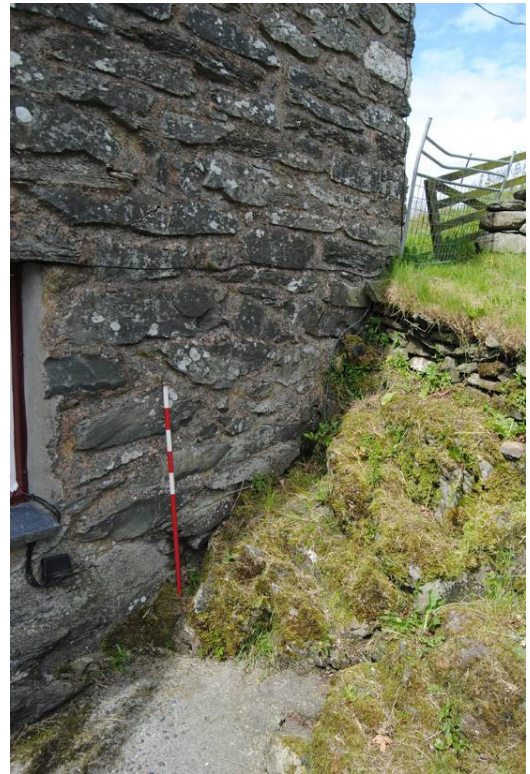
Plate 9: Detail of bedrock at north-east corner.

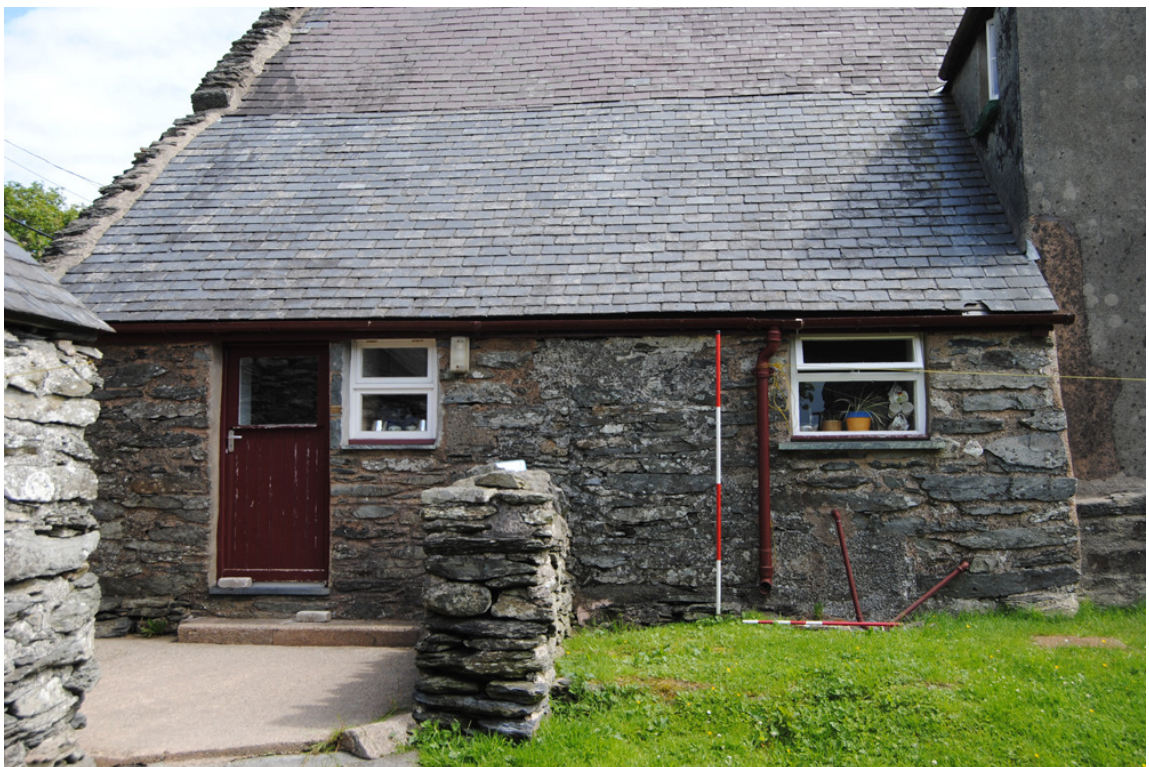
Plate 10: Undated, pent-roofed extension to north-west corner (note straight joint to right of boundary wall).

- 4.4.1 A stone-built, single-storey extension with mono-pitch, pent roof occupies the north-west angle between the north and south ranges (Plate 10). A straight joint within the stonework of the west elevation indicates that the extension was added in two phases, though the relative chronology is unclear. Internally, the fitting out of the extension as a modern kitchen / utility room (divided by modern partition) has served to obscure any original arrangements.

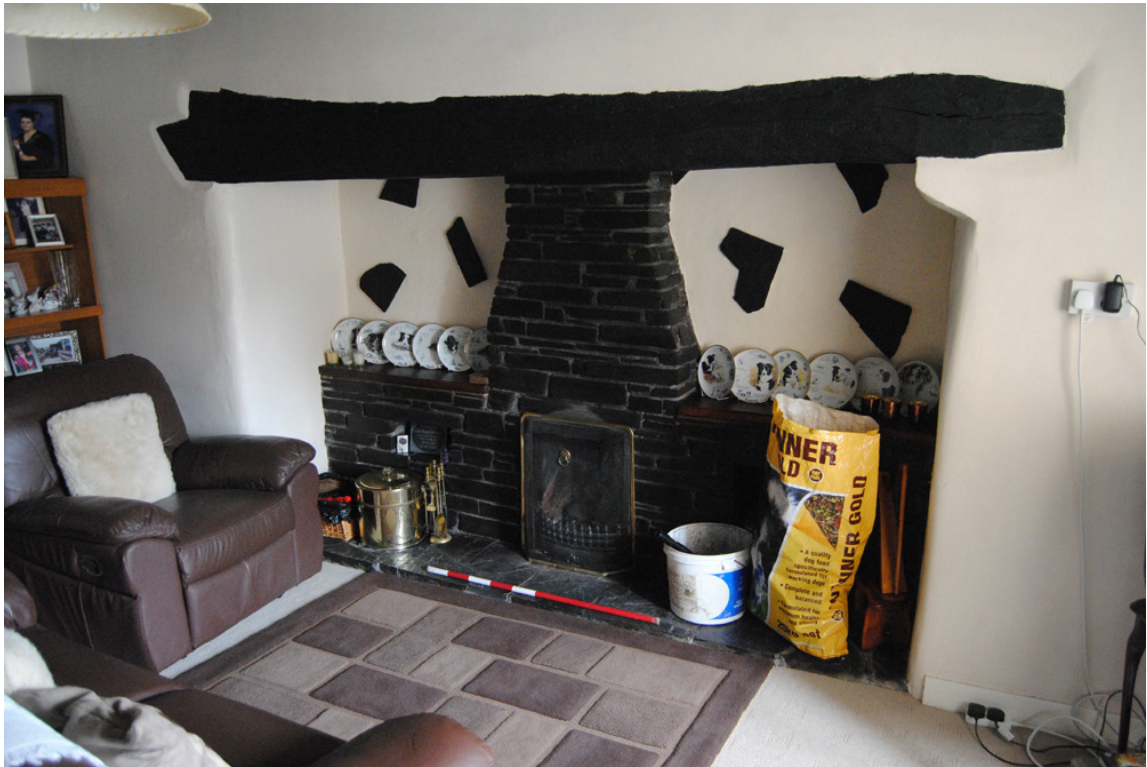
Plate 11: Room [GF01], principal fireplace to east wall.

- 4.2.4 Room [GF01] is located to the east end of the range; it is lit by a small, two-light timber casement with splayed reveals in the south wall and heated by a small, modern fireplace set within a wide, original recess, spanned by a heavy bressummer, within the east gable end (Plate 11). The dominant feature of the room is the exposed timber ceiling structure (Plate 12) of a former, two-bay hall; the ceiling structure extends into room [GF02] to the west, the inserted partition wall being located immediately west of the principal transverse beam. The principal members of the framed ceiling comprise a single main beam aligned transversely across the range into which are jointed two subsidiary longitudinal beams of equal scantling (c.1ft square); all are elaborately moulded with two orders of plain chamfer and quirk, stopped with stepped run-outs and elongated broach stop (Figure 9; Plate 13).<sup>5</sup> The two secondary beams are double-tenoned to the principal transverse beam and double pegged. Original, wide-section joists (6½-7in. wide), unchamfered and aligned north-south, survive to the south-east quadrant of the floor, those to the north-east having been mostly renewed, and are jointed to the longitudinal floor beams using barefaced soffit-tenons, single-pegged. Dendrochronological analysis has established a felling date of 1515/17 for the timbers used in this ceiling structure, a notably early date the implications of which will be discussed further below (see §.6).

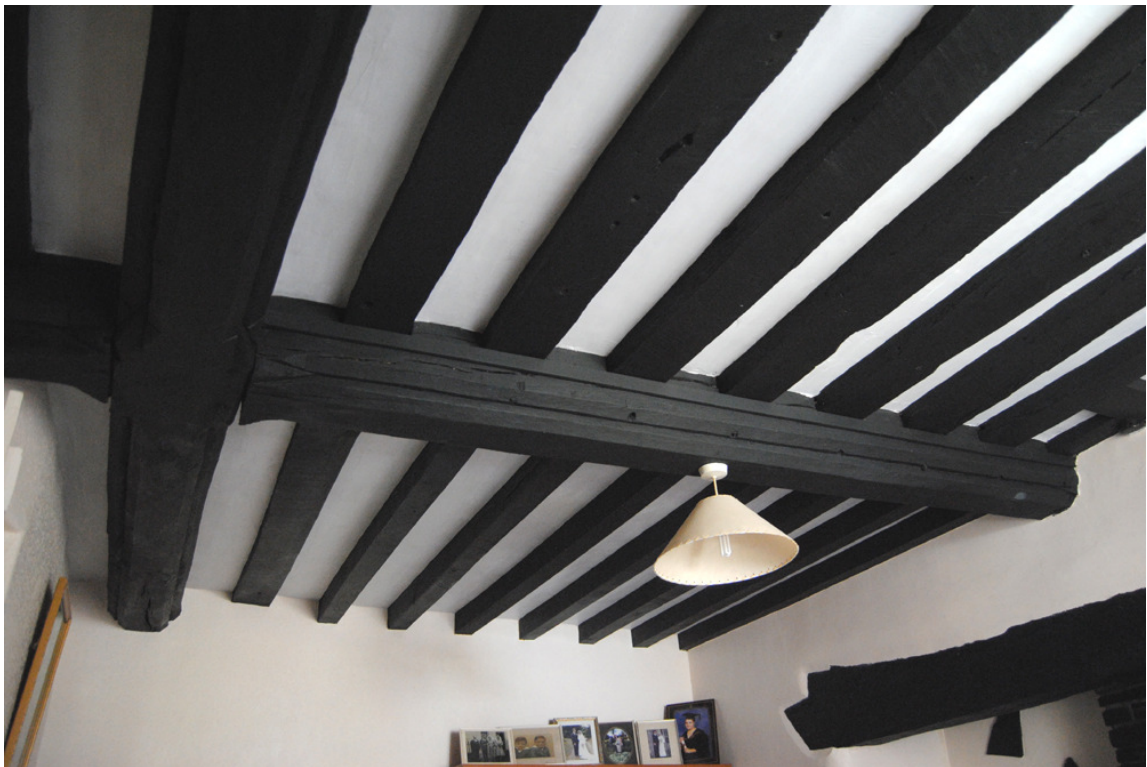
Plate 12: Room [GF01], moulded ceiling beams (dated to 1515/17) and primary joists.

- 5.2 A total of five samples dated of which [dug1] and [dug2] from the south range ceiling were shown to come from trees felled in winter 1515/16 and 1516/17 respectively. Timbers from the north range roof form a group and clearly indicate a later 16<sup>th</sup>-century date for the construction of the kitchen/parlour extension.

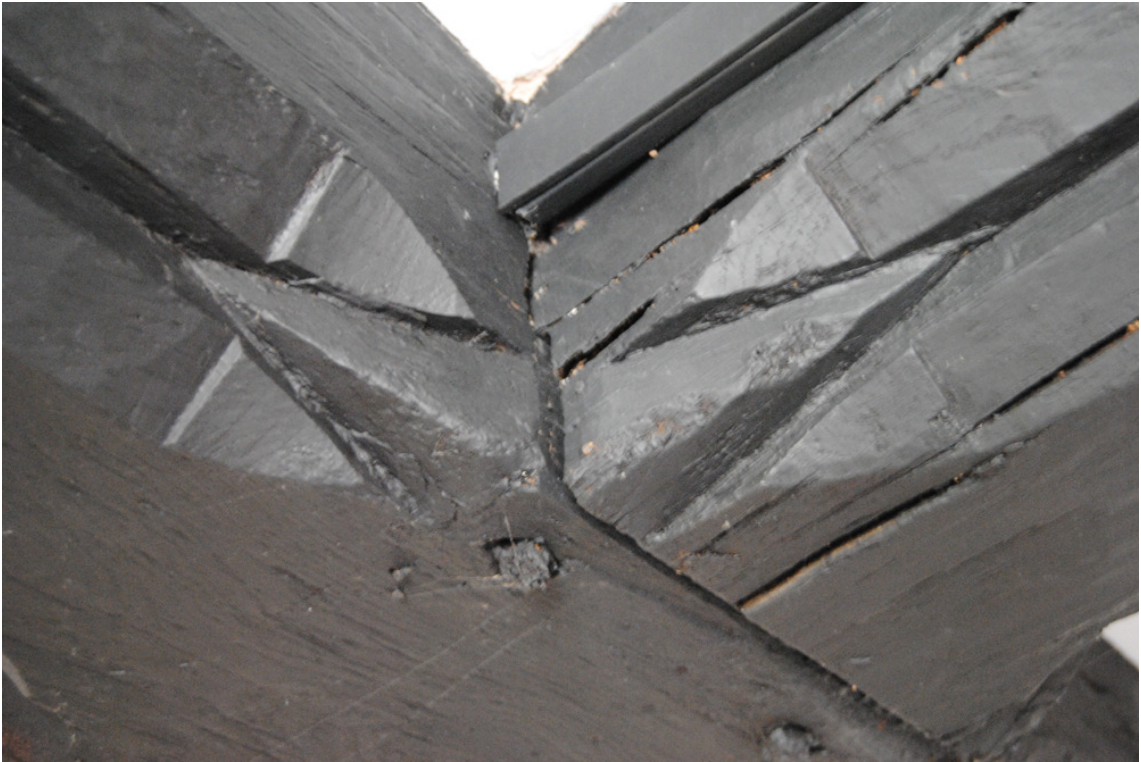
**Plate 13:**Detail of moulding at intersection of transverse (left) and longitudinal (right) floor beams [GF01].

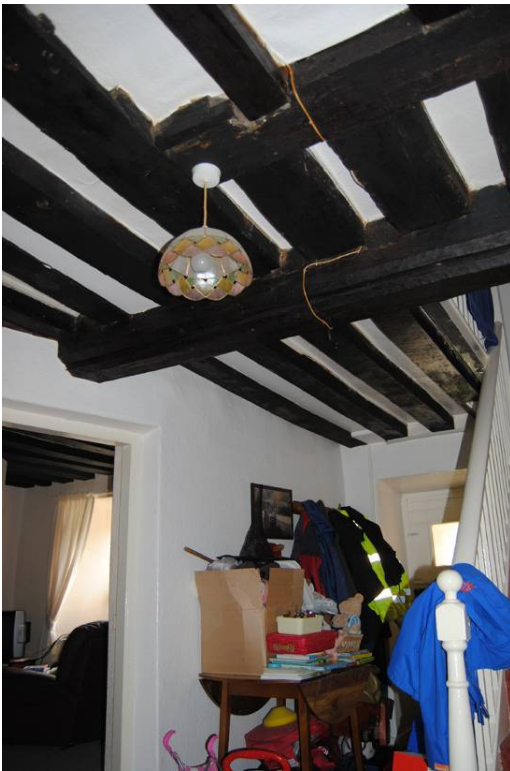
**Plate 14** Continuation of primary floor within hallway [GF02].

- 4.2.6 To the west, Room [GF02] (Plate 14) represents a secondary entrance / stairway hall, extending across the width of the range and created by the insertion of a transverse partition into the former two-bay hall formed by [GF01] and [GF02] combined. Access from the exterior is via a doorway, set unusually towards the eastern end of the south wall with through access to the north range via a doorway at the west end of the north wall.<sup>6</sup> Doorways serving [GF01] and [GF03] are located within the east and west walls respectively. A low recess at the eastern end of the north wall includes a stout timber frame and may represent a former, low doorway.

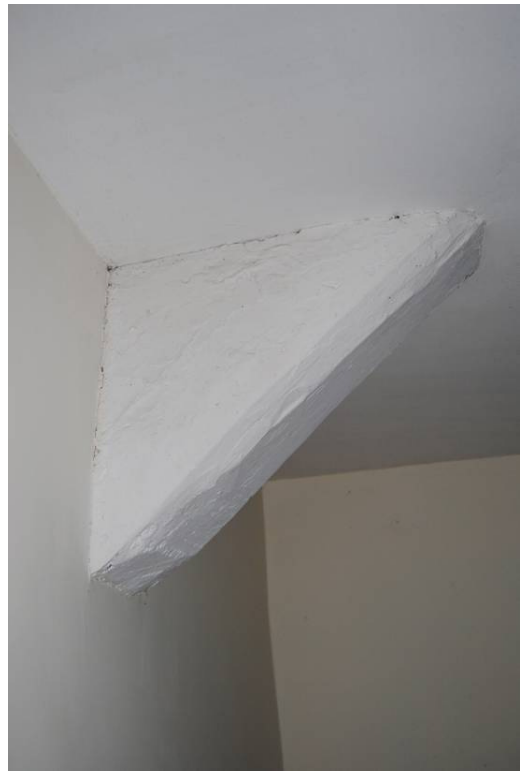
**Plate 15:** Principal rafter foot vis. within [1F01].

4.2.10 The first floor is accessed via the inserted straight-flight stair rising against the west wall of the entrance hallway; this opens onto a wide landing [1F02] opening to the east onto bedroom [1F01] and, to the north, onto bedroom [1F03] and bathroom [1F04]. A doorway within the north wall gives, via a single step down, onto room [1F05] within the north range. All partitions at first floor level of studwork construction while doors are modern insertions; little fabric of interest is visible. The exception is the foot of the northern and southern principal rafters of the easternmost roof truss, visible below the inserted ceiling of bedroom [1F01] (Figure 7; Plate 15).

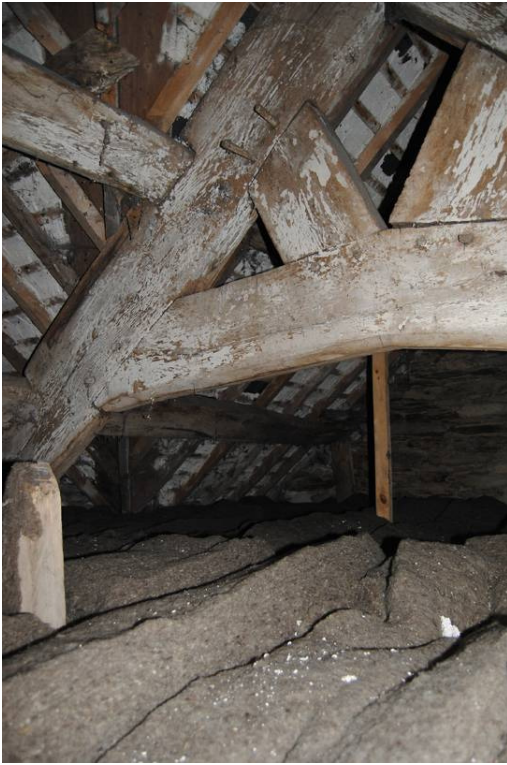
**Plate 16:** Primary collar beam truss at Bay 1/2.

4.2.11 The roof structure of the south range (Figure 6) is of three bays (here numbered 1 to 3 from east to west) and retains a single early truss to the east, at Bay 1/2, above room [1F01] (where the principal rafter feet are visible below an inserted ceiling); the truss is of collar beam form with massive (18in. deep) principals, cranked collar and upper V-strutting (Figure 7; Plate 16), the lower leading edge of the collar and lower principals being plain chamfered. No evidence was recorded for original infilling of the truss, in the form of stave holes to support primary wattle and daub panels, and the truss is assumed to have been open in its original form. The principals support two tiers of side-purlins, trenched over the upper face of the principals, while a redundant socket at the ridge evidences an original, square-section ridge piece (Plate 17). Empty mortices within both the principal rafters and purlins evidence the former existence of longitudinal wind bracing to both levels (Plates 18/19). The western truss of the roof has been renewed in softwood (Plate 20), though wind-brace mortices within the purlins, as observed within Bay 2, indicates that it occupies a primary truss location. Common rafters have been renewed throughout.

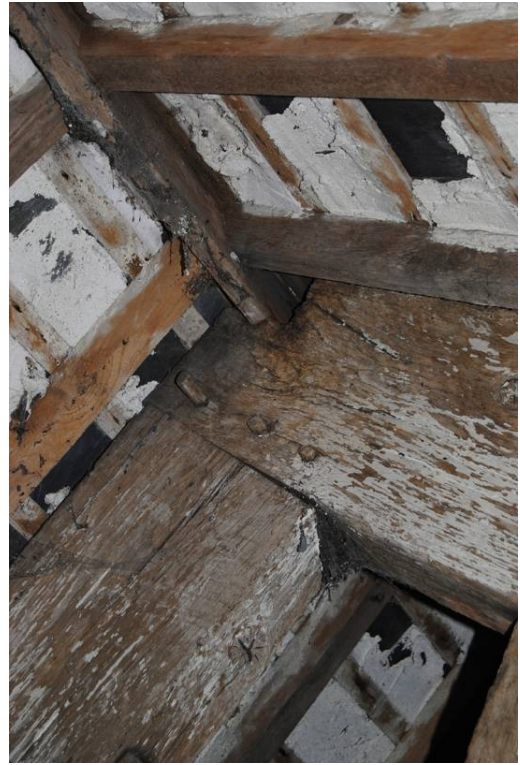
**Figure 17:** Collar beam truss; apex detail.

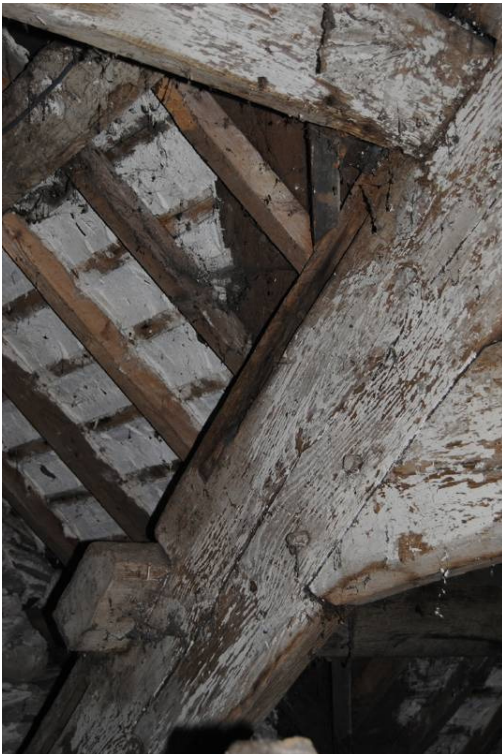
**Plate 18:** Collar beam truss, socket for former wind bracing (upper purlin, north).

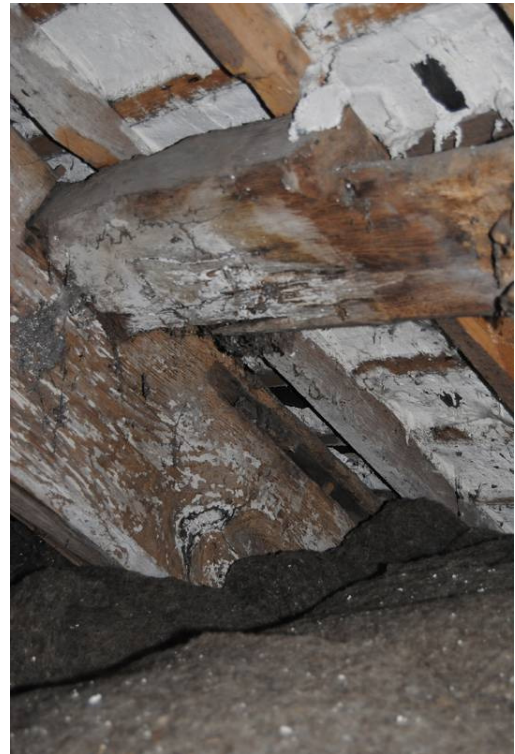
**Plate 19:** Collar beam truss, socket for former wind bracing (lower purlin, south).

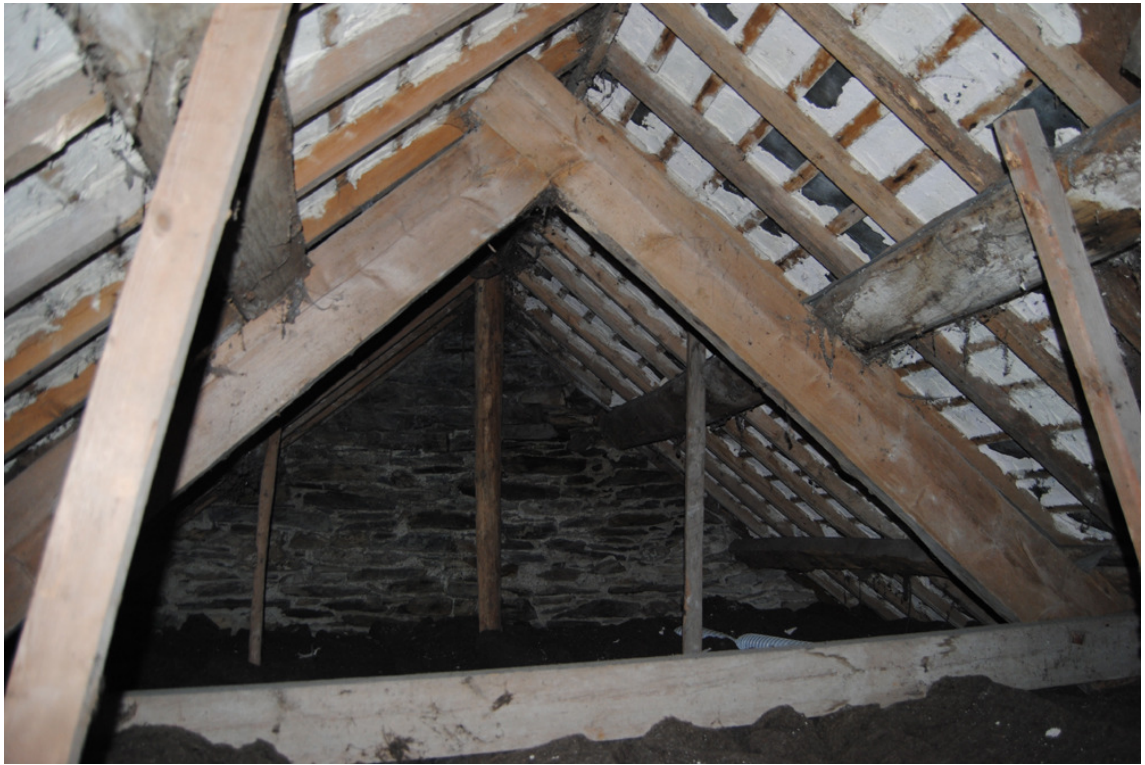
Plate 20: Renewed softwood truss at Bay 2/3.

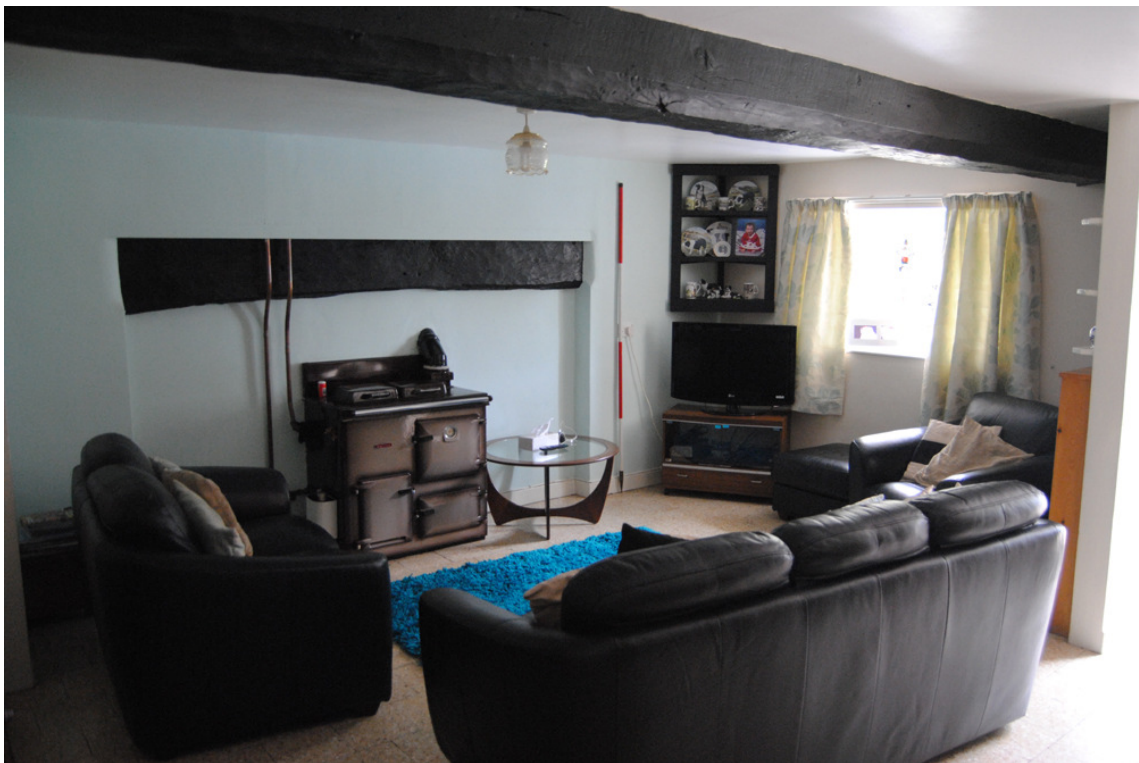
Plate 21: North extension, Room [GF05] looking north-east.

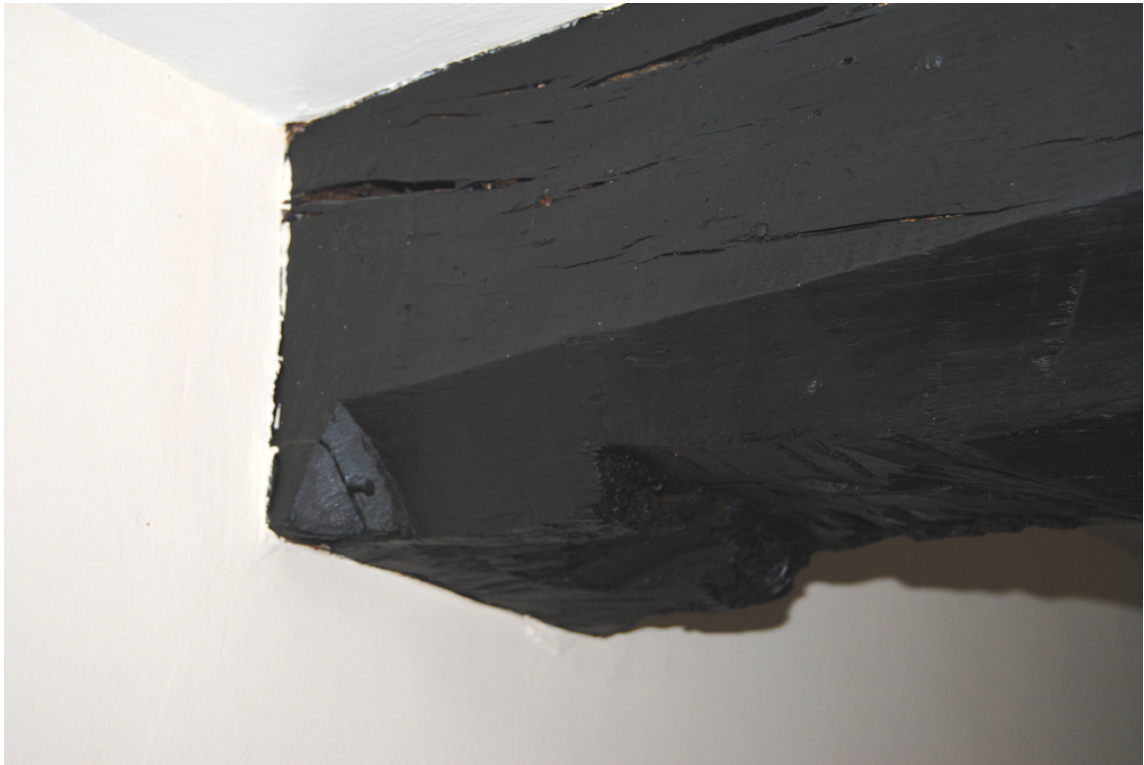
Plate 22: North extension, Room [GF05] detail of transverse beam.

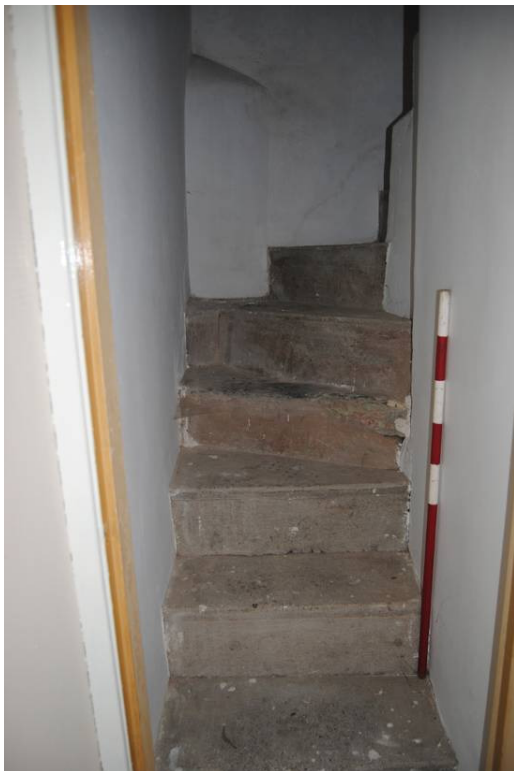
Plate 23: Winder stair from [GF04].

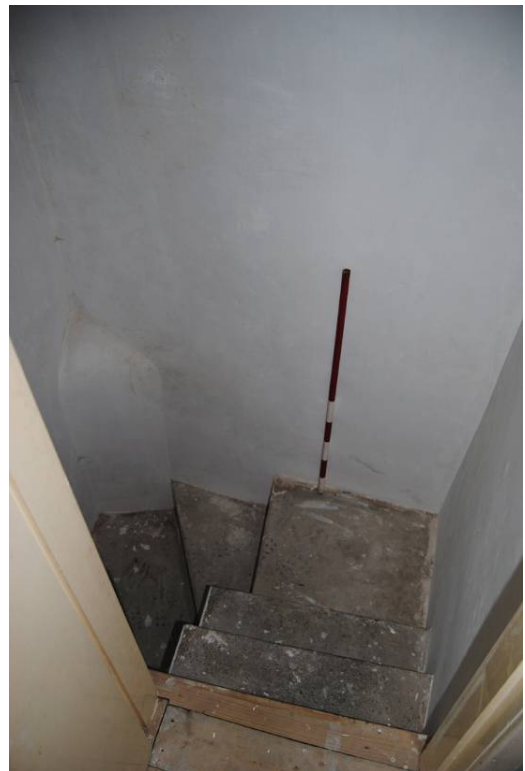
Plate 24: Winder stair from [1F05].

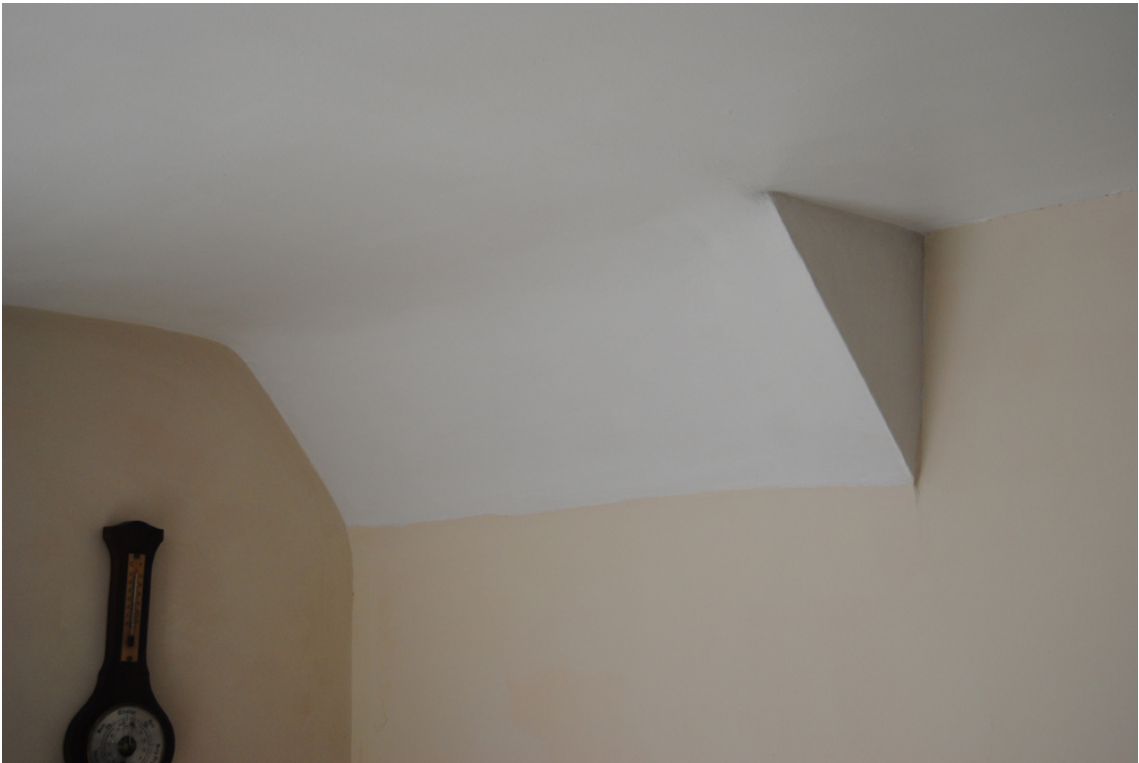
Plate 25: Sloping section of ceiling at south-east corner of [GF04] suggestive of former stair.

- 4.3.2 Internally, the north range comprises a single room at each floor level, lit by superimposed casement windows within the east wall. The ground floor room, [GF04] is spanned east to west by a substantial timber beam with deep (2½ in.) chamfer with straight cut stops to east and west (Plate 22), and is furnished with a wide fireplace opening at the centre of the north wall (Plate 21), spanned by a substantial timber lintel, currently blocked in and housing a Rayburn range. To the west of the fireplace opening, a modern door opens onto a primary, stone-built winder stair (Plates 23/4), rising to the upper floor of the range. A sloping section of ceiling (Plate 25) at the south-west corner of the room, adjacent to the exterior door, is suggestive of a former stair soffit, rising south-north and cutting through the northern wall of the primary range from room [GF01]; modern wall treatments, in particular the dry lining of the north wall of the latter room,<sup>9</sup> negate the verification of this feature.

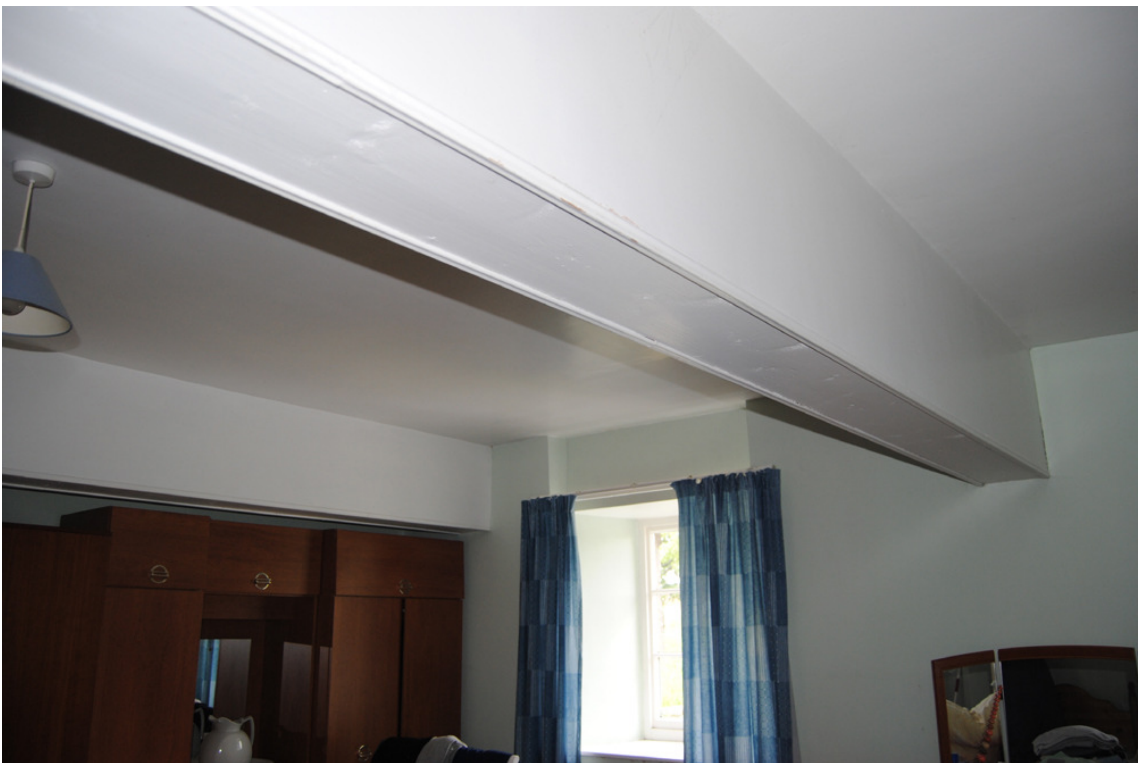
Plate 26: Boxed in transverse (?tie)beams within [1F05].

- 4.3.3 First floor level, accessed via the fireplace stair, again comprises a single space [1F05], lit by a single (reduced) window opening in the east wall housing a two-light timber casement. Wardrobes aligned against the north wall obscure any evidence related to an original fireplace at this level. A door within the south wall of [1F05] communicates, via a single step up, with the upper level of the south range. The room is spanned by two transverse, boxed-in beams (Plate 26); the location and alignment would suggest tie beams associated with the roof trusses above.

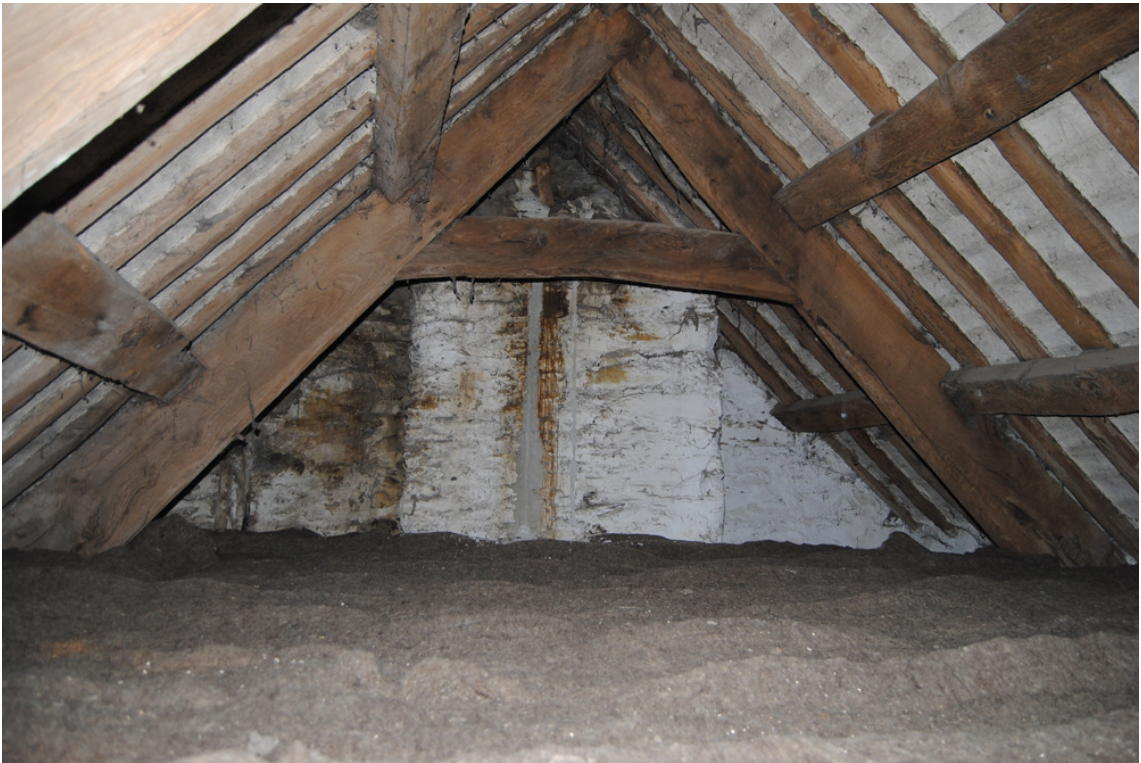
Plate 27: Northern extension; roof structure.

- 4.3.4 The roof of the north range is of three unequal bays defined by two trusses of collar beam form (Figure 8; Plate 27) supporting two tiers of side purlins, trenched over the principals and set into the masonry of the northern gable and southern wall, and a square section ridge piece. Purlins (9 x 4in. scantling) are unchamfered and carry original common rafters (5 x 2in.), five to seven per bay; no evidence was recorded to indicate longitudinal wind bracing. Principal rafters are again of substantial scantling, being 16in. deep, the leading edge both below and above collar level being plain chamfered; the collars, gently cambered and triple pegged to principals, are also chamfered to both bottom and top edges suggesting that they would originally have been exposed to the first floor chamber below.
