North West Wales Dendrochronology Project Ty'n Twr, Bethesda, Gwynedd

**EAS Client Report 2010/01
February 2010**

EAS Client Report 2010/01

Ty'n Twr, Bethesda

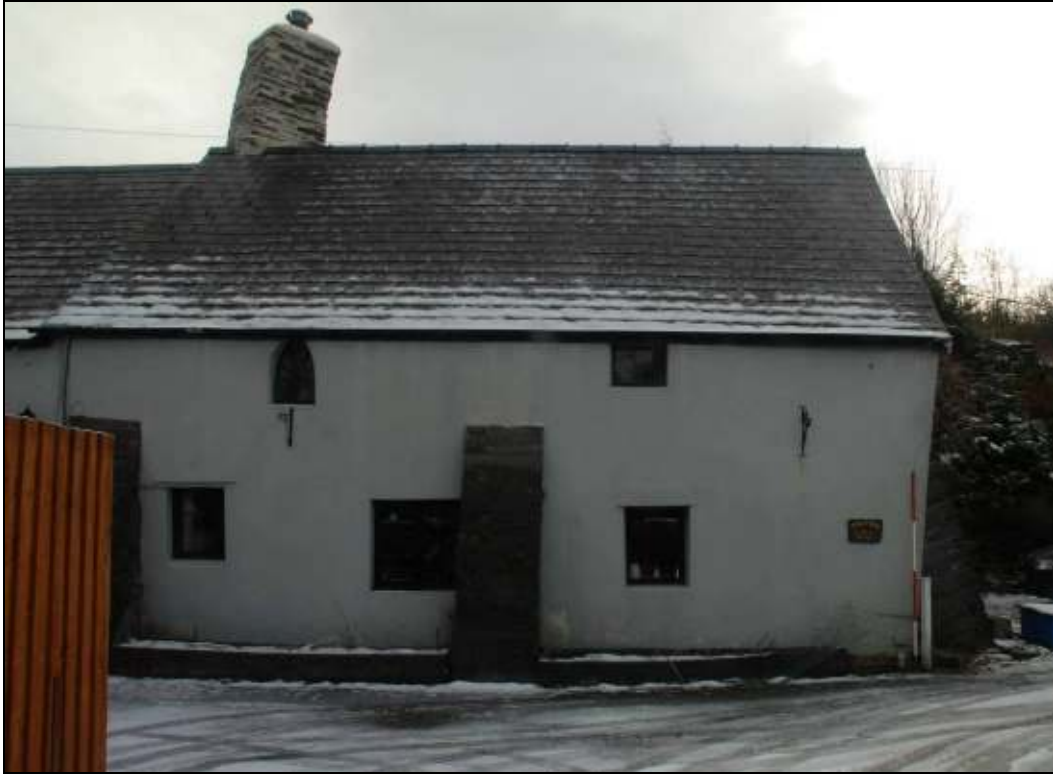
Plate 1: Front elevation

Externally the house consists of two ranges set at right angles, although only the south west end of the main range contains the original structure of the property. This range is a two storey range under a modern slate roof (Plate 1). Now rendered, the original stonework is not available for inspection. There are a series of modern slate buttresses supporting the front elevation and the south west gable end, both of which tend to lean out. The windows in the front elevation contain modern wooden frames; however one of the first floor windows is pointed (Plate 2). The windows also appear to occupy original openings on the front elevation, although the first floor windows in the rear elevations are later additions.

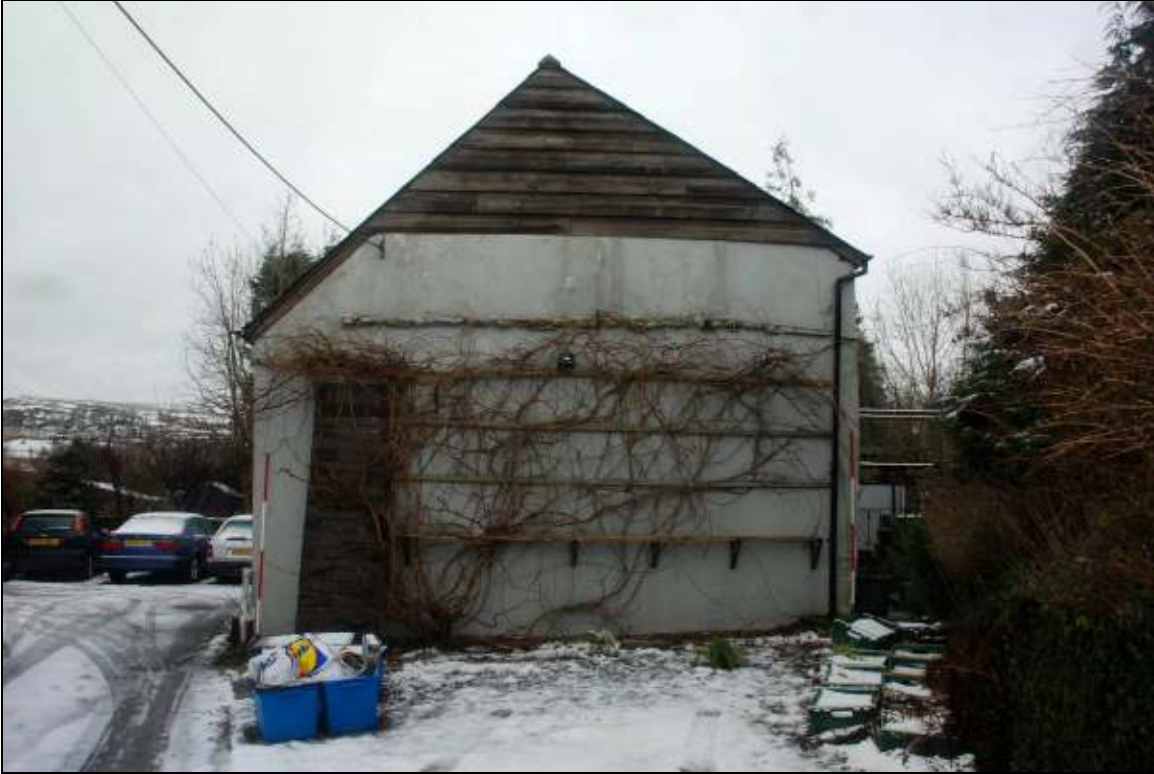
Plate 3: South west gable end

The south west gable end is rendered and has weatherboarding on its upper section, however a line of stones projecting from the surface presumably mark the position of a lean-to, now lost (Plate 3). To the rear of the building a line of stone is exposed at the base of the wall marking the line of the foundations at this point (Plate 4). The chimney is set just off the ridge and is set diagonally (Plate 5). It is constructed of roughly courses stone rubble.

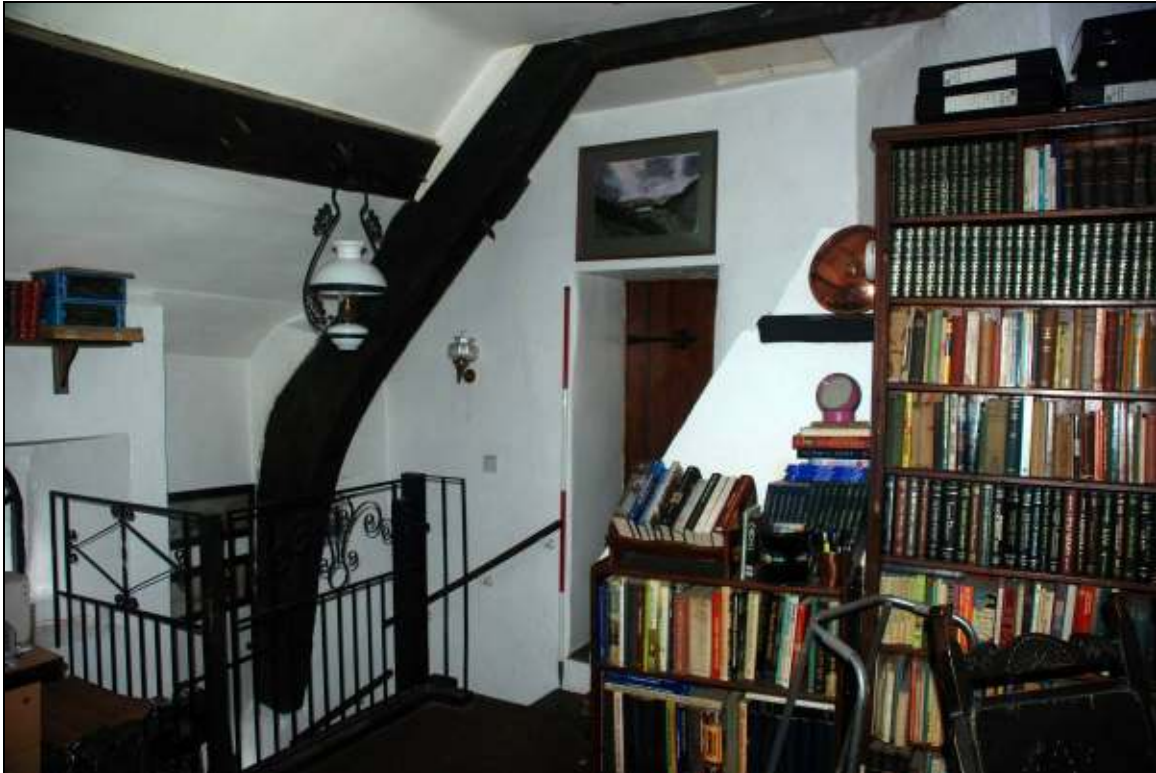
Plate 6: Truss 1, looking north

Internally two cruck trusses have been recorded, both of which have their feet buried in the walls of the house. Truss 1 (Figure 4.1, Plates 6 and 7) has cruck frames with a collar and two pairs of massive purlins. This truss sits over the inserted fireplace and is exposed in the stairwell and first floor only. There has been some movement between the front cruck frame and the lower purlin, however this allows for the trenched joint in the purlin to be seen (Plate 8). The apex of the truss is butt jointed, with a rectangular recess for a ridge piece. Originally there were windbraces between both the cruck frames and at least the lower purlins, one of which survives between Truss 1 and the lower front purlin (Plate 8). The windbrace (Figure 5.2) is decorated with double ogee cusping. The lower front purlin has the mortice holes for the missing windbraces, but it also has a series of wooden pegs at approximately 0.5 – 0.55 m intervals which presumably mark the positions of the common rafters (Figure 5.1, Plate 9). Some of these common rafters appear to survive in the roof space, although they are no longer functional (Plate 10).

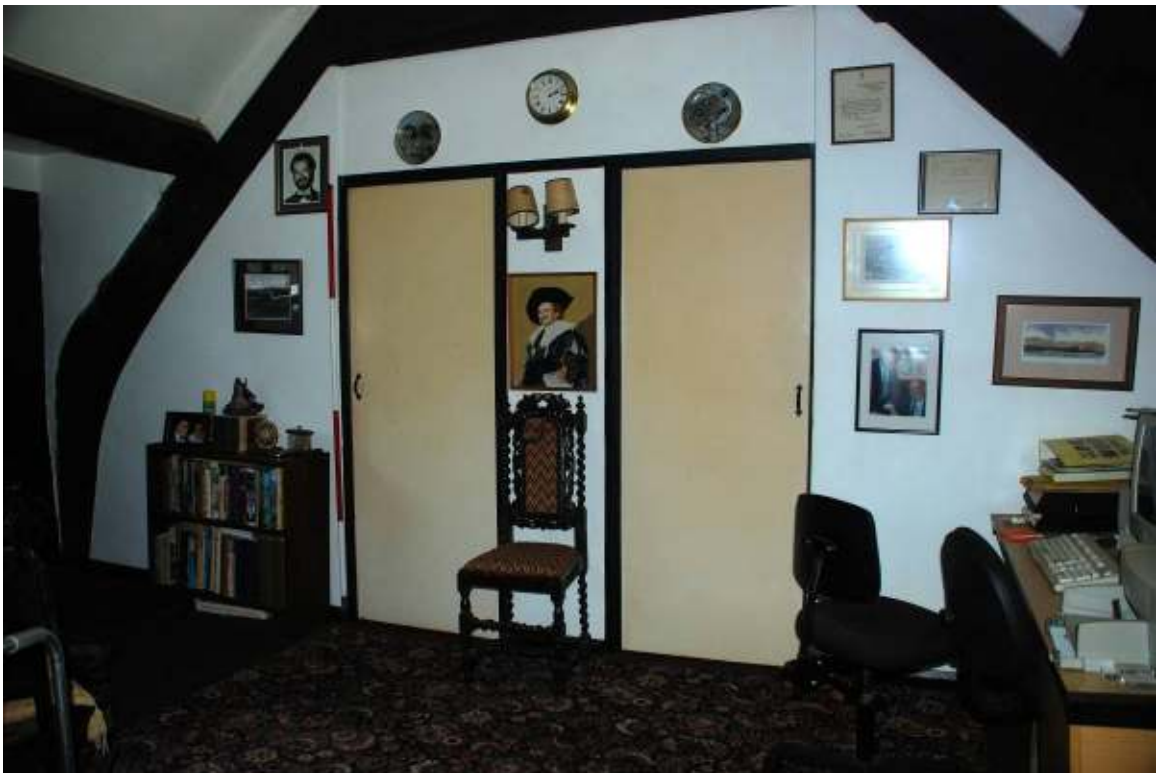
Plate 11: Truss 2 looking north

Truss 2 (Figure 4.2, Plates 11-13) is of similar design to Truss 1, a cruck frame with its feet buried in the walls, with a collar and two pairs of purlins. The collar has been supported by the addition of iron plates, presumably to stabilise the structure. On the ground floor, however, it contains the remains of a post and plank partition (Plates 14 and 15). Now only occupying the central section of the room this feature originally extended to both walls and had a doorway at its south eastern end. The surviving partition has a series of four post, each approximately 0.3 m wide and 70 mm thick, linked by planks 40 mm thick (Figure 5.3). Each of the posts has bevelled edges. The positions of both the missing and surviving posts are marked by a series of carpenter's marks both on the beam forming the top of the partition and on the surviving posts themselves. The marks consist of

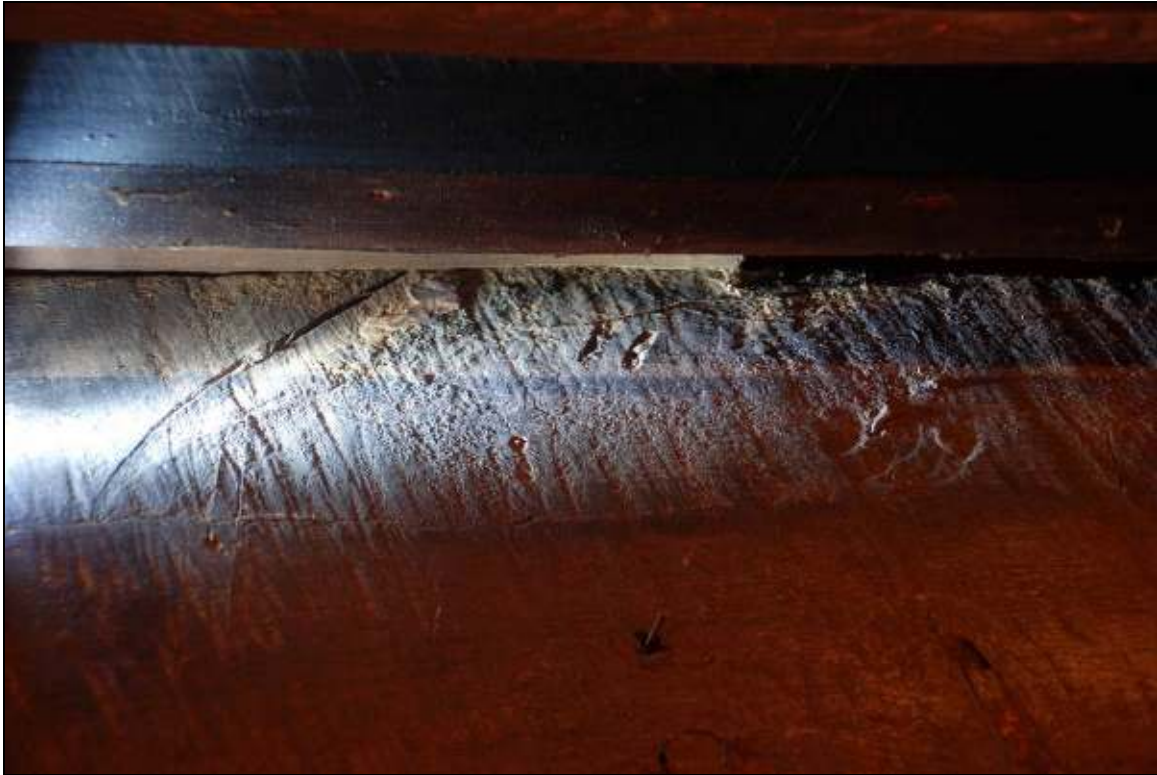
Plate 16: Carpenter's mark of "II" on partition

roman numerals running from two to seven from north west to south east. The numerals are made of simple chisel cuts. The marks of “II” (Plate 16) and “III” (Plate 17) mark the positions of missing posts. “III” is the first of the surviving posts and is marked on both the post and the rail (Plate 18), whilst the marks for “V” are missing, but would be below the transverse beam. The mark for six is “VI” (Plate 19) and for seven “VII” (Plate 20). There are also a series of peg holes in the posts and planks of the partition which may mark the positions of furniture or a canopy attached to this partition. Below the lower rail of the partition has been supported with modern cement losing the relationship with any floor levels.

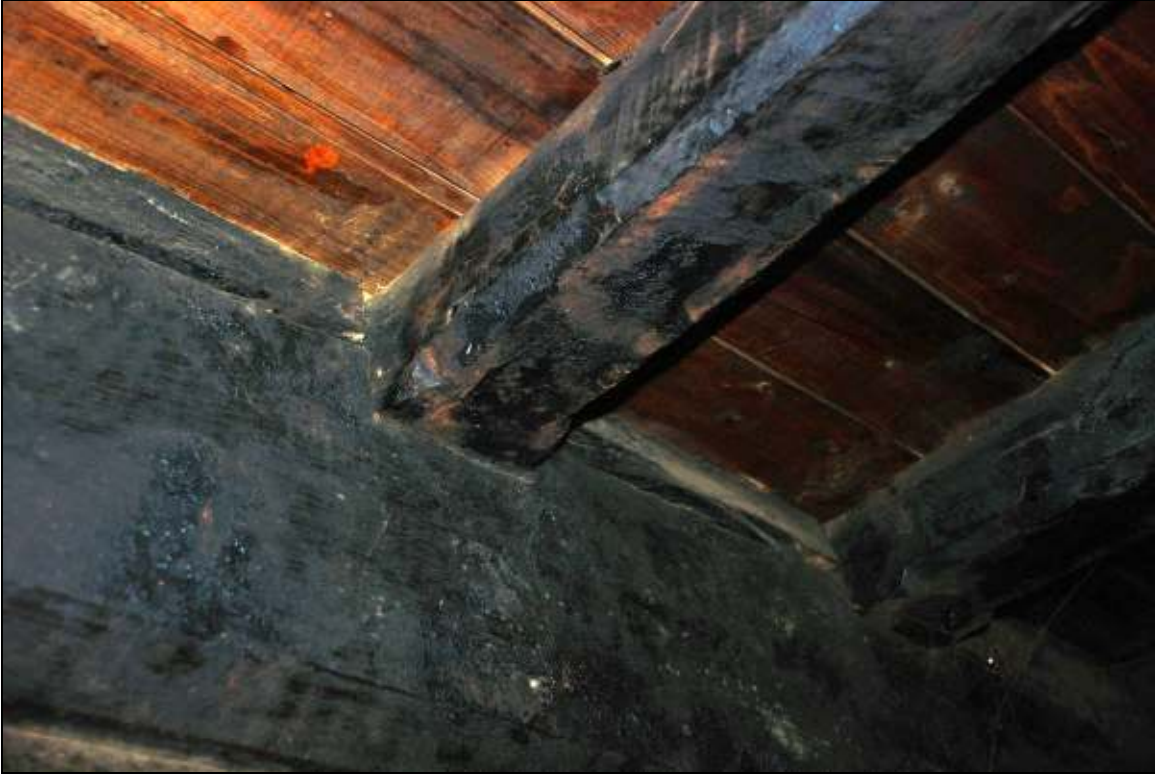
Plate 22: Joist in lower NE room, looking north

It is assumed that the chimney and the floors have been inserted into the pre-existing structure. The fireplace has a large wooden lintel, approximately 0.4 m thick and 3.15 m long. The ceiling of the ground floor north eastern room has a transverse beam, approximately 230mm square with chamfered sides and flat stops at both ends (Plate 21). The joists are largely contemporary with each other, except for the two in the south west corner of the room which are of pine and are clearly replacements. The remaining joists are chamfered and have ogee stops at both ends (Plate 22).

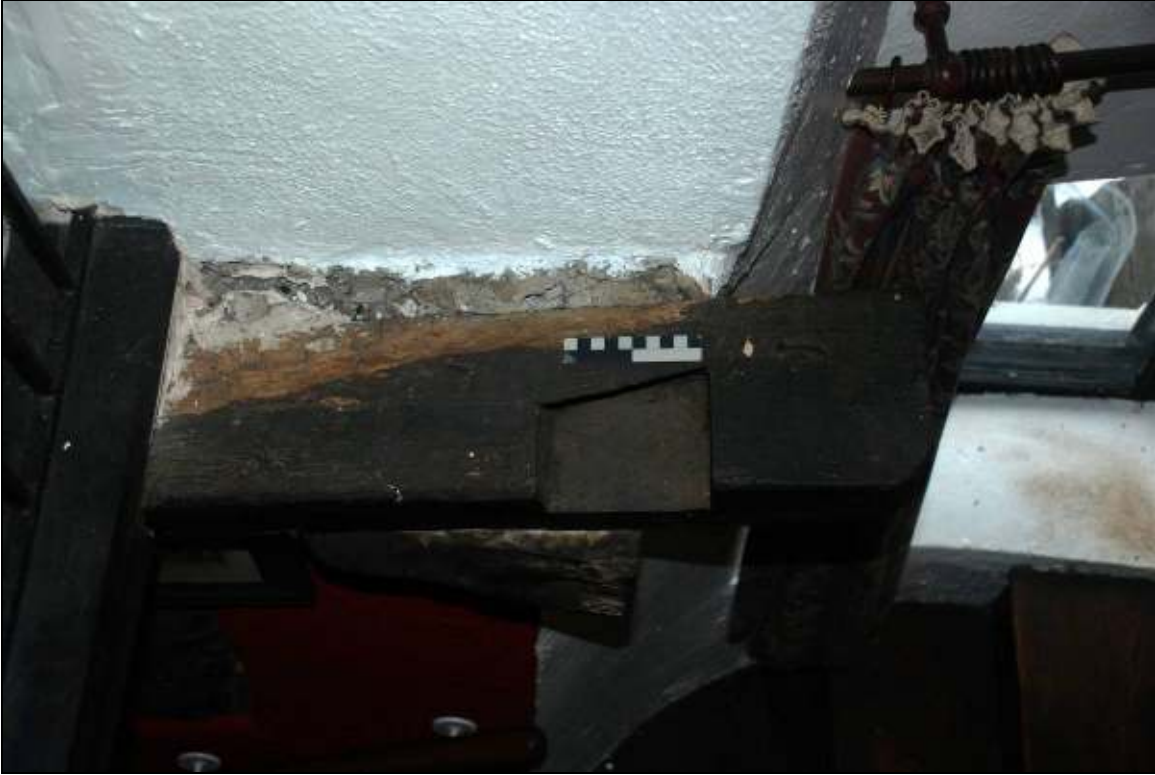
Plate 25: Rail truncated by the insertion of the stair case, looking down

The current staircase is in the northern corner of the north east ground floor room. This is clearly a modern structure, cutting the rail supporting the floor joists on the front wall (Plate 25), but it partly occupies a marked curved recess in the front wall of the property which may have held an earlier staircase (Plate 26).

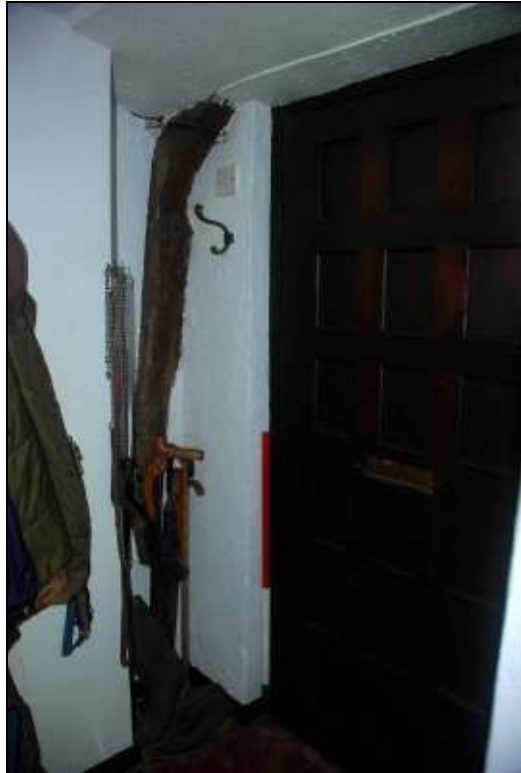
Plate 27: Re-sited door timber, looking west

Within the re-built section of the house, adjacent to the front door is a curved timber (Figure 5.4, Plate 27) which is assumed to be part of the original door structure and has been returned to its original position (Parkinson 1992). It is very worn, but appears to be shaped at its top, possibly suggesting a curved or pointed door head.
