# SKOMER ISLAND WARDEN'S HOUSE, PEMBROKESHIRE

ARCHAEOLOGICAL WATCHING BRIEF  
DECEMBER 2005

RHIF YR ADRODDIAD / REPORT NO. 2005/137  
RHIF Y PROSIECT / PROJECT RECORD NO. 55695

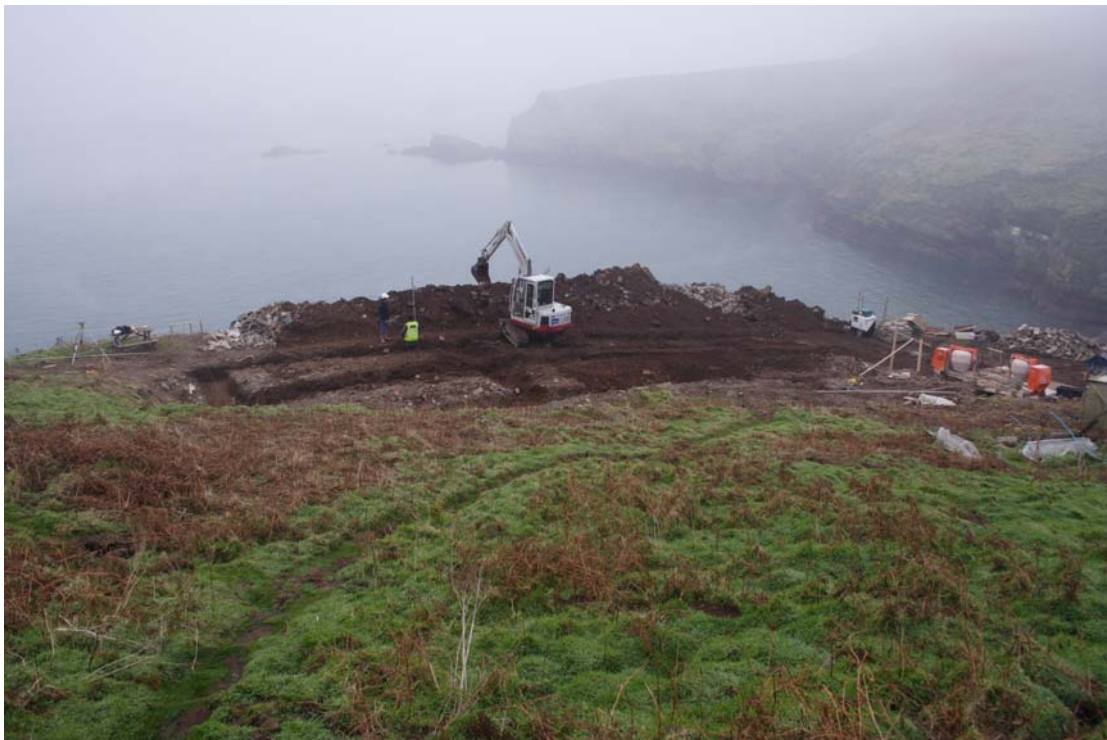
*Front cover: New Warden's House foundation trenches. View east*

A mini tracked digger using a toothed bucket undertook all excavation. Footing trenches were c. 0.8m. Depths of trenches were from around 0.5m deep at the northwest end, to nearly 1m deep at the southeast. The footing trenches consisted of a rectangular trench for the exterior walls and an internal trench running along the middle of the length of the building (photo front cover). The footing imprint was 25m by 8m.

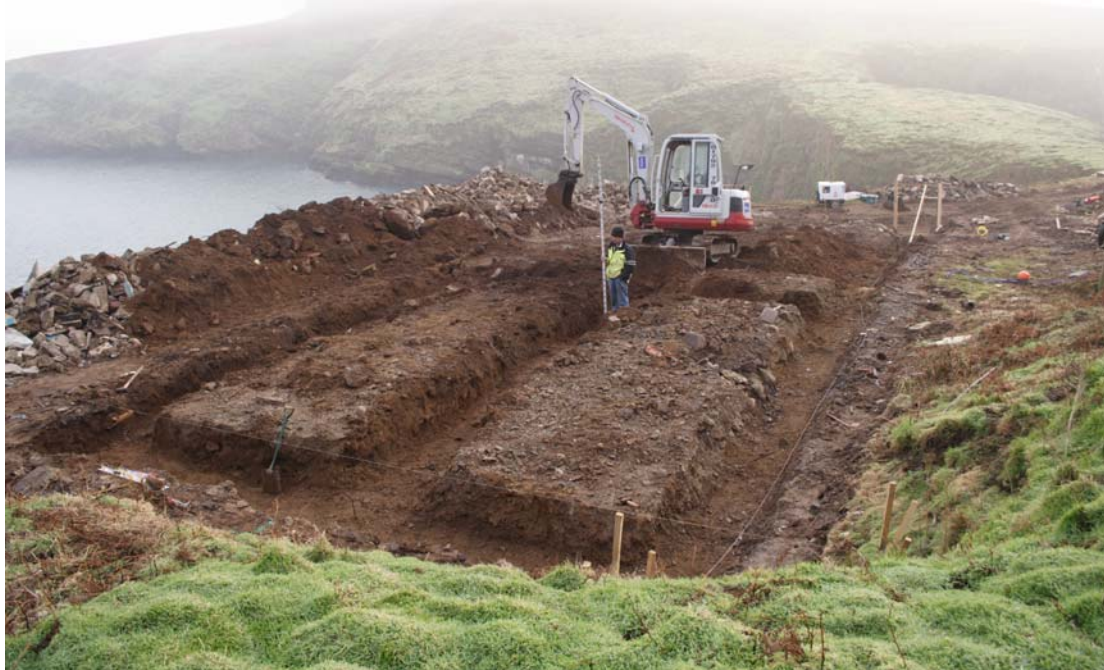
**Photo 1:** Trenches excavated previously. View east

The earlier building had been demolished and its concrete floor taken up. Also the rear and northwestern parts of the footing trenches for the new structure had been excavated and left open (photo 1). It had been intended that all of the footing trenches would have been subject to a watching brief. However, due to delays the building programme was behind schedule and the ferry would not be returning on the day in question. Therefore after consultation it was decided that the footing trenches would be left open for a later visit when the full extent of the groundworks would be undertaken.

As the previous building had been terraced into the hillside any archaeological features in the rear and northwest sides of the building plot would have been destroyed. Also cutting across the platform towards the northwest end was a pipe trench. The footing trench for the front of the new building encountered a considerable amount of concrete and footings along its outer edge. The bases of these structures were removed from within the trench. All of the trenches were excavated down to a red subsoil (shaly stone mixed with varying amounts of sand and clay/silt). Above this was a light brown silty sandy loam, where it had not been dug away by the terracing or suffered from modern disturbance. This was probably the remains of the former topsoil, which was buried below the concrete raft or floor of the earlier building. Within this topsoil there were lenses of darker soil, possibly buried turf layers (photo 2), but also in other places silted in animal burrows. There were also considerable bracken root disturbances in places.
