REPORT OF AIRCRAFT ACCIDENT

ACCIDENT No. 13-5-5-504
9

(1) Place RAF Station, Llanbedr (2) Date May 5, 1943 (3) Time 1330
AIRCRAFT: (4) Type and model Lysander III A (5) A. F. No. V-9512 (6) Station Llanbedr, North Wales
Organization: (7) 8 A.F. & 8 F.C. (8) 6th F. W. (9) 2025th Gunnery Flight (Prov)
(Command and Air Force) (Group) (Squadron)

(56) Nature of accident Ground loop on landing.

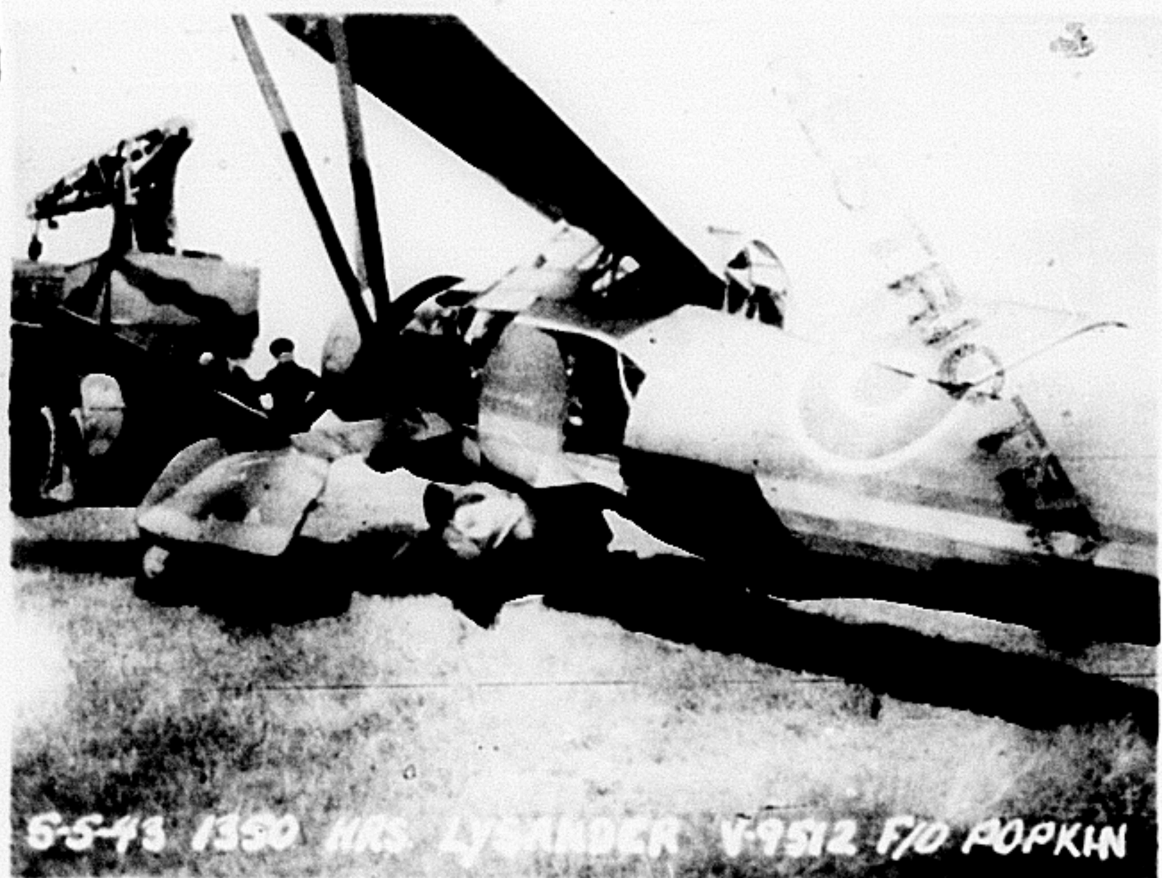
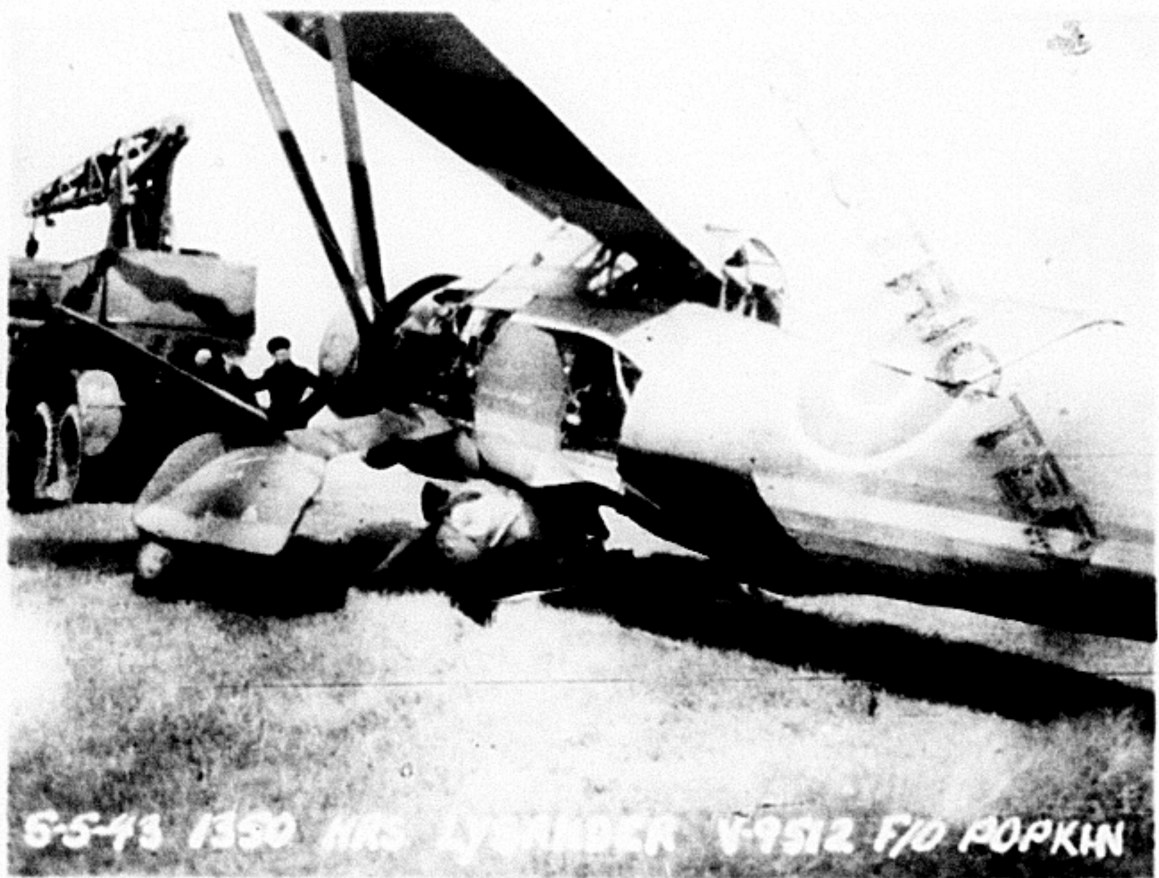
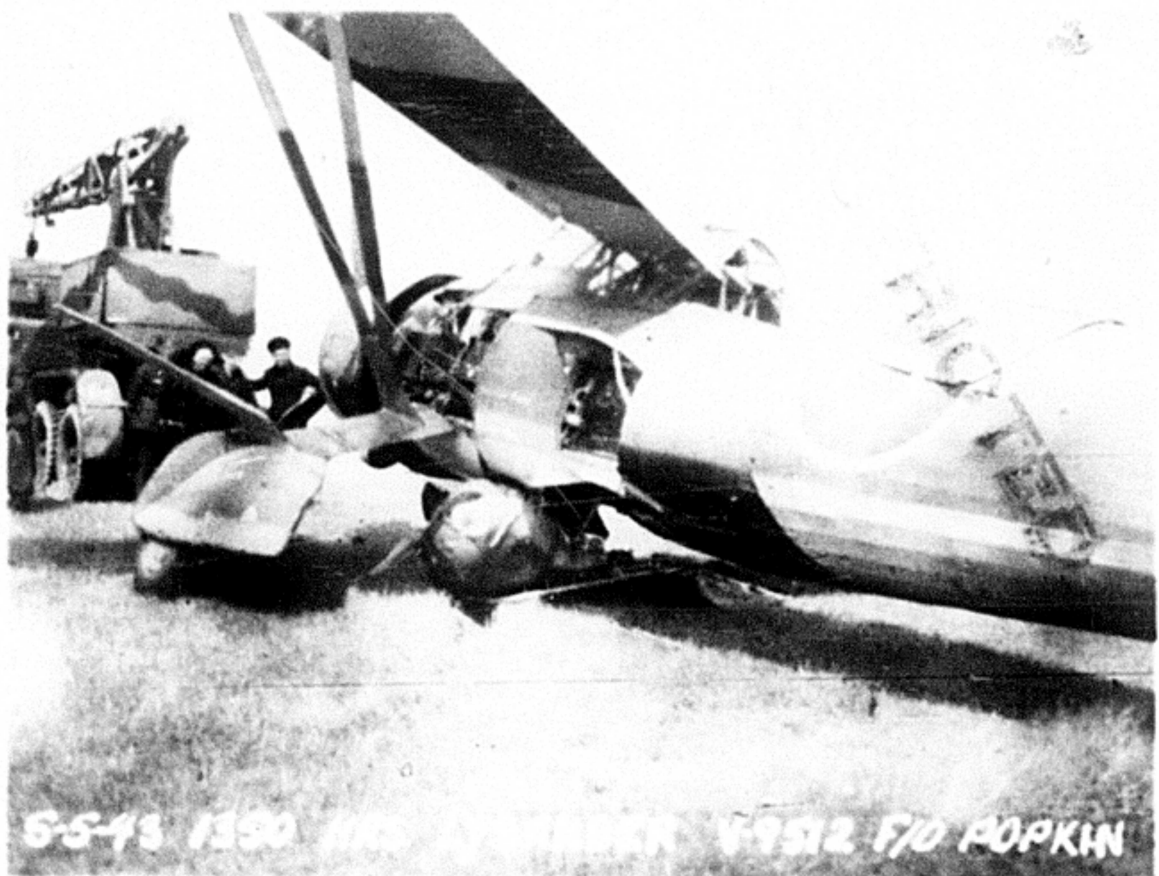
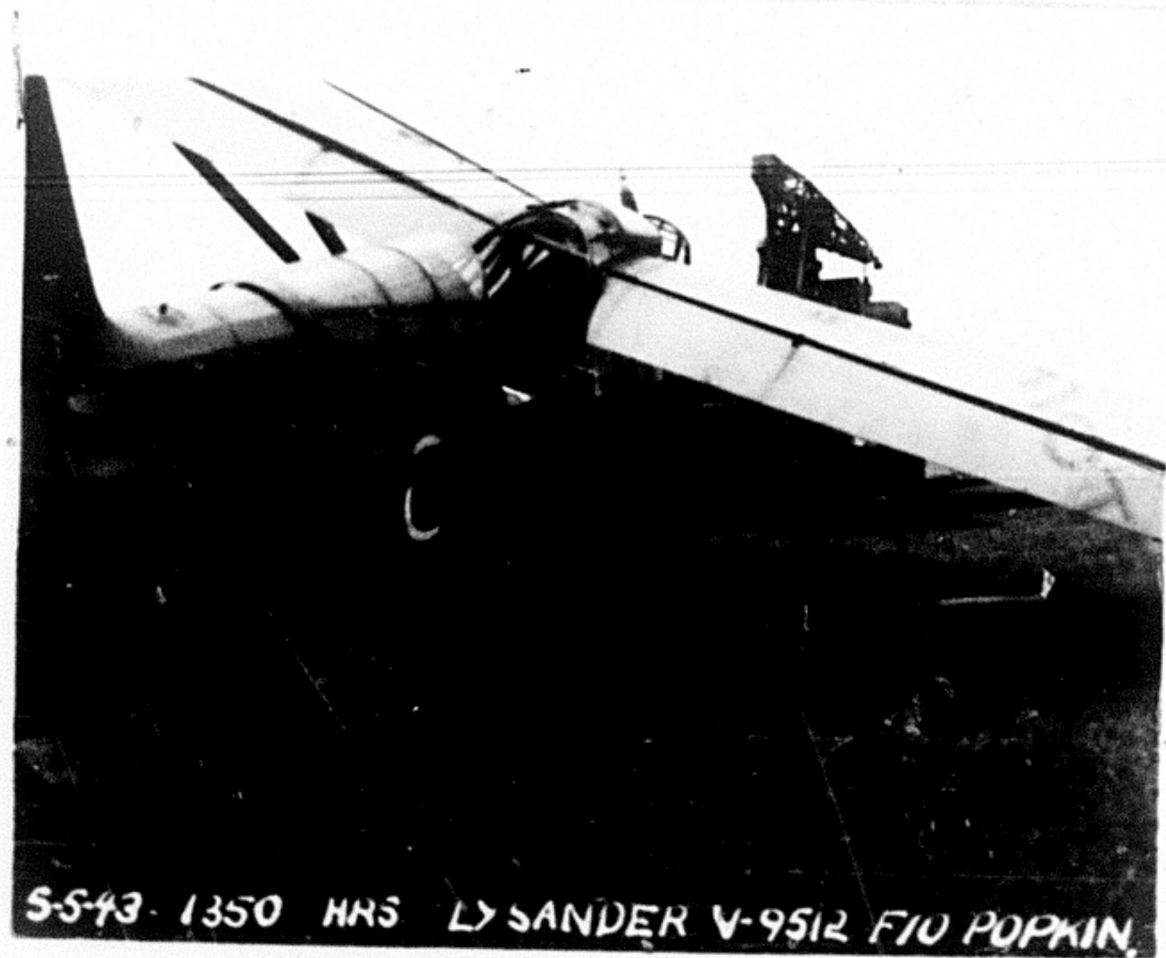
DAMAGE	(49) LIST OF DAMAGED PARTS
(46) Aircraft <u>W 4</u>	Starboard wing, landing gear, tail plane, fuselage belly.
(47) Engine(s) <u>O 4</u>	To be shock load tested.
(48) Propeller(s) <u>M 4</u>	One blade bent.

(57) Cause of accident Strong and gusty cross wind caused aircraft to swing violently upon landing. Tire blew and aircraft ground looped.
