CPAT Report No. 1488

Offa's and Wat's Dykes in Wrexham

Monument Condition Survey

Client name: Cadw
 CPAT Project No: 2102
 Project Name: Wrexham Dykes
 County/LPA: Wrexham
 CPAT Report No: 1488
 Event PRN: Offa's Dyke - PRN 140167; Wat's Dyke - PRN 140168
 Report status: Final
 Confidential: Yes

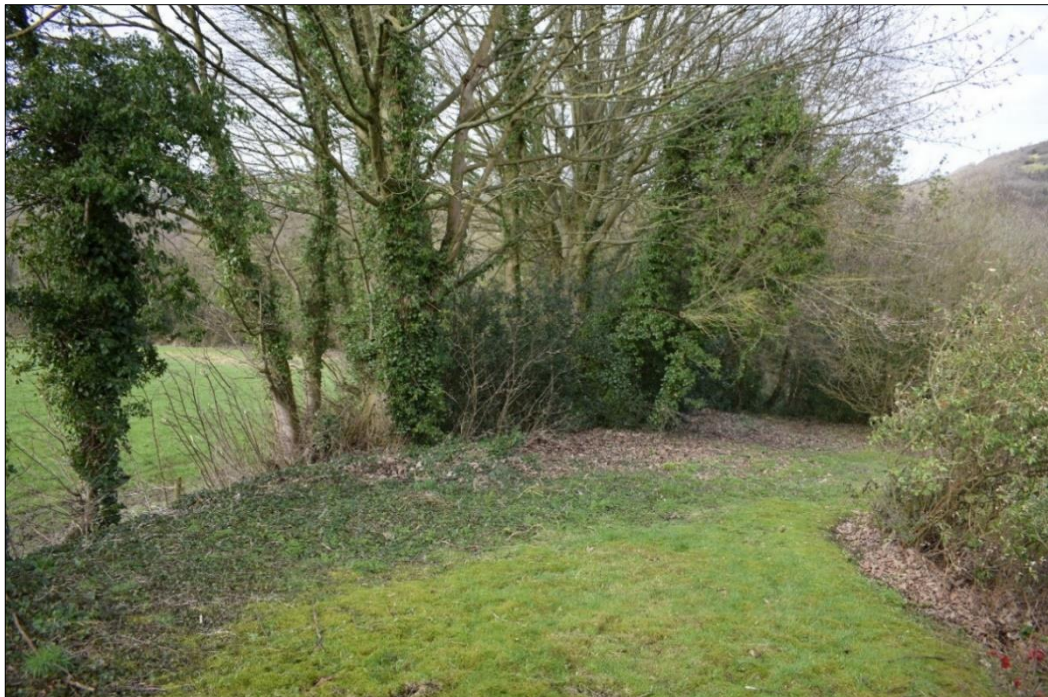
Offa's Dyke Unit 1: View from the south-east of landscaped area of bank CPAT 4315-0006

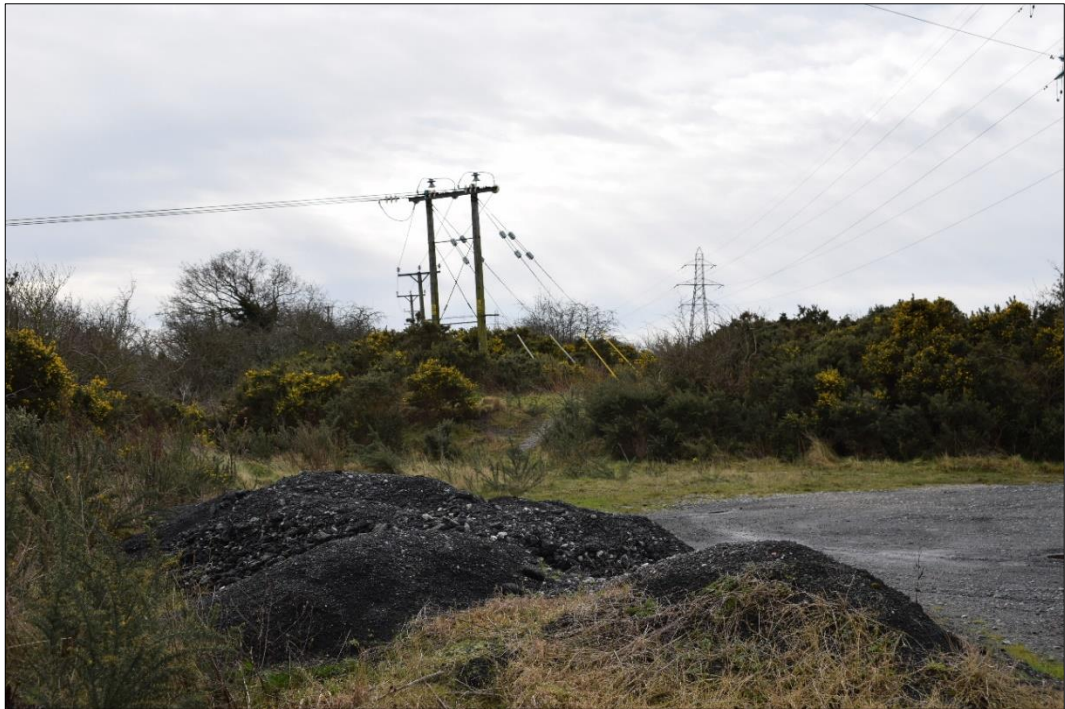
- 3.6. The north part of the bank, adjacent to SAM De222, is in a good condition, while to the south both the bank and the ditch are obscured by dumped material.

Offa's Dyke Unit 2: View from the north of the spoil and scrub (Issue 1). CPAT 4315-0002

- 3.10. The current scheduling does not include all of the upstanding earthwork. Prevent the dumping of any further material and control the existing scrub growth. An evaluation would be required should proposals arise to expand the existing housing estate.

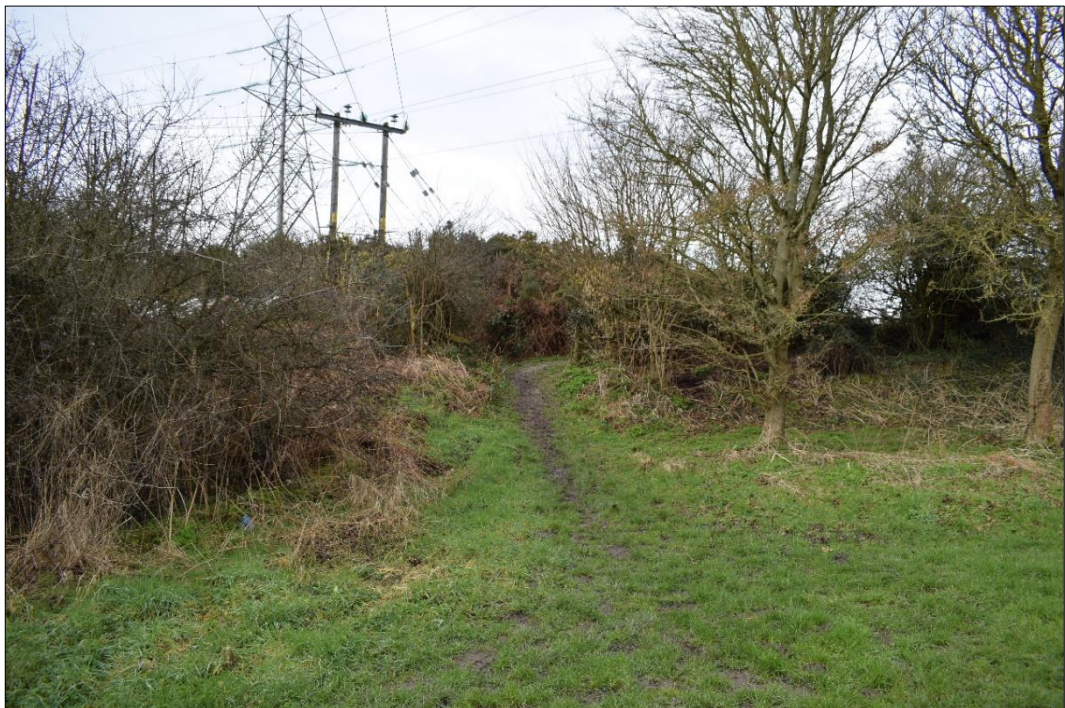
Offa's Dyke Unit 2: View from the east of the path (Issue 2) crossing the dyke. CPAT 4315-0001

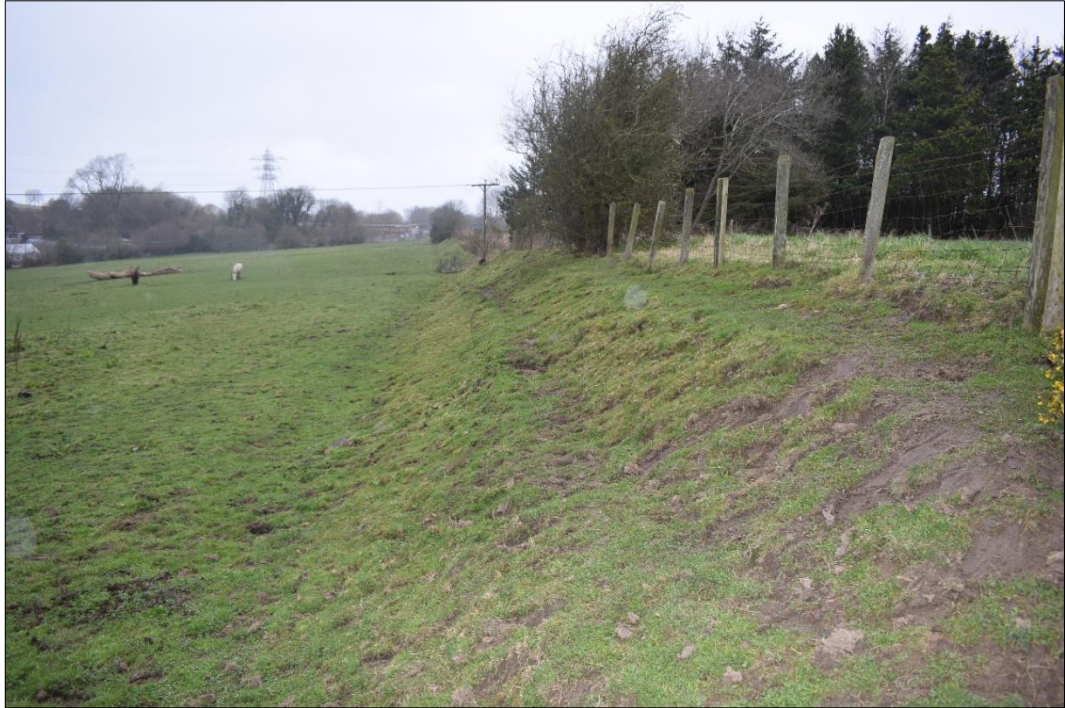
Offa's Dyke Unit 3: View to the north showing the pronounced scarp with minor stock erosion (Issue 1). CPAT 4326-0029

- 3.16. Consideration should be given to restricting the access of horses to the scarp in the northern field and introducing a 'no plough' zone to either side of the fence which follows the line of the bank.

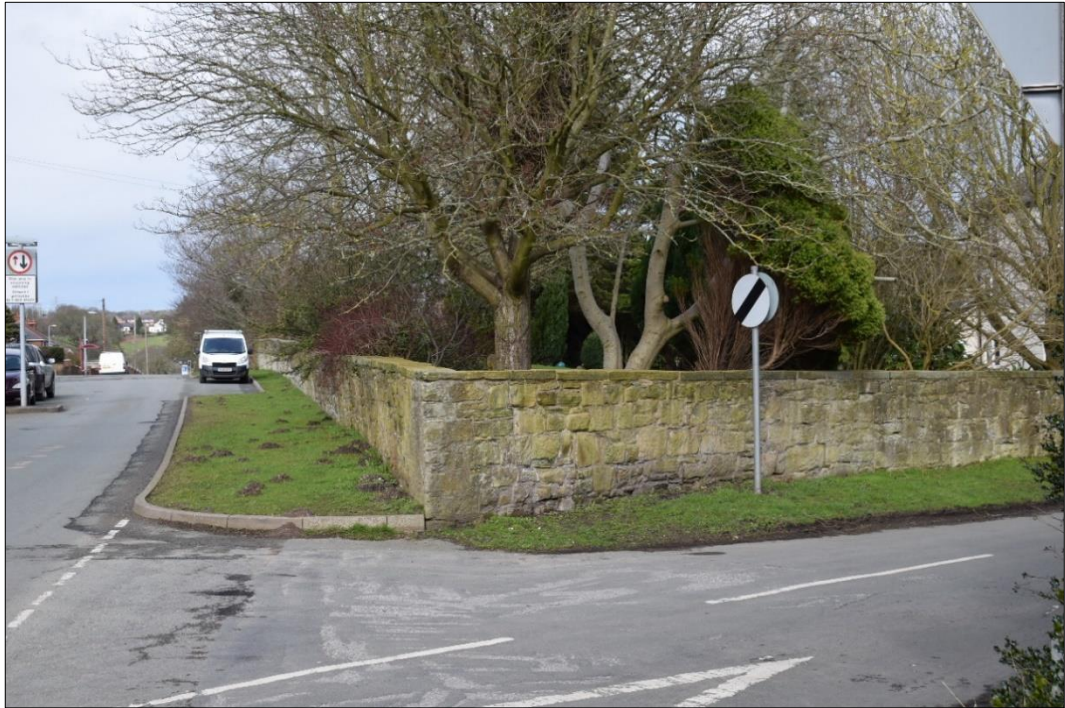
- 3.18. The north part is in reasonable condition, although denuded and covered in trees and scrub. The south part has been heavily modified by landscaping of the garden and the construction of a wall. The line of the ditch is now occupied by the adjoining public road.

Offa's Dyke Unit 4: View from the south showing the wall surrounding the garden.
CPAT 4315-0007

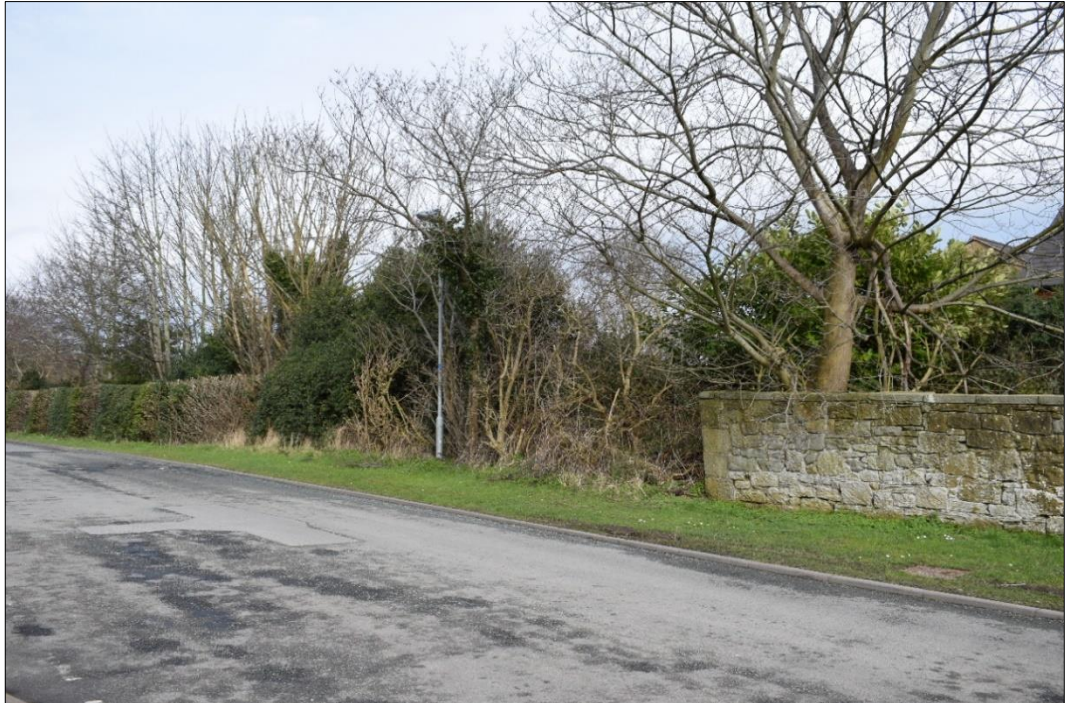
Offa's Dyke Unit 4: View from the south-west of the scrub (Issue 1) covering the
north part of the bank. CPAT 4315-0008

- 3.20. The northern part of the bank is a continuation of that scheduled as SAM De182, which does not therefore include the whole of the upstanding earthwork. Scrub growth within this area should be cleared and regrowth prevented.

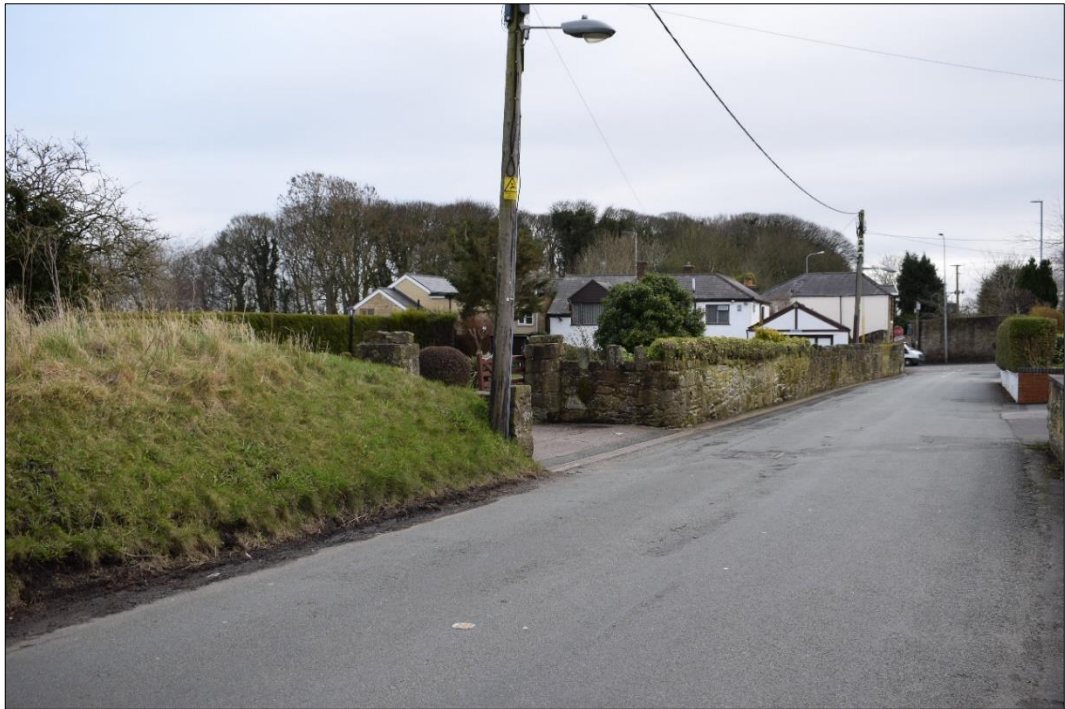
- 3.21. Evidence from LiDAR suggested that a short section of the dyke might survive as an earthwork immediately to the south of SAM De181. However, the area has been levelled within a private garden and no visible remains are present.

Offa's Dyke Unit 5: View from the north-west showing the upstanding section of SAM De181 with the private garden beyond. CPAT 4315-0010

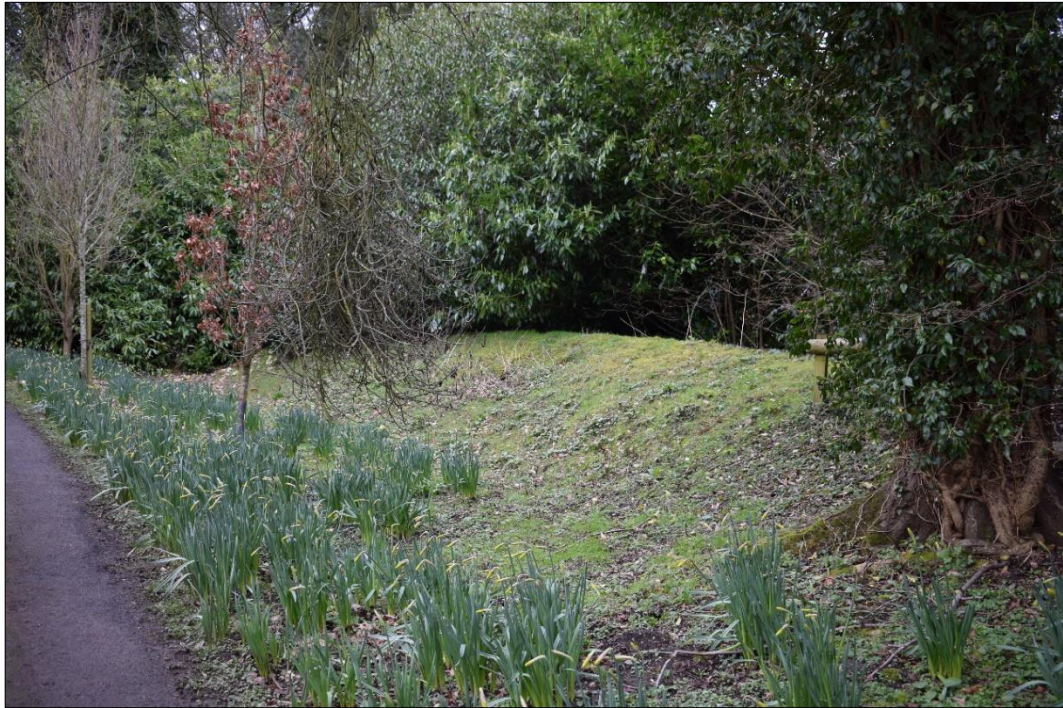
- 3.34. The damage here is historic, when the crematorium was built, and the area is now in good condition, being maintained as part of the garden of contemplation.

Offa's Dyke Unit 8: View from the south-west of what may be a remnant of the bank, with the ditch lying to the left and beneath the crematorium road. CPAT 4315-0011

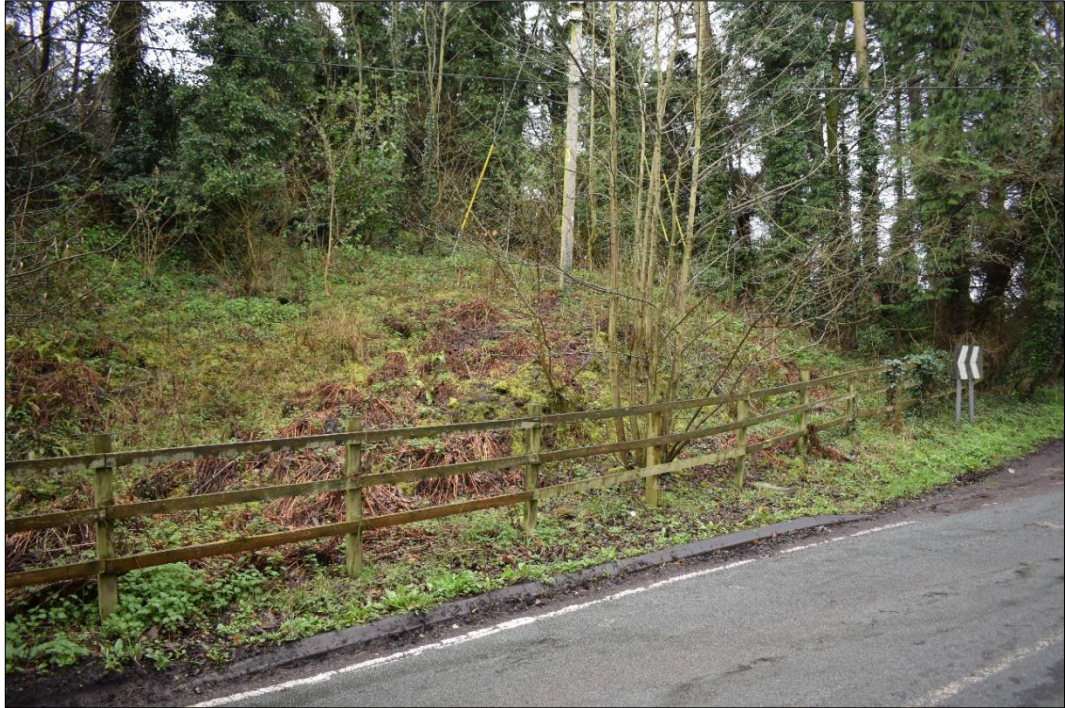
- 3.38. A field visit to the area between SAMs De137 and De174 at Pentre Bychan has shown that there is no surviving evidence for the dyke in a small area of woodland to the south of the B5426, which occupies the south side of a stream valley, having been terraced into the slope.

Offa's Dyke Unit 9: lost section of dyke alongside road. CPAT 4326-0032

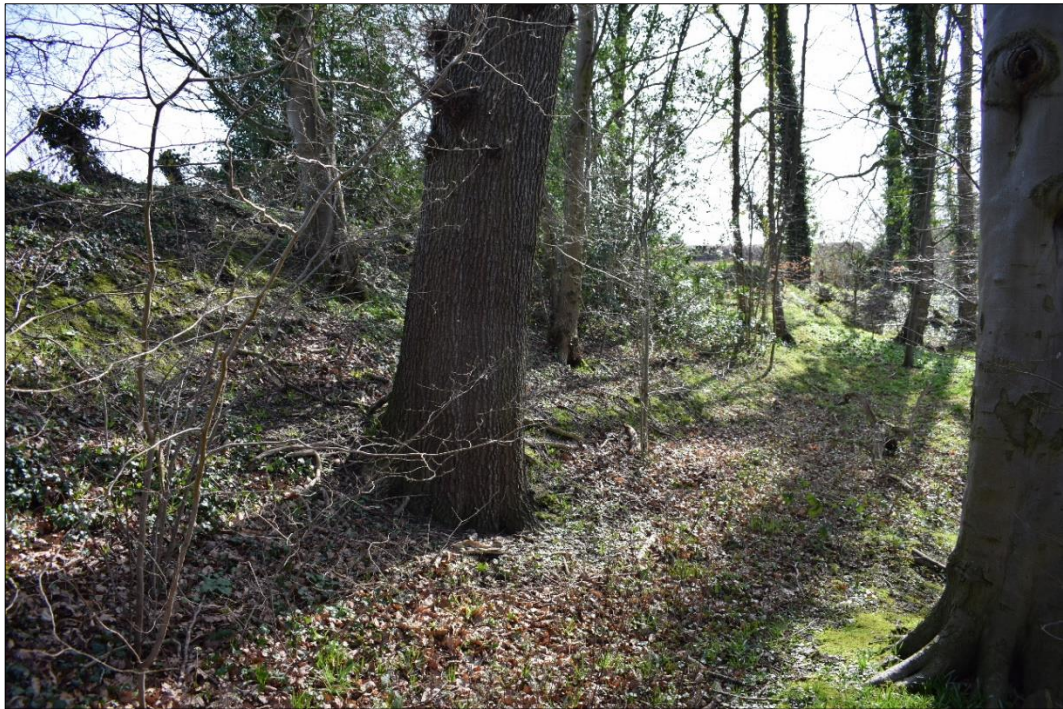
- 3.42. Overall the section is in a good condition, although damaged in the past by the creation of the road and some landscaping near the farm buildings. The area is now woodland, with trees and small shrubs and minor evidence for burrowing animals. Some spoil from the farm has been dumped on the east side of the bank, obscuring part of the earthwork.

Offa's Dyke Unit 10: View from the north-west showing the trees (Issue 2) on the bank in within the area of the ditch, together with the dumped material (Issue 3), visible top left. CPAT 4315-0012

- 3.46. The upstanding earthwork is not currently afforded statutory protection. The dyke here is in generally good condition, but should not be encroached upon further by dumped material.

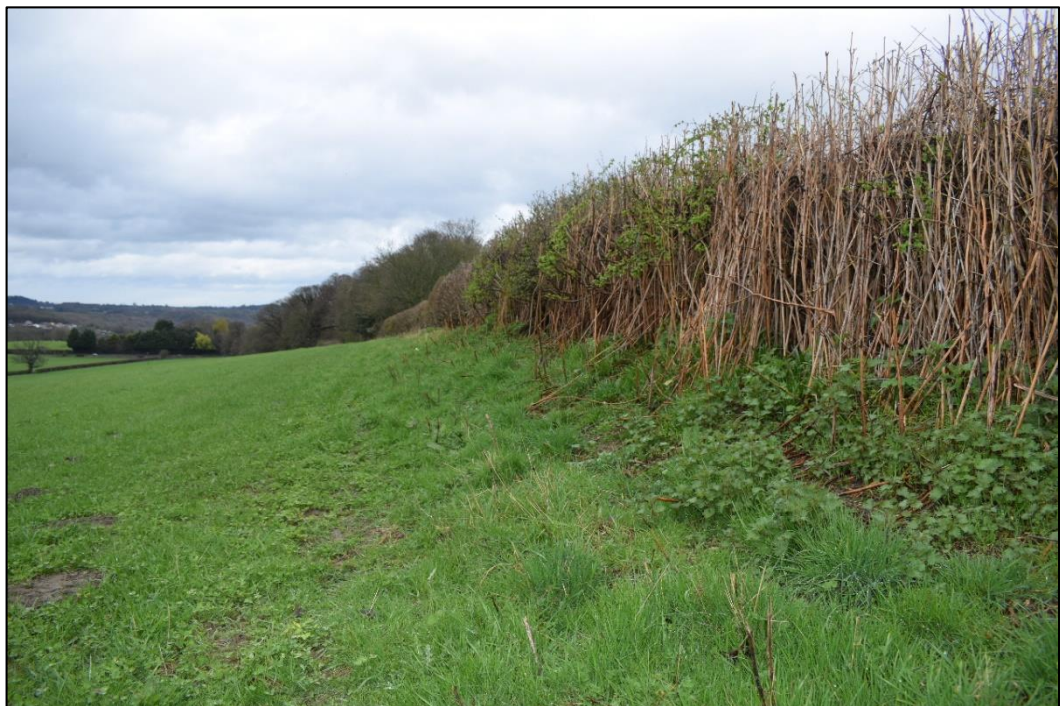
Offa's Dyke Unit 11: View from the south-west along the line of the dyke. CPAT 4326-0035

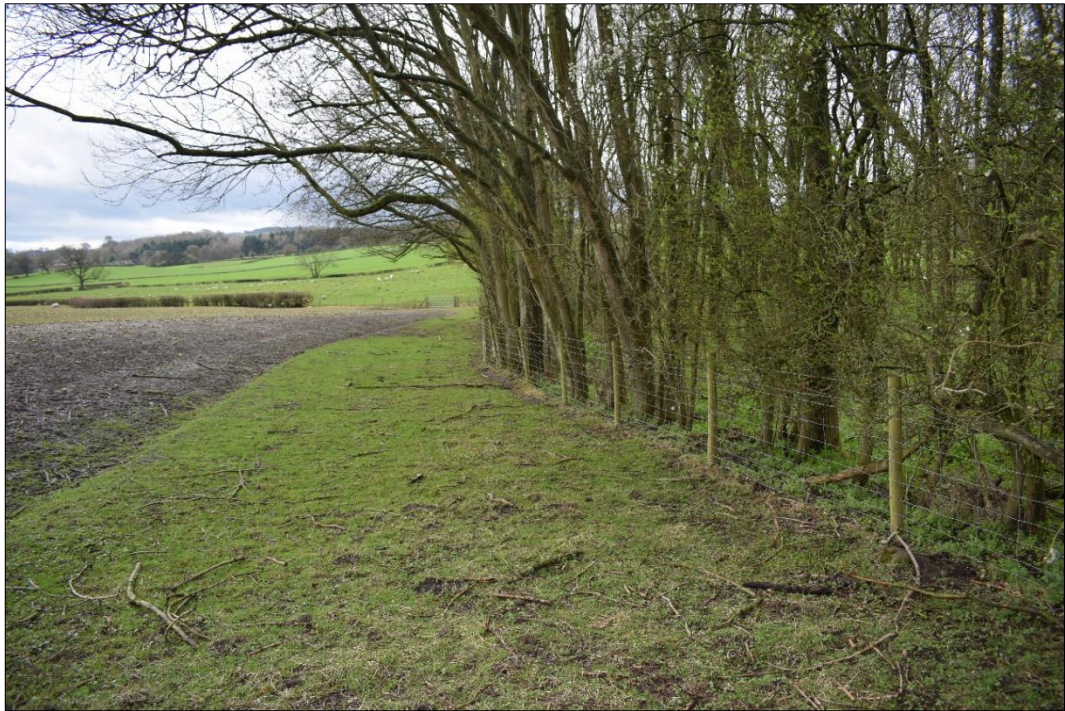
Offa's Dyke Unit 12: View from the north-east showing the levelled bank to the left with the fenceline running along the base of the ditch. CPAT 4326-0039

- 3.59. Address the agricultural regime to prevent further plough damage.

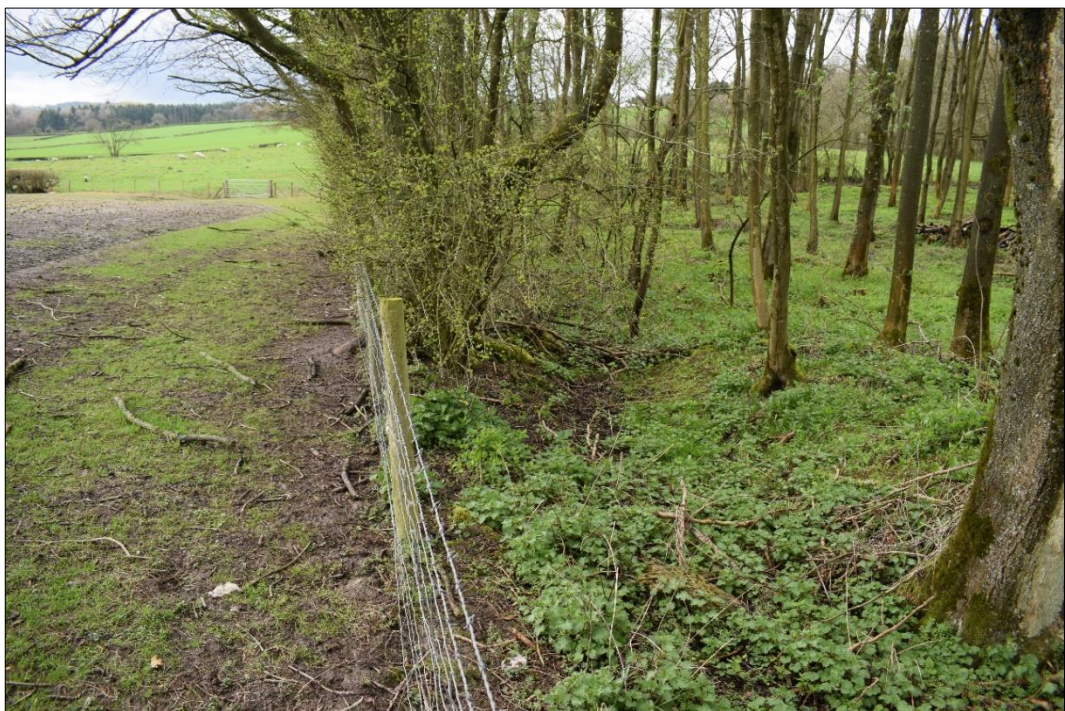
Offa's Dyke Unit 12: View from the north-east showing the slight earthwork of the ditch within woodland. CPAT 4326-0040

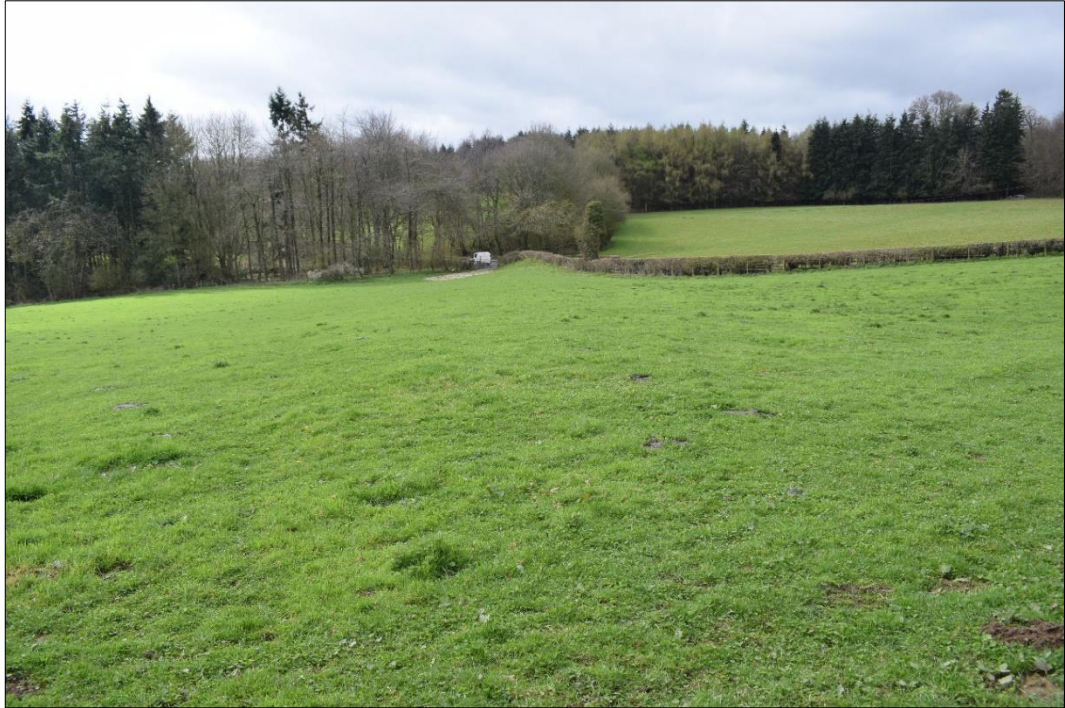
Offa's Dyke Unit 14

The dyke crosses a pasture field and is in good condition with no obvious management issues.

Offa's Dyke Unit 14: View to south-east, showing the low earthwork of the bank.
CPAT 4326-0050

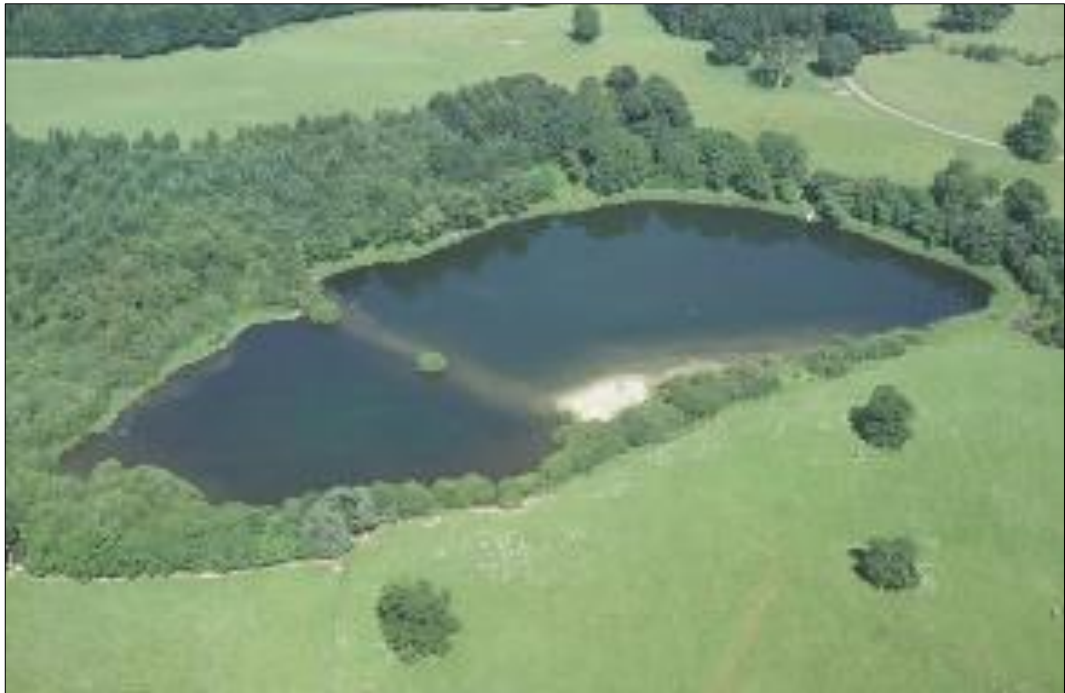
Offa's Dyke Unit 15

- 3.66. The bank here survives well, but is submerged beneath an ornamental lake within Chirk Castle park. There is a short unscheduled section to the south of the lake where there is no visible trace of a bank or ditch, the earthwork reappearing within SAM De198.

Offa's Dyke Unit15: Aerial photograph of the bank visible beneath the surface of the ornamental lake in Chirk Castle park. CPAT 03-c-0532

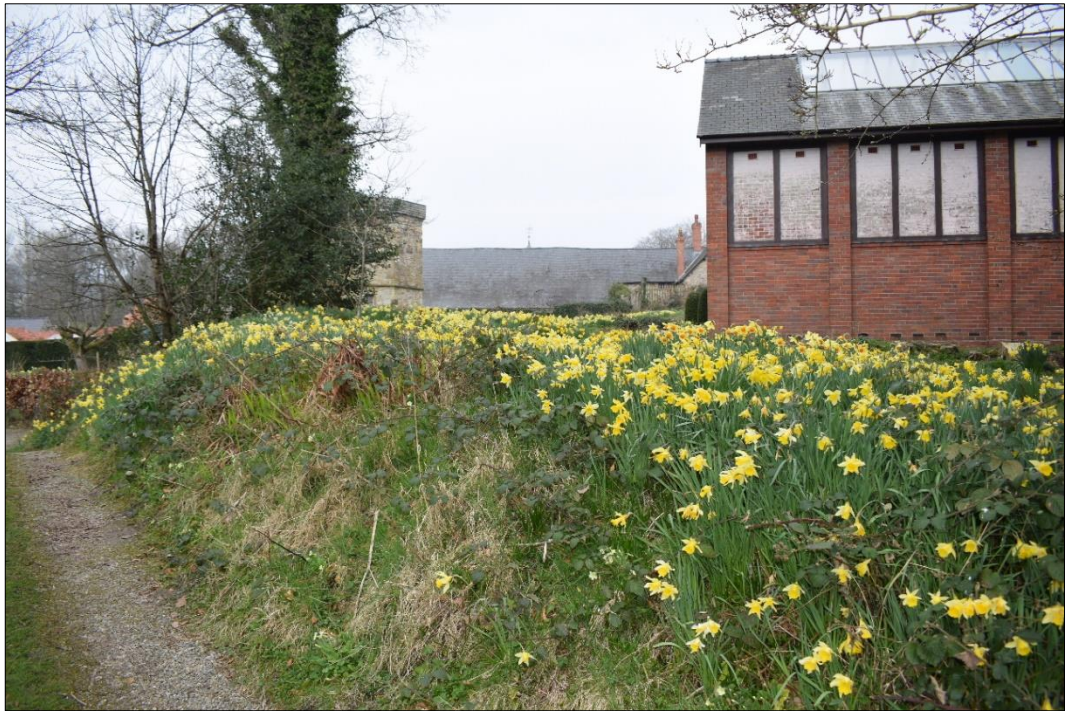
- 3.70. The surviving bank is in good condition, although with some trees and scrub obscuring the monument on the south side of the access road.

Offa's Dyke Unit 16: View from the south showing the upstanding bank at Chirk Castle Home Farm. CPAT 4326-0015

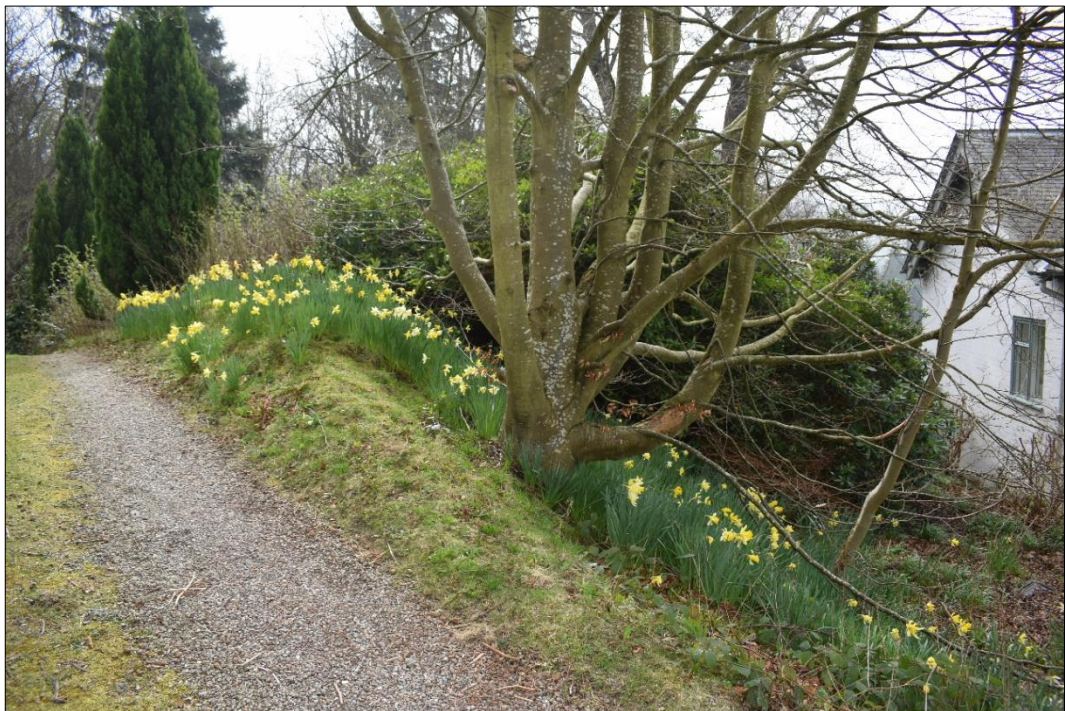
Offa's Dyke Unit 16: View from the north showing the trees and scrub (Issue 1) bank at Chirk Castle Home Farm. CPAT 4326-0019

- 3.72. The upstanding bank is a continuation of that scheduled as SAM De134. The southern section, adjacent to the scheduled section, should be cleared of scrub vegetation to improve the visibility of the bank.

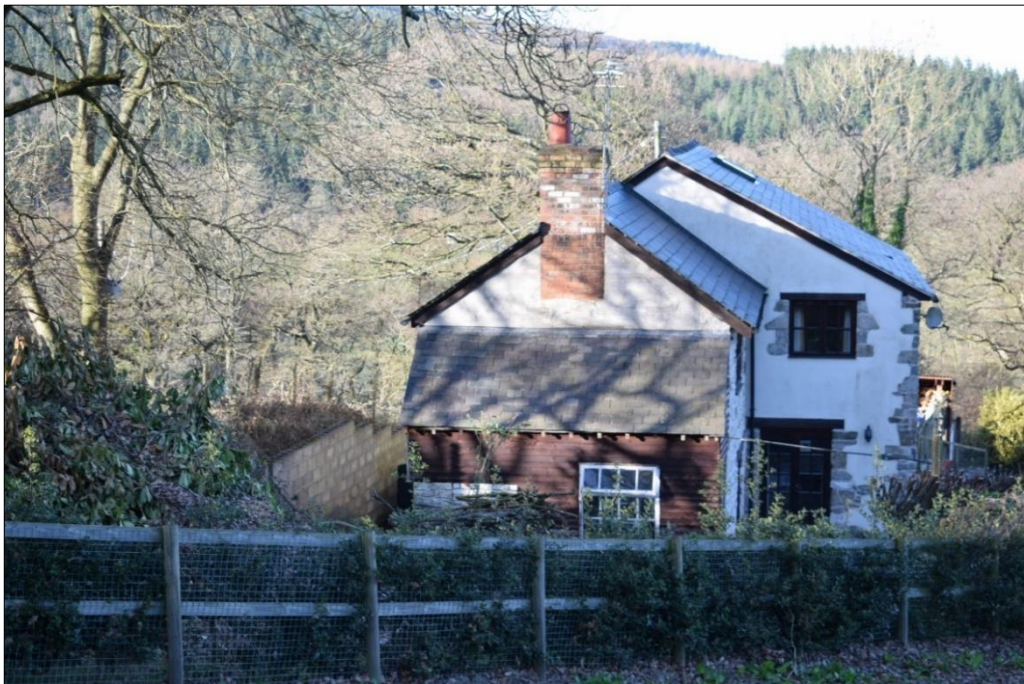
Offa's Dyke Unit 17: View from the south of the concrete block revetment at Croft Cottage (Issue 2). CPAT 4315-0023

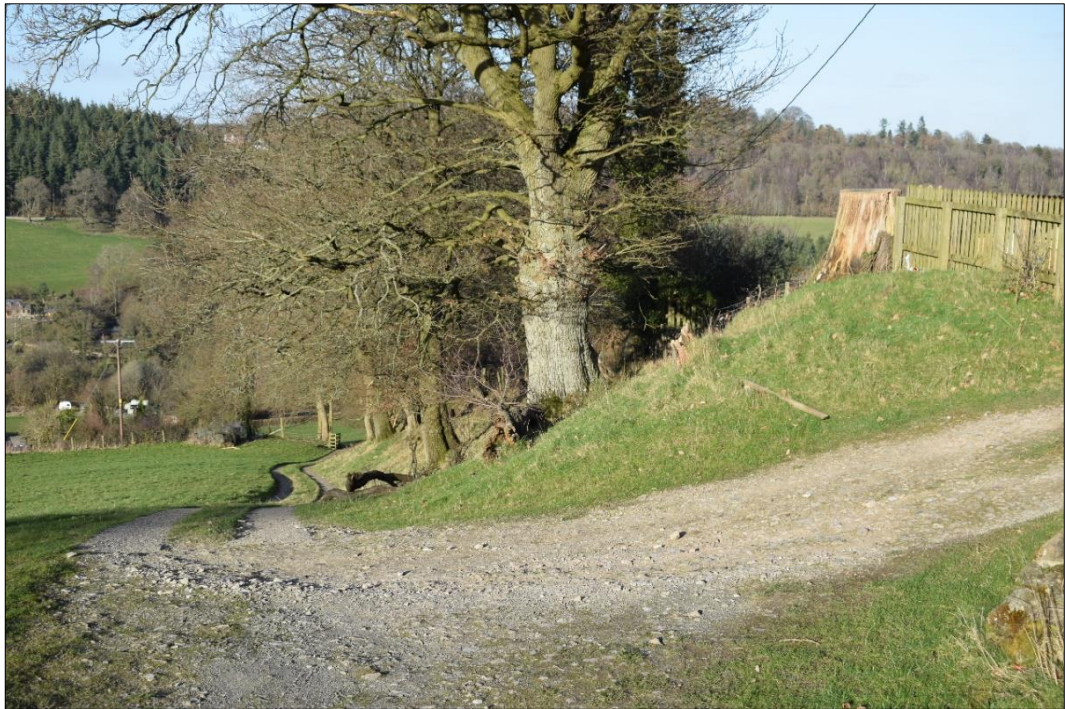
Offa's Dyke Unit 17: View from south-south-west of the vehicle erosion (Issue 3).
CPAT 4315-0019

Action: While there is no active erosion by the tracks there is the potential for further damage if they were altered. Any upgrading/relaying of the tracks should be managed carefully to prevent damage.

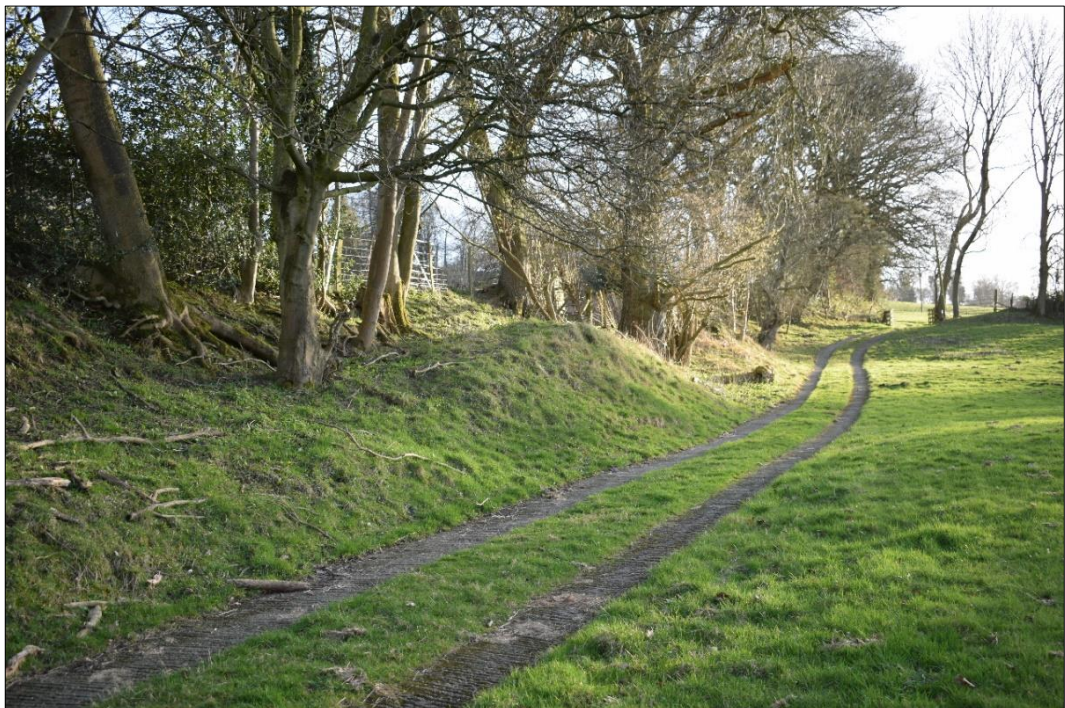
- 3.79. Much of this section of the dyke has trees along the earthwork. Some of these are mature and susceptible to high winds given their location.

Offa's Dyke Unit 17: View from the north of the trees growing on the dyke (Issue 4).
CPAT 4315-0021

Action: Monitor their condition and fell if necessary.

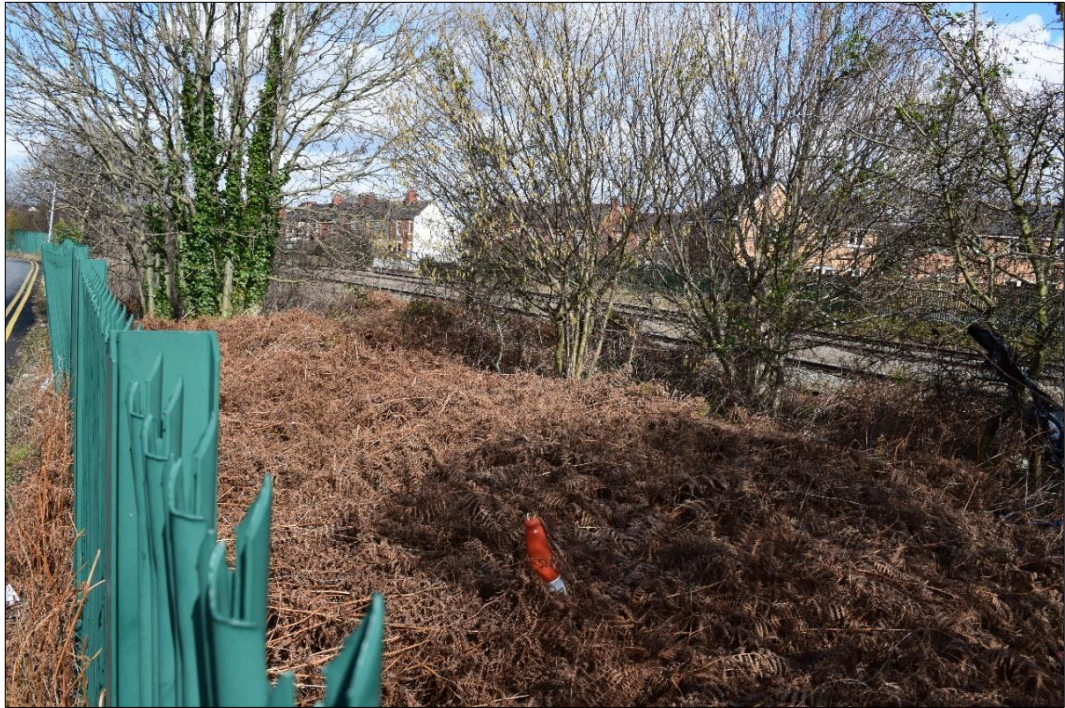
Wat's Dyke Unit 1: View from the south of the bank, covered in bracken (Issue 1).
CPAT 4317-0013

- 4.5. Regardless of where the visible remains are those of the dyke the control of bracken and the removal of rubbish and dumped material would enhance this and the adjacent scheduled section.

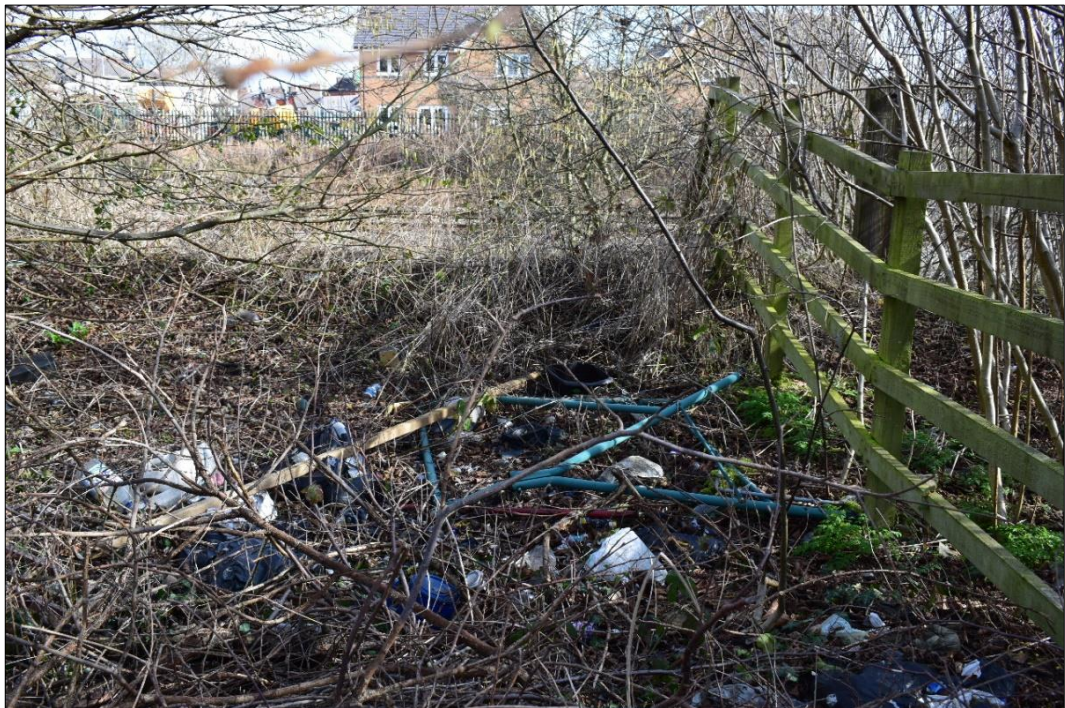
Wat's Dyke Unit 1: View from the west showing dumped material to the west of
the bank (Issue 2). CPAT 4317-0015

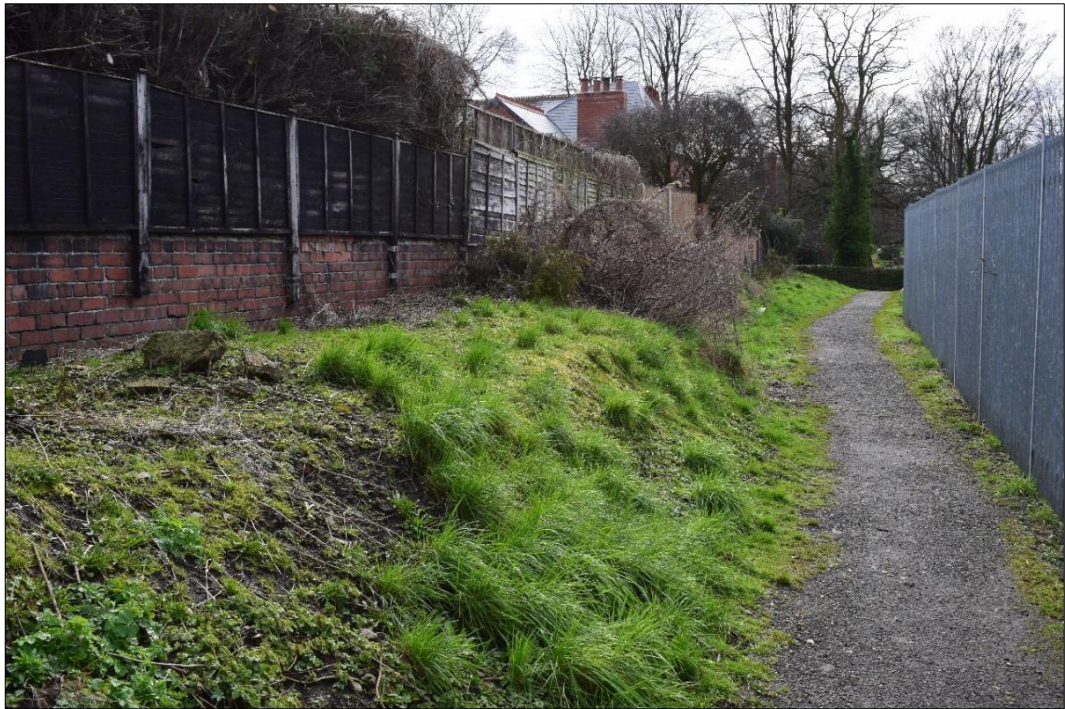
Wat's Dyke Unit 3: View from the north along the line of the dyke. CPAT 4317-0024

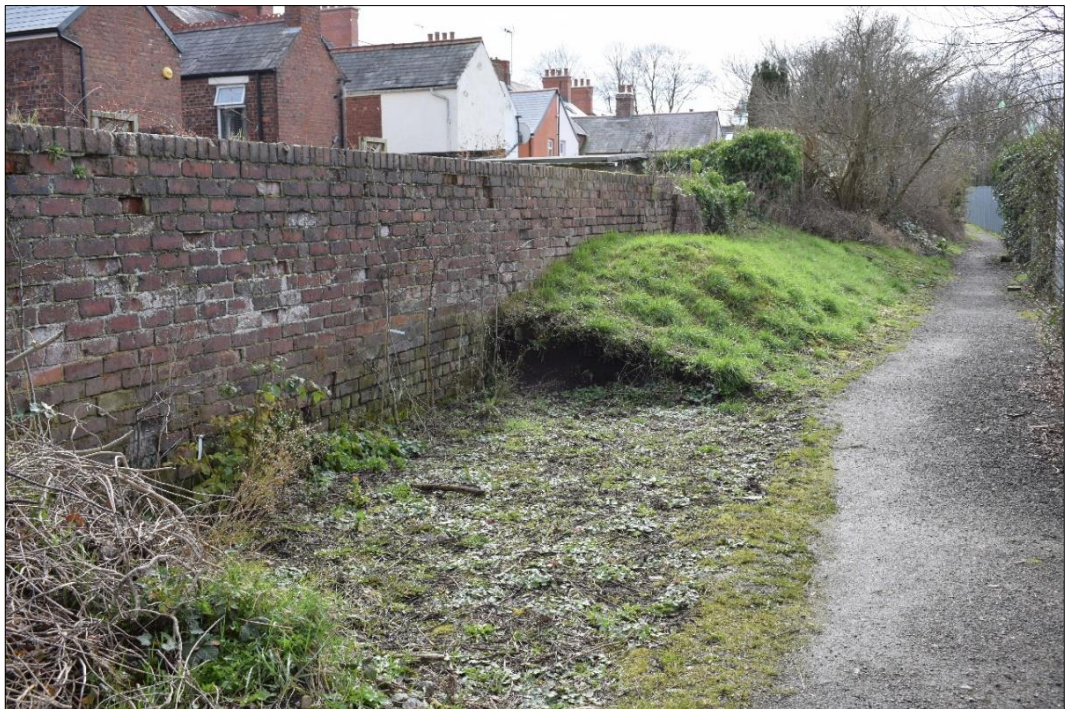
Wat's Dyke Unit 3: View from the north showing section through bank. CPAT 4317-0026

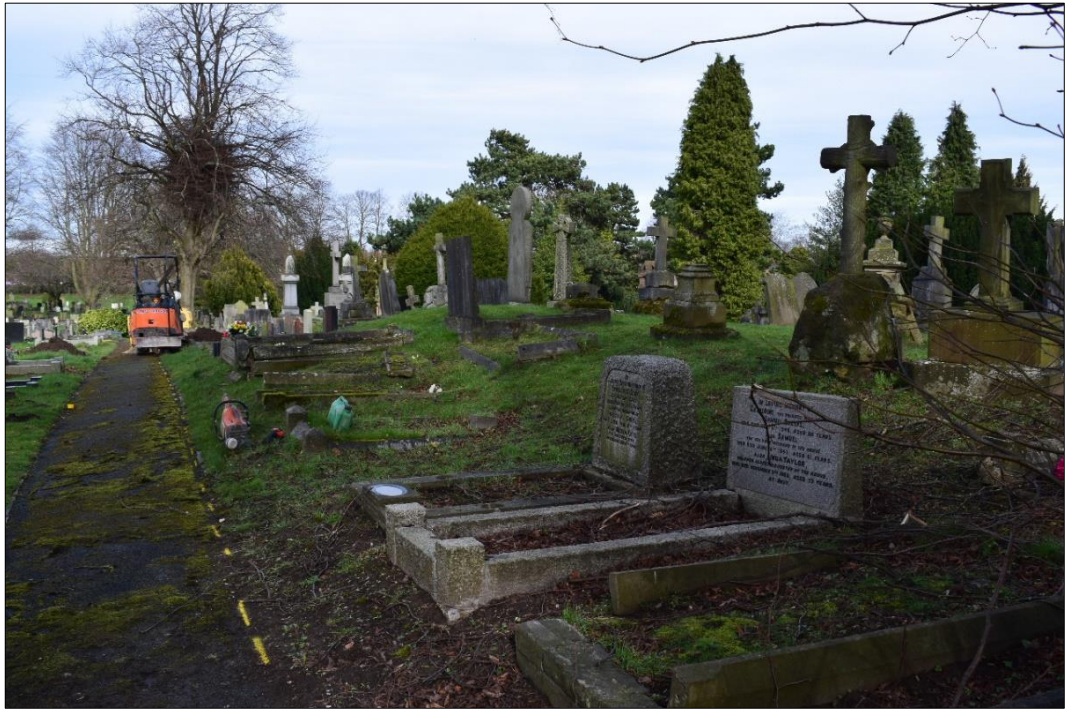
Wat's Dyke Unit 4: View from the south of the southern extent of the dyke in the cemetery. CPAT 4317-0034

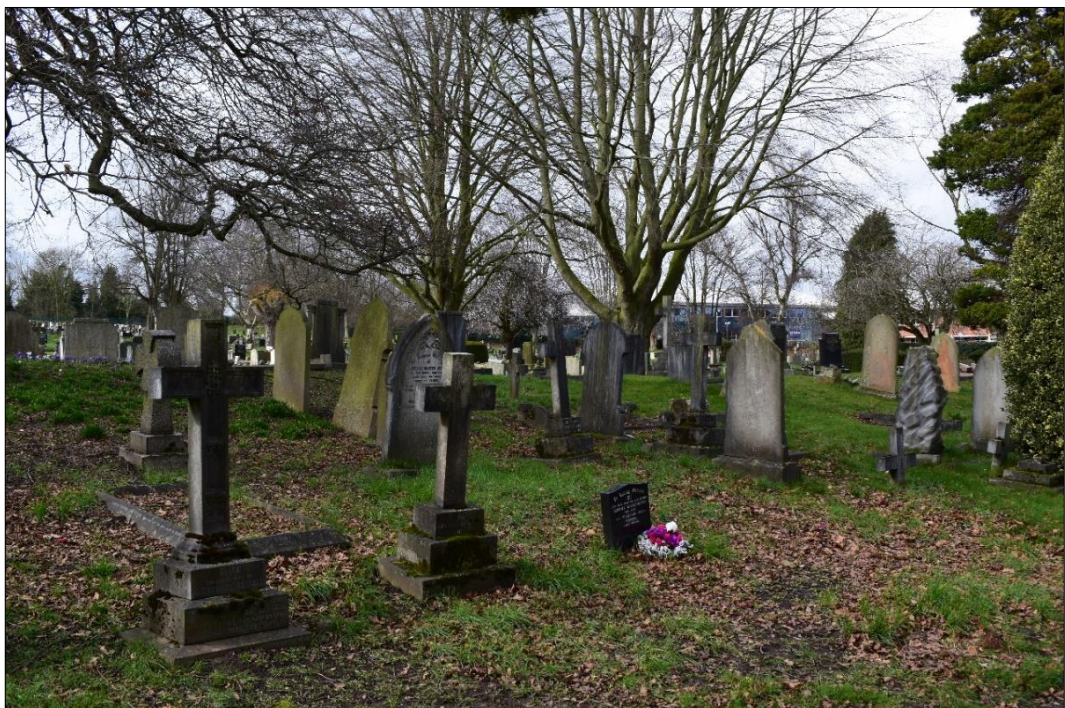
Wat's Dyke Unit 4: View from the east of the dyke within the middle of the cemetery. CPAT 4317-0038

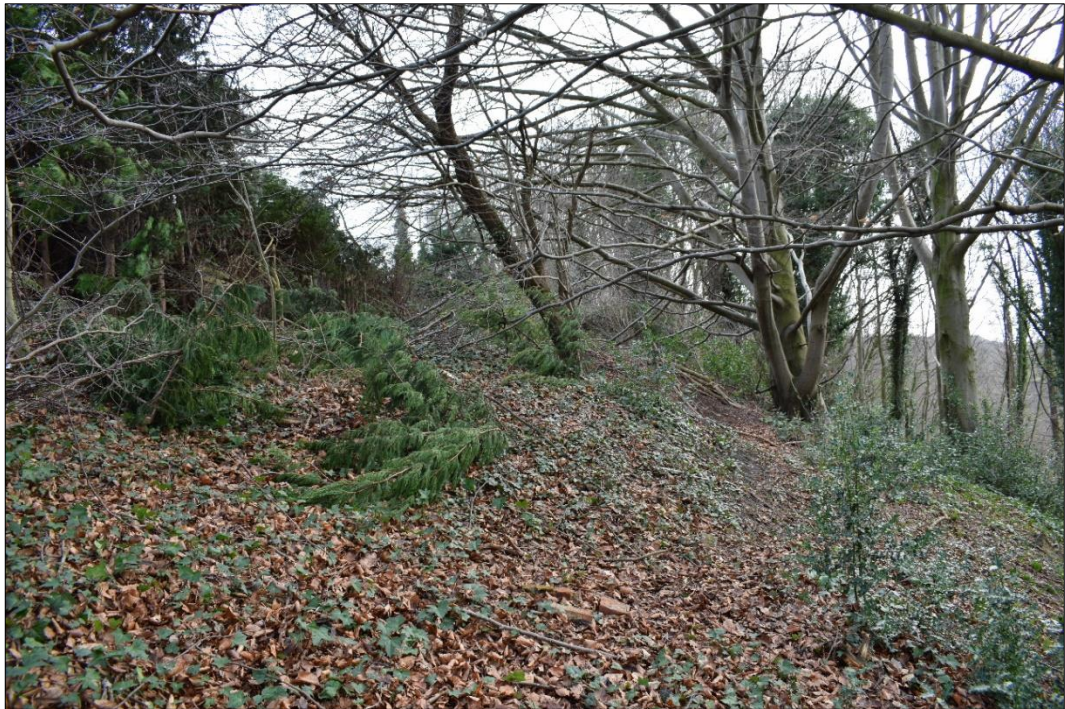
Wat's Dyke Unit 5: View from the north-west looking along the line of the ditch, with the bank top left, showing the scrub vegetation (Issue 1). CPAT 4311-0017

- 4.20. Clear scrub and remove dumped material, preventing further dumping. The condition of this section is in stark contrast with the adjacent scheduled section which has been cleared recently by the National Trust.

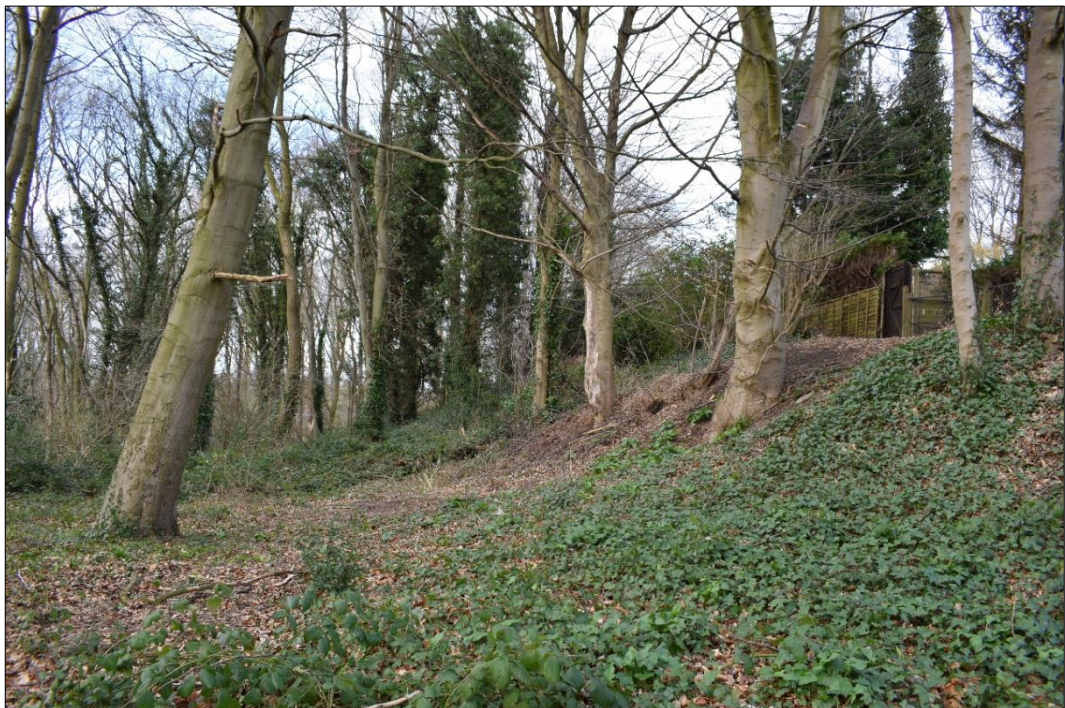
Wat's Dyke Unit 5: View from the scheduled section to the south-east. CPAT 4311-0018
